## FLOOD RISK AND DRAINAGE ASSESSMENT

**Cleator Mill,  
Proposed Residential Development,  
Flood Risk Assessment.**

RO/FRA/RES/19002.1

# Cleator Flood Asset Condition Assessment

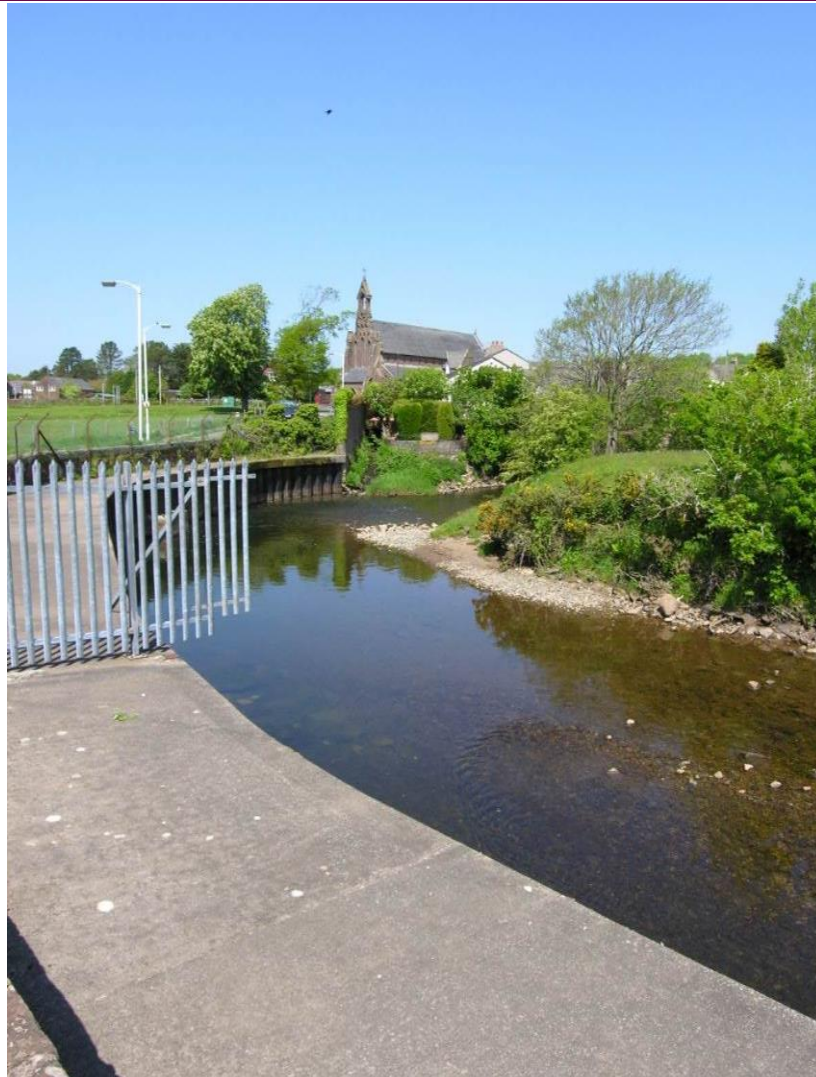
**Photo 1 – Hard flood defences between 1896 & 1726**

The proposed development has engineered hard flood defences to the northeastern extent, downstream of the hard defences, soft earth defences exist continuing north to the extents of the Kangol Factory/premises. These defences afford the site a level of protection to the 1:200-year modelled return period, which is confirmed by the Environment Agency River Ehen model from 2016. The location of the modelled reference points has been cross-referenced against a topographical survey undertaken; this is included in Appendix C; which includes sections showing the flood levels against the existing ground levels. Given the reliance of flood defences RAB Consultants were appointed to update the previous condition survey undertaken, A copy of the report is included in Appendix D.

The survey identifies various works which need undertaken immediately and within 1 year, it is recommended these works are carried out prior to works commencing, the total estimate value is £25,300 for the works as identified in the RAB report (RAB; 2869). It is then recommended that a condition survey be completed every 5 years as part of the management company's duties and the results are shared with the Environment Agency to ensure the flood defences are maintained and any further defects are rectified as part of the Environment Agencies' powers, should the Environment Agency deem that improvement/maintenance works necessary. At the most vulnerable point, on the northern boundary with the River Ehen hard defences are located on the right boundary located between modelled node points 1896 and 1726, as can be seen in Figure 3. The Environment Agency data shows these hard defences are at a 1:200-year standard. Based upon their model and information supplied as part of Product 4. These conditions are generally identified as being condition grade 2, which is a Good state of repair, except for some minor vegetation which is noted as condition grade 3. The vegetation should be dealt with and made good to ensure this

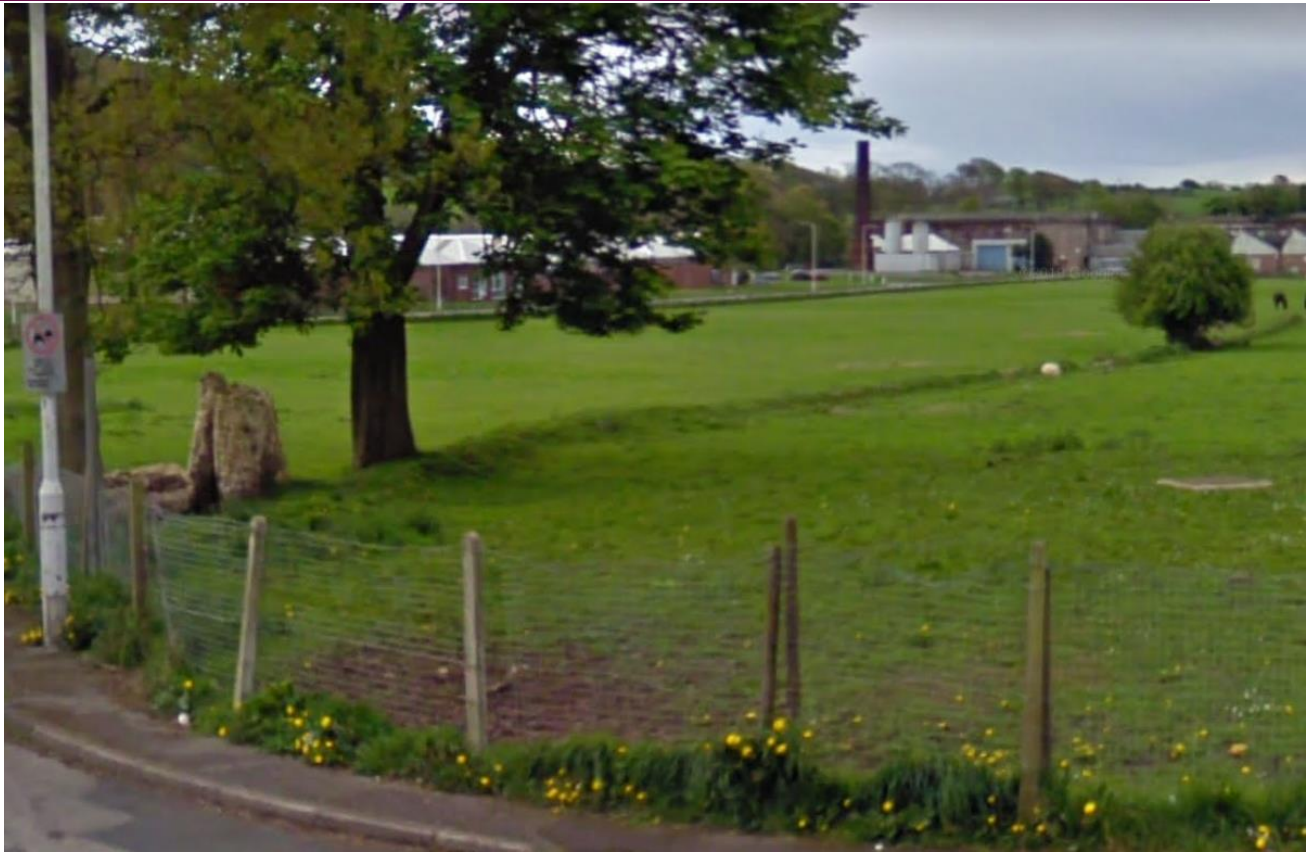
The flow route itself is somewhat questionable given the topography given the kerb face along the road is circa 100mm and the route of flows appears to follow a raised mound as can be seen in picture 2 below;

Photo 2 – Raised mound and kerbs along overland flood route

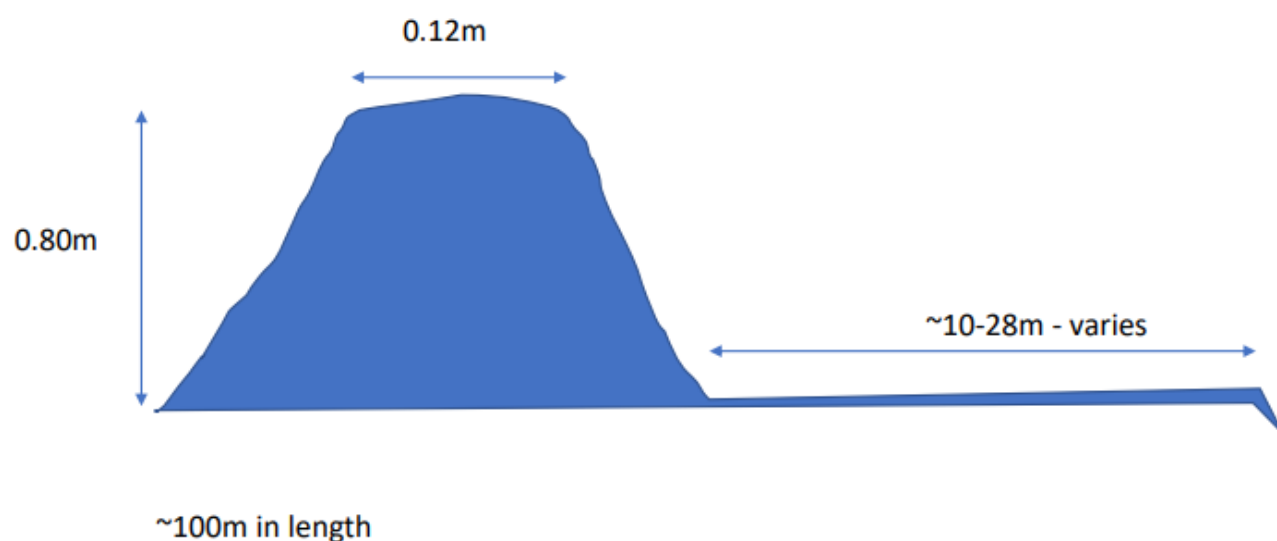
### CL1 – Embankment

Small earth embankment protecting residential properties behind.

Variant weighting used for crest as <4m wide. Drainage pipe running through entire width of embankment, low spots, some animal holes and rutting on crest, landward face and exposed face have some holes and uneven slopes but are well vegetated. Undermining, minor erosion and light foreign objects present on channel side but currently stable.

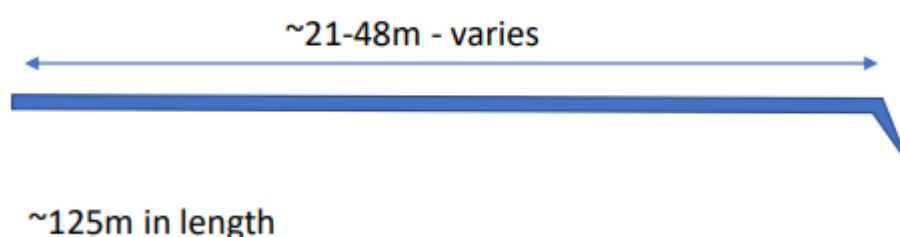
## CL2 – Natural High Ground

Natural high ground located in a grass field in front of residential properties with a width of 21-48m between the channel side and road.

Significant undermining, erosion and presence of light foreign objects on channel side. High ground in good condition.

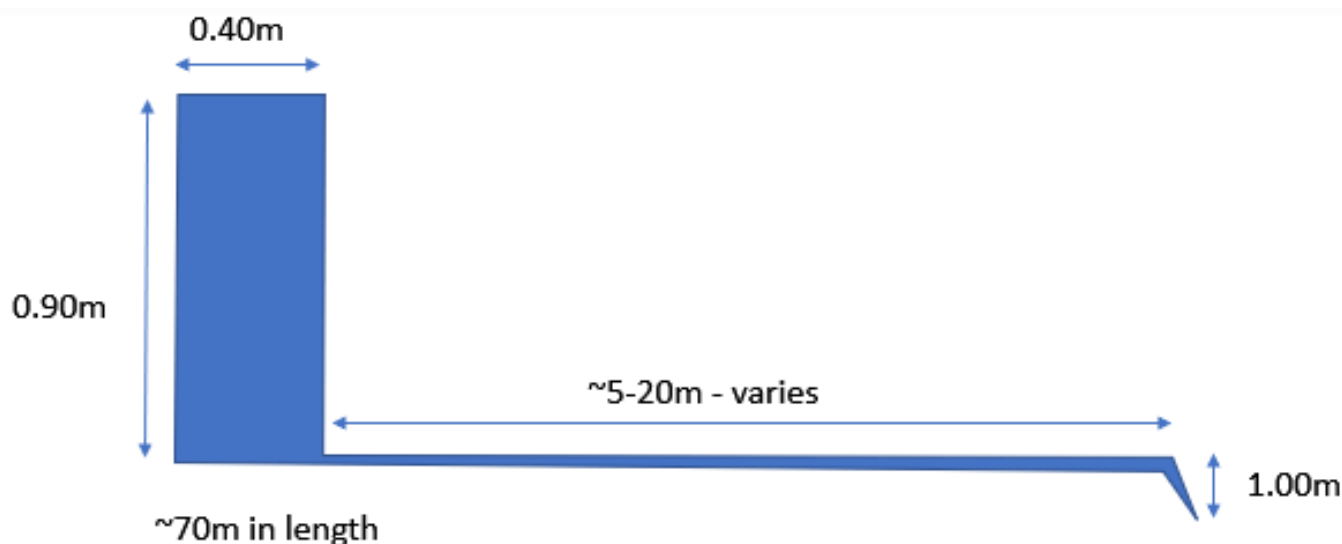
## CL3 – Wall

Stone wall next to road protecting residential properties but not designed as a flood wall.

Variant weightings used for both faces as no revetments. Significant mortar loss to crest, holes through wall, bulging of wall where light foreign objects are growing in front on wall, distorting its shape and some erosion to channel side.

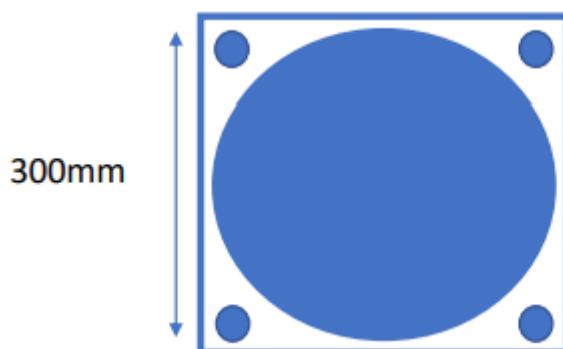
## CL4 – Outfall

300mm diameter flapped outfall with concrete apron located on channel side in front of wall. Owner and operator unknown.

Vegetation around headwall. Unable to see through pipe and no CCTV footage available.

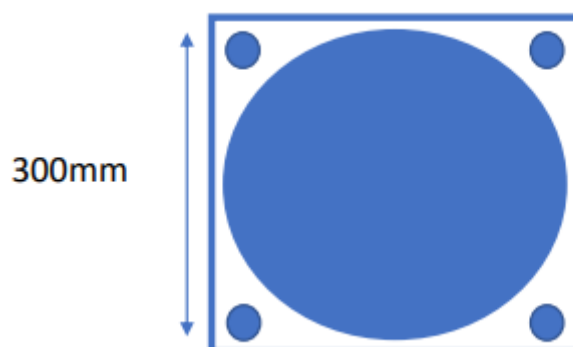
## CL5 – Outfall

300mm diameter flapped outfall with no apron located on channel side in front of wall. Owner and operator unknown.

Outfall in good condition, very minor corrosion present on frame and flap valve. Unable to see through pipe and no CCTV footage available.

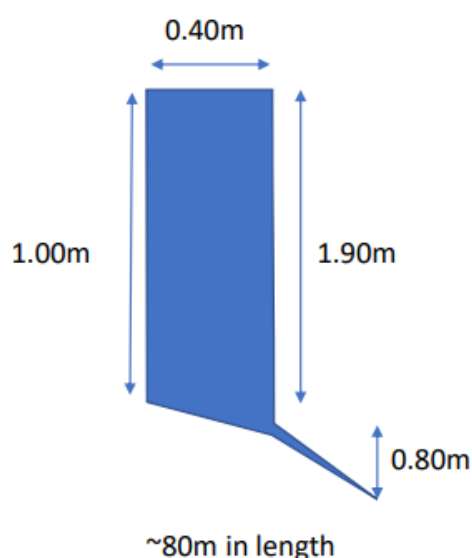
## CL6 – Wall

Stone wall with 6 highway outfalls in wall connecting to previous wall, also not a flood wall.

Heavy foreign objects growing towards channel on berm and channel side and undermining on channel side causing channel side to be unstable. Ivy growth on wall, heavy foreign objects growing close to wall causing bulging to wall and capping stones lost from crest halfway across wall.

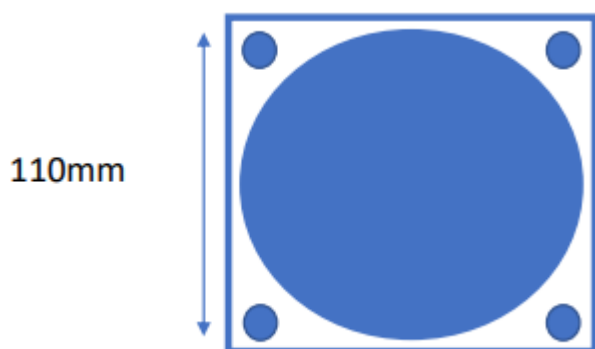
## CL7 – Outfall

110mm diameter flapped highway outfall located within stone wall.

No signs of corrosion to flap valve or frame, pipe has minor leaf debris but no blockages or damage. Downstream headwall has some cracks, vegetation growth and mortar loss.

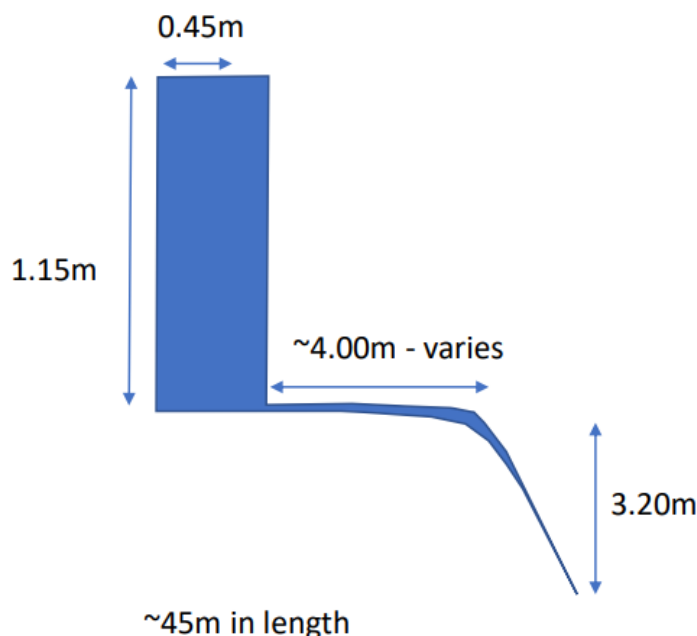
## CL15 – Wall

Masonry wall with capping stones with berm and channel side heavily vegetated with tree growth through wall.

Several heavy foreign objects on berm and channel side. Severe mortar loss in landward face, exposed face difficult to inspect but wall covered in ivy and some tree roots and growing through it. Crest is uneven where ivy has grown around it.

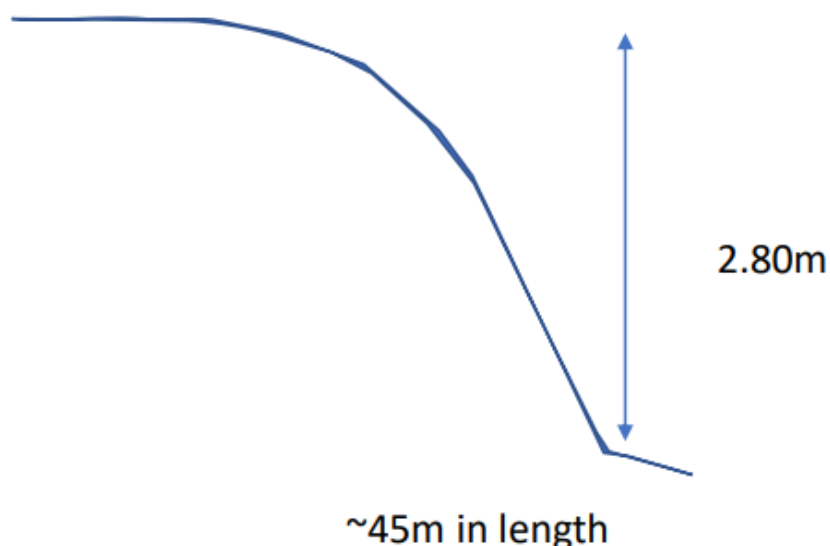
## CL17 – Natural High Ground

Natural high ground heavily vegetated with tree growth with brick building directly behind.

Heavy foreign objects on channel side leaning towards channel. Building <3m from channel on high ground.

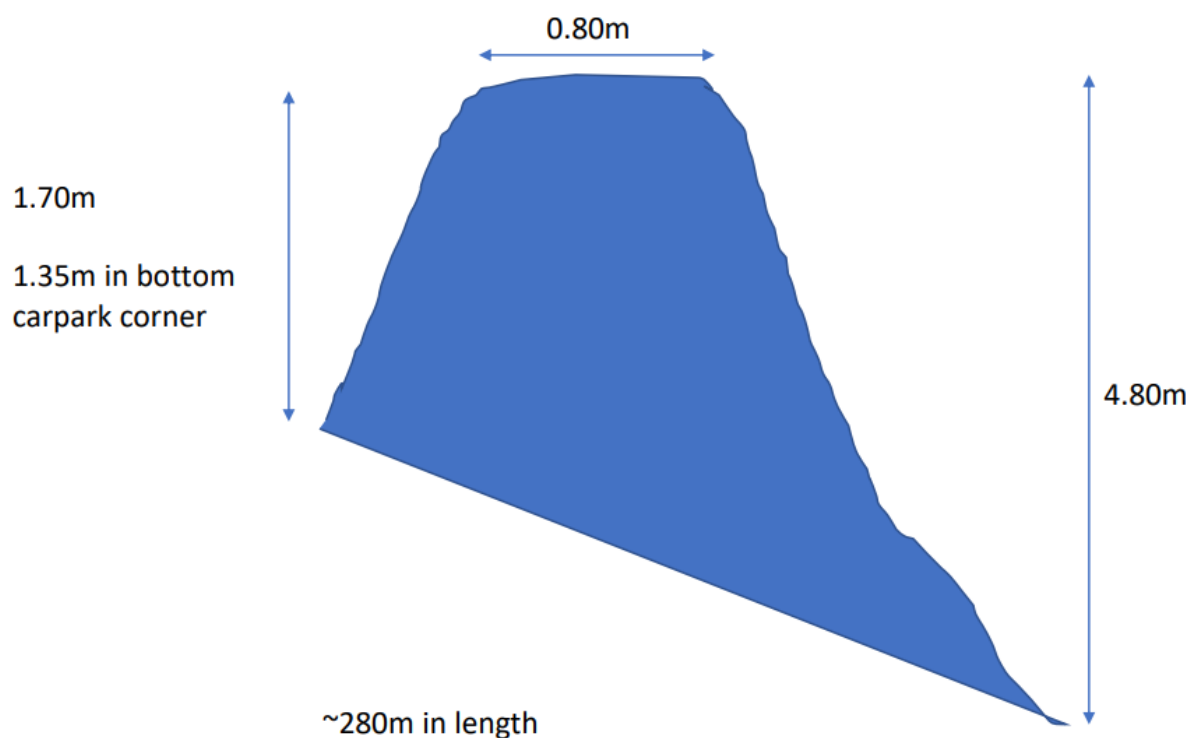
## CL18 – Embankment

Earth embankment with unknown construction materials and unstable tree-ridden channel side, reducing stability of embankment. Unlikely to have clay core and may be comprised of waste material.

Low points and rutting in crest but well vegetated. Variant used for exposed face due to steepness. Exposed and landward faces have isolated bare patches. Telegraph pole behind embankment but embankment build around it. Severe undermining of channel side around heavy foreign objects with extensive root exposure.

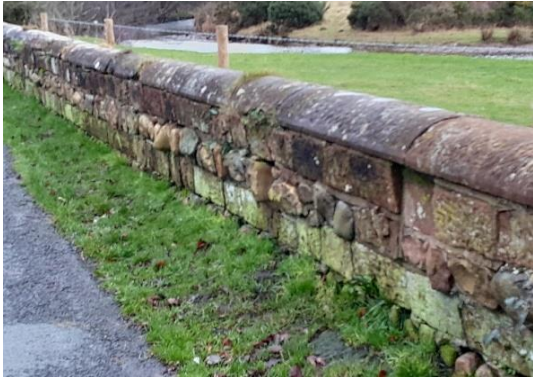
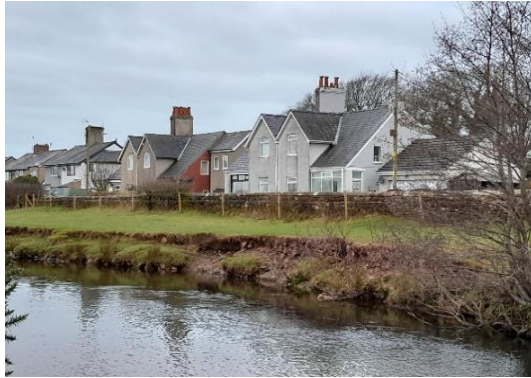
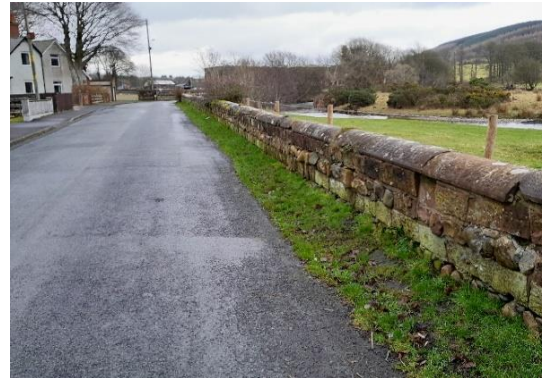
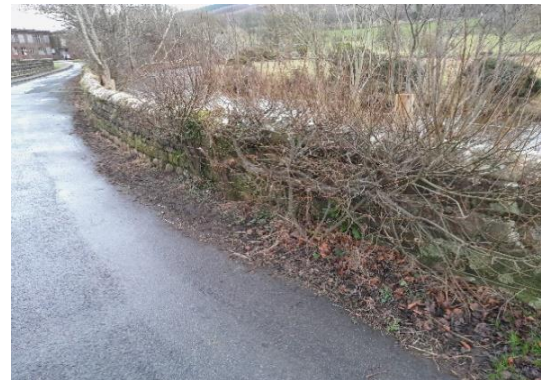
| Asset ID | CL3 | Frequency | | | | | |
|---|---|---|---|---|---|---|---|
| Comments | Variant weightings used for both faces as no revetments. Significant mortar loss to crest, holes through wall, bulging of wall where light foreign objects are growing in front on wall, distorting its shape and minor erosion to channel side. | | | | | | |

| Asset ID | CL3 | Frequency | | | | | |
|---|---|---|---|---|---|---|---|
| Recommendations | Rebuild wall and remove trees in front of wall. | | | | | | |

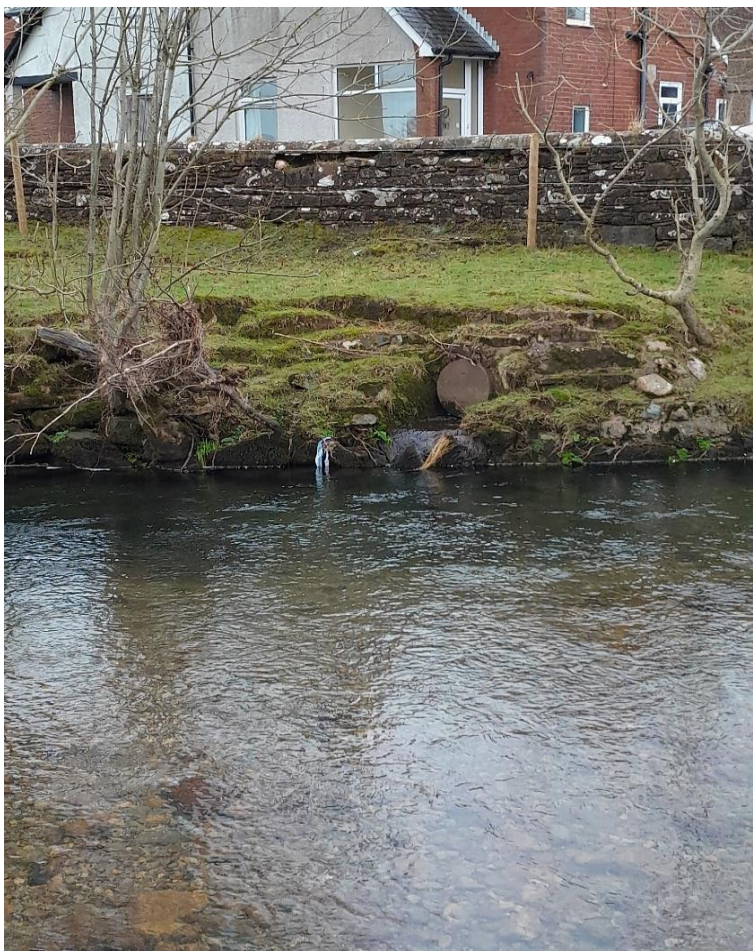
| <b>Asset ID</b> | CL4 | <b>Frequency</b> | | <b>RESILIENCE<br/>&amp; FLOOD RISK</b> | | | |

| <b>Comments</b> | Vegetation around headwall. Unable to see through pipe and no CCTV footage available. | | | | | | |

| <b>Recommendations</b> | Conduct a CCTV survey to inspect pipe and remove vegetation around headwall. | | | | | | |

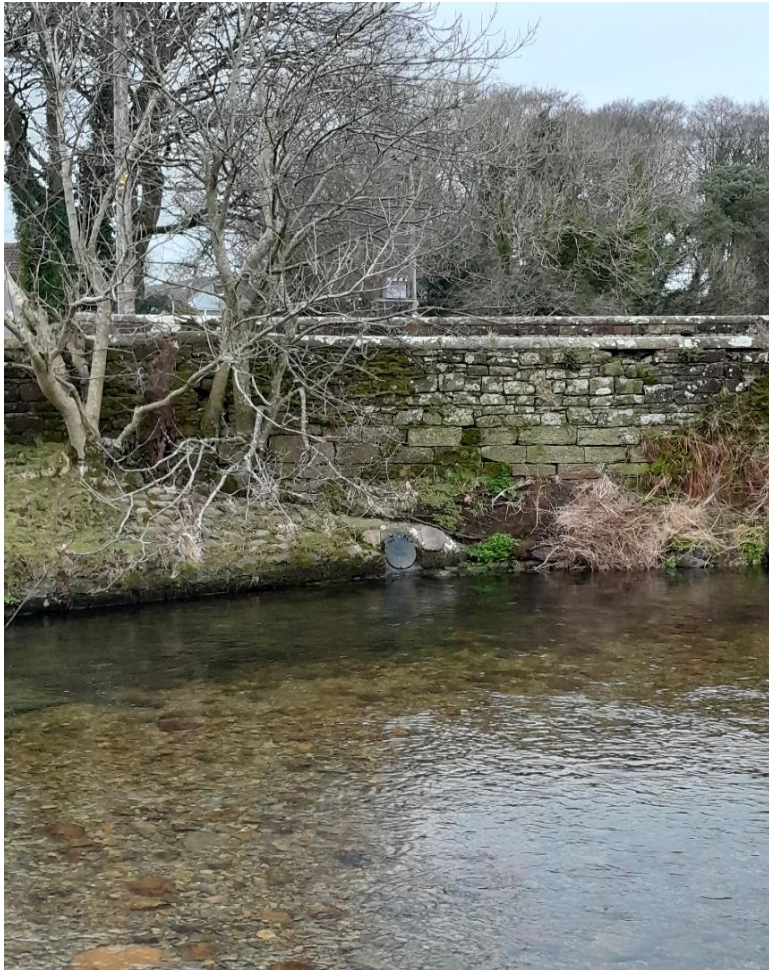
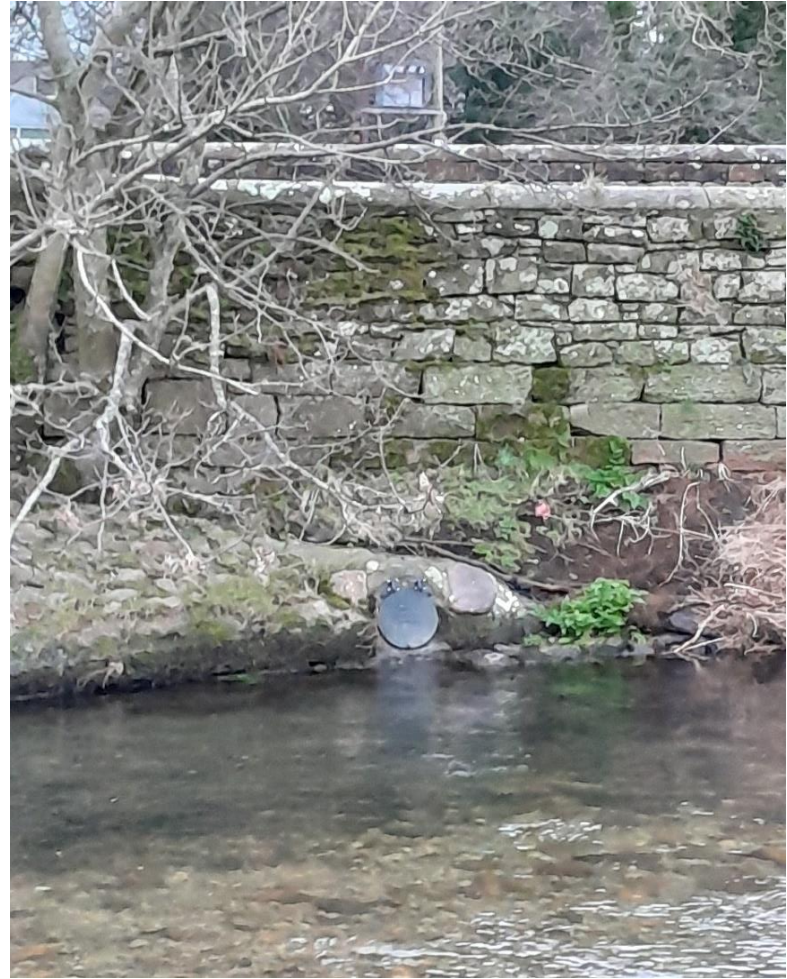
| <b>Asset ID</b> | CL5 | <b>Frequency</b> | | | | | |

| <b>Comments</b> | Outfall in good condition, very minor corrosion present on frame and flap valve. Unable to see through pipe and no CCTV footage available. | | | | | | |

| <b>Recommendations</b> | Conduct a CCTV survey to inspect pipe. | | | | | | |

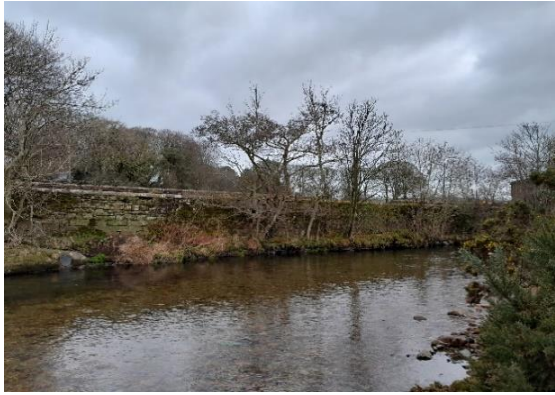
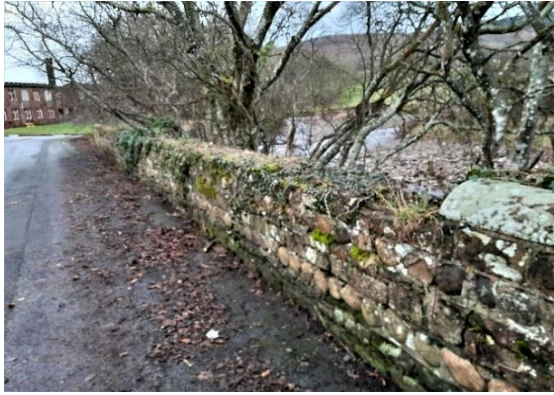
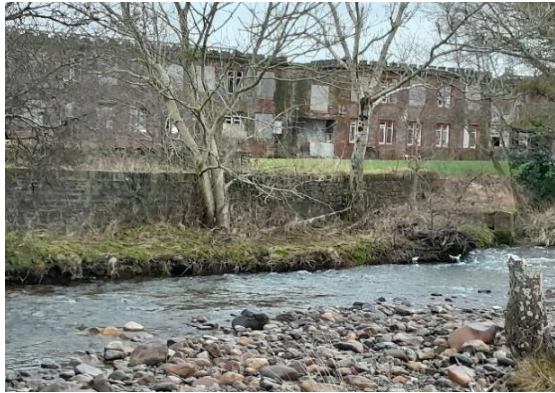
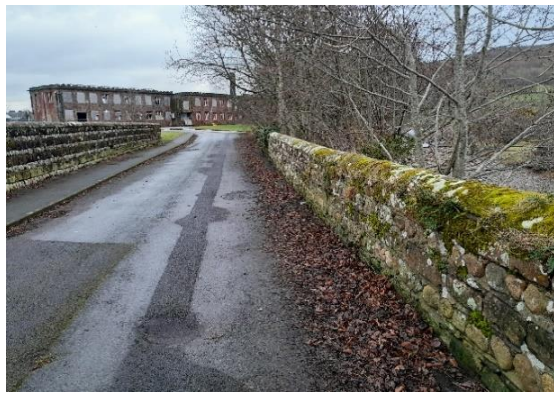
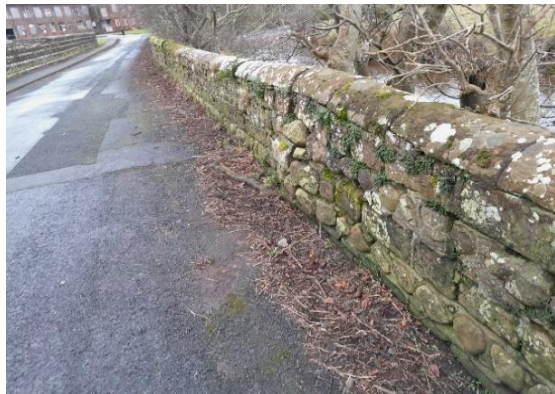
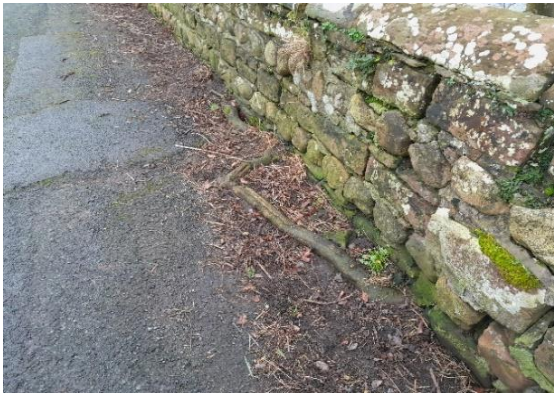
| Asset ID | CL6 | Frequency | | | | | |
|---|---|---|---|---|---|---|---|
| Comments | Heavy foreign objects growing towards channel on berm and channel side and undermining on channel side causing channel side to be unstable. Ivy growth on wall, heavy foreign objects growing close to wall causing bulging to wall and capping stones lost from crest halfway across wall. | | | | | | |

| Asset ID | CL6 | Frequency | | | | | |
|---|---|---|---|---|---|---|---|
| Recommendations | Rebuild wall, remove unstable trees and remove trees next to wall. | | | | | | |

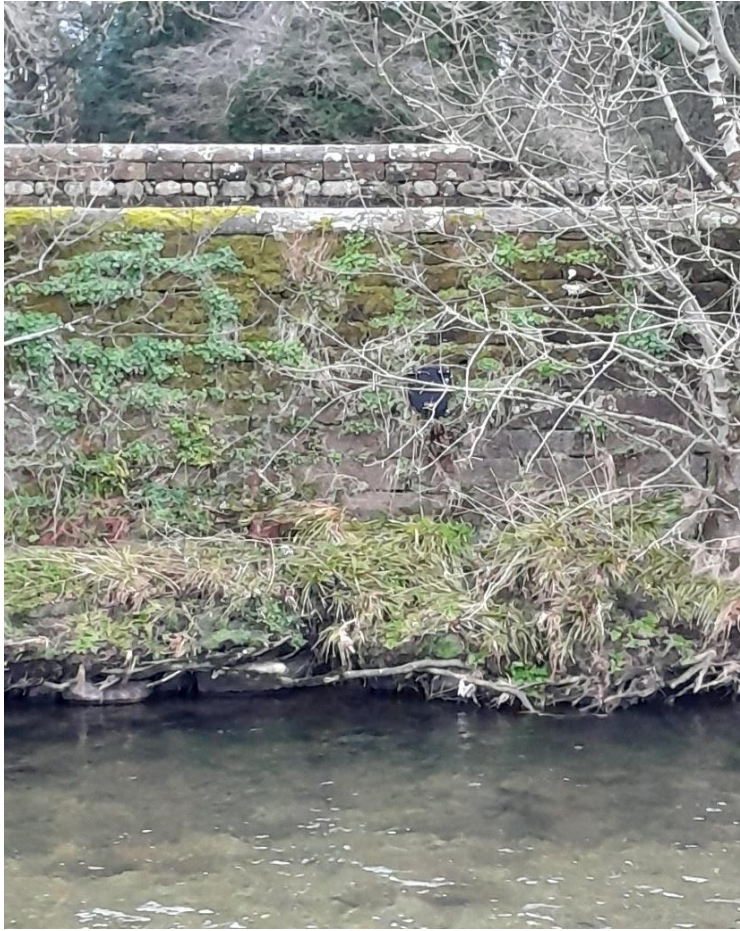
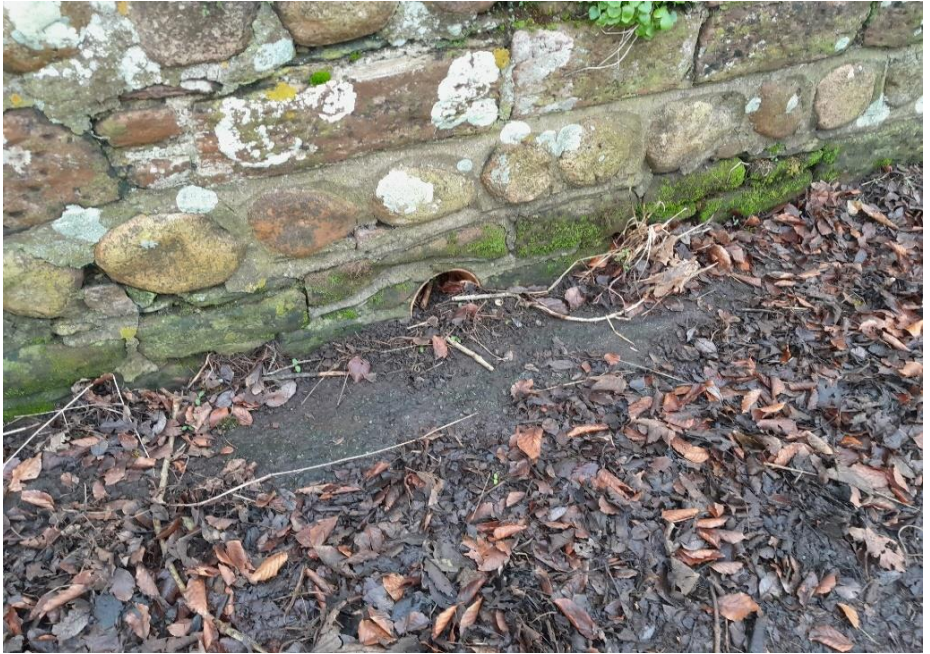
| Asset ID | CL7 | Frequency | | | | | |
|---|---|---|---|---|---|---|---|
| Comments | No signs of corrosion to flap valve or frame, pipe has minor leaf debris but no blockages or damage. Downstream headwall has some cracks, vegetation growth and mortar loss. | | | | | | |

| Asset ID | CL7 | Frequency | | | | | |
|---|---|---|---|---|---|---|---|
| Recommendations | Continue with ongoing vegetation maintenance. | | | | | | |

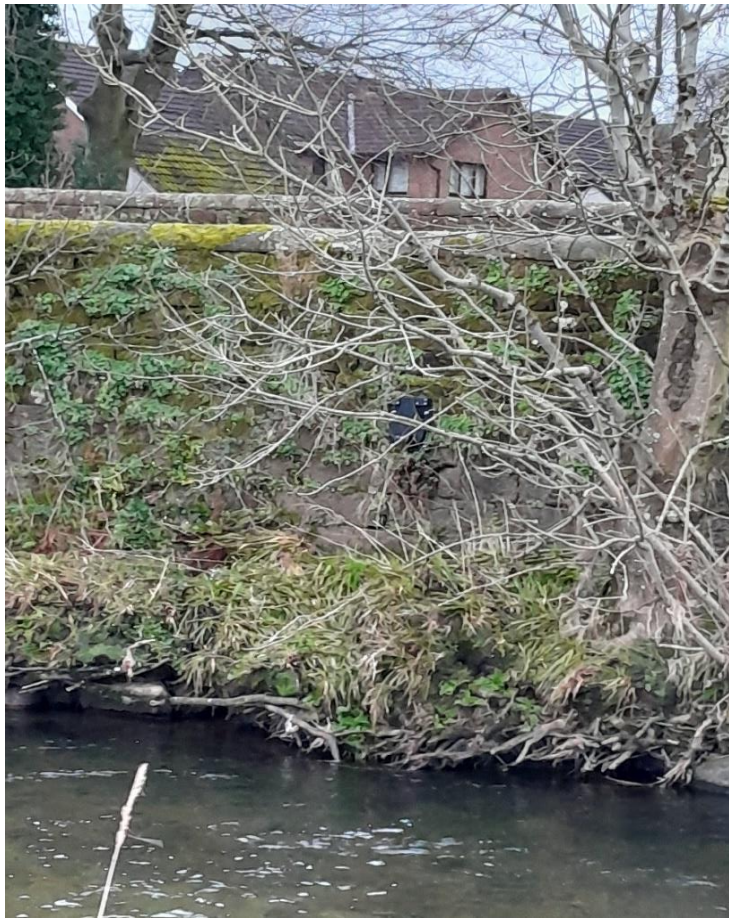
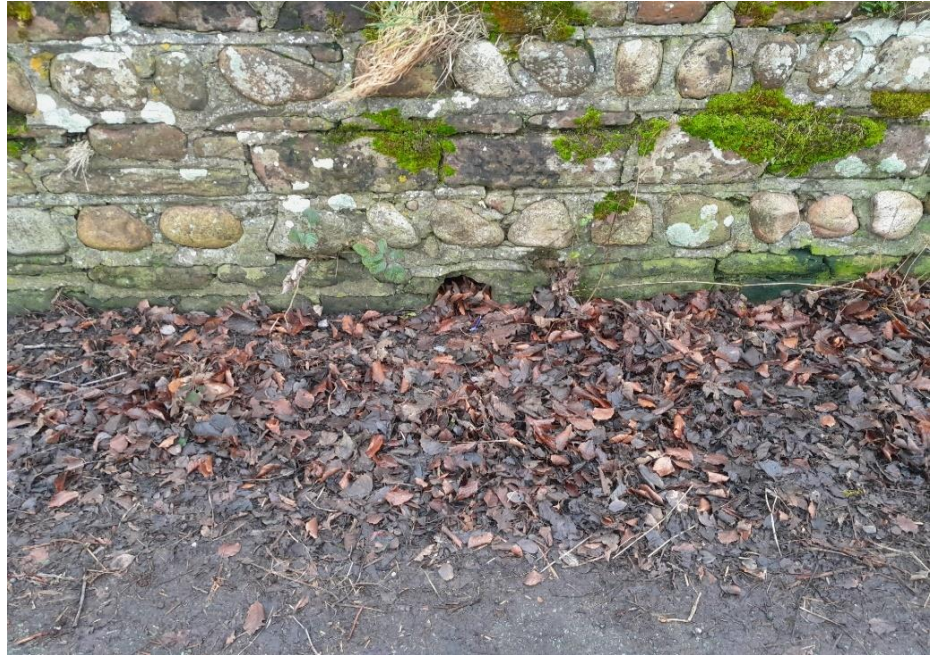
| <b>Comments</b> | No signs of corrosion to flap valve or frame, pipe has minor leaf debris but no blockages or damage. Minor crack to downstream headwall, vegetation growth and mortar loss. | | | | | | |

| <b>Recommendations</b> | Continue with ongoing vegetation maintenance. | | | | | | |

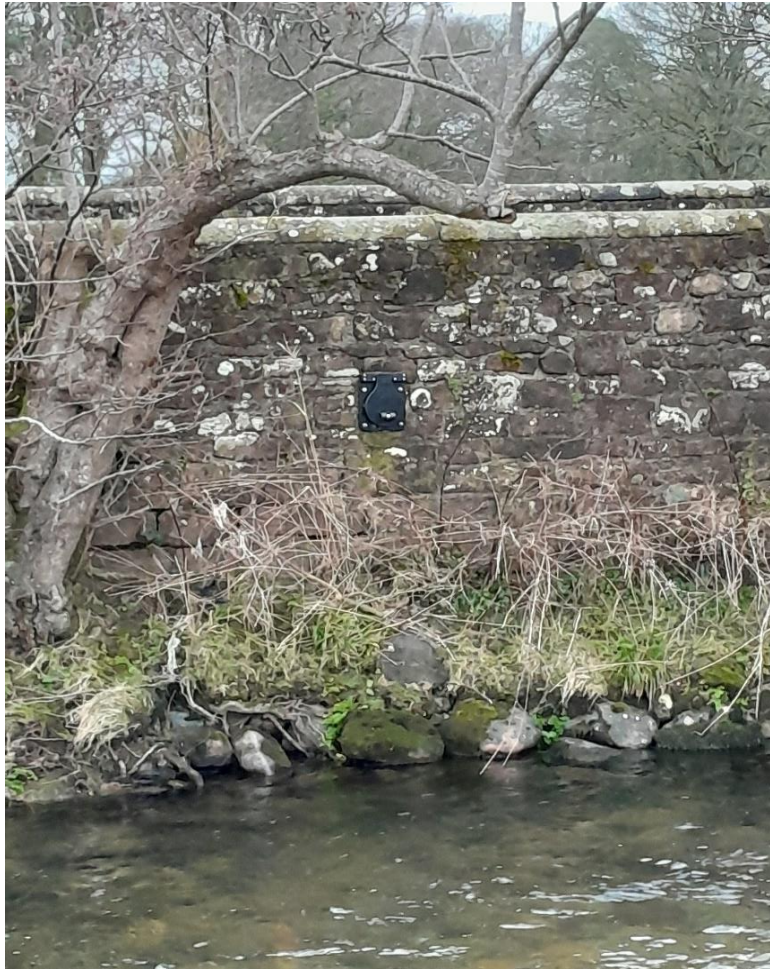
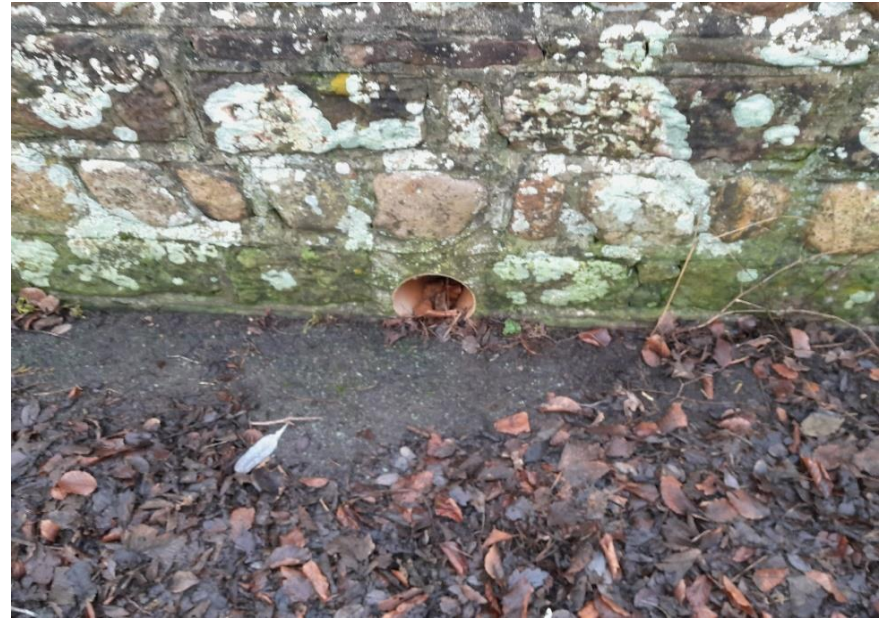
| <b>Comments</b> | No corrosion to flap valve or frame. Cracks and mortar loss on headwall. Pipe has minor leaf debris but no blockages or damage. | | | | | | |

| <b>Recommendations</b> | Remove vegetation and continue with vegetation maintenance. | | | | | | |

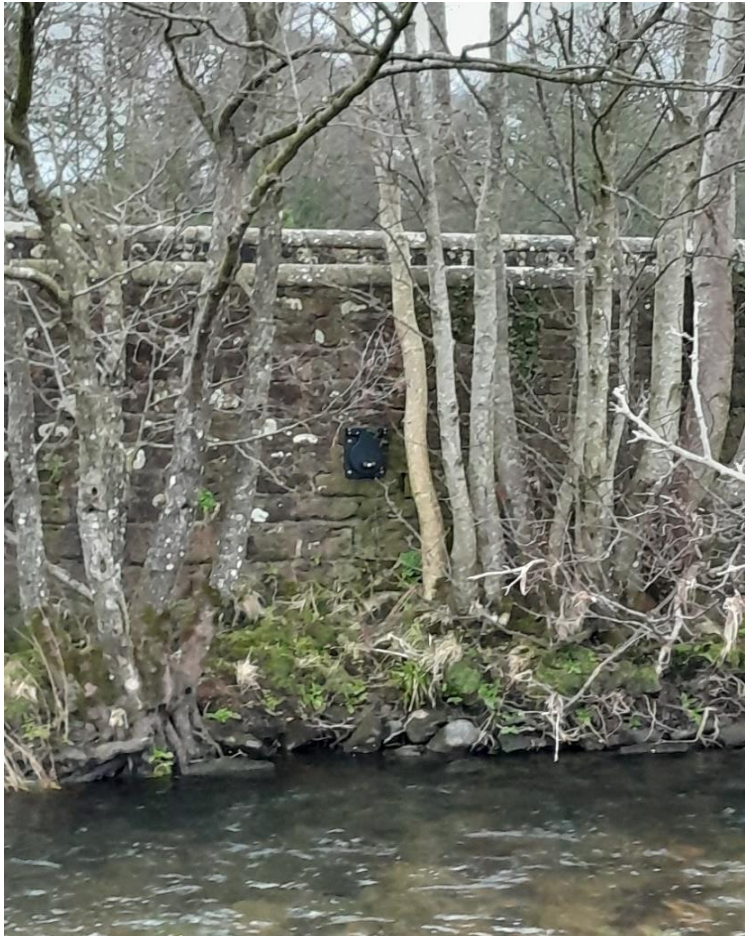
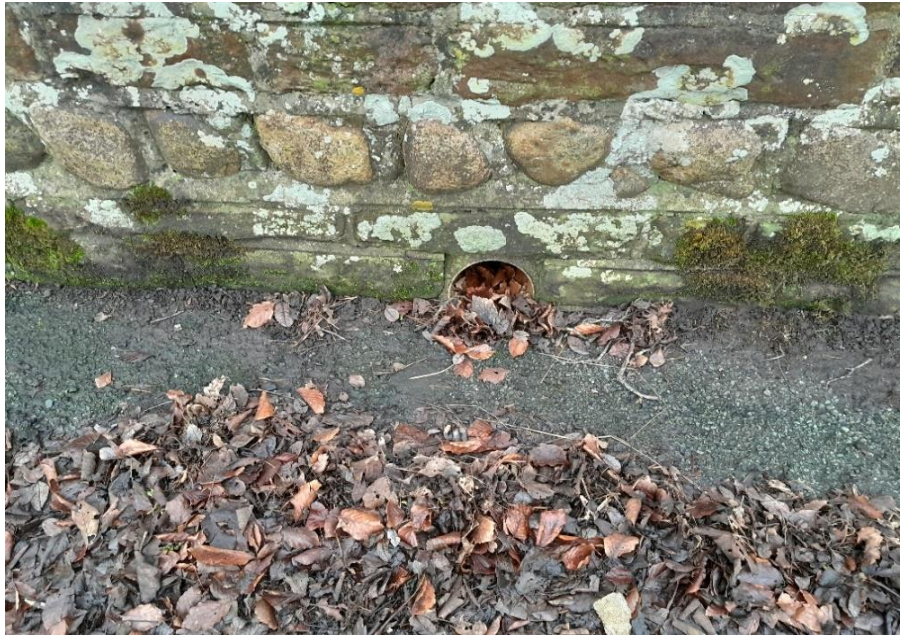
| <b>Comments</b> | Ivy growth around frame and headwall. No corrosion to flap valve. Cracks and vegetation growth on headwall. Pipe has minor leaf debris but no blockages or damage. | | | | | | |

| <b>Recommendations</b> | Remove vegetation and continue with vegetation maintenance. | | | | | | |

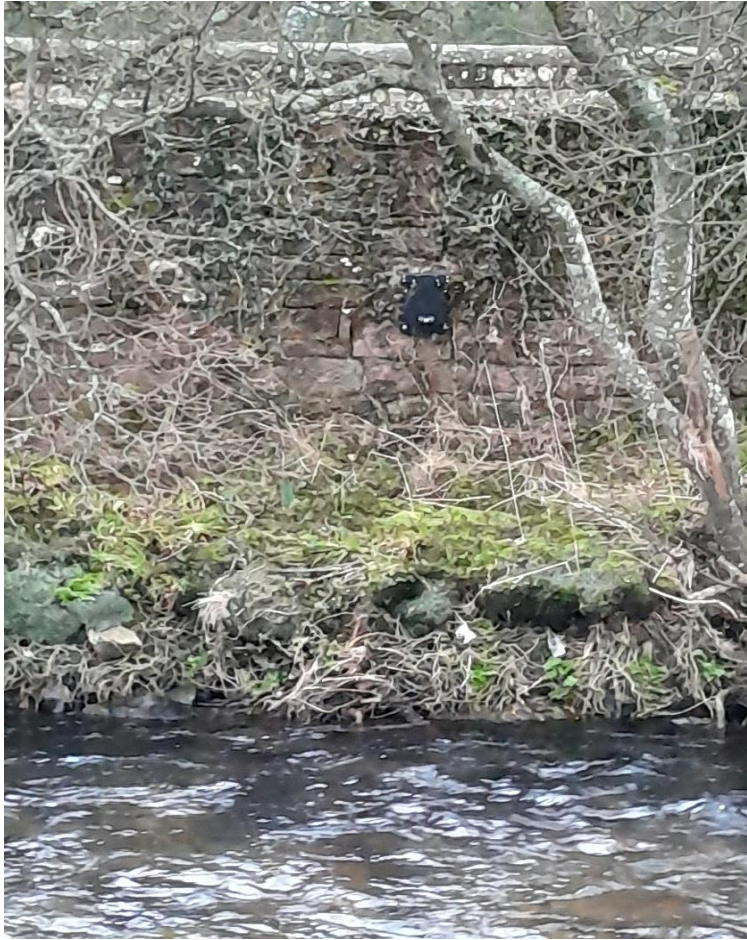
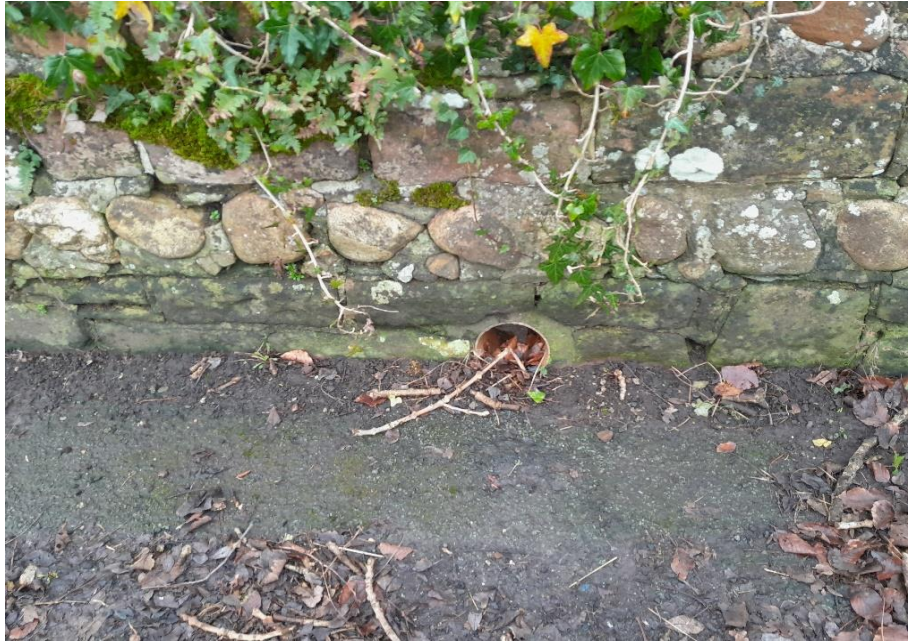
| <b>Comments</b> | Ivy growth around frame and headwall. No corrosion to flap valve. Minor cracks and vegetation growth on headwall. Pipe has vegetation debris but no blockages or damage. | | | | | | |

| <b>Recommendations</b> | Remove vegetation and continue with vegetation maintenance. | | | | | | |

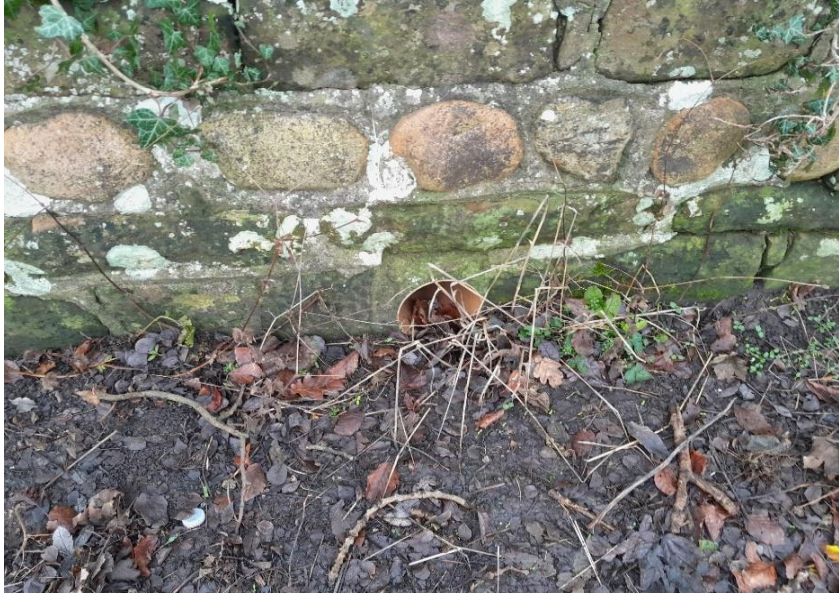
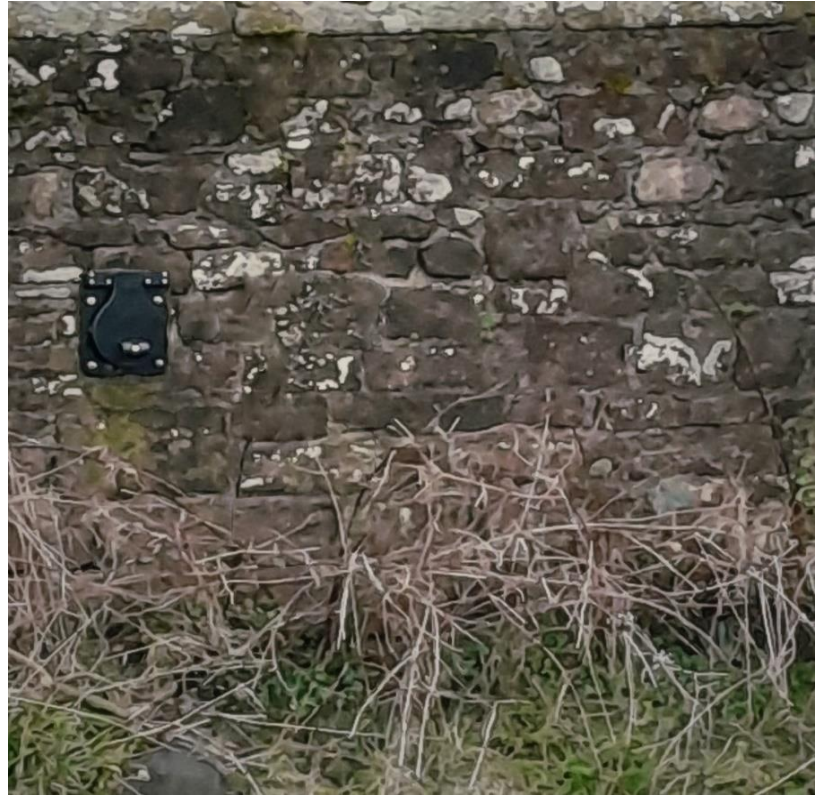
| Asset ID | CL12 | Frequency | | | | | |

| Asset ID | CL12 | Frequency | | | | | |
|---|---|---|---|---|---|---|---|
| Comments | No corrosion to flap valve or frame. Minor cracks, mortar loss and minor vegetation growth on headwall. Pipe has minor leaf debris but no blockages or damage. | | | | | | |

| Asset ID | CL12 | Frequency | | | | | |
|---|---|---|---|---|---|---|---|
| Recommendations | Remove vegetation and continue with vegetation maintenance. | | | | | | |

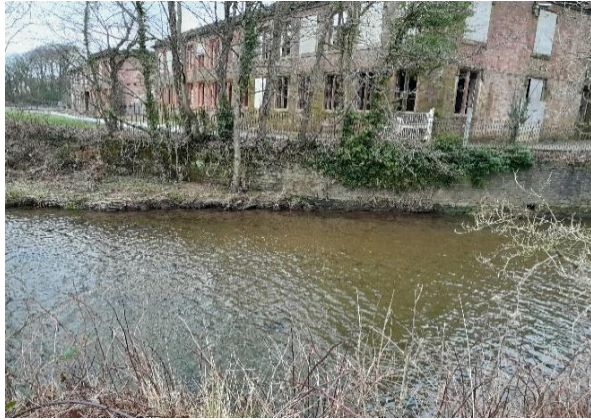
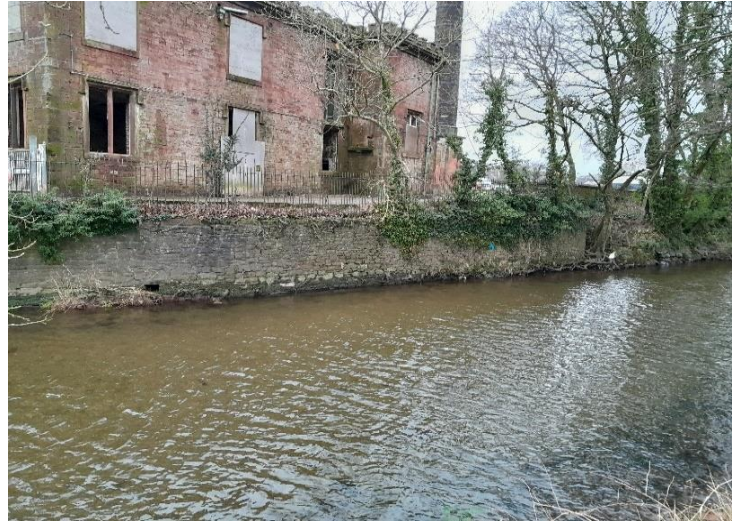
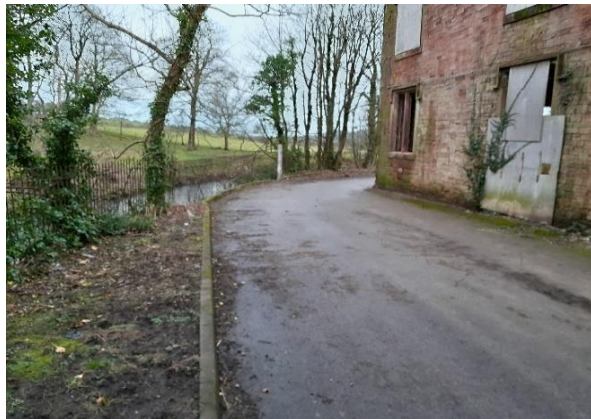
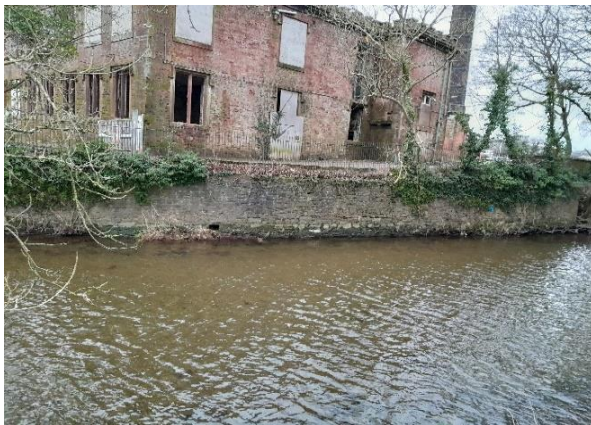
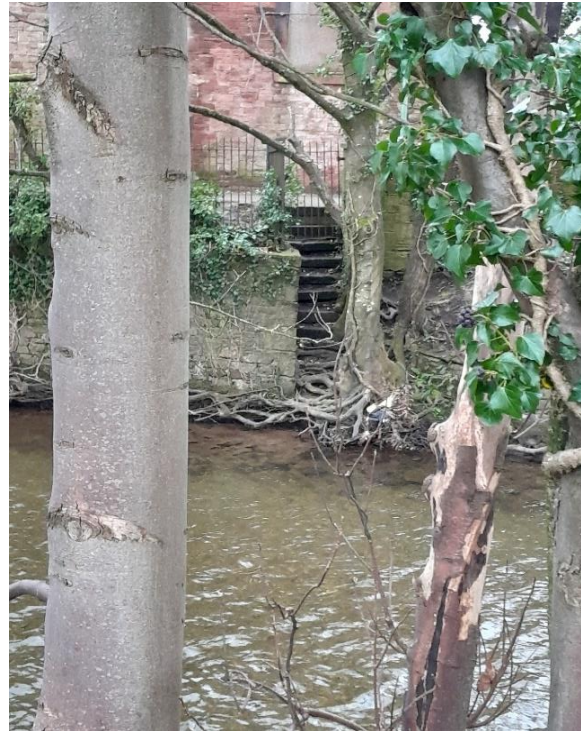
| <b>Comments</b> | Light foreign objects and ivy growing in front of and on top of channel side wall. High ground is road in good condition. Heavy foreign object upstream with roots growing into channel side brickwork. | | | | | | | |

| <b>Recommendations</b> | Remove trees on top of and in front of channel side brickwork. Remove ivy. | | | | | | | |
