## FLOOD RISK AND DRAINAGE ASSESSMENT

**Cleator Mill,  
Proposed Residential Development,  
Flood Risk Assessment.**

RO/FRA/RES/19002.1

# Cleator Flood Asset Condition Assessment

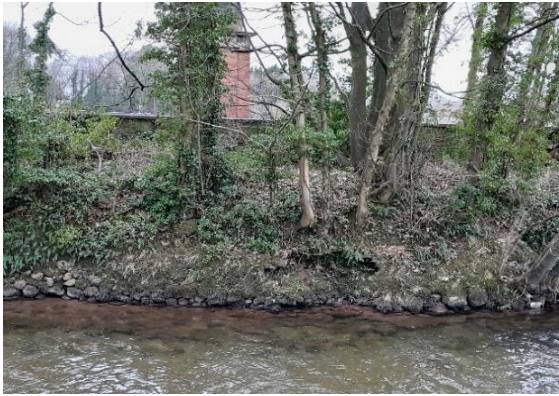
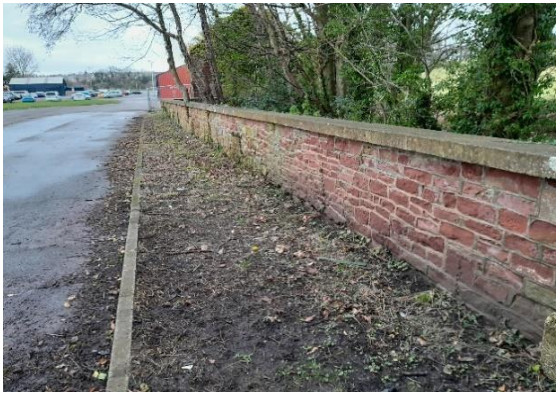
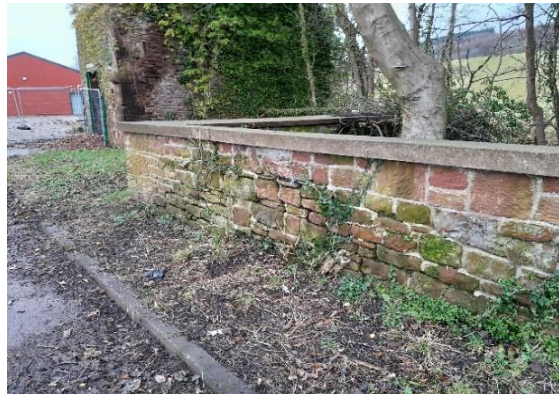
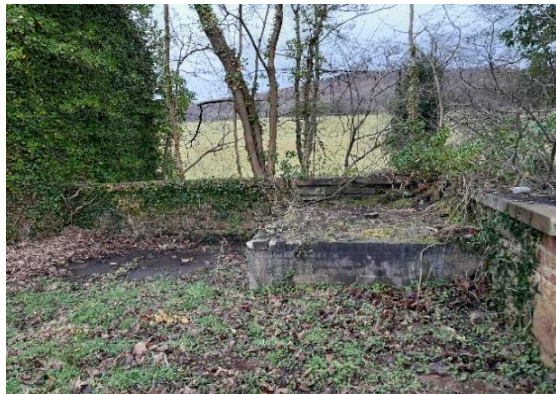
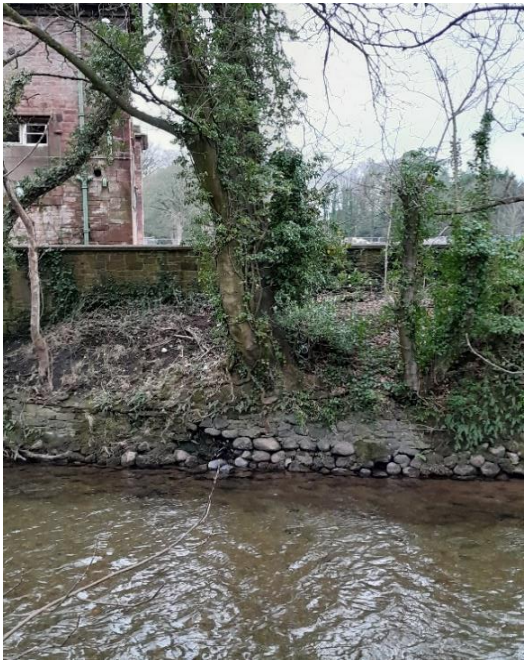
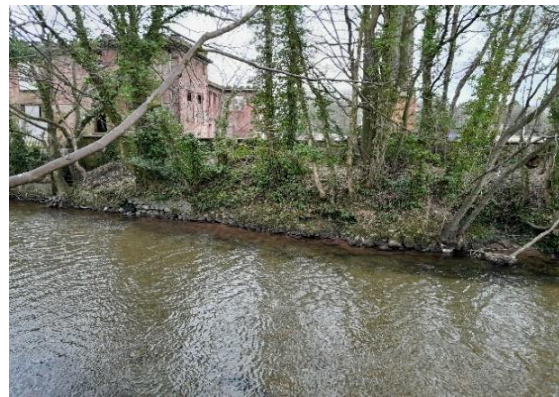
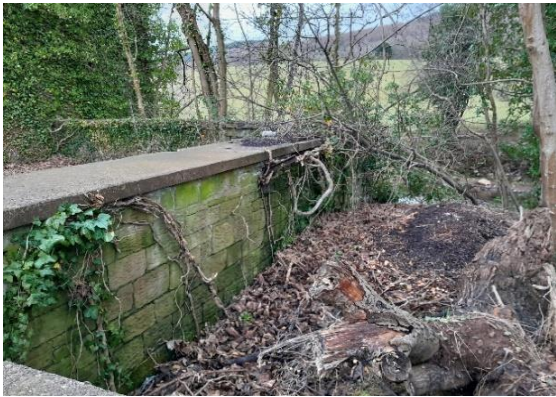
| Asset ID | CL15 | Frequency | | | | | |
|---|---|---|---|---|---|---|---|
| Comments | Several heavy foreign objects on berm and channel side. Severe mortar loss in landward face, exposed face difficult to inspect but wall covered in ivy and some tree roots and growing through it. Crest is uneven where ivy has grown around it. | | | | | | |

| Asset ID | CL15 | Frequency | | | | | |
|---|---|---|---|---|---|---|---|
| Recommendations | Rebuild wall, remove ivy and remove trees growing into wall. | | | | | | |

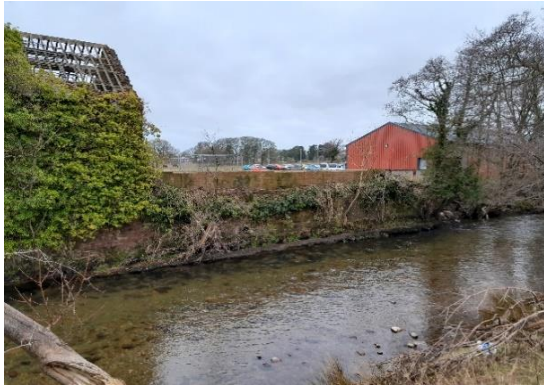
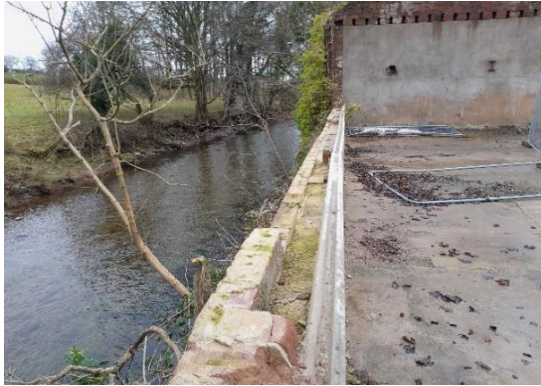
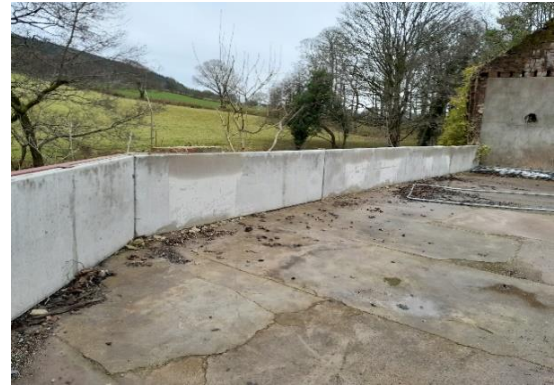
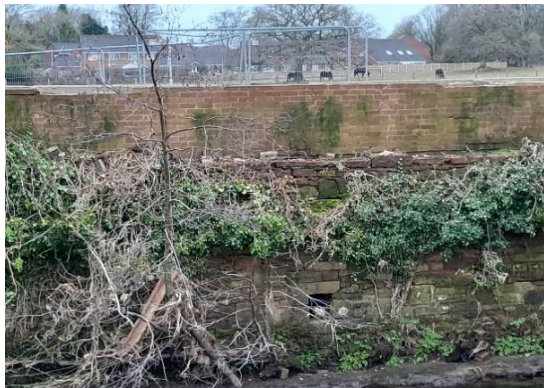
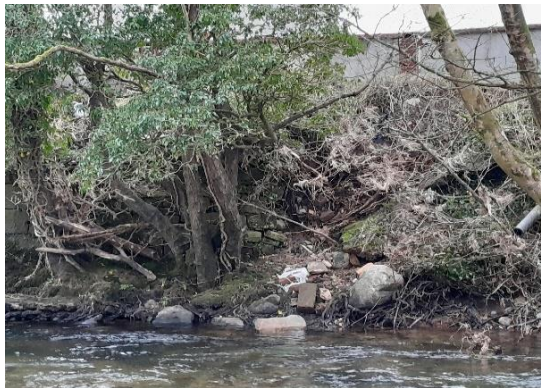
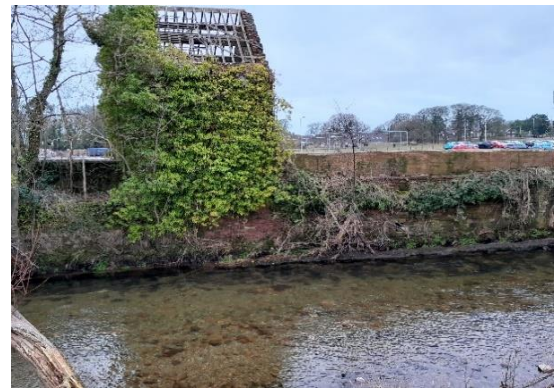
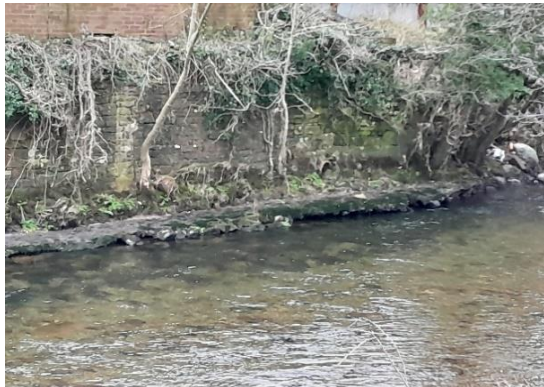
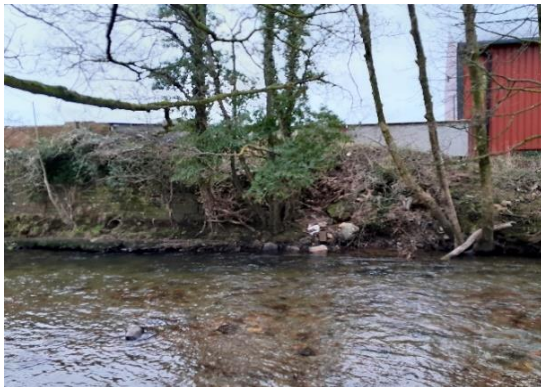
| <b>Comments</b> | Extensive ivy growth, channel side wall is walling down with severe brick loss and root penetration. Heavy foreign objects growing on channel side causing brick displacement and loss. Crest is uneven due to brick loss but landward face is made from concrete slabs in good condition. | | | | | | |

| <b>Recommendations</b> | Rebuild wall and remove heavy foreign objects. | | | | | | |

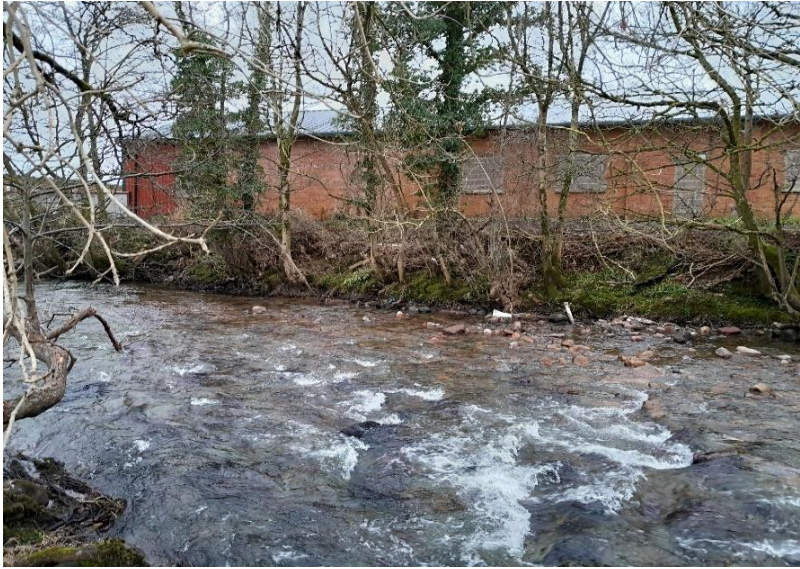
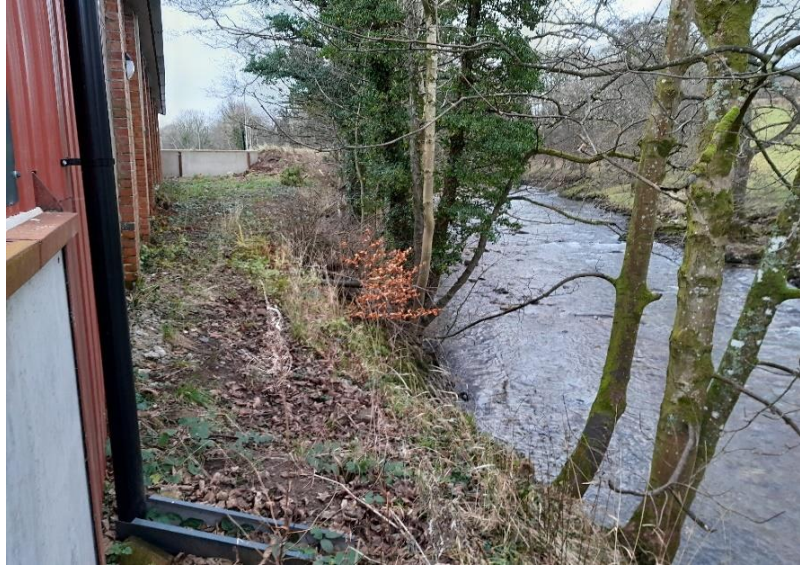
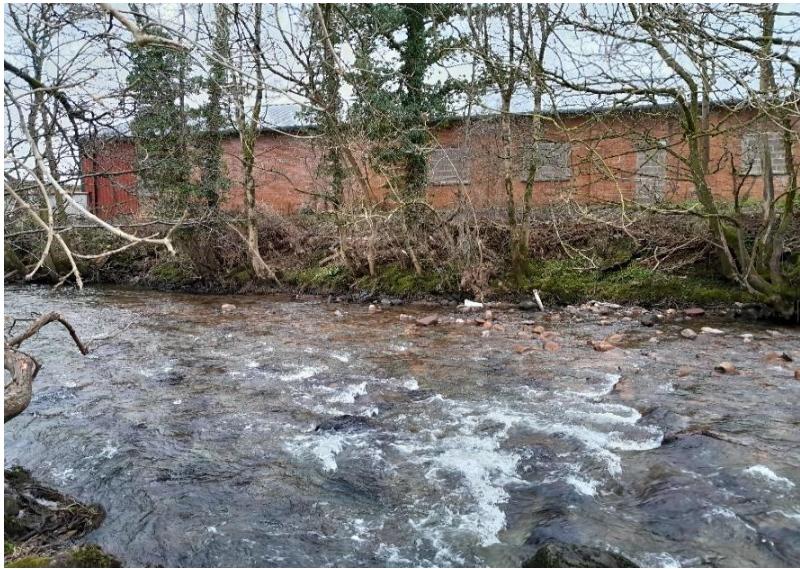
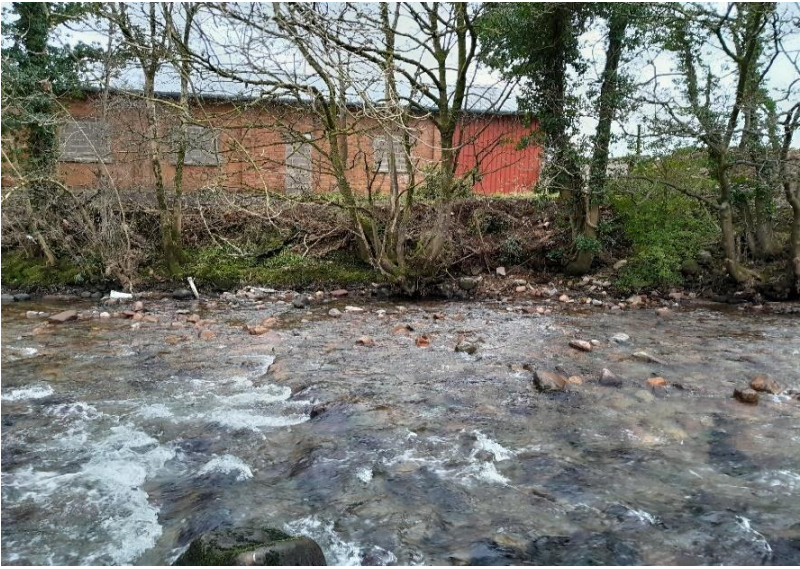
| Asset ID | CL17 | Frequency | | | | | |

| Asset ID | CL17 | Frequency | | | | | |
|---|---|---|---|---|---|---|---|
| Comments | Heavy foreign objects on channel side leaning towards channel. Building <3m from channel on high ground. | | | | | | |

| Asset ID | CL17 | Frequency | | | | | |
|---|---|---|---|---|---|---|---|
| Recommendations | Continue with vegetation maintenance and monitor tree growth. | | | | | | |

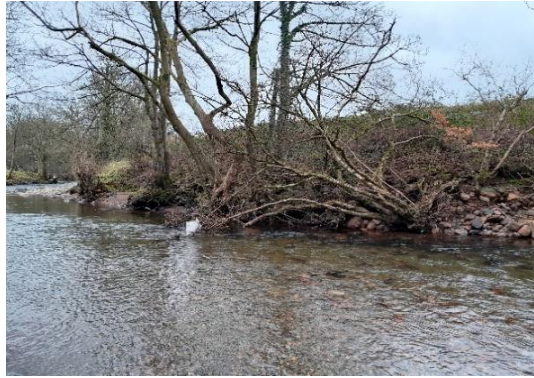
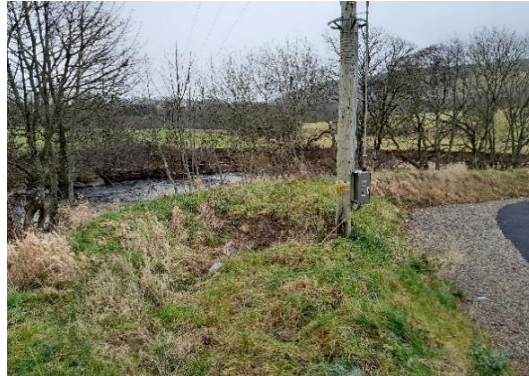
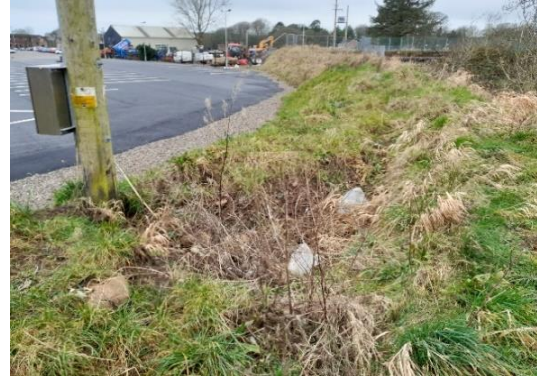
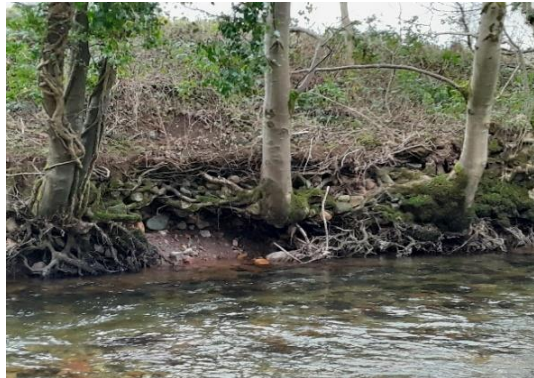
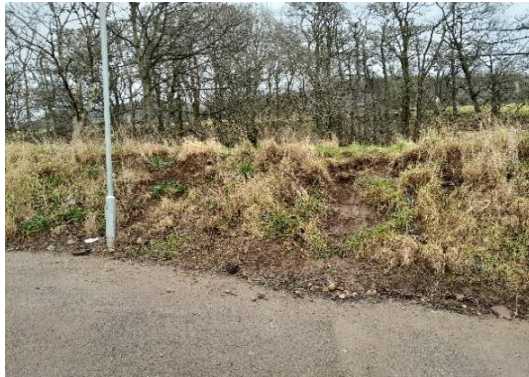
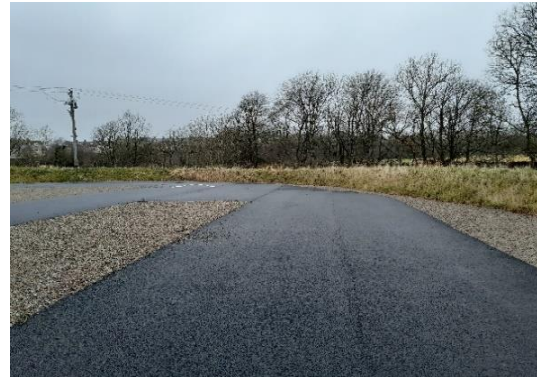
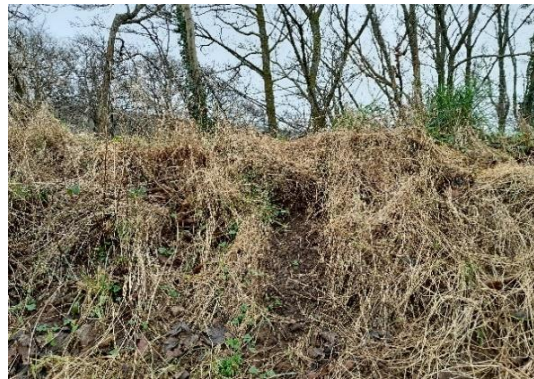
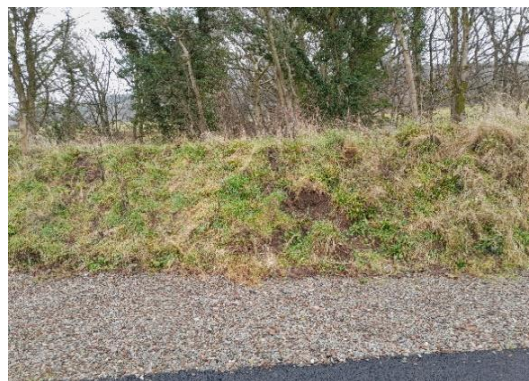
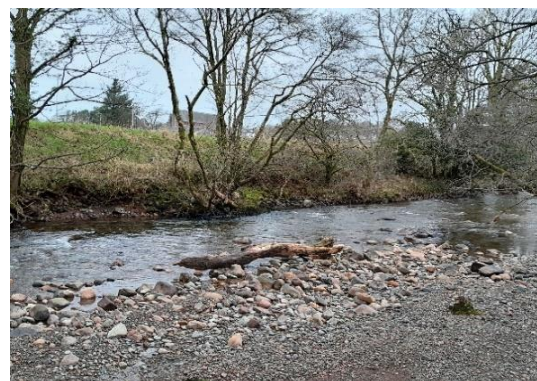
| <b>Comments</b> | Low points and rutting in crest but well vegetated. Variant used for exposed face due to steepness. Exposed and landward faces have isolated bare patches. Telegraph pole behind embankment but embankment build around it. Severe undermining of channel side around heavy foreign objects with extensive root exposure. | | | | | | |

| <b>Recommendations</b> | Remove unstable trees on channel side, infill low spots on crest and seed bare patches. | | | | | | |

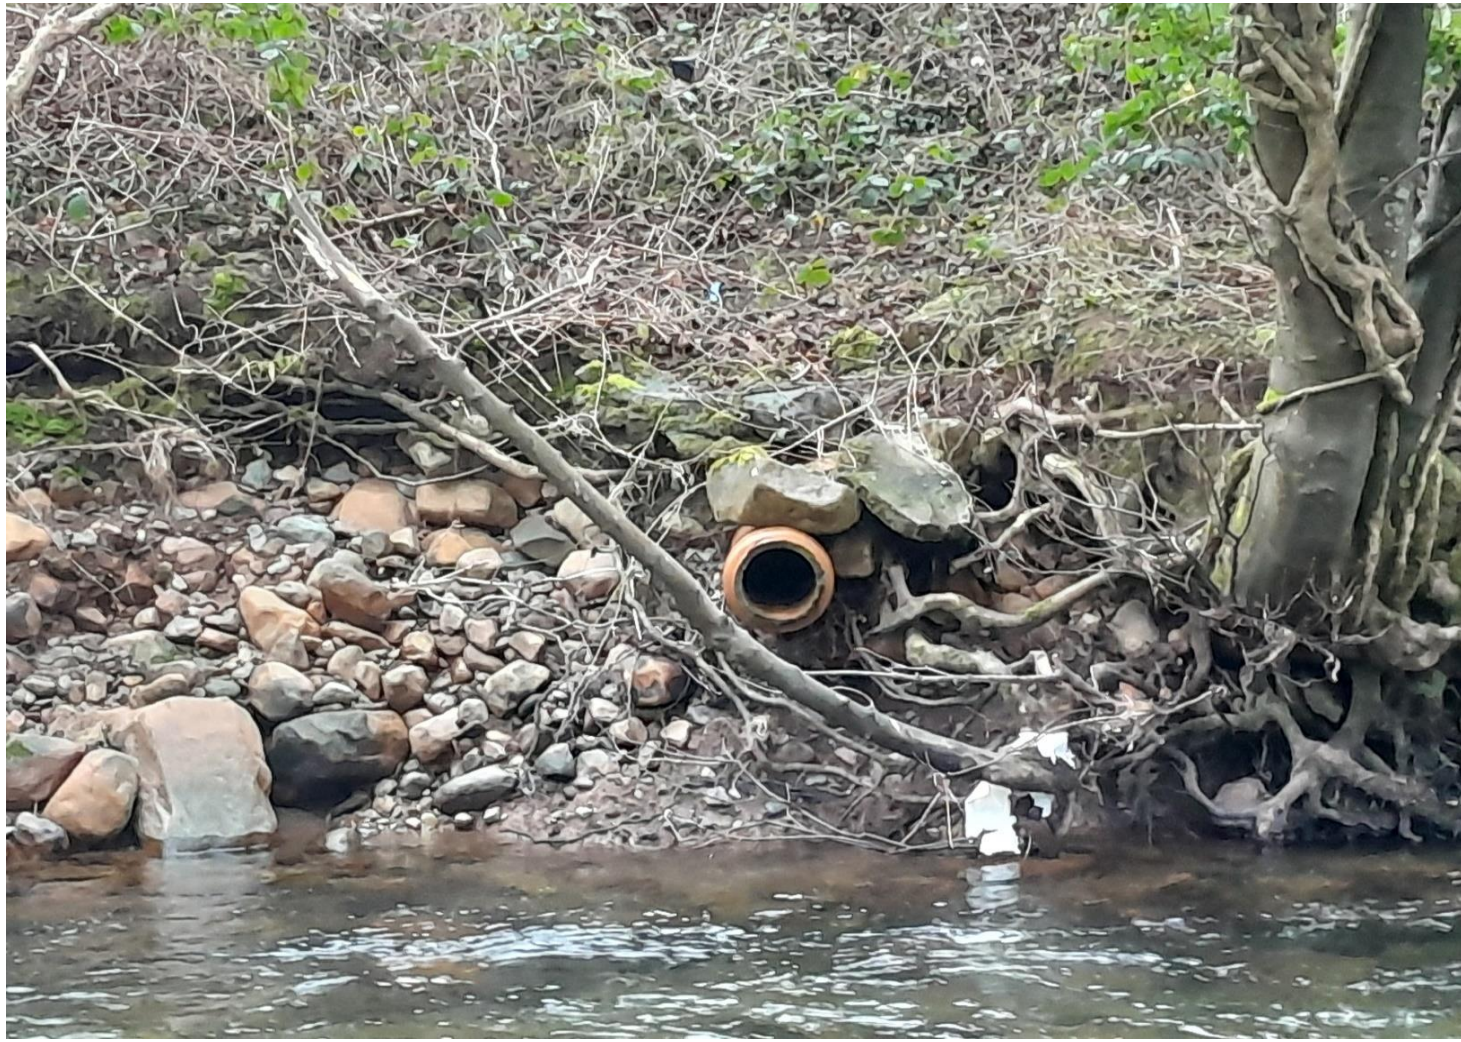
| Asset ID | CL20 | Frequency | | | | | |

| Asset ID | CL20 | Frequency | | | | | |
|---|---|---|---|---|---|---|---|
| Comments | Downstream headwall in pieces. Unable to see through pipe and no CCTV footage available. | | | | | | |

| Asset ID | CL20 | Frequency | | | | | |
|---|---|---|---|---|---|---|---|
| Recommendations | Rebuild headwall and conduct CCTV inspection of pipe. | | | | | | |

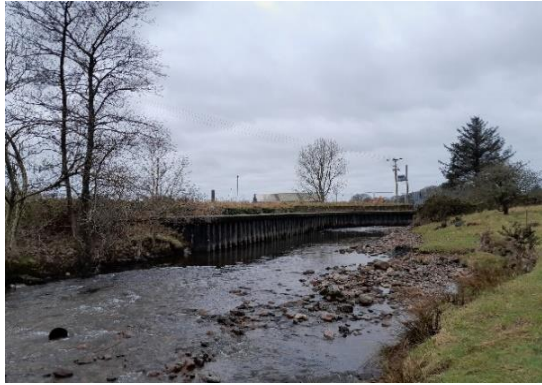
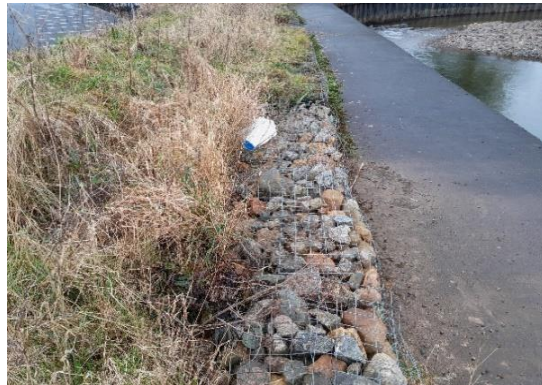
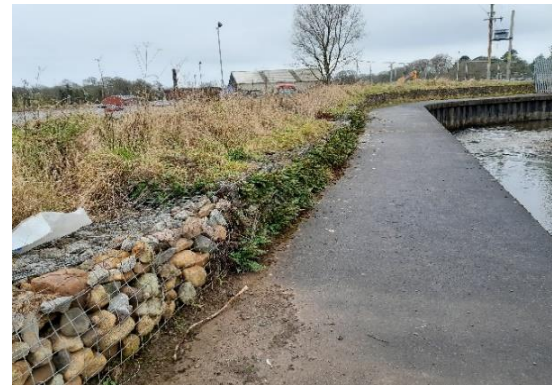
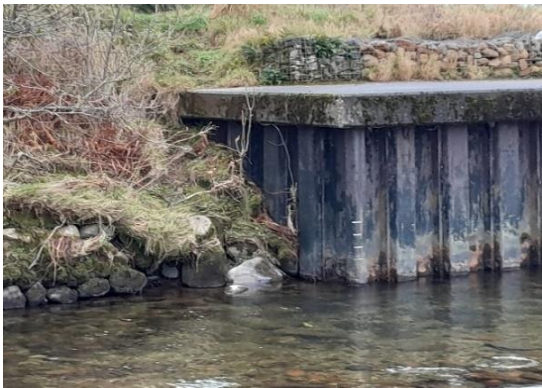
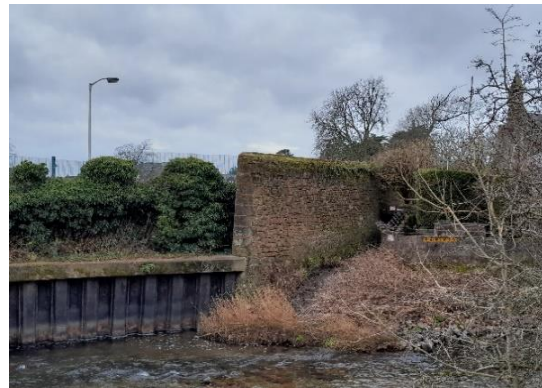
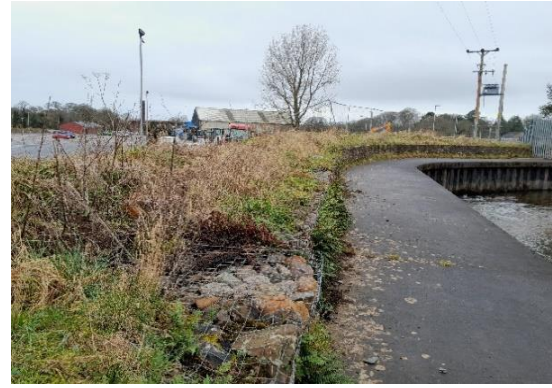
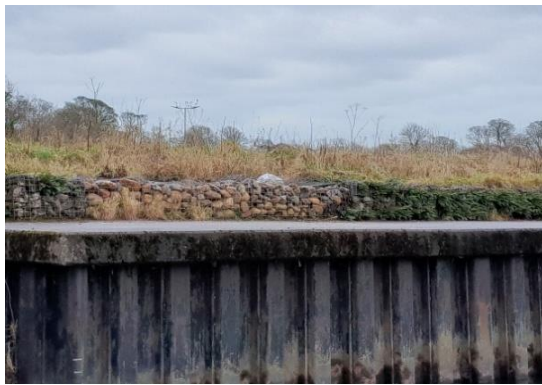
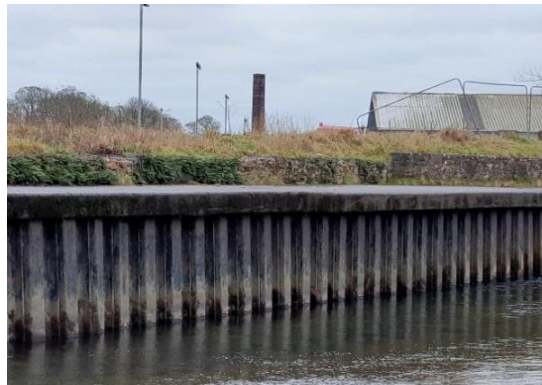
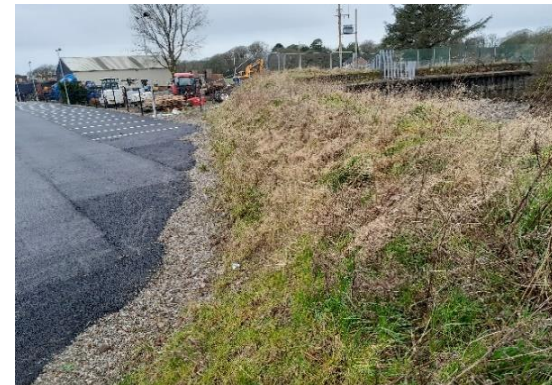
| <b>Comments</b> | Berm 2 and channel side in good condition with minor cosmetic defects to sheet piles. Vegetation growth through gabion baskets with a few broken wires but no gabion displacement. Uneven ground on exposed face 1 and landward face but well vegetated. Rutting and low spots in isolated places on crest. Variants used on crest as less than 4m wide and landward face due to steepness. | | | | | | |

| <b>Recommendations</b> | Remove vegetation in gabions and repair wires. Infill low spots on crest. | | | | | | |
