## **PHASE 2: SUPPLEMENTARY GROUND INVESTIGATION**

**PROPOSED COMMERCIAL DEVELOPMENT OF LAND**

**ADJACENT TO ST THOMAS CROSS ROUNDABOUT**

**VALE VIEW, EGREMONT, CUMBRIA**

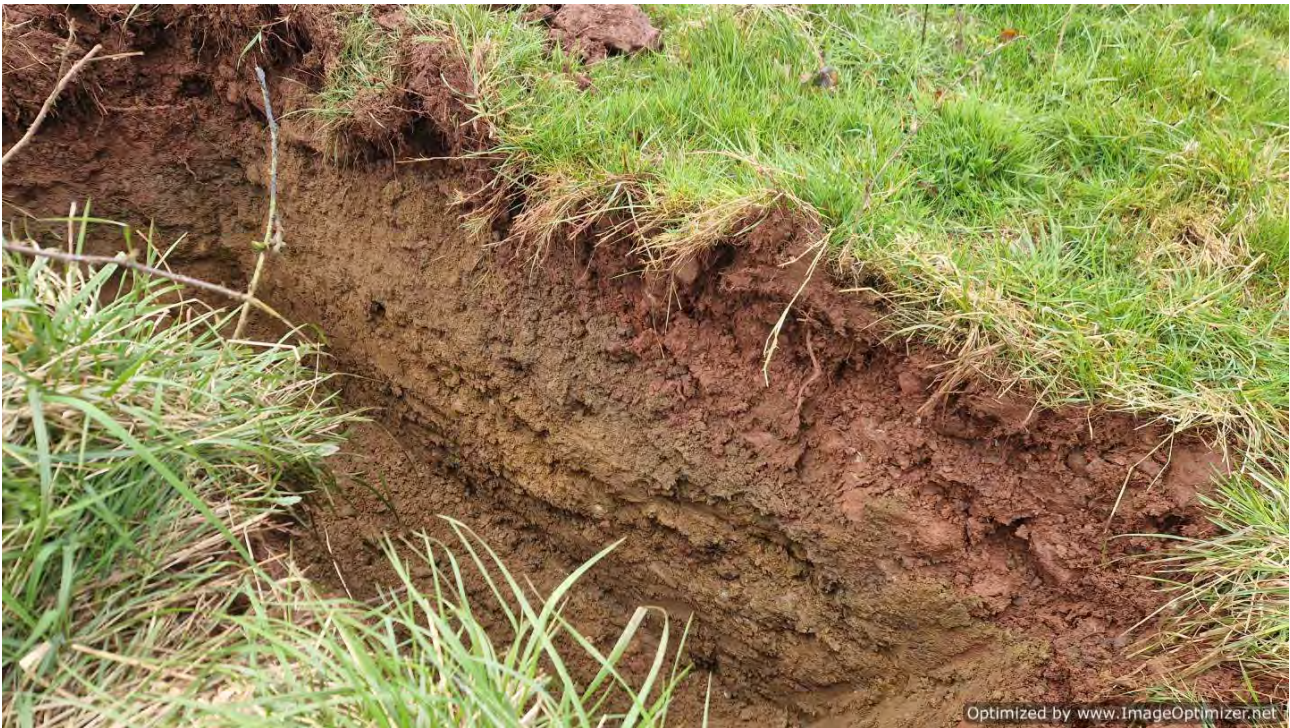
| Depth From (m) | Depth To (m) | Strata Description | Legend | Testing / Samples |
|---|---|---|---|---|
| | | End of trial hole at 1.10m.<br>Trial hole remained open and dry on completion.<br>Trial hole backfilled with arisings on completion. | | |

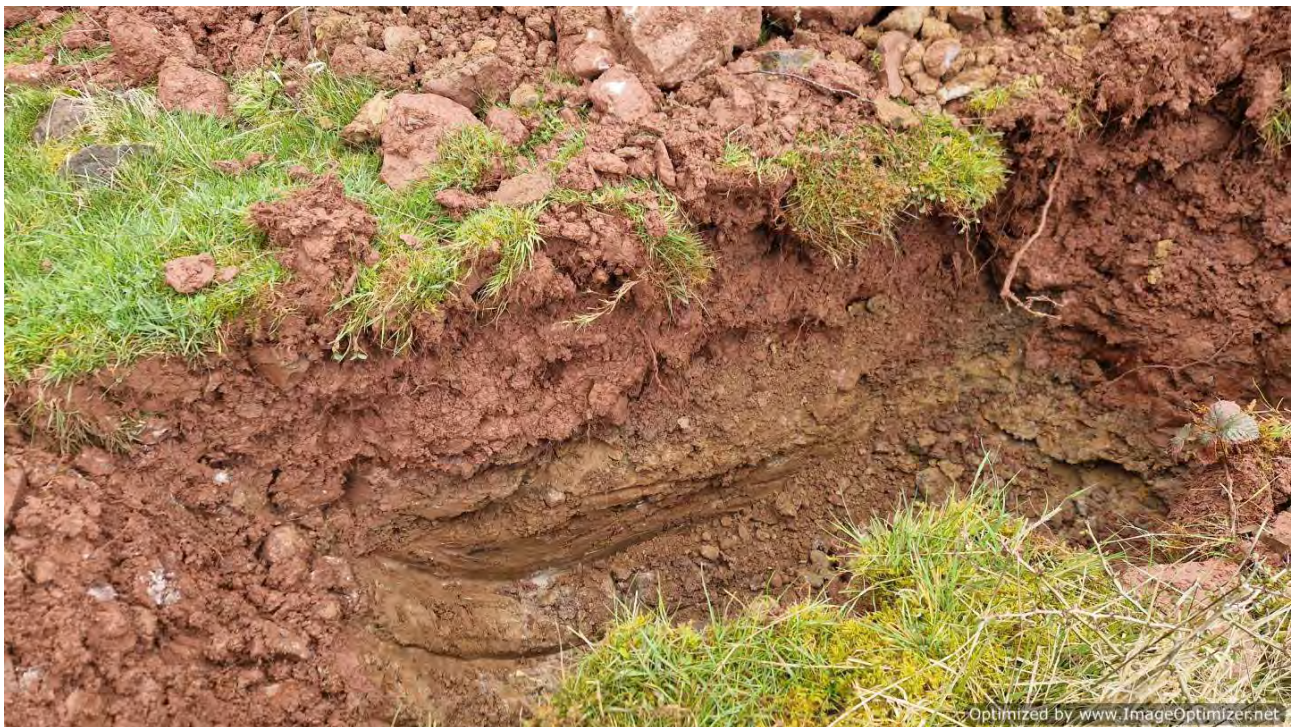
| Depth From (m) | Depth To (m) | Strata Description | Legend | Testing / Samples |
|---|---|---|---|---|
| | | End of trial hole at 1.70m.<br>Trial hole remained open and dry on completion.<br>Trial hole backfilled with arisings on completion. | | |

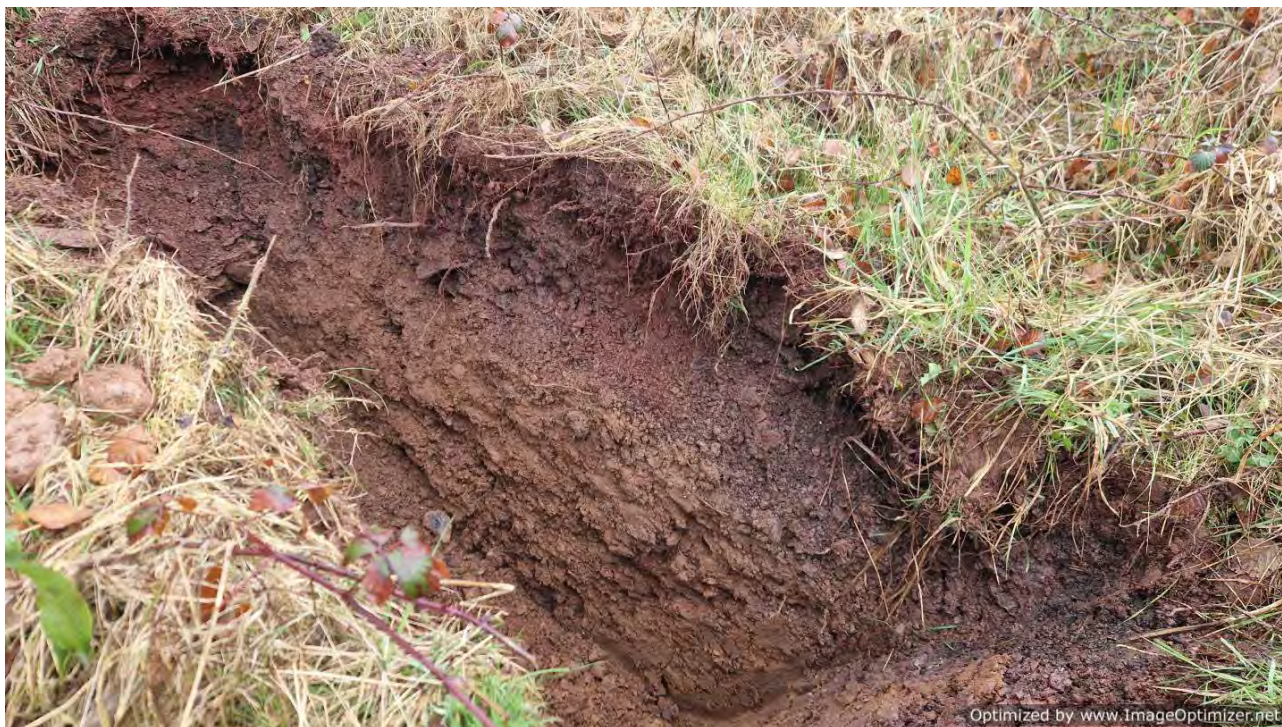
| Depth From (m) | Depth To (m) | Strata Description | Legend | Testing / Samples |
|---|---|---|---|---|
| | | End of trial hole at 1.30m.<br>Trial hole remained open and dry on completion.<br>Trial hole backfilled with arisings on completion. | | |

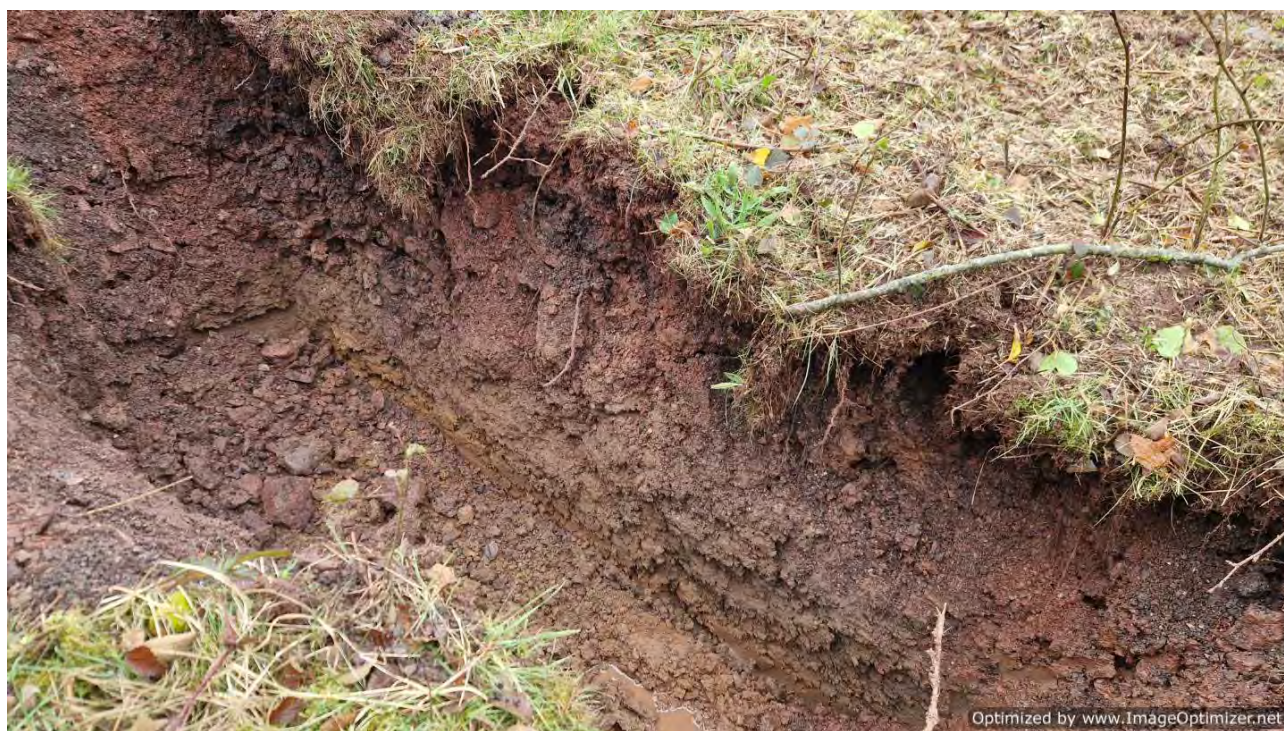
| Depth From (m) | Depth To (m) | Strata Description | Legend | Testing / Samples |
|---|---|---|---|---|
| | | End of trial hole at 1.00m.<br>Trial hole remained open and dry on completion.<br>Trial hole backfilled with arisings on completion. | | |
