# HERITAGE STATEMENT

## FULL RENOVATION OF EXISTING No 11 TERRACE HOUSES

St Bees, 1-11 Lonsdale Terrace, Parish Council, Cumbria

M.A.C Architects, Project Number: 2019:303

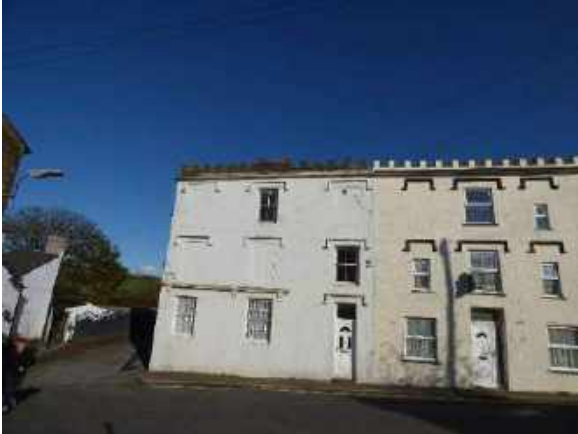
The entrance to the apartment at first and second floor is accessed from Finkle Street and it is proposed to retain this.

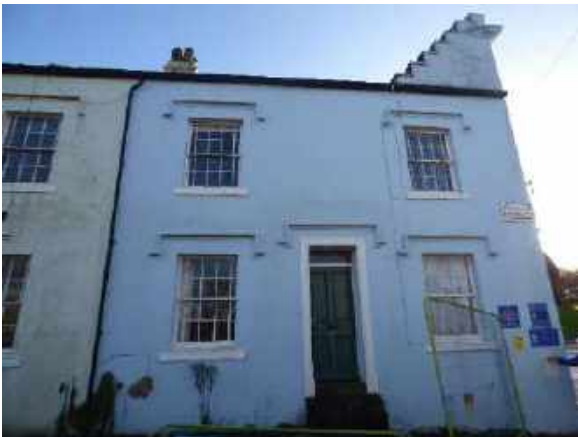
Left: The main entrance on the west facade is mentioned in the listing text and is to be entirely retained.

Both front and rear elevations are currently rendered, with colour to the front and side and natural to the rear. All elevations require to be prepared for render repairs and redecoration by specialist using lime render and stucco (Parax LTD) to be applied by specialist.

The stucco features above the windows and door on the front elevation will be carefully restored by a specialist. Colour of all render and stucco to match existing.

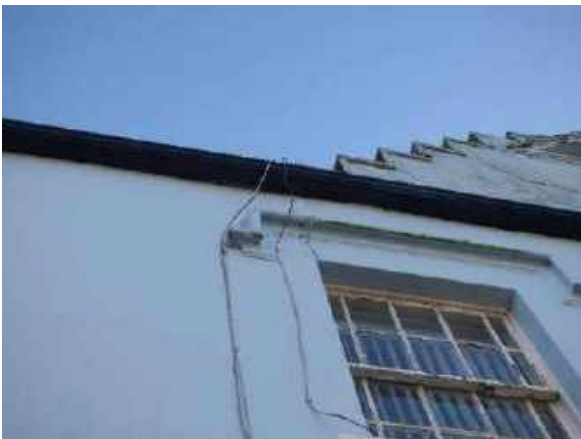
The existing door and frame are to be retained and made good with the provision of new ironmongery. Once repaired full decoration will be undertaken.

Existing gutters and downpipes to be retained, repaired where necessary and decorated.

All existing single glazed windows to be replaced with new white painted slim profile double glazed.

'heritage' windows to match the existing style by specialist supplier such as Batty Joinery, specialists in historic and listed building joinery works.

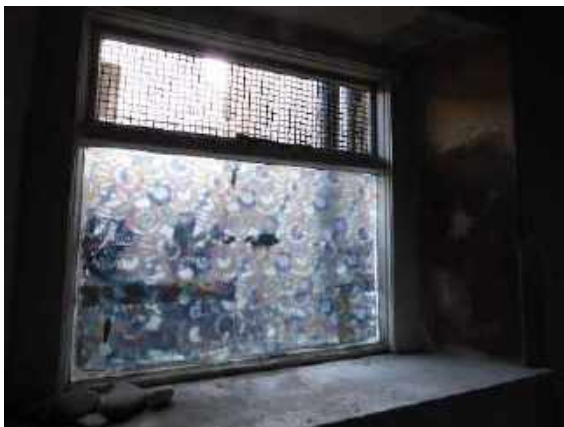
Left: The ground floor window to the rear is not original and requires replacement. The proposed replacement will reinstate the original Georgian style of window.

Existing external cills to be repaired and decorated.

Existing Velux windows to be replaced with Velux conservation rooflights (or rooflight company, heritage rooflights) (size to match existing), and new flashings to suit.

Localised lead repair work may be required to chimneys, to prevent leaking.

Roof to be repaired where necessary with slates to match existing to make the roof completely watertight.

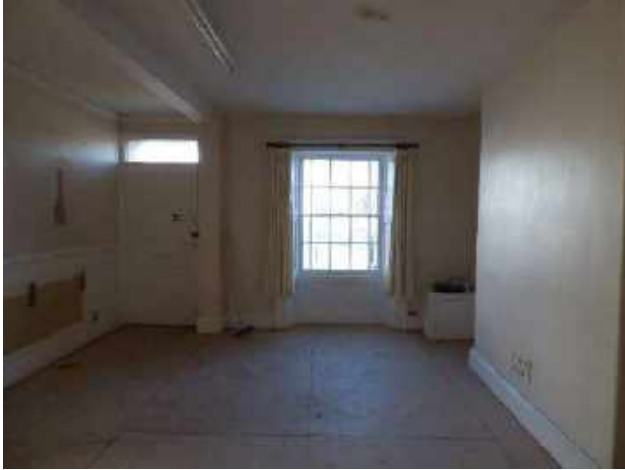
Much of the original historic internal fabric has been removed, although there are elements that have been saved and it is intended to reinstate elements of the building that have been removed, such as the cornices and skirtings.

The existing door and fanlight are to be refurbished and decorated.

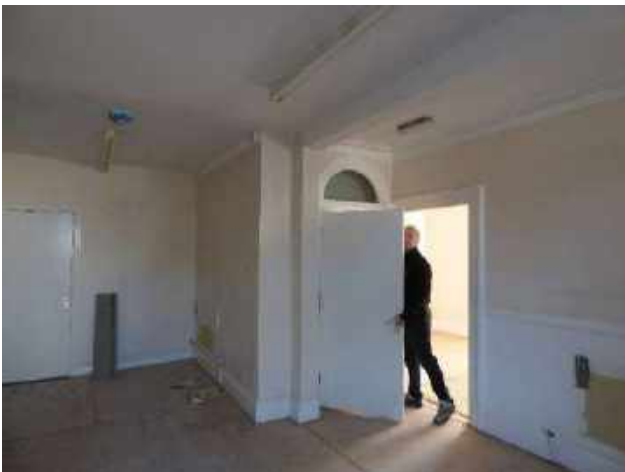
Modern strip light fittings are to be removed and all walls, ceilings and floors made good. The existing floor has been over-boarded. It is intended to overlay an oak engineered floor.

Finish with Georgian style skirting to match existing (there are examples of skirting within the rooms, and it is proposed to match up with these and repair / replace, as necessary).

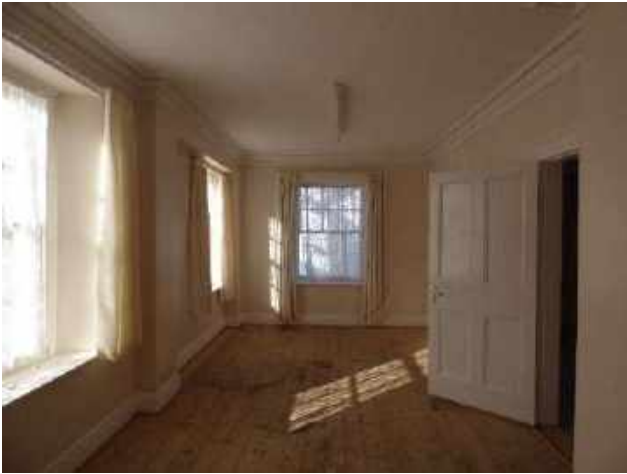
Both existing windows have the original shutters to the inside of the windows which are in excellent condition. It is proposed for these to be retained and carefully restored and decorated.

New doors at ground floor to be provided as heritage style four panel painted timber fire doors to enhance the heritage asset.

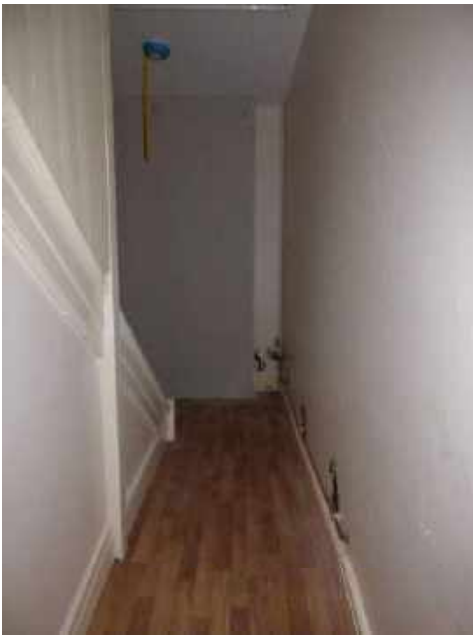
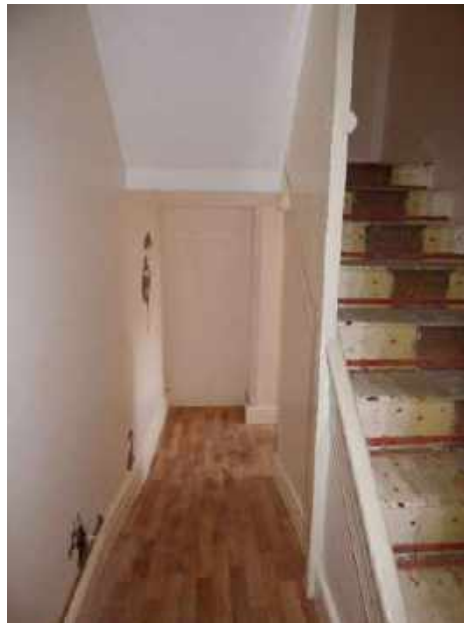
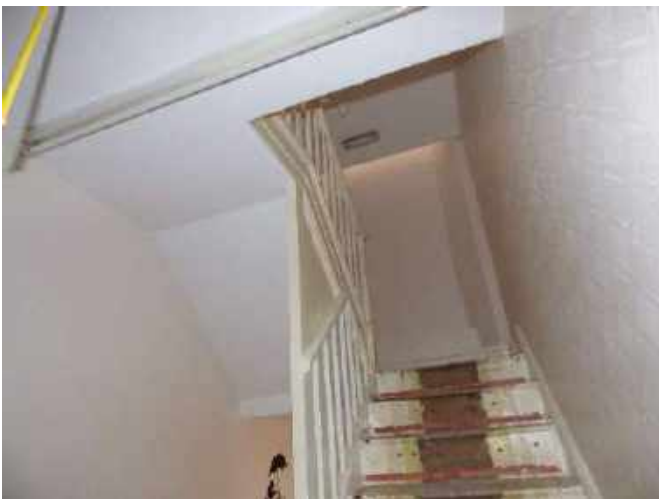
The existing staircase at ground floor has been modified as part of later alterations to the building. It is proposed to reinstate balusters and rails to match the existing to the lower part of the staircase, where they have been removed.

The existing staircase is to be retained as existing throughout the rest of the building.

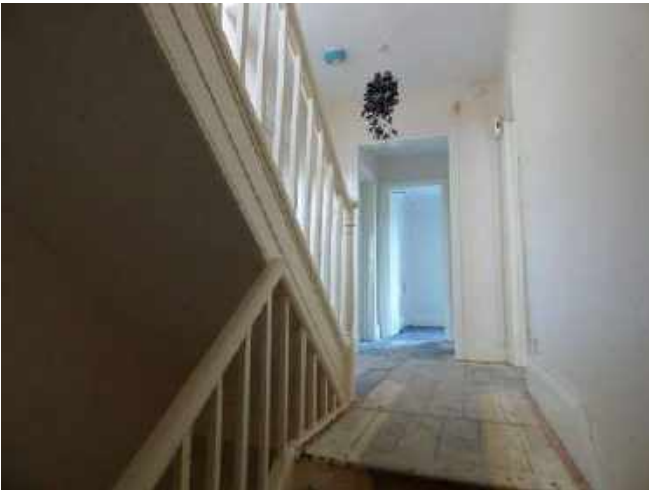
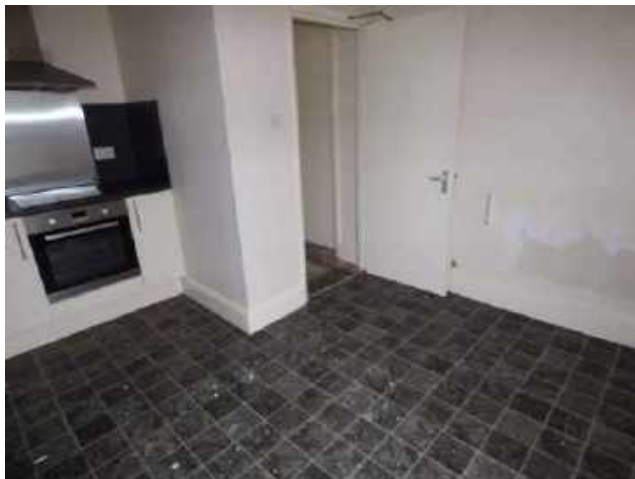
Existing kitchen, bathroom and living area at the front of the first floor, has lost most of the original heritage features.

It is proposed to remain as existing subject to minor decorative repairs. Flush panel doors to be replaced with heritage style 4 panel painted timber fire doors to enhance the heritage asset.

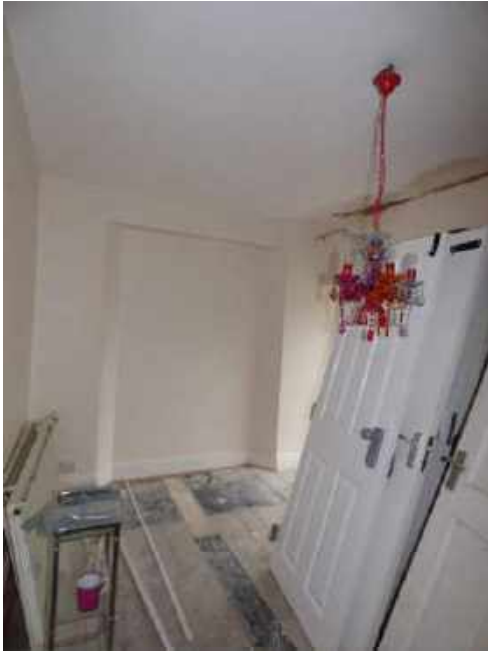
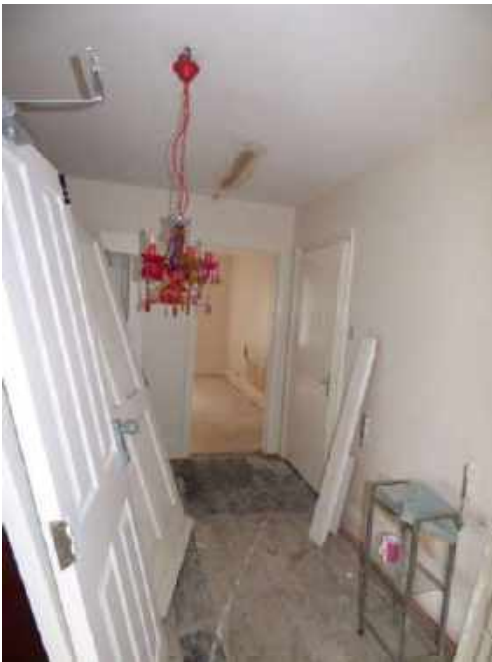
Existing living area at the rear of the first floor is proposed to remain as existing subject to minor decorative repairs. Flush panel doors to be replaced with heritage style 4 panel painted timber fire doors to enhance the heritage asset.

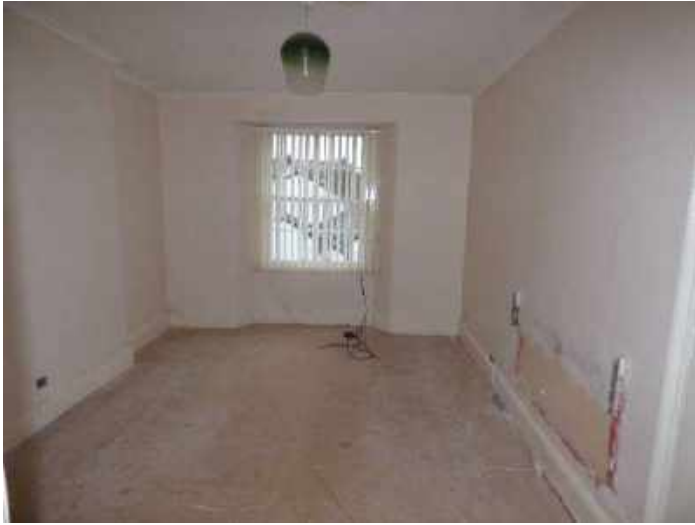
Existing living area at first floor is proposed to remain as existing subject to minor decorative repairs. Flush panel doors to be replaced with heritage style four panel painted timber fire doors to enhance the heritage asset.

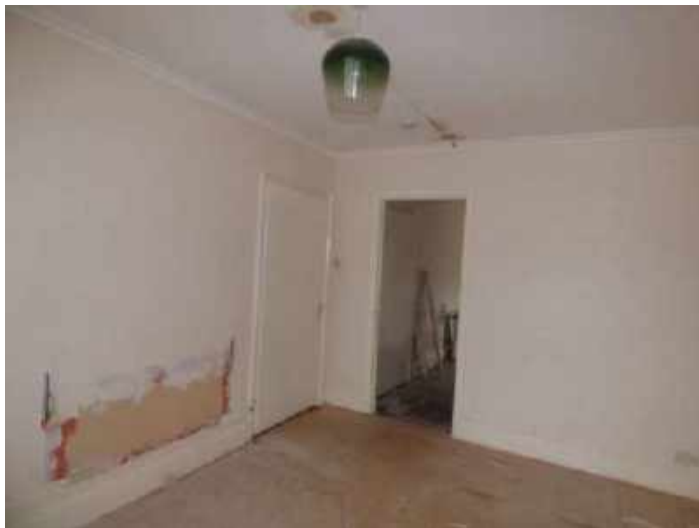
Existing living area at first floor is proposed to remain as existing subject to minor decorative repairs. Flush panel doors to be replaced with heritage style 4 panel painted timber fire doors to enhance the heritage asset.

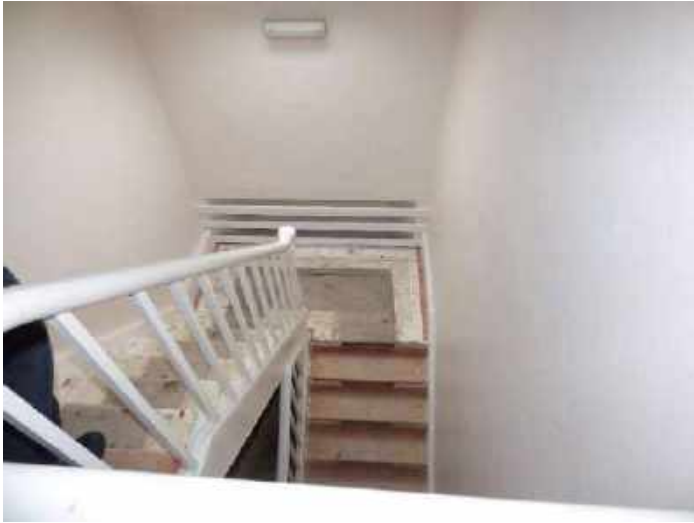
Handrail, balusters, and rails are original and are to be retained.

Apply an insulated plasterboard 62mm thick to underside of sloping ceiling, tape and skim and undertake full decorations.

Remove existing Velux and replace with heritage style rooflight (Velux or similar).

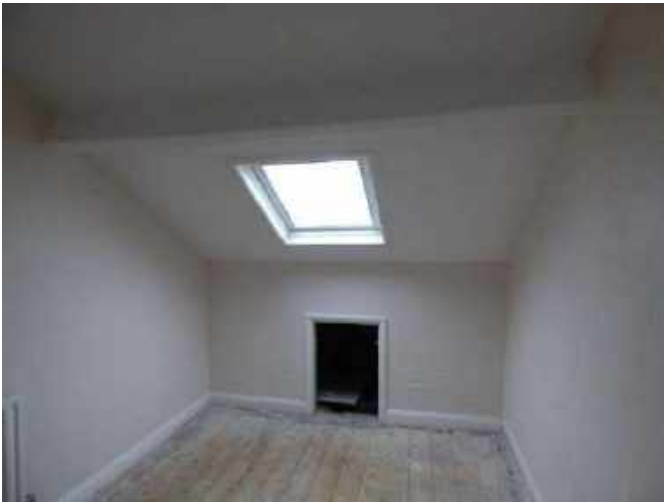
**Attic Bedroom (gable end)**

Floorboards are in good condition (but may require minor repairs).

Remove all damp and damaged / blown plasterwork and repair with lime plaster.

And new heritage rooflight windows (Velux or similar).

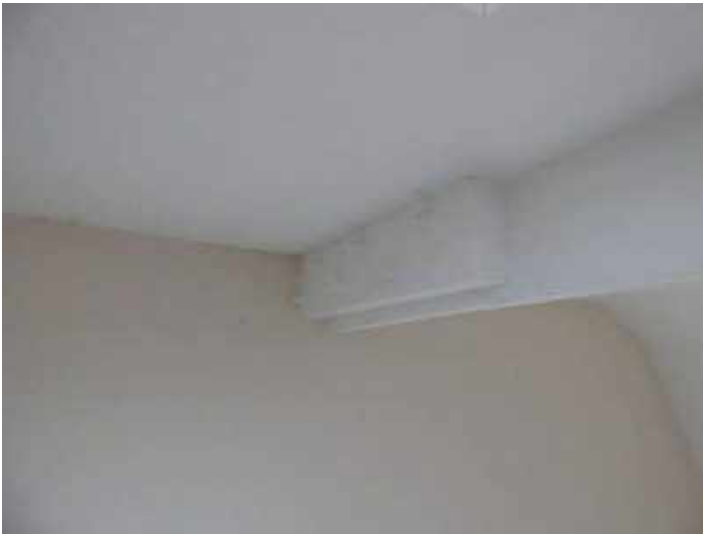
#### Attic Bedroom

Floorboards are in good condition (but may require minor repairs.

Remove all damp and damaged / blown plasterwork and repair with lime plaster and skim and decorate throughout.

Existing flush panel doors are to be removed and replaced with new heritage style four panel fire rated doors.

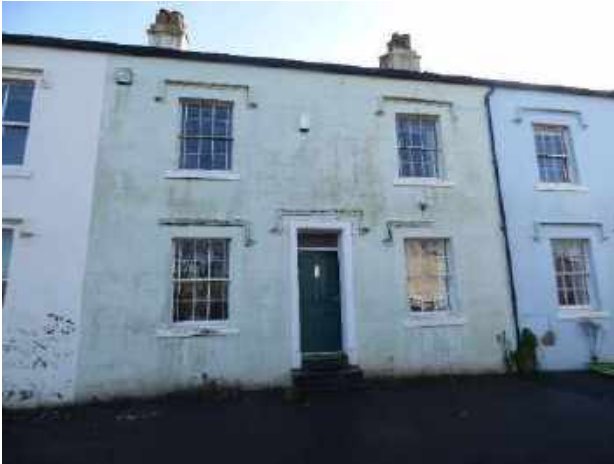
Left: The main entrance is mentioned in the listing text and is to be entirely retained.

Both front and rear elevations are currently rendered, with colour to the front and side and natural to the rear. All elevations require to be prepared for render repairs and redecoration by specialist using lime render and stucco (Parax LTD) to be applied by specialist.

The stucco features above the windows and door on the front elevation will be carefully restored by a specialist. Colour of all render and stucco to match existing.

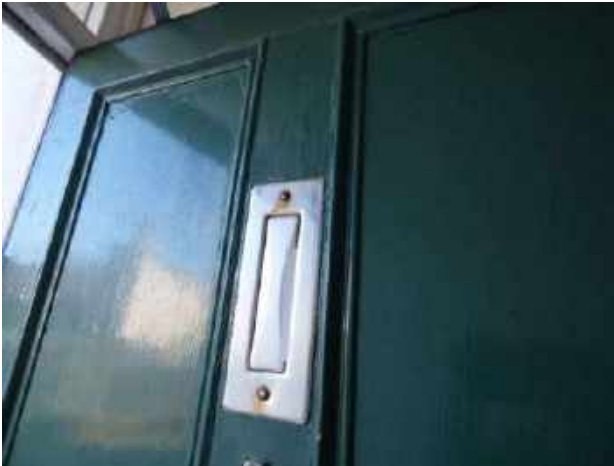
The existing door and frame are to be retained and made good with the provision of new ironmongery. Once repaired full decoration will be undertaken.

Existing gutters and downpipes to be retained, repaired where necessary and decorated.

All existing single glazed windows to be replaced with new white painted slim profile double glazed 'heritage' windows to match the existing style by specialist supplier such as Batty Joinery Ltd, specialists in historic and listed building joinery works.

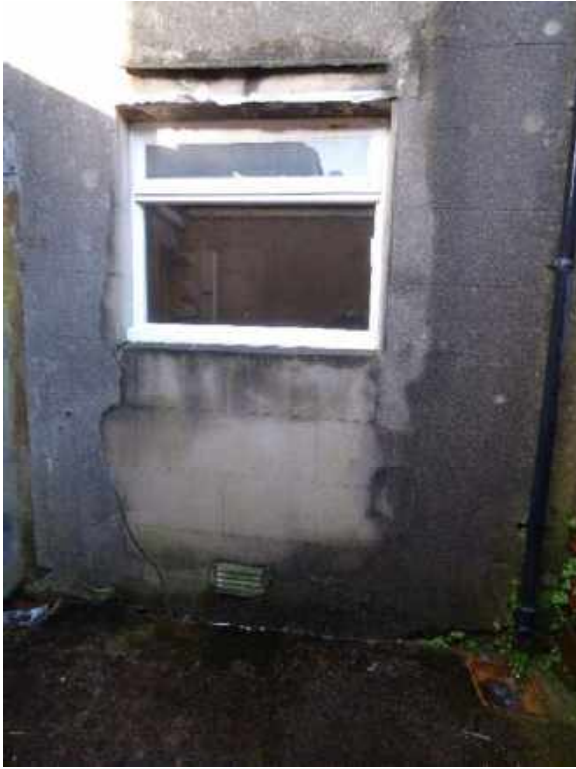
Left: The ground floor window to the kitchen is not original and requires replacement. The proposed replacement will reinstate the original Georgian style of window, in the original opening (which has been walled up), with a double-glazed slimline heritage painted timber window that would have been originally installed.

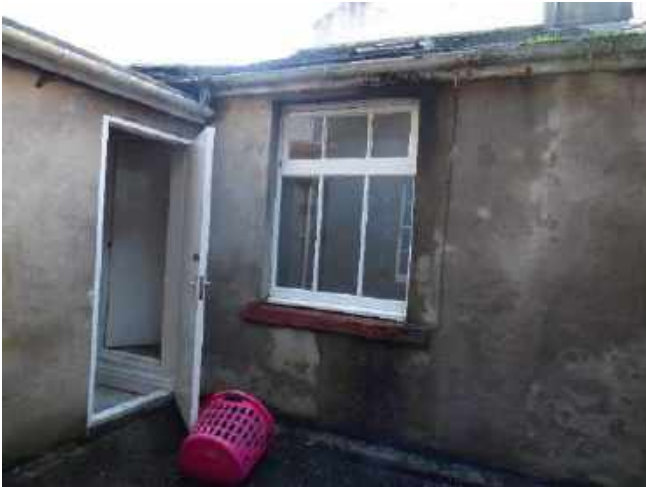
Poorly constructed 'link' building to be removed to return the original building back to its former configuration.

Above, Rear of property to be retained— render to be repaired by specialist and decorated with off-white (cream) render.

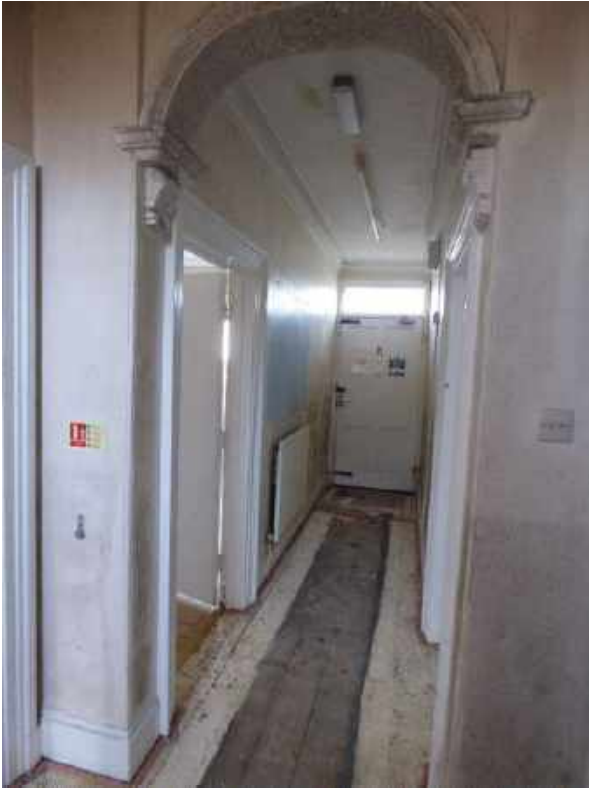
Left: The existing walls and floor are generally in good condition.

Redundant M&E to be removed and wall / ceiling finishes made good, and primed, prepared, and fully decorated.

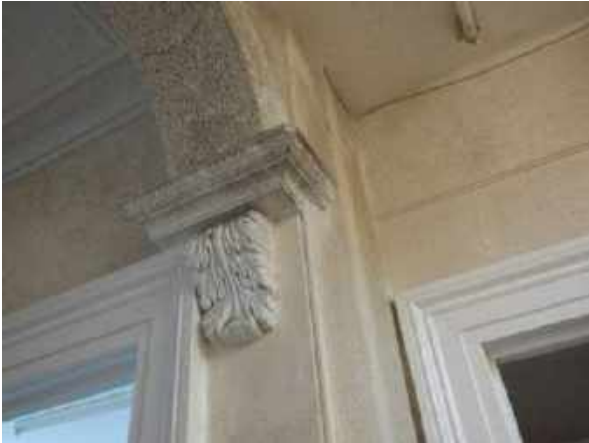
Left: period features to be retained, including archway and architraves. (Modern lighting to all be stripped out and make good surfaces). All architraves and plaster features to be retained.

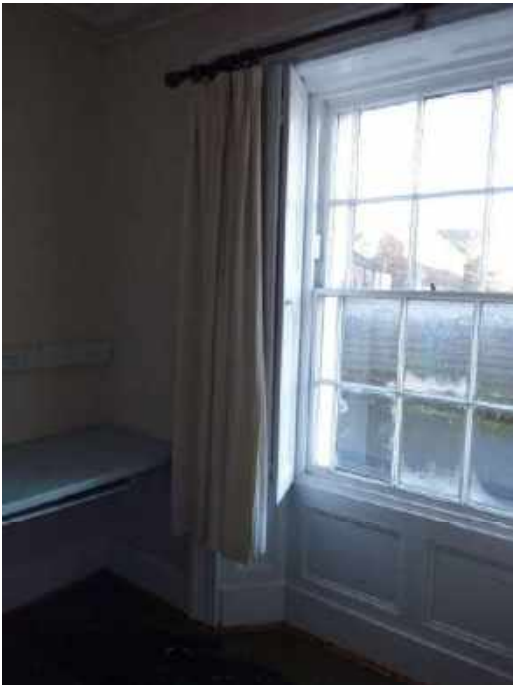
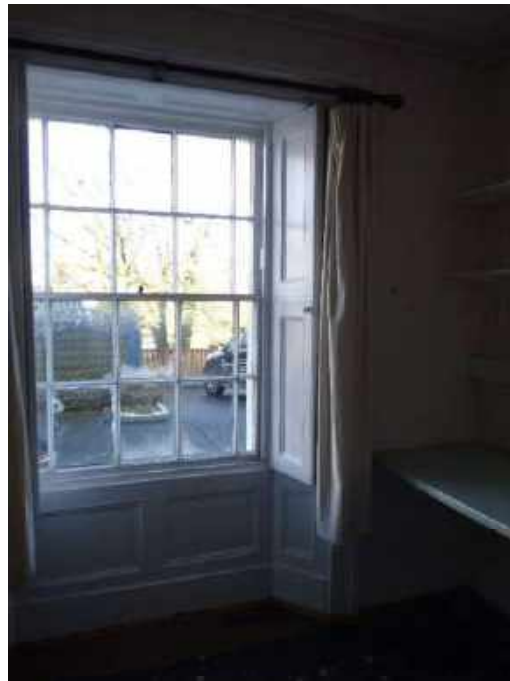
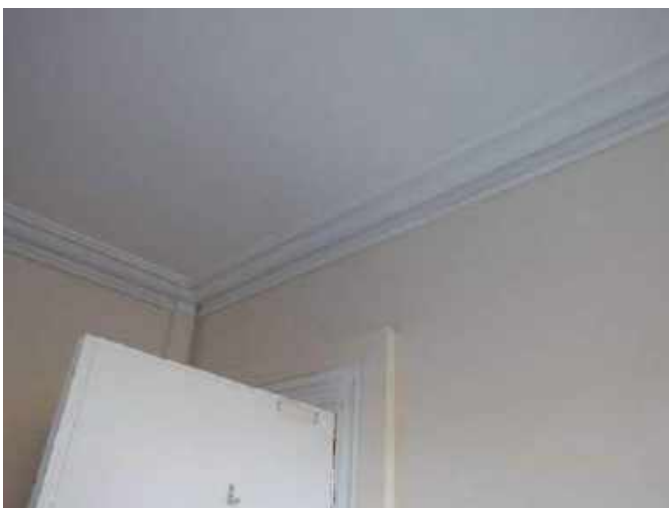
Above: In the existing study, the period features below and to the sides of the existing window are in good condition, it is proposed to carefully refurbish the existing timber shutters.

Left: Existing cornice to be made good in locations where redundant services are to be removed and where hairline cracks have appeared.

Existing architraves, and skirtings to be retained and made good.

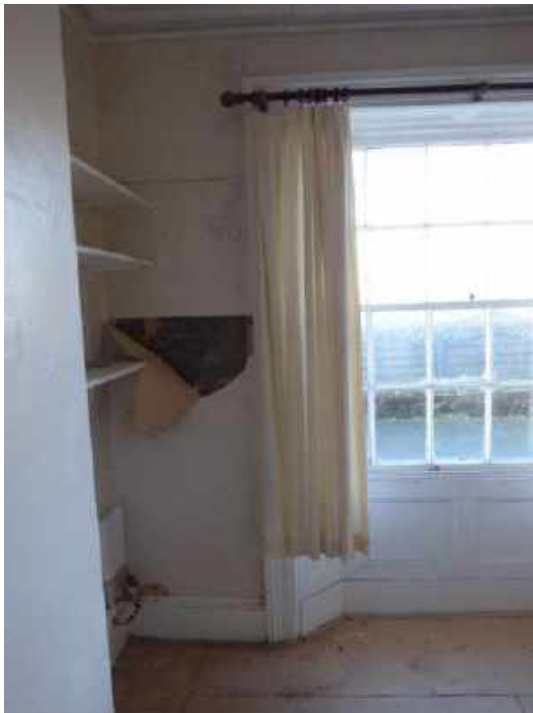
Above: In the existing lounge at the front of the property and

Left and below: the existing dining area to the rear of the property, the period features below and to the sides of the existing window are in good condition, it is proposed to carefully refurbish the existing timber shutters.

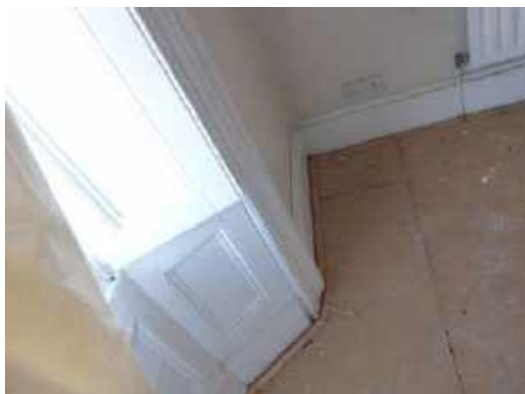
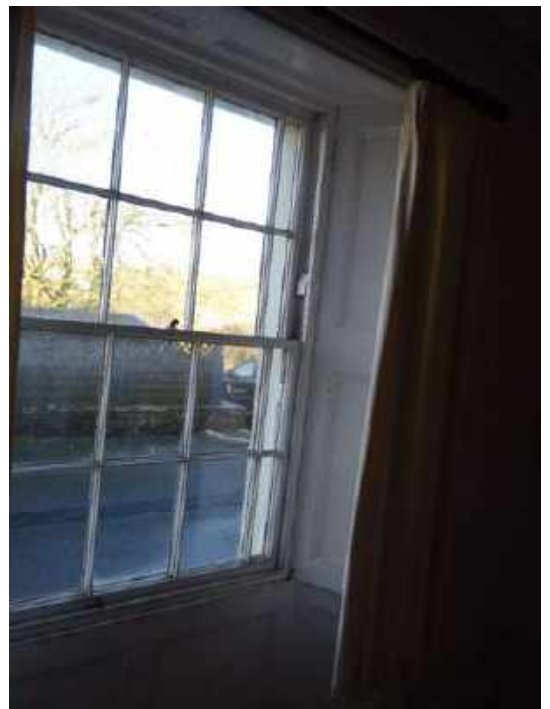
Below: Existing cornice to be made good in locations and where hairline cracks have appeared.

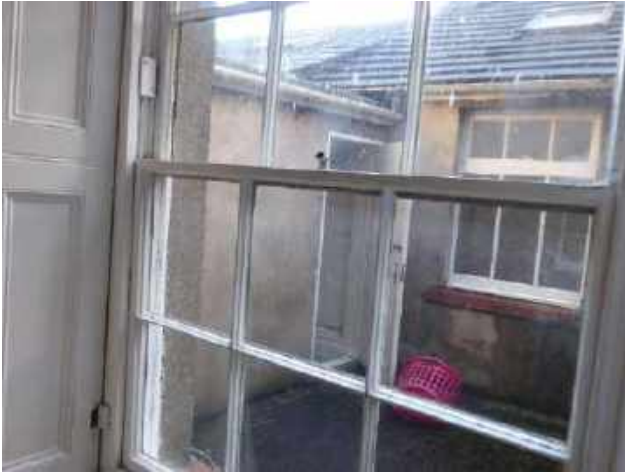
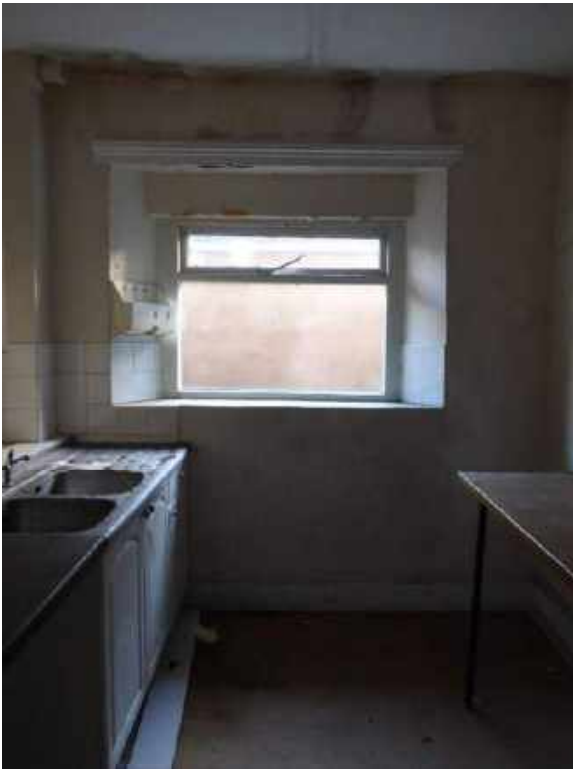
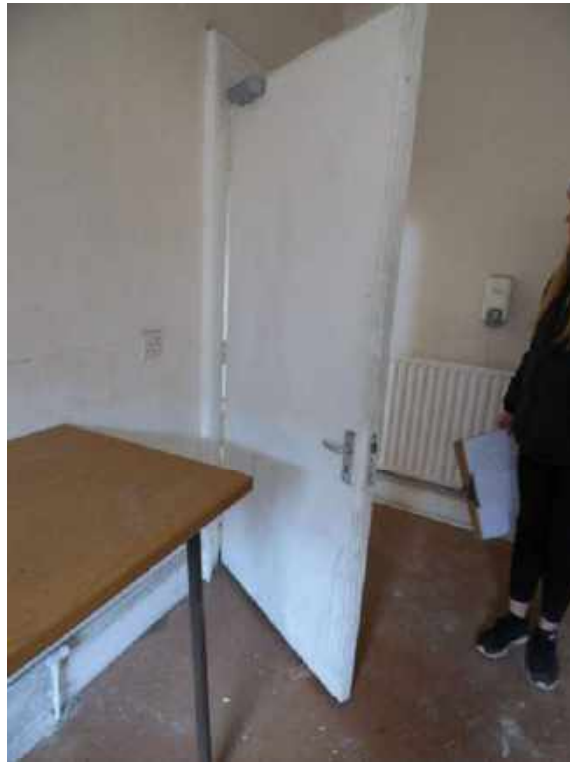
Existing modern single glazed window to be replaced by new double glazed heritage sash hardwood painted timber window, that would have been installed originally. The existing opening is to be adjusted to return the window opening to its original size.

Flush panel doors to be replaced with heritage style four panel painted timber fire doors to enhance the heritage asset.

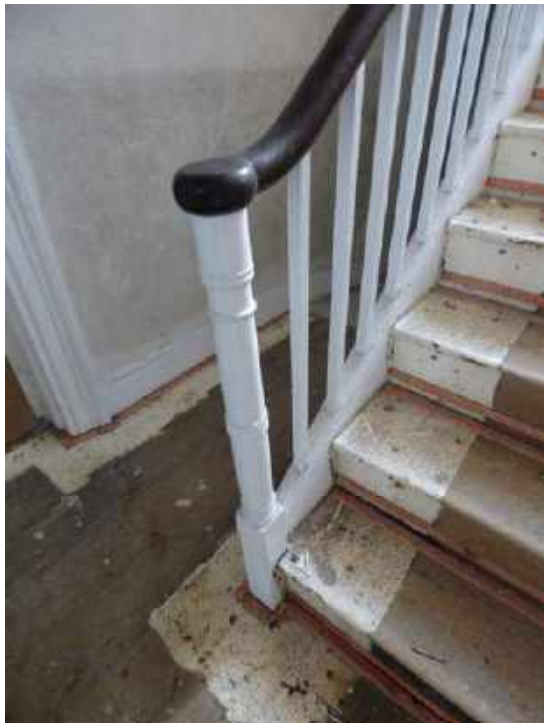
Left: Retain original staircase, which is in good condition. One missing baluster between first and second floor staircase to be provided with new baluster to match existing.

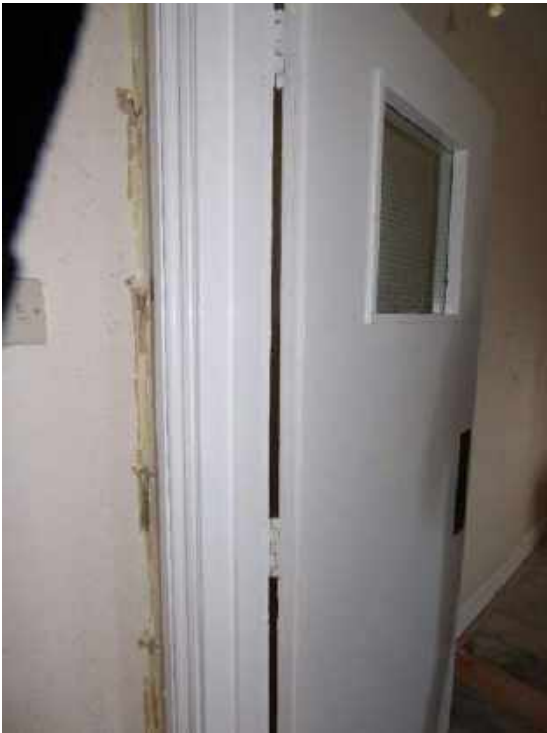
Left and Below: Existing bathroom, all to be completely renovated. All existing FF&E and M&E to be removed and all surface finishes to be completely removed and walls made good.

New Georgian heritage style 4 panel door to be provided and installed by specialist joinery company such as Batty Joinery Ltd. All fabric damage to be carefully repaired. New four panelled heritage door to be provided and installed.

Bathroom to be reduced in size to accommodate new en-suite to master bedroom.

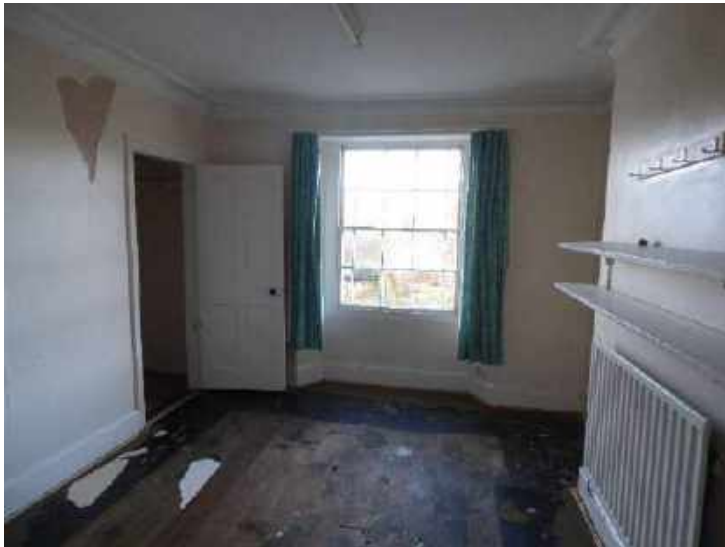
Front bedroom (First floor RHS), cornice, skirtings, and architraves to be retained. Existing flush panelled door to be replaced with new Georgian heritage style 4 panel fire door to be provided and installed by specialist joinery company such as Batty Joinery Ltd.

Existing floorboards in good condition.

It is proposed to form new doorway with architraves to match existing, and new four panelled door, into a new en-suite to be formed from part of the existing over large bathroom to make efficient use of the space and reflect the requirements of modern-day living.

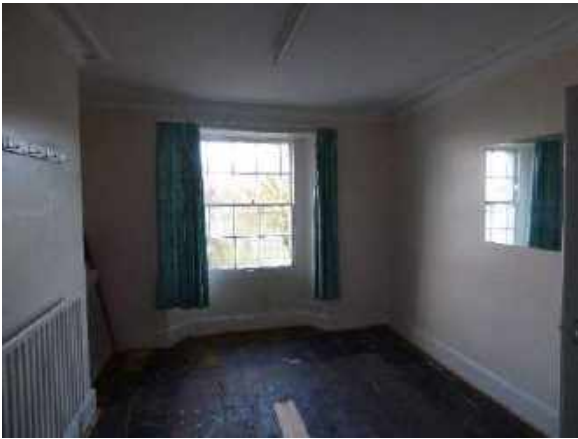
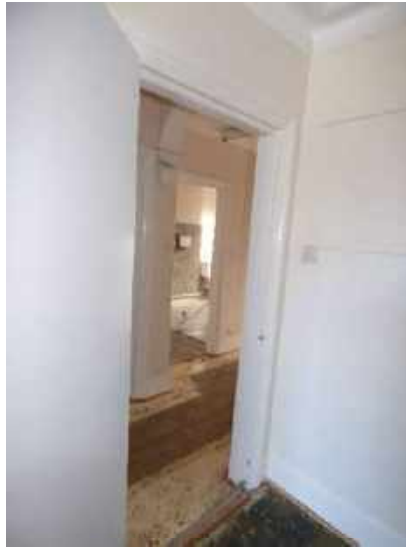
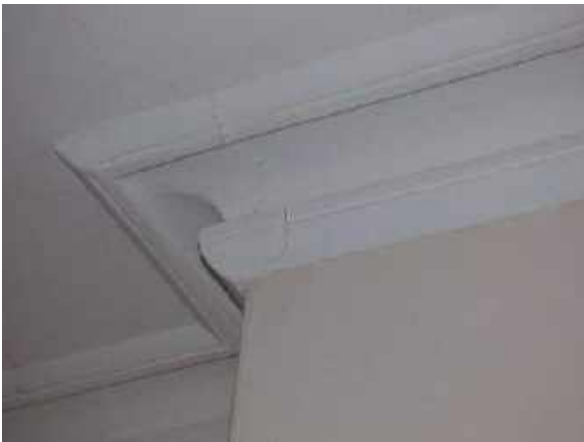
Front bedroom (First floor LHS), cornice, skirtings, and architraves to be retained. Existing flush panelled door to be replaced with new Georgian heritage style four panel fire door to be provided and installed by specialist joinery company such as Batty Joinery Ltd.

Existing floorboards in good condition. Minor repairs may be necessary.

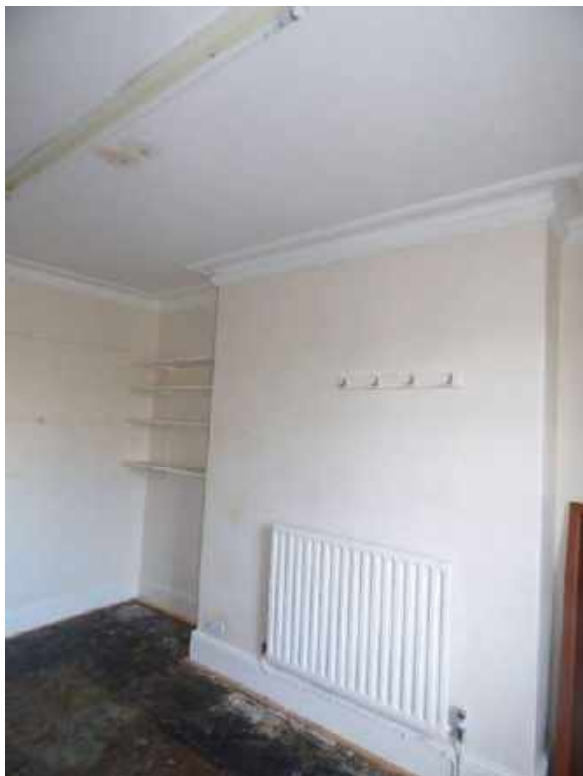
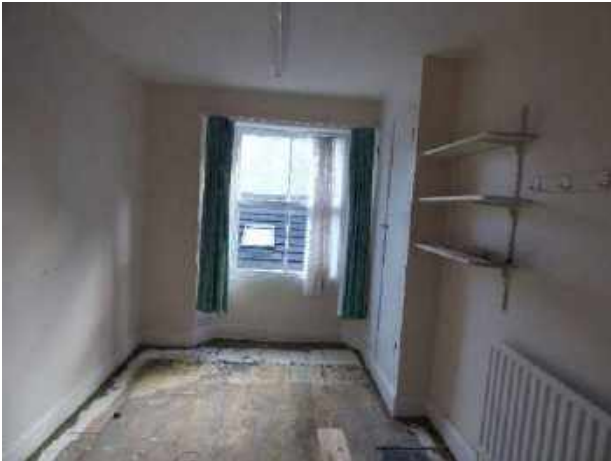
Rear bedroom existing skirtings and architraves to be retained. Existing modern flush panelled door to be replaced with new Georgian heritage style 4 panel door fire door to be provided and installed by specialist joinery company such as Batty Joinery Ltd.

Damp ingress has affected plasterwork by window. It is proposed to rake back existing blown plaster and repair with new lime plaster. The installation of the new window should resolve the damp ingress.

Existing floorboards in good condition. Minor repairs may be necessary.

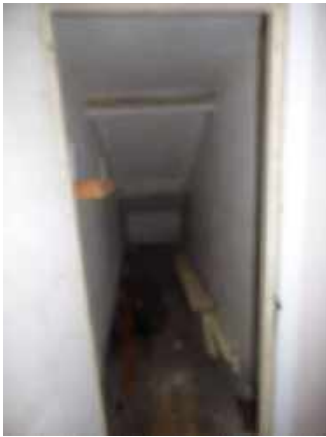
Left: Attic Store is proposed to be converted into a bathroom to be shared by the attic bedrooms by increasing the size of the room to each side to allow for the new bathroom.

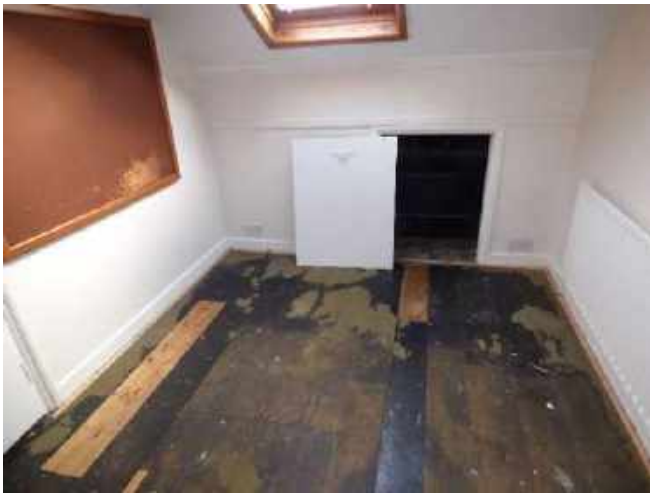
Left: Attic Bedroom

New plasterboard std partition to be installed in lieu of removal of part of existing store / bedroom partition to allow for bathroom to be useable size.

In the bedroom remove all damp and damaged / blown plasterwork and repair with lime plaster and skim and decorate throughout.

Floorboards are in good condition (but may require minor repairs).

Existing flush panel doors are to be removed and replaced with new heritage style 4 panel fire doors.

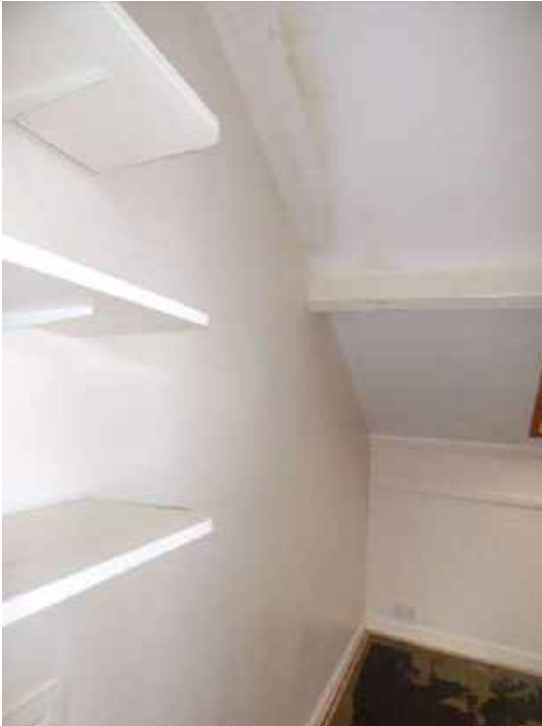
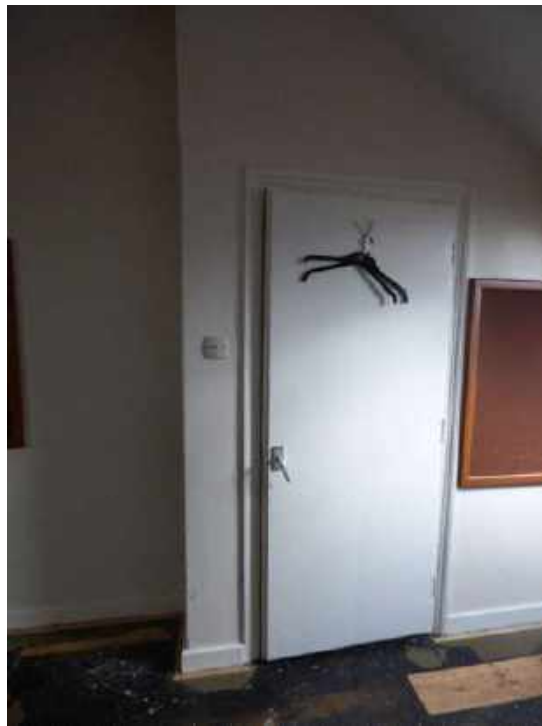
Above and below: Attic Bedroom

New plasterboard std partition to be installed in lieu of removal of part of existing store / bedroom partition to allow for bathroom to be useable size.

In the bedroom remove all damp and damaged / blown plasterwork and repair with lime plaster and skim and decorate throughout.

Apply an insulated plasterboard 62mm thick to underside of ceiling tape and skim and undertake full decorations. New heritage rooflights to be installed to replace existing rooflights.

Floorboards are in good condition (but may require minor repairs).

Existing flush panel doors are to be removed and replaced with new heritage style 4 panel fire doors.

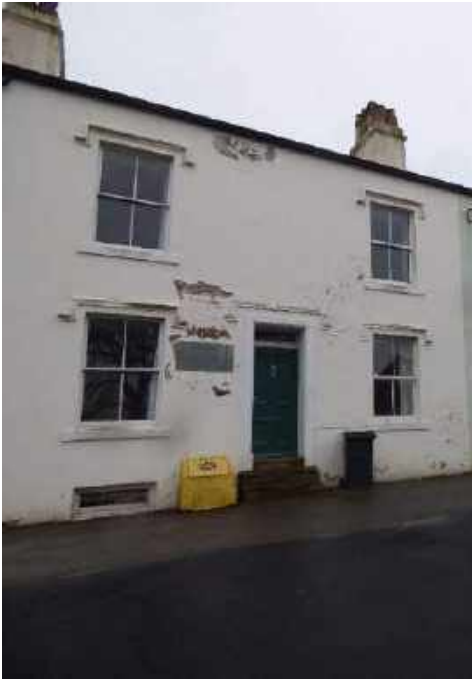
Left: The main entrance is mentioned in the listing text and is to be entirely retained.

Both front and rear elevations are currently rendered, with colour to the front and side and natural to the rear. All elevations require to be prepared for render repairs and redecoration by specialist using lime render and stucco (Parax LTD) to be applied by specialist.

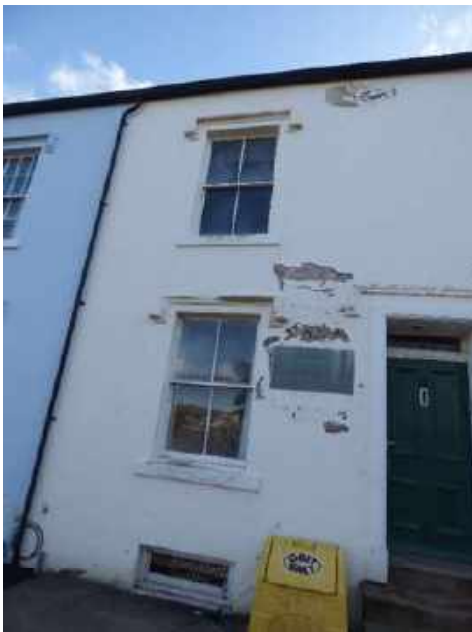
All existing single glazed windows to replace with new white painted slim profile double glazed.

'heritage' windows to match the existing style by specialist supplier such as Batty Joinery Ltd, specialists in historic and listed building joinery works.

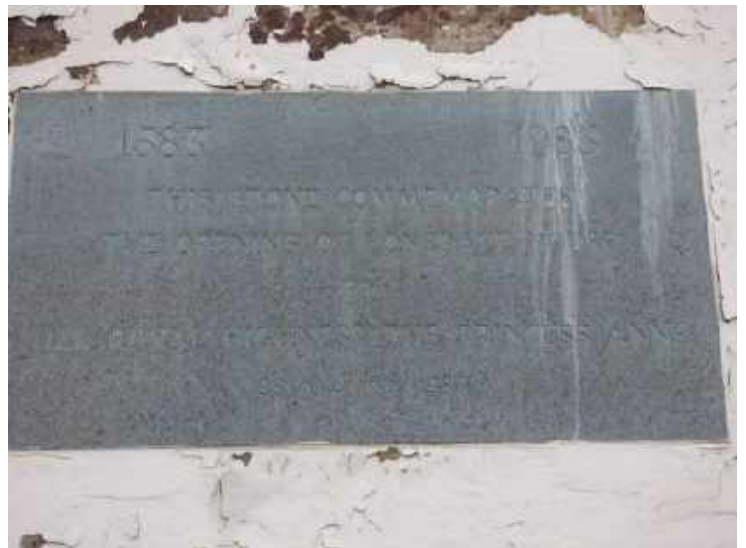
Above: Commemoration stone to be cleaned and restored to mark the opening of Lonsdale House on 28<sup>th</sup> June 1983 by HRH Princess Ann.

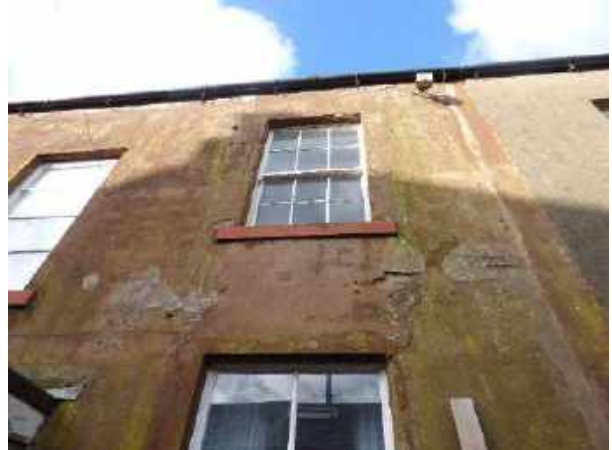
Existing gutters and downpipes to be retained, repaired where necessary and decorated.

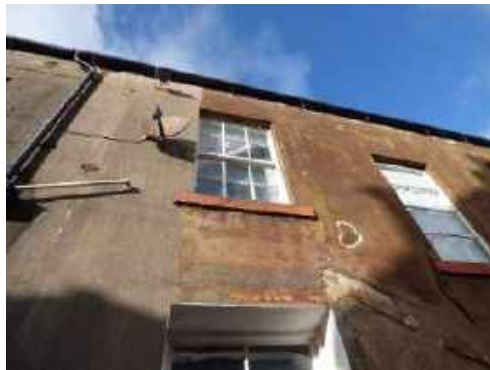
All existing single glazed windows to replace with new white painted slim profile double glazed.  
'heritage' windows to match the existing style by specialist supplier such as Batty Joinery Ltd.

Existing cills to be repaired and decorated.

Existing Velux windows to be replaced with Velux conservation rooflights (or Rooflight company, heritage rooflights) (size to match existing), and new flashings to suit.

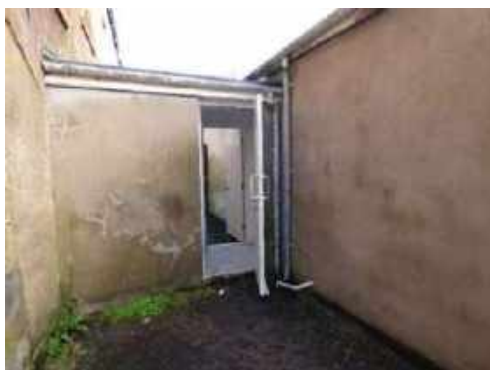
Localised lead repair work may be required to chimneys, to prevent damp ingress.

Rear of property, and outbuilding – render to be repaired by specialist and decorated with off white colour.

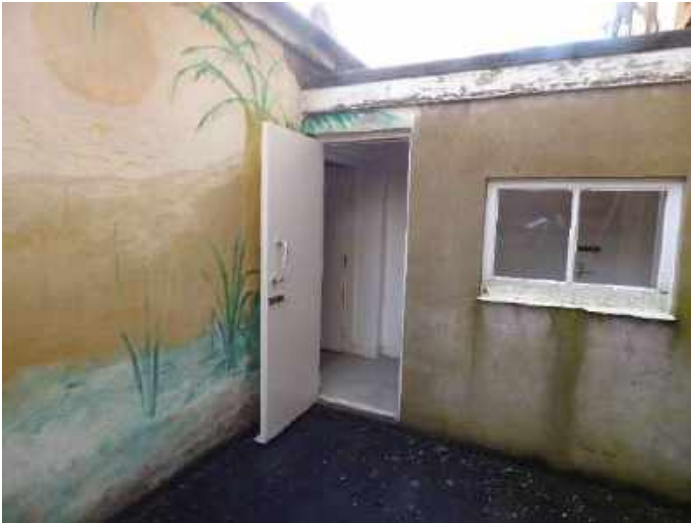
Existing link building to be completely removed and the existing house to be made good. New door to rear to be Georgian style as front door.

Part of the existing outbuilding to be carefully demolished to allow for additional recreation space for the property, while retaining an outbuilding to provide a home office or storage for the property.

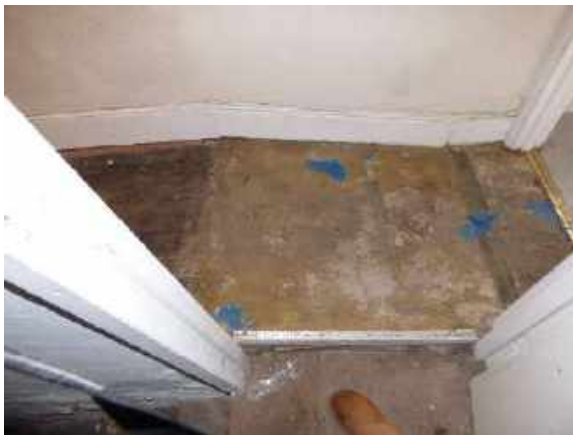
Left: The existing walls and floors are generally in good condition.

Redundant M&E to be removed and wall / ceiling finishes made good, and primed, prepared, and fully decorated.

Handrails, balusters, and rails are original, and to be retained.

Flush panel doors to be replaced with heritage style four panel painted timber fire doors to enhance the heritage asset.

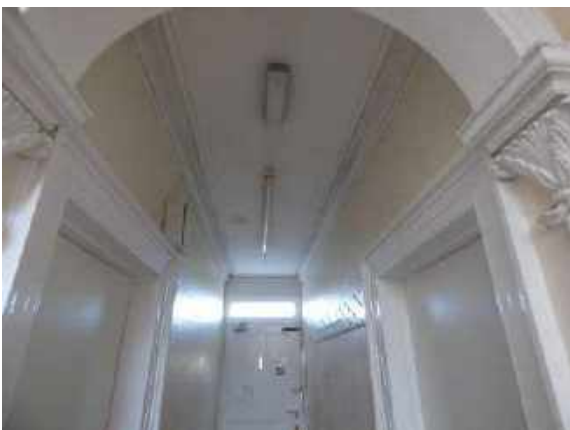
Left: Period features to be retained, including archway and architraves. (Modern lighting to all be stripped out and make good surfaces). All architraves and plaster features to be retained.

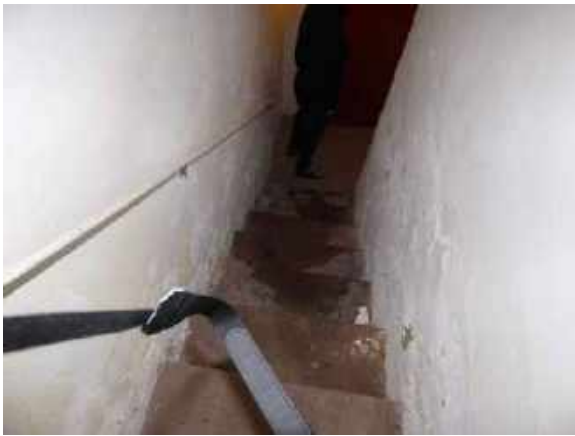
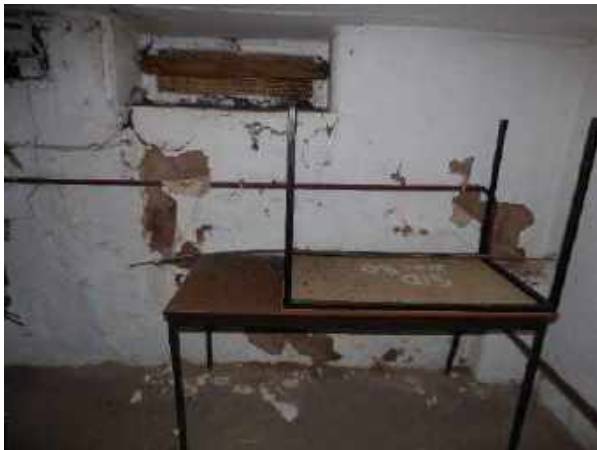
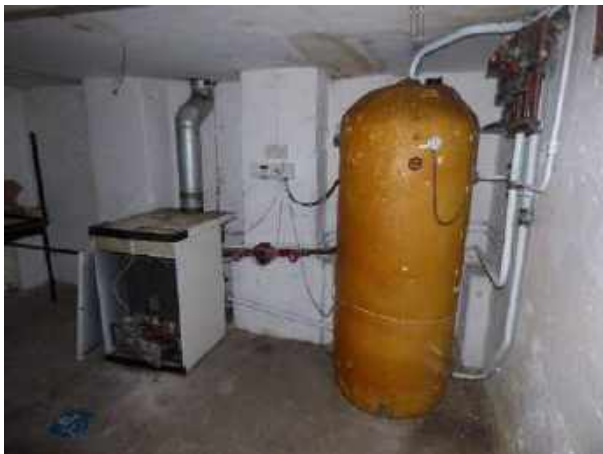
Left: The basement

The existing walls and floor are generally in sound condition so would be suitable for the application of damp proof slurry system. All existing paint and surface finishes must be removed and made good including all snots removed, and damage to existing surfaces, prior to the installation of a Koster Polysil NB1. This migratory crystalline tanking slurry is used to seal below ground structures against water ingress.

Koster NB1 is considered to be a Type A waterproofing system as defined by BS8102:2009 and is generally used to seal the inside face of basement structures, slabs and retaining walls.

Koster NB1 works by both providing a physical barrier against water ingress as well as providing a migratory crystal sealant that penetrates deep into the structure to seal micropores and cracks against water ingress.

Once applied then the walls can be prepared and primed for decorating and for the floor finish to be installed. Complete new boiler and heating system is required, new distribution boards etc.

The walls down to the basement also require the full treatment.
