# HERITAGE STATEMENT

## FULL RENOVATION OF EXISTING No 11 TERRACE HOUSES

St Bees, 1-11 Lonsdale Terrace, Parish Council, Cumbria

M.A.C Architects, Project Number: 2019:303

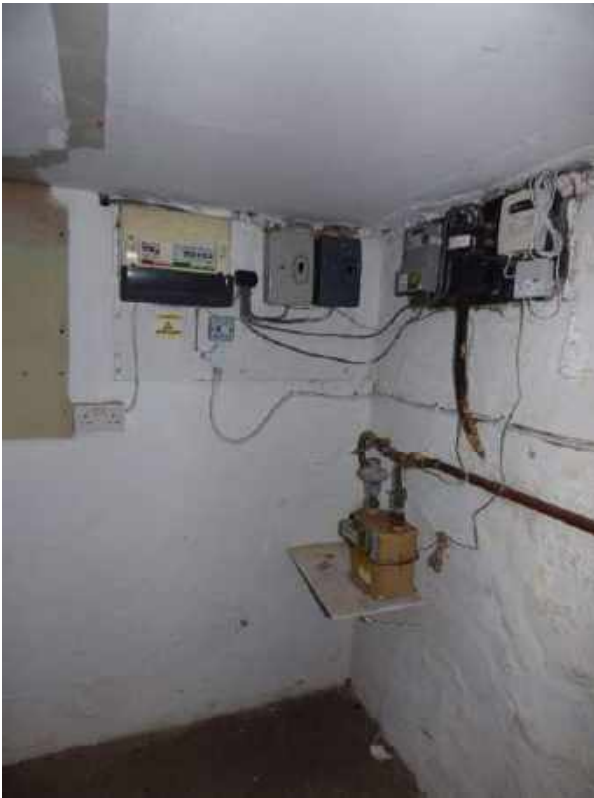
In the basement all existing services are to be carefully stripped out and replaced with new compliant infrastructure.

Existing window to basement requires replacement and reveals made good.

All existing services to be carefully removed and new gas and electric services installed.

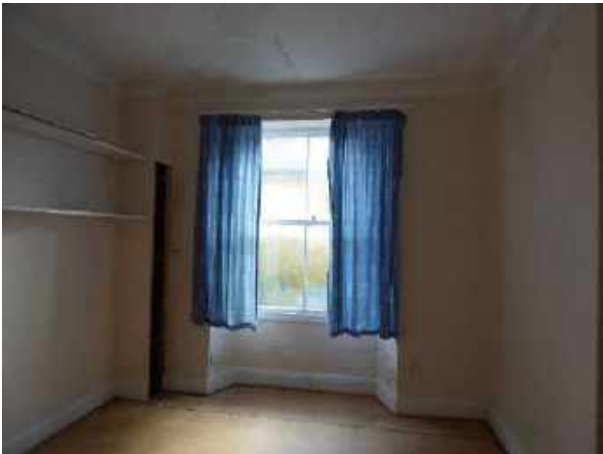
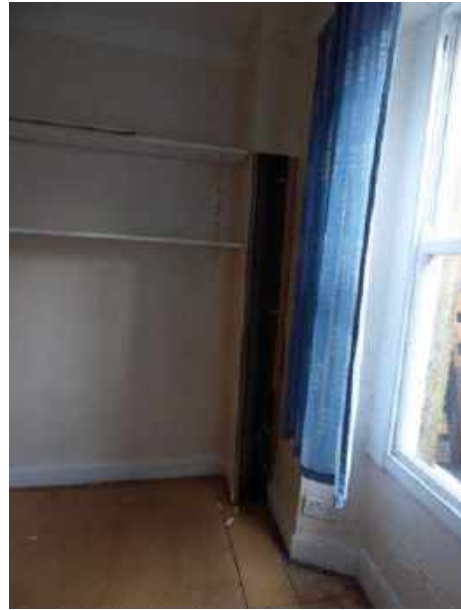
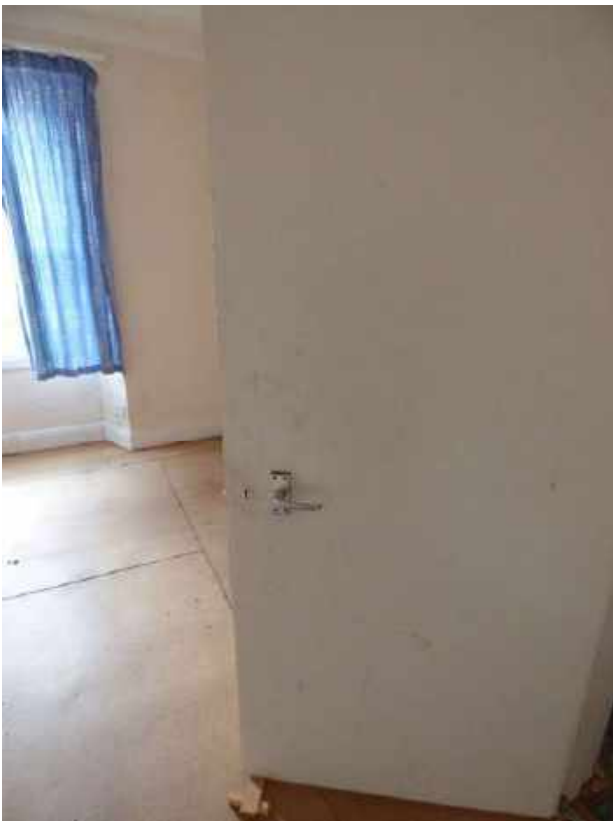
In the existing study, the period features below and to the sides of the existing window are in good condition, it is proposed to carefully refurbish the existing timber shutters.

Left: Existing cornice to be made good in locations where redundant services are to be removed and where hairline cracks have appeared.

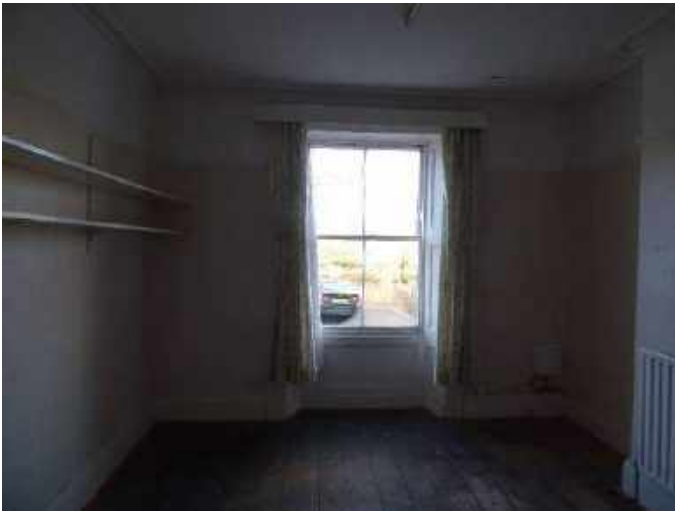
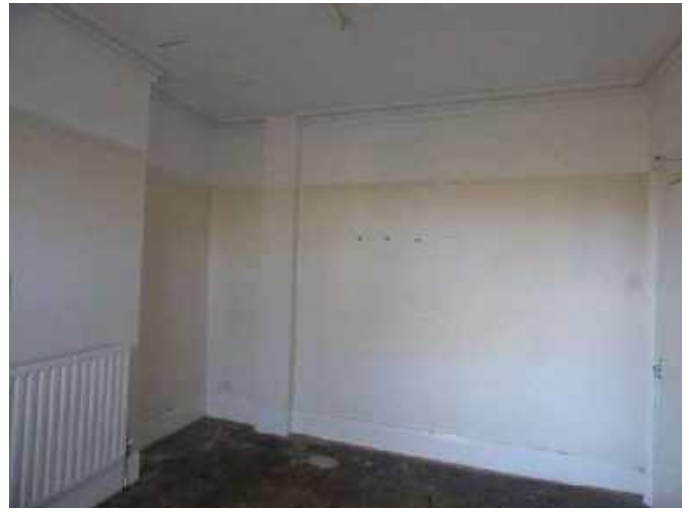
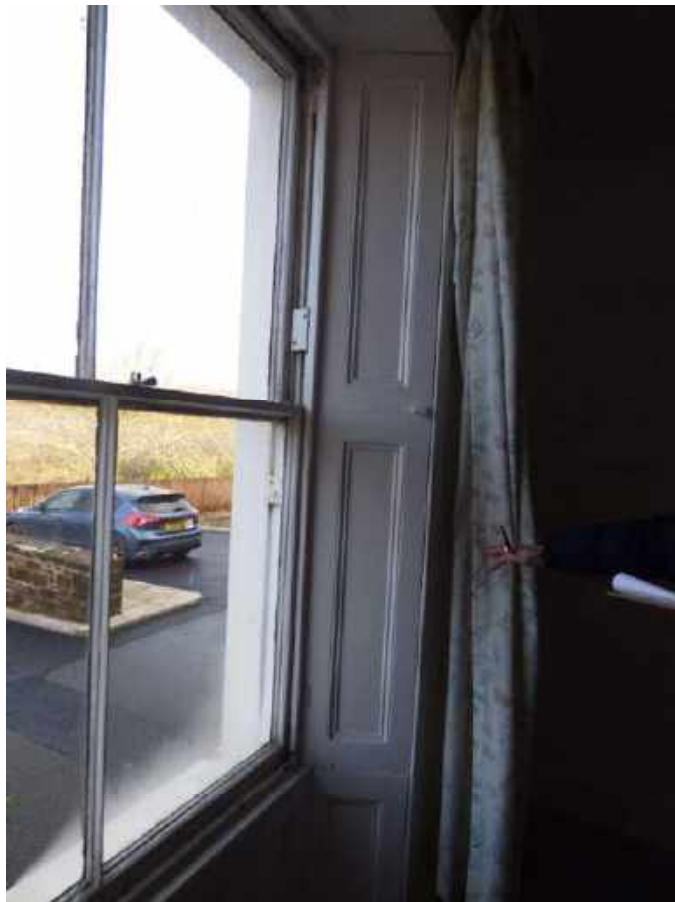
Above: In the existing lounge at the front of the property and

Left and below: the existing dining area to the rear of the property, the period features below and to the sides of the existing window are in good condition, it is proposed to carefully refurbish the existing timber shutters.

Below: Existing cornice to be made good in locations and where hairline cracks have appeared.

Existing architraves, and skirtings to be retained and made good.

Flush panel fire door to be replaced with heritage style four panelled fire doors to enhance the heritage asset.

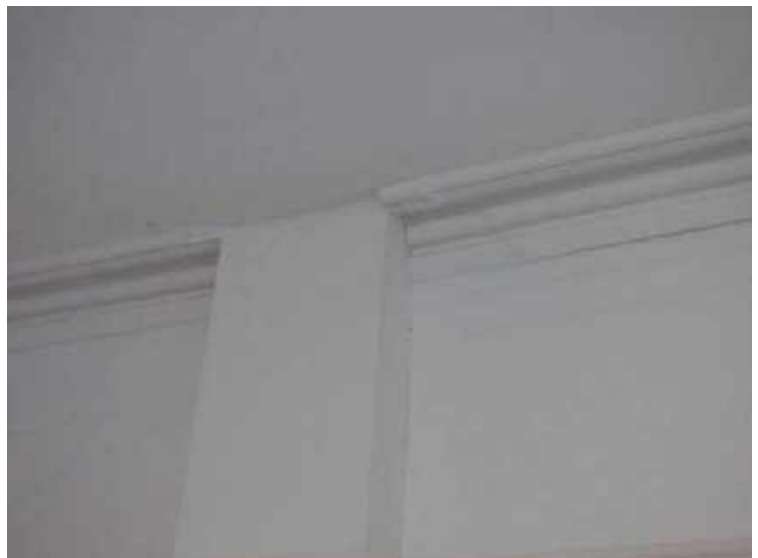
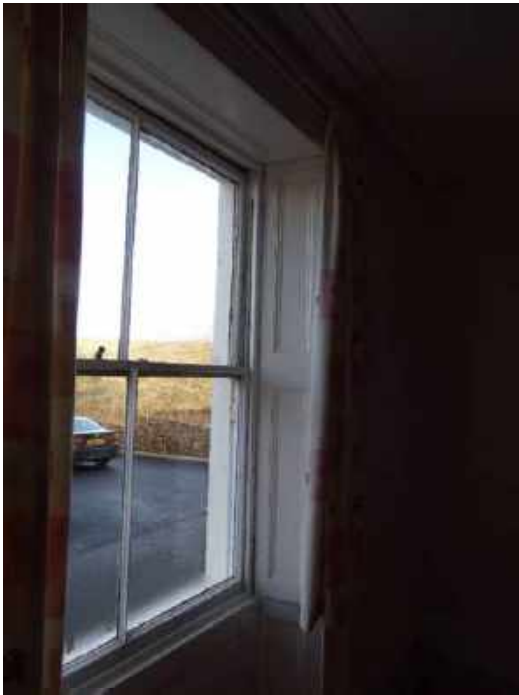
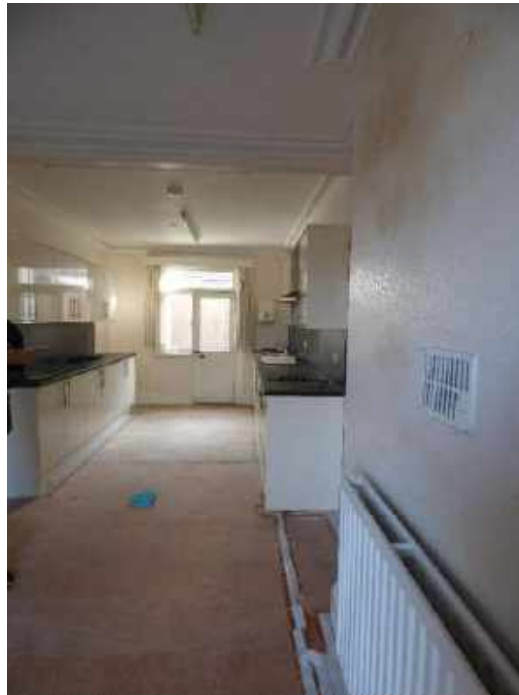
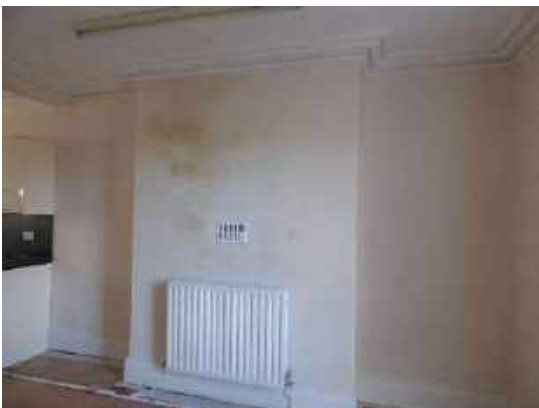
Above, Right, and below: In the existing lounge, the period features below and to the sides of the existing windows both front and back are in good condition, it is proposed to carefully refurbish the existing timber shutters.

Existing cornice to be made good in locations where redundant services are to be removed and where hairline cracks have appeared.

Existing architraves, and skirtings to be retained and made good.

Flush panel doors to be replaced with heritage style four panel painted timber fire doors to enhance the heritage asset.

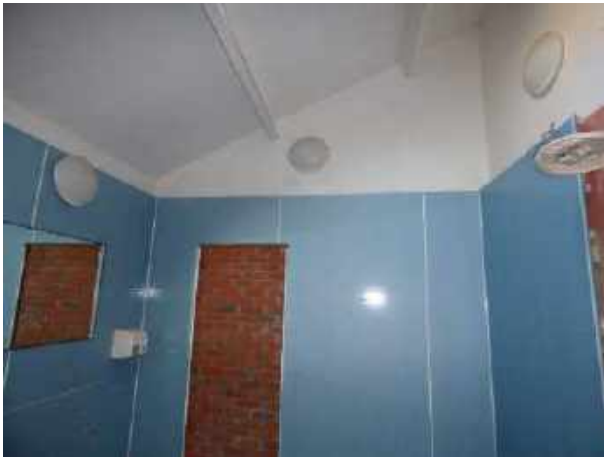
The existing outbuilding will be reduced in size to allow for more amenity space externally.

Within the existing building to be retained all internal finishes to be stripped out and walls to be made good, to provide accommodation for storage or a home office.

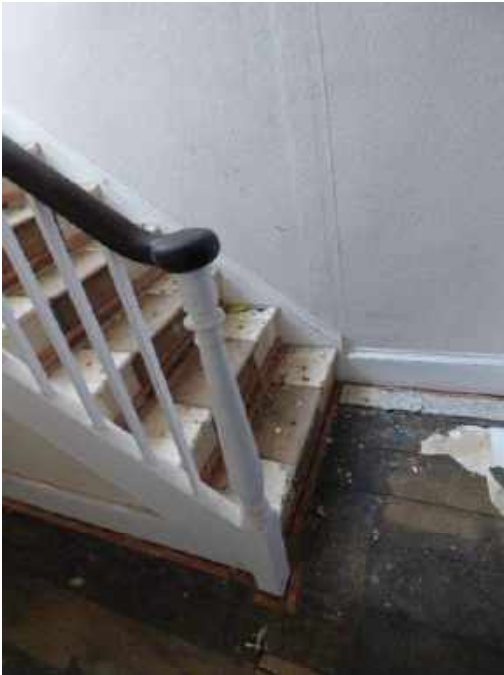
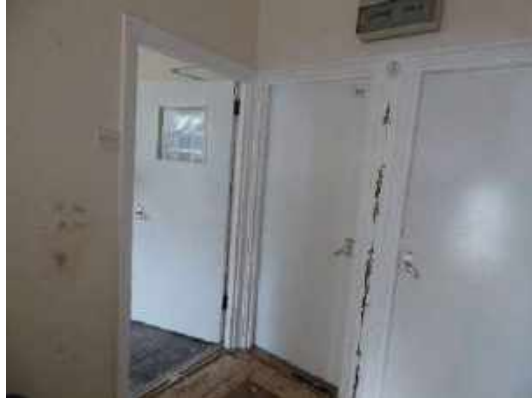
Retain original staircase, which is in good condition.

All period features to be retained.

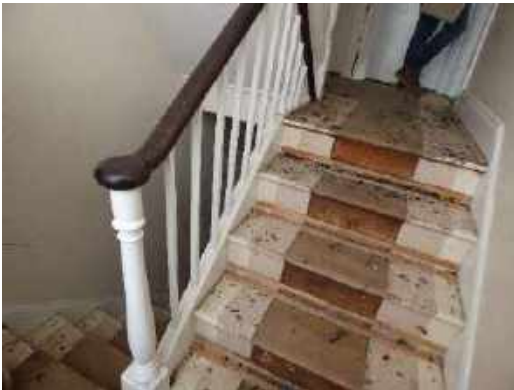
Retain architraves and skirtings. Replace existing flush panel doors with new four panelled heritage style fire doors by specialist joinery company.

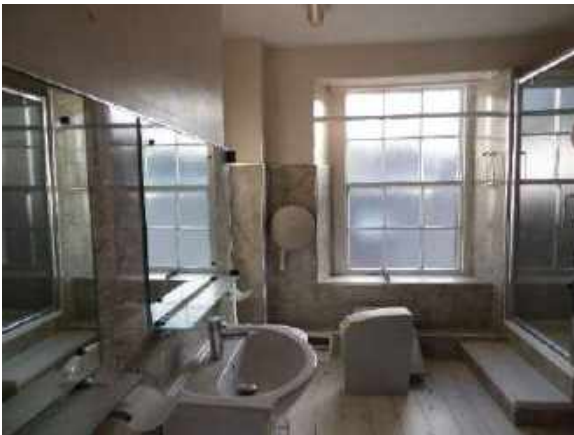
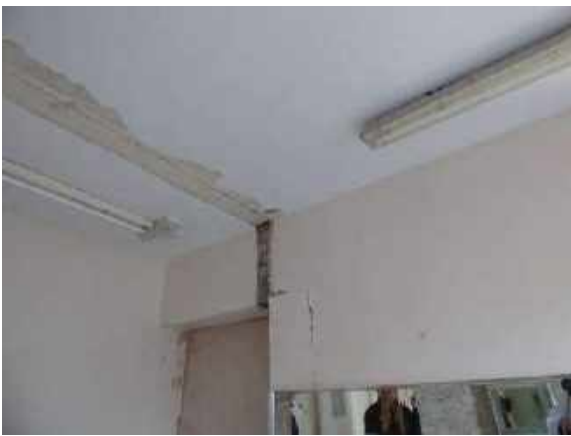
Left: Existing bathroom to be reduced in size to allow for new en-suite to master which backs on to the bathroom. This allows for a decent sized family bathroom and a new en-suite providing accommodation suitable for modern day living.

Existing ceiling to be made good and provide and install new extract fan linked back to light switch.

Glazing to new heritage style Georgian double glazed sash window to be obscure.

New bathroom door to be new four panelled heritage style door - bathroom door does not need to be a fire rated door.

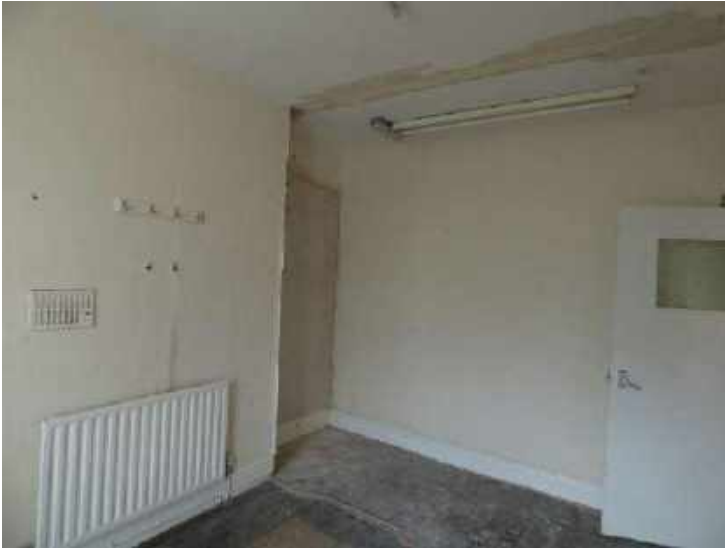
Rear bedroom skirtings and architraves to be retained. Existing flush panelled door to be replaced with new Georgian heritage style 4 panel door to be provided and installed by specialist joinery company such as Batty Joinery Ltd.

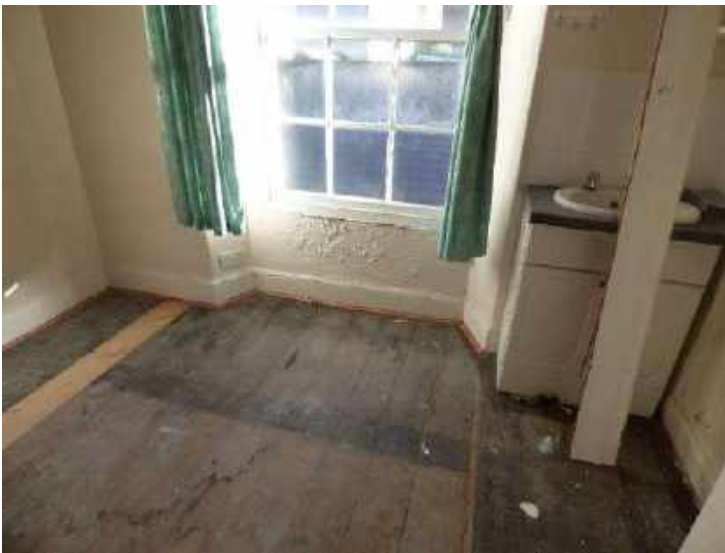
Existing floorboards generally in good condition.

Damp and associated blown plaster below window and to window reveals to be repaired with lime plaster. New heritage style double glazed window will be fitted to ensure no water ingress.

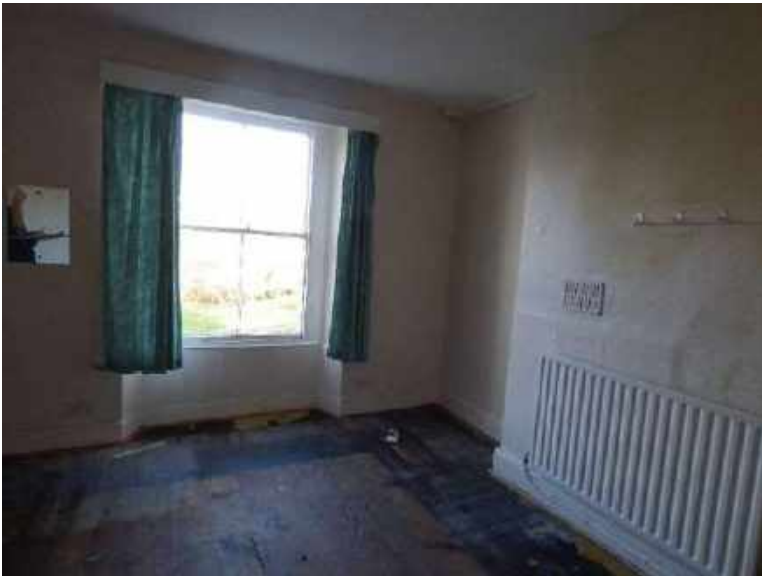
Front bedroom (First floor RHS), skirtings and architraves to be retained. Existing flush panelled door to be replaced with new Georgian heritage style 4 panel door to be provided and installed by specialist joinery company such as Batty Joinery Ltd.

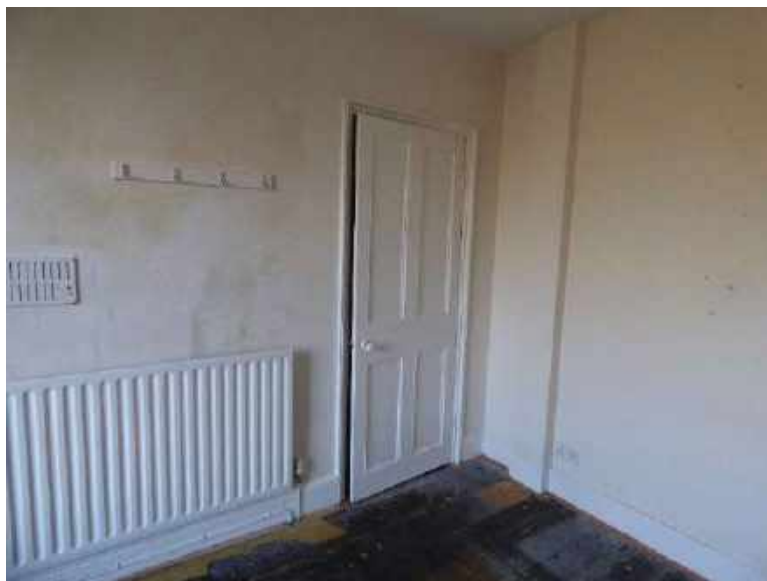
Existing floorboards in good condition.

It is proposed to form new doorway with architraves to match existing, and new four panelled door, into a new en-suite to be formed from part of the existing over large bathroom to make efficient use of the space and reflect the requirements of modern-day living.

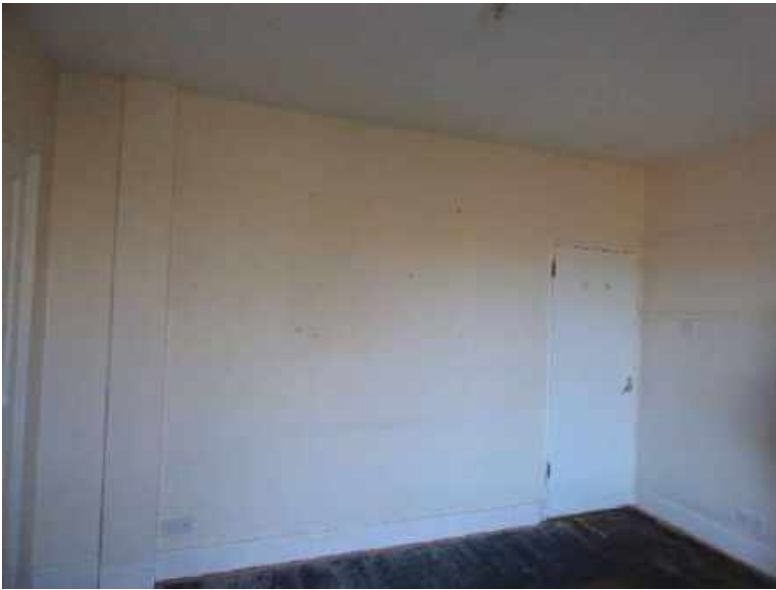
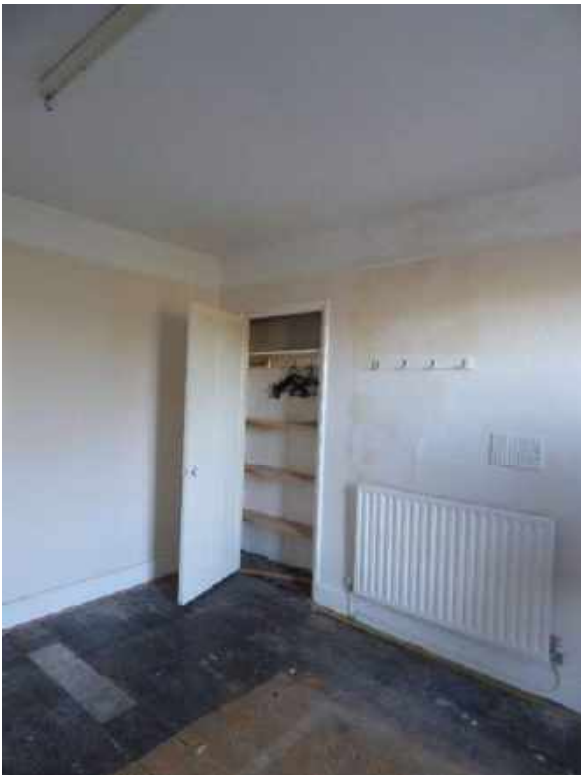
Front bedroom (First floor LHS), cornice, skirtings and architraves to be retained. Existing flush panelled door to be replaced with new Georgian heritage style 4 panel door to be provided and installed by specialist joinery company such as Batty Joinery Ltd.

Existing floorboards generally in good condition.

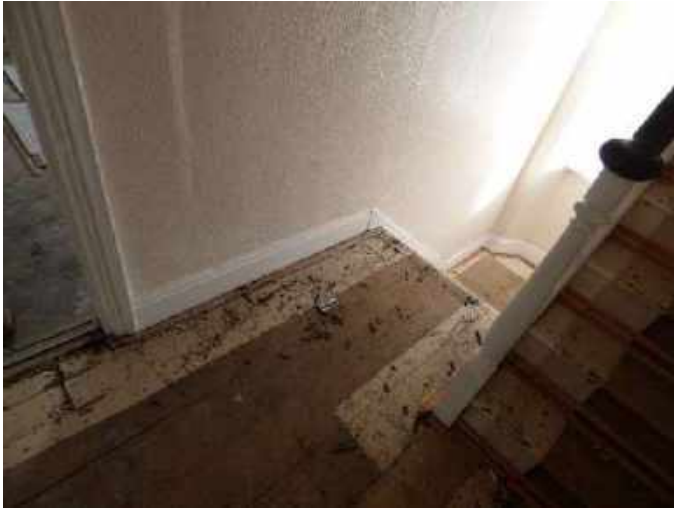
Left and below:

Handrail, balusters, and rails are original and are to be retained.

Apply an insulated plasterboard 62mm thick to underside of sloping ceiling, to enhance the performance of the building fabric.

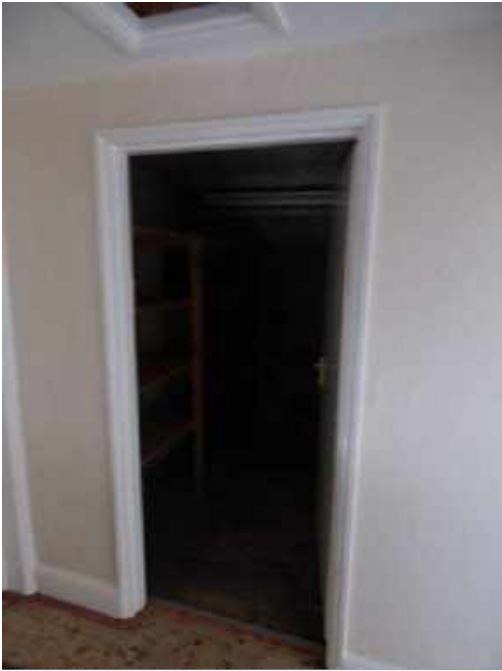
Left: Attic Store is proposed to be converted into a bathroom to be shared by the attic bedrooms by increasing the size of the room to each side to allow for the new bathroom.

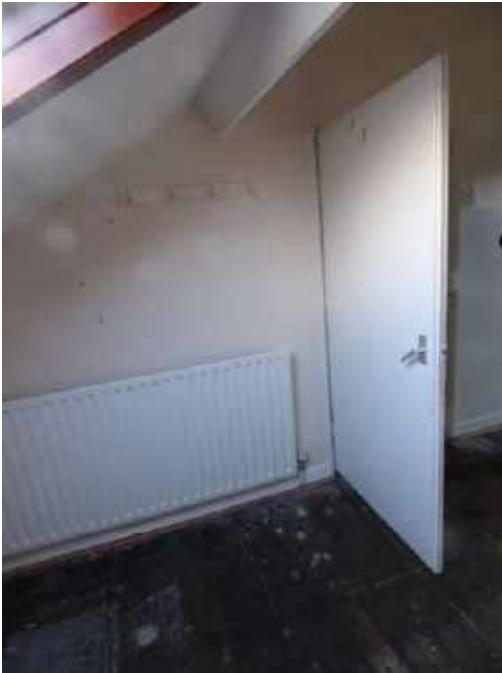
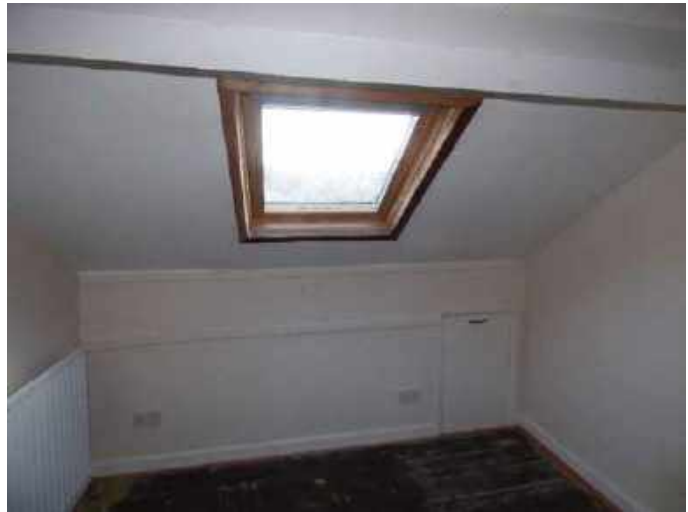
Left and below: Attic Bedroom.

In the bedroom remove all damp and damaged / blown plasterwork and repair with lime plaster and skim and decorate throughout.

Floorboards are generally in good condition (but may require minor repairs).

New plasterboard std partition to be installed in lieu of removal of part of existing store / bedroom partition to allow for bathroom to be useable size.

Apply an insulated plasterboard 62mm thick to underside of ceiling tape and skim and undertake full decorations. Replace existing rooflights to with new heritage style rooflights (Velux or similar).

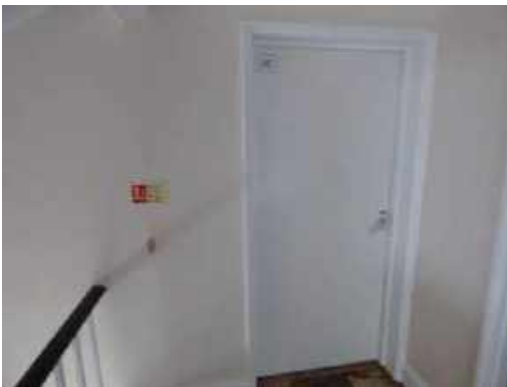
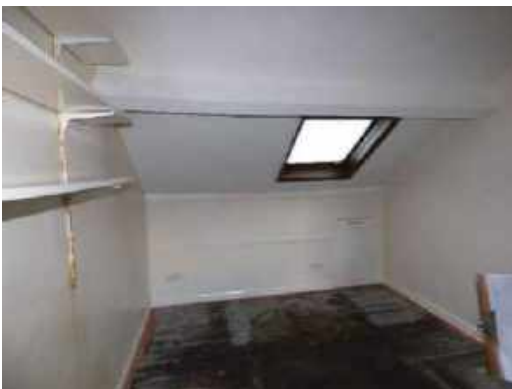
Existing flush panel doors are to be removed and replaced with new heritage style 4 panel fire doors.

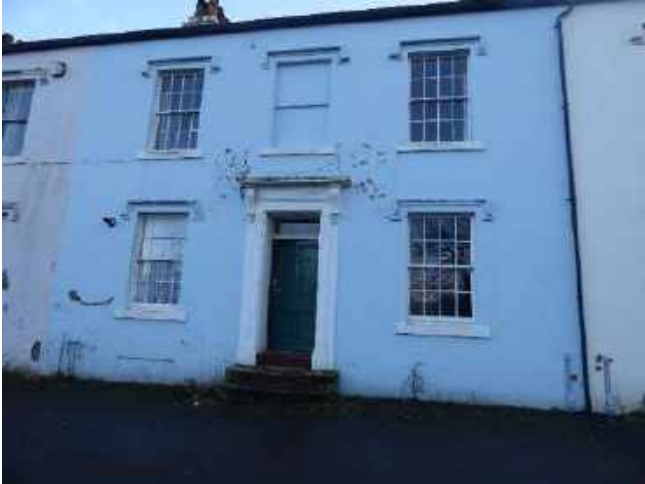
Left: The main entrance is mentioned in the listing text and is to be entirely retained.

Both front and rear elevations are currently rendered, with colour to the front and side and natural to the rear. All elevations require to be prepared for render repairs and redecoration by specialist using lime render and stucco (Parax LTD) to be applied by specialist. The stucco features above the windows and door on the front elevation will be carefully restored by a specialist. Colour of all render and stucco to match existing.

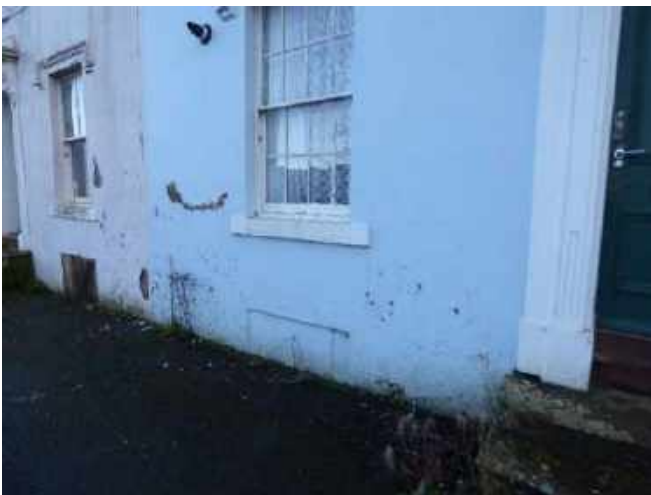
The existing door and frame are to be retained and made good with the provision of new ironmongery. Once repaired full decoration will be undertaken.

Existing gutters and downpipes to be retained, repaired where necessary and decorated.

All existing single glazed windows to replace with new white painted slim profile double glazed. 'heritage' windows to match the existing style by specialist supplier such as Batty Joinery, specialists in historic and listed building joinery works.

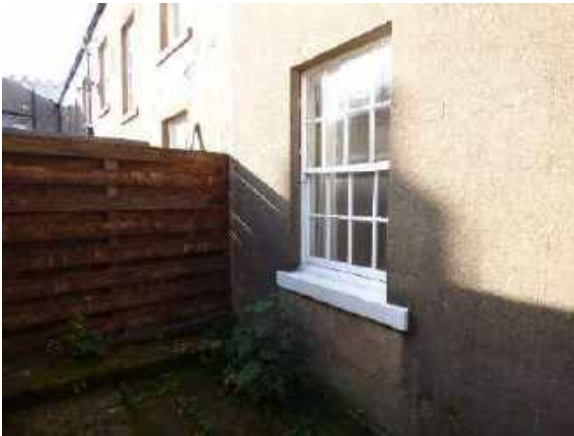
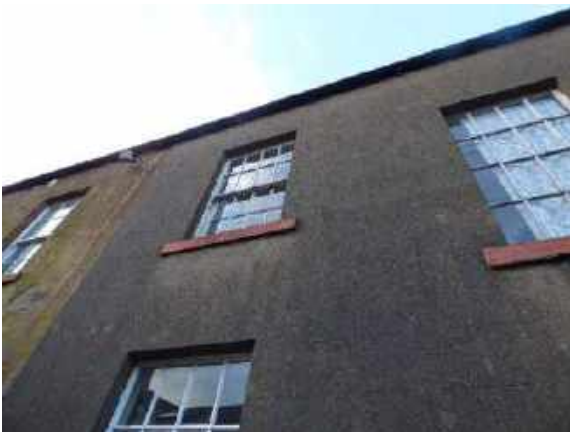
Left and below:

The rear courtyard is divided by a single storey 'link' building to an outbuilding at the rear. It is proposed to demolish this link structure as it is in extremely poor condition, and also to reduce the size of the existing rear building, to provide additional amenity space for the property and allow more light into the existing dwelling.

Windows to be replaced with new painted timber double glazed heritage style sash windows by specialist joinery company such as Batty joinery ltd.

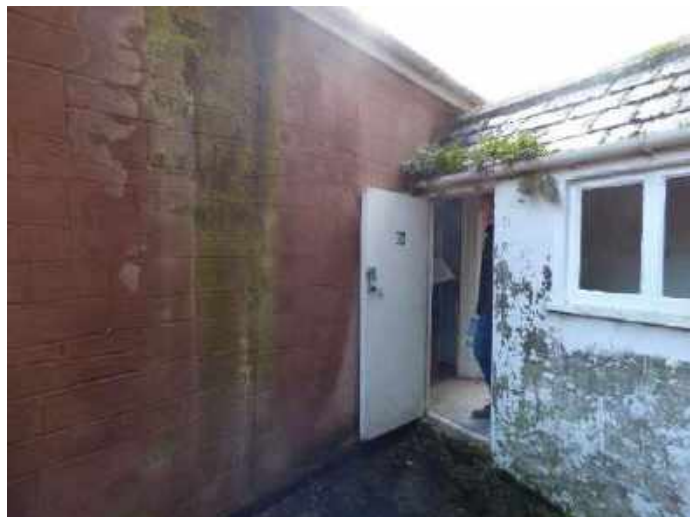
Rear of property – render to be repaired by specialist and decorated with off white render.

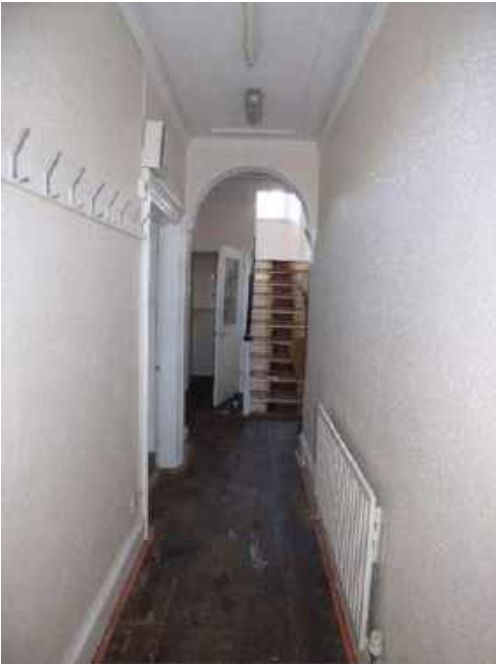
Left: The existing walls and floor are generally in good condition.

Redundant M&E to be removed and wall / ceiling finishes made good, and primed, prepared, and fully decorated.

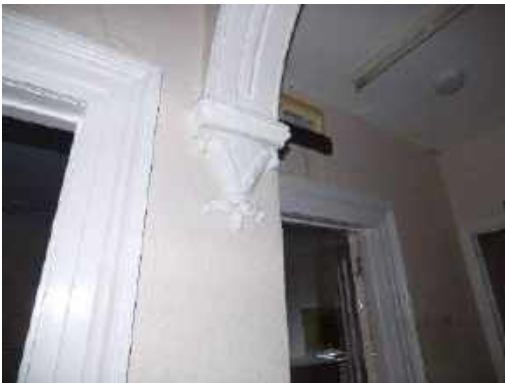
Left: period features to be retained, including archway and architraves. (Modern lighting to all be stripped out and make good surfaces). All architraves and plaster features to be retained.

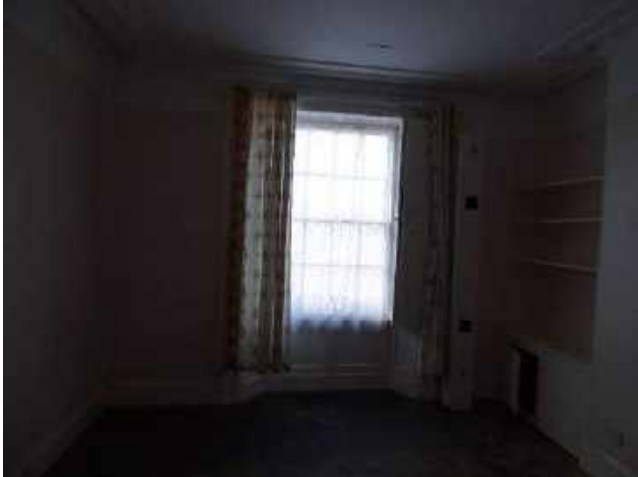
Left: In the existing study, the period features below and to the sides of the existing window are in good condition, it is proposed to carefully refurbish the existing timber shutters.

Left: Existing cornice to be made good in locations where redundant services are to be removed and where hairline cracks have appeared.

Existing architraves, and skirtings to be retained and made good.

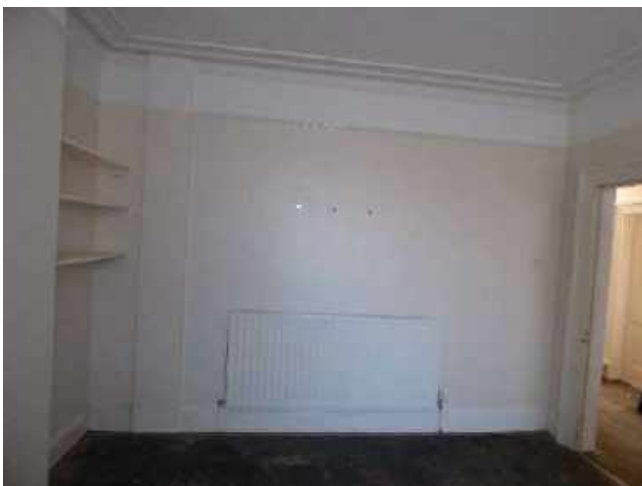
Flush panel doors to be replaced with heritage style 4 panel painted timber fire doors to enhance the heritage asset.

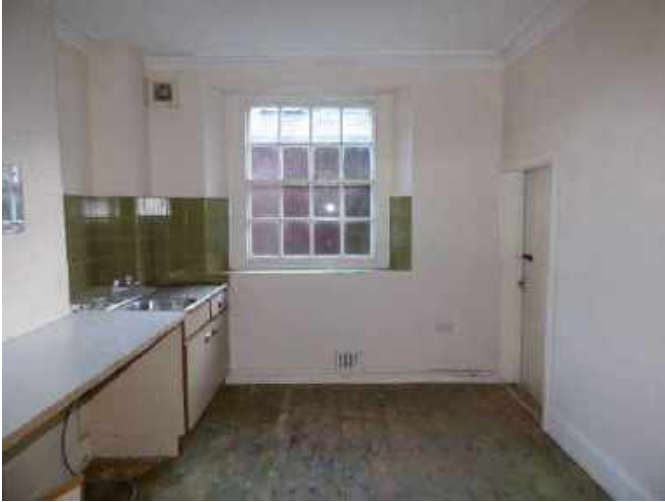
Left and below: the existing kitchen area to the rear of the property, the period features below and to the sides of the existing window are in good condition.

Below: Existing cornice to be made good in locations and where hairline cracks have appeared.

Existing architraves, and skirtings to be retained and made good.

Flush panel doors to be replaced with heritage style 4 panel painted timber fire doors to enhance the heritage asset.

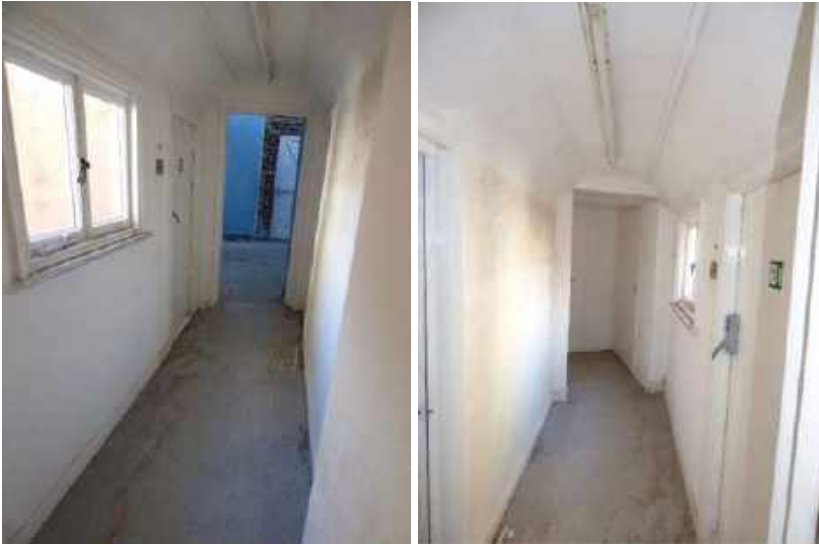
Left: Existing single skin ink building extension to be removed.

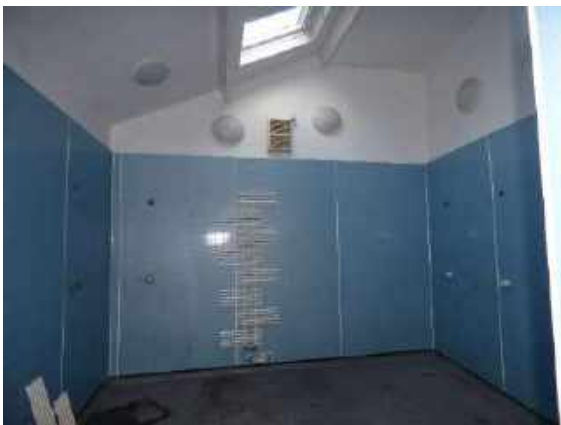
Left: original shower block to be reduced in size to provide additional amenity space to the property. All existing fixtures and fittings to be removed. The building then will become a new home office / store.

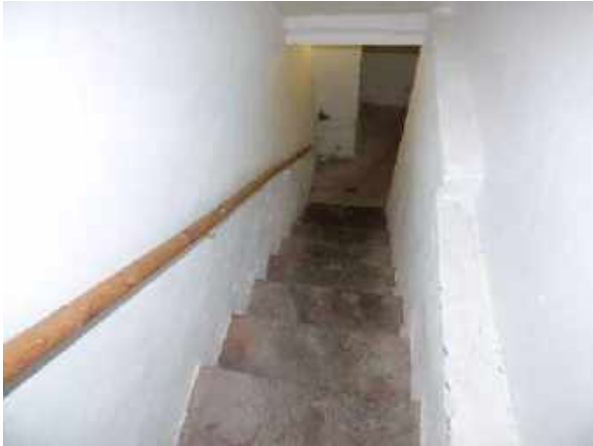
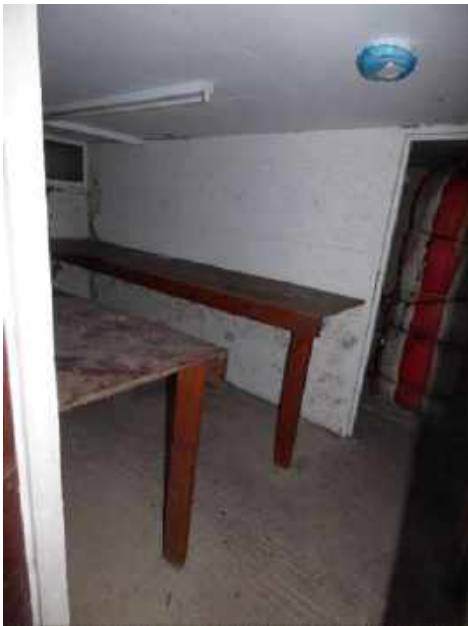
The existing walls and floor to the basement are generally in sound condition so would be suitable for the application of damp proof slurry system. All existing paint and surface finishes must be removed and made good including all snots removed, and damage to existing surfaces, prior to the installation of a Koster Polysil NB1. This migratory crystalline tanking slurry is used to seal below ground structures against water ingress.

Koster NB1 is considered to be a Type A waterproofing system as defined by BS8102:2009 and is generally used to seal the inside face of basement structures, slabs and retaining walls.

Koster NB1 works by both providing a physical barrier against water ingress as well as providing a migratory crystal sealant that penetrates deep into the structure to seal micropores and cracks against water ingress.

Once applied then the walls can be prepared and primed for decorating and for the floor finish to be installed. Complete new boiler and heating system is required, new distribution boards etc.

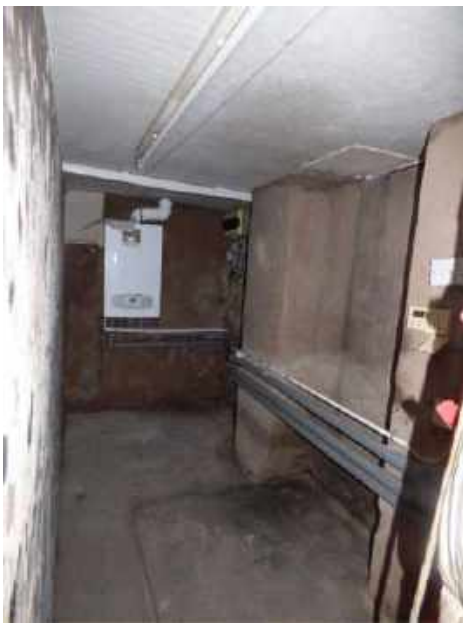
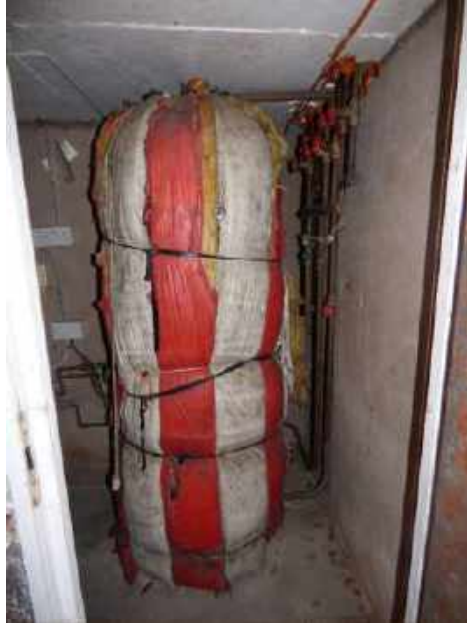
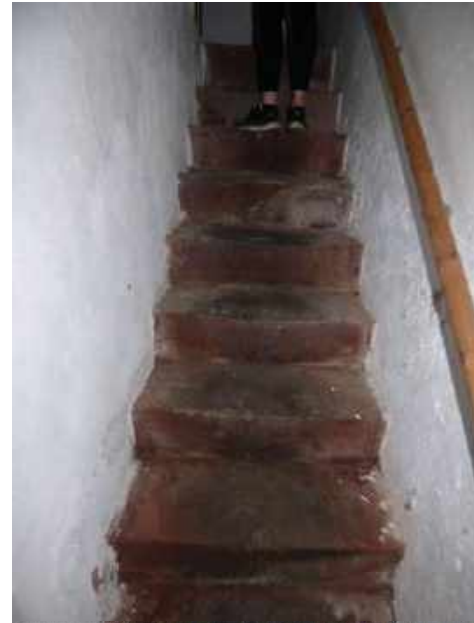
Above:

The walls down to the basement also require the full treatment.

In the basement all existing services are to be carefully stripped out and replaced with new compliant infrastructure.

Existing window to basement has been walled up. This is to be removed and reveals made good. Allow for the installation of a new double glazed heritage style window.

All existing services to be carefully removed and new gas and electric services installed.

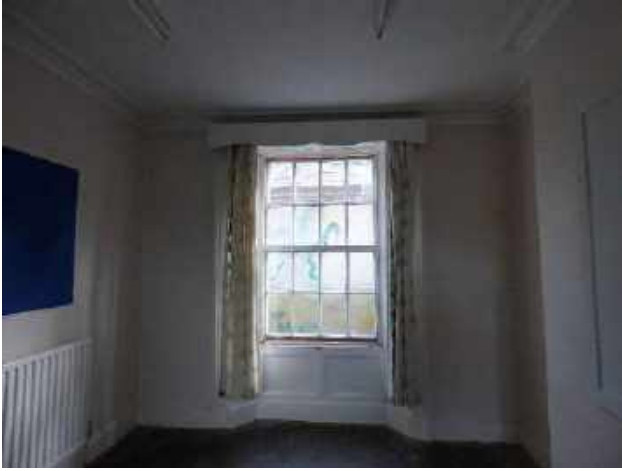
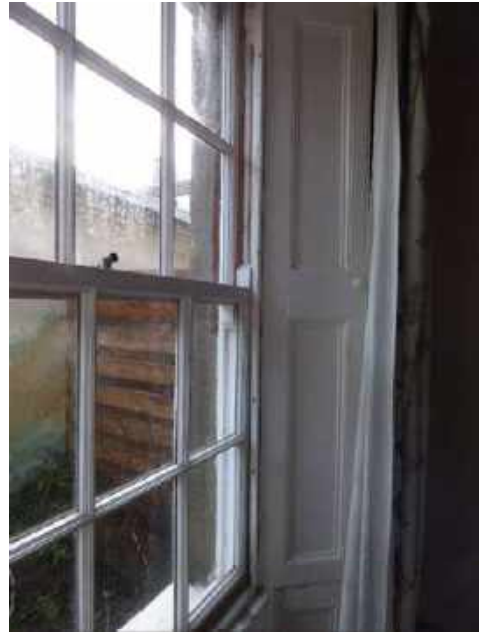
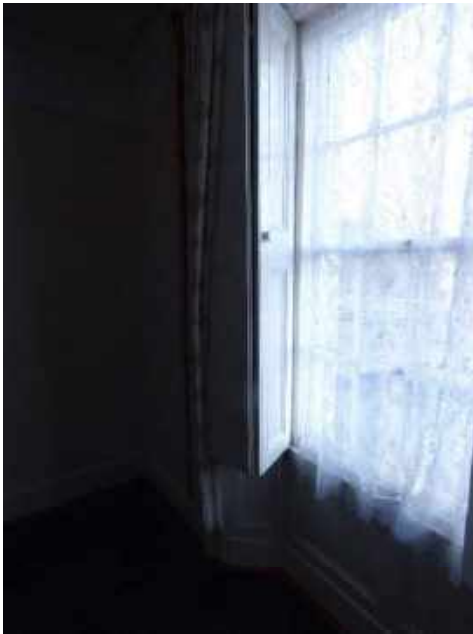
Above and Left: In the existing study, the period features below and to the sides of the existing windows both front and back are in good condition, it is proposed to carefully refurbish the existing timber shutters.

Existing cornice to be made good in locations where redundant services are to be removed and where hairline cracks have appeared.

Existing architraves, and skirtings to be retained and made good.

Flush panel doors to be replaced with heritage style 4 panel painted timber fire doors to enhance the heritage asset.

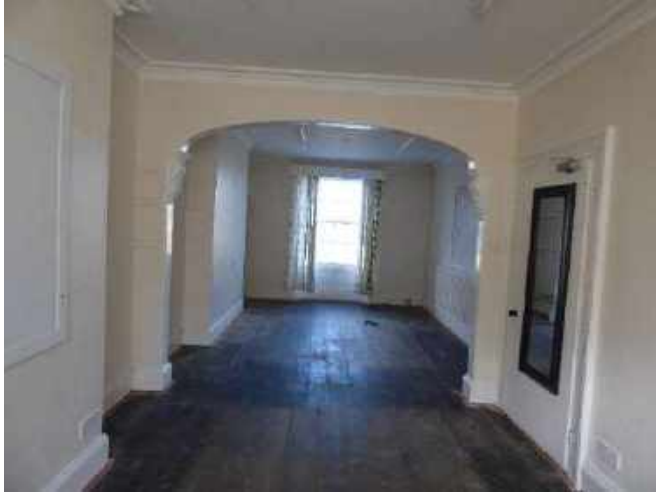
Left: period features to be retained, including archway and architraves. (Modern lighting to all be stripped out and make good surfaces). All architraves and plaster features to be retained.

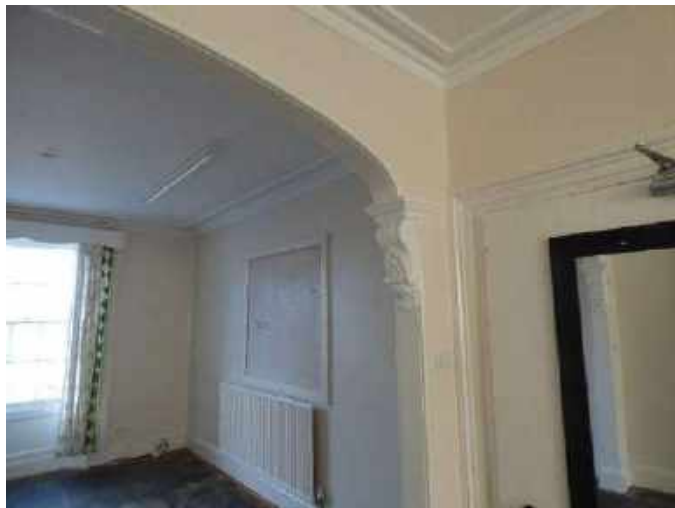
Above and Left: In the existing lounge, the period features below and to the sides of the existing windows both front and back are in good condition, it is proposed to carefully refurbish the existing timber shutters.

Existing cornice to be made good in locations where redundant services are to be removed and where hairline cracks have appeared.

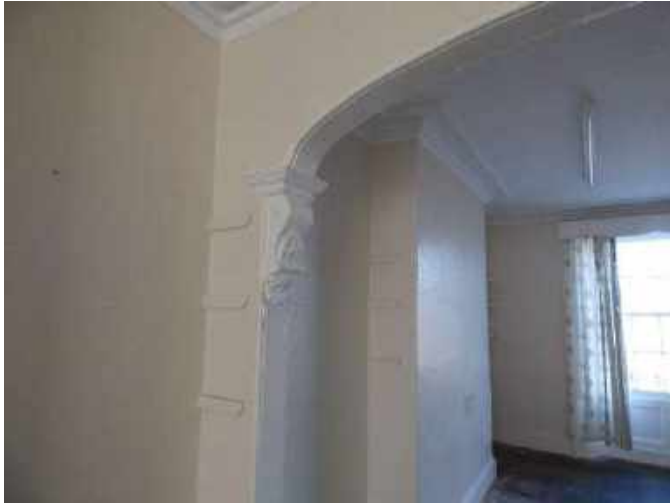
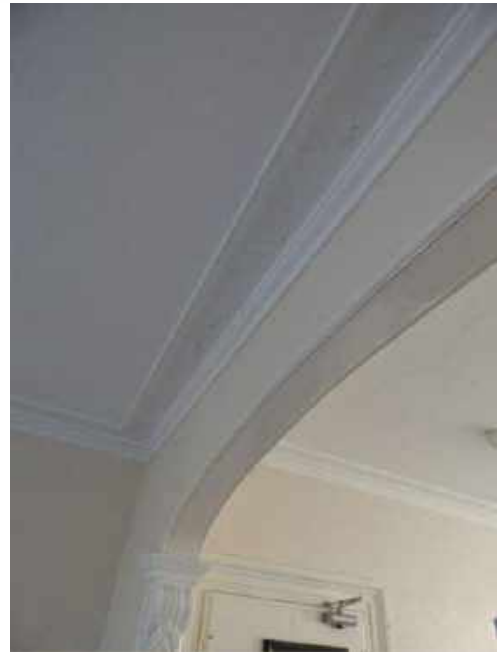
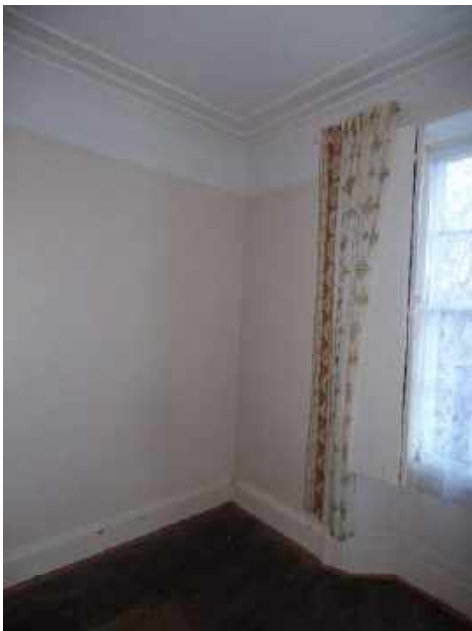
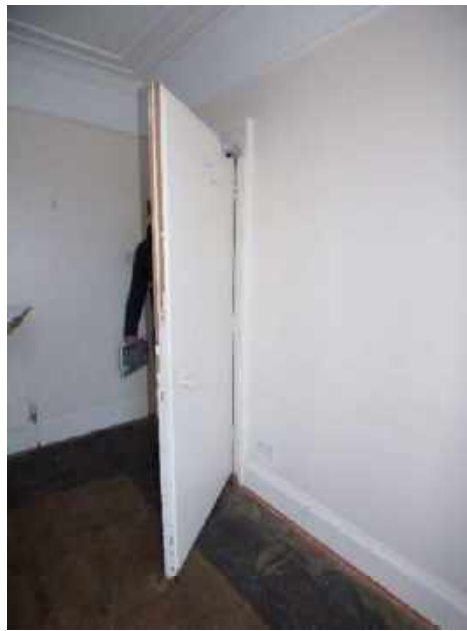
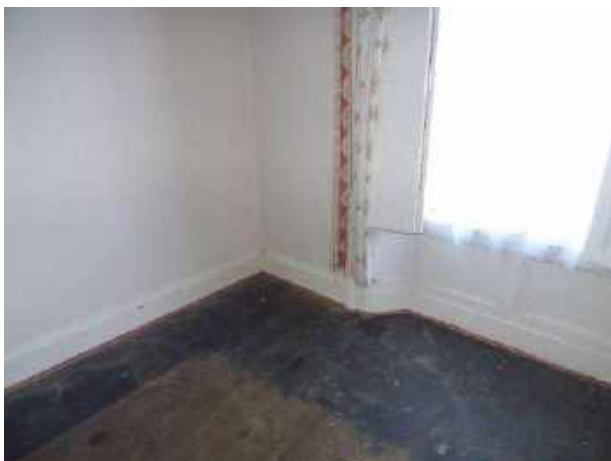
Existing architraves, and skirtings to be retained and made good.

Flush panel doors to be replaced with heritage style four panel painted timber fire doors to enhance the heritage asset.

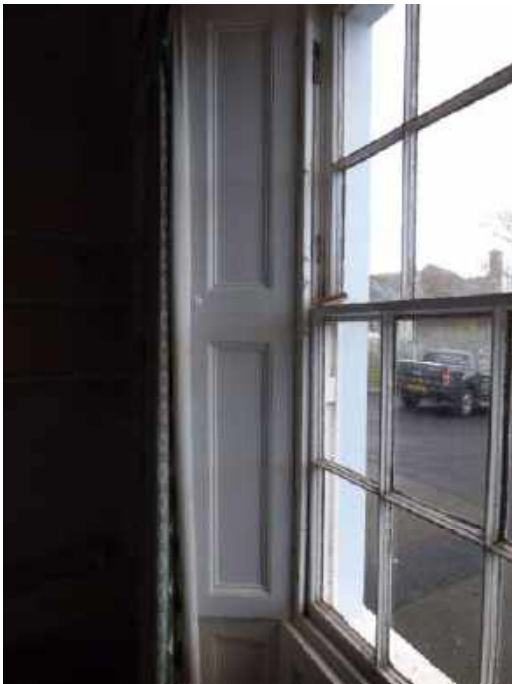
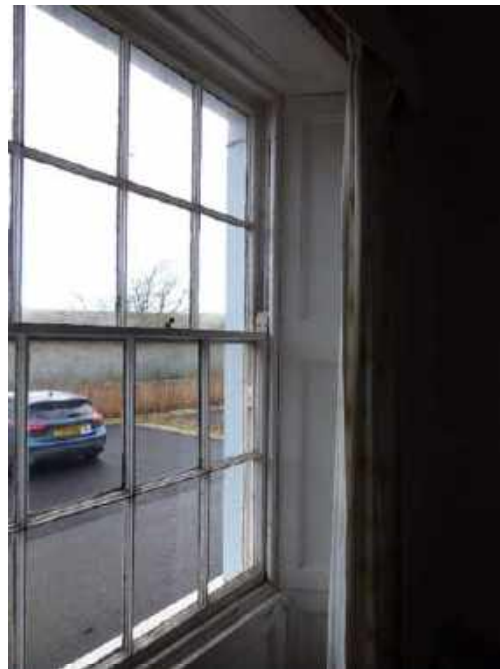
Above: In the existing lounge, the period features below and to the sides of the existing windows both front and back are in good condition, it is proposed to carefully refurbish the existing timber shutters.

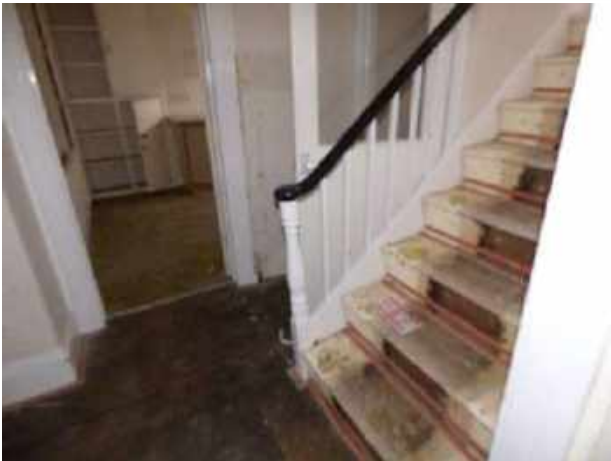
Retain original staircase, which is in good condition.

The requirement for the steel post at the top of the staircase

To be confirmed by structural engineer, if possible, the intention is to remove and strengthen the balusters if required to revert to the original staircase detail.
