# HERITAGE STATEMENT

## FULL RENOVATION OF EXISTING No 11 TERRACE HOUSES

St Bees, 1-11 Lonsdale Terrace, Parish Council, Cumbria

M.A.C Architects, Project Number: 2019:303

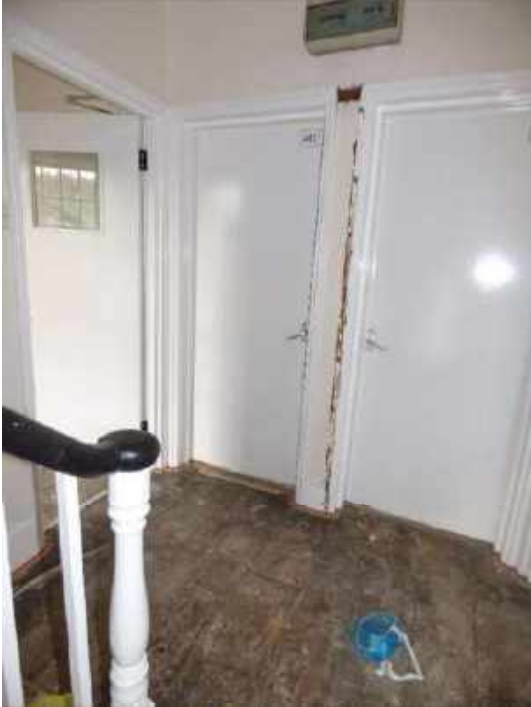
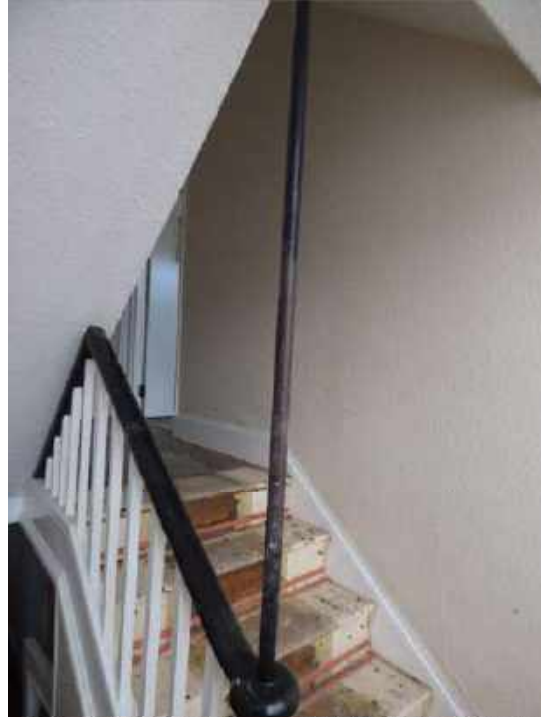
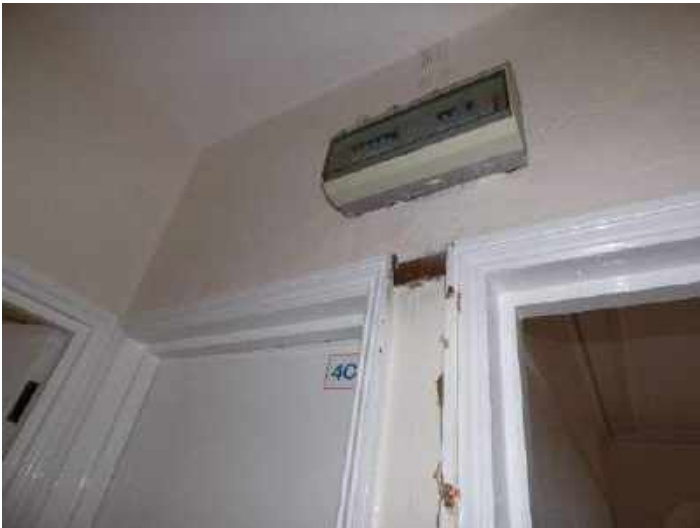
Original architraves to be retained.

Redundant M&E fixtures and fittings to be removed and surfaces made good.

Flush panel doors to be replaced with heritage style Georgian 4 panel fire doors.

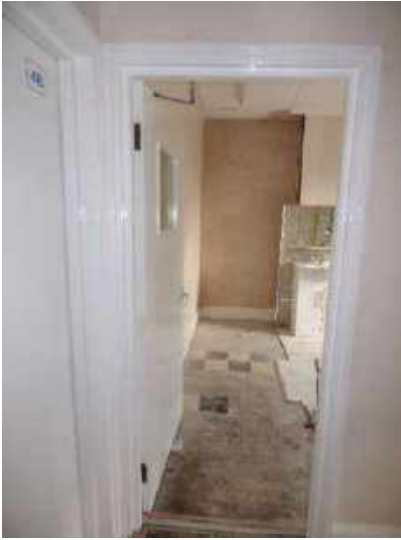
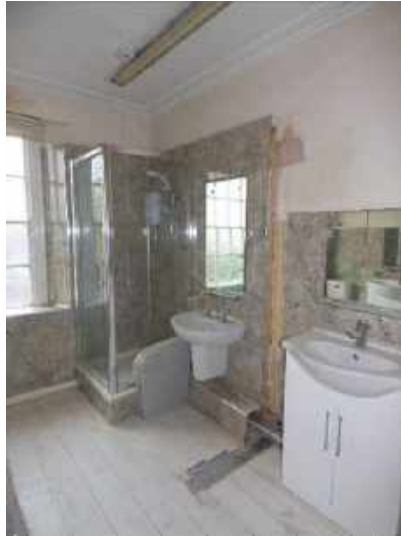
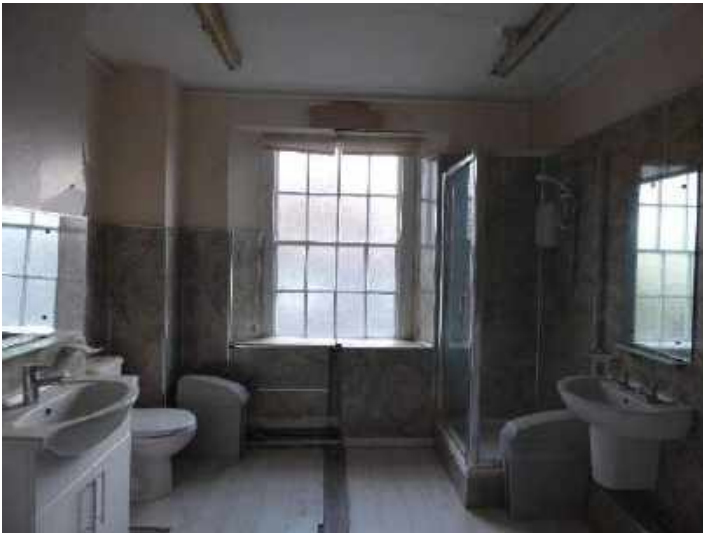
Left and above: Existing bathroom, to be completely renovated. All existing FF&E and M&E to be removed and all surface finishes to be completely removed and walls made good.

New Georgian heritage style four panel door to be provided and installed by specialist joinery company such as Batt Joinery Ltd. All fabric damage to be carefully repaired.

Bathroom to be reduced in size to allow for the installation of a new en-suite to the master bedroom.

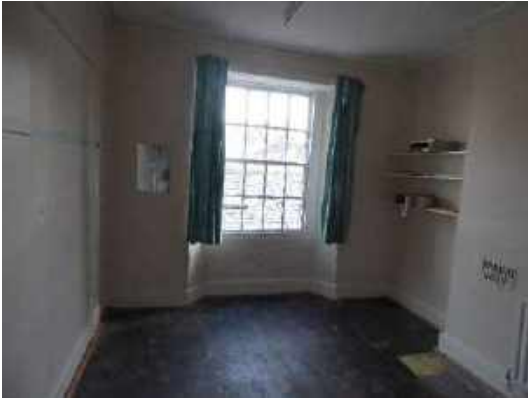
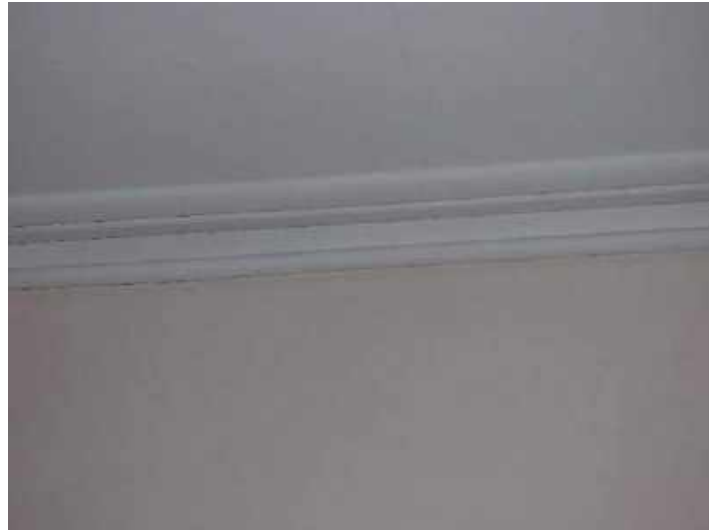
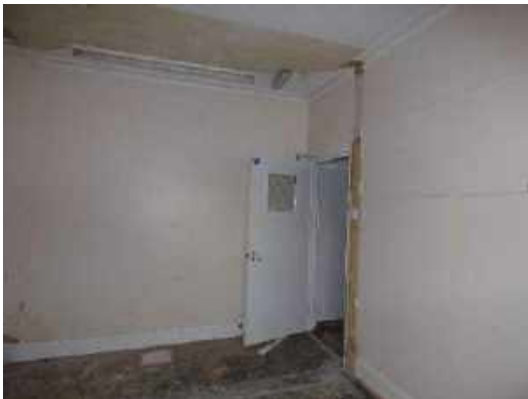
Left and above: Rear bedroom existing skirtings and architraves to be retained. Existing modern flush panelled door to be replaced with new Georgian heritage style four panel door to be provided and installed by specialist joinery company such as Batty Joinery Ltd.

Existing floorboards in good condition.

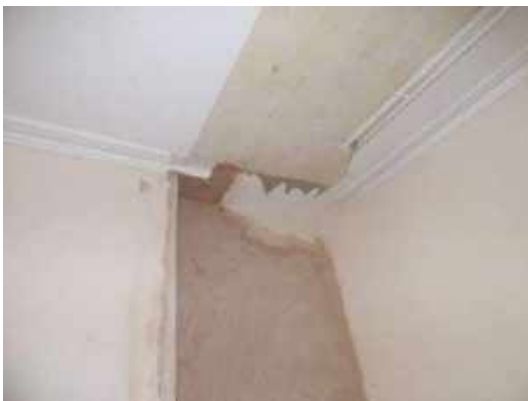
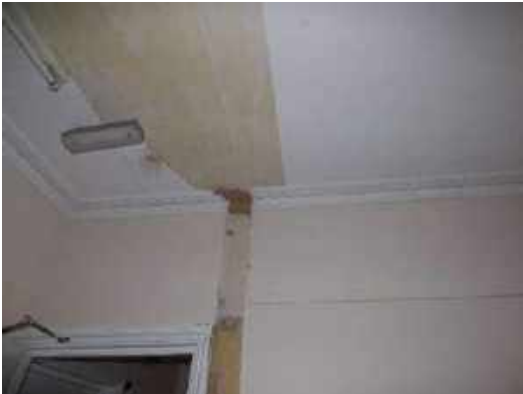
Front bedroom (First floor LHS), cornice, skirtings and architraves to be retained. Existing flush panelled door to be replaced with new Georgian heritage style four panel door to be provided and installed by specialist joinery company such as Batty Joinery Ltd.

Existing floorboards in good condition.

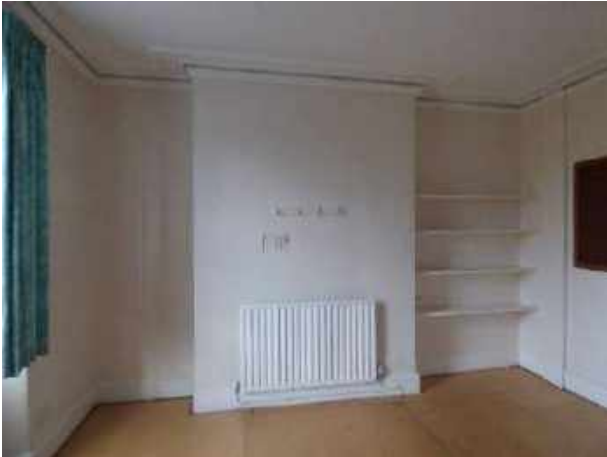
Front bedroom (First floor RHS), cornice, skirtings and architraves to be retained. Existing flush panelled door to be replaced with new Georgian heritage style 4 panel door to be provided and installed by specialist joinery company such as Batty Joinery Ltd.

Existing floorboards generally in good condition.

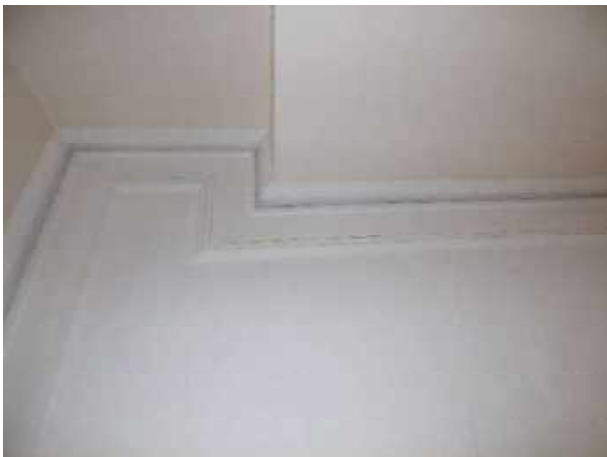
It is proposed to form new doorway with architraves to match existing, and new four panelled door, into a new en-suite to be formed from part of the existing over large bathroom to make efficient use of the space and reflect the requirements of modern-day living.

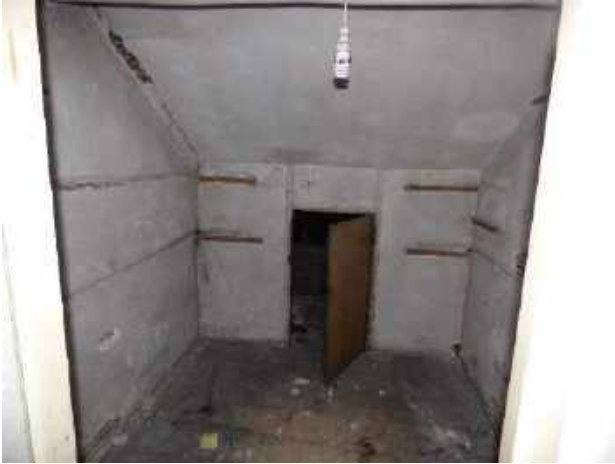
Left: Attic Store is proposed to be converted into a bathroom to be shared by the attic bedrooms by increasing the size of the room to each side to allow for the new bathroom.

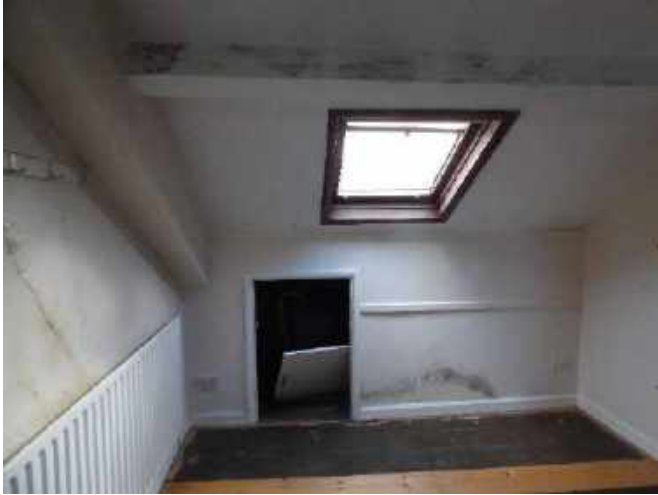
Left: Attic Bedroom

In the bedroom remove all damp and damaged / blown plasterwork and repair with lime plaster and skim and decorate throughout.

New plasterboard stud partition to be installed in lieu of removal of part of existing store / bedroom partition to allow for bathroom to be useable size.

Apply an insulated plasterboard 62mm thick to underside of ceiling tape and skim and undertake full decorations. New heritage style rooflights to be installed.

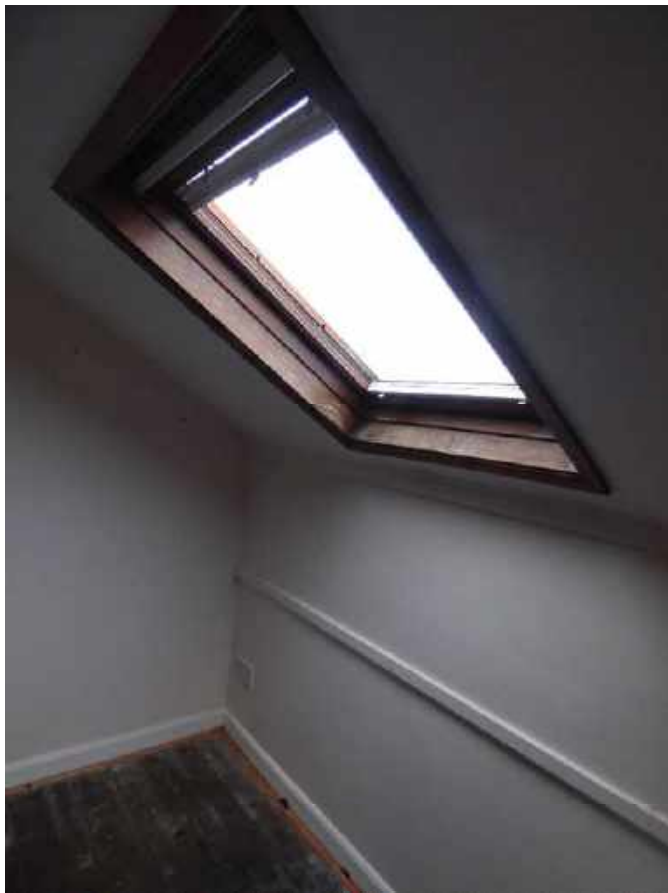
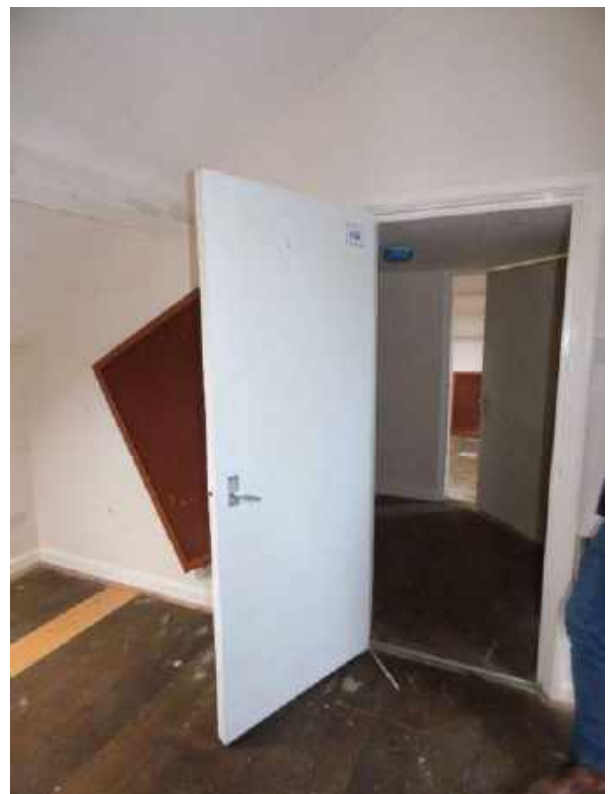
Floorboards are in good condition (but may require minor repairs).

Existing flush panel doors are to be removed and replaced with new heritage style four panel fire doors.

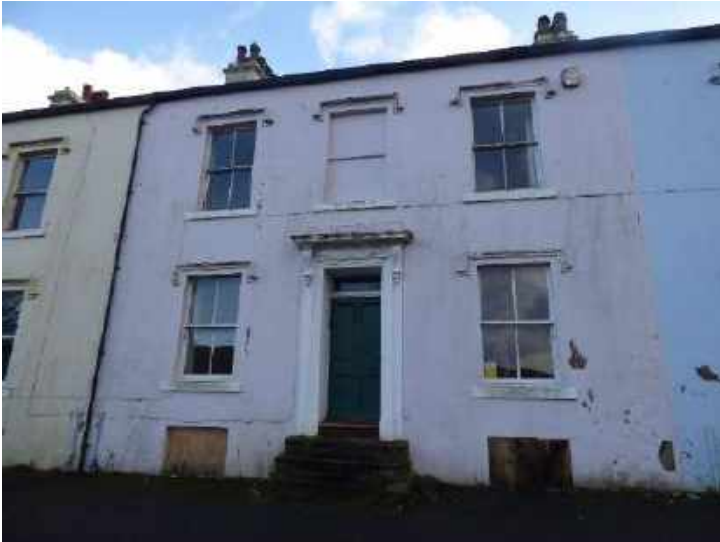
Left: The main entrance is mentioned in the listing text and is to be entirely retained.

Both front and rear elevations are currently rendered, with colour to the front and side and natural to the rear. All elevations require to be prepared for render repairs and redecoration by specialist using lime render and stucco (Parax LTD) to be applied by specialist.

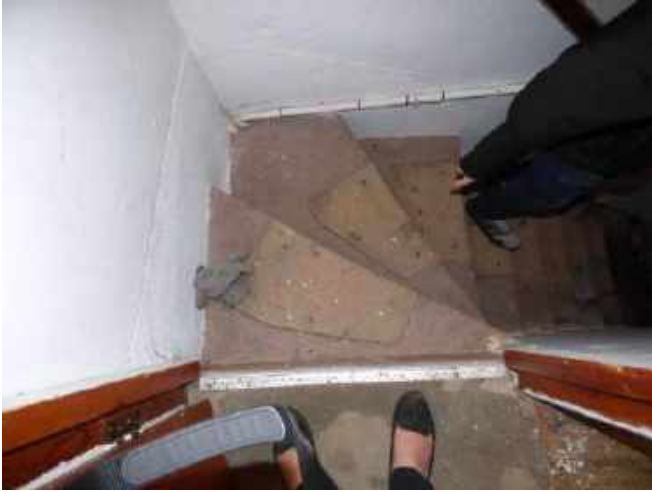
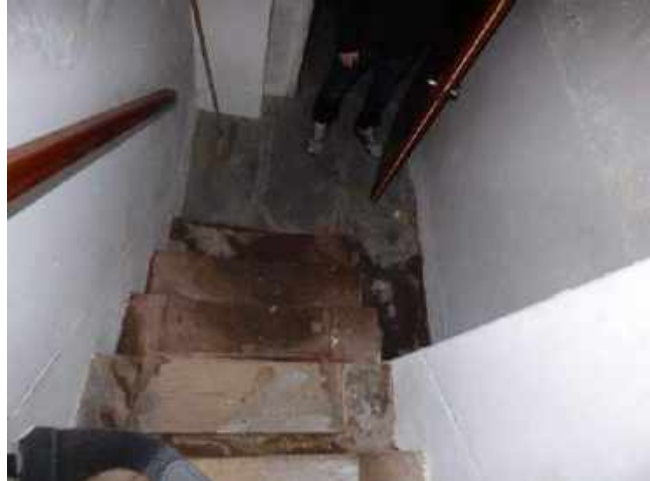
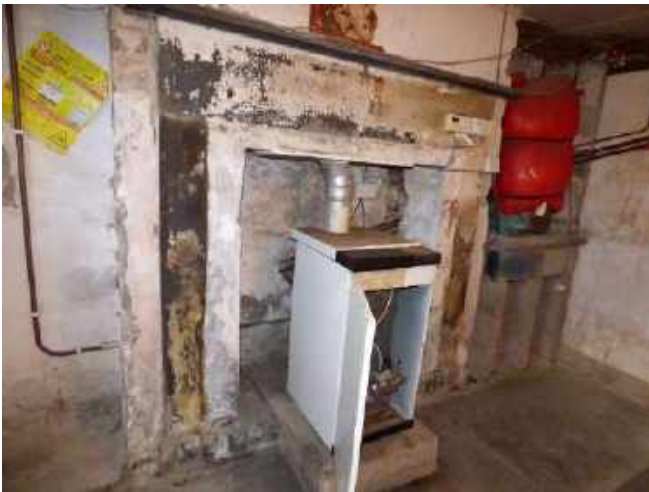
Left and above: Basement.

The existing walls and floor are generally in sound condition so would be suitable for the application of damp proof slurry system. All existing paint and surface finishes must be removed, and damage to existing paint and surface finishes must be removed and made good including all snots removed, and damage to existing surfaces, prior to the installation of a Koster Polysil NB1. This migratory crystalline tanking slurry is used to seal below ground structures against water ingress.

Providing a migratory crystal sealant that penetrates deep into the structure to seal micropores and cracks against water ingress.

Once applied then the walls can be prepared and primed for decorating and for the floor finish to be installed. Complete new boiler and heating system is required, new distribution boards etc.

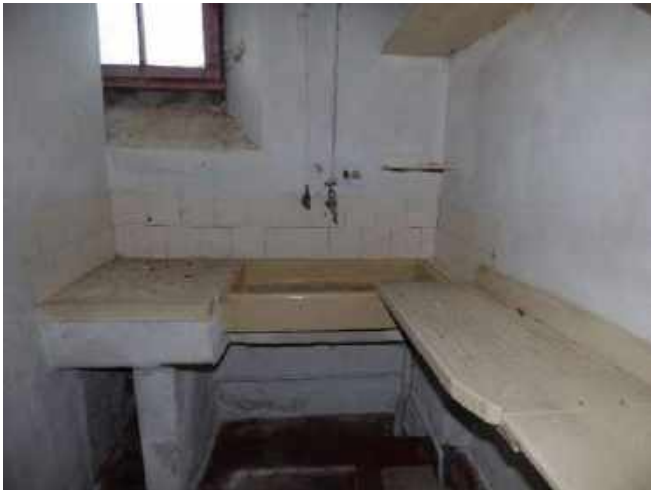
The walls down to the basement also require the full treatment.

Existing window to basement to be removed and replaced with new double glazed heritage window. Existing reveals to be made good.

All existing services to be carefully removed and new gas and electric services installed.

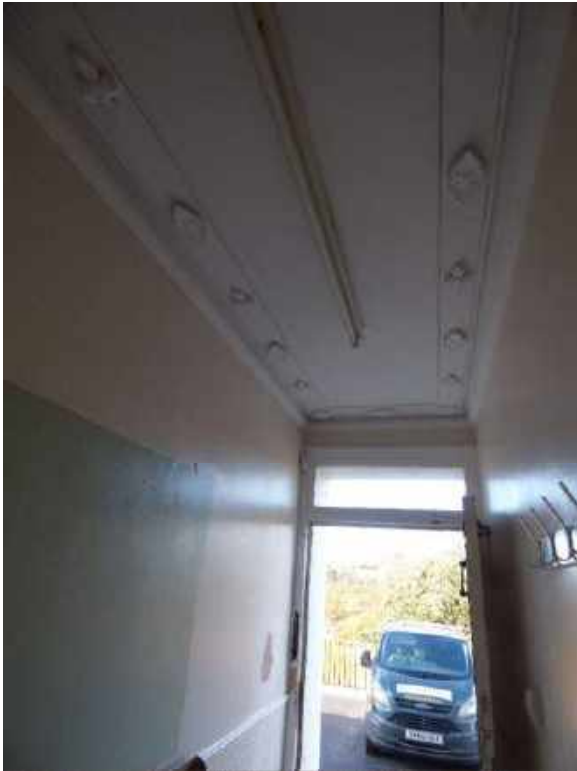
Left and below: The existing walls and floor are generally in good condition.

Redundant M&E to be removed and wall/ceiling finishes made good, and primed, prepared and fully decorated.

Flush panel doors to be replaced with heritage style panel painted timber fire doors to enhance the heritage asset.

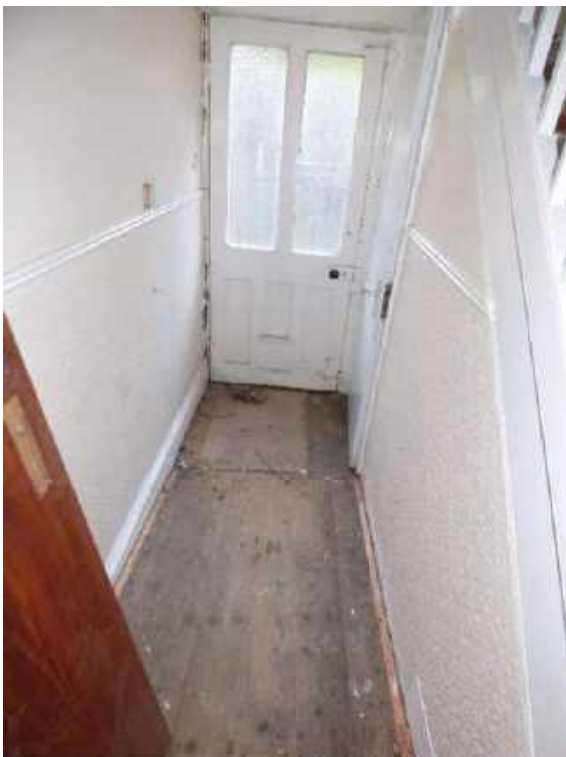
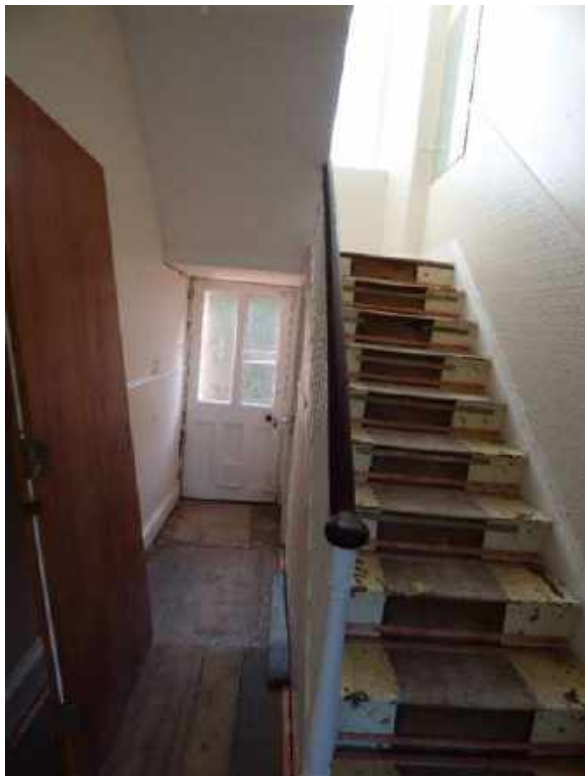
Retain original staircase, which is in good condition.

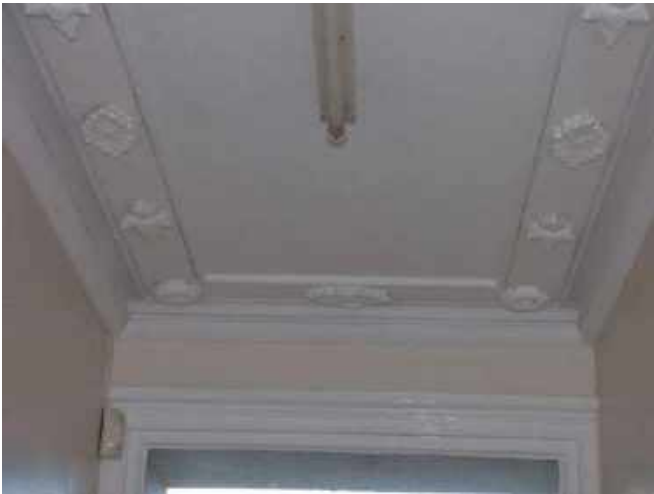
Left: Period features to be retained, including archway and architraves. (Modern lighting to all be stripped out and make good surfaces). All architraves and plaster features to be retained.

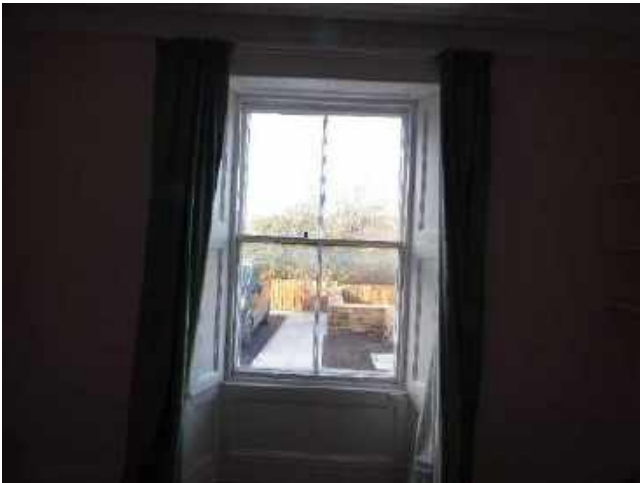
In the existing study, the period features below and to the sides of the existing window are in good condition, it is proposed to carefully refurbish the existing timber shutters.

Below: Existing cornice to be made good in locations where redundant services are to be removed and where hairline cracks have appeared.

Existing architraves, and skirtings to be retained and made good.

Flush panel doors to be replaced with heritage style four panel painted timber fire doors to enhance the heritage asset.

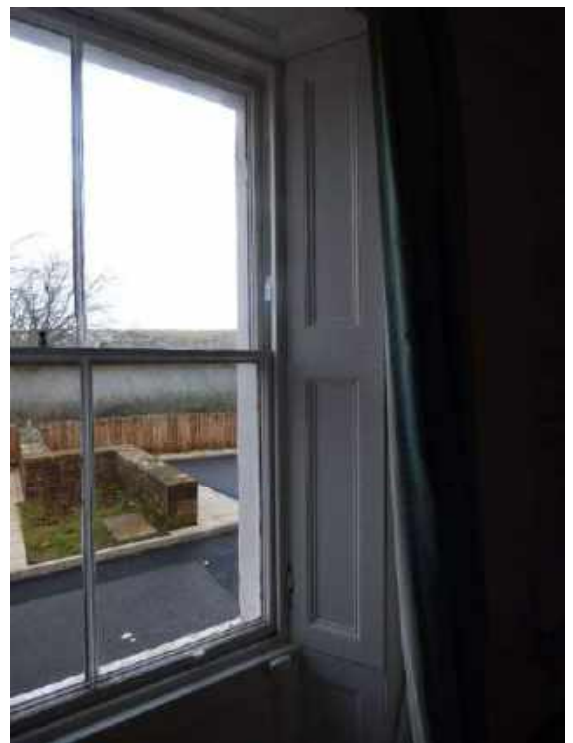
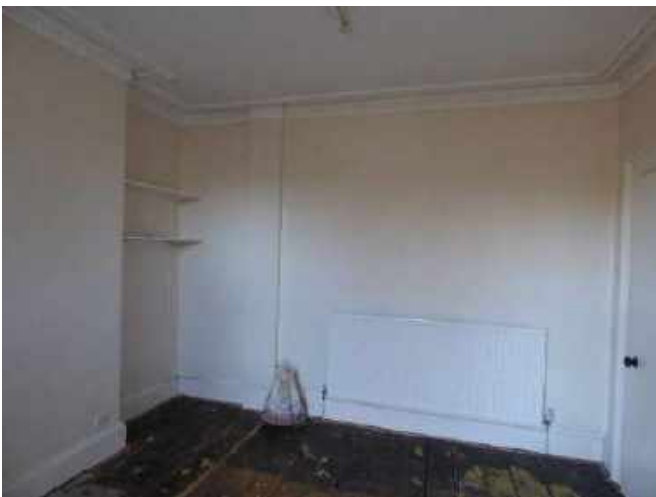
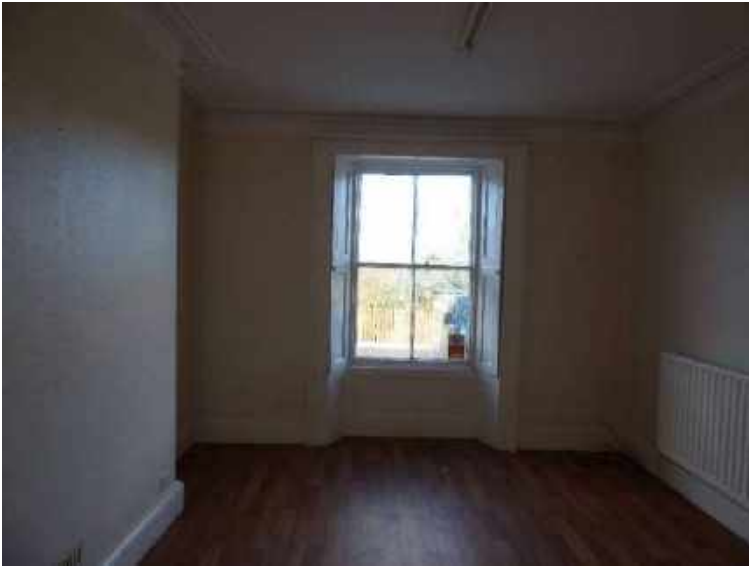
Above, right, and below: In the existing lounge at the front of the property and the existing dining area to the rear of the property, the period features below and to the sides of the existing window are in good condition, it is proposed to carefully refurbish the exiting timber shutters.

Below: Existing cornice to be made good in locations and where hairline cracks have appeared.

Existing architraves and skirtings to be retained and made good.

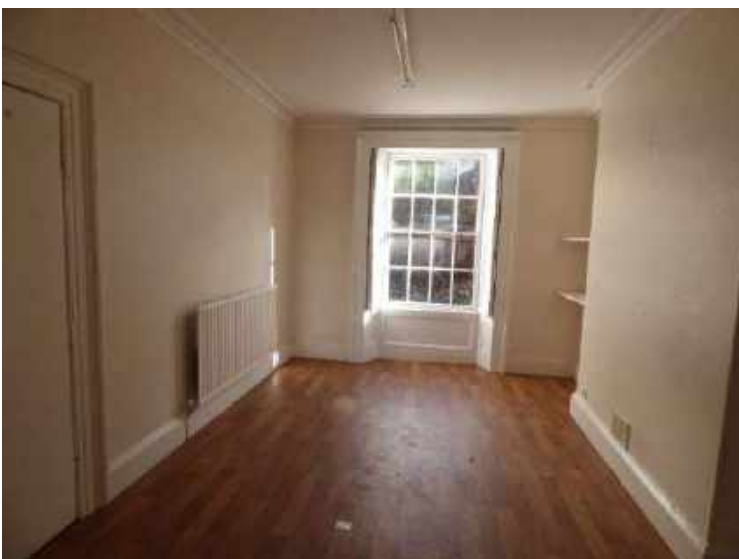
Below: In the existing lounge, the period features below and to the sides of the existing windows both front and back are in good condition, it is proposed to carefully refurbish the existing timber shutters

Existing cornice to be made good in locations where redundant services are to be removed and where hairline cracks have appeared.

Existing architraves and skirtings to be retained and repaired where necessary.

Flush panel doors to be replaced with heritage style for panel painted timber fire doors to enhance the heritage asset.

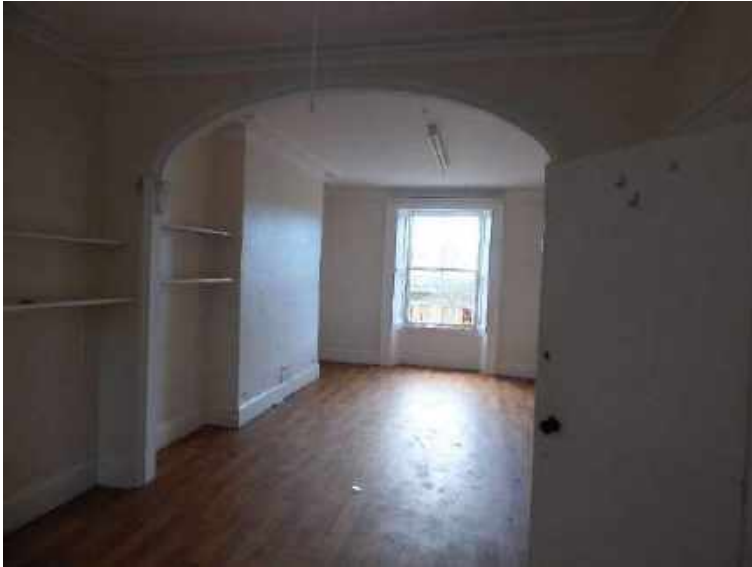
Left and below: In the existing lounge, the period features below and to the sides of the existing windows both front and back are in good condition, it is proposed to carefully refurbish the existing timber shutters.

Existing cornice to be made good in locations where redundant services are to be removed and where hairline cracks have appeared.

Existing architraves and skirtings to be retained and made good.

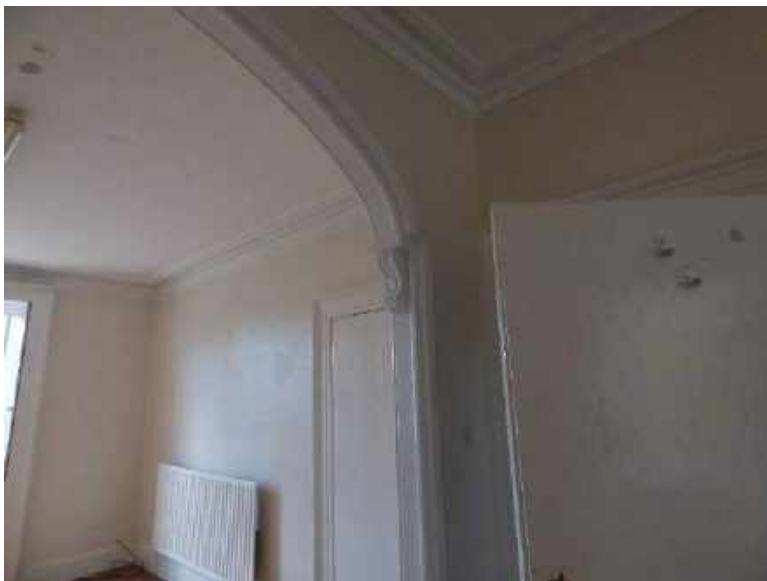
Above and right: period features to be retained, including archway and architraves. (Modern lighting to all be stripped out and make good surfaces). All architraves and plaster features to be retained.

Flush panel doors to be replaced with heritage style four panel painted timber fire doors to enhance the heritage asset.

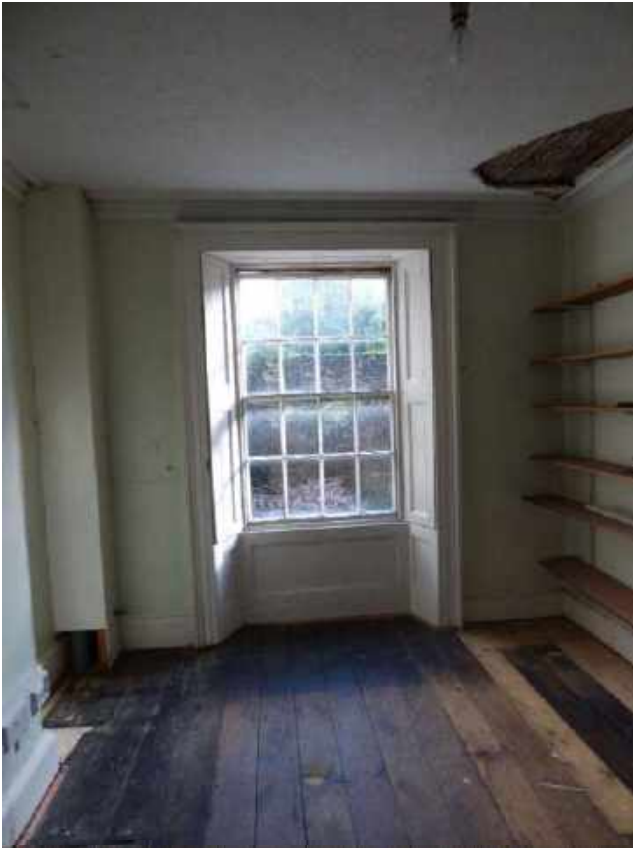
Left and below: The period features below and to the sides of the existing window are in good conditions, it is proposed to carefully refurbish the existing timber shutters.

Existing cornice to be made good in locations where redundant services are to be removed and where hairline cracks have appeared.

Existing architraves and skirtings with heritage style four panel painted timber fire doors.

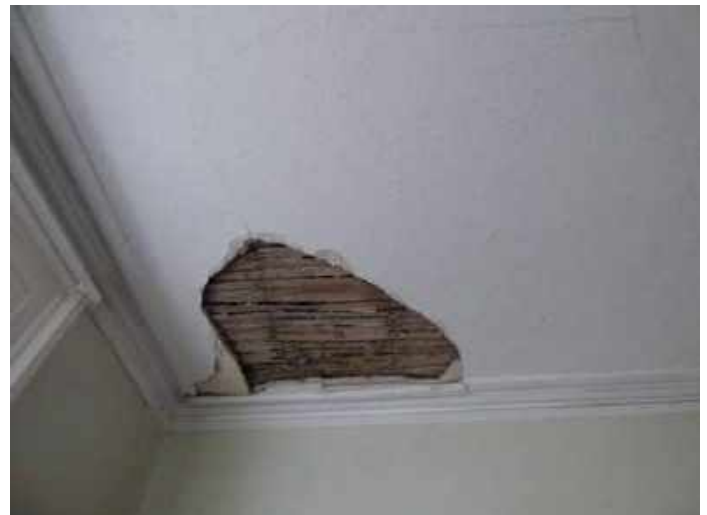
Left and below: The period features below and to the sides of the existing window are in good conditions, it is proposed to carefully refurbish the existing timber shutters.

Existing cornice to be made good in locations where redundant services are to be removed and where hairline cracks have appeared.

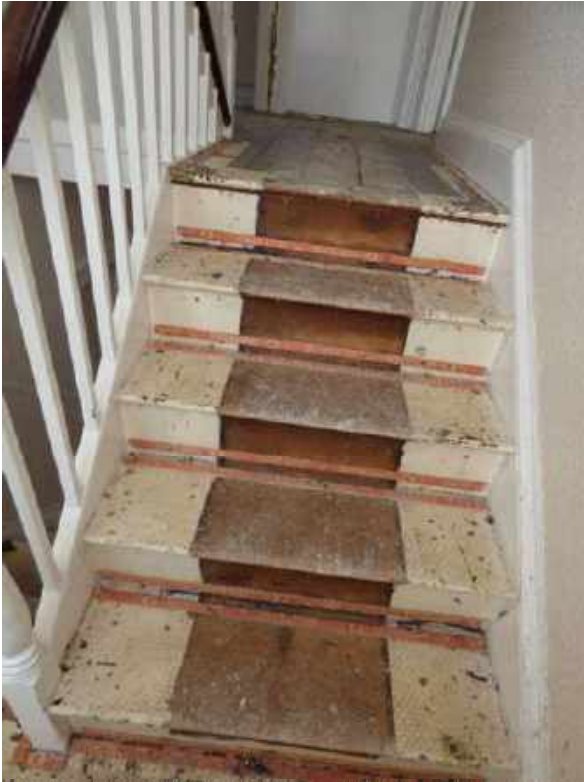
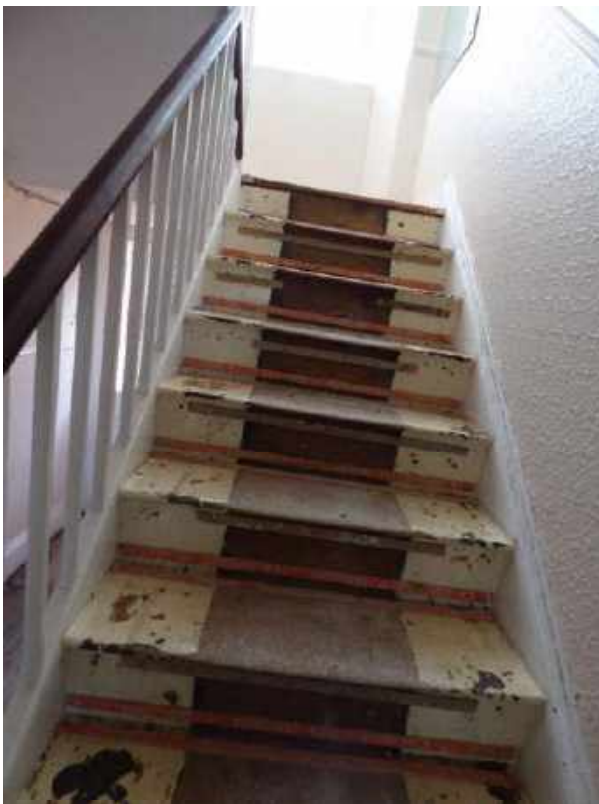
Retain original staircase, which is in good condition.

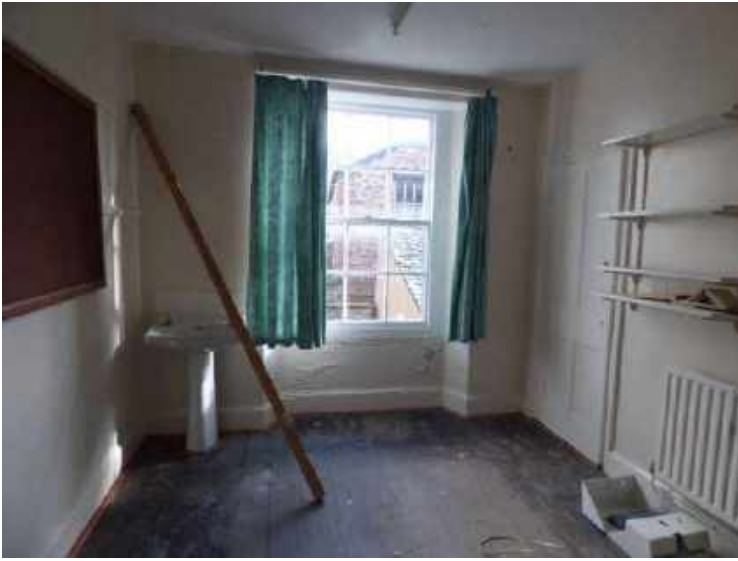
Existing floorboards are generally in good

condition.

Rear bedroom skirtings and architraves to be retained. Existing flush panelled door to be replaced with new Georgian heritage style four panel fire door to be provided by specialist joinery company such as Batty Joinery Ltd.

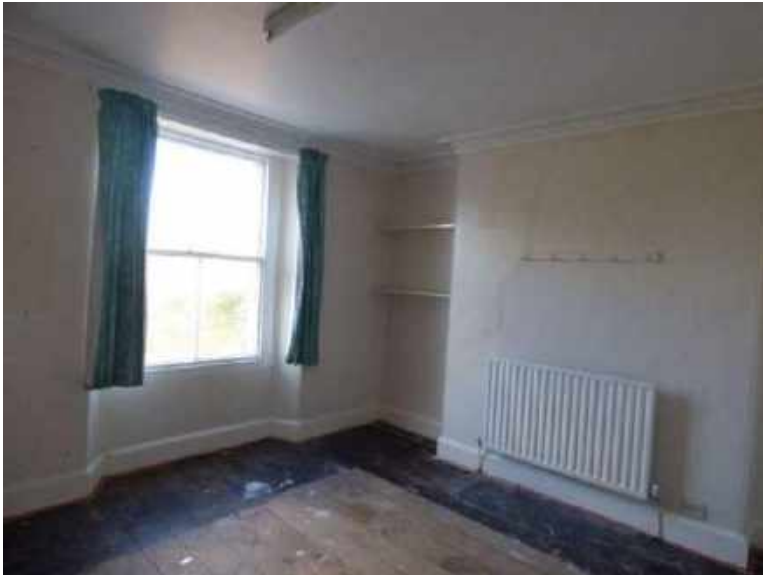
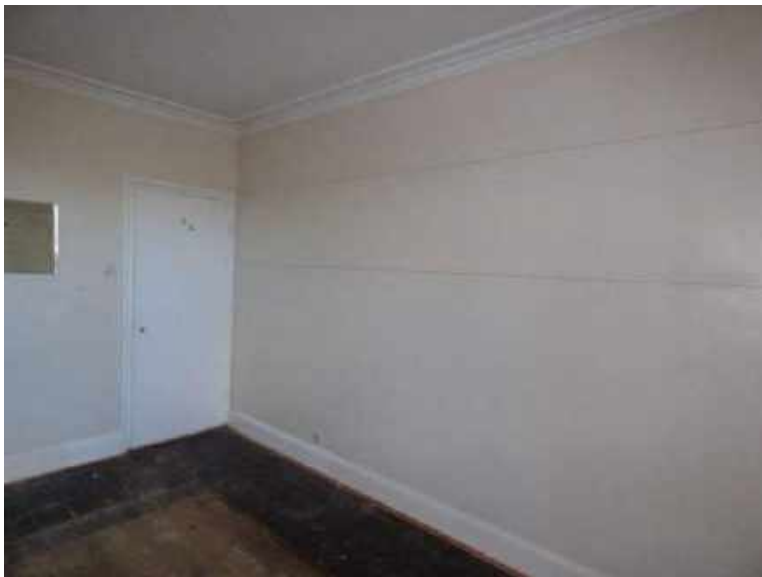
Existing floorboards in generally good condition.

Front bedroom (master) skirtings and architraves to be retained. Existing flush panelled door to be replaced with new Georgian heritage style 4 panel door to be provided and installed by specialist joinery company such as Batty Joinery Ltd.

Form new opening into new en-suite with new architraves and door to match the rest of the property.

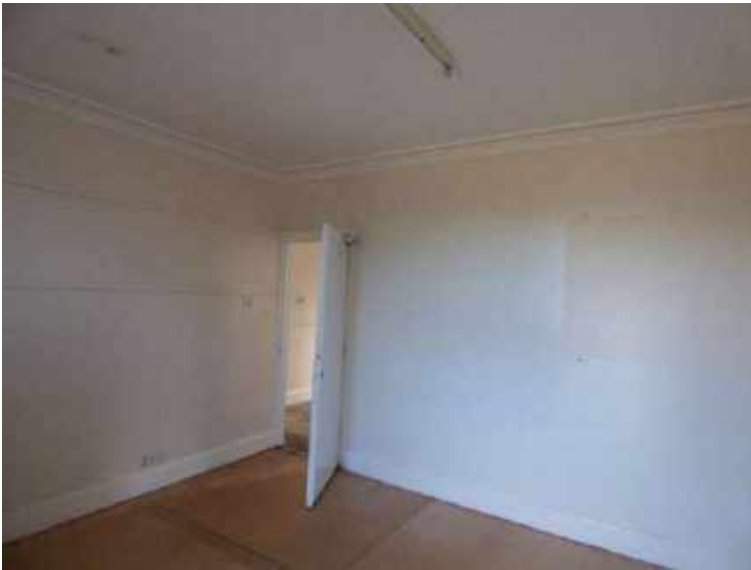
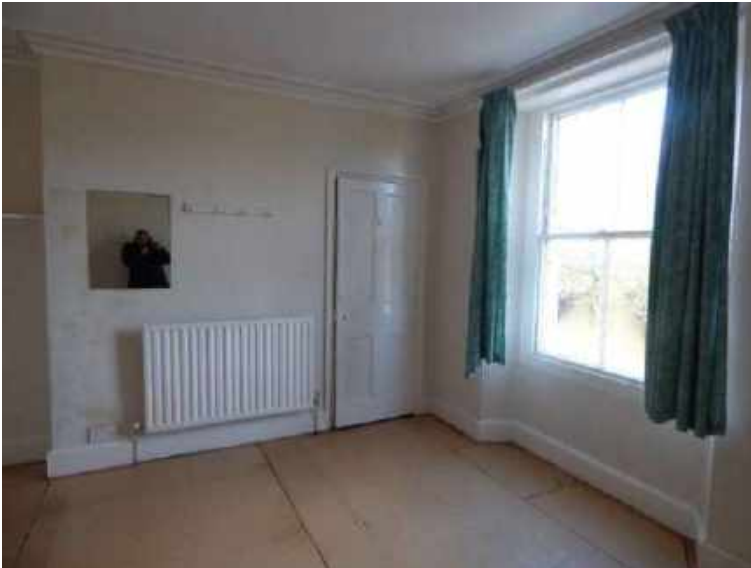
Existing floorboards have been concealed and over-boarded using large chipboard planks. It is proposed to lift the chipboard and evaluate the condition of the existing flooring underneath.

Front bedroom skirtings and architraves to be retained. Existing flush panelled door to be replaced with new Georgian heritage style 4 panel door to be provided and installed by specialist joinery company such as Batty Joinery Ltd.

It is likely that the existing timber floorboards may require significant replacement, if this is the case, the floorboards will be replaced as required on a like for like basis.

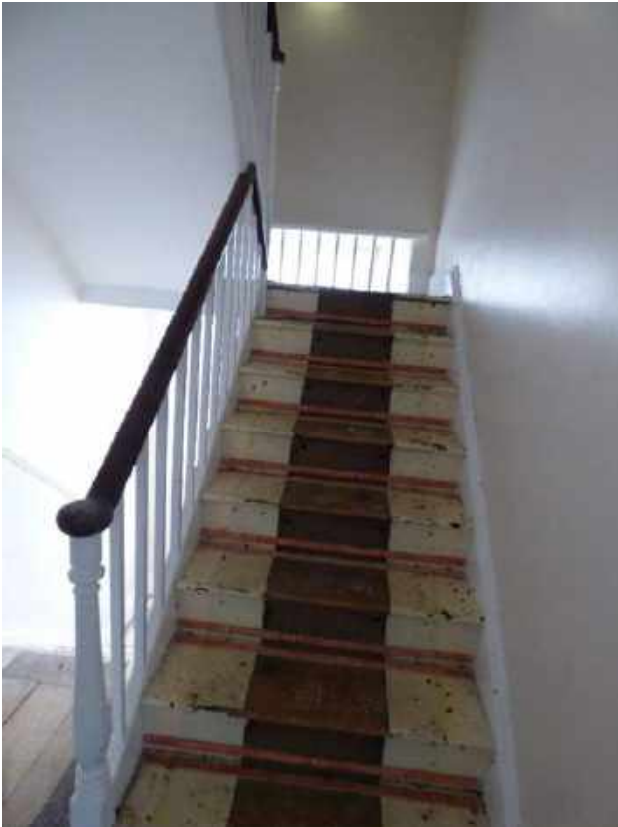
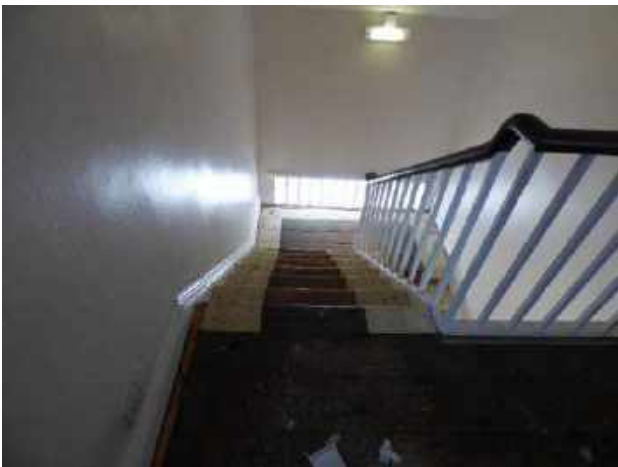
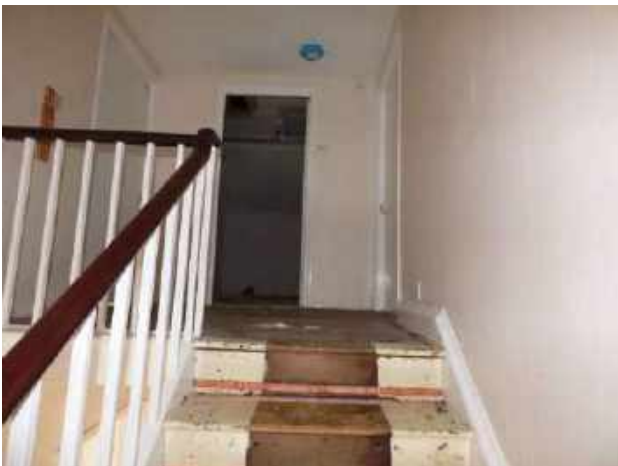
Left and below: Handrail, balusters and rails are original and are to be retained. Missing baluster to be replaced with matching baluster and decorated to match existing.

Apply and insulated plasterboard 62mm thick to underside of sloping ceiling, tape and skim and undertake full decoration.

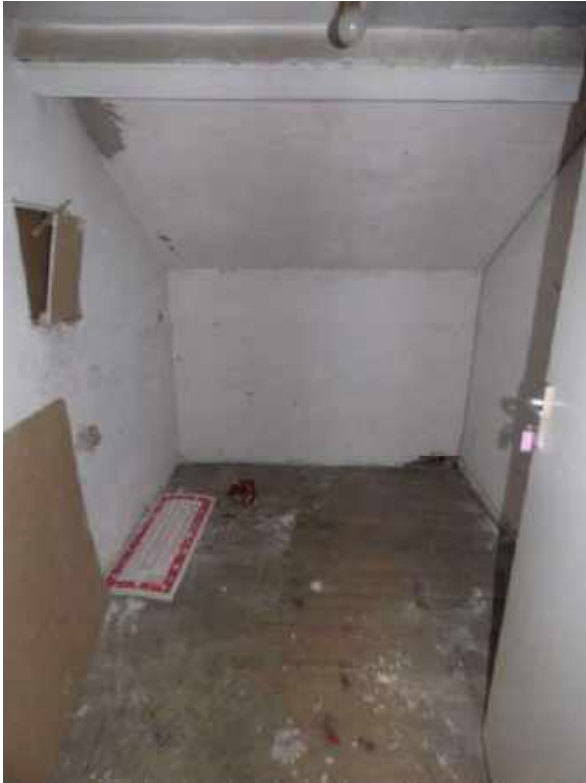
Left: Existing attic store is proposed to be converted into a bathroom to be shared by the attic bedrooms by increasing the size of room to each side to allow for the new bathroom.

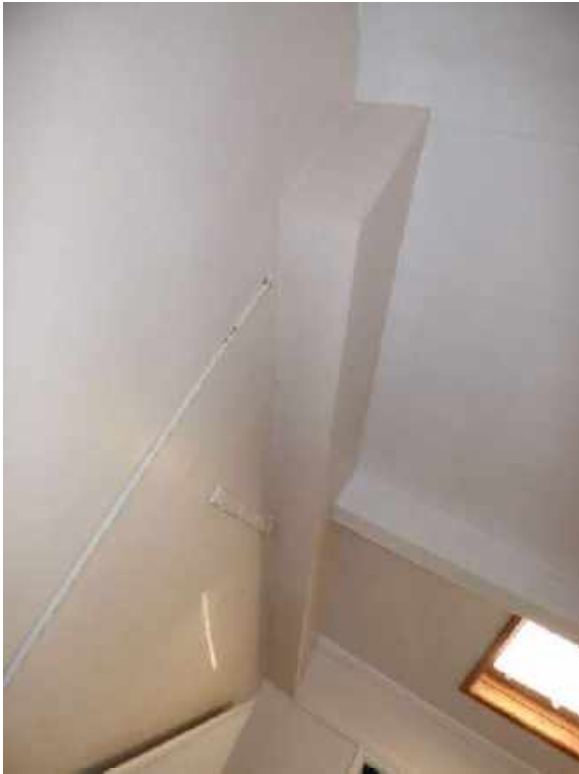
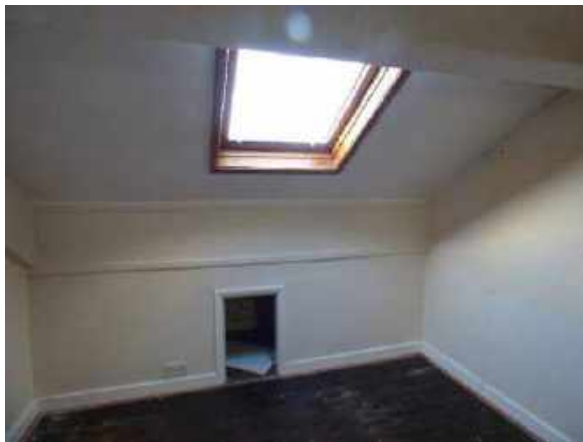
Left and below: Attic bedroom.

In the bedroom, remove all damp and damaged/blown plasterwork and repair with lime plaster and skim and decorate throughout.

Floorboards are in good condition (but may require minor repairs)

Provide and install new heritage rooflight window to replace the existing rooflights.

Existing flush panel doors are to be removed and replaced with new heritage style 4 panel doors.

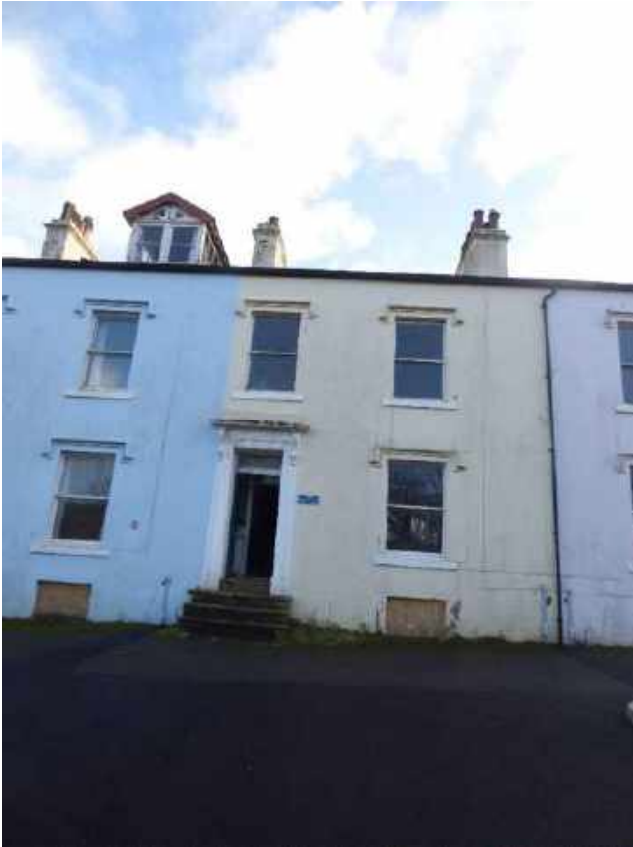
Left: The main entrance is mentioned in the listing text and is to be entirely retained.

Both front and rear elevations are currently rendered, with colour to the front and side and natural to the rear. All elevations require to be prepared for render repairs and redecoration by specialist using lime render and stucco (Parax LTD) to be applied by specialist.

The existing door and frame are to be retained and made good with the provision of new ironmongery. Once repaired full decoration will be undertaken.

Existing gutters and downpipes to be retained, repaired where necessary and decorated.

All existing single glazed windows to replace with new white painted slim profile timber double glazed 'heritage' windows to match the existing style by specialist supplier such as Batty Joinery, specialists in historic and listed building joinery works.

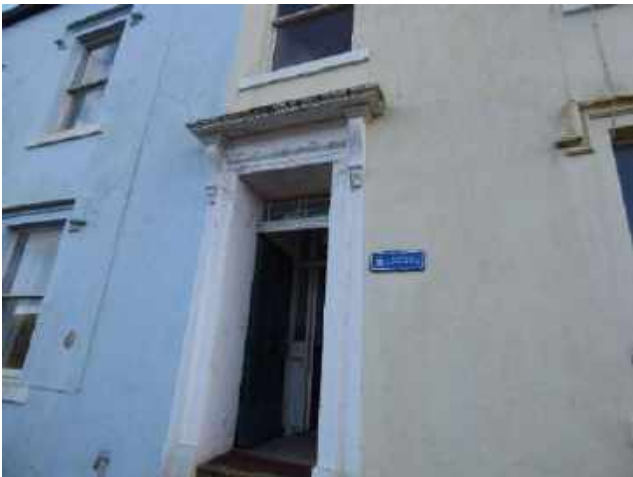
The blue plaque by the door states that this property was for the Lonsdale house Mistress. It is not proposed to retain this as it is a modern sign, and it is proposed to revert the property back to its historic purpose.

The existing stone steps to be cleaned up, and new painted metal handrails provided, that would have originally been installed.

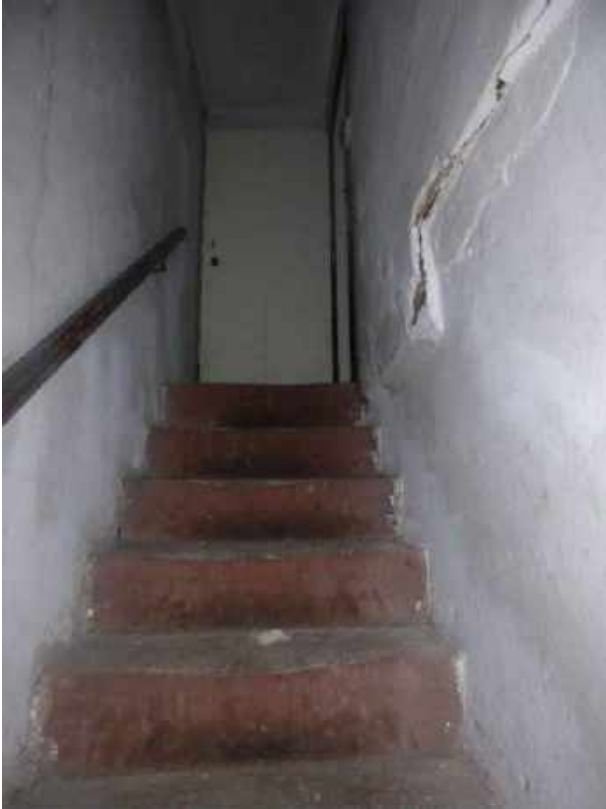
Left: The basement.

The existing walls and floor are generally in sound condition so would be suitable for the application of damp proof slurry system. All existing paint and surface finishes must be removed and made good including all snots removed, and damage to existing surfaces, prior to the installation of a Koster Polysil NB1.

This migratory crystalline tanking slurry is used to seal below ground structures against water ingress.

Koster NB1 works by both providing a physical barrier against water ingress as well as providing a migratory crystal sealant that penetrates deep into the structure to seal micropores and cracks against water ingress.

Once applied then the walls can be prepared and primed for decorating and for the floor finishes to be installed. Complete new boiler and heating system is required, new distribution boards, etc.

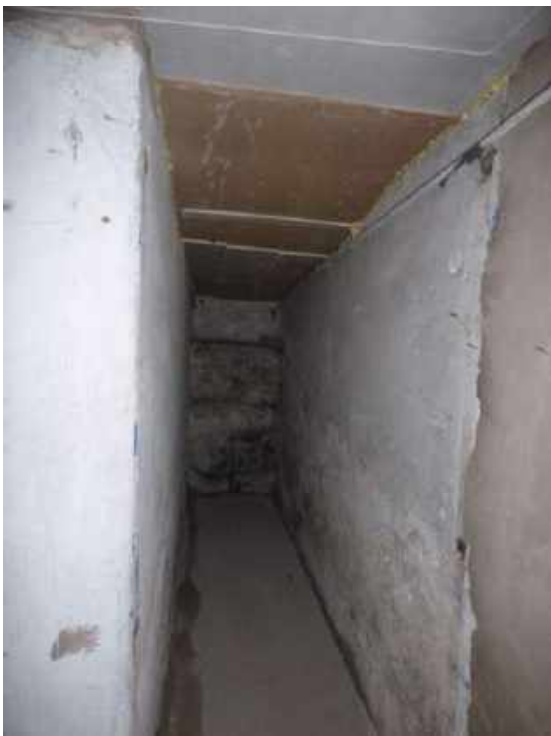
The walls down to the basement also require full treatment.

In the basement all existing services are to be carefully stripped out and replaced with new compliant infrastructure.
