# HERITAGE STATEMENT

## FULL RENOVATION OF EXISTING No 11 TERRACE HOUSES

St Bees, 1-11 Lonsdale Terrace, Parish Council, Cumbria

M.A.C Architects, Project Number: 2019:303

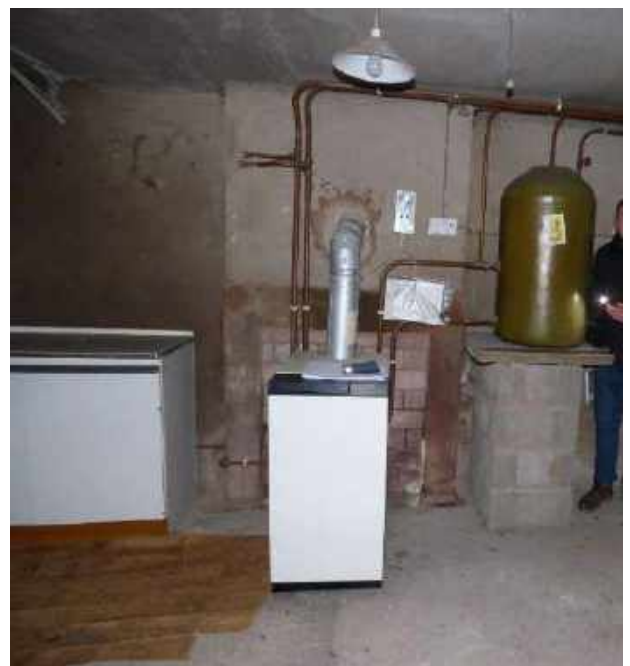
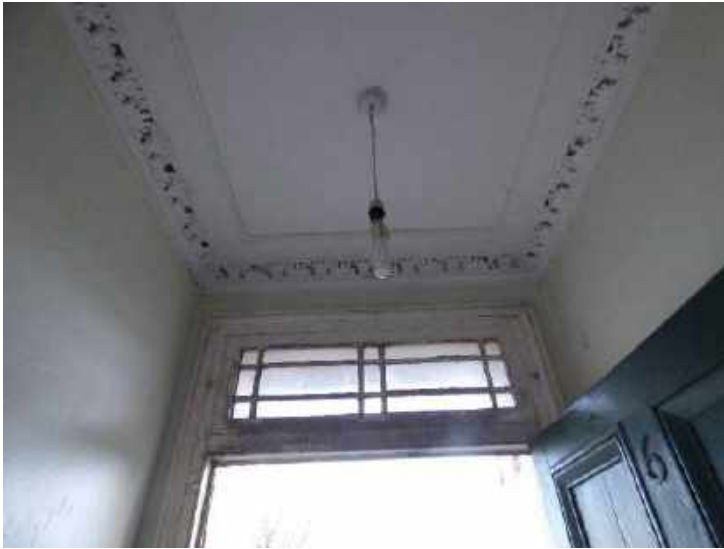
Left: Entrance, hall, and stairs.

The existing walls and floor are generally in good condition.

Redundant M&E to be removed and wall/ceiling finishes made good, and primed and fully decorated.

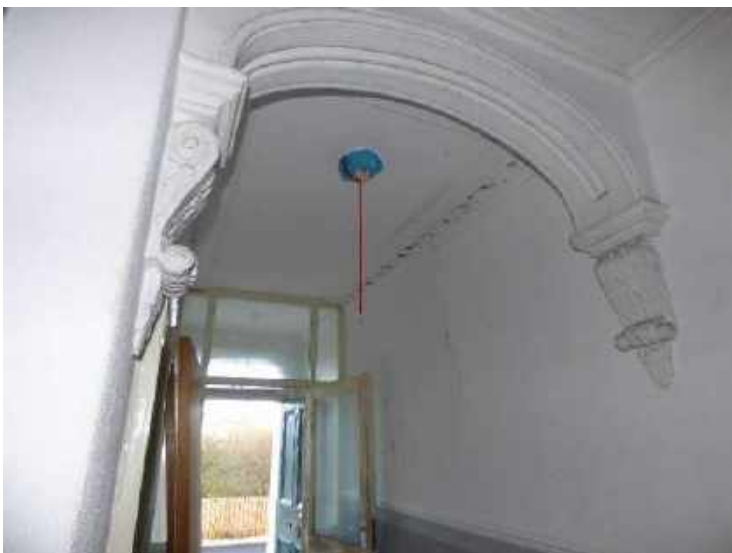
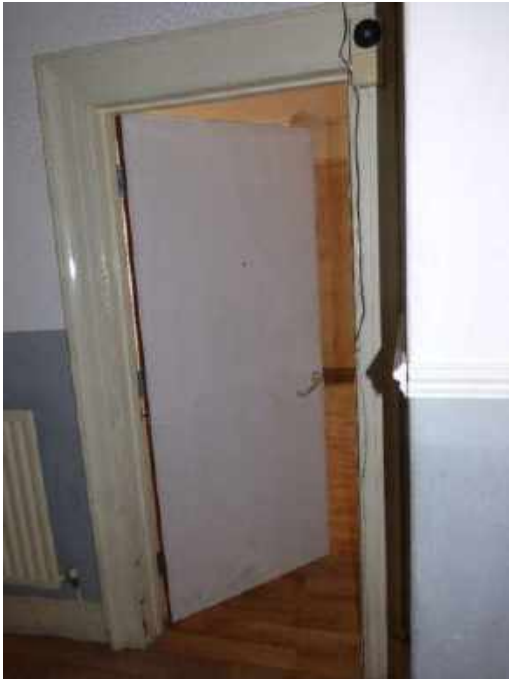
The handrails, balusters, and rails are not original; however it is proposed to be retain them, and decorate so they are more in keeping with the historic context of the property.

Flush panel doors to be replaced with heritage style four panel painted timber fire doors by Batty joinery Ltd or similar to enhance the heritage asset.

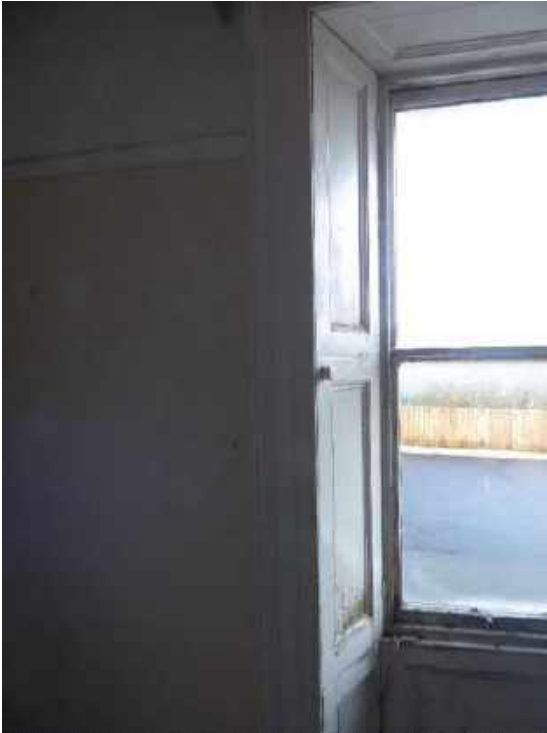
In the existing lounge, the period features below and to the sides of the existing windows both front and back are in good condition, it is proposed to carefully refurbish the existing timber shutters.

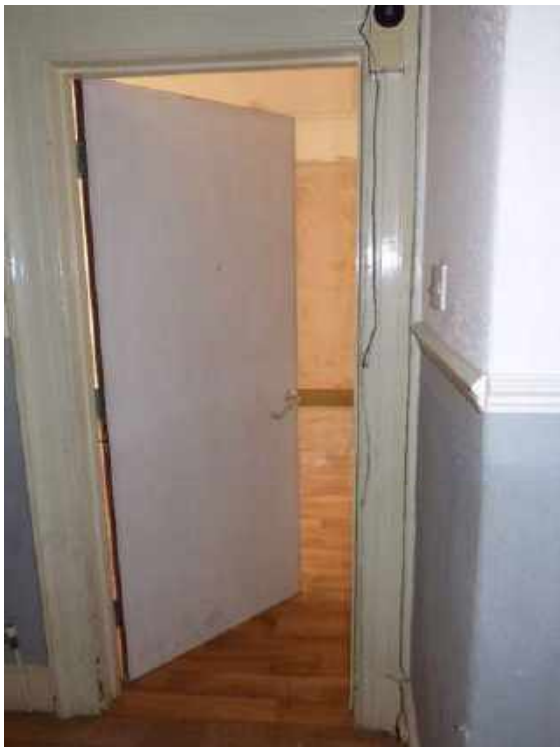
The dining room requires repairs to the ceiling and walls affected by damp ingress.

Flush panel doors to be replaced with heritage style four panel painted timber fire doors to enhance heritage asset.

Blown plaster will be removed and replaced with lime plaster.

Architraves will be repaired.

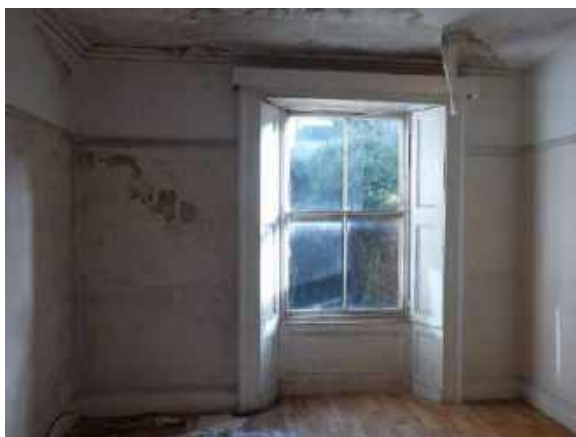
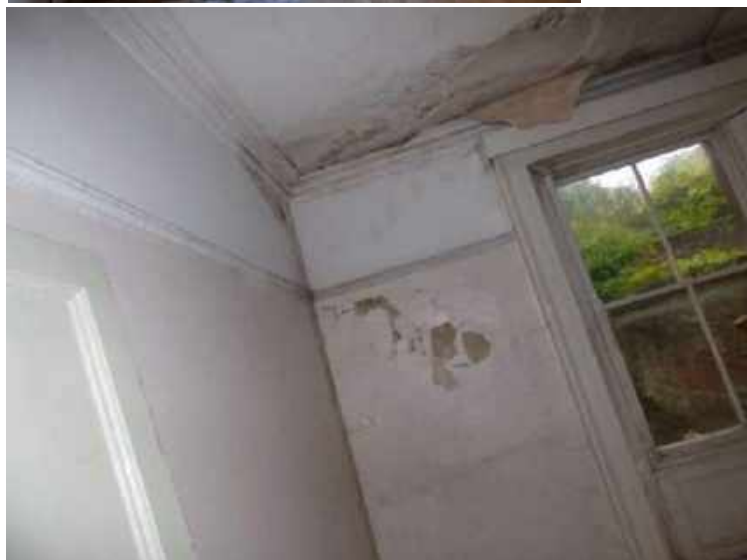
The existing shutters are generally in good condition but require minor restoration works to restore them.

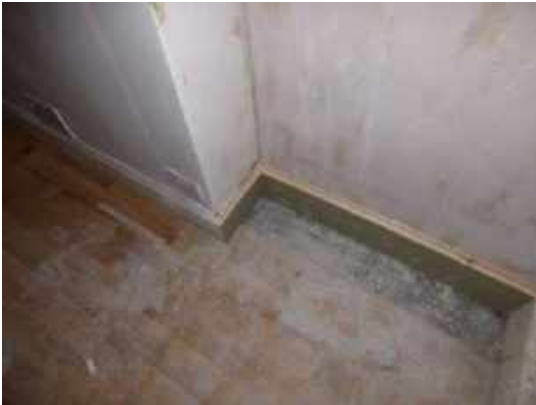
Not all the skirting is consistent. It is proposed to remove the recently installed skirting (where a doorway was walled up from the properties previous use as a school building) and replace with skirting to match the existing. It is proposed to reinstate the picture rail to match existing. It is proposed to form a new opening between dining and living as undertaken historically in houses 1-5, to make more suitable living accommodation for the present day.

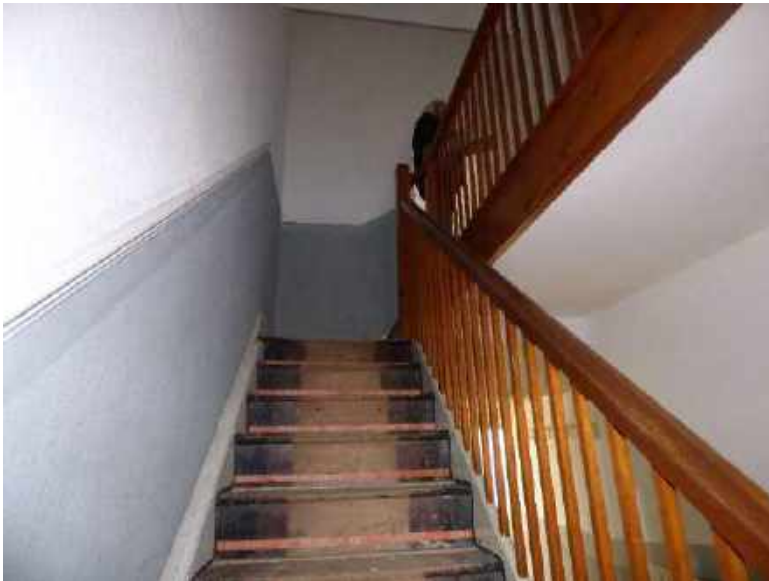
Left Retain staircase, which although not original is in good condition. Its is proposed to redecorate.

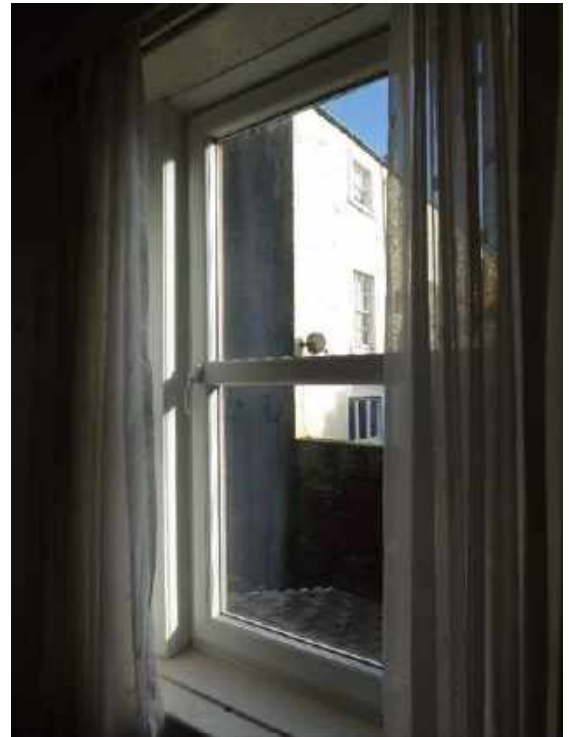
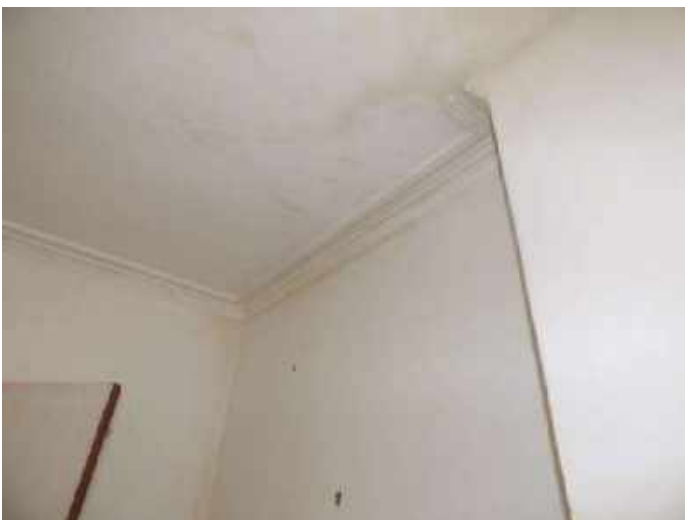
Existing floorboards in generally good condition, with minor repairs being required. Damaged floorboards to be replaced with boards to match existing.

Above, right, and below: Rear bedroom skirtings, cornices and architraves to be retained. Flush panel door to be replaced with new Georgian heritage style 4 panel door to be provided and installed by specialist joinery comp any such as Batty joinery ltd.

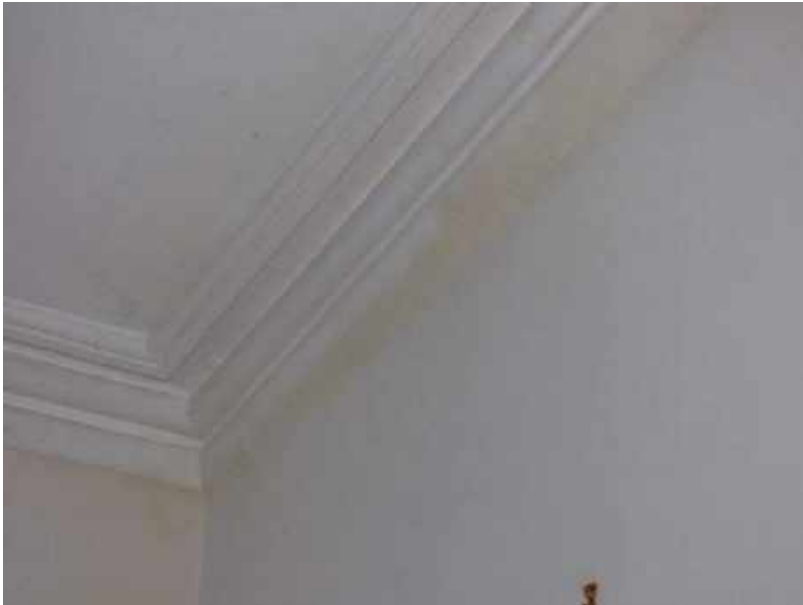
Front bedroom (First floor LHS) cornice, skirtings, and architraves to be retained. Existing flush panelled door to be replaced with new Georgian heritage style 4 panelled door to be provided and installed by specialist joinery company such as Batty Joinery Ltd.

Existing floorboards in good condition.

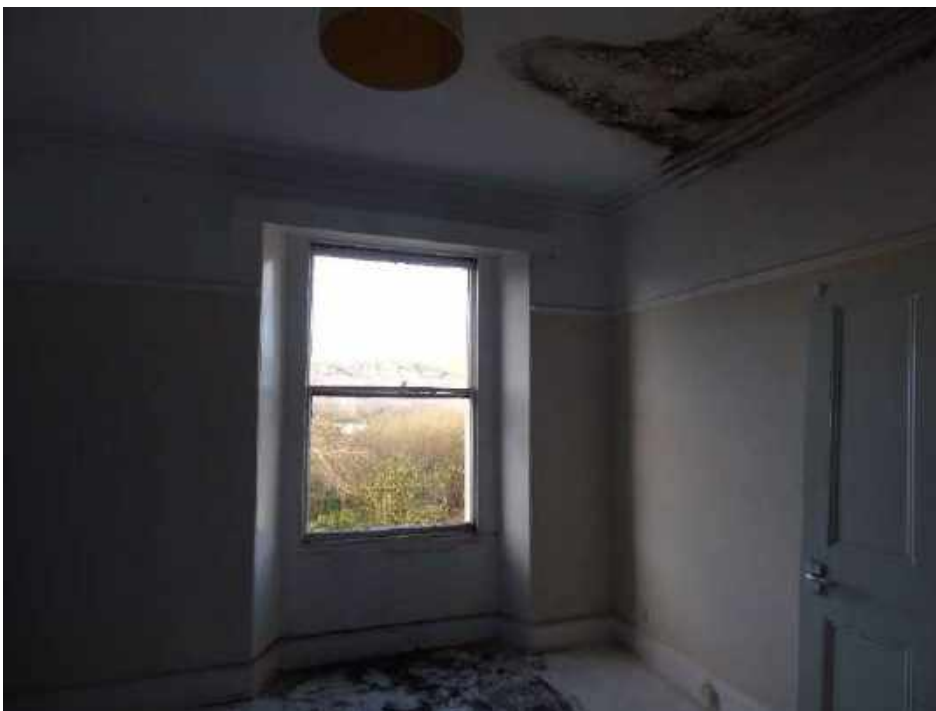
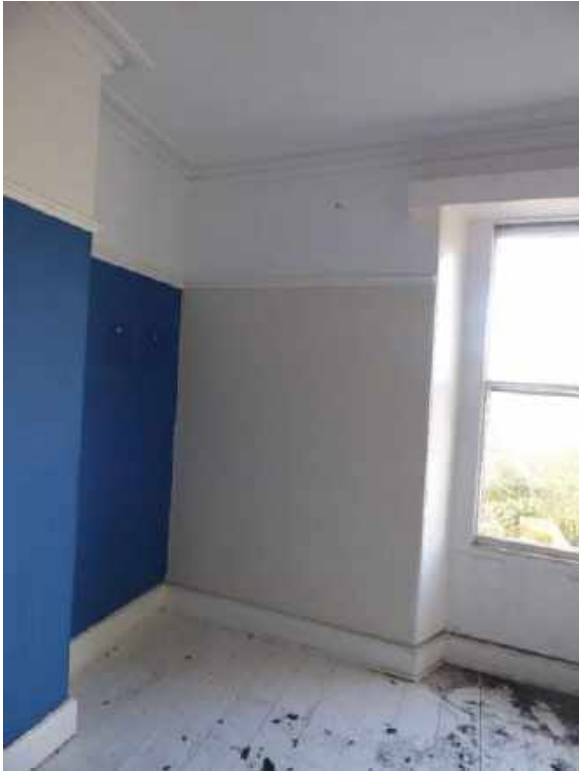
Front bedroom (First floor LHS) cornice, skirtings, and architraves to be retained. Existing flush panelled door to be replaced with new Georgian heritage style 4 panelled door to be provided and installed by specialist joinery company such as Batty Joinery Ltd.

Existing floorboards in good condition.

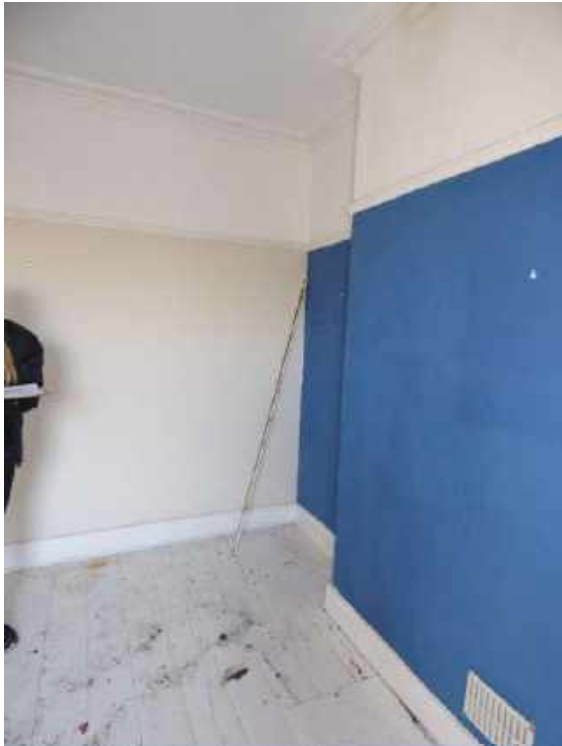
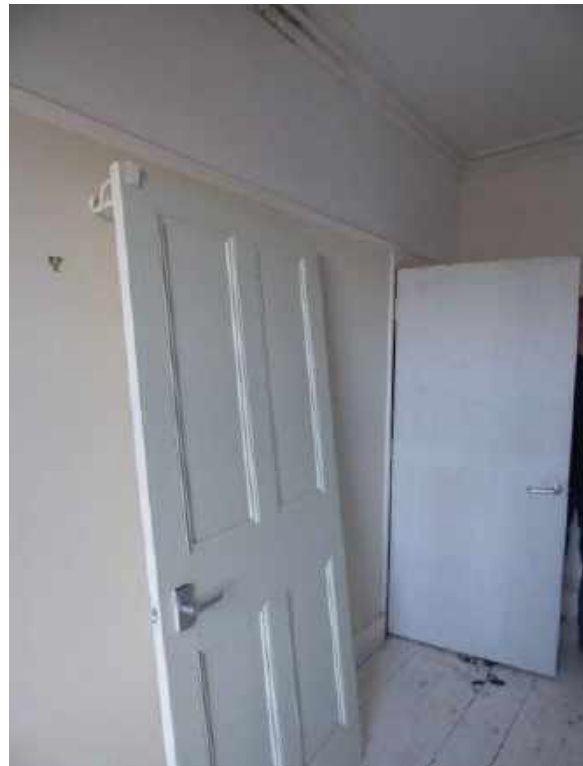
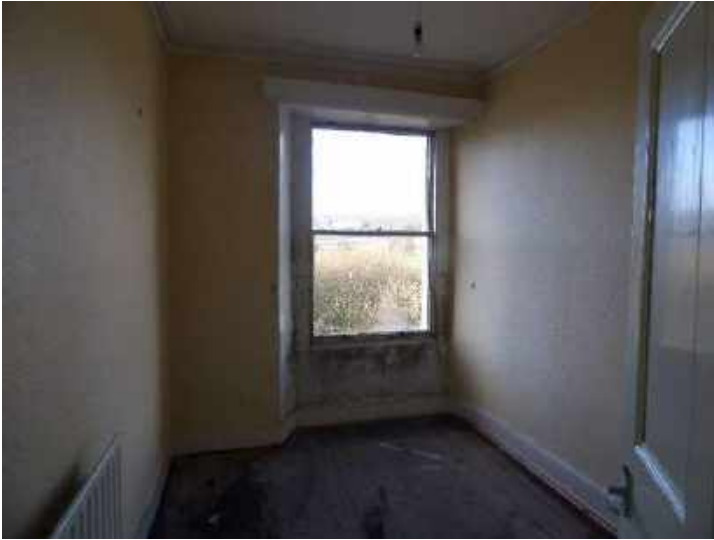
Front bedroom (First floor RHS), cornices, skirtings and architraves to be retained. Existing flush panelled door to be replaced with new Georgian heritage style 4 panelled fire door to be provided and installed by specialist joinery company such as Batty Joinery Ltd.

Existing floorboards generally in good condition

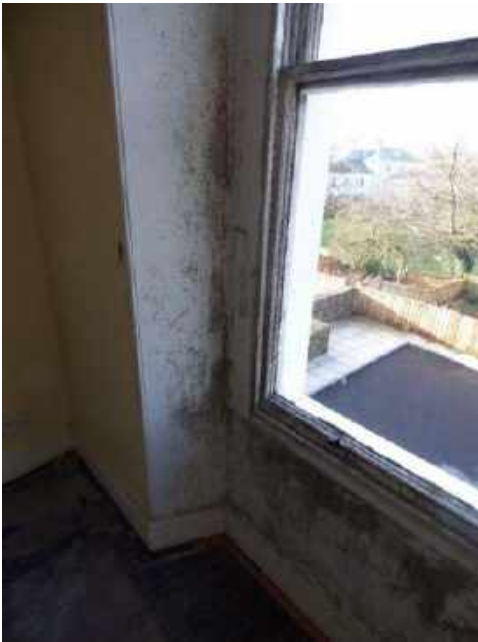
Left: Damp ingress around windows has blown the existing plaster. It is proposed to replace damaged plaster with lime plaster. New heritage style windows being installed will resolve the damp ingress.

Damp damage to plaster ceiling to be removed and reinstated. Any damage to lath and plaster to be repaired by specialist.

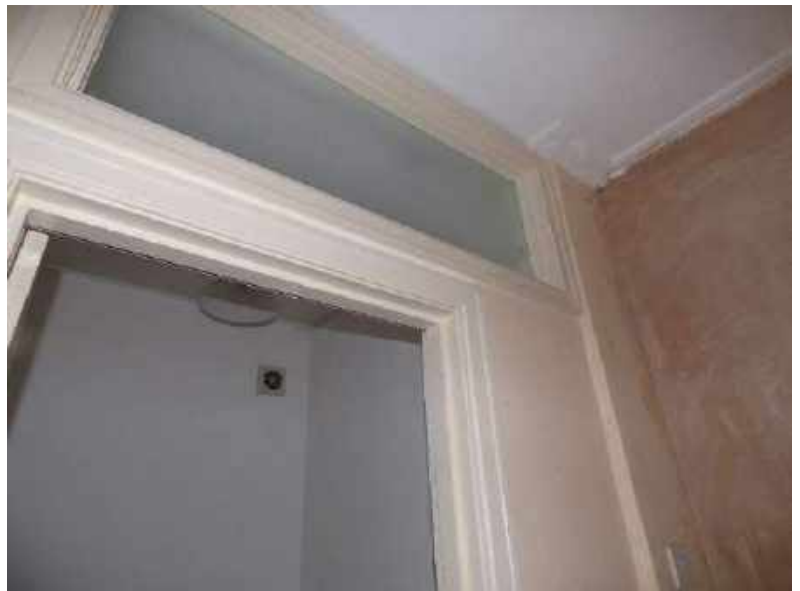
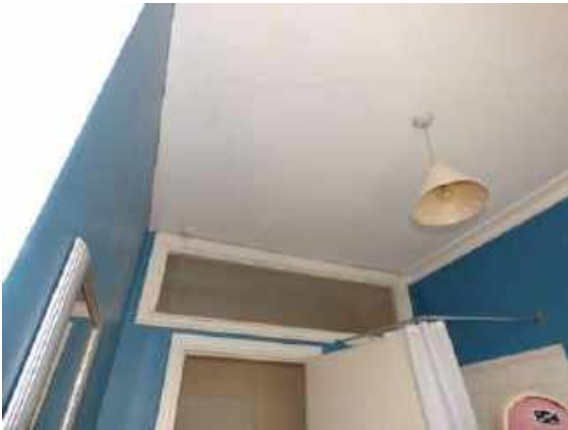
Left and below: Existing ceiling to be made good and provide and install new extract fan linked back to light switch.

Glazing to new heritage style Georgian double glazed sash window to be obscure.

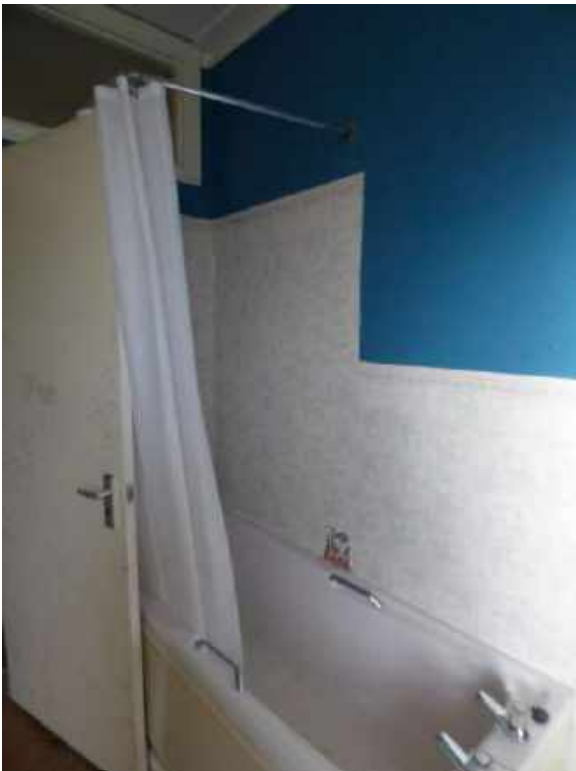
New bathroom door to be 4 panelled heritage style door – bathroom door does not need to be a fire rated door.

All finished to be made good and skirtings to match the original to be installed.

Blown plaster to be removed and new lime plaster repairs to be undertaken. Floor to be made good with floorboards to match the existing.

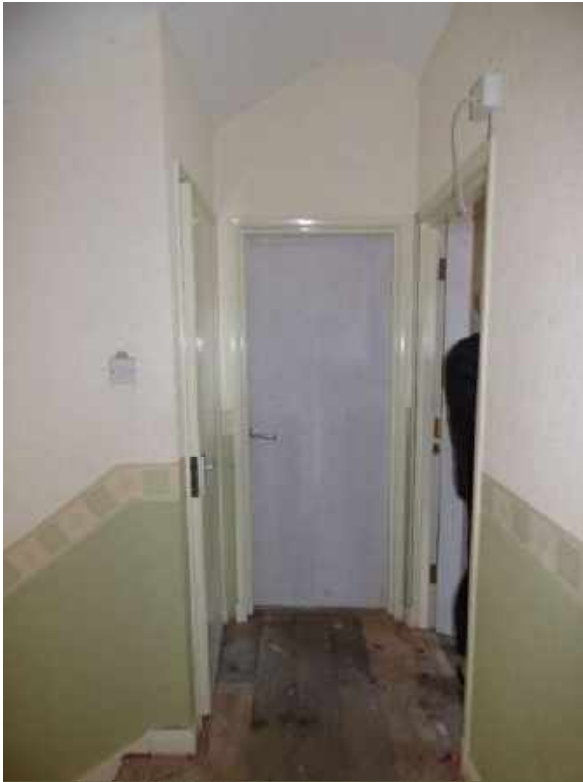
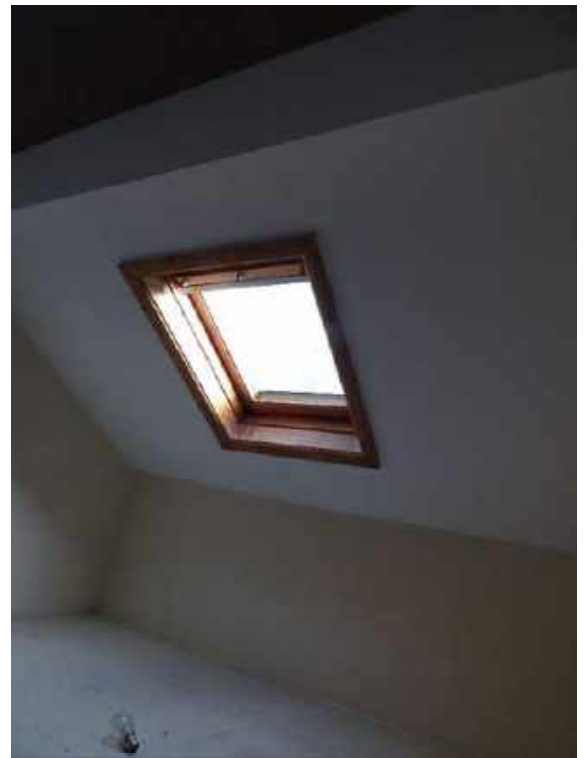
Second Floor Landin area to be reconfigured along with the layout of the second floor.

62mm thick insulated plasterboard to be applied to underside of sloping ceiling, tape and skim and undertake full decorations.

Existing rooflights to be replaced with new heritage style rooflights.

Existing flush panel doors are to be removed and replaced with heritage style 4 panel fire doors by specialist joinery company such as Batty Joinery Ltd.

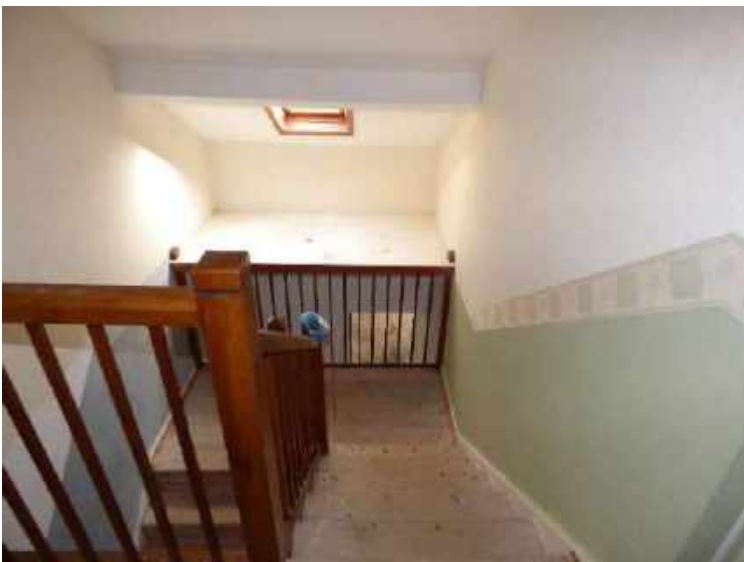
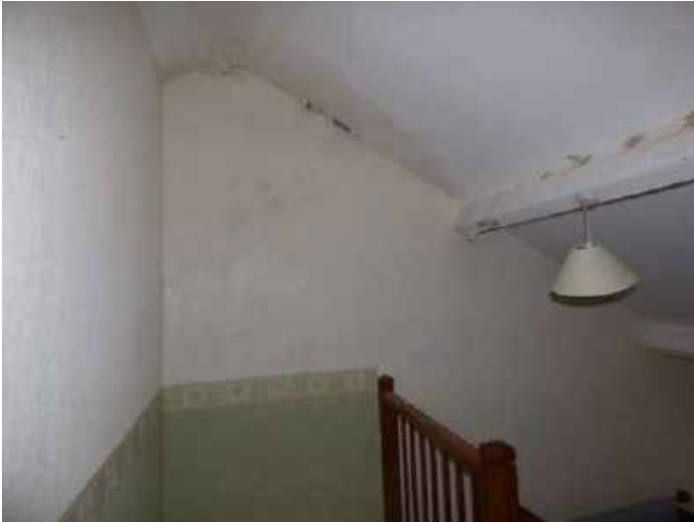
Damaged plasterwork to be repaired with lime plaster.

62mm thick insulated plasterboard to be applied to underside of sloping ceiling, tape and skim and undertake full decorations.

Existing store is not original and is proposed to be removed as part of the reconfiguration of the space.

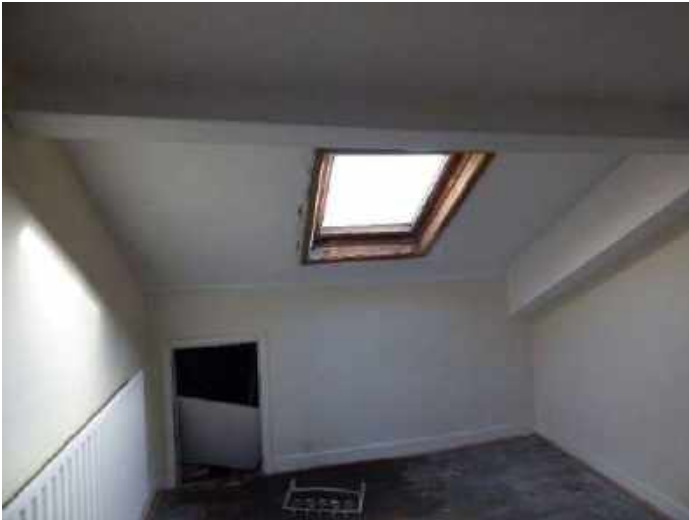
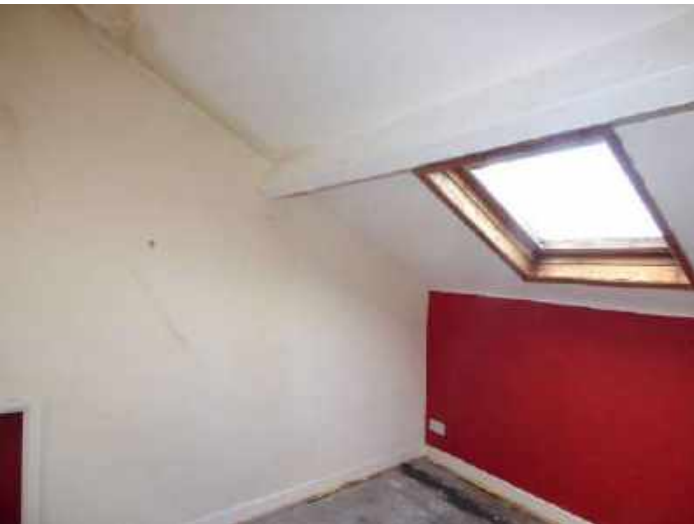
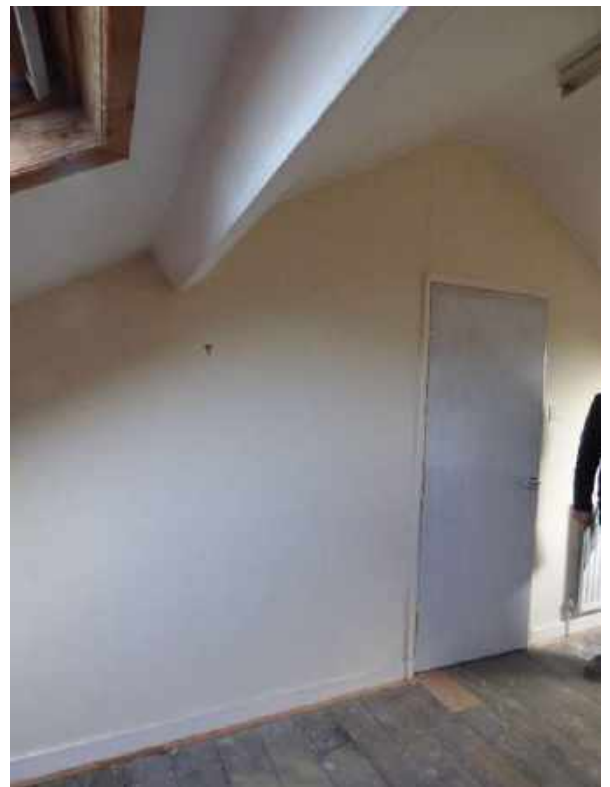
Left and below: Attic bedroom.

Bedrooms to be reconfigured to improve the space at second floor.

In the bedroom all damp and damaged/blown plasterwork will be repaired with lime plaster and skim and decorate throughout.

Areas of water ingress to be investigated and roof repairs undertaken a necessary.

Floorboards are in good condition (but may require minor repairs, due to damp ingress).

Existing flush panel doors are to be removed and replaced with new heritage style 4 panel fire doors.

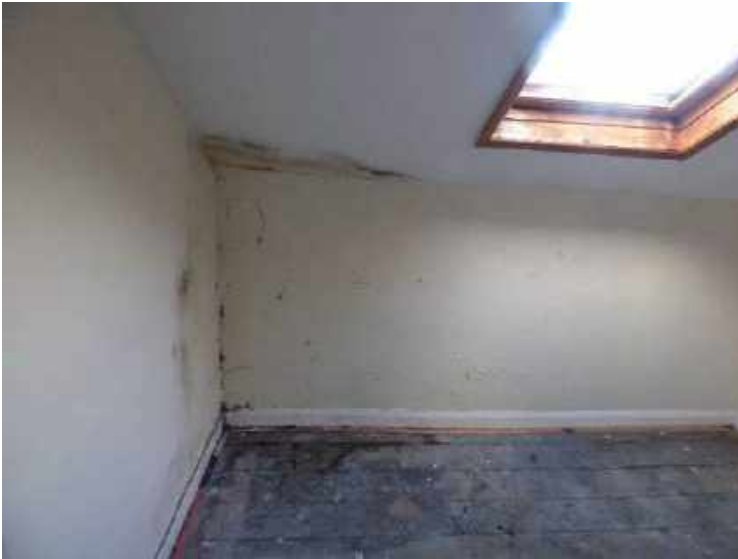
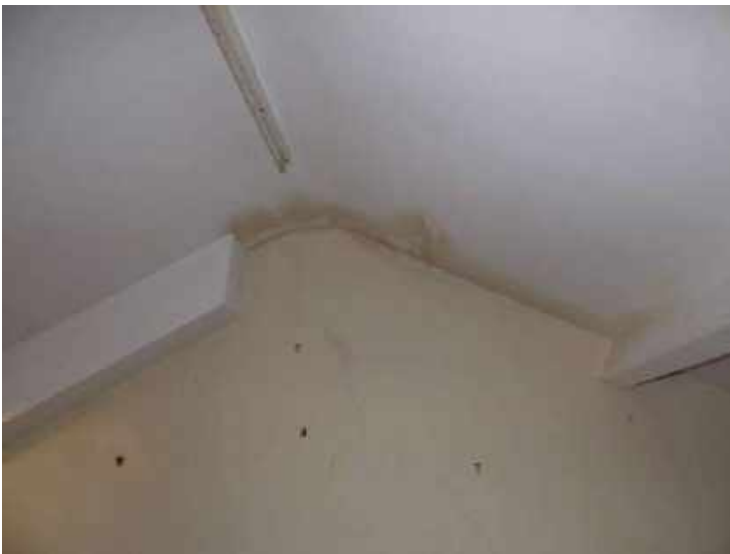
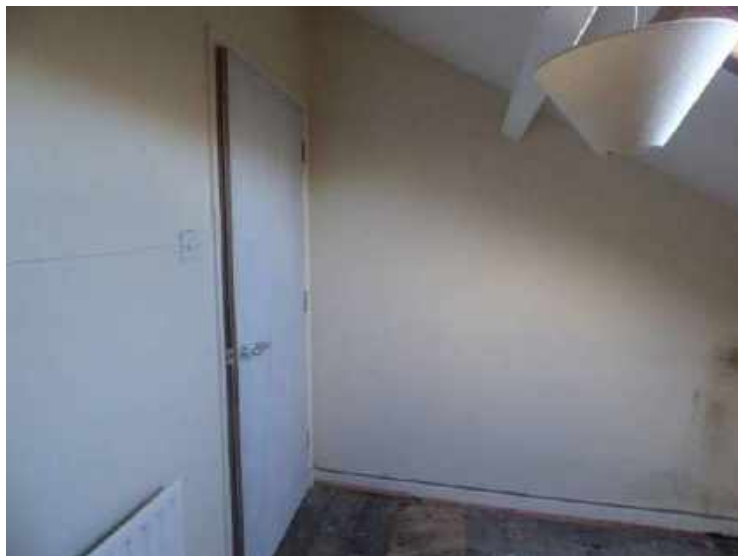
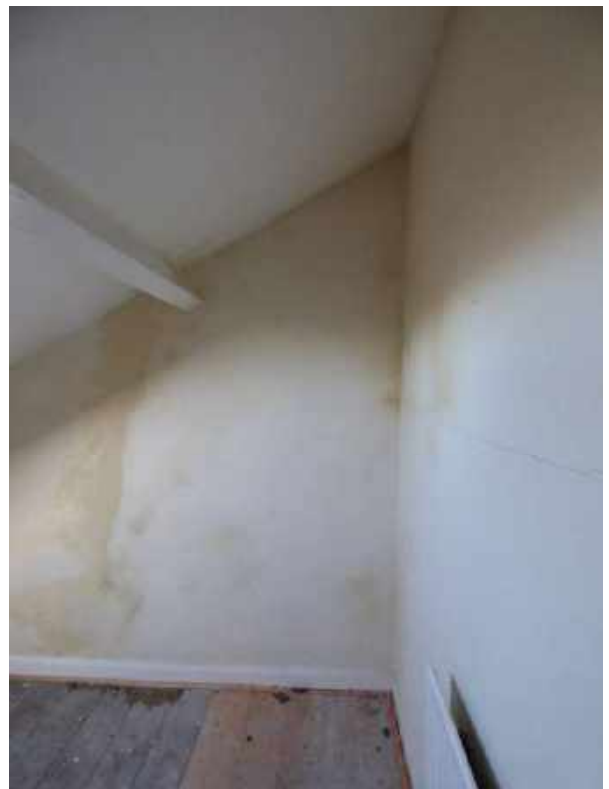
Left and below: Small attic bedroom.

Bedrooms to be reconfigured to improve the space at second floor.

In the bedroom all damp and damaged/blown plasterwork will be repaired with lime plaster and skim and decorate throughout.

Areas of water ingress to be investigated and roof repairs undertaken a necessary.

Floorboards are in good condition (but may require minor repairs, due to damp ingress).

Existing flush panel doors are to be removed and replaced with new heritage style 4 panel fire doors.

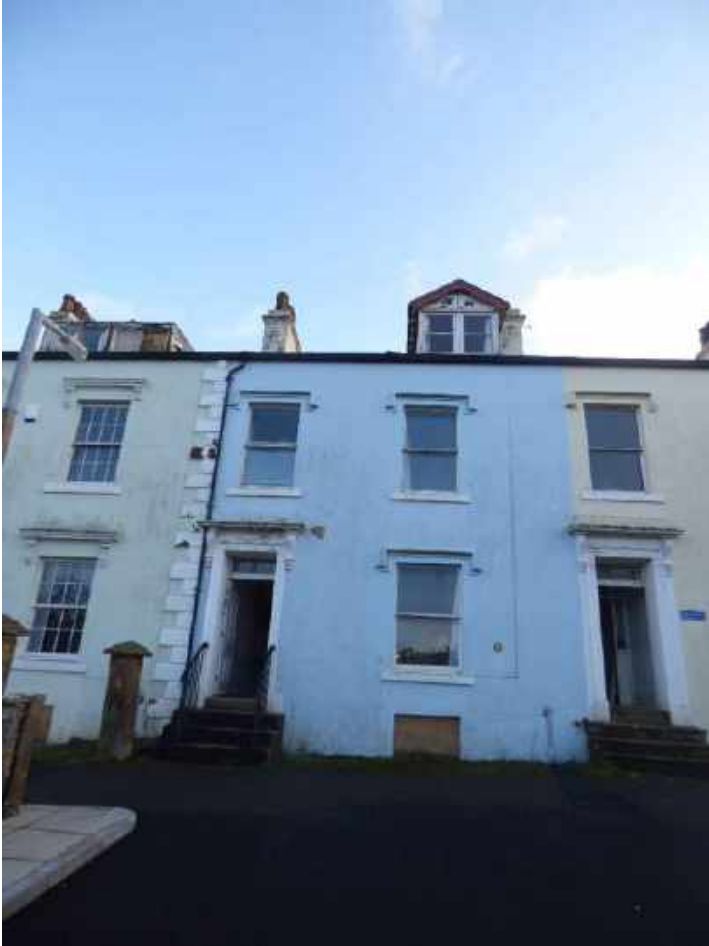
Left: The main entrance is mentioned in the listing text and is to be entirely retained.

Both front and rear elevations are currently rendered, with colour to the front and side and natural to the rear. All elevations require to be prepared for render repairs and redecoration by specialist using lime render and stucco (Parax LTD) to be applied by specialist. The stucco features above the windows and door on the front elevation will be carefully restored by a specialist. Colour of all render and stucco to match existing.

The existing door and frame are to be retained and made good with the provision of new ironmongery. Once repaired full decoration will be undertaken.

Existing gutters and downpipes to be retained, repaired where necessary and decorated.

All existing single glazed windows to replace with new white painted slim profile timber double glazed 'heritage' windows to match the existing style by specialist supplier such as Batty Joinery, specialists in historic and listed building joinery works.

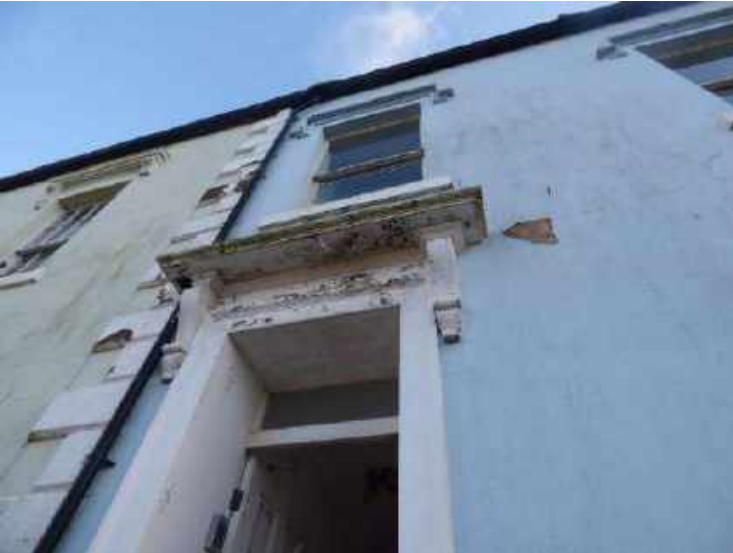
All single glazed windows to be replaced with new white painted slim profile double glazed 'heritage' windows to match the existing style by specialist supplier such as Batty Joinery.

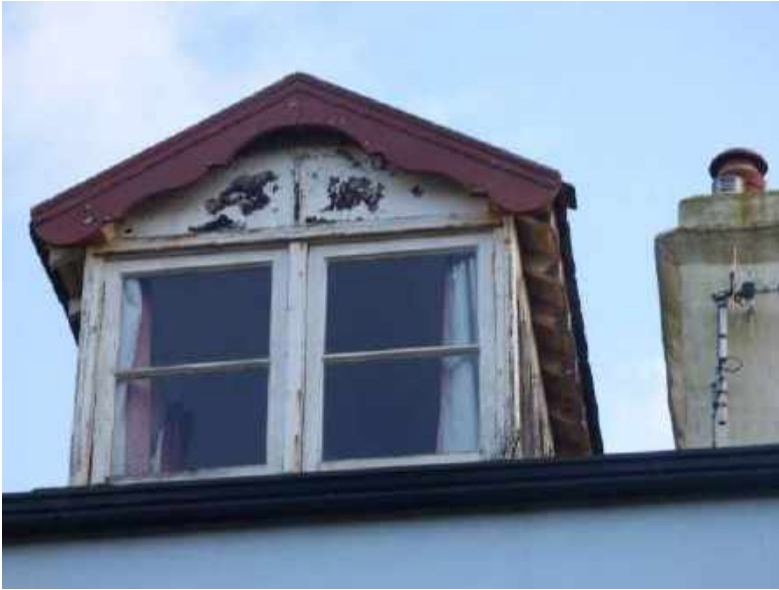
Existing dormer windows are in extremely poor condition. Considerable fabric damage internally has been the result of the extent of damage to these dormers. It is proposed to completely rebuild these in the same style as indicated on the proposed elevations with double glazed heritage style windows.

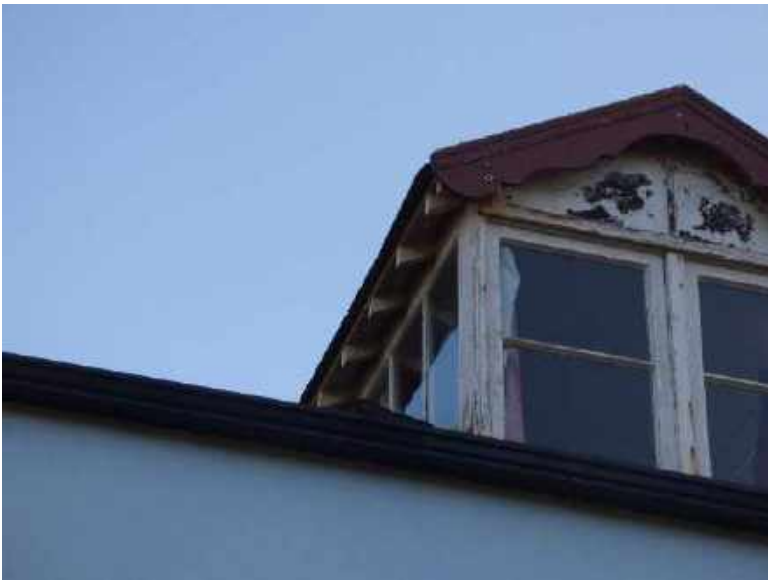
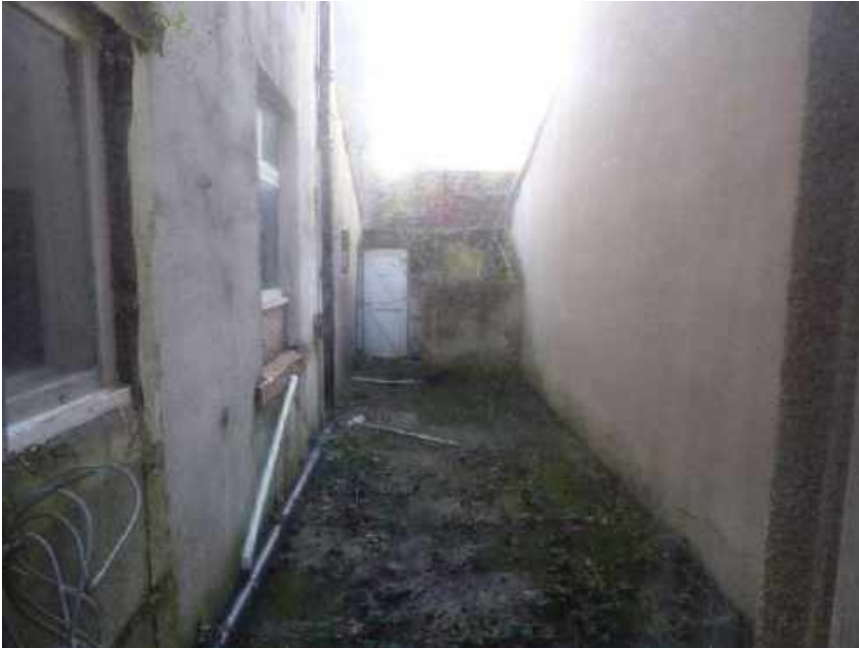
Modern windows installed to the rear of the property, to be replaced with traditional heritage style double glazed painted timber windows.

Existing external walls to be repaired with lime render and decorated off white, to create a more aesthetically pleasing rear courtyard area.

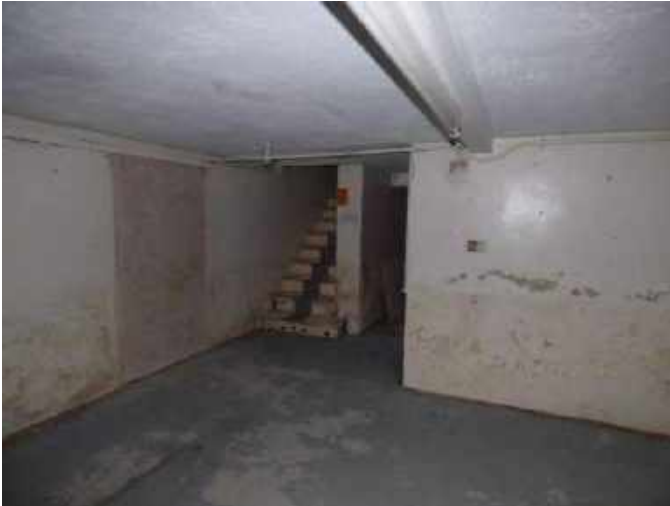
The existing basement walls and floor are generally in sound condition but suffering from damp ingress. It is proposed to protect the basement by the application of damp proof slurry system. All existing paint and surface finishes must be removed and made good including all snots removed and damage to existing surfaces, prior to the installation of a Koster Polysil NB1.

Koster NB1 is considered to be a type A waterproofing system as defined by BS8102:2009 and is generally used to seal the inside of basement structures, slabs and retaining walls. Koster NB1 works by both providing a physical barrier against water ingress as well as providing a migratory crystal sealant that penetrates deep into the structure to seal micropores and cracks against ingress.

Once applied then the walls can be prepared and primed for decorating and for the floor finish to be installed. Complete new boiler and heating system is required, new distribution boards etc.

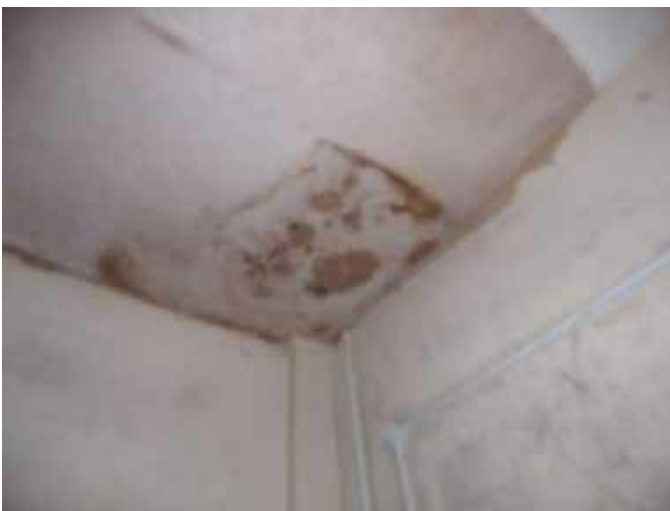
The walls down to the basement also require the full treatment.

In the basement all existing services are to be carefully stripped out and replaced with compliant infrastructure.

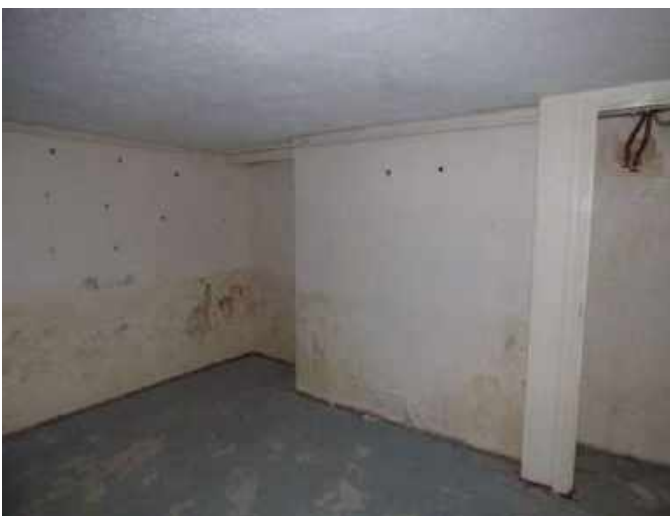
Existing window to basement to be removed and reveals made good. New double glazed heritage timber painted windows.

All existing services to be carefully removed and new gas and electric services installed.

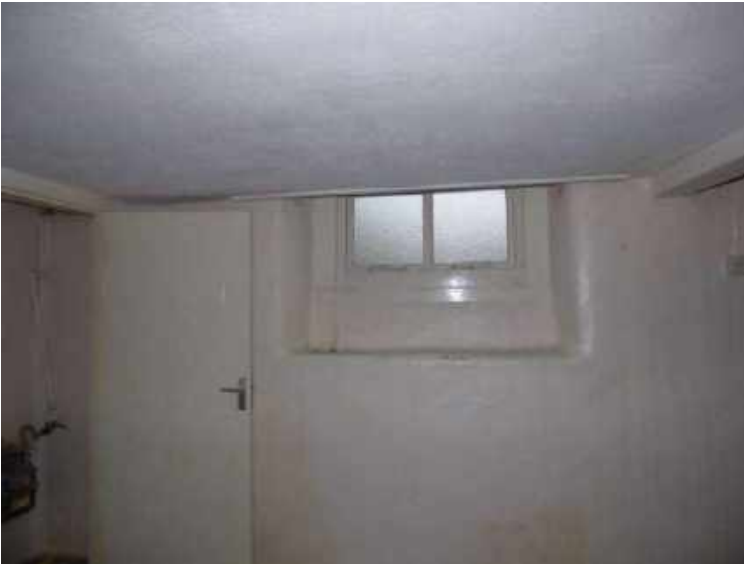
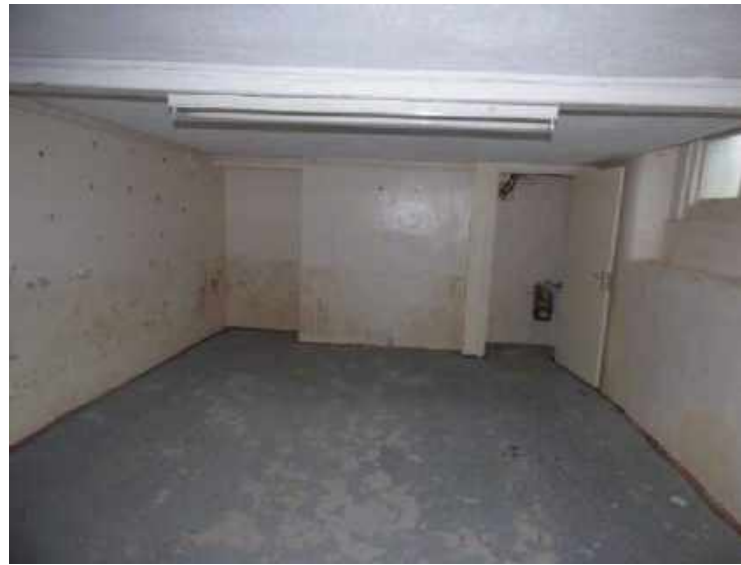
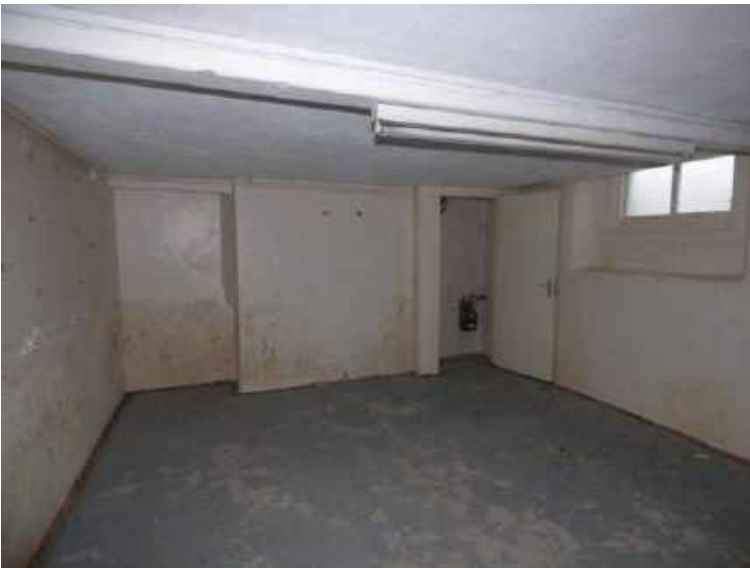
Views of basement to be renovated.

It is clear to identify where damp is penetrating the structure.

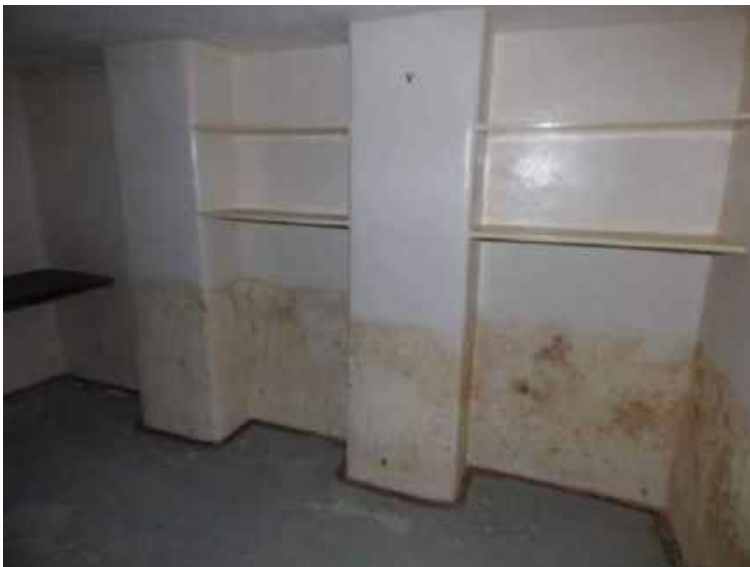
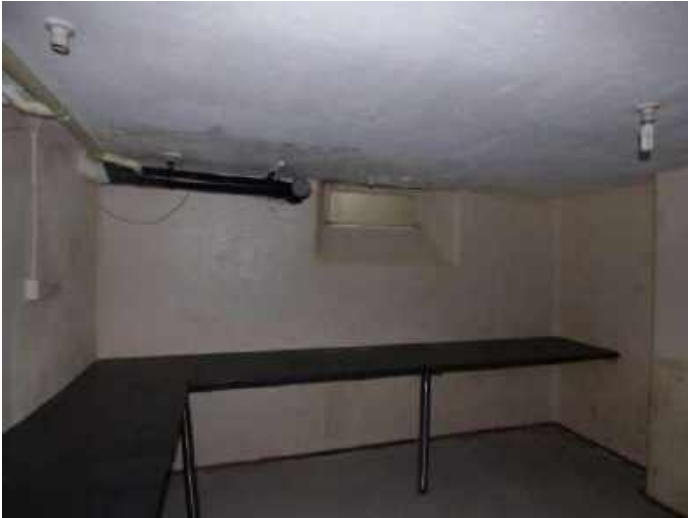
Views of basement to be renovated to create a dry area for basement storage.

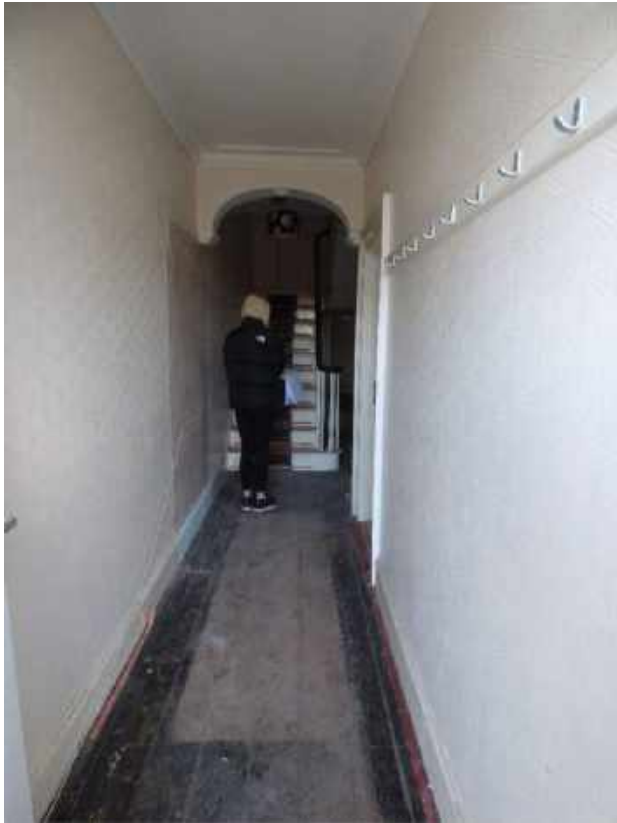
Left: The existing walls and floor are generally in good condition.

Handrail, baluster, and rails are original and to be retained.

Flush panel doors to be replaced with heritage style 4 panel painted timber fire doors to enhance the heritage asset.

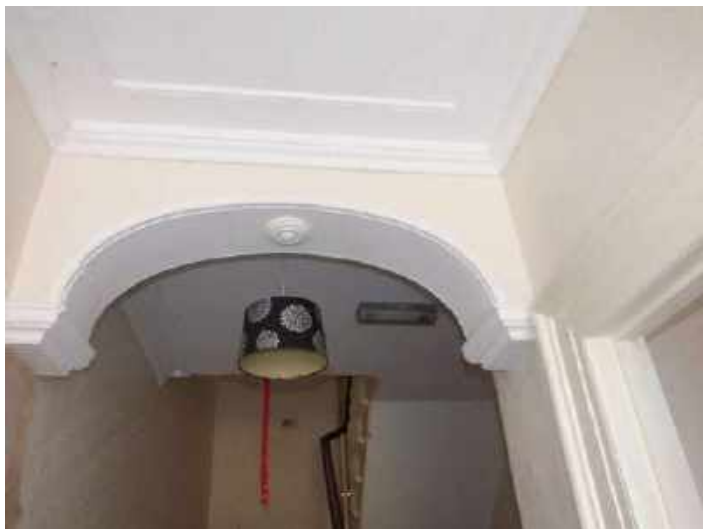
Left: Period features to be retained, including archway and architraves. (Modern lighting to all be stripped out and make good surfaces). All architraves and plaster features to be retained.

Original staircase to be retained.

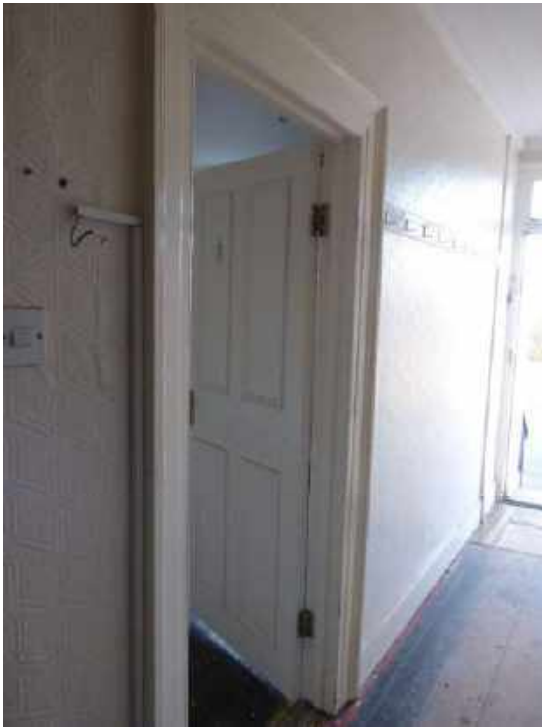
Existing doors potentially could be refurbished with intumescent paint to create fire doors alternatively they may need to be replaced with new 4 panelled Fire doors in the same style. Fire protection will be required by building control.
