# HERITAGE STATEMENT

## FULL RENOVATION OF EXISTING No 11 TERRACE HOUSES

St Bees, 1-11 Lonsdale Terrace, Parish Council, Cumbria

M.A.C Architects, Project Number: 2019:303

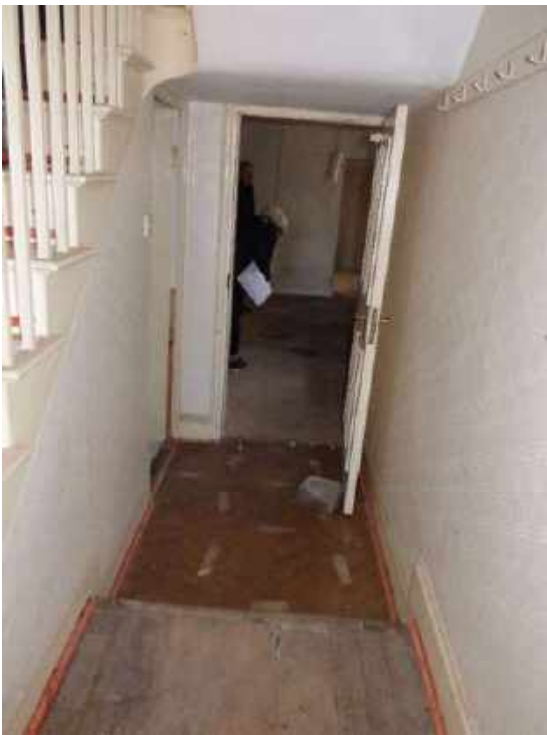
Left: Existing ramp to be removed and original step to be reinstated.

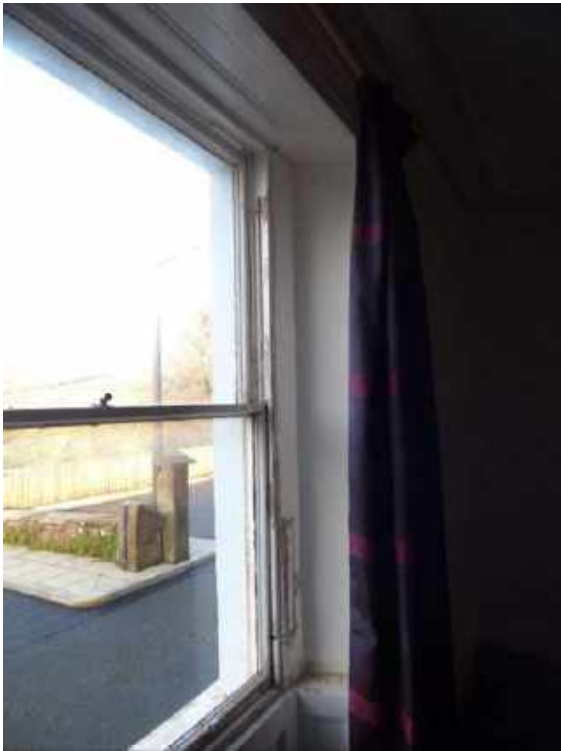
Left: In the existing lounge, the period features below and to the sides of the existing window are generally in good condition, it is proposed to carefully refurbish the existing timber shutters, which require careful minor repairs by a specialist.

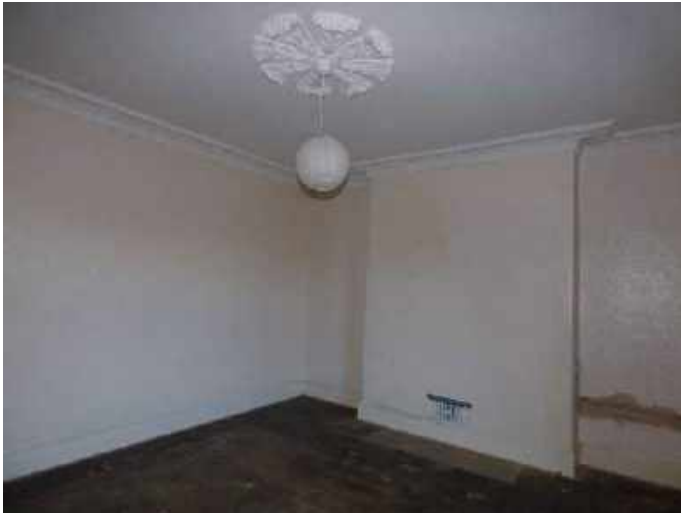
Left: Existing cornice is in excellent condition.

Existing architraves and skirtings to be retained and made good, where required.

Retain existing ceiling rose.

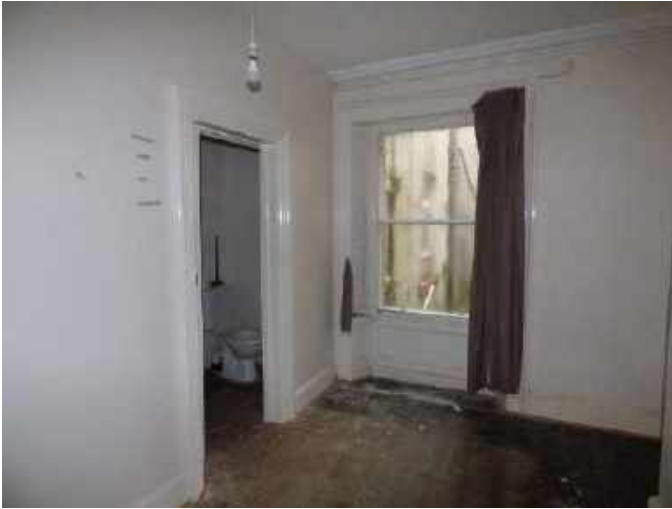
Left: In the existing dining room, the period features below and to the sides of the existing windows are in good condition, it is proposed to carefully refurbish the existing timber shutters.

Existing cornice to be made good in locations where redundant services are to be removed, here the stud partition to a bathroom has been installed and where hairline cracks have appeared.

Existing architraves and skirtings to be retained and made good.

Flush panel doors to be replaced with heritage style 4 panel timber fire doors to enhance the heritage asset.

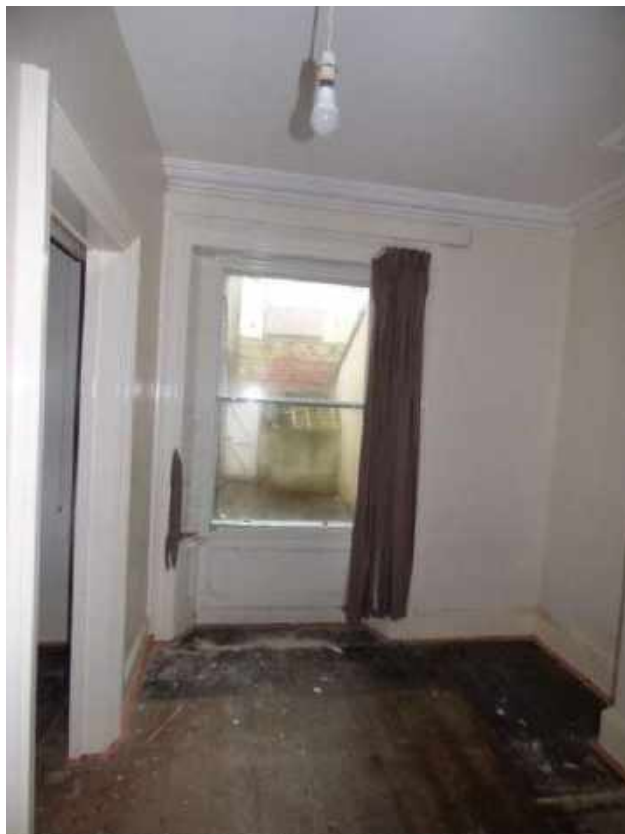
Left: The existing room I partitioned with a stud partition to provide a downstairs bathroom. It is proposed to remove this bathroom and all the associated fixtures and fittings. None are original.

It is proposed to return the room back to its original state, except for forming a new opening between dining and lounge (in keeping with the openings within houses 1-5), to facilitate more open plan living.

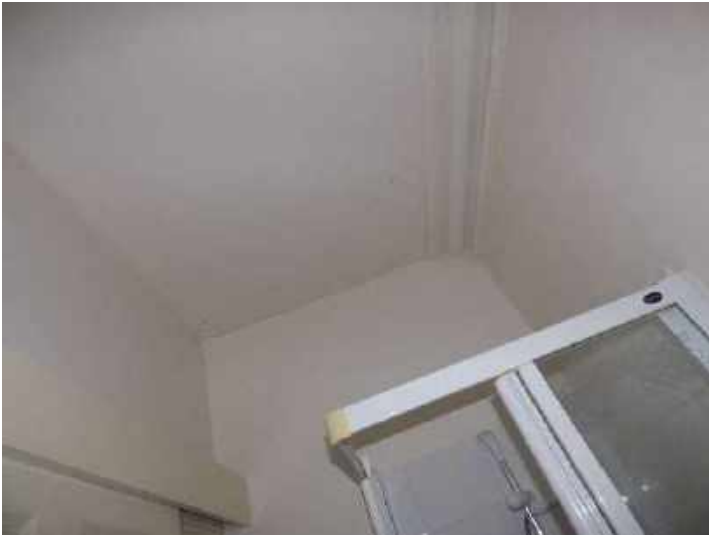
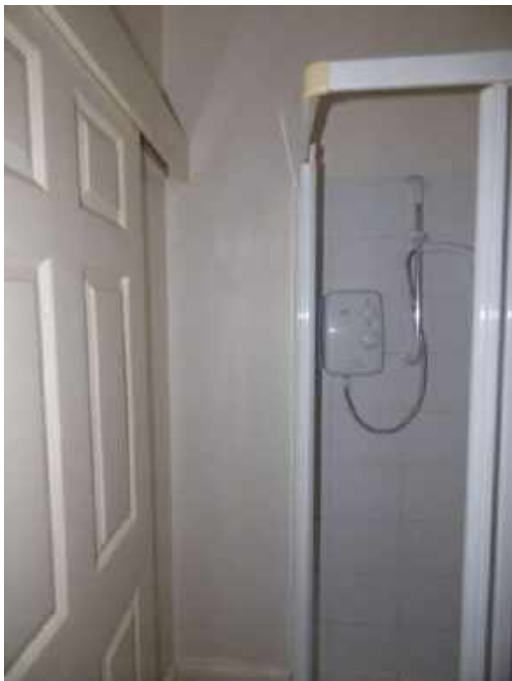
Left and below: Existing bathroom to be completely removed including stud partitions.

Cornices and skirtings to be made good where partitions removed.

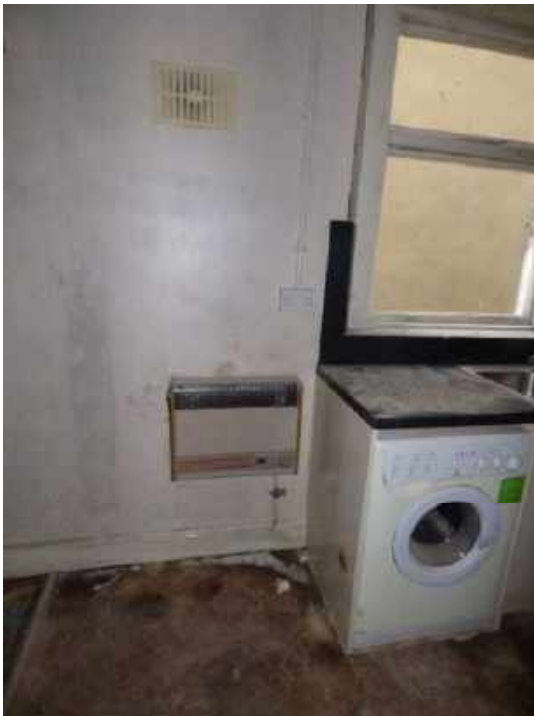
Left and below; In the existing kitchen, the existing kitchen will be completely removed. The existing modern single glazed windows will be removed and replaced with heritage painted double glazed sash windows. The existing floor has been over-boarded with a ply decking. It is proposed to lift the ply decking and examine the original floors. It is proposed to apply water resistant chipboard, subject to the sub floor and the condition of the joists etc which may require replacement.

Existing services to be removed and walls, and ceilings made good.

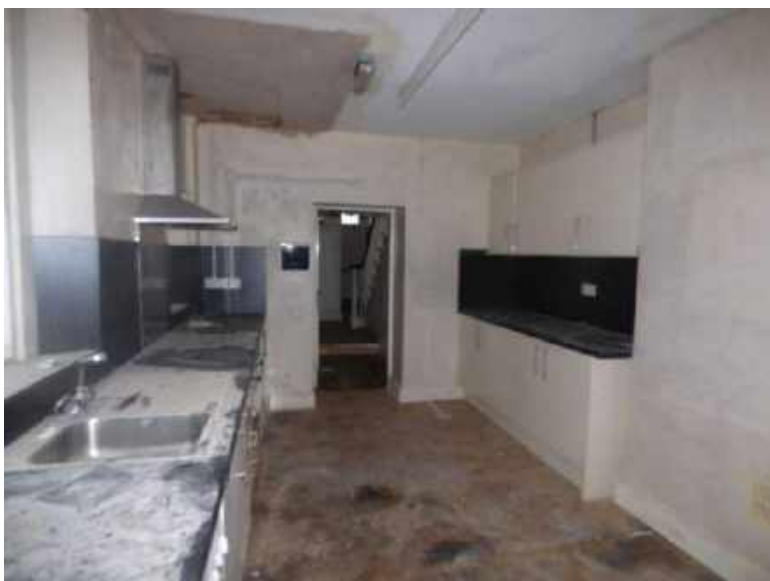
Above: Existing utility and WC to be reconfigured.

Blown plasterwork to be removed and reinstated with lime plaster and skim finish.

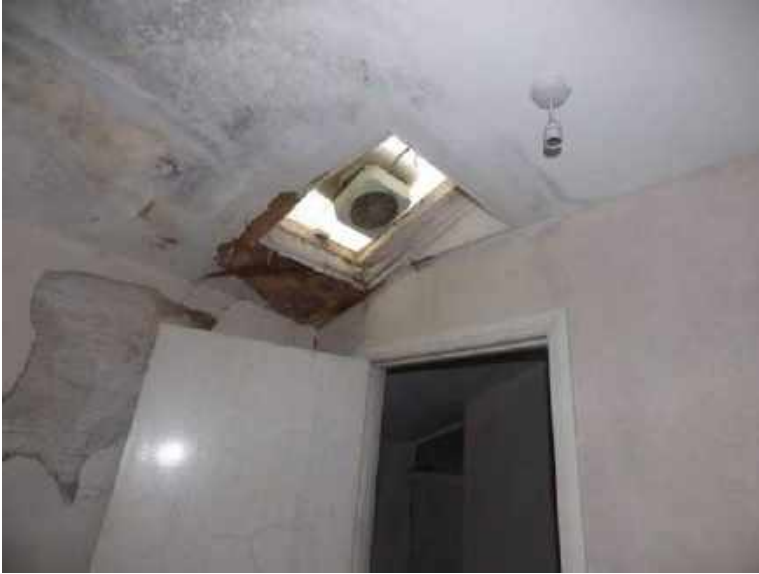
Below: Roof above utility and w.c. requires significant repairs to slate roof and to lead flashings (which require replacement). Blown plasterwork to be removed and reinstated with lime plaster and skim finish.

Plasterwork to ceiling to be removed and replaced with 82mm thick insulated plasterboard.

Existing rooflight to be replaced with new heritage style rooflight.

All walls, floor, ceilings to be made good and prepared for full decoration.

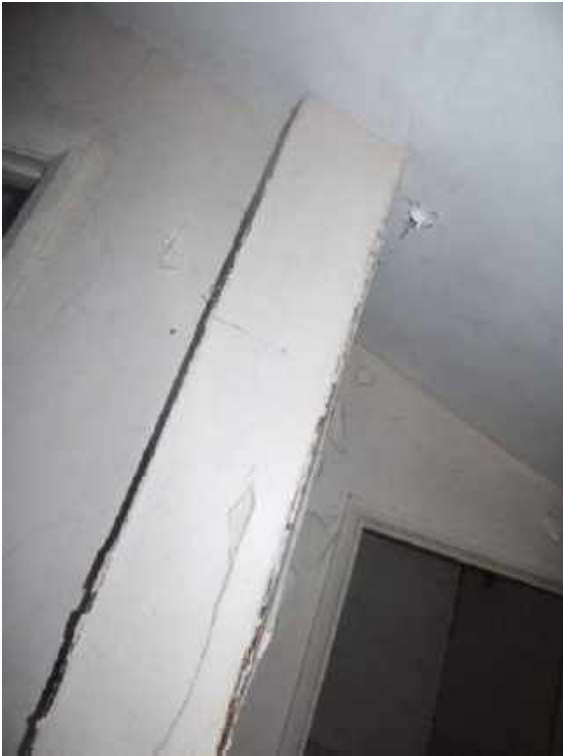
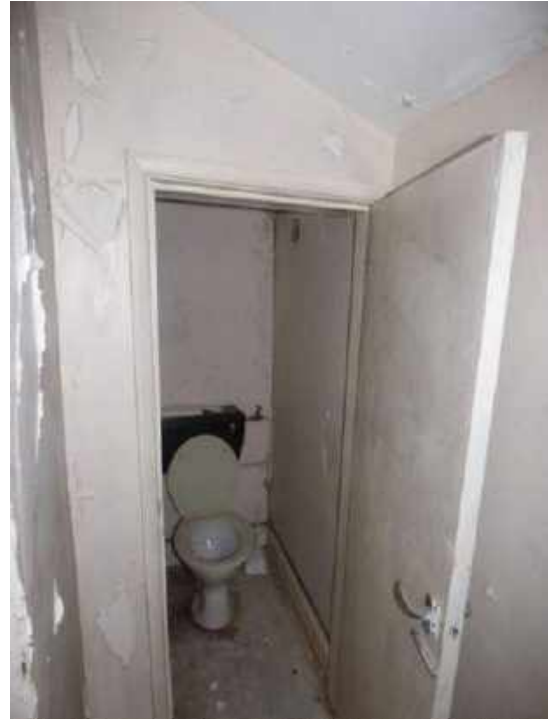
Above and below: Existing wc to be removed, as part of the reconfiguration of the area, and new sanitaryware to be provided. All walls, floor, ceilings to be made good and prepared for full decoration.

Existing rear door to be removed and replaced with a new hardwood painted door to match the front door (in style), and Georgian style ironmongery.

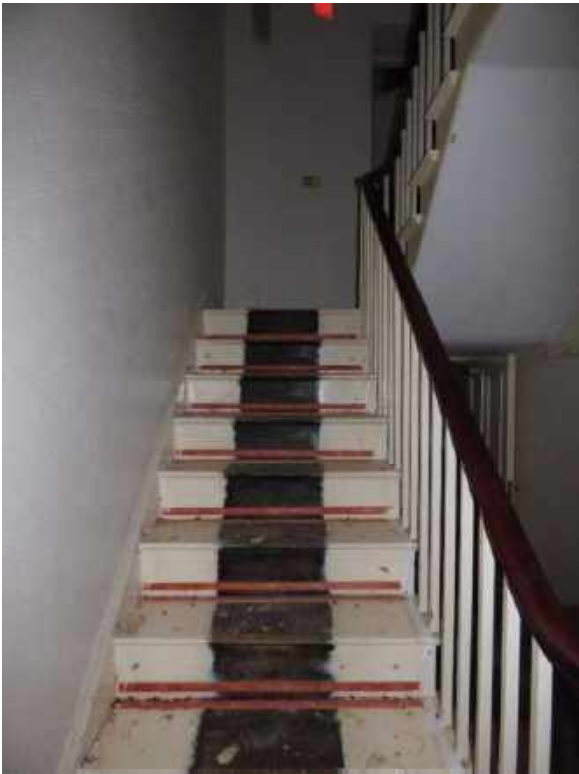
Left: Handrail, balusters and rails are original and are to be retained.

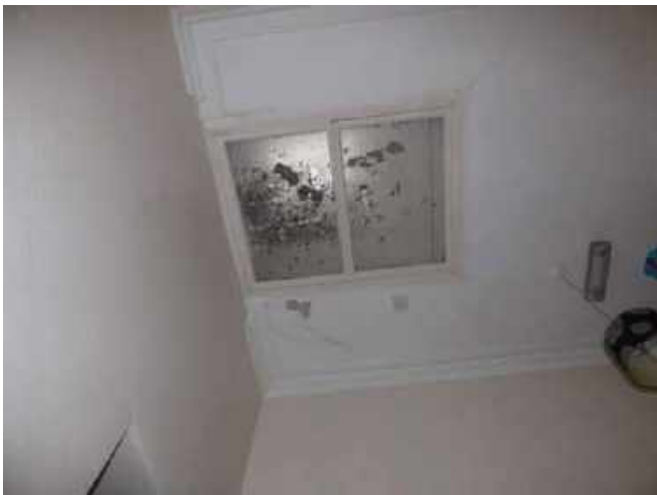
Left: Ceiling glass to be removed and ceiling to be boarded up and cornice to be reinstated where it has been cut out to form glazed aperture.

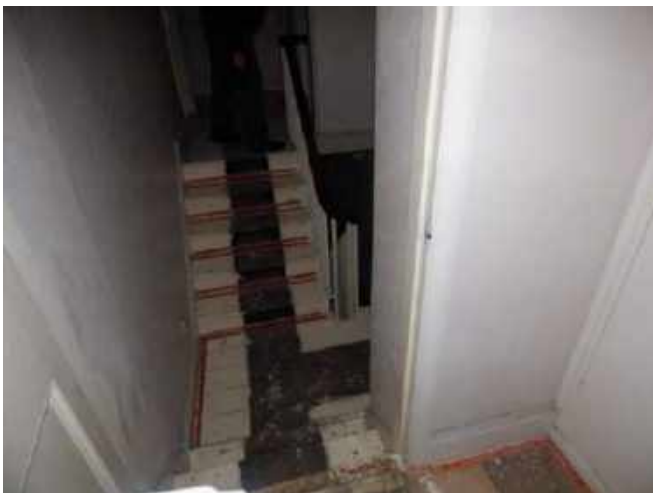
Left: At first floor all existing architraves and skirting to be retained.

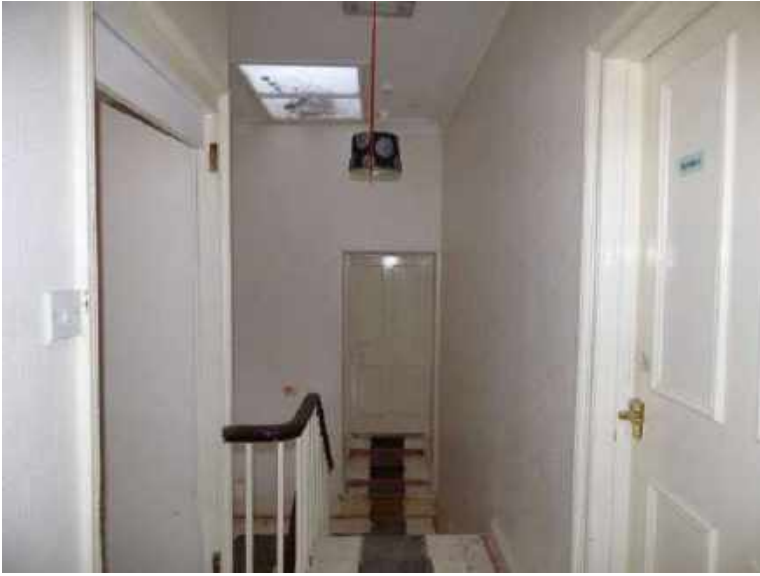
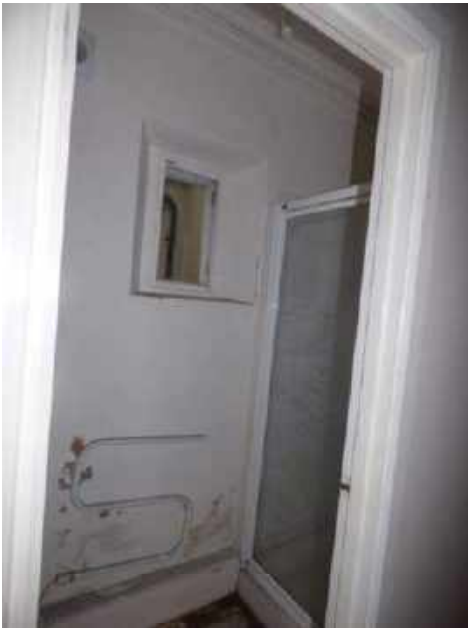
Left: The existing shower room is not original and it is proposed to remove to reconfigure the space.

skirtings to be reinstated to match the existing.

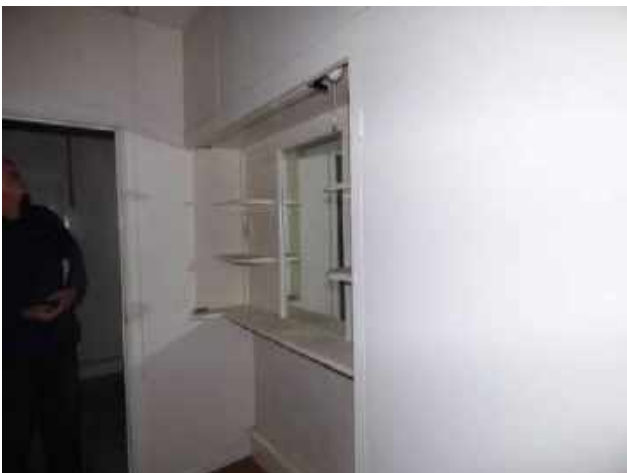
Left: existing corridor to bathroom.

Recent features added as part of the room as part of the conversion to dormitory accommodation to be removed and walls reinstated as original.

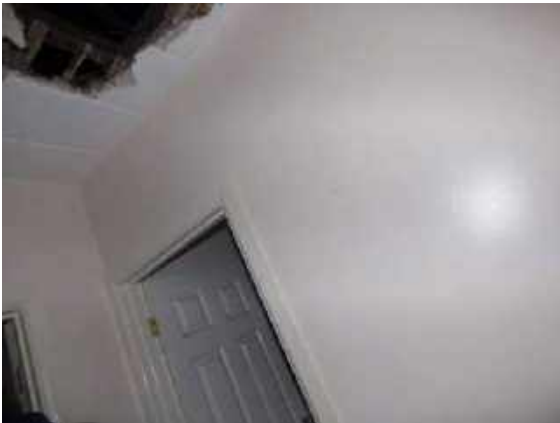
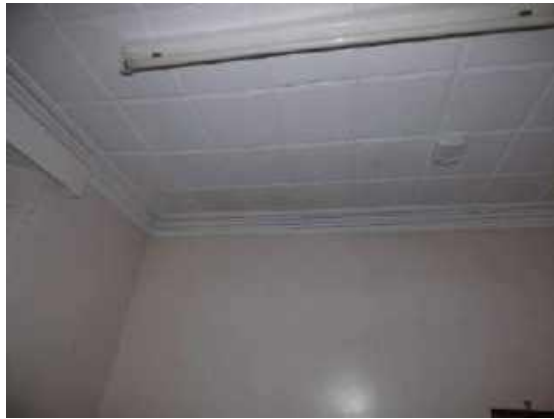
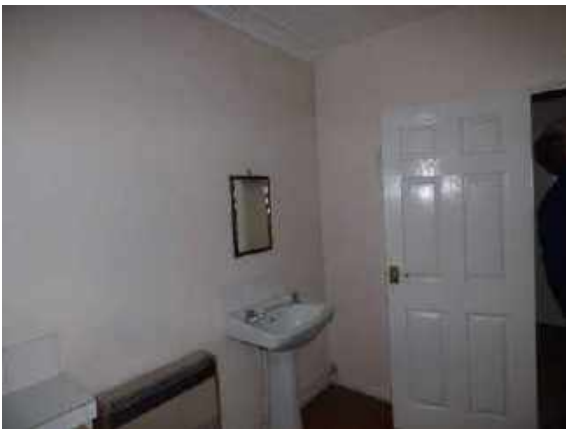
Above, left, and below: Existing bathroom. The existing ceiling finishes to be removed, and the ceiling to be made good including remediation of lath and plaster ceiling by specialist.

Existing modern window to be removed and replaced with new painted timber double glazed heritage style Georgian sash window with obscure glazing.

Existing modern replica six panel door to be replaced with new traditional timber four panelled Georgian style door – bathroom door does not need to be a fire door.

All finishes to be made good, and cornice to be reinstated where currently removed and new skirtings to match the original to be installed.

Existing floor is not original, so it is proposed to replace with moisture resistant chipboard.

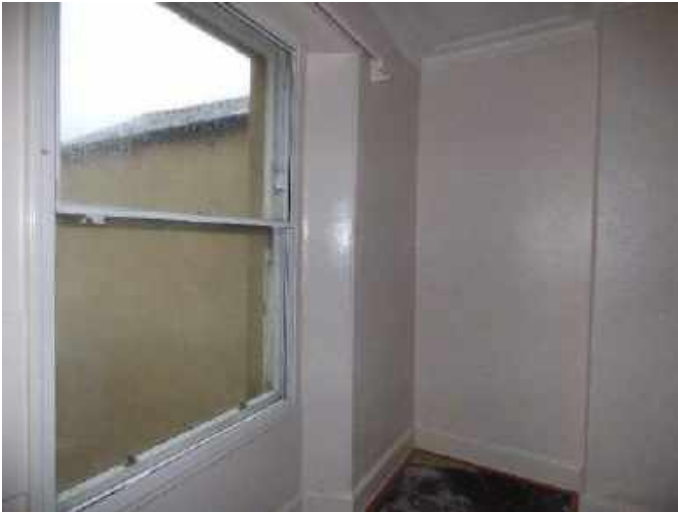
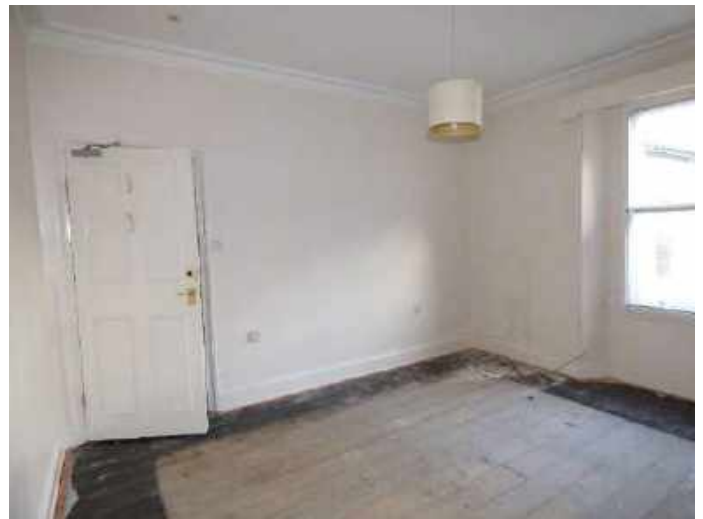
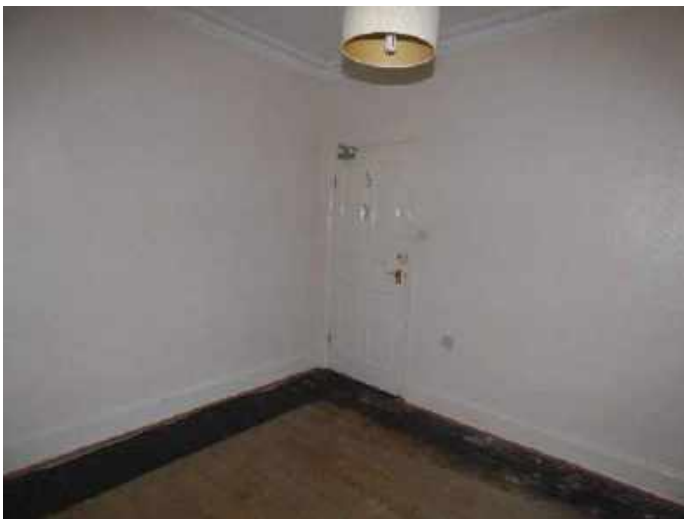
Rear bedroom.

Existing floorboards generally in good condition. Minor repairs to plaster work in window reveals to be repaired.

Skirtings and architraves to be retained and repaired where necessary. Existing door to be replaced with new Georgian heritage style 4 panel door to be provided and installed by specialist joinery company such as Batty Joinery Ltd.

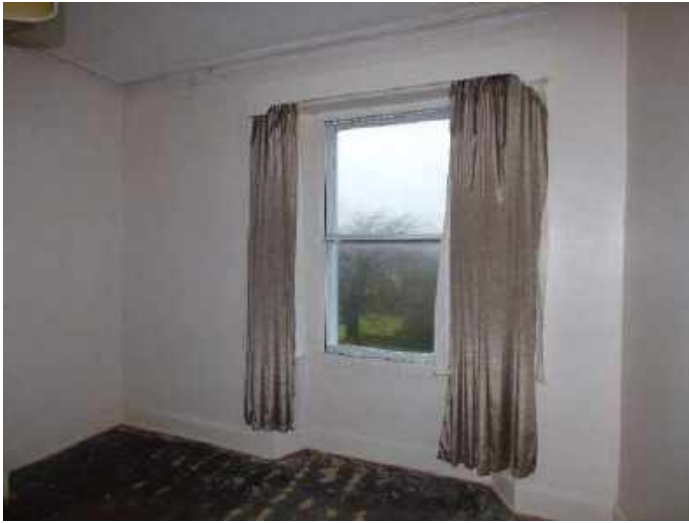
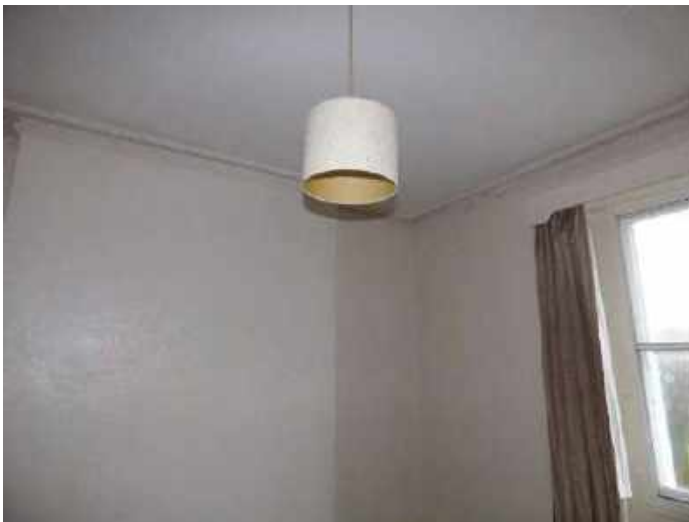
Left: Large front bedroom. Skirtings, cornices, and architraves to be retained and minor repairs where necessary. Existing flush panelled door to be replaced with new Georgian heritage style 4 panel door to be provided and installed by specialist joinery company such as Batty Joinery Ltd.

Existing floorboards in good condition.

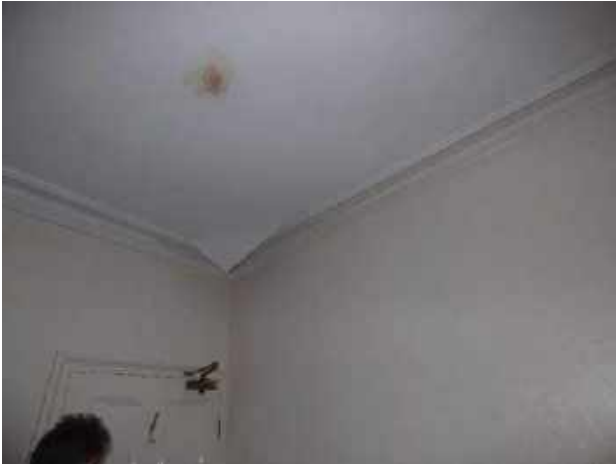
Left: Front Bedroom (small) skirtings and architraves to be retained, existing door to be replaced with new Georgian heritage style 4 panel door to be provided and installed by specialist joinery company such as Batty Joinery Ltd.

Damp damage to plastered ceiling to be repaired due to water ingress in attic.

Existing floorboards generally in good condition.

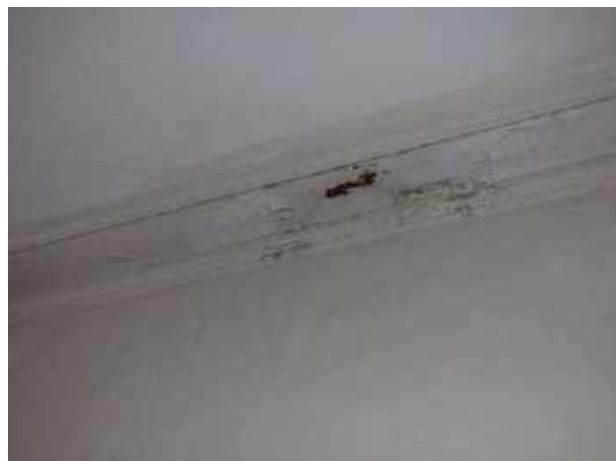
Below Left: Existing cornice damaged due to water ingress from attic room above. Cornice to be repaired.

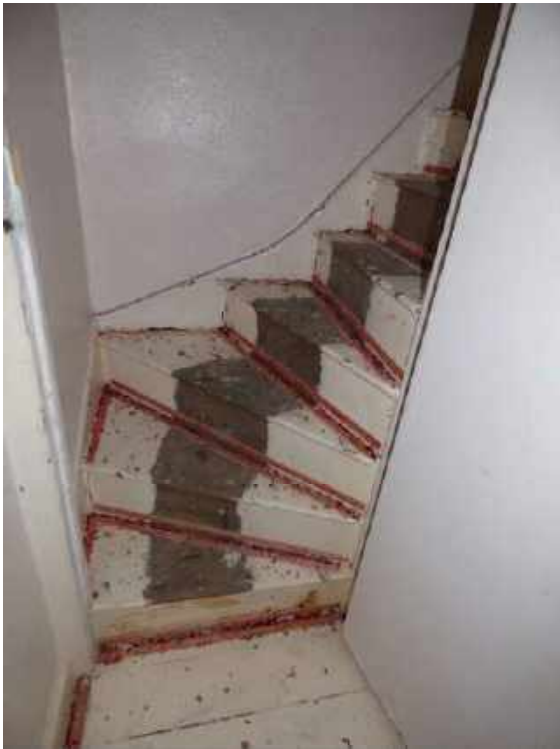
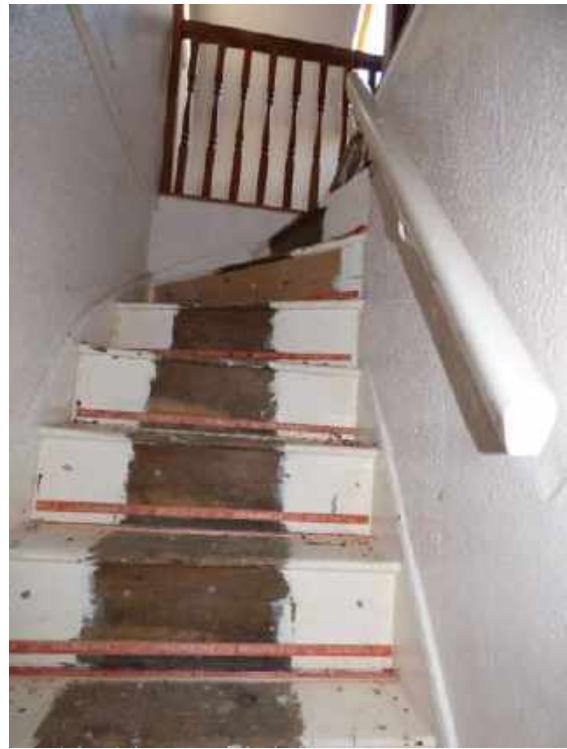
Above and left: Staircase to attic room.

Handrail, balusters, and rails are not original; however, it is proposed to replace to suit reconfigured attic space with handrails and balusters to match the existing.

Apply an insulated plasterboard 62mm thick to underside of sloping ceiling, above staircase. Boards to be taped and skimmed.

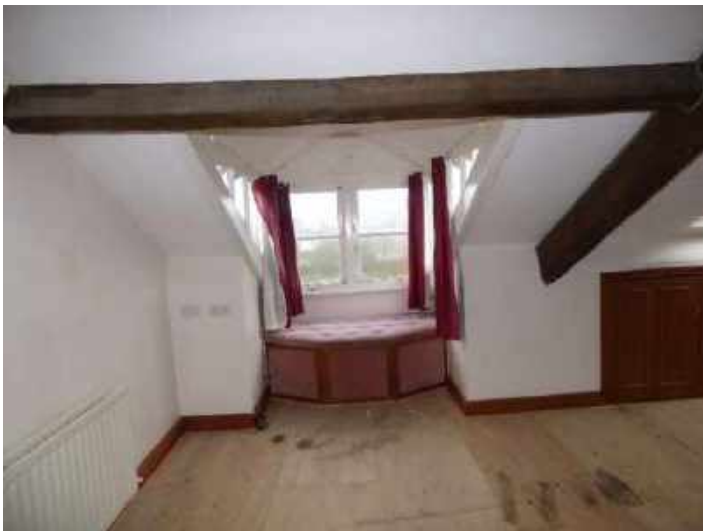
All damp and damaged/blown plasterwork to be repaired with lime plaster and skim and decorate throughout.

Apply an insulated plasterboard 62mm thick underside of ceiling tape and skim and undertake full decorations. Replace existing modern rooflights with new heritage style Velux rooflight (or Rooflight company equivalent).

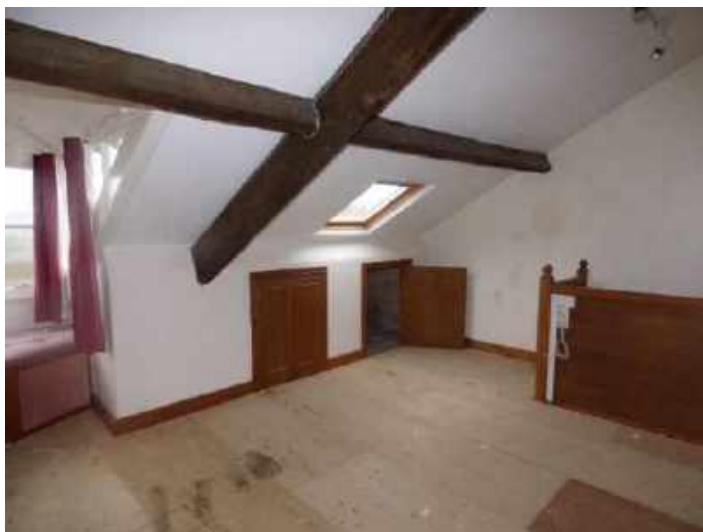
Floorboards are not the original and likely to have been installed due to water ingress. It is proposed to replace with softwood timber floorboards. The skirtings are not original, and it is proposed to remove them and replace with new soft wood skirtings to match the skirtings throughout the rest of the property.

New doors to be provided to newly formed rooms to be 4 panelled Georgian style timber doors to match the doors being reinstated throughout the rest of the property. Doors to be fire rated.

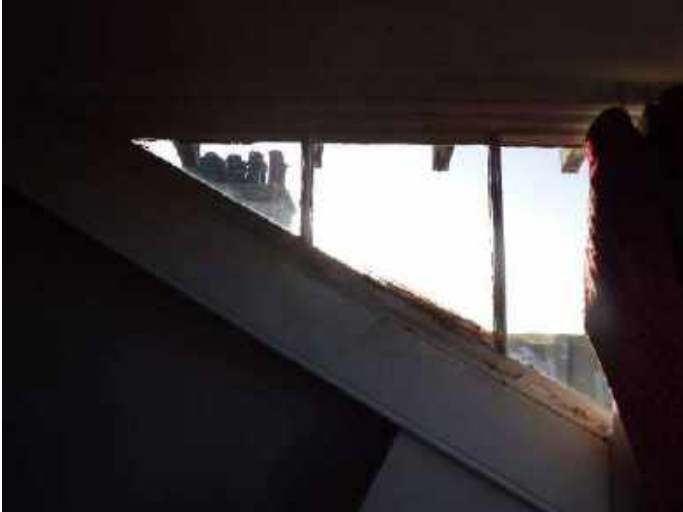
The existing dormer window has suffered considerable damage, with windows missing and considerable fabric damage due to water ingress.

It is proposed to reconstruct the dormer windows to the same details as the existing, with new double glazed heritage style windows. Refer to plan and elevations as proposed.

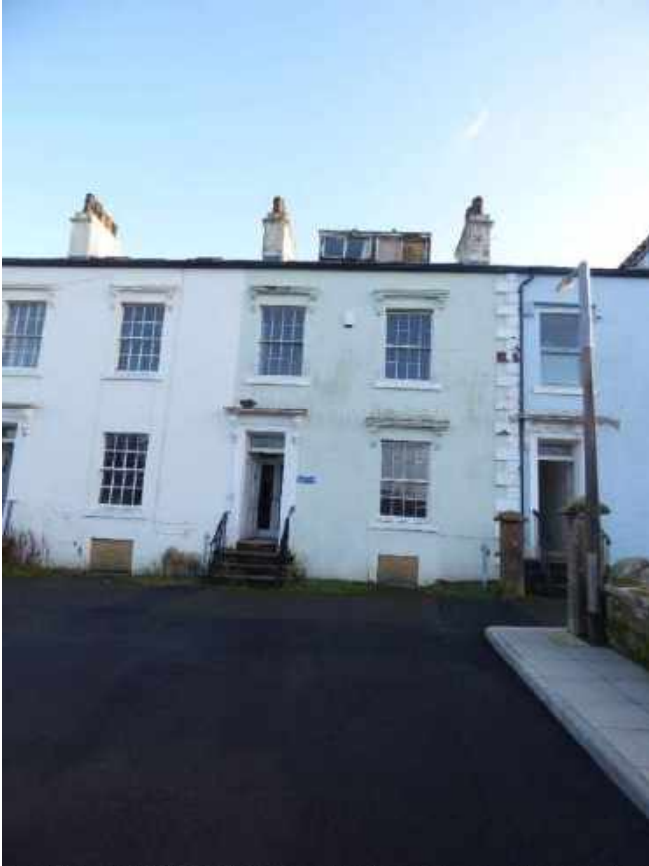
Left: The main entrance is mentioned in the listing text and is to be entirely retained.

Both front and rear elevations are currently rendered, with colour to the front and side and natural to the rear. All elevations require to be prepared for render repairs and redecoration by specialist using lime render and stucco (Parax LTD) to be applied by specialist.

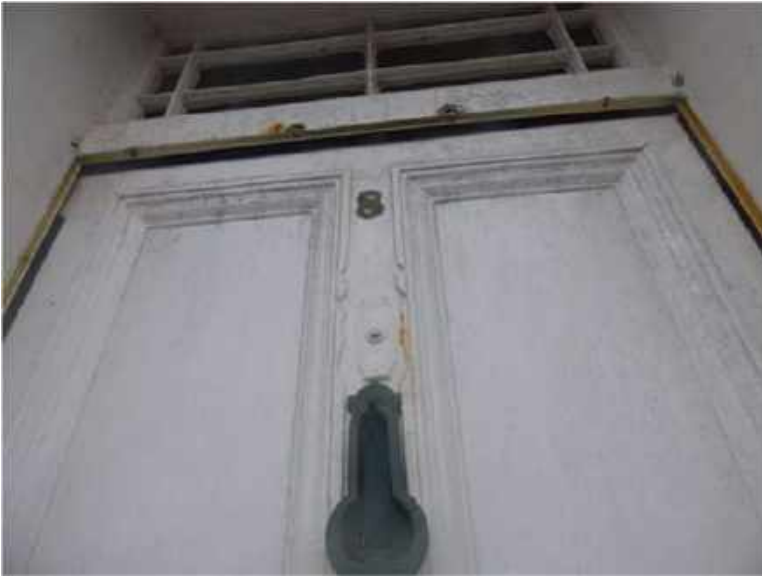
Existing door and fanlight to be retained and repaired.

All existing single glazed windows to be replaced with new white painted slim profile double glazed 'heritage windows to match the existing style by specialist supplier such as Batty joinery Ltd.

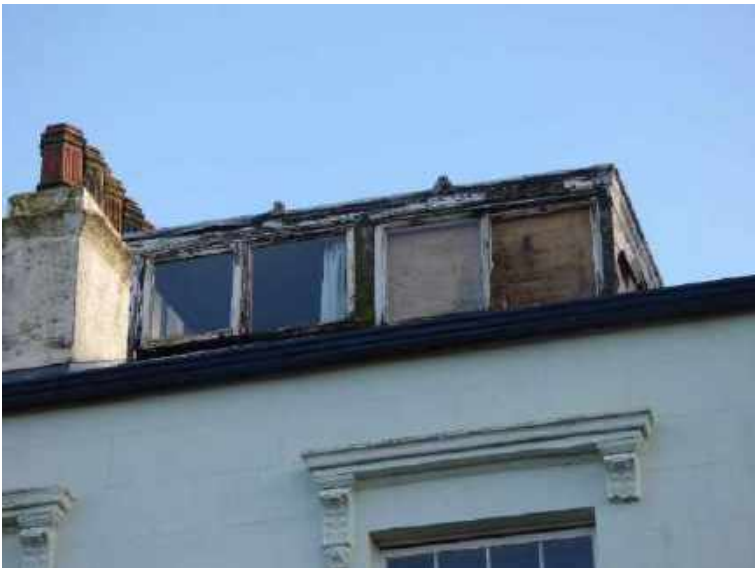
Left: Dormer windows to front of property have been damaged beyond repair, and it is therefore proposed to replace with a new dormer window, with painted timber heritage style double glazing.

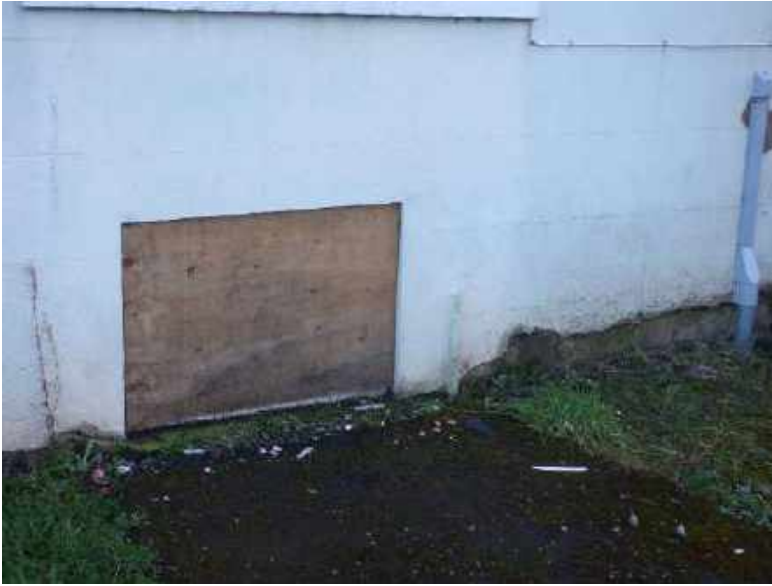
Boarded up window to basement on front elevation, to have new double glazed heritage style window reinstated by specialist such as Batty Joinery Ltd.

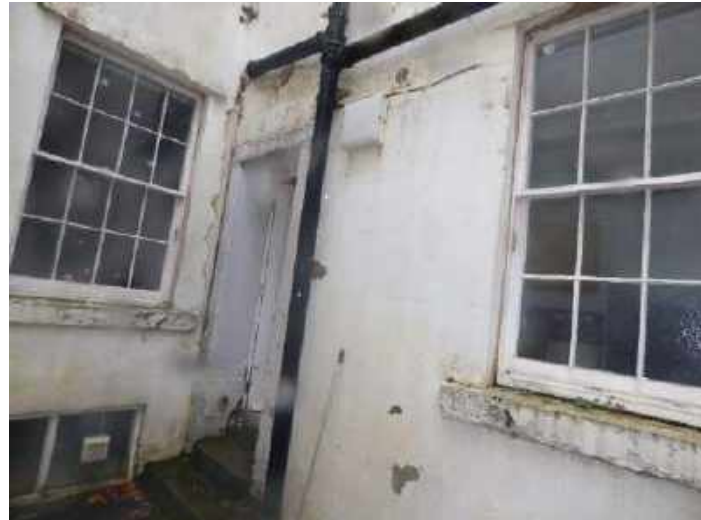
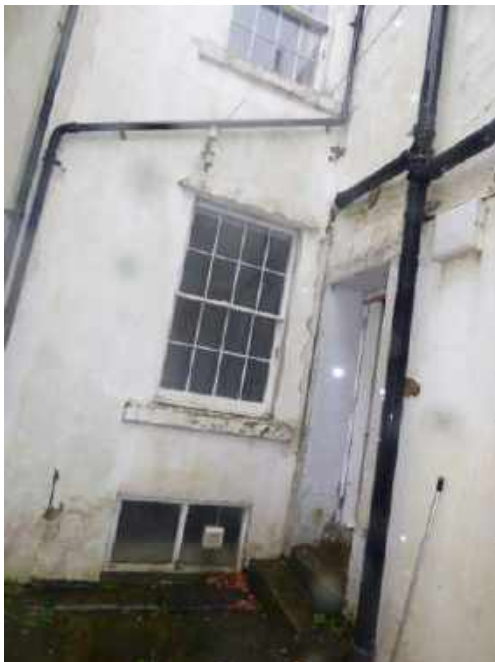
Rear of property – render to be repaired by specialist and decorated with off white render.

New door to be provided to rear to be Georgian style as front door.

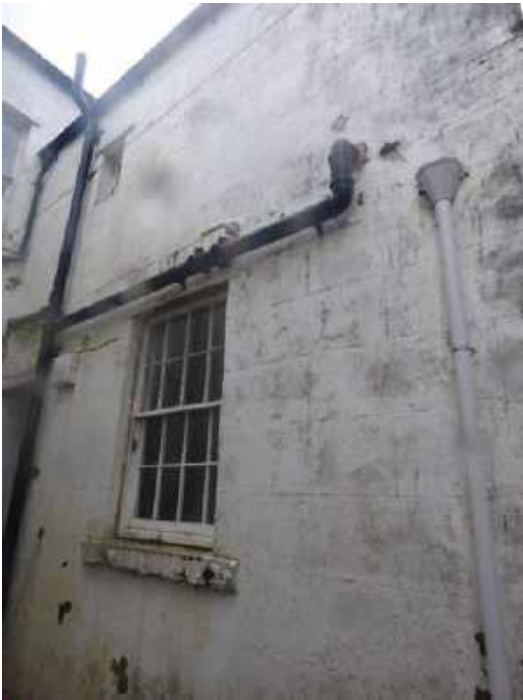
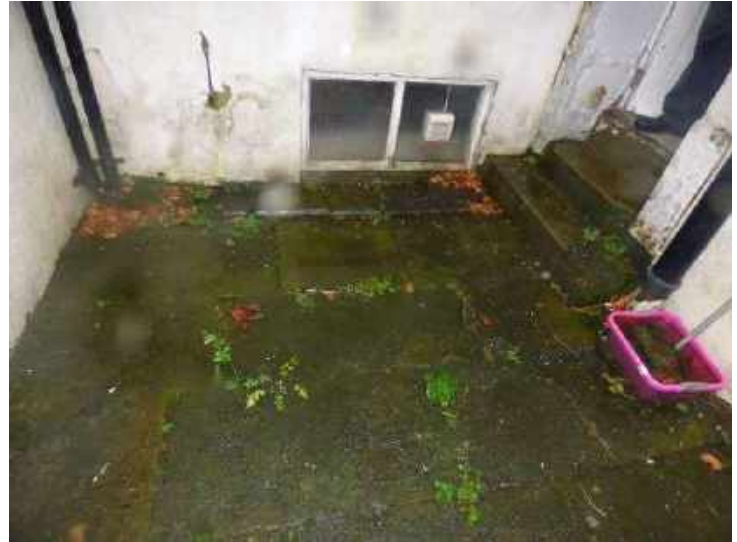
Rear of property – render to be repaired by specialist and decorated with off white render.

Windows to be replaced with new heritage style double glazed Georgian windows by specialist (such as Batty Joinery Ltd).

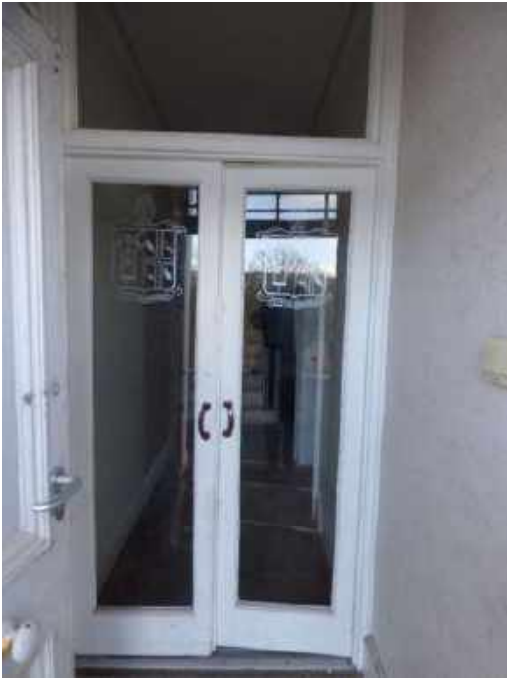
Left and below: New lobby installed when the building was converted into a dormitory to be removed.

Existing parquet floor to be retained and restored.

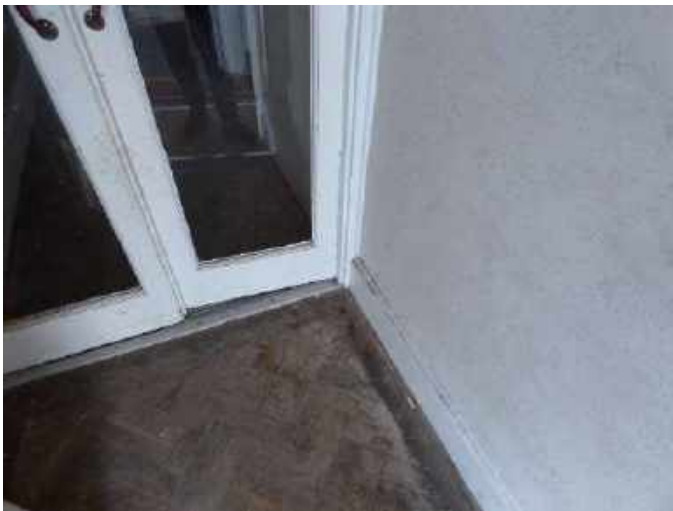
Left: Modern doors and clerestory glazing to be removed and walls, floor, and ceiling to be made good.

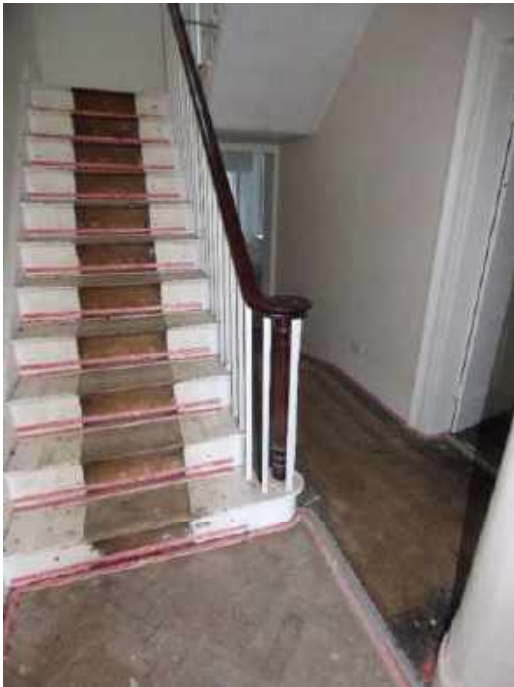
Existing staircase. Handrails, balusters, and rails are original and to be retained.

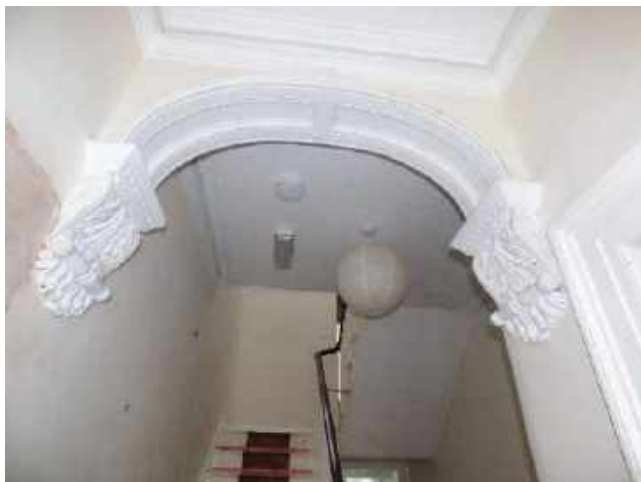
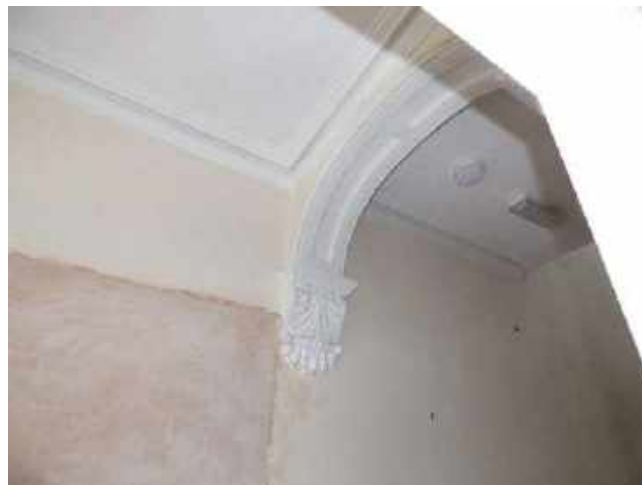
Above and below: Redundant M&E to be removed and wall/ceiling finishes made good.

Period features to be retained, including archway and architraves.

(Modern lighting to all be stripped out and surfaces restored.

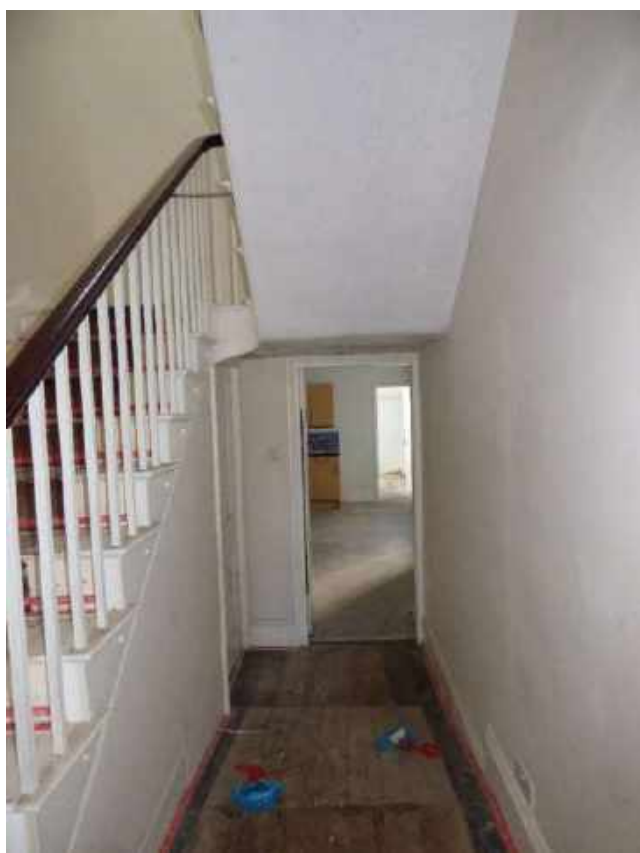
Flush panel doors to be replaced with heritage style four panel painted timber fire doors to enhance the heritage asset.

Existing ramp to be removed and original step down to kitchen to be reinstated.

Existing floorboards in good condition.

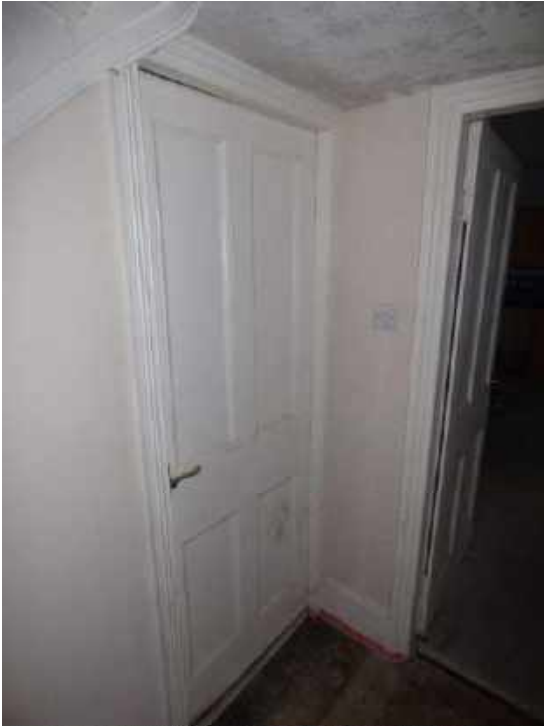
Left: Doors to all existing rooms to be replaced with new 4 panel fire doors to match existing. All existing architraves and skirtings to be retained.

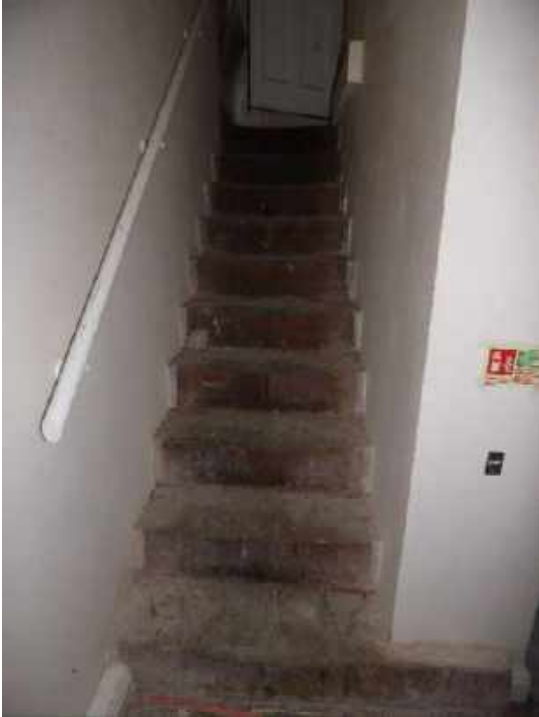
Left: Basement.

The existing walls and floor are generally in sound condition so would be suitable for the application of damp proof slurry system. All existing paint and surface finished must be removed and made good including all snots removed and damage to existing surfaces, prior to the installation of a Koster Polysil NB1.

Existing walls have previously been plastered, but not with a suitable waterproof system and damp is penetrating through.

Koster NB1 works by providing both a physical barrier against water ingress as well as providing a migratory crystal sealant that penetrates deep into the structure to seal micropores and cracks against water ingress.

Once applied then the walls can be prepared and primed for decorating and for the floor finish to be installed. Complete new boiler and heating system is required, new distribution boards etc.

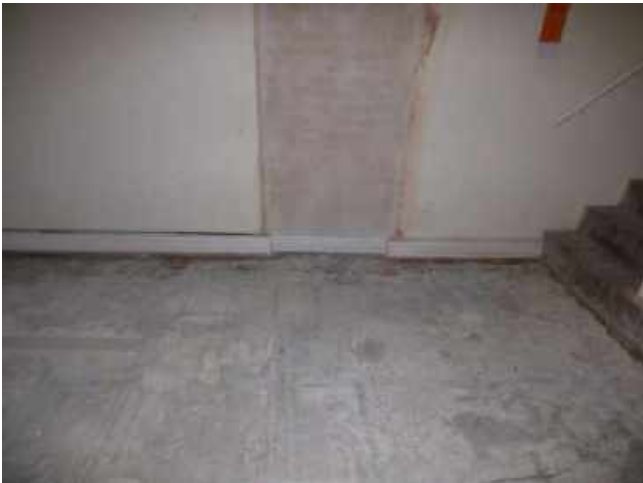
The walls down to the basement also require the full treatment.

In the basement all existing services are to be carefully stripped out and replaced with new compliant infrastructure.

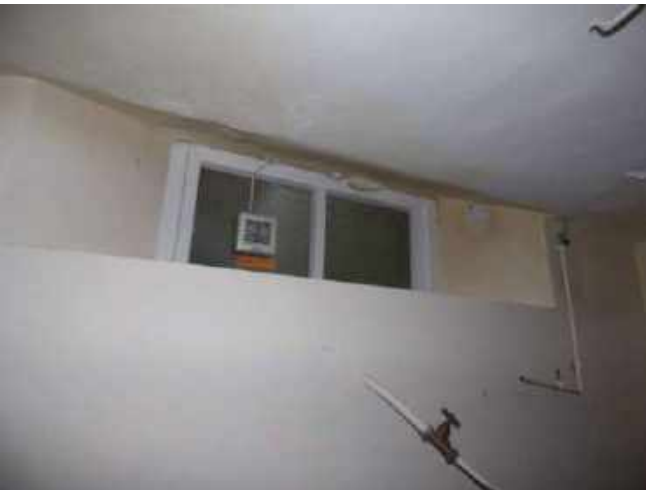
Existing window to basement to be removed and replaced with new heritage style slimline double glazed timber window. Existing reveals to be made good.

All existing services to be carefully removed and new gas and electric services installed.

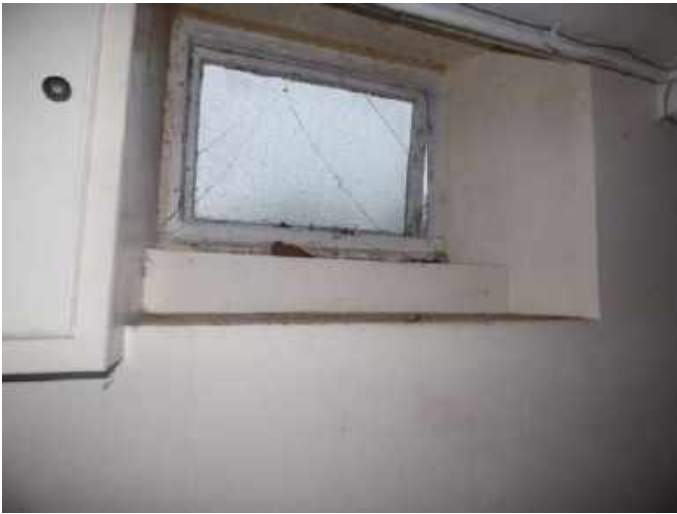
Left: Existing window to be replaced.
