# HERITAGE STATEMENT

## FULL RENOVATION OF EXISTING No 11 TERRACE HOUSES

St Bees, 1-11 Lonsdale Terrace, Parish Council, Cumbria

M.A.C Architects, Project Number: 2019:303

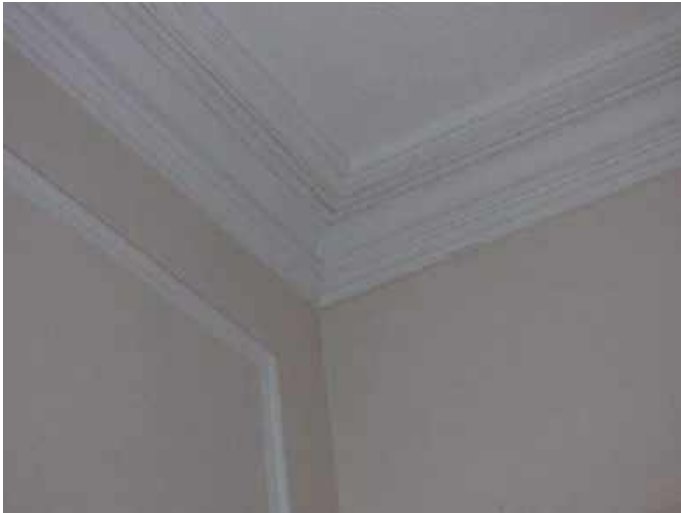
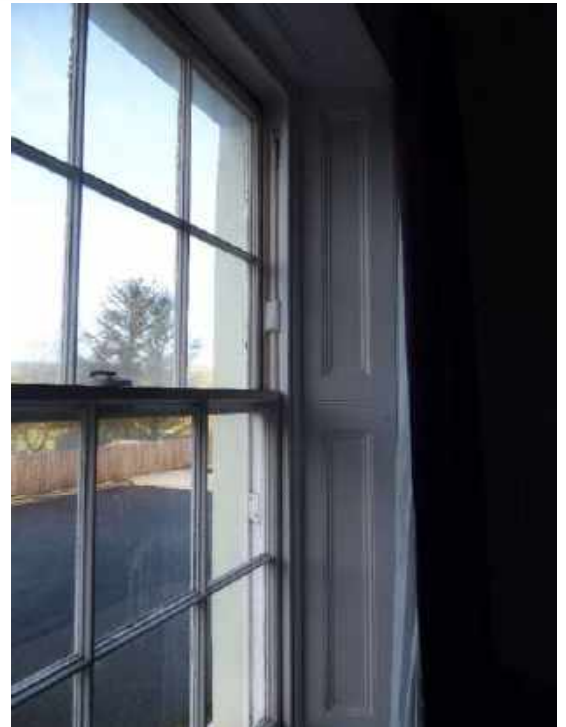
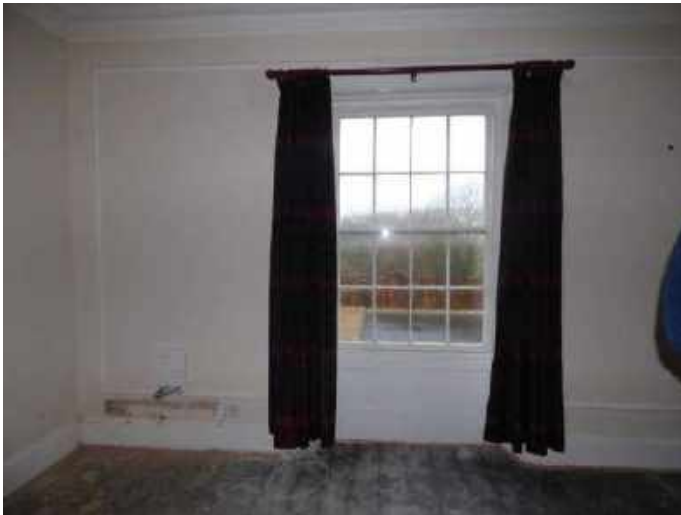
Above: In the existing front room, the features below and to the sides of the existing window are in good condition, it is proposed to carefully refurbish the existing timber shutters.

Left: Existing cornice to be retained and period features to walls to be retained and made good where required.

Existing architraves, and skirtings to be retained and made good.

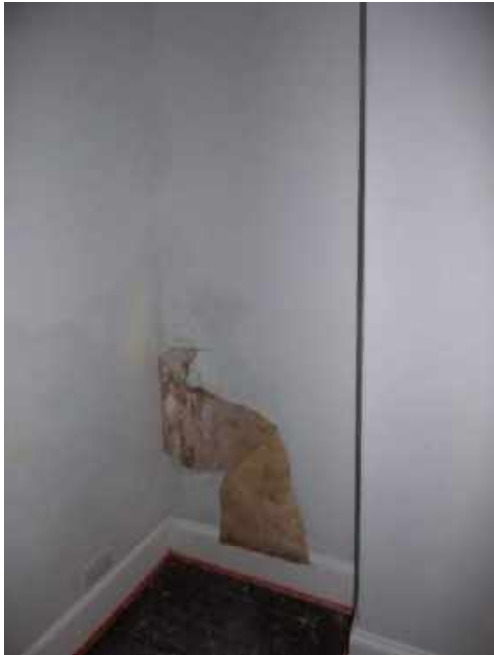
Left and below: In the existing dining room at the rear of the property, the period features below and to the sides of the existing window are in good condition, it is proposed to carefully refurbish the existing timber shutters.

Existing cornice to be made good in locations and where hairline cracks have appeared.

Here plasterwork has been damaged from damp ingress, blown plaster is to be removed, and reinstated with lime plaster finish.

Existing door to be replaced with heritage style four panel painted timber fire door to enhance the heritage asset.

Wall between dining and lounge to be opened (in the same style as the houses 1-5), to provide through living space to reflect the requirements of modern-day living.

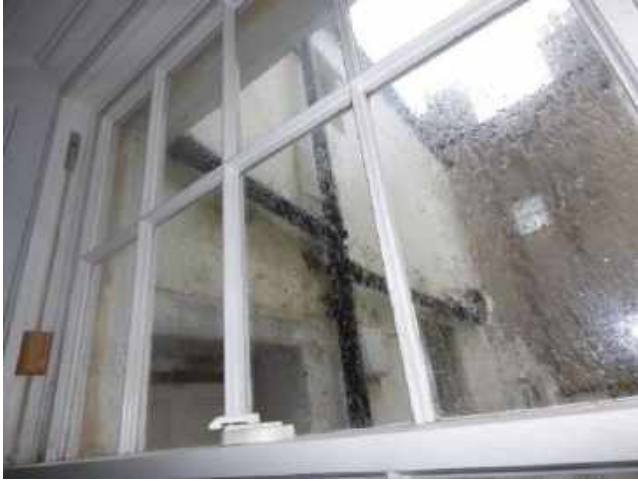
Left: In the existing dining room, the existing window is proposed to be replaced with a new heritage style double glazed timber window.

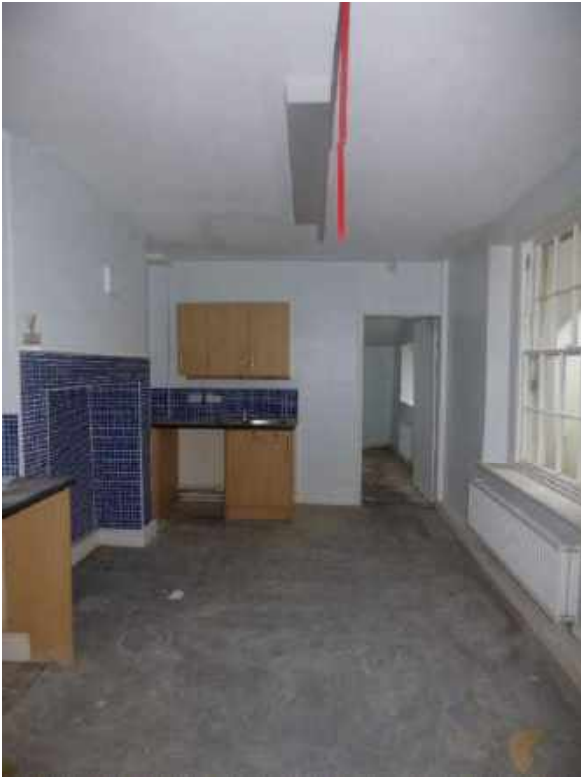
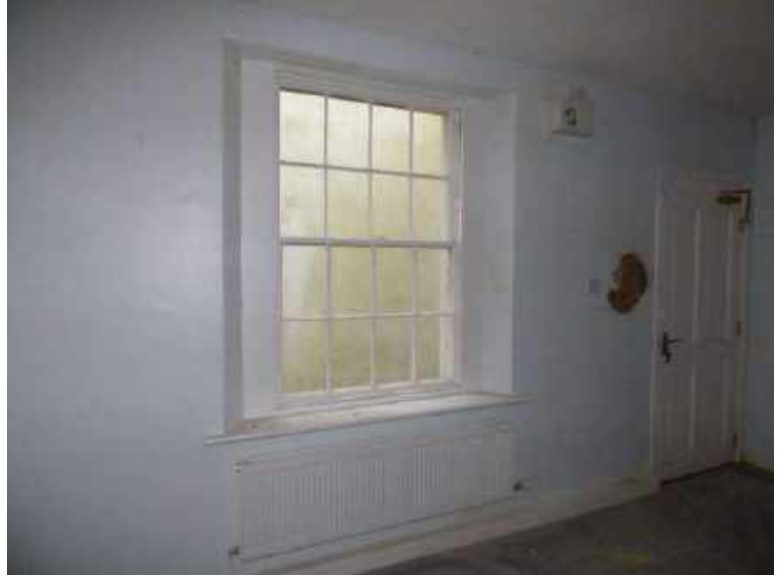
Above, left, and below: In the existing kitchen, the existing M&E services are to be removed and modern kitchen removed. Internal walls and ceilings to be made good.

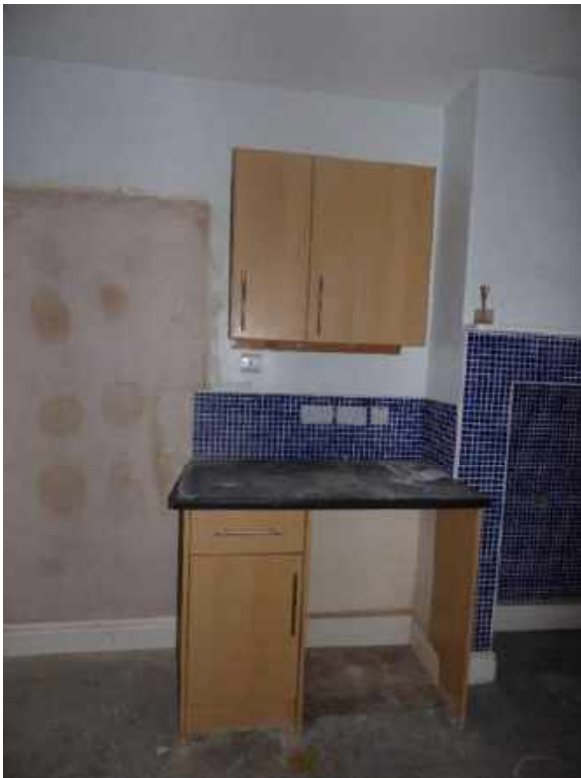
Existing cornice to be made good in locations where redundant services are to be removed and where hairline cracks have appeared.

Existing architraves and skirtings to be retained and made repaired.

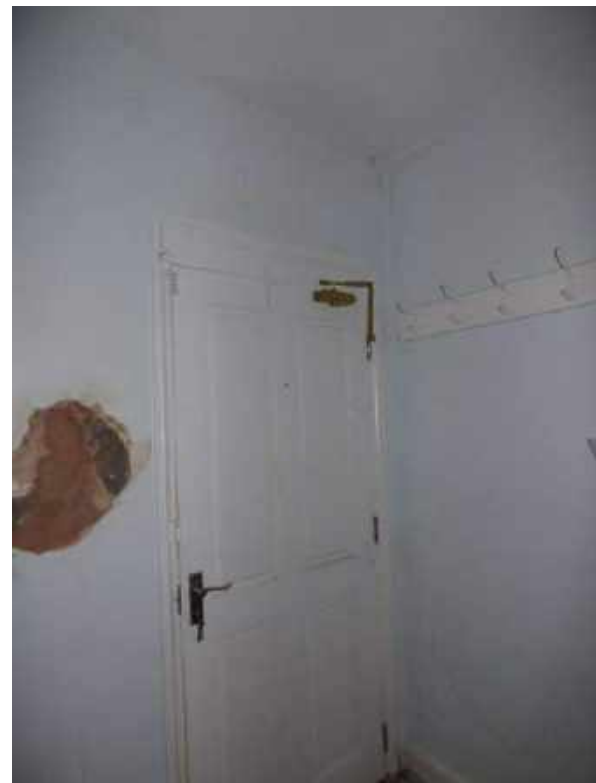
Left: Water ingress through the roof has damaged the existing ceiling.

Roof and ceiling to be repaired to match existing.

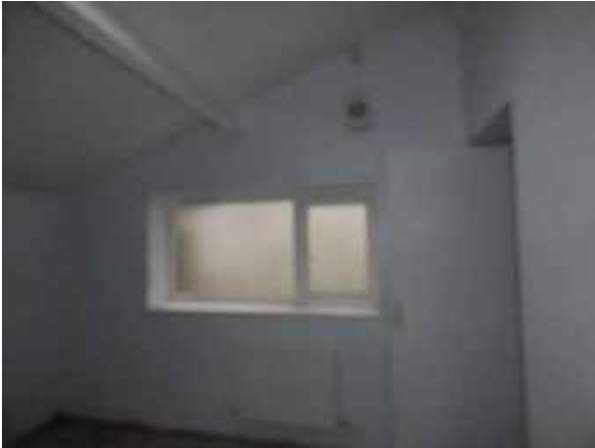
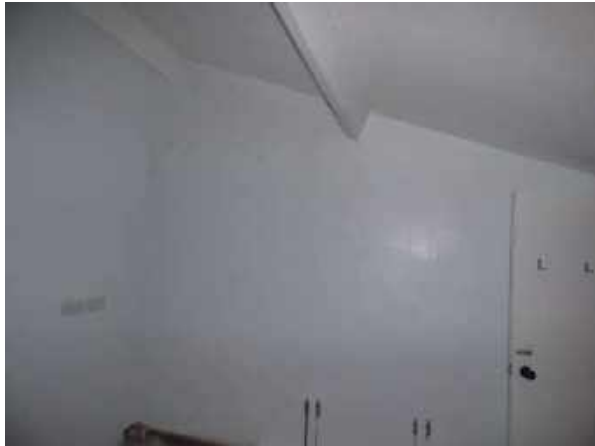
Left and below: The existing wc and utility area is to be reconfigured. All internal finishes to be stripped out and ceilings, walls, and floors to be made good.

Roof to be repaired and ceiling to receive new insulated plasterboard.

Modern windows to be replaced with heritage style double glazed timber windows.

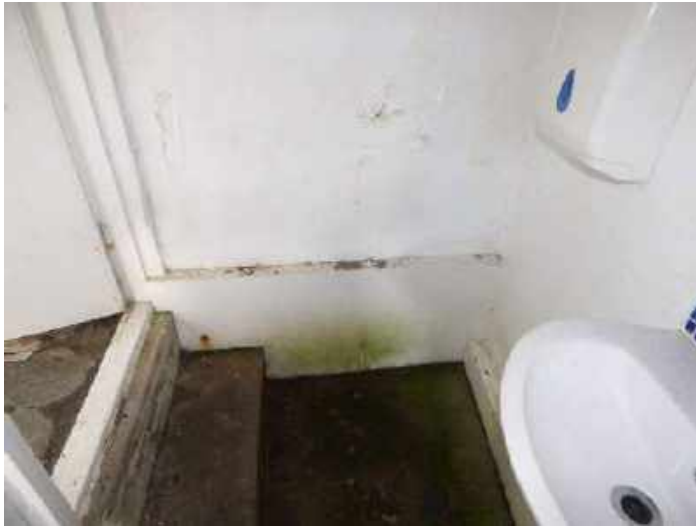
Left: Existing wc area to be reconfigured. Existing ceiling to be repaired.

Damp treatment is to be provided as Koster NB1 system.

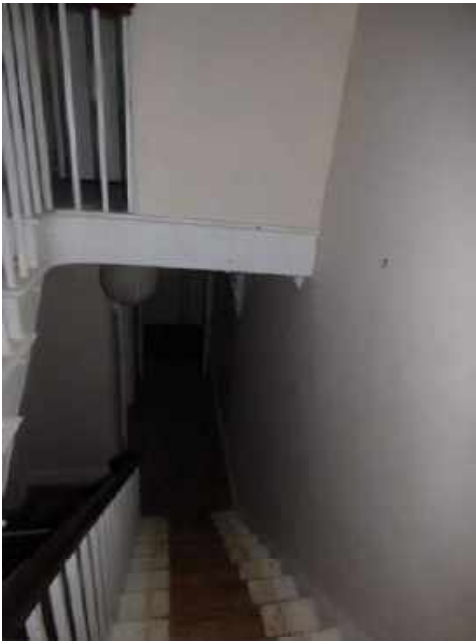
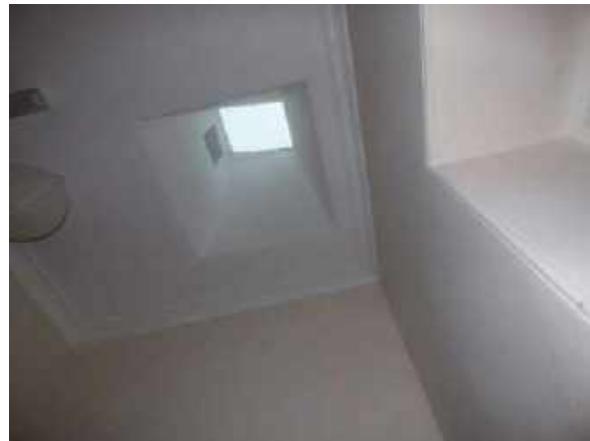
Retain original staircase, which is in good condition.

Handrail, balusters, and rails are original and are to be retained. Missing Baluster to be replaced with matching baluster and decorated to match existing.

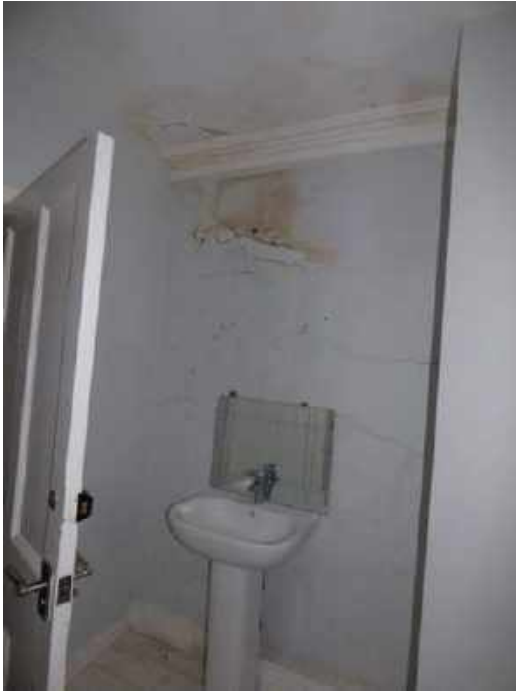
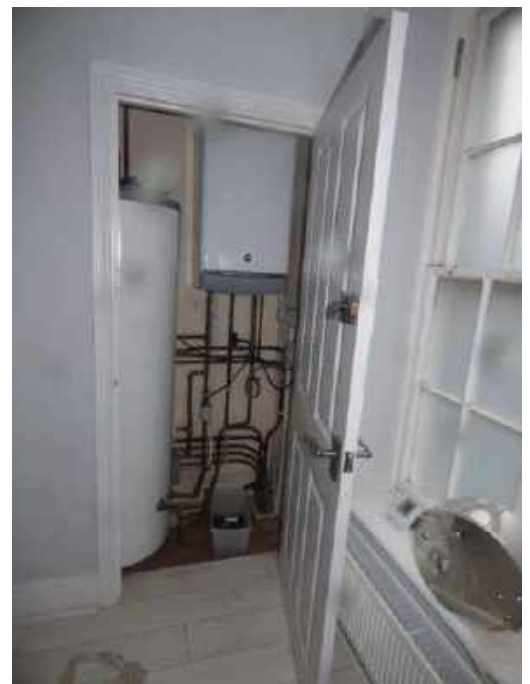
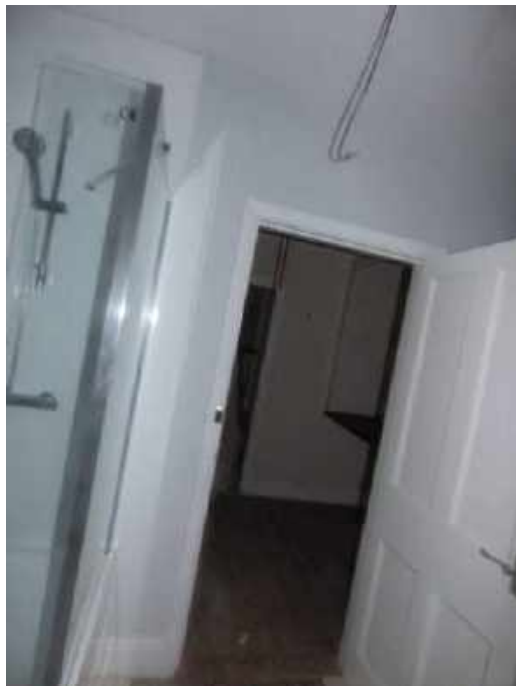
Existing bathroom - skirtings and architraves to be retained. Existing flush panelled door to be replaced with new Georgian heritage style 4 panel door to be provided and installed by specialist joinery company such as Batty Joinery Ltd.

Ceiling and walls to be repaired where damaged from moisture ingress from leaking roof. Localised repairs to roof to be undertaken to ensure watertightness is achieved. All repairs to match existing.

New window to be installed with obscure glazing.

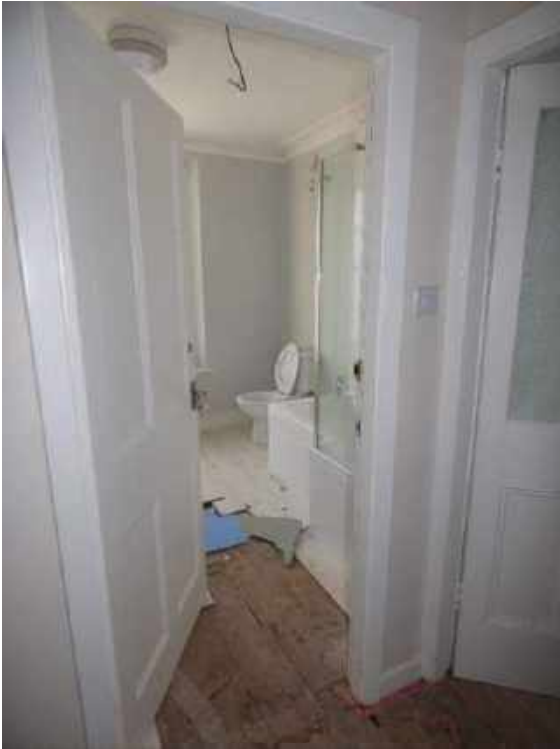
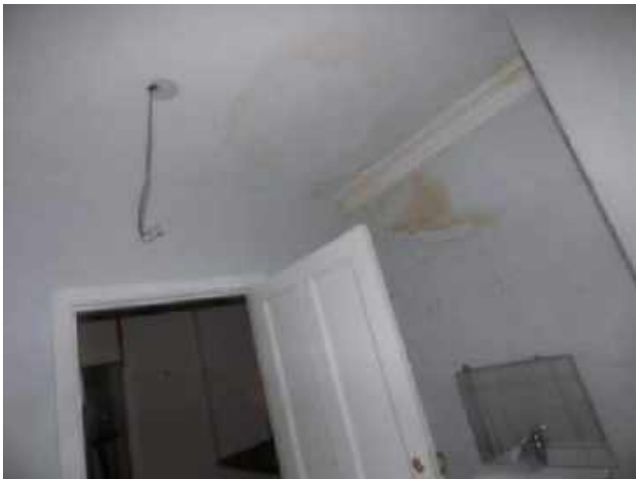
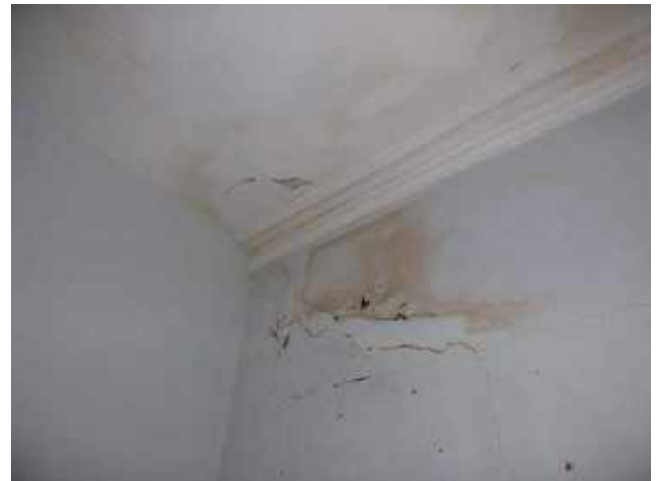
Above and right: Cornice to be installed to match existing on stud partition wall. Blown plaster to be carefully removed and new lime plaster finish to be carefully applied to repair finishes.

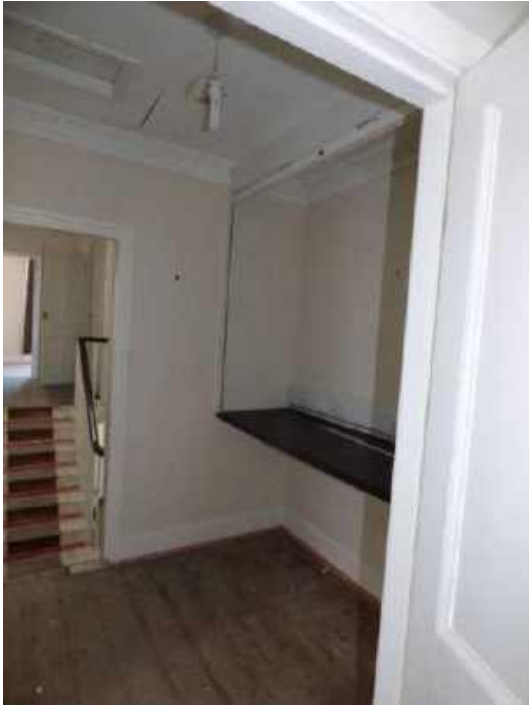
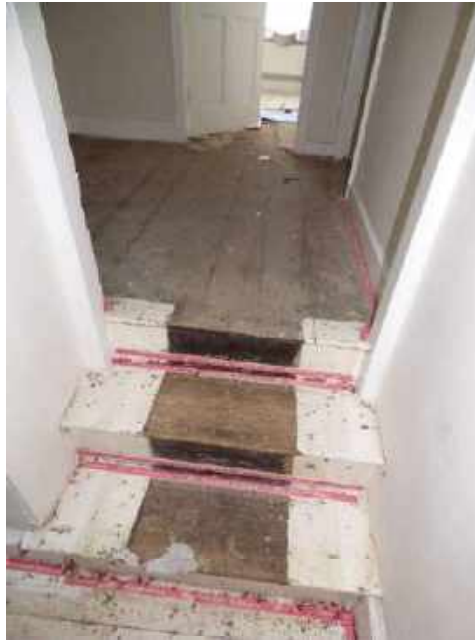
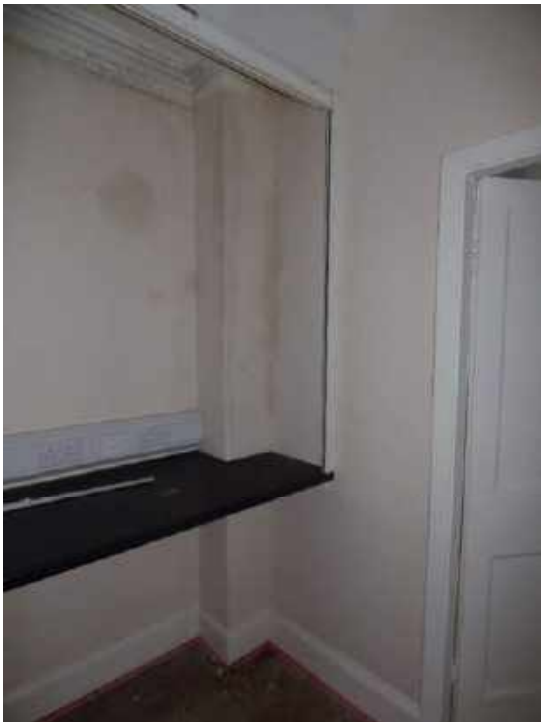
Left and above: Lobby to bathroom and existing wc to be reconfigured to make better use of space. Ceiling and walls to be repaired further to damp ingress damage.

Cornice to be provided where missing.

Existing non original fixtures and fittings to be removed and walls to be made good.

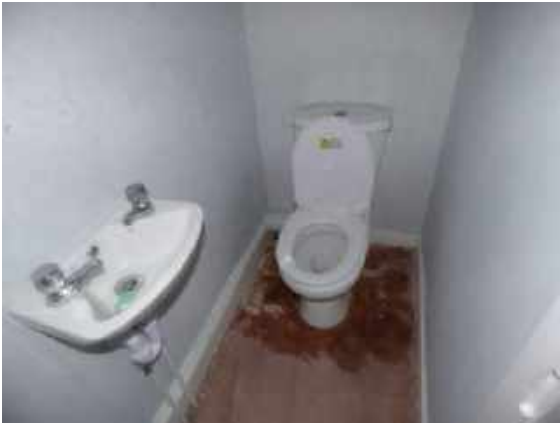
Left: Existing w.c. (not original) to be stripped out and space reconfigured. All skirtings and cornices to be reinstated to match existing.

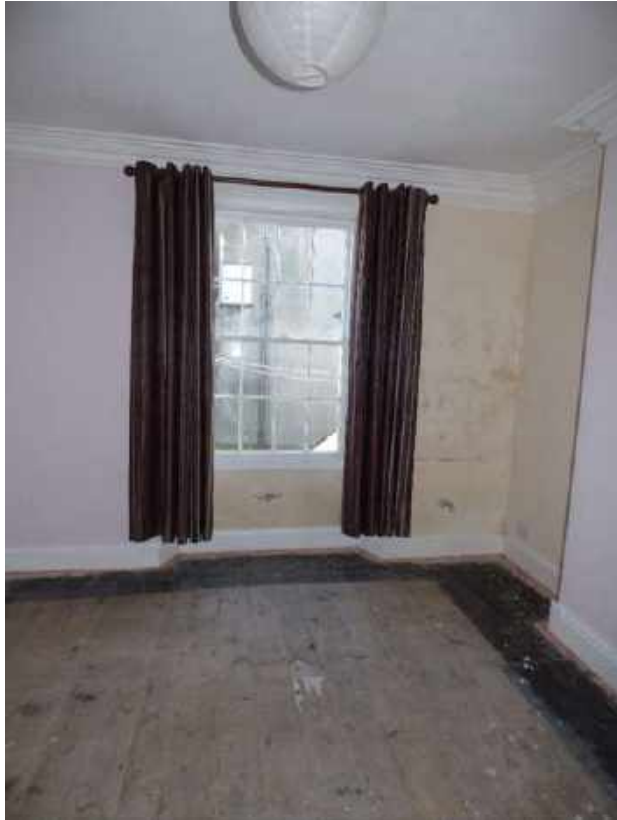
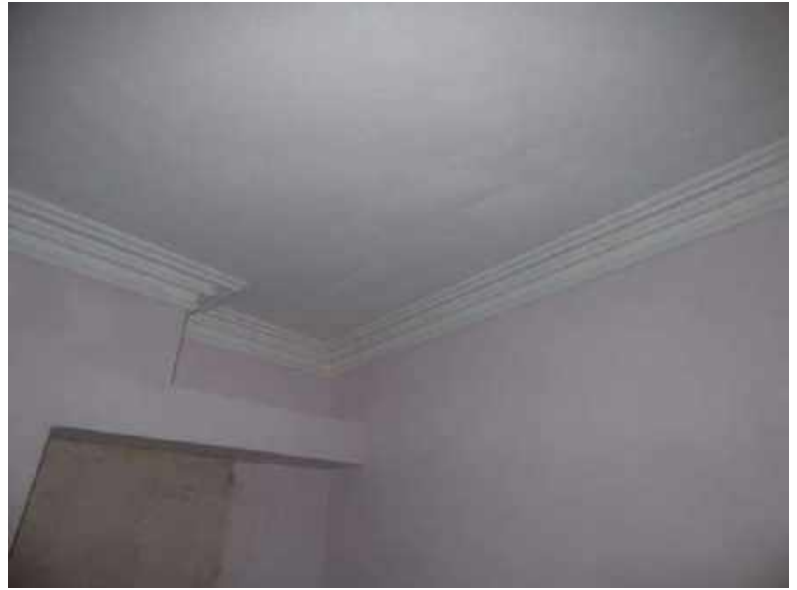
Rear bedroom skirtings, cornices, and architraves to be retained. Existing flush panel door to be replaced with new Georgian heritage style four panel door to be provided and installed by specialist joinery company such as Batty Joinery Ltd.

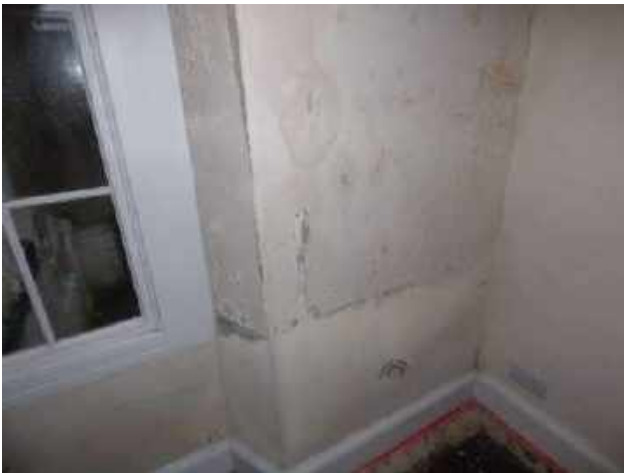
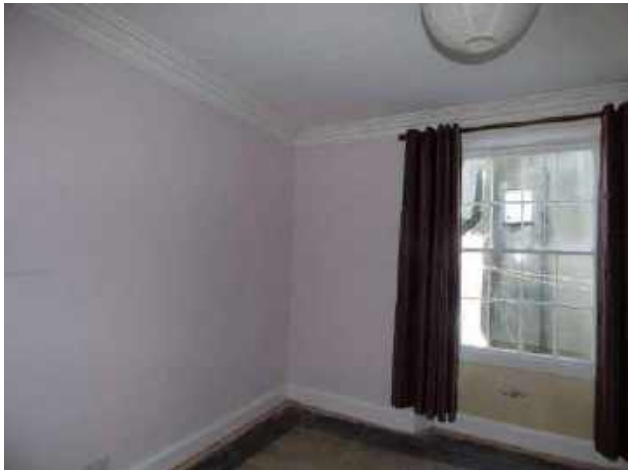
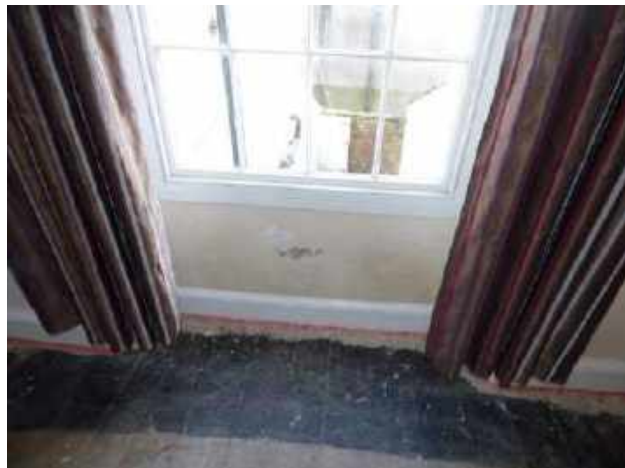
Left and below: Blown plasterwork to be repaired with lime plaster below window.

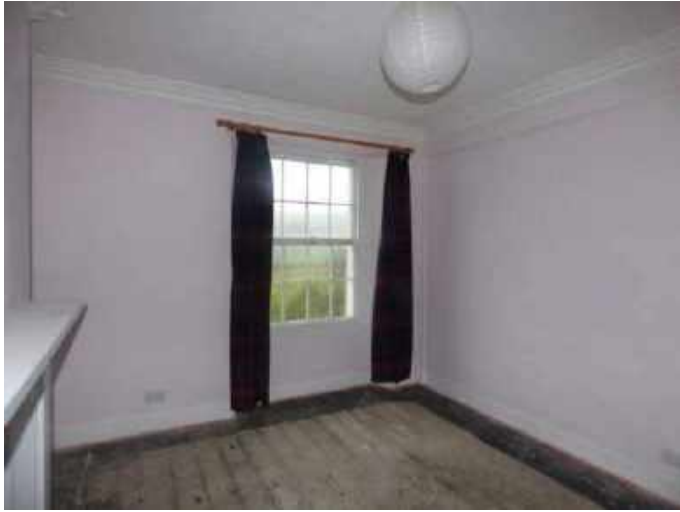
Large front bedroom, skirtings, covings, and architraves to be retained. Existing panelled door to be replaced with new Georgian heritage style four fire panel door.

Existing floorboards in good condition.

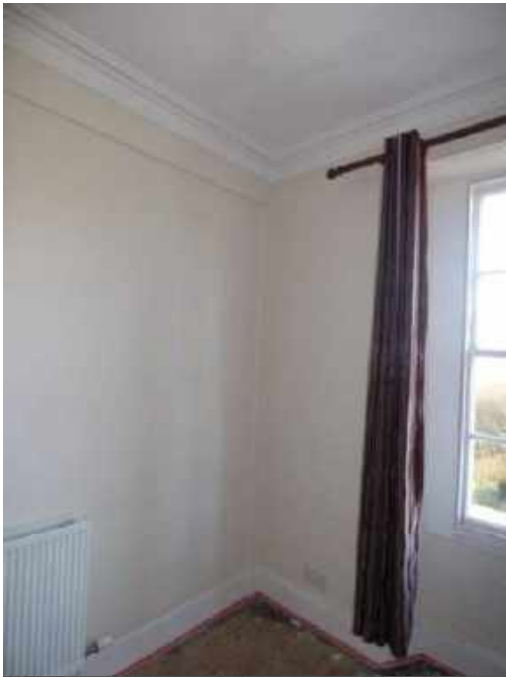
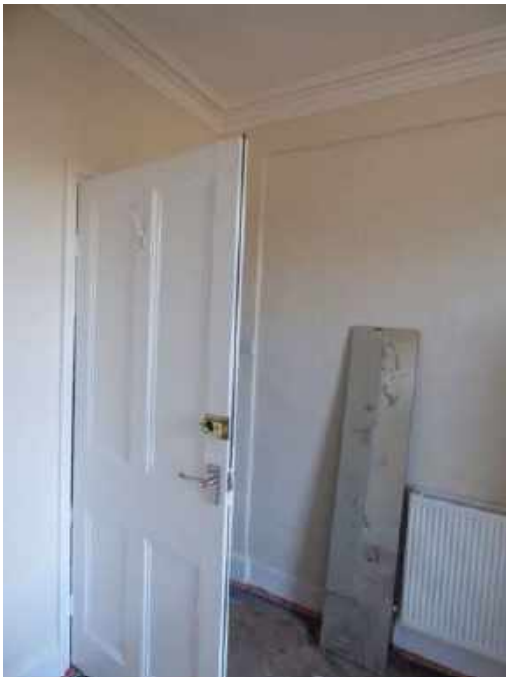
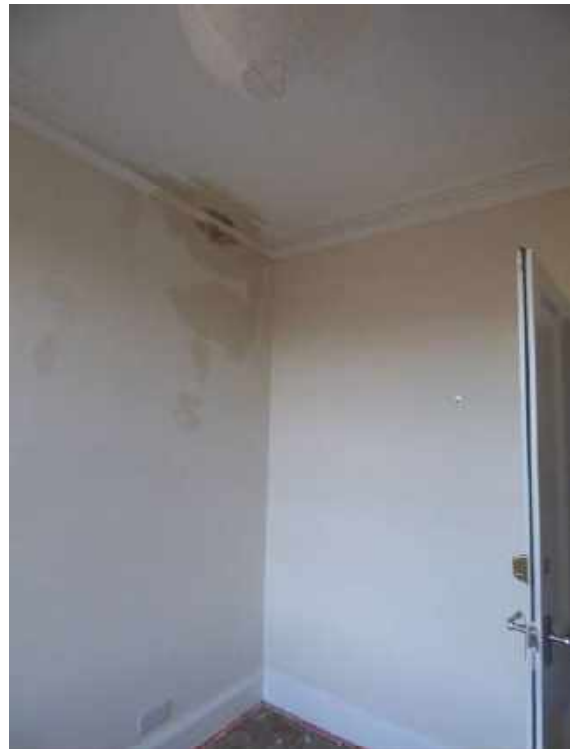
Existing small front bedroom - cornice, skirtings, and architraves to be retained. Existing door to be removed and new Georgian heritage style four panel door to be provided and installed by specialist joinery company such as Batty Joinery Ltd. In new location.

Blown plaster to walls and ceiling to be replaced and repaired with lime plaster all to match existing.

Existing doorway to be walled up to match existing.

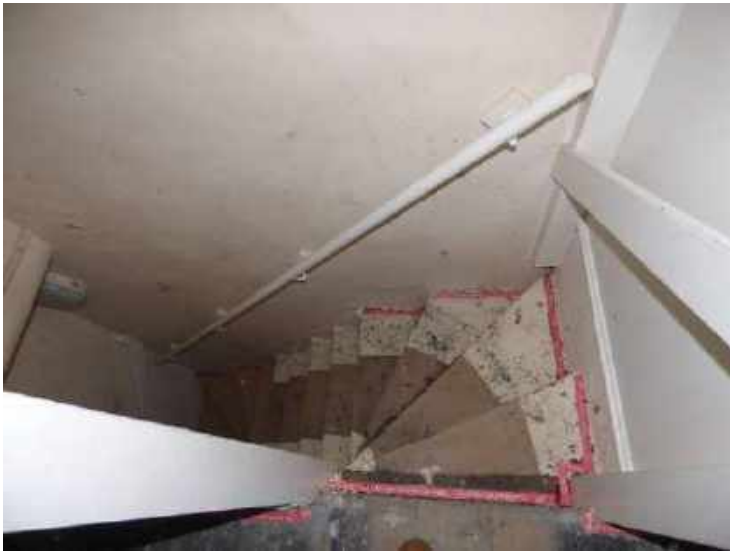
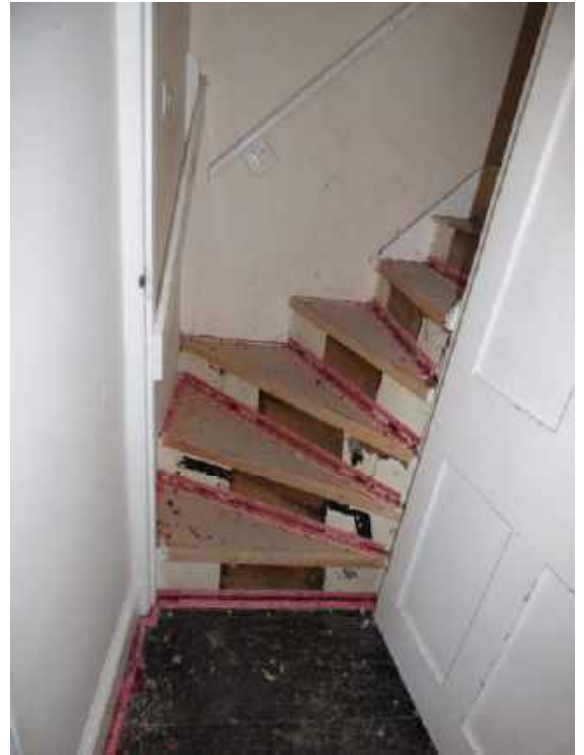
Above and right: Staircase to attic rooms.

At the top of the staircase on the landing, remove all damp and damaged/blown plasterwork and repair with lime plaster and skim and decorate throughout.

Provide and install new Georgian style heritage four panelled fire door to match existing (refer also to D&A statement).

Replace existing modern rooflights with new heritage rooflight windows (Velux or Rooflight company or similar)

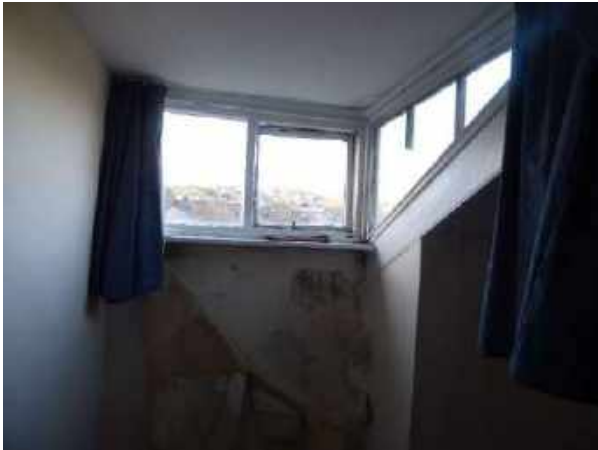
Left: the attic space has suffered from severe damp ingress which has caused considerable fabric damage.

The dormer window has degraded to an extent that it requires complete replacement. The dormer window is between two existing rooms, which are to be reconfigured to make the space within the attic more usable.

It is proposed to completely reconstruct the dormer windows in a style to match dormer windows on other properties, so there is consistency with the design approach.

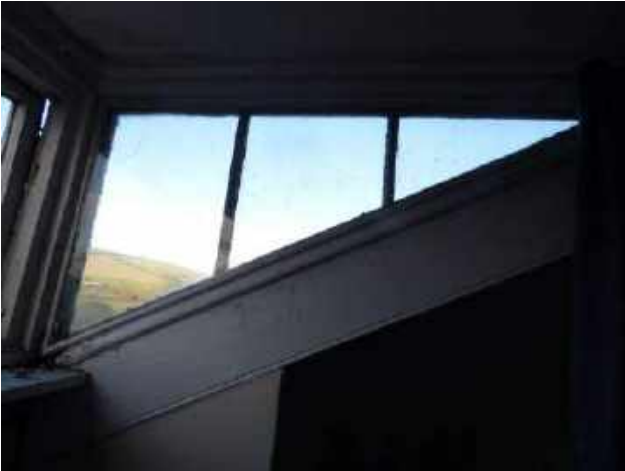
Left - Attic bedroom:

Floorboards require minor repairs.

In the bedroom remove all damp and damaged/blown plasterwork and repair with lime plaster and skim and decorate throughout.

Existing doors are to be removed and replaced with new heritage style four panel fire doors.

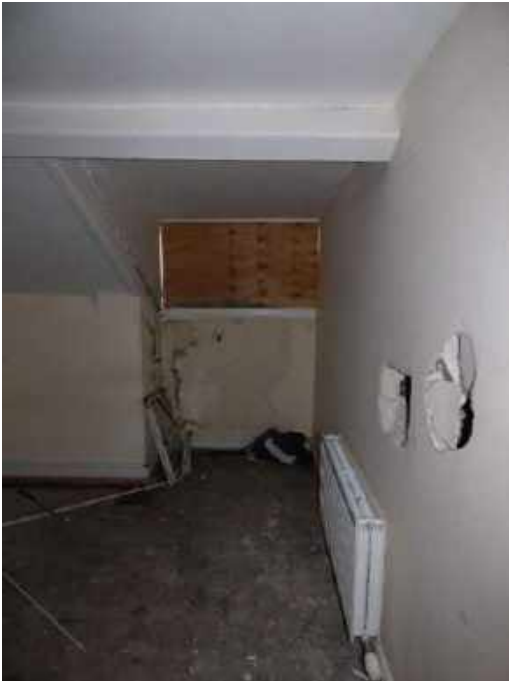
Left: Existing dormer glazed window no longer exists to the second bedroom, and the dormer cheeks are damaged beyond simply repairing them. A new dormer is proposed.

The existing bedroom partition is damaged. It is proposed to remove this wall and reconfigure the space.

In the bedroom remove all damp and damaged/blown plasterwork and repair with lime plaster and skim and decorate throughout.

Apply an insulated plasterboard 62mm thick to underside of ceiling tape and skim and undertake full decorations.

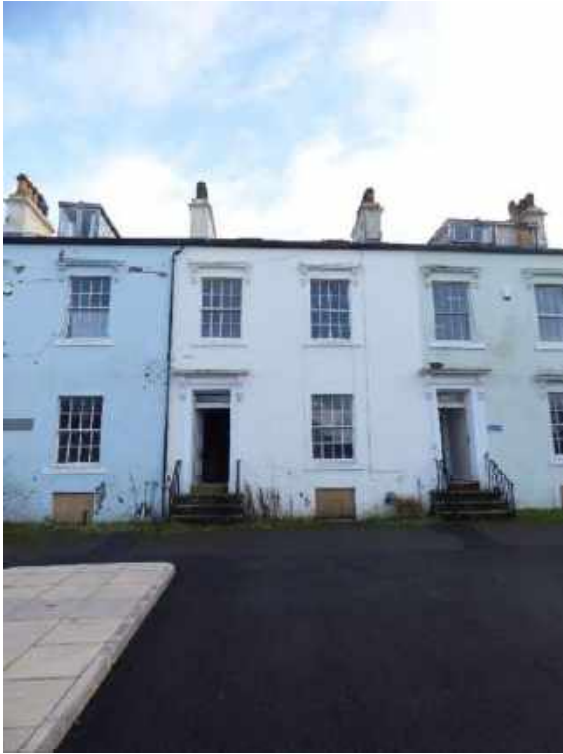
Left: The main entrance is mentioned in the listing text and is to be entirely retained.

Both front and rear elevations are currently rendered, with colour to the front and side and natural to the rear. All elevations require to be prepared for render repairs and redecoration by specialist using lime render and stucco (Parax LTD) to be applied by specialist.

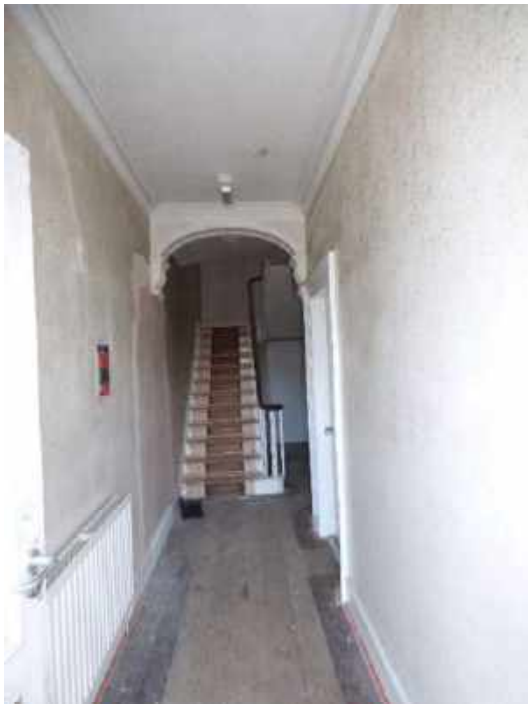
Left: The existing walls and floor are generally in good condition.

Redundant M&E to be removed and wall/ceiling finishes made good and primed, prepared and fully decorated.

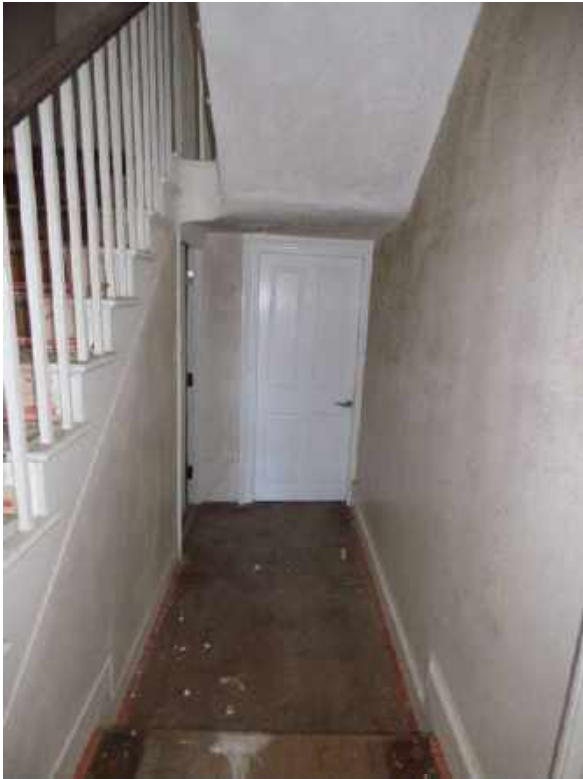
Existing staircase is original and is in excellent condition.

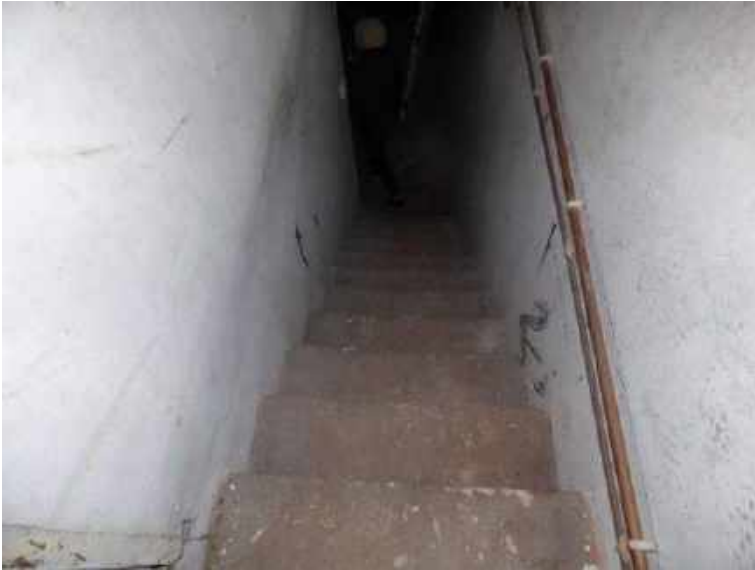
Left: The basement

The existing walls and floor are generally in sound condition so would be suitable for this application of damp proof slurry system. All existing paint and surface finishes must be removed and made good including all snots removed, and damage to existing surfaces, prior to the installation of a Koster Polysil NB1.

This migratory crystalline tanking slurry is used to seal below ground structures against water ingress.

Koster NB1 is considered to be a Type A waterproofing system as defined by BS8102:2009 and is generally used to seal the inside face of basement structures against water ingress.

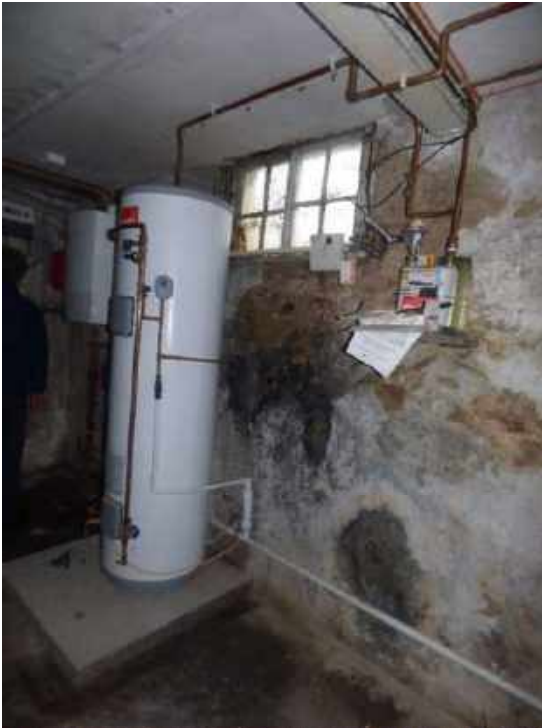
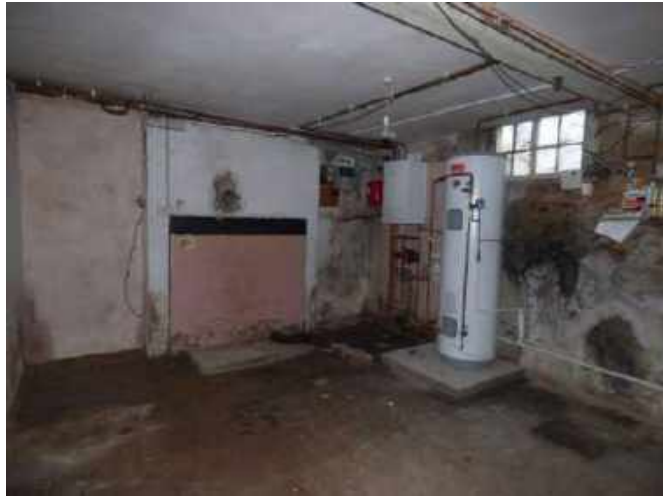
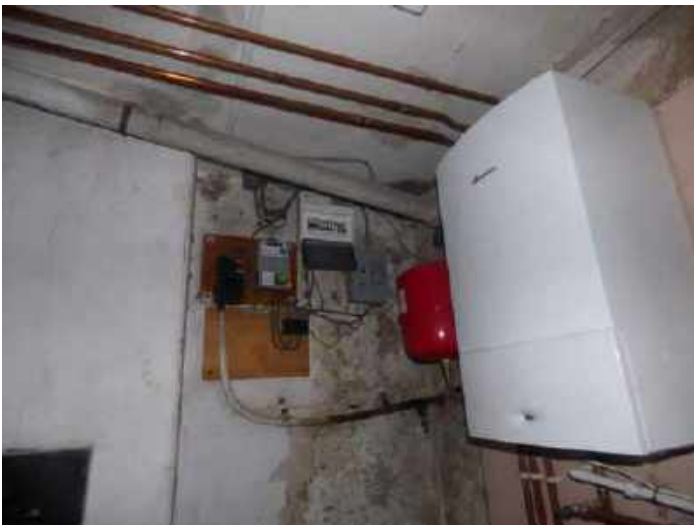
Left and above: New boiler installations have been undertaken prior to the sale of the properties.

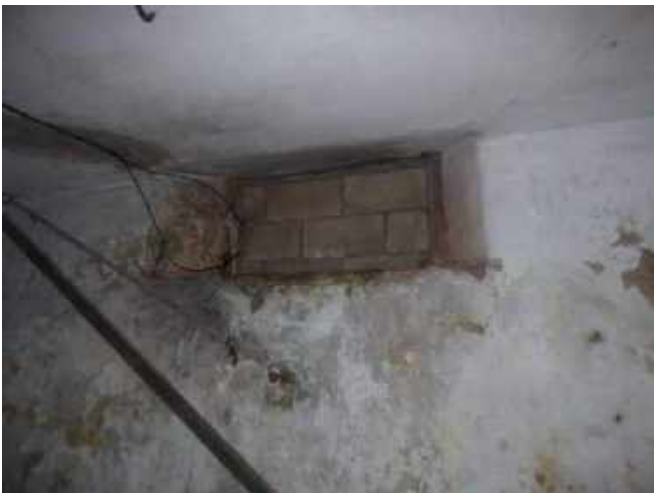
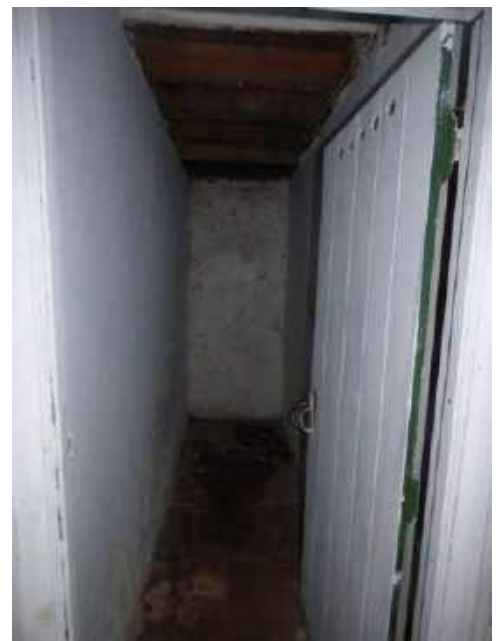
Below, left: Former window has been walled up. It is proposed to wall up properly with insulation and masonry.

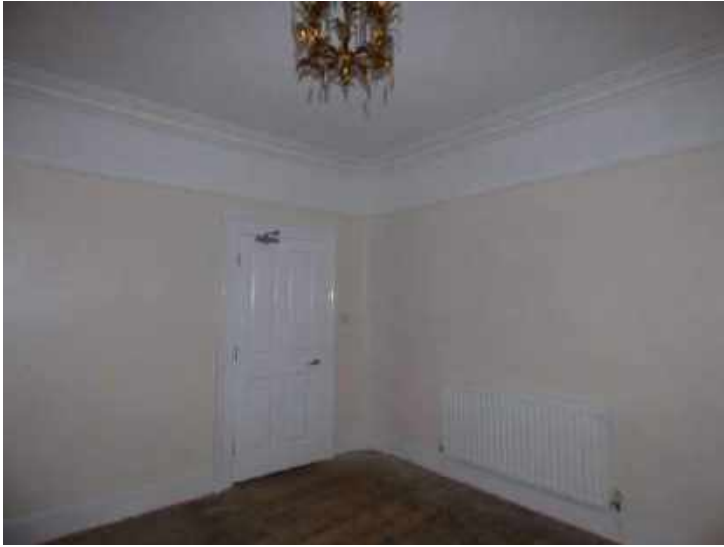
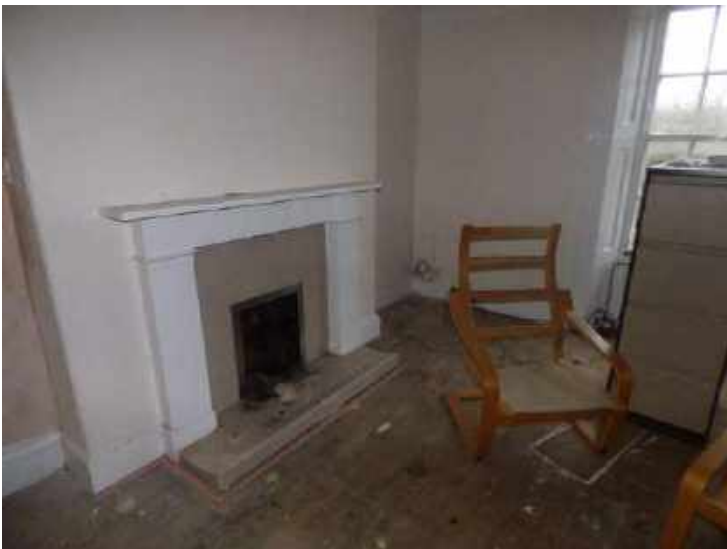
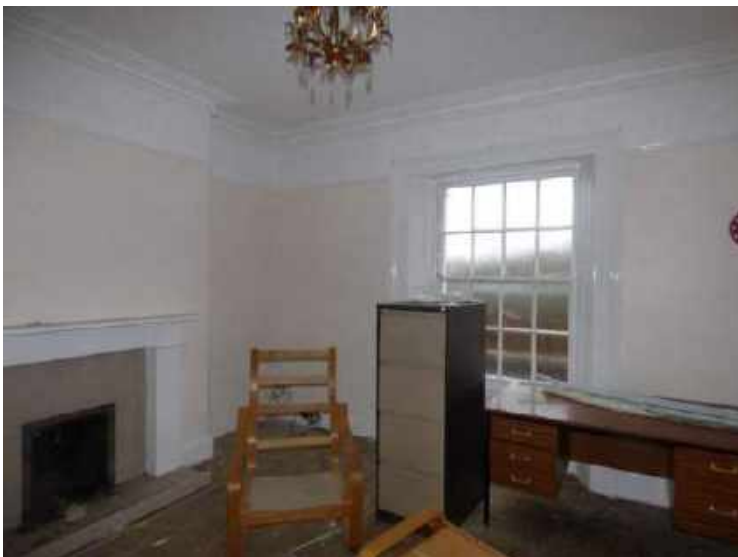
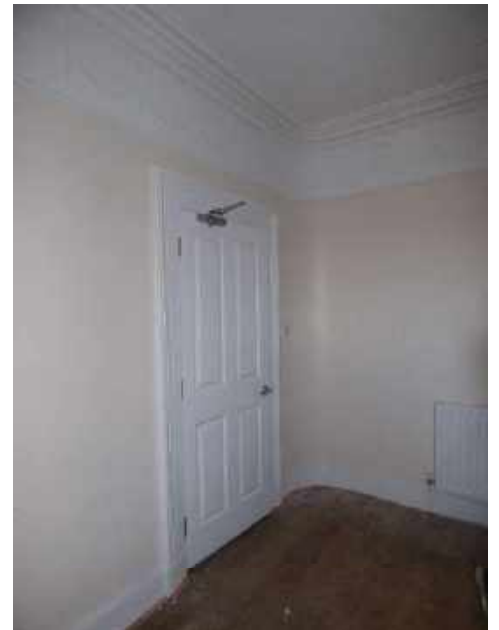
Left and below: In the existing front room, the period features below and to the sides of the existing window are in good condition, it is proposed to carefully refurbish the existing timber shutters.

Existing cornices, picture rail is all in excellent condition and are to be retained.

Existing architraves and skirtings to be retained and made good.

Existing doors to be replaced with heritage style four panel painted timber fire doors to enhance the heritage asset.

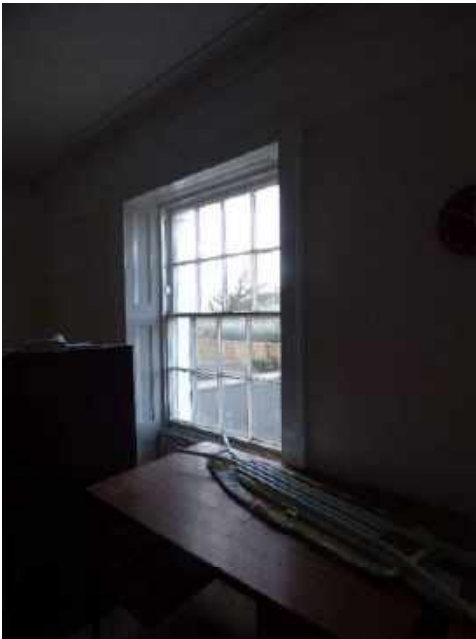
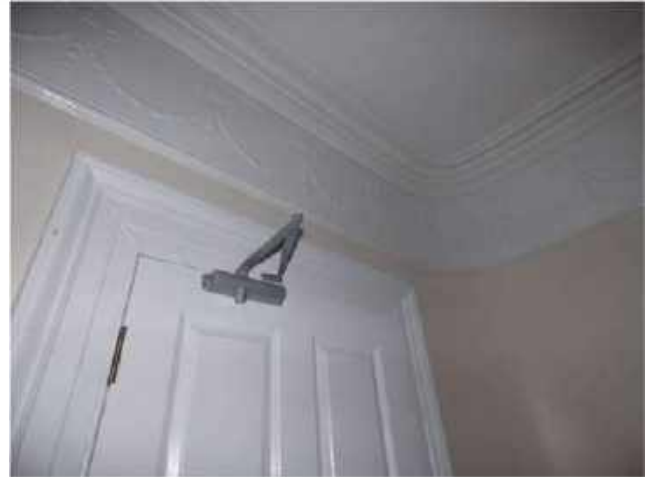
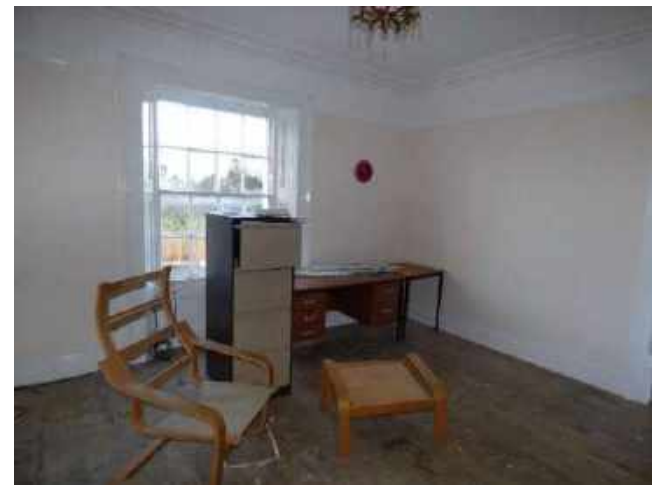
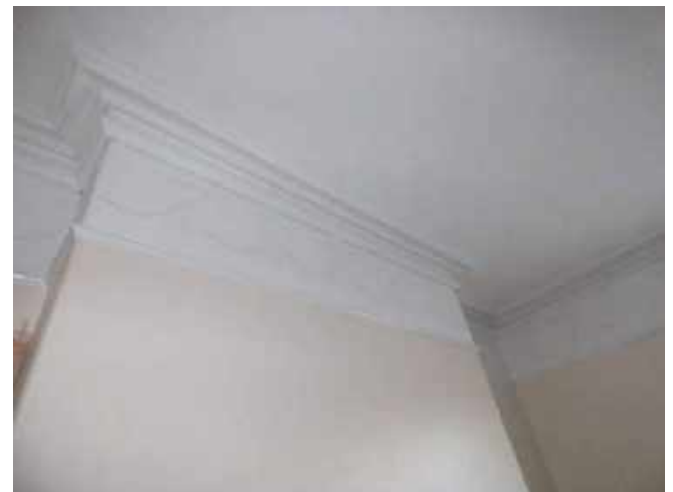
Right, above, and below: In the existing lounge at the front of the property, it is proposed to carefully refurbish the existing timber shutters.

Fireplace is not original and is not proposed to retain it.

Existing architraves and skirtings to be retained and made good.

It is proposed to form a new opening between lounge and dining to create a more open plan living environment.
