# HERITAGE STATEMENT

## FULL RENOVATION OF EXISTING No 11 TERRACE HOUSES

St Bees, 1-11 Lonsdale Terrace, Parish Council, Cumbria

M.A.C Architects, Project Number: 2019:303

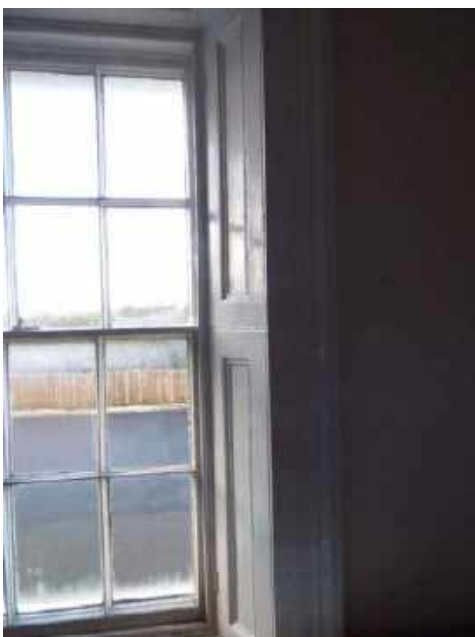
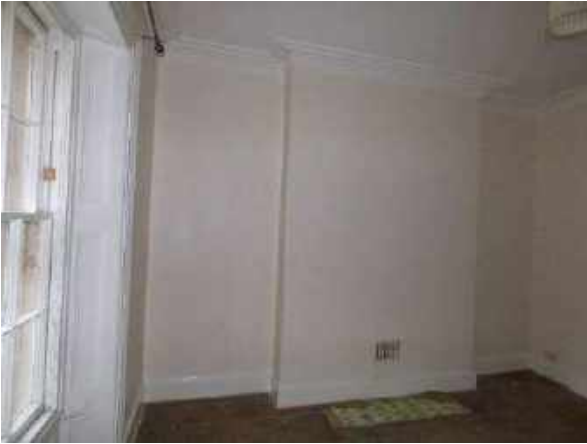
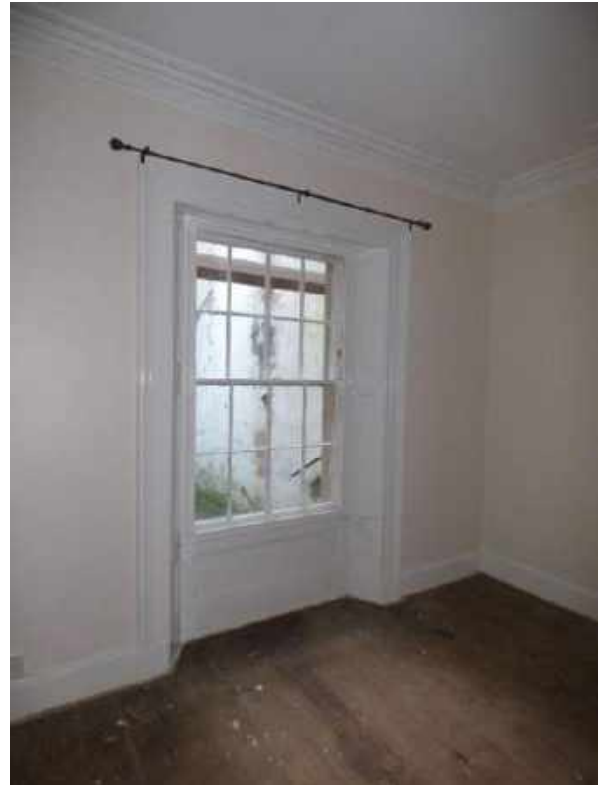
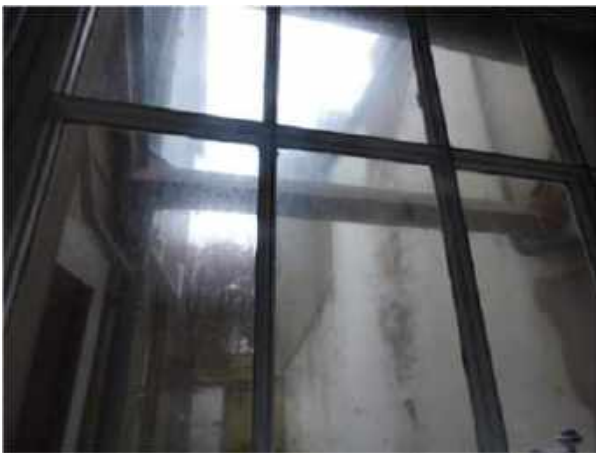
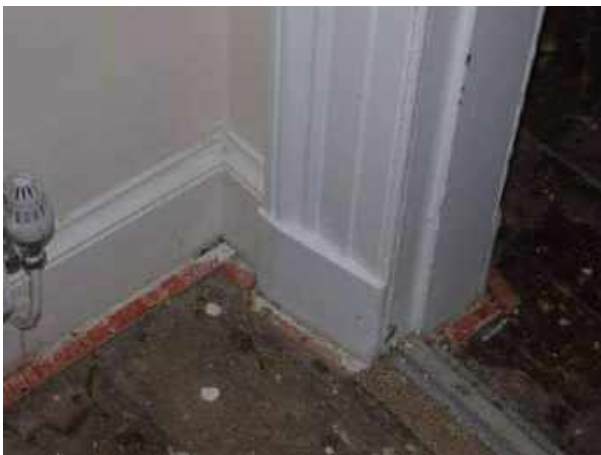
In the existing dining room, the period features below and to the sides of the features below and to the sides of the existing windows both front and back are in good condition, it is proposed to carefully refurbish the existing timber shutters.

Existing cornice to be retained.

Existing door to be replaced with heritage style four panel painted timber fire door to enhance the heritage asset.

New opening to be formed between existing dining and lounge to accommodate open space living area (as with houses 1-5). Openings to be below cornices, which will remain intact.

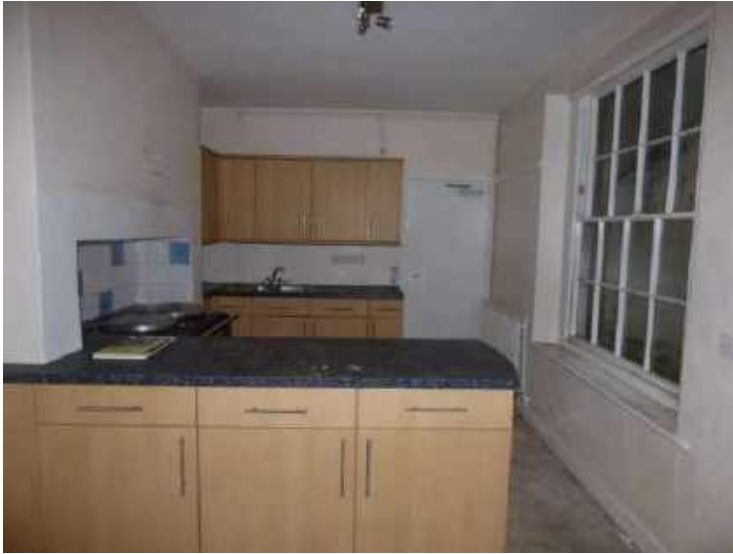
In the existing kitchen it is proposed to remove all fixtures and fittings.

Blown plaster to existing walls to be repaired with new lime plaster and made good.

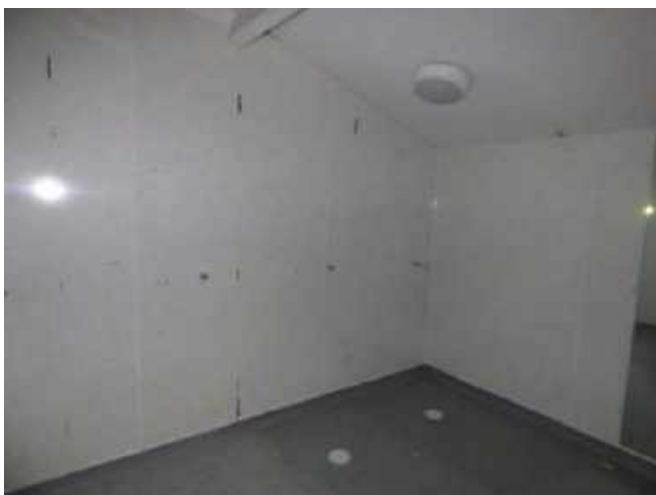
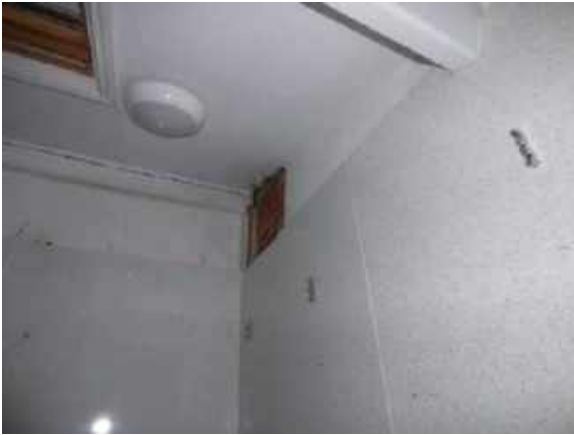
Left and below: The existing shower block to be reconfigured.  
The roof may require some minor repairs to make watertight.

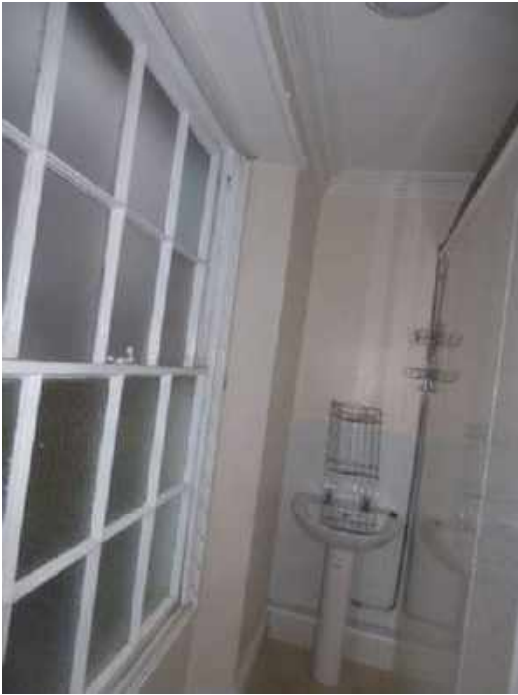
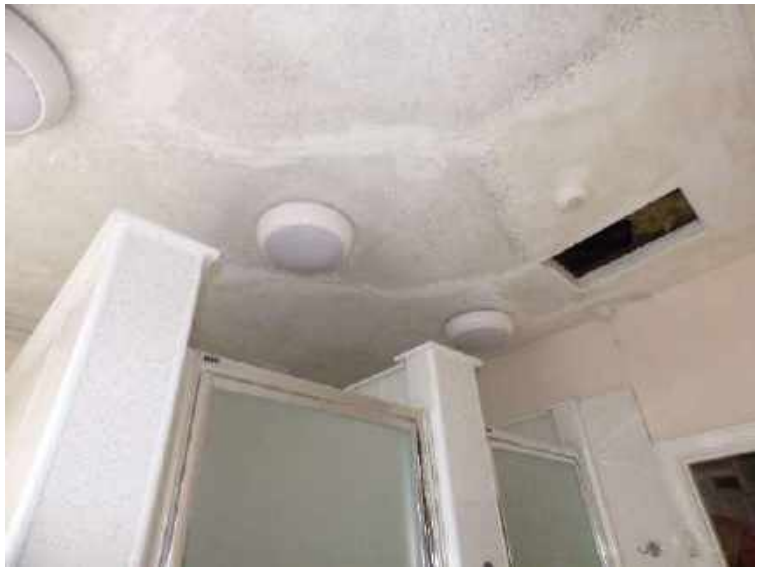
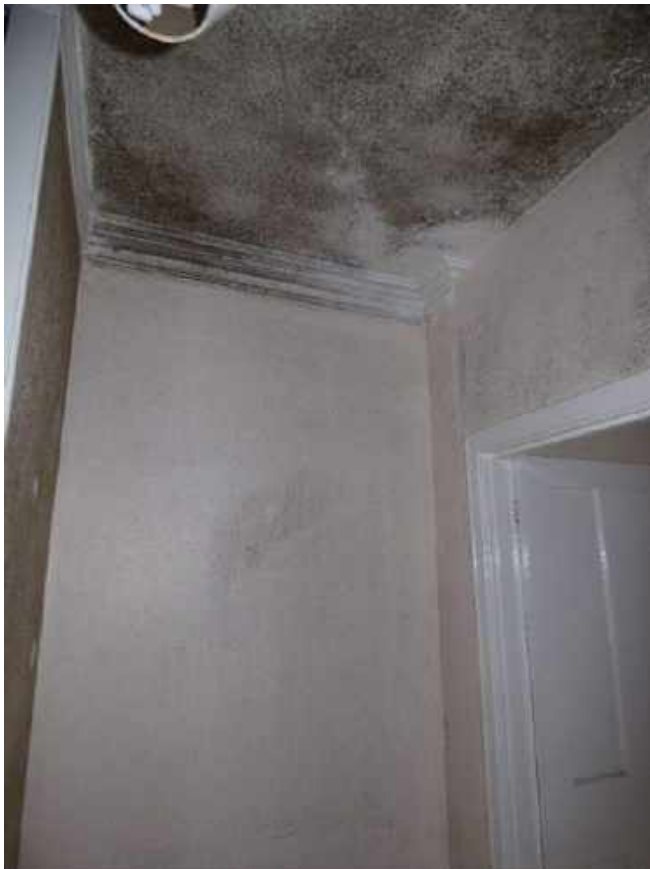
Left and above: Existing ceiling to be made good by removing mould and replacing blown plaster with lime plaster as required.

Glazing to new heritage style Georgian double glazed sash window to be obscure.

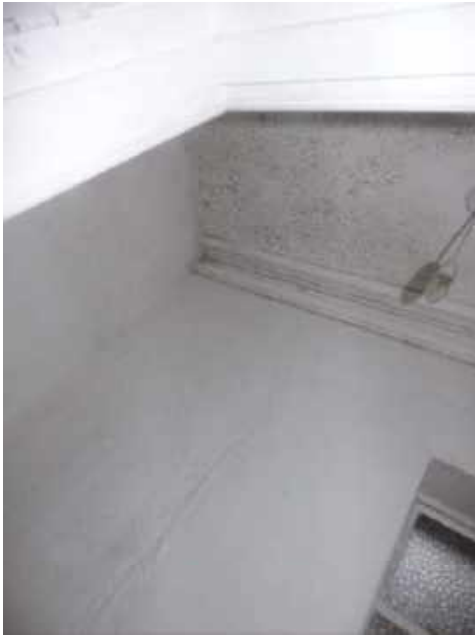
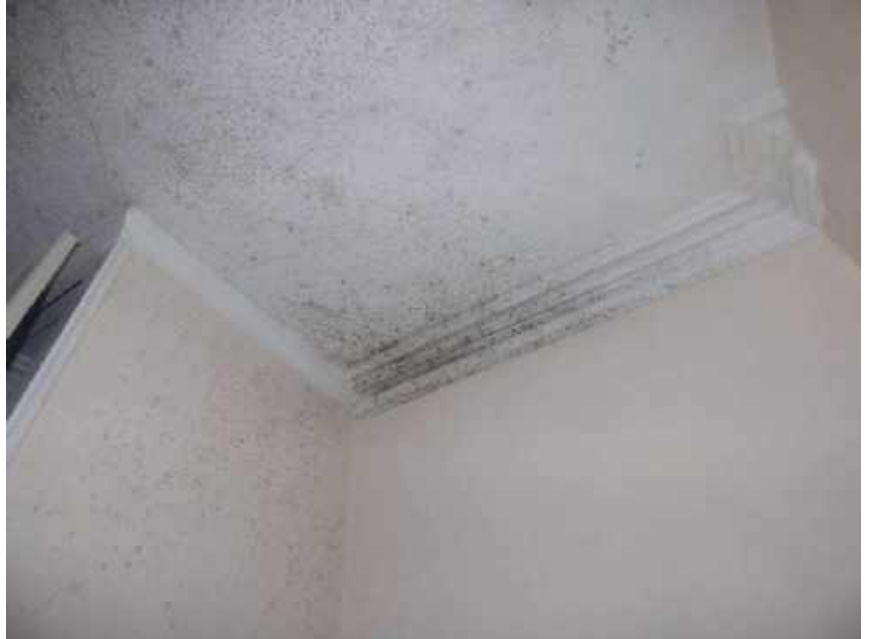
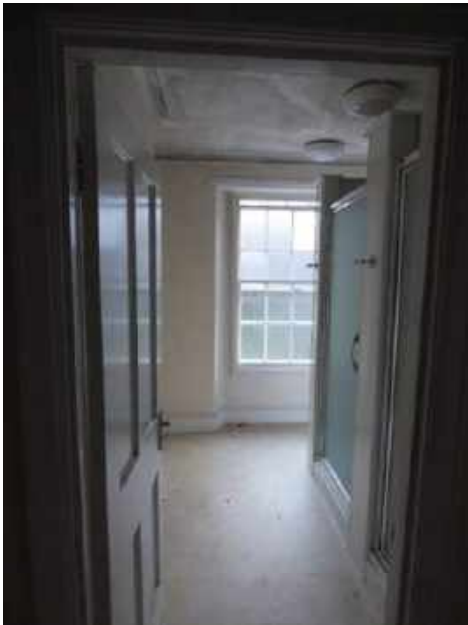
First floor w.c. to be reconfigured, and cornices and skirtings to be reinstated. All existing plasterwork affected by damp to be repaired and or reinstated as required. Roof to be repaired to ensure completely watertight.

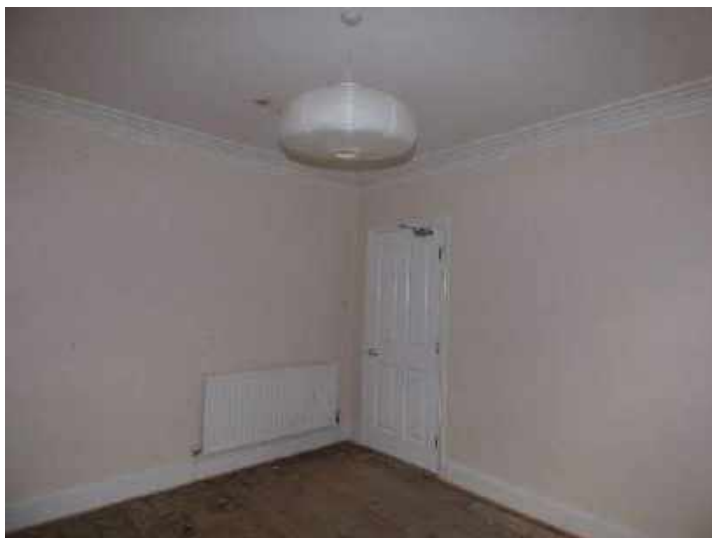
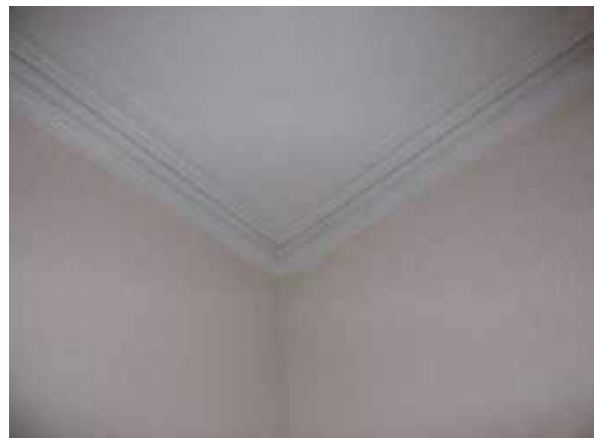
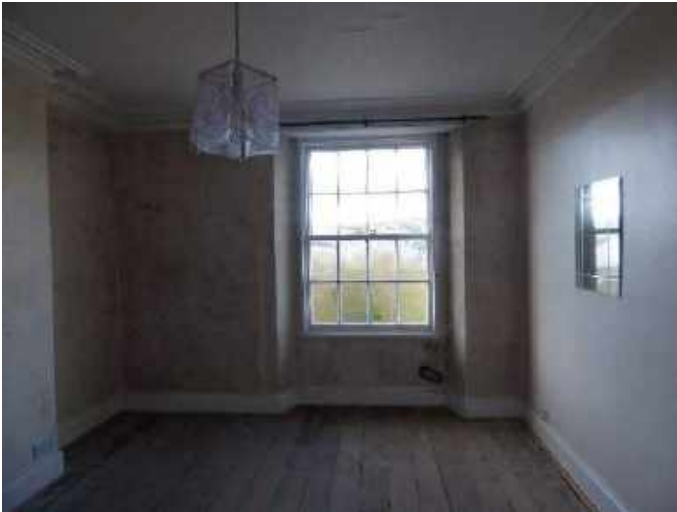
Damp ingress evident with mould to walls and ceiling.

Large front bedroom, skirtings and architraves to be retained. Existing door to be replaced with new Georgian heritage style four panel door to be provided and installed by specialist joinery company such as Batty Joinery Ltd.

Attic and roof to be made watertight.

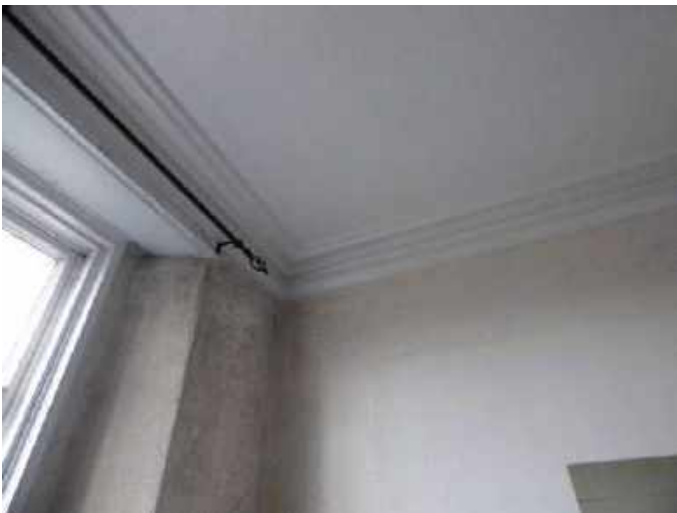
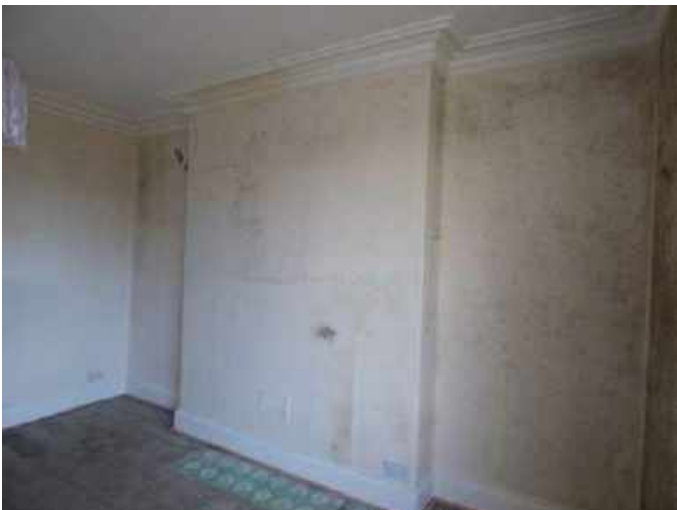
Existing floorboards in good condition

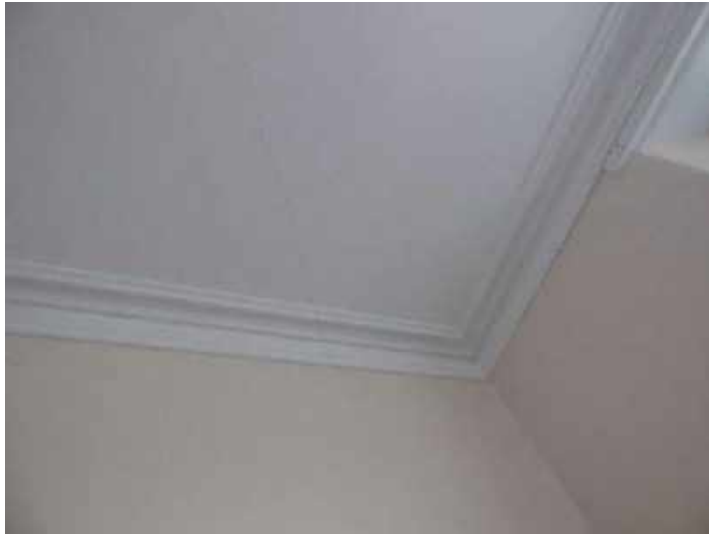
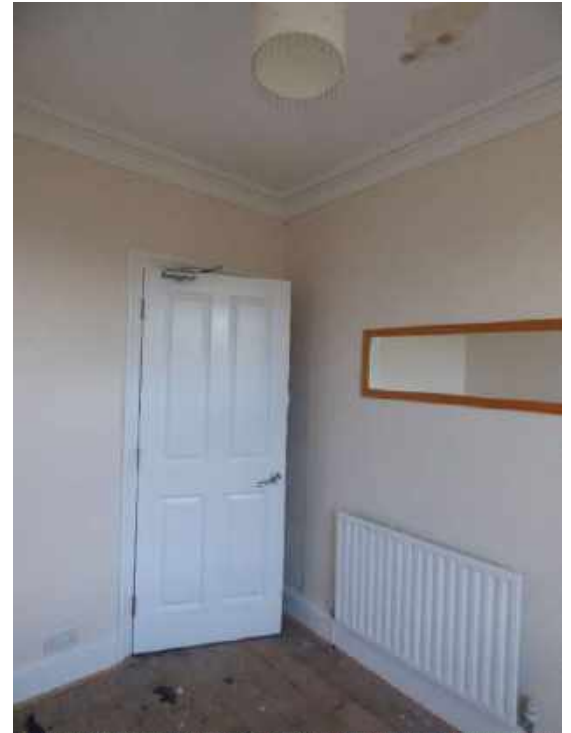
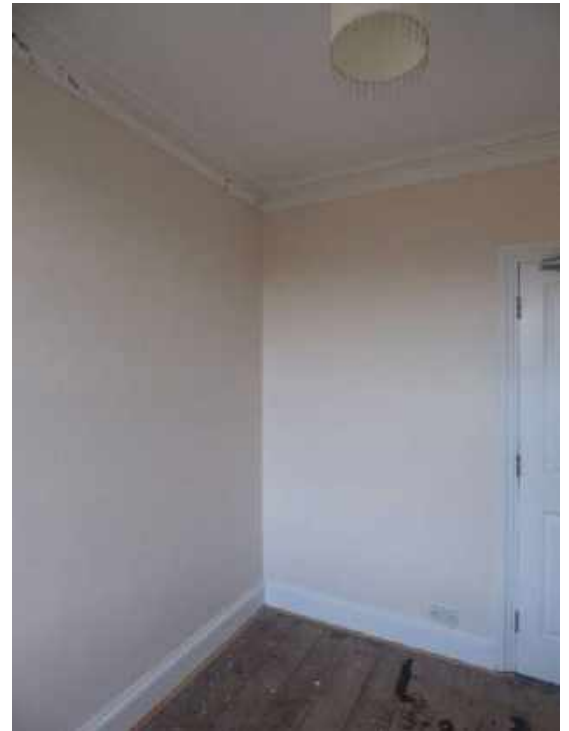
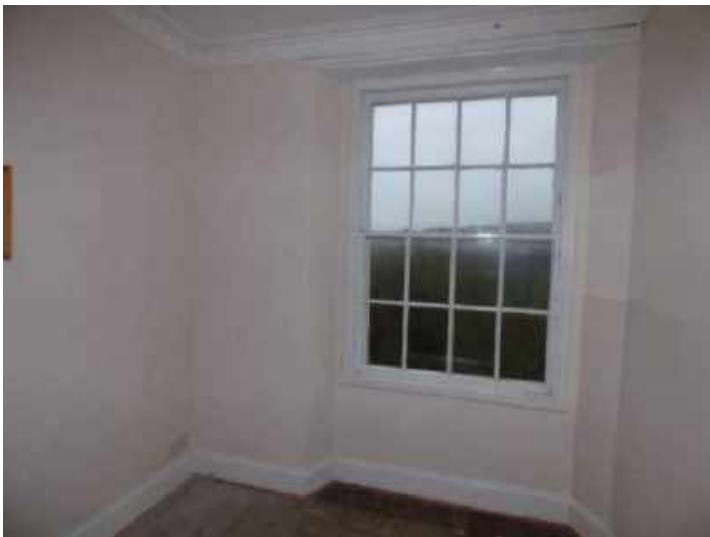
Existing floorboards in good condition.

Existing small bedroom skirtings and architraves to be retained.  
Existing door to be removed and new doorway from proposed master bedroom to be provided and installed with new Georgian heritage style four panel door to be provided and installed by specialist joinery company such as Batty Joinery Ltd.

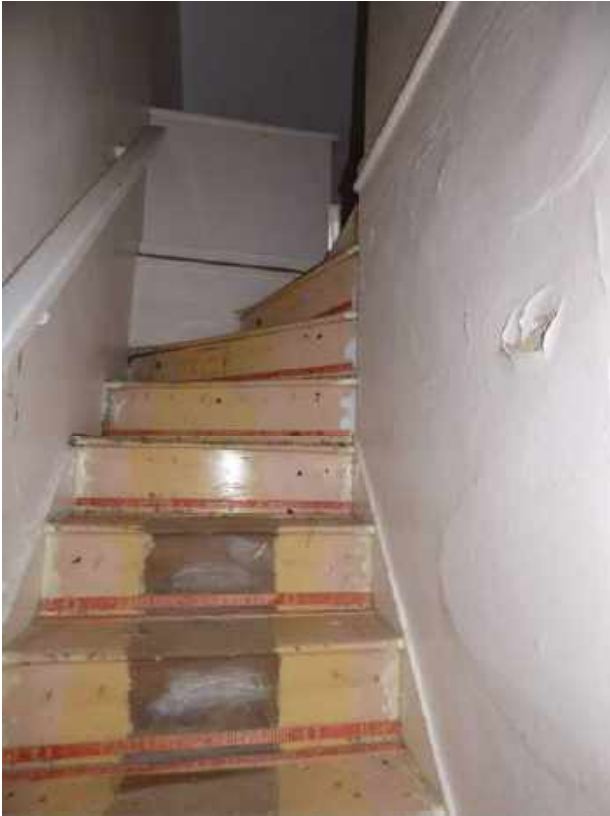
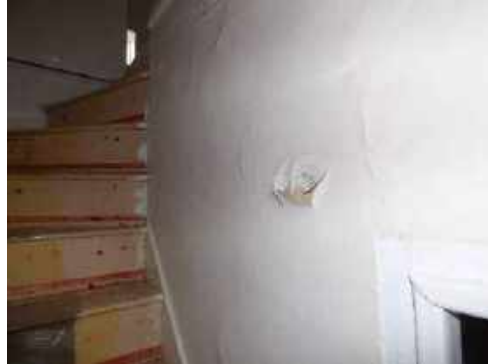
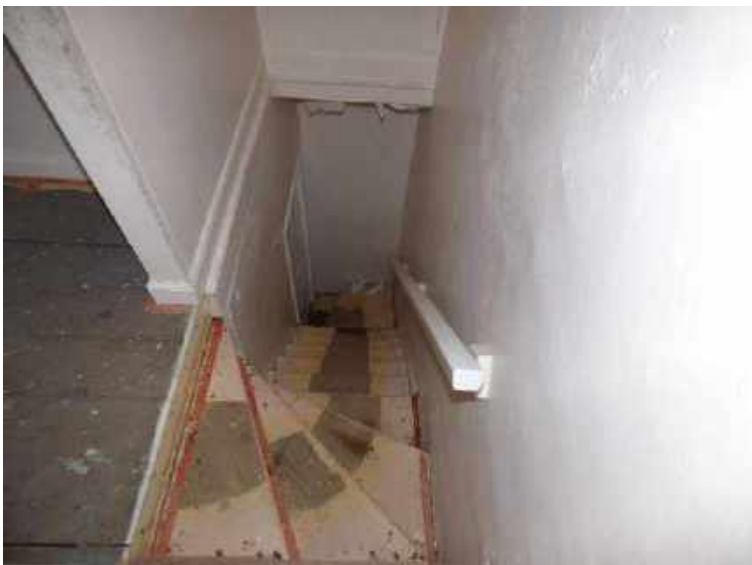
Existing staircase to attic. Existing walls require minor fabric repairs.

New four panelled fire door to be installed at first floor.

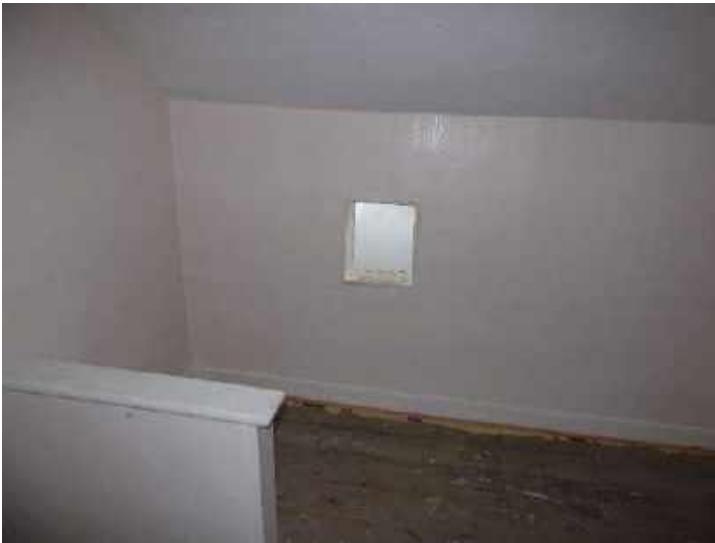
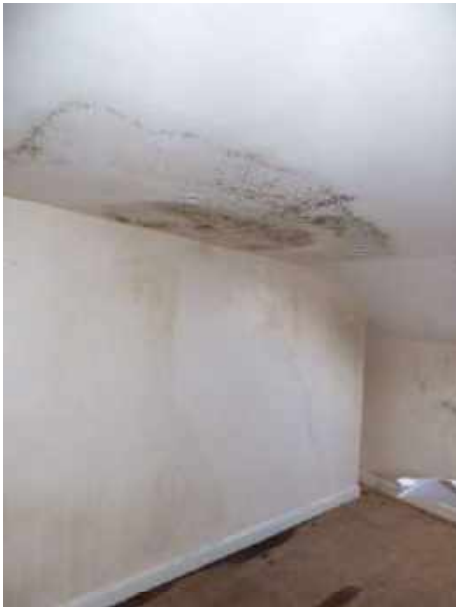
Left: Attic landing.

Floorboards are in good condition (but require minor repairs).

Existing window to be walled up.

Existing damaged plaster to be replaced and repaired with lime plaster.

Apply an insulated plasterboard 62mm thick to underside of ceiling tape and skim and undertake full decorations. New rooflights to be installed.

Provide and install new heritage rooflight windows (Velux or similar)

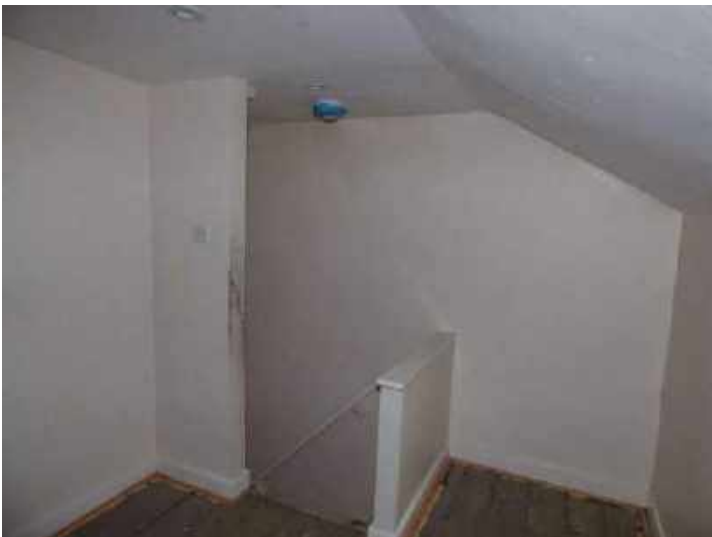
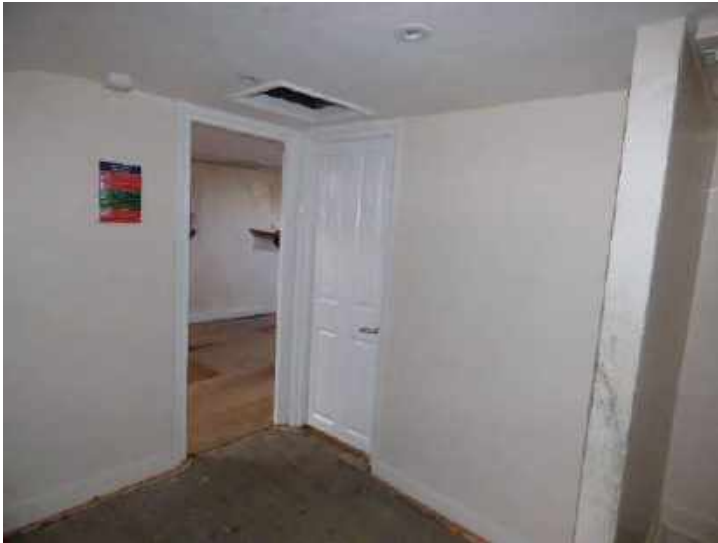
Left: Attic bedroom

Floorboards are in good condition (but require minor repairs).

The existing attic bedrooms are to be reconfigured to maximise the space.

In the bedroom it is proposed to remove all blown plasterwork and repair with lime plaster and skim.

Existing doors are to be removed and replaced with new heritage style four panel fire doors.

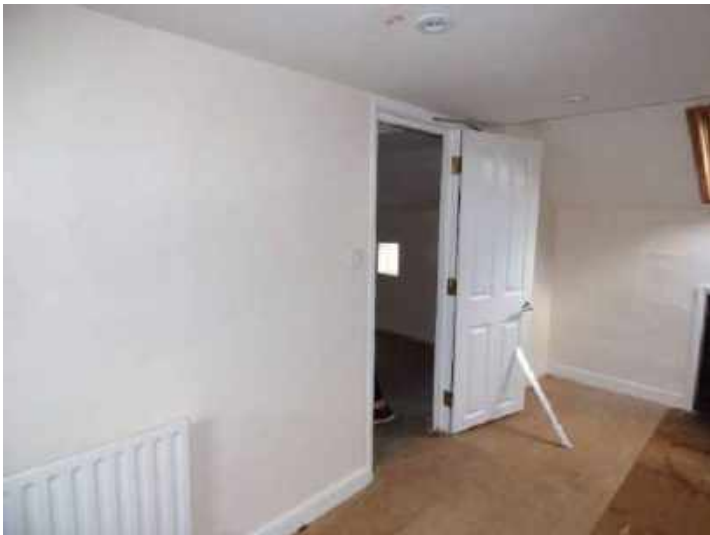
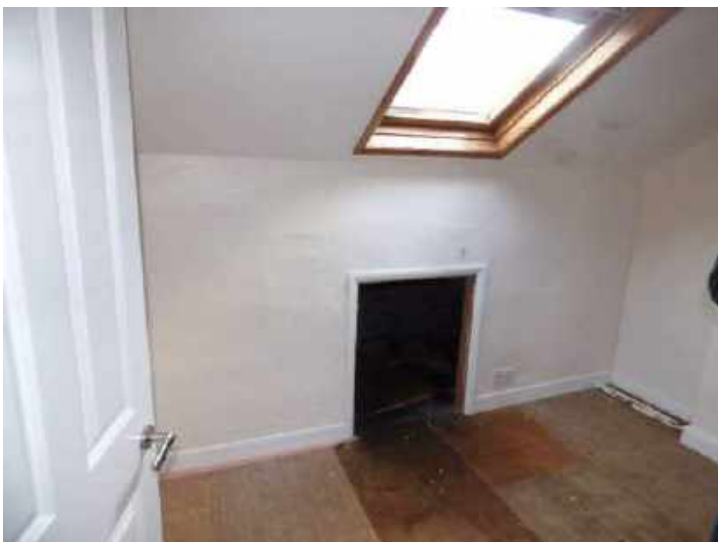
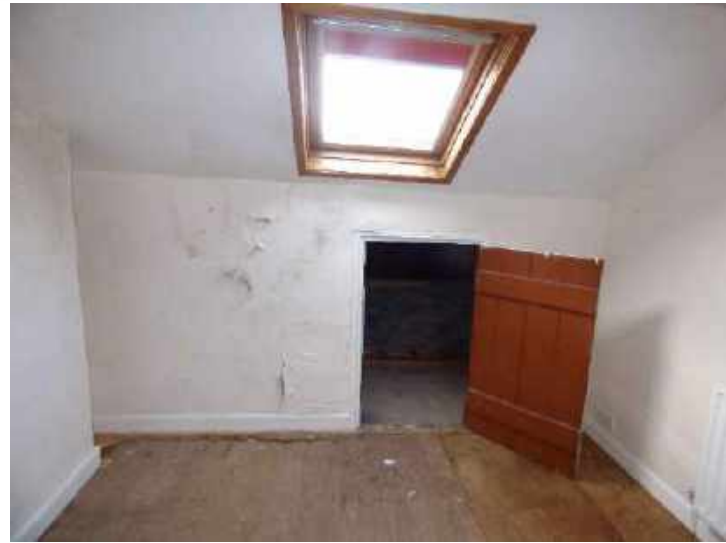
Left: Attic bedroom

Floorboards are not original and it is proposed to replace with T&G timber floorboards

The existing small attic bedroom will be reconfigured to maximise the space.

In the bedroom it is proposed to remove all blown plasterwork and repair with lime plaster and skim.

Existing doors are to be removed and replaced with new heritage style four panel fire doors.

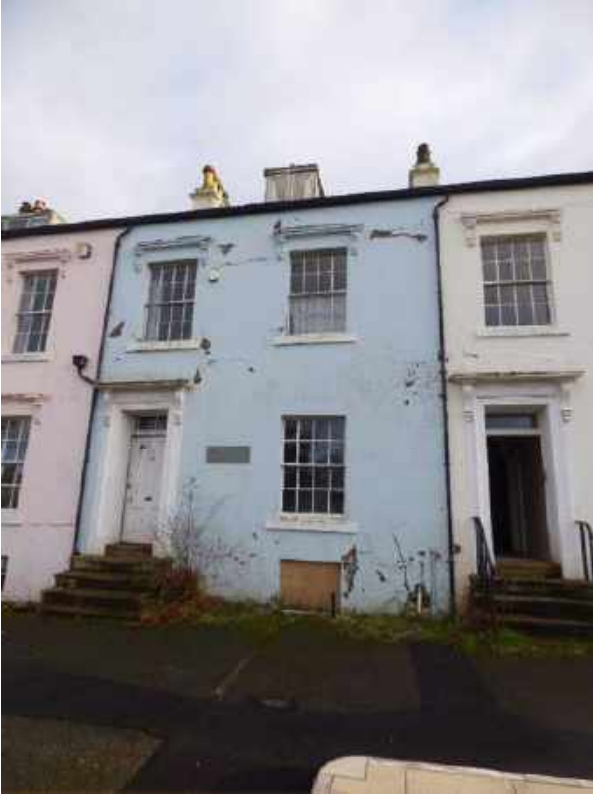
Left: The main entrance is mentioned in the listing text and is to be entirely retained.

Both front and rear elevations are currently rendered, with colour to the front and side and natural to the rear. All elevations require to be prepared for render repairs and redecoration by specialist using lime render and stucco (Parax LTD) to be applied by specialist.

The existing door and frame are to be retained and made good with the provision of new ironmongery. Once repaired full decoration will be undertaken.

Existing gutters and downpipes to be retained, repaired where necessary and decorated.

All existing single glazed windows to replace with new white painted slim profile timber double glazed 'heritage' windows to match the existing style by specialist supplier such as Batty Joinery, specialists in historic and listed building joinery works.

The existing stone steps to be cleaned up, and new painted metal handrails provided, that would have originally been installed to be reinstated – refer to D&A statement for details.

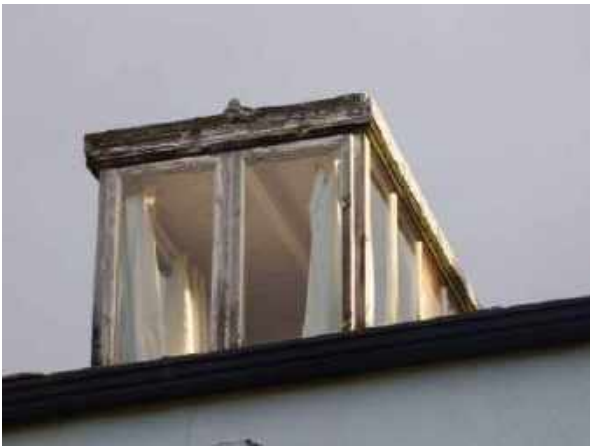
Existing dormer window is in extremely poor condition and it is proposed to completely reconstruct the dormer, in a style to match the other dormer windows on the adjacent buildings.

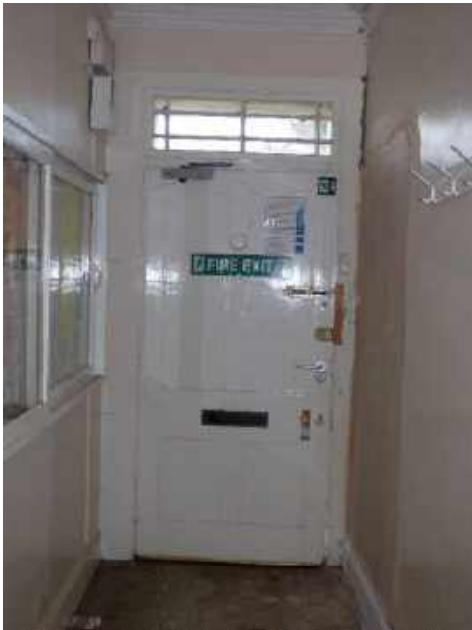
Left: The existing walls and floor are generally in good condition.

Handrail, balusters and rails to the staircase are original and to be retained.

Redundant M&E to be removed and wall/ceiling finishes made good, primed, prepared and fully decorated.

Doors to be replaced with heritage style four panel painted timber fire doors to enhance the heritage asset.

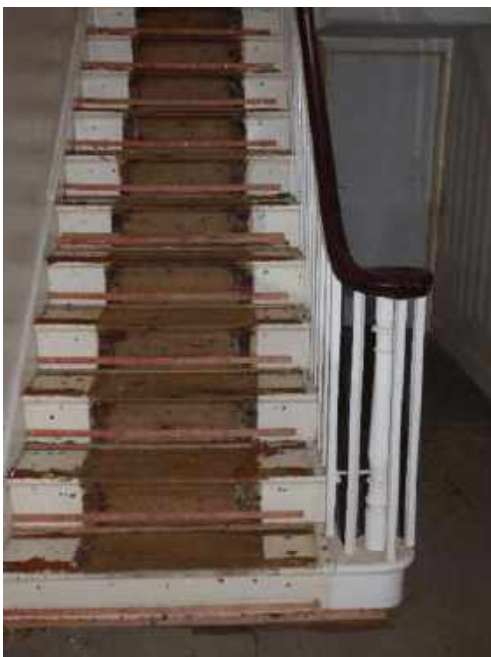
Below: Period features to be retained, including archway and architraves, (Modern lighting to all be stripped out and make good surfaces). All architraves and plaster features to be retained.

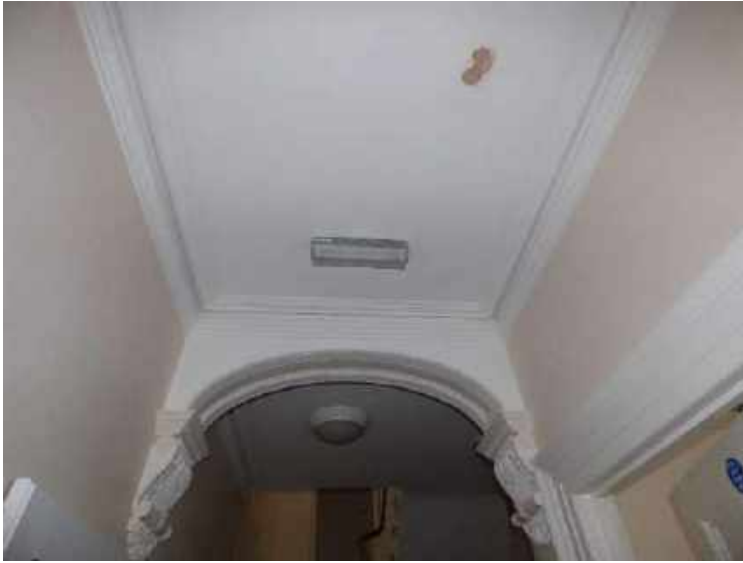
Left: Cornices, architraves and skirtings all in good condition and to be retained.

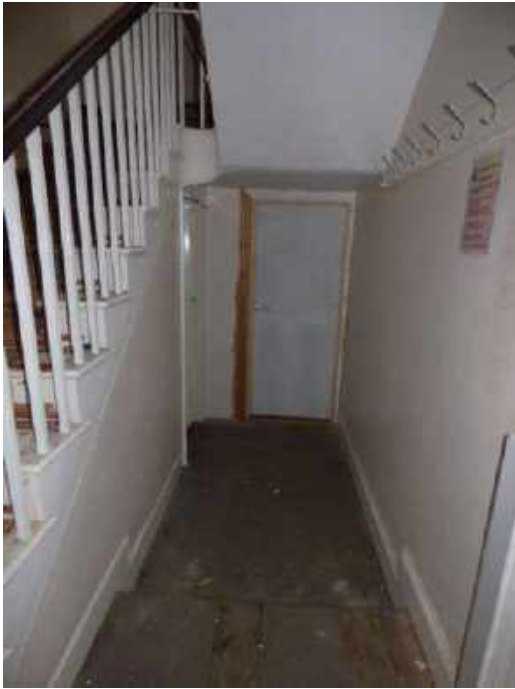
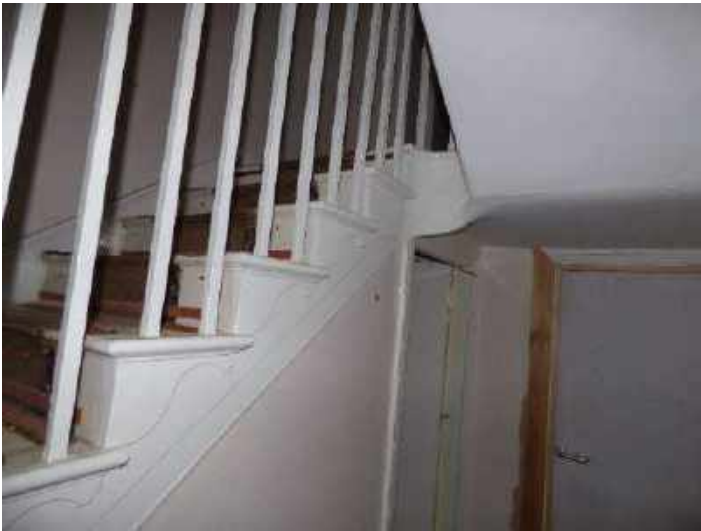
Left and below: The existing walls and skirtings and floor are generally in good condition.

Redundant M&E to be removed and wall ceiling finishes made good.

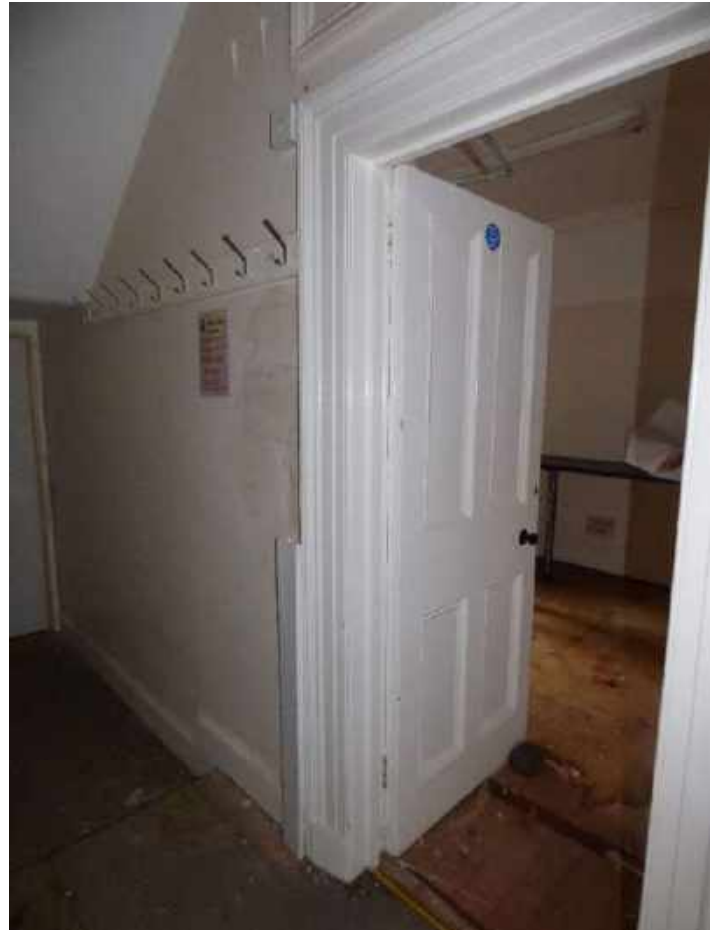
Left: The existing basement, the existing walls and floor are generally in sound condition so would be suitable for the application of damp proof slurry system.

All existing paint and surface finishes must be removed and made good including all snots removed, and damage to existing surfaces, prior to the installation of a Koster Polysil NB1.

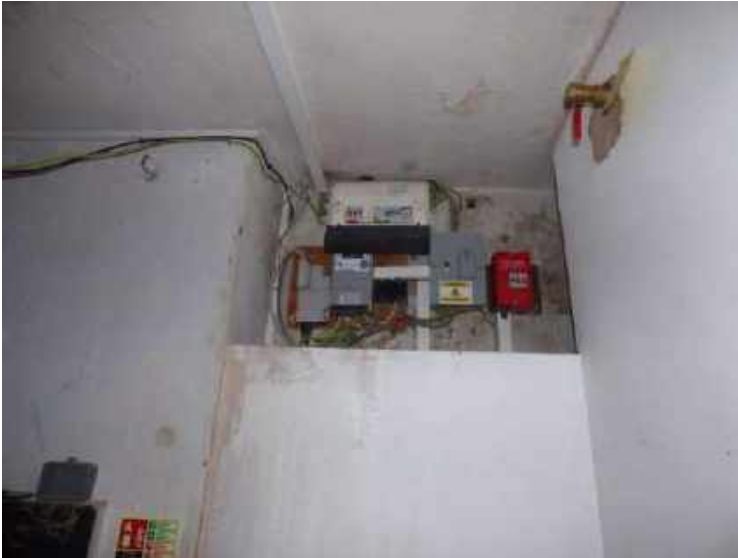
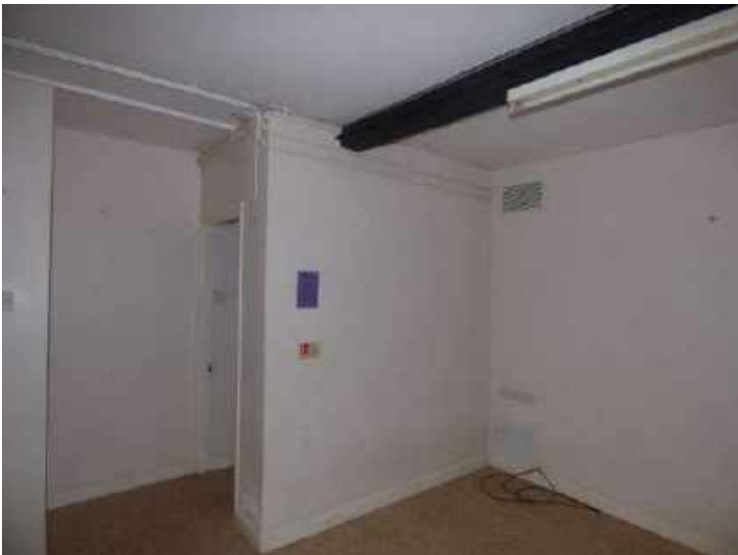
Walls have been boarded over but not treated properly for damp, so it is proposed to remove the boards and apply waterproofing.

This migratory crystalline tanking slurry is used to seal below ground structures against water ingress.

Once applied then the walls can be prepared and primed for decorating and for the floor finishes to be installed. Complete new boiler and heating system is required, new distribution boards, etc.

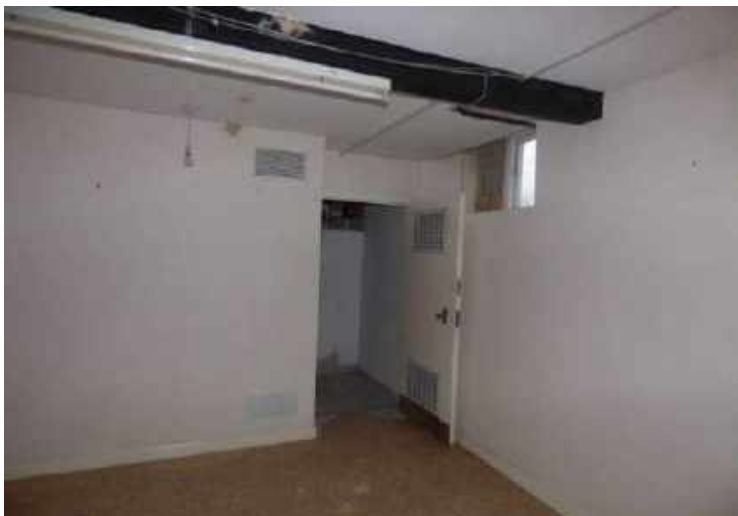
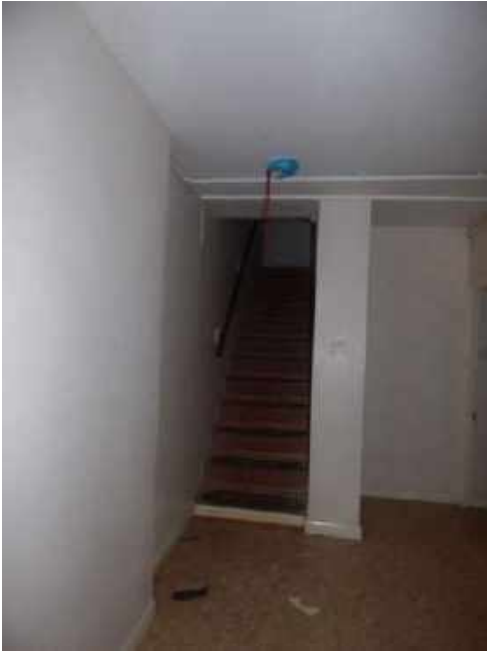
The walls down to the basement also require the full treatment.

In the basement all existing services are to be carefully stripped out and replaced with new compliant infrastructure.

Existing window to basement to be removed and reveals made good.

All existing services to be carefully removed and new gas and electric services installed.

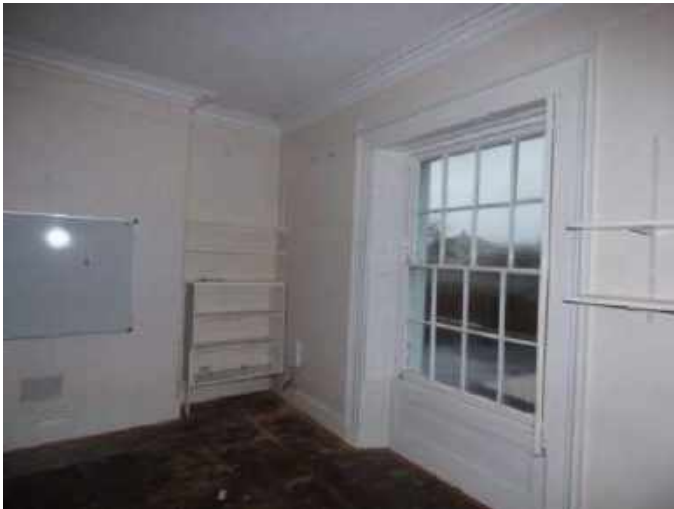
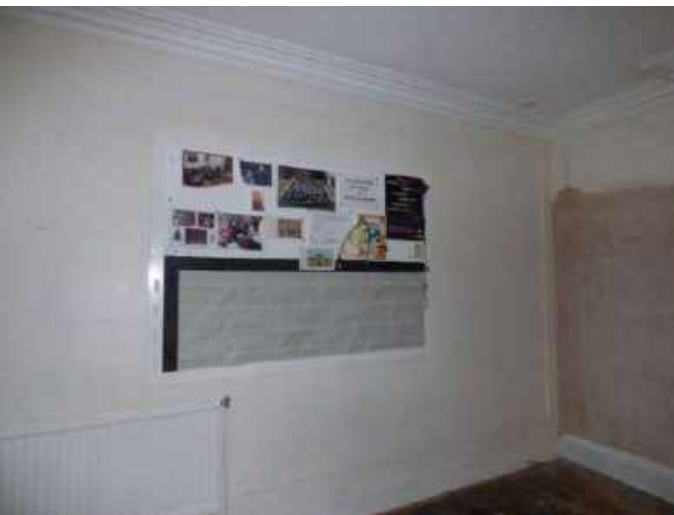
In the existing lounge, the period features below and to the side of the existing window are in good condition, it is proposed to carefully refurbish the existing shutters.

The existing cornice to be made good in locations where redundant services are to be removed and where hairline cracks have appeared.

Existing architraves and skirting to be retained and made good.

Flush panel doors to be replaced with heritage style four panel painted timber fire doors to enhance the heritage asset.

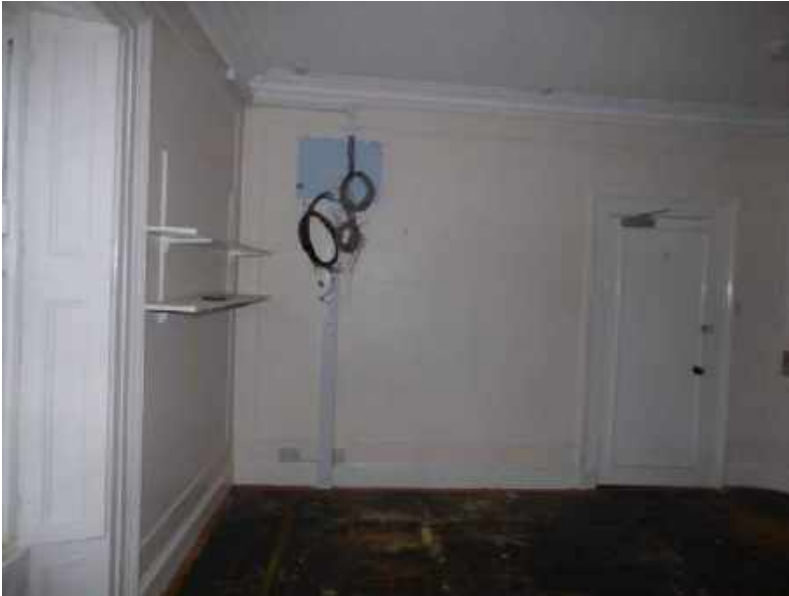
Architraves, skirtings, and cornices are all in good condition and are to be retained.

Left: Existing services to be stripped out and walls made good.

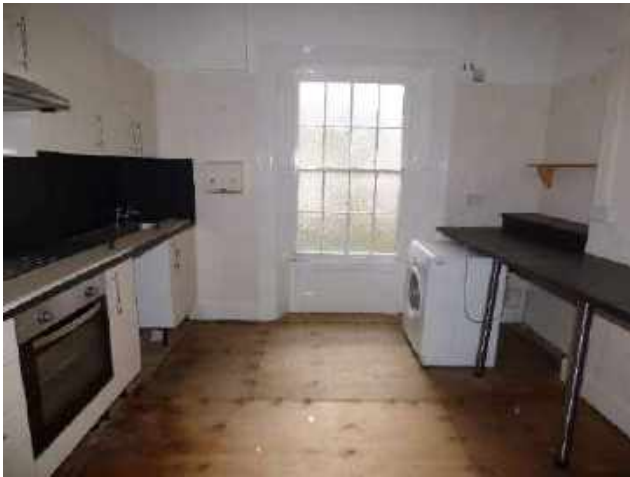
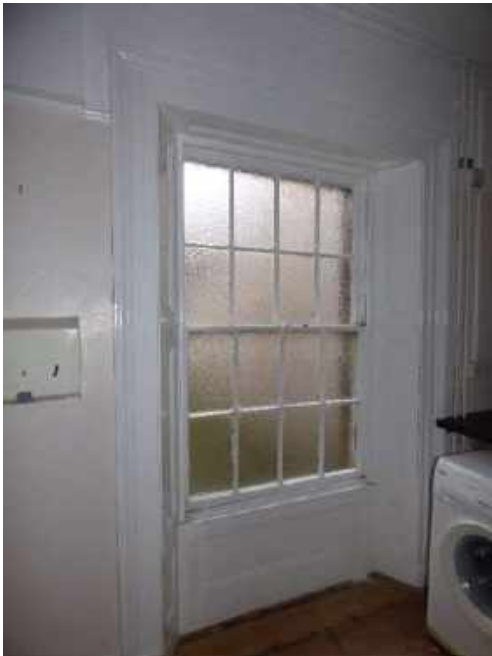
The exiting kitchen dining area to the rear of the property.

The period features below and to the sides of the existing window are in good condition, it is proposed to carefully refurbish the existing timber shutters.

Below: Existing cornice to be made good in locations and where hairline cracks have appeared.

The existing floor is not original as it is plywood boarded, so it is proposed to lift the existing floor and investigate the condition of floor joists and then replace with timber floorboards.

Flush panel doors to be replaced with heritage style four panel painted timber fire doors to enhance the heritage asset.

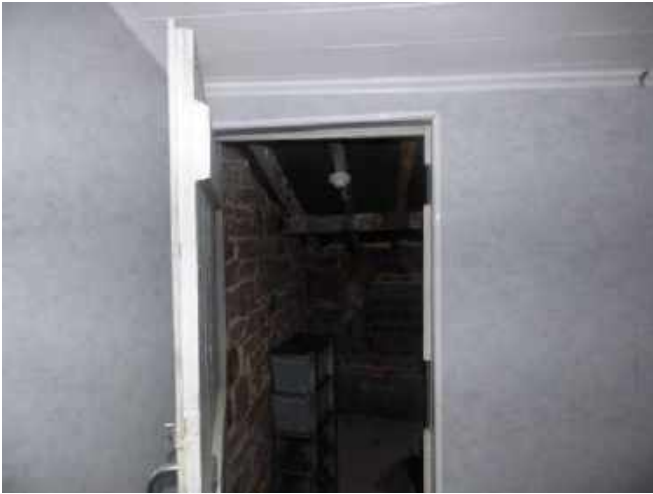
Left: Views of the existing shower block. The area behind the proposed new kitchen will be reconfigured to accommodate a new utility and w.c.

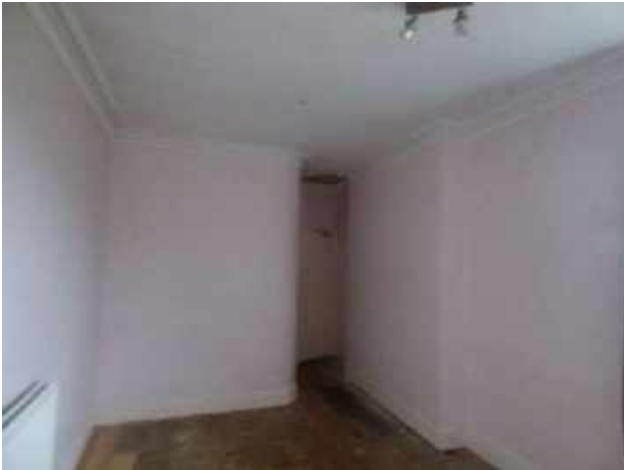
Existing bedroom to be reconfigured into a new family bathroom. The existing bathroom is too small for use as a family bathroom.

Glazing to new heritage style Georgian double glazed sash window to be obscure.

New bathroom door to be anew four panelled door – bathroom door does not need to be a fire rated door.

The damaged ceiling is to be repaired with lime plaster.

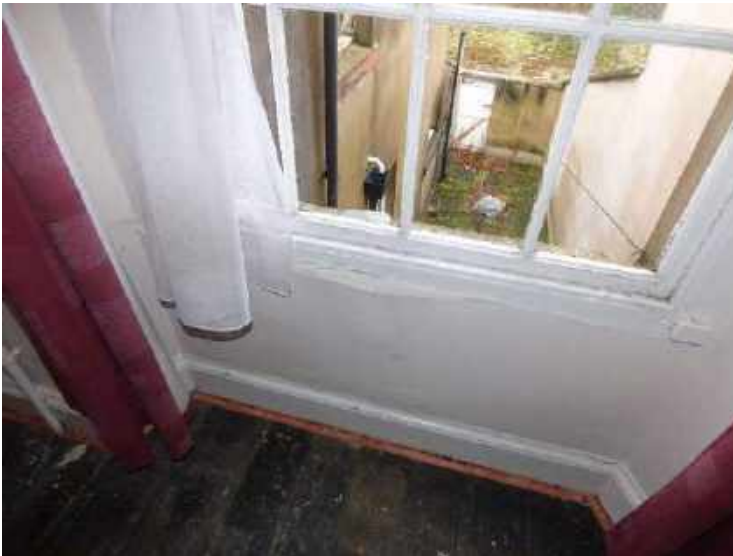
Rear bedroom skirtings and architraves to be retained. Existing flush panelled door to be replaced with new heritage style four panel door to be provided and installed by specialist joinery company such as Batty Joinery Ltd.

Existing floorboards in good condition.

Evidence of damp damage to ceiling and surrounding the existing window are to be repaired with lime plaster.
