# HERITAGE STATEMENT

## FULL RENOVATION OF EXISTING No 11 TERRACE HOUSES

St Bees, 1-11 Lonsdale Terrace, Parish Council, Cumbria

M.A.C Architects, Project Number: 2019:303

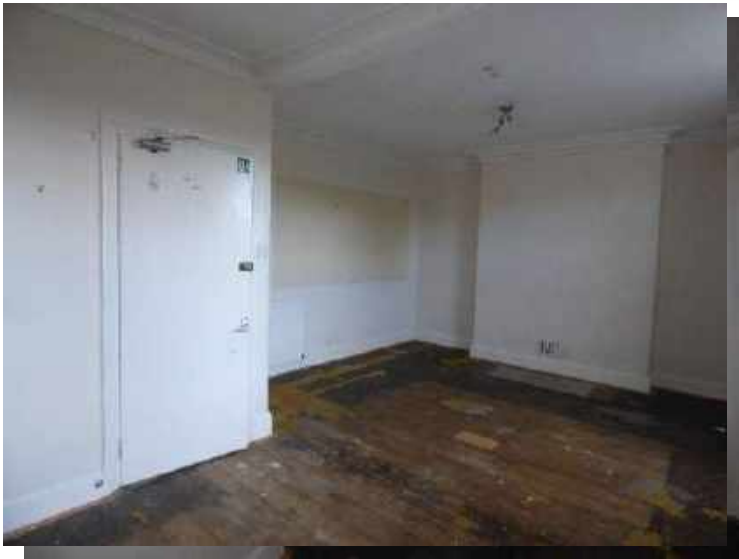
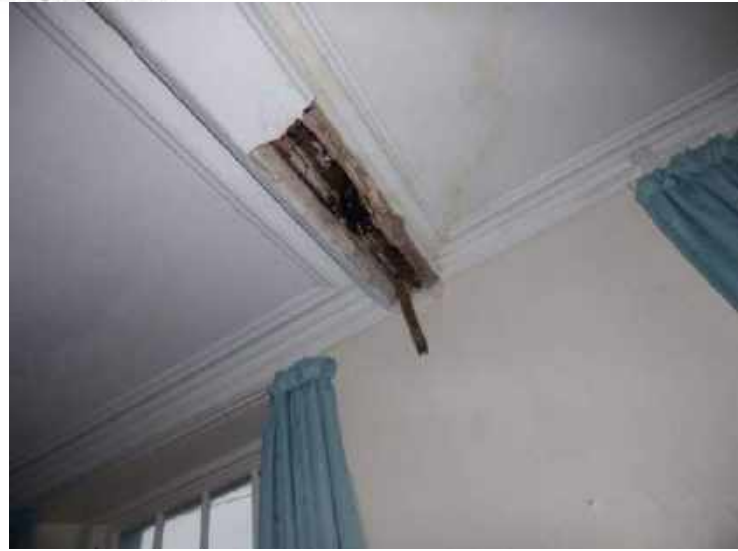
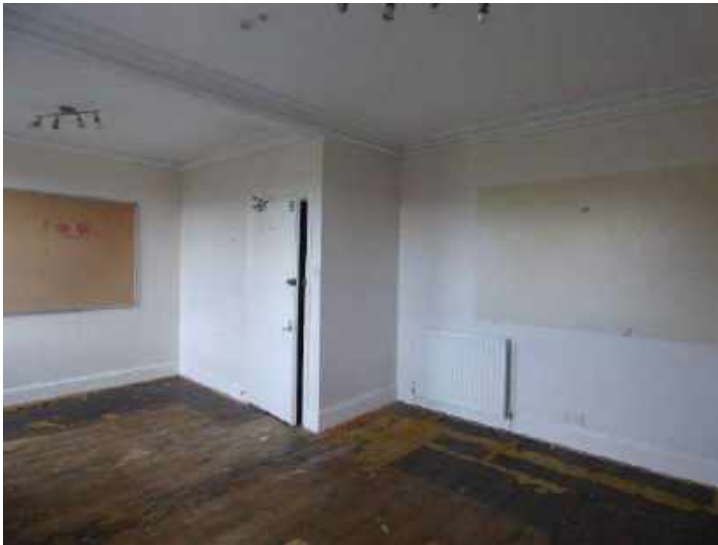
Front bedroom skirtings and architraves to be retained. Wall to be reinstated (where existing down stand is) between bedroom and new EnSite, and existing doorway to be walled up to where the small bedroom would once have been to form the en-suite.

Existing floorboards in good condition.

Existing flush panelled door to be replaced with new heritage style four panel fire door to be provided and installed by specialist joinery company such as Batty Joinery Ltd. In original location (has been walled up).

With architraves to match the existing.

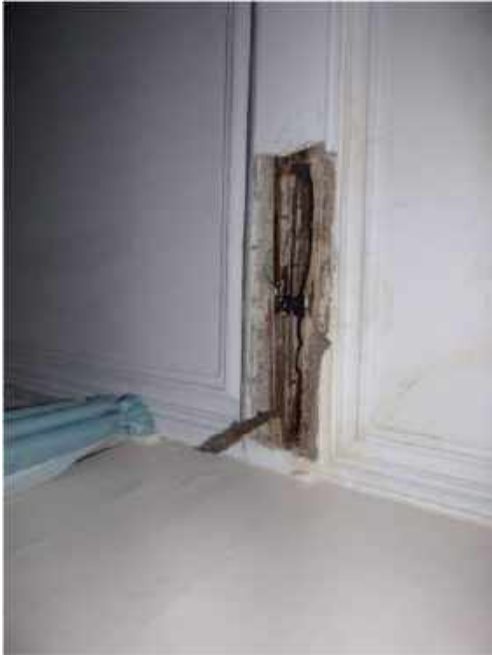
Damaged down stand timber beam to be replaced. Damaged cornice to be repaired and reinstated.

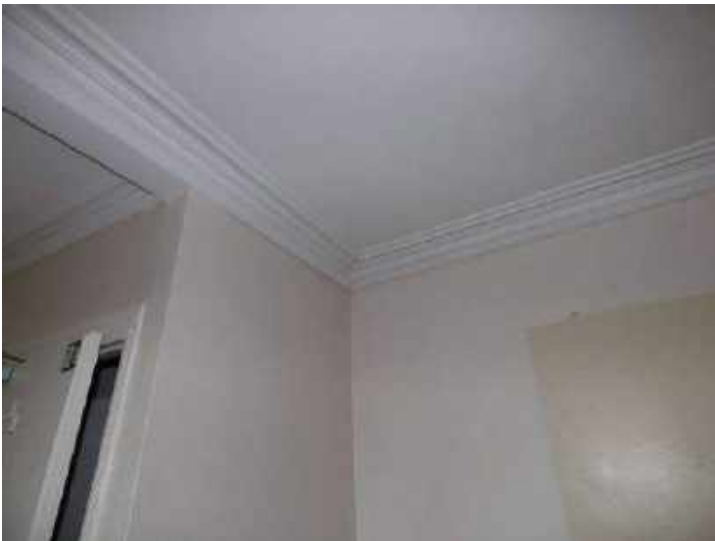
Location of original doorway which has been walled up. Original doorway to be reinstated.

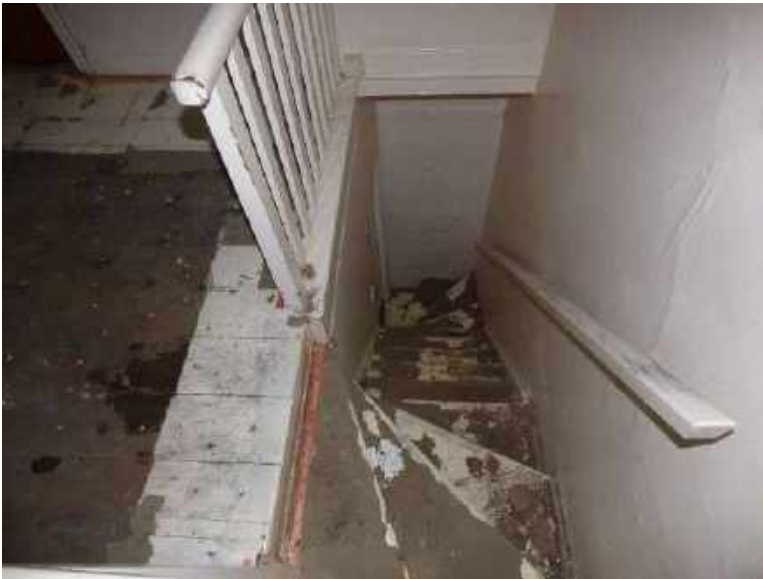
Existing staircase to attic rooms. New balustrade and handrail to be installed to match the existing at ground / first floor and at a height to comply with building regulations.

Apply an insulated plasterboard 62mm thick to underside of sloping ceiling, tape and skim and undertake full decorations.

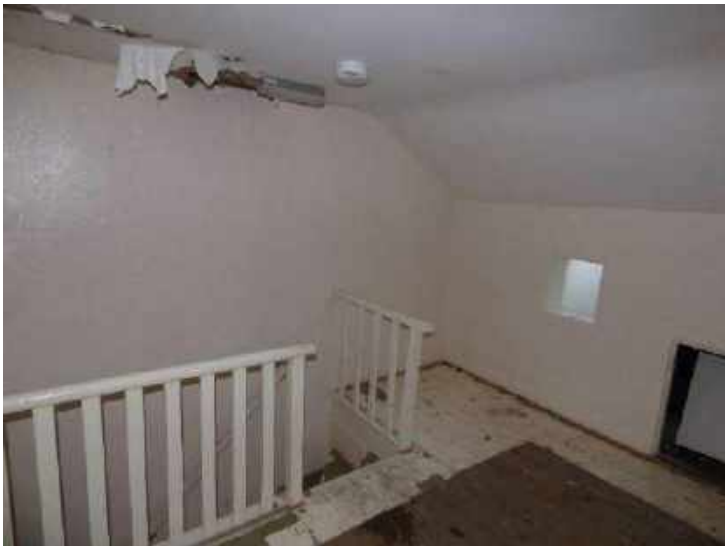
The modern doors are to be replaced with four panelled fire doors to match the rest of the property.

Damaged plaster to ceiling to be repaired with a lime plaster finish.

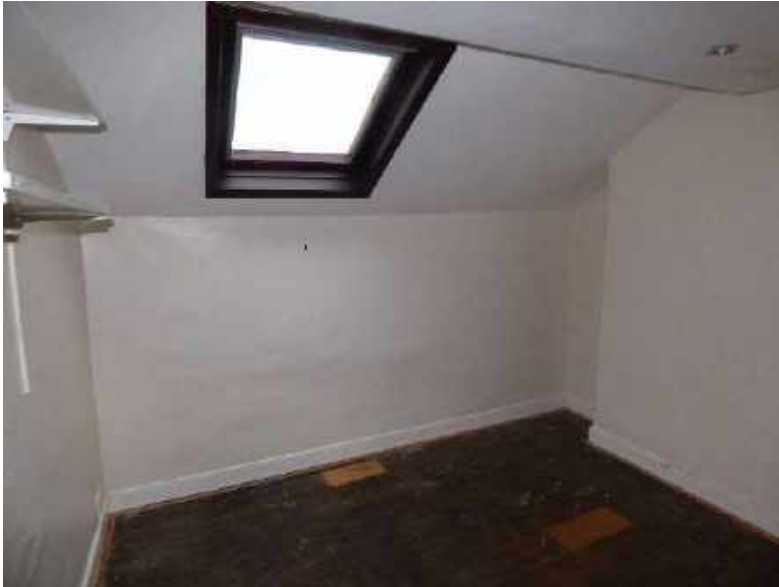
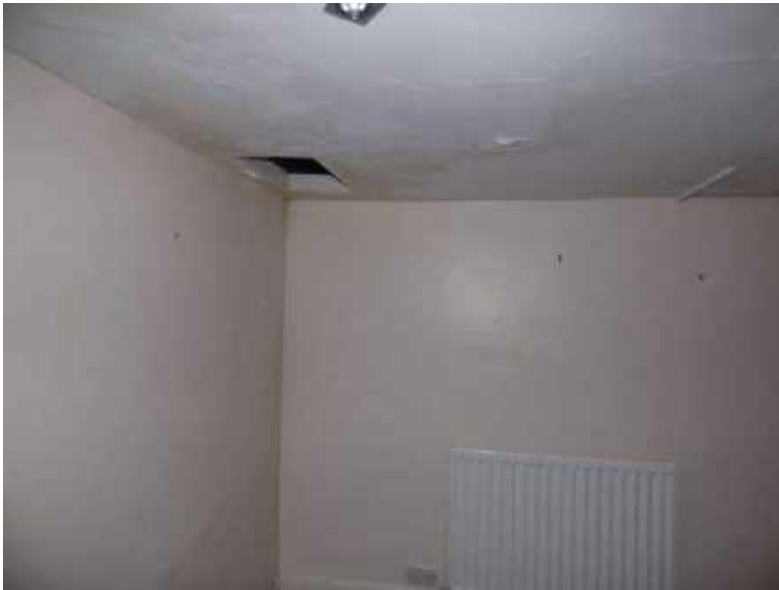
Floorboards are in good condition (but may require some minor repairs)

Apply an insulated plasterboard 62mm thick to underside of ceiling, tape and skim and undertake full decoration. New rooflights to be installed.

Provide and install new heritage window and new heritage rooflight (Velux or similar).

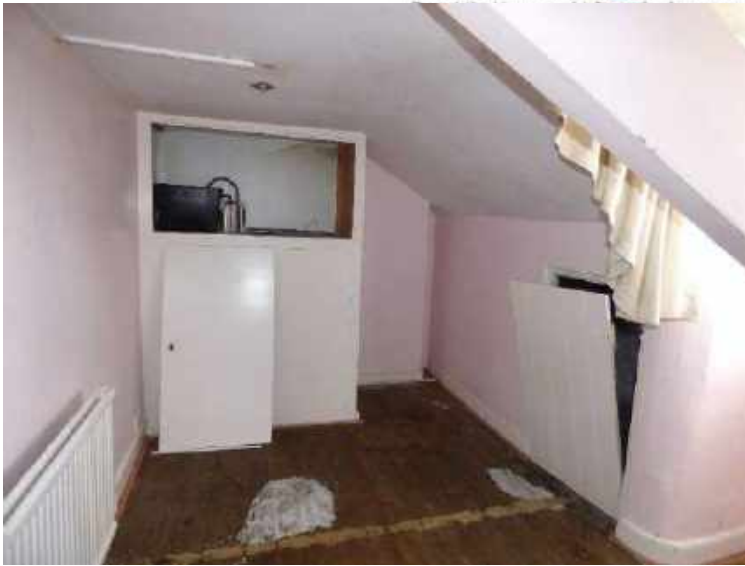
Left: Attic bedroom

Remove all damp and damaged/blown plaster and repair with lime plaster and skim and decorate throughout.

New plasterboard stud partitions to be installed in reconfigured attic space.

Apply an insulated plasterboard 62mm thick to the underside of ceiling, tape and skim and undertake full decoration.

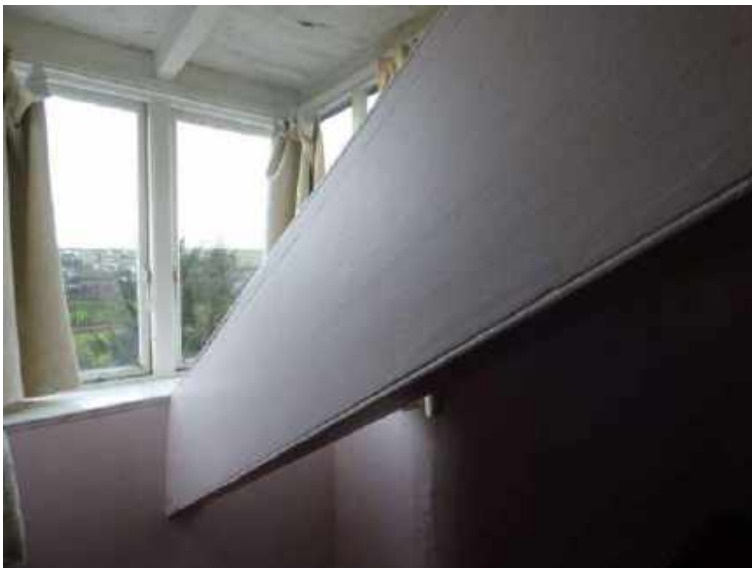
Floorboards are in good condition (but may require some minor repairs)

It is proposed to remove the timber beam that slices through the existing dormer and for the structural engineer to design supports either side of the new dormer window.

Provide and install new heritage window and new heritage rooflights (Velux or similar), in lieu of existing modern rooflights.

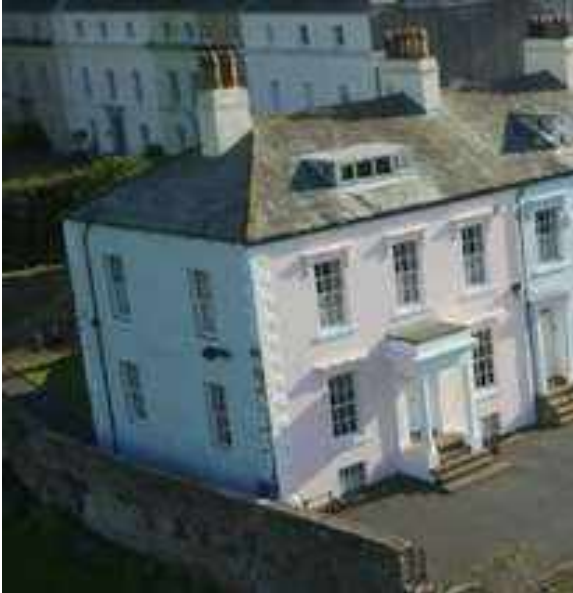
Left: The main entrance is mentioned in the listing text and is to be entirely retained.

Both front and rear elevations are currently rendered, with colour to the front and white render to the side side and rear. All elevations require to be prepared for render repairs and redecoration by specialist using lime render and stucco (Parax LTD) to be applied by specialist.

The stucco features above the windows and door on the front elevation will be carefully restored by a specialist. Colour of all render and stucco to match existing.

The existing door and frame are to be retained and made good with the provision of new ironmongery. Once repaired full decoration will be undertaken.

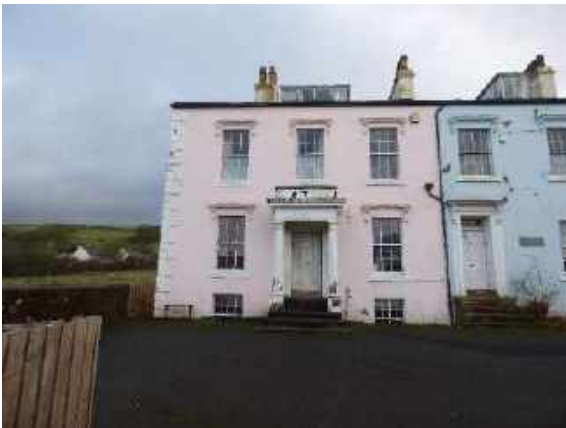
Existing gutters and downpipes to be retained, repaired where necessary and decorated.

All existing single glazed windows to replace with new white painted slim profile timber double glazed 'heritage' windows to match the existing style by specialist supplier such as Batty Joinery, specialists in historic and listed building joinery works.

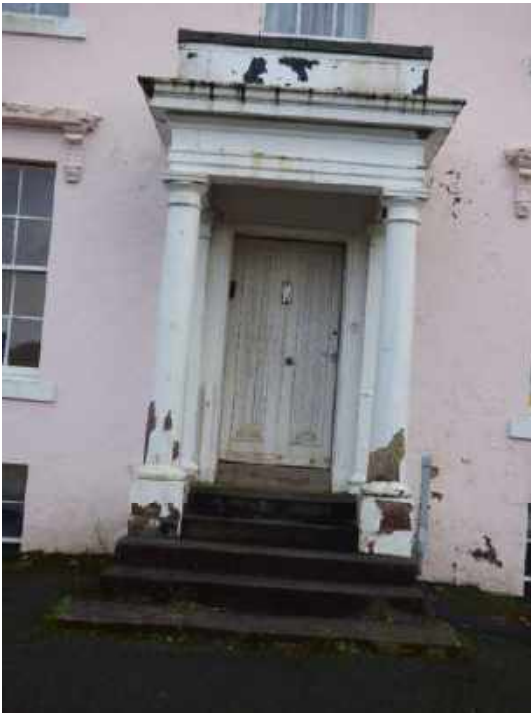
The existing stone steps to be cleaned up and the portico at the front to be restored and redecorated.

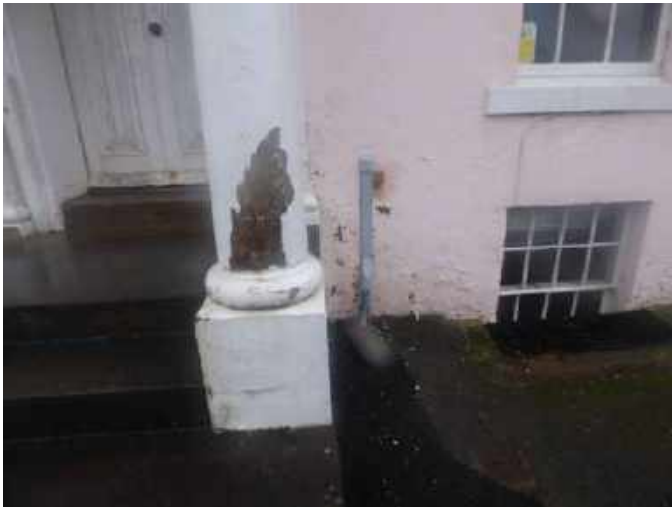
Existing cills to be repaired and decorated.

Localised lead repair work required to chimneys, to prevent leaking.

Existing gutters and downpipes to be retained, repaired where necessary and decorated.

All existing glazed windows to be replaced with new white painted slim profile double glazed 'heritage' windows to match the existing style by specialist supplier such as Betty Joinery Ltd.

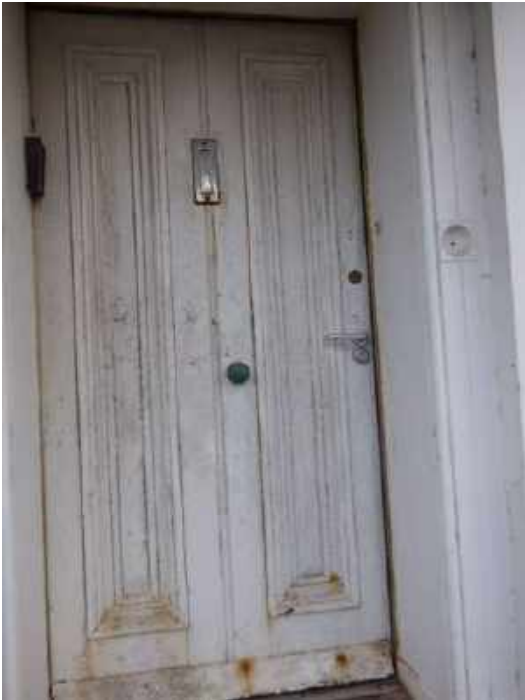
Left: Existing door to be repaired and rehung. Existing portico to be fully repaired and redecorated.

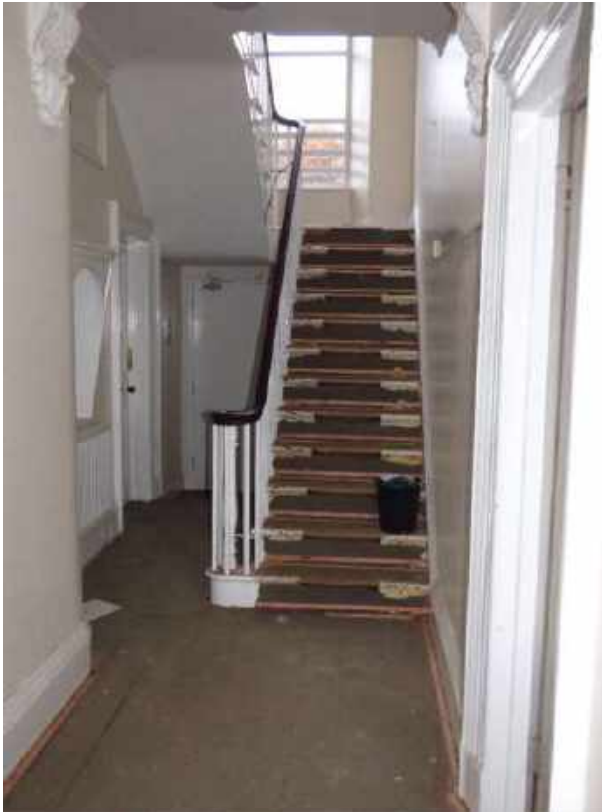
Left: The existing walls and floor are generally in good condition.

Redundant M& E to be removed and wall/ceiling finishes made good and primed, prepared and fully decorated.

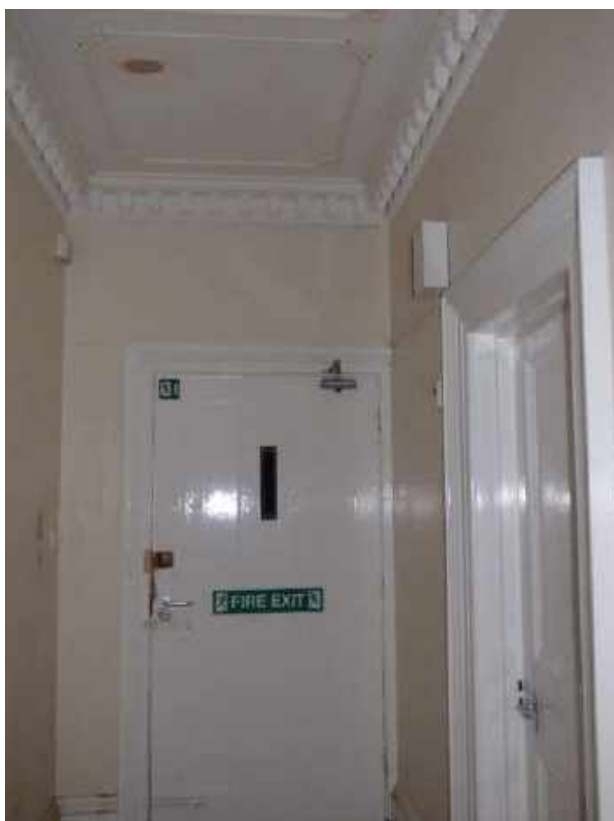
Left: Period features to be retained, including archway and architraves. (Modern lighting to all be stripped out and make good services./ All architraves and plaster features to be retained.

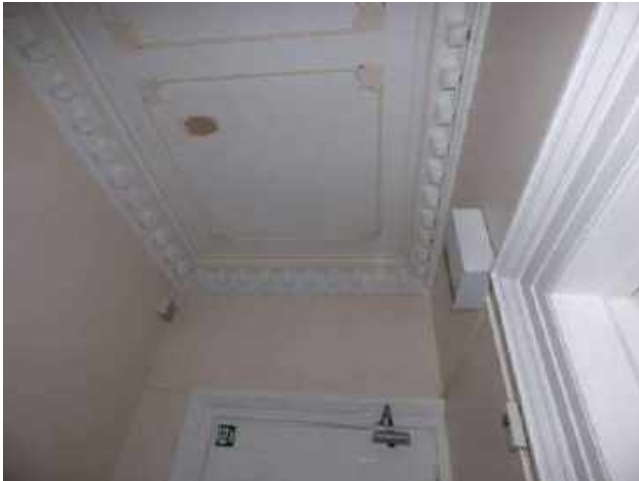
Period features are in extremely good condition and all are to be retained.

Ceiling to be repaired where existing light fittings are to be removed.

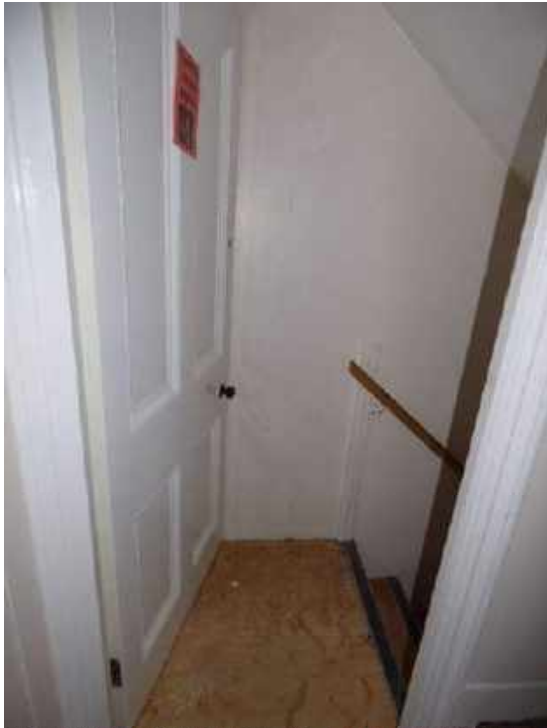
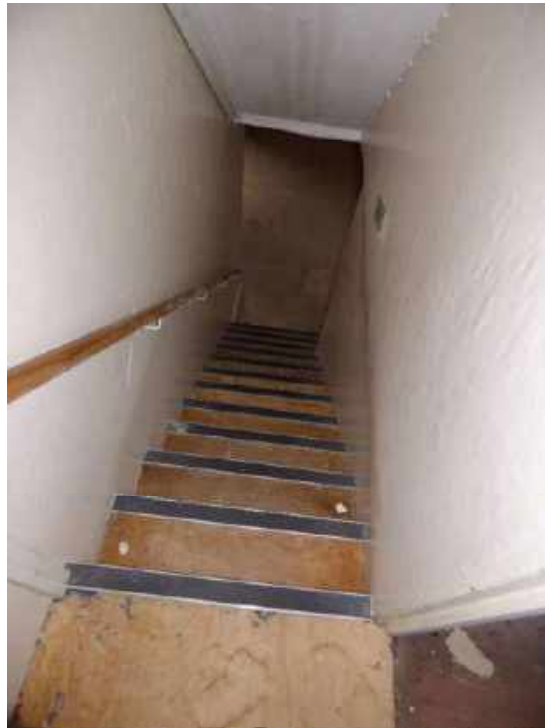
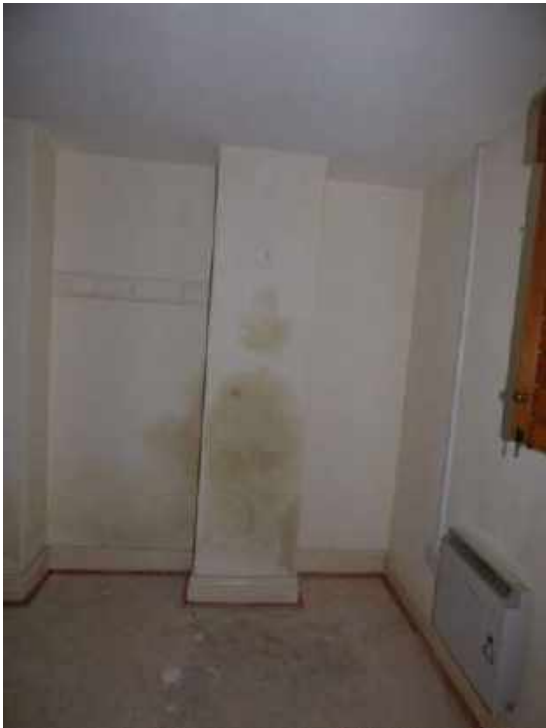
The existing basement. The existing walls and floor are generally in sound condition so would be suitable for the application of damp proof slurry system.

Some of the walls have been overboarded, but the basement has not been treated for damp and moisture is penetrating the walls that have been overboarded.

All existing paint and surface finishes must be removed and made good including all snots removed, and damage to existing surfaces, prior to the installation of a Koster Polysil NB1. This migratory crystalline tanking slurry is used to seal below ground structures against water ingress.

Koster NB1 is considered to be a Type A waterproofing system as defined by BS8102:2009 and is generally used to seal the inside face of basement structures, slabs and retaining walls.

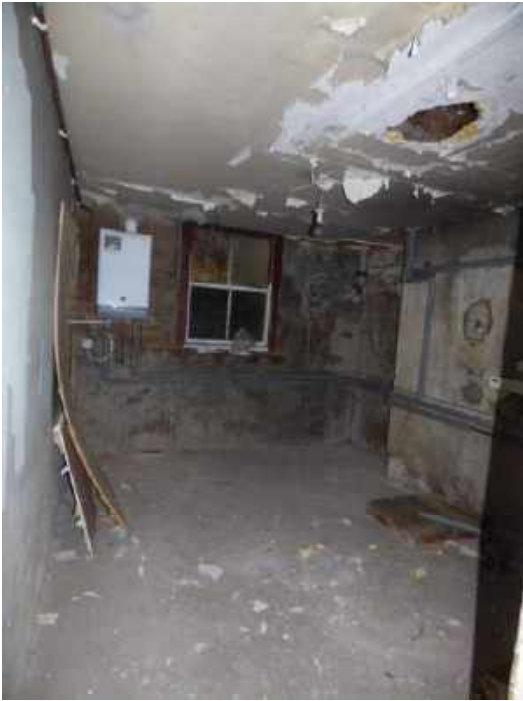
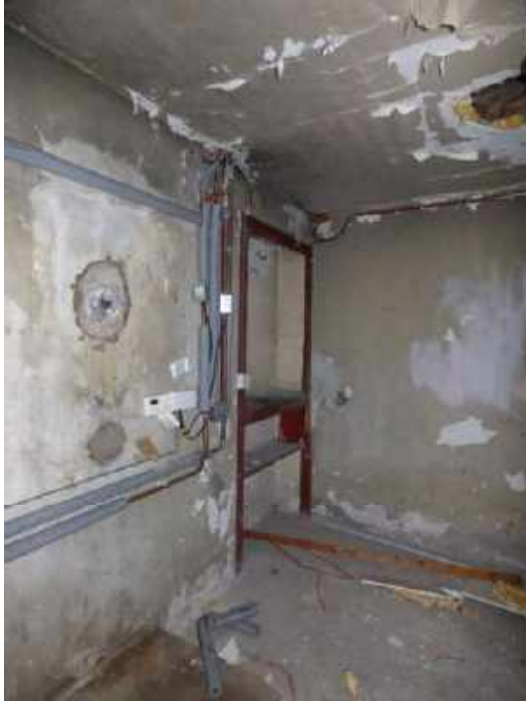
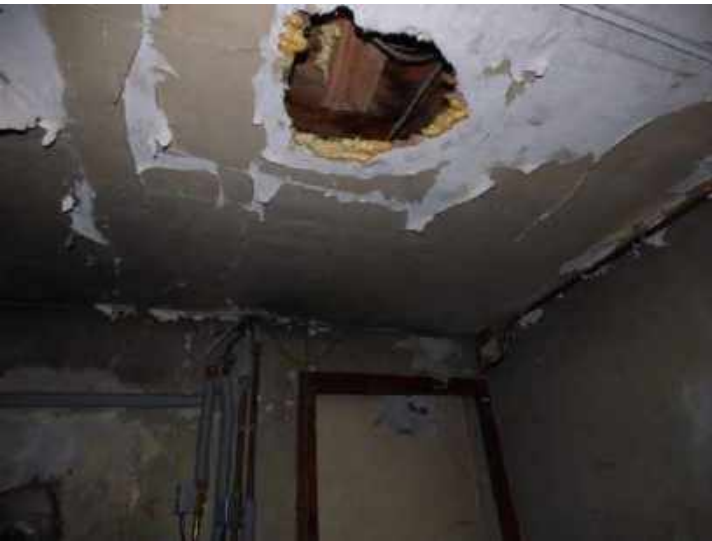
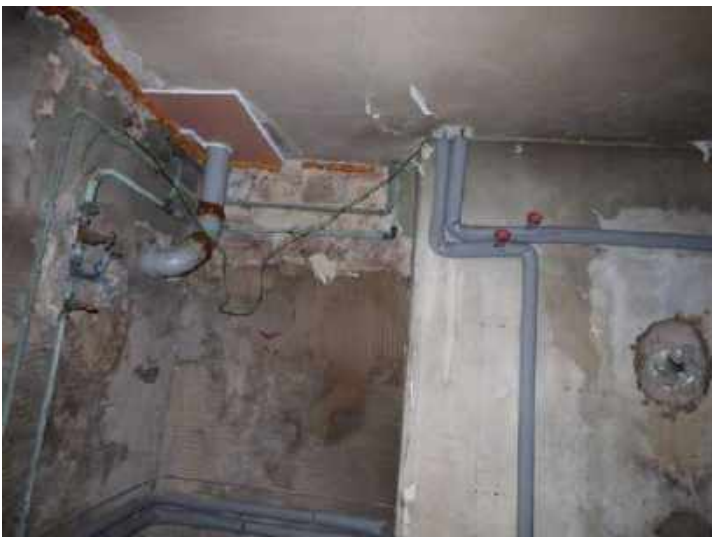
Damp affects the entire basement.

All redundant M&E, conduits and FF&E to be removed.

Ceiling to be repaired with fire resistant plasterboard.

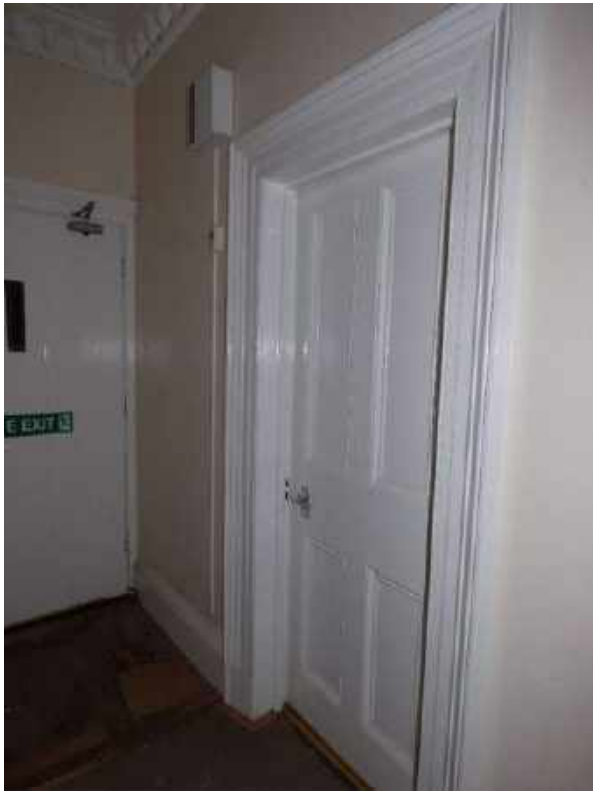
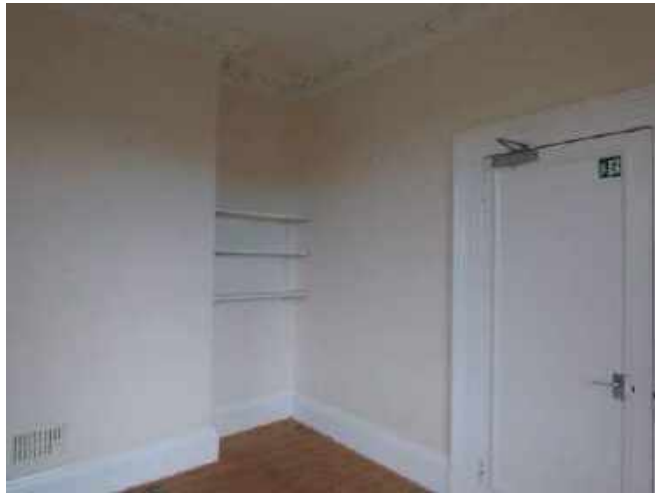
Existing front room requires minor damp treatment and walls to be made good following repairs.

Minor damp patch repair required to ceiling.

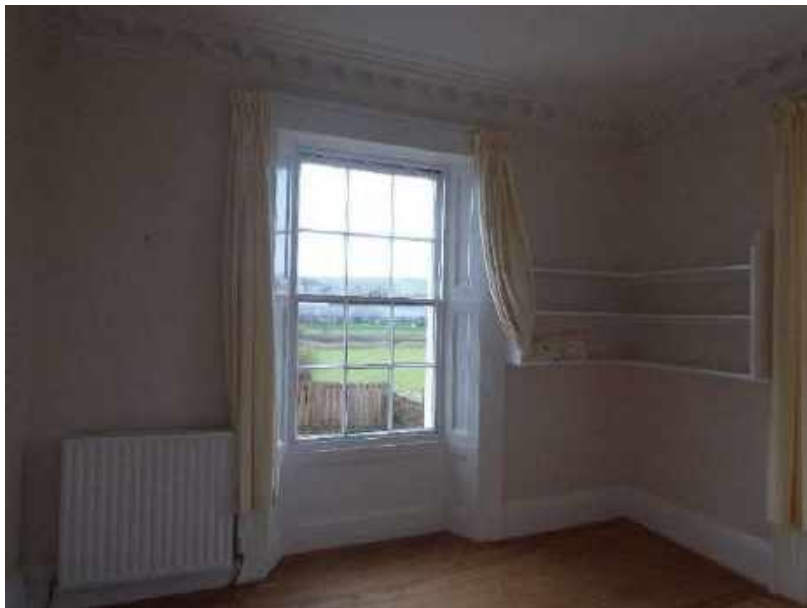
The period features below and to the sides of the existing window are in good condition, it is proposed to carefully refurbish the existing timber shutters.

Left: Existing cornice to be made good in locations where redundant services are to be removed and where hairline cracks have appeared.

Existing architraves and skirtings to be retained and made good.

Flush panel doors to be replaced with heritage style four panel painted timber fire doors to enhance the heritage asset.

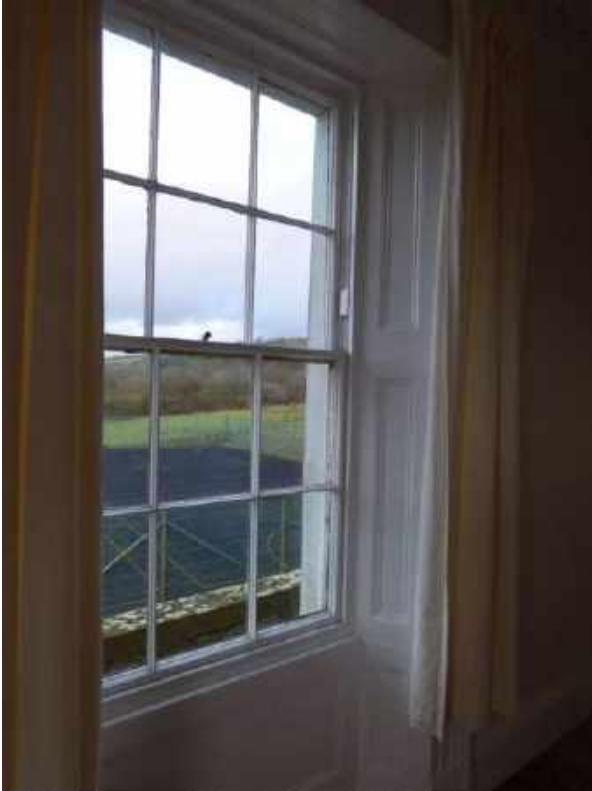
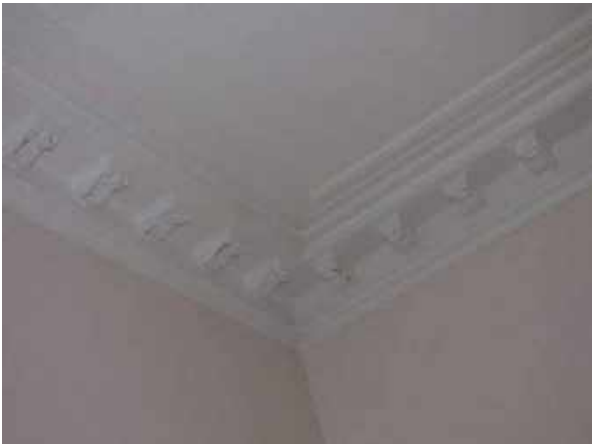
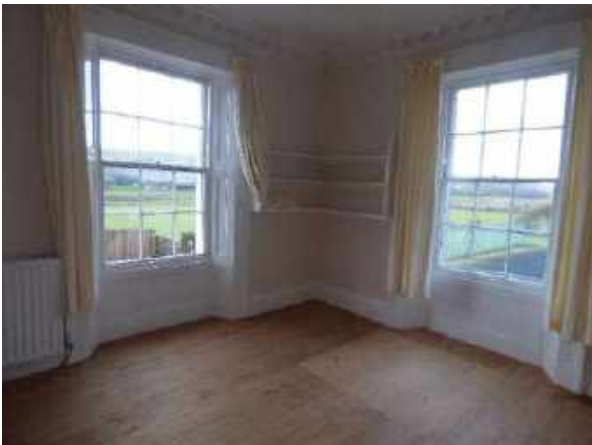
In the existing dining room at the rear of the property the period features below and to the sides of the existing window are in good condition, it is proposed to carefully refurbish the existing timber shutters.

Below: existing cornice to be made good in locations and where hairline cracks have appeared.

Existing architraves and skirtings to be retained and made good.

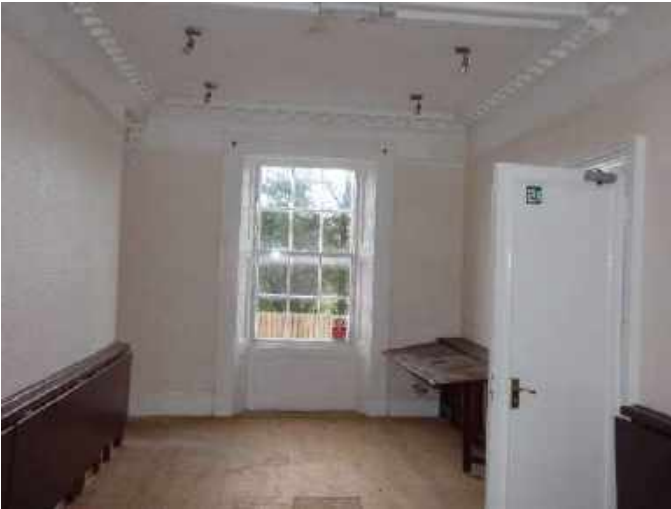
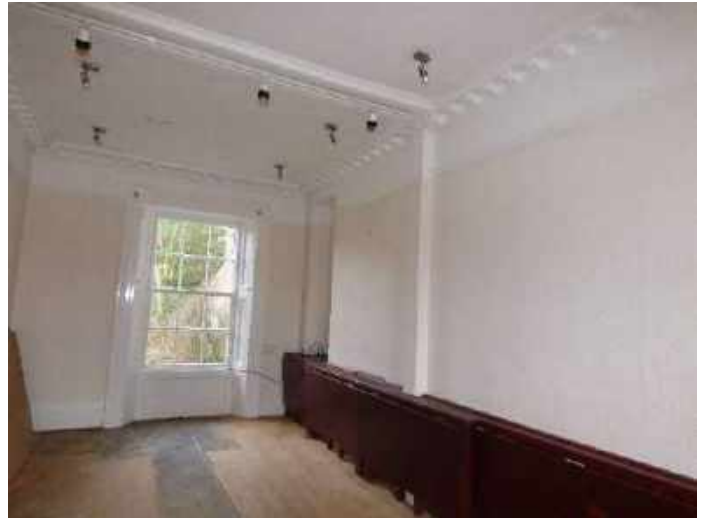
Above and below: In the existing through lounge, the period features below and to the sides of the existing windows both front and back are in good condition. It is proposed to carefully refurbish the existing timber shutters.

Existing cornice to be made good in locations where redundant services are to be removed and where hairline cracks have appeared.

The existing floor is not original and is plywood. It is proposed to lift the plywood boards and examine the existing joists to ensure that they are in good condition, and reinstate and repair as necessary.

Flush panel doors to be replaced with heritage style painted timber fire doors to enhance the heritage asset.

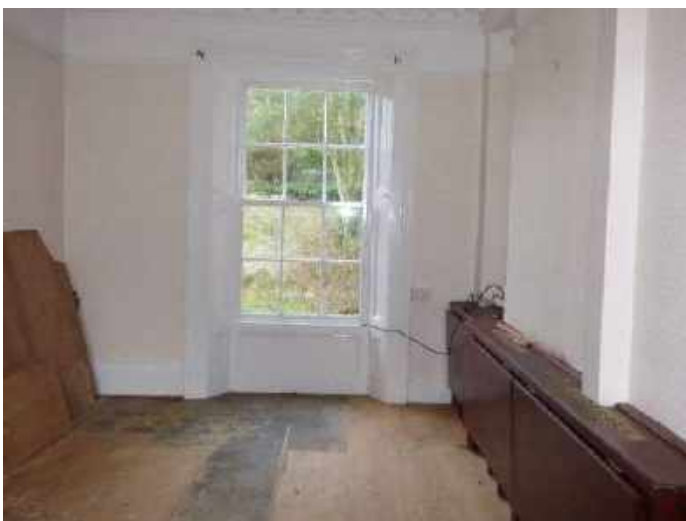
Existing cornice to be made good in locations where redundant services are to be removed and where hairline cracks have appeared.

Existing architraves and skirtings to be retained and made good.

Flush panel doors to be replaced with heritage style painted timber fire doors to enhance the heritage asset.

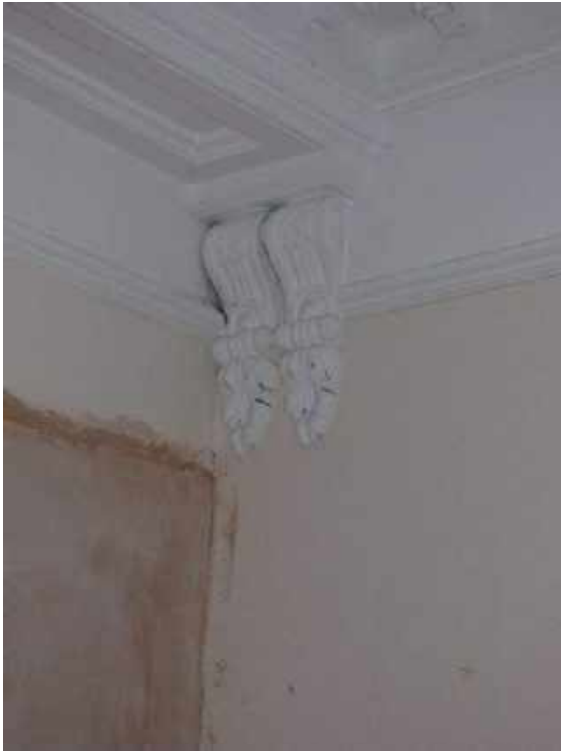
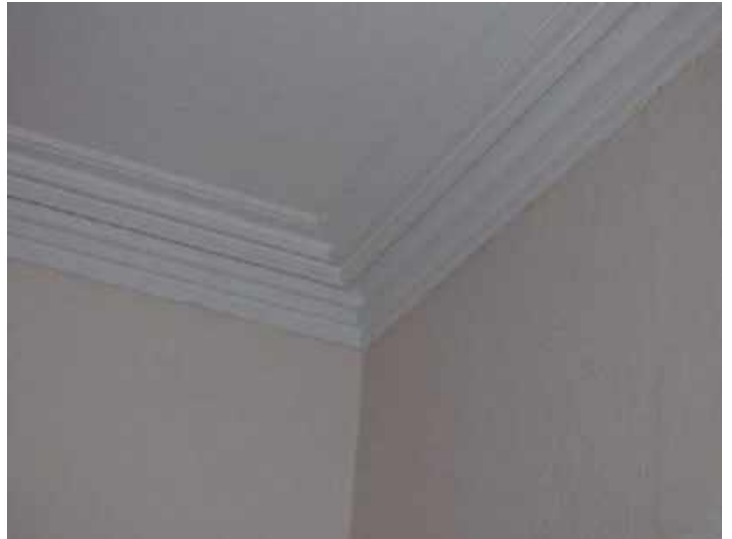
Above: Period features have remained in excellent condition and are to be retained.

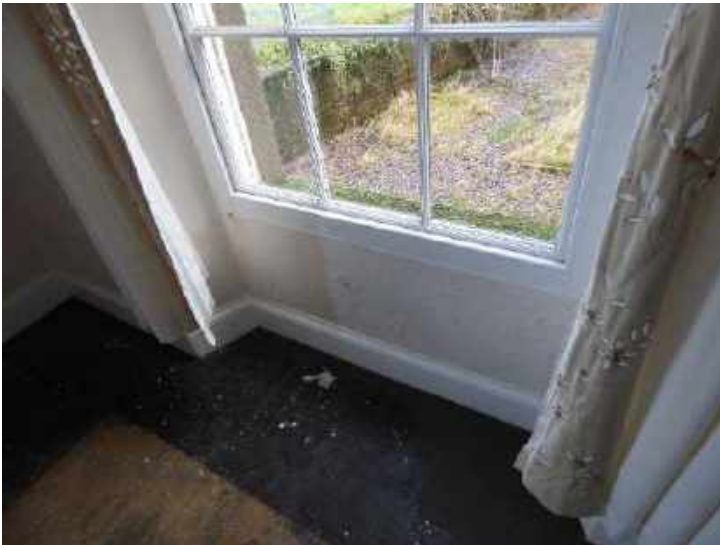
Left: In the existing dining room at the rear of the property

the period features below and to the sides of the existing windows are in good condition, it is proposed to carefully refurbish the existing timber shutters.

Below: existing cornice to be made good in locations and where hairline cracks have appeared.

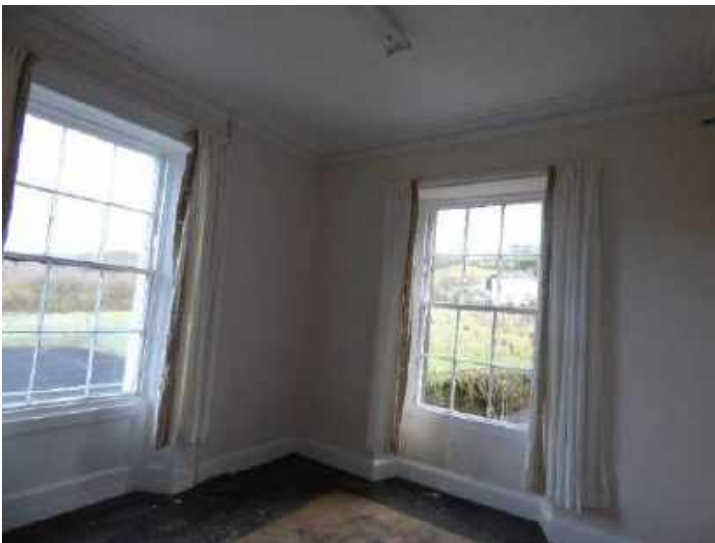
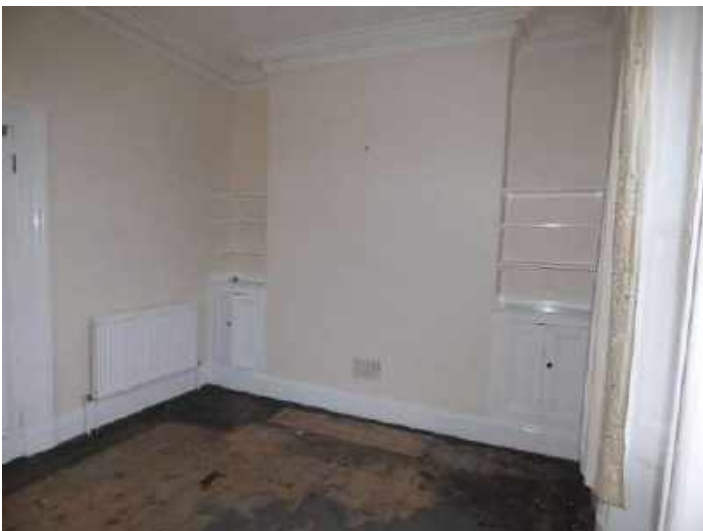
Existing architraves and skirtings to be retained and made good.

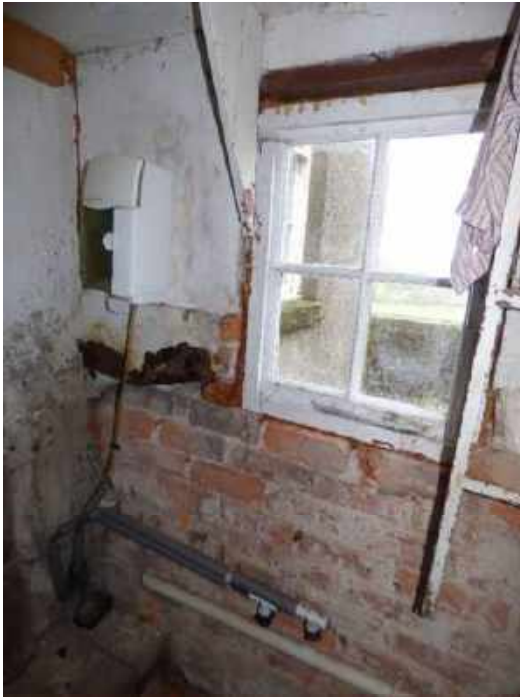
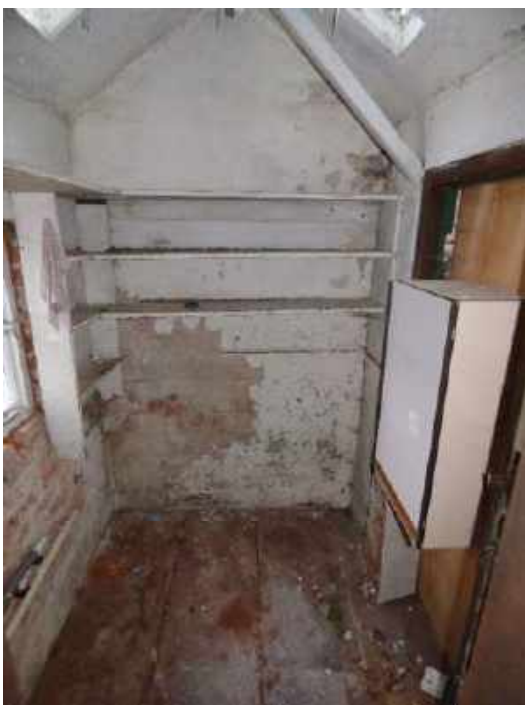
Left:

The existing rear porch is in addition to the original building and is in poor condition. The porch conceals the original rear entrance door which it is proposed to reinstate.

It is proposed to remove the porch completely, and make good the existing building where it was attached.

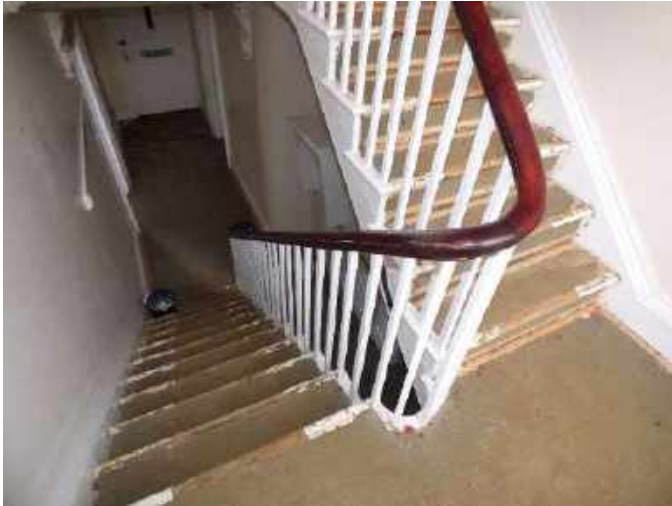
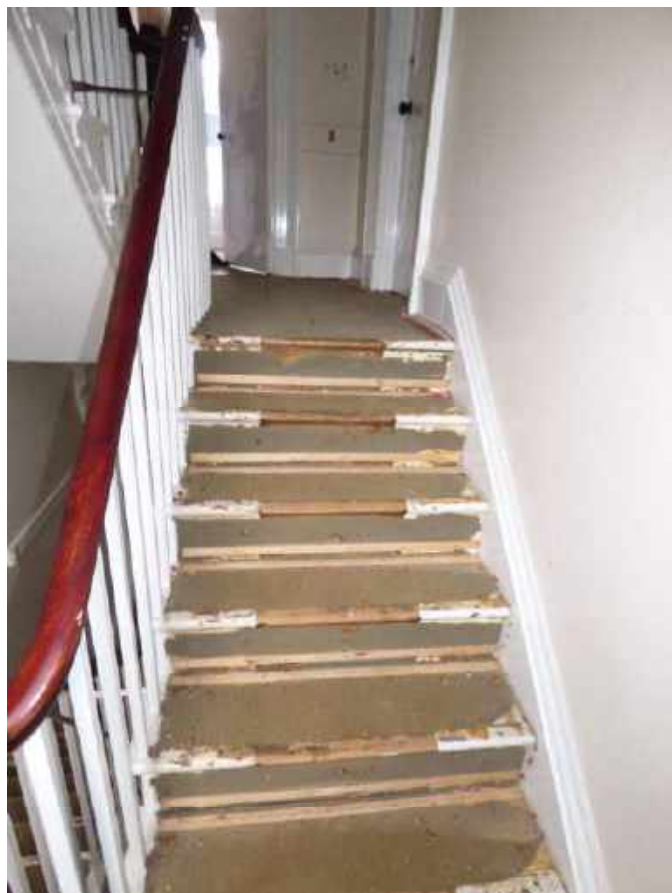
Retain the original staircase, which is in good condition.

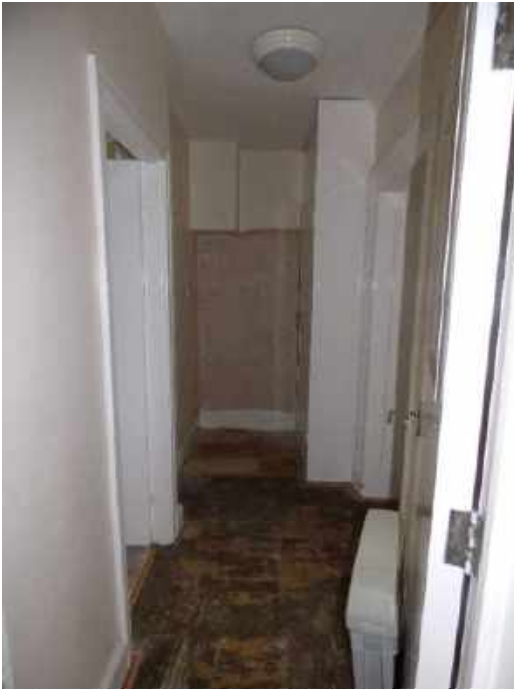
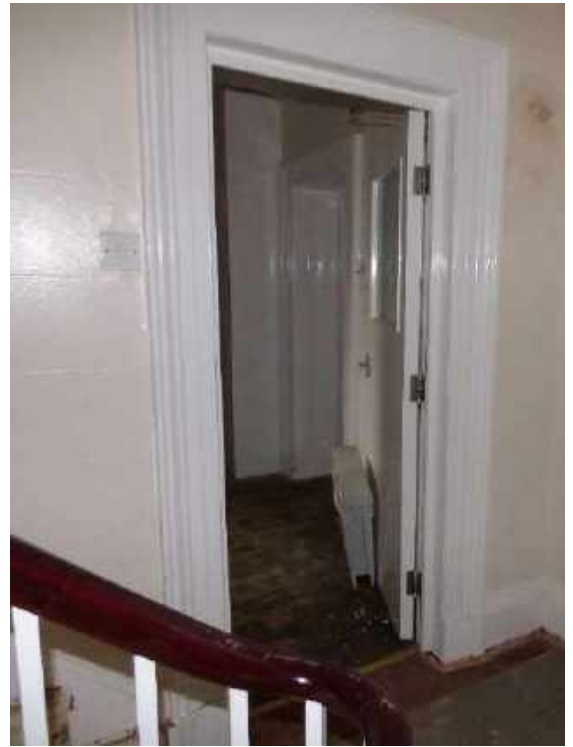
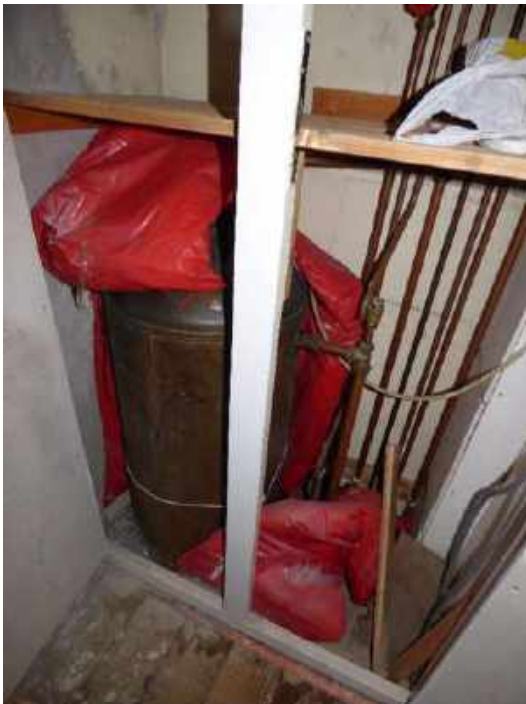
Left and above:

Existing bathroom area at first floor to be reconfigured, to make use as a house bathroom.

Ceiling to be made good following reconfiguration works.

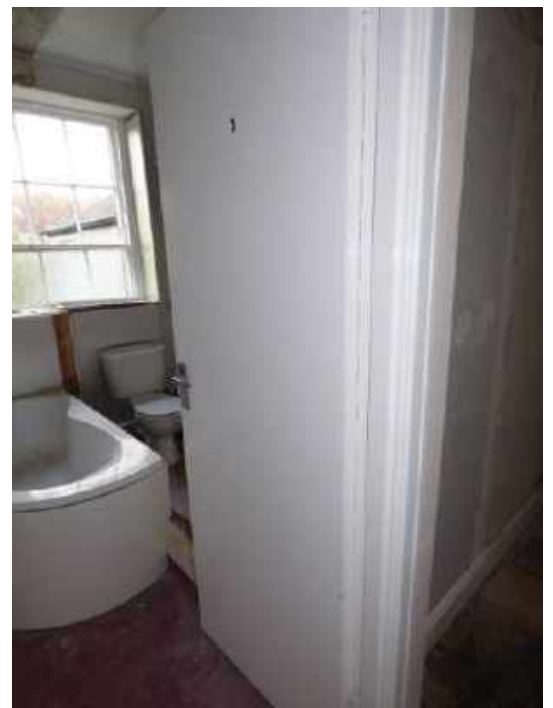
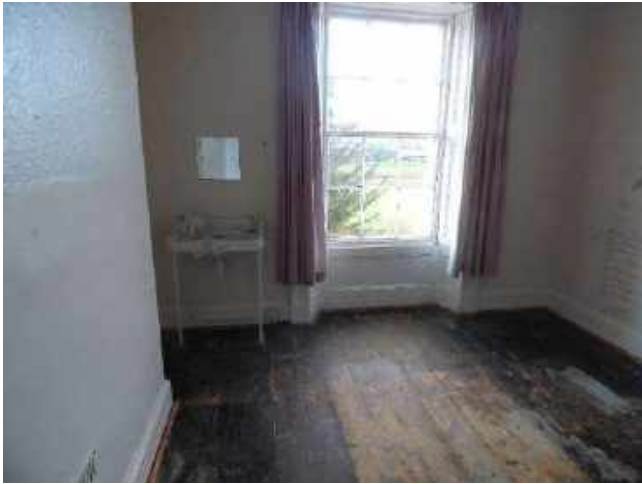
Left and below:

Rear bedroom, skirting and architraves to be retained.  
Existing flush panelled door to be replaced with new Georgian heritage style four panel fire door to be provide and installed by specialist joinery company such as Batty Joinery Ltd .

Existing floorboards in good condition.
