# HERITAGE STATEMENT

## FULL RENOVATION OF EXISTING No 11 TERRACE HOUSES

St Bees, 1-11 Lonsdale Terrace, Parish Council, Cumbria

M.A.C Architects, Project Number: 2019:303

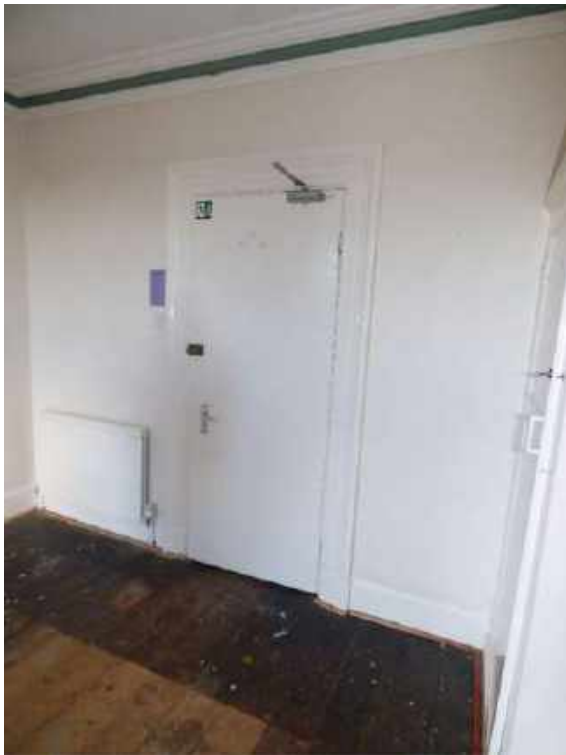
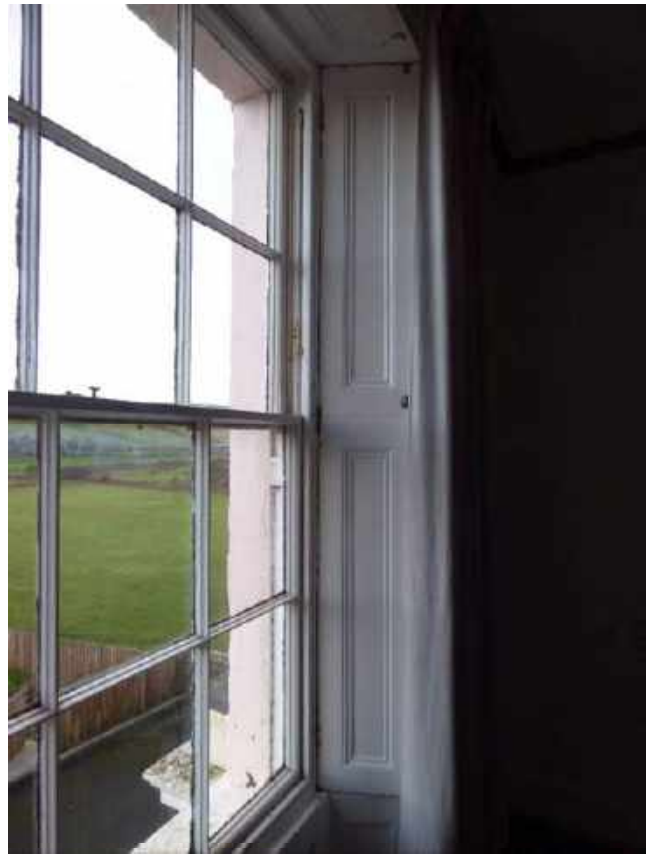
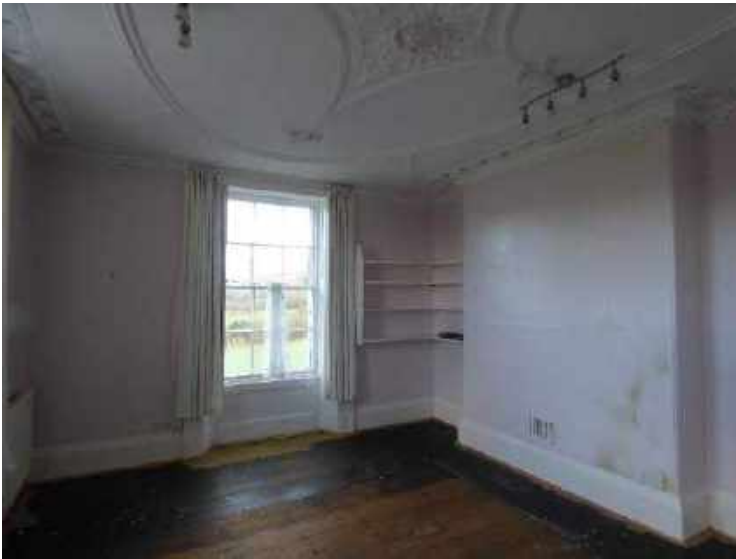
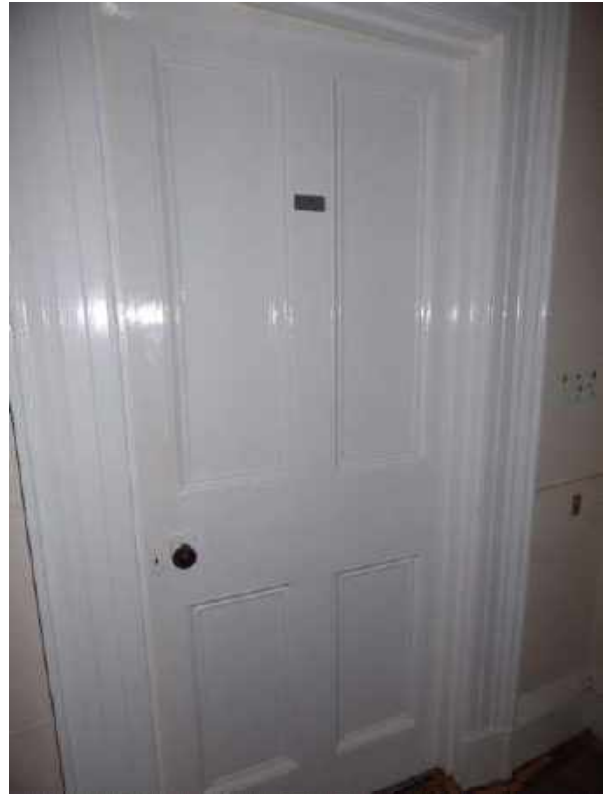
Above and left:

Front bedroom has stunning heritage features in excellent condition. Skirtings, cornices and architraves to be retained. Existing flush panelled door to be replaced with new Georgian heritage style four panel fire door to be provided and installed by specialist joinery company such as Batty Joinery Ltd.

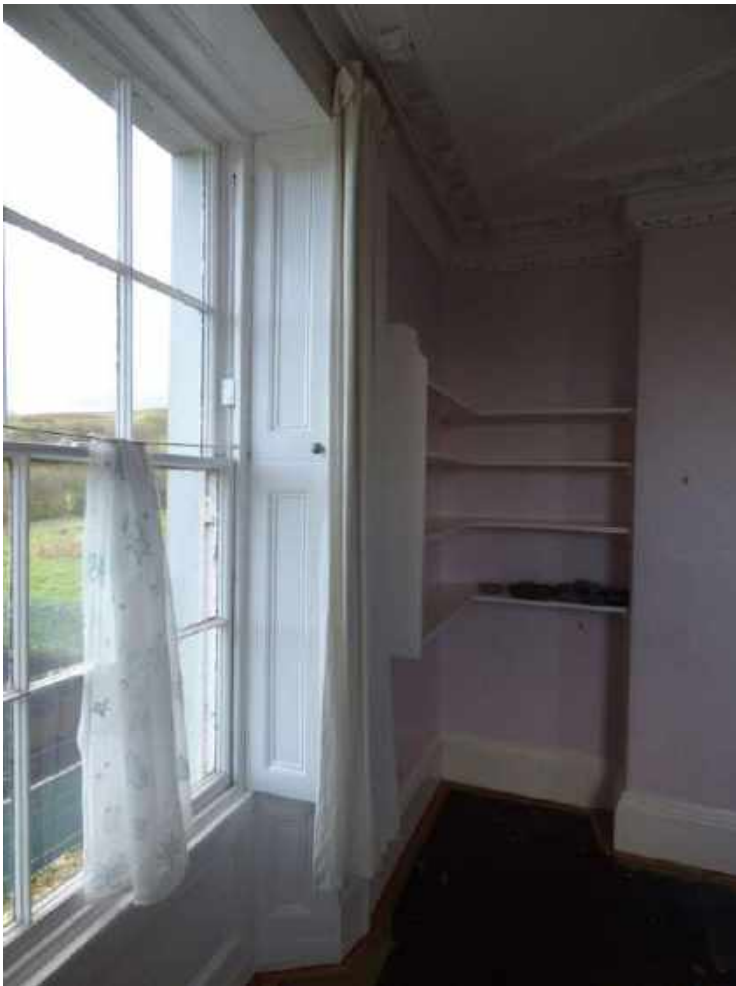
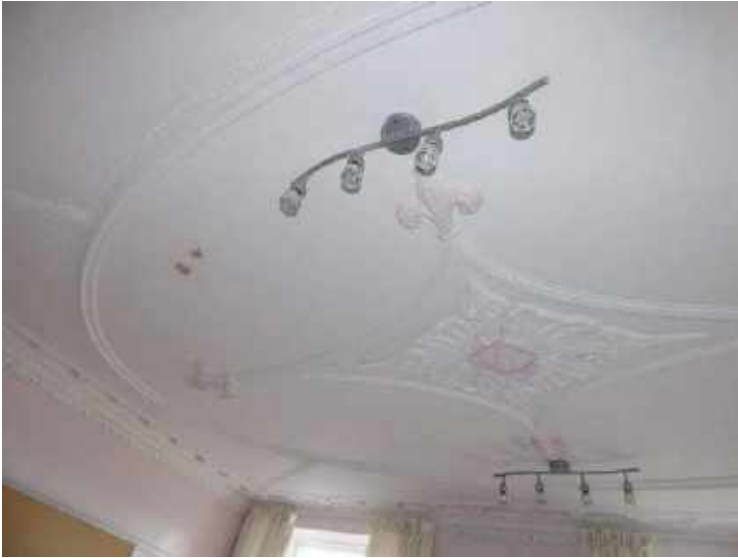
Left: Intricate ceiling moulds are to be retained, and existing lighting to be removed.

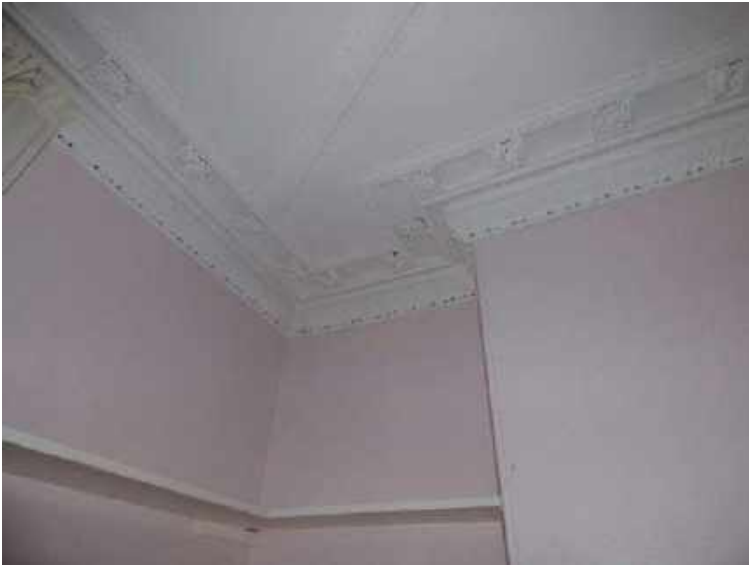
Left Cornice to be retained.

All walls, floors ceilings etc to be made good, following removal of redundant services.

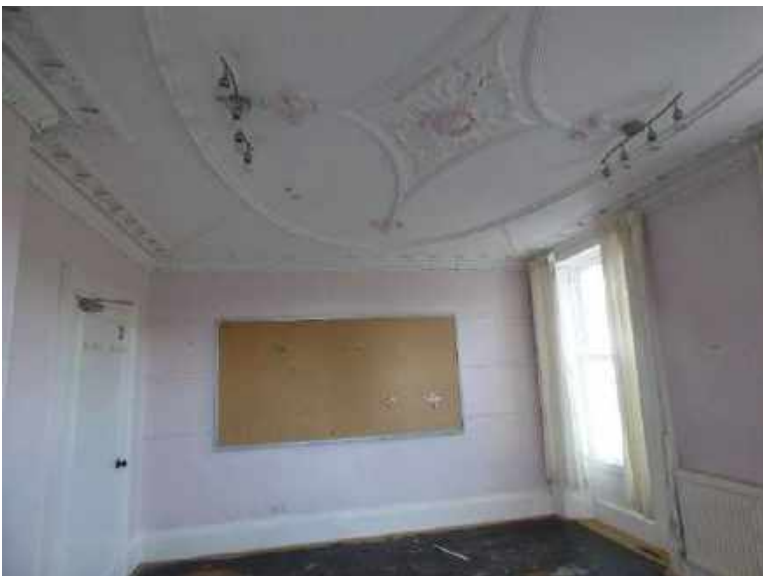
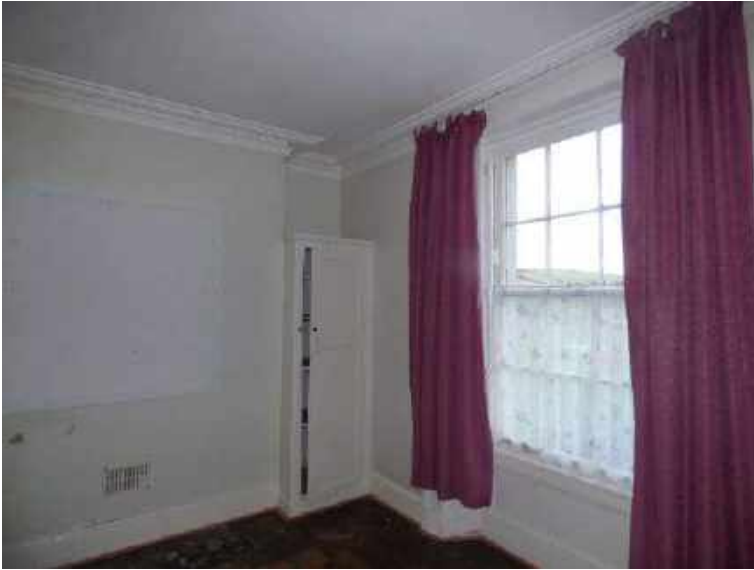
Left:

Front bedroom, skirtings, cornices and architraves to be retained. Existing flush panelled door to be replaced with new Georgian heritage style four panel door to provided and installed by specialist joinery company such as Batty Joinery Ltd.

Bedroom to become en-suite to master bedroom, so glazing to bathroom window to be obscure.

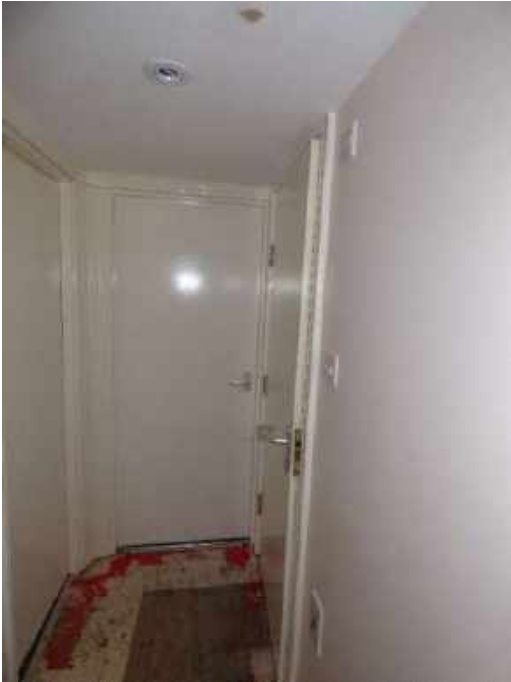
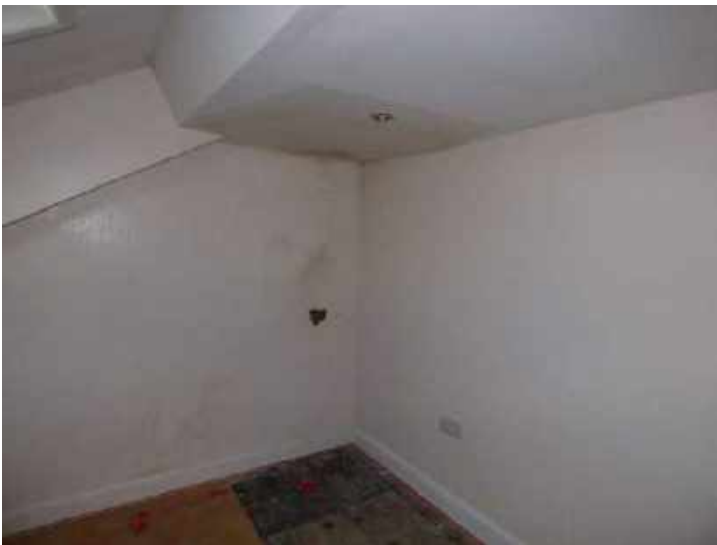
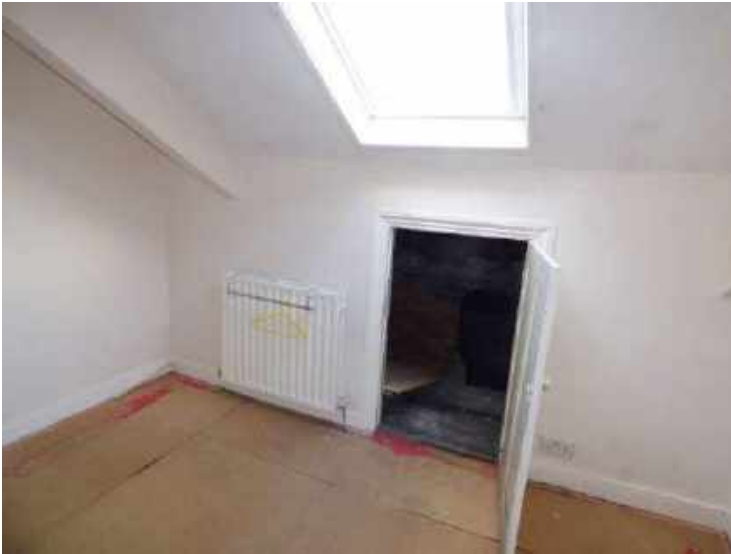
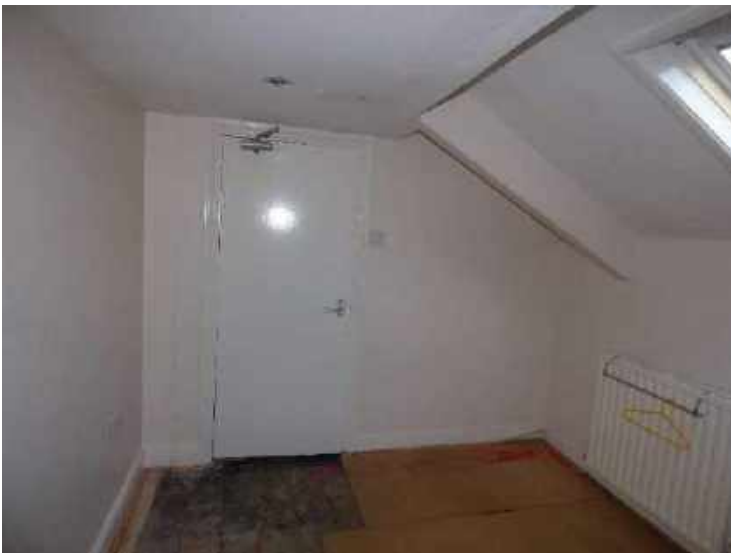
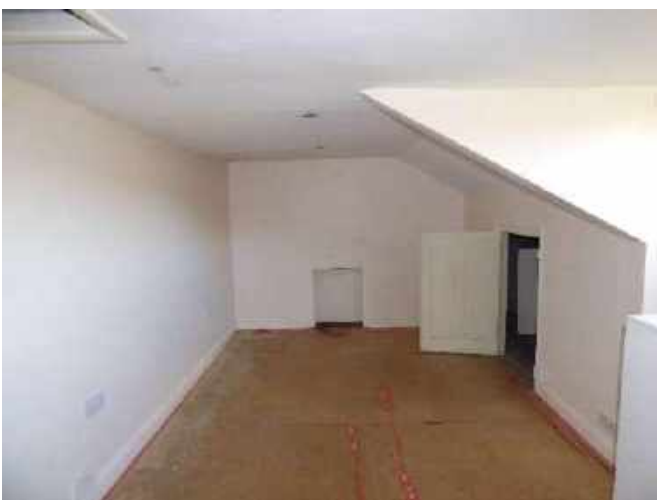
Left and following pages:

Kitchen / Living areas

Repair existing ceiling following repairs to slate roof and replacement lead flashings to chimneys.

Remove all damp and damaged / blown plasterwork and repair with lime plaster and skim and decorate throughout.

Once ceiling has been repaired, apply an insulated plasterboard 62mm thick to underside of ceiling tape and skim, and undertake full decorations.

Completely remove existing dormer and reconstruct new dormer (compliant with statutory requirements).

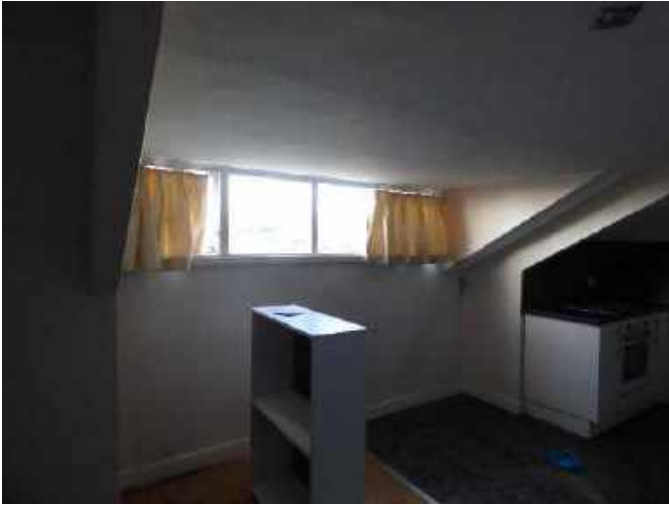
Left and below: All redundant fixtures and fittings to be removed and rooms to be reconfigured to convert existing 'apartment' back into bedroom accommodation.

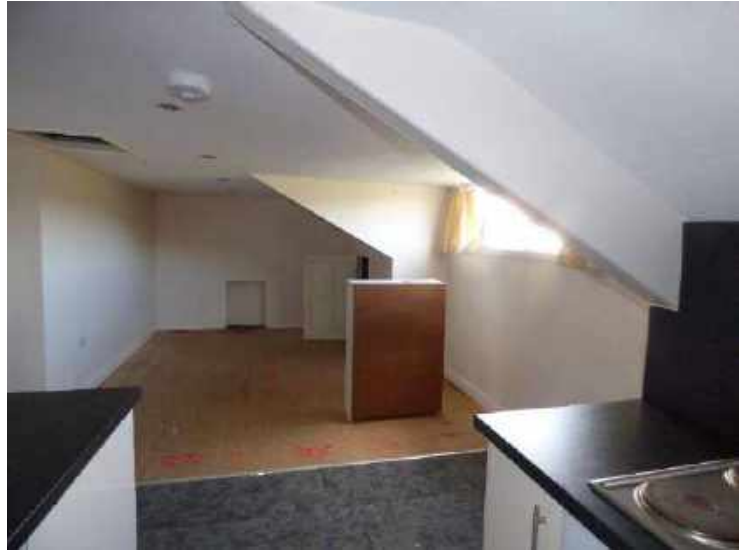
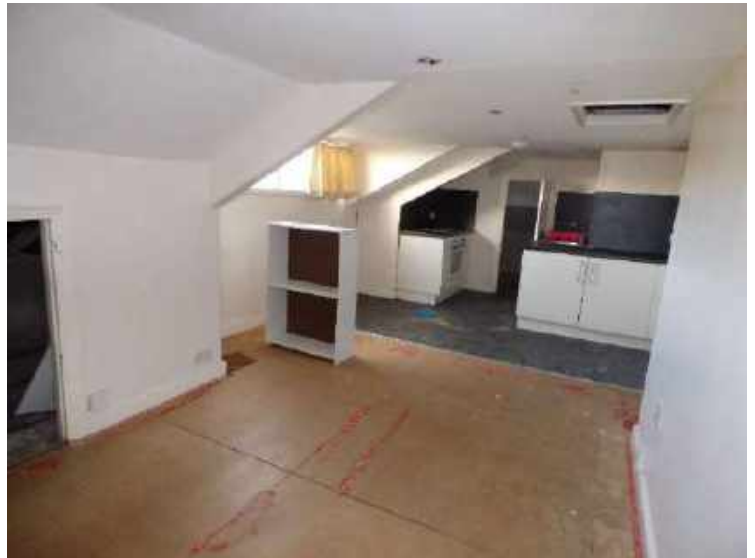
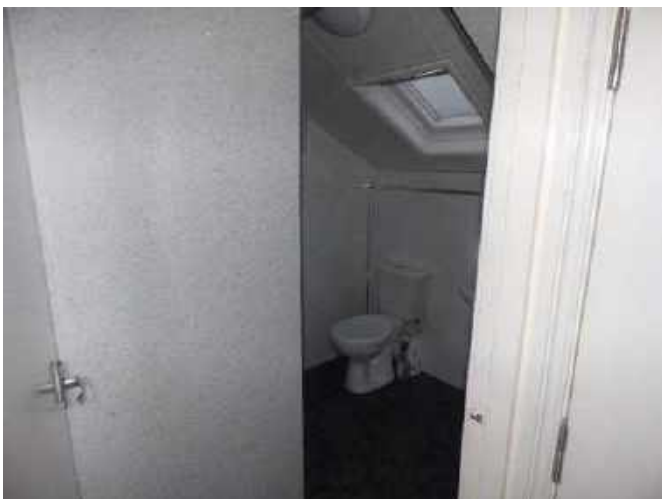
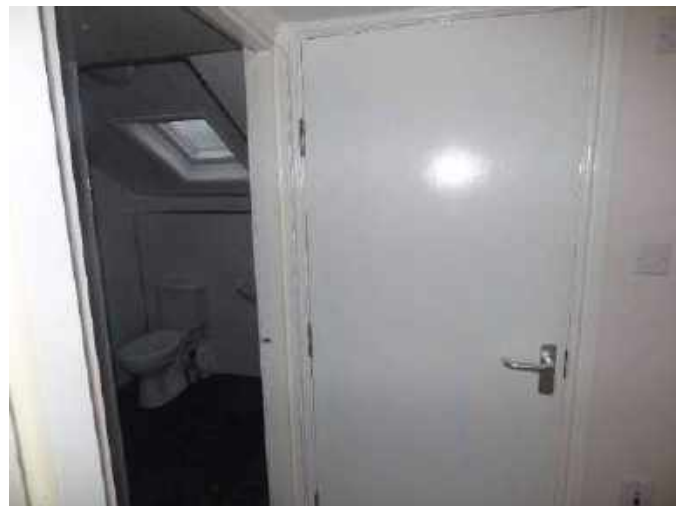
Existing flush panel fire doors to be replaced with four panel heritage style doors.

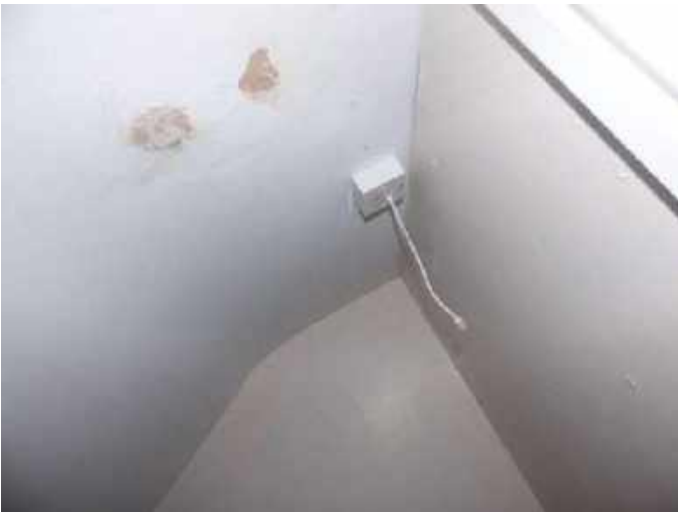
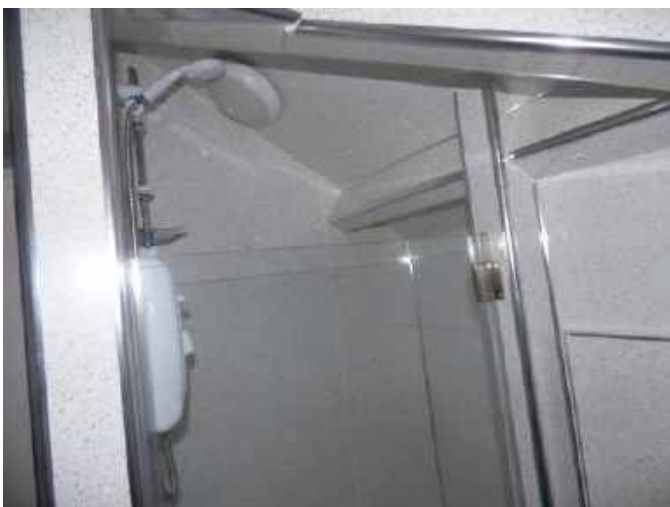
Existing bathroom.

Replace existing sanitaryware with new. Remove existing wall finishes and install new tile finishes to walls and floor.

New heritage rooflight to be provided and installed. Ceiling and walls to be made good.

Replace existing modern door with new four panelled Georgian style traditional door.
