# HERITAGE STATEMENT

## FULL RENOVATION OF EXISTING No 11 TERRACE HOUSES

St Bees, 1-11 Lonsdale Terrace, Parish Council, Cumbria

M.A.C Architects, Project Number: 2019:303

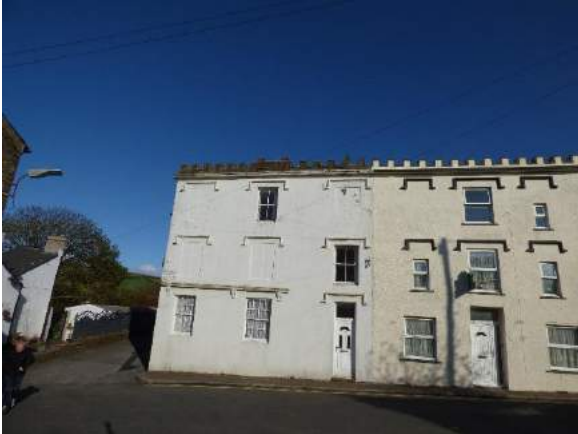
Left: The main entrance on the west facade is mentioned in the listing text and is to be entirely retained.

Investigations to the blind windows have confirmed that the walls behind are solid masonry and no internal openings were in these locations, so they have never actually been windows.

The entrance to the apartment at first and second floor is accessed from Finkle Street and it is proposed to retain this.

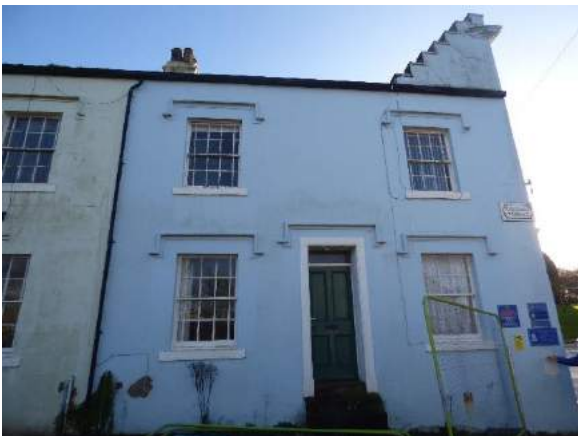
Both front and rear elevations are currently rendered, with colour to the front and side and natural to the rear. All elevations require to be prepared for render repairs and redecoration by specialist using lime render and stucco (Parax LTD) to be applied by specialist.

The stucco features above the windows and door on the front elevation will be carefully restored by a specialist. Colour of all render and stucco to match existing.

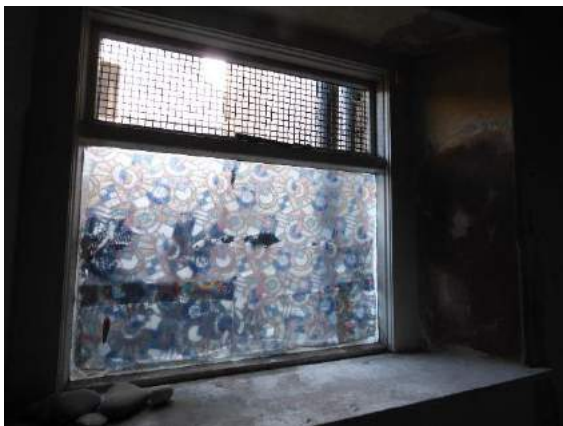
Left: The ground floor window to the rear is not original and requires replacement. The proposed replacement will reinstate the original Georgian style traditional door as whilst the dwelling was built in the mid-19<sup>th</sup> Century, which would be some years after the end of the Georgian period, even if counting the Regency but reflect the style none the less.

All existing features are to be retained.

Existing external cills to be repaired and decorated.

Existing Velux windows to be replaced with Velux conservation rooflights (or rooflight company, heritage rooflights) (size to match existing), and new flashings to suit.

Localised lead repair work may be required to chimneys, to prevent leaking.

Roof to be repaired where necessary with slates to match existing to make the roof completely watertight.

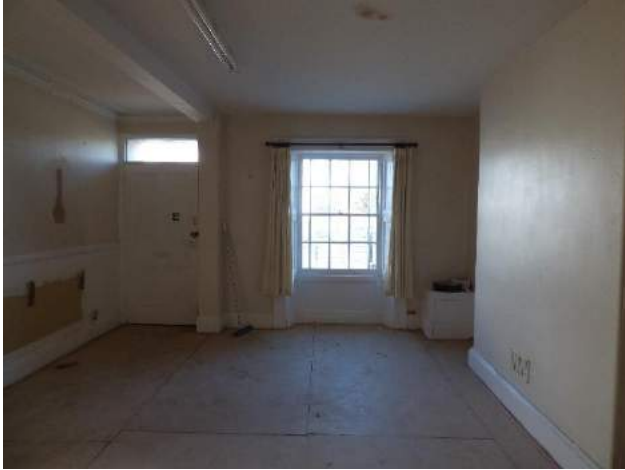
Much of the original historic internal fabric has been removed, although there are elements that have been saved and it is intended to reinstate elements of the building that have been removed, such as the cornices and skirtings.

The existing door and fanlight are to be refurbished and decorated.

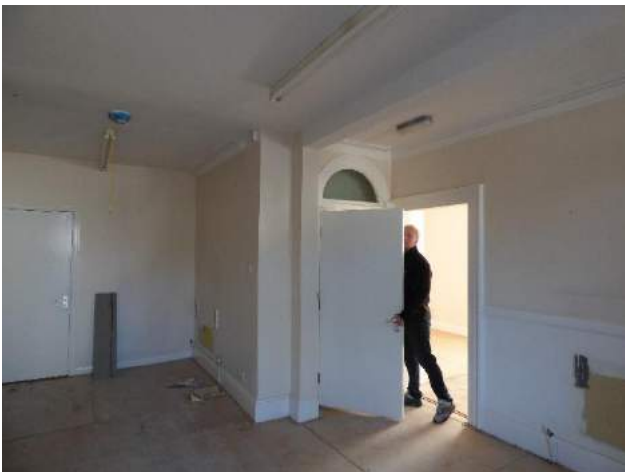
Modern strip light fittings are to be removed and all walls, ceilings and floors made good. The existing floor has been over-boarded. It is intended to overlay an oak engineered floor.

Finish with Georgian style skirting to match existing (there are examples of skirting within the rooms, and it is proposed to match up with these and repair / replace, as necessary).

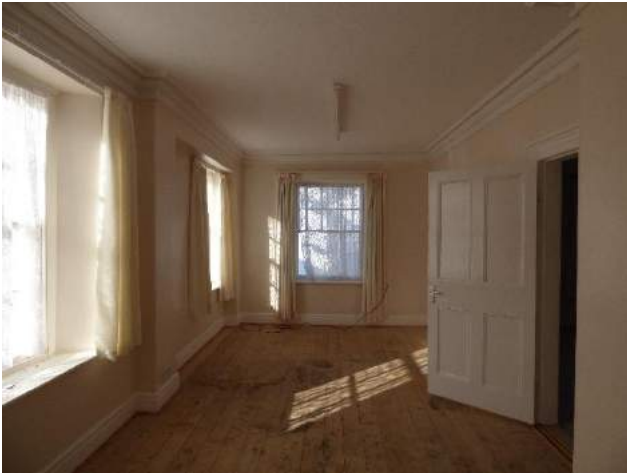
Both existing windows have the original shutters to the inside of the windows which are in excellent condition. It is proposed for these to be retained and carefully restored and decorated.

New doors at ground floor to be provided as heritage style four panel painted timber fire doors to enhance the heritage asset. Where possible it is proposed to refurbish any original doors with door closers and intumescent paint subject to building control approval.

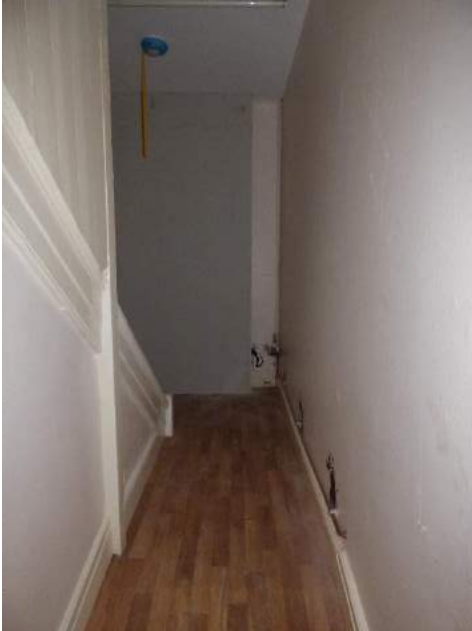
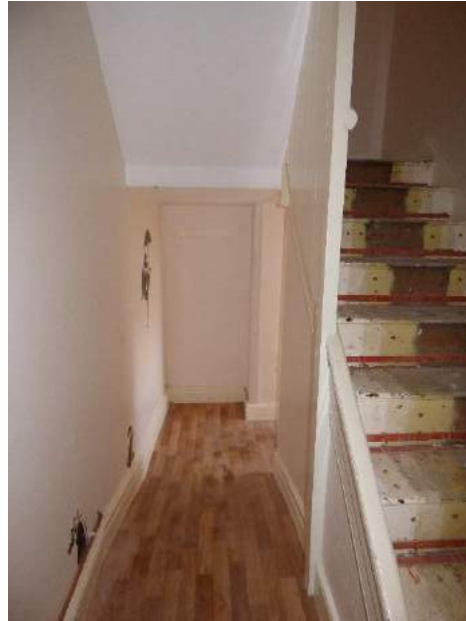
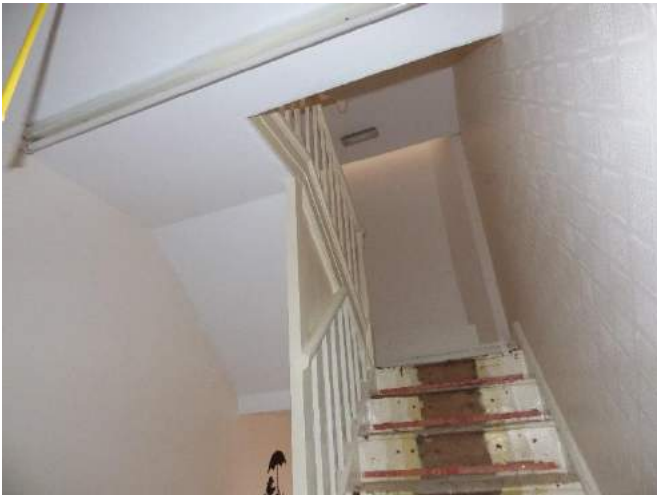
The existing staircase at ground floor has been modified as part of later alterations to the building. It is proposed to reinstate balusters and rails to match the existing to the lower part of the staircase, where they have been removed.

The existing staircase is to be retained as existing throughout the rest of the building.

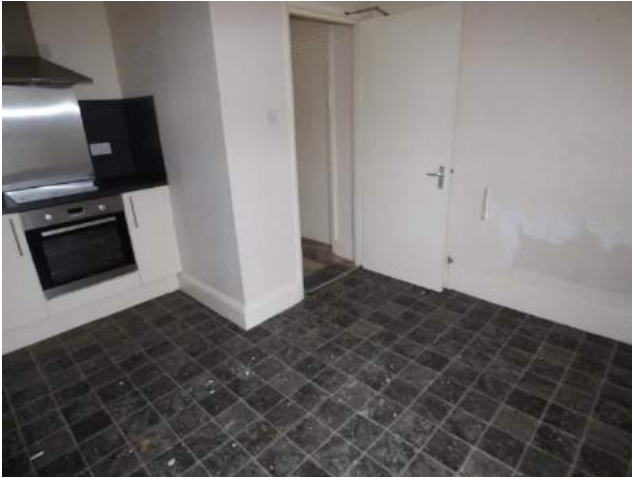
Existing kitchen, bathroom and living area at the front of the first floor, has lost most of the original heritage features.

It is proposed to remain as existing subject to minor decorative repairs. Flush panel doors to be replaced with heritage style 4 panel painted timber fire doors to enhance the heritage asset. Where possible it is proposed to refurbish any original doors with door closers and intumescent paint subject to building control approval.

Original floors to be made good using T & G flooring to match existing where required.

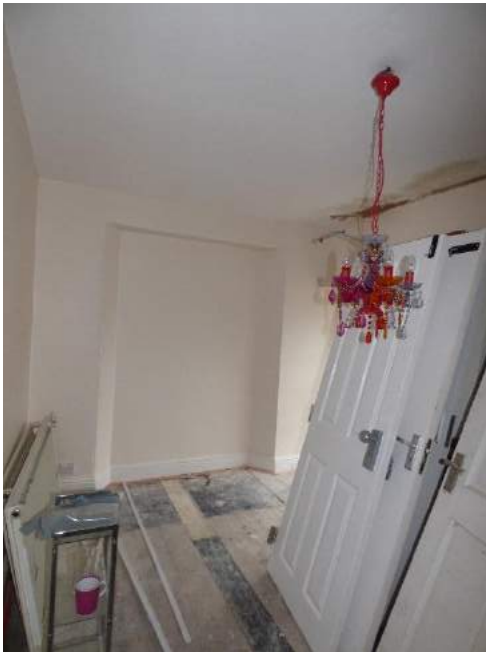
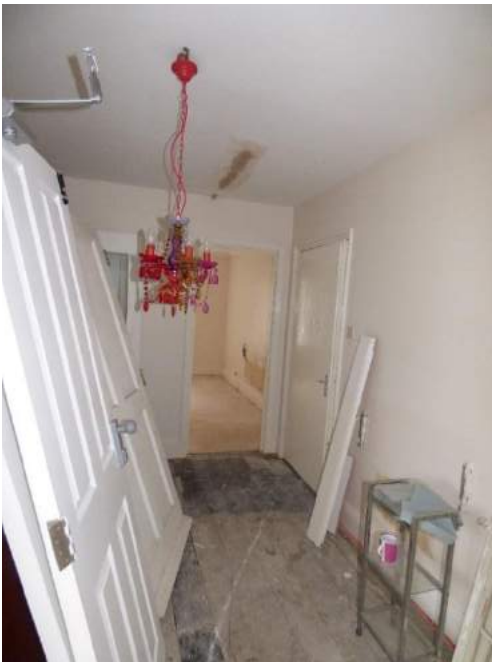
Existing living area at the rear of the first floor is proposed to remain as existing subject to minor decorative repairs. Flush panel doors to be replaced with heritage style 4 panel painted timber fire doors to enhance the heritage asset. Where possible it is proposed to refurbish any original doors with door closers and intumescent paint subject to building control approval.

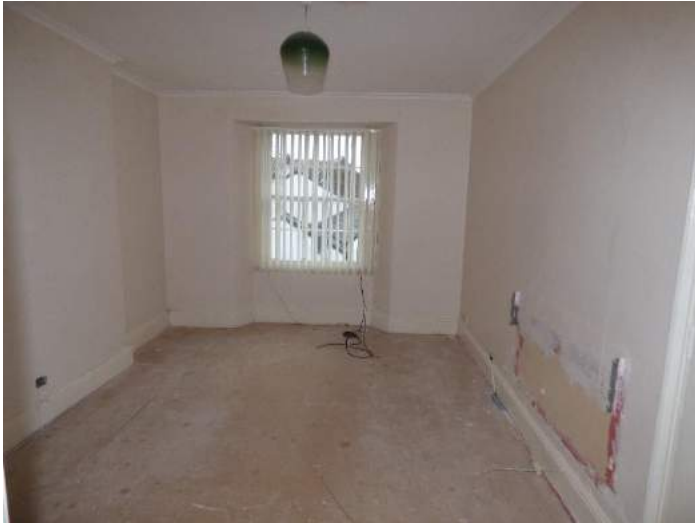
Existing living area at first floor is proposed to remain as existing subject to minor decorative repairs. Flush panel doors to be replaced with heritage style four panel painted timber fire doors to enhance the heritage asset.

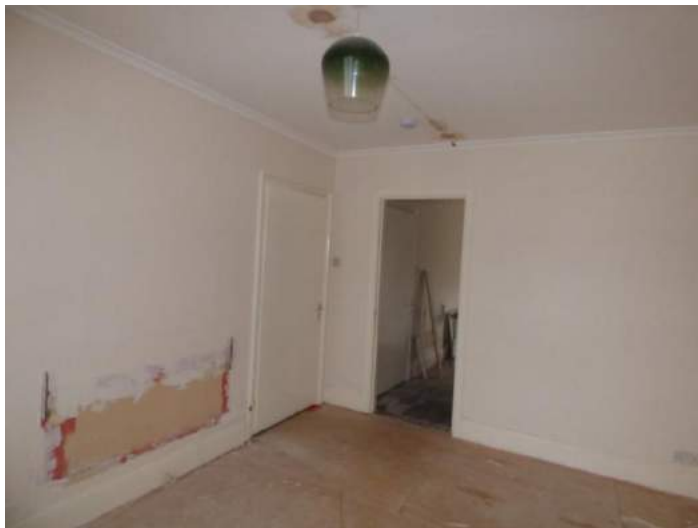
Existing living area at first floor is proposed to remain as existing subject to minor decorative repairs. Flush panel doors to be replaced with heritage style 4 panel painted timber fire doors to enhance the heritage asset.

Where possible it is proposed to refurbish any original doors with door closers and intumescent paint subject to building control approval.

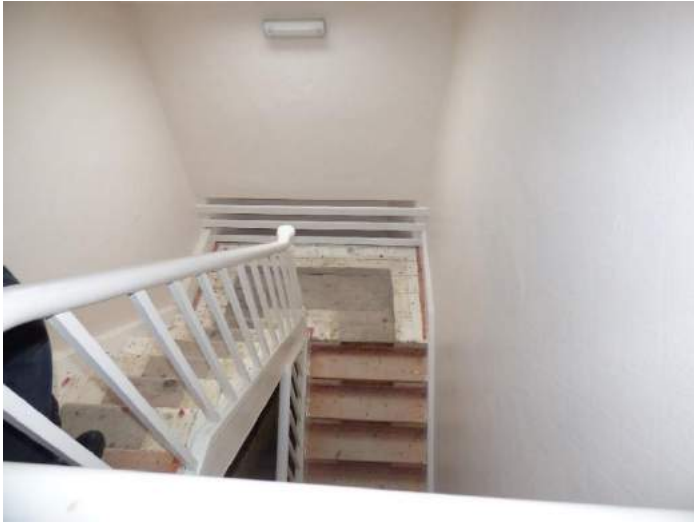
Handrail, balusters and rails are original and are to be retained.

Apply an insulated plasterboard 62mm thick to underside of sloping ceiling. The laminated plasterboard and PIR has a vapour barrier incorporated so interstitial moisture would be prevented, tape and skim and undertake full decorations.

Remove existing Velux and replace with heritage style rooflight (Velux or similar) with flashing kit that mounts unit flush with

the roof surface.

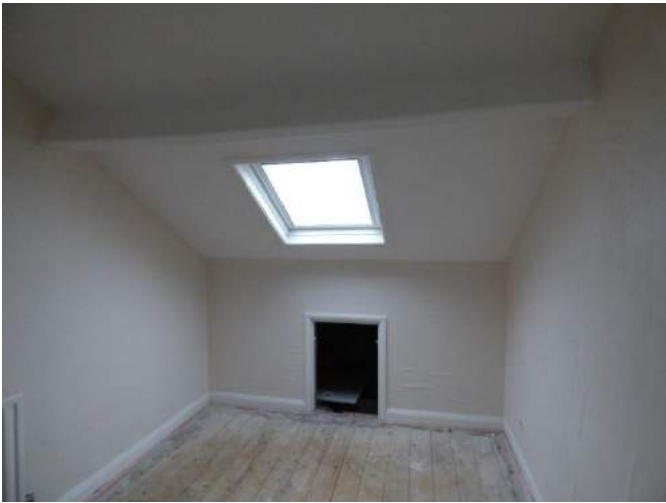
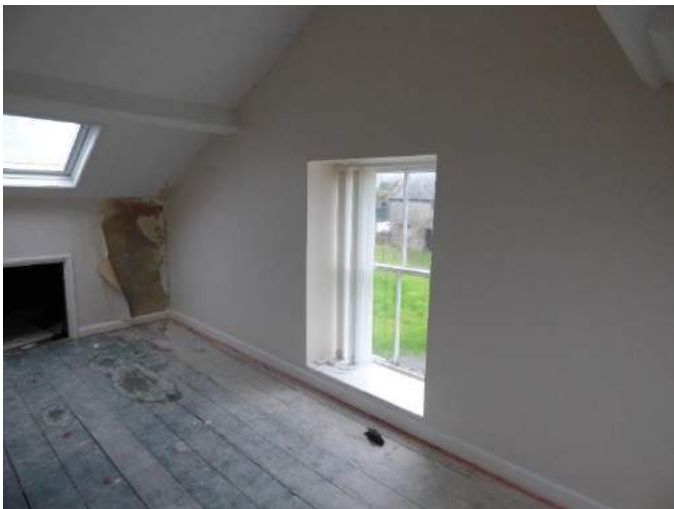
#### Attic Bedroom (gable end)

Floorboards are in good condition (but may require minor repairs).

Existing flush panel doors are not original and it is proposed for these to be removed and replaced with new heritage style four panel fire rated doors.

Remove all damp and damaged / blown plasterwork and repair with lime plaster. (Solo lime plaster from Lime Centre).

Apply an insulated plasterboard 62mm thick to underside of ceiling. The Laminated plasterboard and PIR has a vapour barrier incorporated so interstitial moisture would be prevented. New rooflights to be installed with flashing kit that mounts unit flush with the roof surface.

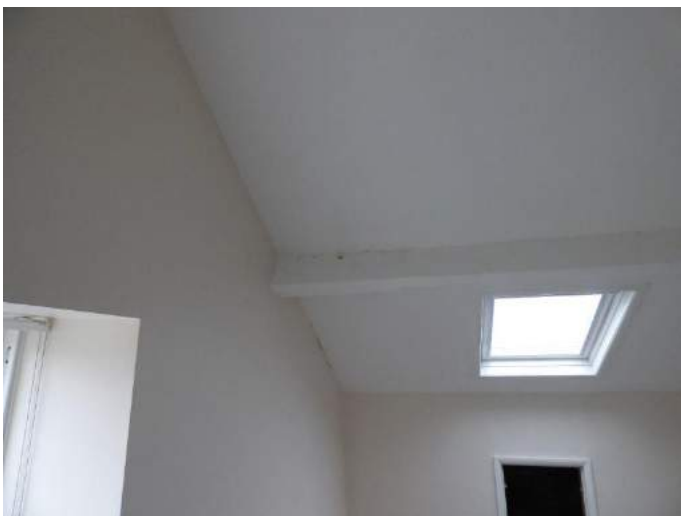
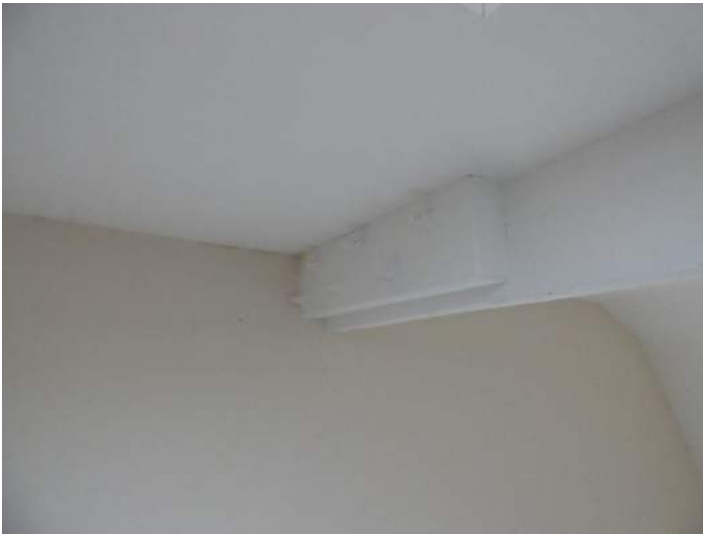
#### Attic Bedroom

Floorboards are in good condition (but may require minor repairs).

Existing flush panel doors are not original and are to be removed and replaced with new heritage style four panel fire rated doors.

Remove all damp and damaged / blown plasterwork and repair with lime plaster and skim and decorate throughout.

Apply an insulated plasterboard 62mm thick to underside of ceiling tape and skim, and undertake full decorations. The laminated plasterboard and PIR has a vapour barrier incorporated so interstitial moisture would be prevented. New rooflights to be installed with flashing kit that mounts unit flush with the roof surface.

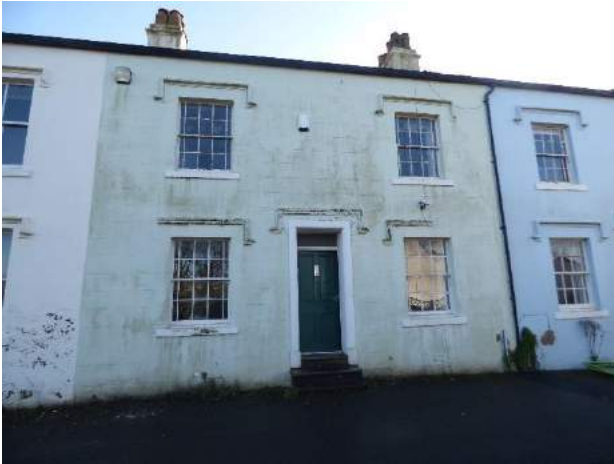
Left: The main entrance is mentioned in the listing text and is to be entirely retained.

Both front and rear elevations are currently rendered, with colour to the front and side and natural to the rear. All elevations require to be prepared for render repairs and redecoration by specialist using lime render and stucco (Parax LTD) to be applied by specialist.

The stucco features above the windows and door on the front elevation will be carefully restored by a specialist. Colour of all render and stucco to match existing.

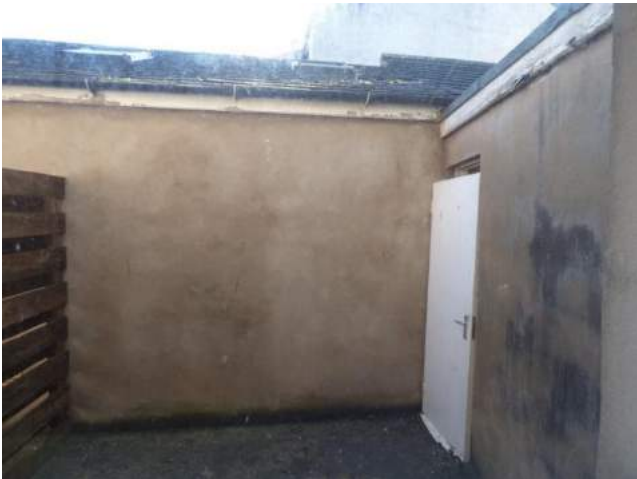
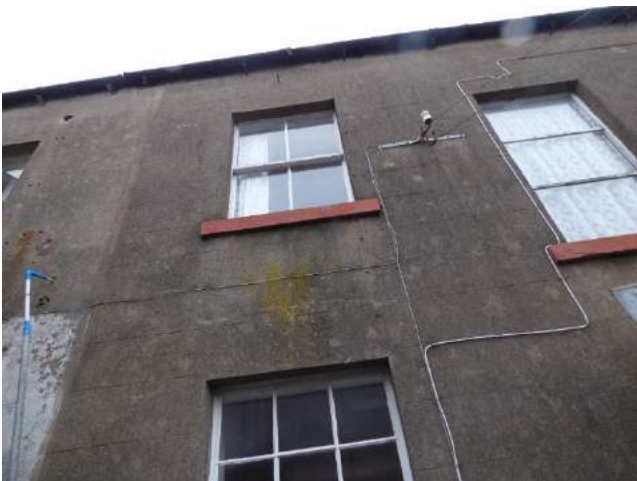
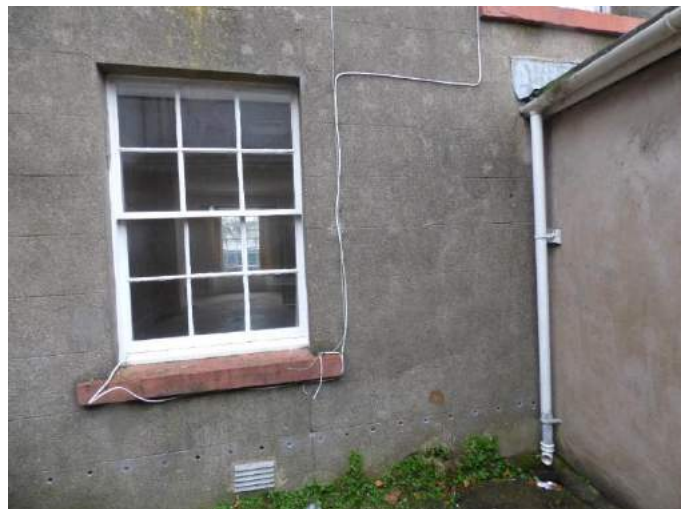
The rear courtyard is divided by a single storey 'link' building to an outbuilding at the rear. It is proposed to demolish both these structures. The link building is in extremely poor condition, and also to demolish the existing rear building, as they were a later mid-century addition to the property and the intention is to restore the rear garden to its original state

to provide additional amenity space for the property and allow more light into the existing dwelling.

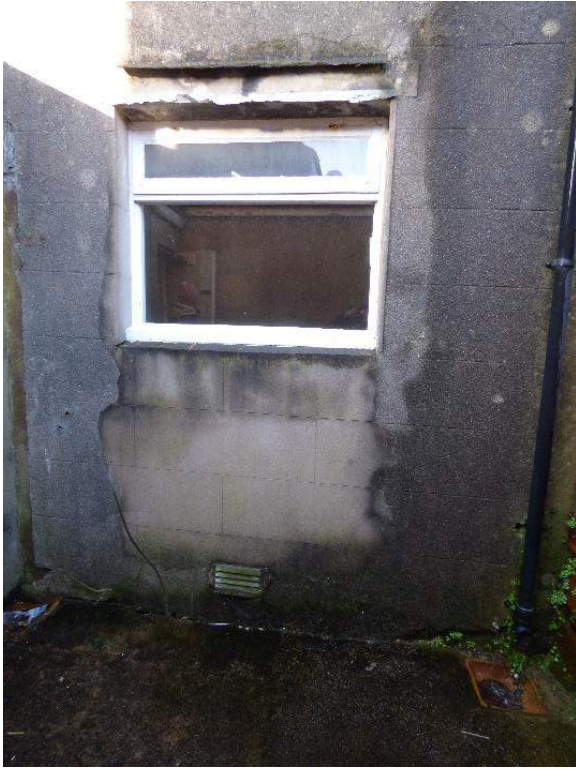
Left: The ground floor window to the kitchen is not original and requires replacement. The proposed replacement will reinstate the original Georgian style of window, in the original opening (which has been walled up), with a double-glazed slimline heritage painted timber window that would have been originally installed.

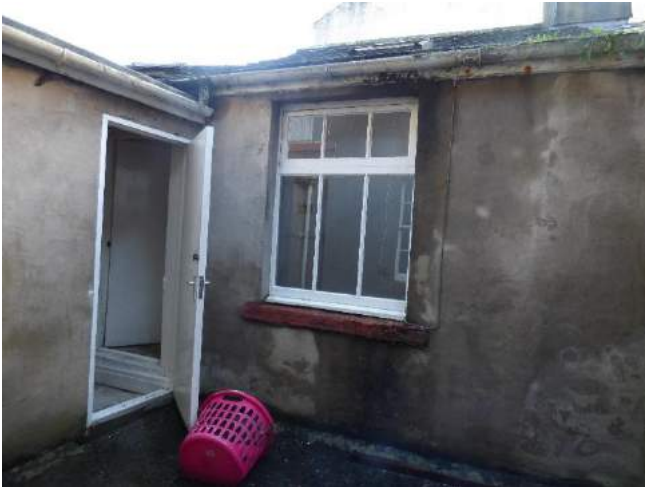
Poorly constructed 'link' building and out building to be removed to return the original building back to its former configuration.

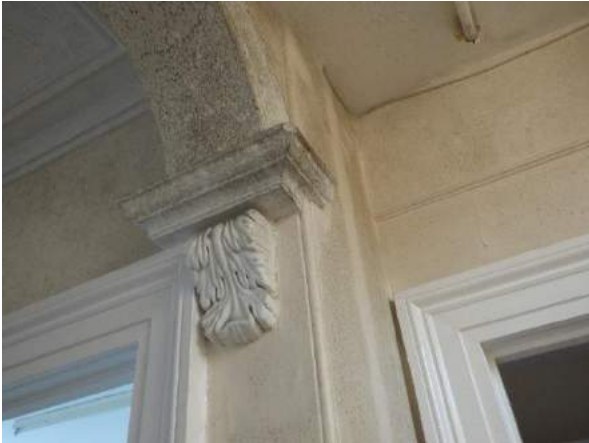
Left: period features to be retained, including archway and architraves. (Modern lighting to all be stripped out and make good surfaces). All architraves and plaster features to be retained.

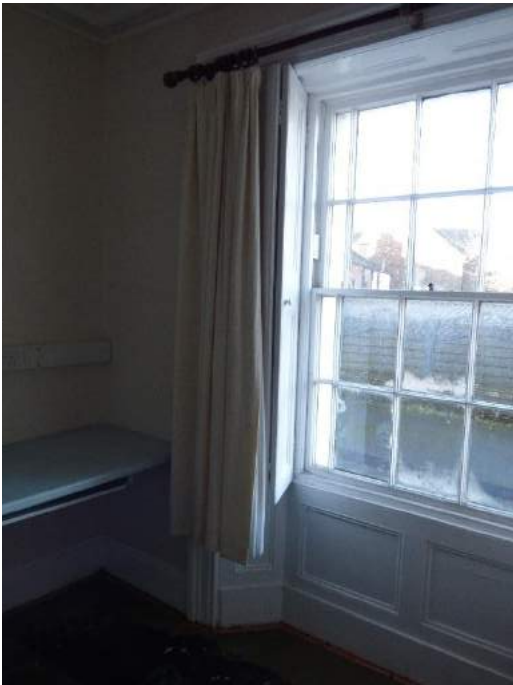
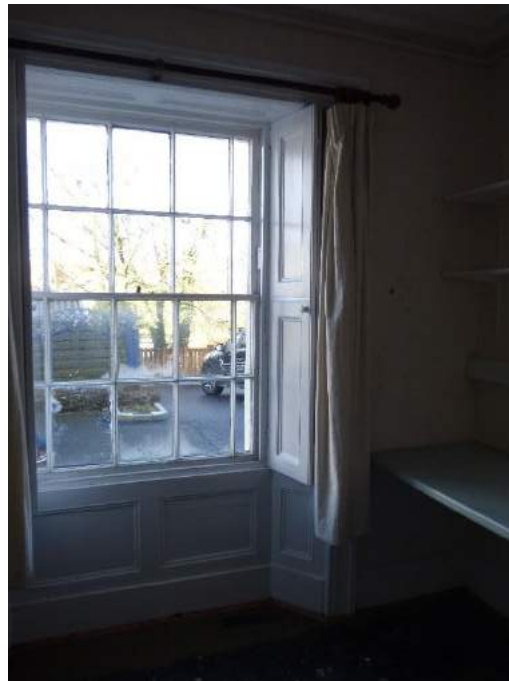
Above: In the existing study, the period features below and to the sides of the existing window are in good condition, it is proposed to carefully refurbish the existing timber shutters.

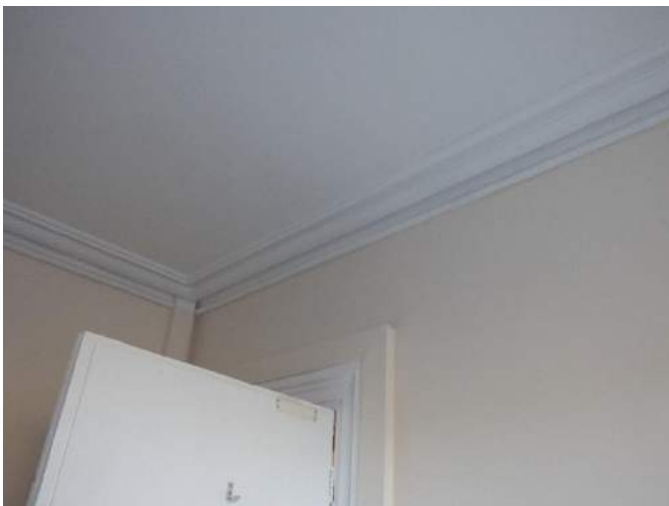
Left: Existing cornice to be made good in locations where redundant services are to be removed and where hairline cracks have appeared.

Existing architraves, and skirtings to be retained and made good.

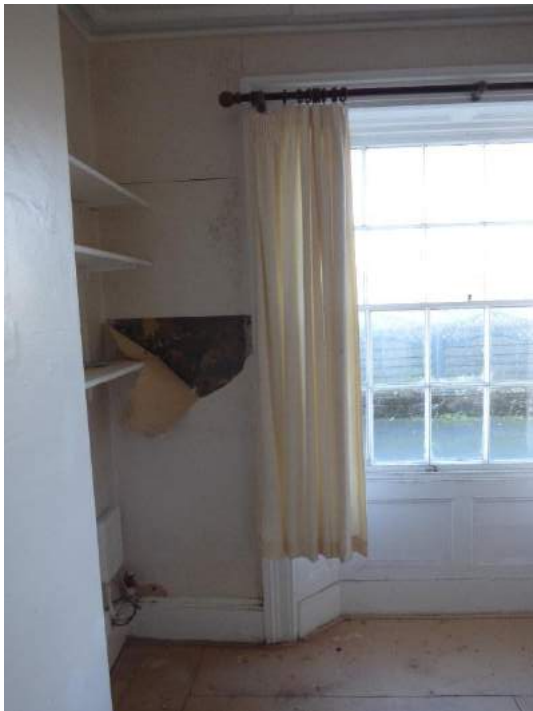
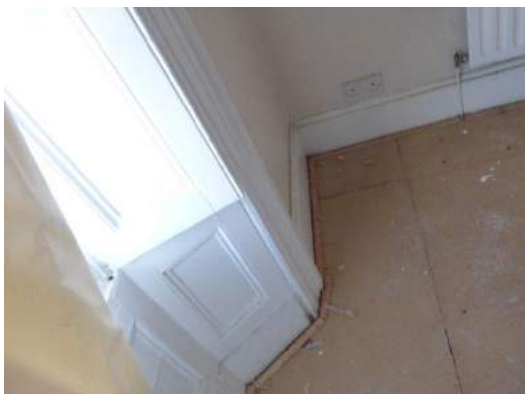
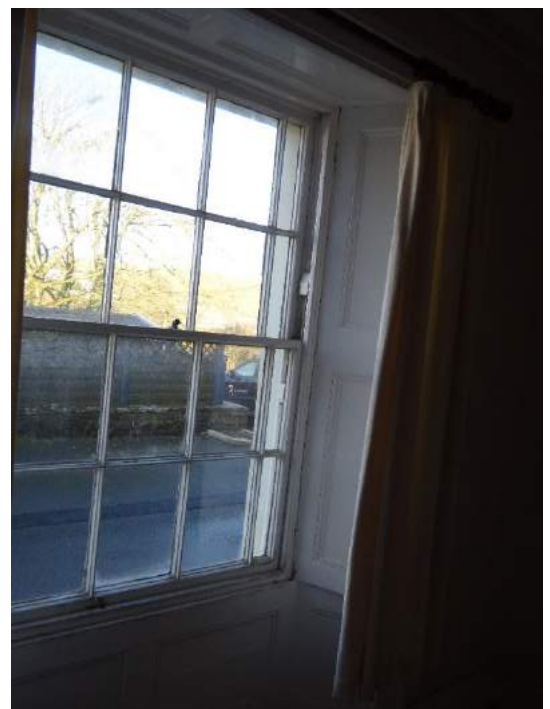
Above: In the existing lounge at the front of the property and

Left and below: the existing dining area to the rear of the property, the period features below and to the sides of the existing window are in good condition, it is proposed to carefully refurbish the existing timber shutters.

Below: Existing cornice to be made good in locations and where hairline cracks have appeared.

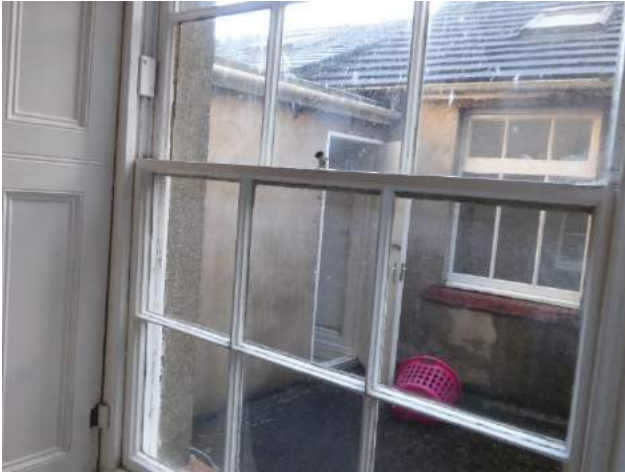
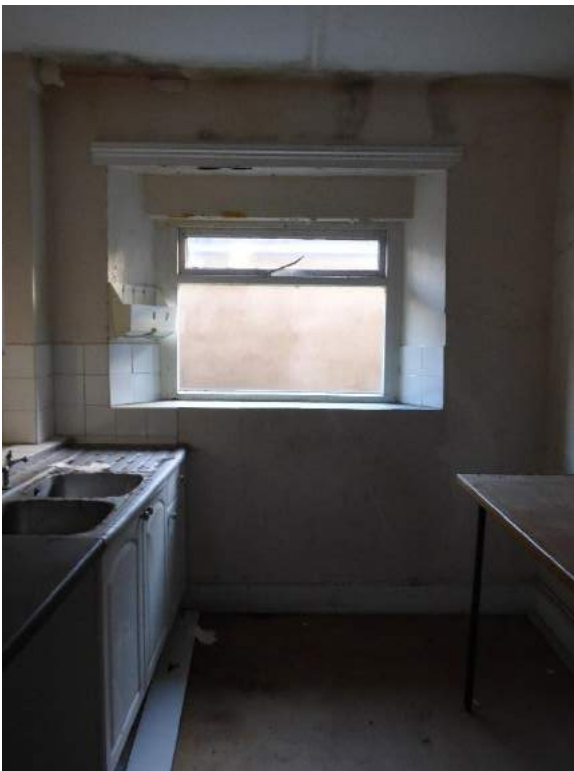
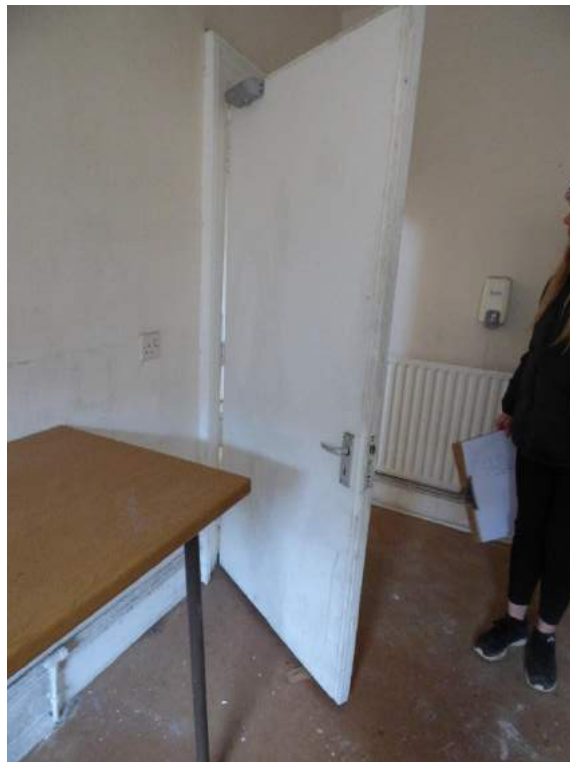
Flush panel doors to be replaced with heritage style four panel painted timber fire doors to enhance the heritage asset. Where possible it is proposed to refurbish any original doors with door closers and intumescent paint subject to building control approval.

Existing modern single glazed window to be replaced by new double glazed heritage sash hardwood painted timber window, that would have been installed originally. The existing opening is to be adjusted to return the window opening to its original size.

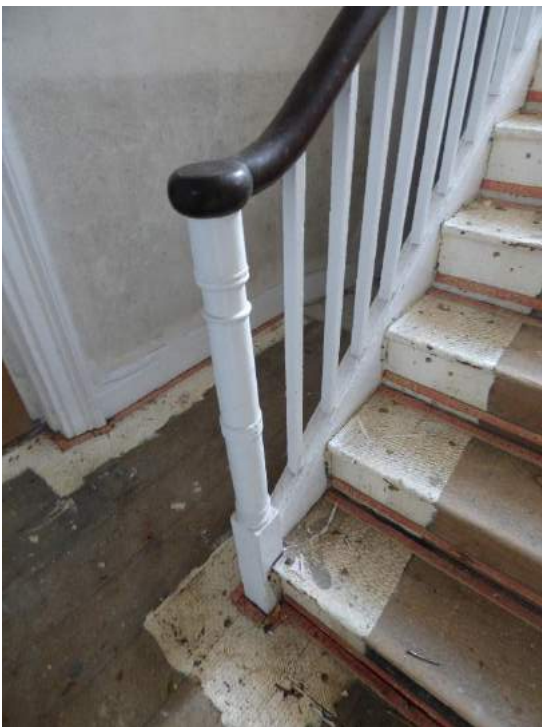
Left: Retain original staircase, which is in good condition. One missing baluster between first and second floor staircase to be provided with new baluster to match existing.

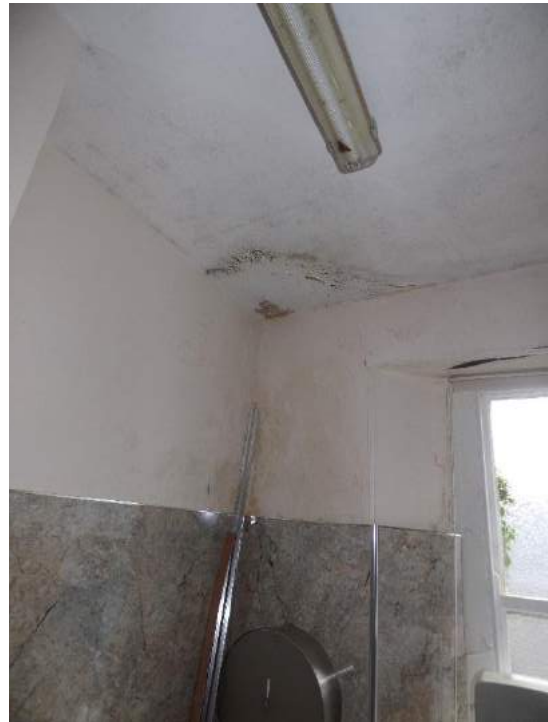
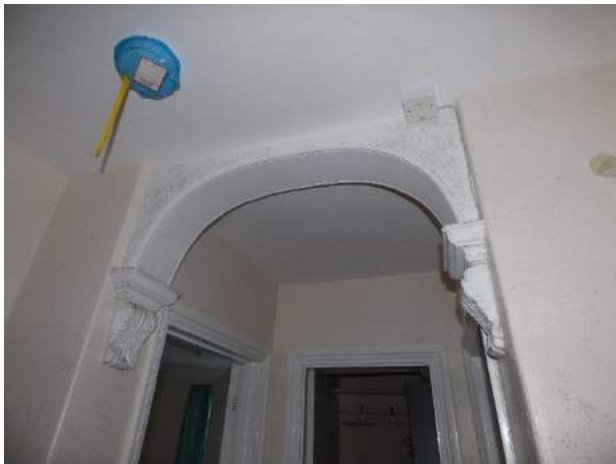
First floor landing area:  
Period features to be retained.

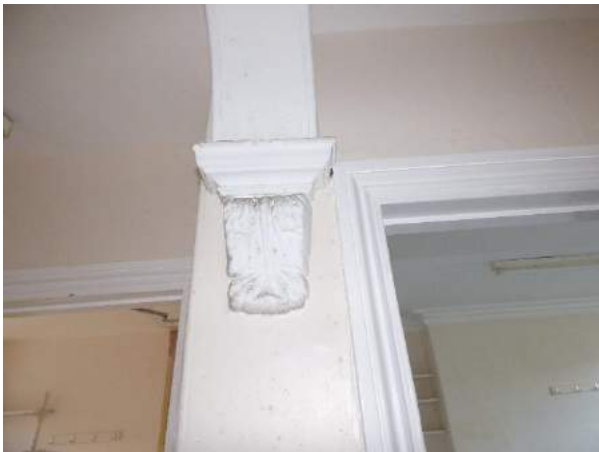
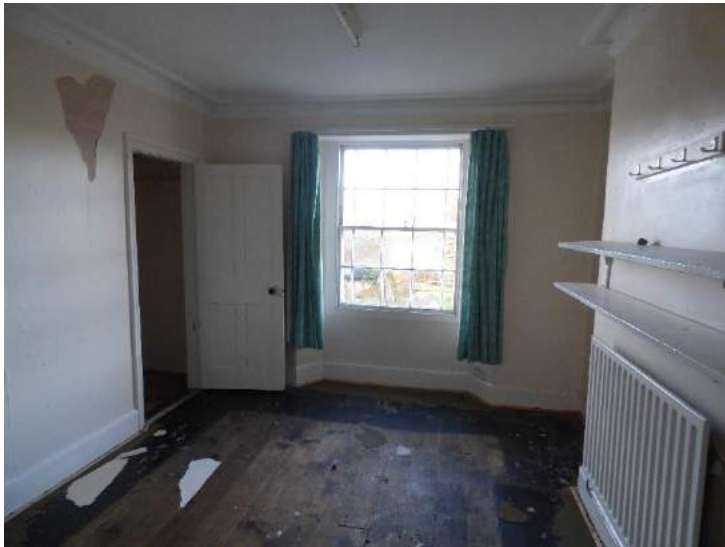
Front bedroom (First floor RHS), cornice, skirtings, and architraves to be retained. Existing flush panelled door to be replaced with new Georgian heritage style 4 panel fire door to be provided and installed by specialist joinery company such as Batty Joinery Ltd.

Existing floorboards in good condition.

It is proposed to form new doorway with architraves to match existing, and new four panelled door, into a new en-suite to be formed from part of the existing over large bathroom to make efficient use of the space and reflect the requirements of modern-day living.

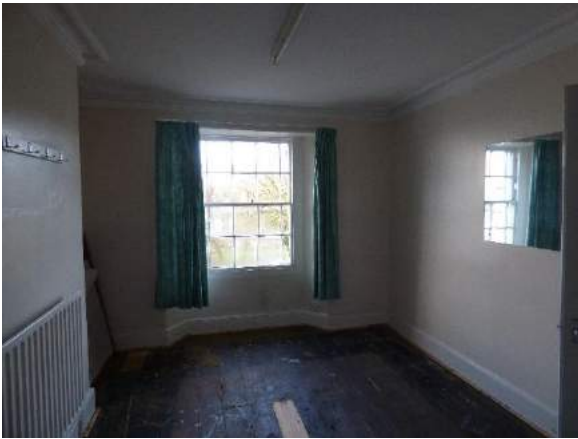
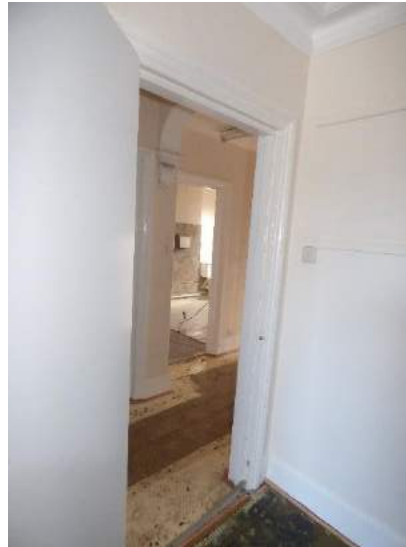
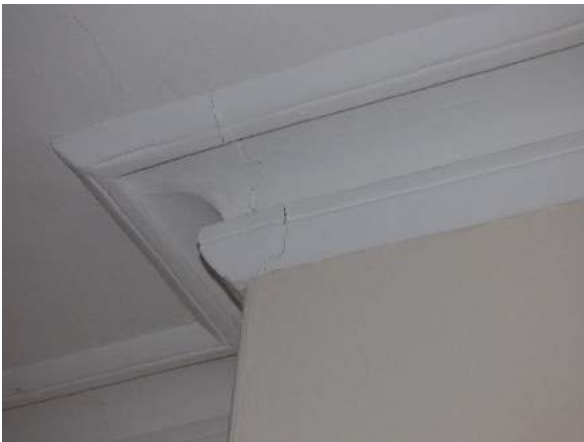
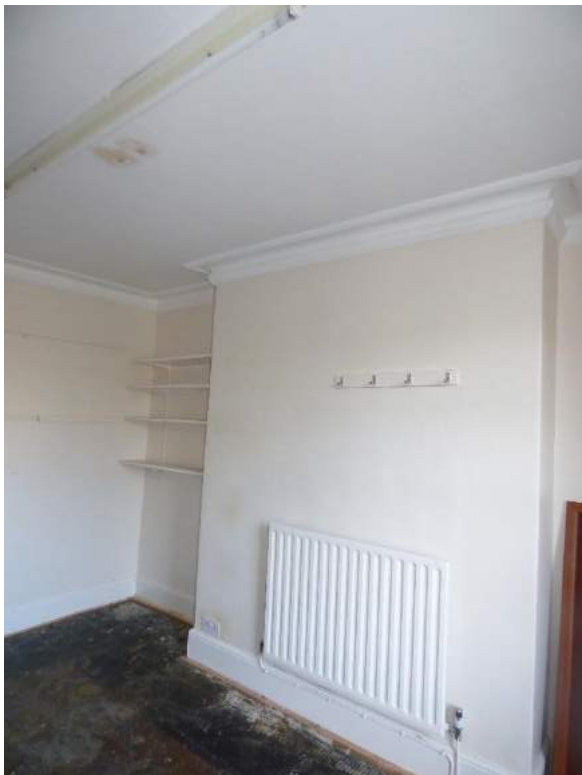
Front bedroom (First floor LHS), cornice, skirtings, and architraves to be retained. Existing flush panelled door to be replaced with new Georgian heritage style four panel fire door to be provided and installed by specialist joinery company such as Batty Joinery Ltd. Where possible it is proposed to refurbish any original doors with door closers and intumescent paint subject to building control approval.

Existing floorboards in good condition. Minor repairs may be necessary.

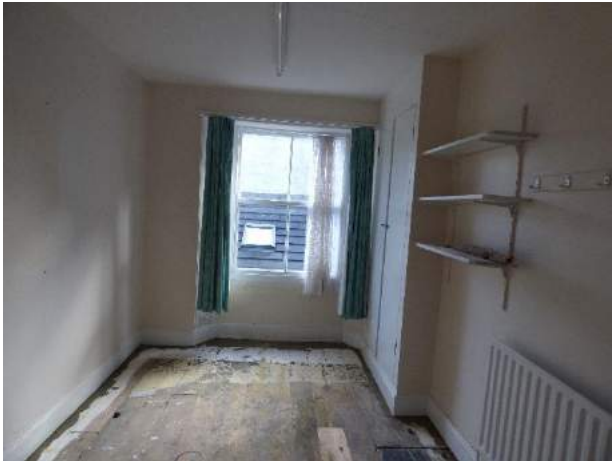
Damp ingress has affected plasterwork by window. It is proposed to rake back existing blown plaster and repair with new lime plaster. The installation of the new window should resolve the damp ingress.

Existing floorboards in good condition. Minor repairs may be necessary.

Rear bedroom existing skirtings and architraves to be retained. Existing modern flush panelled door to be replaced with new Georgian heritage style 4 panel door fire door to be provided and installed by specialist joinery company such as Batty Joinery Ltd.

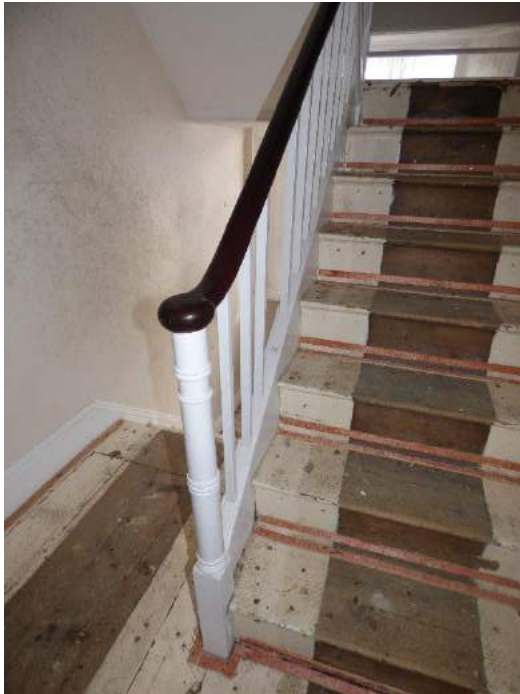
Handrail, balusters, and rails are original and are to be retained. Missing baluster to be replaced with matching baluster and decorated to match existing.

Apply an insulated plasterboard 62mm thick to underside of ceiling. The Laminated plasterboard and PIR has a vapour barrier incorporated so interstitial moisture would be prevented. Tape and skim and undertake full decorations.

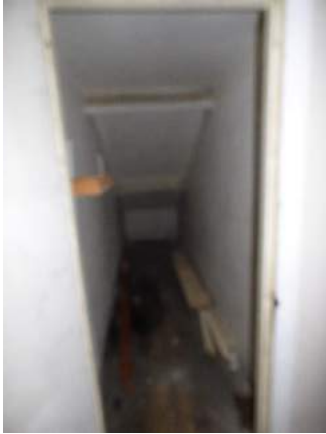
Left: Attic Bedroom

Left: Attic Store is proposed to be converted into a bathroom to be shared by the attic bedrooms by increasing the size of the room to each side to allow for the new bathroom.

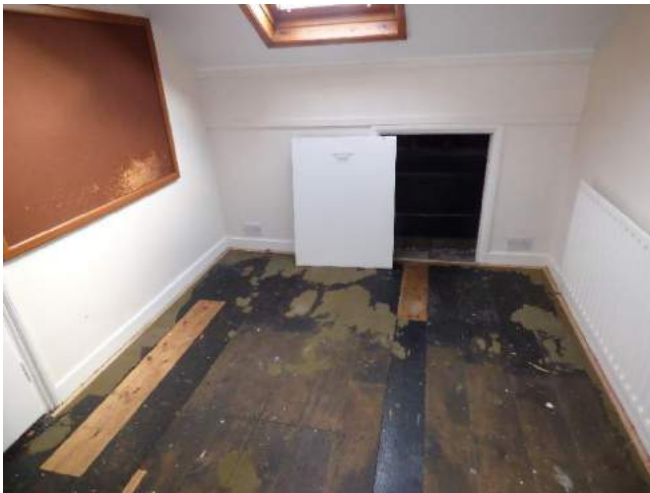
In the bedroom remove all damp and damaged / blown plasterwork and repair with lime plaster (Solo lime plaster from Lime Centre).and skim and decorate throughout.

Floorboards are in good condition (but may require minor repairs).

New plasterboard stud partition to be installed in lieu of removal of part of existing store / bedroom partition (existing lath and plaster) to allow for bathroom to be useable size.

Apply an insulated plasterboard 62mm thick to underside of ceiling. The Laminated plasterboard and PIR has a vapour barrier incorporated so interstitial moisture would be prevented. New rooflights to be installed with flashing kit that mounts unit flush with the roof surface.

Existing flush panel doors are to be removed and replaced with new heritage style 4 panel fire doors.

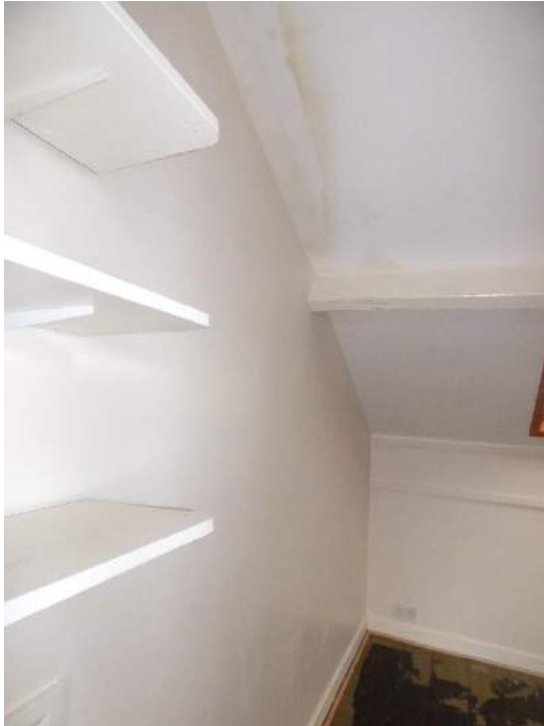
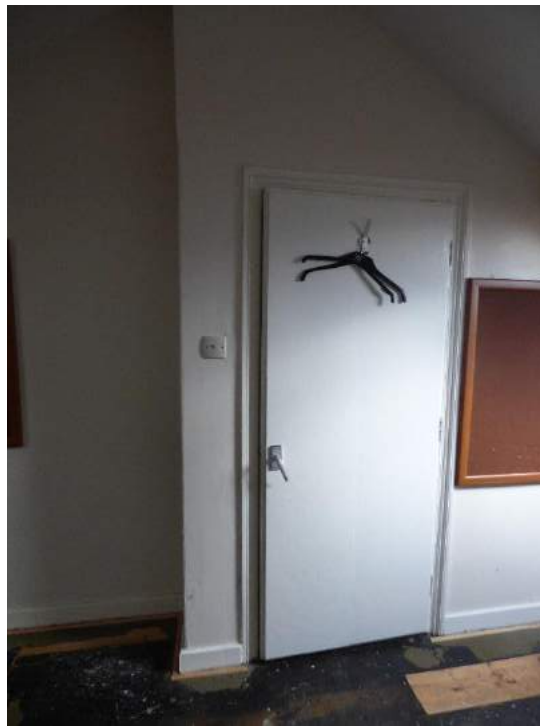
Above and below: Attic Bedroom

In the bedroom remove all damp and damaged / blown plasterwork and repair with lime plaster (Solo lime plaster) and skim and decorate throughout.

Floorboards are in good condition (but may require minor repairs).

New plasterboard stud partition to be installed in lieu of removal of part of existing store / bedroom partition to allow for bathroom to be useable size.

Apply an insulated plasterboard 62mm thick to underside of ceiling tape and skim. The laminated plasterboard and PIR has a vapour barrier incorporated so interstitial moisture would be prevented and undertake full decorations. New heritage style rooflights to be installed replacing the existing modern velux rooflights with flashing kit that mounts unit flush with the roof surface.

Existing flush panel doors are to be removed and replaced with new heritage style 4 panel fire doors.

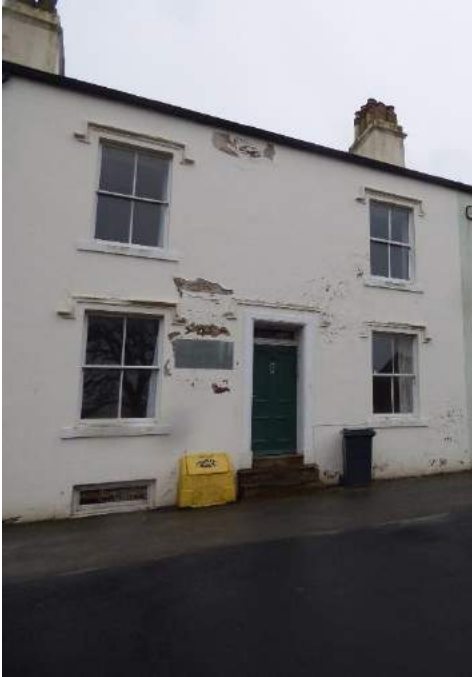
Left: The main entrance is mentioned in the listing text and is to be entirely retained.

Both front and rear elevations are currently rendered, with colour to the front and side and natural to the rear. All elevations require to be prepared for render repairs and redecoration by specialist using lime render and stucco (Parax LTD) to be applied by specialist.

The existing door and frame are to be retained and made good with the provision of new ironmongery. Once repaired full decoration will be undertaken.

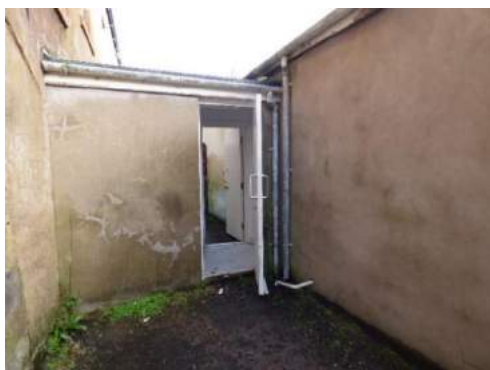
Localised lead repair work may be required to chimneys, to prevent damp ingress.

Rear of property, – render to be repaired by specialist and decorated with off white colour.

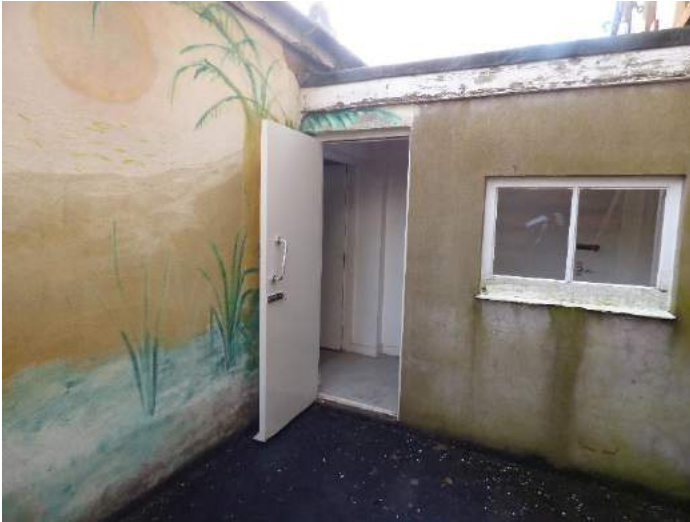
It is proposed to demolish the existing link and rear building, as they were a later mid-century addition to the property and are not good quality construction, so it is the intention is to restore the rear garden to its original state to allow for additional recreation space for the property.

Existing link building to be completely removed and the existing house to be made good. New door to rear to be Georgian style as front door as although the estimate for the date of the buildings is mid-19<sup>th</sup> Century, which would be some years after the end of the Georgian period, even if the counting the Regency, but reflect the style none the less.

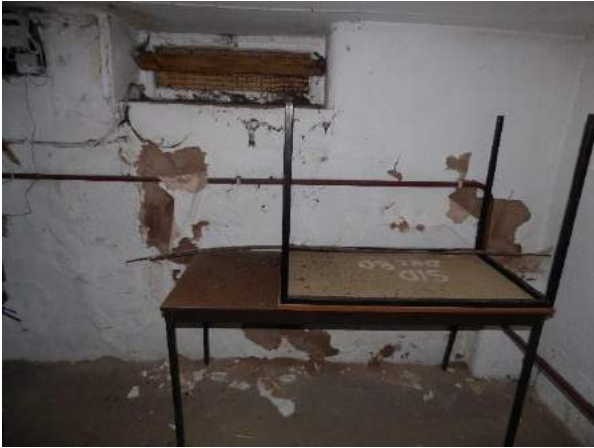
Left: The basement

The existing walls and floor are generally in sound condition so would be suitable for the application of damp proof slurry system. All existing paint and surface finishes must be removed and made good including all snots removed, and damage to existing surfaces, prior to the installation of a Koster Polysil NB1. This migratory crystalline tanking slurry is used to seal below ground structures against water ingress.

Koster NB1 works by both providing a physical barrier against water ingress as well as providing a migratory crystal sealant that penetrates deep into the structure to seal micropores and cracks against water ingress.

Once applied then the walls can be prepared and primed for decorating and for the floor finish to be installed. Complete new boiler and heating system is required, new distribution boards etc.
