# HERITAGE STATEMENT

## FULL RENOVATION OF EXISTING No 11 TERRACE HOUSES

St Bees, 1-11 Lonsdale Terrace, Parish Council, Cumbria

M.A.C Architects, Project Number: 2019:303

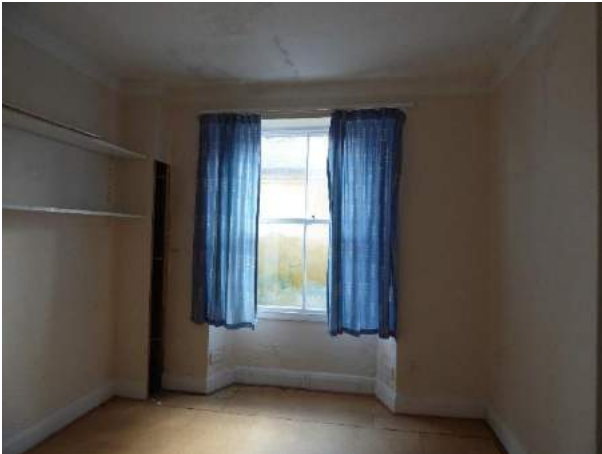
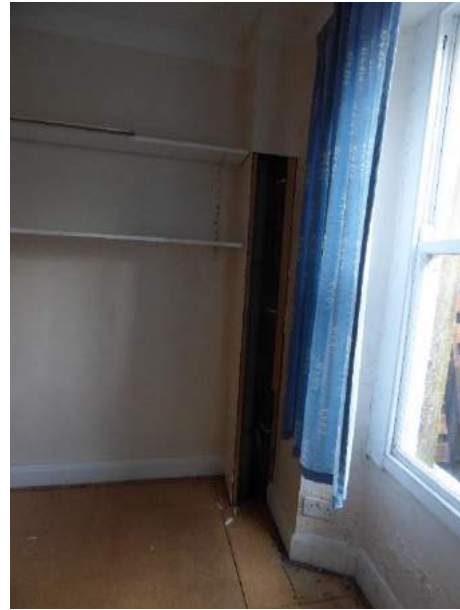
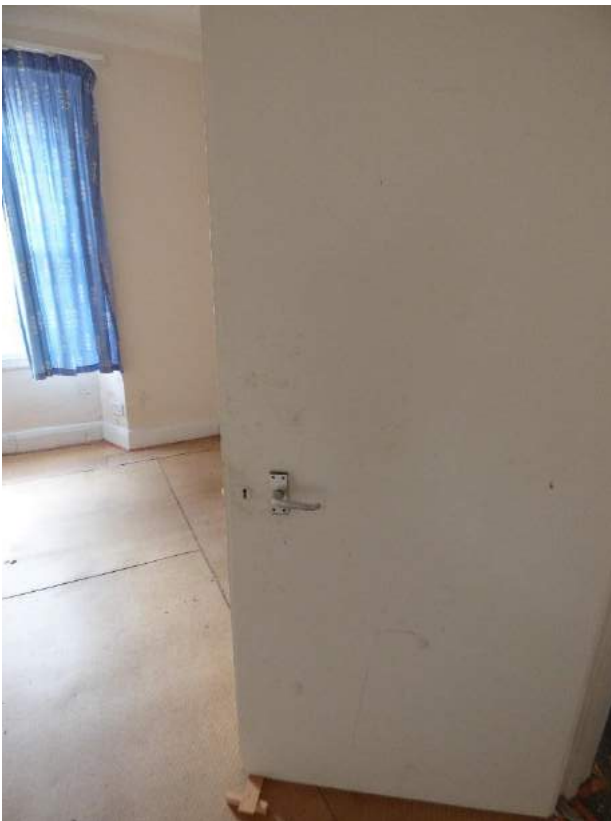
In the existing study, the period features below and to the sides of the existing window are in good condition, it is proposed to carefully refurbish the existing timber shutters.

Left: Existing cornice to be made good in locations where redundant services are to be removed and where hairline cracks have appeared.

Flush panel doors to be replaced with heritage style 4 panel painted timber fire doors to enhance the heritage asset.

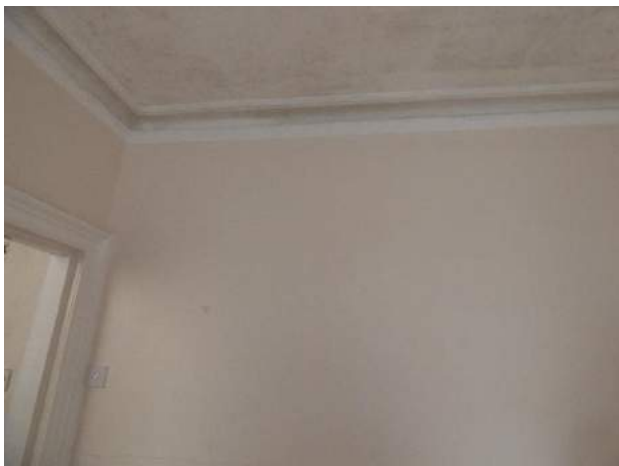
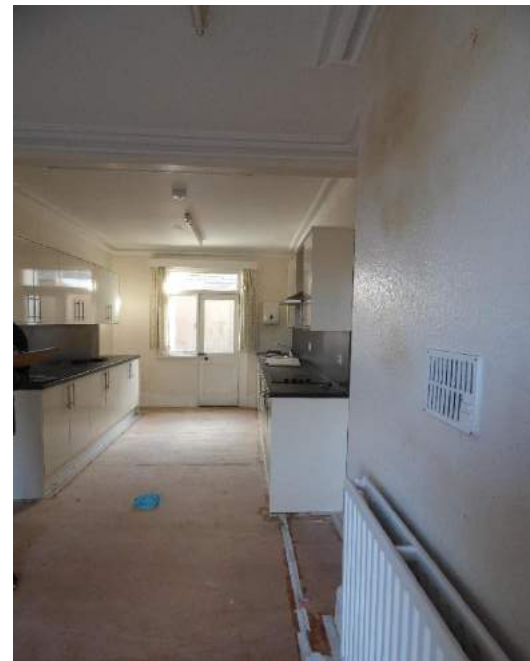
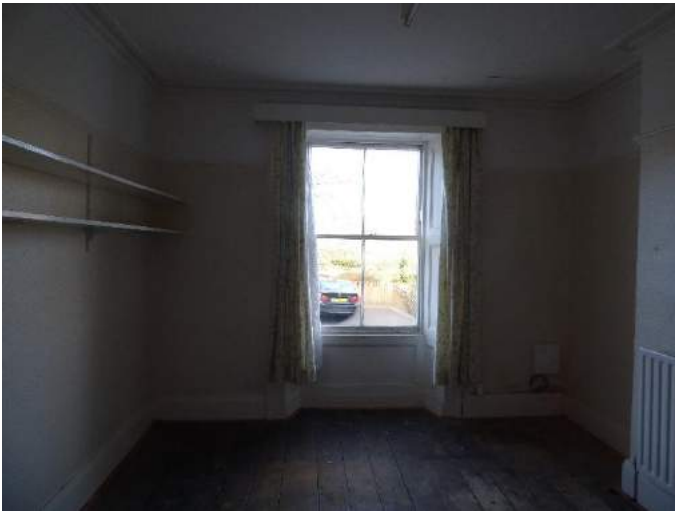
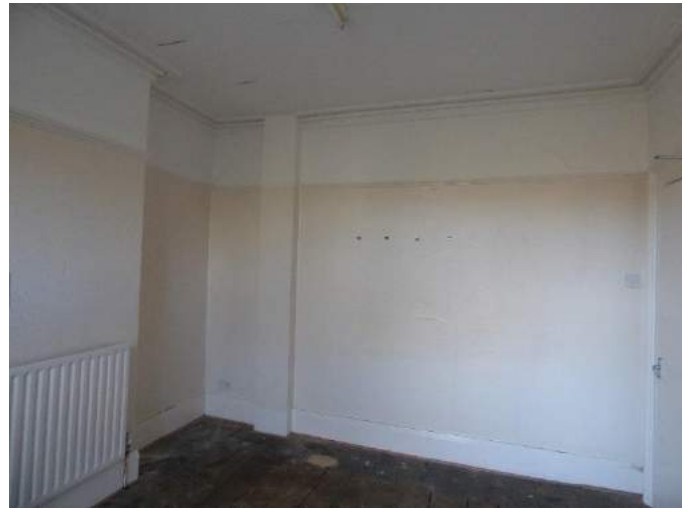
Above: In the existing lounge at the front of the property and

Right and below: The existing dining area to the rear of the property, the period features below and to the sides of the existing window are

in good condition, it is proposed to carefully refurbish the existing timber shutters.

cornice to be made good in locations and where hairline cracks have appeared.

Existing architraves, and skirtings to be retained and made good.

Flush panel fire door to be replaced with heritage style four panelled fire doors to enhance the heritage asset. Where possible it is proposed to refurbish any original doors with door closers and intumescent paint subject to building control approval.

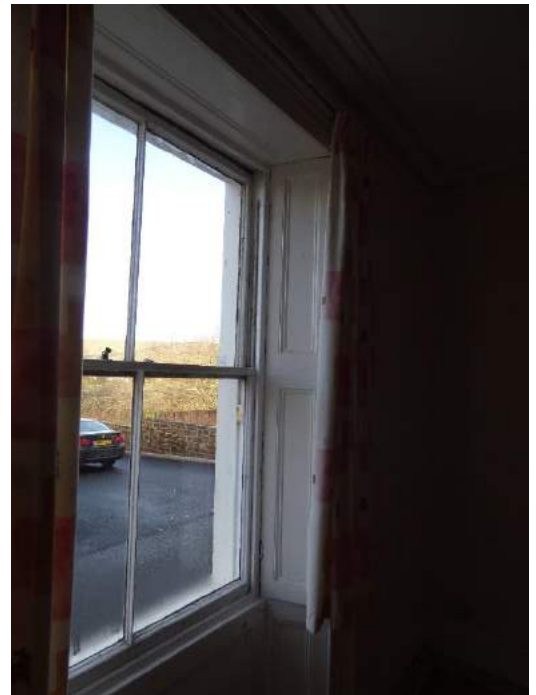
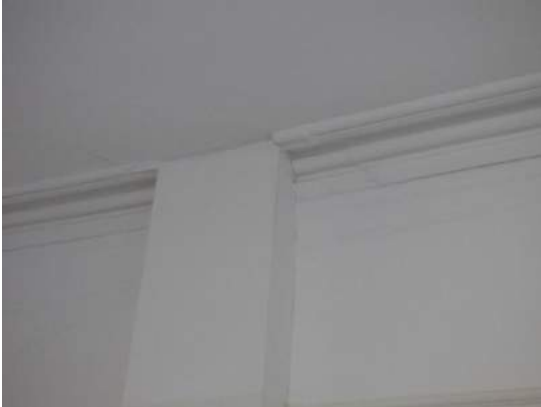
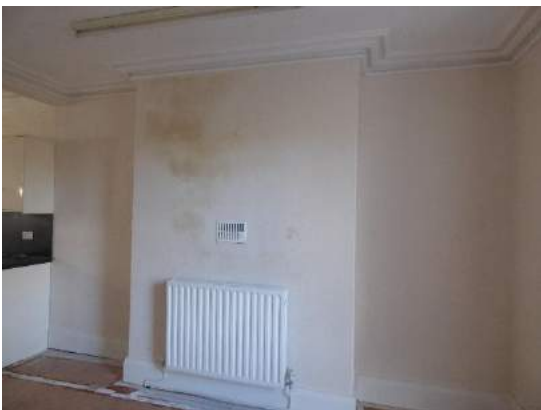
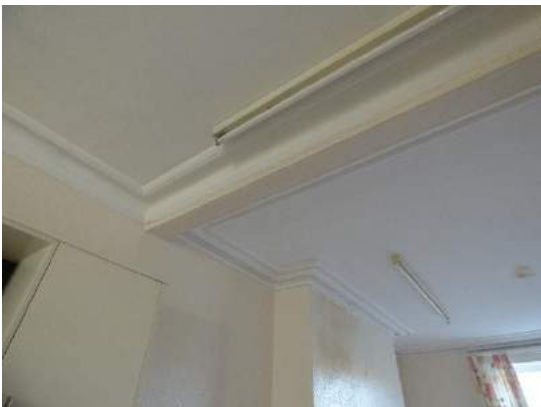
Above, Right, and below: In the existing lounge, the period features below and to the sides of the existing windows both front and back are in good condition, it is proposed to carefully refurbish the existing timber shutters.

Existing cornice to be made good in locations where redundant services are to be removed and where hairline cracks have appeared.

Existing architraves, and skirtings to be retained and made good.

Flush panel doors to be replaced with heritage style four panel painted timber fire doors to enhance the heritage asset.

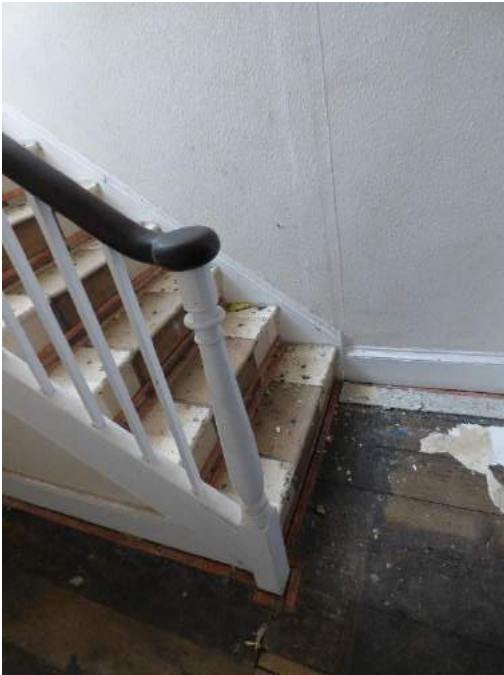
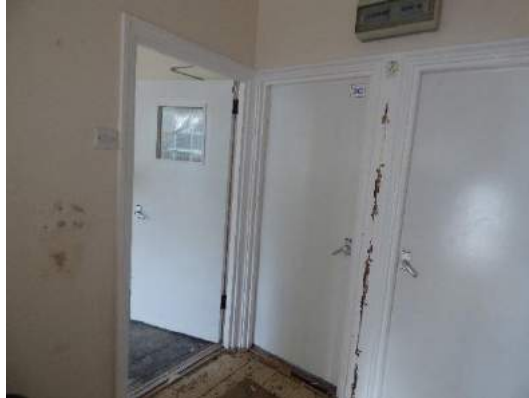
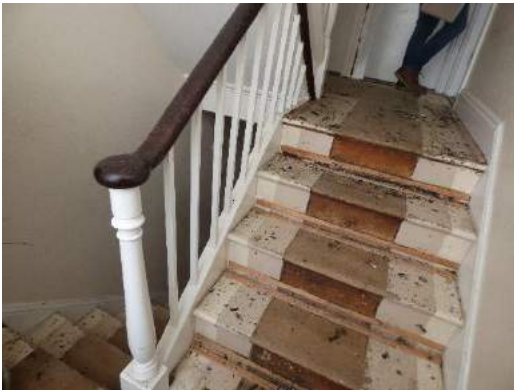
Retain original staircase, which is in good condition.

All period features to be retained.

Retain architraves and skirtings. Replace existing flush panel doors with new four panelled heritage style fire doors by specialist joinery company.

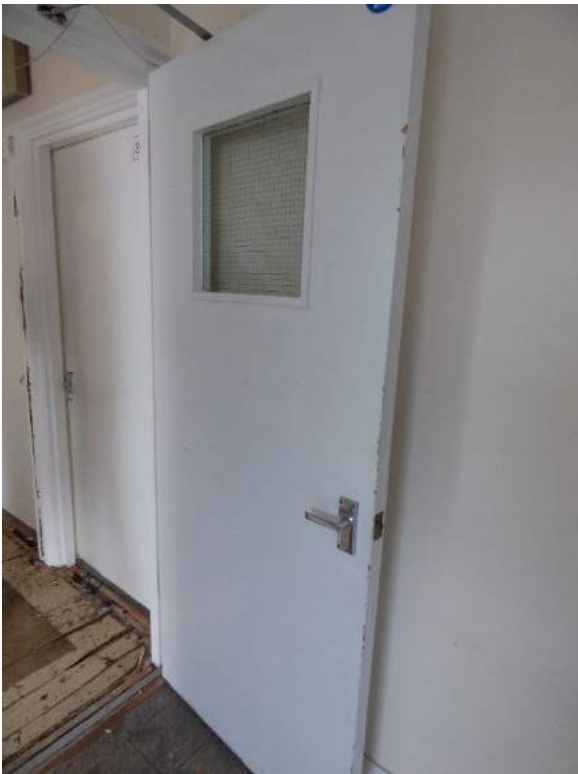
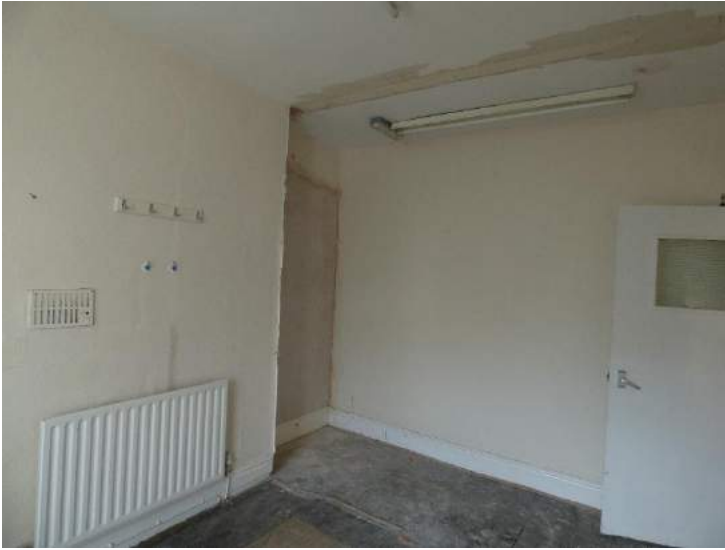
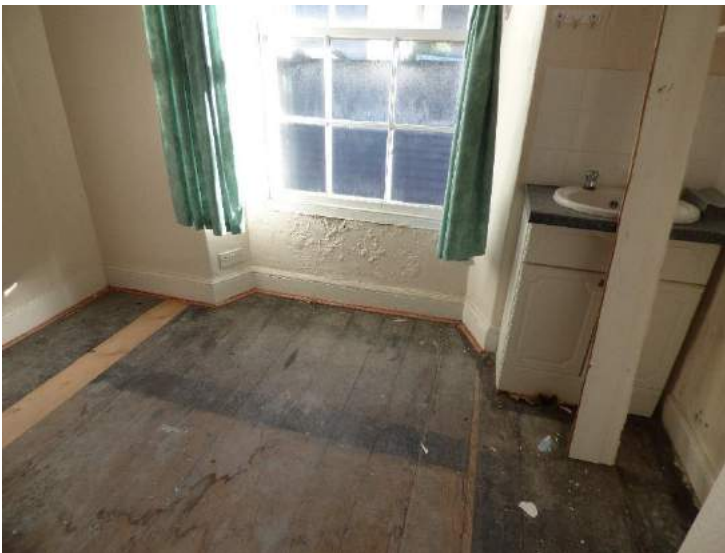
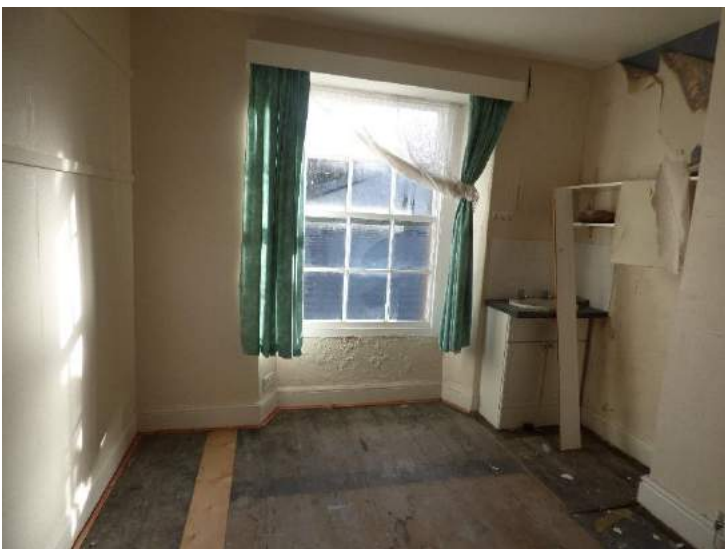
Existing floorboards generally in good condition.

Damp and associated blown plaster below window and to window reveals to be repaired with lime plaster. New heritage style double glazed window will be fitted to ensure no water ingress.

Rear bedroom skirtings and architraves to be retained. Existing flush panelled door to be replaced with new Georgian heritage style 4 panel door to be provided and installed by specialist joinery company such as Batty Joinery Ltd.

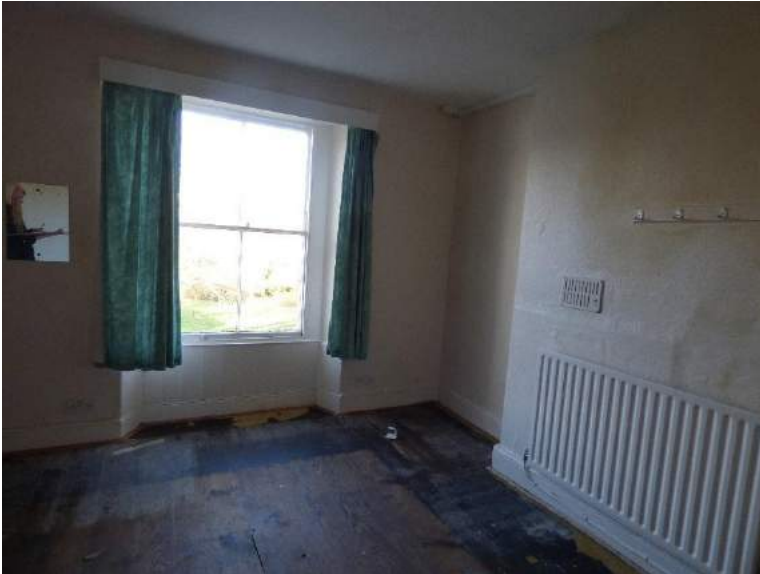
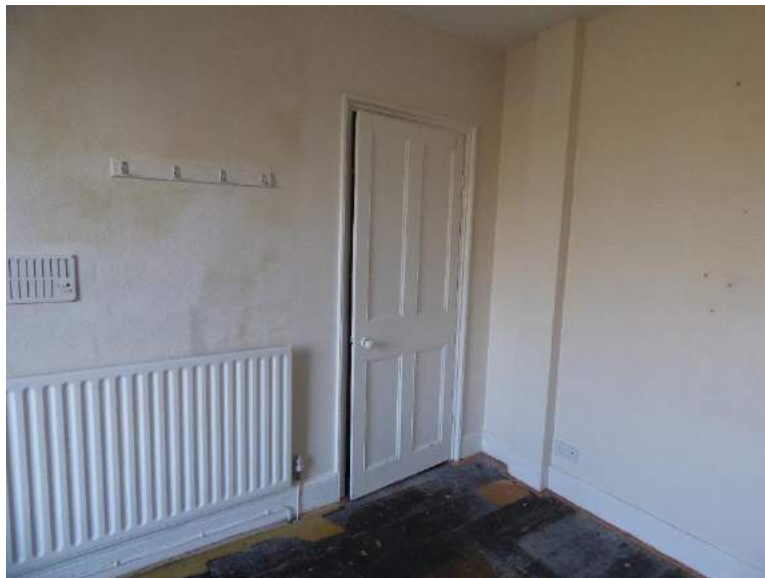
Existing floorboards in good condition.

Front bedroom (First floor RHS), skirtings and architraves to be retained. Existing flush panelled door to be replaced with new Georgian heritage style 4 panel door to be provided and installed by specialist joinery company such as Batty Joinery Ltd. Where possible it is proposed to refurbish any original doors with door closers and intumescent paint subject to building control approval.

It is proposed to form new doorway with architraves to match existing, and new four panelled door, into a new en-suite to be formed from part of the existing over large bathroom to make efficient use of the space and reflect the requirements of modern-day living.

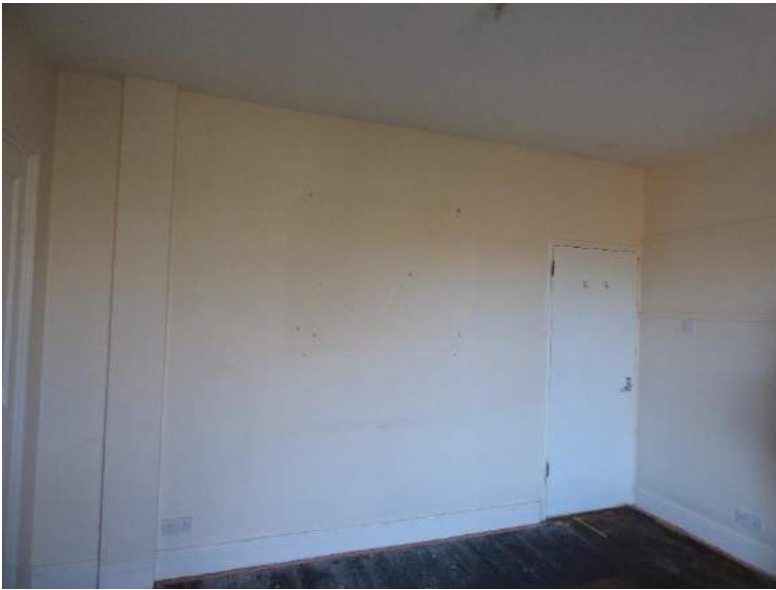
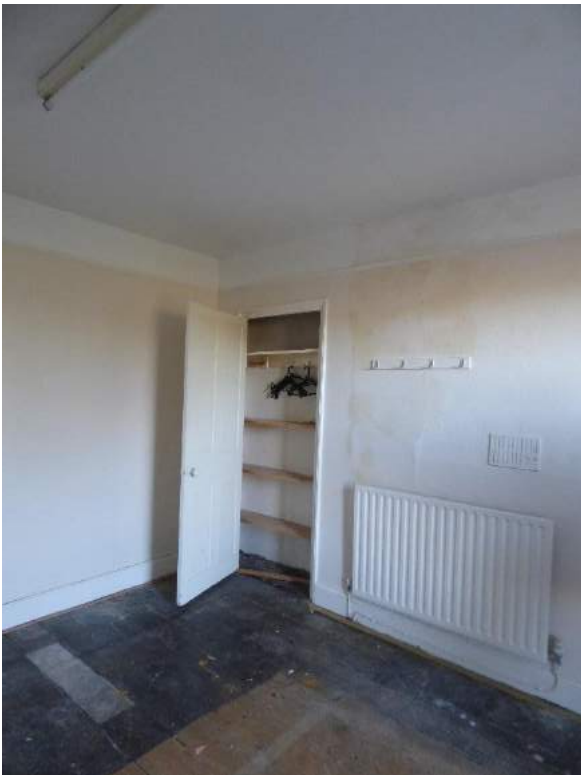
Existing floorboards generally in good condition.

Front bedroom (First floor LHS), cornice, skirtings and architraves to be retained. Existing flush panelled door to be replaced with new Georgian heritage style 4 panel door to be provided and installed by specialist joinery company such as Batty Joinery Ltd.

Where possible it is proposed to refurbish any original doors with door closers and intumescent paint subject to building control approval.

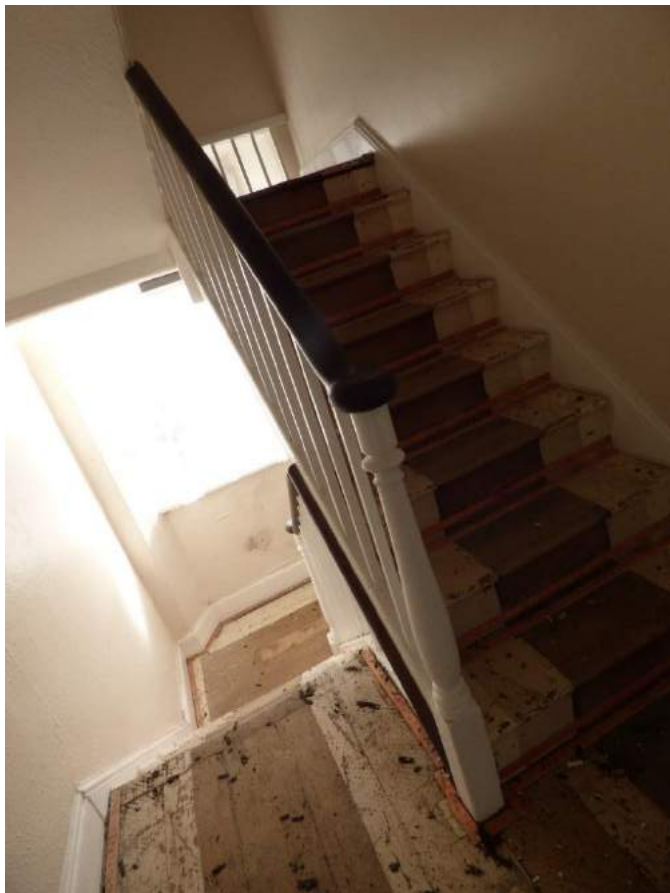
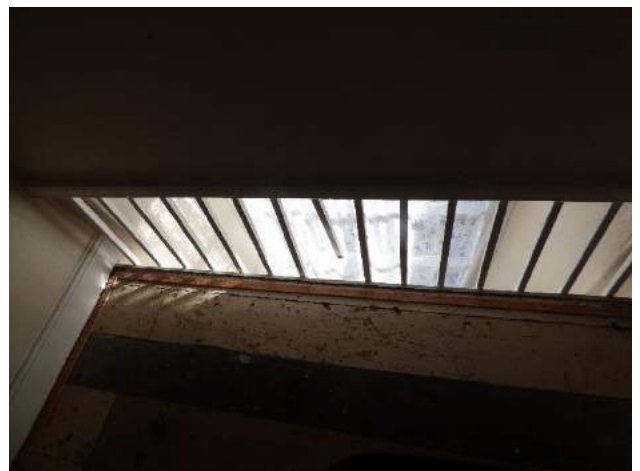
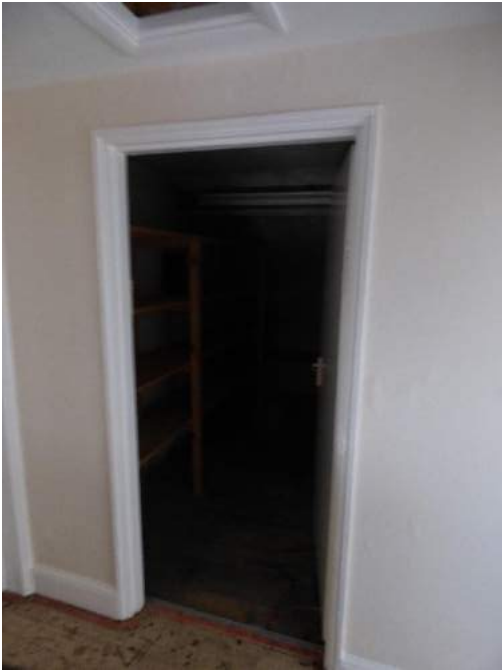
Left: Attic Store is proposed to be converted into a bathroom to be shared by the attic bedrooms by increasing the size of the room to each side to allow for the new bathroom.

Floorboards are in good condition (but may require minor repairs).

In the bedroom remove all damp and damaged / blown plasterwork and repair with lime plaster and skim and decorate throughout.

Existing modern flush panel doors are to be removed and replaced with new heritage style 4 panel doors.

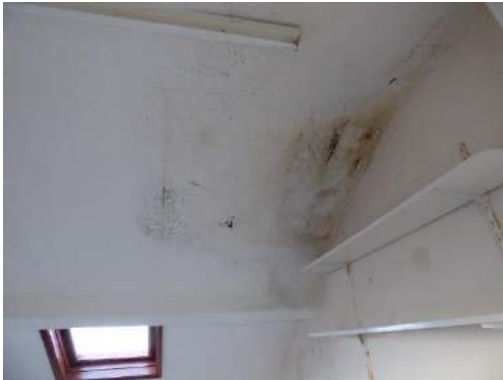
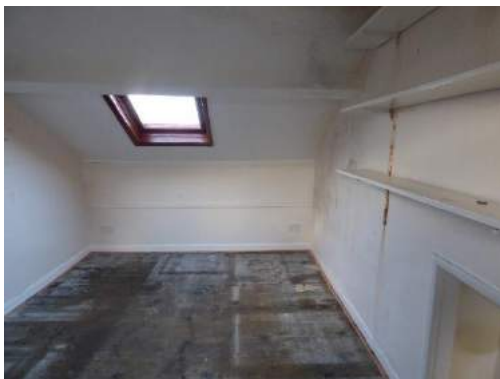
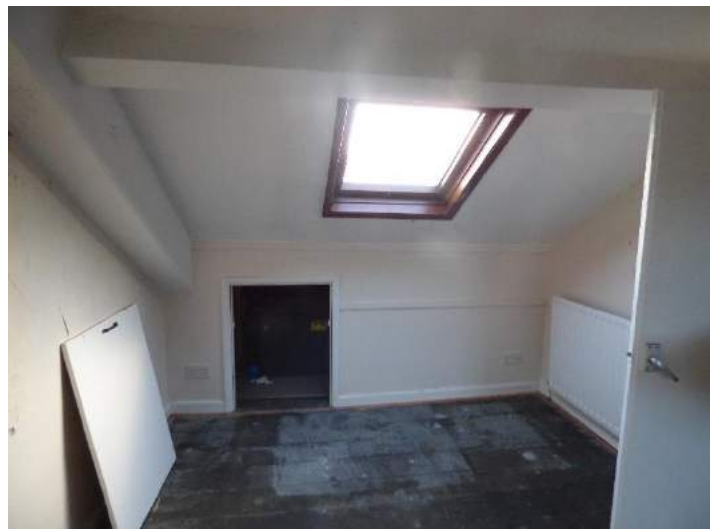
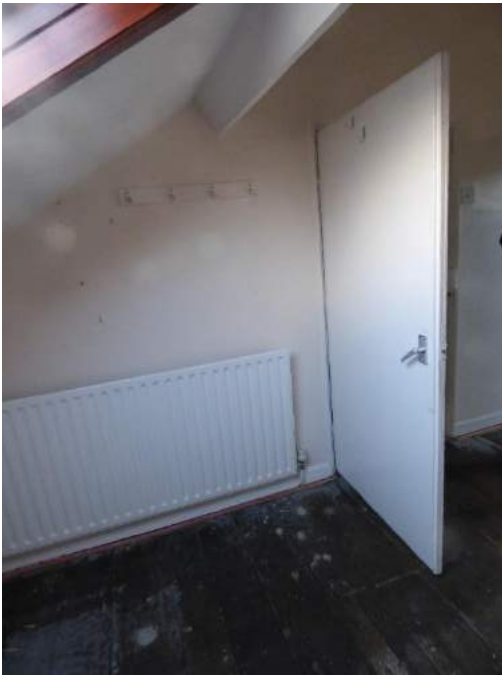
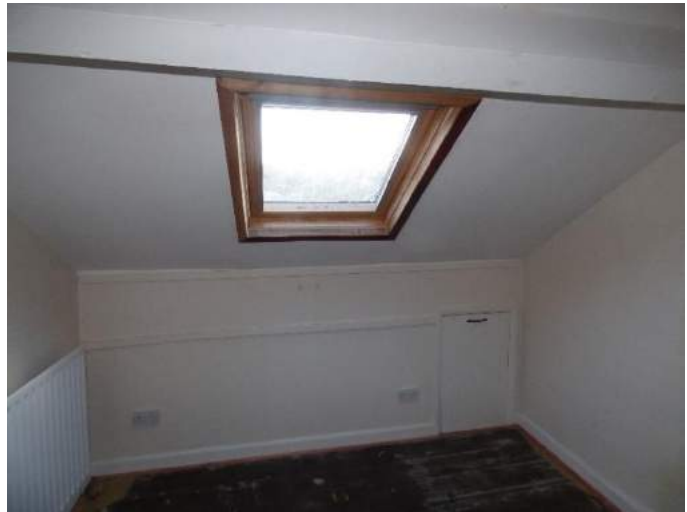
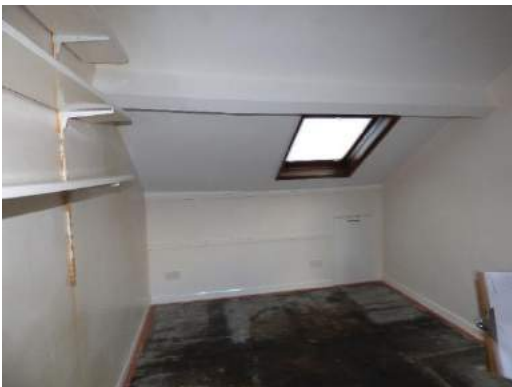
Left and below: Attic Bedroom.

Floorboards are generally in good condition (but may require minor

New plasterboard std partition to be installed in lieu of removal of part of existing store / bedroom partition to allow for bathroom to be useable size.

In the bedroom remove all damp and damaged / blown plasterwork and repair with lime plaster (Solo lime plaster from Lime Centre) and skim and decorate throughout.

Apply an insulated plasterboard 62mm thick to underside of ceiling tape and skim and undertake full decorations. Replace existing rooflights to with new heritage style rooflights (Velux or similar).

Existing modern flush panel doors are to be removed and replaced with new heritage style 4 panel fire doors.

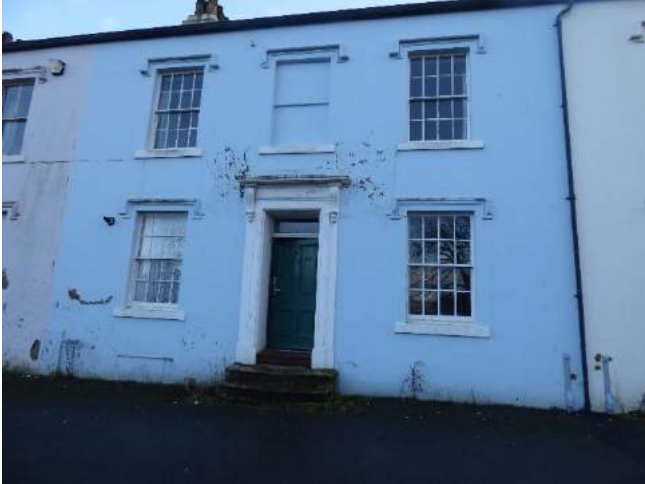
Left: The main entrance is mentioned in the listing text and is to be entirely retained.

Both front and rear elevations are currently rendered, with colour to the front and side and natural to the rear. All elevations require to be prepared for render repairs and redecoration by specialist using lime render and stucco (Parax LTD) to be applied by specialist.

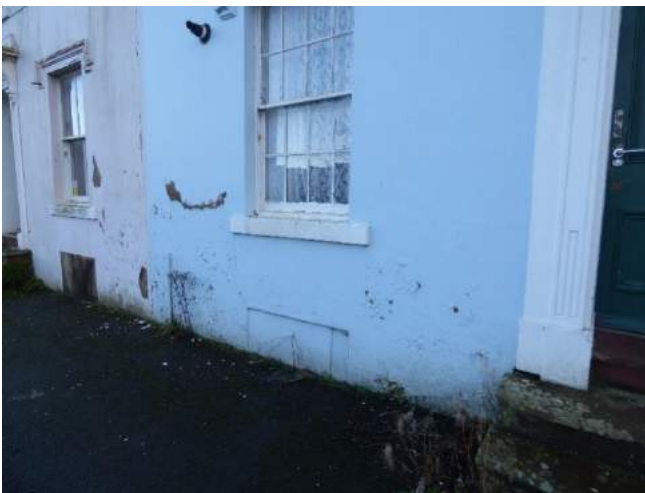
The stucco features above the windows and door on the front elevation will be carefully restored by a specialist. Colour of all render and stucco to match existing.

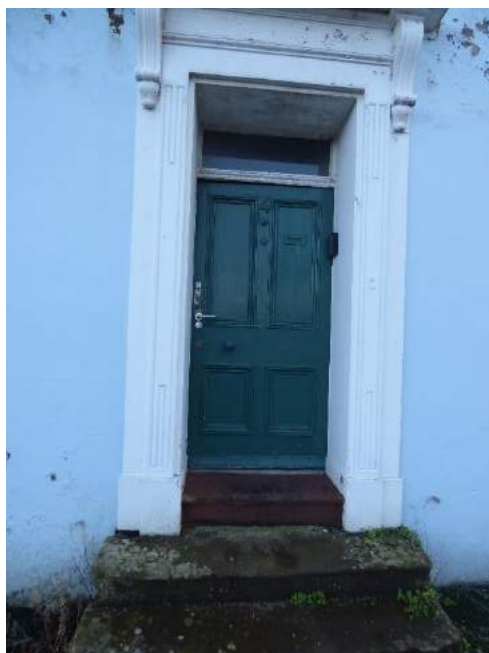
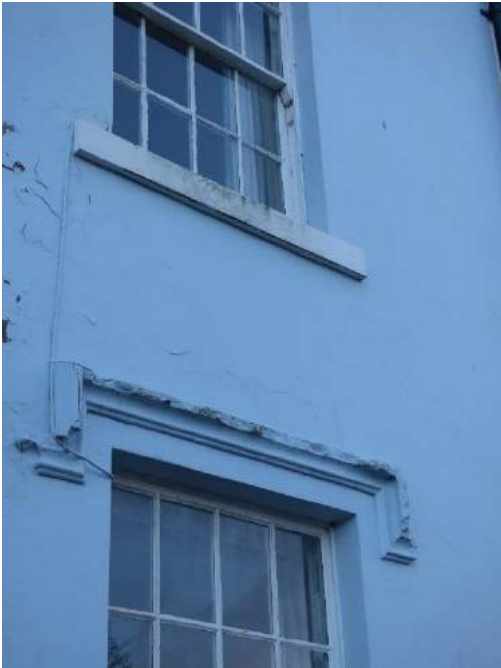
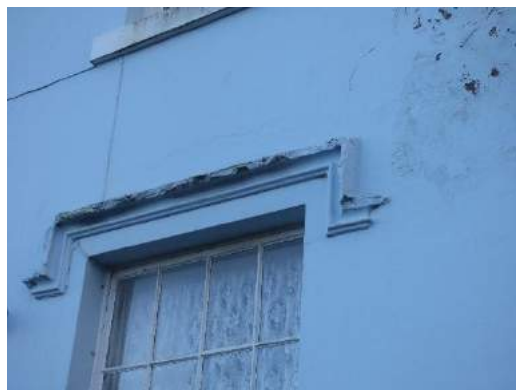
The existing door and frame are to be retained and made good with the provision of new ironmongery. Once repaired full decoration will be undertaken.

Existing gutters and downpipes to be retained, repaired where necessary and decorated.

All existing single glazed windows to either be refurbished with new double glazed slimline heritage sashes within the original frame or to be replaced with new white painted slim profile double glazed. If new heritage windows are to be provided the new 'heritage' windows to be provided by specialist supplier such as Batty Joinery, specialists in historic and listed building joinery works.

It is proposed to reinstate the handrails that would have originally been either side of the steps. Refer to details in D&A statement.

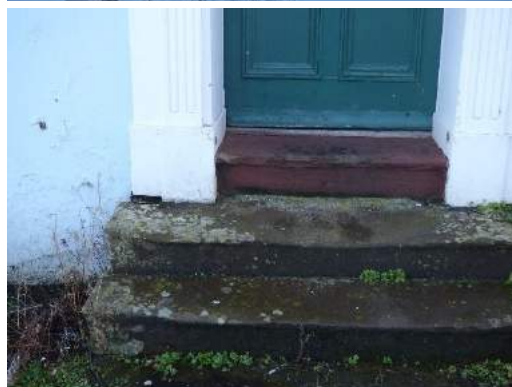
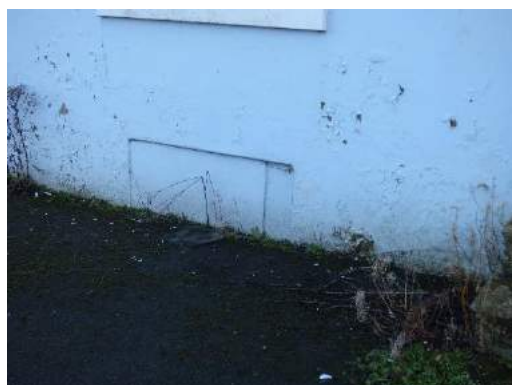
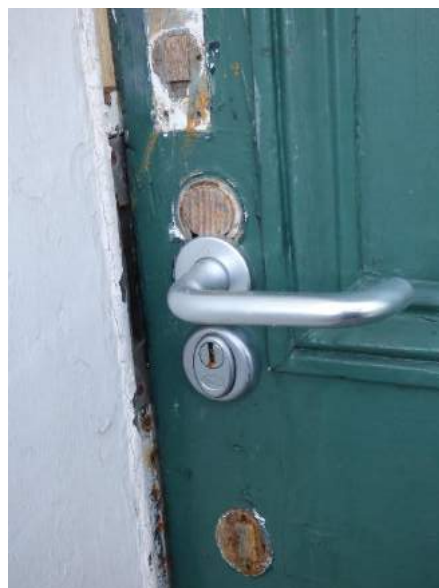
Below: Existing front door to be made good and redecorated.

The existing stone steps to be cleaned up, and new painted metal handrails provided, that would have originally been installed.

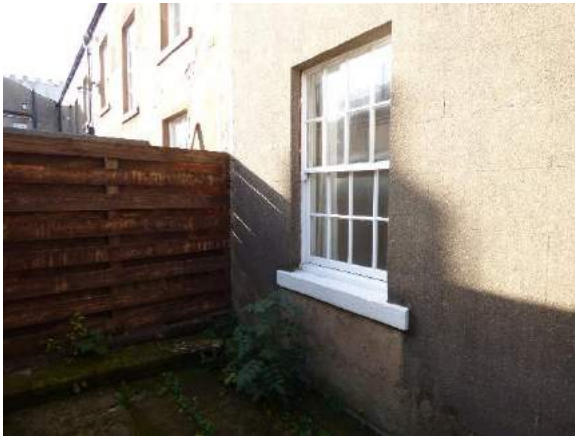
Left and below:

The rear courtyard is divided by a single storey 'link' building to an outbuilding at the rear. It is proposed to demolish this link structure as it is in extremely poor condition, and also to demolish the existing rear building, which was a mid-20<sup>th</sup> Century addition to the property to facilitate washroom accommodation for the boarding house, to provide additional amenity space for the property and allow more light into the existing dwelling.

All existing single glazed windows to either be refurbished with new double glazed slimline heritage sashes within the original frame or to be replaced with new white painted slim profile double glazed. If new heritage windows are to be provided the new

'heritage' windows to be provided by specialist supplier such as Batty Joinery, specialists in historic and listed building joinery works.

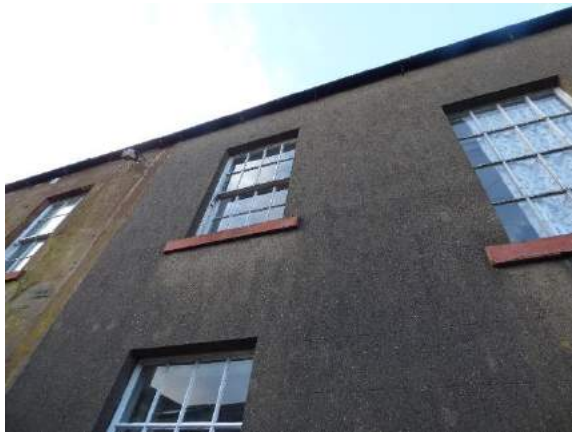
Rear of property – render to be repaired by specialist and decorated with off white render.

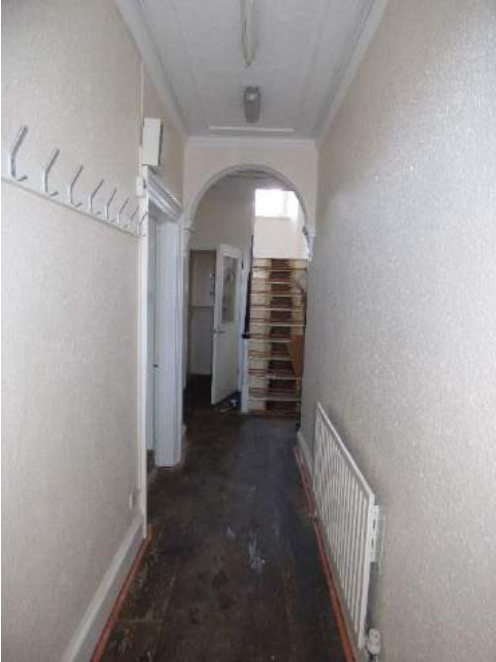
Left: The existing walls and floor are generally in good condition.

Redundant M&E to be removed and wall / ceiling finishes made good, and primed, prepared, and fully decorated.

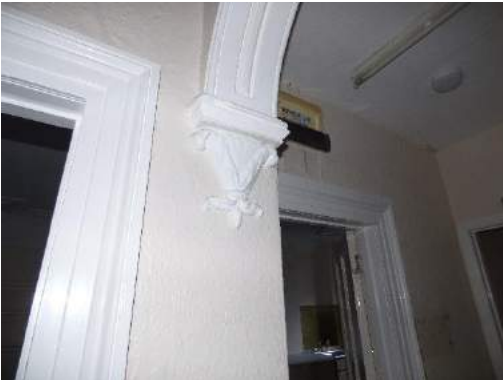
Left: period features to be retained, including archway and architraves. (Modern lighting to all be stripped out and make good surfaces). All architraves and plaster features to be retained.

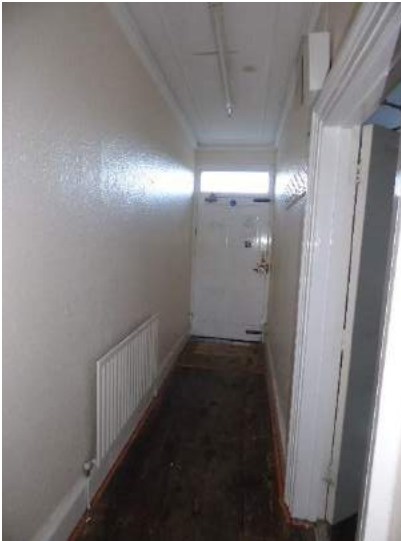
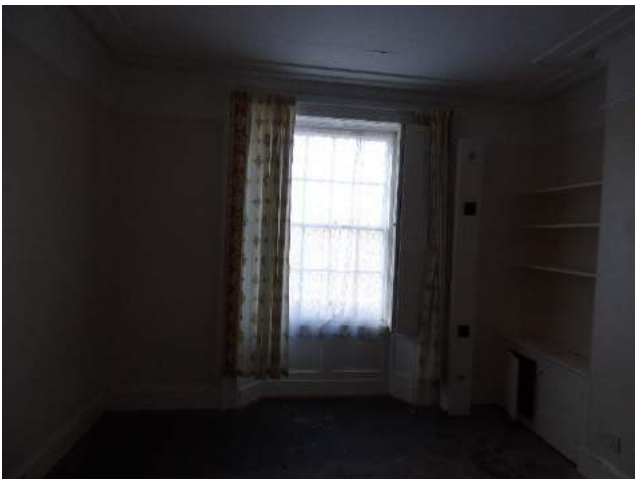
Left: In the existing study, the period features below and to the sides of the existing window are in good condition, it is proposed to carefully refurbish the existing timber shutters.

Left: Existing cornice to be made good in locations where redundant services are to be removed and where hairline cracks have appeared.

Existing architraves, and skirtings to be retained and made good.

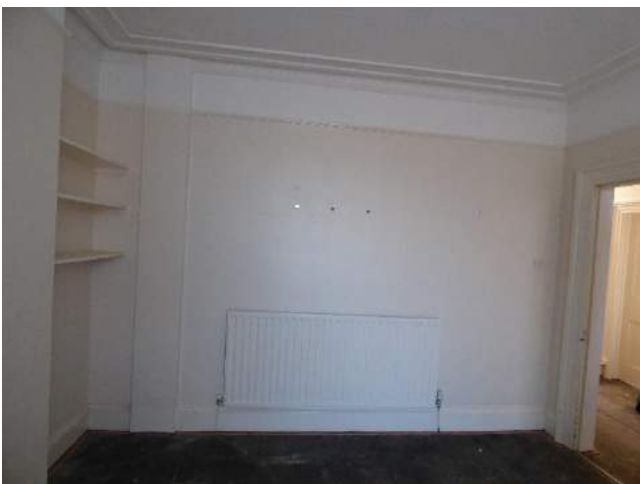
Flush panel doors to be replaced with heritage style 4 panel painted timber fire doors to enhance the heritage asset.

Where possible it is proposed to refurbish any original doors with door closers and intumescent paint subject to building control approval.

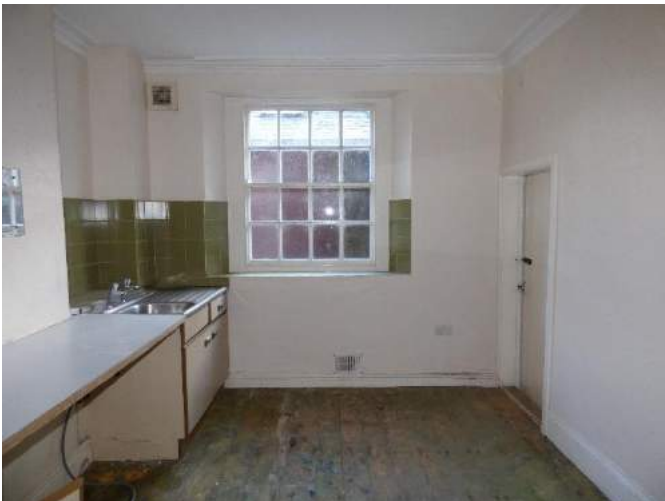
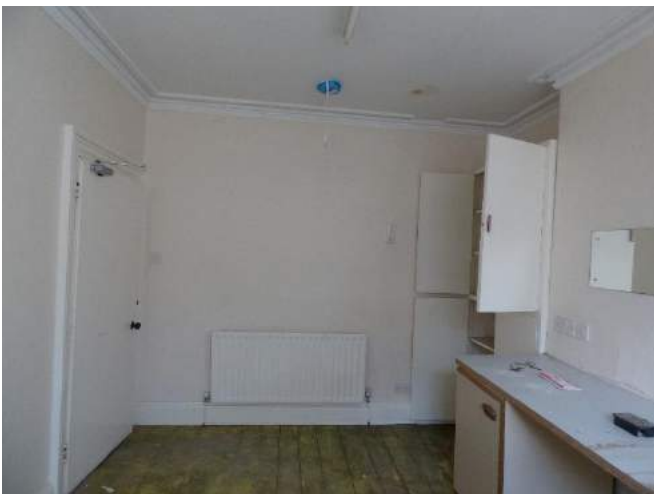
Left and below: the existing kitchen area to the rear of the property, the period features below and to the sides of the existing window are in good condition.

Below: Existing cornice to be made good in locations and where hairline cracks have appeared.

Flush panel doors to be replaced with heritage style 4 panel painted timber fire doors to enhance the heritage asset.

Where possible it is proposed to refurbish any original doors with door closers and intumescent paint subject to building control approval.

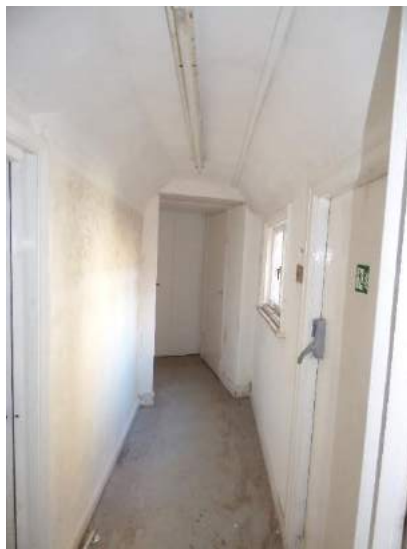
Left: Existing single skin link building extension to be removed.

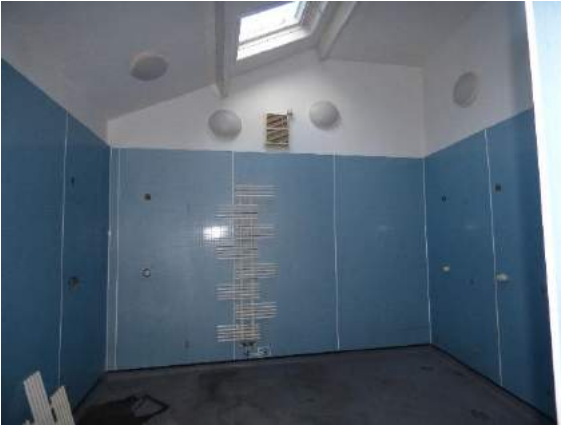
Left: Shower block to be removed to provide additional amenity space to the property. Not original building. Constructed mid-20<sup>th</sup> Century to provide washroom facilities for the boarding house.

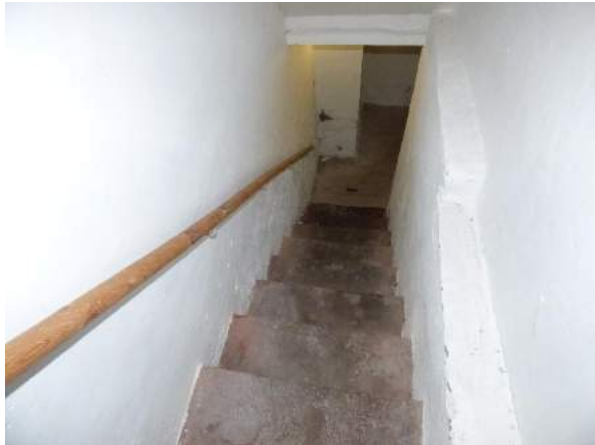
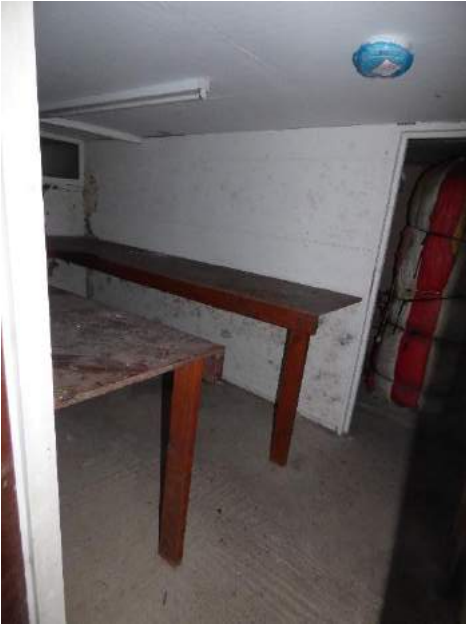
The existing walls and floor to the basement are generally in sound condition so would be suitable for the application of damp proof slurry system. All existing paint and surface finishes must be removed and made good including all snots removed, and damage to existing surfaces, prior to the installation of a Koster Polysil NB1. This migratory crystalline tanking slurry is used to seal below ground structures against water ingress.

Koster NB1 is considered to be a Type A waterproofing system as defined by BS8102:2009 and is generally used to seal the inside face of basement structures, slabs and retaining walls.

Koster NB1 works by both providing a physical barrier against water ingress as well as providing a migratory crystal sealant that penetrates deep into the structure to seal micropores and cracks against water ingress.

Once applied then the walls can be prepared and primed for decorating and for the floor finish to be installed. Complete new boiler and heating system is required, new distribution boards etc.

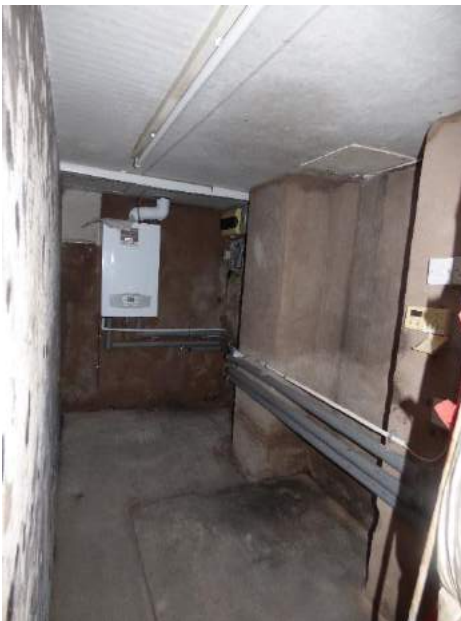
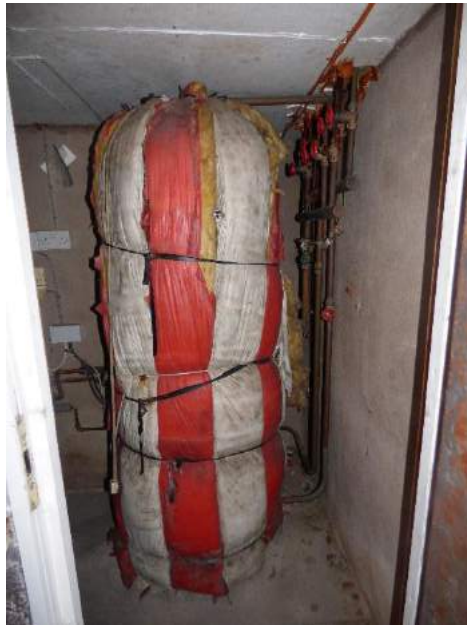
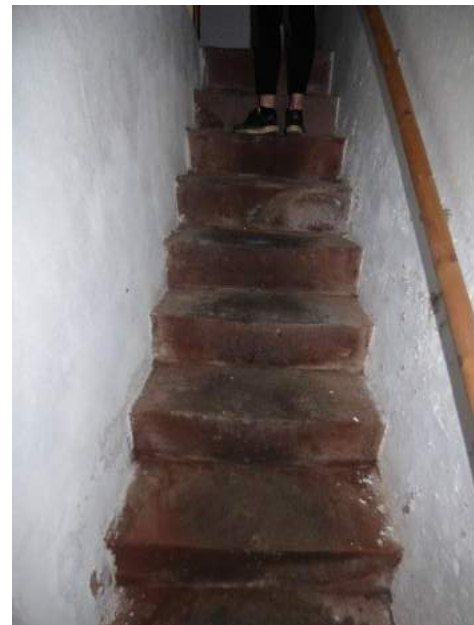
The walls down to the basement also require the full treatment.

Existing window to basement has been walled up. This is to be removed and reveals made good. Allow for the installation of a new double glazed heritage style window. We propose side hinged casements for the basement windows.

In the basement all existing services are to be carefully stripped out and replaced with new compliant infrastructure.

All existing services to be carefully removed and new gas and electric services installed.

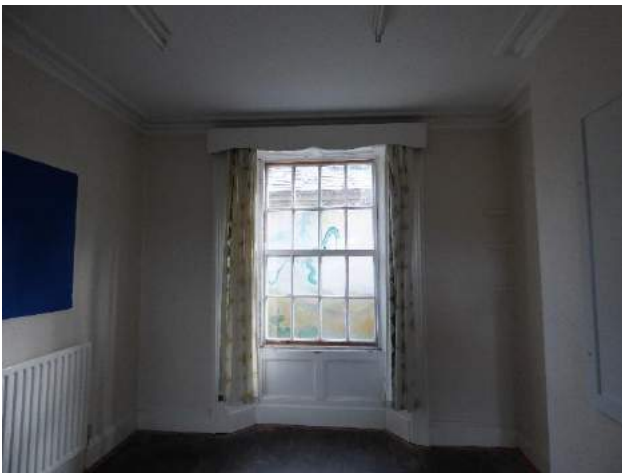
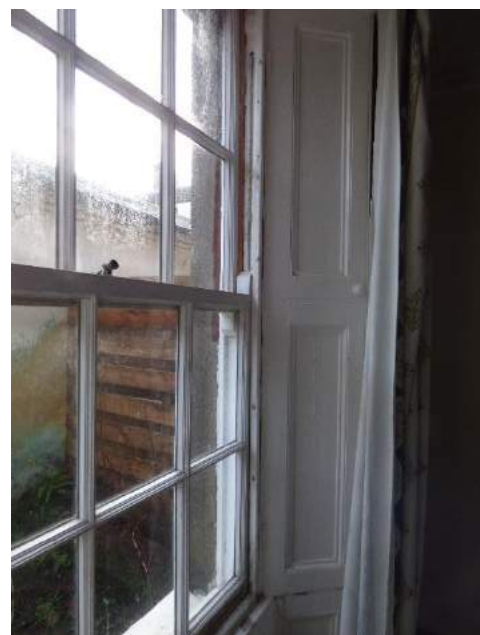
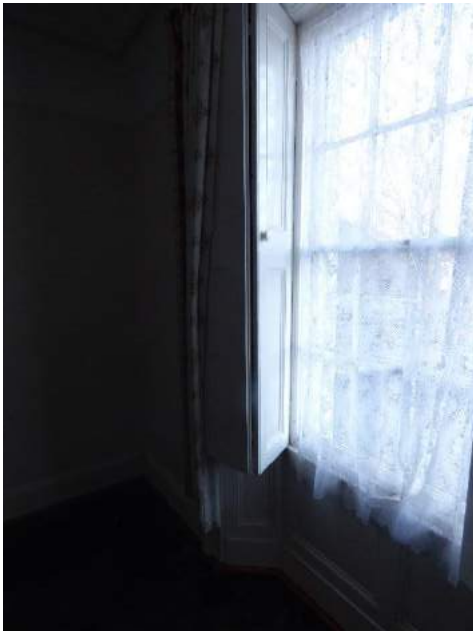
Above and Left: In the existing study, the period features below and to the sides of the existing windows both front and back are in good condition, it is proposed to carefully refurbish the existing timber shutters.

Existing cornice to be made good in locations where redundant services are to be removed and where hairline cracks have appeared.

Flush panel doors to be replaced with heritage style 4 panel painted timber fire doors to enhance the heritage asset.

Where possible it is proposed to refurbish any original doors with door closers and intumescent paint subject to building control approval.

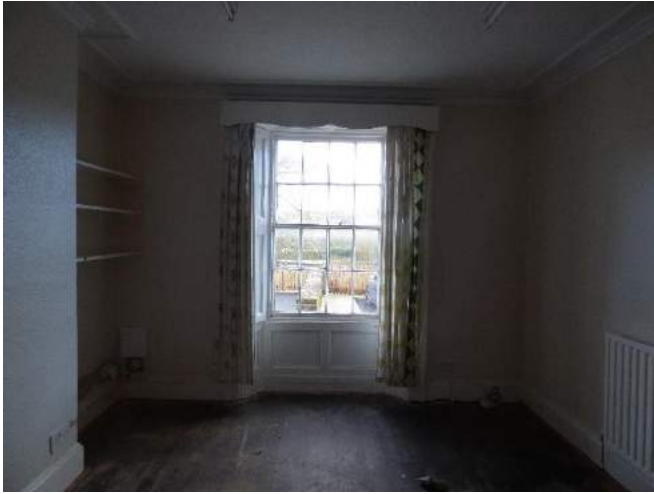
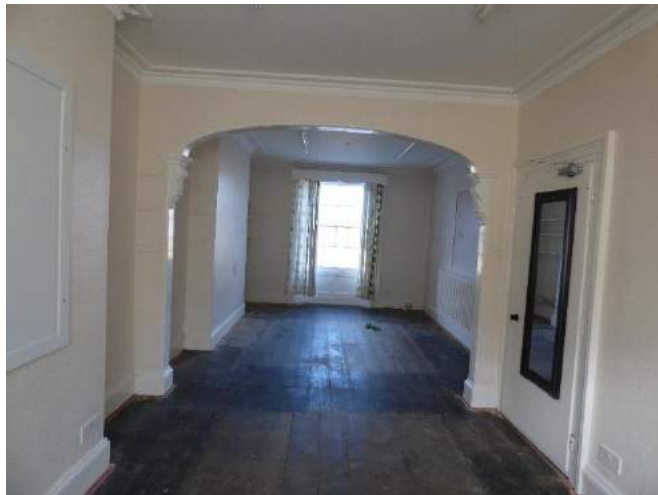
Left: period features to be retained, including archway and architraves. (Modern lighting to all be stripped out and make good surfaces). All architraves and plaster features to be retained.

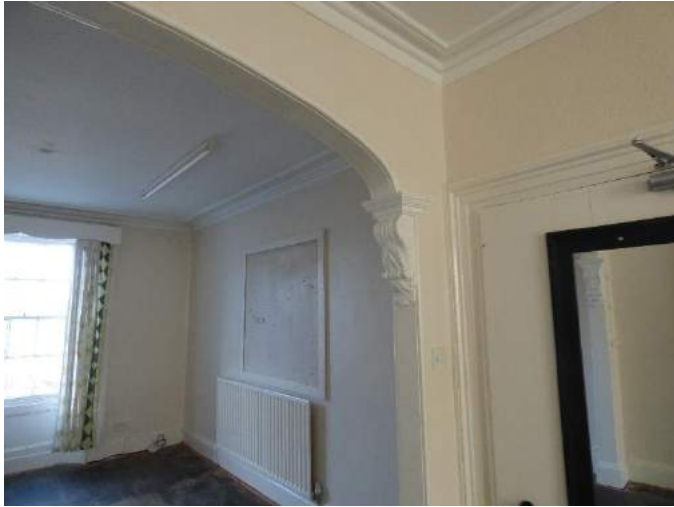
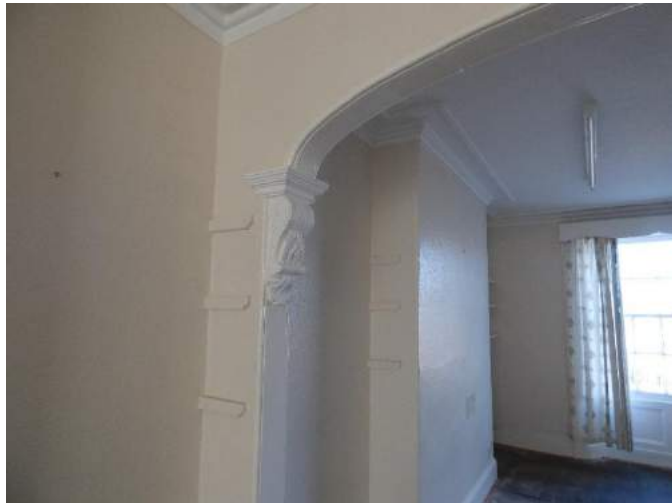
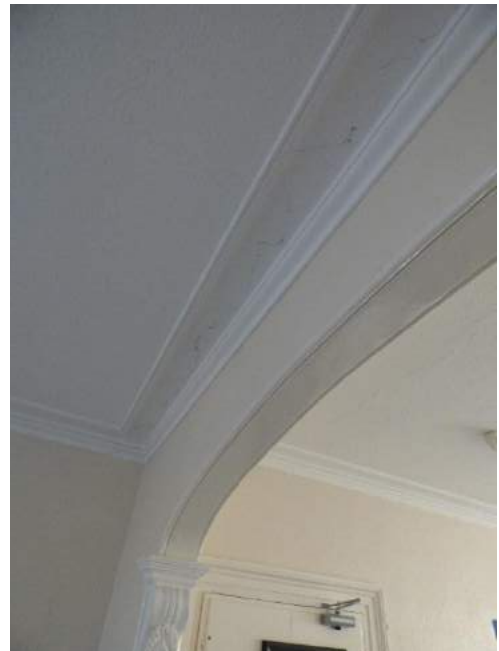
Above and Left: In the existing lounge, the period features below and to the sides of the existing windows both front and back are in good condition, it is proposed to carefully refurbish the existing timber shutters.

Existing cornice to be made good in locations where redundant services are to be removed and where hairline cracks have appeared.

Flush panel doors to be replaced with heritage style four panel painted timber fire doors to enhance the heritage asset. Where possible it is proposed to refurbish any original doors with door closers and intumescent paint subject to building control approval.
