# HERITAGE STATEMENT

## FULL RENOVATION OF EXISTING No 11 TERRACE HOUSES

St Bees, 1-11 Lonsdale Terrace, Parish Council, Cumbria

M.A.C Architects, Project Number: 2019:303

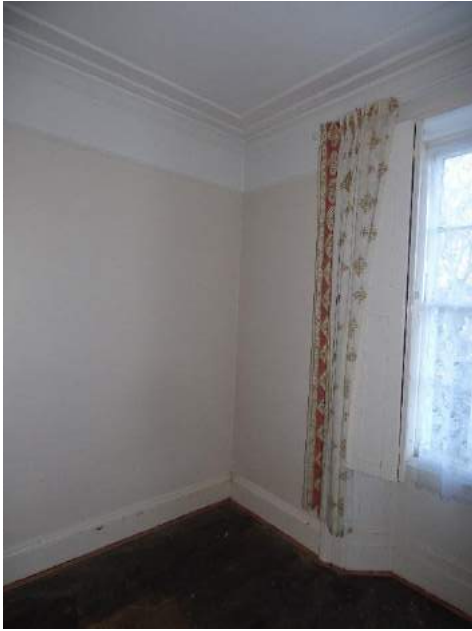
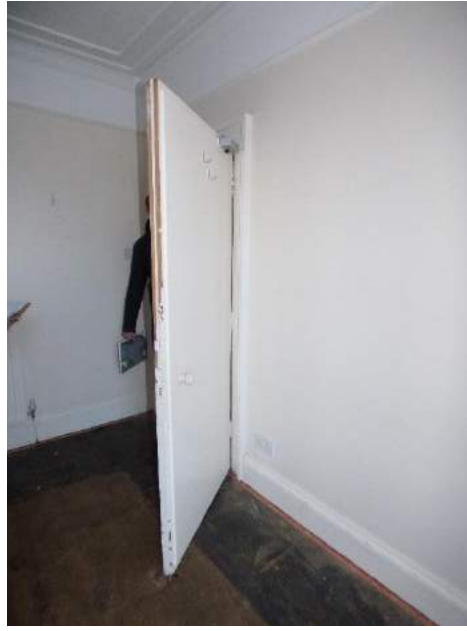
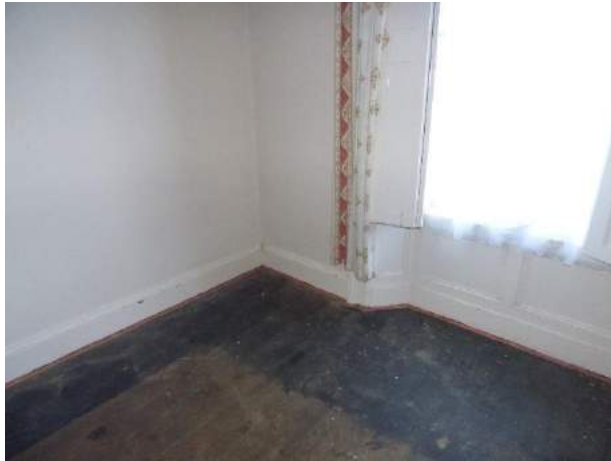
Above and Left: In the existing lounge, the period features below and to the sides of the existing windows both front and back are in good condition, it is proposed to carefully refurbish the existing timber shutters.

Existing cornice to be made good in locations where redundant services are to be removed and where hairline cracks have appeared.

Existing architraves, and skirtings to be retained and made good.

Flush panel doors to be replaced with heritage style four panel painted timber fire doors to enhance the heritage asset. Where possible it is proposed to refurbish any original doors with door closers and intumescent paint subject to building control approval.

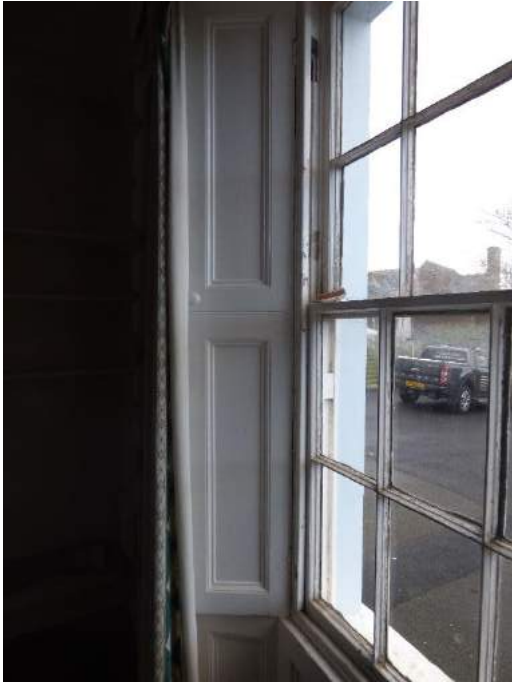
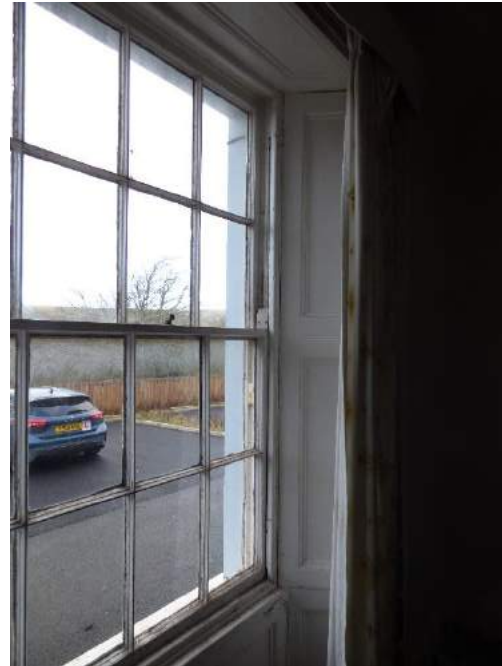
Above: In the existing lounge, the period features below and to the sides of the existing windows both front and back are in good condition, it is proposed to carefully refurbish the existing timber shutters.

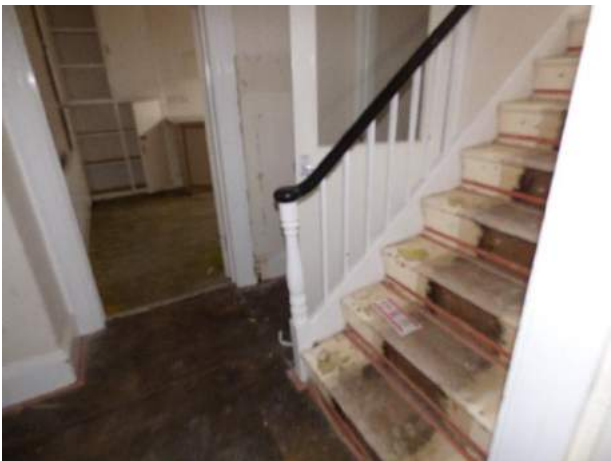
Retain original staircase, which is in good condition.

The requirement for the steel post at the top of the staircase

To be confirmed by structural engineer, if possible, the intention is to remove and strengthen the balusters if required to revert to the original staircase detail.

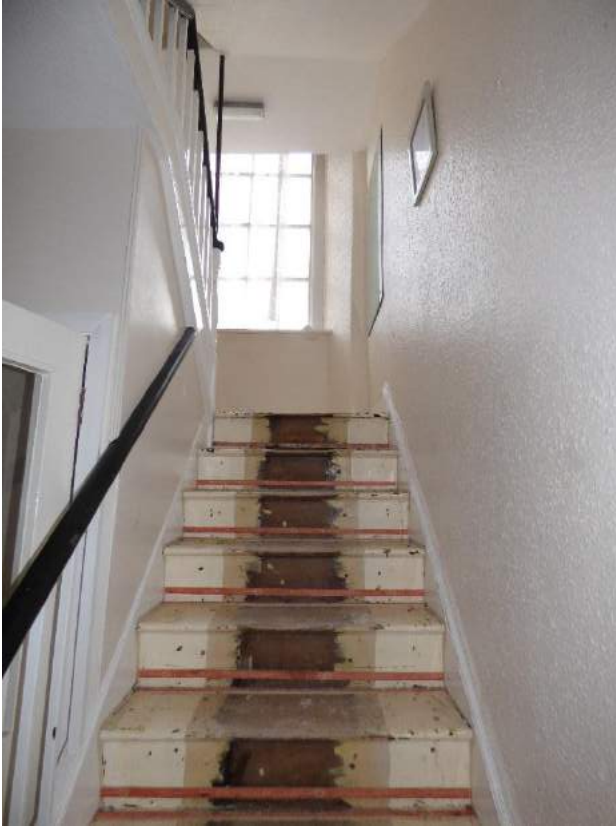
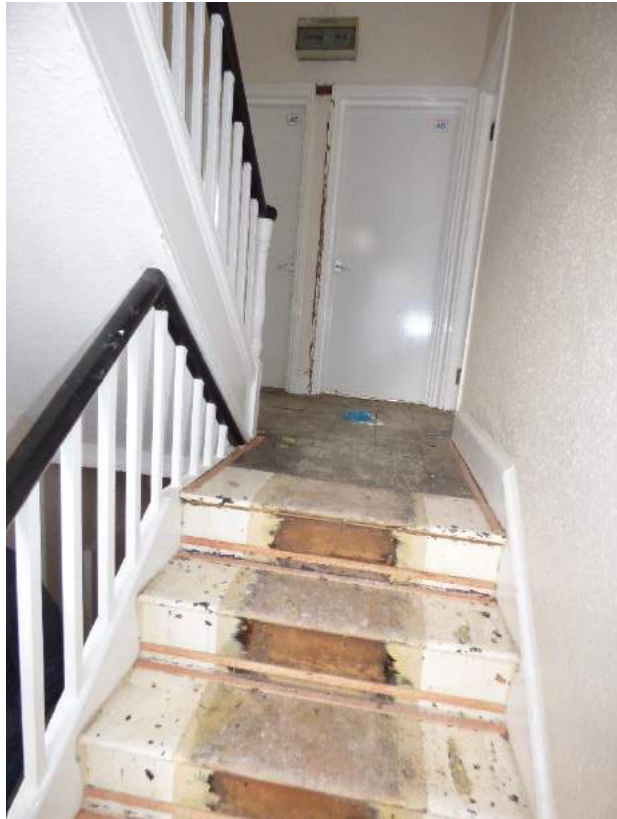
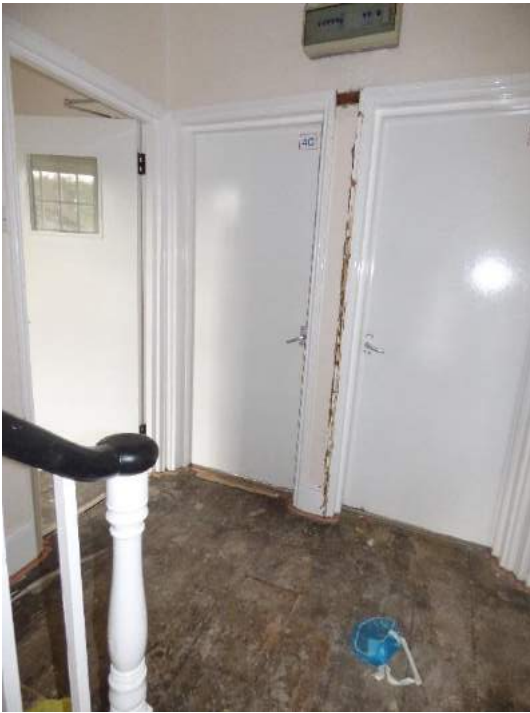
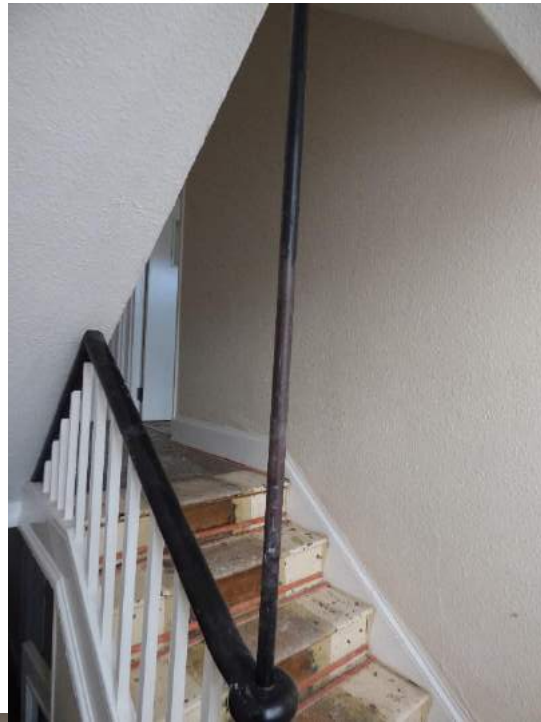
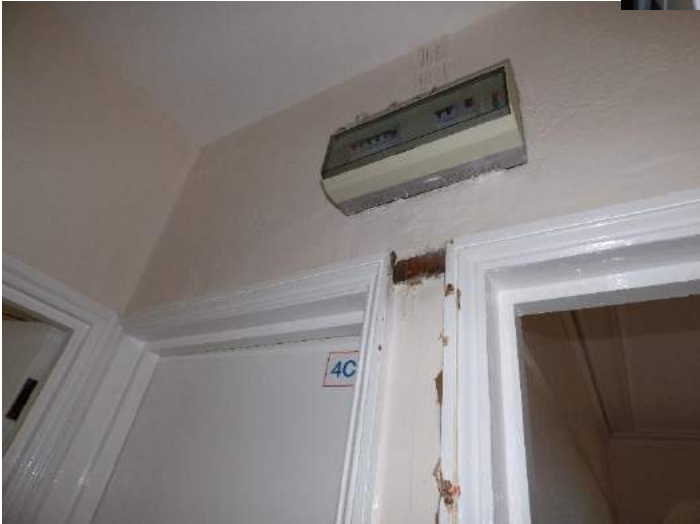
Original architraves to be retained.

Redundant M&E fixtures and fittings to be removed and surfaces made good.

Flush panel doors to be replaced with heritage style Georgian 4 panel fire doors.

Where possible it is proposed to refurbish any original doors with door closers and intumescent paint subject to building control approval.

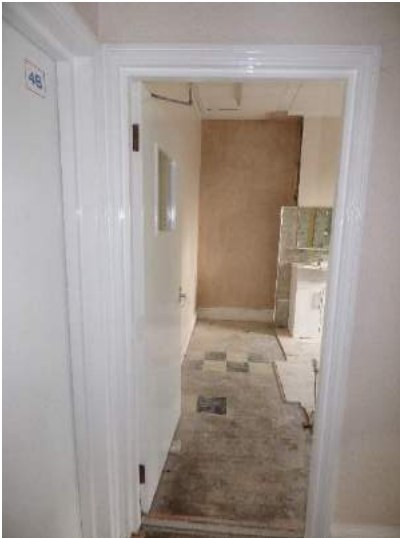
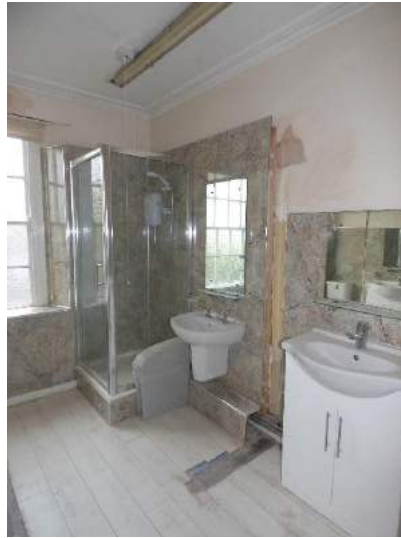
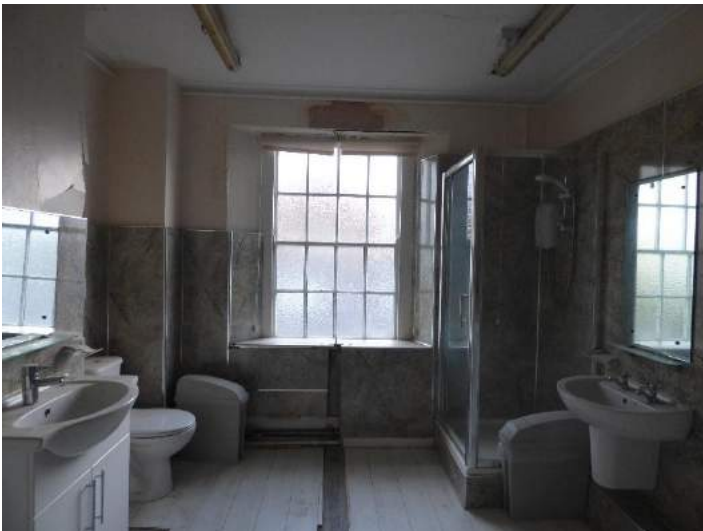
Left and above: Existing bathroom, to be completely renovated. All existing FF&E and M&E to be removed and all surface finishes to be completely removed and walls made good.

New Georgian heritage style four panel door to be provided and installed by specialist joinery company such as Batt Joinery Ltd. All fabric damage to be carefully repaired. To replace existing modern flush glazed door.

Bathroom to be reduced in size to allow for the installation of a new en-suite to the master bedroom.

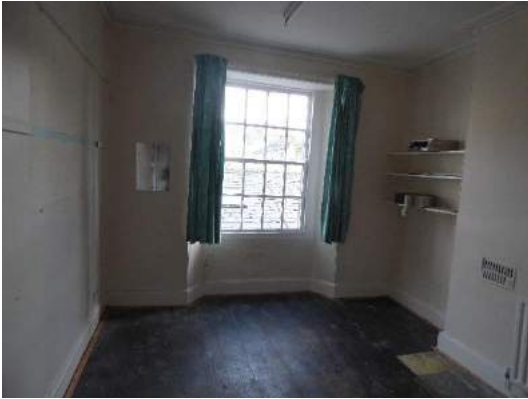
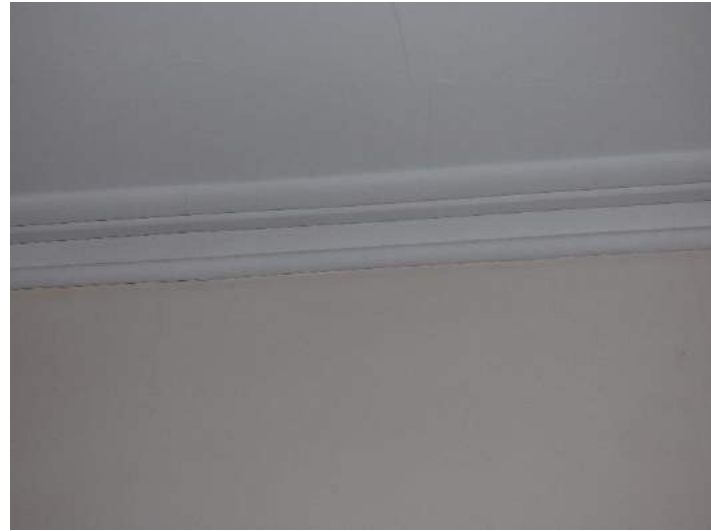
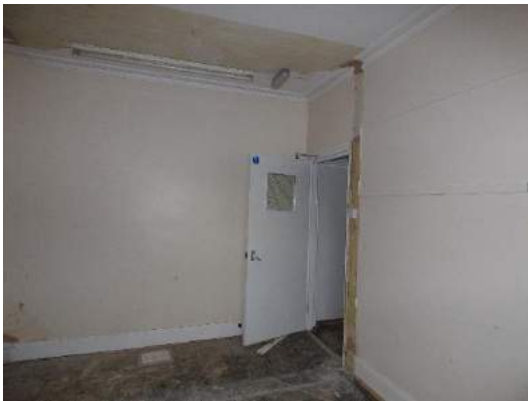
Left and above: Rear bedroom existing skirtings and architraves to be retained. Existing modern flush panelled door to be replaced with new Georgian heritage style four panel door to be provided and installed by specialist joinery company such as Batty Joinery Ltd.

Existing floorboards in good condition.

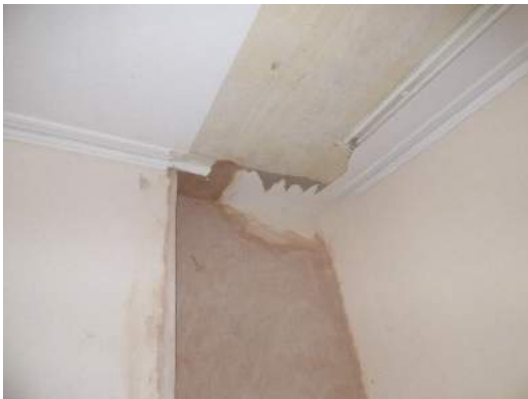
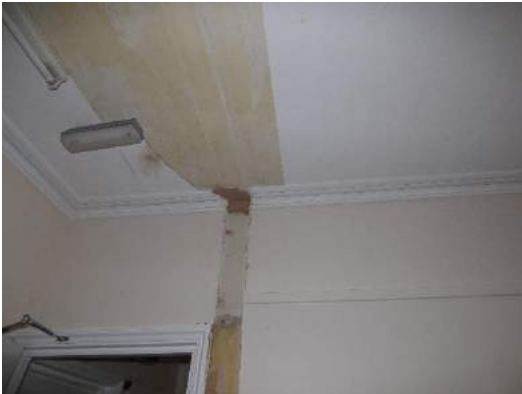
Front bedroom (First floor LHS), cornice, skirtings, and architraves to be retained.

Existing floorboards in good condition.

Existing flush panelled door to be replaced with new Georgian heritage style four panel door to be provided and installed by specialist joinery company such as Batty Joinery Ltd. Where possible it is proposed to refurbish any original doors with door closers and intumescent paint subject to building control approval.

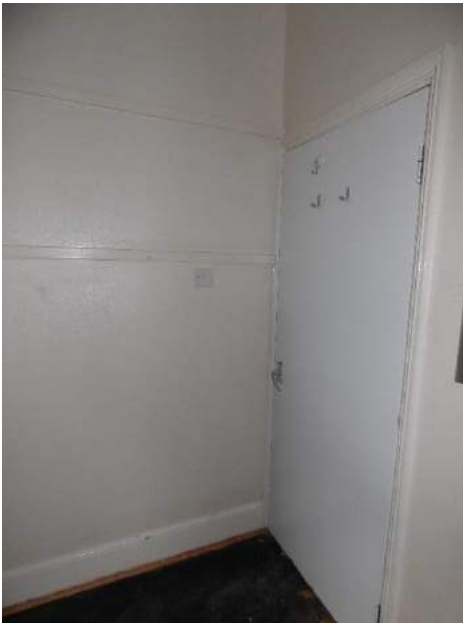
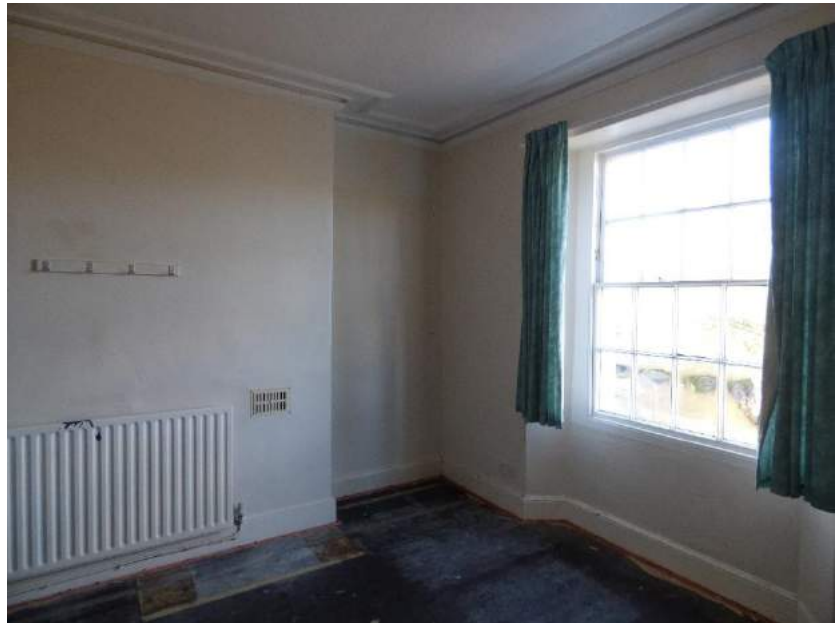
Front

bedroom (First floor RHS), cornice, skirtings and architraves to be retained. Existing flush panelled door to be replaced with new Georgian heritage style 4 panel door to be provided and installed by specialist joinery company such as Batty Joinery Ltd. Where possible it is proposed to refurbish any original doors with door closers and intumescent paint subject to building control approval.

Existing floorboards generally in good condition.

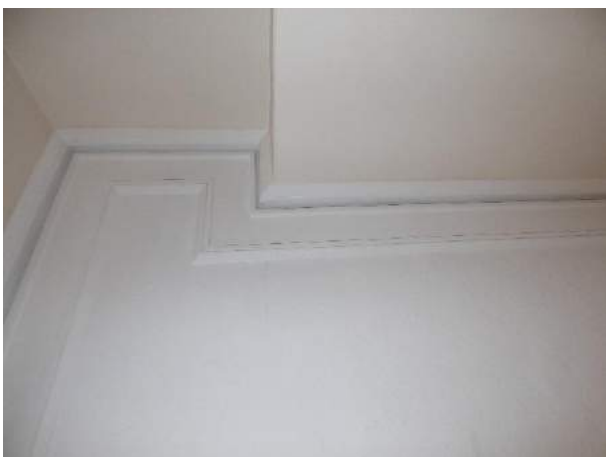
It is proposed to form new doorway with architraves to match existing, and new four panelled door, into a new en-suite to be formed from part of the existing over large bathroom to make efficient use of the space and reflect the requirements of modern-day living.

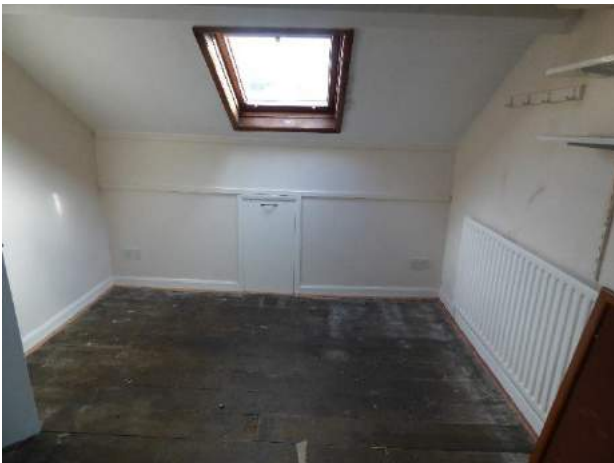
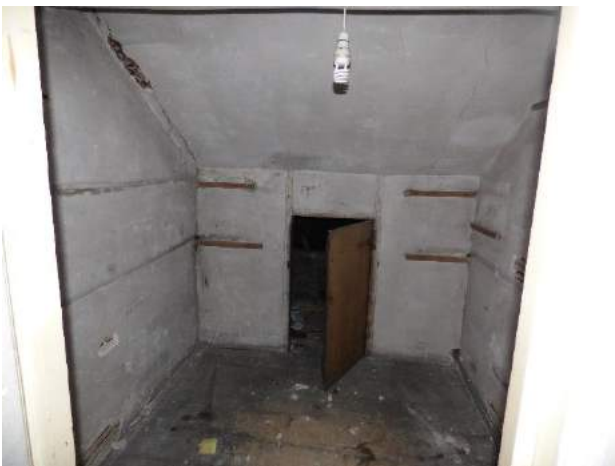
Left: Attic Store is proposed to be converted into a bathroom to be shared by the attic bedrooms by increasing the size of the room to each side to allow for the new bathroom.

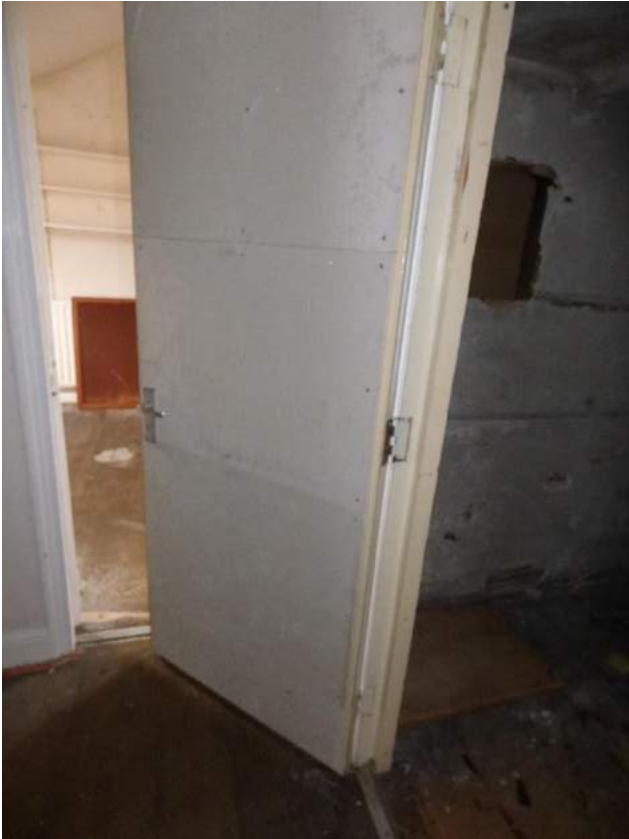
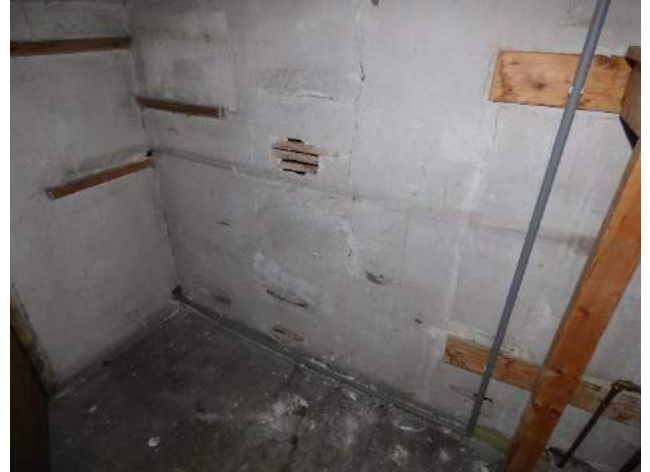
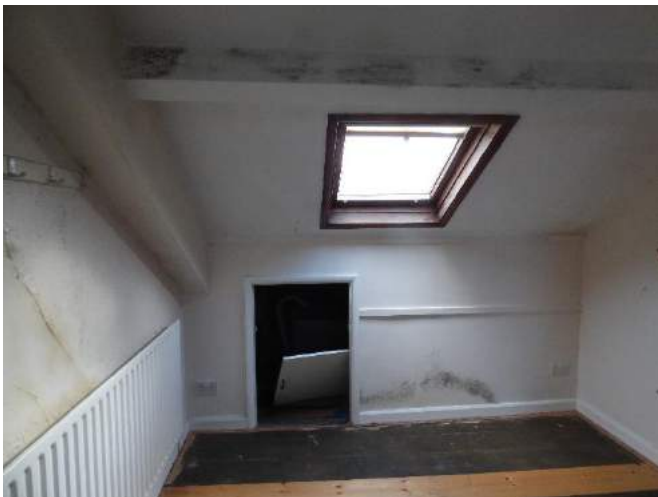
Left: Attic Bedroom

In the bedroom remove all damp and damaged / blown plasterwork and repair with lime plaster (Solo lime plaster from Lime Centre) and skim and decorate throughout.

Floorboards are in good condition (but may require minor repairs).

New plasterboard stud partition to be installed in lieu of removal of part of existing store / bedroom partition to allow for bathroom to be useable size.

Replace modern Velux windows with heritage rooflight windows (Velux or similar with flashing kit that mounts unit flush with the roof surface).

Existing flush panel doors are to be removed and replaced with new heritage style four panel fire doors.

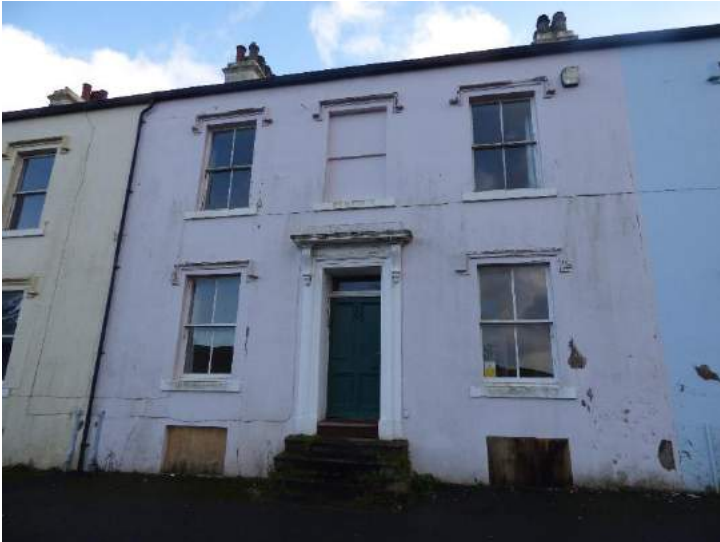
Left: The main entrance is mentioned in the listing text and is to be entirely retained.

Both front and rear elevations are currently rendered, with colour to the front and side and natural to the rear. All elevations require to be prepared for render repairs and redecoration by specialist using lime render and stucco (Parax LTD) to be applied by specialist.

The stucco features above the windows and door on the front elevation will be carefully restored by a specialist. Colour of all render and stucco to match existing.

The existing door and frame are to be retained and made good with the provision of new ironmongery. Once repaired full decoration will be undertaken.

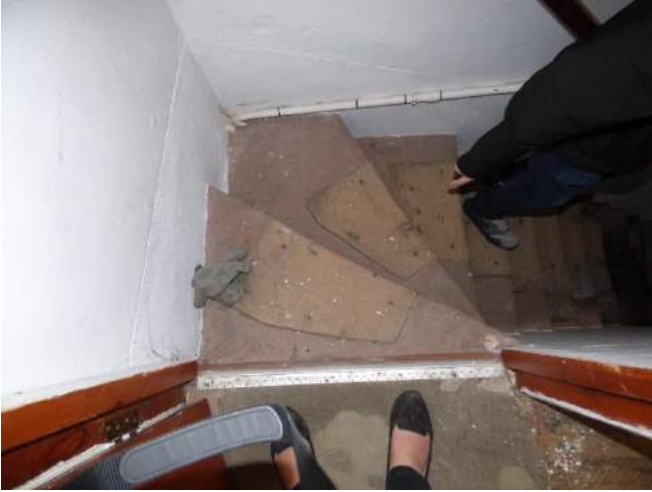
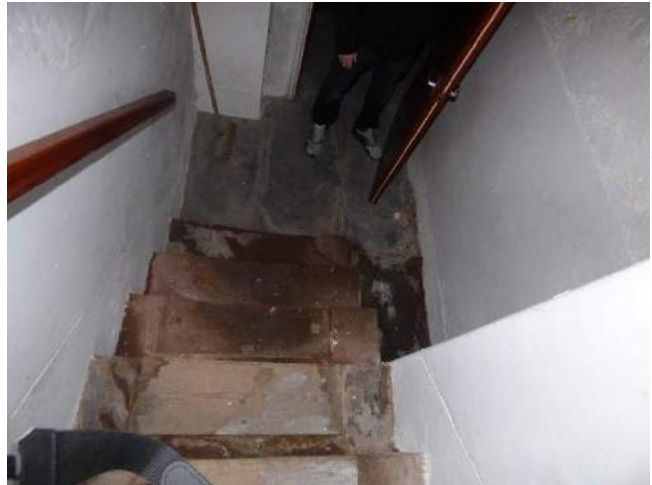
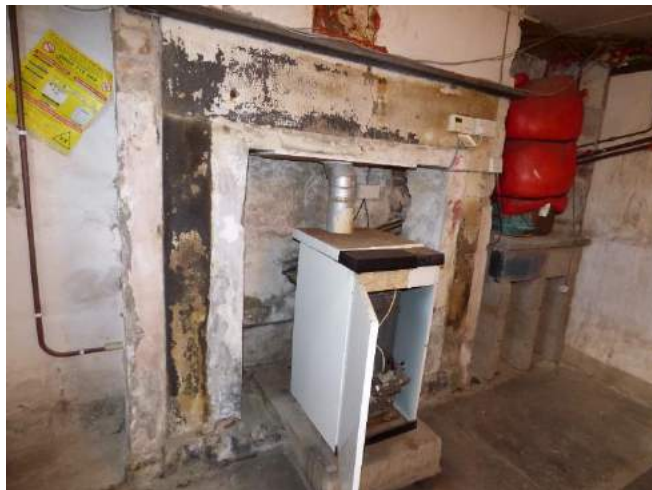
Left and above: Basement.

The existing walls and floor are generally in sound condition so would be suitable for the application of damp proof slurry system. All existing paint and surface finishes must be removed, and damage to existing paint and surface finishes must be removed and made good including all snots removed, and damage to existing surfaces, prior to the

Existing window to basement to be removed and replaced with new double glazed heritage window. Existing reveals to be made good.

All existing services to be carefully removed and new gas and electric services installed.

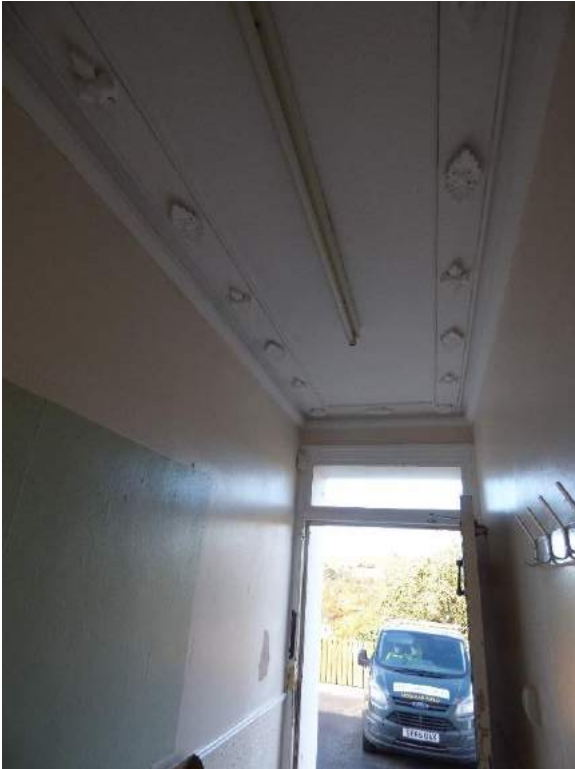
Left and below: The existing walls and floor are generally in good condition.

Redundant M&E to be removed and wall/ceiling finishes made good, and primed, prepared and fully decorated.

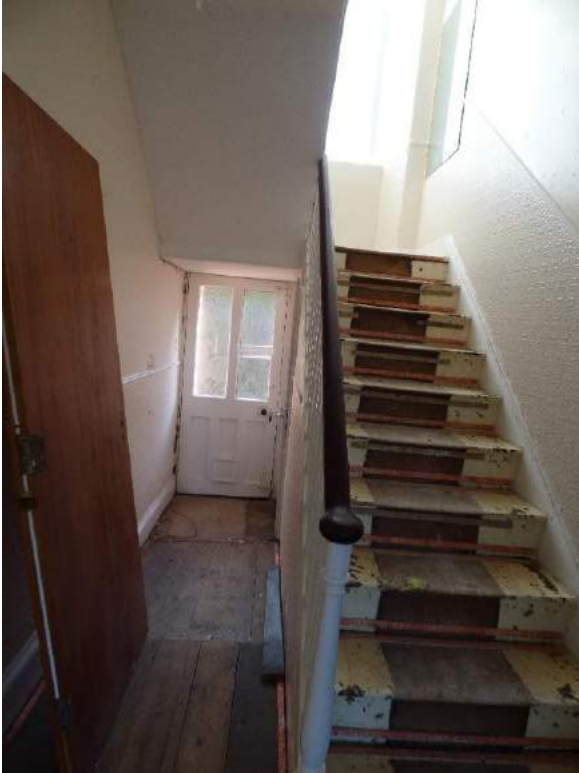
Retain original staircase, which is in good condition.

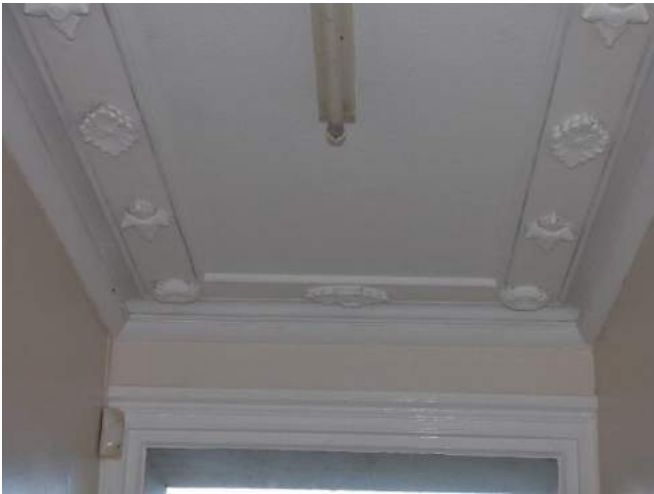
Left: Period features to be retained, including archway and architraves. (Modern lighting to all be stripped out and make good surfaces). All architraves and plaster features to be retained.

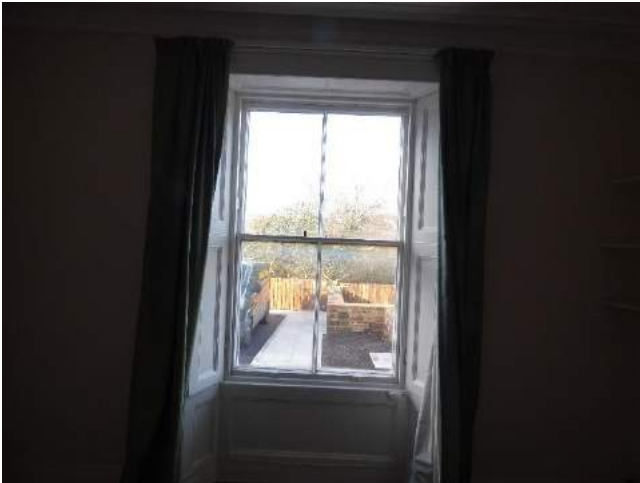
In the existing study, the period features below and to the sides of the existing window are in good condition, it is proposed to carefully refurbish the existing timber shutters.

Below: Existing cornice to be made good in locations where redundant services are to be removed and where hairline cracks have appeared.

Flush panel doors to be replaced with heritage style four panel painted timber fire doors to enhance the heritage asset.

Where possible it is proposed to refurbish any original doors with door closers and intumescent paint subject to building control approval.

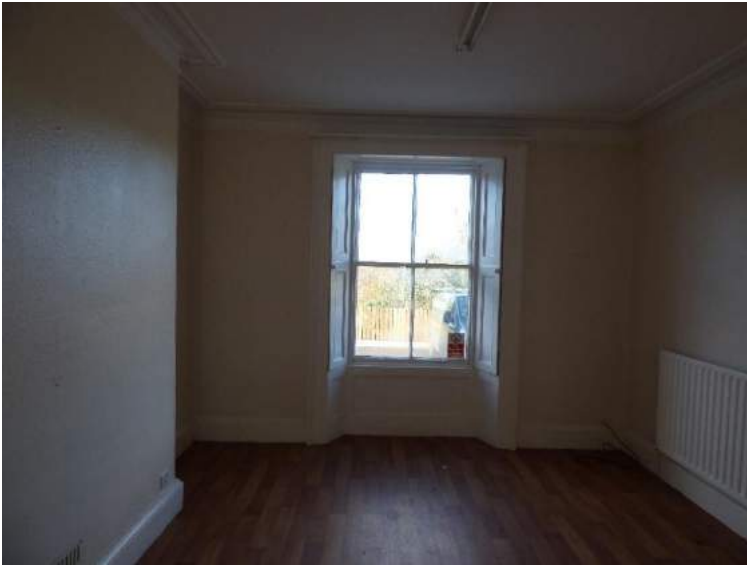
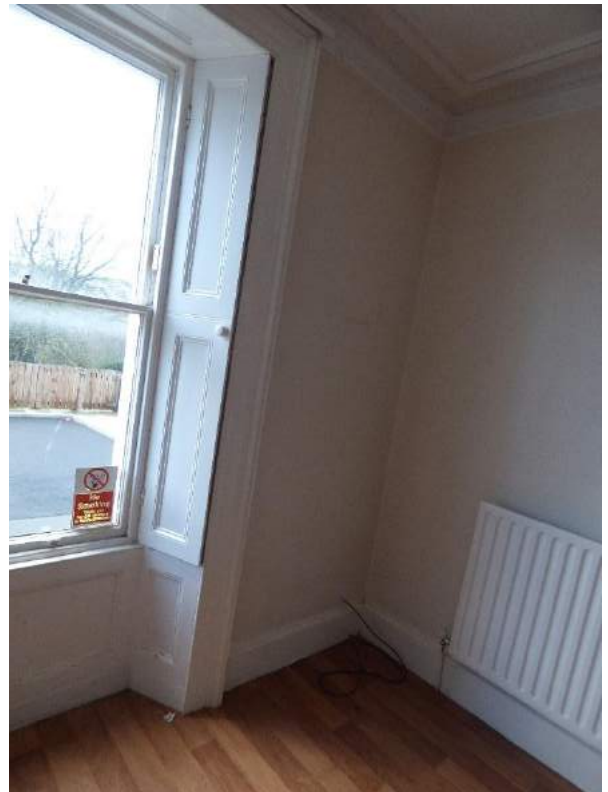
Above, right, and below: In the existing lounge at the front of the property and the existing dining area to the rear of the property, the period features below and to the sides of the existing window are in good condition, it is proposed to carefully refurbish the exiting timber shutters.

Below: Existing cornice to be made good in locations and where hairline cracks have appeared.

Existing architraves and skirtings to be retained and made

good.

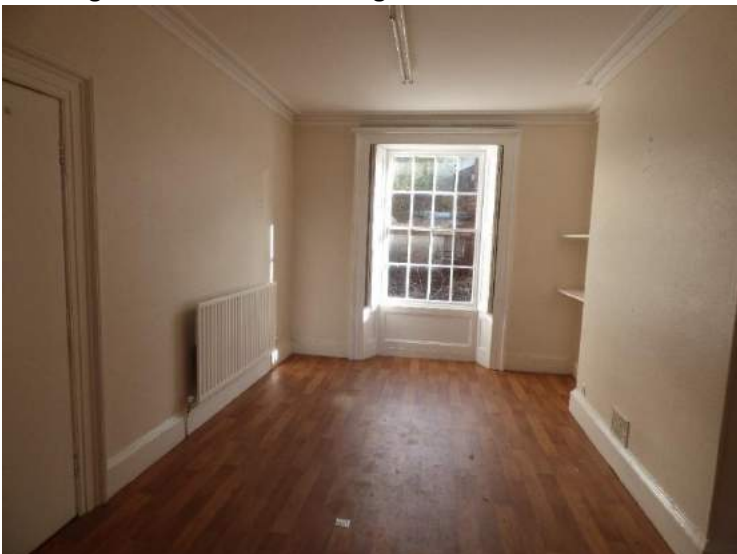
Below: In the existing lounge, the period features below and to the sides of the existing windows both front and back are in good condition, it is proposed to carefully refurbish the existing timber shutters

Existing cornice to be made good in locations where redundant services are to be removed and where hairline cracks have appeared.

Existing architraves and skirtings to be retained and repaired where necessary.

Flush panel doors to be replaced with heritage style for panel painted timber fire doors to enhance the heritage asset.

Where possible it is proposed to refurbish any original doors with door closers and intumescent paint subject to building control approval.

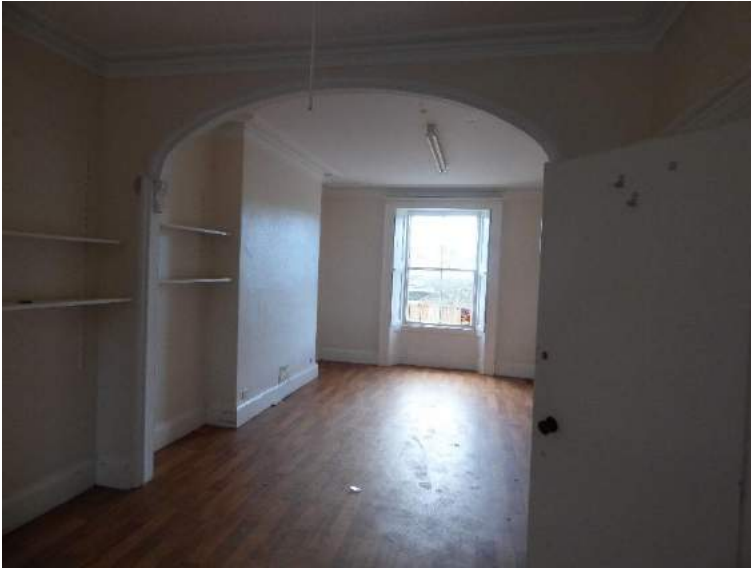
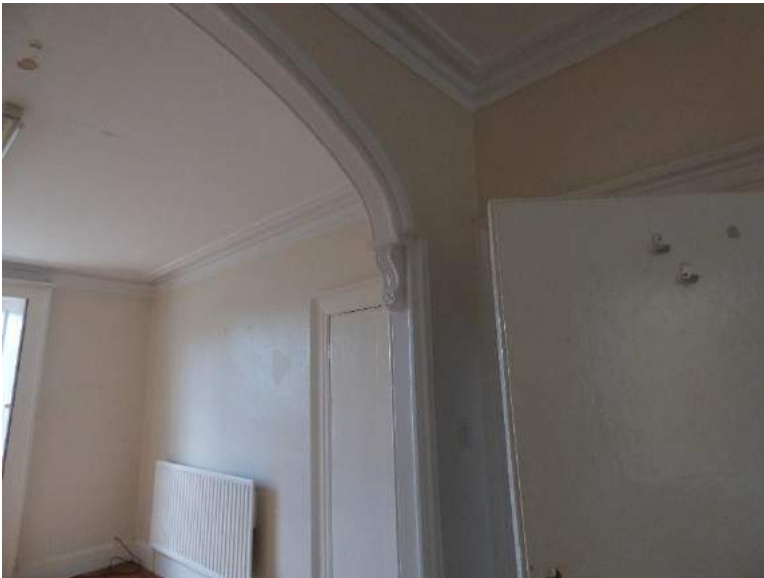
Left and below: In the existing lounge, the period features below and to the sides of the existing windows both front and back are in good condition, it is proposed to carefully refurbish the existing timber shutters.

Existing cornice to be made good in locations where redundant services are to be removed and where hairline cracks have appeared.

Existing architraves and skirtings to be retained and made good.

Flush panel doors to be replaced with heritage style four panel painted timber fire doors to enhance the heritage asset.

Where possible it is proposed to refurbish any original doors with door closers and intumescent paint subject to building control approval.

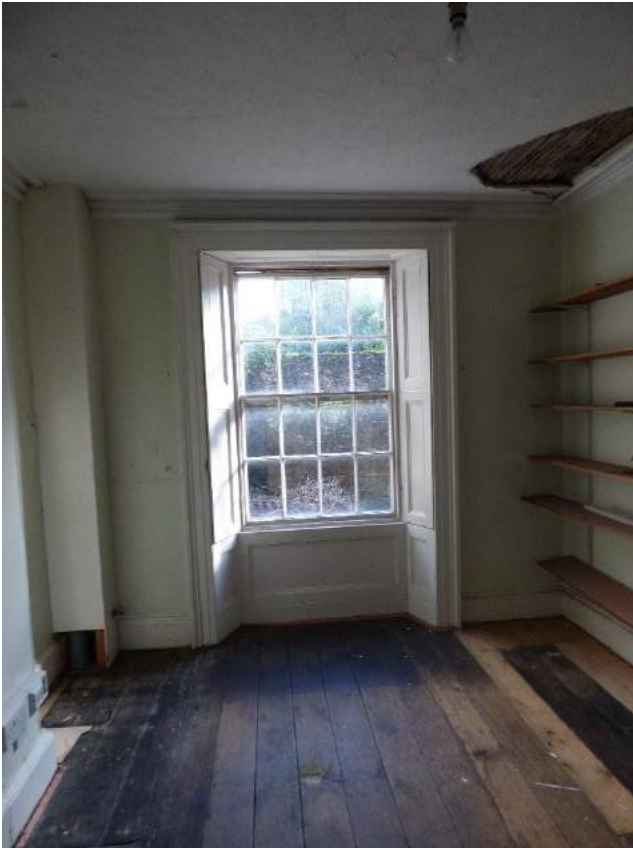
Above and right: period features to be retained, including archway and architraves. (Modern lighting to all be stripped out and make good surfaces). All architraves and plaster features to be retained.

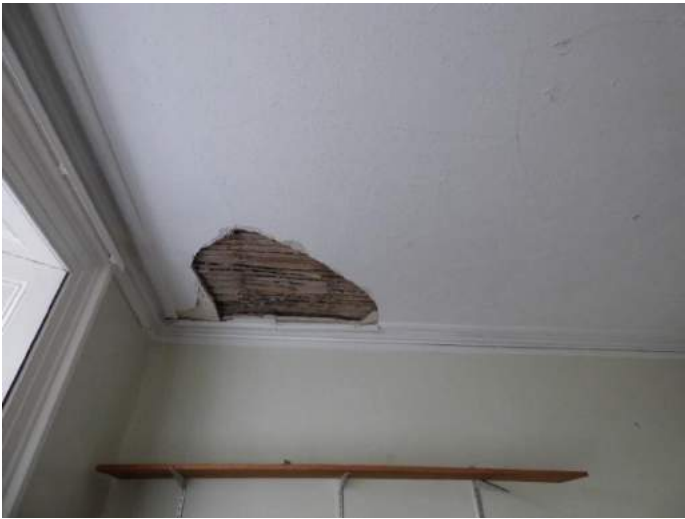
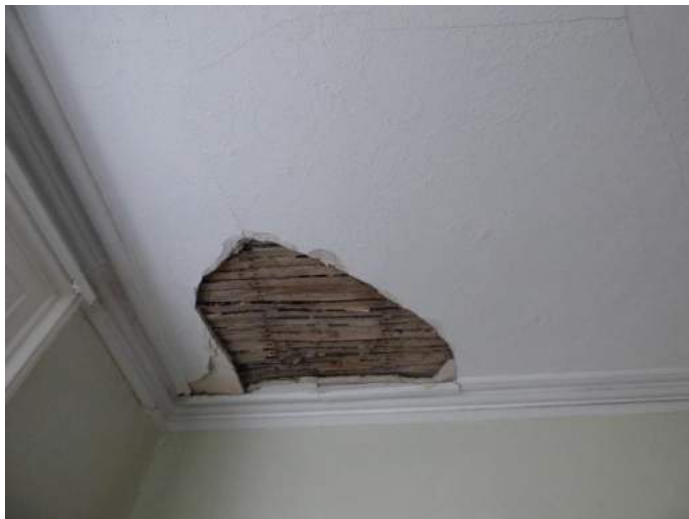
Left and below: Ceiling to be repaired to original lath and plaster ceiling by specialist using lime plaster.

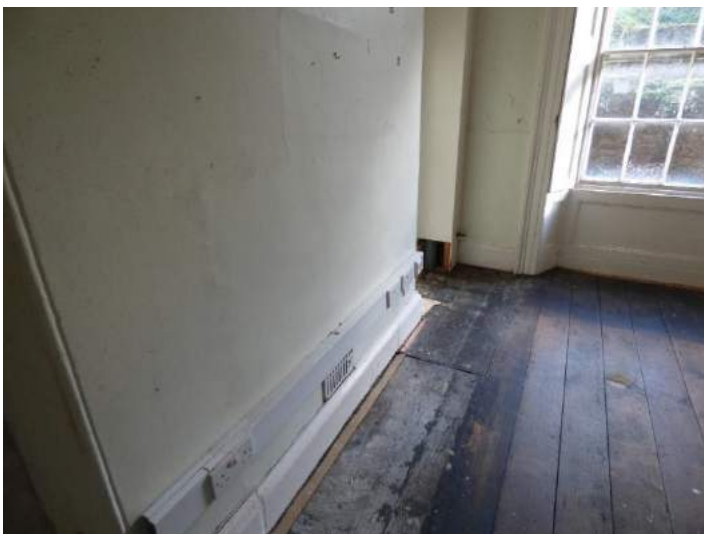
Left and below: The period features below and to the sides of the existing window are in good conditions, it is proposed to carefully refurbish the existing timber shutters.

Existing cornice to be made good in locations where redundant services are to be removed and where hairline cracks have appeared.

Existing architraves and skirtings with heritage style four panel painted timber fire doors.

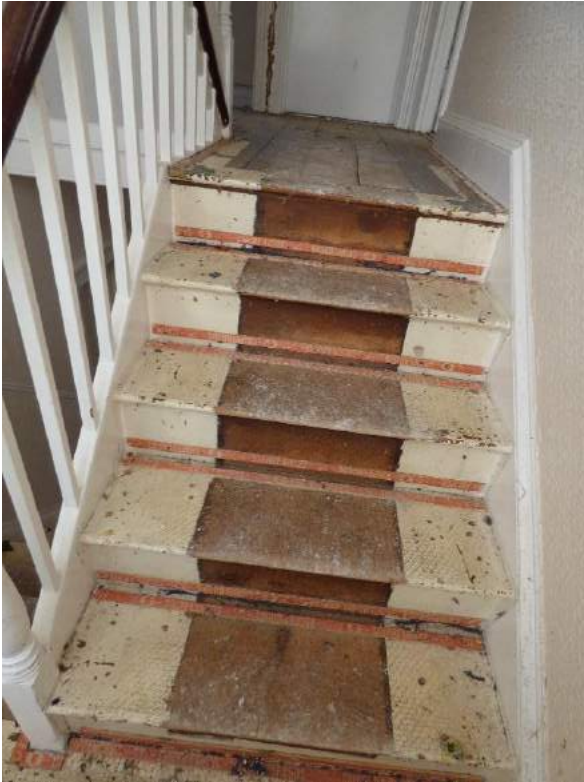
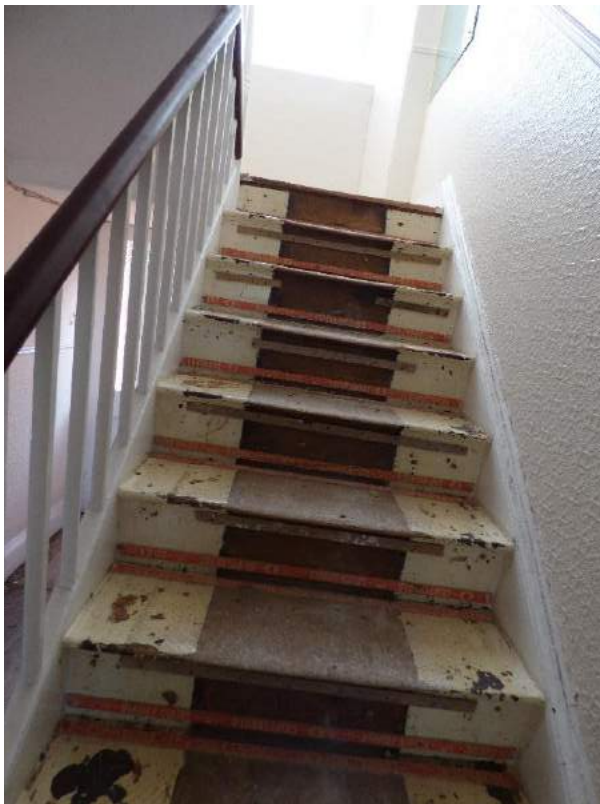
Retain original staircase, which is in good condition.

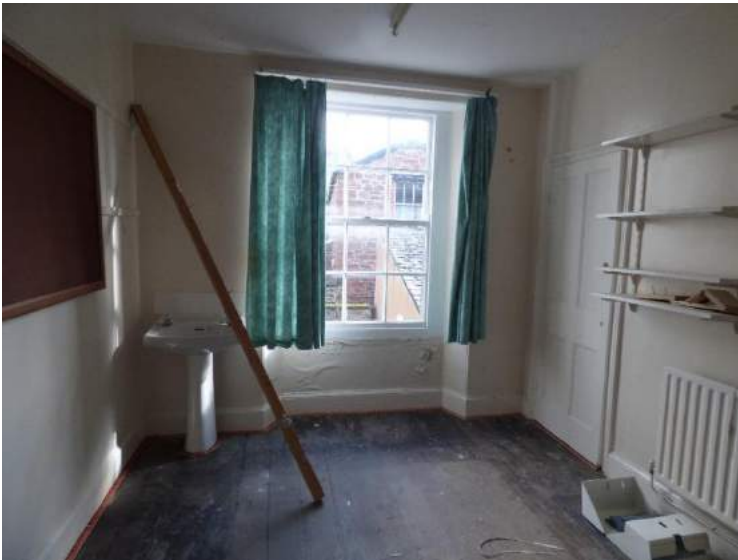
Rear bedroom skirtings and architraves to be retained. Existing flush panelled door to be replaced with new Georgian heritage style four panel fire door to be provided by specialist joinery company such as Batty Joinery Ltd.

Existing floorboards are generally in good condition.

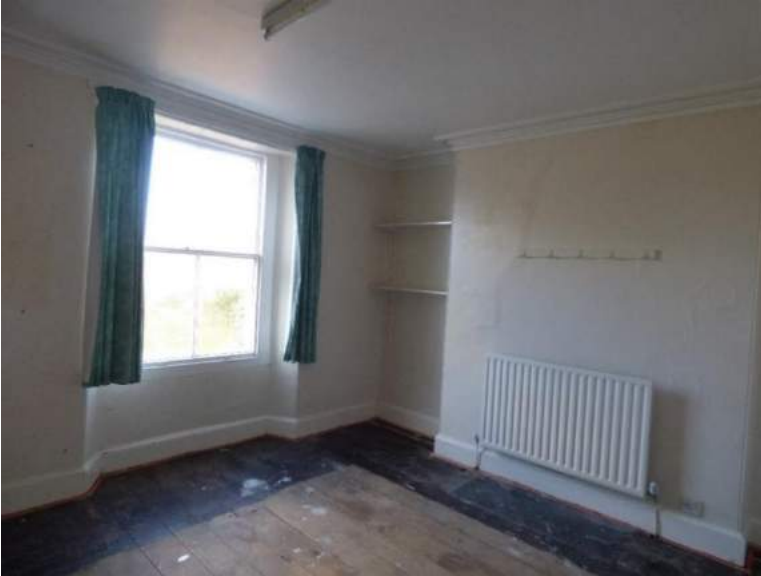
Front bedroom (master) skirtings and architraves to be retained. Existing flush panelled door to be replaced with new Georgian heritage style 4 panel door to be provided and installed by specialist joinery company such as Batty Joinery Ltd.

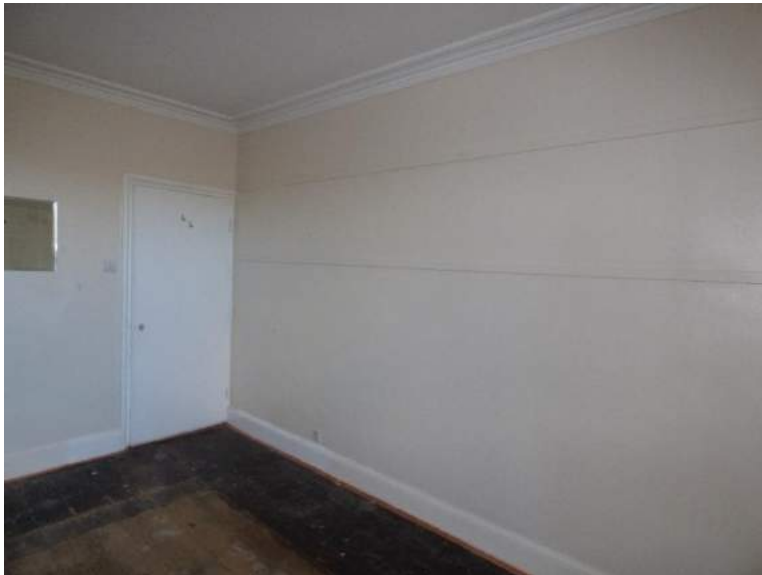
Existing floorboards in generally good condition.

Where possible it is proposed to refurbish any original doors with door closers and intumescent paint subject to building control approval.

Form new opening into new en-suite with new architraves and door to match the rest of the property.

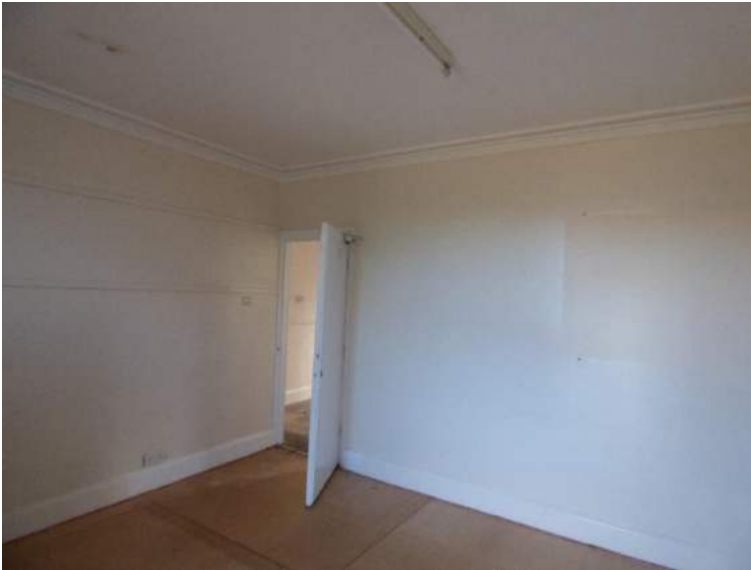
Front bedroom skirtings and architraves to be retained. Existing flush panelled door to be replaced with new Georgian heritage style 4 panel door to be provided and installed by specialist joinery company such as Batty Joinery Ltd.

Existing floorboards have been concealed and over-boarded using large chipboard planks. It is proposed to lift the chipboard and evaluate the condition of the existing flooring underneath.

It is likely that the existing timber floorboards may require significant replacement, if this is the case, the floorboards will be replaced as required on a like for like basis.

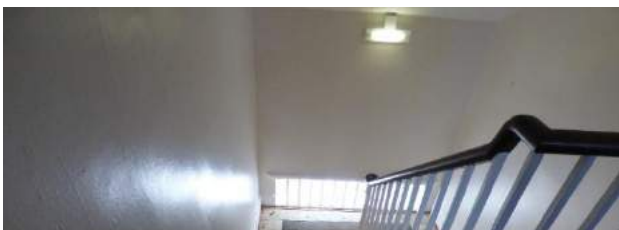
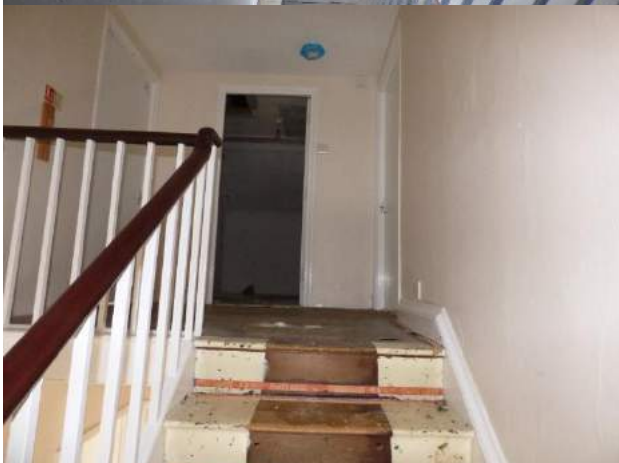
Left and below: Handrail, balusters and rails are original and are to be retained. Missing baluster to be replaced with matching baluster and decorated to match existing.

Apply an insulated plasterboard 62mm thick to underside of ceiling. The Laminated plasterboard and PIR has a vapour barrier incorporated so interstitial moisture would be prevented.

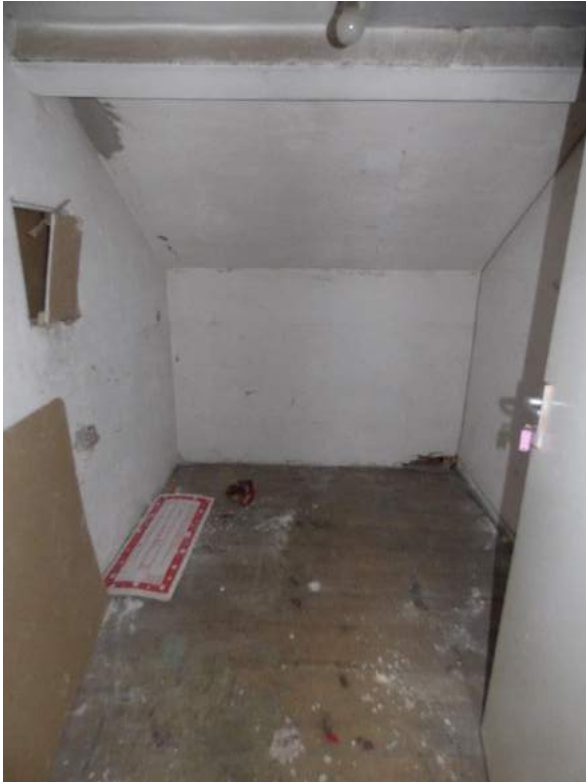
Left: Existing attic store is proposed to be converted into a bathroom to be shared by the attic bedrooms by increasing the size of room to each side to allow for the new bathroom.
