# HERITAGE STATEMENT

## FULL RENOVATION OF EXISTING No 11 TERRACE HOUSES

St Bees, 1-11 Lonsdale Terrace, Parish Council, Cumbria

M.A.C Architects, Project Number: 2019:303

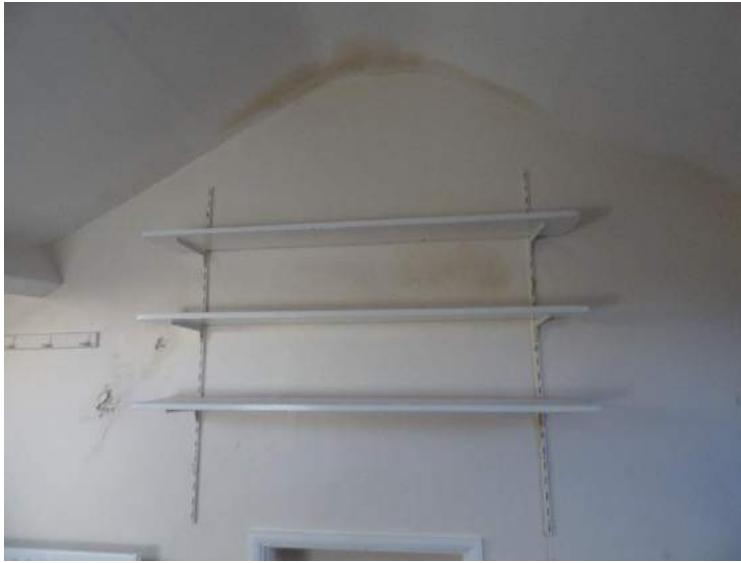
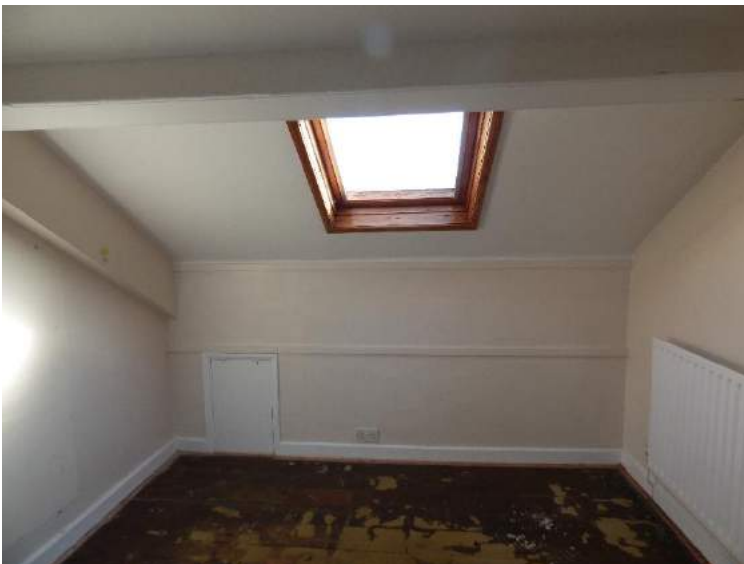
Left and below: Attic bedroom.

New plasterboard stud partition to be installed in lieu of removal of part of existing store/bedroom partition to allow for bathroom to be useable size.

Apply an insulated plasterboard 62mm thick to underside of ceiling. The Laminated plasterboard and PIR has a vapour barrier incorporated so interstitial moisture would be prevented.

New heritage style rooflights to replace modern Velux rooflights (Velux or similar with flashing kit that mounts unit flush with the roof surface).

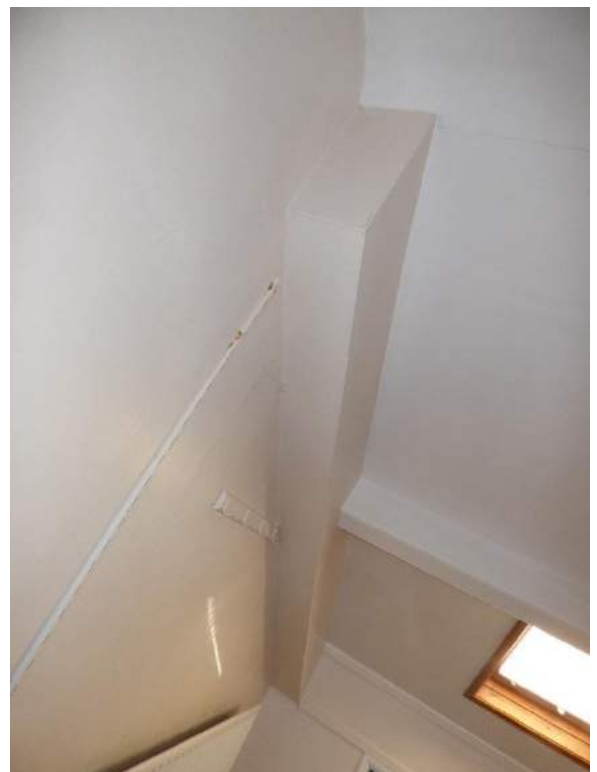
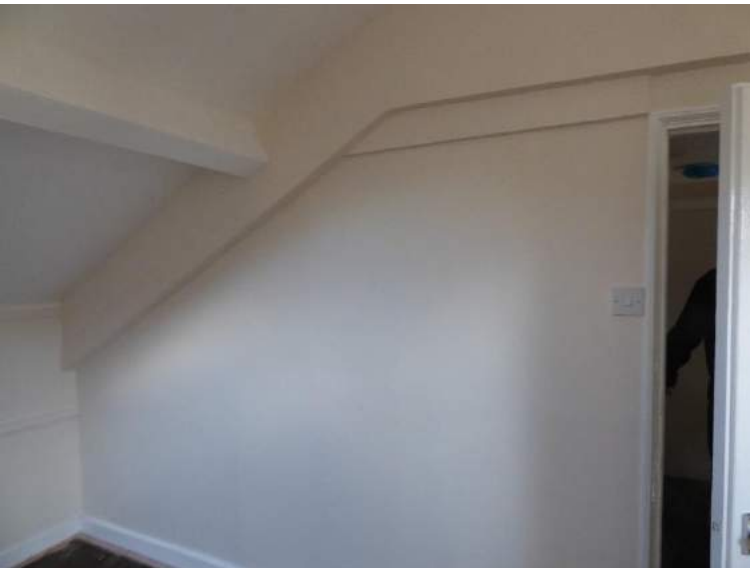
Left and below: Attic bedroom.

In the bedroom, remove all damp and damaged/blown plasterwork and repair with lime plaster and skim and decorate throughout.

Apply an insulated plasterboard 62mm thick to underside of ceiling tape and skim and undertake full decoration. New rooflight to be installed.

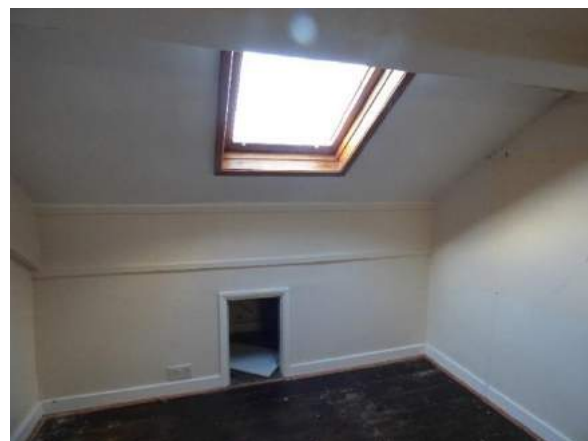
Provide and install new heritage rooflight window to replace the existing rooflights.

Floorboards are in good condition (but may require minor repairs)

Existing flush panel doors are to be removed and replaced with new heritage style 4 panel doors.

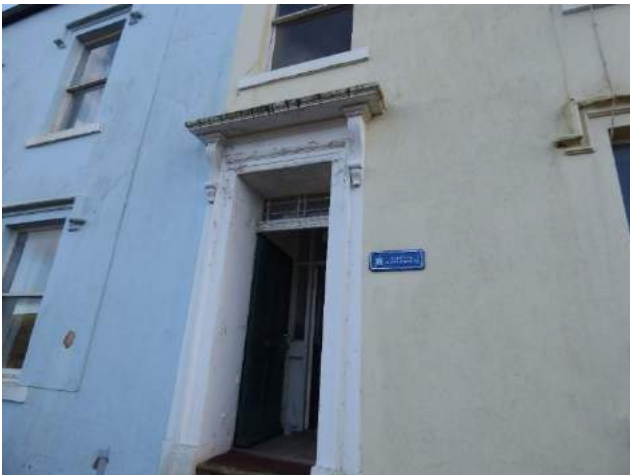
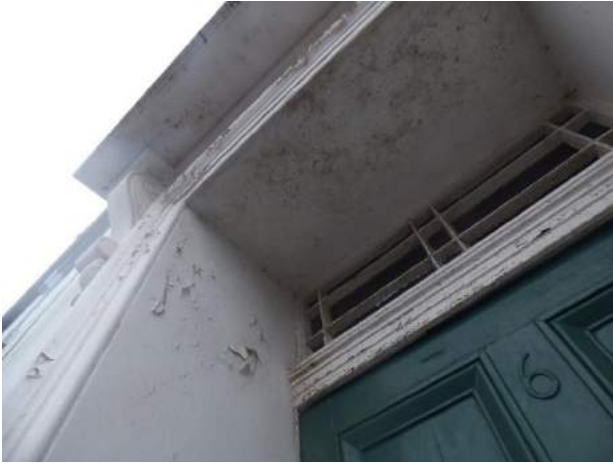
Left and below: Existing gutters and downpipes to be retained, repaired where necessary and decorated.

All existing single glazed windows to replace with new white painted slim profile double glazed. 'Heritage' windows to match the existing style by specialist supplier such as Batty Joinery Ltd.

Existing cills to be repaired and decorated.

Existing Velux rooflight windows to be replaced with Velux conservation rooflights (Velux or Rooflight Company, or similar with flashing kit that mounts unit flush with the roof surface).

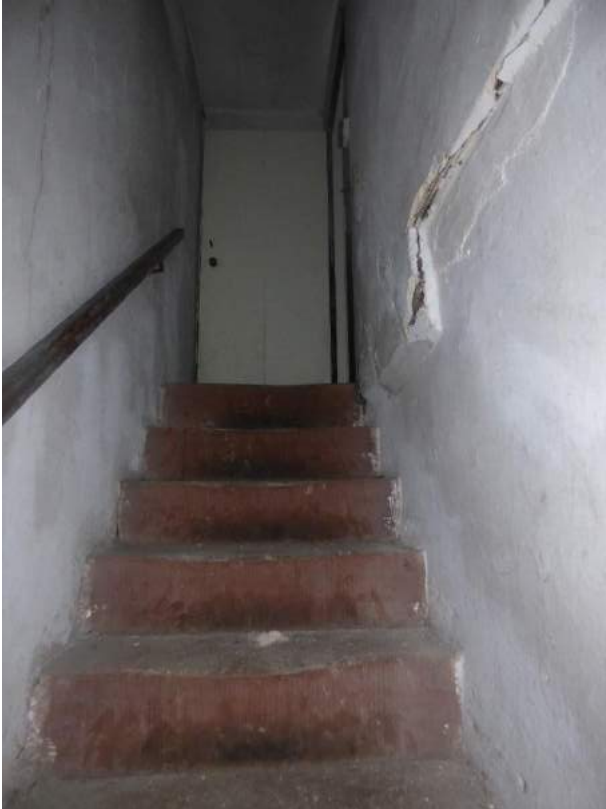
Left: The basement.

The existing walls and floor are generally in sound condition so would be suitable for the application of damp proof slurry system. All existing paint and surface finishes must be removed and made good including all snots removed, and damage to existing surfaces, prior to the installation of a Koster Polysil NB1.

Koster NB1 works by both providing a physical barrier against water ingress as well as providing a migratory crystal sealant that penetrates deep into the structure to seal micropores and cracks against water ingress.

Kloster NB1 is a breathable water proof system which will enhance the thermal value of the building without increasing the moisture content of the wall.

The walls down to the basement also require full treatment.

In the basement all existing services are to be carefully stripped out and replaced with new compliant infrastructure.

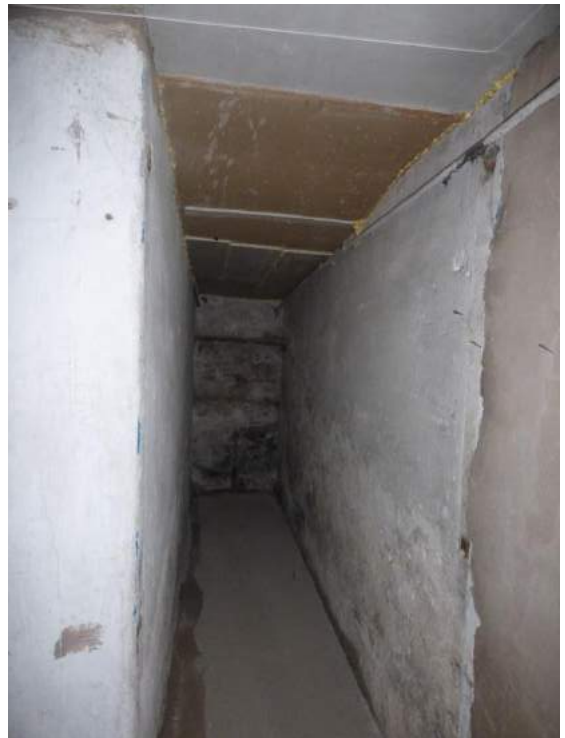
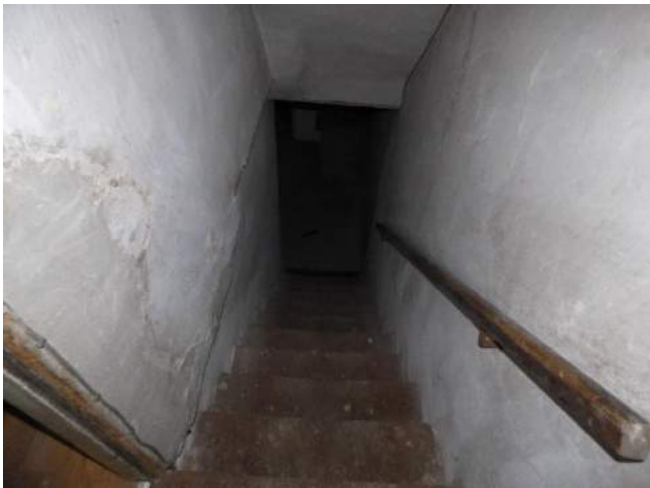
Existing services to be carefully removed and new gas and electric services installed.

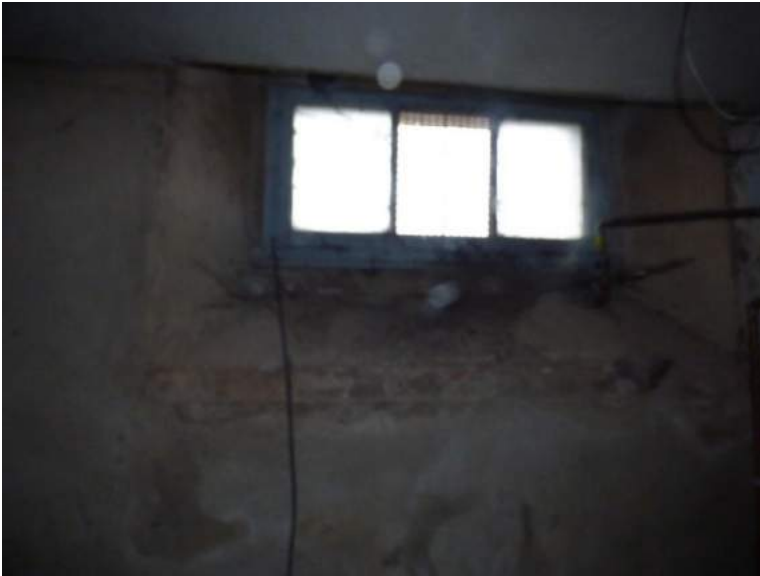
Existing window to basement to be removed and new heritage style double glazed window to be installed. Windows to be side – hinged in style to match existing. Reveals to be made good.

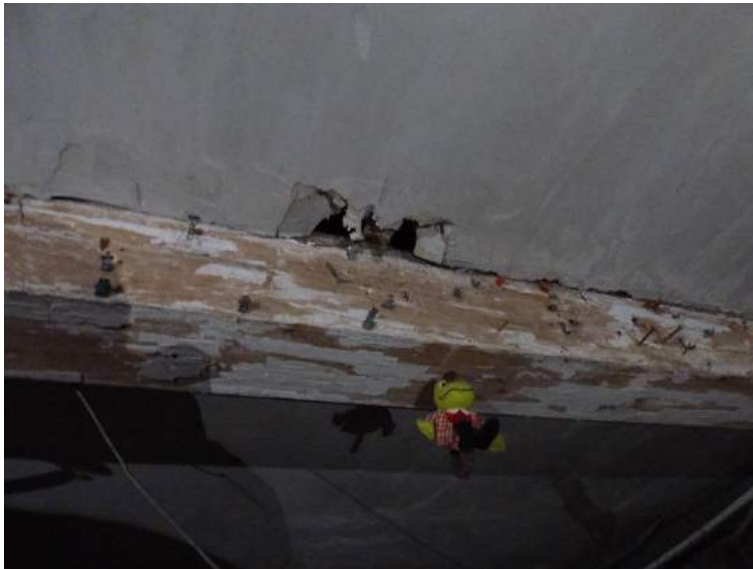
Left: Repairs to Fireline board or reinstatement to ensure fire resistance required to basement.

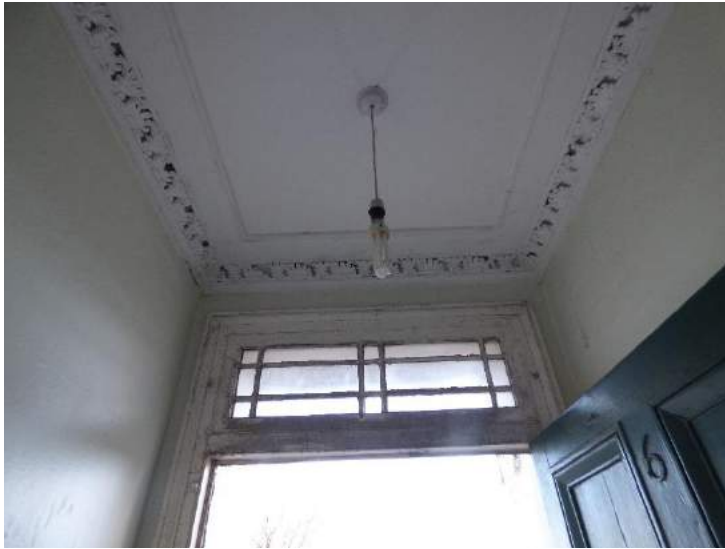
Left: Entrance, hall, and stairs.

The existing walls and floor are generally in good condition.

Redundant M&E to be removed and wall/ceiling finishes made good, and primed and fully decorated.

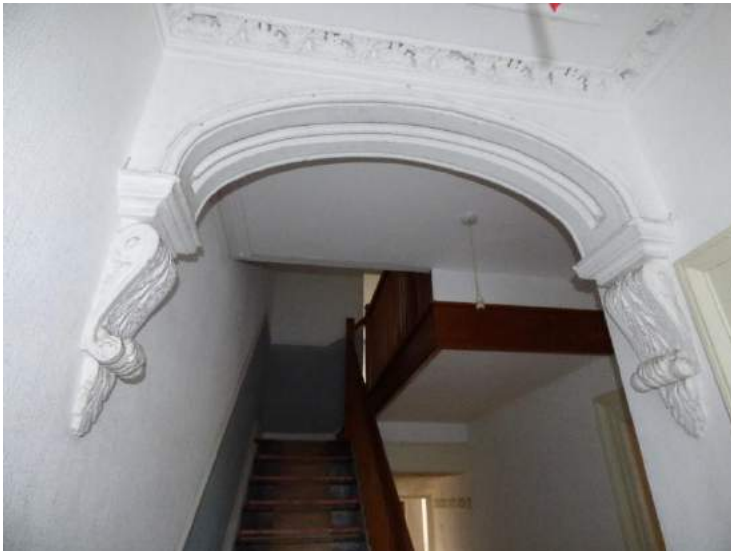
The ramp in the hallway is proposed to be removed and the original step down to be reinstated.

Left: Period features to be retained, including archway and architraves. (Modern lighting to all be stripped out and make good surfaces). All architraves and plaster features to be retained.

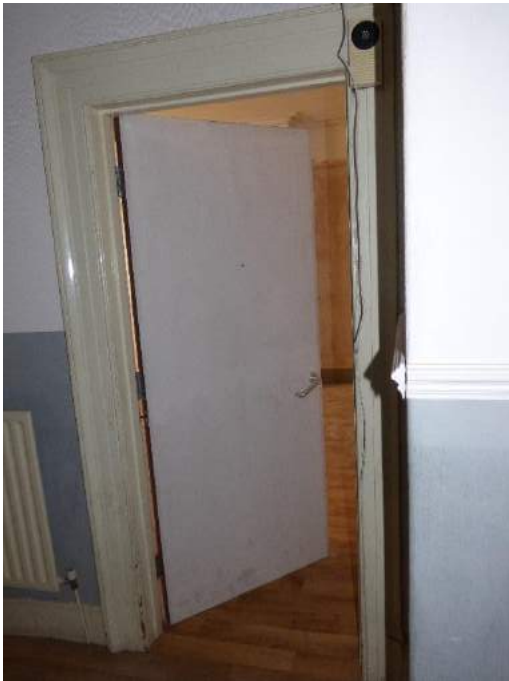
The handrails, balusters, and rails are not original; however it is proposed to be retain them, and decorate so they are more in keeping with the historic context of the property.

Flush panel doors to be replaced with heritage style four panel painted timber fire doors by Batty joinery Ltd or similar to enhance the heritage asset.

Where possible it is proposed to refurbish any original doors with door closers and intumescent paint subject to building control approval.

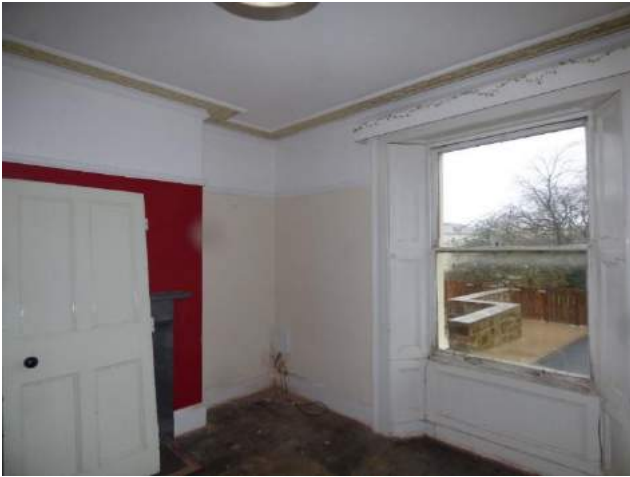
Left: Existing lounge architraves, cornices, and skirtings to be retained and repaired where hairline cracks have appeared.

It is proposed to form a new opening between the lounge and dining area to create more open plan living as already undertaken in properties 1-5. The fireplace is not original, and it is proposed to replace with a more in keeping fireplace.

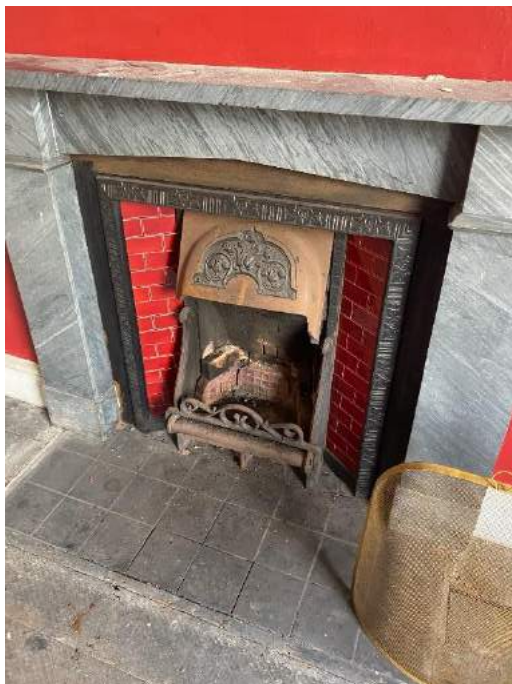
Left: The existing fire place is to be retained, however it is proposed to replace the surround and tiles (which are not original), with a more in keeping traditional fire surround with traditional tiles that reflect the period of the property.

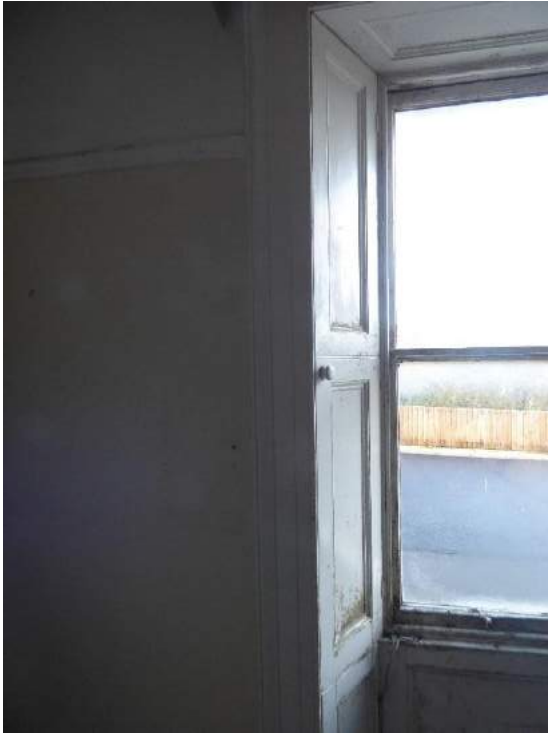
In the existing lounge, the period features below and to the sides of the existing windows both front and back are in good condition, it is proposed to carefully refurbish the existing timber shutters.

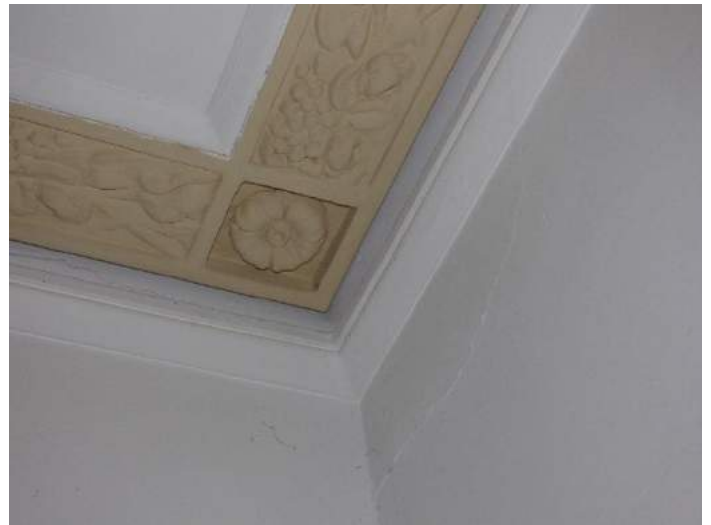
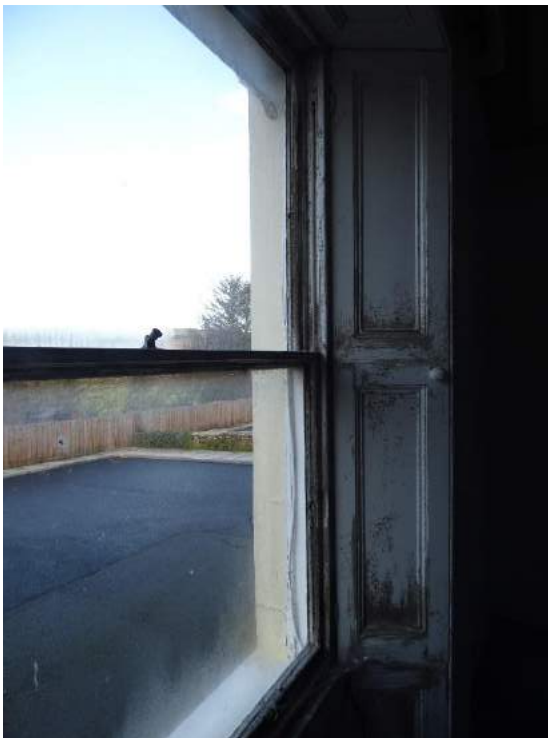
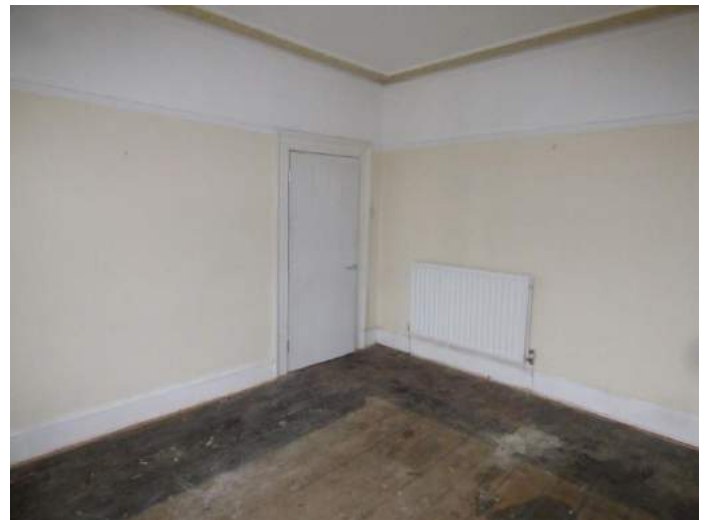
Existing cornice to be made good in locations where redundant services are to be removed and where hairline cracks have appeared.

Existing architraves and skirtings to be retained and made good.

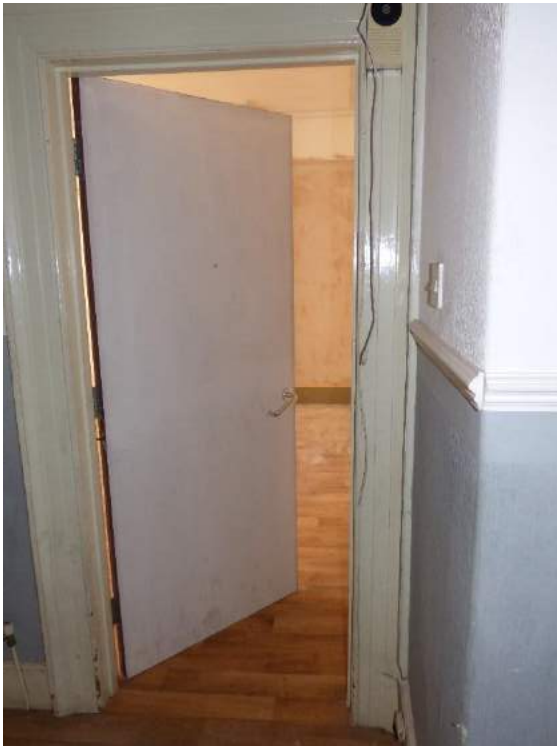
Flush panel doors to be replaced with heritage style four panel painted timber fire doors by Batty joinery Ltd or like enhance the heritage asset.

The existing four panel door present is proposed to be utilised for the new en-suite being installed on the first floor.

Where possible it is proposed to refurbish any original doors with door closers and intumescent paint subject to building control approval.

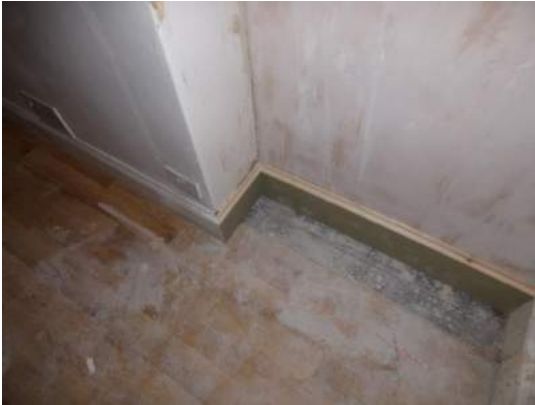
The dining room requires repairs to the ceiling and walls affected by damp ingress.

Blown plaster will be removed and replaced with lime plaster.

Architraves will be repaired.

Flush panel doors to be replaced with heritage style four panel painted timber fire doors to enhance heritage asset. Where possible it is proposed to refurbish any original doors with door closers and intumescent paint subject to building control approval.

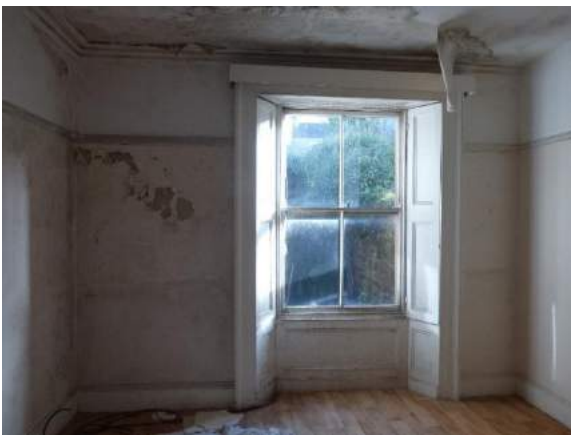
The existing shutters are generally in good condition but require minor restoration works to restore them.

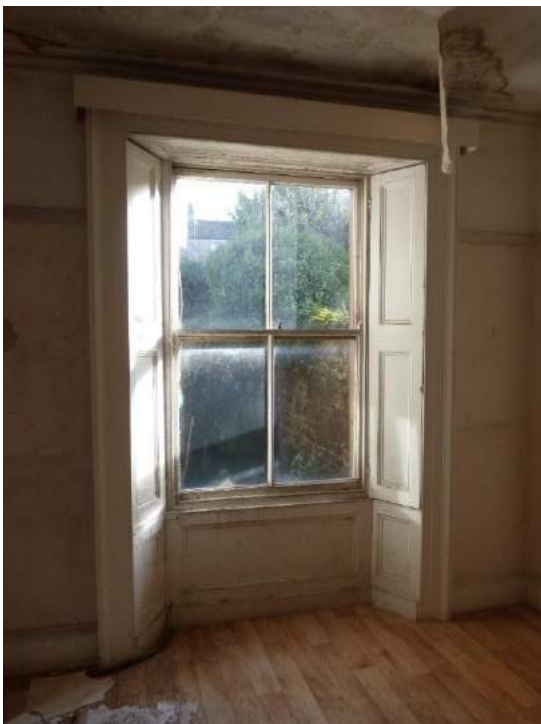
Not all the skirting is consistent. It is proposed to remove the recently installed skirting (where a doorway was walled up from the properties previous use as a school building) and replace with skirting to match the existing. It is proposed to reinstate the picture rail to match existing. It is proposed to form a new opening between dining and living as undertaken historically in houses 1-5, to make more suitable living accommodation for the present day.

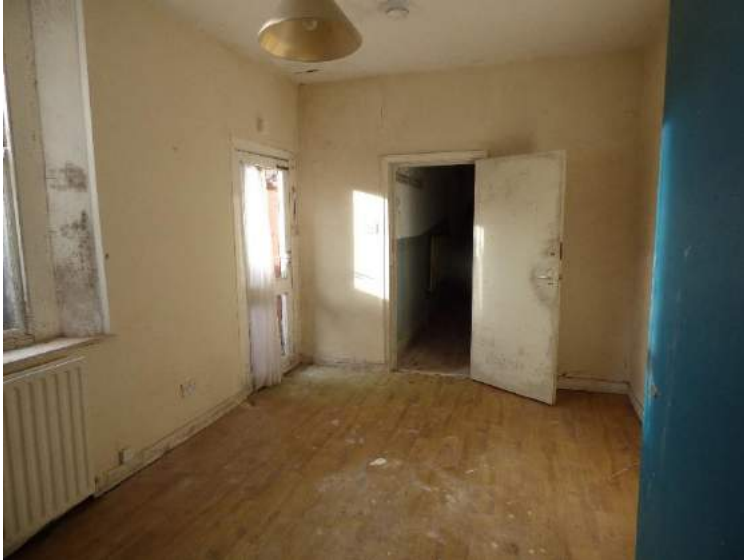
Left and below: Flush panel doors to be replaced with heritage style four panel painted timber fire doors to enhance heritage asset.

Where possible it is proposed to refurbish any original doors with door closers and intumescent paint subject to building control approval.

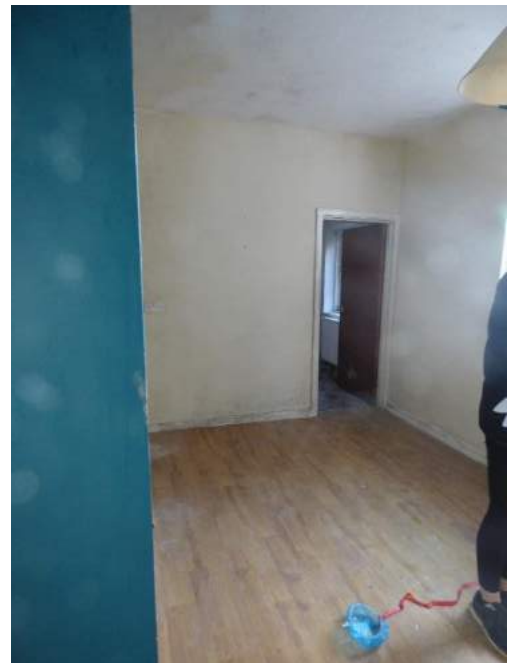
Left: rear door to be replaced with a Georgian style as front door.

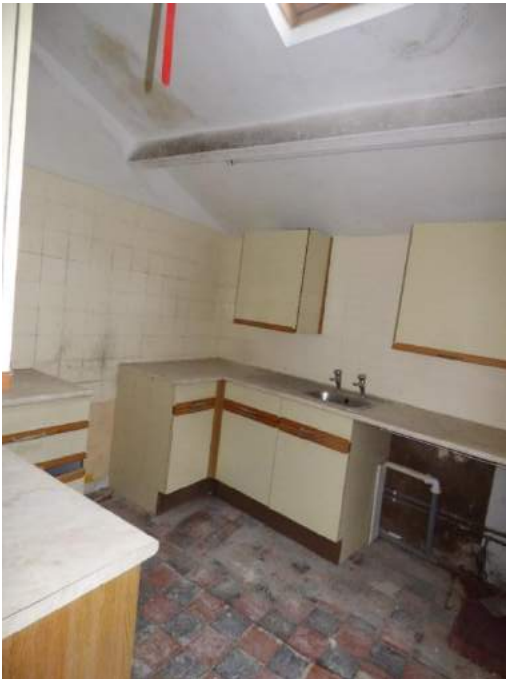
Left: Existing utility spaces to be fully renovated.

All damp and damaged/blown plasterwork and repair with lime plaster (Solo lime plaster from Lime Centre).and skim and decorate throughout.

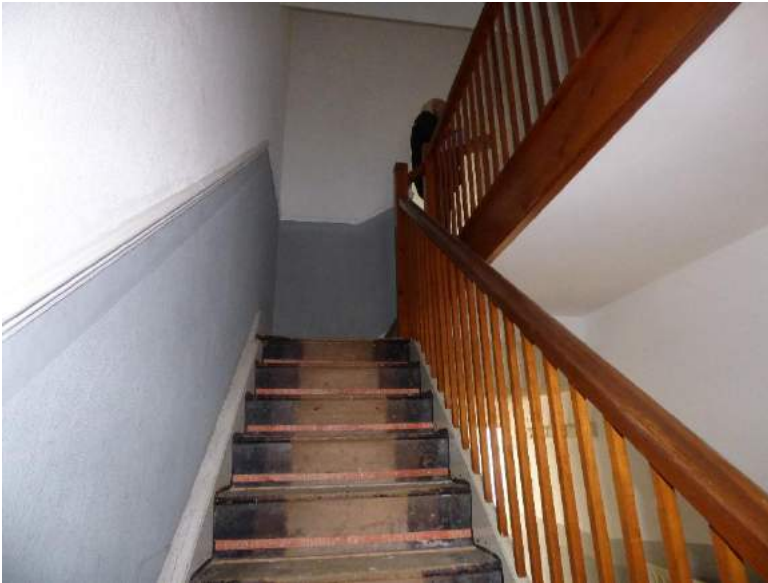
Left Retain staircase, which although not original is in good condition. Its is proposed to redecorate.

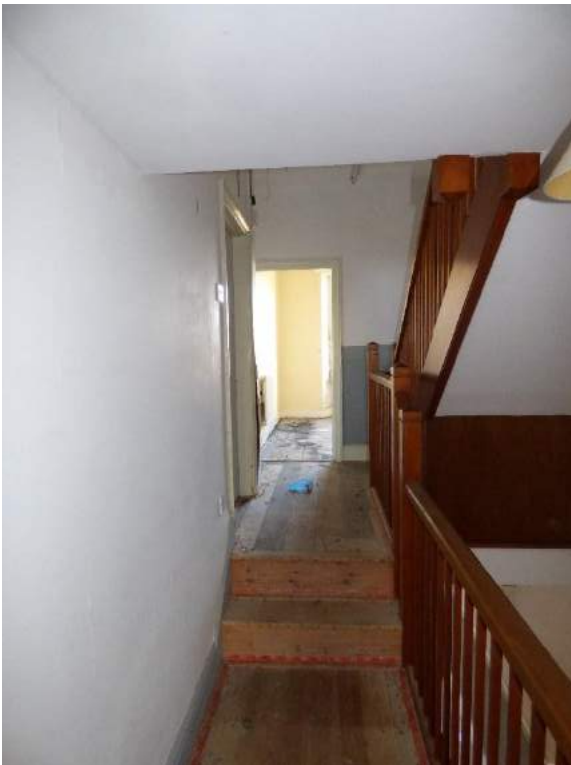
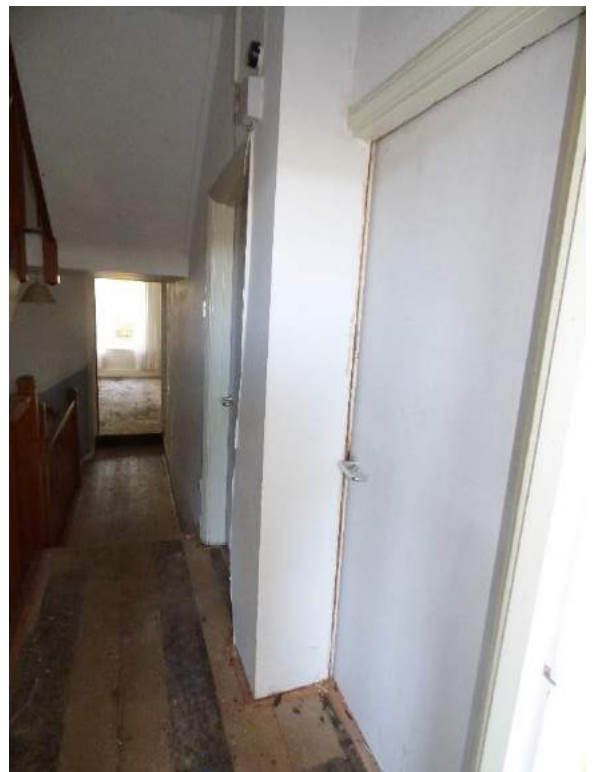
Existing rear bedroom requires considerable plaster repair work, due to damp ingress. Remove all damp and damaged / blown plasterwork and repair with lime plaster (Solo lime plaster from Lime Centre).

Lath and plaster generally in good condition, however damaged plasterwork will require specialist reinstatement.

Existing flush panel door to be replaced with new Georgian heritage style 4 panel door to be provided and installed by specialist Joinery Company such as Batty Joinery Ltd. Where possible it is proposed to refurbish any original doors with door closers and intumescent paint subject to building control approval.

Skirtings to be repaired / replaced to match existing as required.

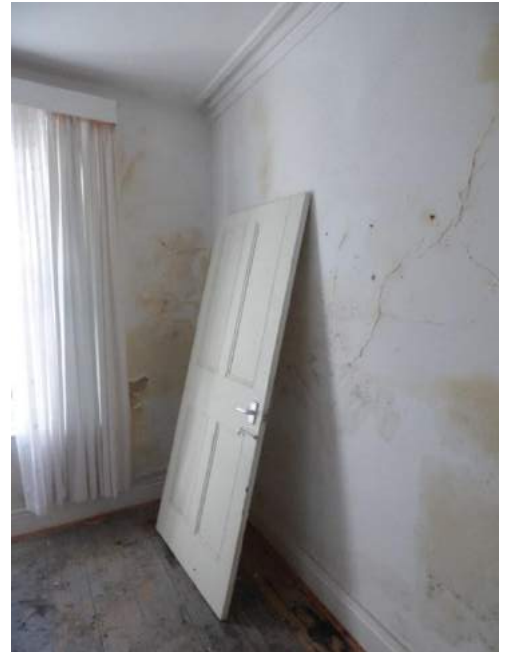
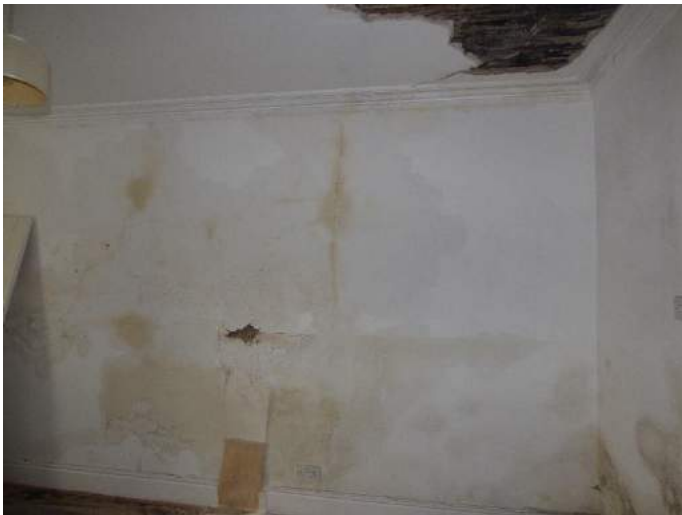
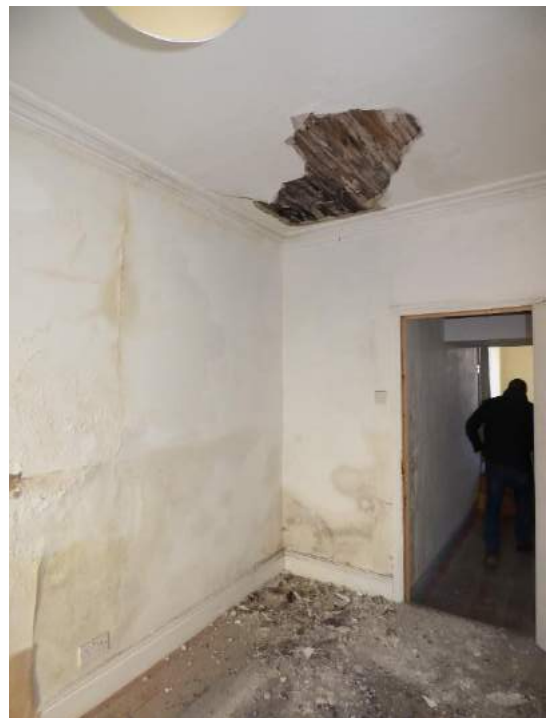
Above, right, and below: Rear bedroom skirtings, cornices and architraves to be retained. Flush panel door to be replaced with new Georgian heritage style 4 panel door to be provided and installed by specialist joinery comp any such as Batty joinery ltd.

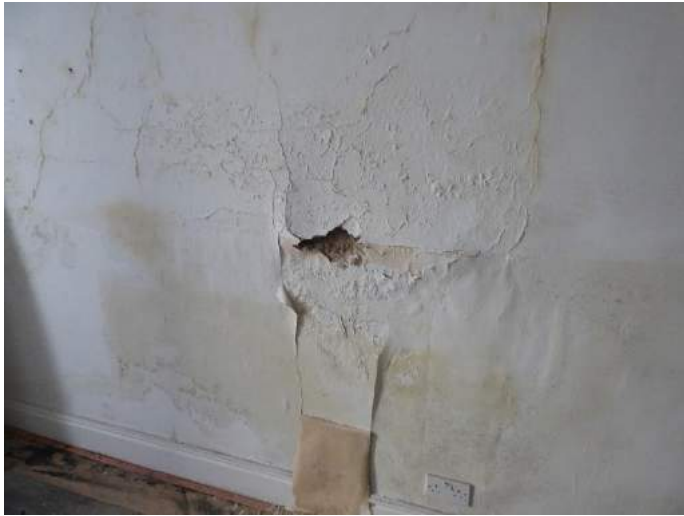
Left: Damp ingress to be resolved by repairs to external wall and render. Blown plaster to be removed and new plastering to be undertaken using lime plaster (Solo lime plaster from Lime Centre).

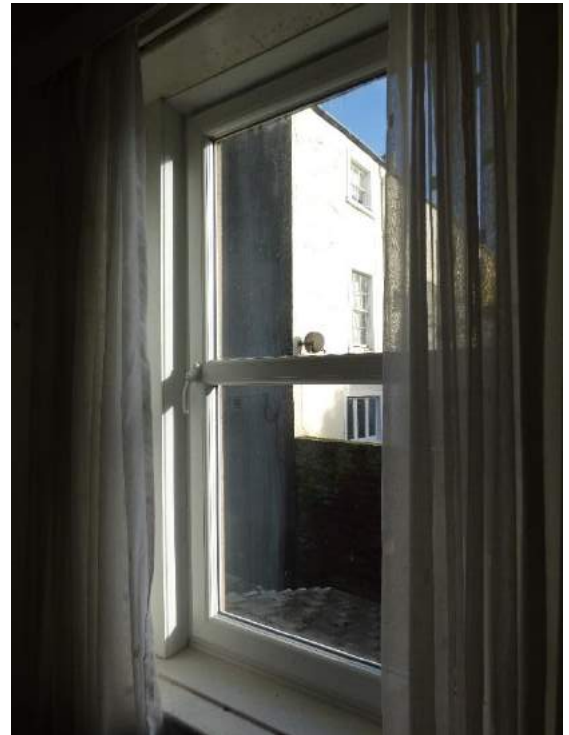
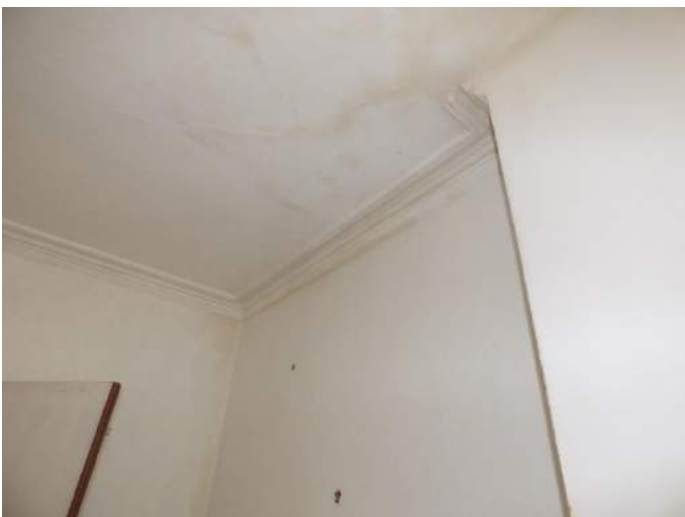
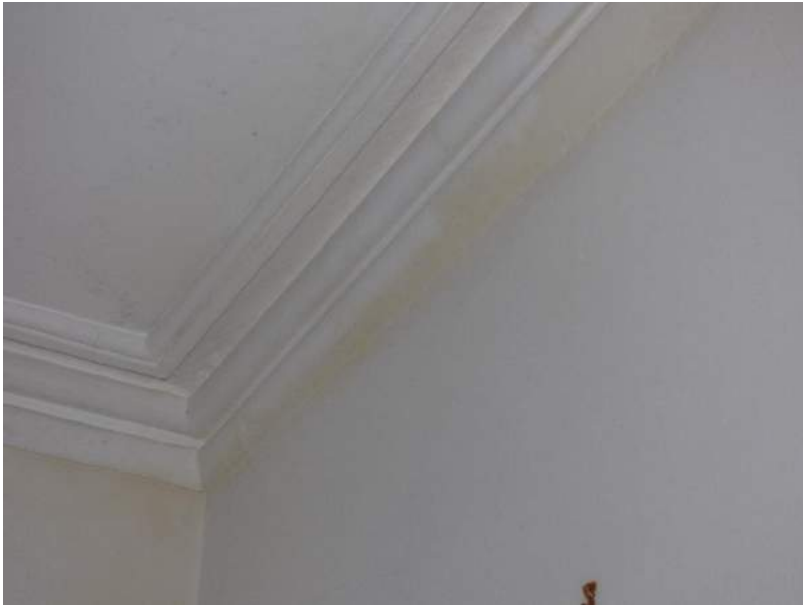
Existing floorboards in generally good condition, with minor repairs being required. Damaged floorboards to be replaced with boards to match existing.

Where possible it is proposed to refurbish any original doors with door closers and intumescent paint subject to building control approval.

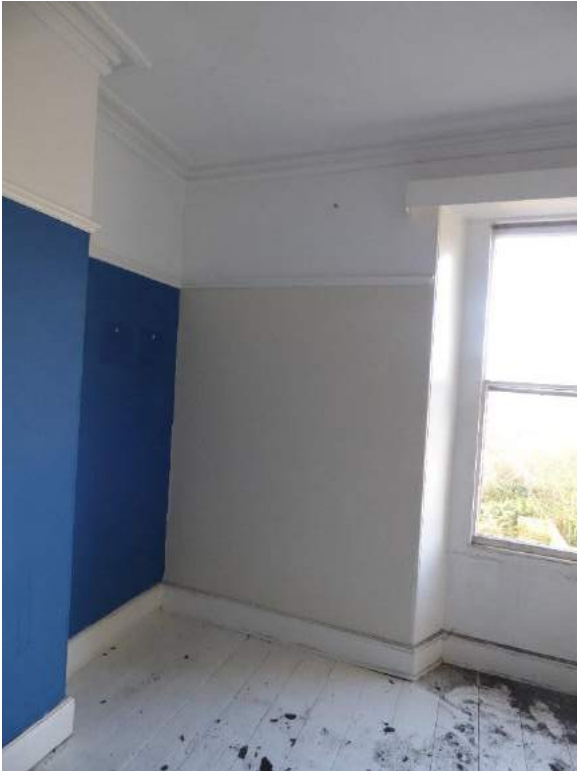
Front bedroom (First floor LHS) cornice, skirtings, and architraves to retained. Existing flush panelled door to be replaced with new Georgian heritage style 4 panelled door to be provided and installed by specialist joinery company such as Batty Joinery Ltd.

Existing floorboards in good condition.

Where possible it is proposed to refurbish any original doors with door closers and intumescent paint subject to building control approval.

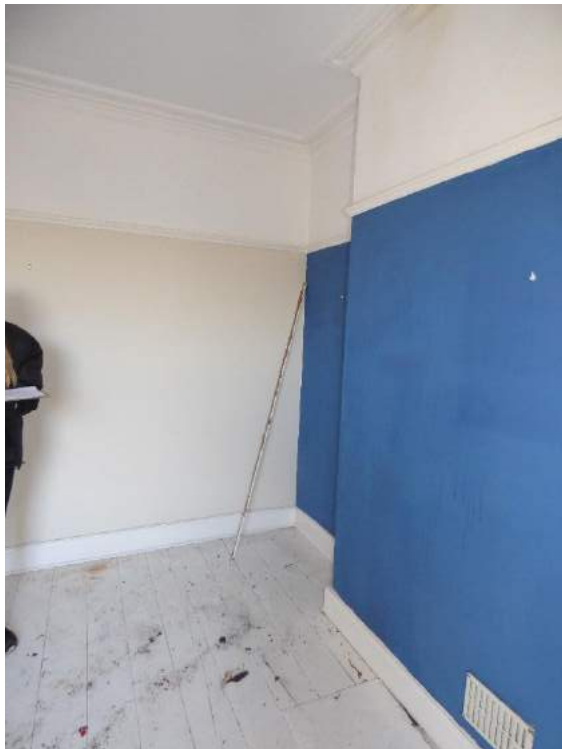
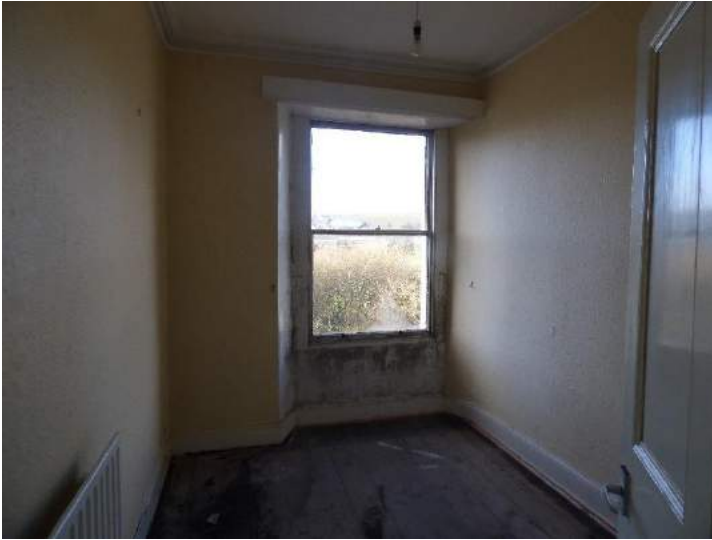
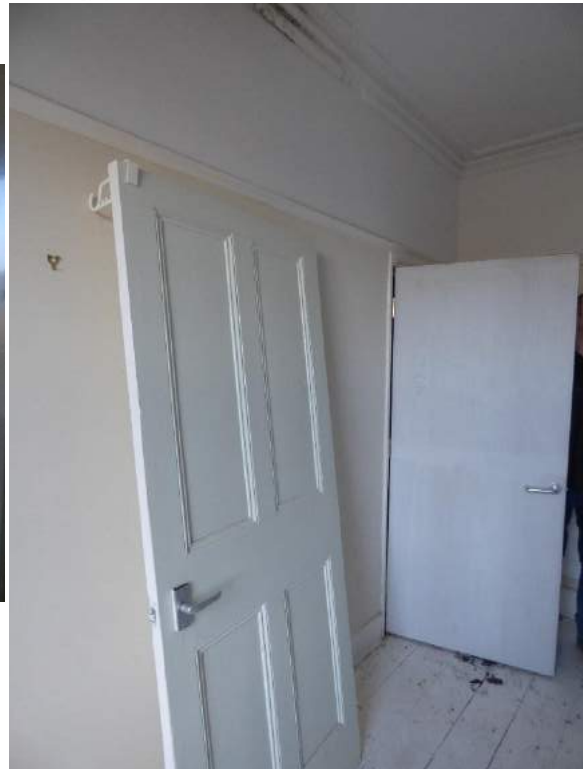
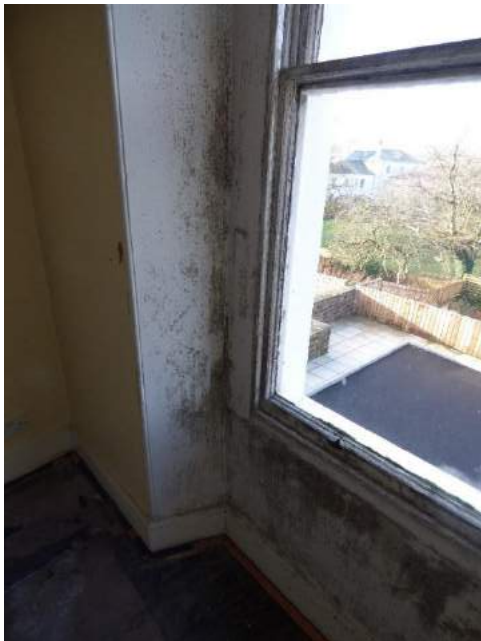
Front bedroom (First floor RHS), cornices, skirtings and architraves to be retained. Existing flush panelled door to be replaced with new Georgian heritage style 4 panelled fire door to be provided and installed by specialist joinery company such as Batty Joinery Ltd. Where possible it is proposed to refurbish any original doors with door closers and intumescent paint subject to building control approval.

Existing floorboards generally in good condition

Left: Damp ingress around windows has blown the existing plaster. It is proposed to replace damaged plaster with lime plaster. New heritage style windows being installed will resolve the damp ingress.

Damp damage to plaster ceiling to be removed and reinstated. Any damage to lath and plaster to be repaired by specialist.

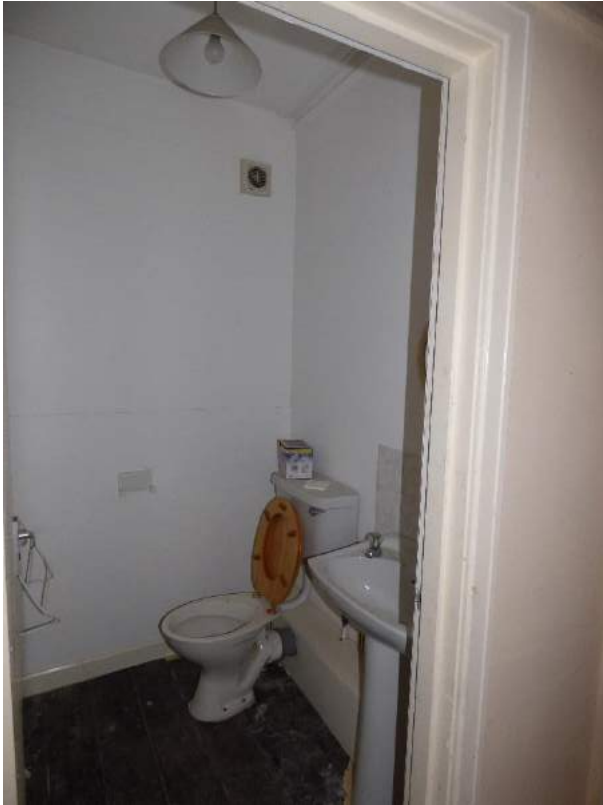
Existing w.c. to be removed and landing area to be reconfigured.

Partitions are not original.

Floors to be made good using timber floorboards to match existing.

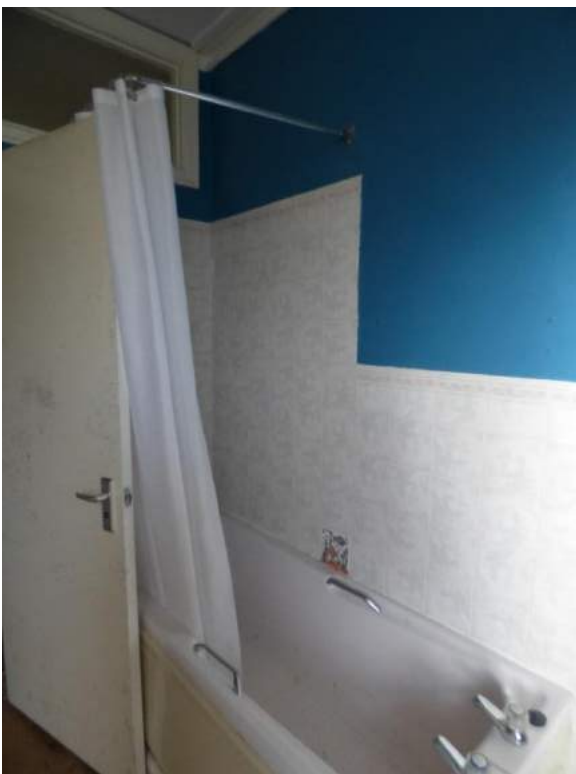
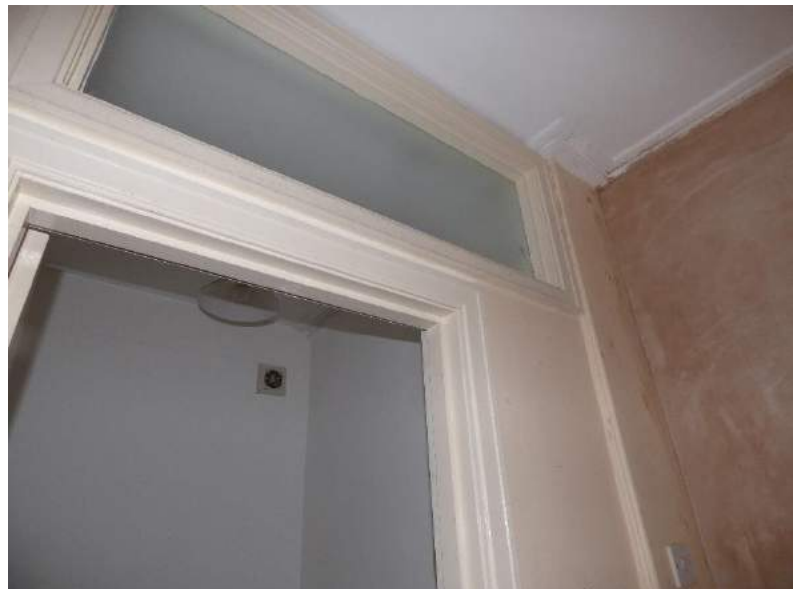
Left and below: Existing ceiling to be made good and provide and install new extract fan linked back to light switch.

Glazing to new heritage style Georgian double glazed sash window to be obscure.

New bathroom door to be 4 panelled heritage style door to replace exiting modern door – bathroom door does not need to be a fire rated door.

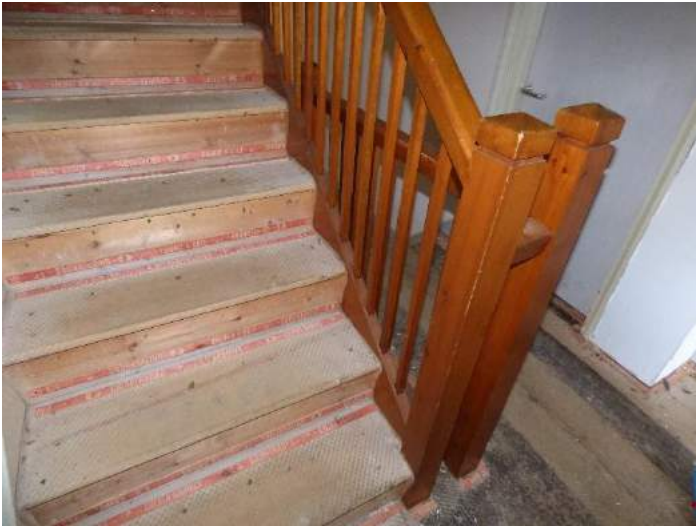
All finishes to be made good and skirtings to match the original to be installed.

Blown plaster to be removed and new lime plaster repairs to be undertaken. Floor to be made good with floorboards to match the existing.

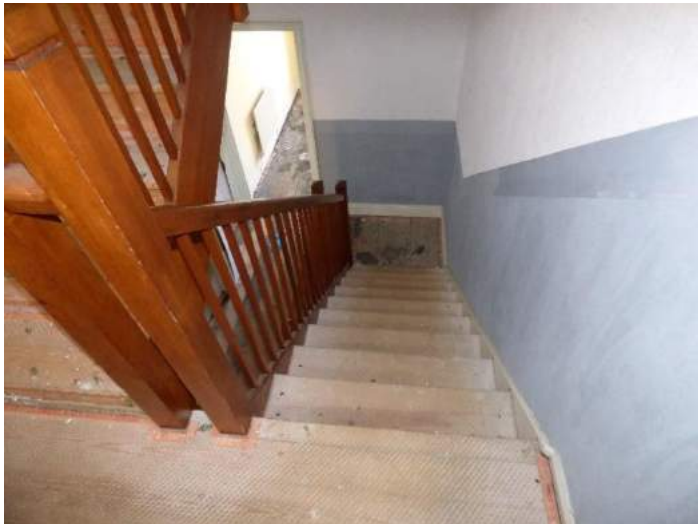
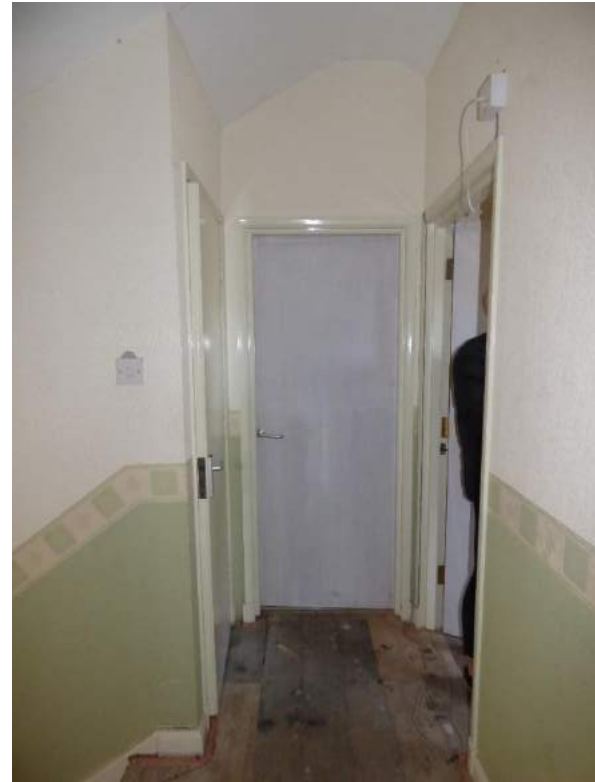
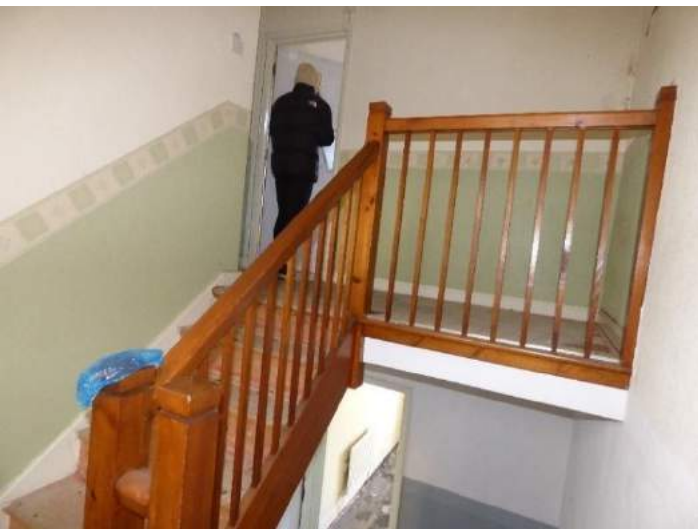
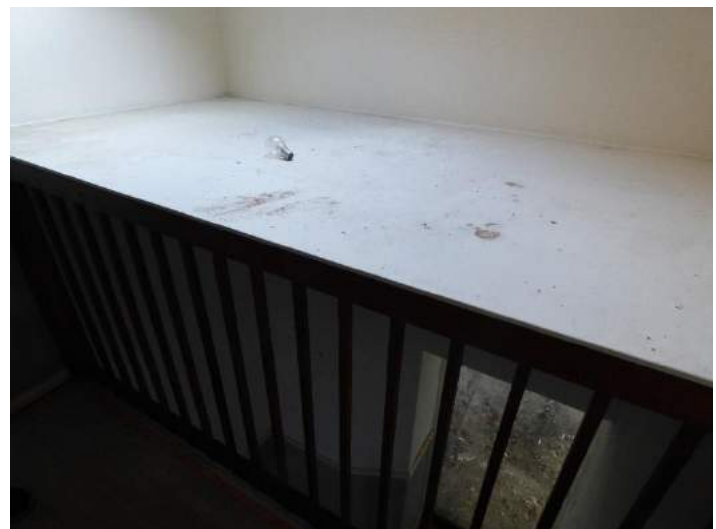
Left and below:

Second Floor Landing area to be reconfigured along with the layout of the second floor.

Apply an insulated plasterboard 62mm thick to underside of ceiling. The Laminated plasterboard and

PIR has a vapour barrier incorporated so interstitial moisture would be prevented. New heritage style rooflights to be installed to replace existing modern style Velux rooflights with flashing kit that mounts unit flush with the roof surface.

Existing rooflights to be replaced with new heritage style rooflights.
