# HERITAGE STATEMENT

## FULL RENOVATION OF EXISTING No 11 TERRACE HOUSES

St Bees, 1-11 Lonsdale Terrace, Parish Council, Cumbria

M.A.C Architects, Project Number: 2019:303

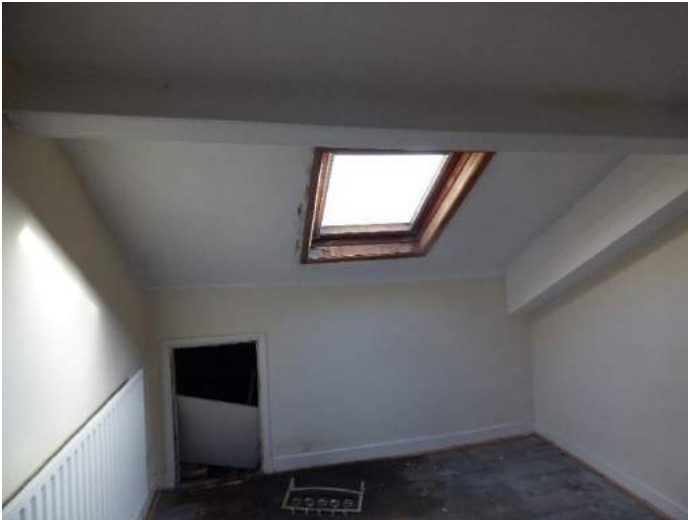
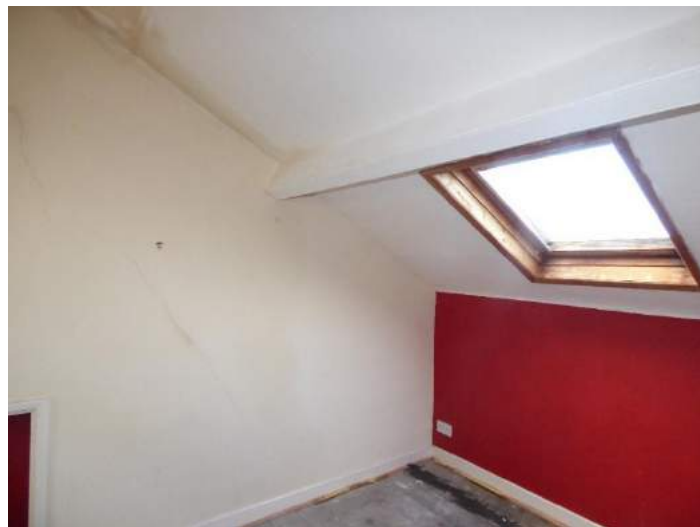
Left and below: Attic bedroom.

Bedrooms to be reconfigured to improve the space at second floor.

In the bedroom all damp and damaged/blown plasterwork will be repaired with lime plaster (Solo lime plaster from Lime Centre). and skim and decorate throughout.

Areas of water ingress to be investigated and roof repairs undertaken a necessary.

Apply an insulated plasterboard 62mm thick to underside of ceiling. The Laminated plasterboard and PIR has a vapour barrier incorporated so interstitial moisture would be prevented tape and skim and undertake full decorations. New heritage style rooflights to be installed in lieu of the modern style Velux windows. New heritage rooflight windows (Velux or similar with flashing kit that mounts unit flush with

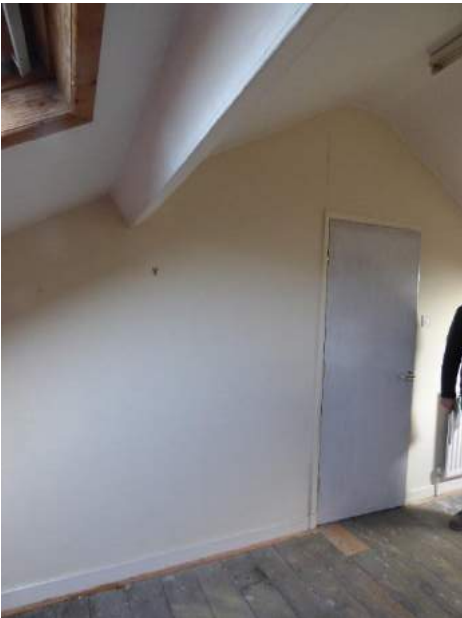
Left and below: Small attic bedroom.

Bedrooms to be reconfigured to improve the space at second floor.

In the bedroom all damp and damaged/blown plasterwork will be repaired with lime plaster (Solo lime plaster from Lime Centre) and skim and decorate throughout.

Areas of water ingress to be investigated and roof repairs undertaken a necessary.

Apply an insulated plasterboard 62mm thick to underside of ceiling. The Laminated plasterboard and PIR has a vapour barrier incorporated so interstitial moisture would be prevented.

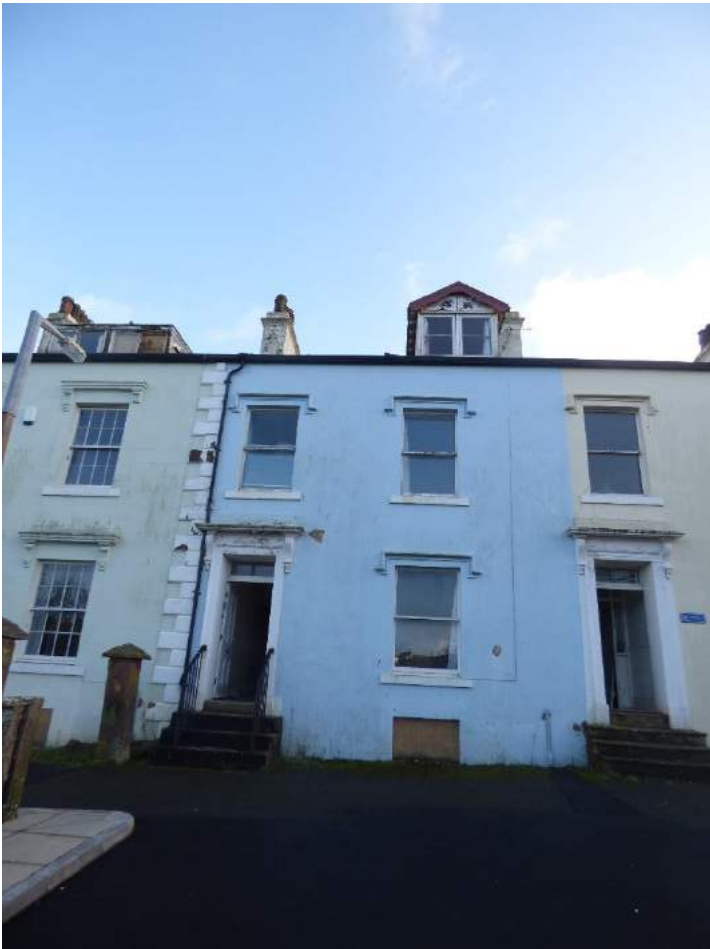
Left: The main entrance is mentioned in the listing text and is to be entirely retained.

Both front and rear elevations are currently rendered, with colour to the front and side and natural to the rear. All elevations require to be prepared for render repairs and redecoration by specialist using lime render and stucco (Parax LTD) to be applied by specialist. The stucco features above the windows and door on the front elevation will be carefully restored by a specialist. Colour of all render and stucco to match existing.

The existing door and frame are to be retained and made good with the provision of new ironmongery. Once repaired full decoration will be undertaken.

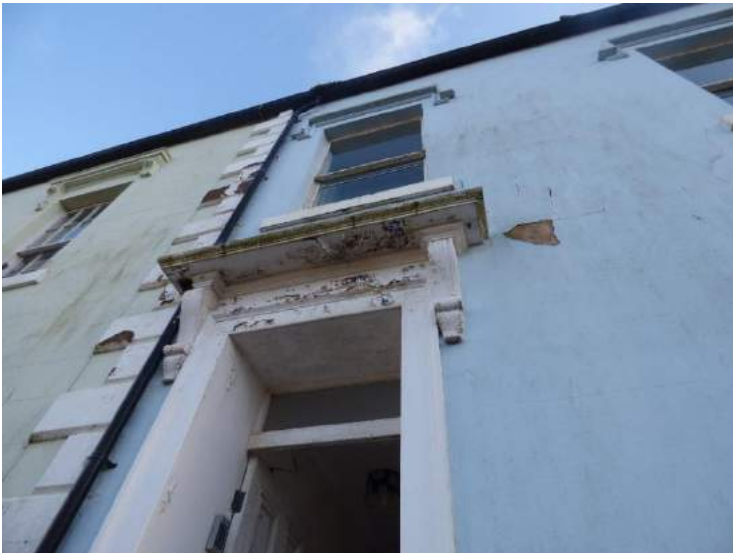
All single glazed windows to be replaced with new white painted slim profile double glazed 'heritage' windows to match the existing style by specialist supplier such as Batty Joinery.

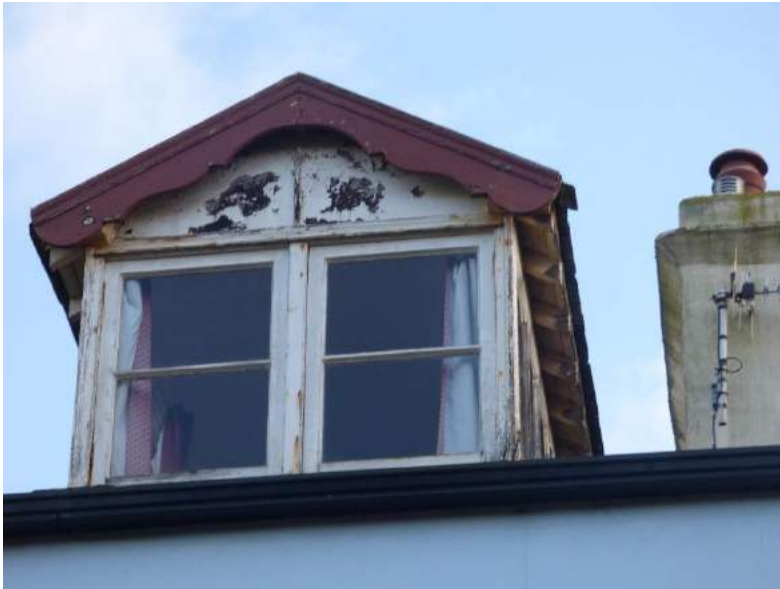
Existing dormer windows are in extremely poor condition. Considerable fabric damage internally has been the result of the extent of damage to these dormers. It is proposed to completely rebuild these in the same style as indicated on the proposed elevations with double glazed heritage style windows.

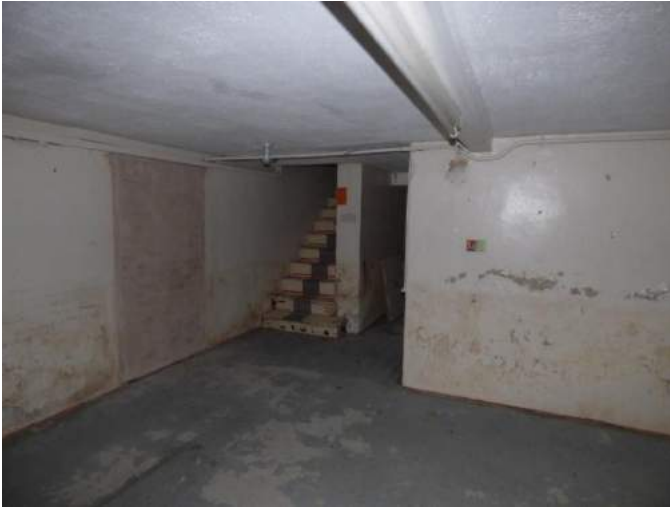
The existing basement walls and floor are generally in sound condition but suffering from damp ingress. It is proposed to protect the basement by the application of damp proof slurry system. All existing paint and surface finishes must be removed and made good including all snots removed and damage to existing surfaces, prior to the installation of a Koster Polysil NB1.

Koster NB1 is considered to be a type A waterproofing system as defined by BS8102:2009 and is generally used to seal the inside of basement structures, slabs and retaining walls. Koster NB1 works by both providing a physical barrier against water ingress as well as providing a migratory crystal sealant that penetrates deep into the structure to seal micropores and cracks against ingress.

Once applied then the walls can be prepared and primed for decorating and for the floor finish to be installed. Complete new boiler and heating system is required, new distribution boards etc.

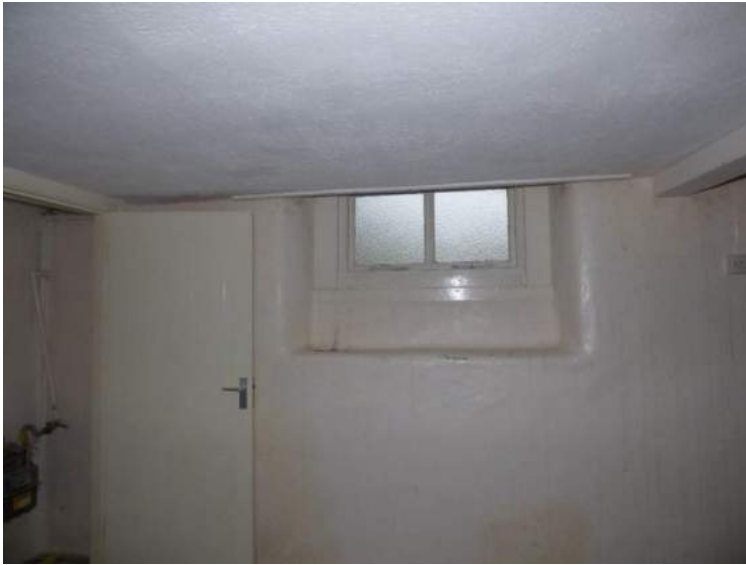
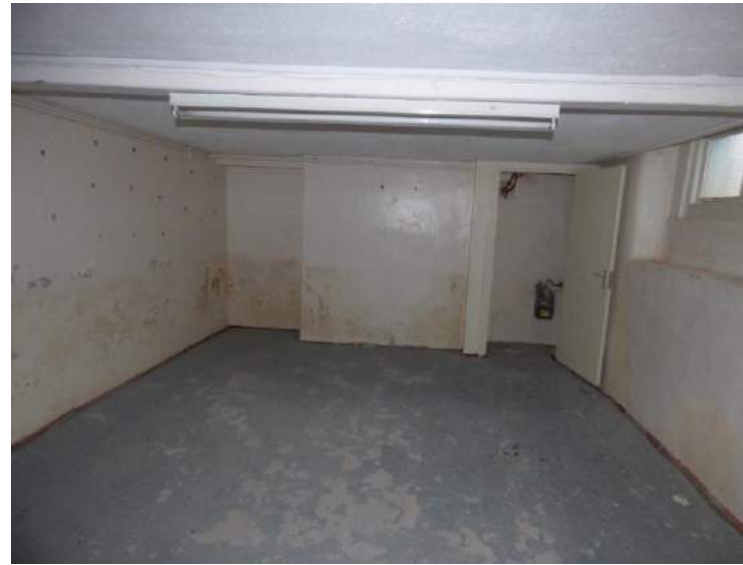
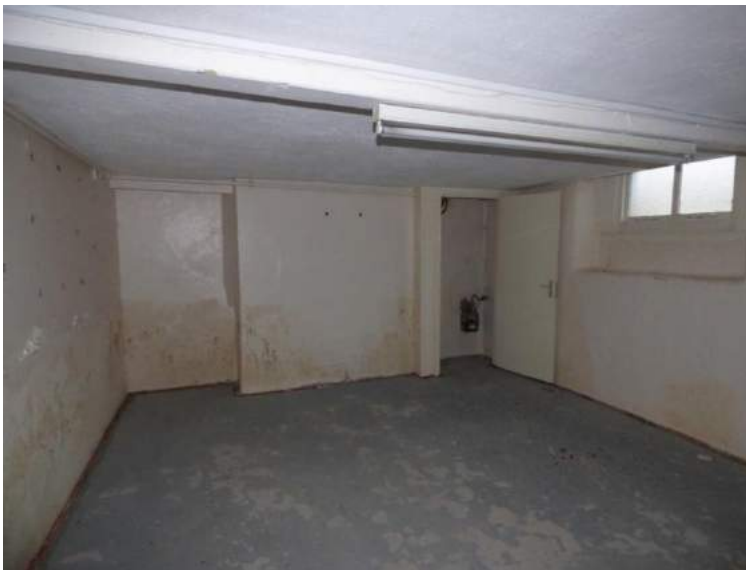
Views of basement to be renovated.

It is clear to identify where damp is penetrating the structure.

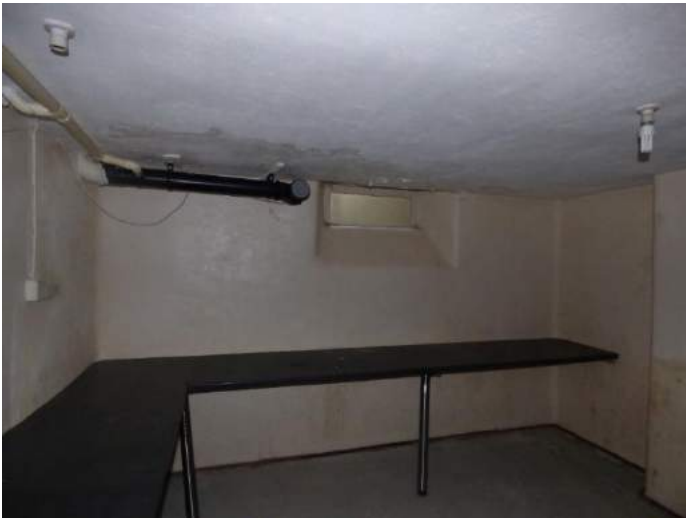
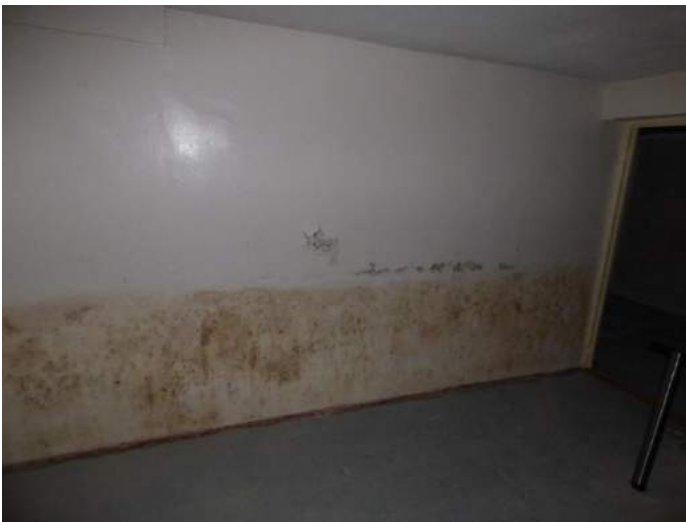
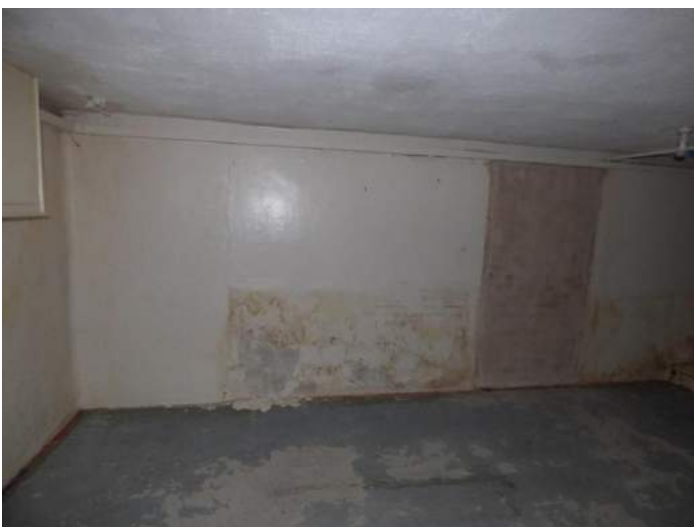
Views of basement to be renovated to create a dry area for basement storage.

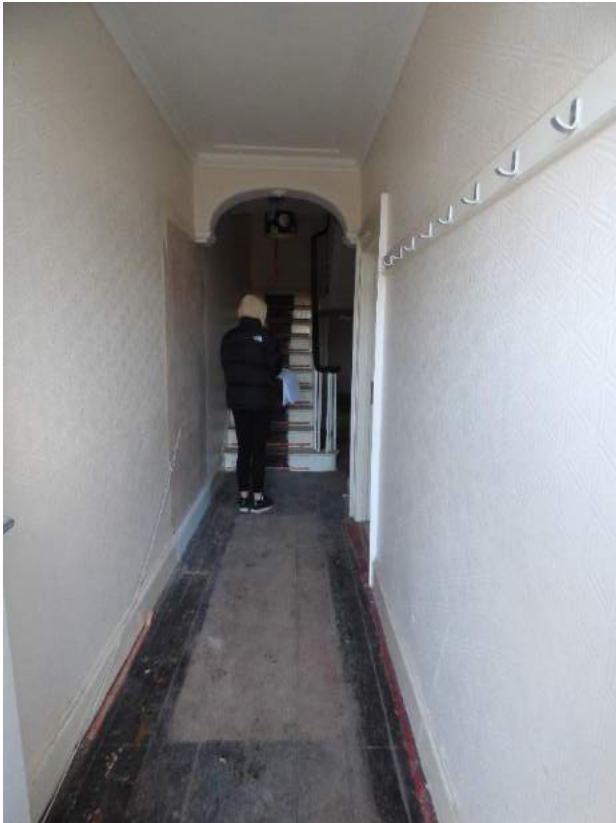
Left: The existing walls and floor are generally in good condition.

Flush panel doors to be replaced with heritage style 4 panel painted timber fire doors to enhance the heritage asset.

Where possible it is proposed to refurbish any original doors with door closers and intumescent paint subject to building control approval.

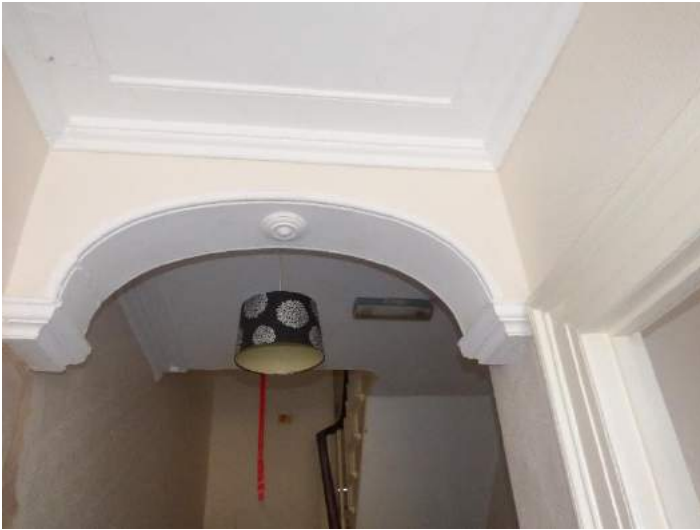
Left: Period features to be retained, including archway and architraves. (Modern lighting to all be stripped out and make good surfaces). All architraves and plaster features to be retained.

Original staircase to be retained.

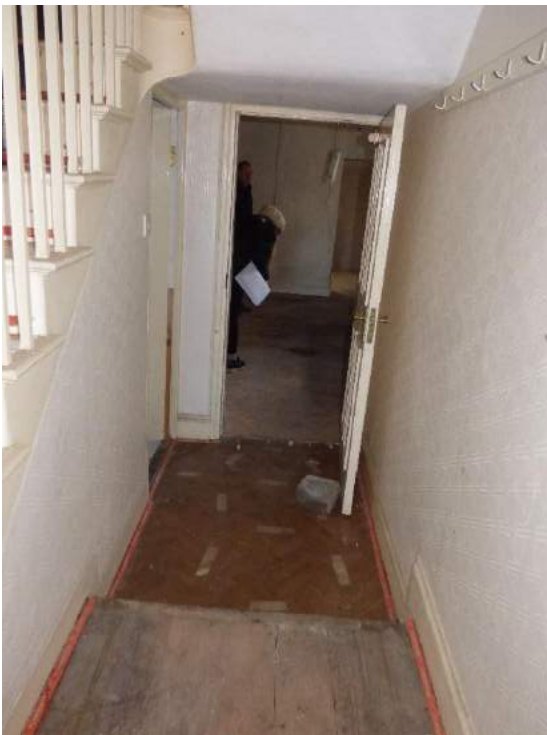
Left: Existing ramp to be removed and original step to be reinstated.

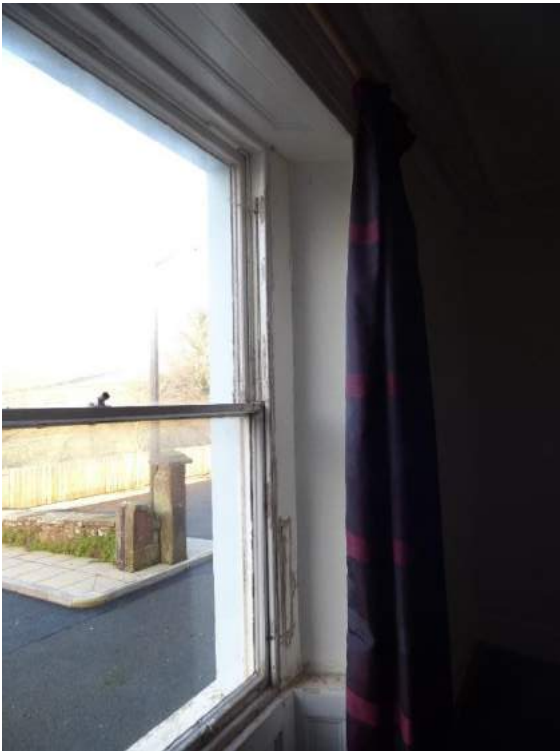
Left: In the existing lounge, the period features below and to the sides of the existing window are generally in good condition, it is proposed to carefully refurbish the existing timber shutters, which require careful minor repairs by a specialist.

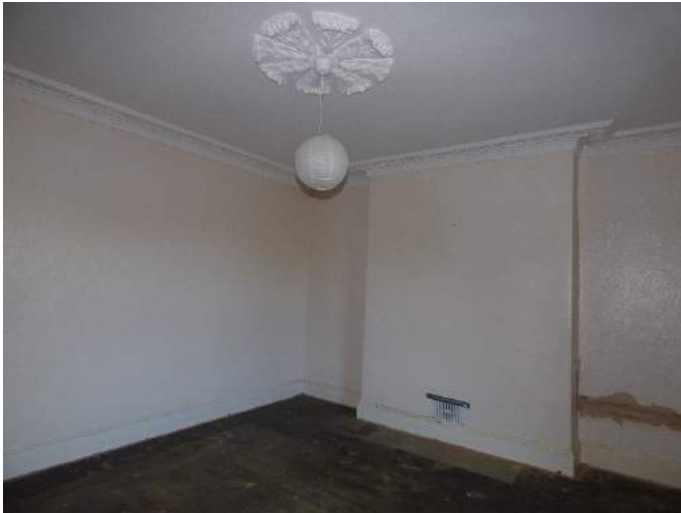
Left: Existing cornice is in excellent condition.

Existing architraves and skirtings to be retained and made good, where required.

Retain existing ceiling rose.

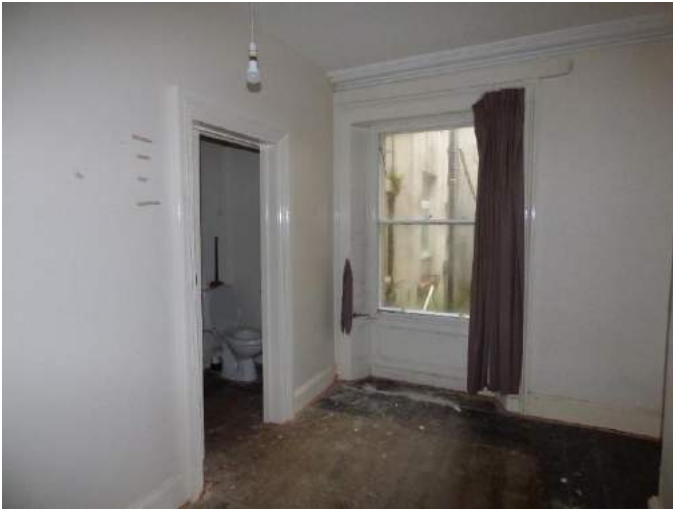
Left: In the existing dining room, the period features below and to the sides of the existing windows are in good condition, it is proposed to carefully refurbish the existing timber shutters.

Existing cornice to be made good in locations where redundant services are to be removed, here the stud partition to a bathroom has been installed and where hairline cracks have appeared.

Flush panel doors to be replaced with heritage style 4 panel timber fire doors to enhance the heritage asset.

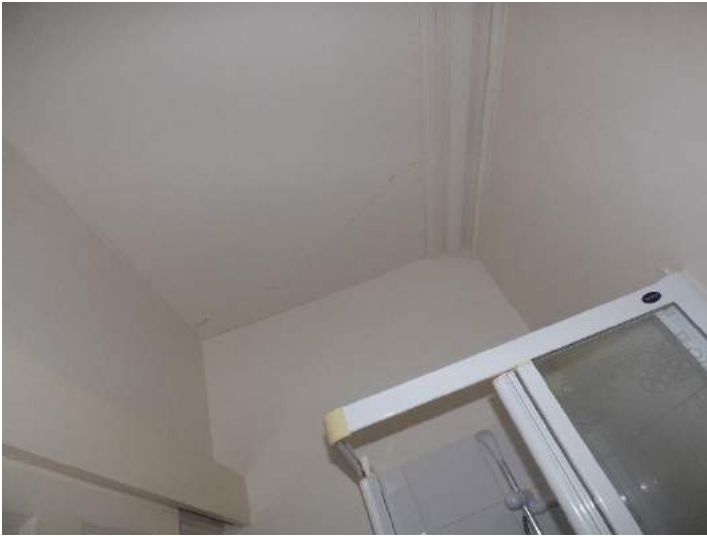
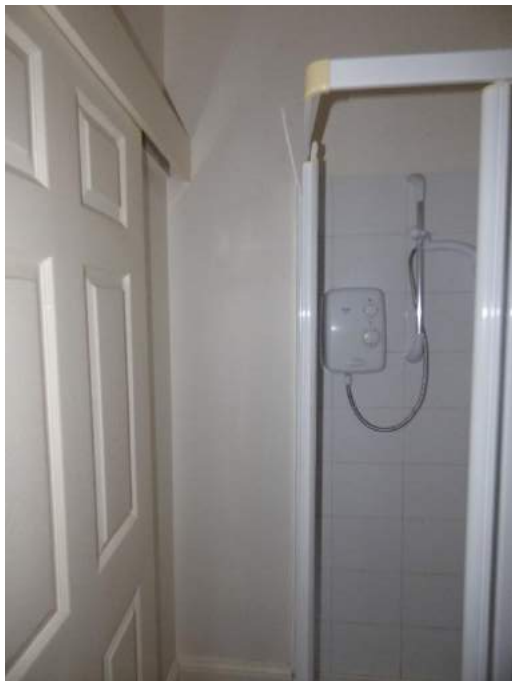
Left and below: Existing bathroom to be completely removed including stud partitions.

Cornices and skirtings to be made good where partitions removed.

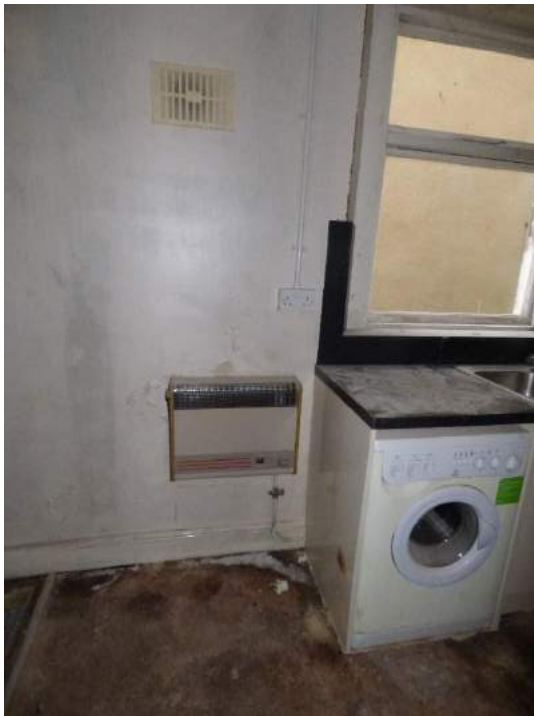
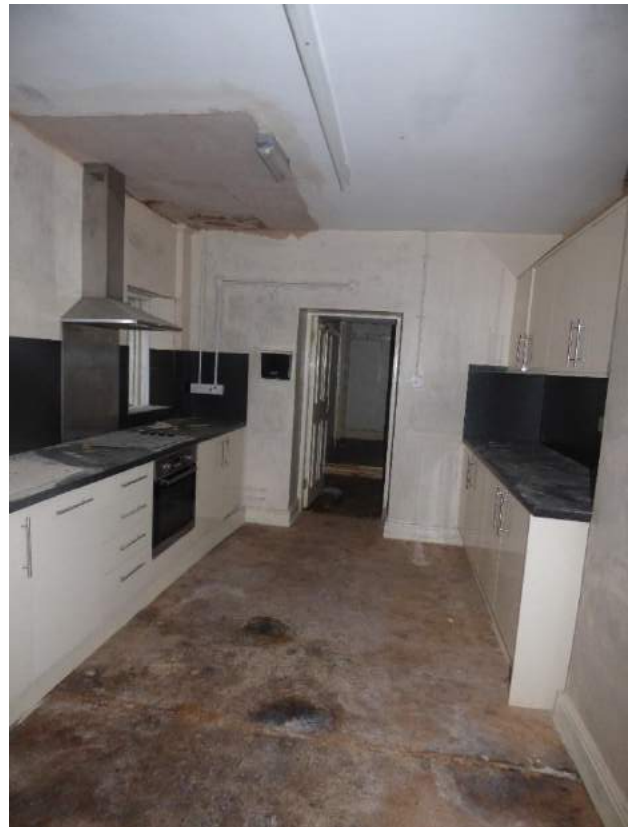
Left and below; In the existing kitchen, the existing kitchen will be completely removed. The existing modern single glazed windows will be removed and replaced with heritage painted double glazed sash windows. The existing floor has been over-boarded with a ply decking. It is proposed to lift the ply decking and examine the original floors. It is proposed to apply water resistant chipboard, subject to the sub floor and the condition of the joists etc which may require replacement.

Existing services to be removed and walls, and ceilings made good.

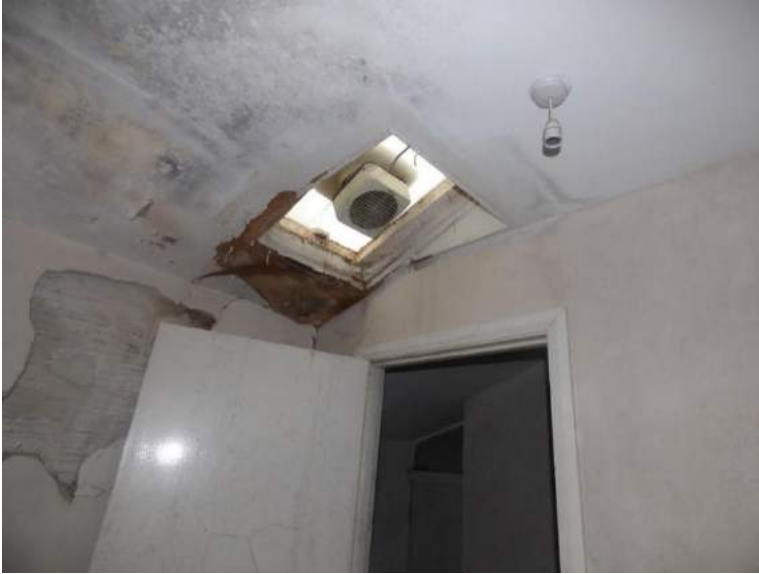
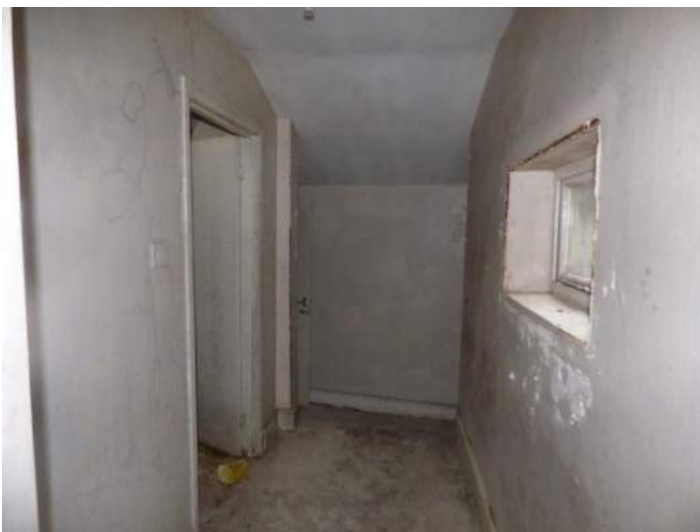
Above: Existing utility and WC to be reconfigured.

Below: Roof above utility and w.c. requires significant repairs to slate roof and to lead flashings (which require replacement). Blown plasterwork to be removed and reinstated with lime plaster and skim finish. (Solo lime plaster from Lime Centre).

Blown plasterwork to be removed and reinstated with lime plaster and skim finish.

Apply an insulated plasterboard 62mm thick to underside of ceiling. The Laminated plasterboard and PIR has a vapour barrier incorporated so interstitial moisture would be prevented. New rooflights to be installed with flashing kit that mounts unit flush with the roof surface.

All walls, floor, ceilings to be made good and prepared for full decoration.

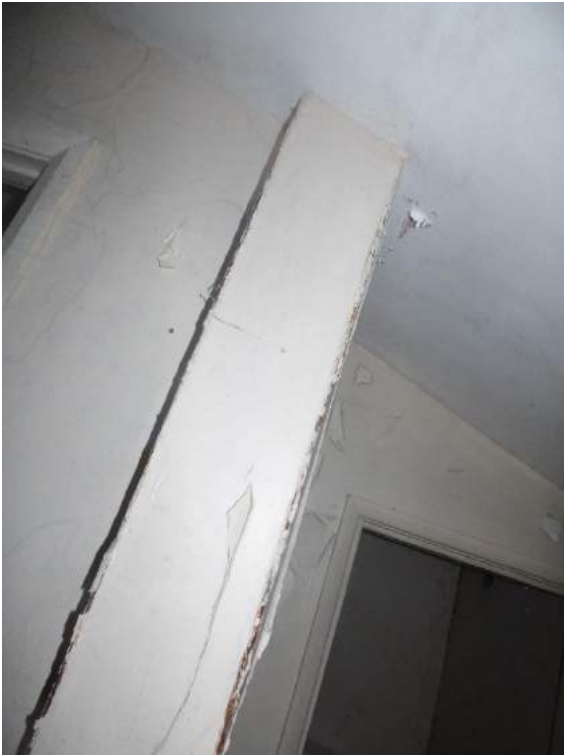
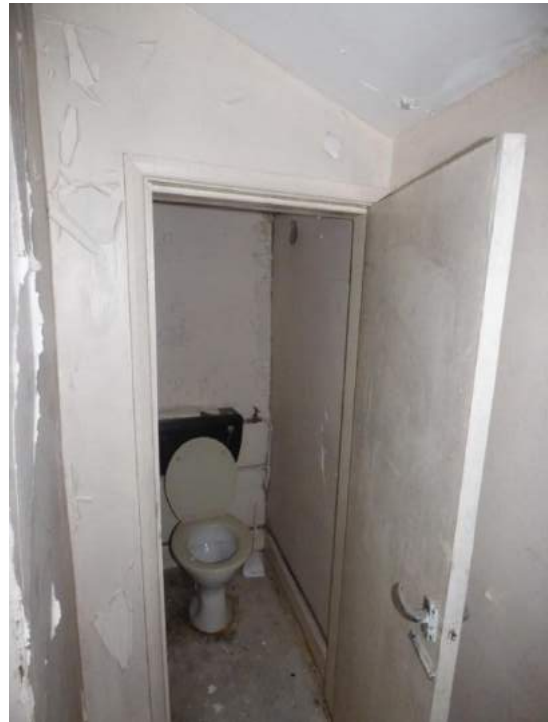
Above and below: Existing wc to be removed, as part of the reconfiguration of the area, and new sanitaryware to be provided. All walls, floor, ceilings to be made good and prepared for full decoration.

Existing rear door to be removed and replaced with a new hardwood painted door to match the front door (in style), and Georgian style ironmongery.

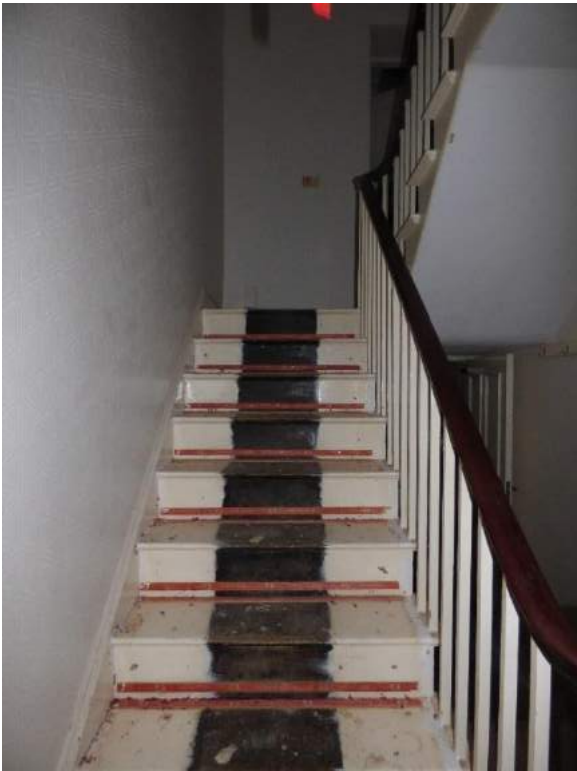
Left: Handrail, balusters and rails are original and are to be retained.

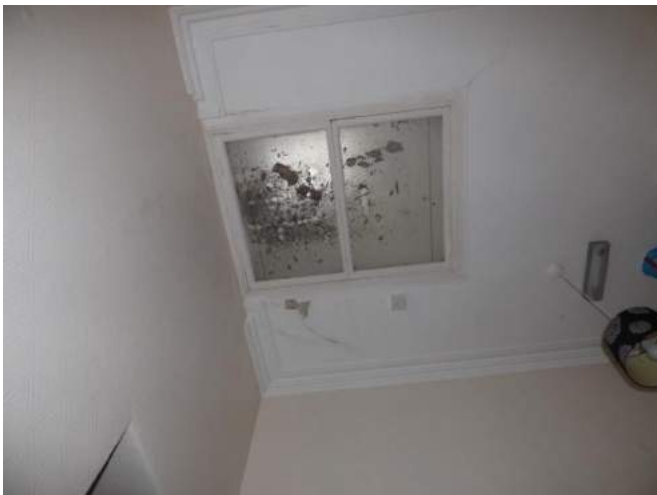
Left: Ceiling glass to be removed and ceiling to be boarded up and cornice to be reinstated where it has been cut out to form glazed aperture.

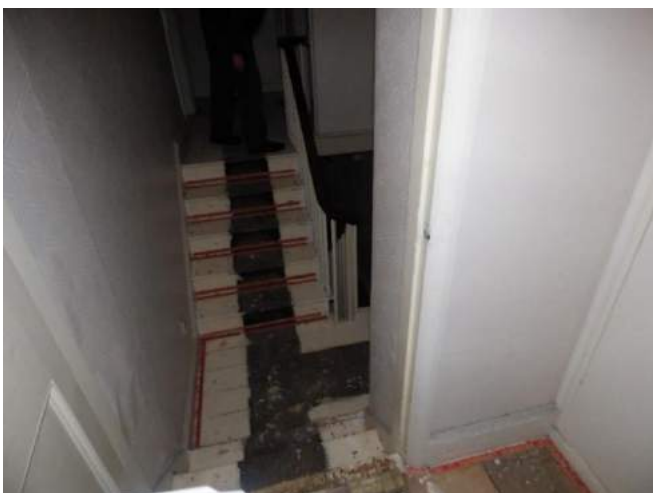
Left: At first floor all existing architraves and skirting to be retained.

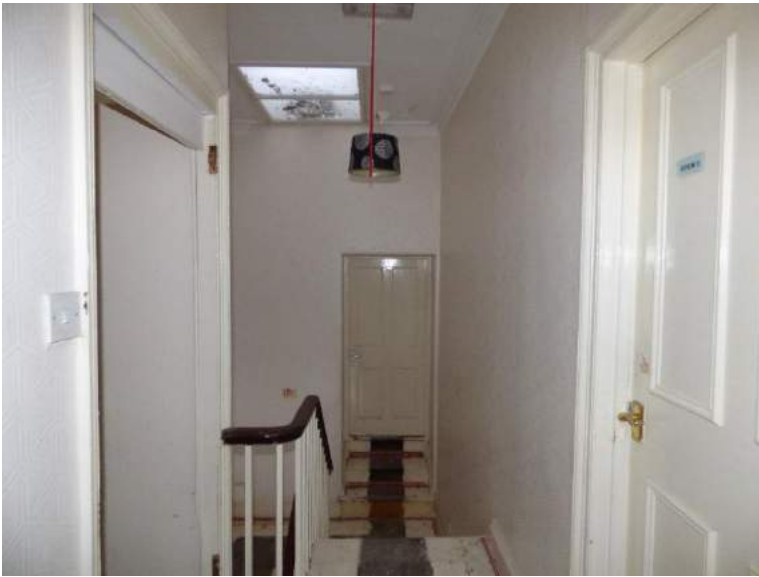
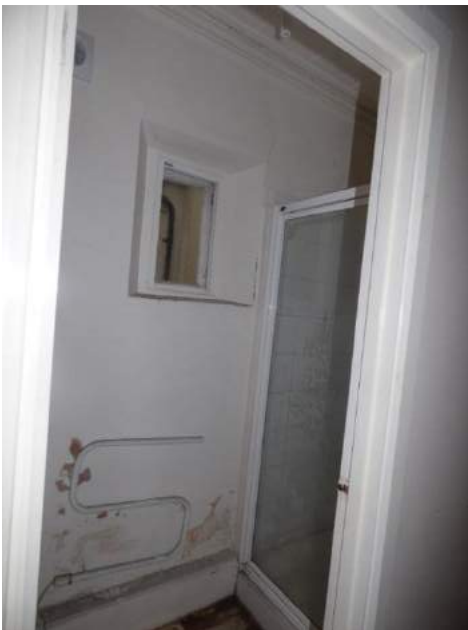
Left: The existing shower room is not original and it is proposed to remove to reconfigure the space.

skirtings to be reinstated to match the existing.

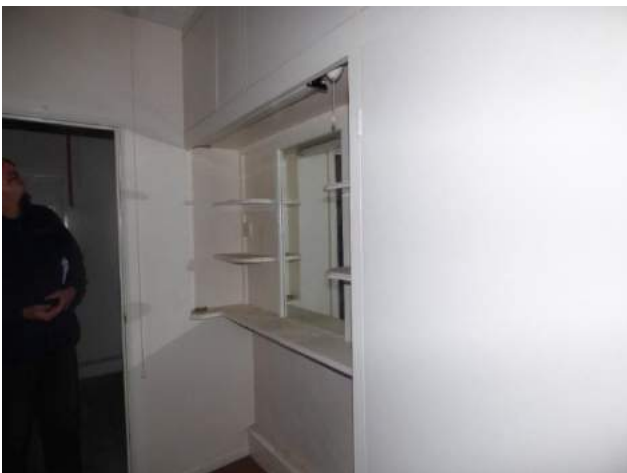
Left: existing corridor to bathroom.

Recent features added as part of the room as part of the conversion to dormitory accommodation to be removed and walls reinstated as original.

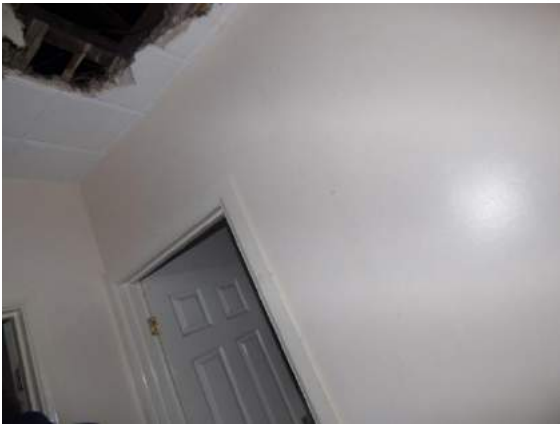
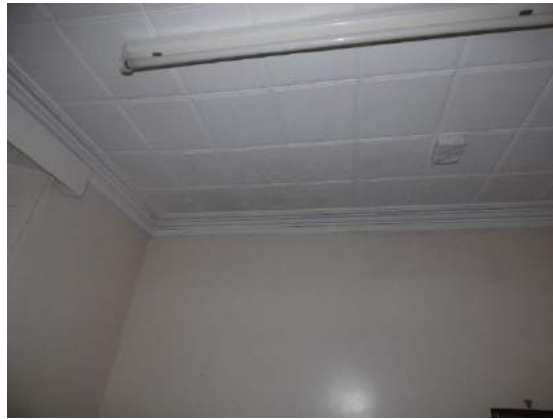
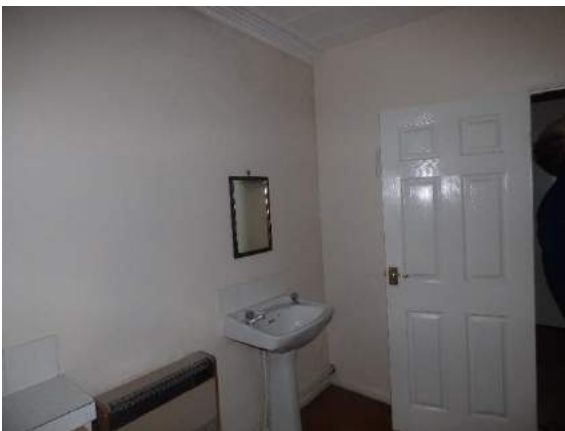
Above, left, and below: Existing bathroom. The existing ceiling finishes to be removed, and the ceiling to be made good including remediation of lath and plaster ceiling by specialist.

Existing floor is not original, so it is proposed to replace with moisture resistant chipboard.

Existing modern window to be removed and replaced with new painted timber double glazed heritage style Georgian sash window with obscure glazing.

Existing modern replica six panel door to be replaced with new traditional timber four panelled Georgian style door – bathroom door does not need to be a fire door.

All finishes to be made good, and cornice to be reinstated where currently removed and new skirtings to match the original to be installed.

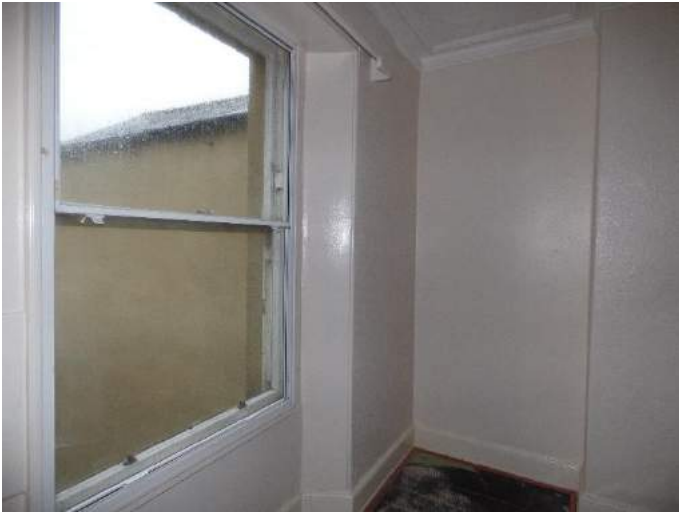
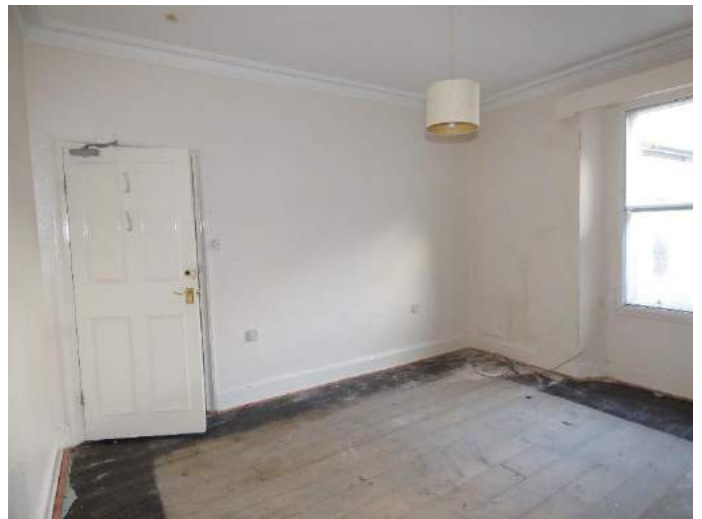
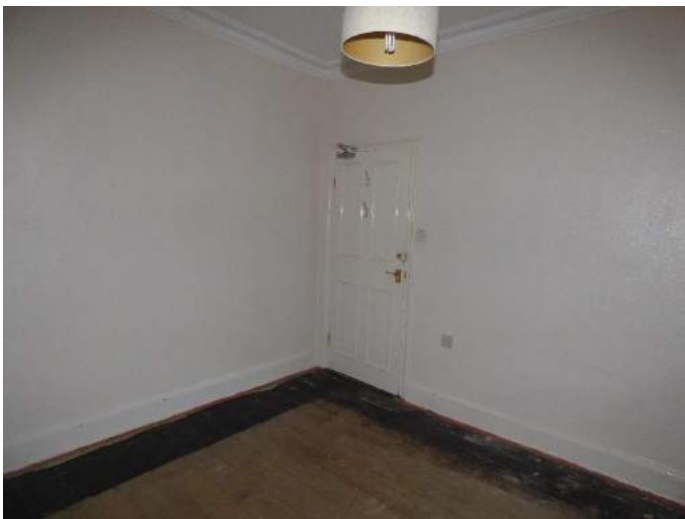
Rear bedroom.

Skirtings and architraves to be retained and repaired where necessary. Existing door to be replaced with new Georgian heritage style 4 panel door to be provided and installed by specialist joinery company such as Batty Joinery Ltd.

Existing floorboards generally in good condition. Minor repairs to plaster work in window reveals to be repaired.

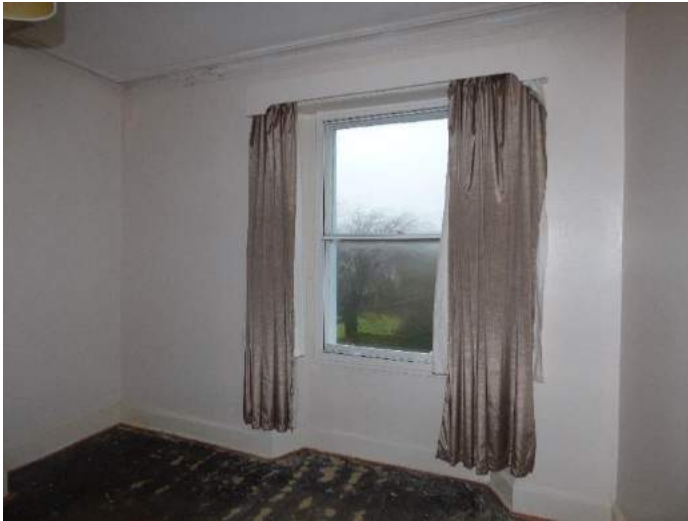
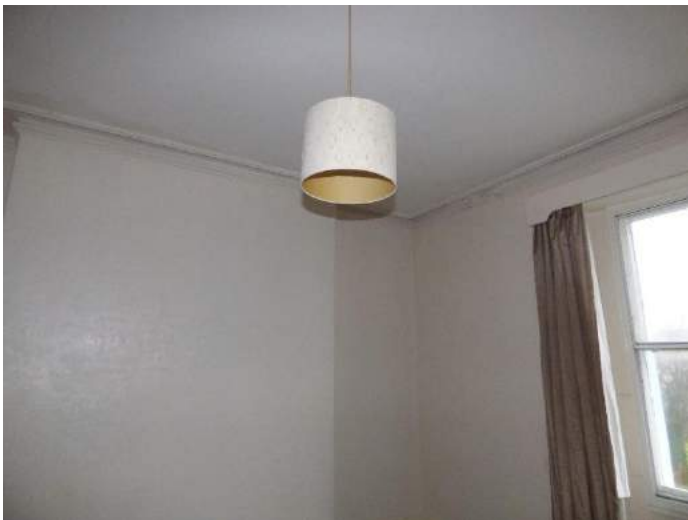
Left: Large front bedroom. Skirtings, cornices, and architraves to be retained and minor repairs where necessary. Existing flush panelled door to be replaced with new Georgian heritage style 4 panel door to be provided and installed by specialist joinery company such as Batty Joinery Ltd. Where possible it is proposed to refurbish any original doors with door closers and intumescent paint subject to building control approval.

Existing floorboards in good condition.

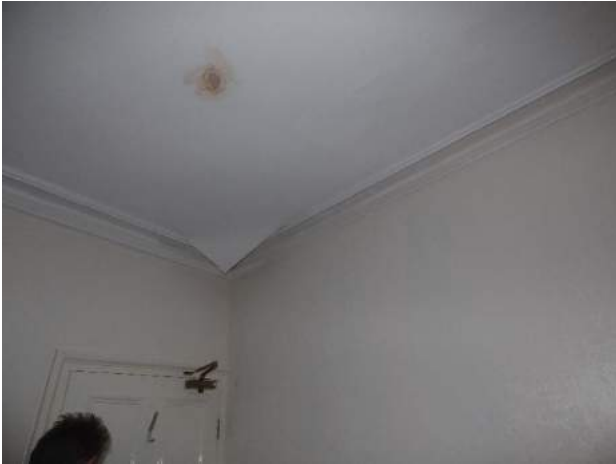
Left: Front Bedroom (small) skirtings and architraves to be retained, existing door to be replaced with new Georgian heritage style 4 panel door to be provided and installed by specialist joinery company such as Batty Joinery Ltd. Where possible it is proposed to refurbish any original doors with door closers and intumescent paint subject to building control approval.

Damp damage to plastered ceiling to be repaired due to water ingress in attic.

Existing floorboards generally in good condition.

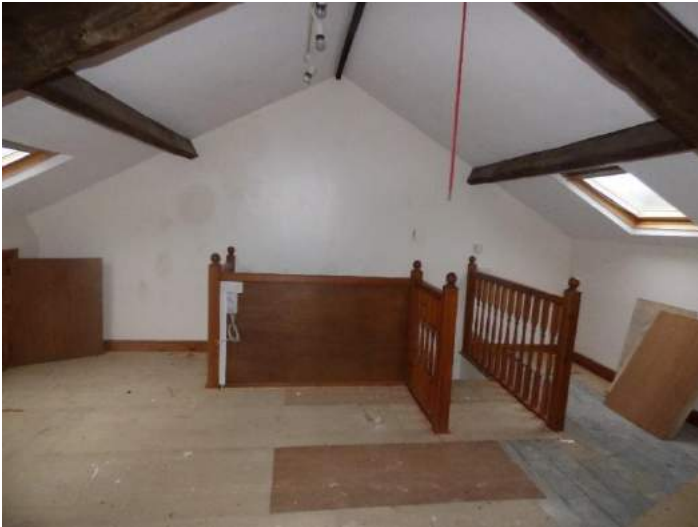
Existing attic space is proposed to be reconfigured to provide additional bedroom accommodation.

New plasterboard stud partitions to be installed to form new spaces.

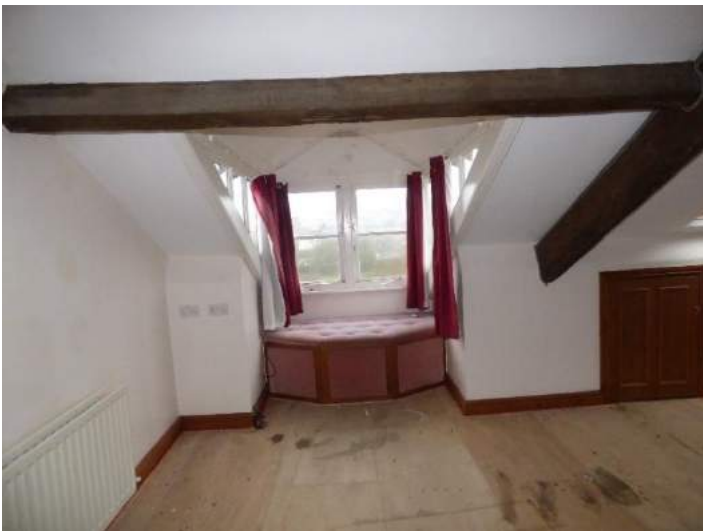
All damp and damaged/blown plasterwork to be repaired with lime plaster (Solo lime plaster from Lime Centre) and skim and decorate throughout.

Apply an insulated plasterboard 62mm thick to underside of ceiling. The Laminated plasterboard and PIR has a vapour barrier incorporated so interstitial moisture would be prevented. New rooflights to be installed with flashing kit that mounts unit flush with the roof surface.

Tape and skim and undertake full decorations. Replace existing modern rooflights with new heritage style Velux rooflight (or Rooflight company equivalent).

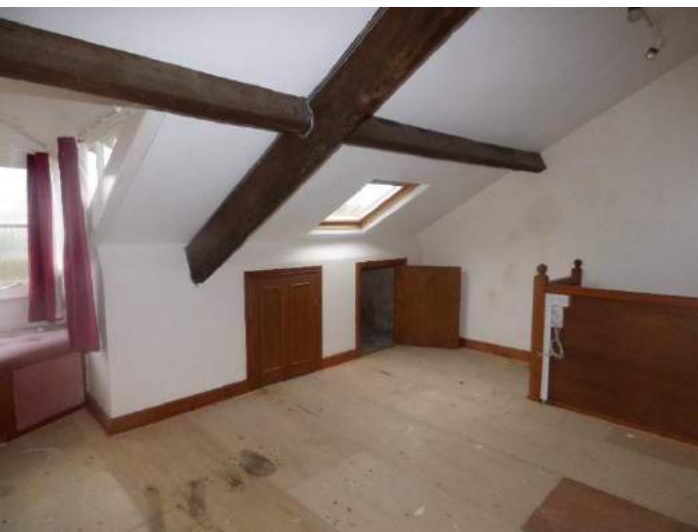
Floorboards are not the original and likely to have been installed due to water ingress. It is proposed to replace with softwood timber floorboards. The skirtings are not original, and it is proposed to remove them and replace with new soft wood skirtings to match the skirtings throughout the rest of the property.

New doors to be provided to newly formed rooms to be 4 panelled Georgian style timber doors to match the doors being reinstated throughout the rest of the property. Doors to be fire rated.

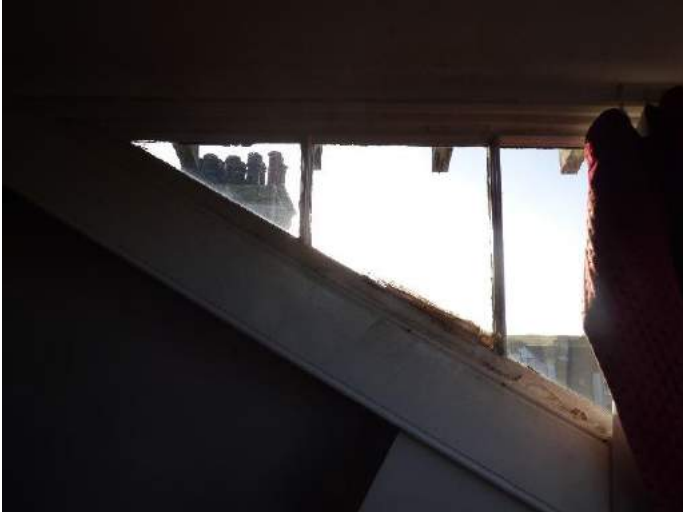
The existing dormer window has suffered considerable damage, with windows missing and considerable fabric damage due to water ingress.

It is proposed to reconstruct the dormer windows to the same details as the existing, with new double glazed heritage style windows. Refer to plan and elevations as proposed.

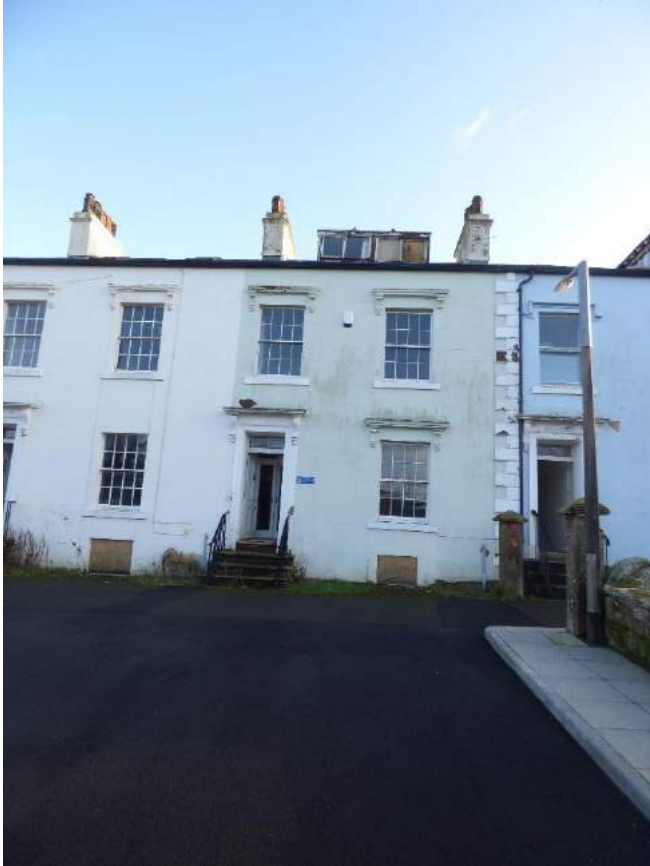
Left: The main entrance is mentioned in the listing text and is to be entirely retained.

Both front and rear elevations are currently rendered, with colour to the front and side and natural to the rear. All elevations require to be prepared for render repairs and redecoration by specialist using lime render and stucco (Parax LTD) to be applied by specialist.

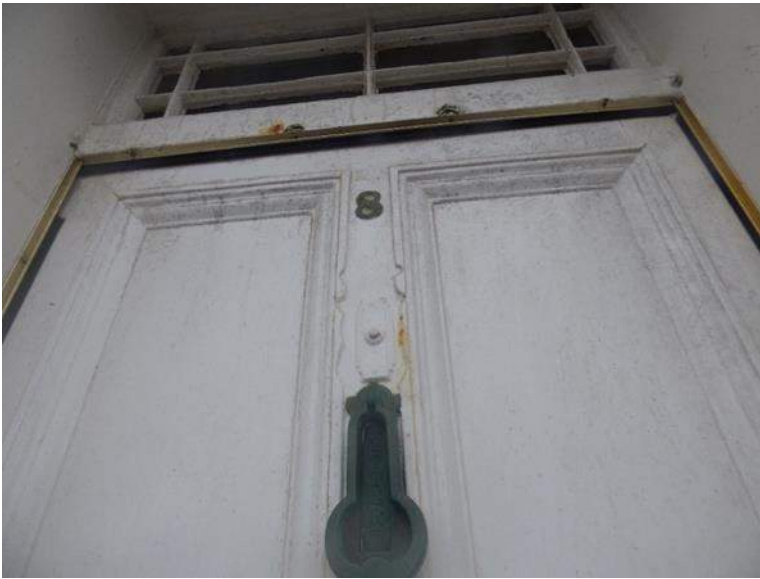
Existing door and fanlight to be retained and repaired.

All existing single glazed windows to be replaced with new white painted slim profile double glazed 'heritage windows to match the existing style by specialist supplier such as Batty joinery Ltd.

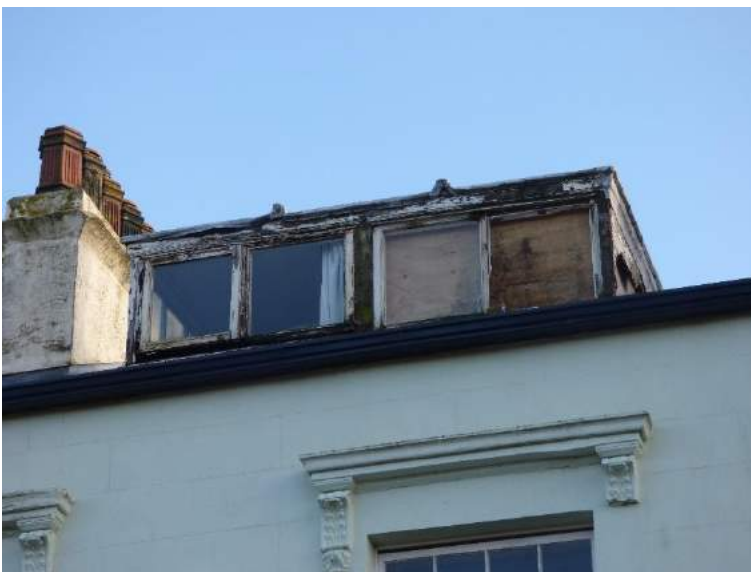
Left: Dormer windows to front of property have been damaged beyond repair, and it is therefore proposed to replace with a new dormer window, with painted timber heritage style double glazing.

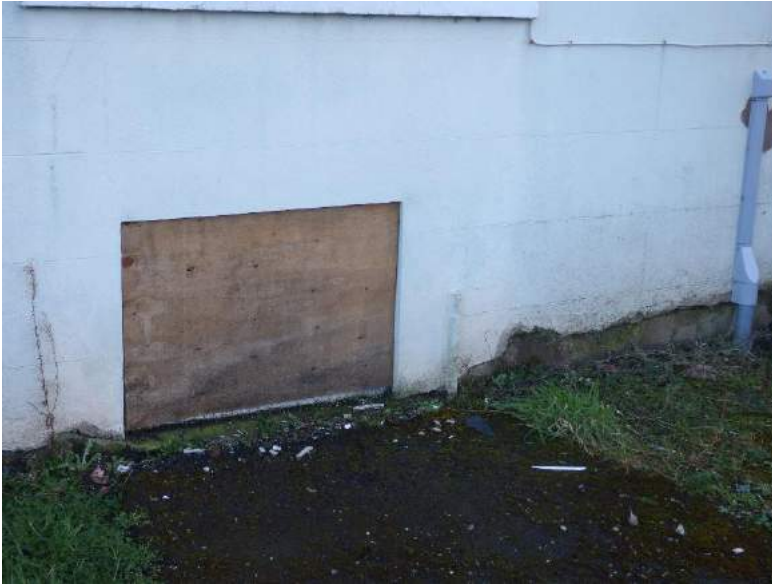
Boarded up window to basement on front elevation, to have new double glazed heritage style double glazed side hung casement window reinstated by specialist such as Batty Joinery Ltd.
