# HERITAGE STATEMENT

## FULL RENOVATION OF EXISTING No 11 TERRACE HOUSES

St Bees, 1-11 Lonsdale Terrace, Parish Council, Cumbria

M.A.C Architects, Project Number: 2019:303

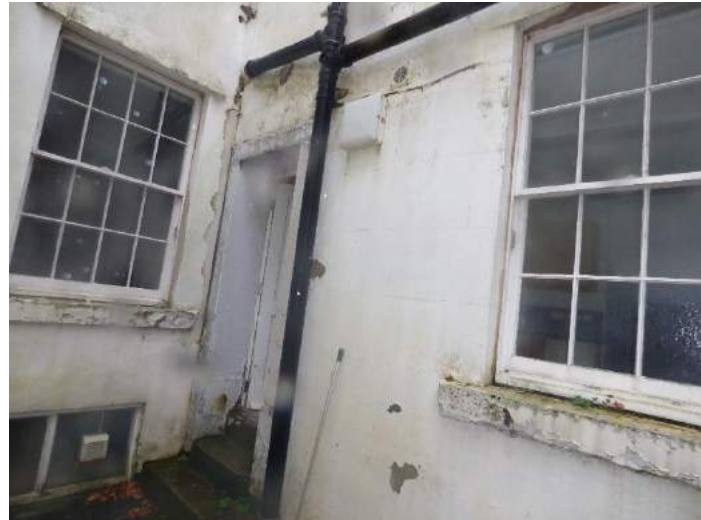
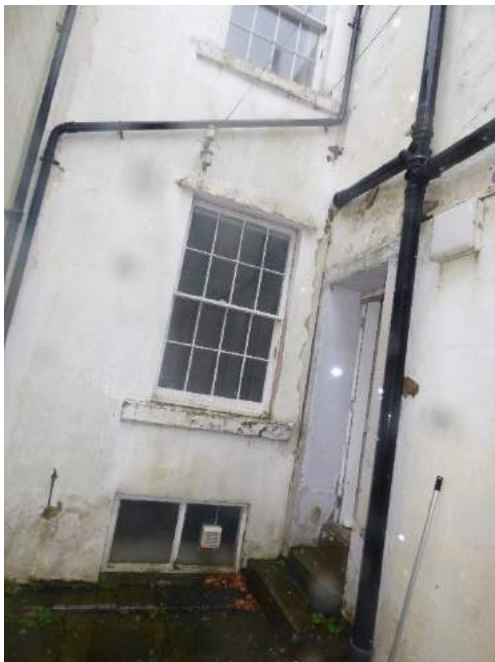
Rear of property – render to be repaired by specialist and decorated with off white render.

New door to be provided to rear to be Georgian style as front door.

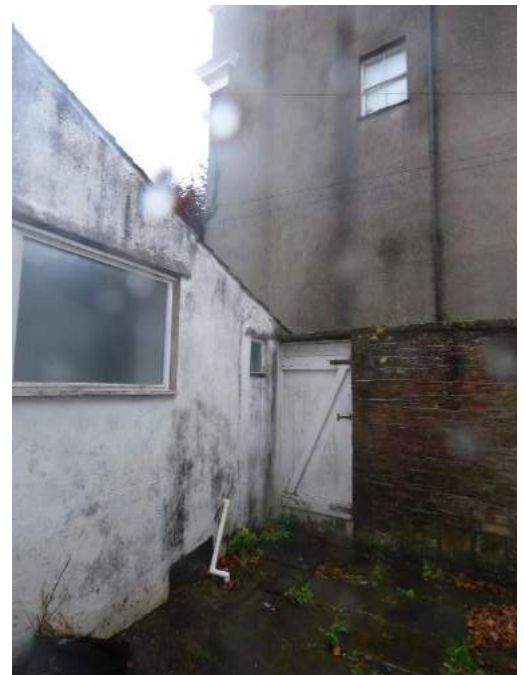
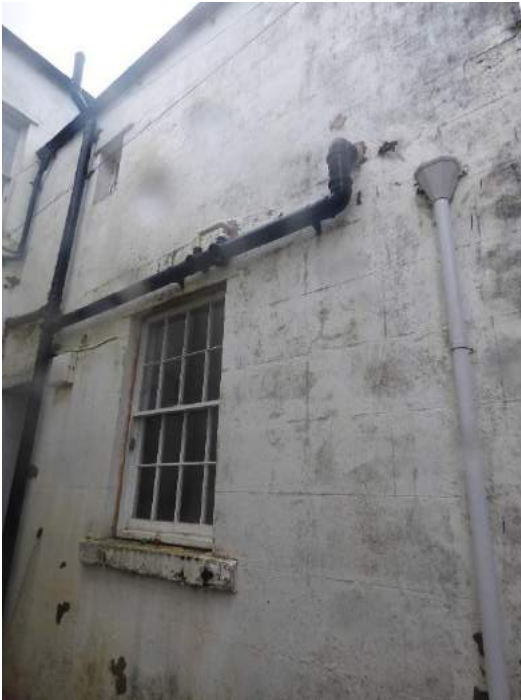
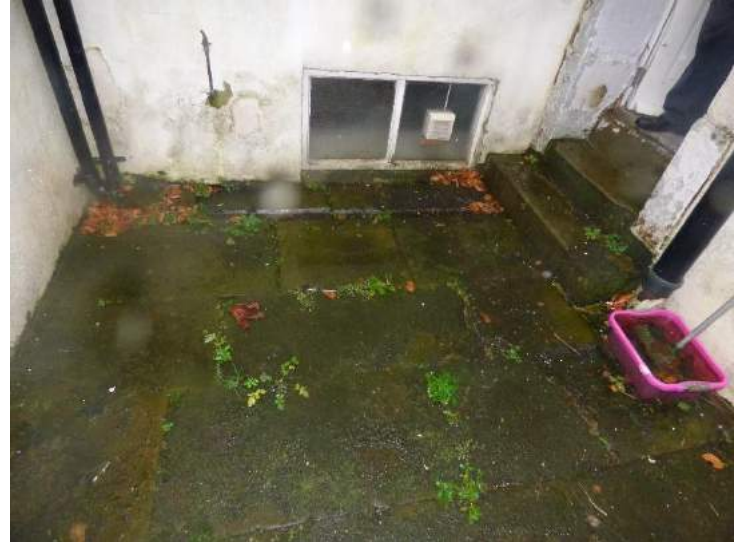
Rear of property – render to be repaired by specialist and decorated with off white render.

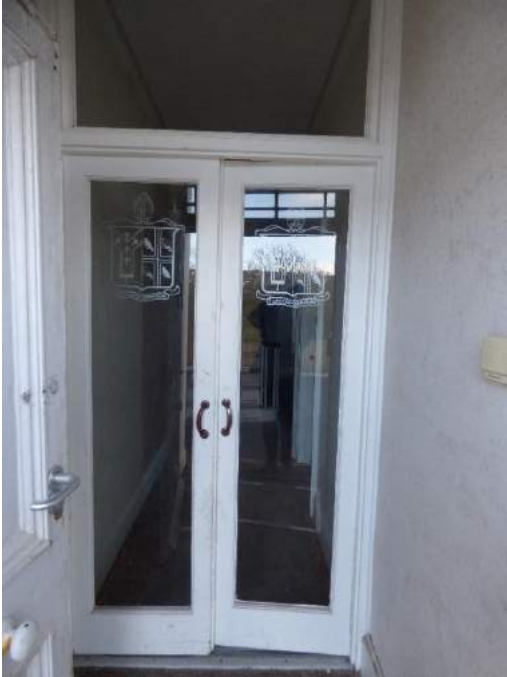
Left and below: New lobby installed when the building was converted into a dormitory to be removed.

Existing parquet floor to be retained and restored.

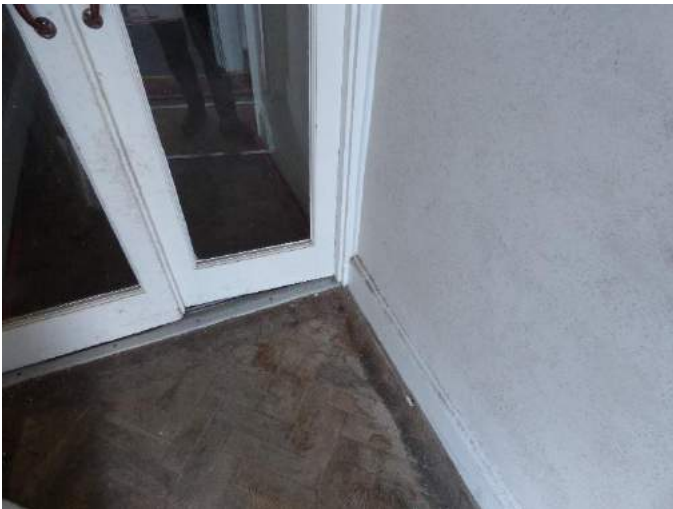
Left: Modern doors and clerestory glazing to be removed and walls, floor, and ceiling to be made good.

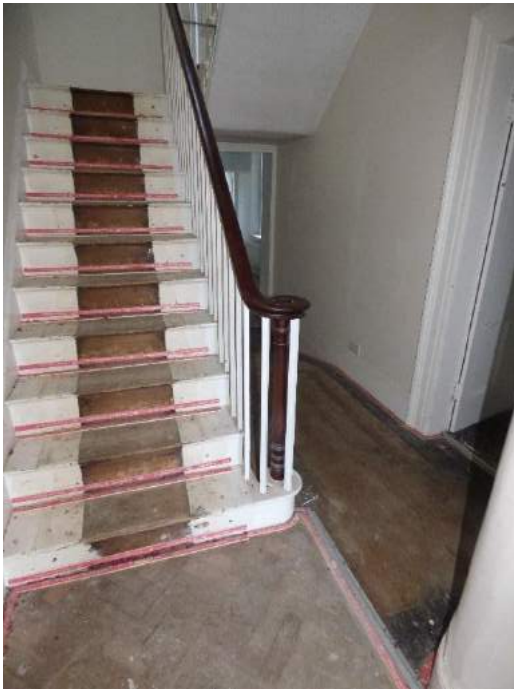
Existing staircase. Handrails, balusters, and rails are original and to be retained.

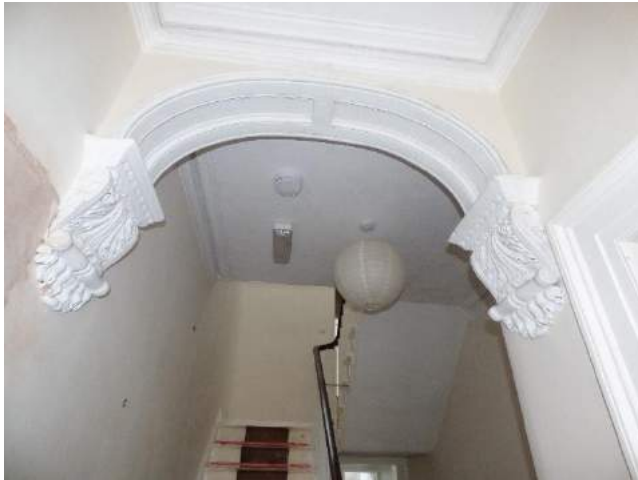
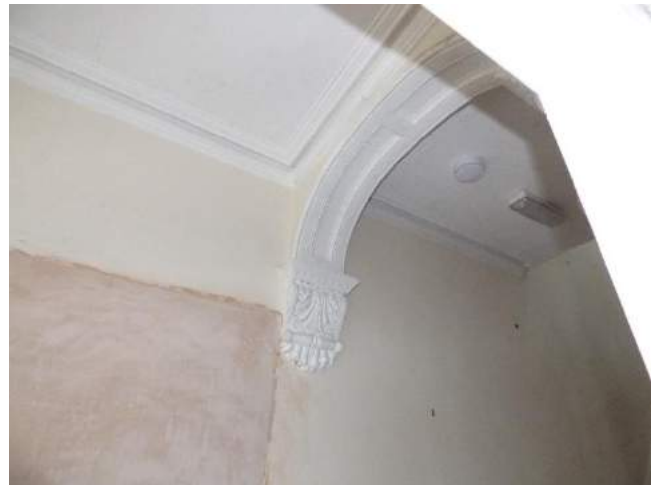
Above and below: Redundant M&E to be removed and wall/ceiling finishes made good.

Period features to be retained, including archway and architraves.

(Modern lighting to all be stripped out and surfaces restored.

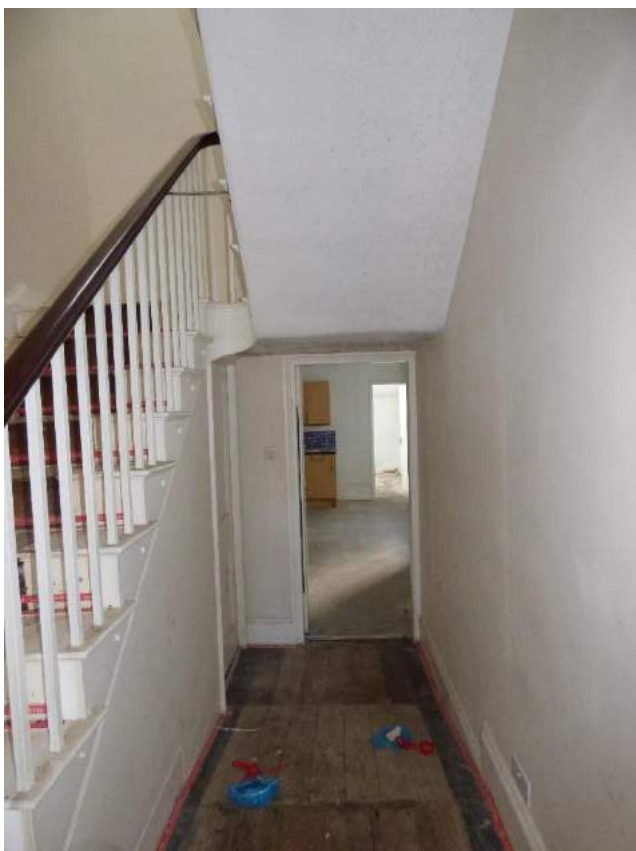
Existing floorboards in good condition.

Flush panel doors to be replaced with heritage style four panel painted timber fire doors to enhance the heritage asset.

Where possible it is proposed to refurbish any original doors with door closers and intumescent paint subject to building control approval.

Existing ramp to be removed and original step down to kitchen to be reinstated.

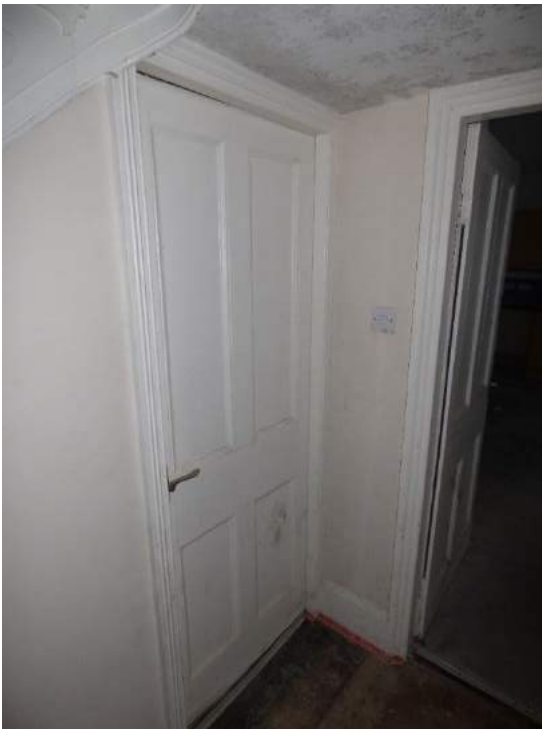
Left: Doors to all existing rooms to be replaced with new 4 panel fire doors to match existing. All existing architraves and skirtings to be retained.

Where possible it is proposed to refurbish any original doors with door closers and intumescent paint subject to building control approval.

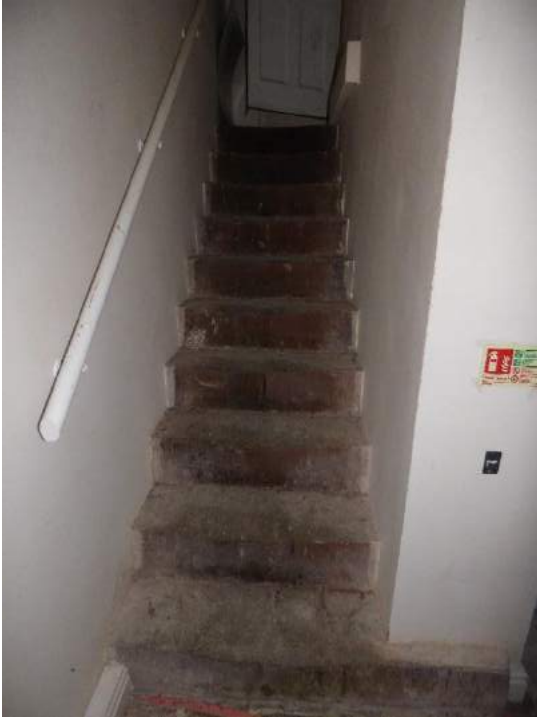
Left: Basement.

The existing walls and floor are generally in sound condition so would be suitable for the application of damp proof slurry system. All existing paint and surface finished must be removed and made good including all snots removed and damage to existing surfaces, prior to the installation of a Koster Polysil NB1.

Koster NB1 works by providing both a physical barrier against water ingress as well as providing a migratory crystal sealant that penetrates deep into the structure to seal micropores and cracks against water ingress.

Kloster NB1 is a breathable water proof system which will enhance the thermal value of the building without increasing the moisture content of the wall.

Once applied then the walls can be prepared and primed for decorating and for the floor finish to be installed. Complete new boiler and heating system is required, new distribution boards etc.

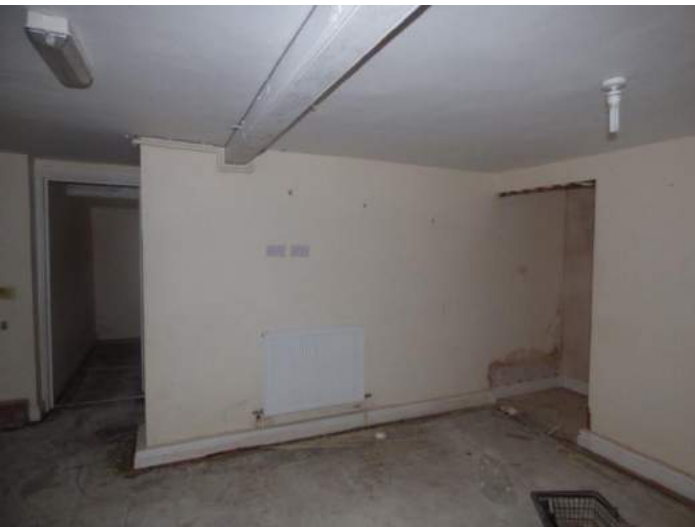
Existing walls have previously been plastered, but not with a suitable waterproof system and damp is penetrating through.

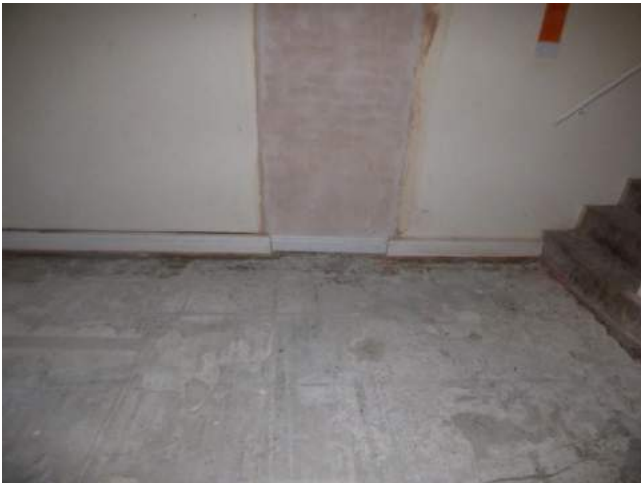
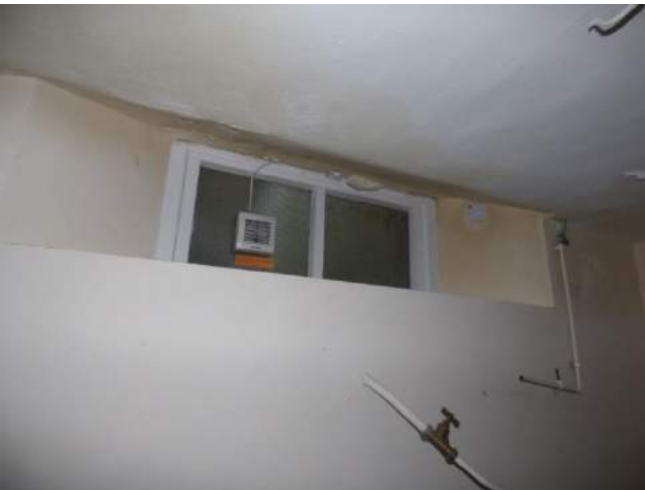
The walls down to the basement also require the full treatment.

In the basement all existing services are to be carefully stripped out and replaced with new compliant infrastructure.

Existing window to basement to be removed and replaced with new heritage style slimline double glazed timber window. It is proposed that the new window be of side hinged casements. Existing reveals to be made good.

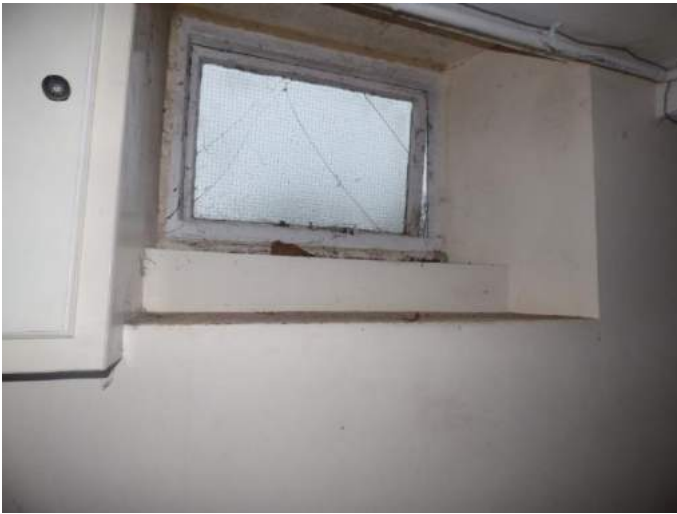
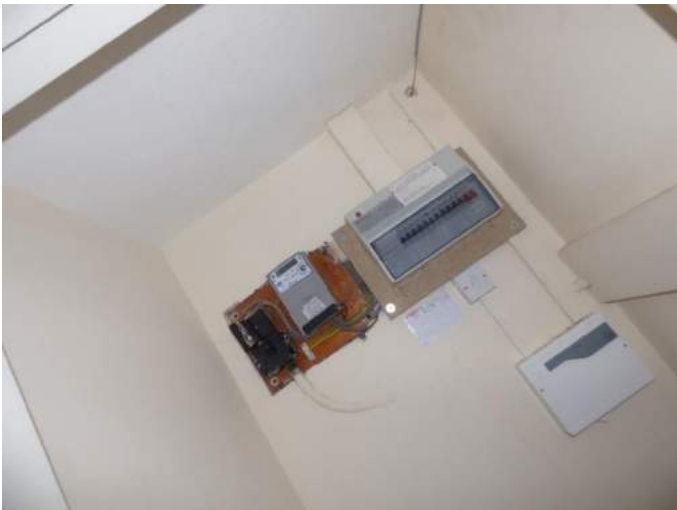
Left: Existing window to be replaced with new slimline double glazed heritage style window with top hinged casement as existing style.

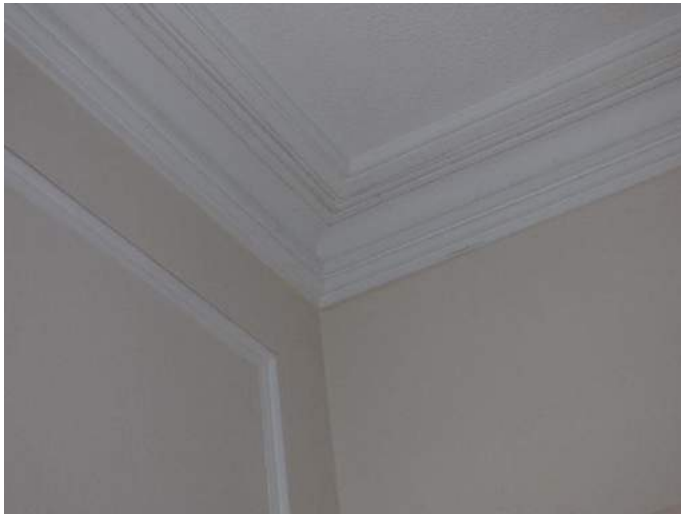
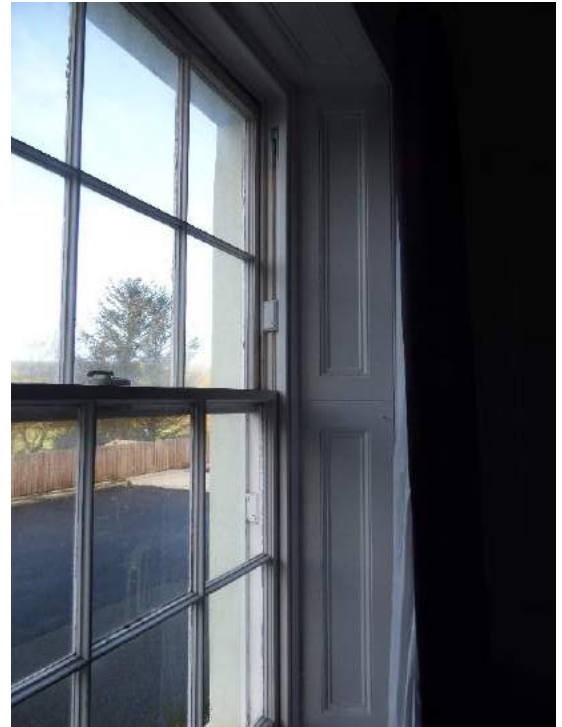
Above: In the existing front room, the features below and to the sides of the existing window are in good condition, it is proposed to carefully refurbish the existing timber shutters.

Left: Existing cornice to be retained and period features to walls to be retained and made good where required.

Existing architraves, and skirtings to be retained and made good.

Below: Existing door to be replaced with heritage style four panel painted timber fire door to enhance the heritage asset.

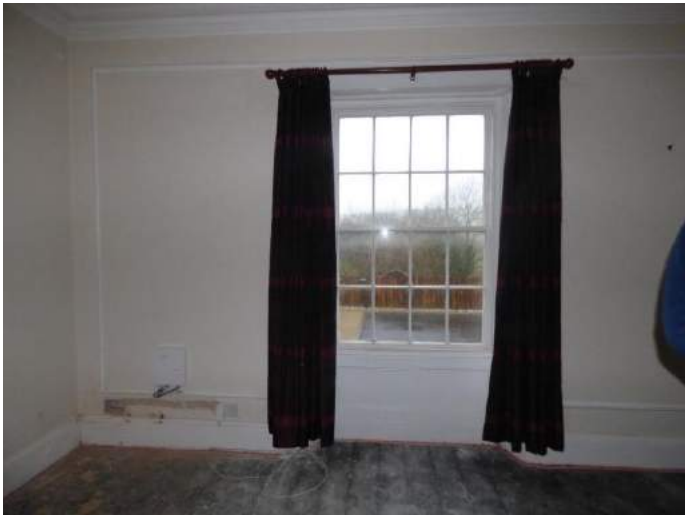
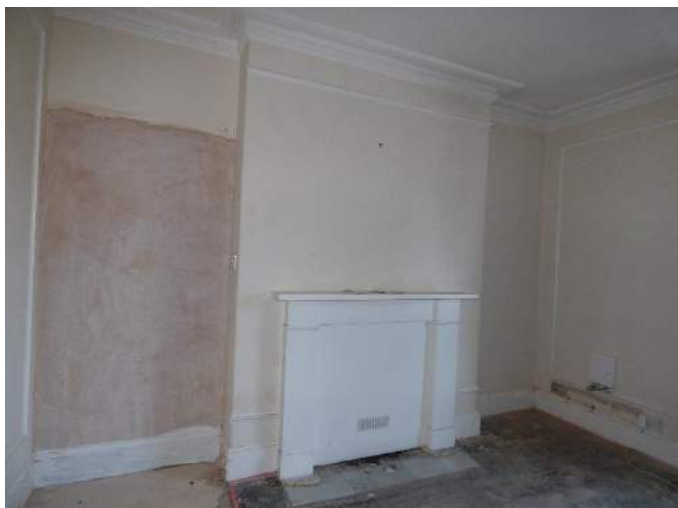
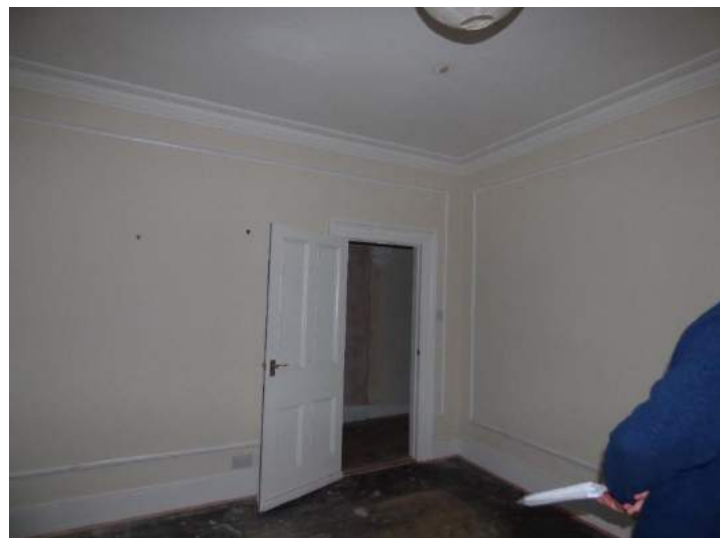
Left and below: In the existing dining room at the rear of the property, the period features below and to the sides of the existing window are in good condition, it is proposed to carefully refurbish the existing timber shutters.

Existing cornice to be made good in locations and where hairline cracks have appeared.

Here plasterwork has been damaged from damp ingress, blown plaster is to be removed, and reinstated with lime plaster finish.

Existing door to be replaced with heritage style four panel painted timber fire door to enhance the heritage asset.

Wall between dining and lounge to be opened (in the same style as the houses 1-5), to provide through living space to reflect the requirements of modern-day living.

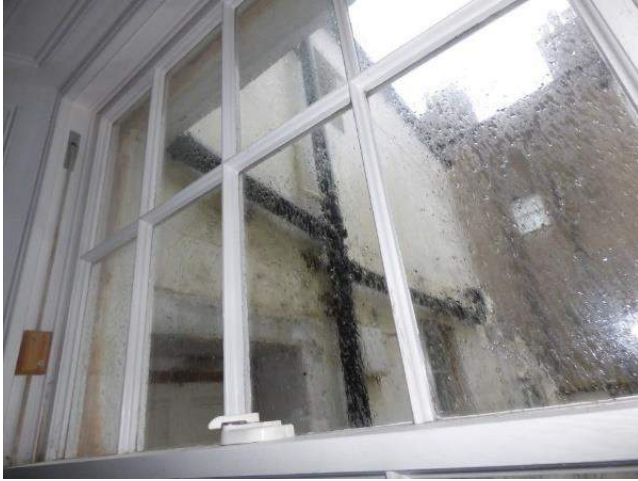
Left: In the existing dining room, the existing window is proposed to be replaced with a new heritage style double glazed timber window or to be refurbished with new double glazed slimline heritage sashes within the original frame.

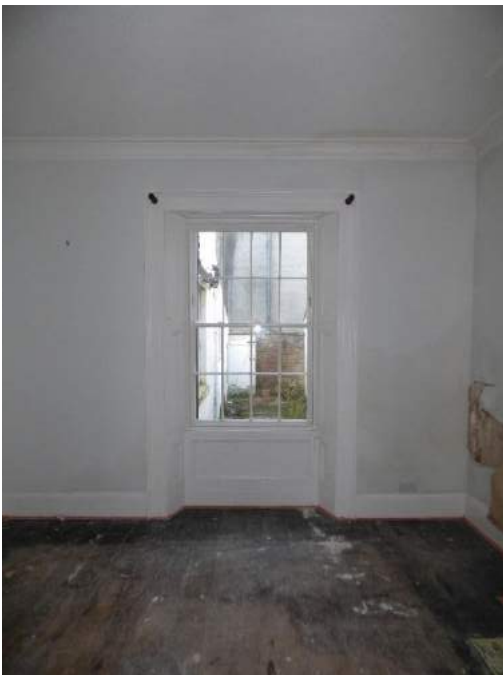
Above, left, and below: In the existing kitchen, the existing M&E services are to be removed and modern kitchen removed. Internal walls and ceilings to be made good.

Existing cornice to be made good in locations where redundant services are to be removed and where hairline cracks have appeared.

Existing architraves and skirtings to be retained and made repaired.

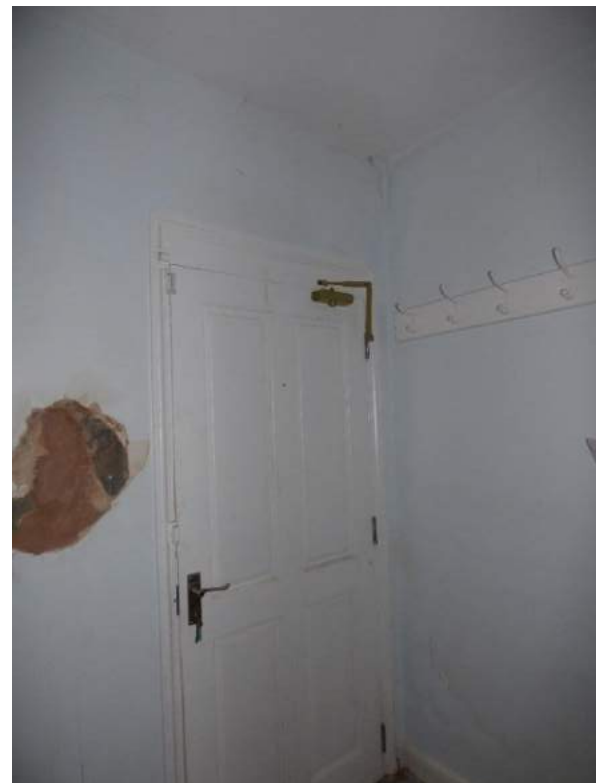
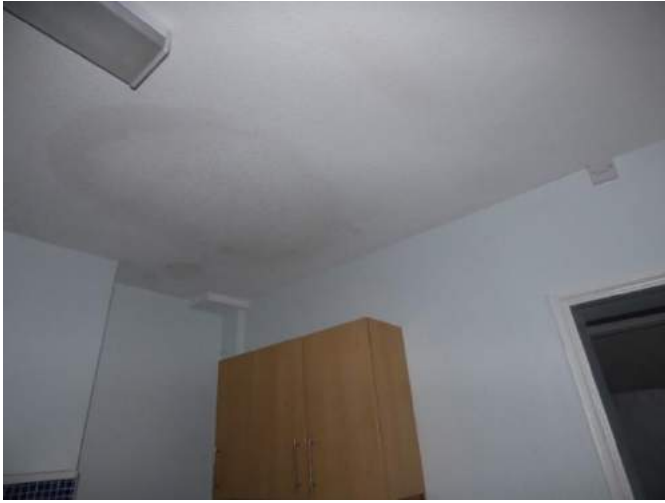
Left: Water ingress through the roof has damaged the existing ceiling.

Roof and ceiling to be repaired to match existing.

New skirtings and architraves to be installed to match the existing in the property.

Existing doors to be replaced with heritage style four panel painted timber fire door to enhance the heritage asset.

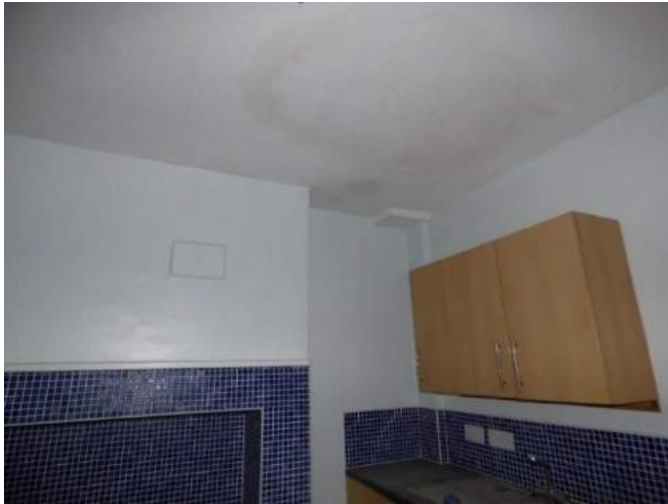
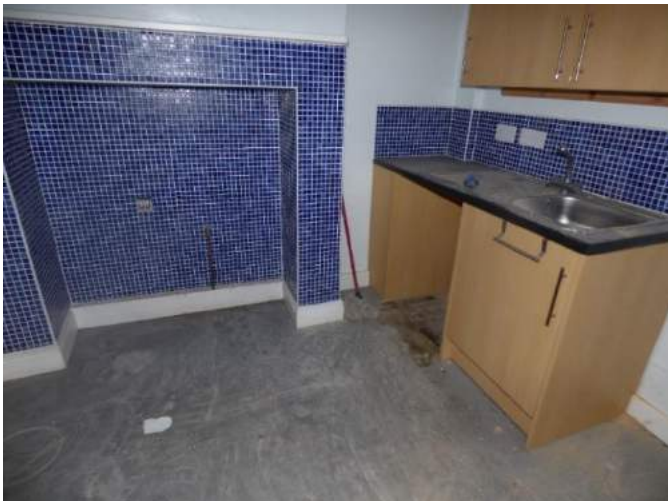
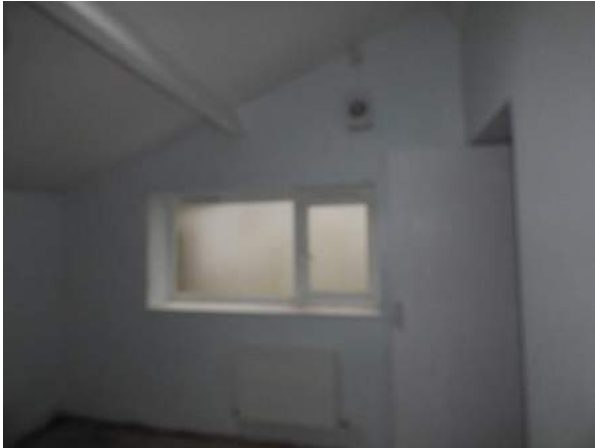
Left and below: The existing wc and utility area is to be reconfigured. All internal finishes to be stripped out and ceilings, walls, and floors to be made good.

Roof to be repaired and ceiling to receive new insulated plasterboard.

Apply an insulated plasterboard 62mm thick to underside of ceiling. The Laminated plasterboard and PIR has a vapour barrier incorporated so interstitial moisture would be prevented. New rooflights to be installed with flashing kit that mounts unit flush with the roof surface.

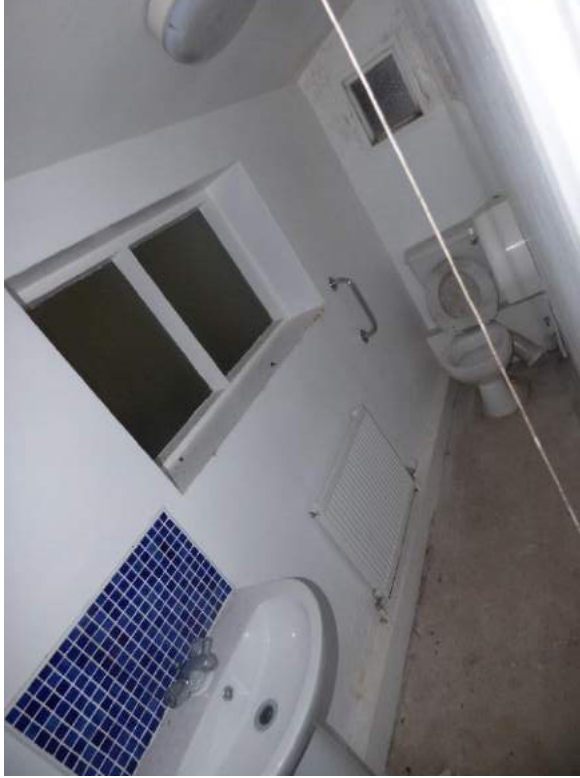
Left: Existing wc area to be reconfigured. Existing ceiling to be repaired.

Damp treatment is to be provided as Koster NB1 system.

Existing window (on rear boundary wall) to be walled up to match existing.

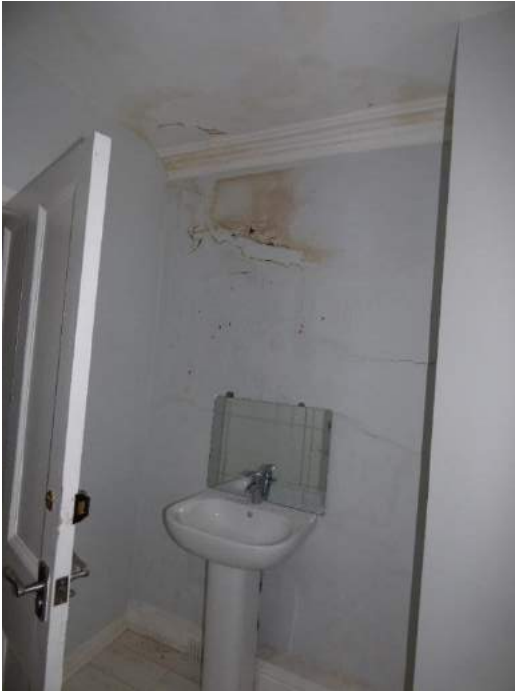
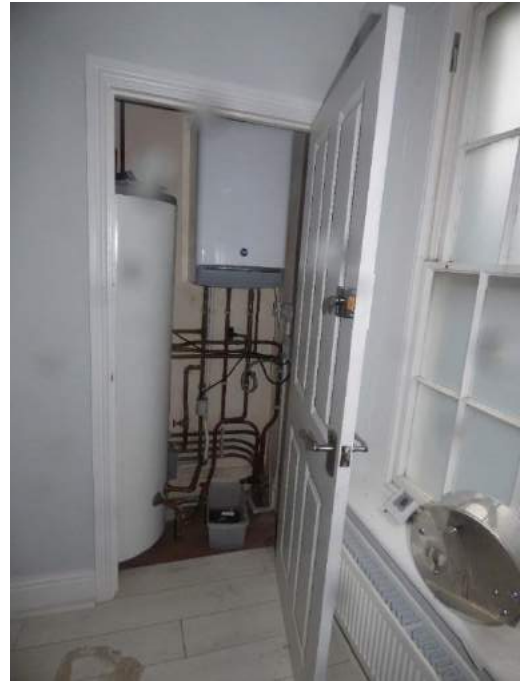
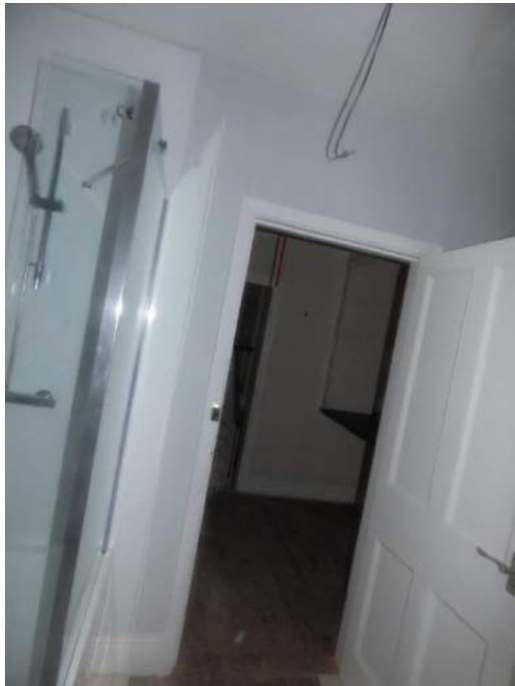
Existing bathroom - skirtings and architraves to be retained. Existing flush panelled door to be replaced with new Georgian heritage style 4 panel door to be provided and installed by specialist joinery company such as Batty Joinery Ltd. Where possible it is proposed to refurbish any original doors with door closers and intumescent paint subject to building control approval.

Ceiling and walls to be repaired where damaged from moisture ingress from leaking roof. Localised repairs to roof to be undertaken to ensure watertightness is achieved. All repairs to match existing.

New window to be installed with obscure glazing.

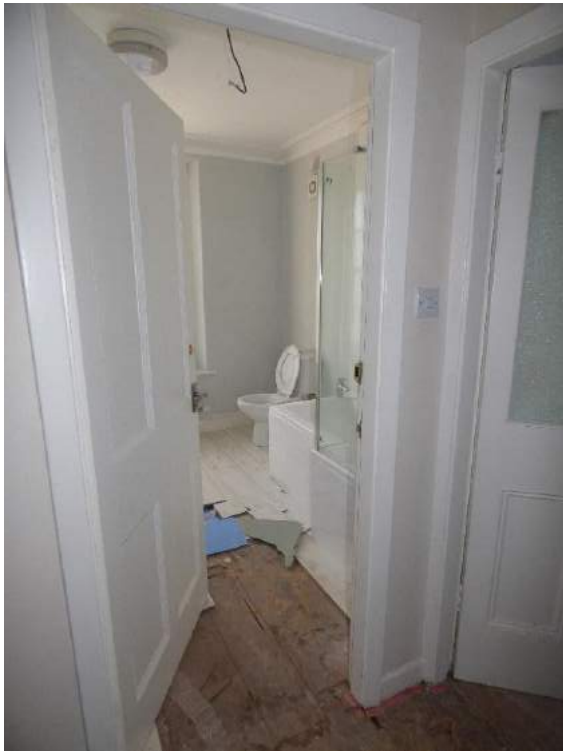
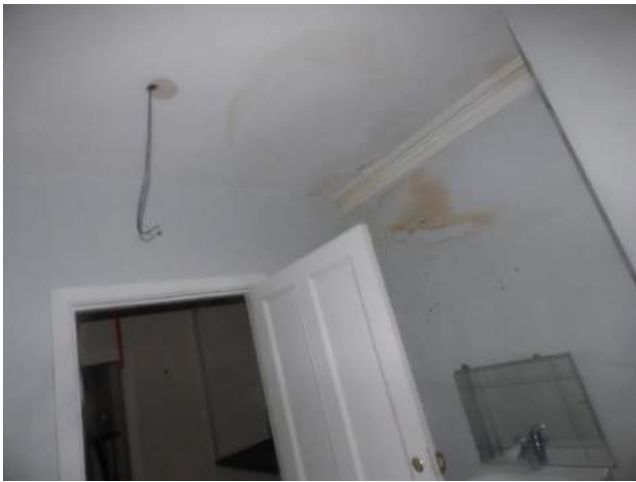
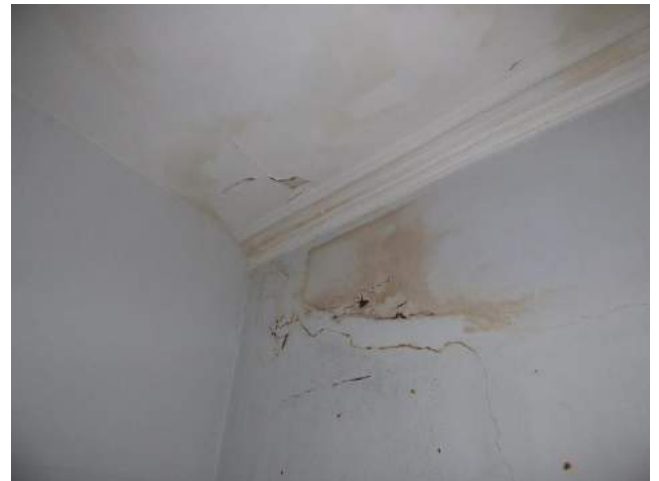
Above and right: Cornice to be installed to match existing on stud partition wall. Blown plaster to be carefully removed and new lime plaster finish to be carefully applied to repair finishes.

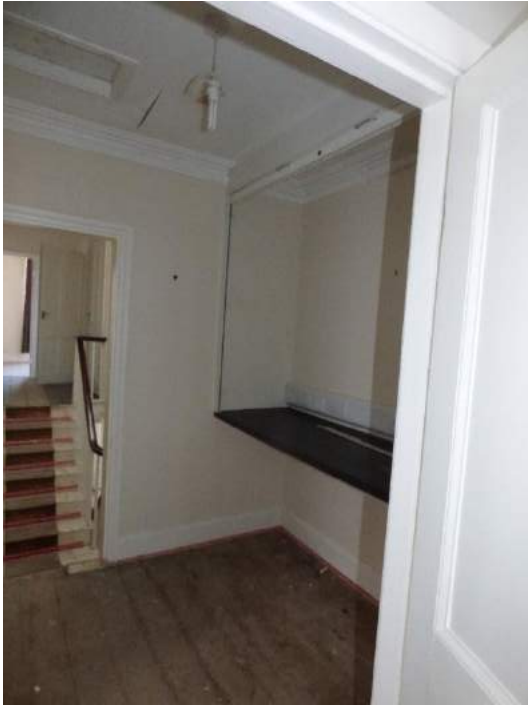
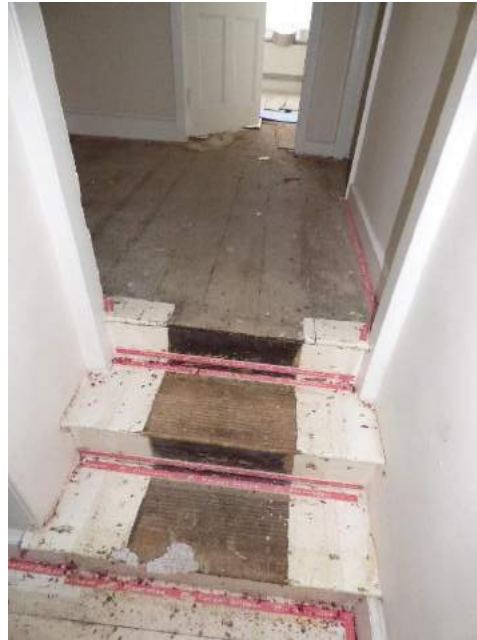
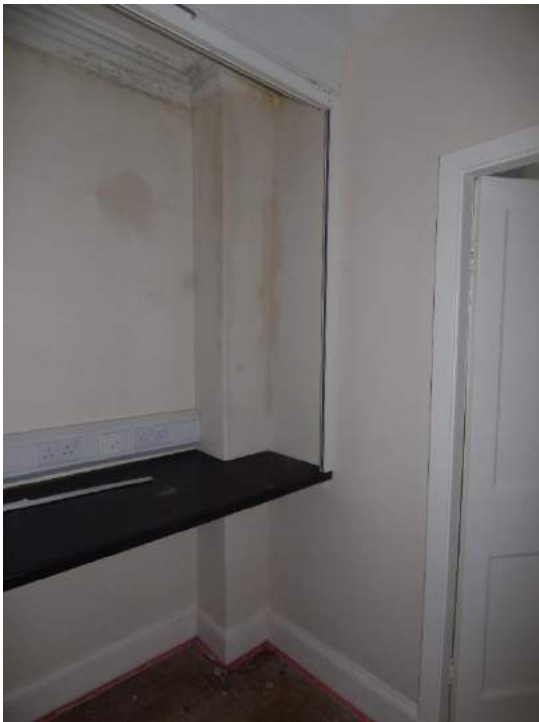
Left and above: Lobby to bathroom and existing wc to be reconfigured to make better use of space. Ceiling and walls to be repaired further to damp ingress damage.

Cornice to be provided where missing.

Existing non original fixtures and fittings to be removed and walls to be made good.

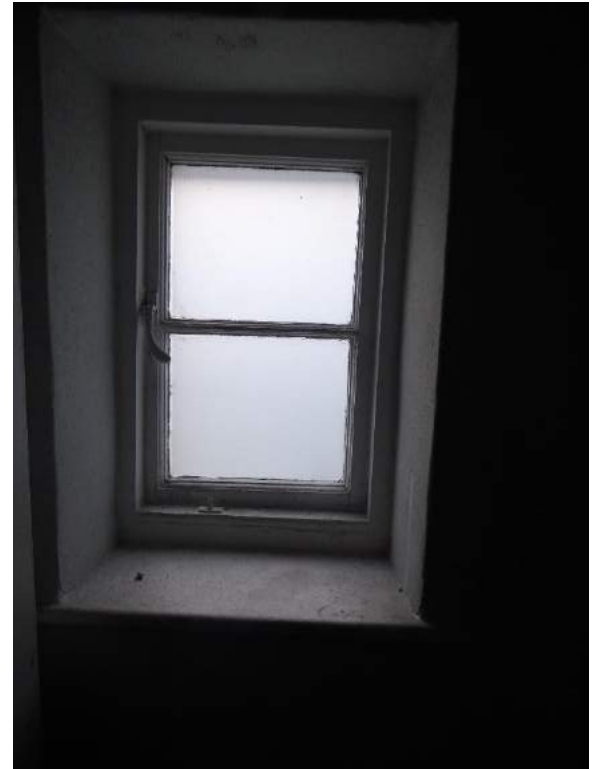
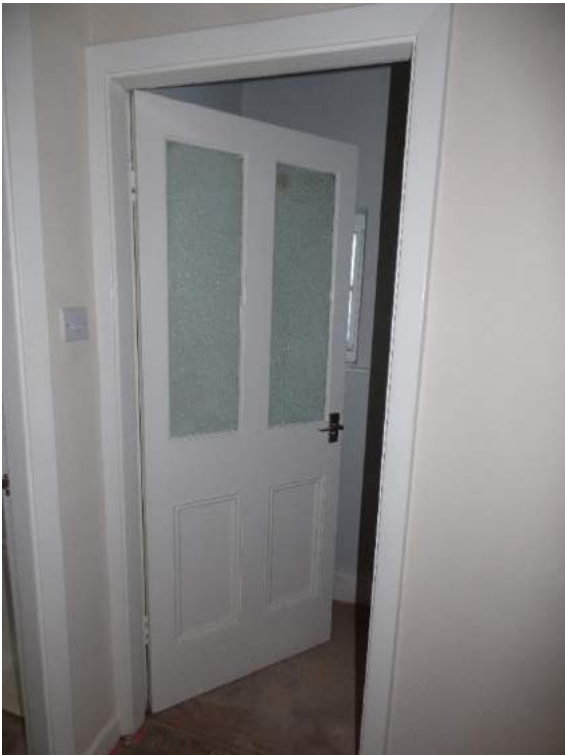
Left: Existing w.c. (not original) to be stripped out and space reconfigured. All skirtings and cornices to be reinstated to match existing.

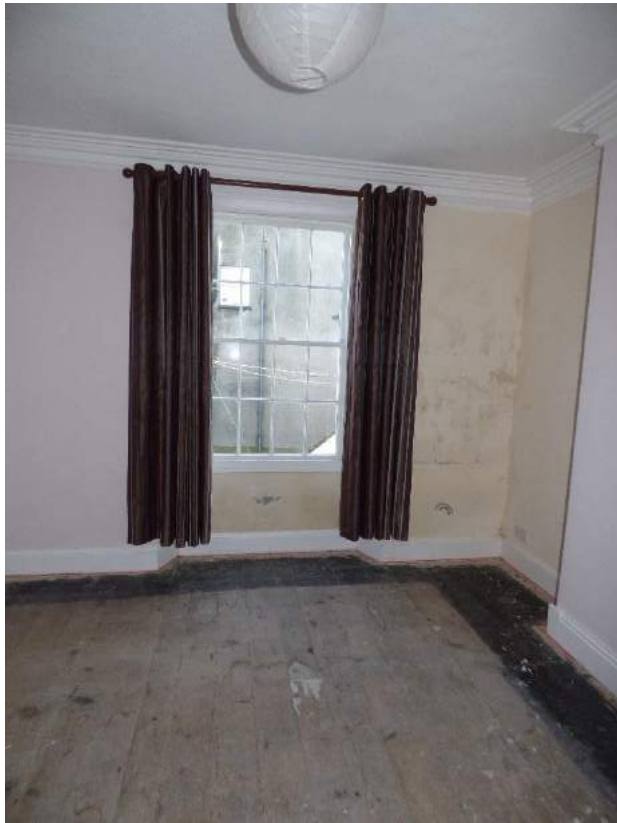
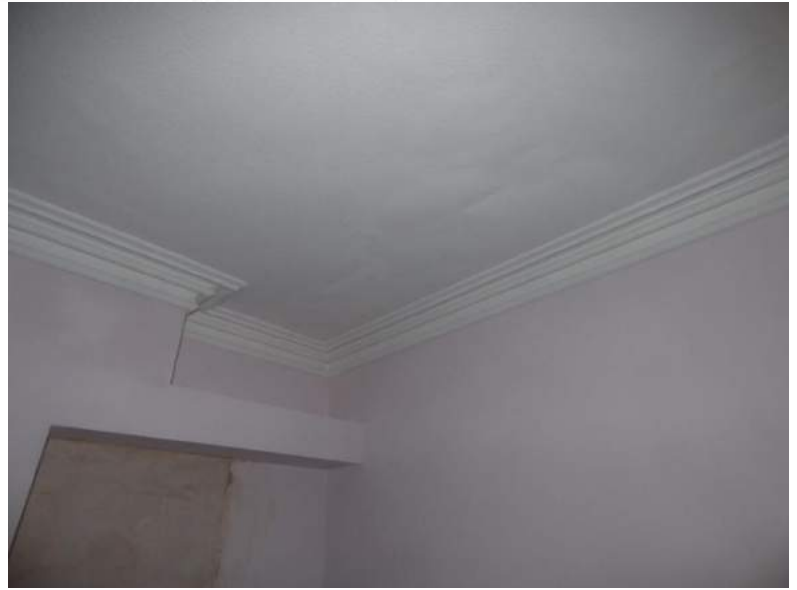
Rear bedroom skirtings, cornices, and architraves to be retained. Existing flush panel door to be replaced with new Georgian heritage style four panel door to be provided and installed by specialist joinery company such as Batty Joinery Ltd.

Where possible it is proposed to refurbish any original doors with door closers and intumescent paint subject to building control approval.

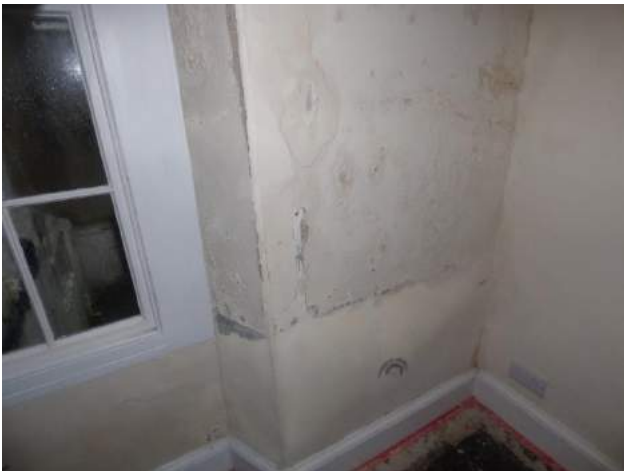
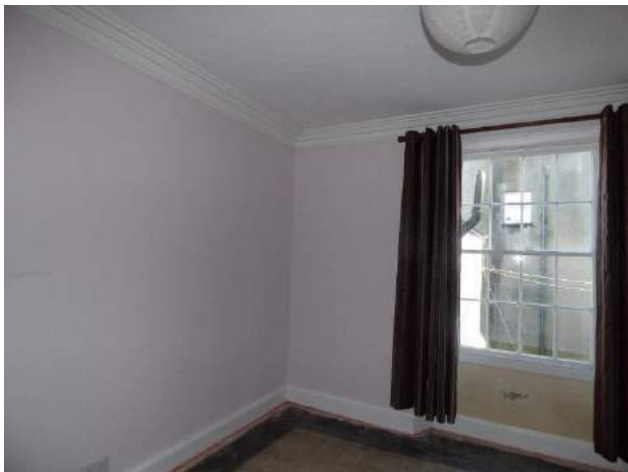
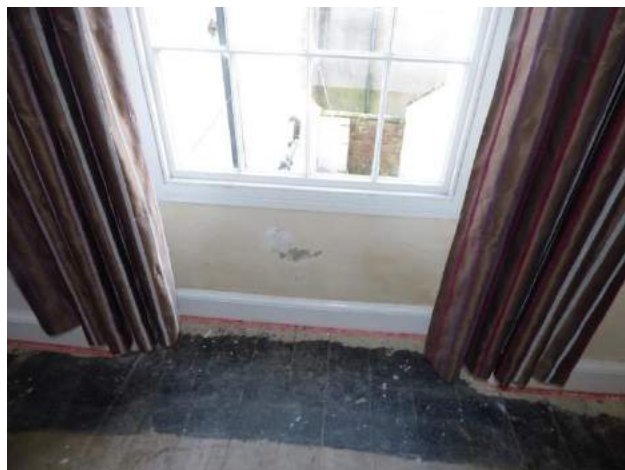
Left and below: Blown plasterwork to be repaired with lime plaster (Solo lime plaster from Lime Centre) below window.

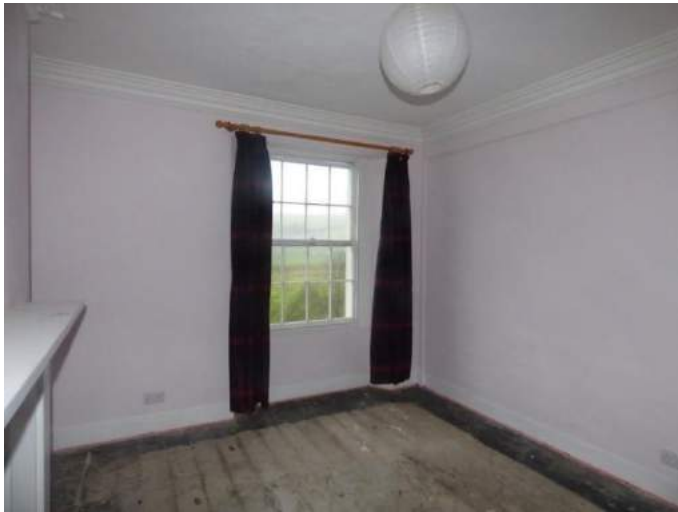
Large front bedroom, skirtings, covings, and architraves to be retained. Existing panelled door to be replaced with new Georgian heritage style four fire panel door.

Existing floorboards in good condition.

Where possible it is proposed to refurbish any original doors with door closers and intumescent paint subject to building control approval.

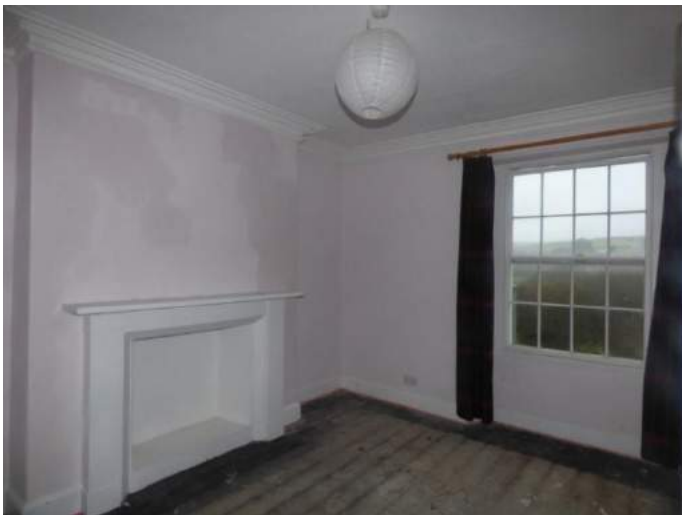
Fire surround to be retained.

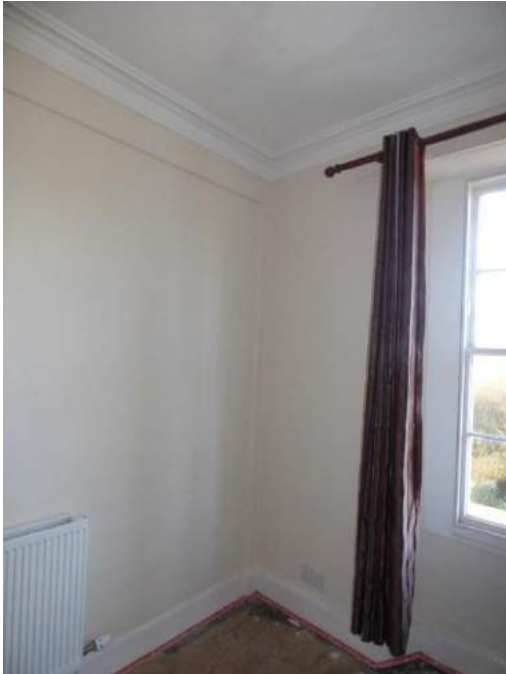
Existing small front bedroom - cornice, skirtings, and architraves to be retained. Existing door to be removed and new Georgian heritage style four panel door to be provided and installed by specialist joinery company such as Batty Joinery Ltd. In new location. Where possible it is proposed to refurbish any original doors with door closers and intumescent paint subject to building control approval.

Blown plaster to walls and ceiling to be replaced and repaired with lime plaster (Solo lime plaster from Lime Centre) all to match existing.

Existing doorway to be walled up to match existing.

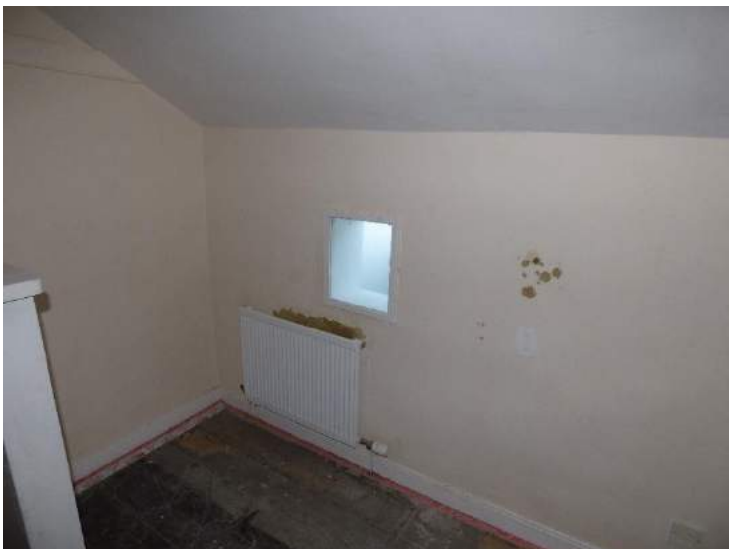
Left: Landing at the top of the staircase.

Floorboards are in good condition (but may require minor repairs)

At the top of the staircase on the landing, remove all damp and damaged/blown plasterwork and repair with lime plaster and skim and decorate throughout.

Apply an insulated plasterboard 62mm thick to underside of ceiling. The Laminated plasterboard and PIR has a vapour barrier incorporated so interstitial moisture would be prevented underside of ceiling tape and skim and undertake full decorations.

Replace existing modern rooflights with new heritage rooflight windows (Velux or Rooflight company or similar) A with flashing kit that mounts unit flush with the roof surface).

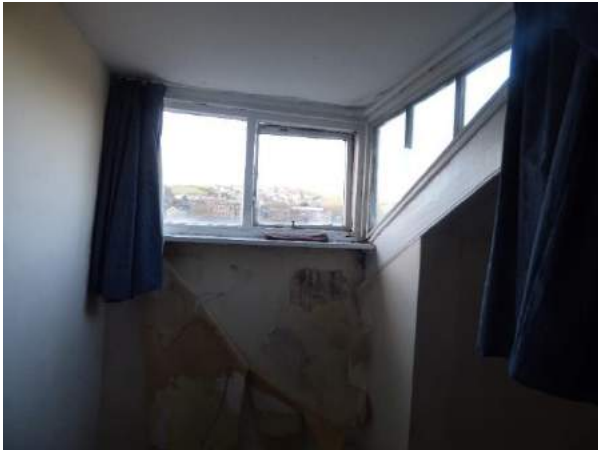
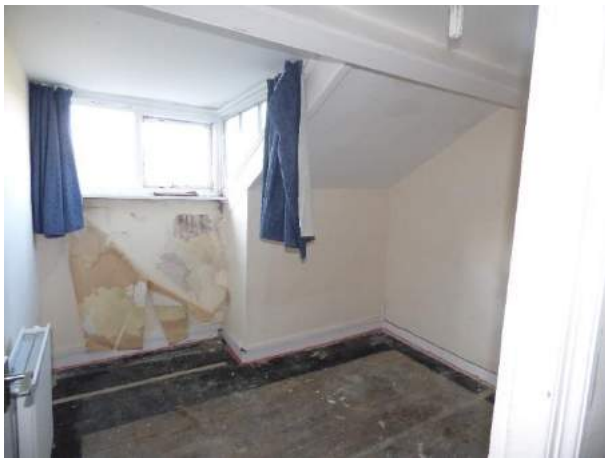
Left: the attic space has suffered from severe damp ingress which has caused considerable fabric damage.

The dormer window has degraded to an extent that it requires complete replacement. The dormer window is between two existing rooms, which are to be reconfigured to make the

It is proposed to completely reconstruct the dormer windows in a style to match dormer windows on other properties, so there is consistency with the design approach.

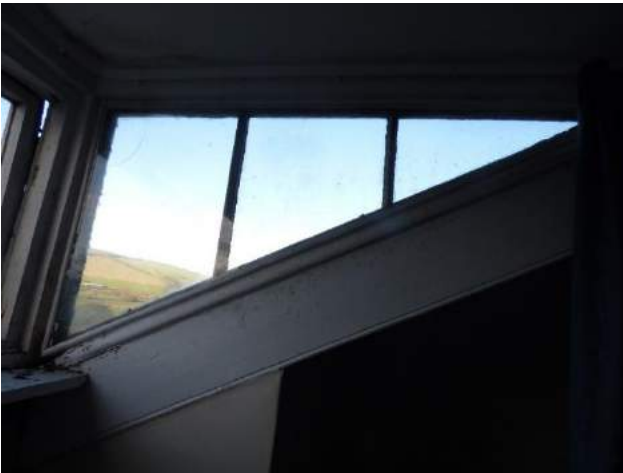
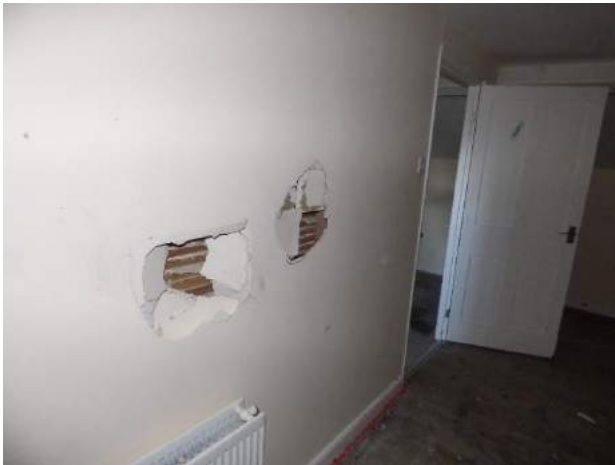
Left - Attic bedroom:

Floorboards require minor repairs.

In the bedroom remove all damp and damaged/blown plasterwork and repair with lime plaster and skim and decorate throughout.

Apply an insulated plasterboard 62mm thick to underside of ceiling. The Laminated plasterboard and PIR has a vapour barrier incorporated so interstitial moisture would be prevented. tape and skim and undertake full decorations. New rooflights to be installed.

Provide and install new heritage rooflight windows (Velux or similar), to replace existing velux windows.

Existing doors are to be removed and replaced with new heritage style four panel fire doors.
