# HERITAGE STATEMENT

## FULL RENOVATION OF EXISTING No 11 TERRACE HOUSES

St Bees, 1-11 Lonsdale Terrace, Parish Council, Cumbria

M.A.C Architects, Project Number: 2019:303

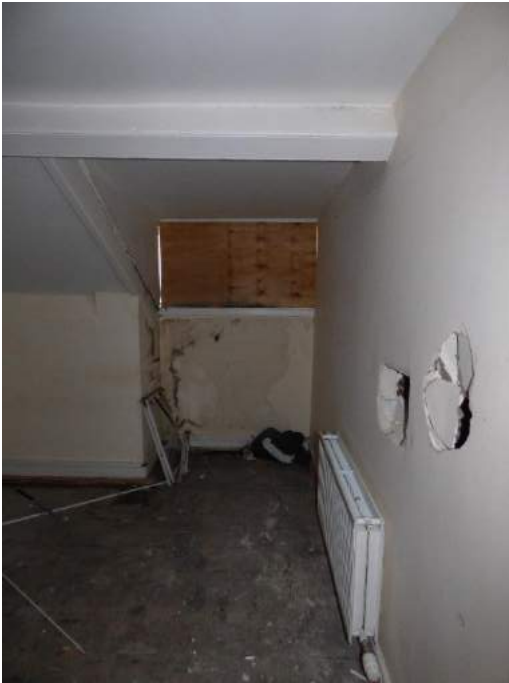
Left: Existing dormer glazed window no longer exists to the second bedroom, and the dormer cheeks are damaged beyond simply repairing them. A new dormer is proposed.

The existing bedroom partition is damaged. It is proposed to remove this wall and reconfigure the space.

In the bedroom remove all damp and damaged/blown plasterwork and repair with lime plaster and skim and decorate throughout.

Apply an insulated plasterboard 62mm thick to underside of ceiling. The Laminated plasterboard and PIR has a vapour barrier incorporated so interstitial moisture would be prevented tape and skim and undertake full decorations.

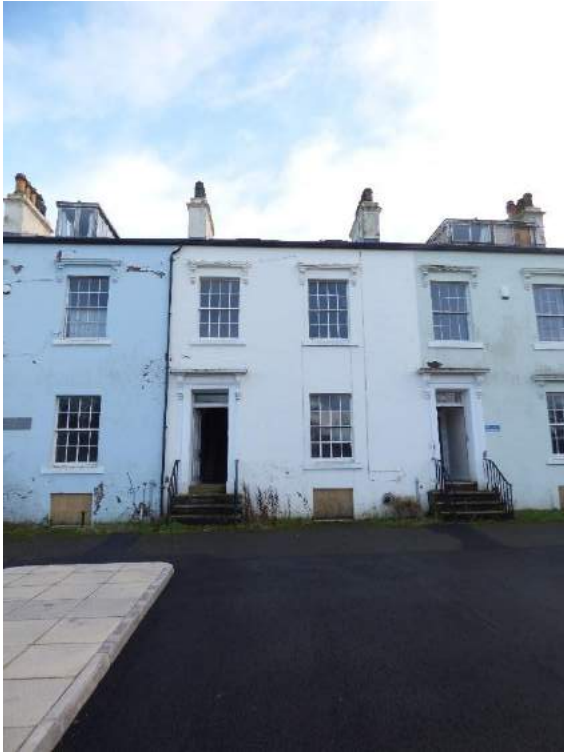
Left: The main entrance is mentioned in the listing text and is to be entirely retained.

Both front and rear elevations are currently rendered, with colour to the front and side and natural to the rear. All elevations require to be prepared for render repairs and redecoration by specialist using lime render and stucco (Parax LTD) to be applied by specialist.

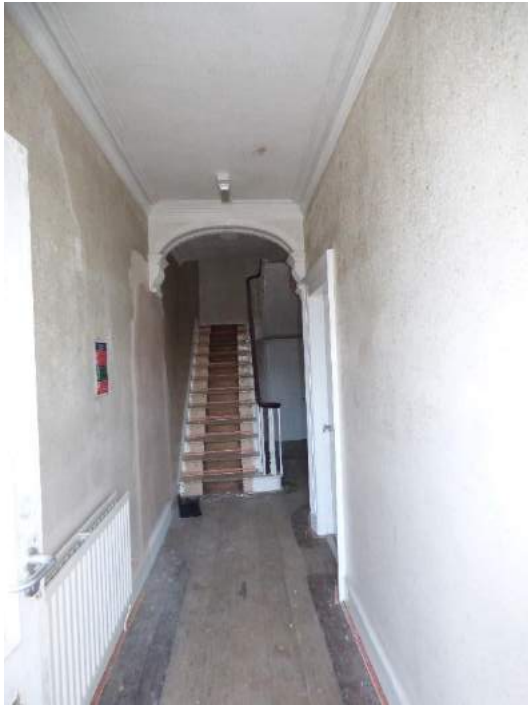
Left: The existing walls and floor are generally in good condition.

Redundant M&E to be removed and wall/ceiling finishes made good and primed, prepared and fully decorated.

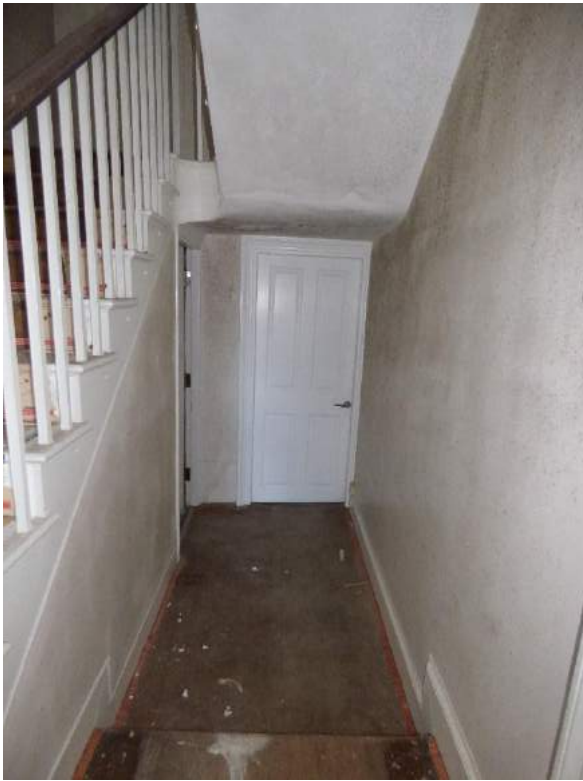
Existing staircase is original and is in excellent condition.

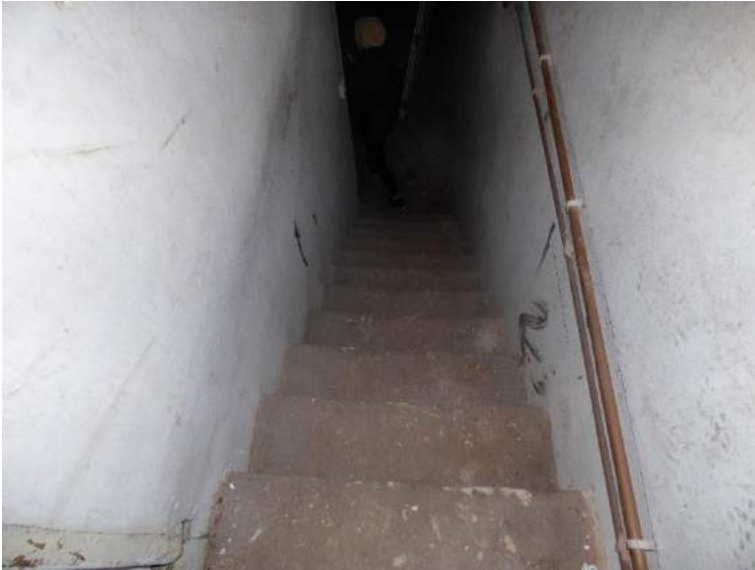
Left: The basement

The existing walls and floor are generally in sound condition so would be suitable for this application of damp proof slurry system. All existing paint and surface finishes must be removed and made good including all snots removed, and damage to existing surfaces, prior to the installation of a Koster Polysil NB1.

This migratory crystalline tanking slurry is used to seal below ground structures against water ingress.

Koster NB1 is considered to be a Type A waterproofing system as defined by BS8102:2009 and is generally used to seal the inside face of basement structures against water ingress.

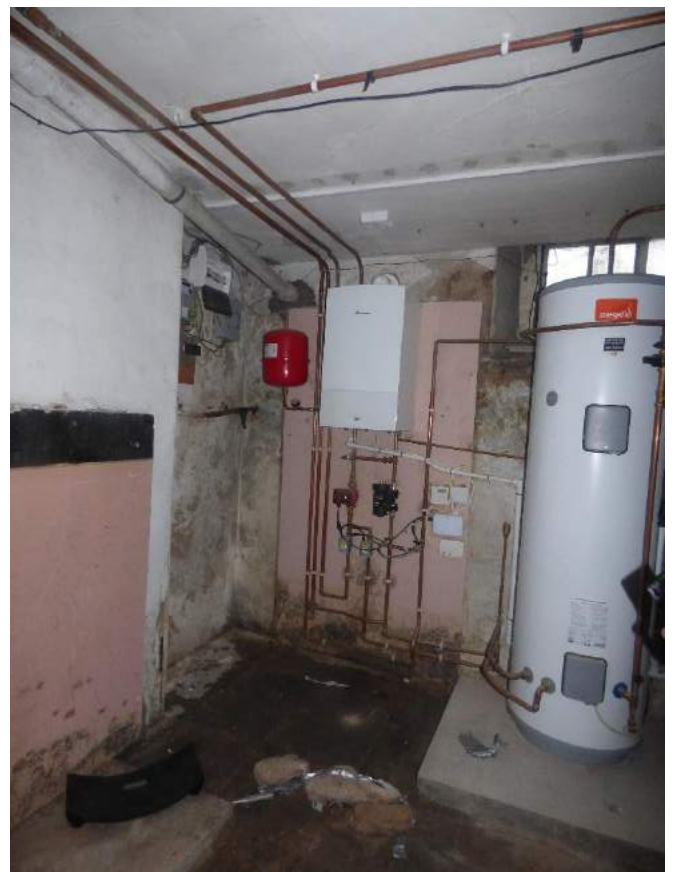
Left and above: New boiler installations have been undertaken prior to the sale of the properties.

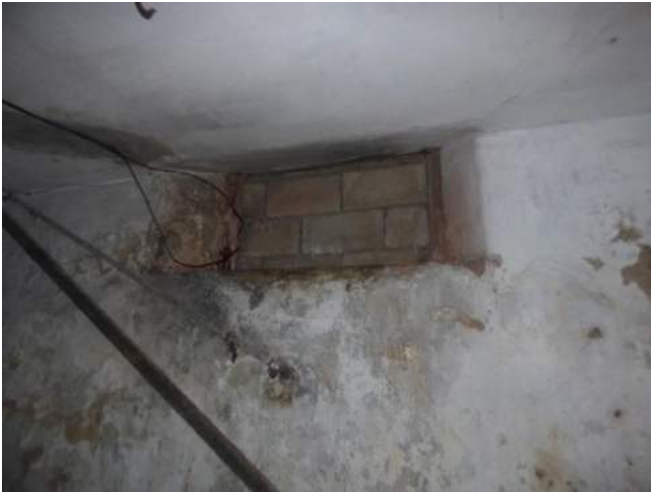
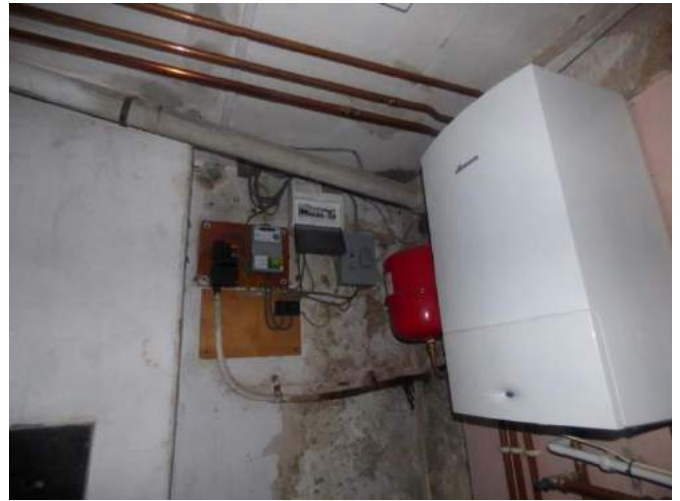
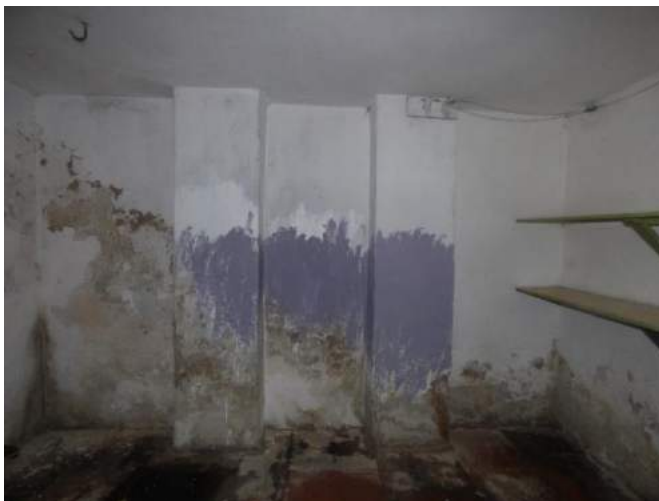
Below, left: Former window has been walled up. It is proposed to wall up properly with insulation and masonry.

The rear of the basement requires new fire doors which will be plain fire rated flush panel doors, to replace the existing.

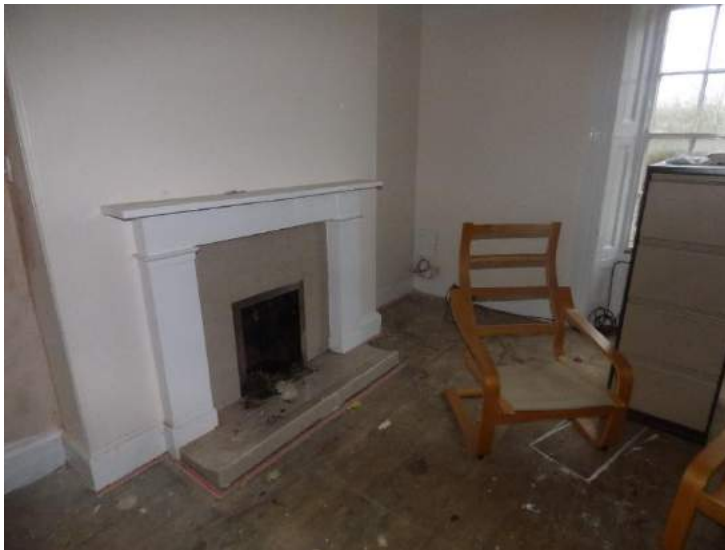
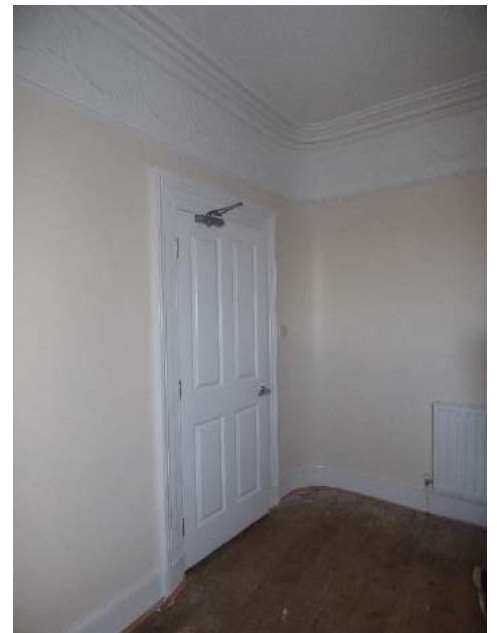
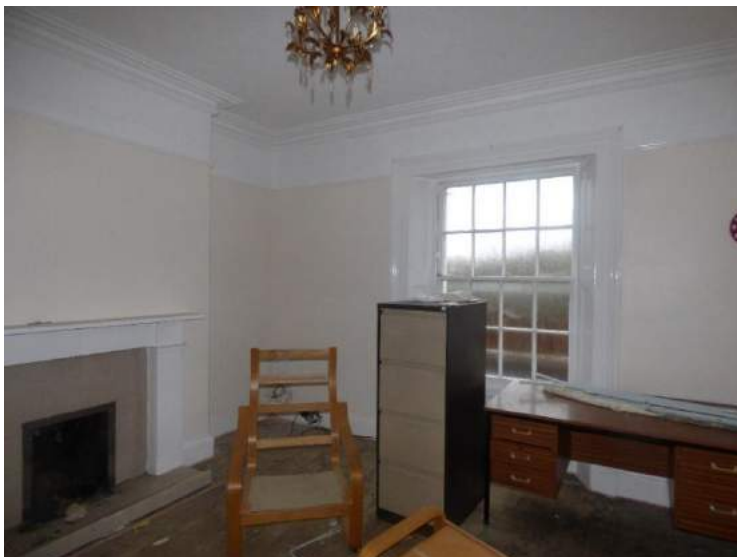
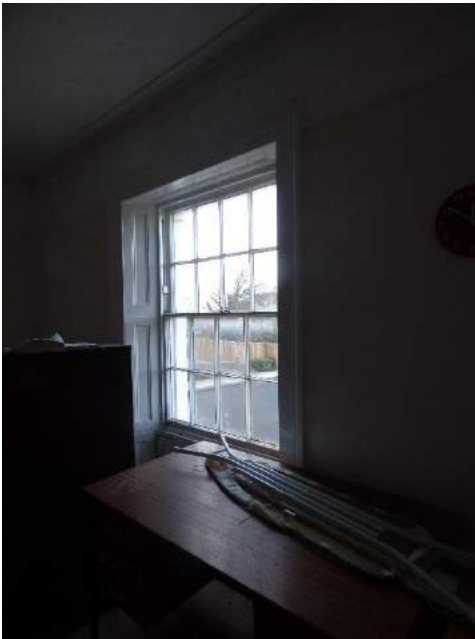
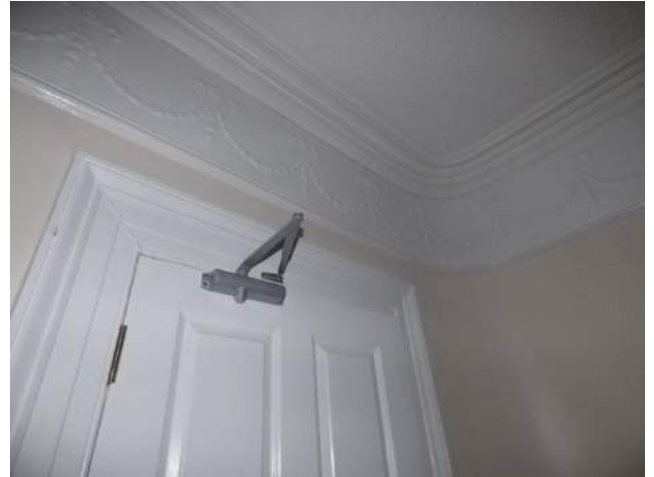
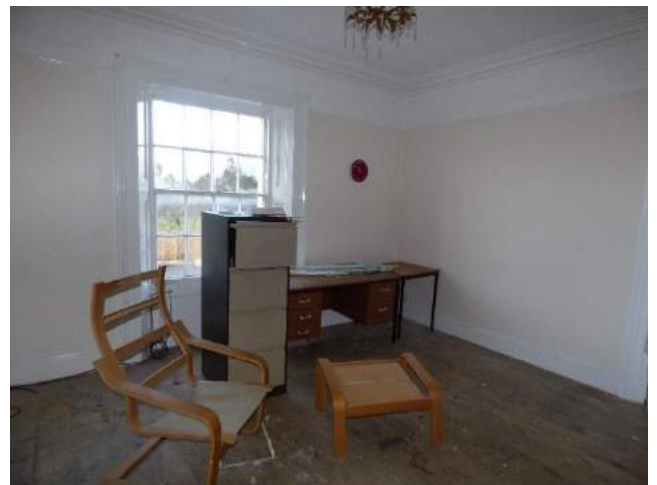
Right, above, and below: In the existing lounge at the front of the property, it is proposed to carefully refurbish the existing timber shutters.

Fireplace is not original and is not proposed to retain it.

Existing architraves and skirtings to be retained and made good.

It is proposed to form a new opening between lounge and dining to create a more open plan living environment. The new opening will be formed 300mm beneath the cornice to ensure cornice features are retained.

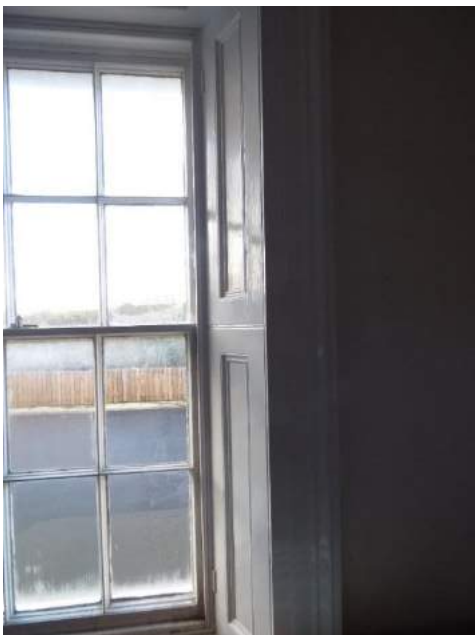
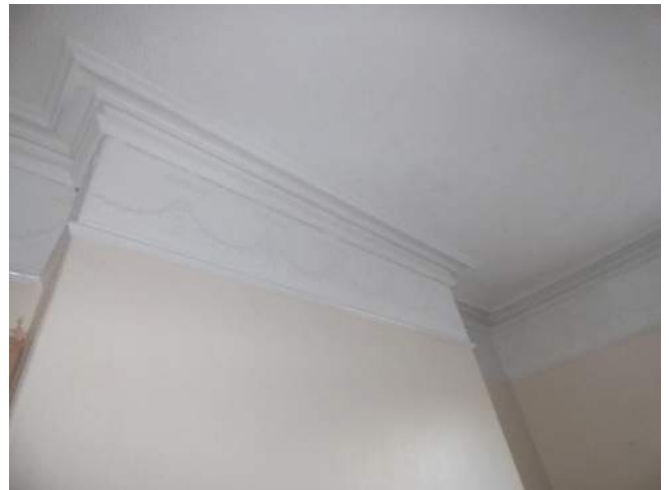
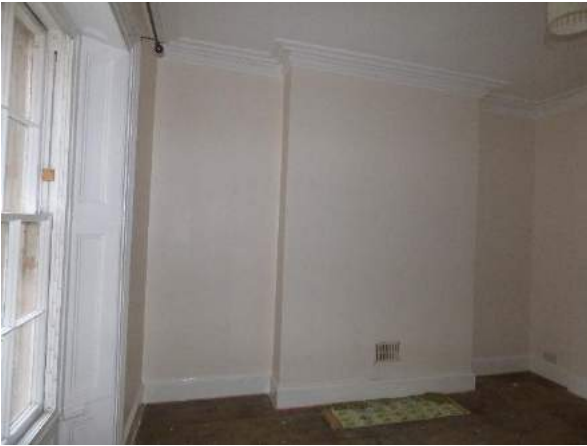
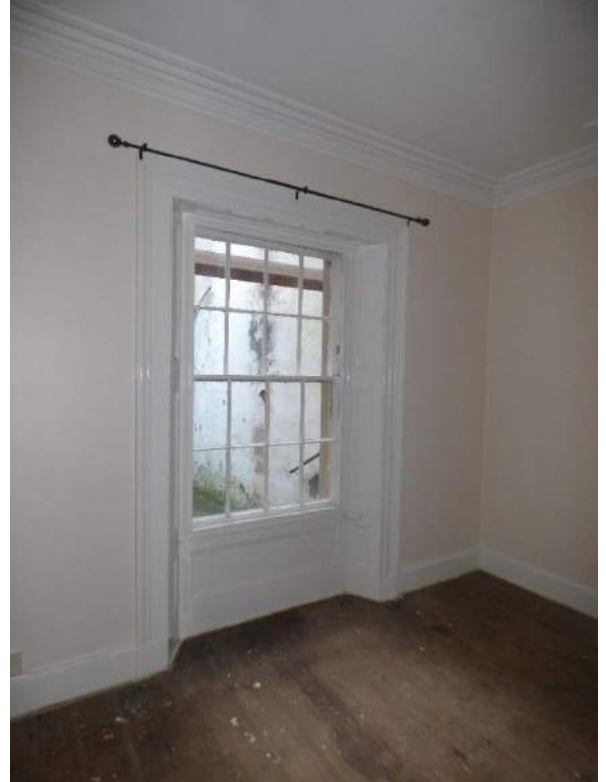
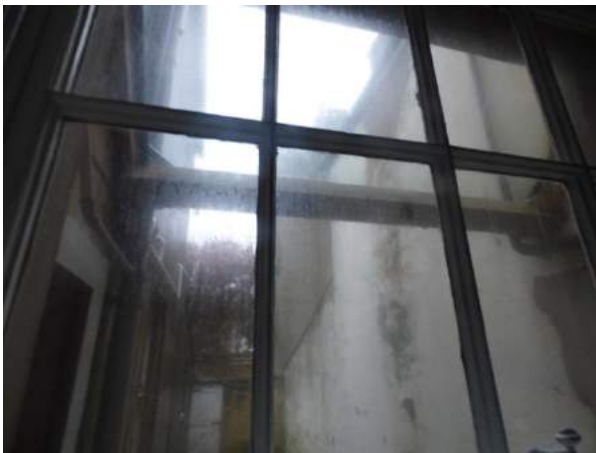
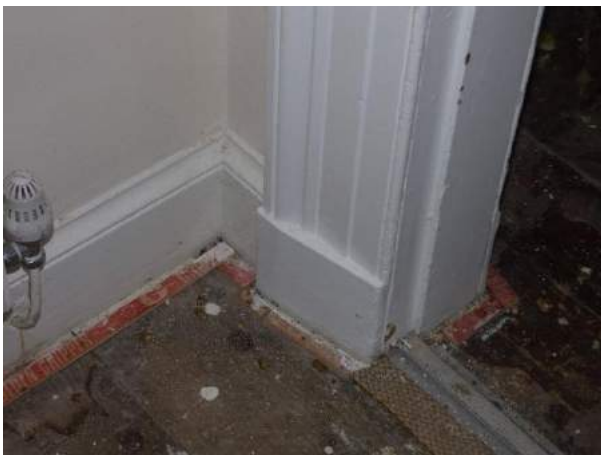
In the existing dining room, the period features below and to the sides of the features below and to the sides of the existing windows both front and back are in good condition, it is proposed to carefully refurbish the existing timber shutters.

Existing cornice to be retained.

Existing door to be replaced with heritage style four panel painted timber fire door to enhance the heritage asset.

New opening to be formed between existing dining and lounge to accommodate open space living area (as with houses 1-5). Openings to be below cornices, which will remain intact.

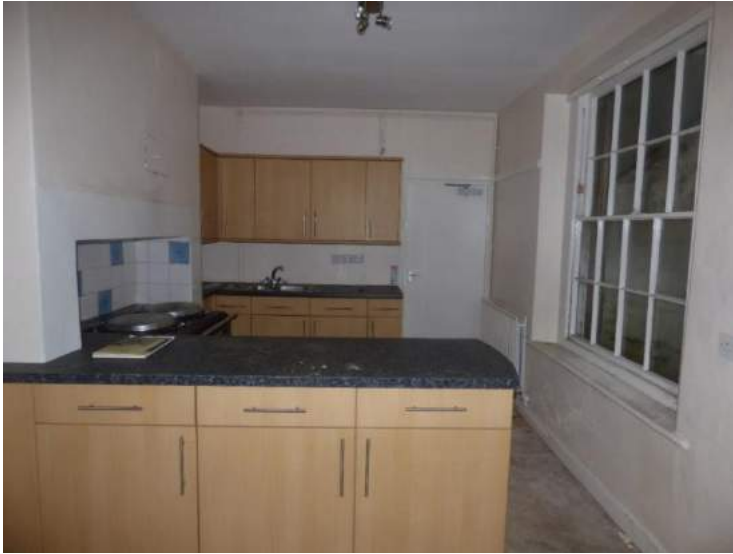
In the existing kitchen it is proposed to remove all fixtures and fittings.

Blown plaster to existing walls to be repaired with new lime paster and made good.

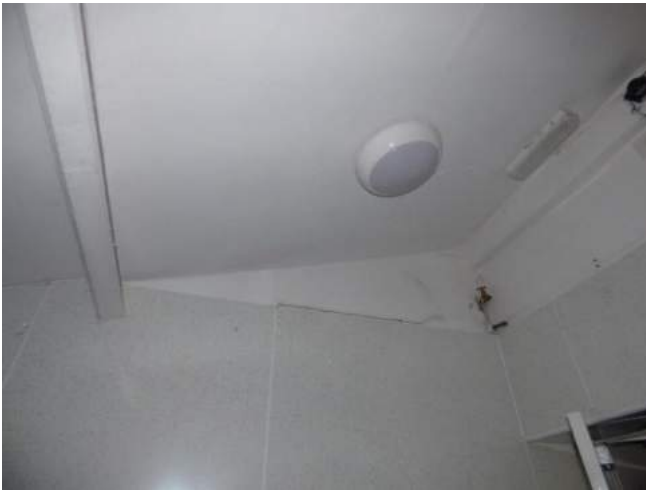
Left: The existing former shower area is to be reconfigured to provide a new utility and w.c. at ground floor.

The existing modern rooflight is proposed to be replaced with a new heritage style rooflight (Velux or Rooflight company or similar). New rooflights to be installed with flashing kit that mounts unit flush with the roof surface

Apply an insulated plasterboard 62mm thick to underside of ceiling. The Laminated plasterboard and PIR has a vapour barrier incorporated so interstitial moisture would be prevented to be taped and skimmed.

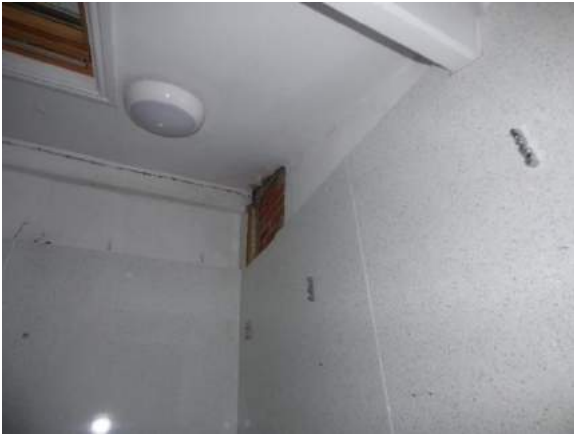
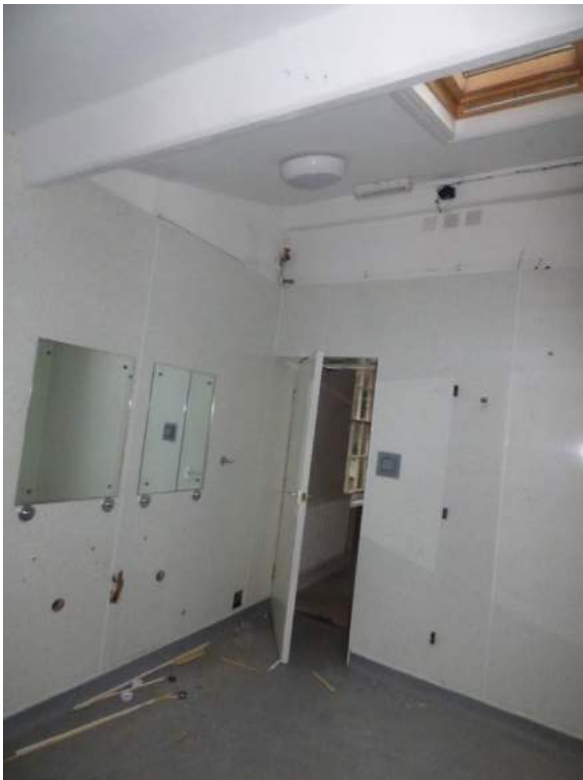
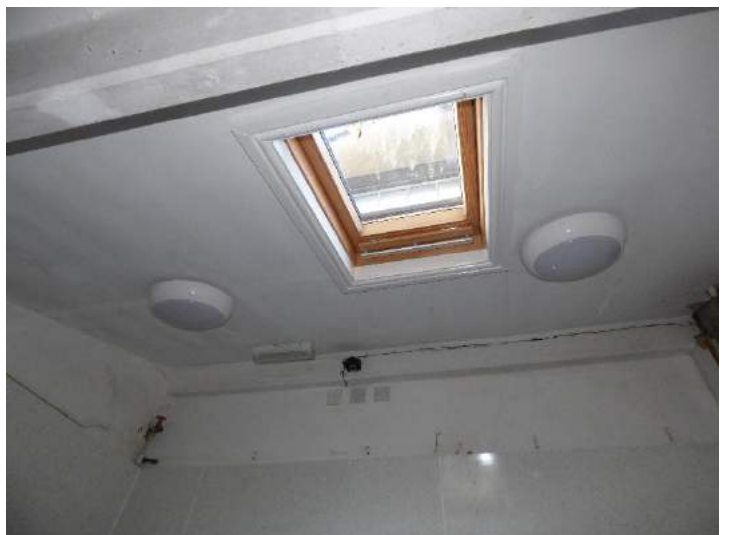
Left and below: The existing shower block to be reconfigured.

The roof may require some minor repairs to make watertight.

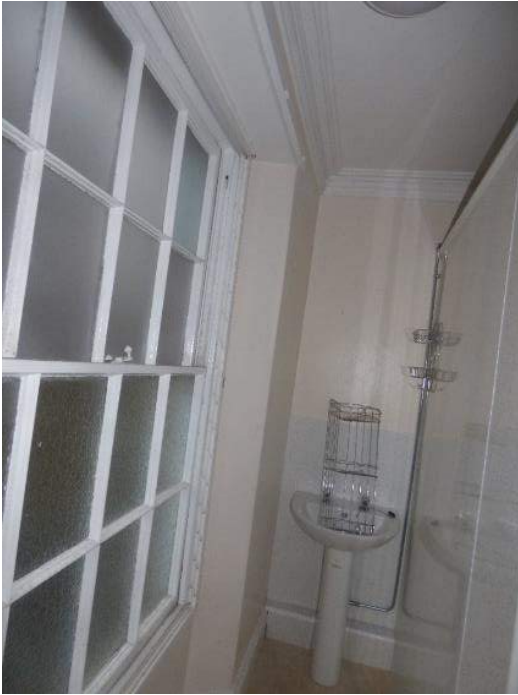
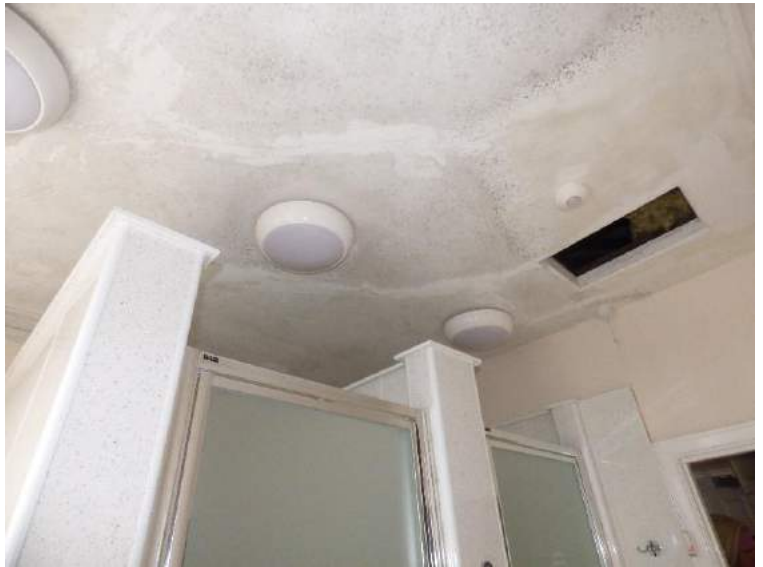
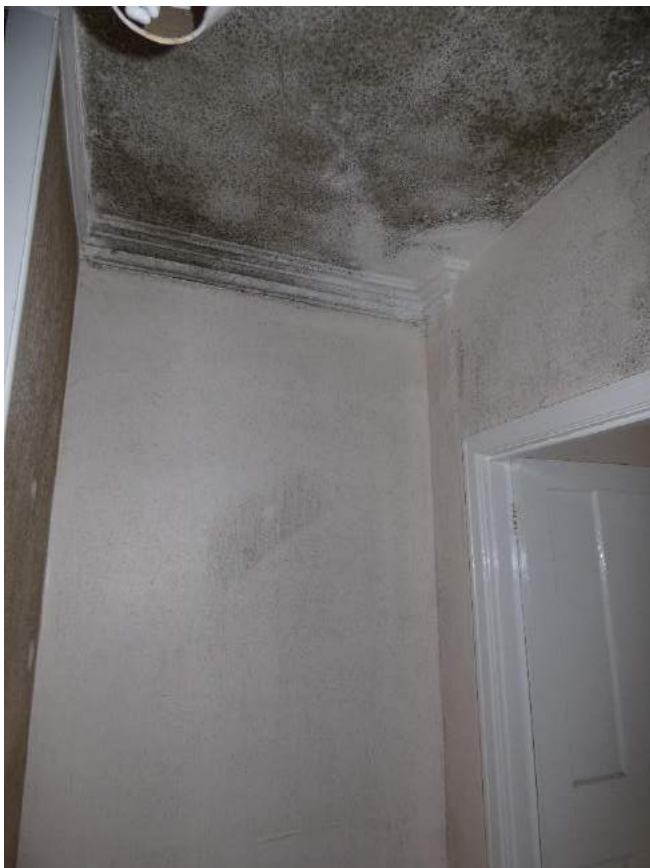
Left and above: Existing ceiling to be made good by removing mould and replacing blown plaster with lime plaster as required.

Glazing to new heritage style Georgian double glazed sash window to be obscure.

New bathroom to be four panelled door to match the existing – bathroom door does not need to be a fire rated door. To replace existing modern bathroom door.

All finishes to be made good, and skirtings to match the original to be installed.

Existing cornices to be made good and skirtings to match existing to be reinstated.

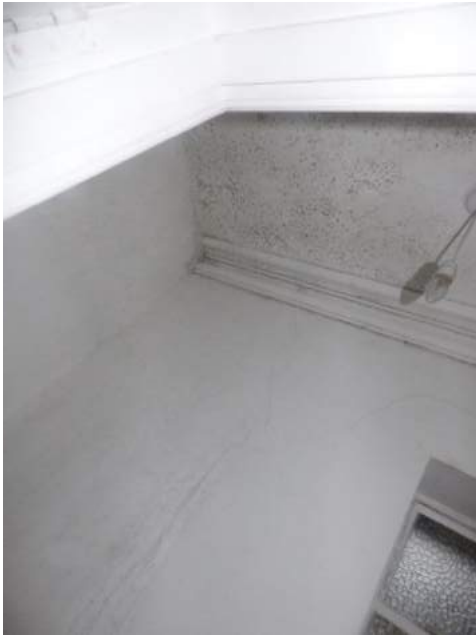
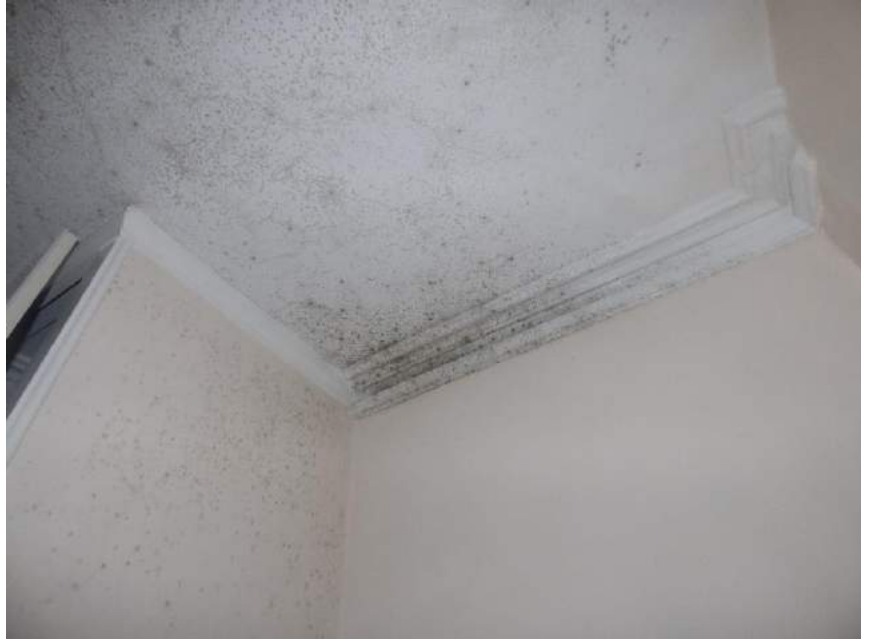
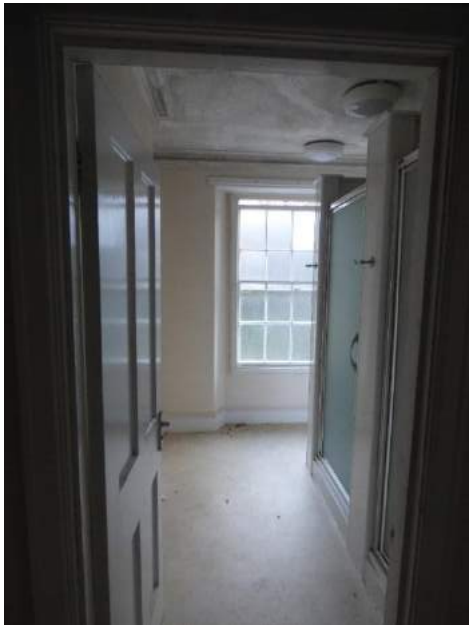
First floor w.c. to be reconfigured, and cornices and skirtings to be reinstated. All existing plasterwork affected by damp to be repaired and or reinstated as required. Roof to be repaired to ensure completely watertight.

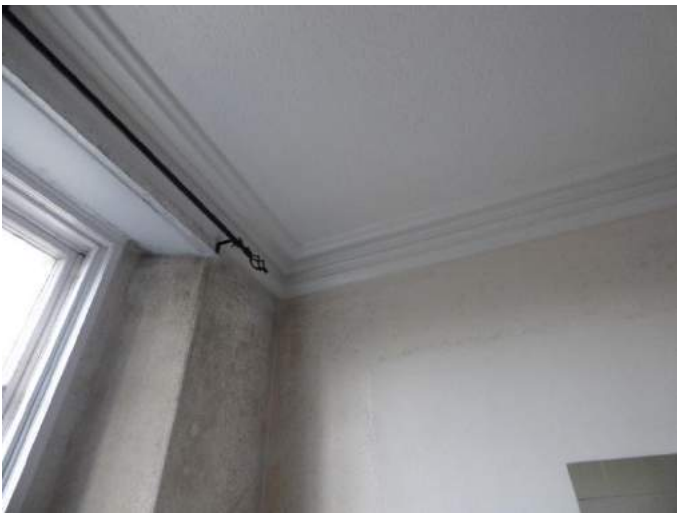
Left:

Damp ingress evident with mould to walls and ceiling.

Existing floorboards in good condition

Large front bedroom, skirtings and architraves to be retained. Existing door to be replaced with new Georgian heritage style four panel door to be provided and installed by specialist joinery company such as Batty Joinery Ltd. Where possible it is proposed to refurbish any original doors with door closers and intumescent paint subject to building control approval.

Attic and roof to be made watertight.

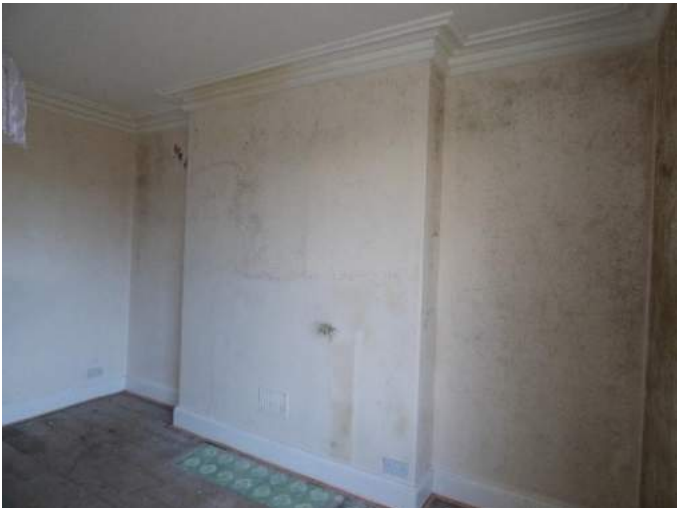
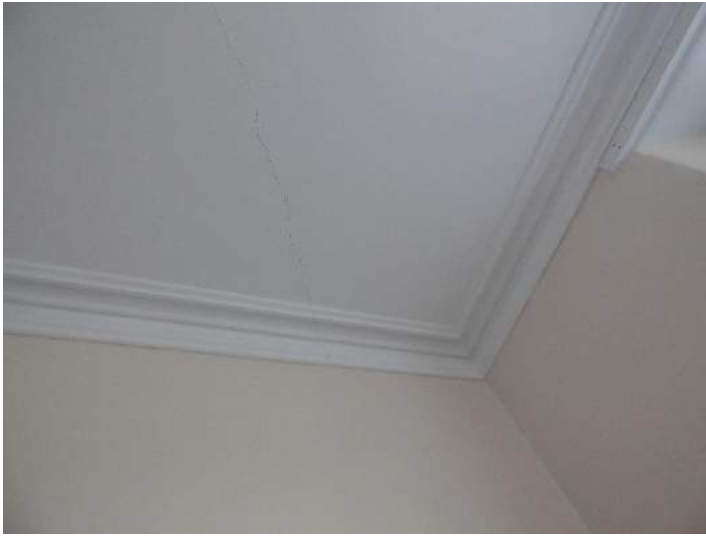
Existing floorboards in good condition.

Existing small bedroom skirtings and architraves to be retained.  
Existing door to be removed and new doorway from proposed master bedroom to be provided and installed with new Georgian heritage style four panel door to be provided and installed by specialist joinery company such as Batty Joinery Ltd. Where possible it is proposed to refurbish any original doors with door closers and intumescent paint subject to building control approval.

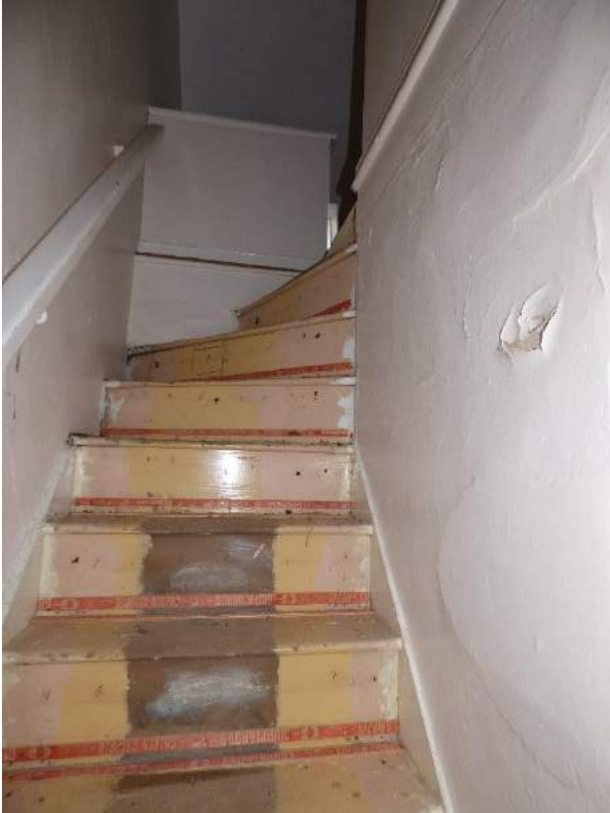
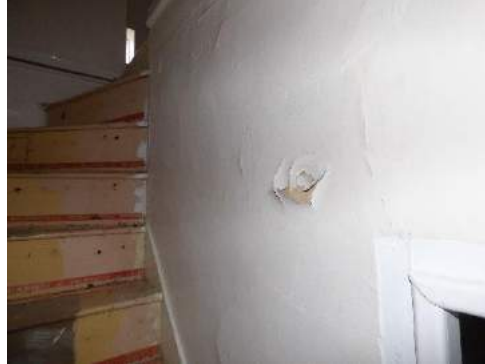
Existing staircase to attic. Existing walls require minor fabric repairs.

New four panelled fire door to be installed at first floor.

Where possible it is proposed to refurbish any original doors with door closers and intumescent paint subject to building control approval.

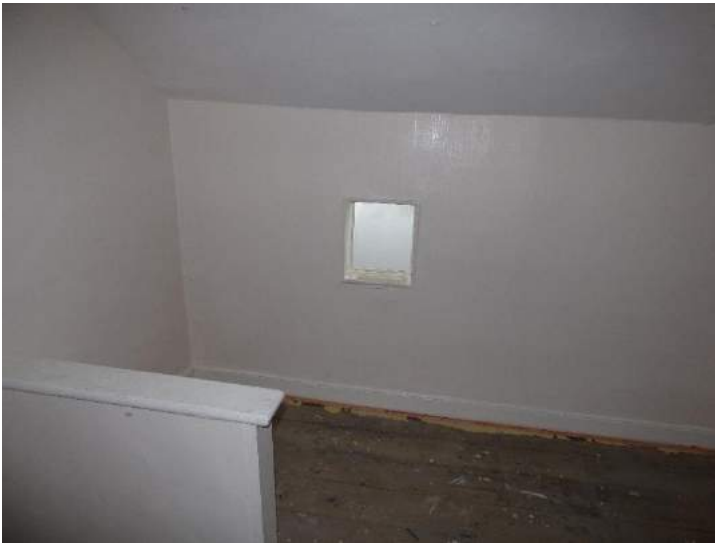
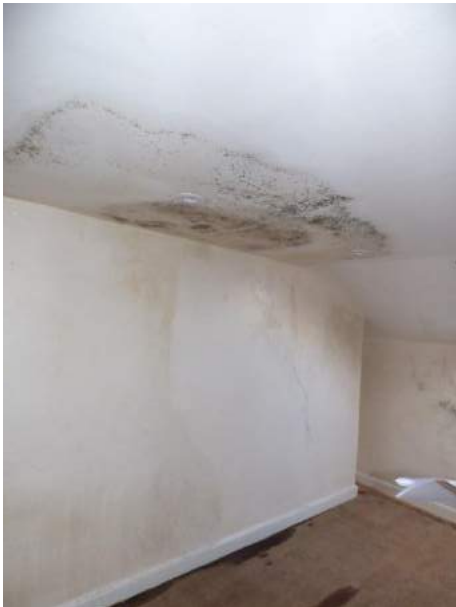
Left: Attic landing.

Floorboards are in good condition (but require minor repairs).

Existing window to be walled up.

Existing damaged plaster to be replaced and repaired with lime plaster (Solo lime plaster from Lime Centre)..

Apply an insulated plasterboard 62mm thick to underside of ceiling. The Laminated plasterboard and PIR has a vapour barrier incorporated so interstitial moisture would be prevented. New rooflights to be installed with flashing kit that mounts unit flush with the roof surface.

Provide and install new heritage rooflight windows (Velux or similar) to replace existing modern Velux rooflights.

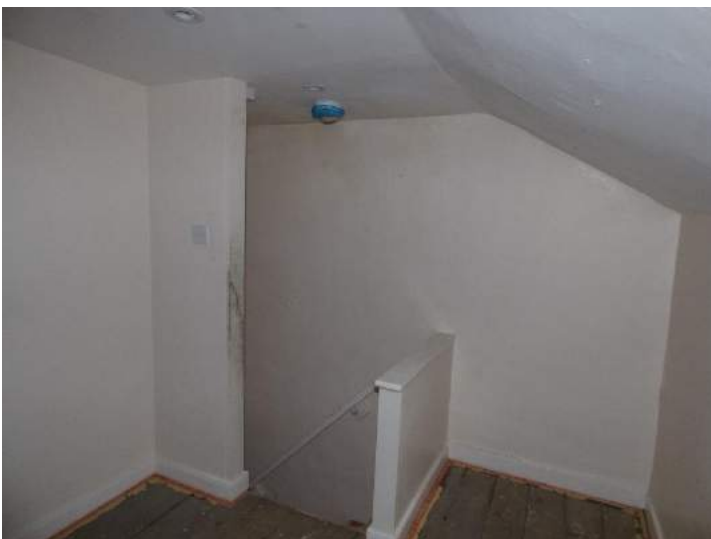
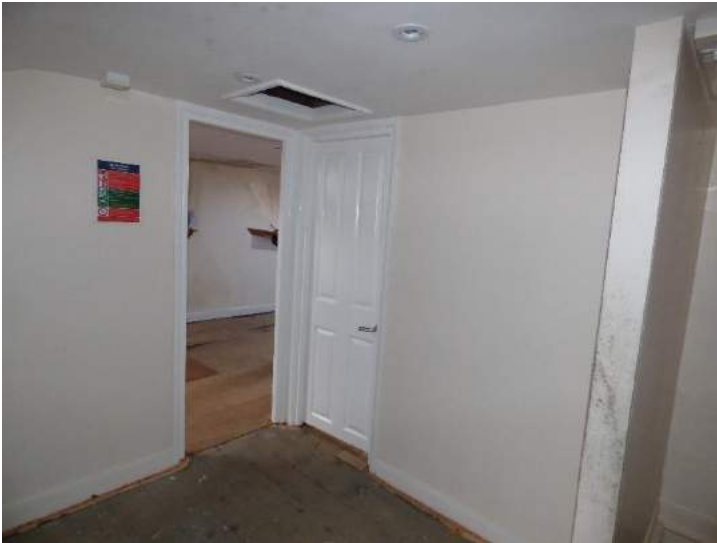
Left: Attic bedroom

Floorboards are in good condition (but require minor repairs).

The existing attic bedrooms are to be reconfigured to maximise the space.

In the bedroom it is proposed to remove all blown plasterwork and repair with lime plaster and skim.

Apply an insulated plasterboard 62mm thick to underside of ceiling. The Laminated plasterboard and PIR has a vapour barrier incorporated so interstitial moisture would be prevented. New rooflights to be installed with flashing kit that mounts unit flush with the roof surface.

Existing doors are to be removed and replaced with new heritage style four panel fire doors.

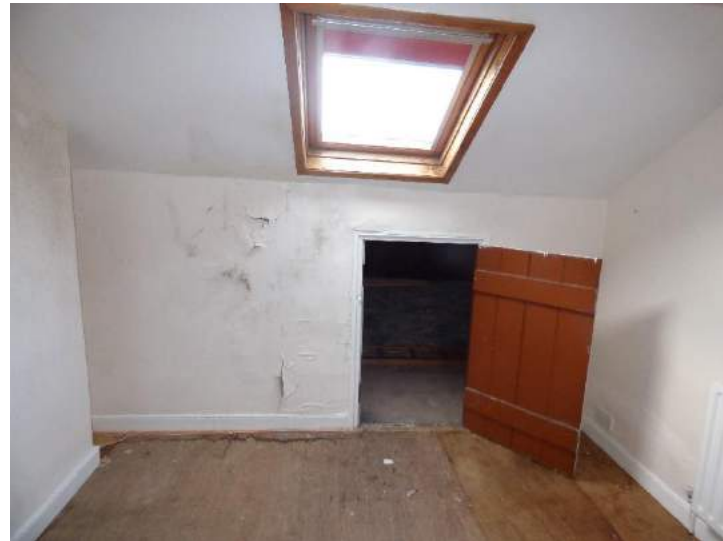
Left: Attic bedroom

Floorboards are not original and it is proposed to replace with T&G timber floorboards

The existing small attic bedroom will be reconfigured to maximise the space.

In the bedroom it is proposed to remove all blown plasterwork and repair with lime plaster and skim.

Apply an insulated plasterboard 62mm thick to underside of ceiling. The Laminated plasterboard and PIR has a vapour barrier incorporated so interstitial moisture would be prevented. New rooflights to be installed with flashing kit that mounts unit flush with the roof surface.

Existing doors are to be removed and replaced with new heritage style four panel fire doors.

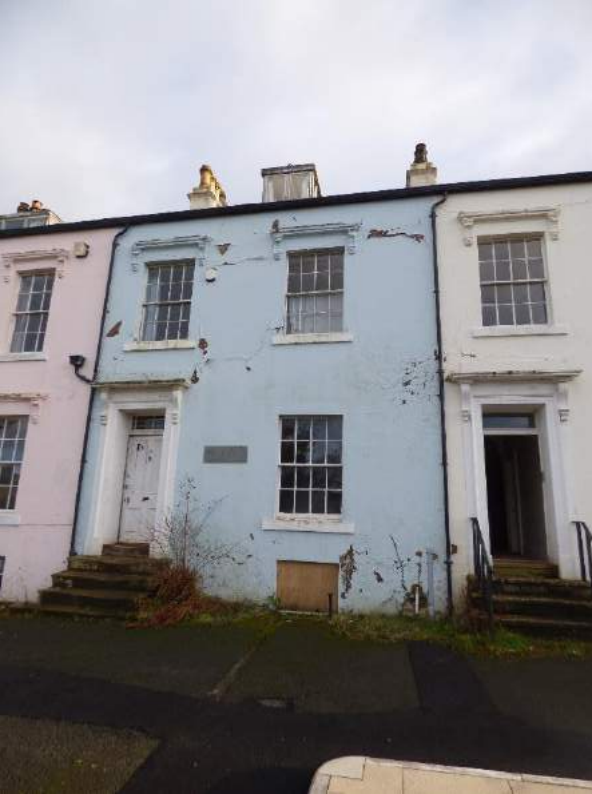
Left: The main entrance is mentioned in the listing text and is to be entirely retained.

Both front and rear elevations are currently rendered, with colour to the front and side and natural to the rear. All elevations require to be prepared for render repairs and redecoration by specialist using lime render and stucco (Parax LTD) to be applied by specialist.

The existing door and frame are to be retained and made good with the provision of new ironmongery. Once repaired full decoration will be undertaken.

Existing gutters and downpipes to be retained, repaired where necessary and decorated.

All existing single glazed windows to either be refurbished with new double glazed slimline heritage sashes within the original frame or to be replaced with new white painted slim profile double glazed. If new heritage windows are to be provided the new 'heritage' windows to be provided by specialist supplier such as Batty Joinery, specialists in historic and listed building joinery works.

The existing stone steps to be cleaned up, and new painted metal handrails provided, that would have originally been installed to be reinstated – refer to D&A statement for details.

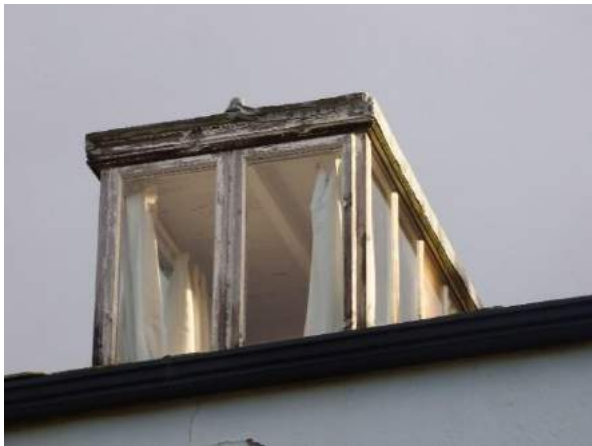
Existing dormer window is in extremely poor condition and it is proposed to completely reconstruct the dormer, in a style to match the other dormer windows on the adjacent buildings.

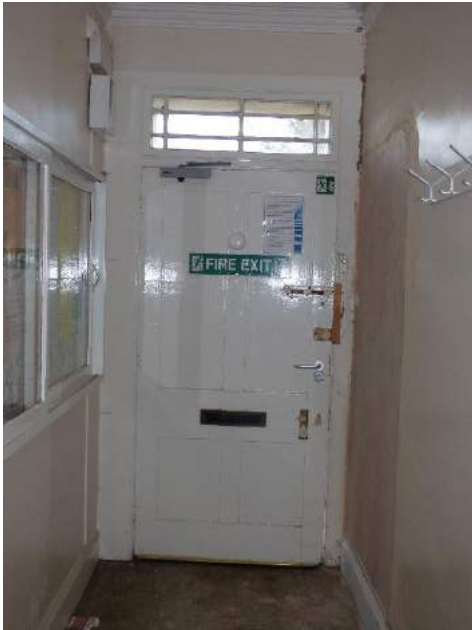
Left: The existing walls and floor are generally in good condition.

Redundant M&E to be removed and wall/ceiling finishes made good, primed, prepared and fully decorated.

Doors to be replaced with heritage style four panel painted timber fire doors to enhance the heritage asset.

Where possible it is proposed to refurbish any original doors with door closers and intumescent paint subject to building control approval.

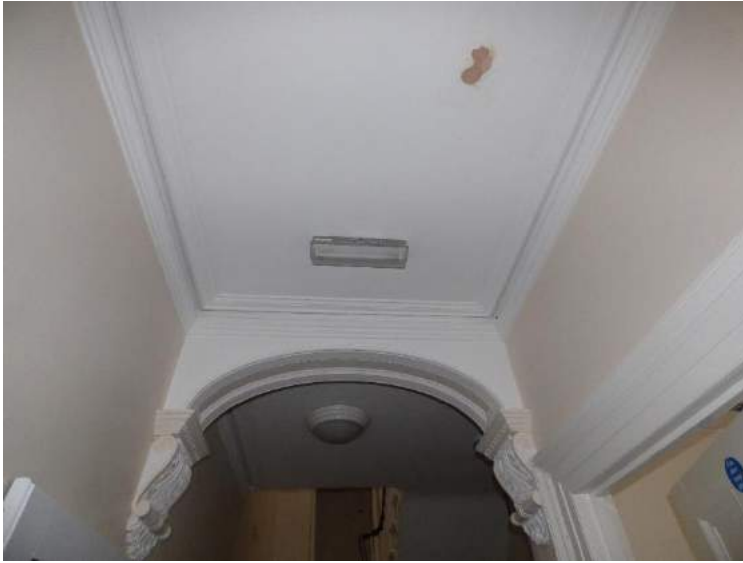
Left: Cornices, architraves and skirtings all in good condition and to be retained.

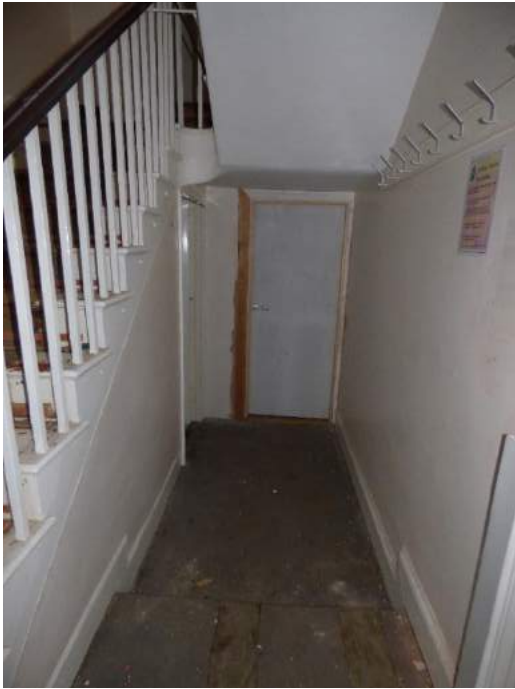
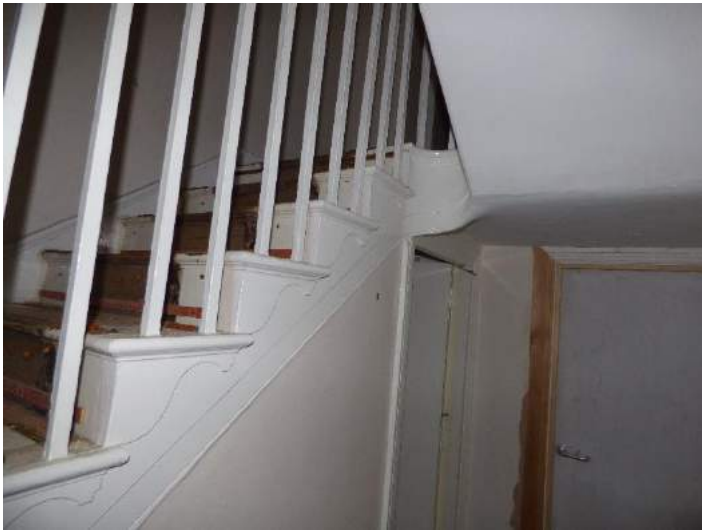
Left and below: The existing walls and skirtings and floor are generally in good condition.

Redundant M&E to be removed and wall ceiling finishes made good.

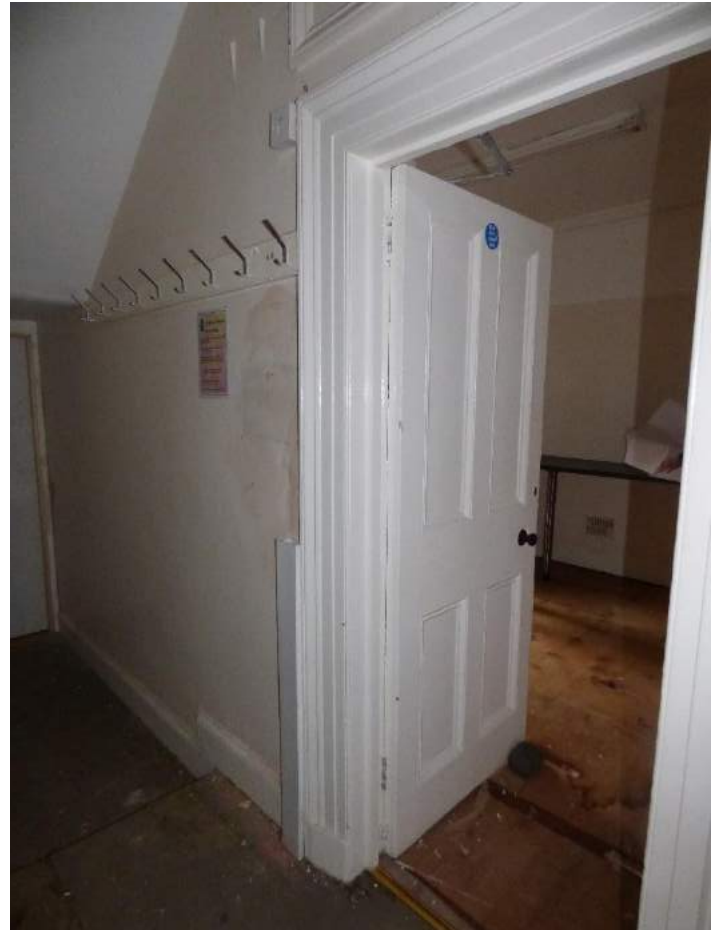
Left: The existing basement, the existing walls and floor are generally in sound condition so would be suitable for the application of damp proof slurry system.

All existing paint and surface finishes must be removed and made good including all snots removed, and damage to existing surfaces, prior to the installation of a Koster Polysil NB1.

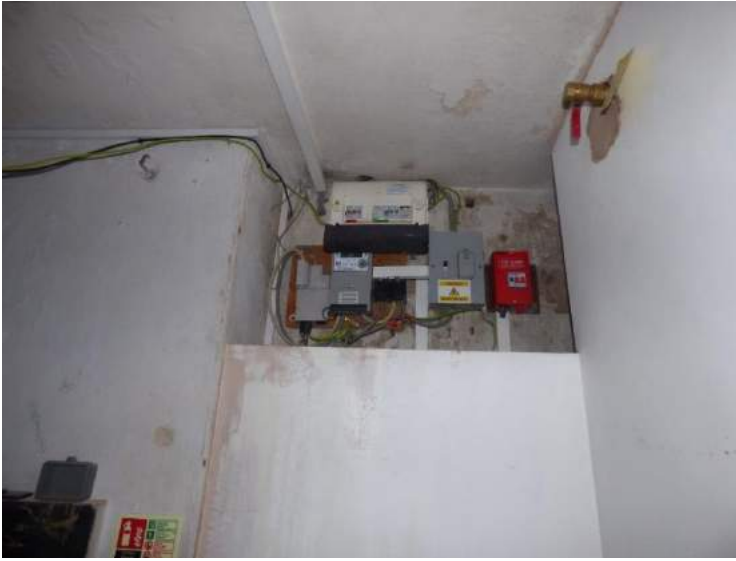
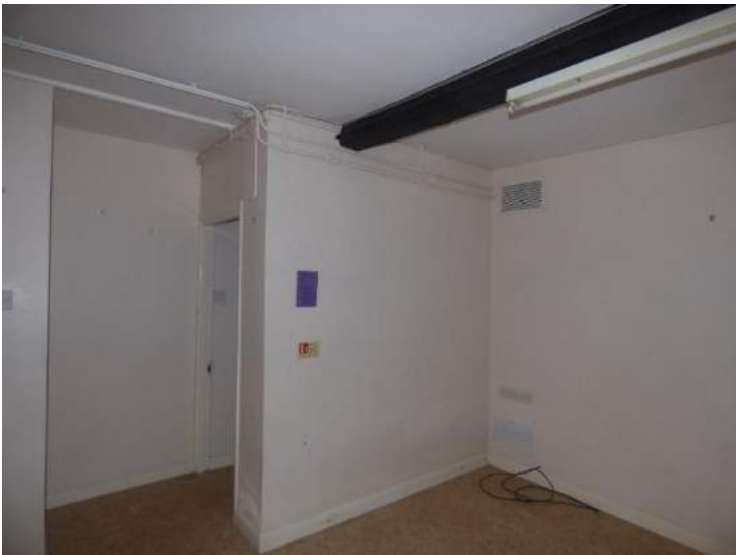
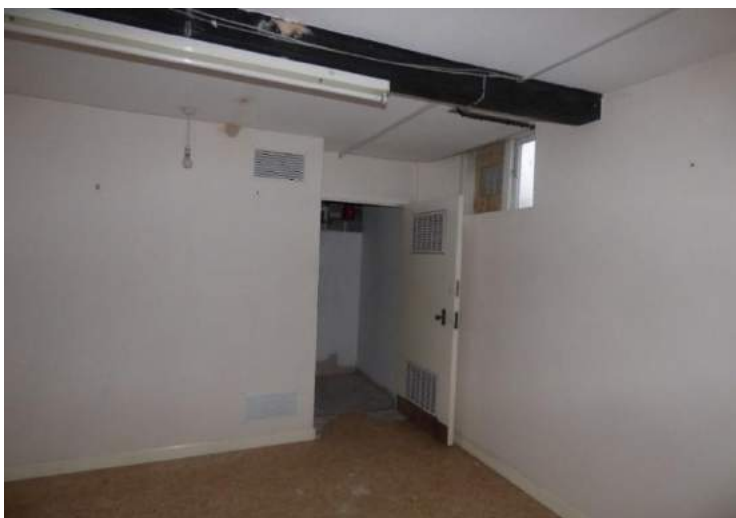
Walls have been boarded over but not treated properly for damp, so it is proposed to remove the boards and apply waterproofing.

This migratory crystalline tanking slurry is used to seal below ground structures against water ingress.

Once applied then the walls can be prepared and primed for decorating and for the floor finishes to be installed. Complete new boiler and heating system is required, new distribution boards, etc.

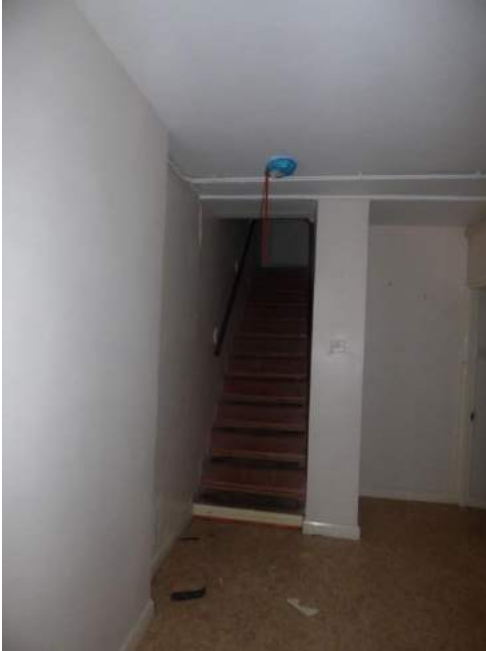
The walls down to the basement also require the full treatment.

In the basement all existing services are to be carefully stripped out and replaced with new compliant infrastructure.

Existing window to basement to be removed and reveals made good.

All existing services to be carefully removed and new gas and electric services installed.
