# HERITAGE STATEMENT

## FULL RENOVATION OF EXISTING No 11 TERRACE HOUSES

St Bees, 1-11 Lonsdale Terrace, Parish Council, Cumbria

M.A.C Architects, Project Number: 2019:303

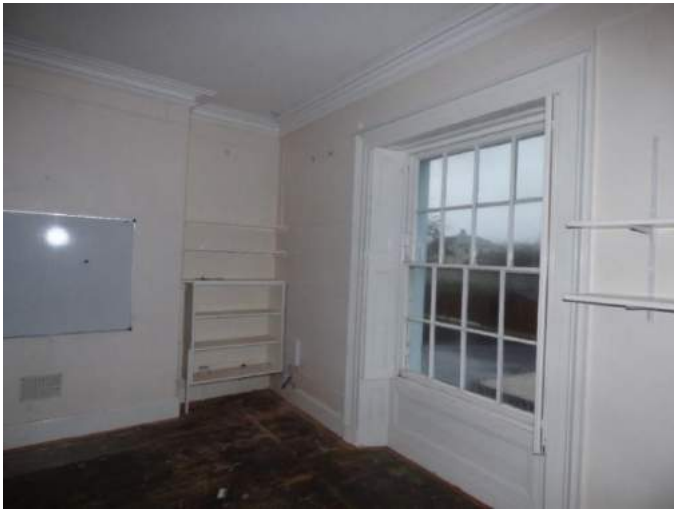
In the existing lounge, the period features below and to the side of the existing window are in good condition, it is proposed to carefully refurbish the existing shutters.

The existing cornice to be made good in locations where redundant services are to be removed and where hairline cracks have appeared.

Existing architraves and skirting to be retained and made good.

Flush panel doors to be replaced with heritage style four panel painted timber fire doors to enhance the heritage asset.

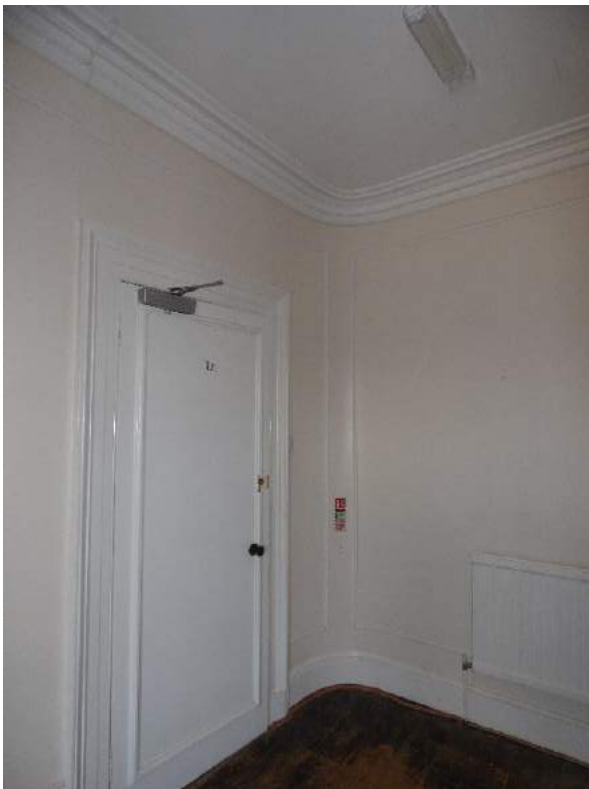
Architraves, skirtings, and cornices are all in good condition and are to be retained.

Left: Existing services to be stripped out and walls made good.

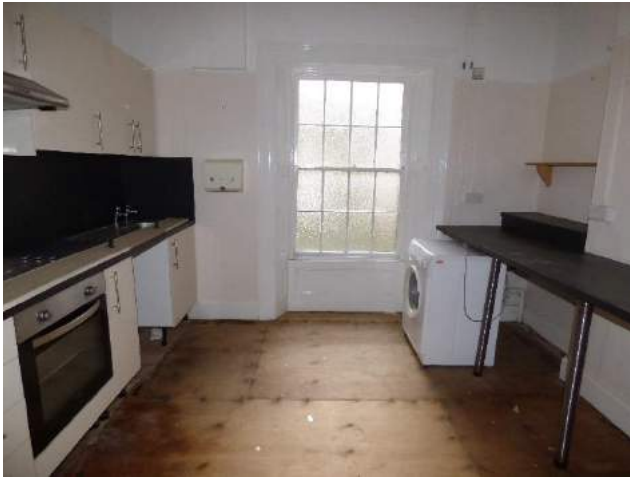
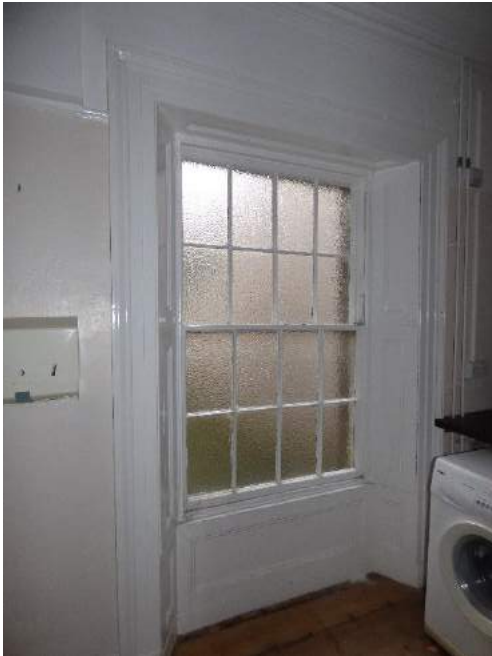
The existing kitchen dining area to the rear of the property.

The period features below and to the sides of the existing window are in good condition, it is proposed to carefully refurbish the existing timber shutters.

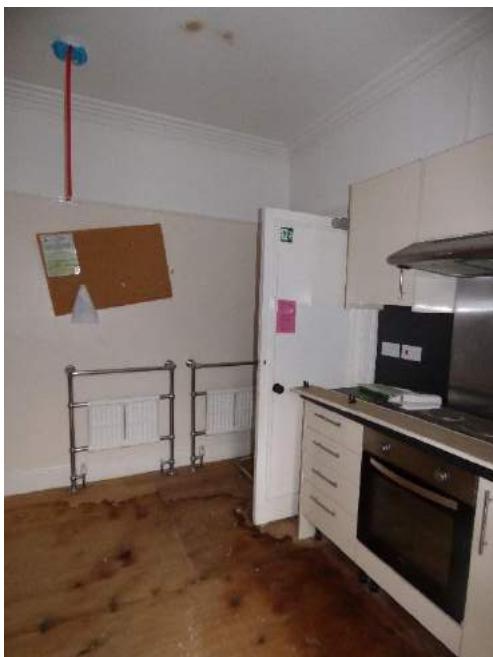
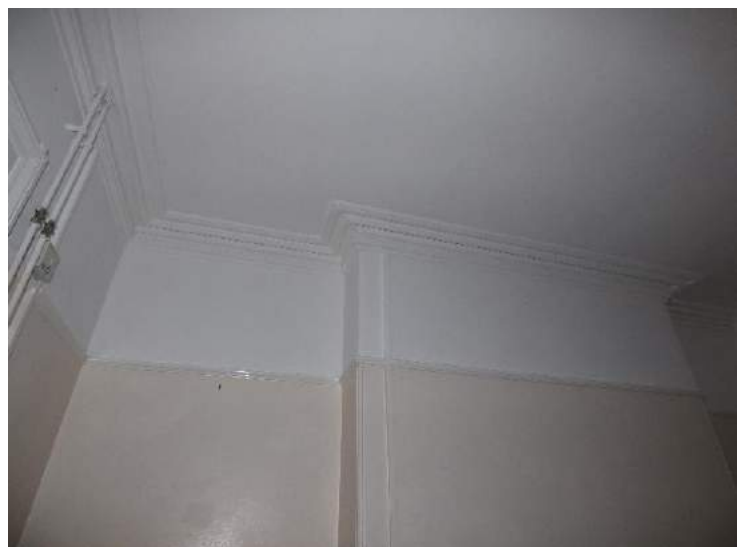
Below: Existing cornice to be made good in locations and where hairline cracks have appeared.

The existing floor is not original as it is plywood boarded, so it is proposed to lift the existing floor and investigate the condition of floor joists and then replace with timber floorboards.

Flush panel doors to be replaced with heritage style four panel painted timber fire doors to enhance the heritage asset.

Where possible it is proposed to refurbish any original doors with door closers and intumescent paint subject to building control approval.

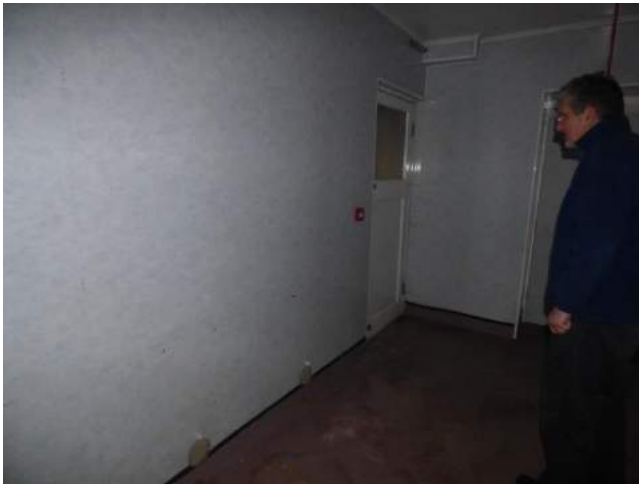
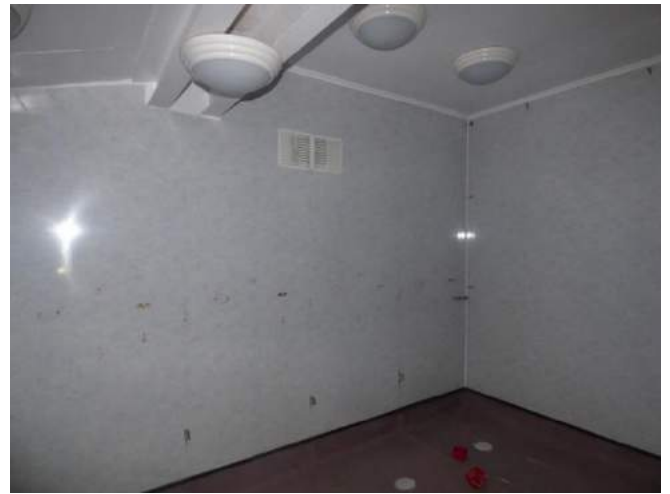
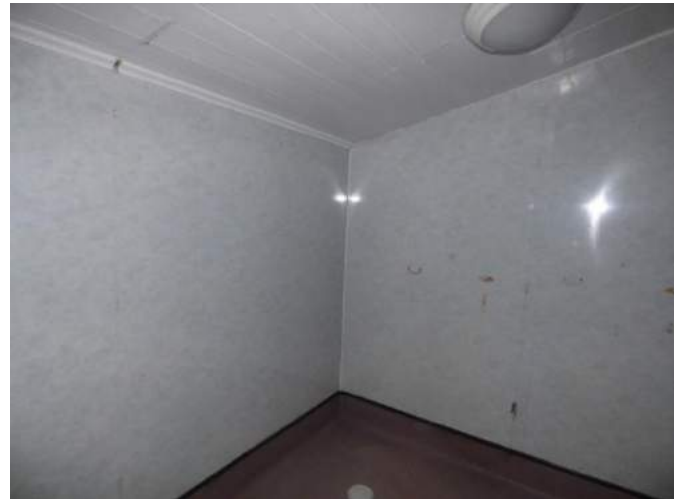
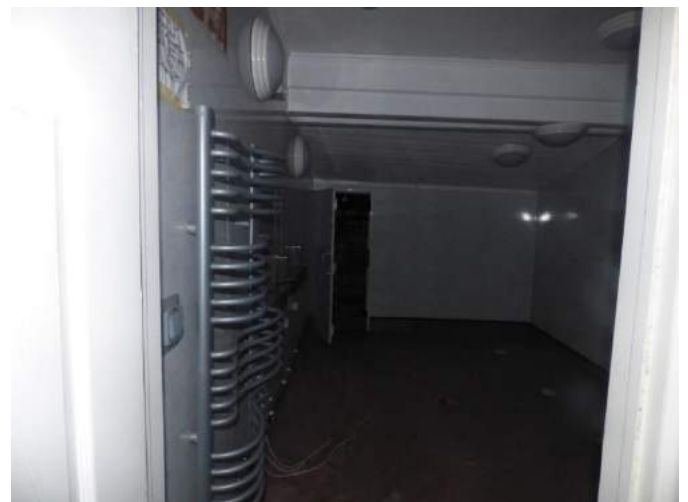
Above and right: The existing former shower block is to be converted back into a kitchen.

All the existing walls and floor finishes are to be stripped out and walls and floors made good. The existing window which has been boarded over will be reinstated with a new heritage style double glazed sash window.

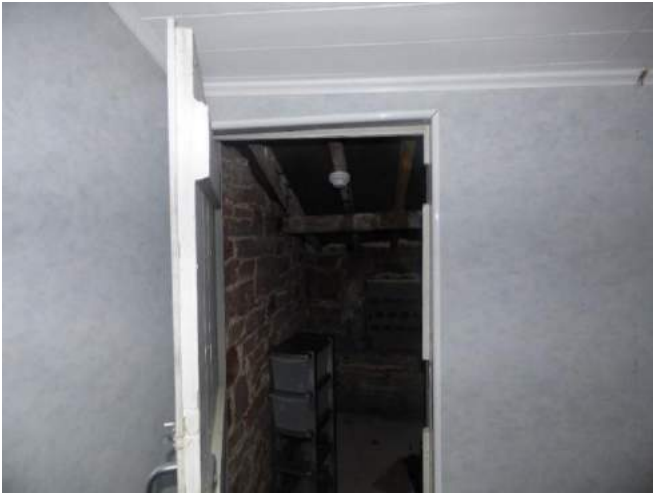
Left: Views of the existing shower block. The area behind the proposed new kitchen will be reconfigured to accommodate a new utility and w.c.

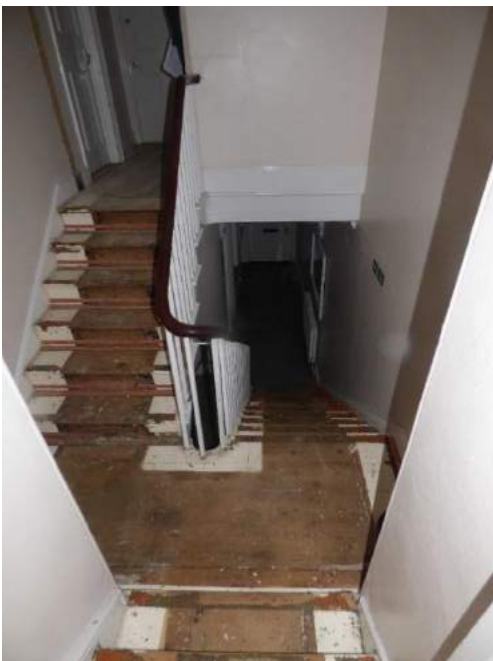
The original staircase is in good condition and is to be retained.

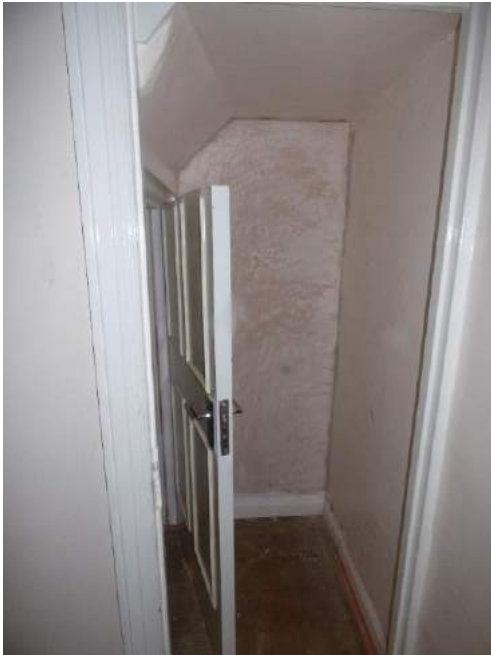
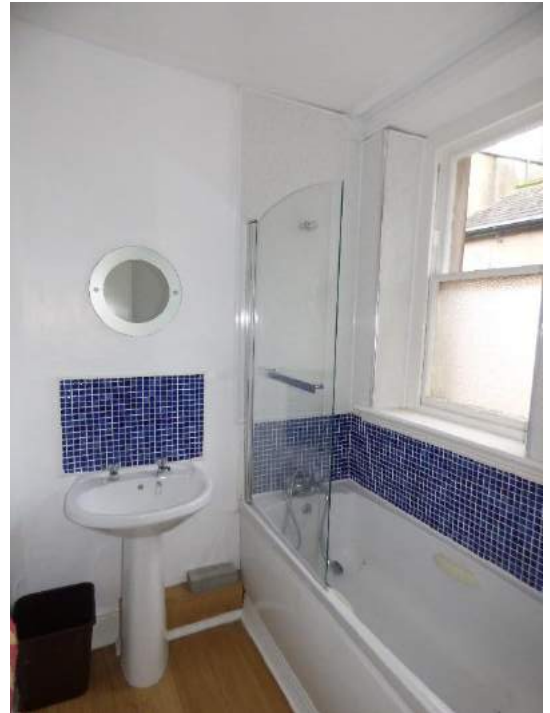
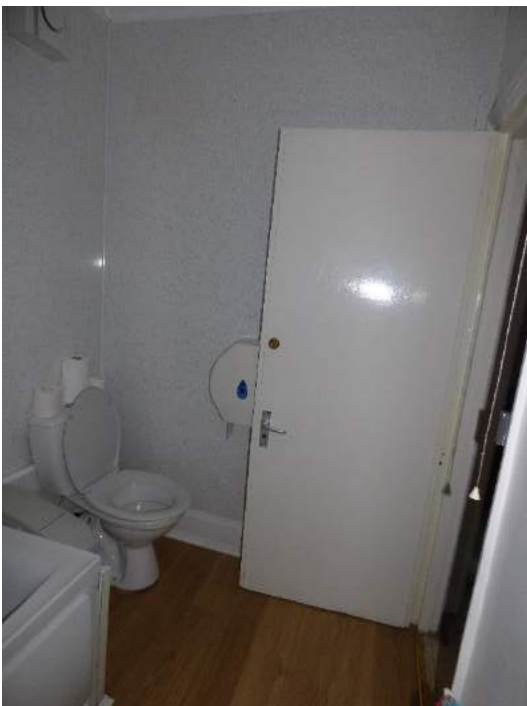
Above left; under stairs storage to be reconfigured to make better use of space.

Above and left: Existing bathroom to be stripped out and the existing walls to be removed to reconfigure this space to be more conducive to modern day living.

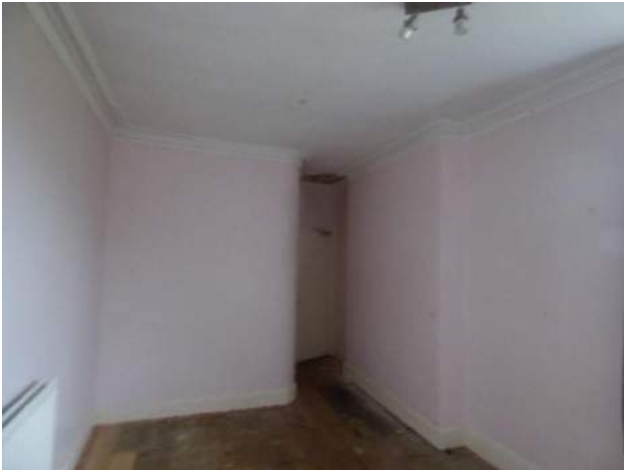
Existing bedroom to be reconfigured into a new family bathroom. The existing bathroom is too small for use as a family bathroom.

Glazing to new heritage style Georgian double glazed sash window to be obscure.

The damaged ceiling is to be repaired with lime plaster.

All finishes to be made good and skirting to match the original to be installed.

The reconfigured spaces will have architraves, cornices and skirtings to match existing.

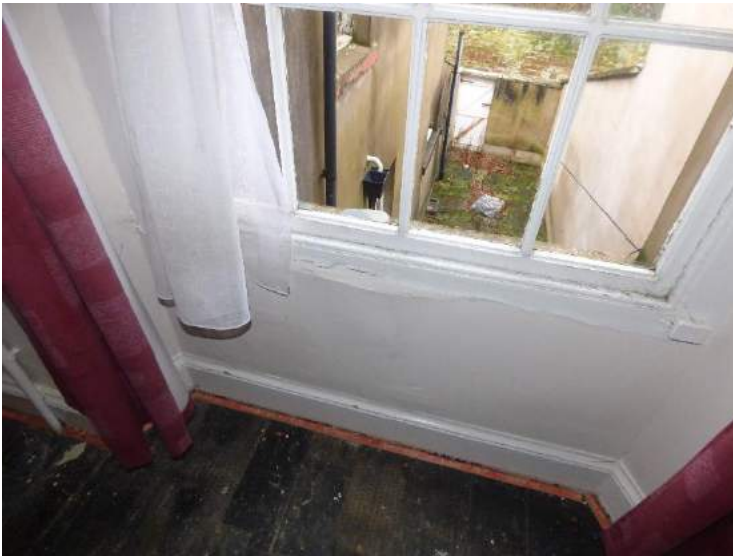
Rear bedroom skirtings and architraves to be retained. Existing flush panelled door to be replaced with new heritage style four panel door to be provided and installed by specialist joinery company such as Batty Joinery Ltd. Where possible it is proposed to refurbish any original doors with door closers and intumescent paint subject to building control approval.

Existing floorboards in good condition.

Evidence of damp damage to ceiling and surrounding the existing window are to be repaired with lime plaster (Solo lime plaster from Lime Centre).

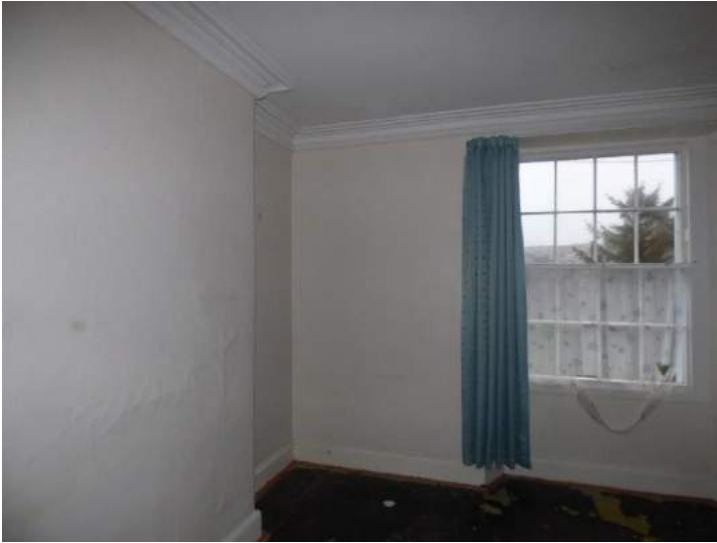
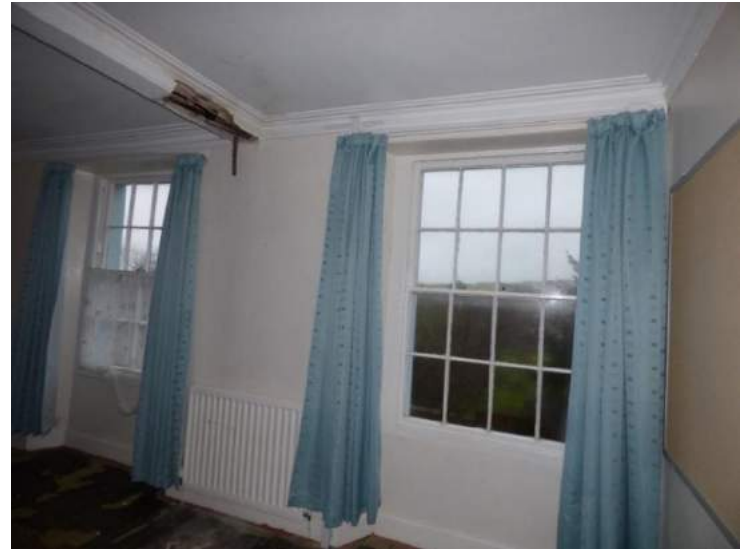
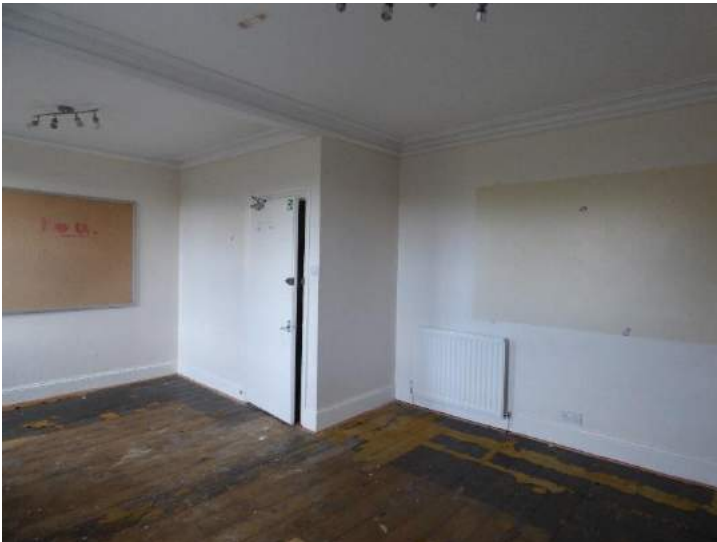
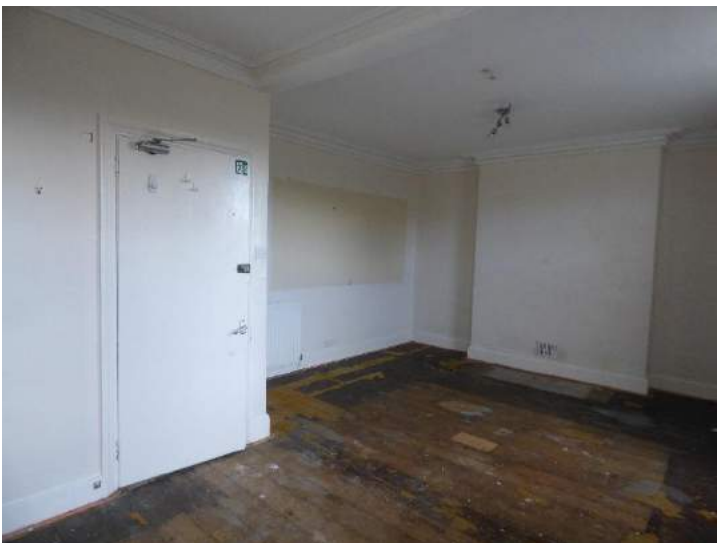
Existing floorboards in good condition.

Front bedroom skirtings and architraves to be retained. Wall to be reinstated (where existing down stand is) between bedroom and new EnSite, and existing doorway to be walled up to where the small bedroom would once have been to form the en-suite.

Existing flush panelled door to be replaced with new heritage style four panel fire door to be provided and installed by specialist joinery company such as Batty Joinery Ltd. In original location (has been walled up). Where possible it is proposed to refurbish any original doors with door closers and intumescent paint subject to building control approval.

With architraves to match the existing.

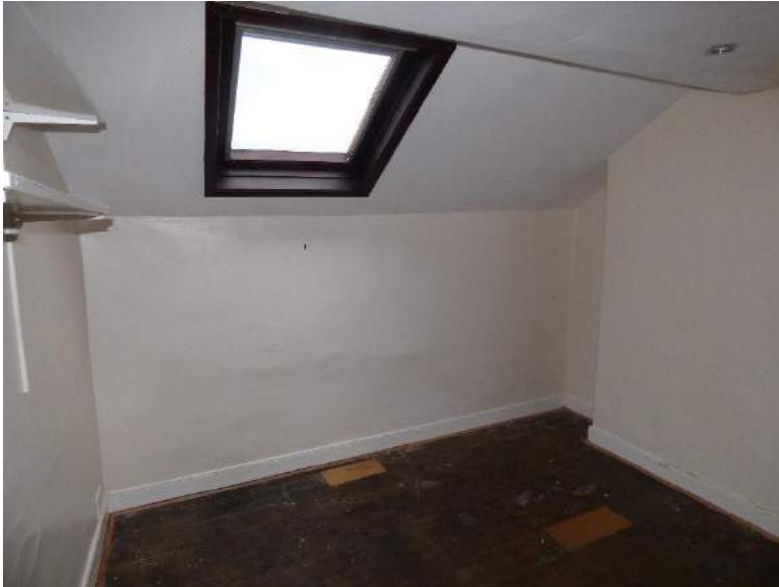
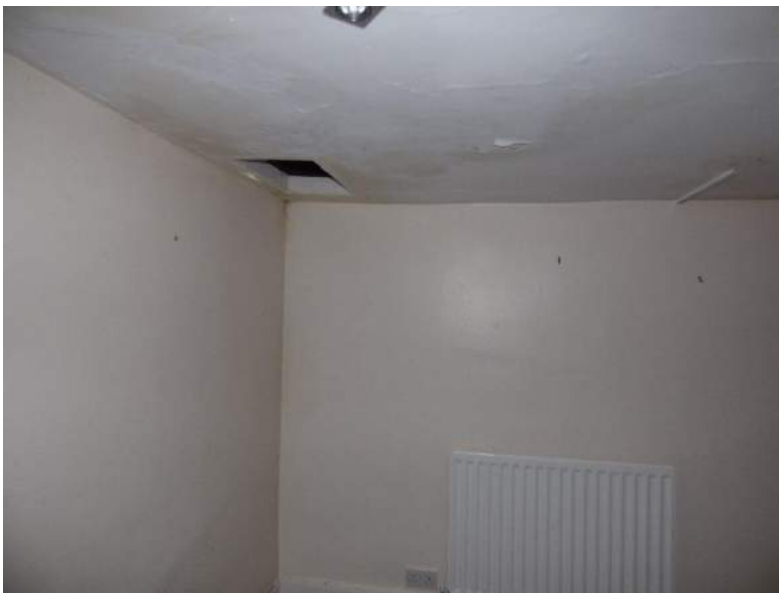
Floorboards are in good condition (but may require some minor repairs)

Apply an insulated plasterboard 62mm thick to underside of ceiling. The Laminated plasterboard and PIR has a vapour barrier incorporated so interstitial moisture would be prevented. New rooflights to be installed with flashing kit that mounts unit flush with the roof surface.

Provide and install new heritage window and new heritage rooflight (Velux or similar).

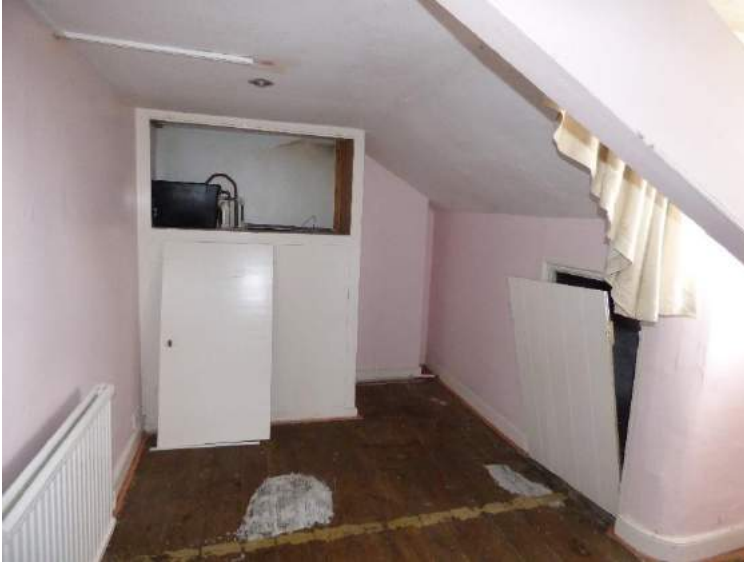
Left: Attic bedroom

Floorboards are in good condition (but may require some minor repairs)

New plasterboard stud partitions to be installed in reconfigured attic space.

Remove all damp and damaged/blown plaster and repair with lime plaster and skim and decorate throughout.

Apply an insulated plasterboard 62mm thick to underside of ceiling. The Laminated plasterboard and PIR has a vapour barrier incorporated so interstitial moisture would be prevented. New rooflights to be installed with flashing kit that mounts unit flush with the roof surface.

It is proposed to remove the timber beam that slices through the existing dormer and for the structural engineer to design supports either side of the new dormer window.

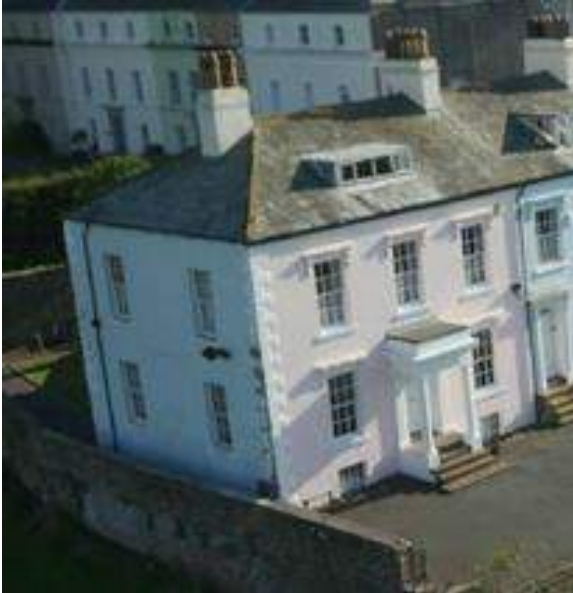
Left: The main entrance is mentioned in the listing text and is to be entirely retained.

Both front and rear elevations are currently rendered, with colour to the front and white render to the side side and rear. All elevations require to be prepared for render repairs and redecoration by specialist using lime render and stucco (Parax LTD) to be applied by specialist.

The stucco features above the windows and door on the front elevation will be carefully restored by a specialist. Colour of all render and stucco to match existing.

The existing door and frame are to be retained and made good with the provision of new ironmongery. Once repaired full decoration will be undertaken.

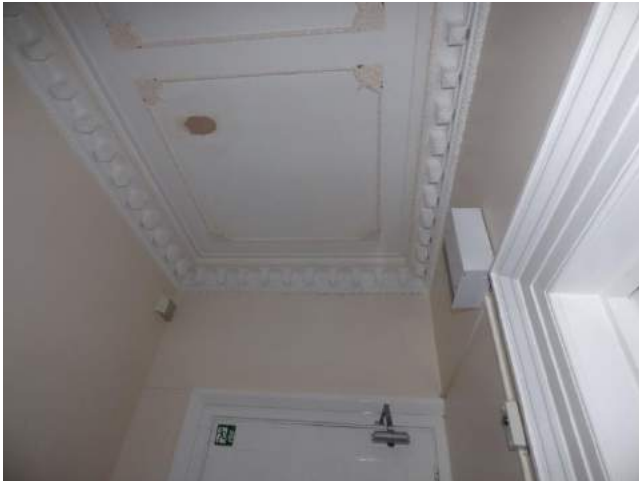
Period features are in extremely good condition and all are to be retained.

Ceiling to be repaired where existing light fittings are to be removed.

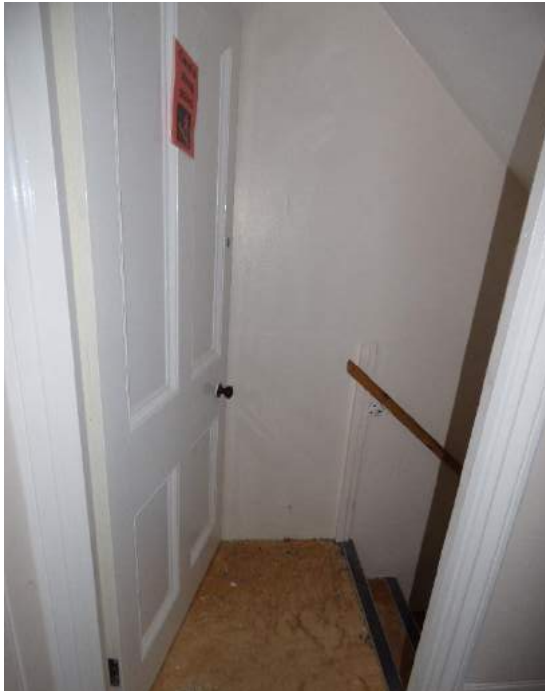
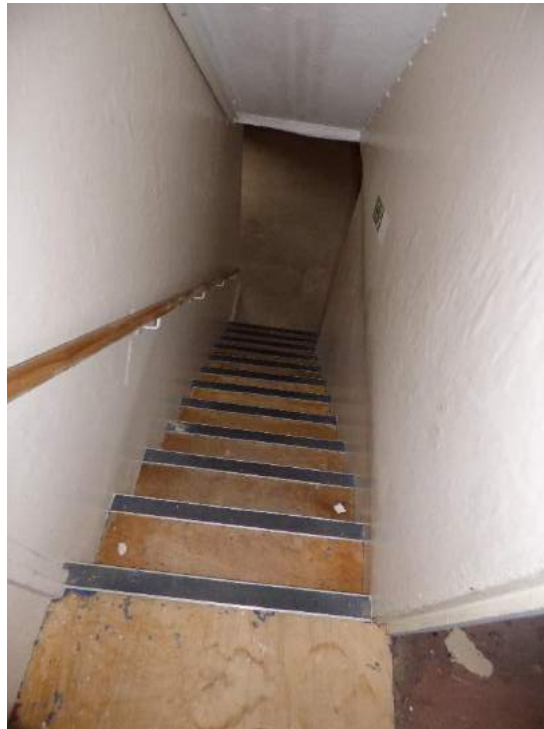
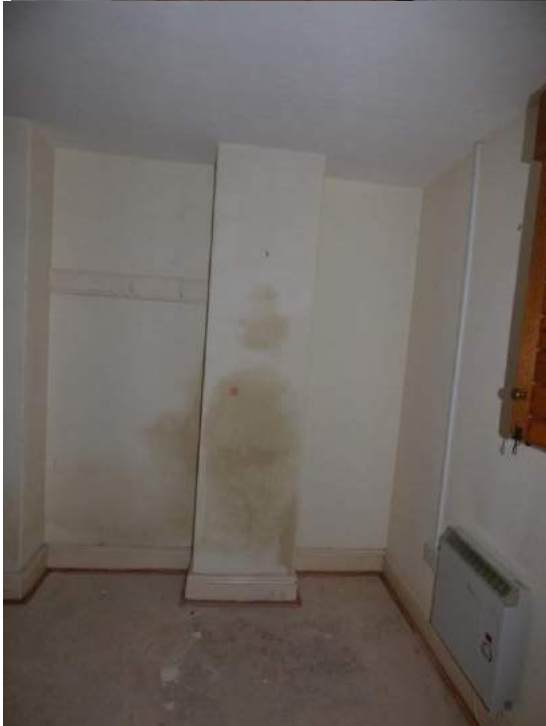
The existing basement. The existing walls and floor are generally in sound condition so would be suitable for the application of damp proof slurry system.

Some of the walls have been overboarded, but the basement has not been treated for damp and moisture is penetrating the walls that have been overboarded.

All existing paint and surface finishes must be removed and made good including all snots removed, and damage to existing surfaces, prior to the installation of a **Koster Polysil NB1**. This migratory crystalline tanking slurry is used to seal below ground structures against water ingress.

**Kloster NB1** is a breathable water proof system which will enhance the thermal value of the building without increasing the moisture content of the wall.

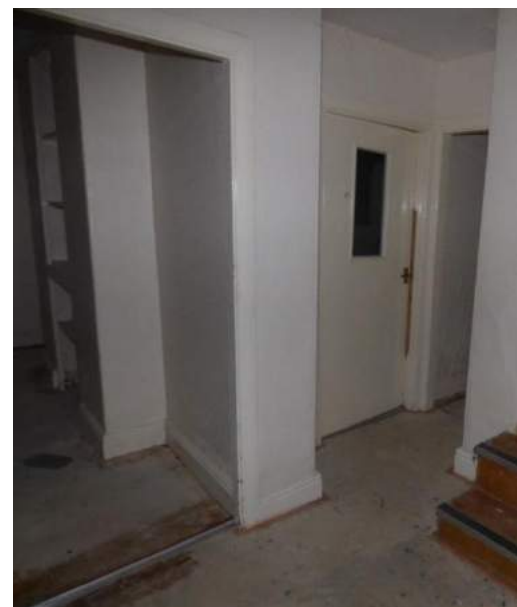
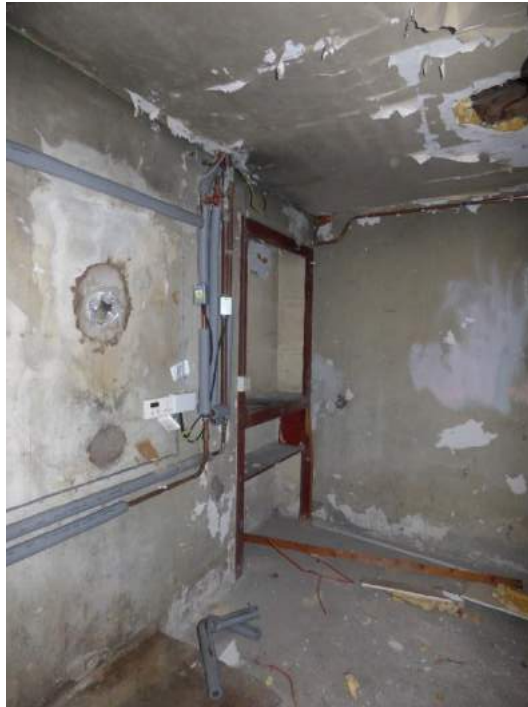
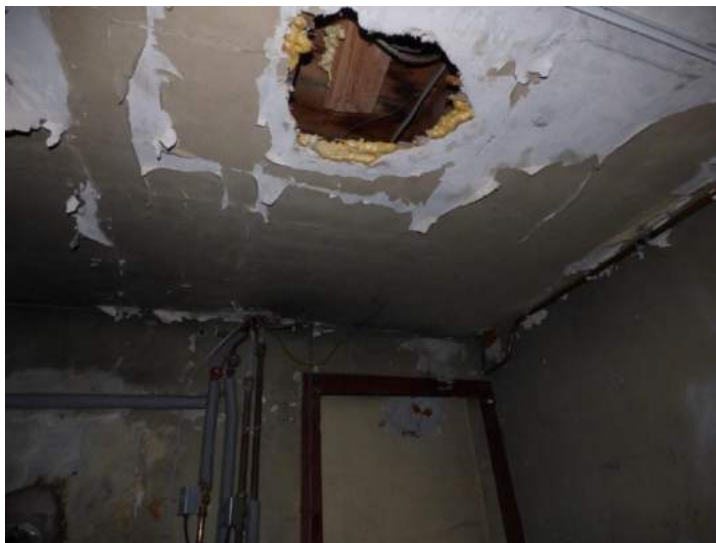
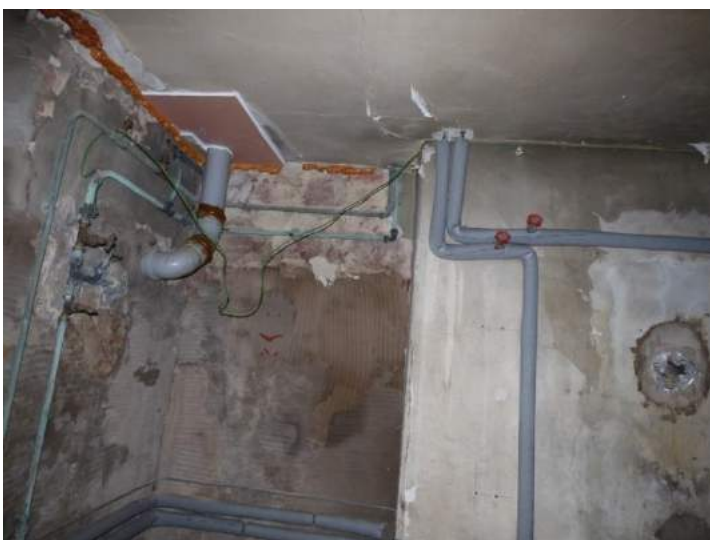
Damp affects the entire basement.

All redundant M&E, conduits and FF&E to be removed.

Ceiling to be repaired with fire resistant plasterboard.

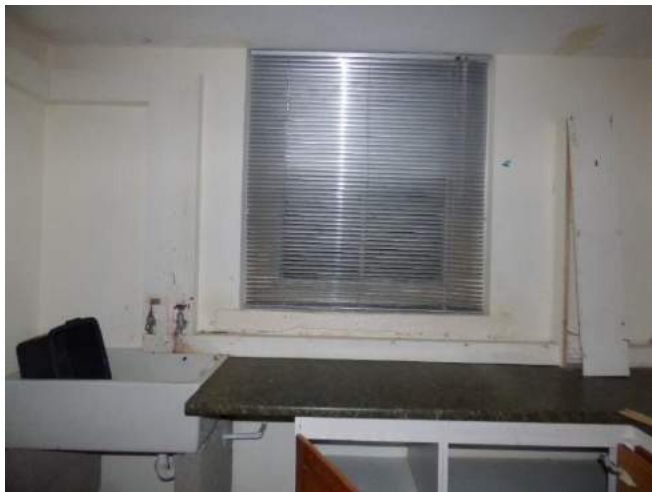
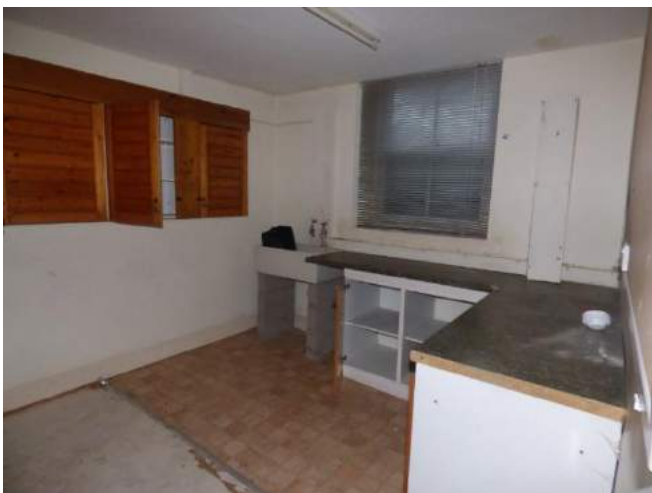
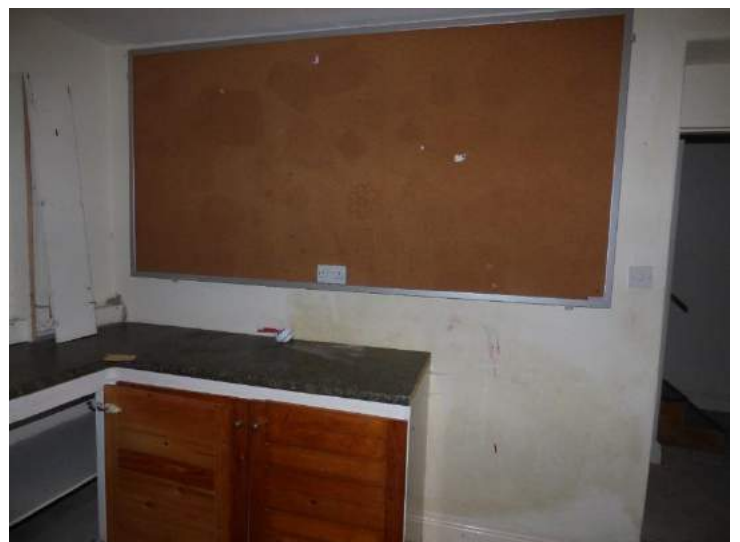
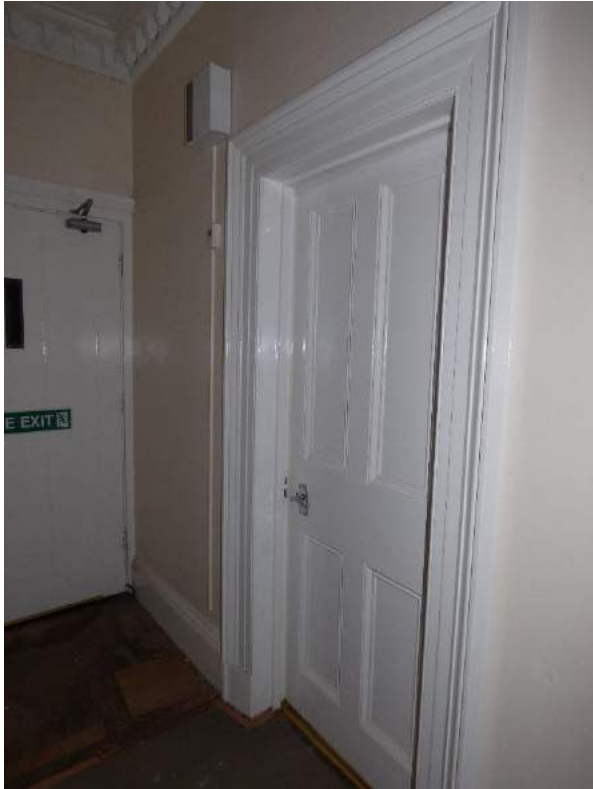
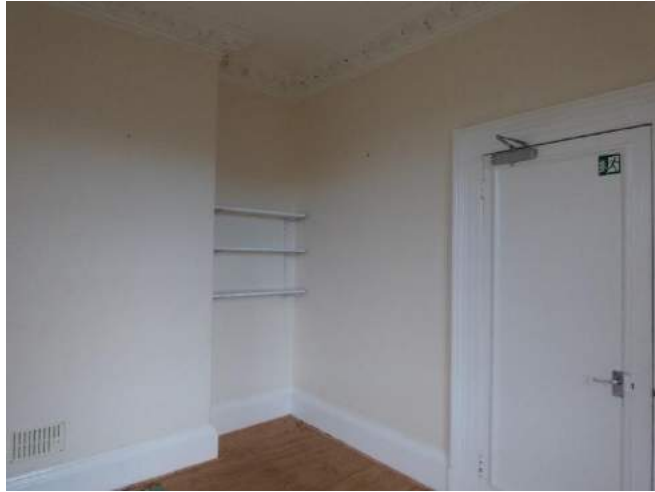
Existing front room requires minor damp treatment and walls to be made good following repairs.

Minor damp patch repair required to ceiling.

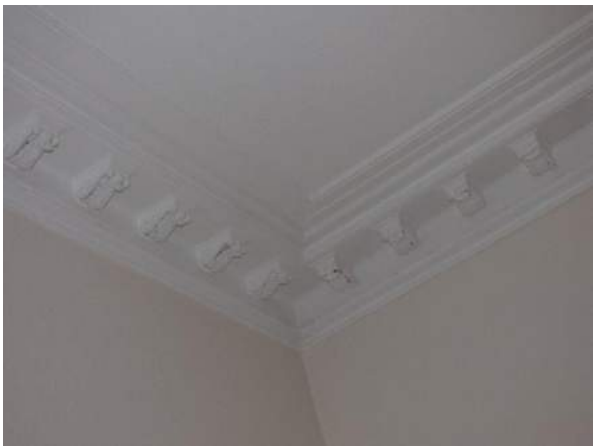
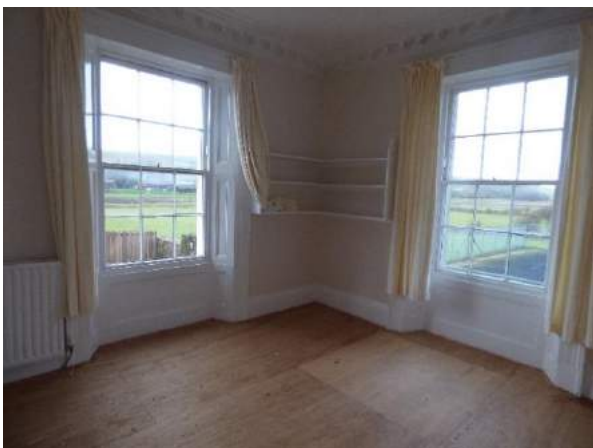
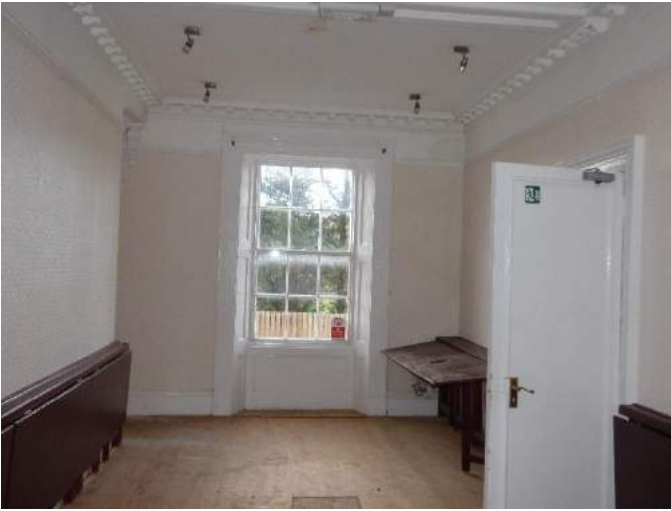
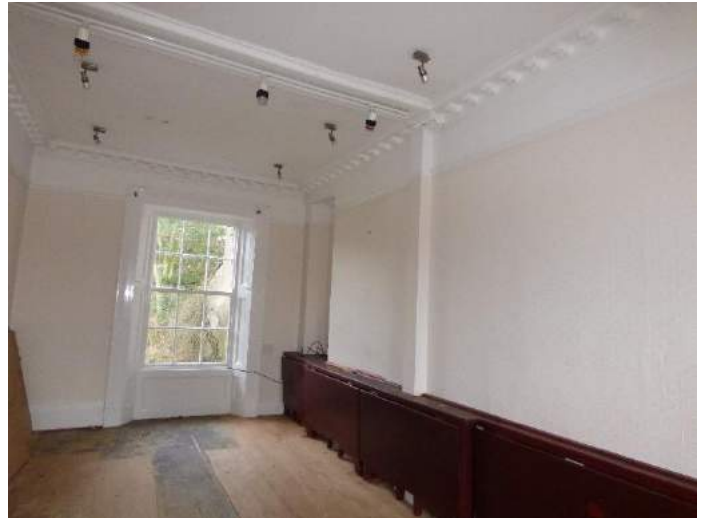
Above and below: In the existing through lounge, the period features below and to the sides of the existing windows both front and back are in good condition. It is proposed to carefully refurbish the existing timber shutters.

Existing cornice to be made good in locations where redundant services are to be removed and where hairline cracks have appeared.

Existing architraves and skirtings to be retained and made good.

Flush panel doors to be replaced with heritage style painted timber fire doors to enhance the heritage asset. Where possible it is proposed to refurbish any original doors with door closers and intumescent paint subject to building control approval.

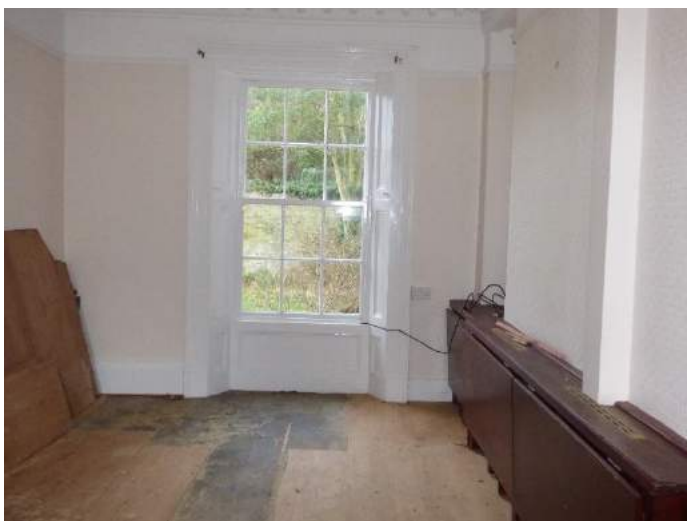
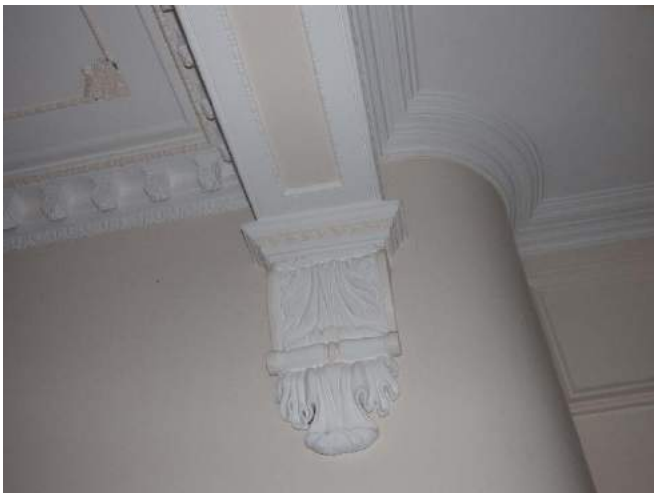
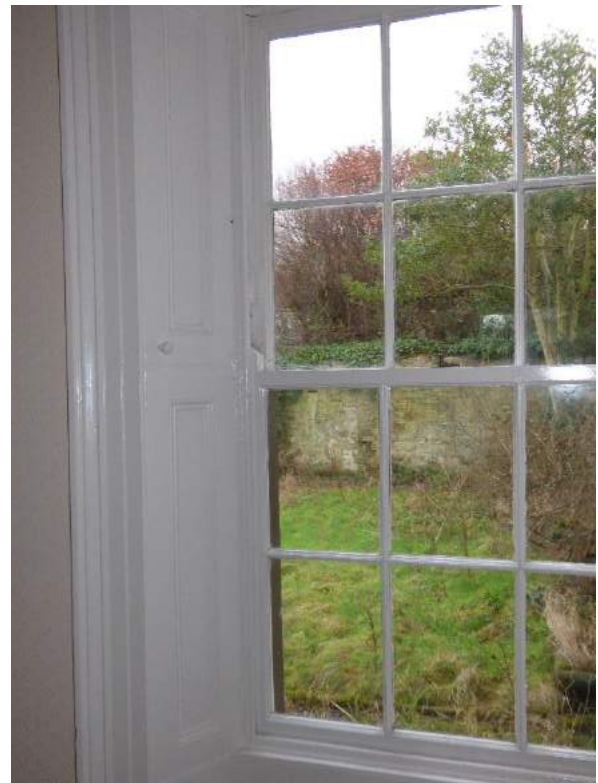
The existing floor is not original and is plywood. It is proposed to lift the plywood boards and examine the existing joists to ensure that they are in good condition, and reinstate and repair as necessary.

Existing cornice to be made good in locations where redundant services are to be removed and where hairline cracks have appeared.

Existing architraves and skirtings to be retained and made

Flush panel doors to be replaced with heritage style painted timber fire doors to enhance the heritage asset.

Where possible it is proposed to refurbish any original doors with door closers and intumescent paint subject to building control approval.

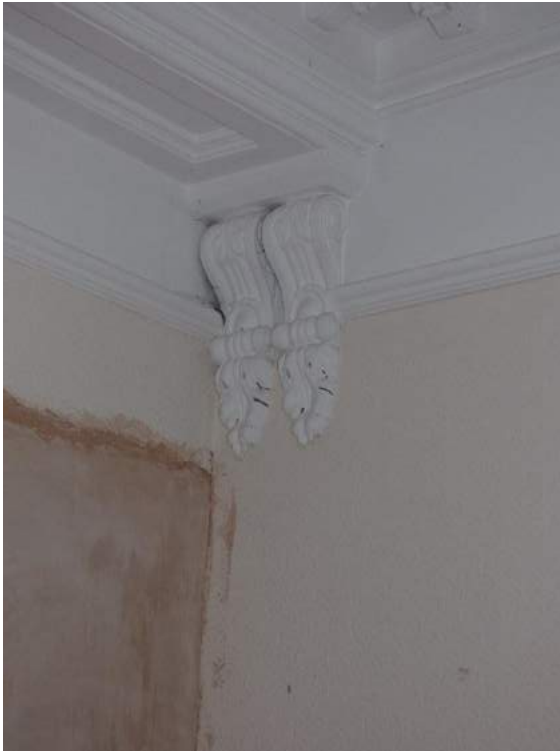
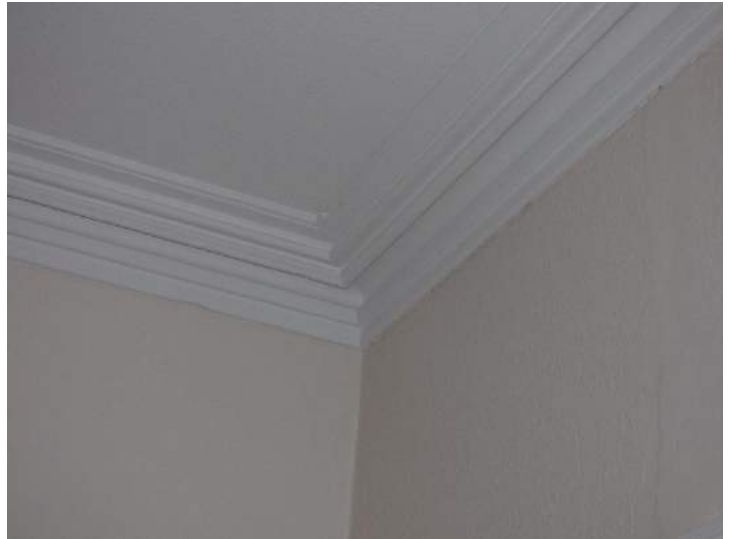
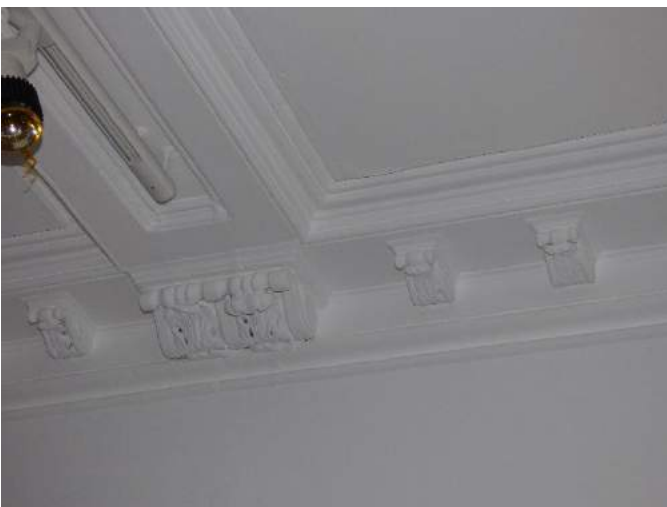
Above: Period features have remained in excellent condition and are to be retained.

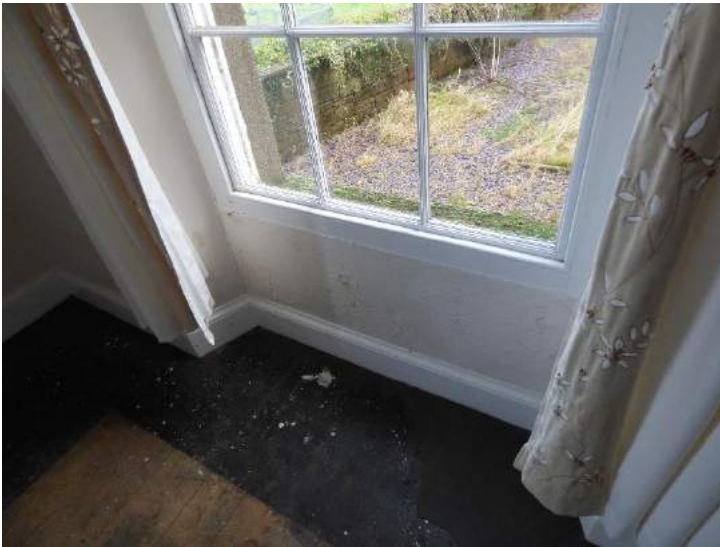
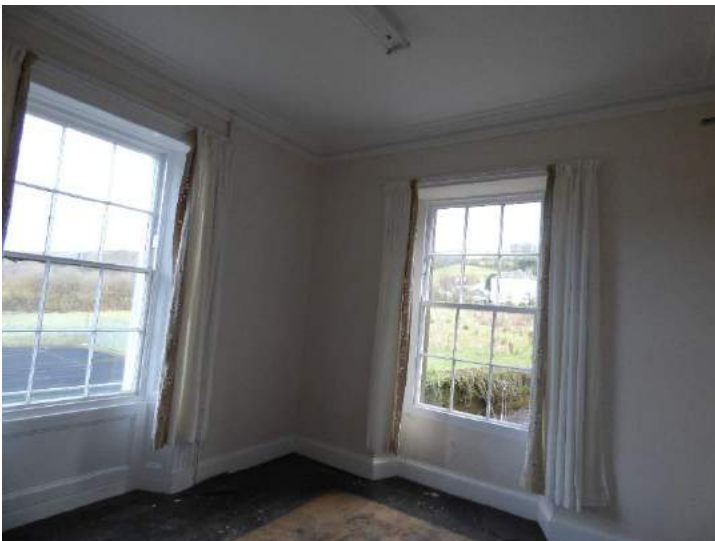
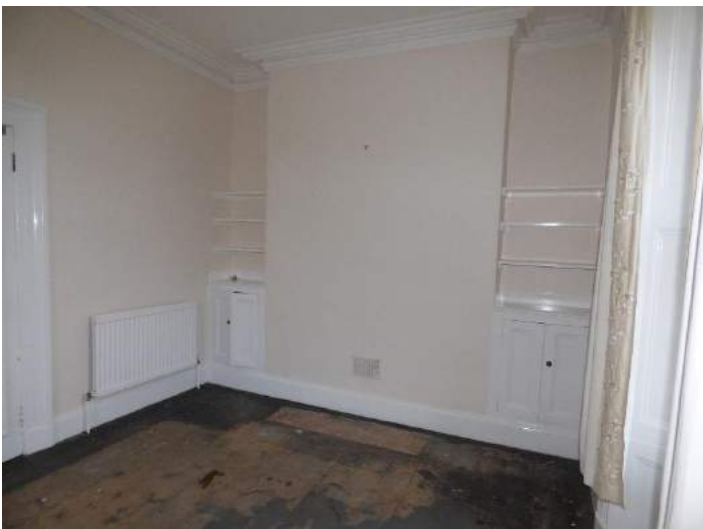
Left: In the existing dining room at the rear of the property

the period features below and to the sides of the existing windows are in good condition, it is proposed to carefully refurbish the existing timber shutters.

Below: existing cornice to be made good in locations and where hairline cracks have appeared.

Existing architraves and skirtings to be retained and made good.

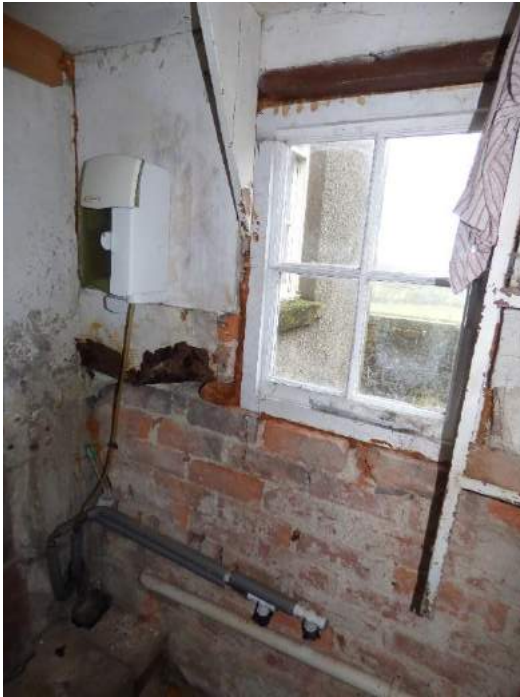
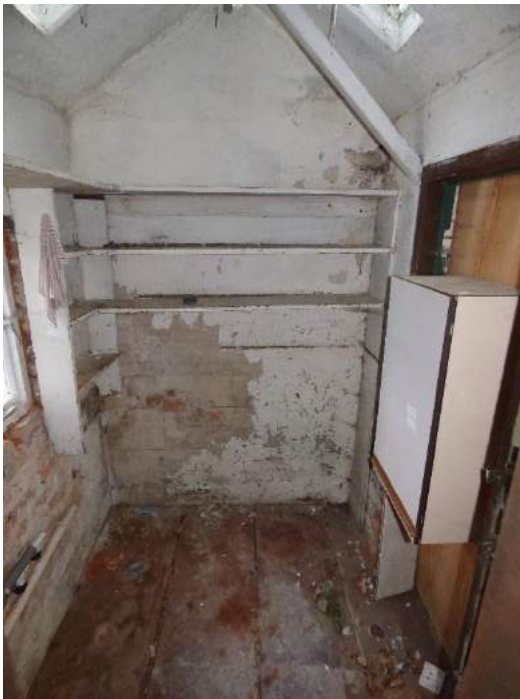
The existing rear porch is in addition to the original building and is in poor condition. The porch conceals the original rear entrance door which it is proposed to reinstate.

It is proposed to remove the porch completely, and reconstruct a new porch to the same design but to contemporary building stand

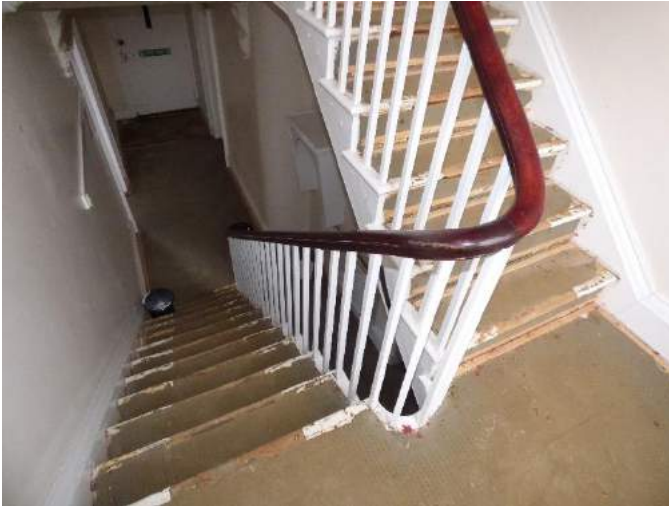
Retain the original staircase, which is in good condition.

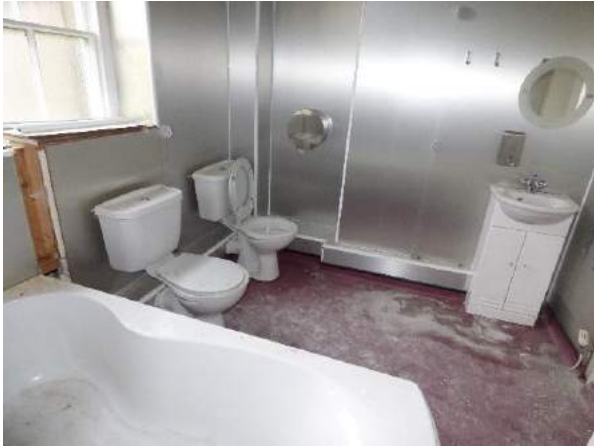
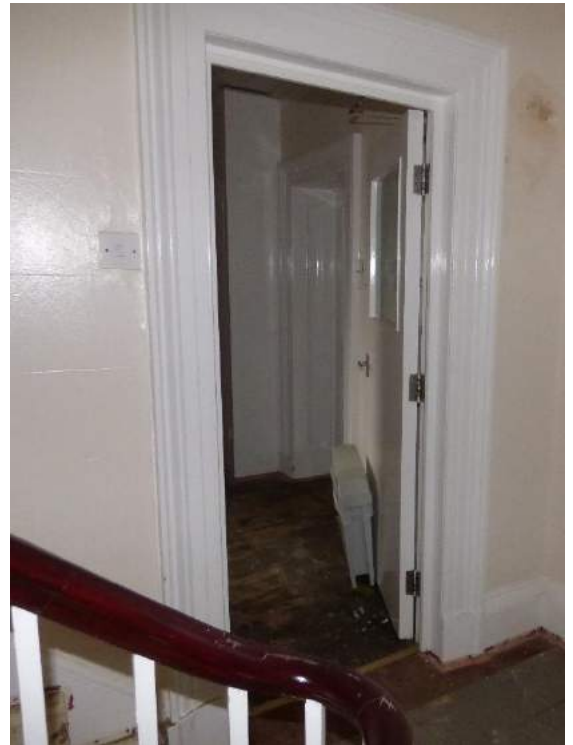
Left and above:

Existing bathroom area at first floor to be reconfigured, to make use as a house bathroom.

Ceiling to be made good following reconfiguration works.
