# HERITAGE STATEMENT

## FULL RENOVATION OF EXISTING No 11 TERRACE HOUSES

St Bees, 1-11 Lonsdale Terrace, Parish Council, Cumbria

M.A.C Architects, Project Number: 2019:303

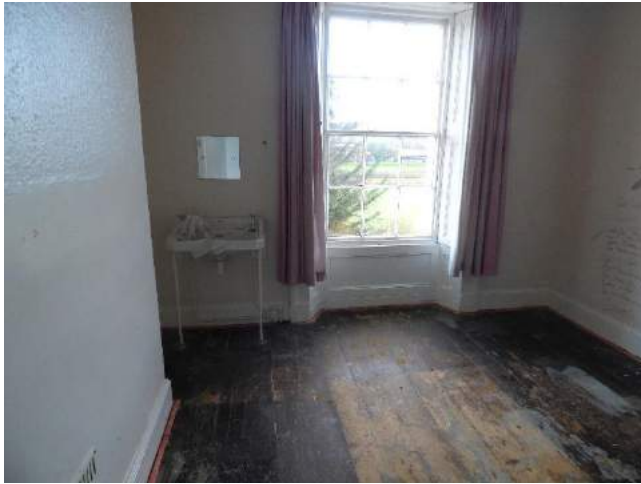
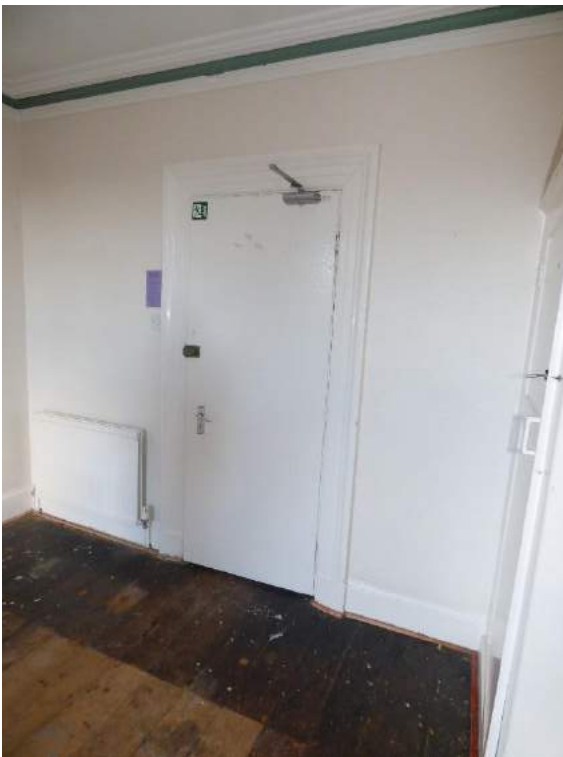
Left and below:

Rear bedroom, skirting and architraves to be retained. Existing flush panelled door to be replaced with new Georgian heritage style four panel fire door to be provided and installed by specialist joinery company such as Batty Joinery Ltd . Where possible it is proposed to refurbish any original doors with door closers and intumescent paint subject to building control approval.

Existing floorboards in good condition.

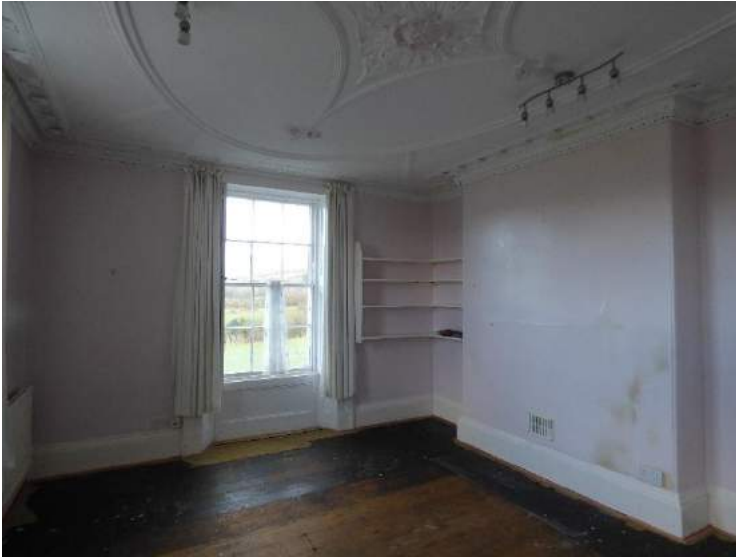
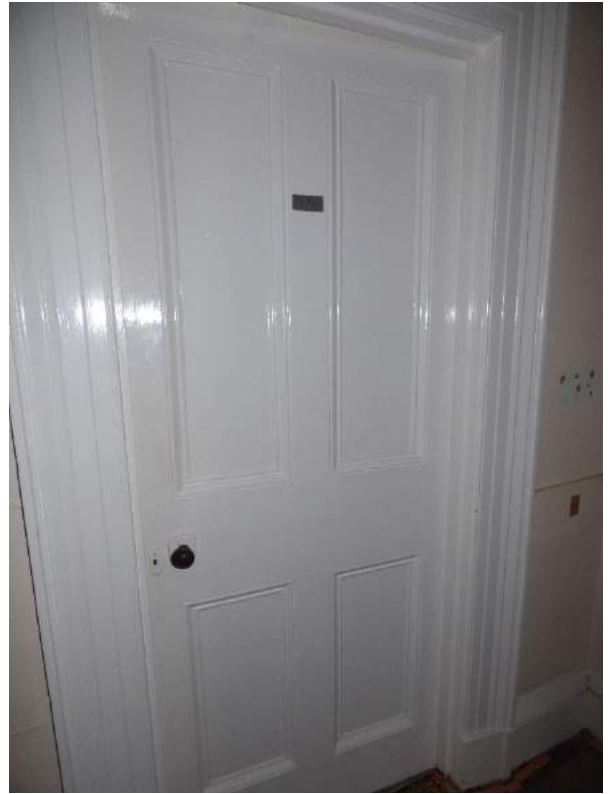
Above and left:

Front bedroom has stunning heritage features in excellent condition. Skirtings, cornices and architraves to be retained. Existing flush panelled door to be replaced with new Georgian heritage style four panel fire door to provided and installed by specialist joinery company such as Batty Joinery Ltd.

Where possible it is proposed to refurbish any original doors with door closers and intumescent paint subject to building control approval.

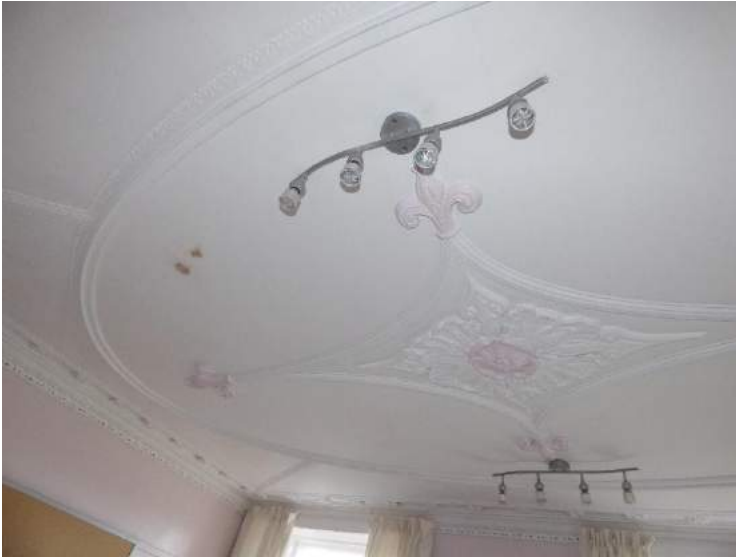
Left: Intricate ceiling moulds are to be retained, and existing lighting to be removed.

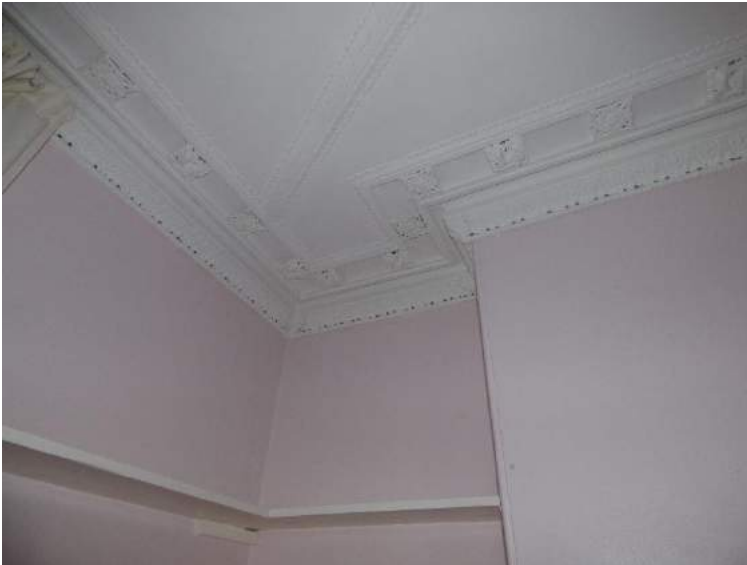
Left Cornice to be retained.

All walls, floors ceilings etc to be made good, following removal of redundant services.

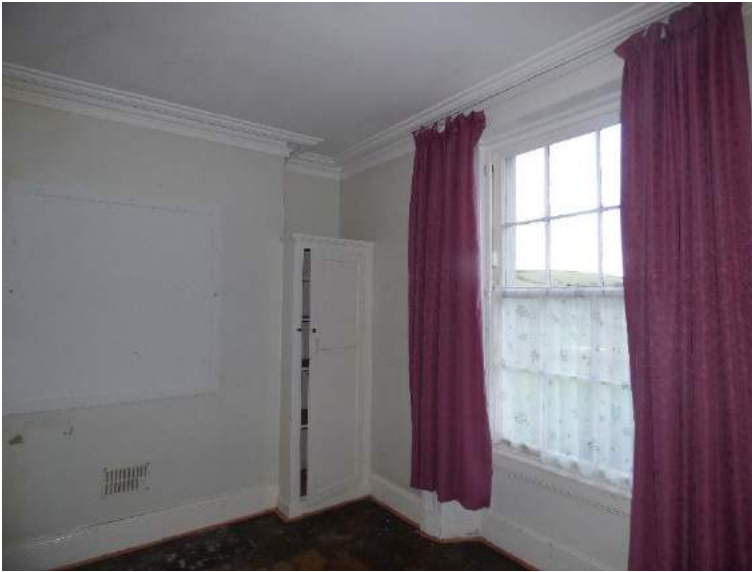
Left:

Front bedroom, skirtings, cornices and architraves to be retained. Existing flush panelled door to be replaced with new Georgian heritage style four panel door to provided and installed by specialist joinery company such as Batty Joinery Ltd. Where possible it is proposed to refurbish any original doors with door closers and intumescent paint subject to building control approval.

Bedroom to become en-suite to master bedroom, so glazing to bathroom window to be obscure.

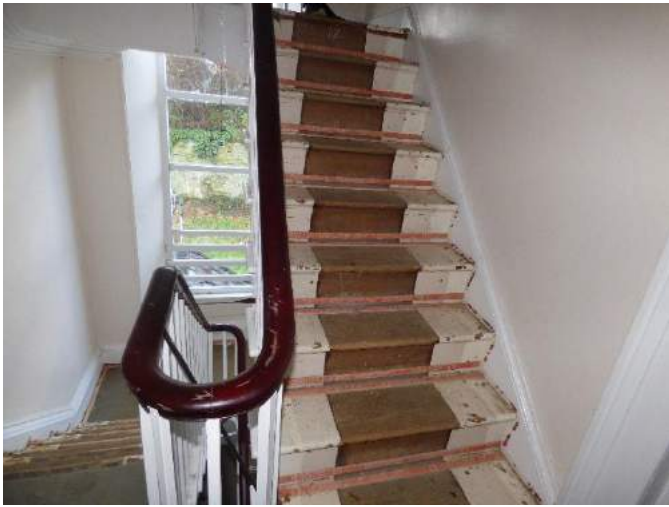
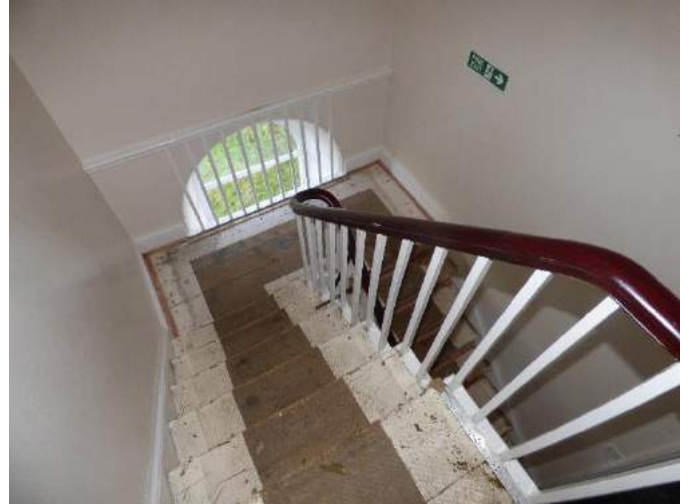
Above and below:

Handrail, balusters and rails are original and are to be retained.

Apply an insulated plasterboard 62mm thick to underside of sloping ceiling, tape and skim and undertake full decorations.

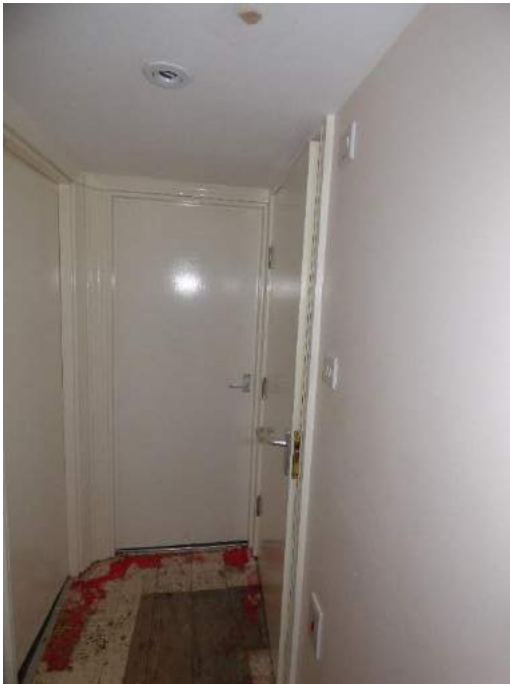
Left and following pages:

Kitchen / Living areas

Repair existing ceiling following repairs to slate roof and replacement lead flashings to chimneys.

Remove all damp and damaged / blown plasterwork and repair with lime plaster and skim and decorate throughout.

Once ceiling has been repaired, apply an insulated plasterboard 62mm thick to underside of ceiling tape and skim, and undertake full decorations.

Completely remove existing dormer and reconstruct new dormer (compliant with statutory requirements).

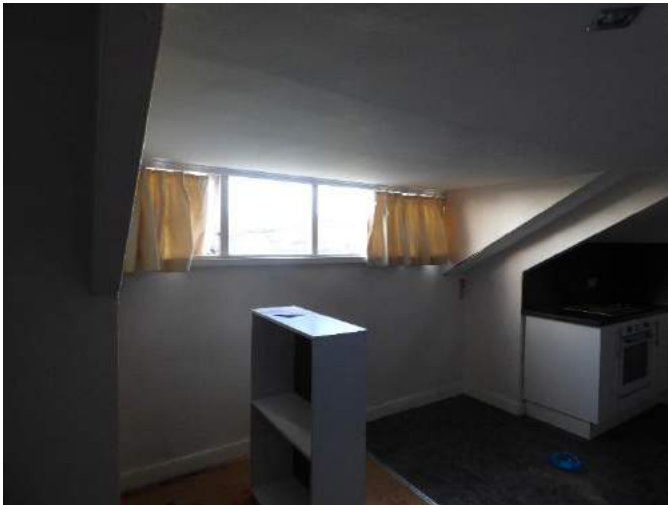
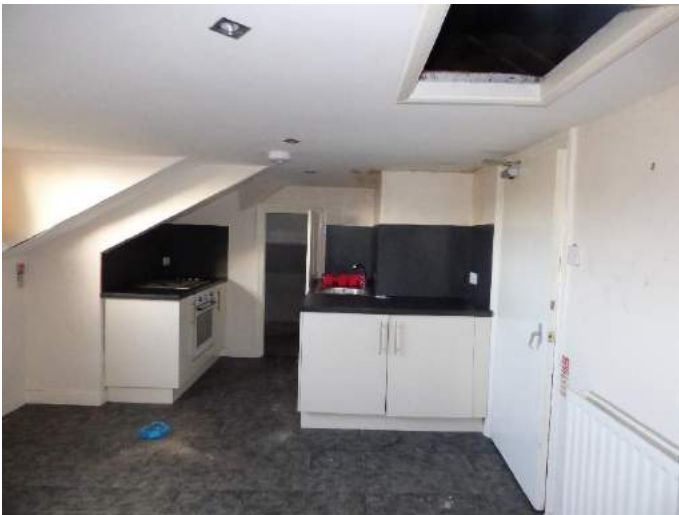
Left and below: All redundant fixtures and fittings to be removed and rooms to be reconfigured to convert existing 'apartment' back into bedroom accommodation.
