# HERITAGE STATEMENT

## FULL RENOVATION OF EXISTING No 11 TERRACE HOUSES

St Bees, 1-11 Lonsdale Terrace, Parish Council, Cumbria

M.A.C Architects, Project Number: 2019:303

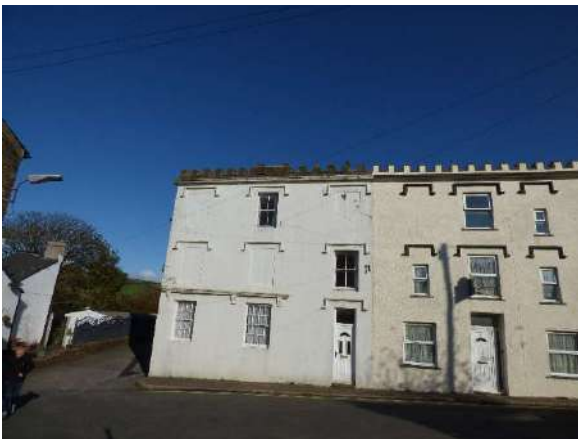
Left: The main entrance on the west facade is mentioned in the listing text and is to be entirely retained.

Investigations to the blind windows have confirmed that that the walls behind are solid masonry and no internal openings were in these locations, so they have never actually been windows.

The entrance to the apartment at first and second floor is accessed from Finkle Street and it is proposed to retain this.

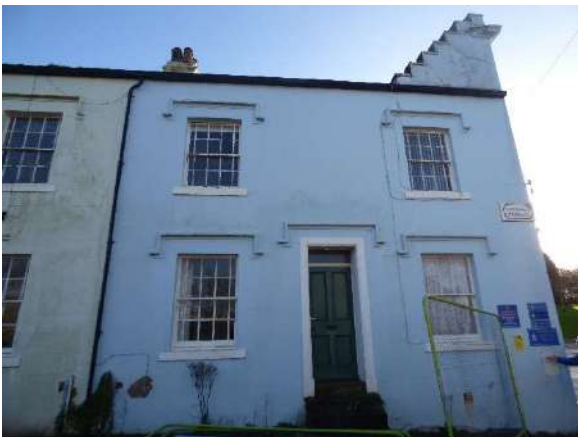
Both front and rear elevations are currently rendered, with colour to the front and side and natural to the rear. All elevations require to be prepared for render repairs and redecoration by specialist using lime render and stucco (Parax LTD) to be applied by specialist.

The stucco features above the windows and door on the front elevation will be carefully restored by a specialist. Colour of all render and stucco to match existing.

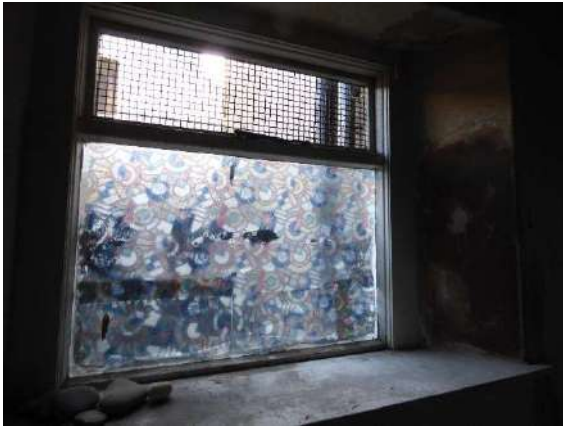
Left: The ground floor window to the rear is not original and requires replacement.

The proposed replacement will reinstate the original Georgian style traditional window as whilst the dwelling was built in the mid-19<sup>th</sup> Century, which would be some years after the end of the Georgian period, even if counting the Regency but reflect the style none the less.

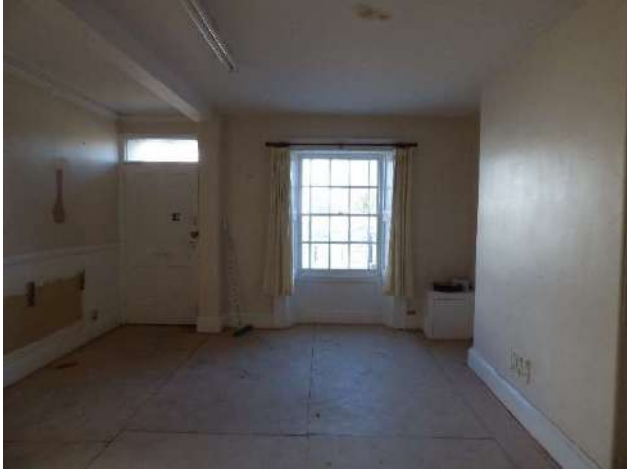
Much of the original historic internal fabric has been removed, although there are elements that have been saved and it is intended to reinstate elements of the building that have been removed, such as the cornices and skirtings.

The existing door and fanlight are to be refurbished and decorated.

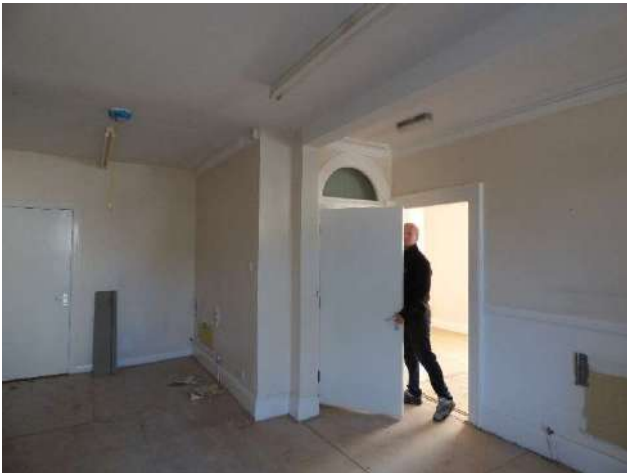
Modern strip light fittings are to be removed and all walls, ceilings and floors made good. The existing floor has been over-boarded. It is intended to overlay an oak engineered floor.

Finish with Georgian style skirting to match existing (there are examples of skirting within the rooms, and it is proposed to match up with these and repair / replace, as necessary).

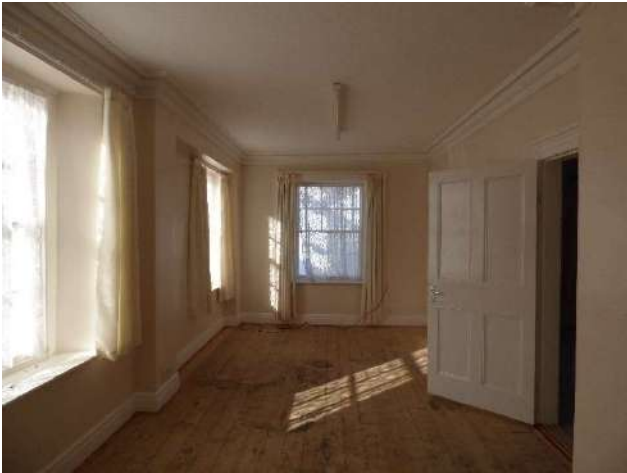
Both existing windows have the original shutters to the inside of the windows which are in excellent condition. It is proposed for these to be retained and carefully restored and decorated.

New doors at ground floor to be provided as heritage style four panel painted timber fire doors to enhance the heritage asset. Where possible it is proposed to refurbish any original doors with door closers and intumescent paint subject to building control approval.

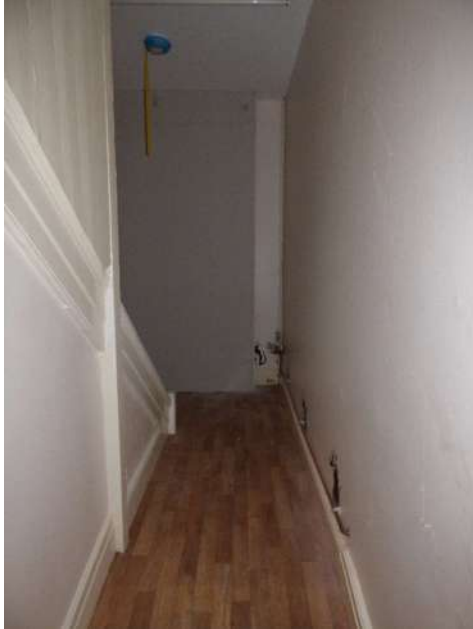
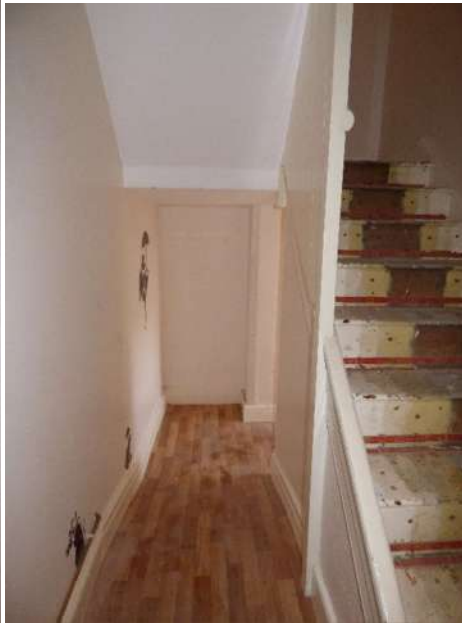
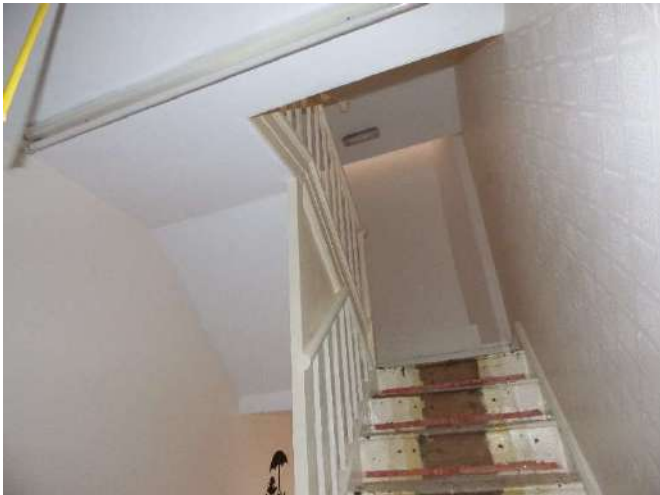
The existing staircase at ground floor has been modified as part of later alterations to the building. It is proposed to reinstate balusters and rails to match the existing to the lower part of the staircase, where they have been removed.

The existing staircase is to be retained as existing throughout the rest of the building.

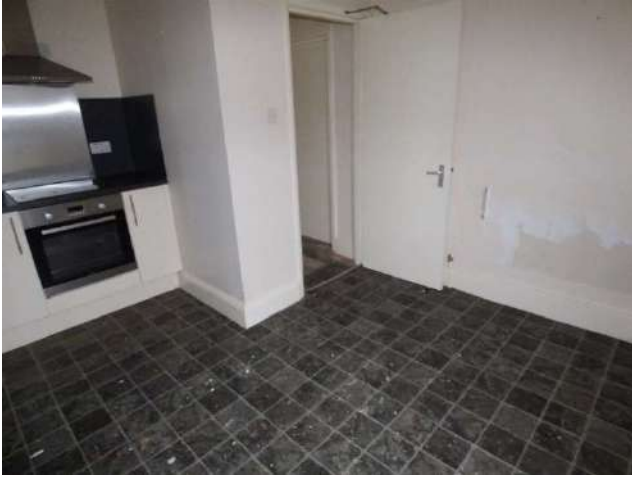
Existing kitchen, bathroom and living area at the front of the first floor, has lost most of the original heritage features.

It is proposed to remain as existing subject to minor decorative repairs. Flush panel doors to be replaced with heritage style 4 panel painted timber fire doors to enhance the heritage asset. Where possible it is proposed to refurbish any original doors with door closers and intumescent paint subject to building control approval.

Original floors to be made good using T & G flooring to match existing where required.

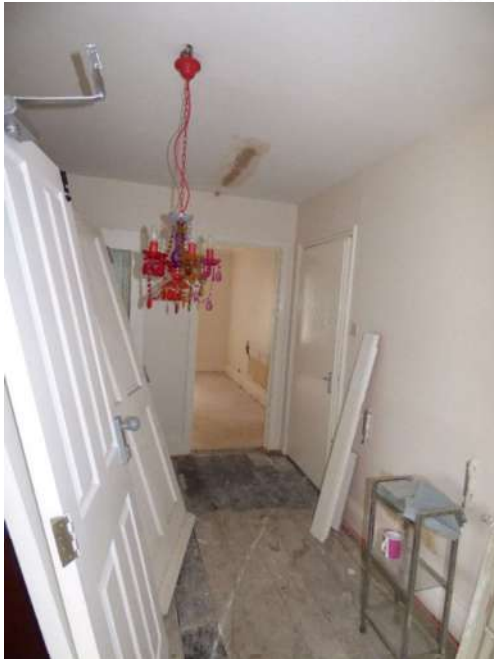
Existing living area at the rear of the first floor is proposed to remain as existing subject to minor decorative repairs. Flush panel doors to be replaced with heritage style 4 panel painted timber fire doors to enhance the heritage asset. Where possible it is proposed to refurbish any original doors with door closers and intumescent paint subject to building control approval.

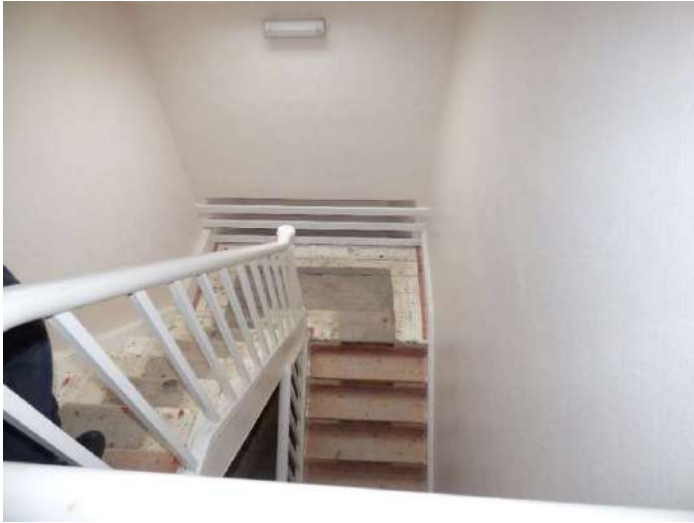
Handrail, balusters and rails are original and are to be retained.

Apply an insulated plasterboard 62mm thick to underside of sloping ceiling. The laminated plasterboard and PIR has a vapour barrier incorporated so interstitial moisture would be prevented, tape and skim and undertake full decorations.

Remove existing Velux and replace with heritage style rooflight (Velux or similar) with flashing kit that mounts unit flush with the roof surface.

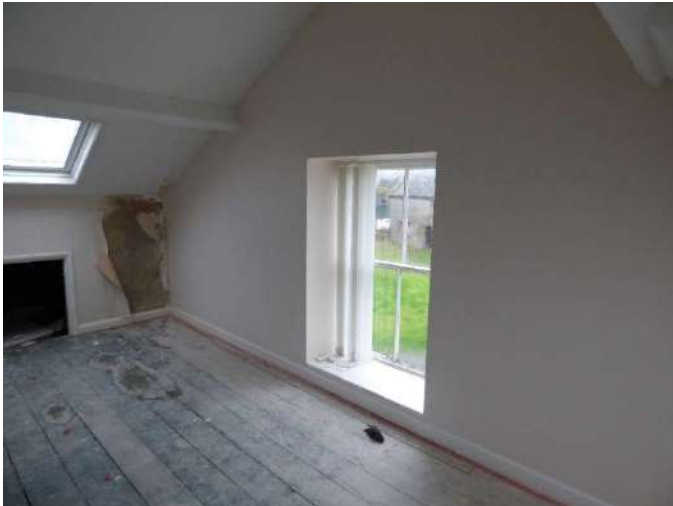
Floorboards are in good condition (but may require minor repairs).

Existing flush panel doors are not original and it is proposed for these to be removed and replaced with new heritage style four panel fire rated doors.

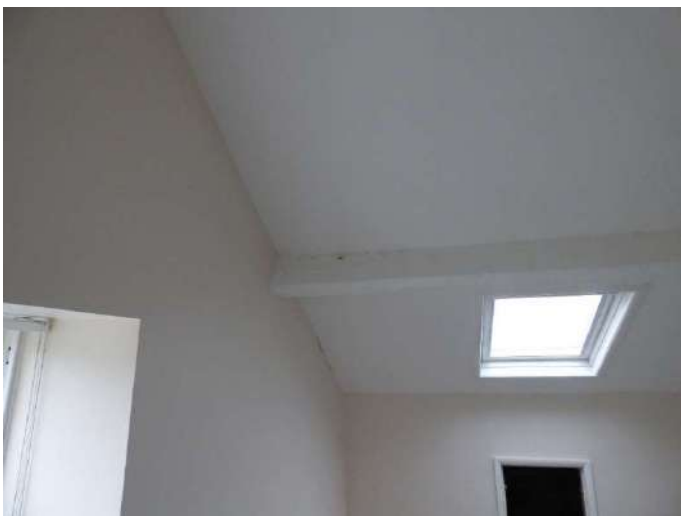
### Attic Bedroom

Floorboards are in good condition (but may require minor repairs).

Existing flush panel doors are not original and are to be removed and replaced with new heritage style four panel fire rated doors.

Remove all damp and damaged / blown plasterwork and repair with lime plaster and skim and decorate throughout.

Apply an insulated plasterboard 62mm thick to underside of ceiling tape and skim, and undertake full decorations. The laminated plasterboard and PIR has a vapour barrier incorporated so interstitial moisture would be prevented. New rooflights to be installed with flashing kit that mounts unit flush with the roof surface.

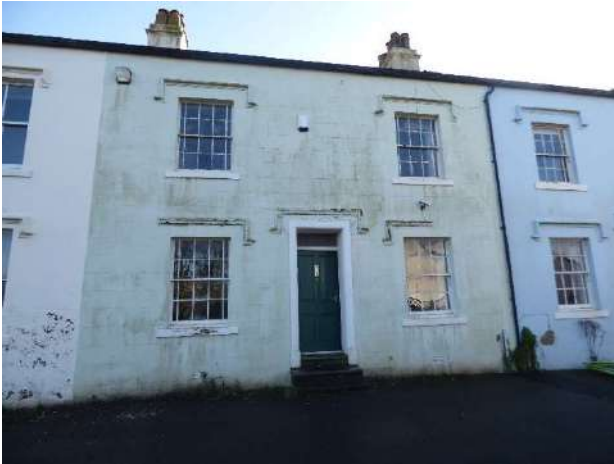
Left: The main entrance is mentioned in the listing text and is to be entirely retained.

Both front and rear elevations are currently rendered, with colour to the front and side and natural to the rear. All elevations require to be prepared for render repairs and redecoration by specialist using lime render and stucco (Parax LTD) to be applied by specialist.

The existing door and frame are to be retained and made good with the provision of new ironmongery. Once repaired full decoration will be undertaken.

Existing gutters and downpipes to be retained, repaired where necessary and decorated.

All existing single glazed windows to either be repaired / replaced (subject to planning condition).

The existing stone steps to be cleaned up, and new painted metal handrails provided, that would have originally been installed.

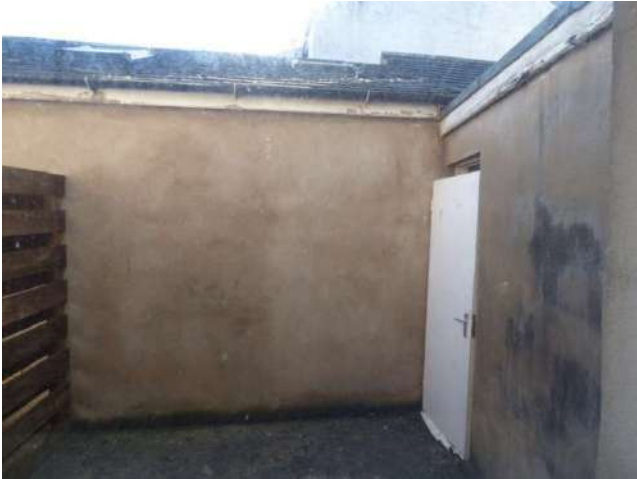
The rear courtyard is divided by a single storey 'link' building to an outbuilding at the rear. It is proposed to demolish both these structures. The link building is in extremely poor condition, and also to demolish the existing rear building, as they were a later mid-century addition to the property and the intention is to restore the rear garden to its original state to provide additional amenity space for the property and allow more light into the existing dwelling.

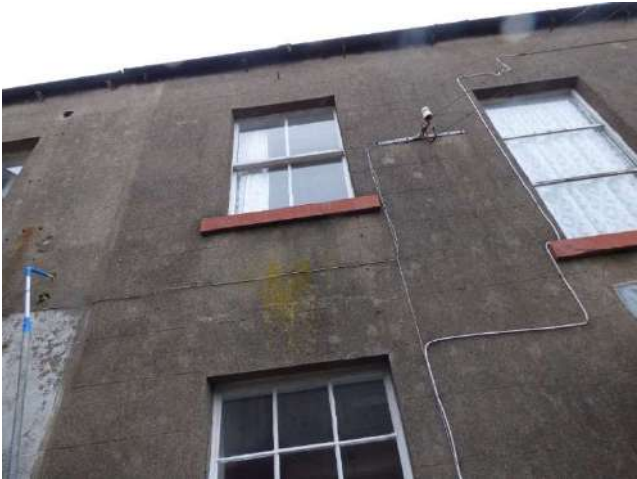
All existing single glazed windows to either be repaired / replaced (subject to planning condition).

Existing cills to be repaired and decorated.

Existing roof windows to be replaced with Velux conservation rooflights (or rooflight company, heritage rooflights)

New heritage rooflight windows (Velux or similar) with flashing kit that mounts unit flush with the roof surface.

Localised lead repair work required to chimneys, to prevent leaking.

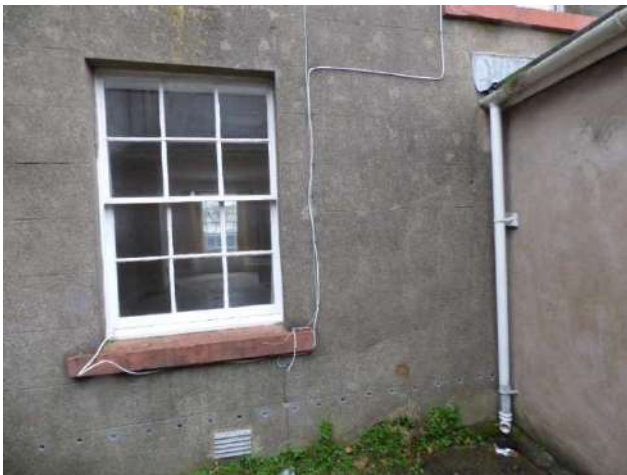
Left: The ground floor window to the kitchen is not original and requires replacement. The proposal is to remove the existing modern window and reinstate the original Georgian style of window, in the original opening (which has been walled up), with a double-glazed slimline heritage painted timber sash – albeit this will be subject to planning condition to reflect what would have been originally installed.

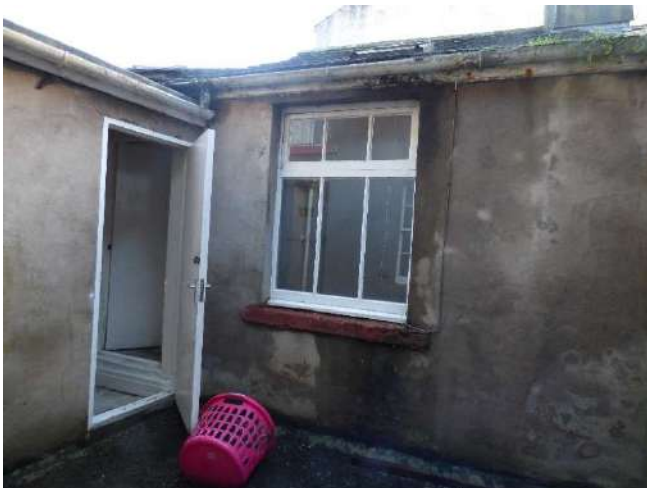
Poorly constructed 'link' building and out-building to be removed to return the original building back to its former configuration.

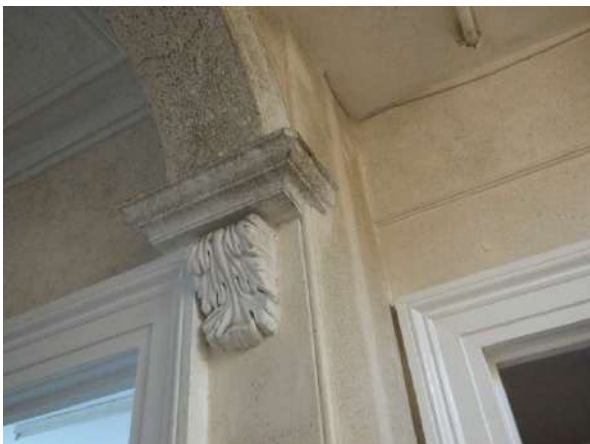
Left: period features to be retained, including archway and architraves. (Modern lighting to all be stripped out and make good surfaces). All architraves and plaster features to be retained.

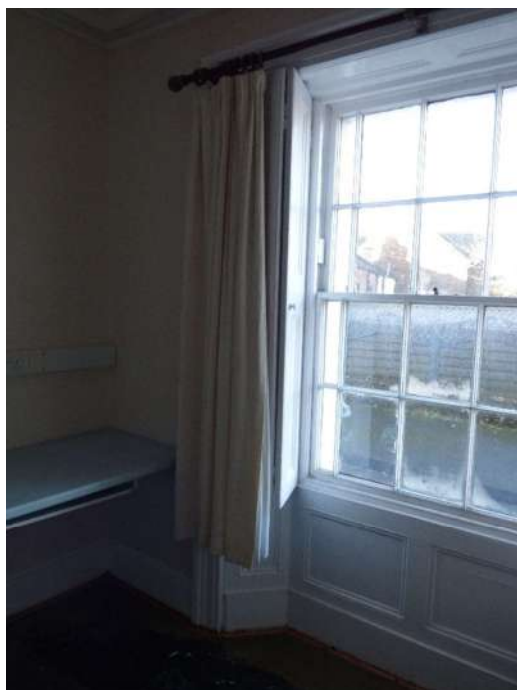
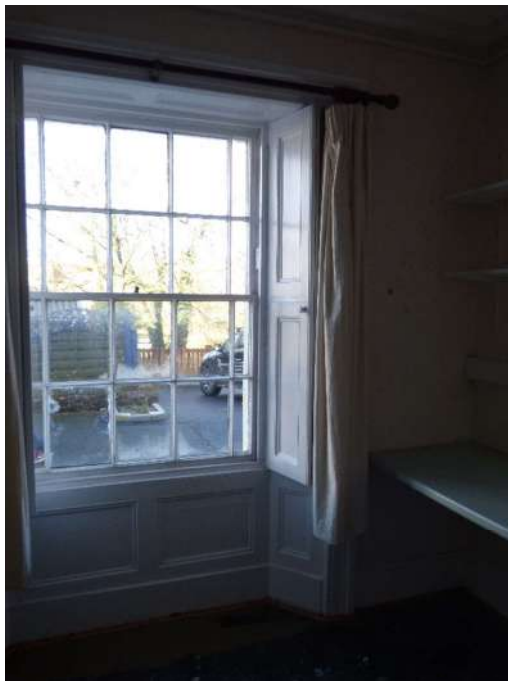
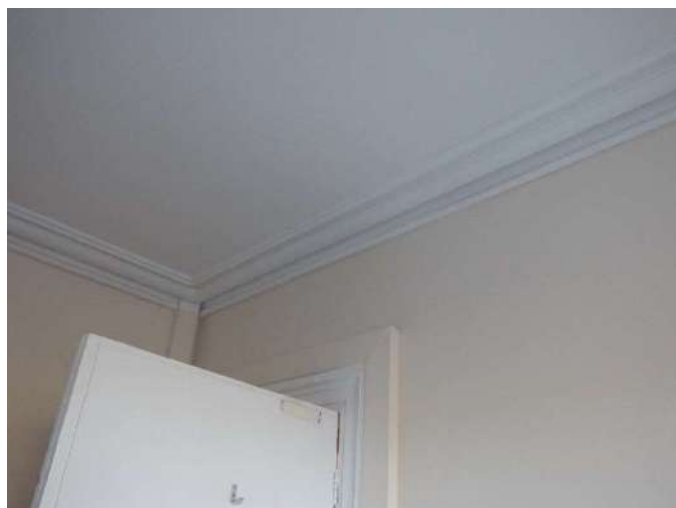
Above: In the existing study, the period features below and to the sides of the existing window are in good condition, it is proposed to carefully refurbish the existing timber shutters.

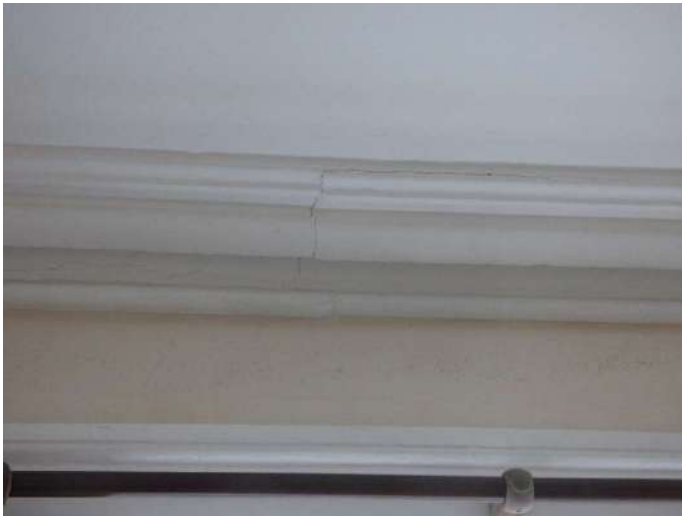
Left: Existing cornice to be made good in locations where redundant services are to be removed and where hairline cracks have appeared.

Existing architraves, and skirtings to be retained and made good.

Flush panel doors to be replaced with heritage style four panel painted timber fire doors to enhance the heritage asset.

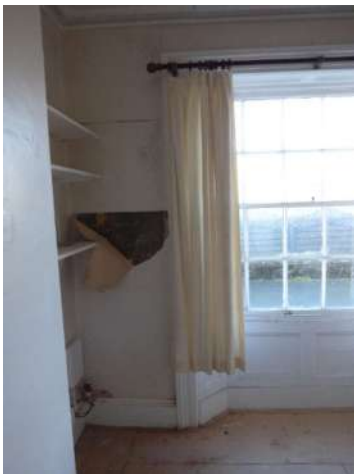
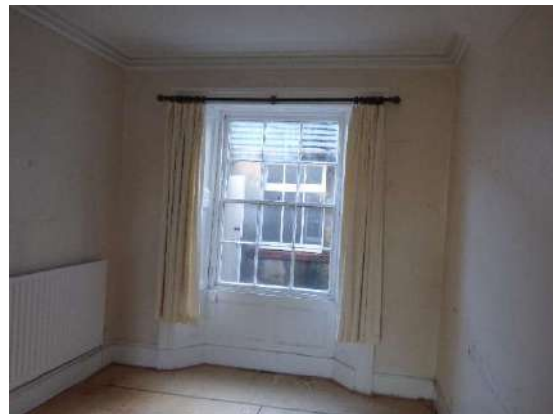
Above: In the existing lounge at the front of the property and

Left and below: the existing dining area to the rear of the property, the period features below and to the sides of the existing window are in good condition, it is proposed to carefully refurbish the existing timber shutters.

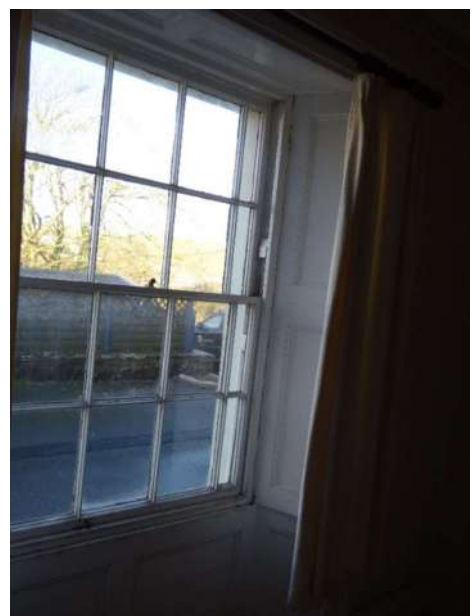
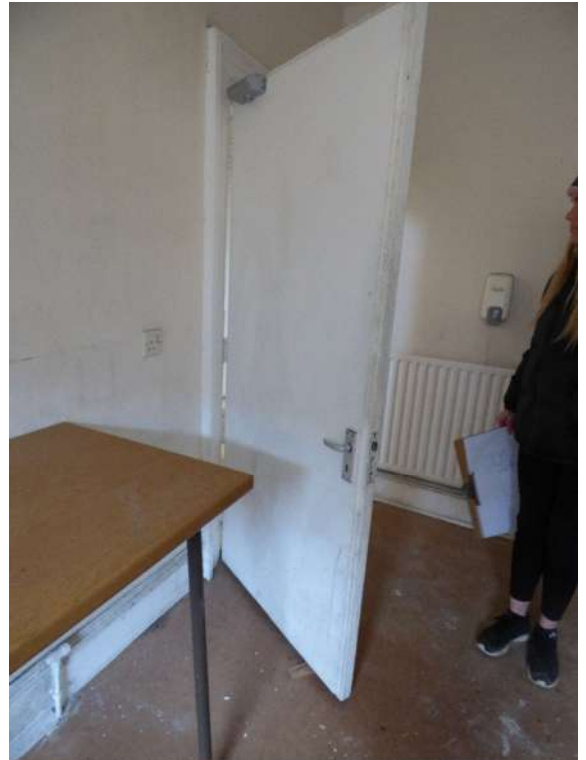
Existing modern single glazed window to be replaced by new double glazed heritage sash hardwood painted timber window, in the style of the original window subject to planning condition. The existing opening is to be adjusted to return the window opening to its original size.

Flush panel doors to be replaced with heritage style four panel painted timber fire doors to enhance the heritage asset. Where possible it is proposed to refurbish any original doors with door closers and intumescent paint subject to building control approval.

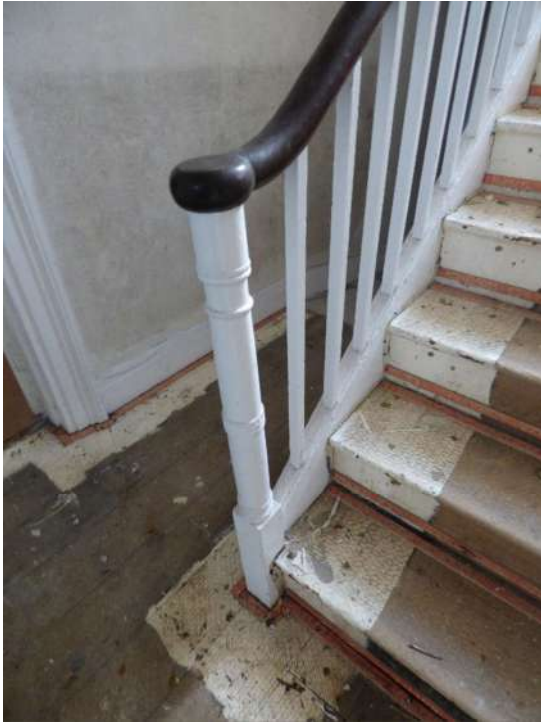
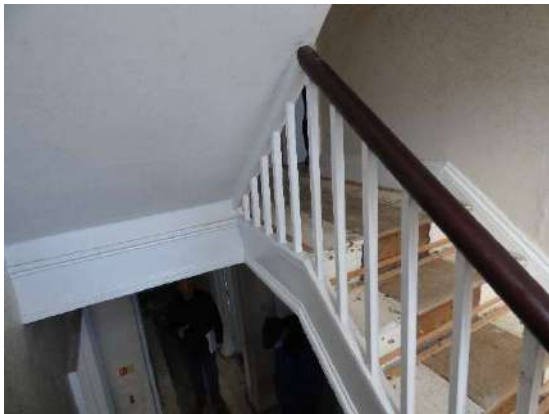
Left: Retain original staircase, which is in good condition. One missing baluster between first and second floor staircase to be provided with new baluster to match existing.

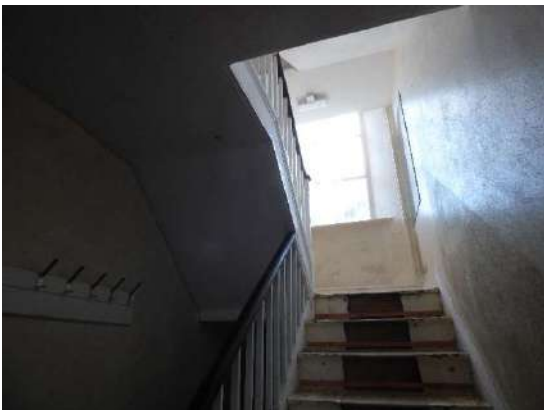
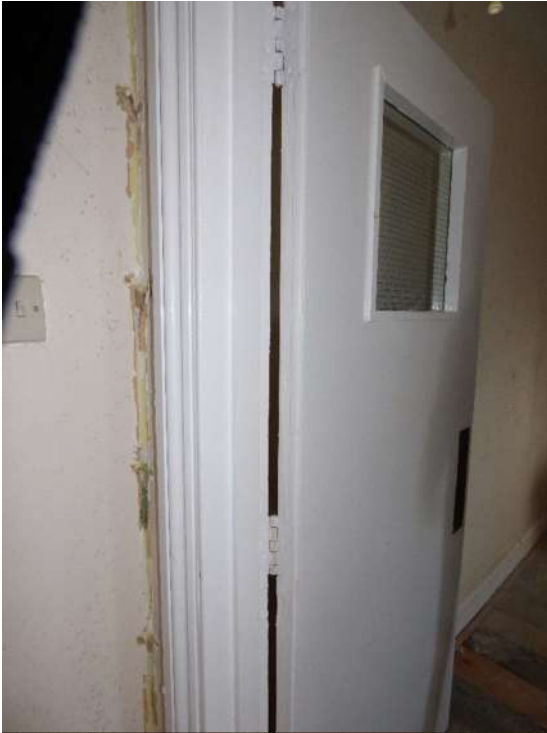
Left and Below: Existing bathroom, all to be completely renovated. All existing FF&E and M&E to be removed and all surface finishes to be completely removed and walls made good.

New Georgian heritage style 4 panel door to be provided to replace modern internal door, and installed by specialist joinery company such as Batty Joinery Ltd. All fabric damage to be carefully repaired. New four panelled heritage door to be provided and installed.

Bathroom to be reduced in size to accommodate new en-suite to master bedroom.

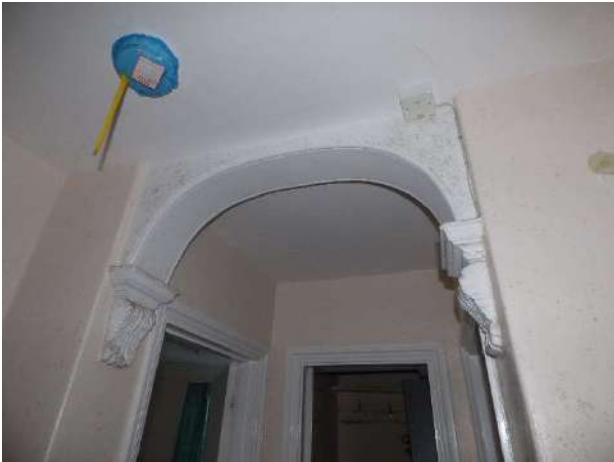
First floor landing area:  
Period features to be retained.

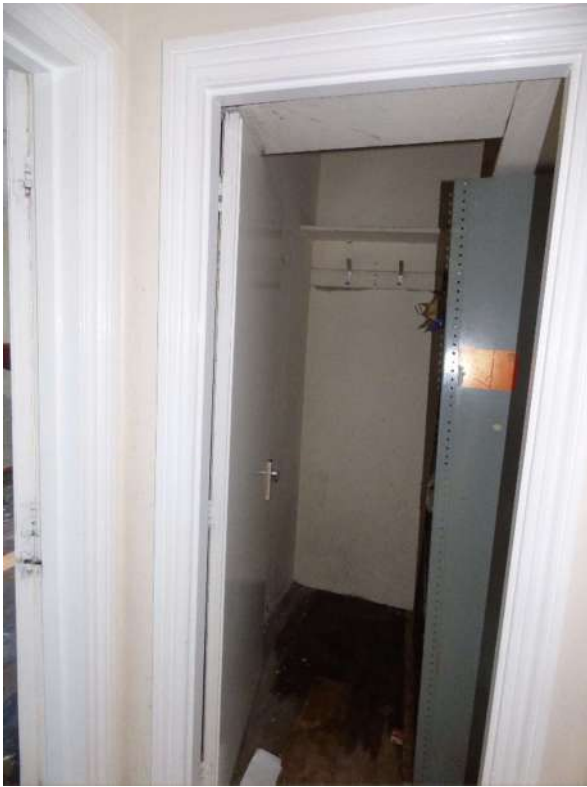
All architraves, to be retained. New Georgian four panel doors to be provided in lieu of flush panel doors.

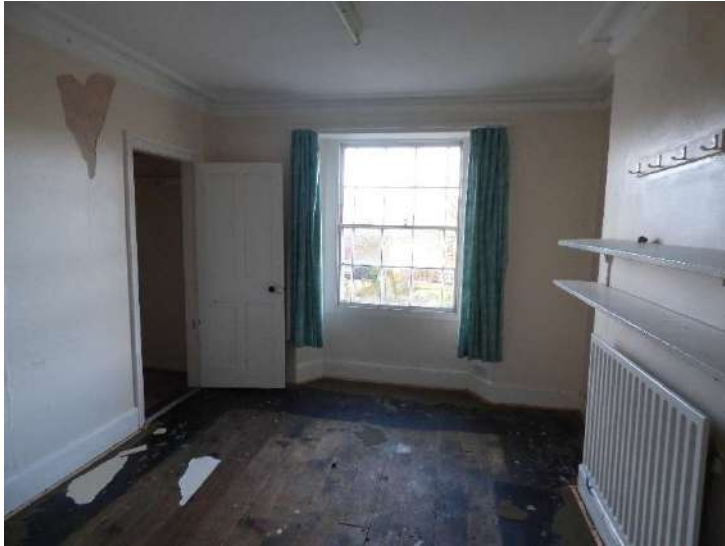
Front bedroom (First floor RHS), cornice, skirtings, and architraves to be retained. Existing flush panelled door to be replaced with new Georgian heritage style 4 panel fire door to be provided and installed by specialist joinery company such as Batty Joinery Ltd.

Existing floorboards in good condition.

It is proposed to form new doorway with architraves to match existing, and new four panelled door, into a new en-suite to be formed from part of the existing over large bathroom to make efficient use of the space and reflect the requirements of modern-day living.

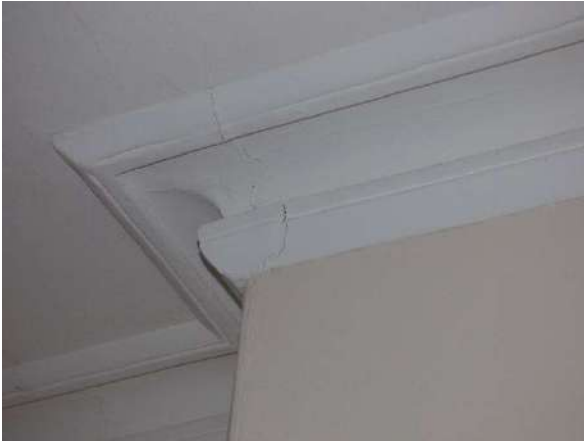
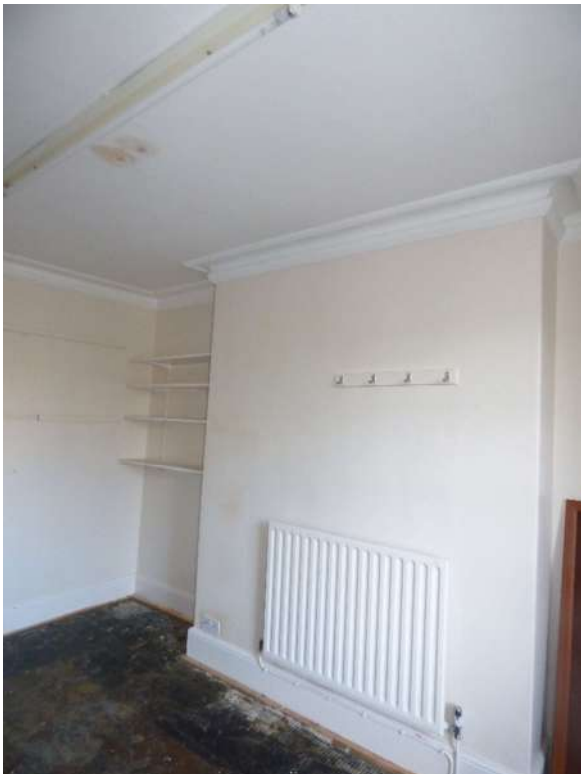
Front bedroom (First floor LHS), cornice, skirtings, and architraves to be retained. Existing flush panelled door to be replaced with new Georgian heritage style four panel fire door to be provided and installed by specialist joinery company such as Batty Joinery Ltd. Where possible it is proposed to refurbish any original doors with door closers and intumescent paint subject to building control approval.

Existing floorboards in good condition. Minor repairs may be necessary.

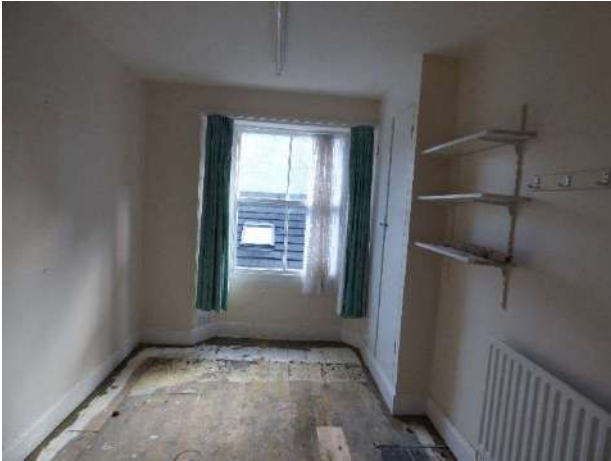
Rear bedroom existing skirtings and architraves to be retained. Existing modern flush panelled door to be replaced with new Georgian heritage style 4 panel door fire door to be provided and installed by specialist joinery company such as Batty Joinery Ltd.

Damp ingress has affected plasterwork by window. It is proposed to rake back existing blown plaster and repair with new lime plaster.

Existing floorboards in good condition. Minor repairs may be necessary.

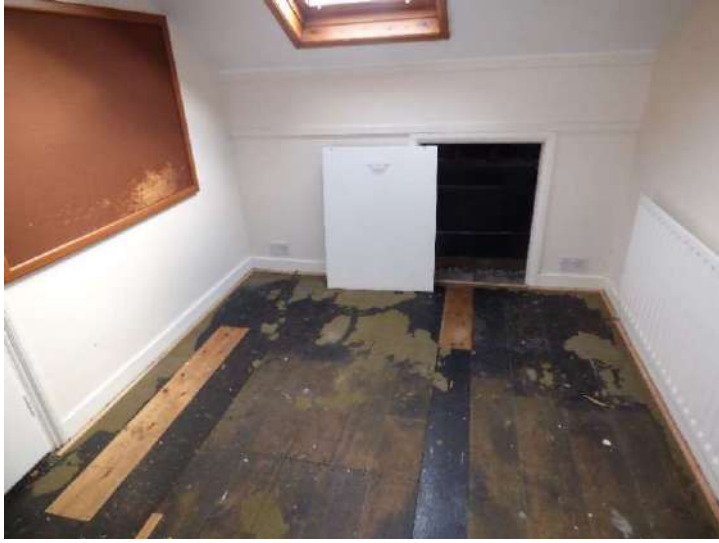
Left: Attic Bedroom

Floorboards are in good condition (but may require minor repairs).

New plasterboard stud partition to be installed in lieu of removal of part of existing store / bedroom partition (existing lath and plaster) to allow for bathroom to be useable size.

In the bedroom remove all damp and damaged / blown plasterwork and repair with lime plaster (Solo lime plaster from Lime Centre).and skim and decorate throughout.

Apply an insulated plasterboard 62mm thick to underside of ceiling. The Laminated plasterboard and PIR has a vapour barrier incorporated so interstitial moisture would be prevented. New rooflights to be installed with flashing kit that mounts unit flush with the roof surface.

Existing flush panel doors are to be removed and replaced with new heritage style 4 panel fire doors.

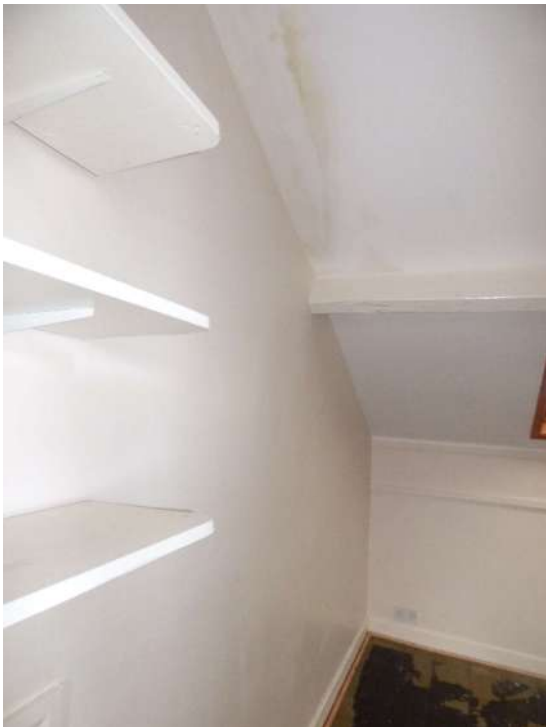
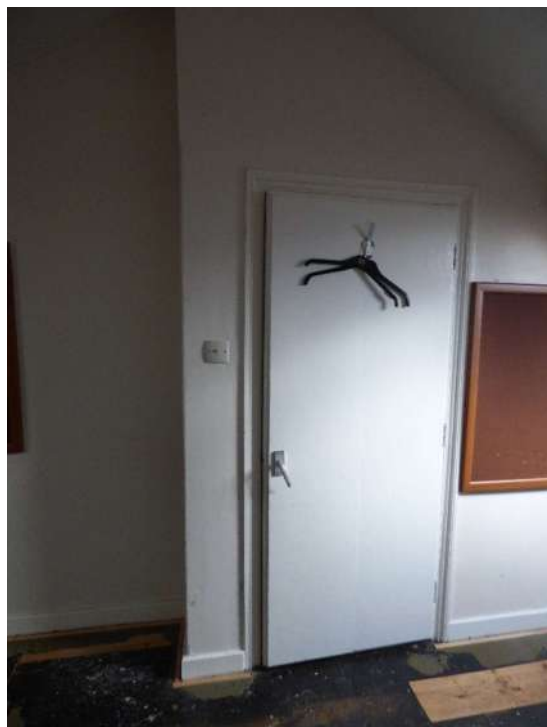
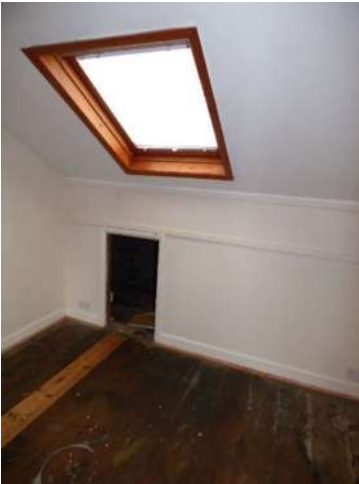
Above and below: Attic Bedroom

Floorboards are in good condition (but may require minor repairs).

New plasterboard stud partition to be installed in lieu of removal of part of existing store / bedroom partition to allow for bathroom to be useable size.

In the bedroom remove all damp and damaged / blown plasterwork and repair with lime plaster (Solo lime plaster) and skim and decorate throughout.

Apply an insulated plasterboard 62mm thick to underside of ceiling tape and skim. The laminated plasterboard and PIR has a vapour barrier incorporated so interstitial moisture would be prevented and undertake full decorations. New heritage style rooflights to be installed replacing the existing modern velux rooflights with flashing kit that mounts unit flush with the roof surface.

Existing flush panel doors are to be removed and replaced with new heritage style 4 panel fire doors.

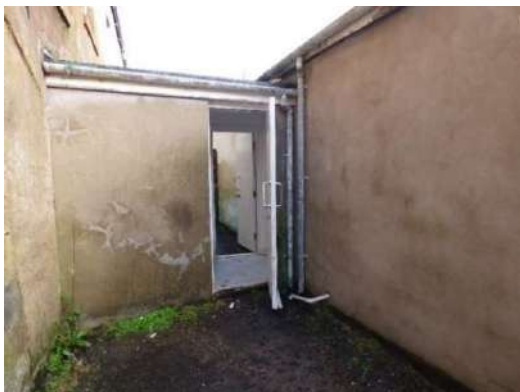
Localised lead repair work may be required to chimneys, to prevent damp ingress.

Rear of property, – render to be repaired by specialist and decorated with off white colour.

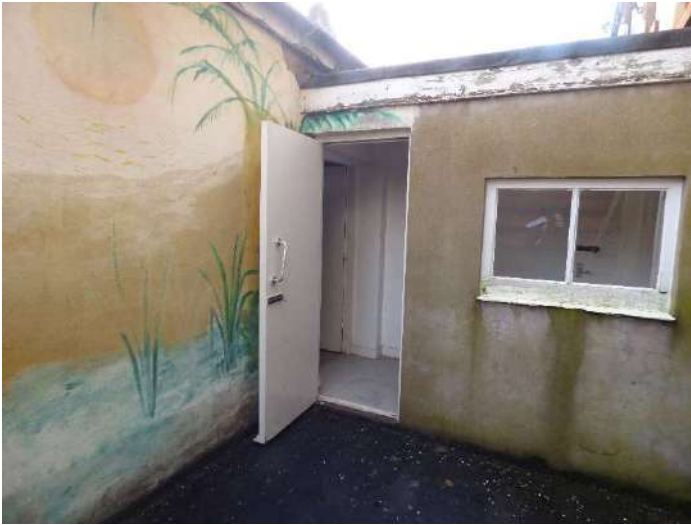
It is proposed to demolish the existing link and rear building, as they were a later mid-century addition to the property and are not good quality construction, so it is the intention is to restore the rear garden to its original state to allow for additional recreation space for the property.

Existing link building to be completely removed and the existing house to be made good. New door to rear to be Georgian style as front door as although the estimate for the date of the buildings is mid-19<sup>th</sup> Century, which would be some years after the end of the Georgian period, even if the counting the Regency, but reflect the style none the less.

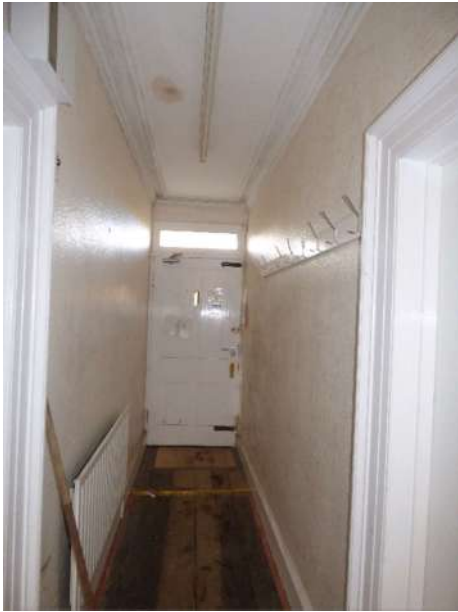
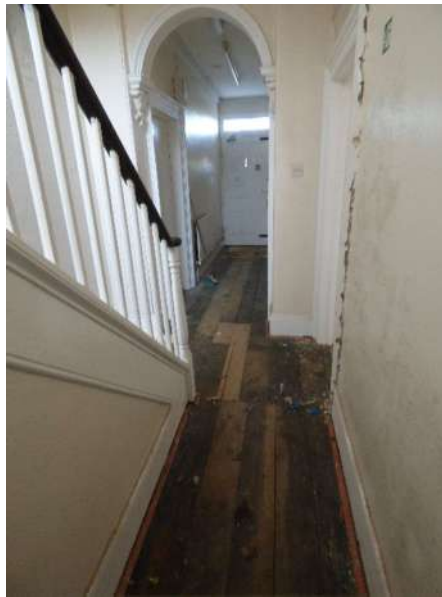
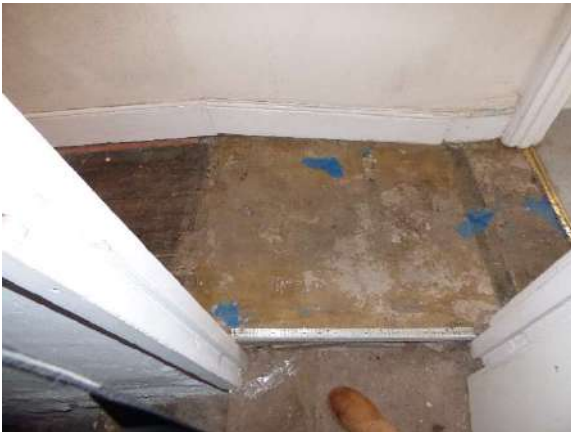
Left: The existing walls and floors are generally in good condition.

Redundant M&E to be removed and wall / ceiling finishes made good, and primed, prepared, and fully decorated.

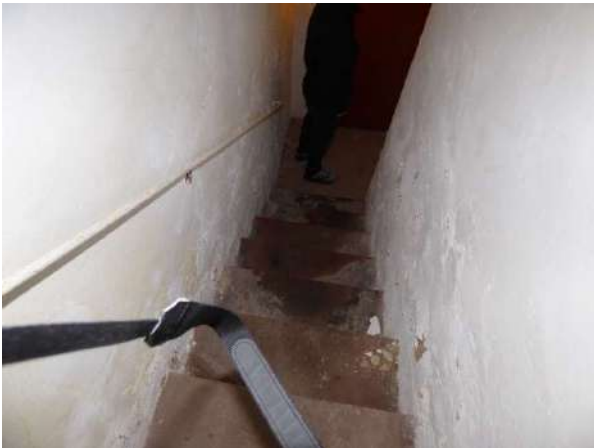
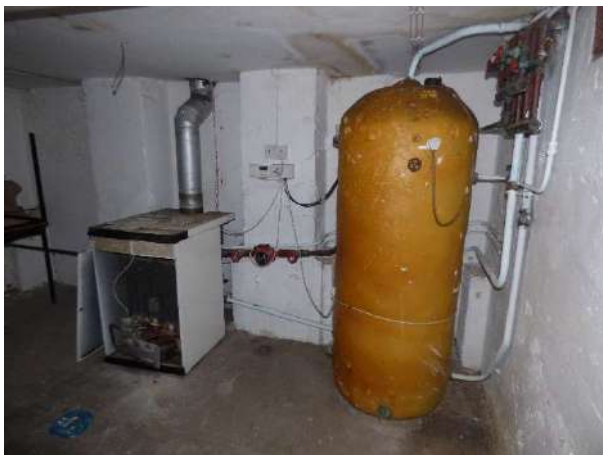
The existing walls and floor are generally in sound condition so would be suitable for the application of damp proof slurry system. All existing paint and surface finishes must be removed and made good including all snots removed, and damage to existing surfaces, prior to the installation of a Koster Polysil NB1. This migratory crystalline tanking slurry is used to seal below ground structures against water ingress.

Koster NB1 is considered to be a Type A waterproofing system as defined by BS8102:2009 and is generally used to seal the inside face of basement structures, slabs and retaining walls.

Koster NB1 works by both providing a physical barrier against water ingress as well as providing a migratory crystal sealant that penetrates deep into the structure to seal micropores and cracks against water ingress.

Once applied then the walls can be prepared and primed for decorating and for the floor finish to be installed. Complete new boiler and heating system is required, new distribution boards etc.

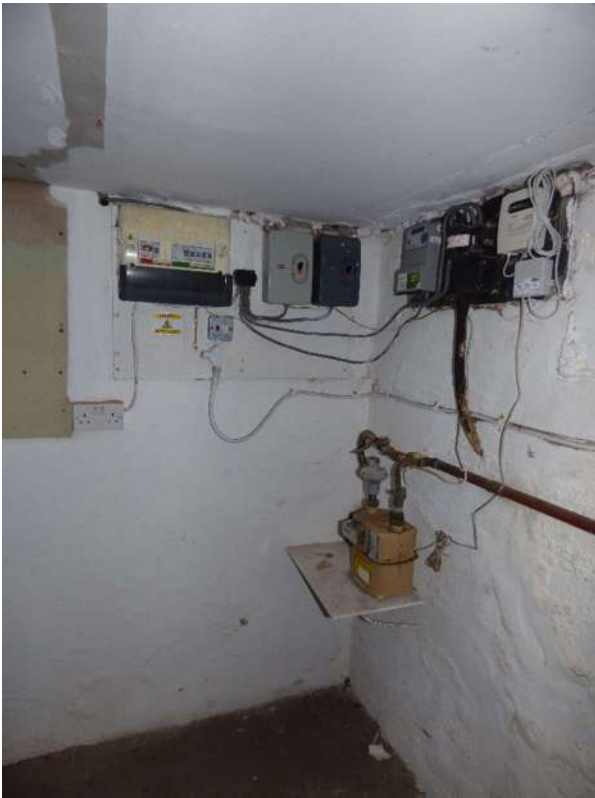
The walls down to the basement also require the full treatment.

In the basement all existing services are to be carefully stripped out and replaced with new compliant infrastructure.

Existing window to basement requires to either be repaired / replaced (subject to planning condition), and reveals made good.

All existing services to be carefully removed and new gas and electric services installed.

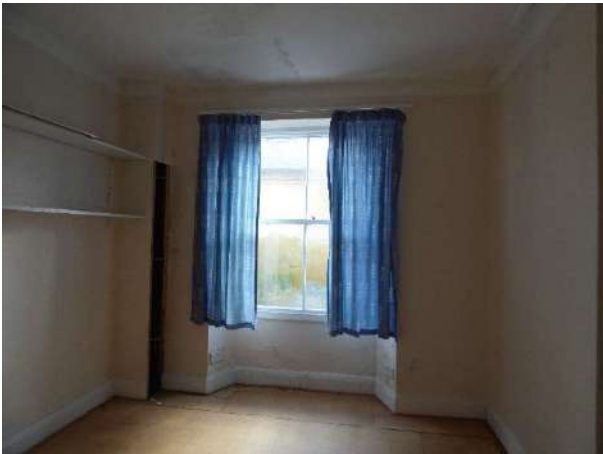
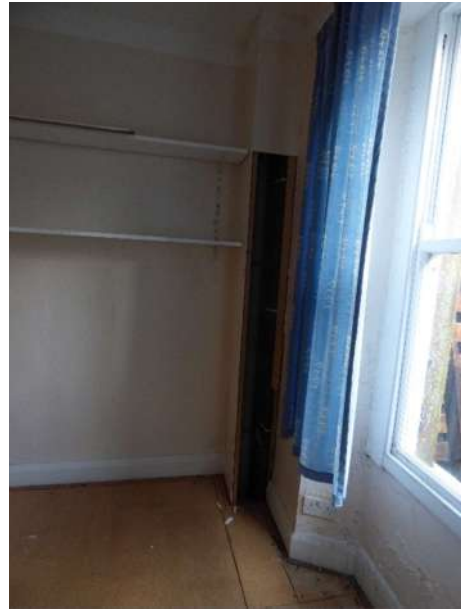
In the existing study, the period features below and to the sides of the existing window are in good condition, it is proposed to carefully refurbish the existing timber shutters.

Left: Existing cornice to be made good in locations where redundant services are to be removed and where hairline cracks have appeared.

Existing architraves, and skirtings to be retained and made good.

Flush panel doors to be replaced with heritage style 4 panel painted timber fire doors to enhance the heritage asset.

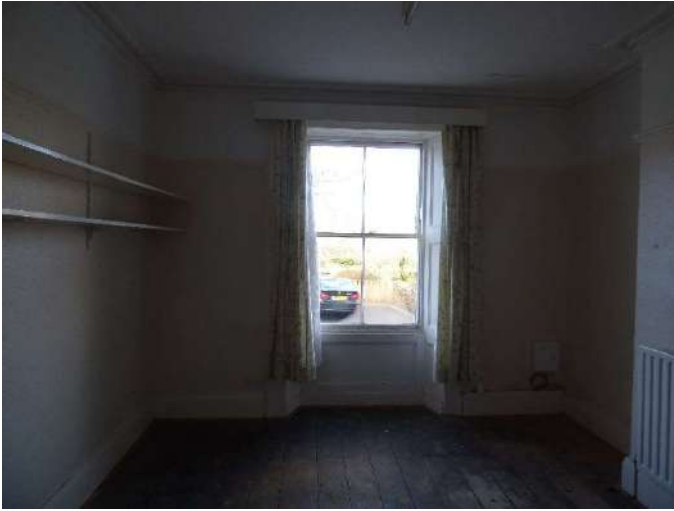
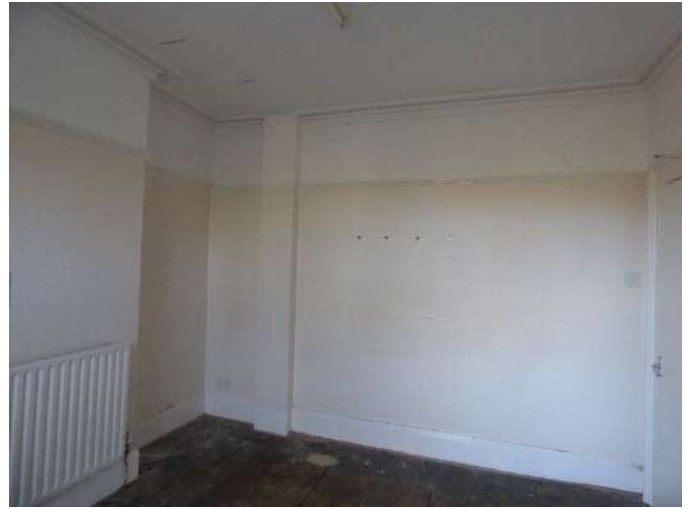
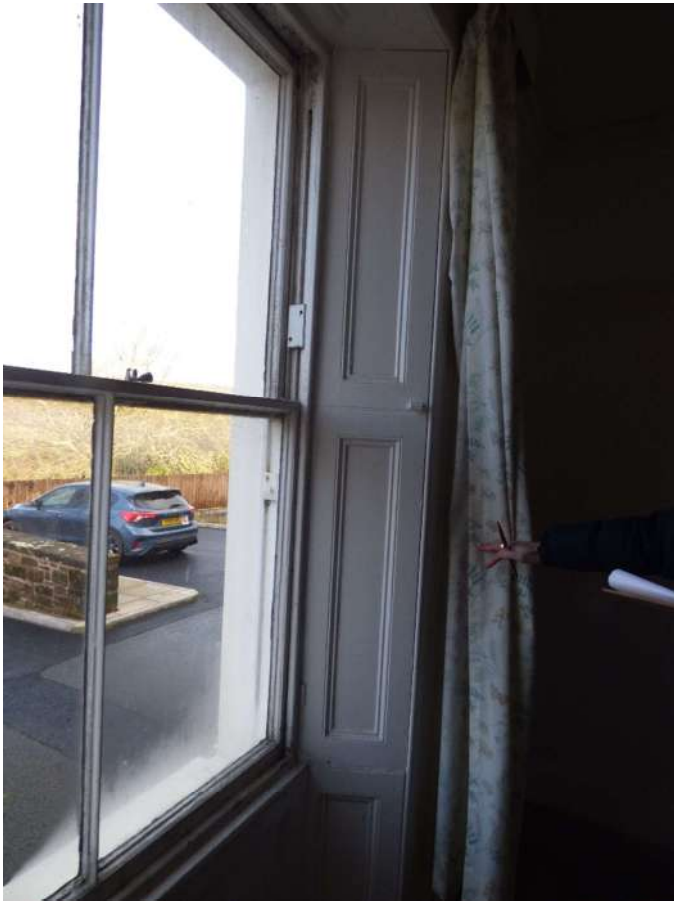
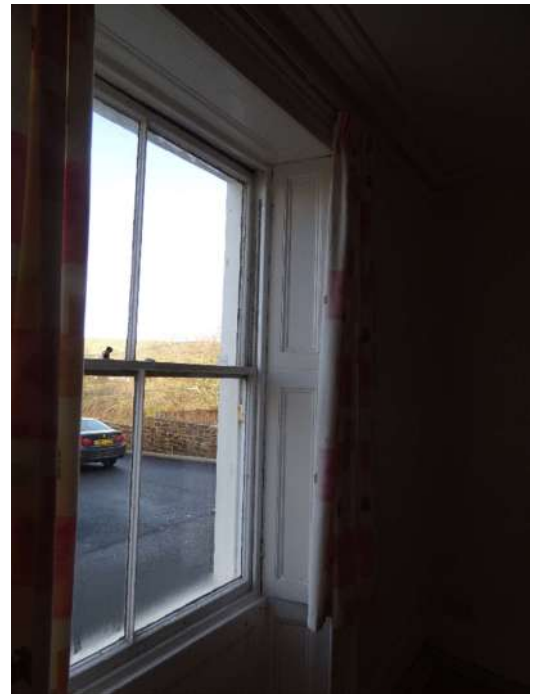
Right and below: The existing dining area to the rear of the property, the period features below and to the sides of the existing window are in good condition, it is proposed to carefully refurbish the existing timber shutters.

Below: Existing cornice to be made good in locations and where hairline cracks have appeared.

Flush panel fire door to be replaced with heritage style four panelled fire doors to enhance the heritage asset.
