# HERITAGE STATEMENT

## FULL RENOVATION OF EXISTING No 11 TERRACE HOUSES

St Bees, 1-11 Lonsdale Terrace, Parish Council, Cumbria

M.A.C Architects, Project Number: 2019:303

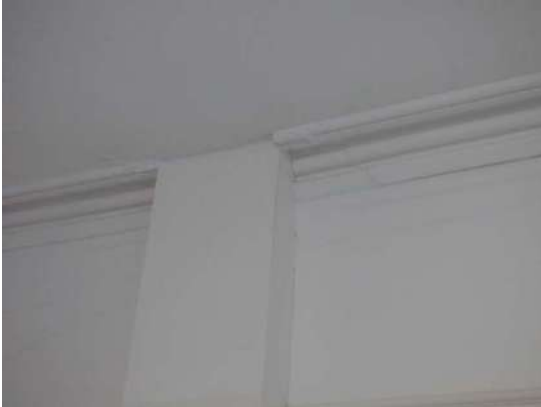
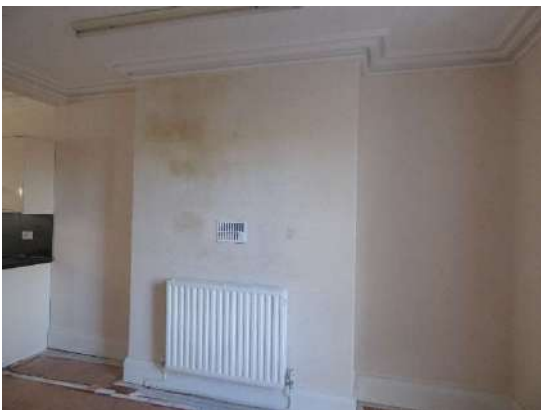
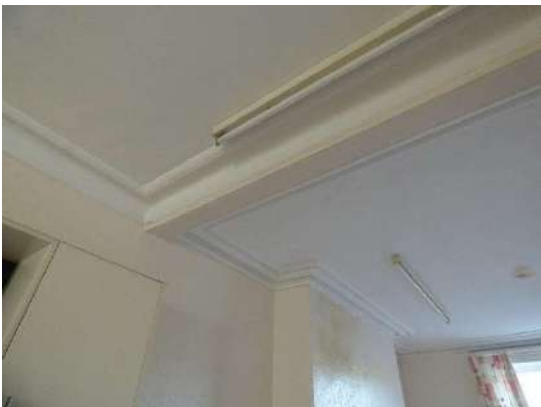
Above, Right, and below: In the existing lounge, the period features below and to the sides of the existing windows both front and back are in good condition, it is proposed to carefully refurbish the existing timber shutters.

Existing cornice to be made good in locations where redundant services are to be removed and where hairline cracks have appeared.

Existing architraves, and skirtings to be retained and made good.

Flush panel doors to be replaced with heritage style four panel painted timber fire doors to enhance the heritage asset.

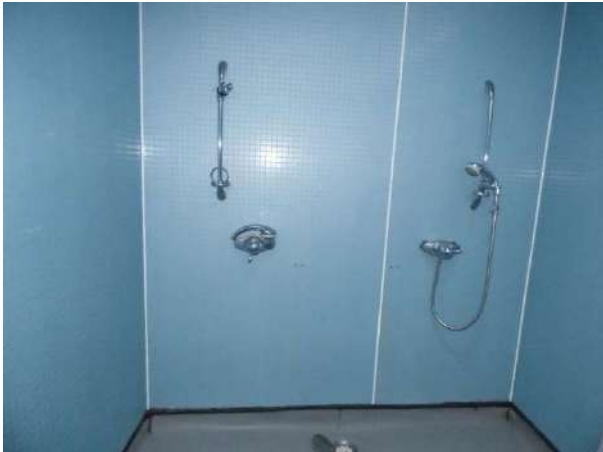
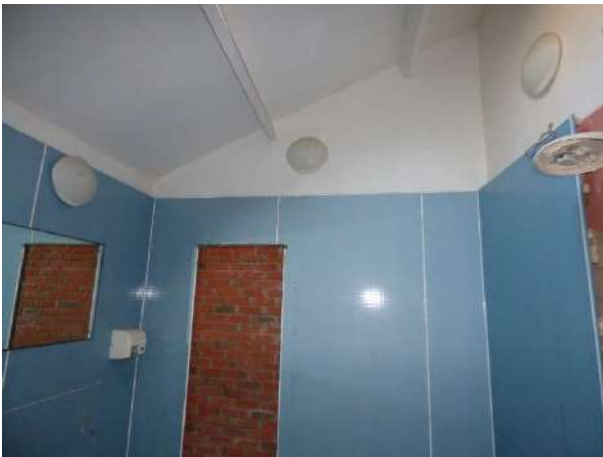
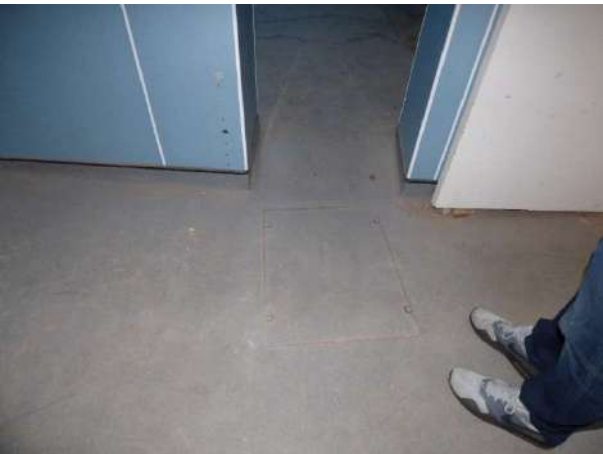
Left: The existing outbuilding is reached by a small, dilapidated corridor. It is proposed to remove this building and the link corridor in their entirety.

The existing outbuilding and link building were constructed mid-20<sup>th</sup> century to provide washroom facilities for the boarding school, however they are not good quality and conversion would be extremely difficult, so it is proposed to remove these and revert the former back garden to its former state allowing for more amenity space externally.

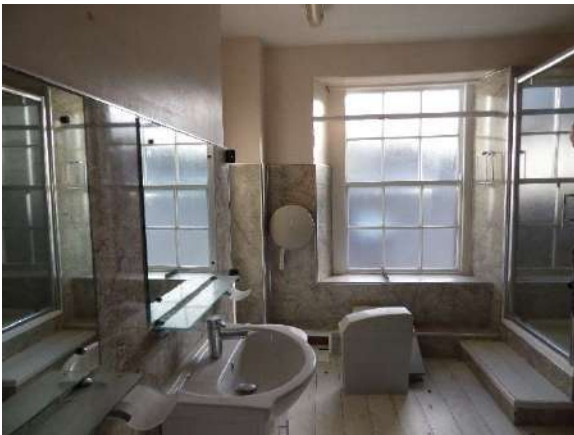
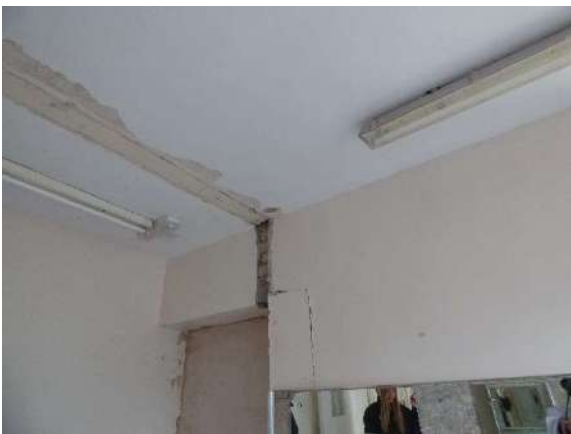
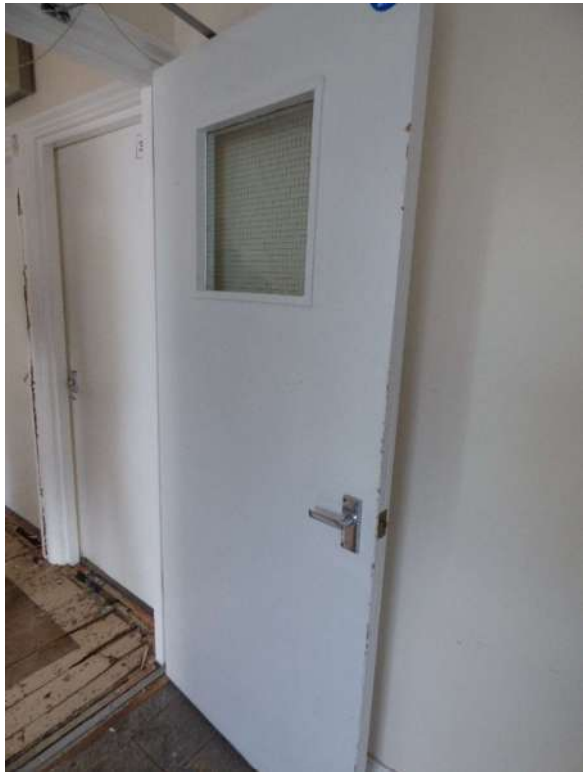
Left: Existing bathroom to be reduced in size to allow for new en-suite to master which backs on to the bathroom. This allows for a decent sized family bathroom and a new en-suite providing accommodation suitable for modern day living.

Existing ceiling to be made good and provide and install new extract fan linked back to light switch.

Existing single glazed windows to either be repaired / replaced (subject to planning condition).

New bathroom door to be new four panelled heritage style door - bathroom door does not need to be a fire rated door.

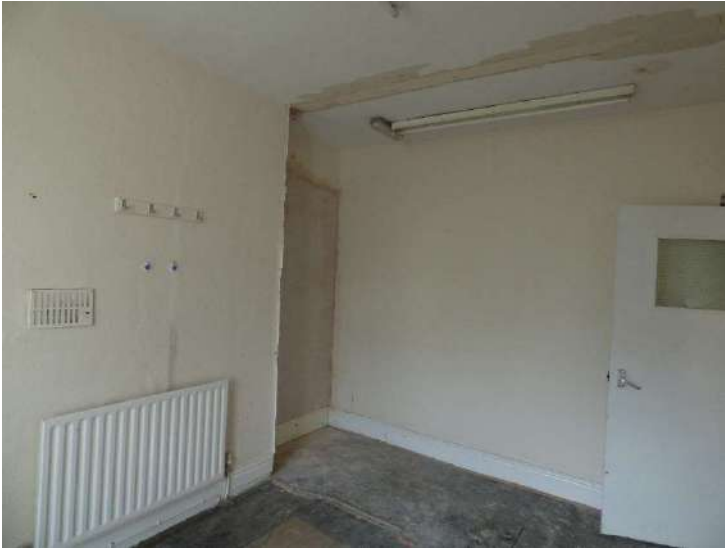
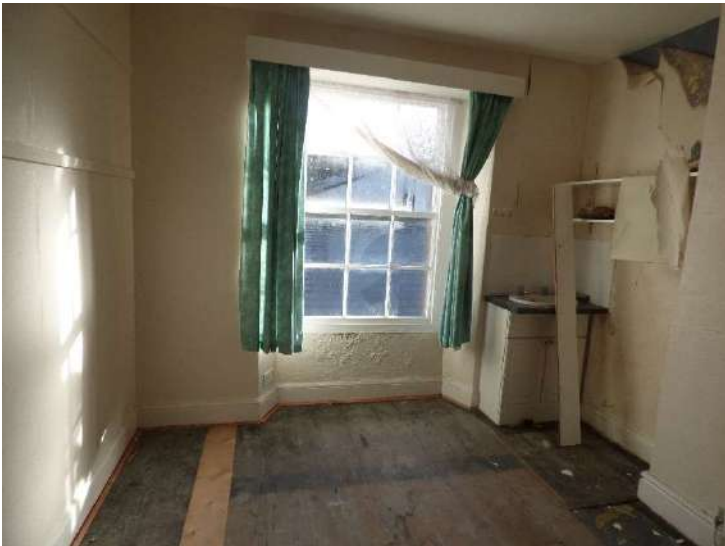
Rear bedroom skirtings and architraves to be retained. Existing flush panelled door to be replaced with new Georgian heritage style 4 panel door to be provided and installed by specialist joinery company such as Batty Joinery Ltd.

Existing floorboards generally in good condition.

Damp and associated blown plaster below window and to window reveals to be repaired with lime plaster. All existing single glazed windows to either be repaired / replaced (subject to planning condition).

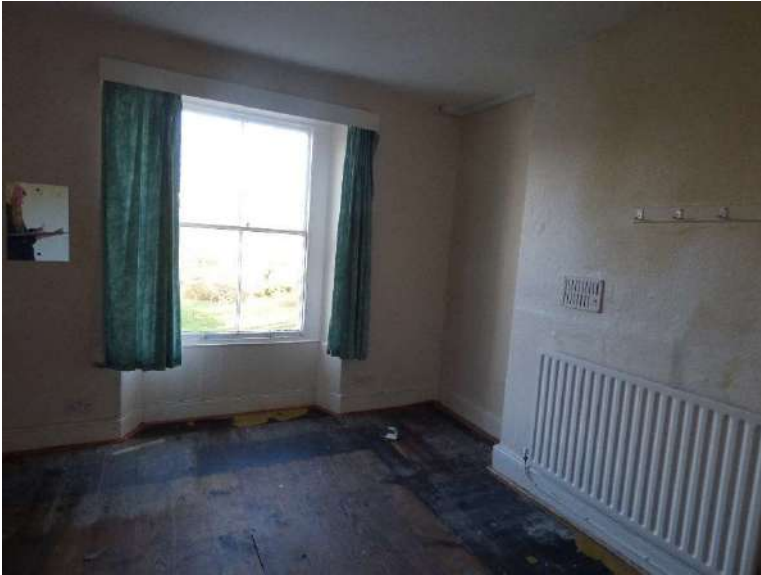
Front bedroom (First floor RHS), skirtings and architraves to be retained. Existing flush panelled door to be replaced with new Georgian heritage style 4 panel door to be provided and installed by specialist joinery company such as Batty Joinery Ltd. Where possible it is proposed to refurbish any original doors with door closers and intumescent paint subject to building control approval.

Existing floorboards in good condition.

It is proposed to form new doorway with architraves to match existing, and new four panelled door, into a new en-suite to be formed from part of the existing over large bathroom to make efficient use of the space and reflect the requirements of modern-day living.

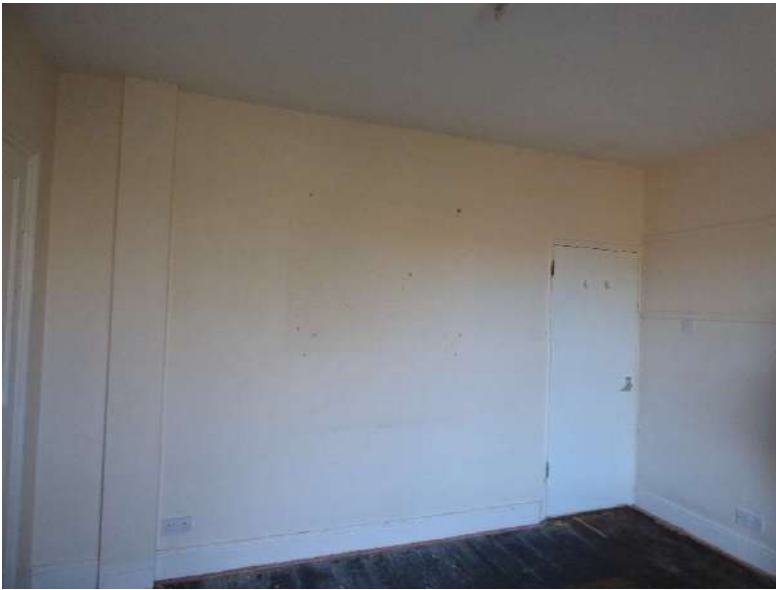
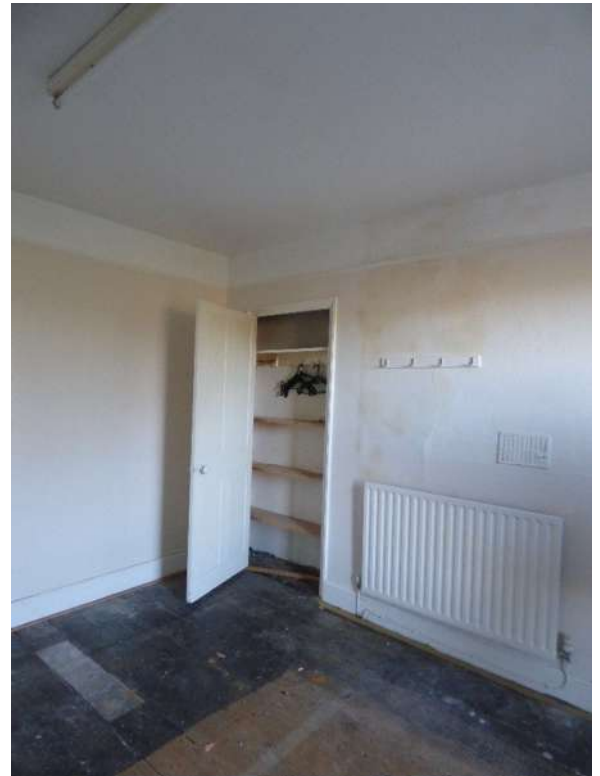
Front bedroom (First floor LHS), cornice, skirtings and architraves to be retained. Existing flush panelled door to be replaced with new Georgian heritage style 4 panel door to be provided and installed by specialist joinery company such as Batty Joinery Ltd.

Existing floorboards generally in good condition.

Where possible it is proposed to refurbish any original doors with door closers and intumescent paint subject to building control approval.

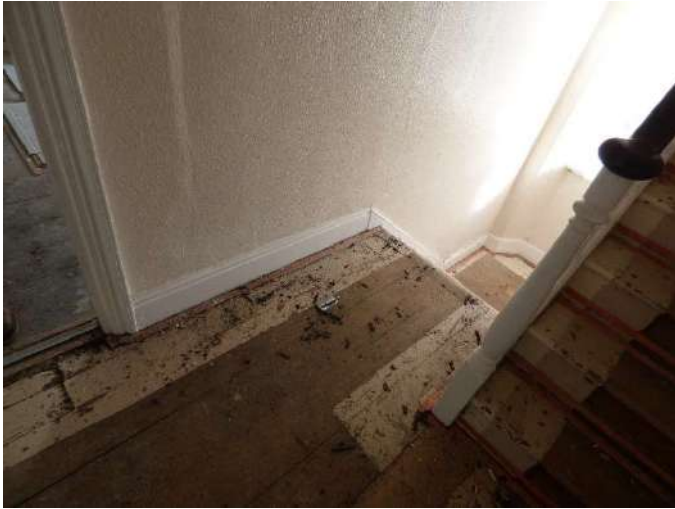
Handrail, balusters, and rails are original and are to be retained.

Apply an insulated plasterboard 62mm thick to underside of ceiling. The Laminated plasterboard and PIR has a vapour barrier incorporated so interstitial moisture would be prevented.

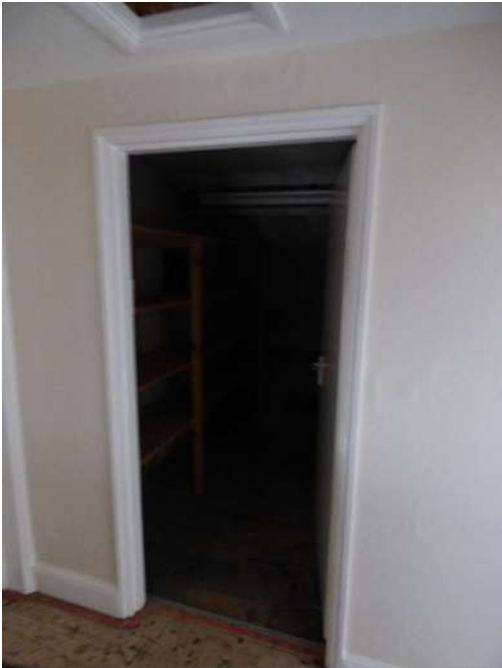
Left: Attic Store is proposed to be converted into a bathroom to be shared by the attic bedrooms by increasing the size of the room to each side to allow for the new bathroom.

Left and below: Attic Bedroom.

In the bedroom remove all damp and damaged / blown plasterwork and repair with lime plaster and skim and decorate throughout.

New plasterboard std partition to be installed in lieu of removal of part of existing store / bedroom partition to allow for bathroom to be useable size.

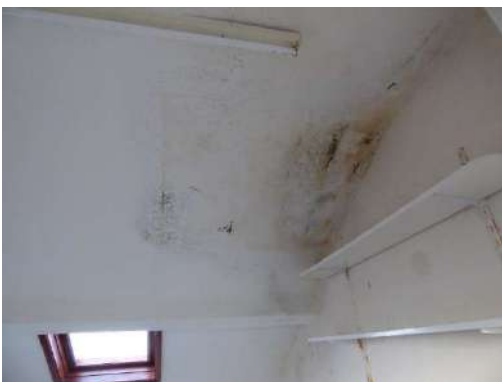
Floorboards are in good condition (but may require minor repairs).

Apply an insulated plasterboard 62mm thick to underside of ceiling tape and skim and undertake full decorations. New rooflights to be installed.

Replace modern Velux rooflight with new heritage rooflight windows (Velux or similar).

Existing modern flush panel doors are to be removed and replaced with new heritage style 4 panel doors.

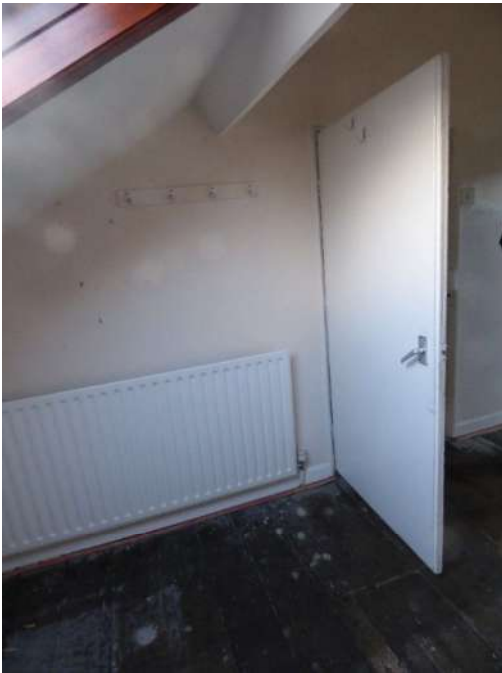
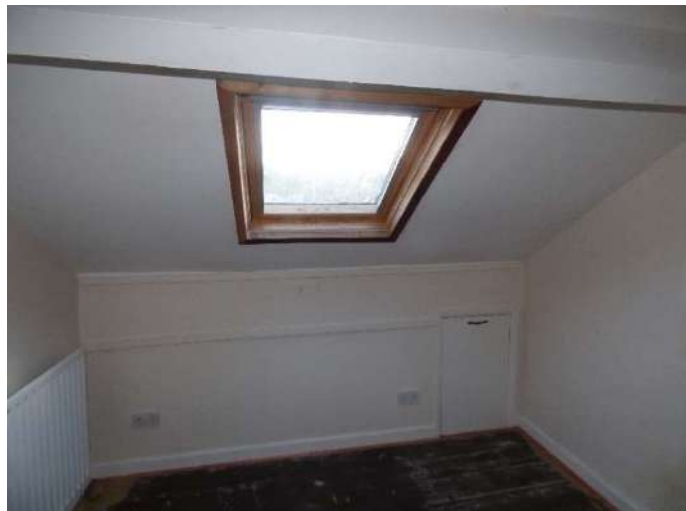
Left and below: Attic Bedroom.

In the bedroom remove all damp and damaged / blown plasterwork and repair with lime plaster (Solo lime plaster from Lime Centre) and skim and decorate throughout.

Floorboards are generally in good condition (but may require minor repairs).

New plasterboard stud partition to be installed in lieu of removal of part of existing store / bedroom partition to allow for bathroom to be useable size.

Apply an insulated plasterboard 62mm thick to underside of ceiling tape and skim and undertake full decorations. Replace existing rooflights to with new heritage style rooflights (Velux or similar).

Existing modern flush panel doors are to be removed and replaced with new heritage style 4 panel fire doors.

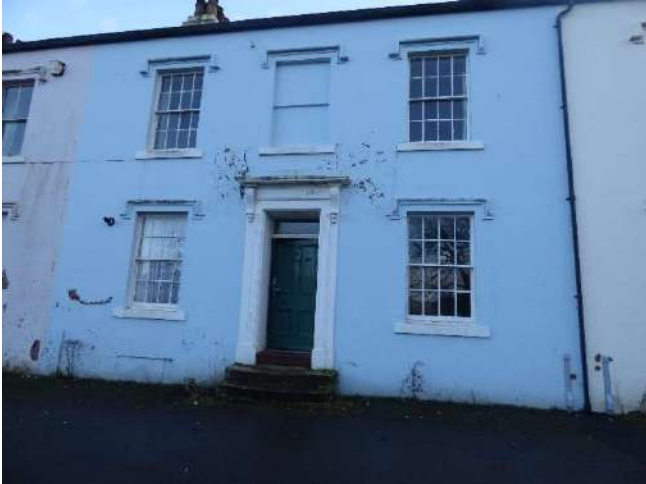
Left: The main entrance is mentioned in the listing text and is to be entirely retained.

Both front and rear elevations are currently rendered, with colour to the front and side and natural to the rear. All elevations require to be prepared for render repairs and redecoration by specialist using lime render and stucco (Parax LTD) to be applied by specialist.

The existing door and frame are to be retained and made good with the provision of new ironmongery. Once repaired full decoration will be undertaken.

Existing gutters and downpipes to be retained, repaired where necessary and decorated.

All existing single glazed windows to either be repaired / replaced (subject to planning condition).

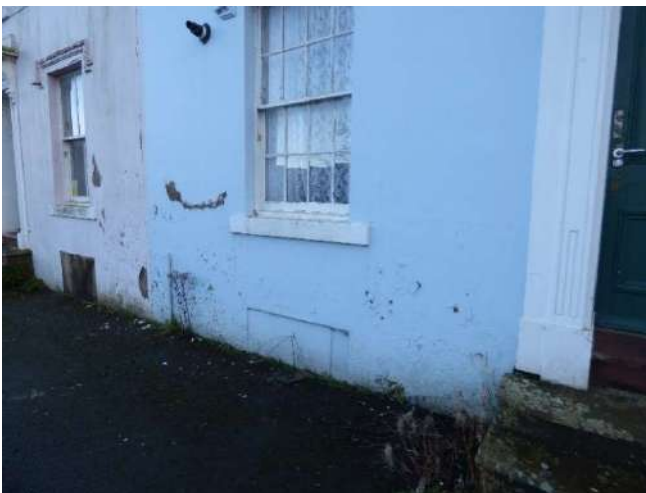
The stucco features above the windows and door on the front elevation will be carefully restored by a specialist. Colour of all render and stucco to match existing.

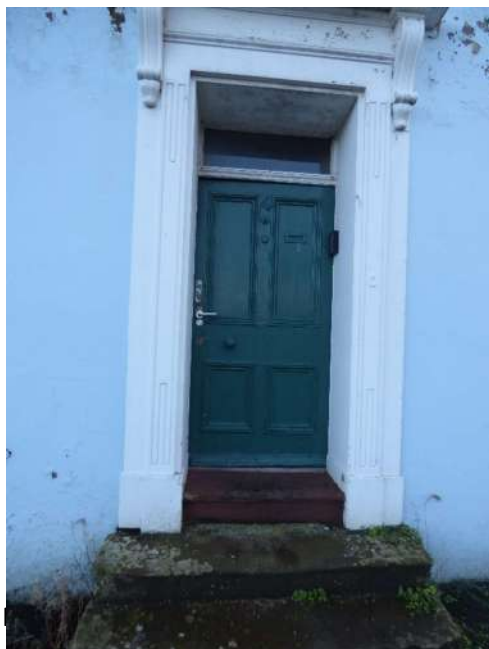
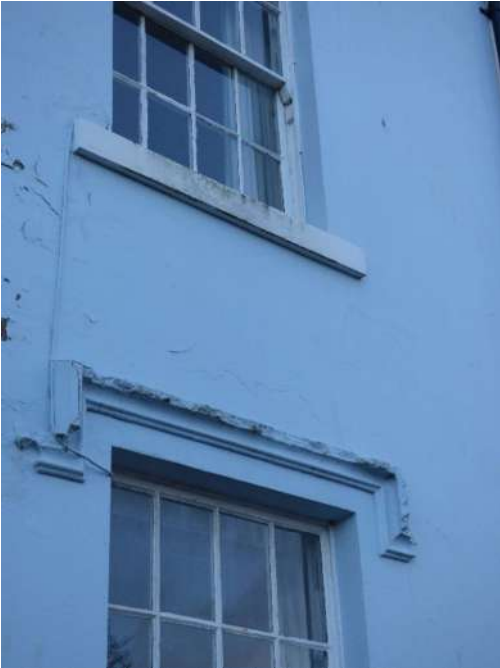
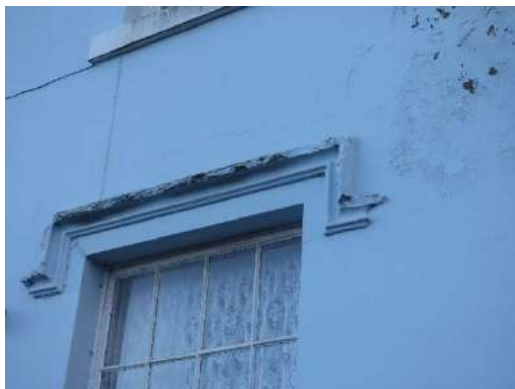
Below: Existing front door to be made good and redecorated.

It is proposed to reinstate the handrails that would have originally been either side of the steps. Refer to details in D&A statement.

The existing stone steps to be cleaned up, and new painted metal handrails provided, that would have originally been installed.

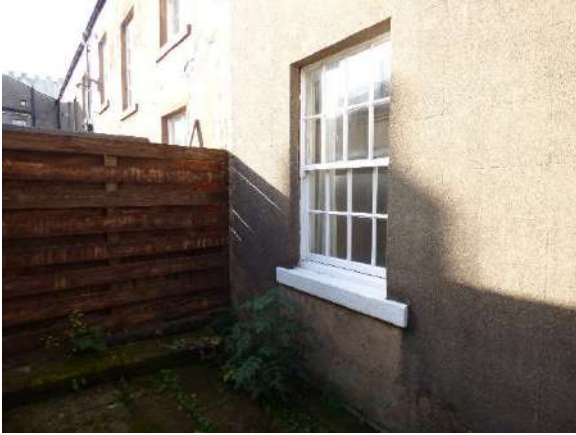
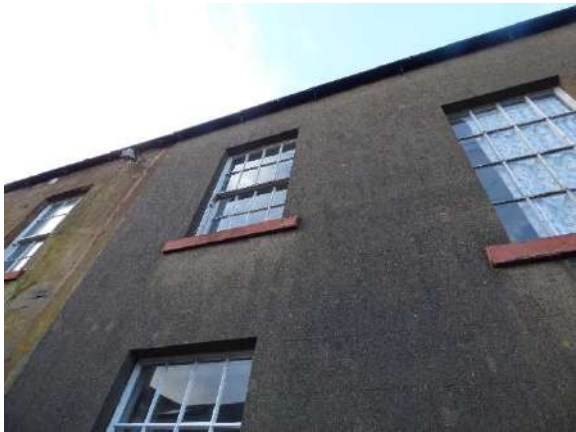
The rear courtyard is divided by a single storey 'link' building to an outbuilding at the rear. It is proposed to demolish this link structure as it is in extremely poor condition, and also to demolish the existing rear building, which was a mid-20<sup>th</sup> Century addition to the property to facilitate washroom accommodation for the boarding house, to provide additional amenity space for the property and allow more light into the existing dwelling.

All existing single glazed windows to either be repaired / replaced (subject to planning condition).

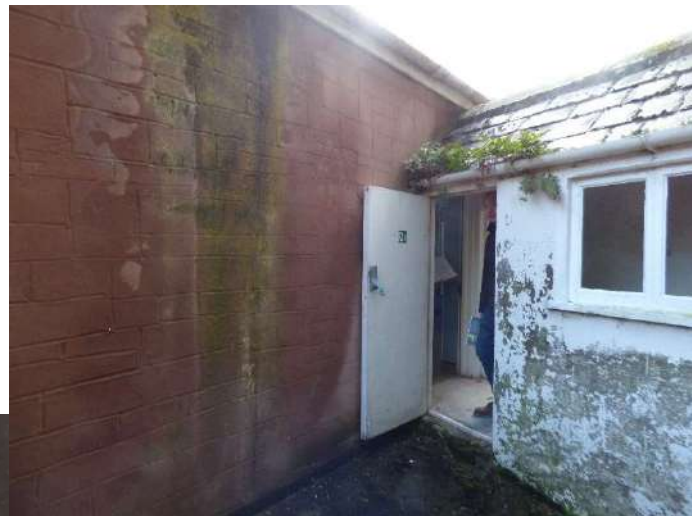
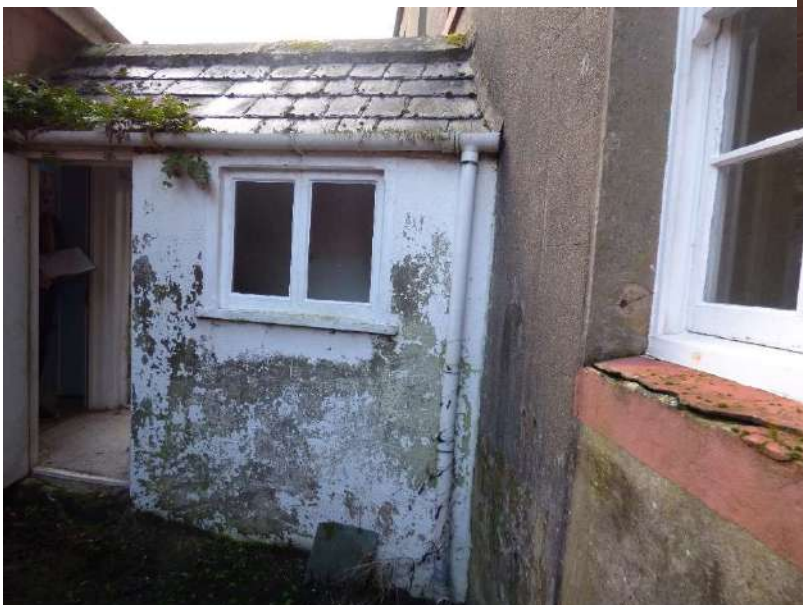
Rear of property – render to be repaired by specialist and decorated with off white render.

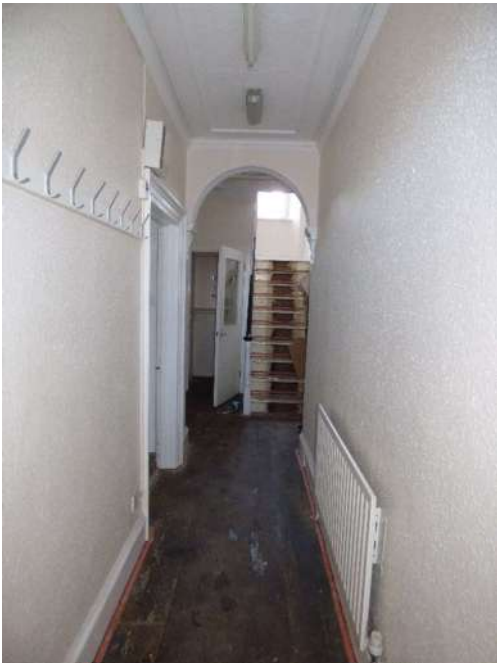
Left: The existing walls and floor are generally in good condition.

Redundant M&E to be removed and wall / ceiling finishes made good, and primed, prepared, and fully decorated.

Flush panel doors to be replaced with heritage style 4 panel heritage asset. Where possible it is proposed to refurbish any original doors with door closers and intumescent paint subject to building control approval.

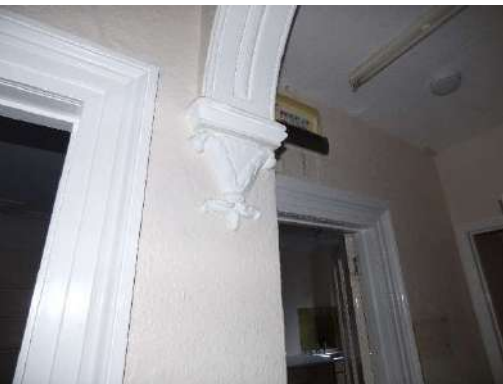
Left: period features to be retained, including archway and architraves. (Modern lighting to all be stripped out and make good surfaces). All architraves and plaster features to be retained.

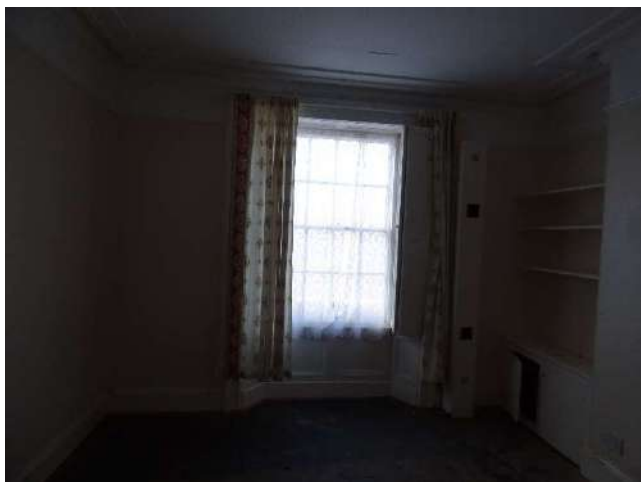
Left: In the existing study, the period features below and to the sides of the existing window are in good condition, it is proposed to carefully refurbish the existing timber shutters.

Left: Existing cornice to be made good in locations where redundant services are to be removed and where hairline cracks have appeared.

Existing architraves, and skirtings to be retained and made good.

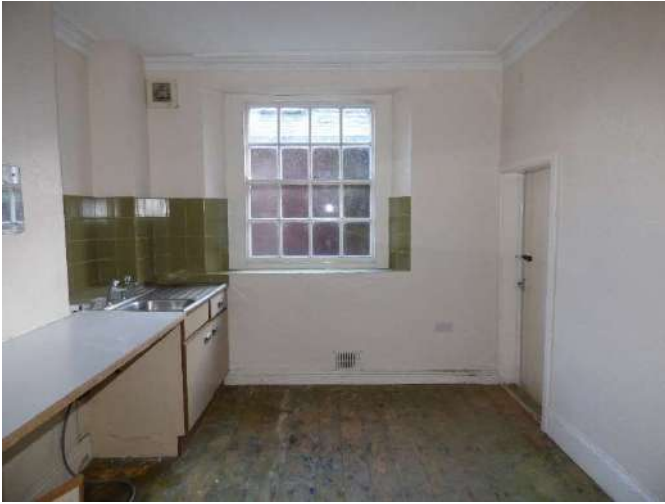
Left and below: the existing kitchen area to the rear of the property, the period features below and to the sides of the existing window are in good condition.

Below: Existing cornice to be made good in locations and where hairline cracks have appeared.

Flush panel doors to be replaced with heritage style 4 panel painted timber fire doors to enhance the heritage asset.

Where possible it is proposed to refurbish any original doors with door closers and intumescent paint subject to building control approval.

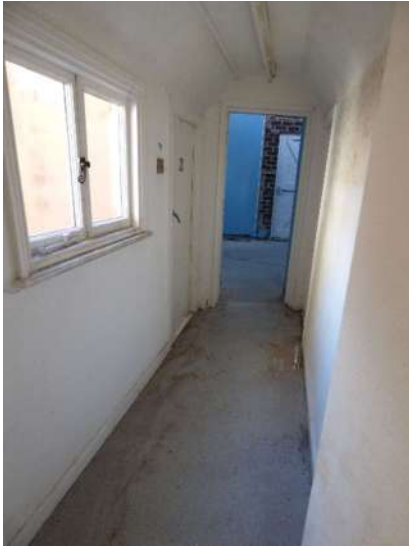
Left: Existing single skin link building extension to be removed.

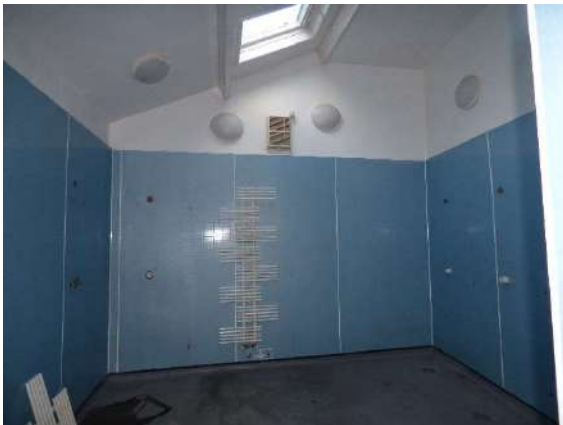
Left: Shower block to be removed to provide additional amenity space to the property. Not original building. Constructed mid-20<sup>th</sup> Century to provide washroom facilities for the boarding house.

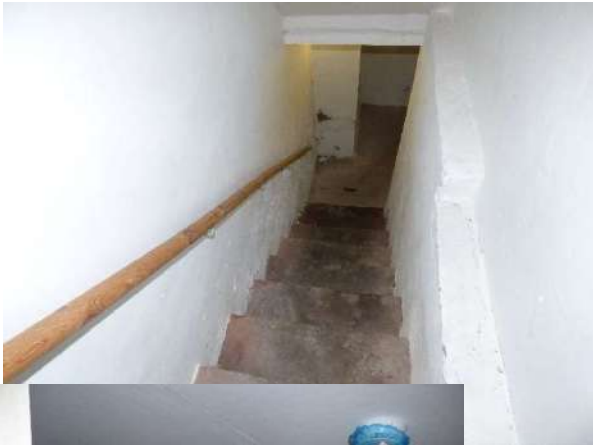
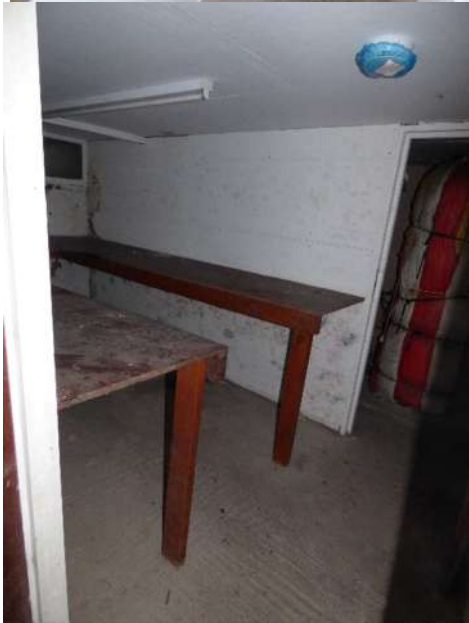
The existing walls and floor to the basement are generally in sound condition so would be suitable for the application of damp proof slurry system. All existing paint and surface finishes must be removed and made good including all snots removed, and damage to existing surfaces, prior to the installation of a Koster Polysil NB1. This migratory crystalline tanking slurry is used to seal below ground structures against water ingress.

Koster NB1 is considered to be a Type A waterproofing system as defined by BS8102:2009 and is generally used to seal the inside face of basement structures, slabs and retaining walls.

Koster NB1 works by both providing a physical barrier against water ingress as well as providing a migratory crystal sealant that penetrates deep into the structure to seal micropores and cracks against water ingress.

Once applied then the walls can be prepared and primed for decorating and for the floor finish to be installed. Complete new boiler and heating system is required, new distribution boards etc.

Kloster NB1 is a breathable water proof system which will enhance the thermal value of the building without increasing the moisture content of the wall.

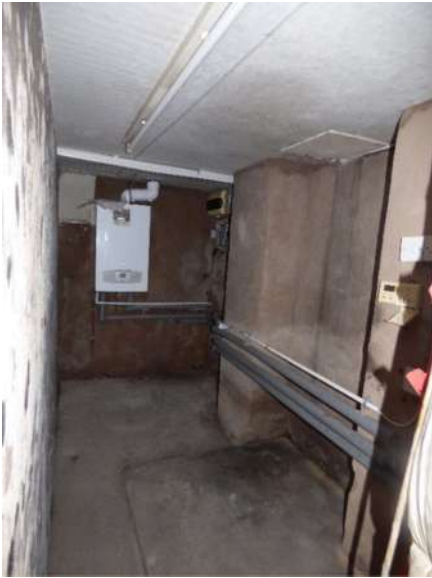
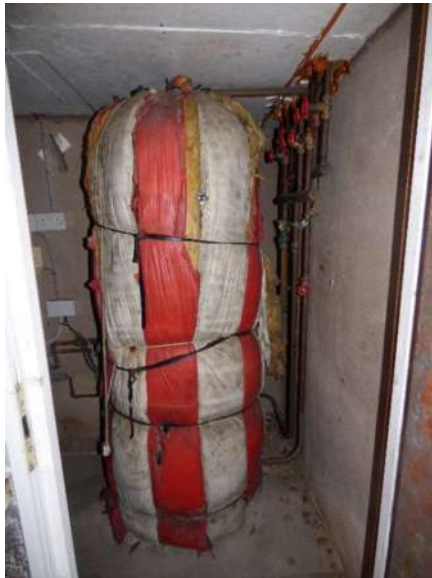
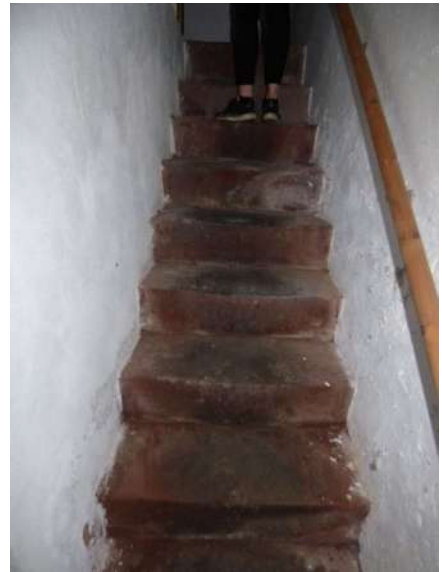
Above:

The walls down to the basement also require the full treatment.

Existing window to basement has been walled up. This is to be removed and reveals made good. The proposed new window to the basement to be subject to planning condition.

In the basement all existing services are to be carefully stripped out and replaced with new compliant infrastructure.

All existing services to be carefully removed and new gas and electric services installed.

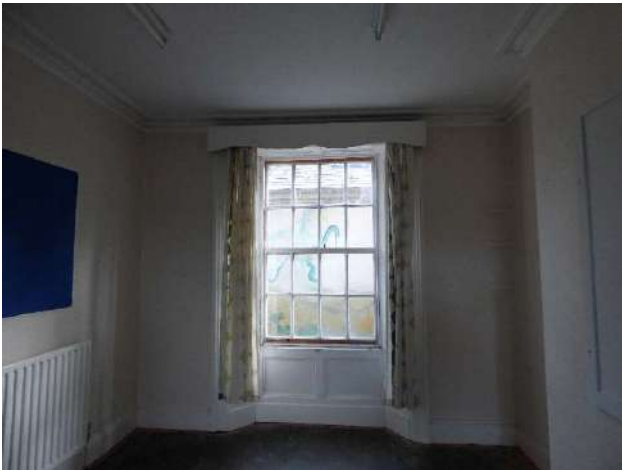
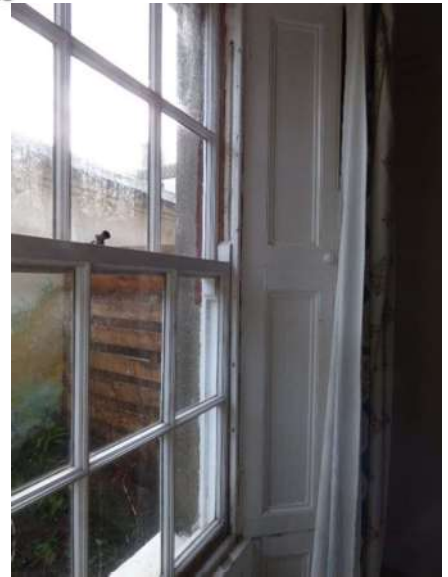
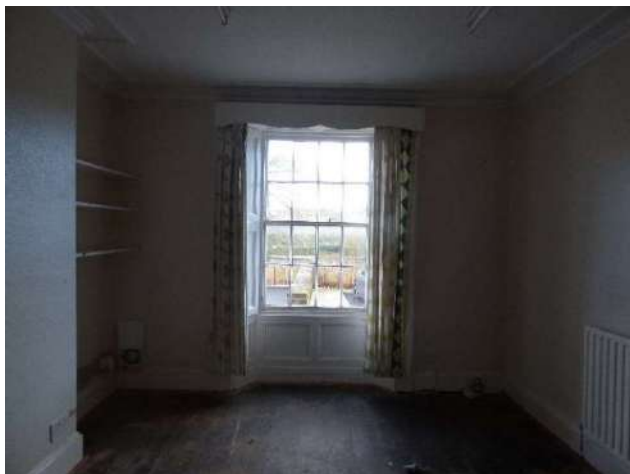
Above and Left: In the existing study, the period features below and to the sides of the existing windows both front and back are in good condition, it is proposed to carefully refurbish the existing timber shutters.

Existing cornice to be made good in locations where redundant services are to be removed and where hairline cracks have appeared.

Flush panel doors to be replaced with heritage style 4 panel painted timber fire doors to enhance the heritage asset.

Where possible it is proposed to refurbish any original doors with door closers and intumescent paint subject to building control approval.

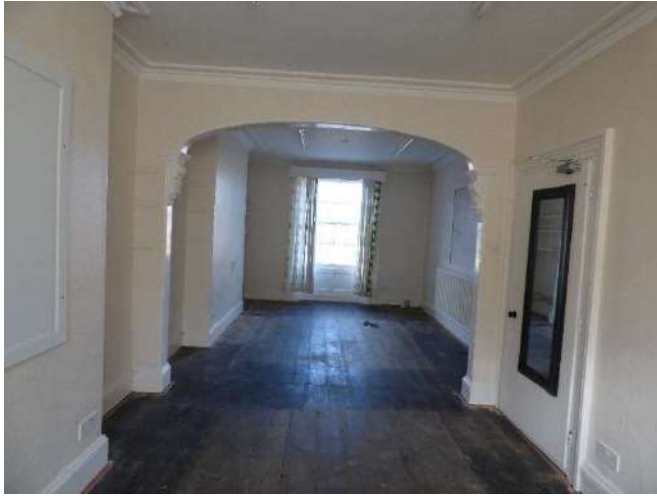
Left: period features to be retained, including archway and architraves. (Modern lighting to all be stripped out and make good surfaces). All architraves and plaster features to be retained.

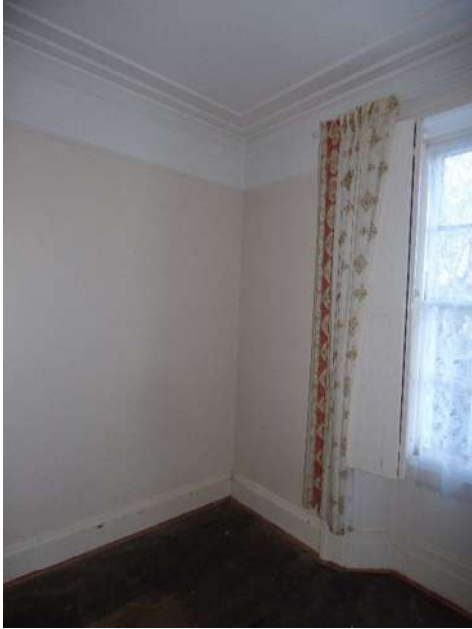
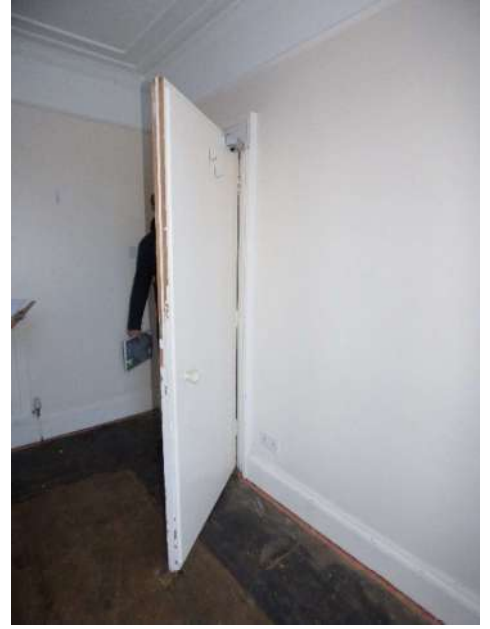
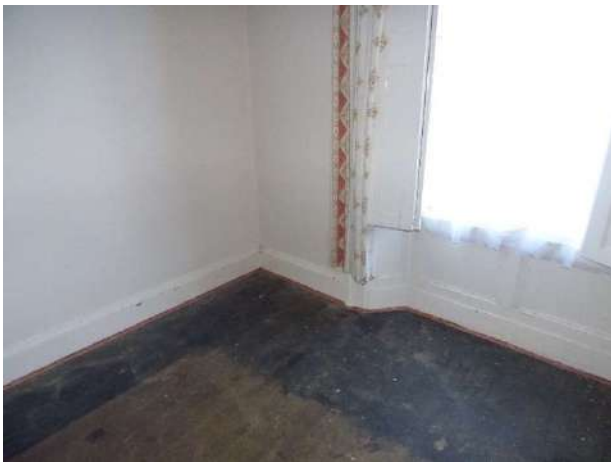
Above and Left: In the existing lounge, the period features below and to the sides of the existing windows both front and back are in good condition, it is proposed to carefully refurbish the existing timber shutters.

Existing cornice to be made good in locations where redundant services are to be removed and where hairline cracks have appeared.

Flush panel doors to be replaced with heritage style four panel painted timber fire doors to enhance the heritage asset. Where possible it is proposed to refurbish any original doors with door closers and intumescent paint subject to building control approval.

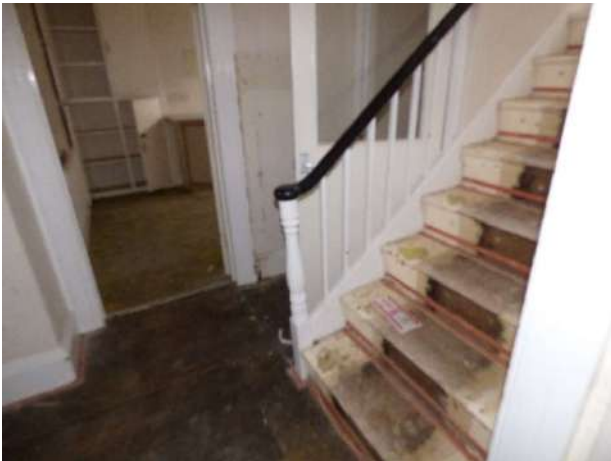
Retain original staircase, which is in good condition.

The requirement for the steel post at the top of the staircase

To be confirmed by structural engineer, if possible, the intention is to remove and strengthen the balusters if required to revert to the original staircase detail.

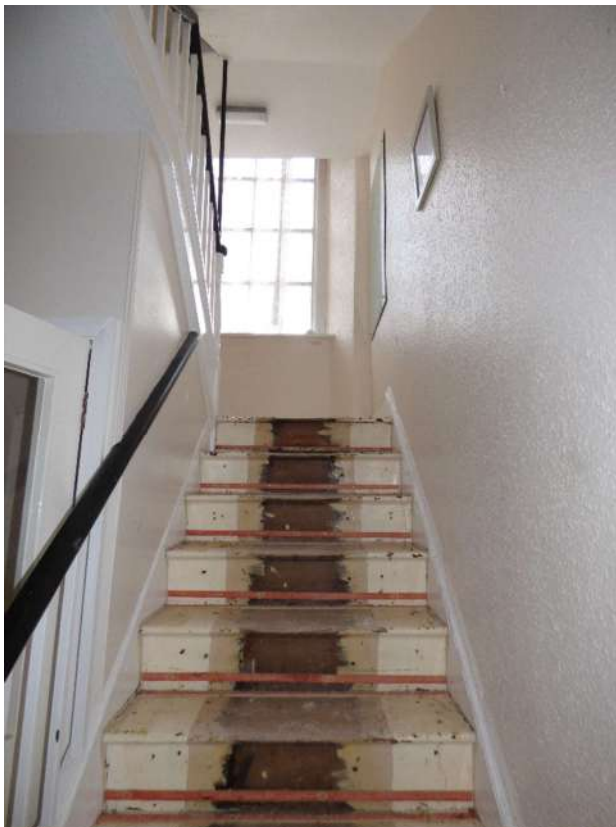
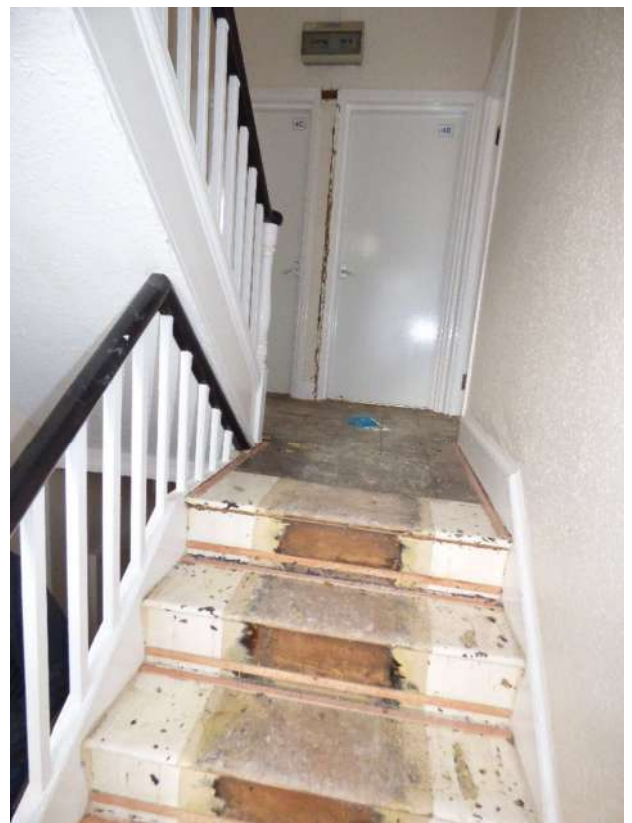
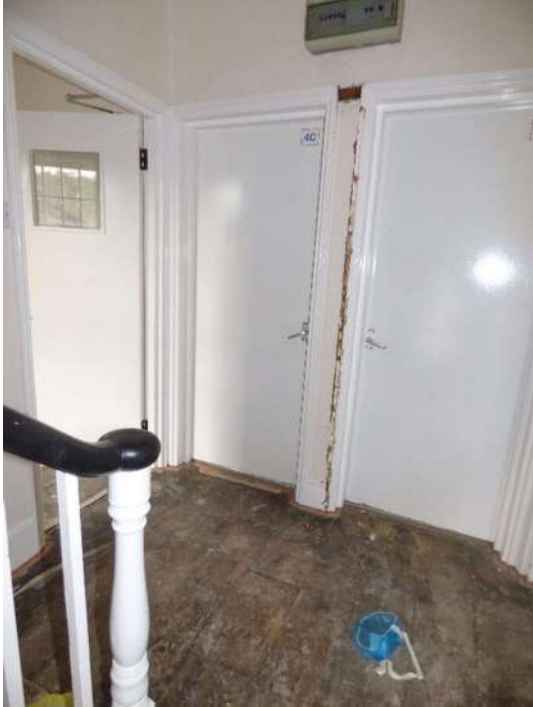
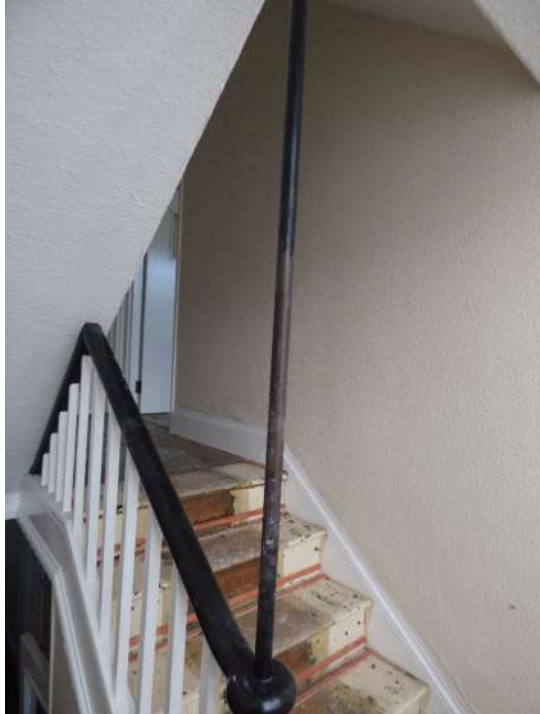
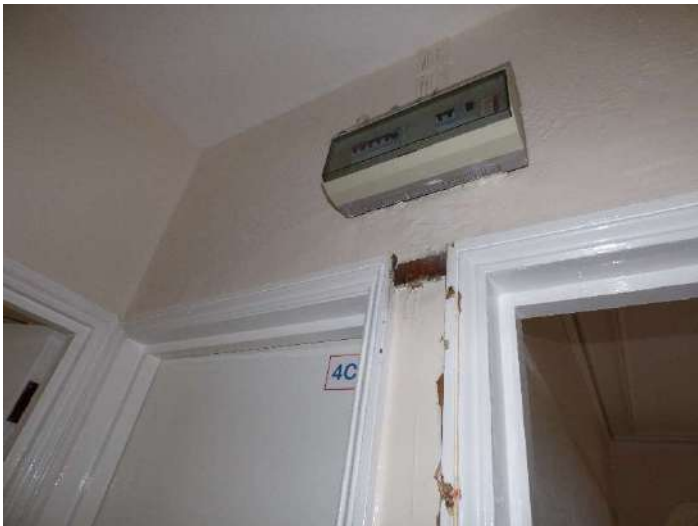
Original architraves to be retained.

Redundant M&E fixtures and fittings to be removed and surfaces made good.

Flush panel doors to be replaced with heritage style Georgian 4 panel fire doors.

Where possible it is proposed to refurbish any original doors with door closers and intumescent paint subject to building control approval.

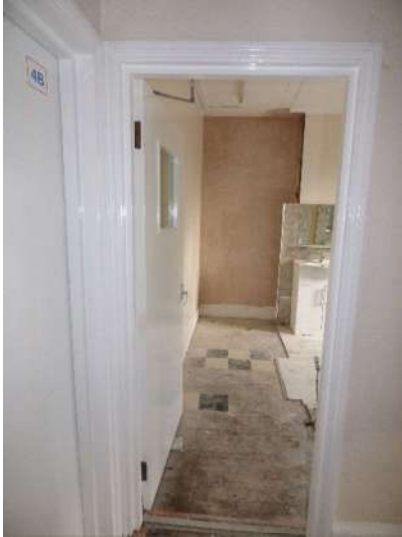
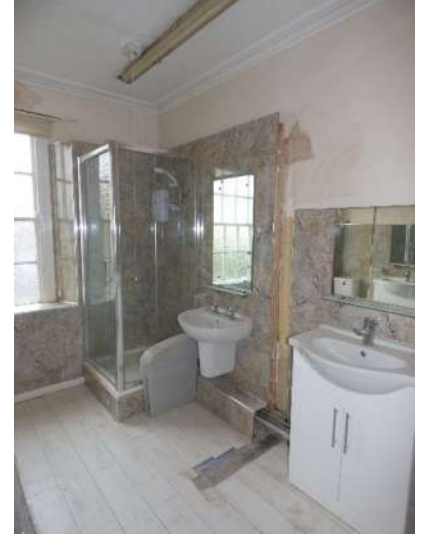
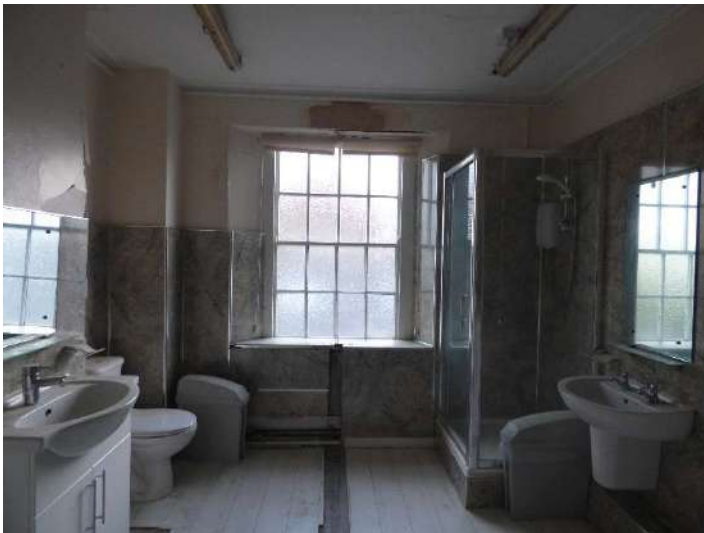
Left and above: Existing bathroom, to be completely renovated. All existing FF&E and M&E to be removed and all surface finishes to be completely removed and walls made good.

New Georgian heritage style four panel door to be provided and installed by specialist joinery company such as Batt Joinery Ltd. All fabric damage to be carefully repaired. To replace existing modern flush glazed door.

Bathroom to be reduced in size to allow for the installation of a new en-suite to the master bedroom.

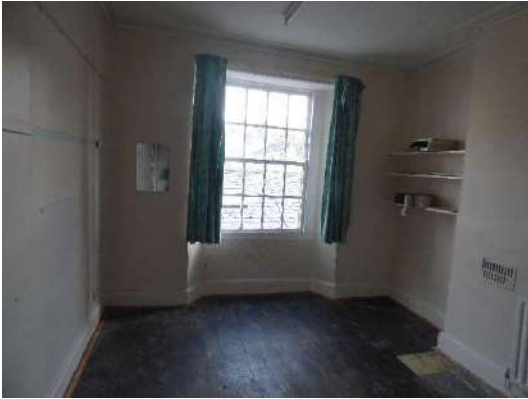
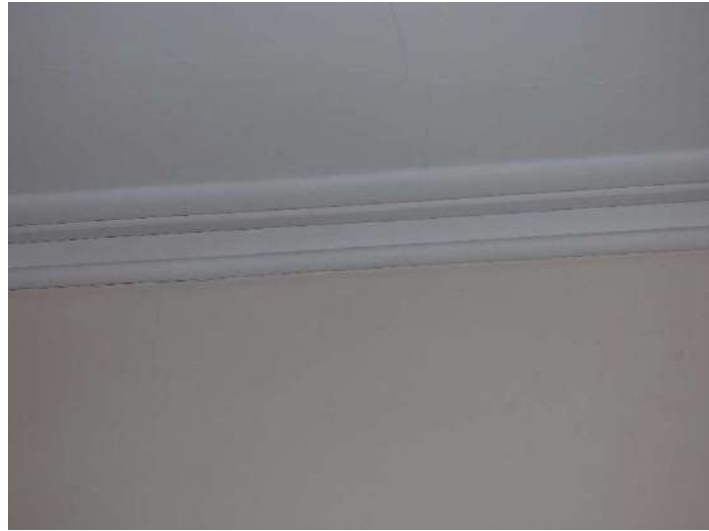
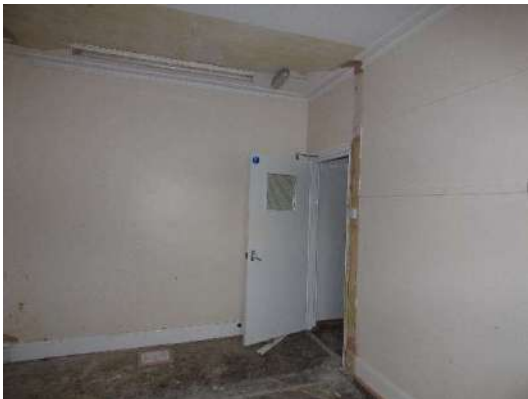
Left and above: Rear bedroom existing skirtings and architraves to be retained. Existing modern flush panelled door to be replaced with new Georgian heritage style four panel door to be provided and installed by specialist joinery company such as Batty Joinery Ltd.

Existing floorboards in good condition.

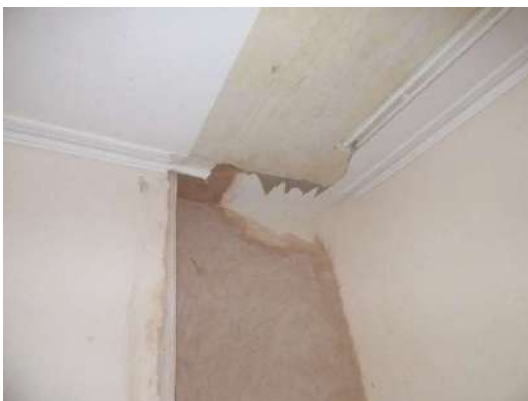
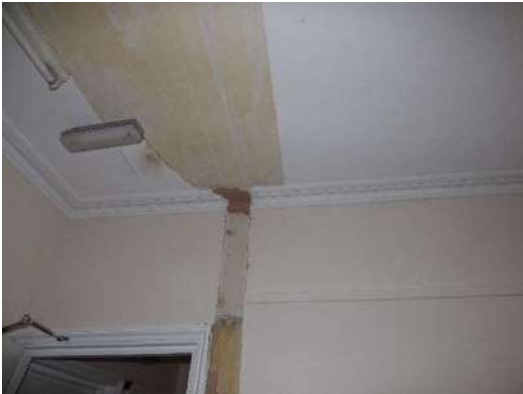
Front bedroom (First floor LHS), cornice, skirtings, and architraves to be retained.

Existing floorboards in good condition.

Existing flush panelled door to be replaced with new Georgian heritage style four panel door to be provided and installed by specialist joinery company such as Batty Joinery Ltd. Where possible it is proposed to refurbish any original doors with door closers and intumescent paint subject to building control approval.
