# HERITAGE STATEMENT

## FULL RENOVATION OF EXISTING No 11 TERRACE HOUSES

St Bees, 1-11 Lonsdale Terrace, Parish Council, Cumbria

M.A.C Architects, Project Number: 2019:303

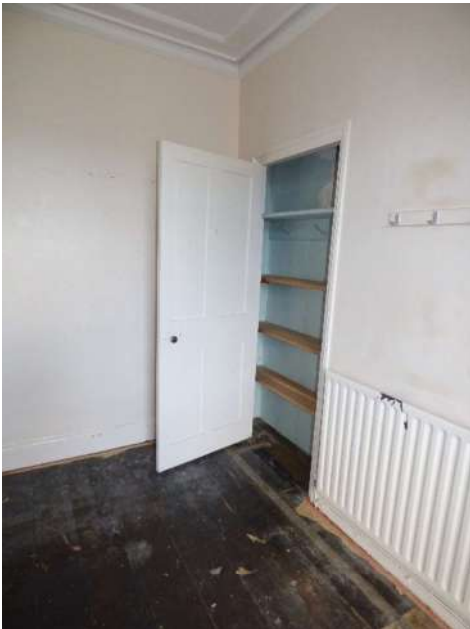
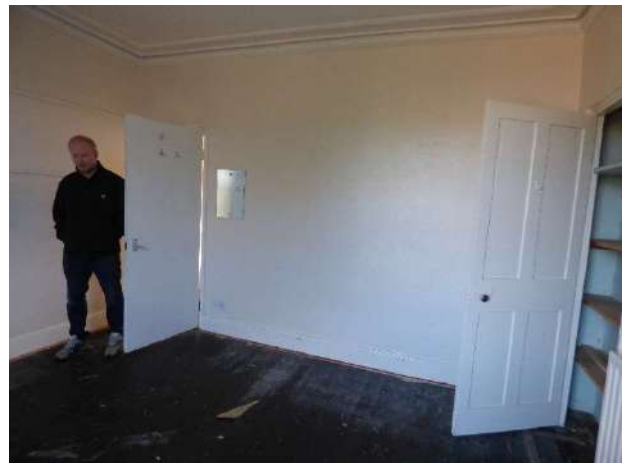
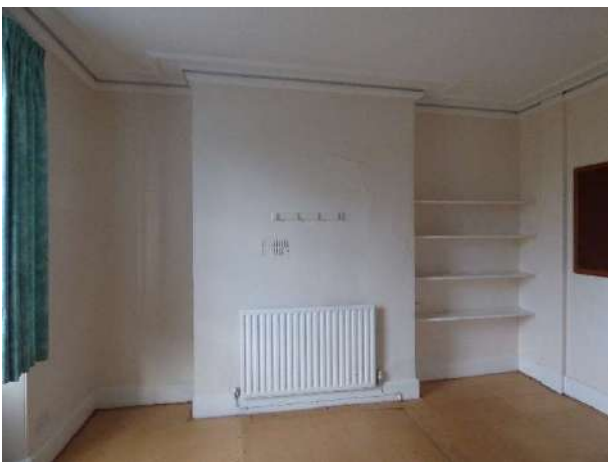
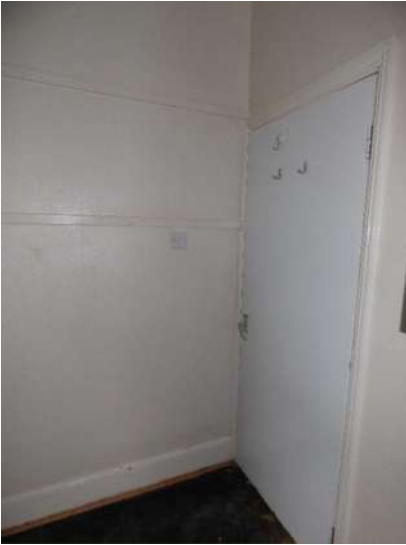
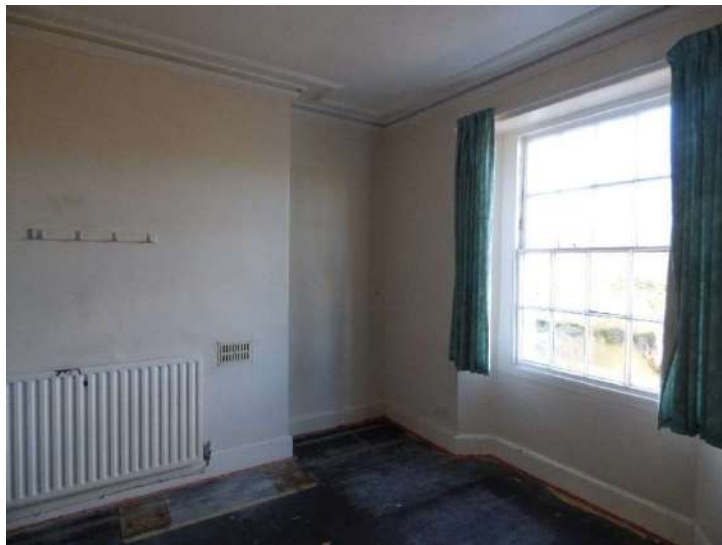
Front bedroom (First floor RHS), cornice, skirtings and architraves to be retained. Existing flush panelled door to be replaced with new Georgian heritage style 4 panel door to be provided and installed by specialist joinery company such as Batty Joinery Ltd. Where possible it is proposed to refurbish any original doors with door closers and intumescent paint subject to building control approval.

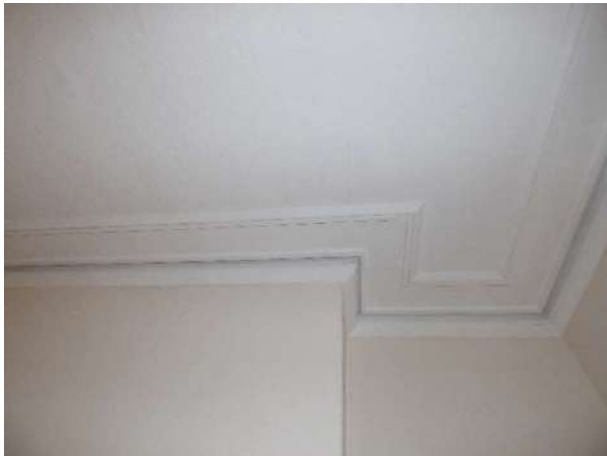
Existing floorboards generally in good condition.

It is proposed to form new doorway with architraves to match existing, and new four panelled door, into a new en-suite to be formed from part of the existing over large bathroom to make efficient use of the space and reflect the requirements of modern-day living.

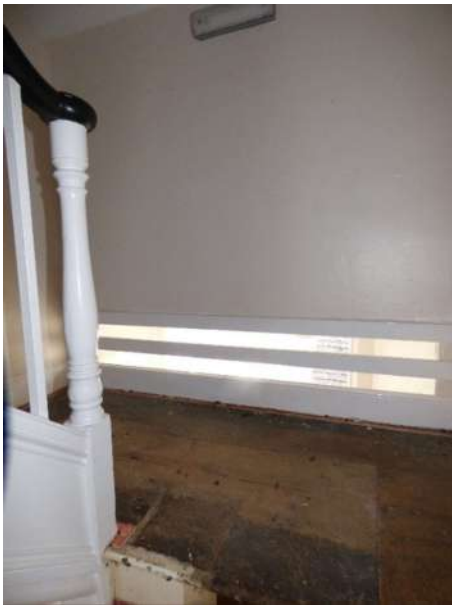
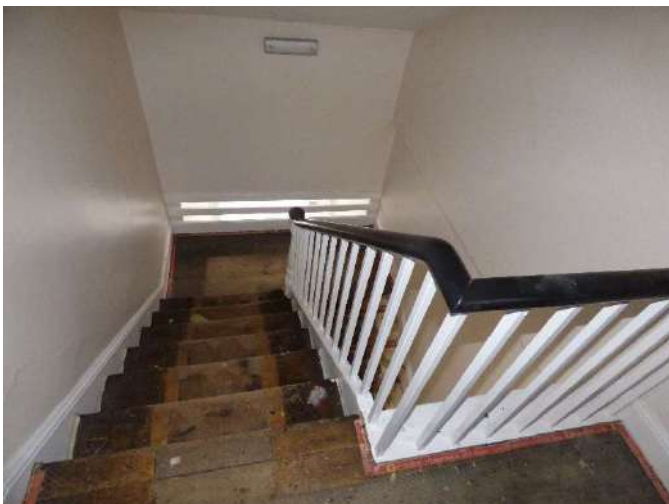
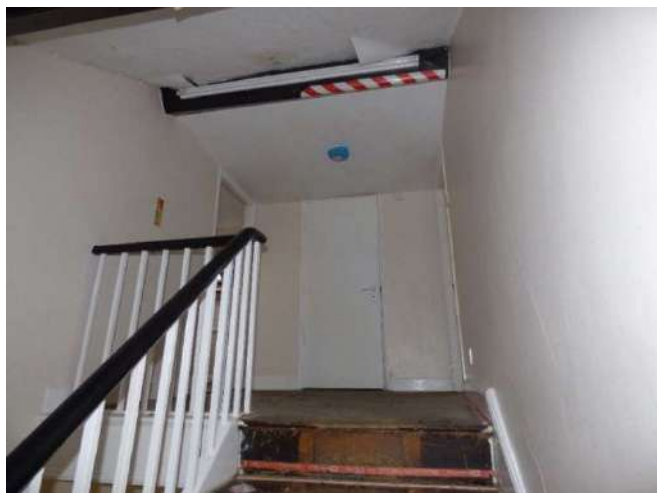
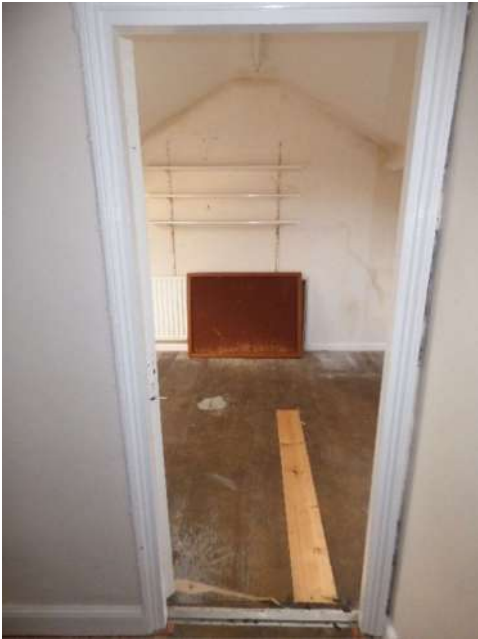
Left and below: Attic Bedroom.

Floorboards are in good condition (but may require minor repairs).

New plasterboard stud partition to be installed in lieu of removal of part of existing store / bedroom partition to allow for bathroom to be useable size.

In the bedroom remove all damp and damaged / blown plasterwork and repair with lime plaster (Solo lime plaster from Lime Centre) and skim and decorate throughout.

Apply an insulated plasterboard 62mm thick to underside of ceiling. The Laminated plasterboard and PIR has a vapour barrier incorporated so interstitial moisture would be prevented and skim and undertake full decorations. New heritage style rooflights to be installed, to replace modern Velux windows currently installed to restore heritage asset (Velux or similar with flashing kit that mounts unit flush with the roof surface).

Existing flush panel doors are to be removed and replaced with new heritage style four panel fire doors.

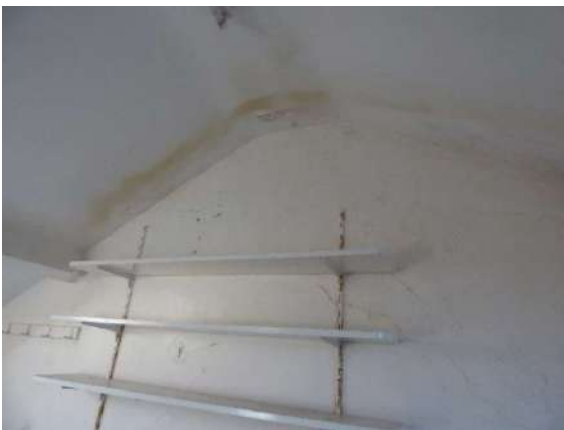
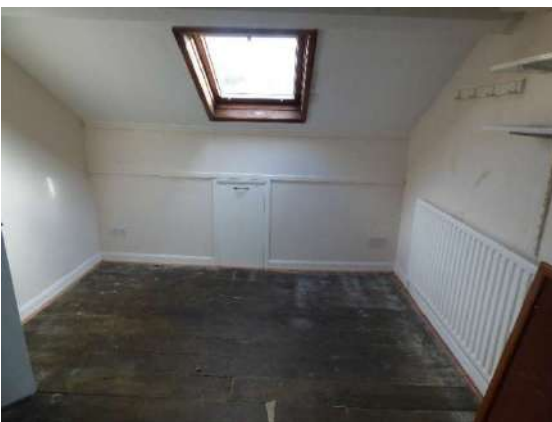
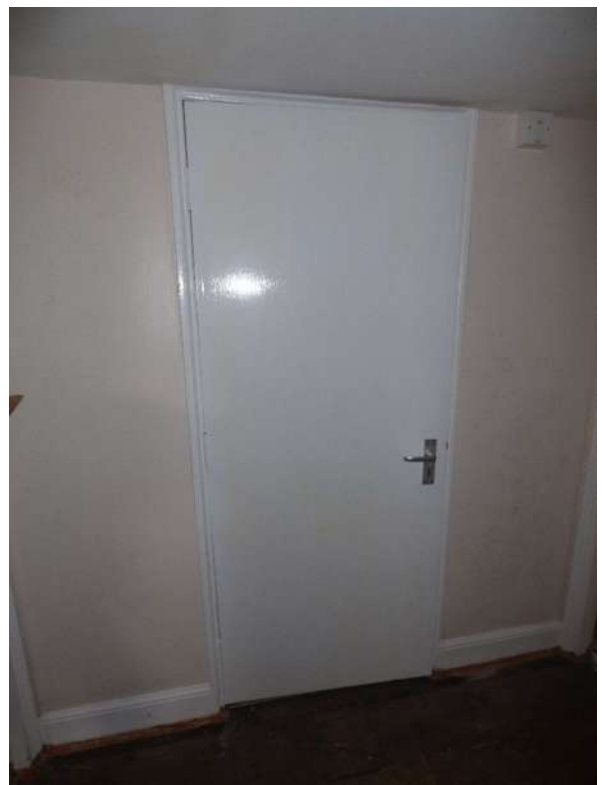
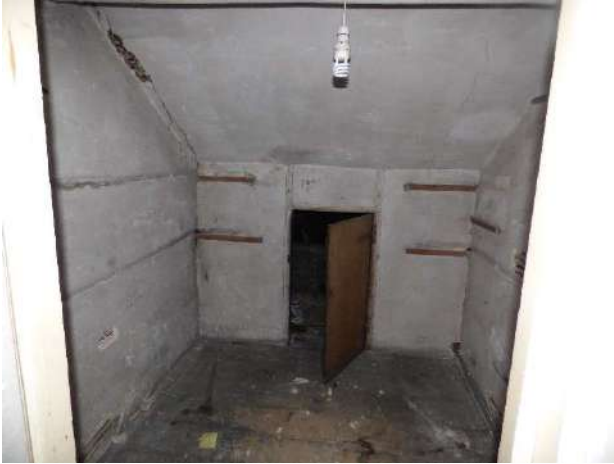
Left: Attic Store is proposed to be converted into a bathroom to be shared by the attic bedrooms by increasing the size of the room to each side to allow for the new bathroom.

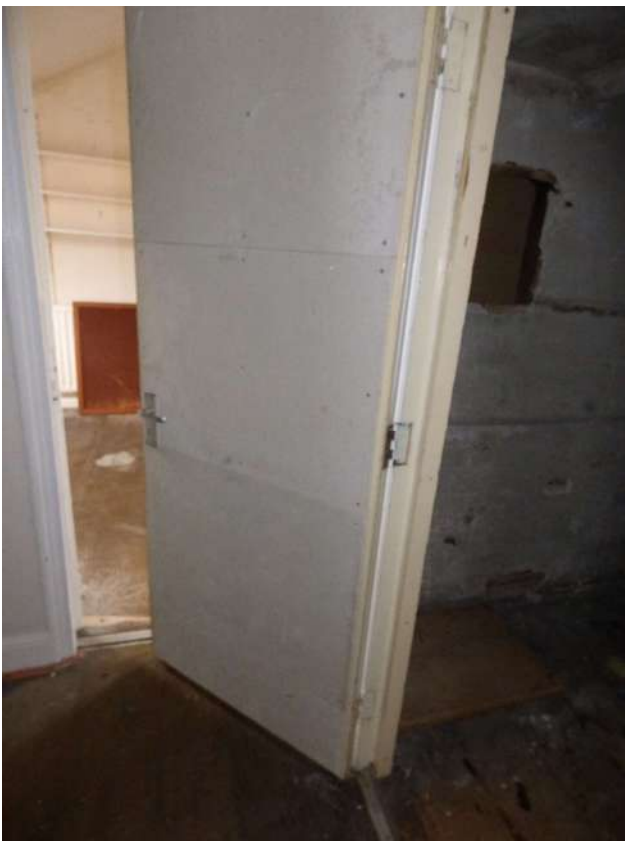
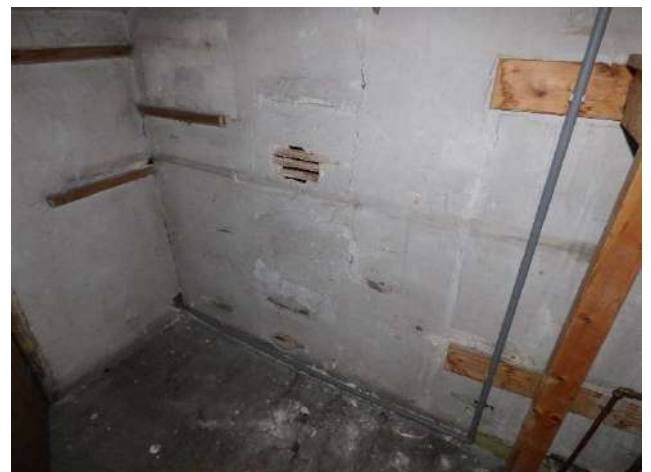
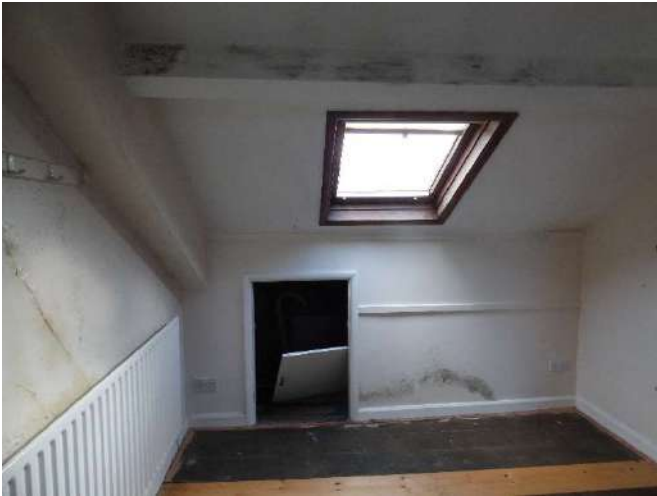
Left: Attic Bedroom

Floorboards are in good condition (but may require minor repairs).

New plasterboard stud partition to be installed in lieu of removal of part of existing store / bedroom partition to allow for bathroom to be useable size.

In the bedroom remove all damp and damaged / blown plasterwork and repair with lime plaster (Solo lime plaster from Lime Centre) and skim and decorate throughout.

Apply an insulated plasterboard 62mm thick to underside of ceiling. The Laminated plasterboard and PIR has a vapour barrier incorporated so interstitial moisture would be prevented.

Replace modern Velux windows with heritage rooflight windows (Velux or similar with flashing kit that mounts unit flush with the roof surface).

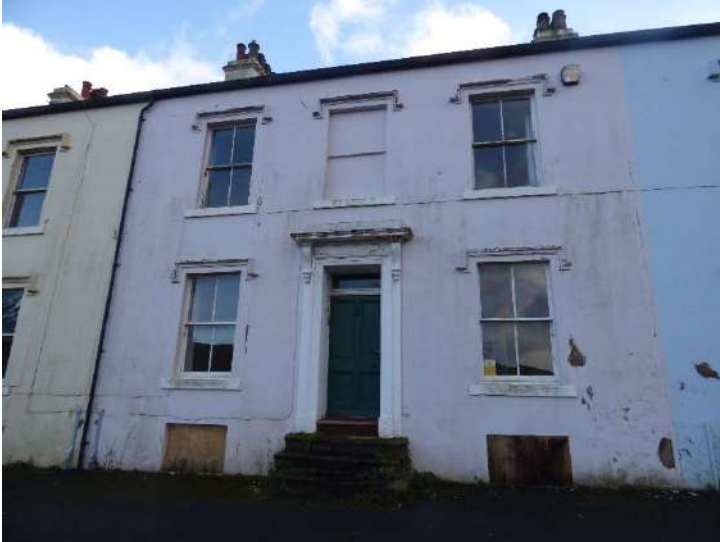
Left: The main entrance is mentioned in the listing text and is to be entirely retained.

Both front and rear elevations are currently rendered, with colour to the front and side and natural to the rear. All elevations require to be prepared for render repairs and redecoration by specialist using lime render and stucco (Parax LTD) to be applied by specialist.

The stucco features above the windows and door on the front elevation will be carefully restored by a specialist. Colour of all render and stucco to match existing.

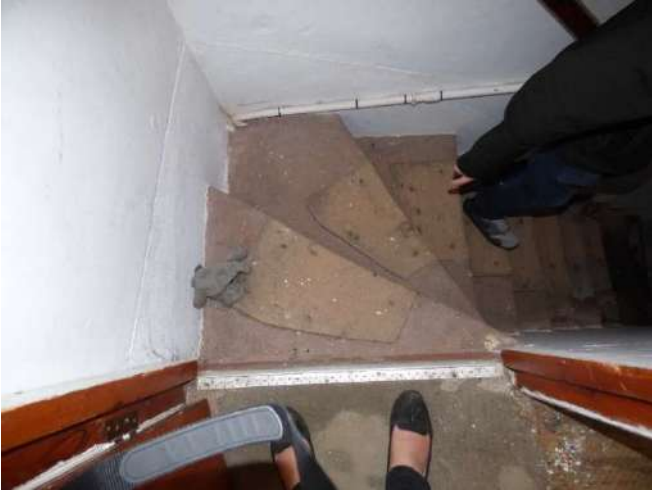
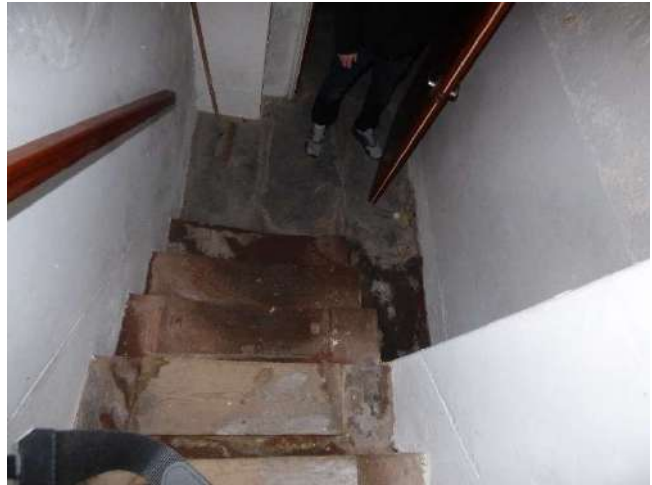
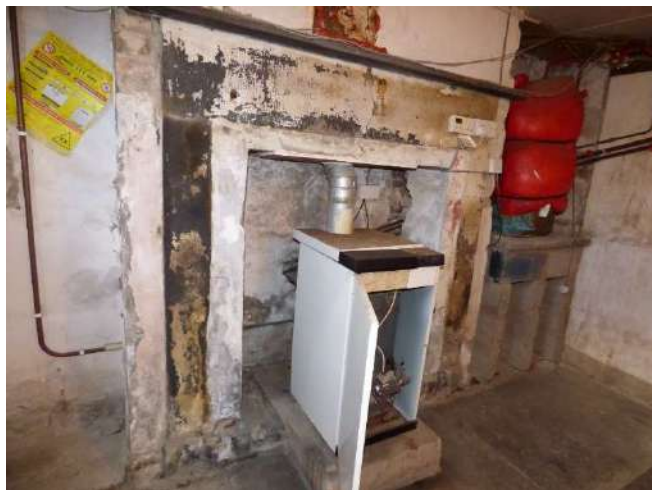
Left and above: Basement.

The existing walls and floor are generally in sound condition so would be suitable for the application of damp proof slurry system. All existing paint and surface finishes must be removed, and damage to existing paint and surface finishes must be removed and made good including all snots removed, and damage to existing surfaces, prior to the

Providing a migratory crystal sealant that penetrates deep into the structure to seal micropores and cracks against water ingress. Klostet NB1 is a breathable water proof system which will enhance the thermal value of the building without increasing the moisture content of the wall.

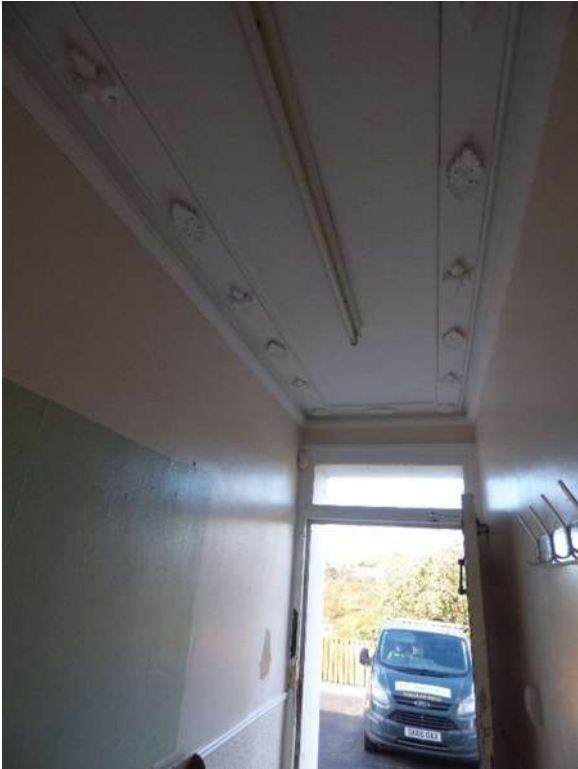
Left and below: The existing walls and floor are generally in good condition.

Redundant M&E to be removed and wall/ceiling finishes made good, and primed, prepared and fully decorated.

Flush panel doors to be replaced with heritage style panel painted timber fire doors to enhance the heritage asset.

Where possible it is proposed to refurbish any original doors with door closers and intumescent paint subject to building control approval.

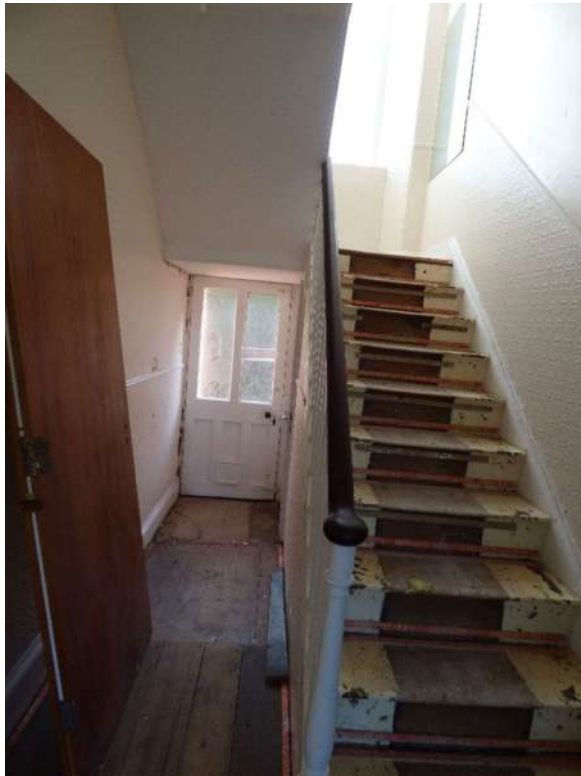
Retain original staircase, which is in good condition.

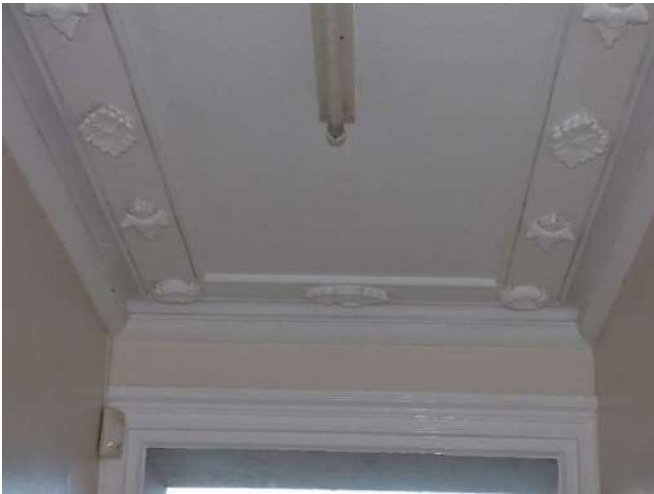
Left: Period features to be retained, including archway and architraves. (Modern lighting to all be stripped out and make good surfaces). All architraves and plaster features to be retained.

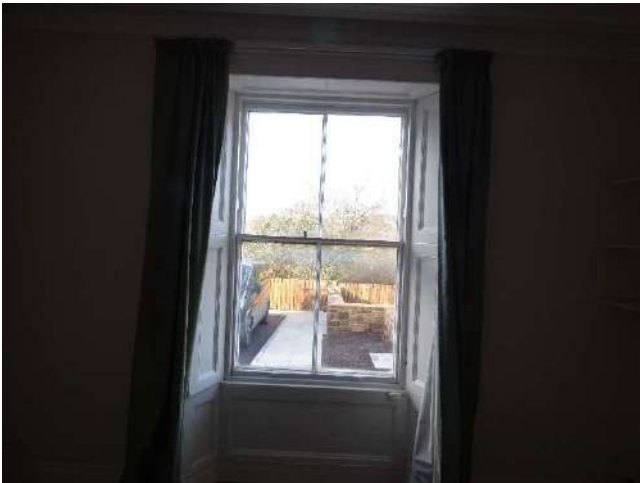
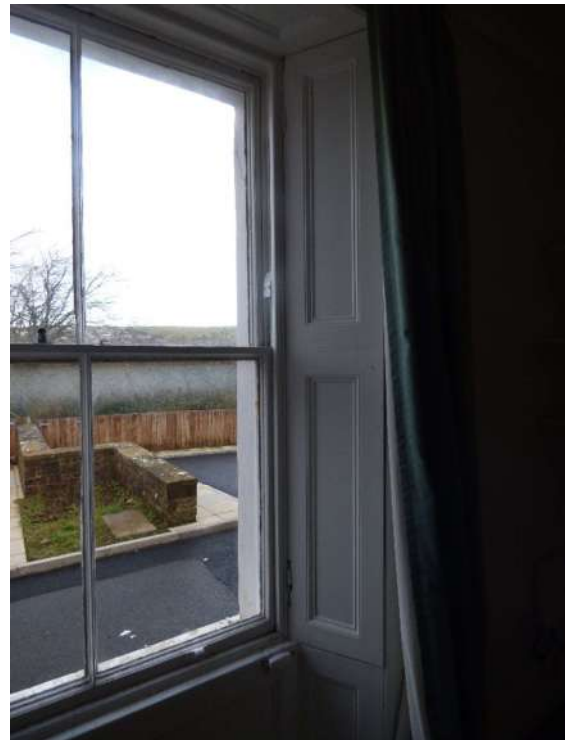
In the existing study, the period features below and to the sides of the existing window are in good condition, it is proposed to carefully refurbish the existing timber shutters.

Below: Existing cornice to be made good in locations where redundant services are to be removed and where hairline cracks have appeared.

Existing architraves, and skirtings to be retained and made good.

Flush panel doors to be replaced with heritage style four panel painted timber fire doors to enhance the heritage asset.

Where possible it is proposed to refurbish any original doors with door closers and intumescent paint subject to building control approval.

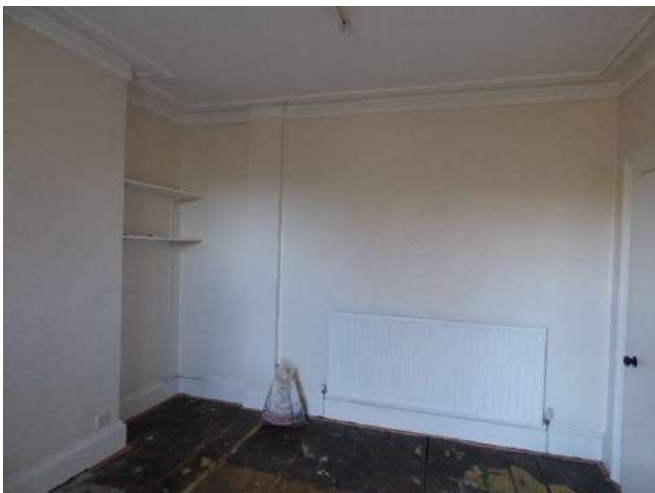
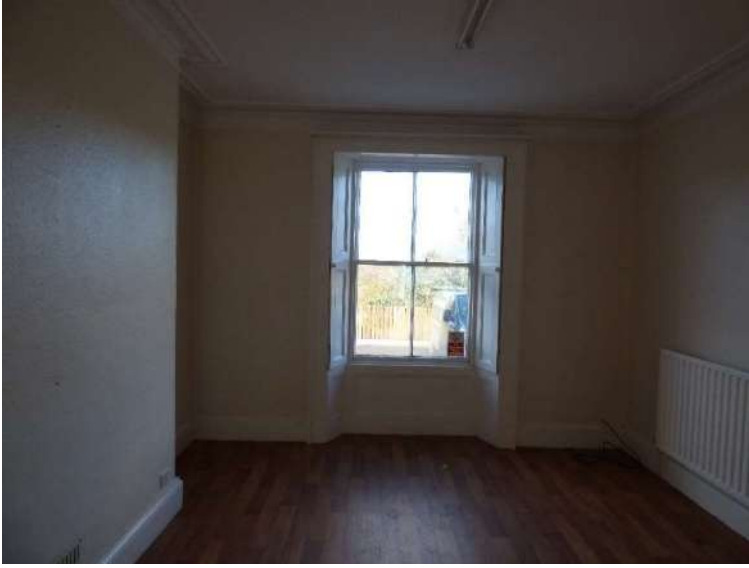
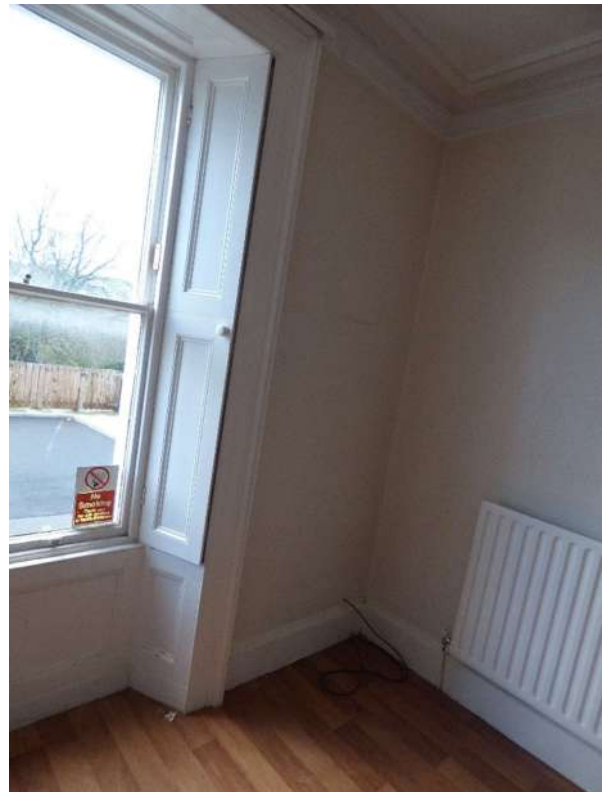
Above, right, and below: In the existing lounge at the front of the property and the existing dining area to the rear of the property, the period features below and to the sides of the existing window are in good condition, it is proposed to carefully refurbish the exiting timber shutters.

Below: Existing cornice to be made good in locations and where hairline cracks have appeared.

Existing architraves and skirtings to be retained and made good.

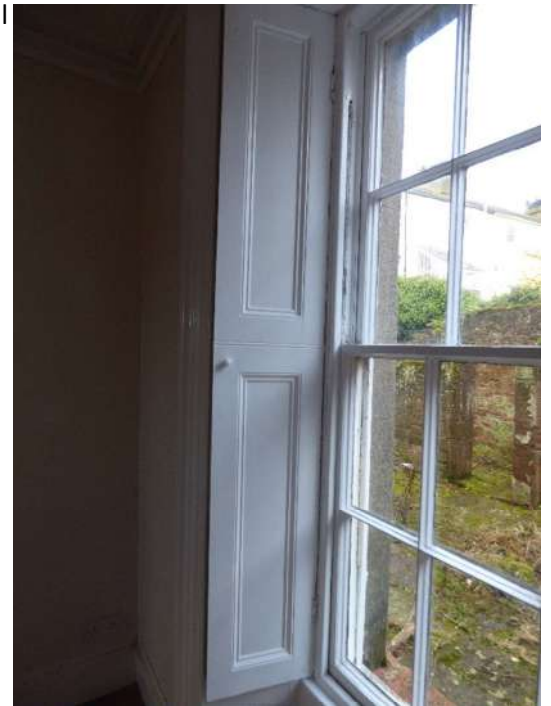
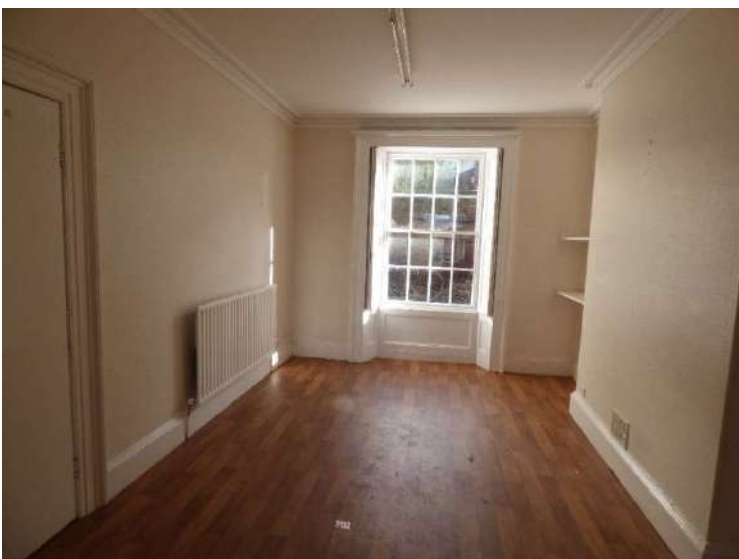
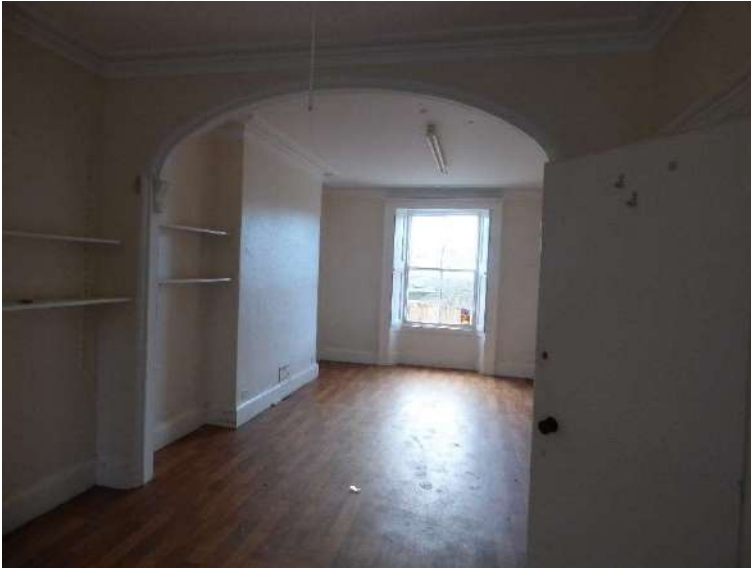
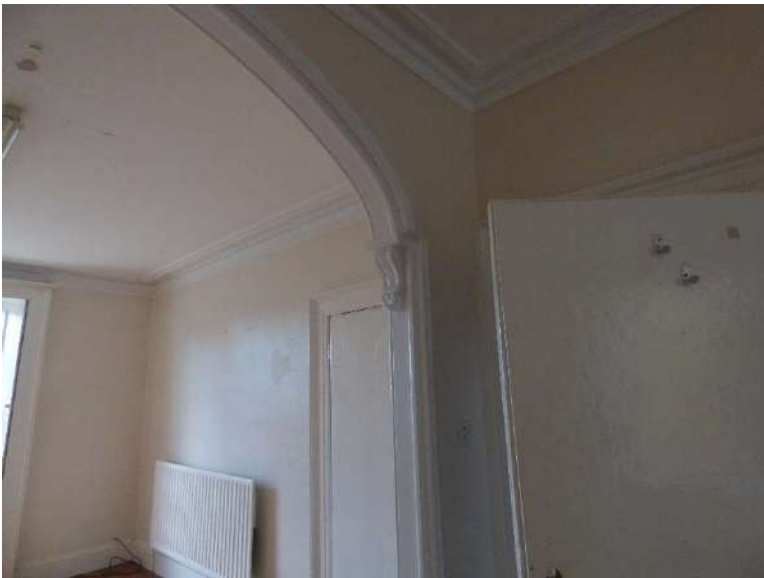
Left and below: In the existing lounge, the period features below and to the sides of the existing windows both front and back are in good condition, it is proposed to carefully refurbish the existing timber shutters.

Existing cornice to be made good in locations where redundant services are to be removed and where hairline cracks have appeared.

Existing architraves and skirtings to be retained and made good.

Flush panel doors to be replaced with heritage style four panel painted timber fire doors to enhance the heritage asset.

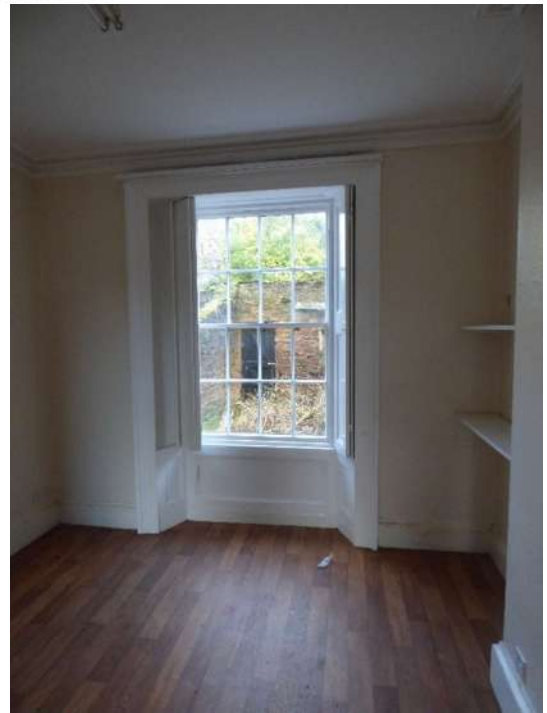
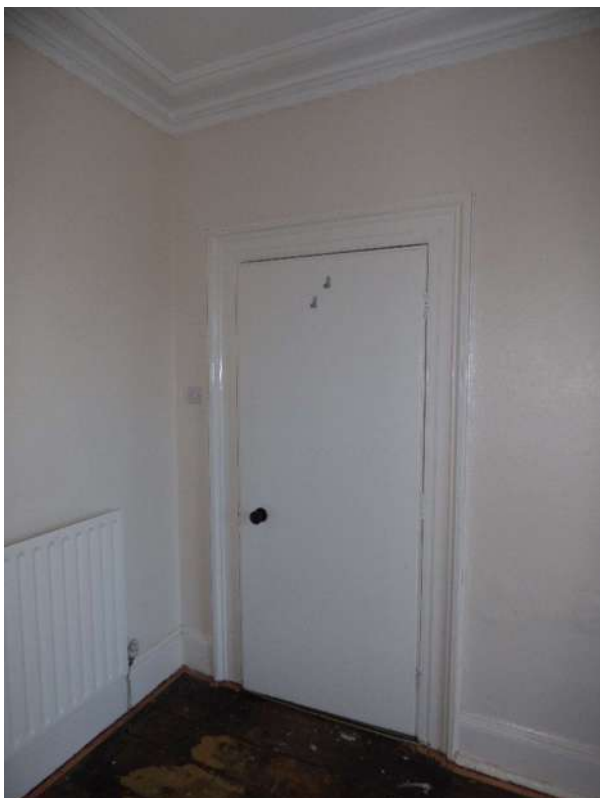
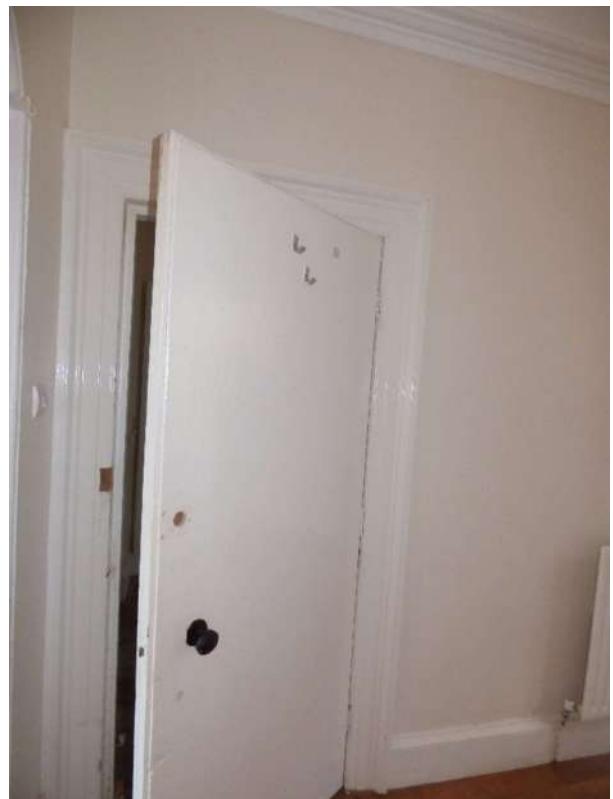
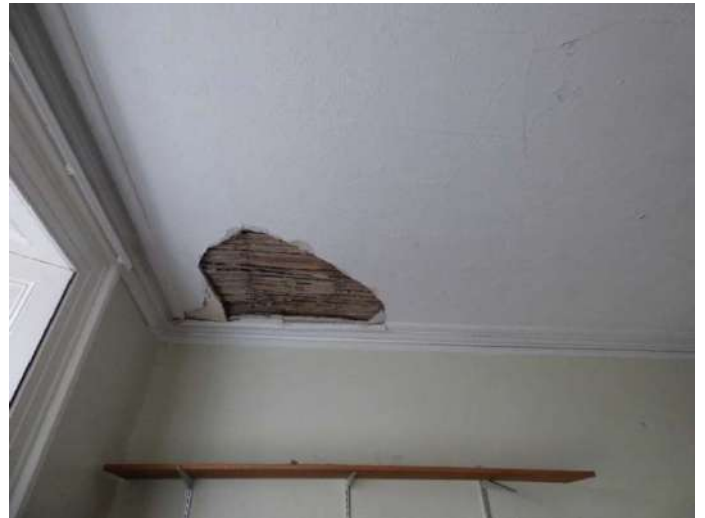
Left and below: The period features below and to the sides of the existing window are in good conditions, it is proposed to carefully refurbish the existing timber shutters.

Existing cornice to be made good in locations where redundant services are to be removed and where hairline cracks have appeared.

Existing architraves and skirtings with heritage style four panel painted timber fire doors.

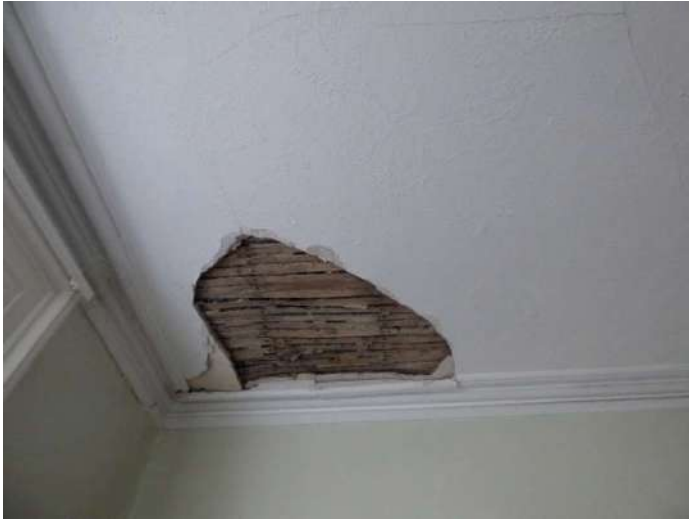
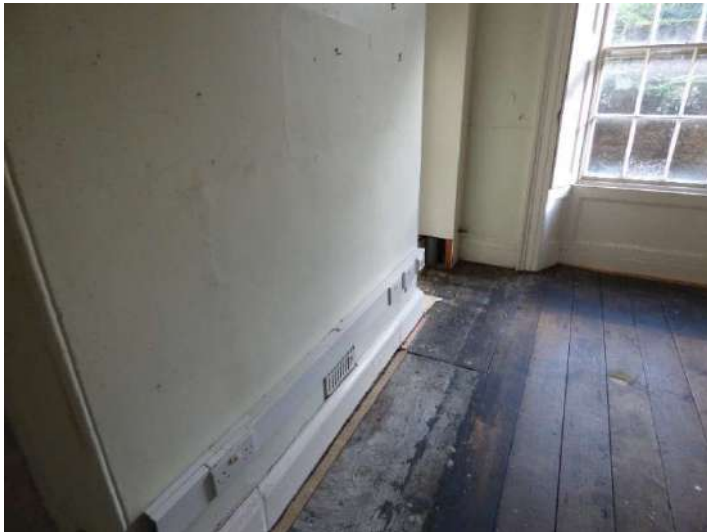
Left and below: The period features below and to the sides of the existing window are in good conditions, it is proposed to carefully refurbish the existing timber shutters.

Existing cornice to be made good in locations where redundant services are to be removed and where hairline cracks have appeared.

Existing architraves and skirtings with heritage style four panel painted timber fire doors.

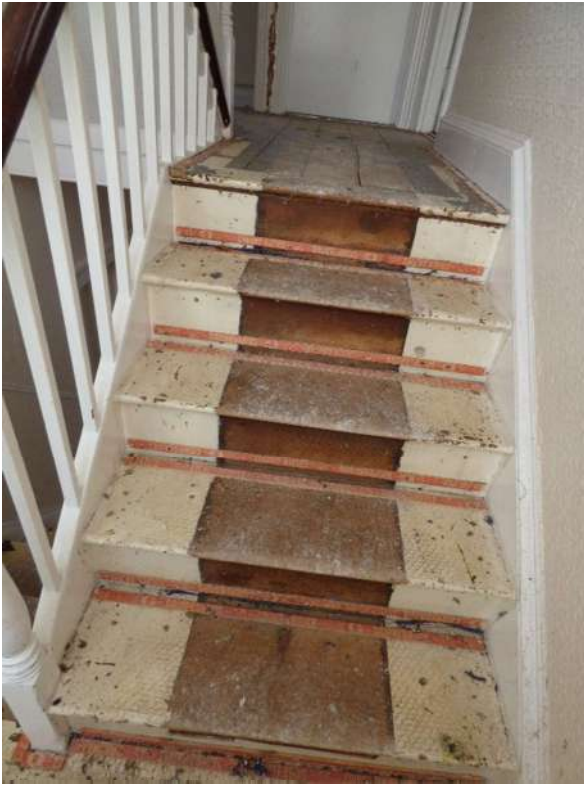
Retain original staircase, which is in good condition.

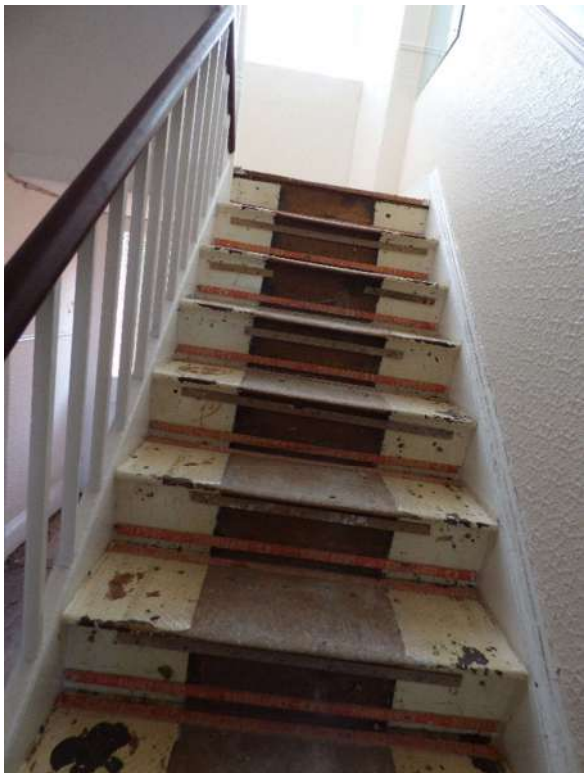
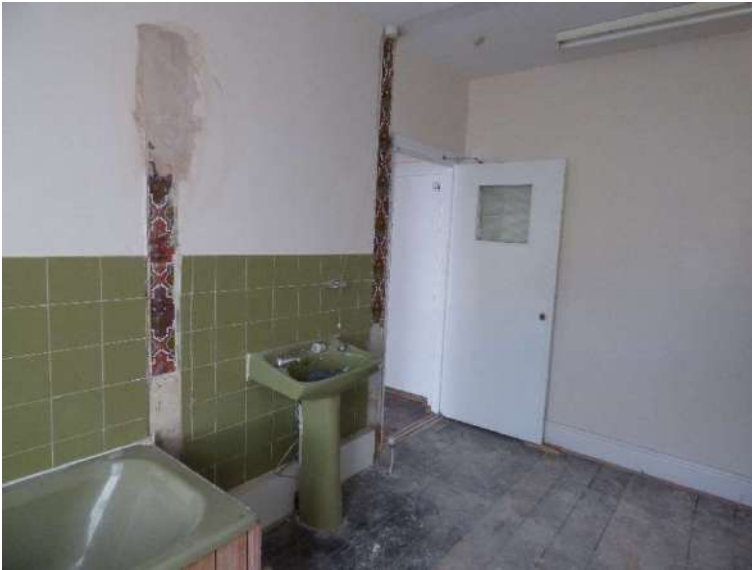
Bathroom at first floor:

Existing tiles, fixtures and fittings are currently being completely removed.

The existing ceiling will be made good with the installation of a new extract fan linked back to light switch

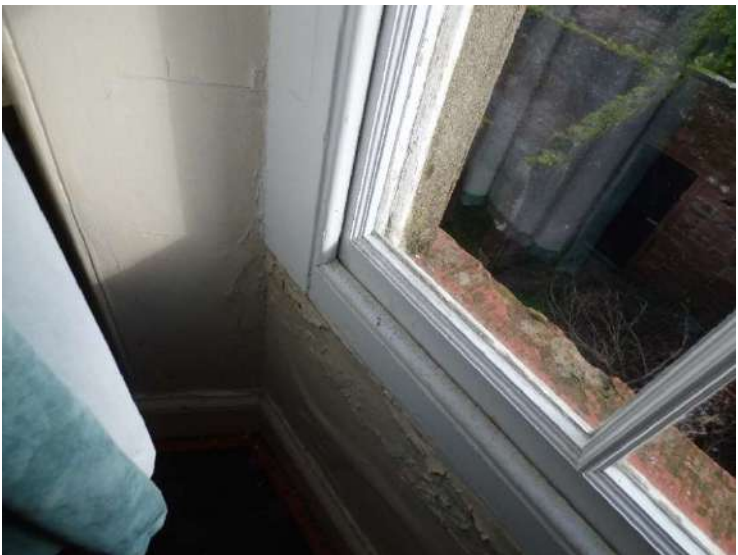
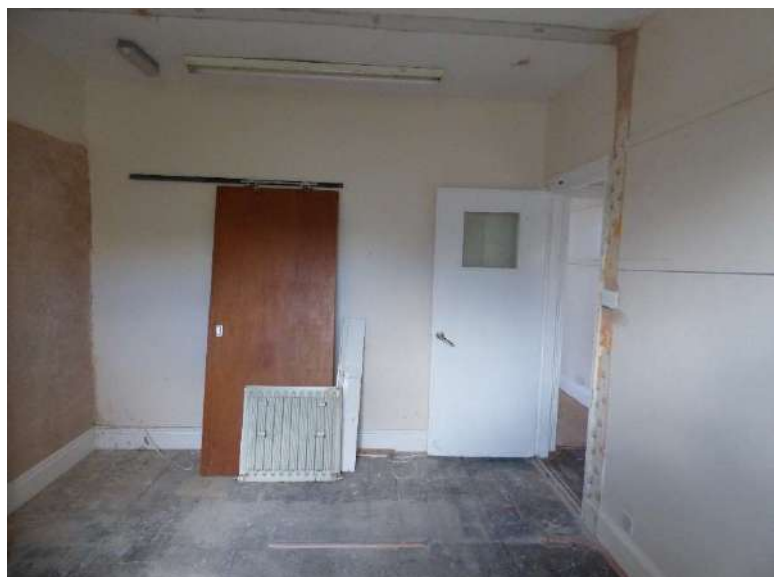
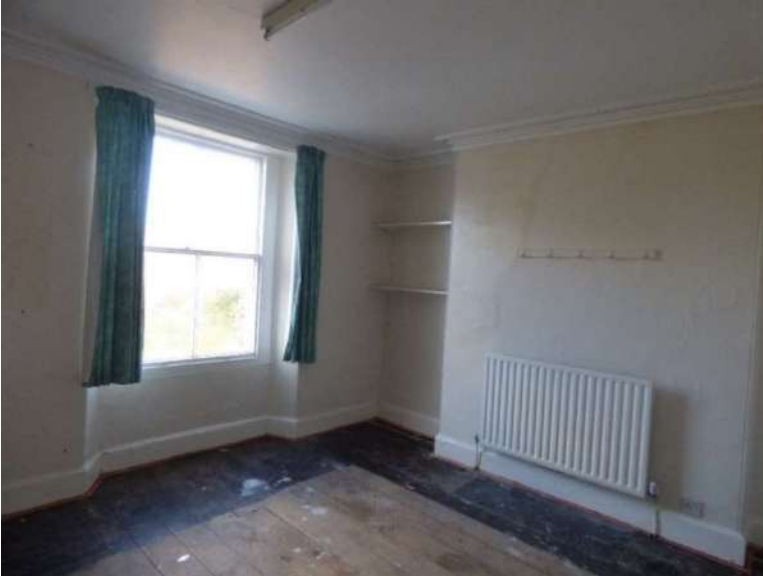
Existing floorboards in generally good condition.

Front bedroom (master) skirtings and architraves to be retained. Existing flush panelled door to be replaced with new Georgian heritage style 4 panel door to be provided and installed by specialist joinery company such as Batty Joinery Ltd.

Form new opening into new en-suite with new architraves and door to match the rest of the property.

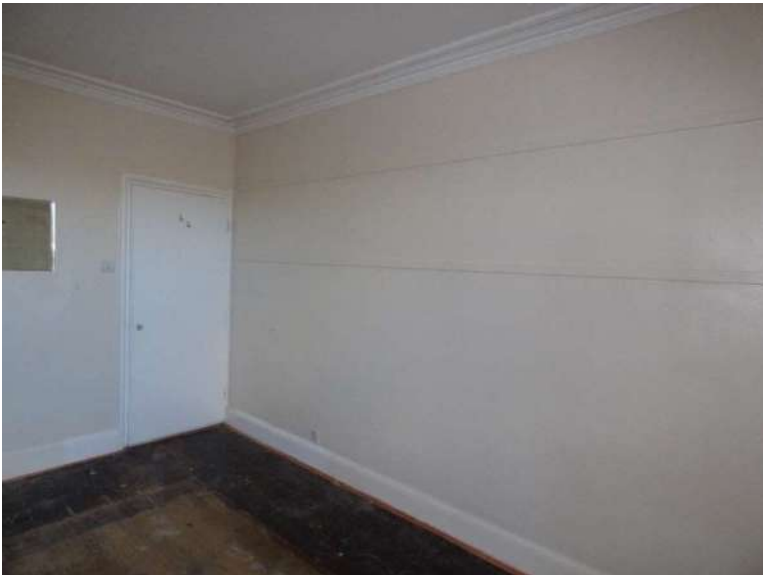
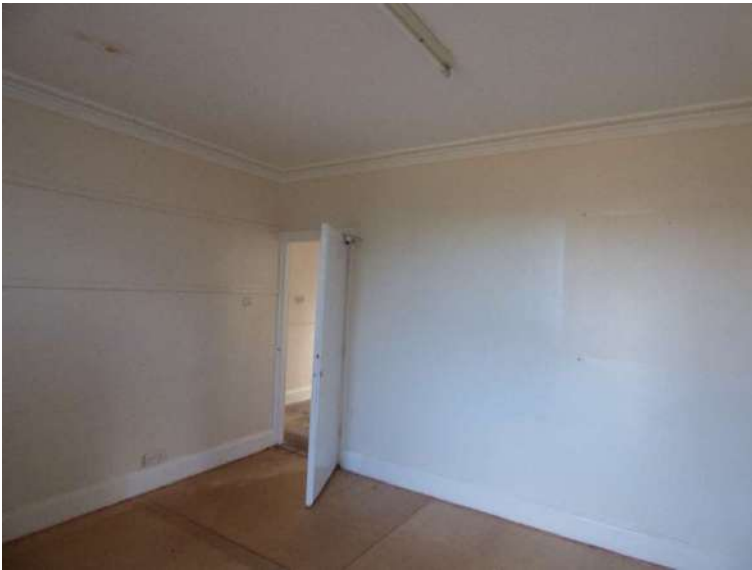
Existing floorboards have been concealed and over-boarded using large chipboard planks. It is proposed to lift the chipboard and evaluate the condition of the existing flooring underneath.

It is likely that the existing timber floorboards may require significant replacement, if this is the case, the floorboards will be replaced as required on a like for like basis.

Front bedroom skirtings and architraves to be retained. Existing flush panelled door to be replaced with new Georgian heritage style 4 panel door to be provided and installed by specialist joinery company such as Batty Joinery Ltd.

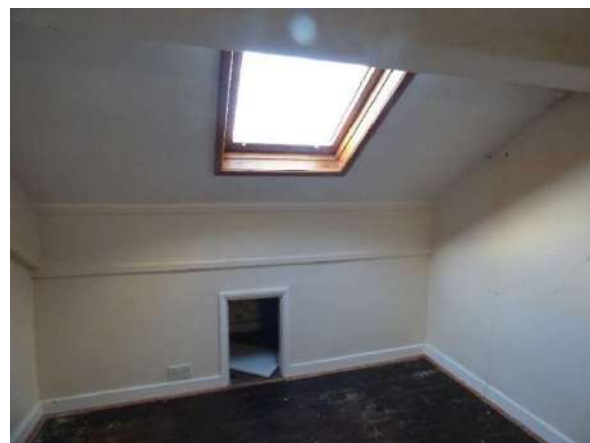
Floorboards are in good condition (but may require minor repairs)

Provide and install new heritage rooflight window to replace the existing modern rooflights.

Existing flush panel doors are to be removed and replaced with new heritage style 4 panel doors.

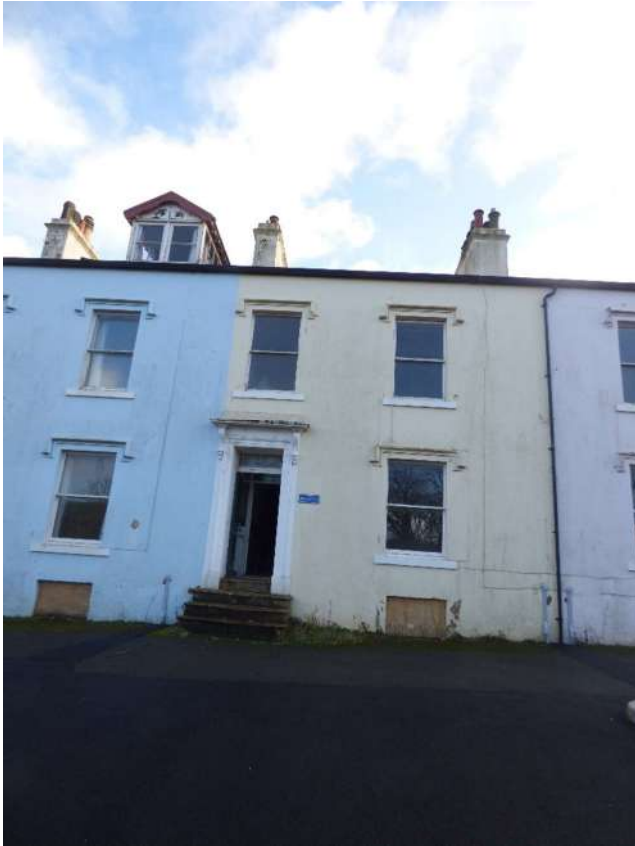
Left: The main entrance is mentioned in the listing text and is to be entirely retained.

Both front and rear elevations are currently rendered, with colour to the front and side and natural to the rear. All elevations require to be prepared for render repairs and redecoration by specialist using lime render and stucco (Parax LTD) to be applied by specialist.

The existing door and frame are to be retained and made good with the provision of new ironmongery. Once repaired full decoration will be undertaken.

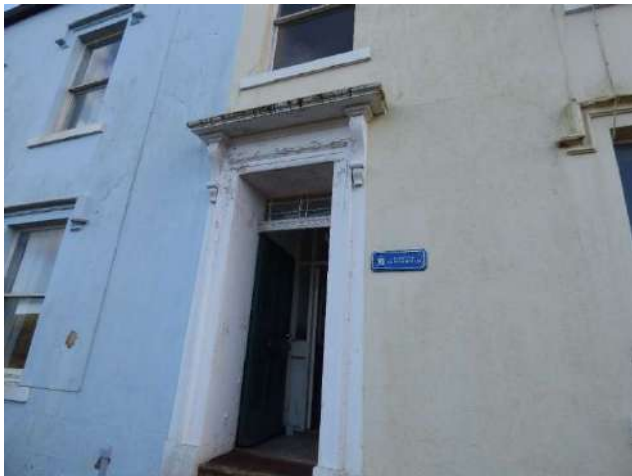
The blue plaque by the door states that this property was for the Lonsdale house Mistress. It is not proposed to retain this as it is a modern sign, and it is proposed to revert the property back to its historic purpose.

All existing single glazed windows to either be repaired / replaced subject to planning condition.

The existing stone steps to be cleaned up, and new painted metal handrails provided, that would have originally been installed.

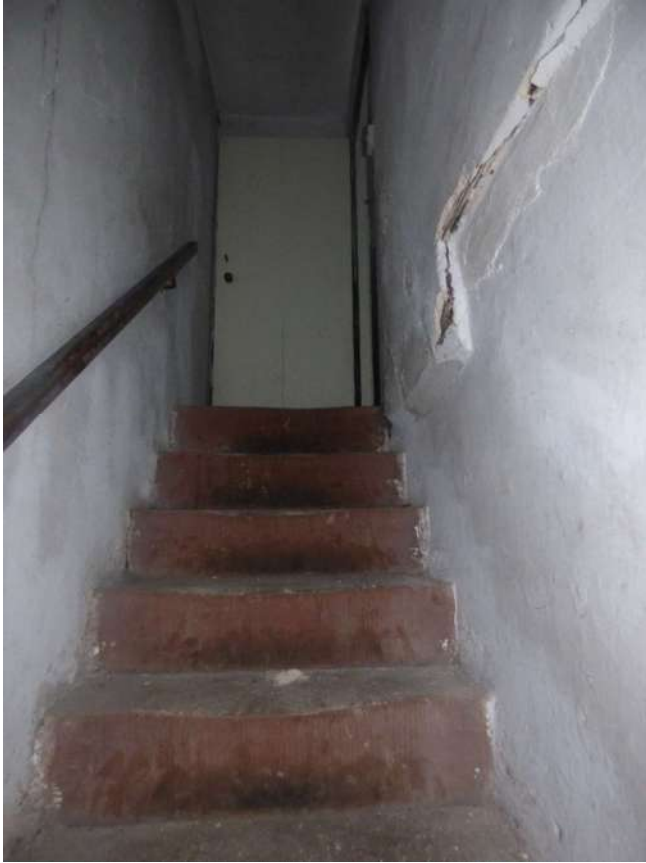
Left: The basement.

The existing walls and floor are generally in sound condition so would be suitable for the application of damp proof slurry system. All existing paint and surface finishes must be removed and made good including all snots removed, and damage to existing surfaces, prior to the installation of a Koster Polysil NB1.

The walls down to the basement also require full treatment.

In the basement all existing services are to be carefully stripped out and replaced with new compliant infrastructure.

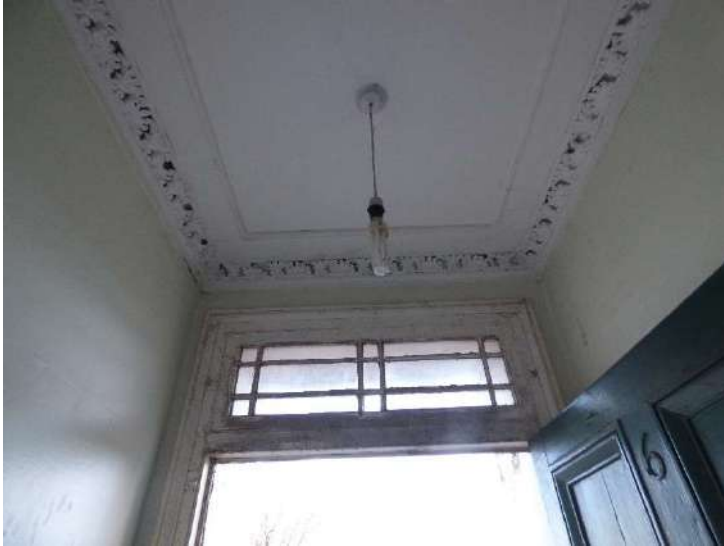
Left: Entrance, hall, and stairs.

The existing walls and floor are generally in good condition.

Redundant M&E to be removed and wall/ceiling finishes made good, and primed and fully decorated.

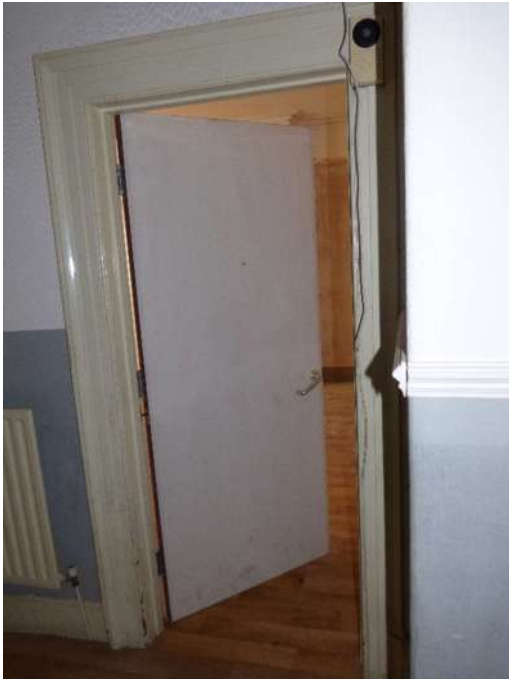
Left: Period features to be retained, including archway and architraves. (Modern lighting to all be stripped out and make good surfaces). All architraves and plaster features to be retained.
