# HERITAGE STATEMENT

## FULL RENOVATION OF EXISTING No 11 TERRACE HOUSES

St Bees, 1-11 Lonsdale Terrace, Parish Council, Cumbria

M.A.C Architects, Project Number: 2019:303

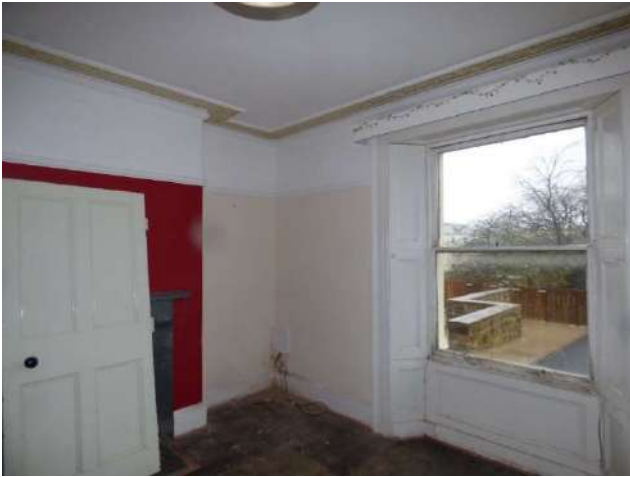
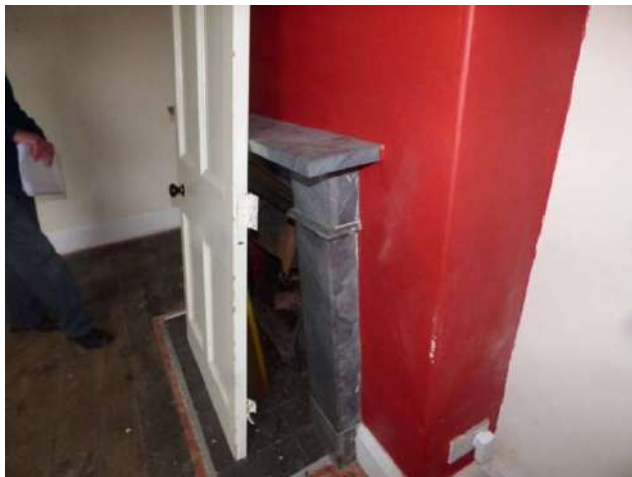
Left: Existing lounge architraves, cornices, and skirtings to be retained and repaired where hairline cracks have appeared.

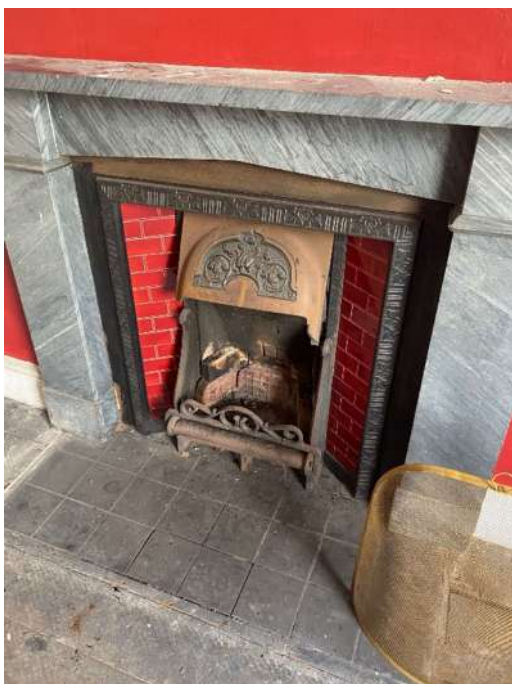
Left: The existing fireplace is to be retained, however it is proposed to replace the surround and tiles (which are not original), with a more in keeping traditional fire surround with traditional tiles that reflect the period of the property.

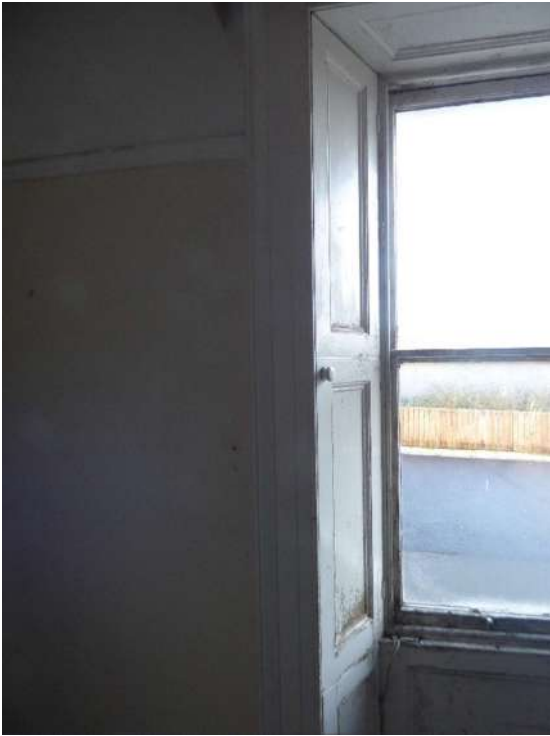
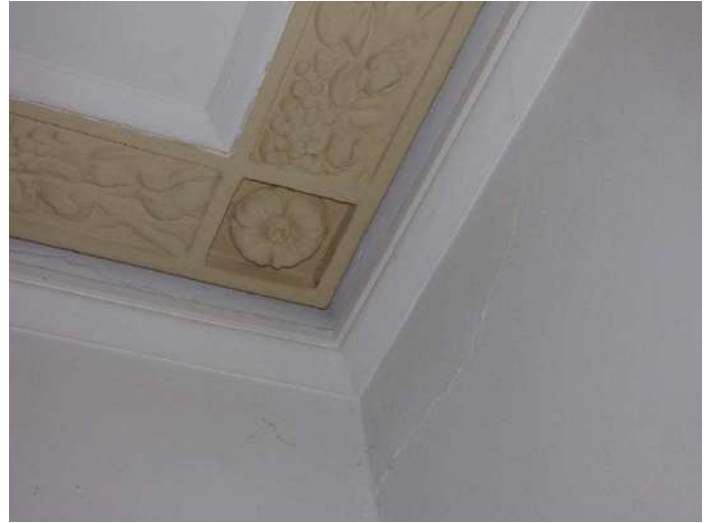
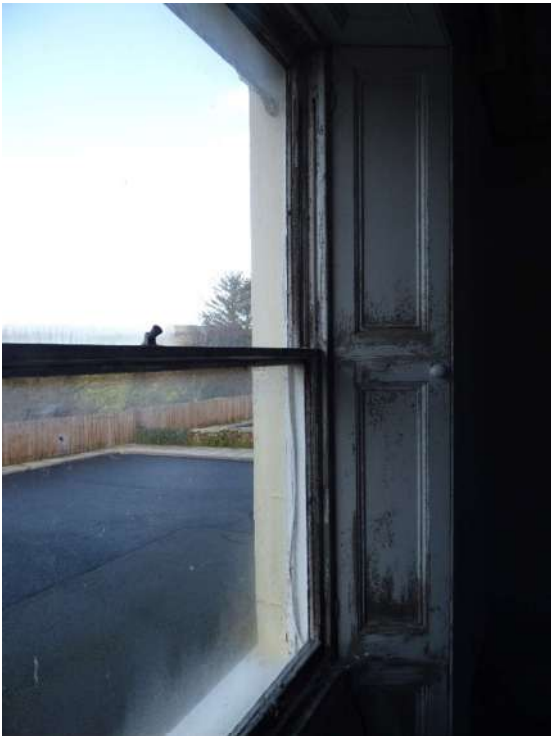
In the existing lounge, the period features below and to the sides of the existing windows both front and back are in good condition, it is proposed to carefully refurbish the existing timber shutters.

Existing cornice to be made good in locations where redundant services are to be removed and where hairline cracks have appeared.

Existing architraves and skirtings to be retained and made good.

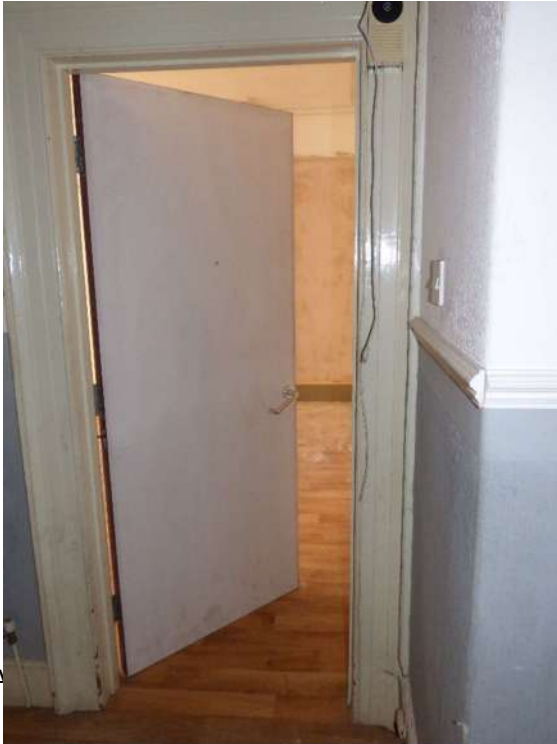
The dining room requires repairs to the ceiling and walls affected by damp ingress.

Flush panel doors to be replaced with heritage style four panel painted timber fire doors to enhance heritage asset. Where possible it is proposed to refurbish any original doors with door closers and intumescent paint subject to building control approval.

Blown plaster will be removed and replaced with lime plaster.

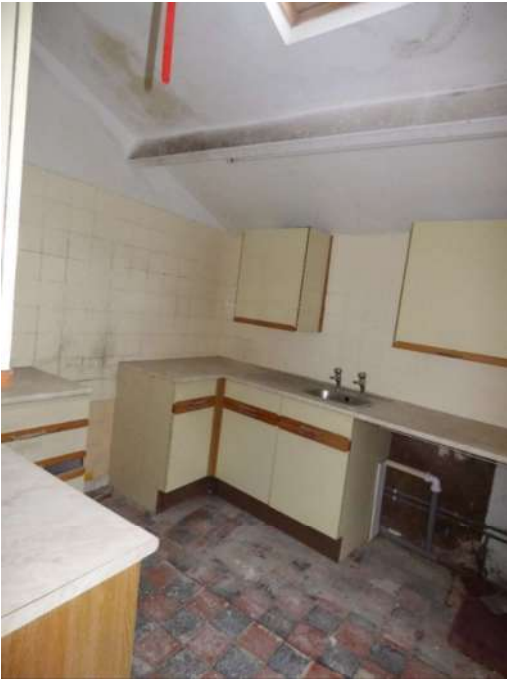
Left: Existing utility spaces to be fully renovated.

All damp and damaged/blown plasterwork and repair with lime plaster (Solo lime plaster from Lime Centre).and skim and decorate throughout.

Apply an insulated plasterboard 62mm thick to underside of ceiling. The Laminated plasterboard and PIR has a vapour barrier incorporated so interstitial moisture would be prevented. New heritage style rooflights to replace existing modern style rooflights and to be installed with flashing kit that mounts unit

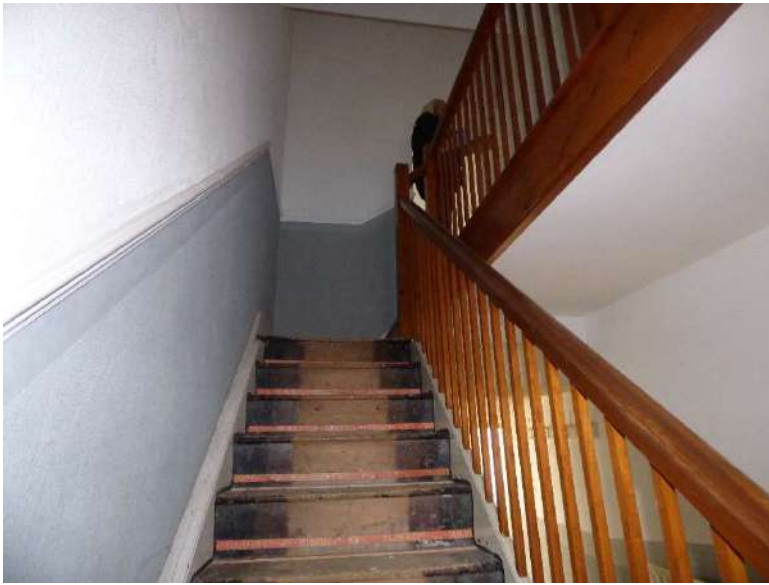
Left Retain staircase, which although not original is in good condition. Its is proposed to redecorate.

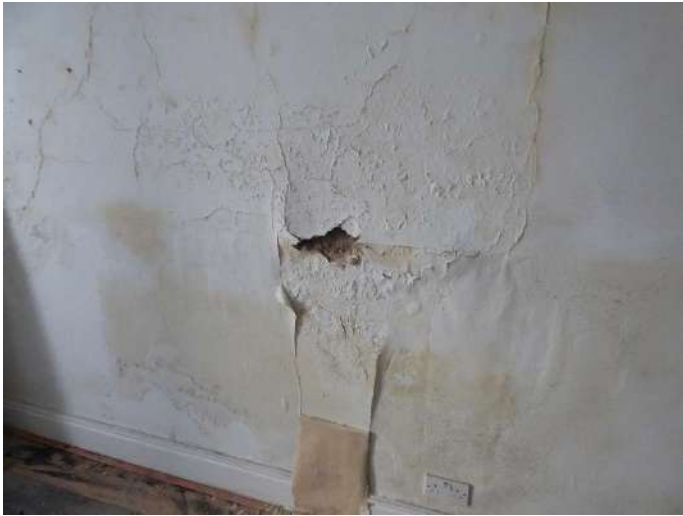
Existing rear bedroom requires considerable plaster repair work, due to damp ingress. Remove all damp and damaged / blown plasterwork and repair with lime plaster (Solo lime plaster from Lime Centre).

Lath and plaster generally requires repair and damaged plasterwork will require specialist reinstatement.

Existing flush panel door to be replaced with new Georgian heritage style 4 panel door to be provided and installed by specialist Joinery Company such as Batty Joinery Ltd. Where possible it is proposed to refurbish any original doors with door closers and intumescent paint subject to building control approval.

Skirtings to be repaired / replaced to match existing as required.

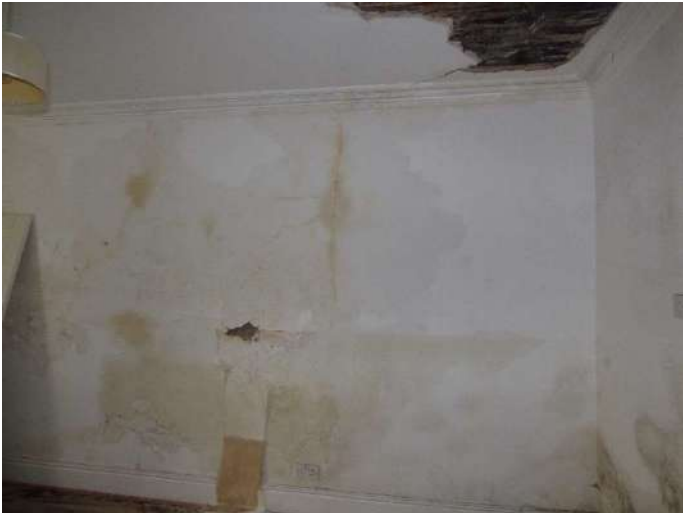
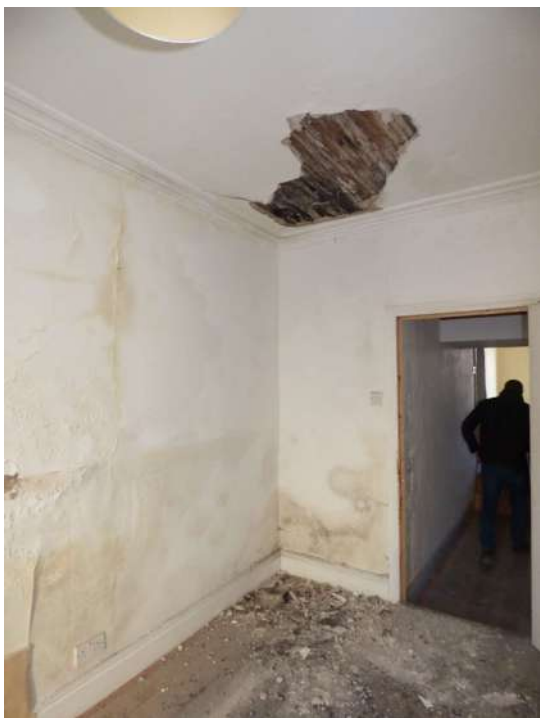
Left: Damp ingress to be resolved by repairs to external wall and render. Blown plaster to be removed and new plastering to be undertaken using lime plaster (Solo lime plaster from Lime Centre).

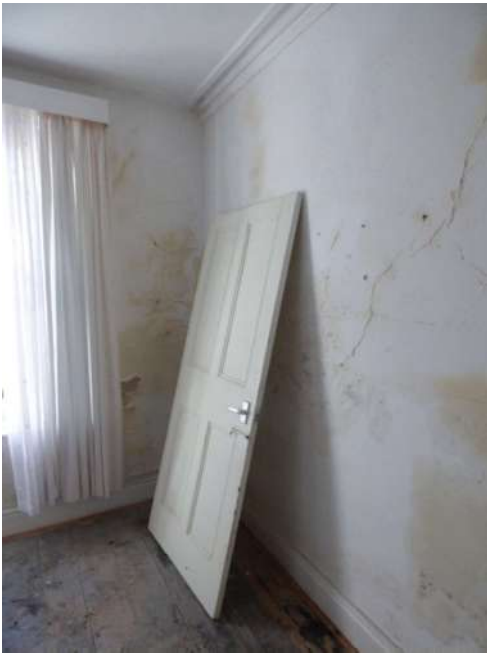
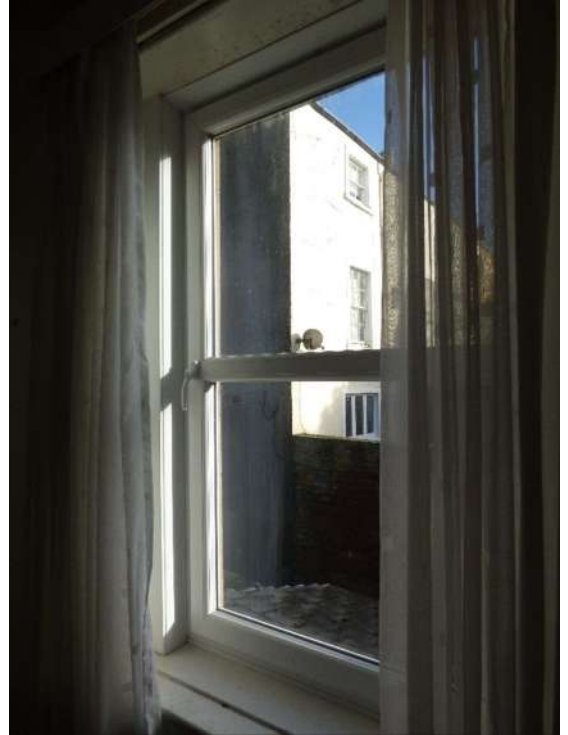
Above, right, and below: Rear bedroom skirtings, cornices and architraves to be retained. Flush panel door to be replaced with new Georgian heritage style 4 panel door to be provided and installed by specialist joinery company such as Batty joinery ltd.

Existing floorboards in generally good condition, with minor repairs being required. Damaged floorboards to be replaced with boards to match existing.

Where possible it is proposed to refurbish any original doors with door closers and intumescent paint subject to building control approval.

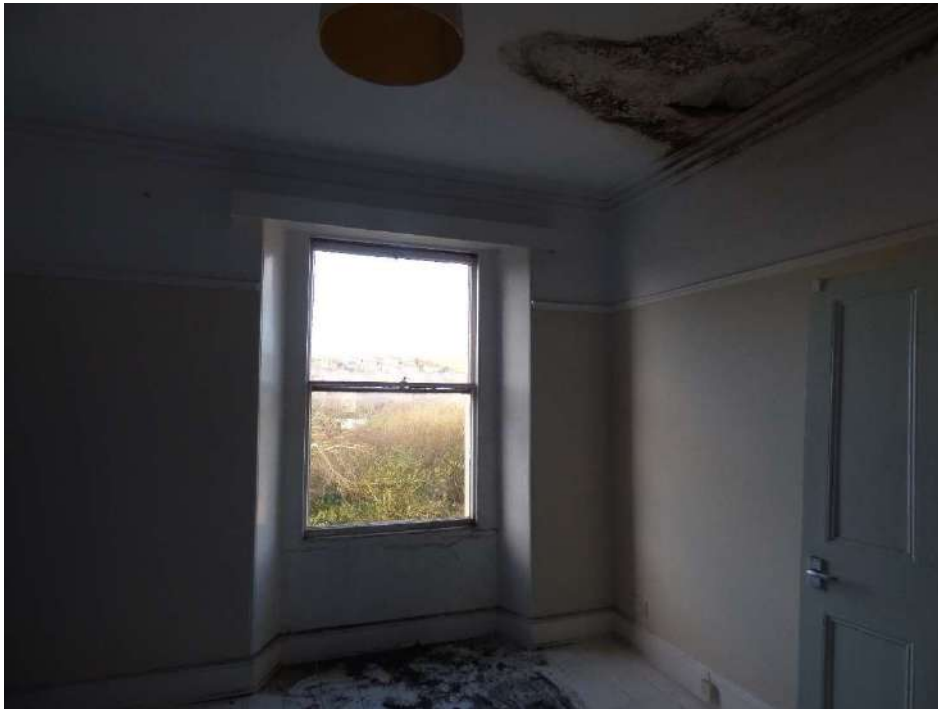
Front bedroom (First floor LHS) cornice, skirtings, and architraves to be retained. Existing flush panelled door to be replaced with new Georgian heritage style 4 panelled door to be provided and installed by specialist joinery company such as Batty Joinery Ltd.

Damaged lath and plaster ceilings to be repaired and restored.

Existing floorboards in good condition.

Where possible it is proposed to refurbish any original doors with door closers and intumescent paint subject to building control approval.

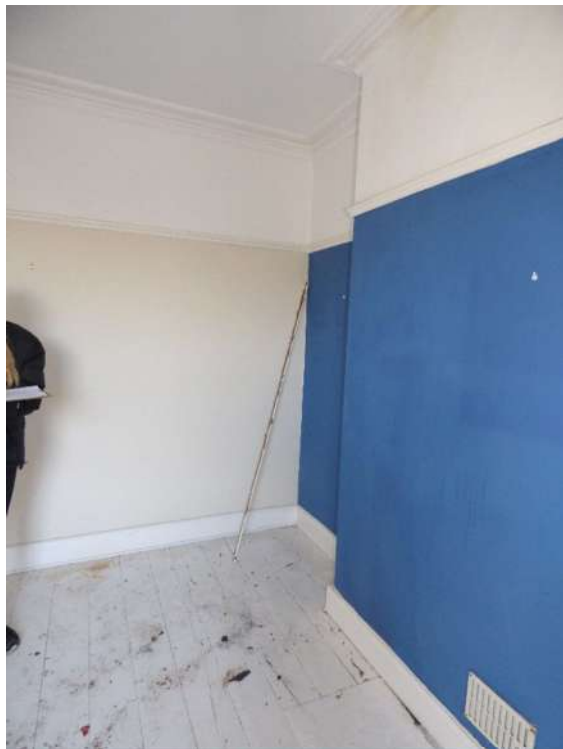
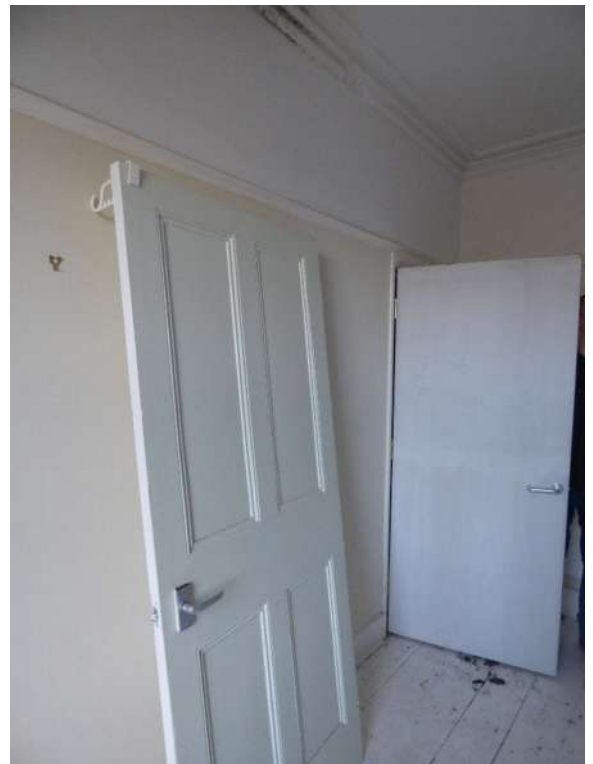
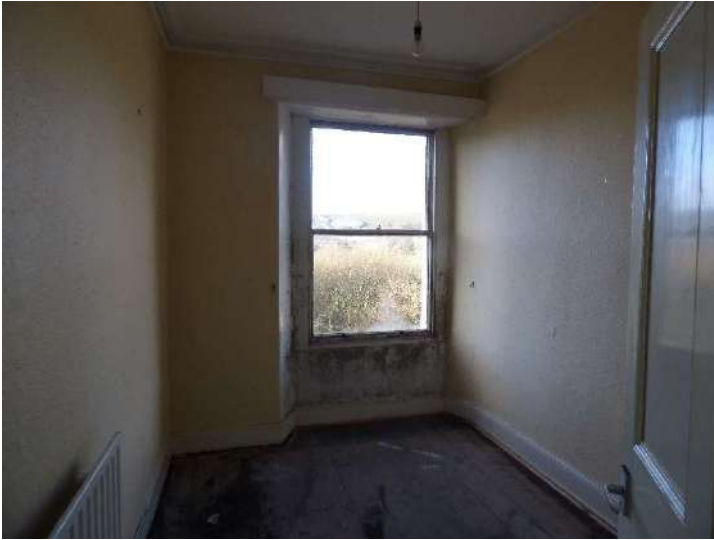
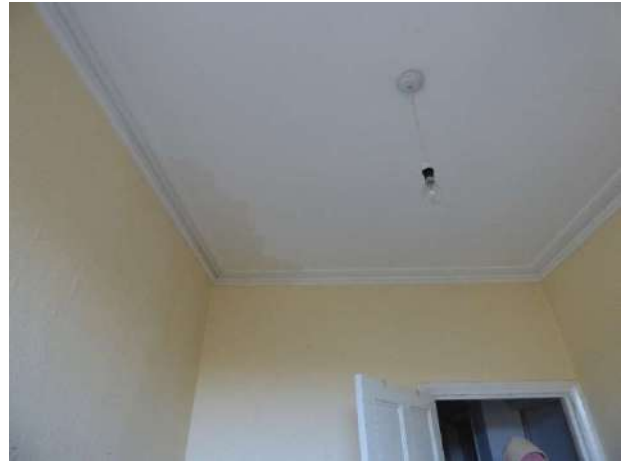
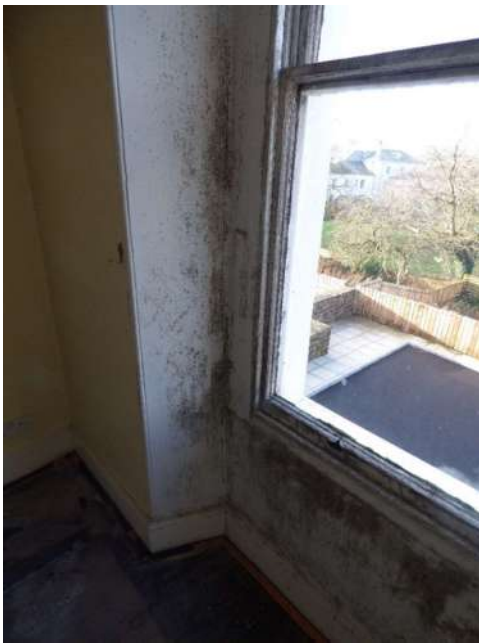
Existing floorboards generally in good condition

Front bedroom (First floor RHS), cornices, skirtings and architraves to be retained. Existing flush panelled door to be replaced with new Georgian heritage style 4 panelled fire door to be provided and installed by specialist joinery company such as Batty Joinery Ltd. Where possible it is proposed to refurbish any original doors with door closers and intumescent paint subject to building control approval.

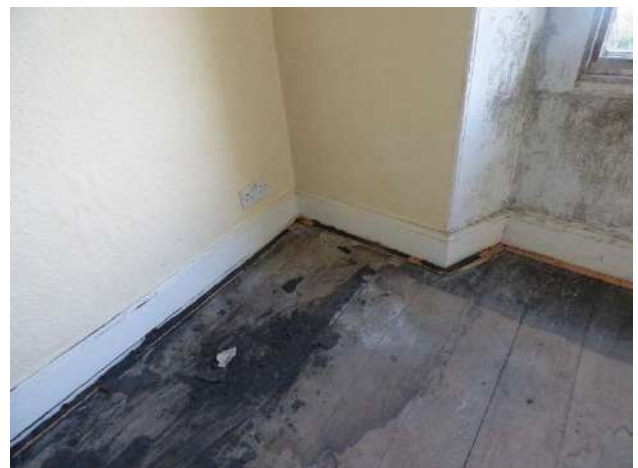
Left: Damp ingress around windows has blown the existing plaster. It is proposed to replace damaged plaster with lime plaster.

Damp damage to plaster ceiling to be removed and reinstated. Any damage to lath and plaster to be repaired by specialist.

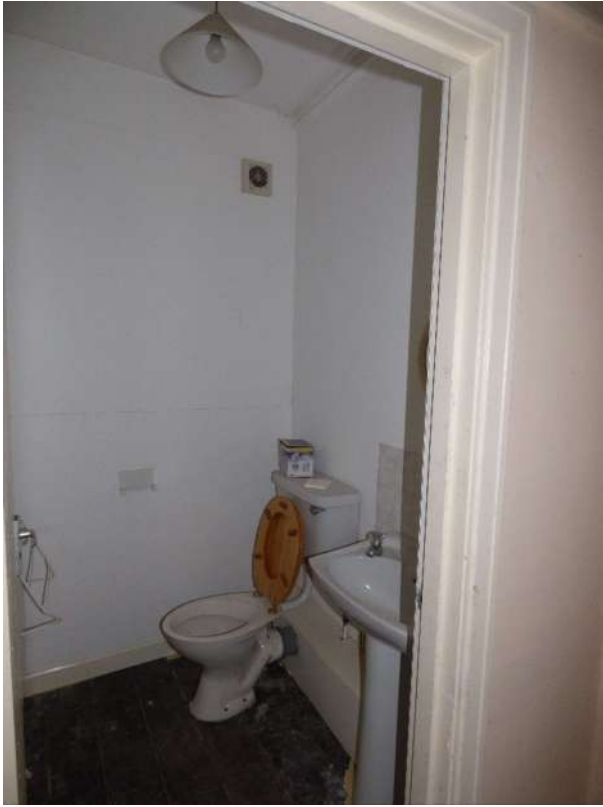
Partitions are not original.

Existing w.c. to be removed and landing area to be reconfigured.

Floors to be made good using timber floorboards to match existing.

All finishes to be made good, and skirtings to match the original to be installed.

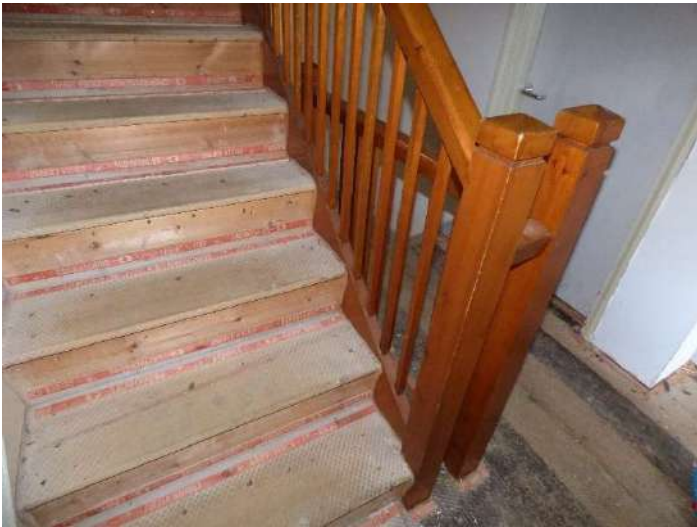
Balustrading is not original but will be retained and decorated to be in keeping with the property.

New handrail and balusters to be installed where railings have been installed (below), and half landing returned to former layout.

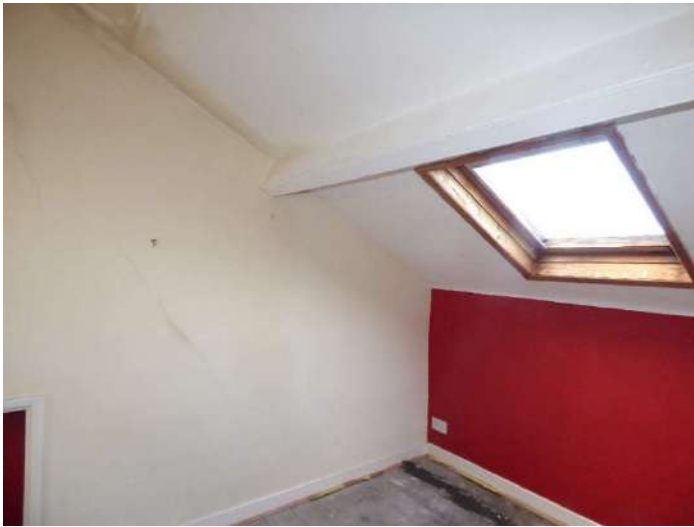
Left and below: Attic bedroom.

Areas of water ingress to be investigated and roof repairs undertaken a necessary.

Bedrooms to be reconfigured to improve the space at second floor.

In the bedroom all damp and damaged/blown plasterwork will be repaired with lime plaster (Solo lime plaster from Lime Centre). and skim and decorate throughout.

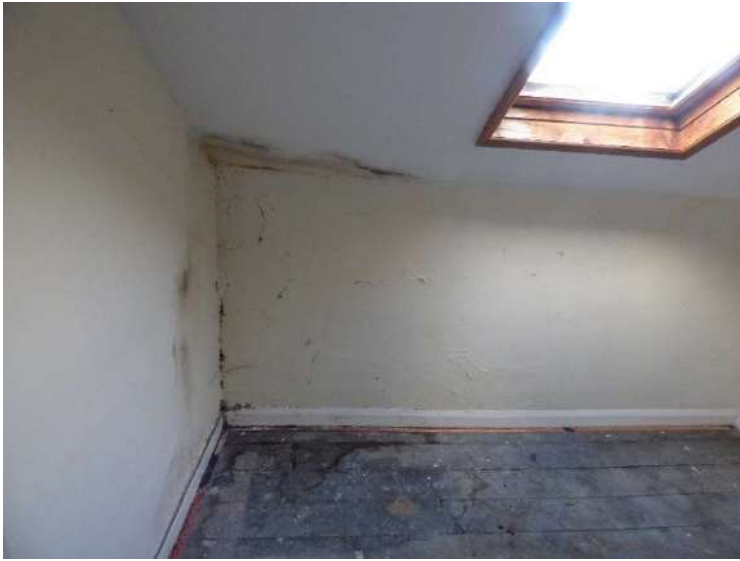
Left and below: Small attic bedroom.

Areas of water ingress to be investigated and roof repairs undertaken a necessary.

Bedrooms to be reconfigured to improve the space at second floor.

In the bedroom all damp and damaged/blown plasterwork will be repaired with lime plaster (Solo lime plaster from Lime Centre) and skim and decorate

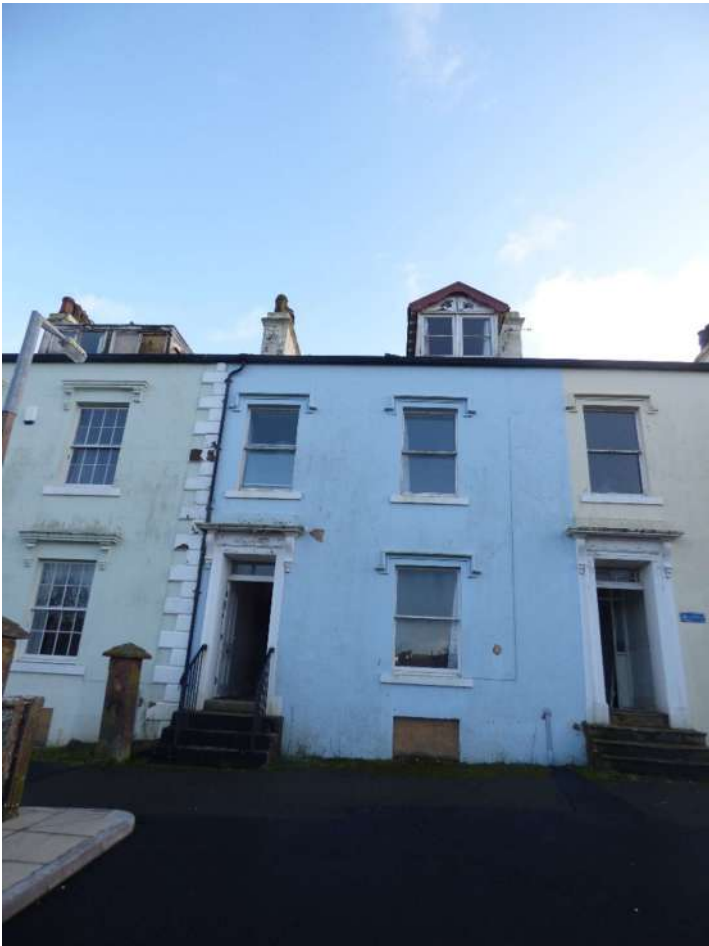
Left: The main entrance is mentioned in the listing text and is to be entirely retained.

Both front and rear elevations are currently rendered, with colour to the front and side and natural to the rear. All elevations require to be prepared for render repairs and redecoration by specialist using lime render and stucco (Parax LTD) to be applied by specialist.

The stucco features above the windows and door on the front elevation will be carefully restored by a specialist. Colour of all render and stucco to match existing.

The existing door and frame are to be retained and made good with the provision of new ironmongery. Once repaired full decoration will be undertaken.

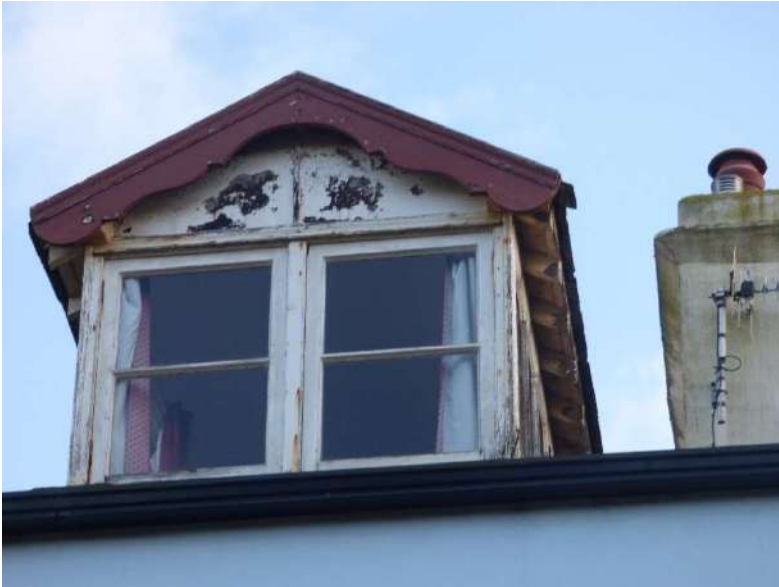
Existing dormer windows are in extremely poor condition. Considerable fabric damage internally has been the result of the extent of damage to these dormers. It is proposed to completely rebuild these in the same style as indicated on the proposed elevations with windows details of which are to be confirmed subject to planning condition.

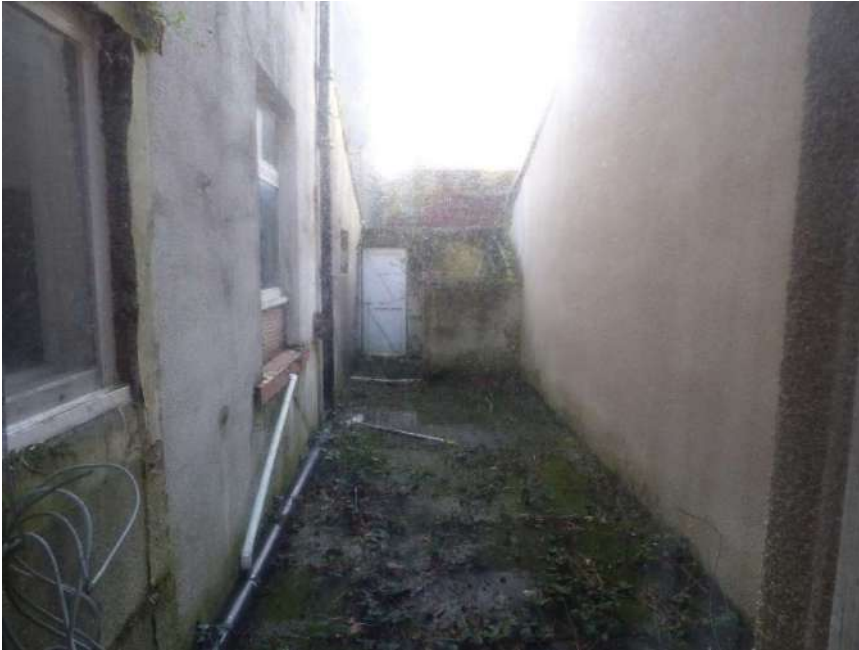
Modern timber / UPVC windows installed to the rear of the property, to be repaired / replaced subject to planning condition.

Existing external walls to be repaired with lime render and decorated off white, to create a more aesthetically pleasing rear courtyard area.

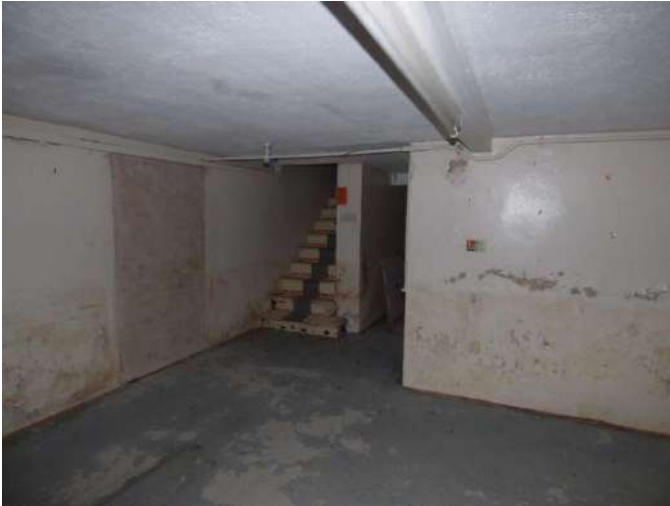
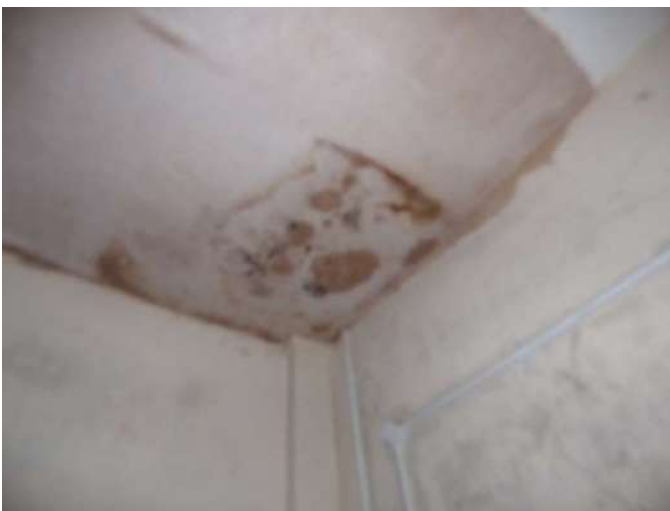
The existing basement walls and floor are generally in sound condition but suffering from damp ingress. It is proposed to protect the basement by the application of damp proof slurry system. All existing paint and surface finishes must be removed and made good including all snots removed and damage to existing surfaces, prior to the installation of a Koster Polysil NB1.

Koster NB1 is considered to be a type A waterproofing system as defined by BS8102:2009 and is generally used to seal the inside of basement structures, slabs and retaining walls. Koster NB1 works by both providing a physical barrier against water ingress as well as providing a migratory crystal sealant that penetrates deep into the structure to seal micropores and cracks against ingress.

The walls down to the basement also require the full treatment.

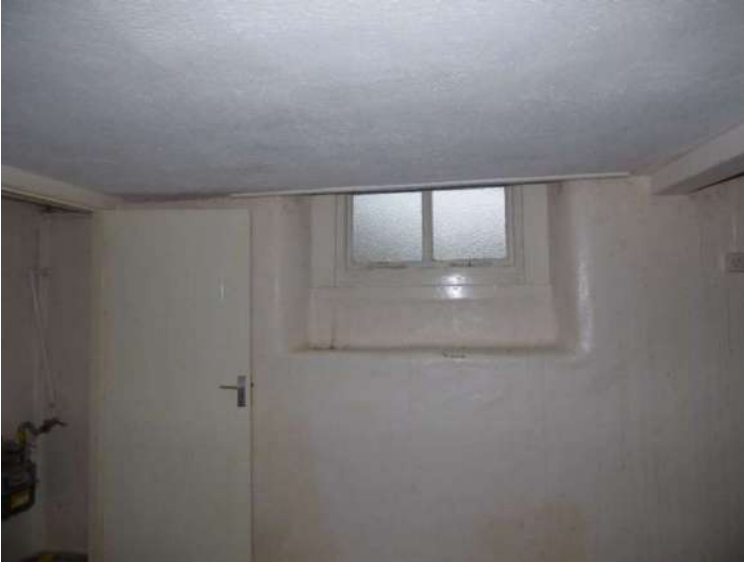
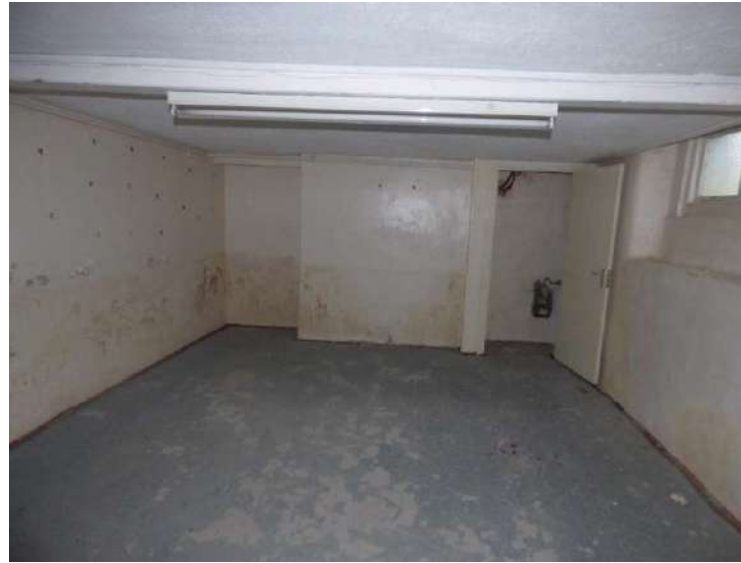
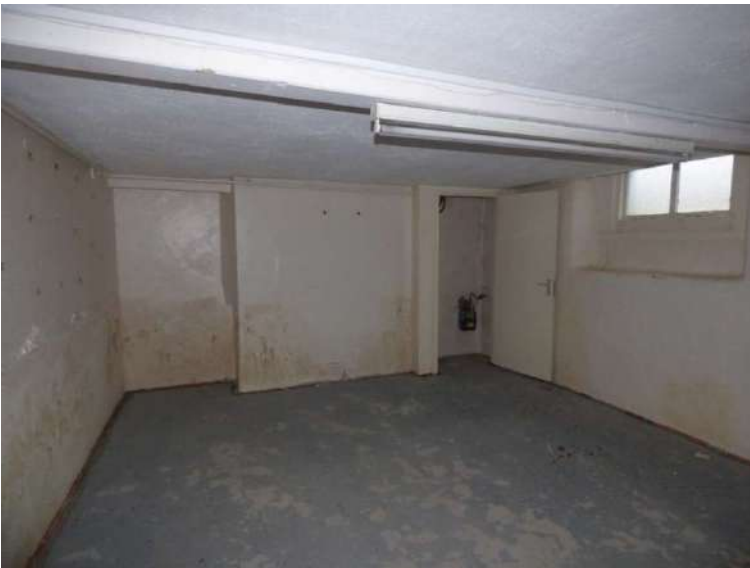
Views of basement to be renovated.

It is clear to identify where damp is penetrating the structure.

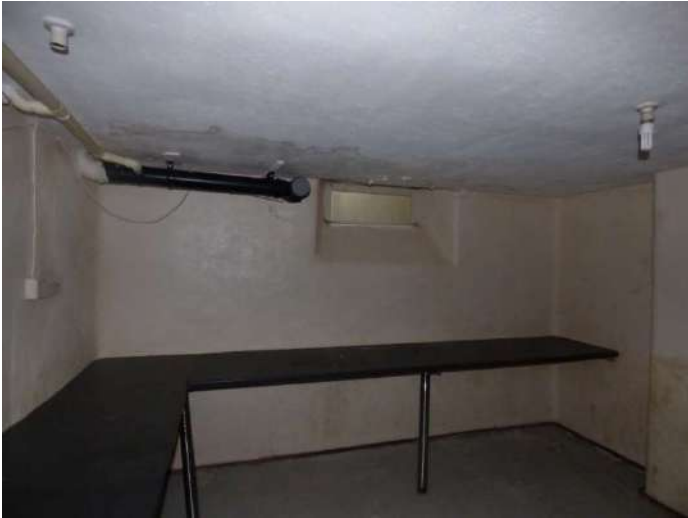
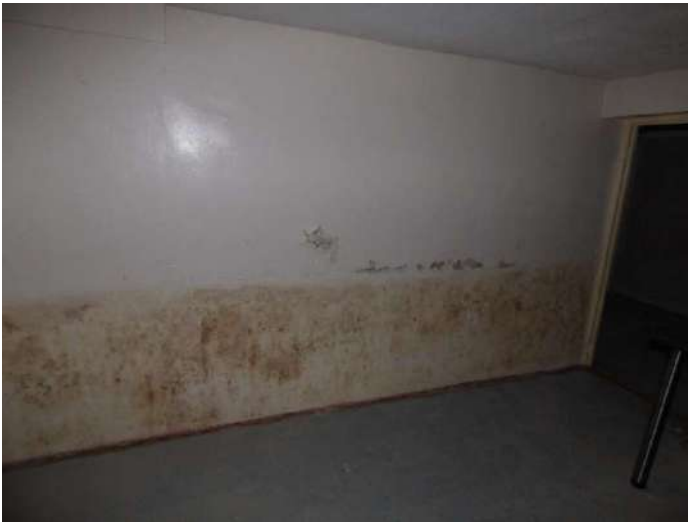
Views of basement to be renovated to create a dry area for basement storage.

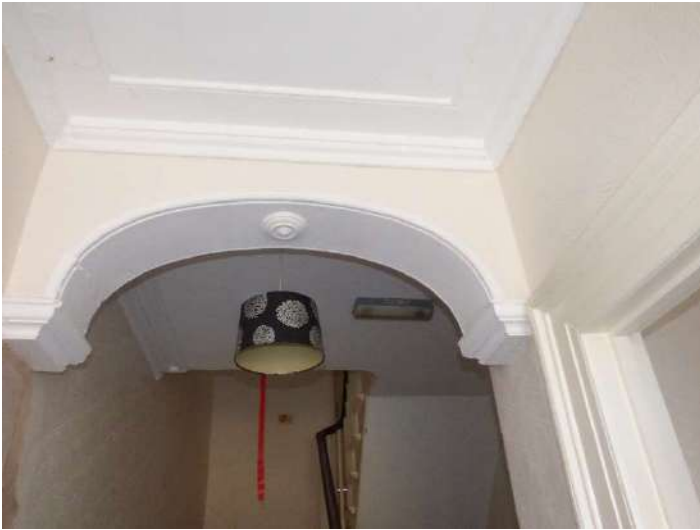
Left: Period features to be retained, including archway and architraves. (Modern lighting to all be stripped out and make good surfaces). All architraves and plaster features to be retained.

Original staircase to be retained.

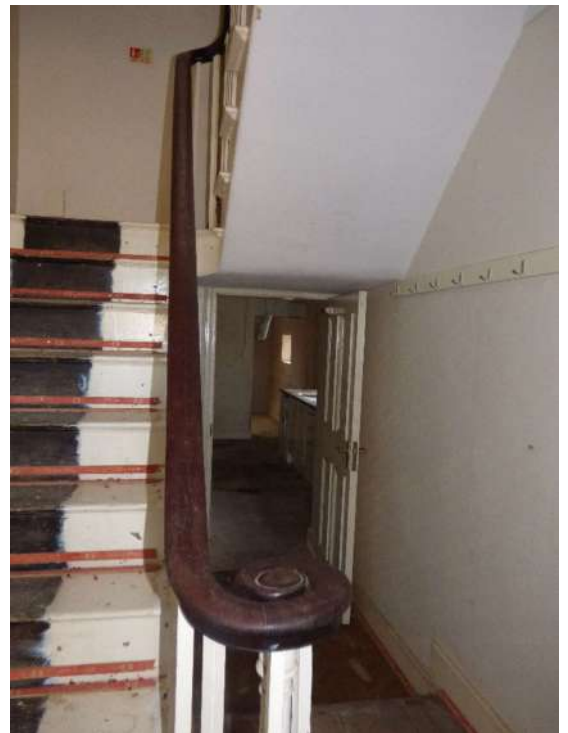
Left: Existing ramp to be removed and original step to be reinstated.

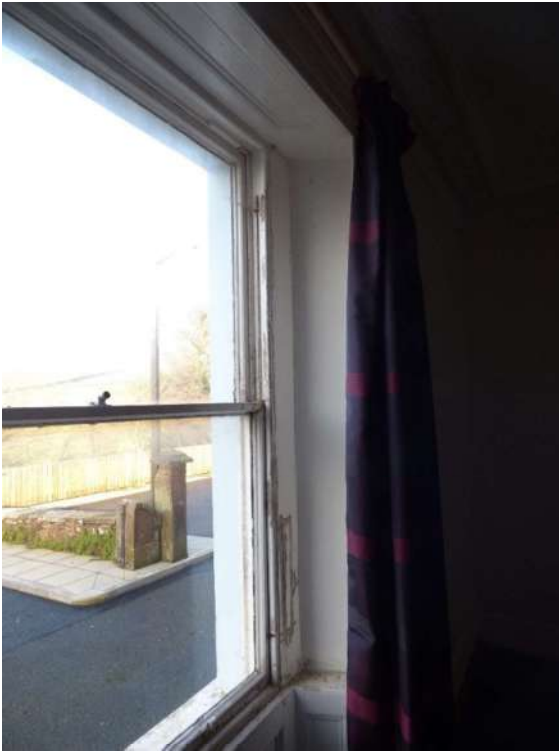
Left: In the existing lounge, the period features below and to the sides of the existing window are generally in good condition, it is proposed to carefully refurbish the existing timber shutters, which require careful minor repairs by a specialist.

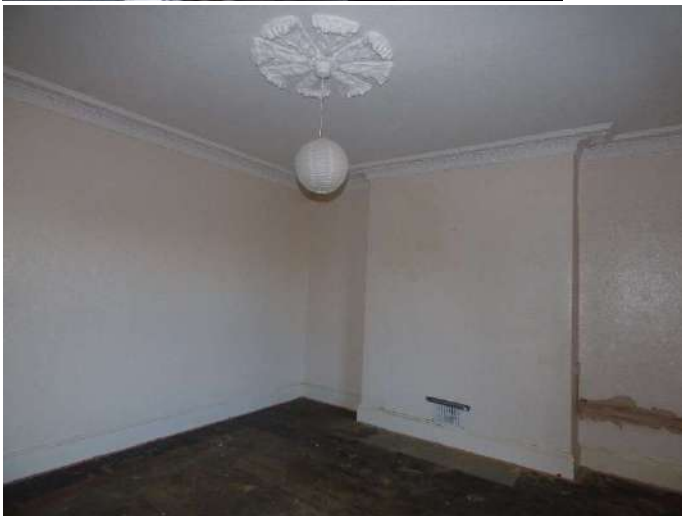
Left: Existing cornice to be made good in locations where redundant services are to be removed and where hairline cracks have appeared.

Existing architraves and skirtings to be retained and made good.

Flush panel doors to be replaced with heritage style 4 panel painted timber fire doors to enhance heritage asset, unless the existing can be suitably refurbished and then an apply an intumescent paint.

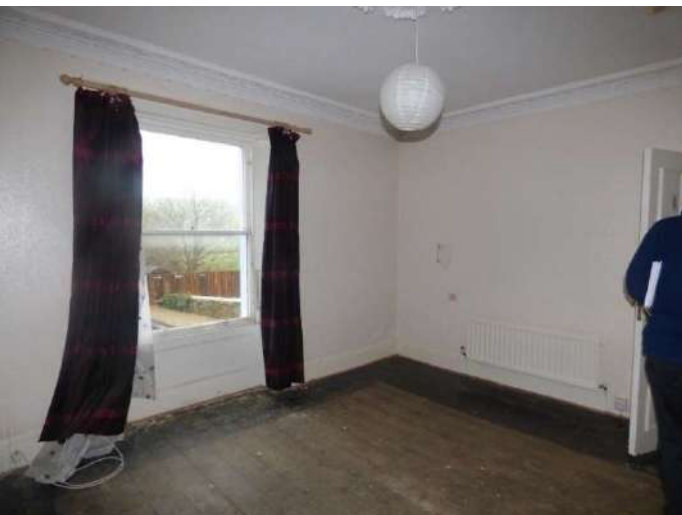
Right: Existing cornice is in excellent condition.

Existing architraves and skirtings to be retained and made good, where required.

Retain existing ceiling rose.

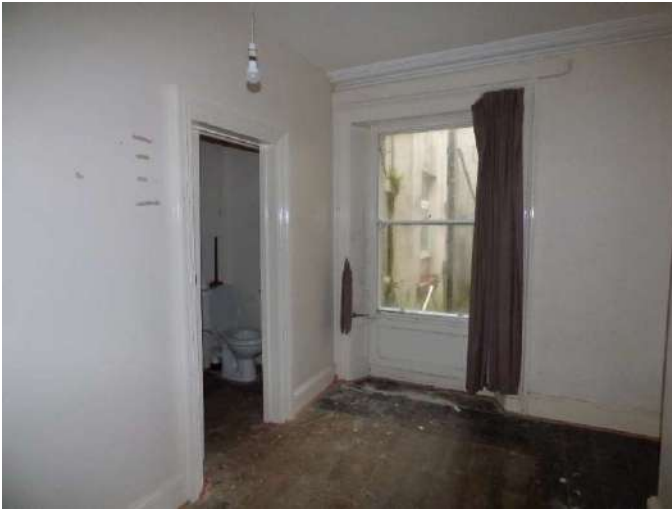
Left: In the existing dining room, the period features below and to the sides of the existing windows are in good condition, it is proposed to carefully refurbish the existing timber shutters.

Existing cornice to be made good in locations where redundant services are to be removed, here the stud partition to a bathroom has been installed and where

Flush panel doors to be replaced with heritage style 4 panel timber fire doors to enhance the heritage asset. Where possible it is proposed to refurbish any original doors with door closers and intumescent paint subject to building control approval.

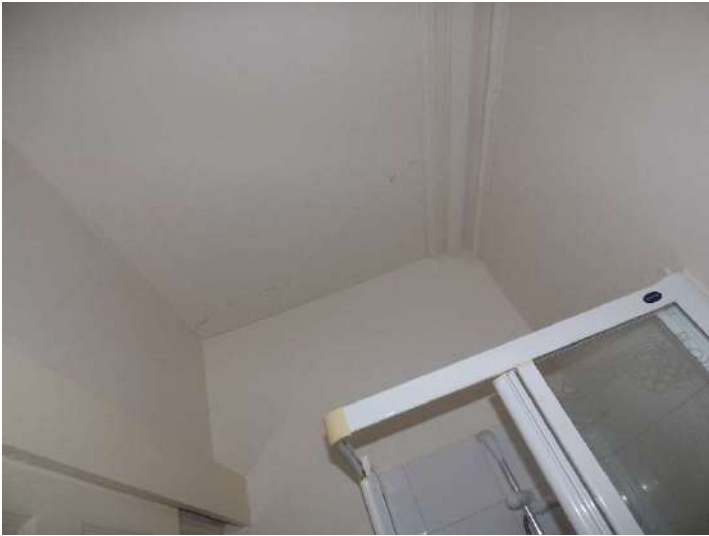
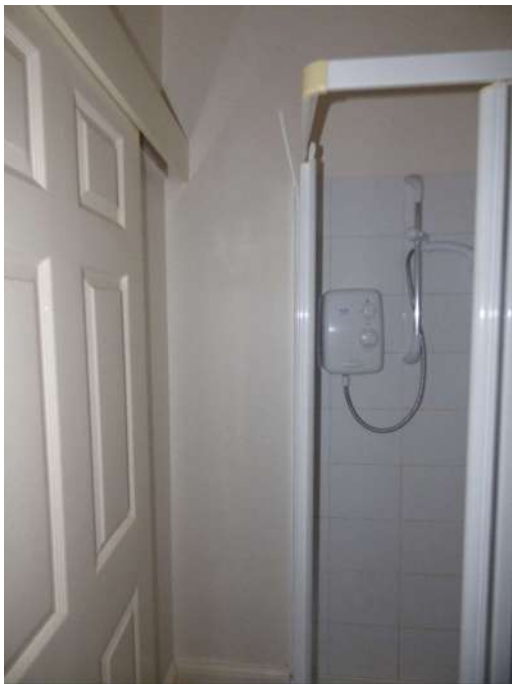
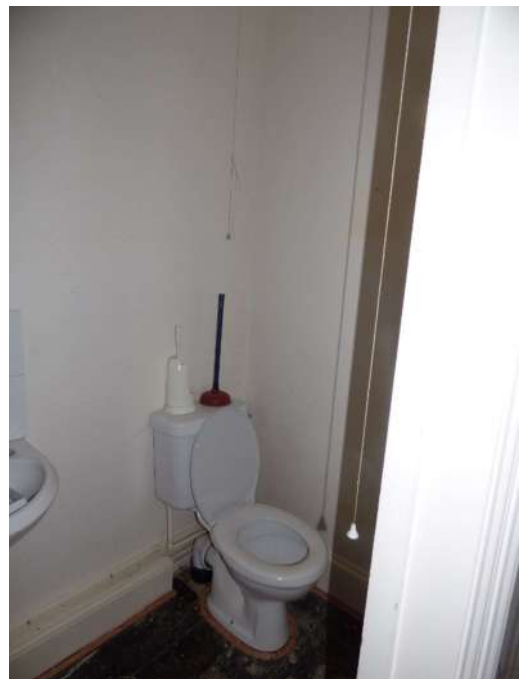
Left and below: Existing bathroom to be completely removed including stud partitions.

Cornices and skirtings to be made good where partitions removed.

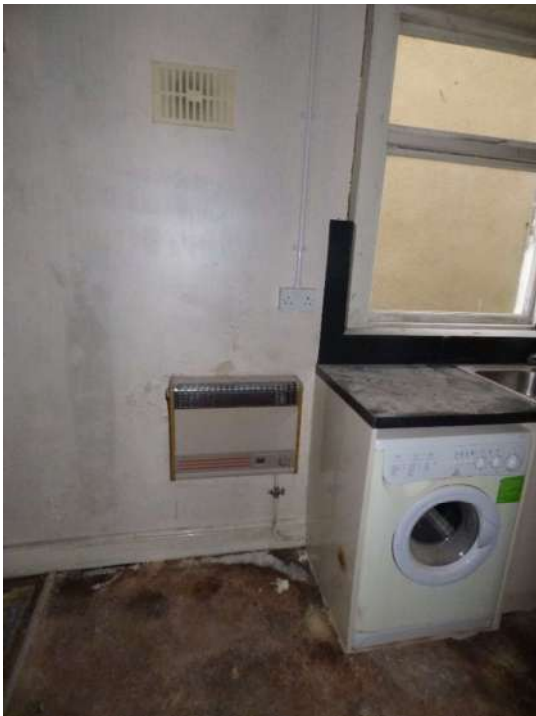
Left and below; In the existing kitchen, the existing kitchen will be completely removed. The existing modern single glazed windows will be replaced / repaired subject to planning condition. The existing floor has been over-boarded with a ply decking. It is proposed to lift the ply decking and examine the original floors. It is proposed to apply water resistant chipboard, subject to the sub floor and the condition of the joists etc which may require replacement.

Existing services to be removed and walls, and ceilings made good.

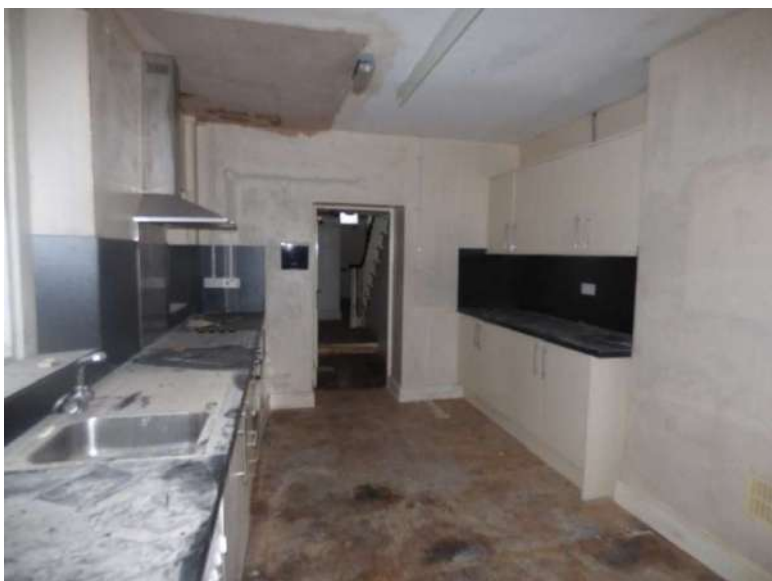
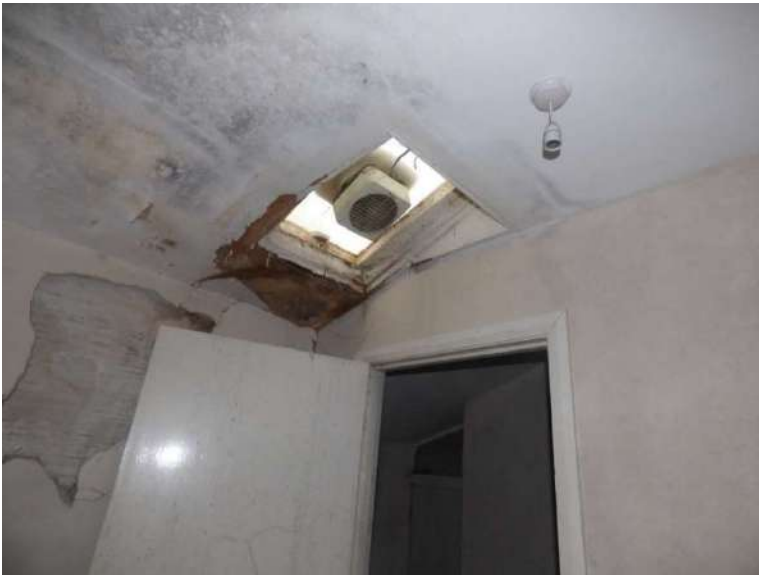
Above: Existing utility and WC to be reconfigured.

Blown plasterwork to be removed and reinstated with lime plaster and skim finish.

Apply an insulated plasterboard 62mm thick to underside of ceiling. The Laminated plasterboard and PIR has a vapour barrier incorporated so interstitial moisture would be prevented. New rooflights to be installed with flashing kit that mounts unit flush with the roof surface.

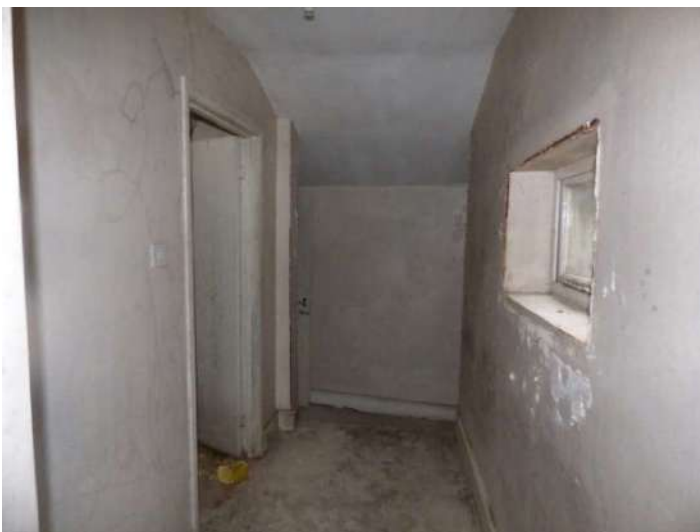
Below: Roof above utility and w.c. requires significant repairs to slate roof and to lead flashings (which require replacement). Blown plasterwork to be removed and reinstated with lime plaster and skim finish. (Solo lime plaster from Lime Centre).

Apply an insulated plasterboard 62mm thick to underside of ceiling. The Laminated plasterboard and PIR has a vapour barrier incorporated so interstitial moisture would be prevented. New rooflights to be installed with flashing kit that mounts unit flush with the roof surface.

All walls, floor, ceilings to be made good and prepared for full decoration.

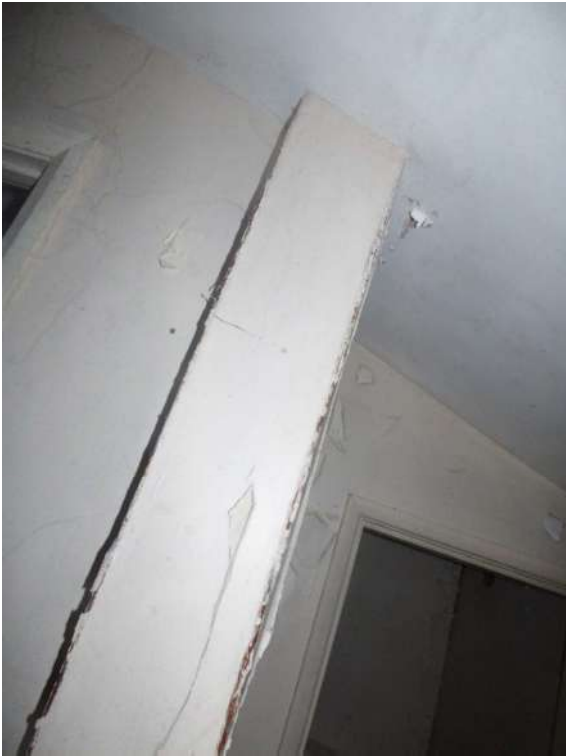
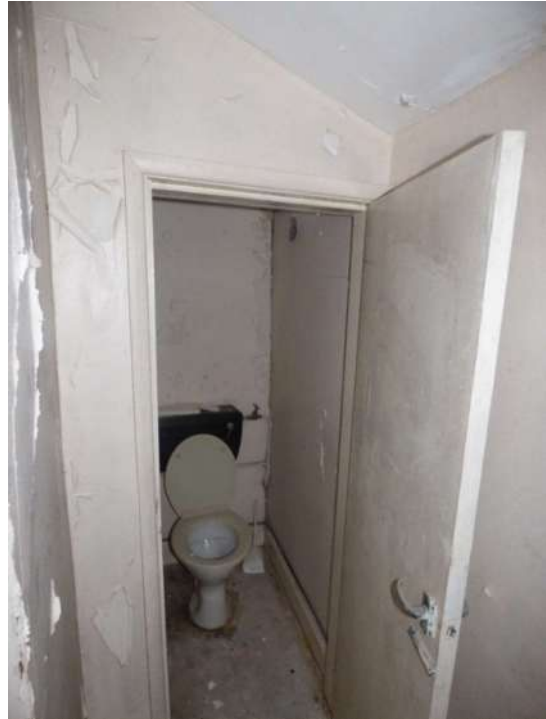
Above and below: Existing wc to be removed, as part of the reconfiguration of the area, and new sanitaryware to be provided. All walls, floor, ceilings to be made good and prepared for full decoration.

Existing rear door to be removed and replaced with a new hardwood painted door to match the front door (in style), and Georgian style ironmongery.
