# HERITAGE STATEMENT

## FULL RENOVATION OF EXISTING No 11 TERRACE HOUSES

St Bees, 1-11 Lonsdale Terrace, Parish Council, Cumbria

M.A.C Architects, Project Number: 2019:303

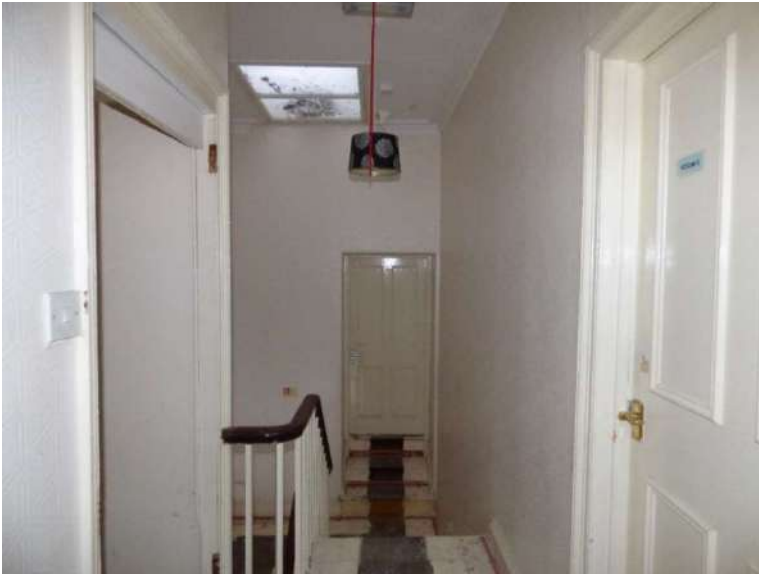
Left: At first floor all existing architraves and skirting to be retained.

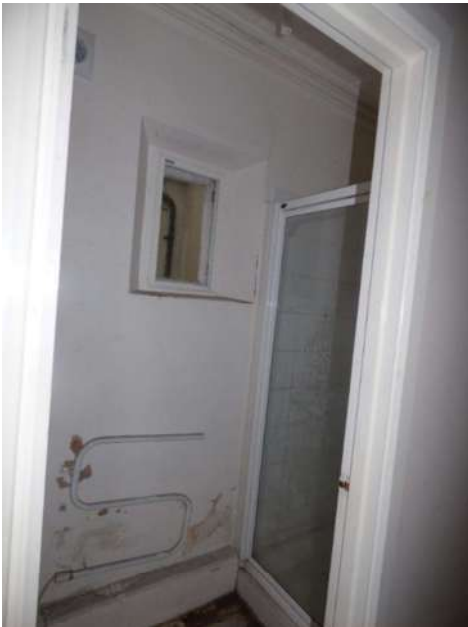
Left: The existing shower room is not original, and it is proposed to remove to reconfigure the space.

skirtings to be reinstated to match the existing.

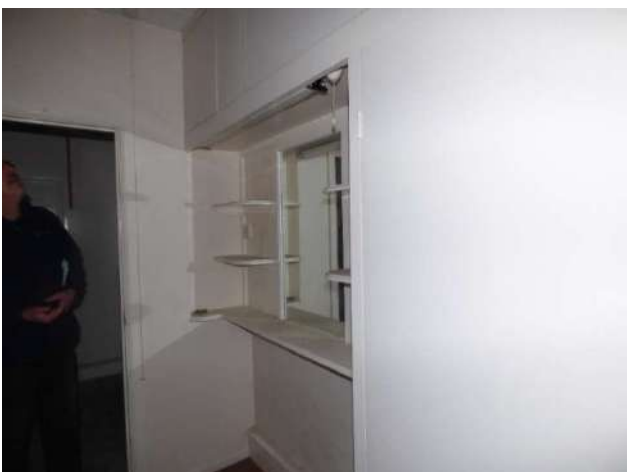
Left: existing corridor to bathroom.

Recent features added as part of the room as part of the conversion to dormitory accommodation to be removed and walls reinstated as original.

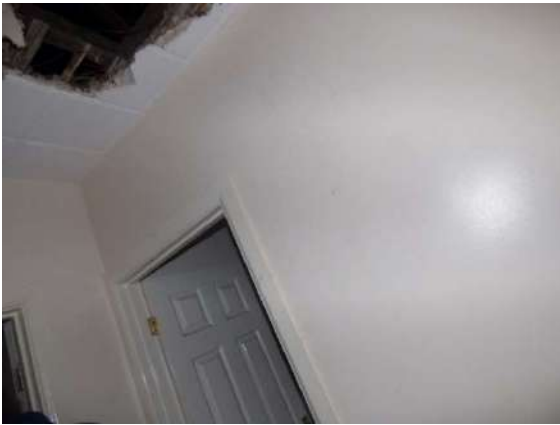
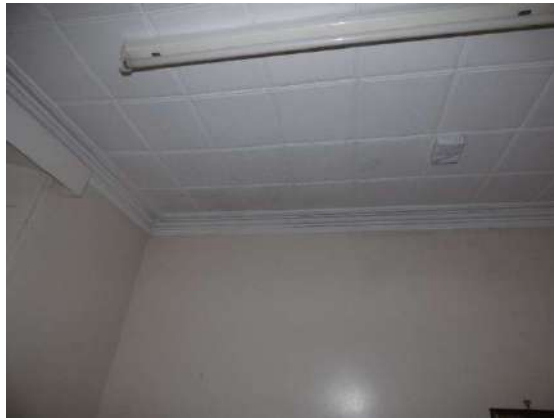
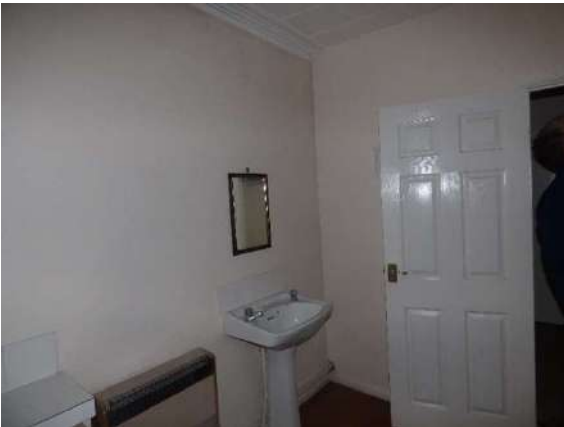
Above, left, and below: Existing bathroom. The existing ceiling finishes to be removed, and the ceiling to be made good including remediation of lath and plaster ceiling by specialist.

Existing modern window to be removed and repaired / replaced subject to planning condition.

Existing modern replica six panel door to be replaced with new traditional timber four panelled Georgian style door – bathroom door does not need to be a fire door.

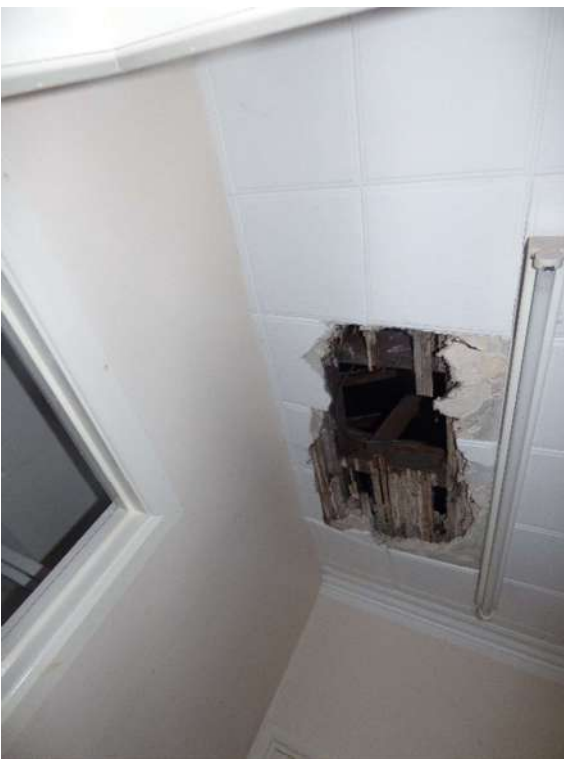
All finishes to be made good, and cornice to be reinstated where currently removed and new skirtings to match the original to be installed.

Existing floor is not original, so it is proposed to replace with moisture resistant chipboard.

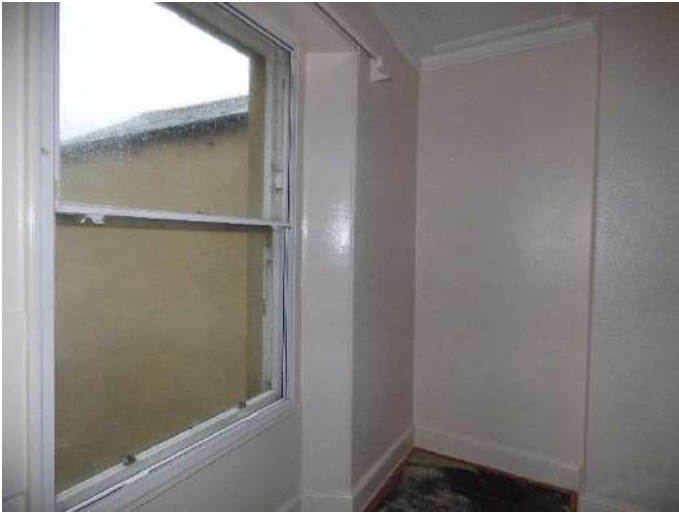
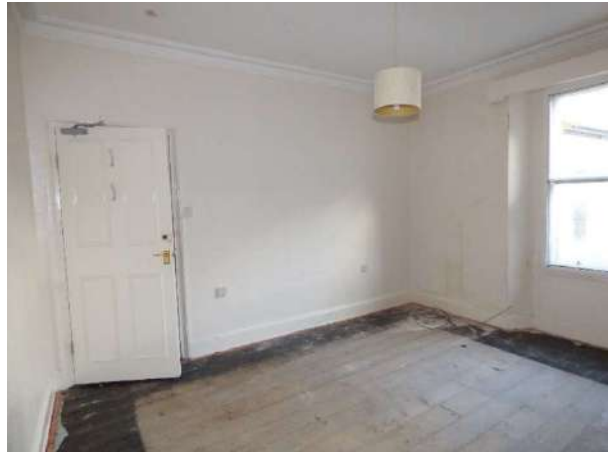
Rear bedroom.

Skirtings and architraves to be retained and repaired where necessary. Existing door to be replaced with new Georgian heritage style 4 panel door to be provided and installed by specialist joinery company such as Batty Joinery Ltd.

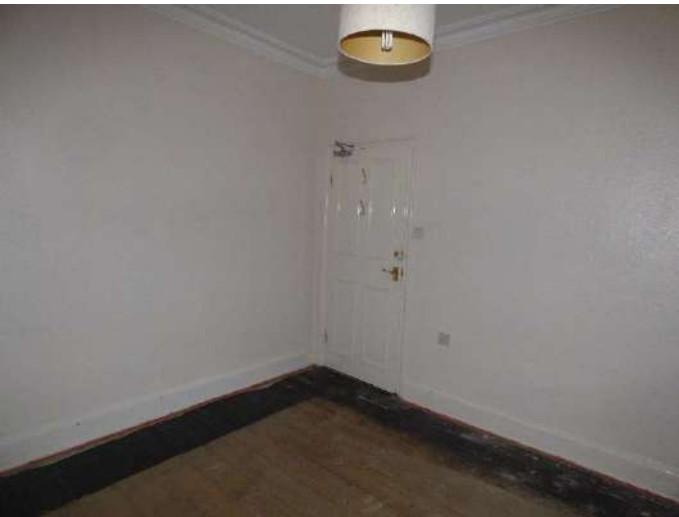
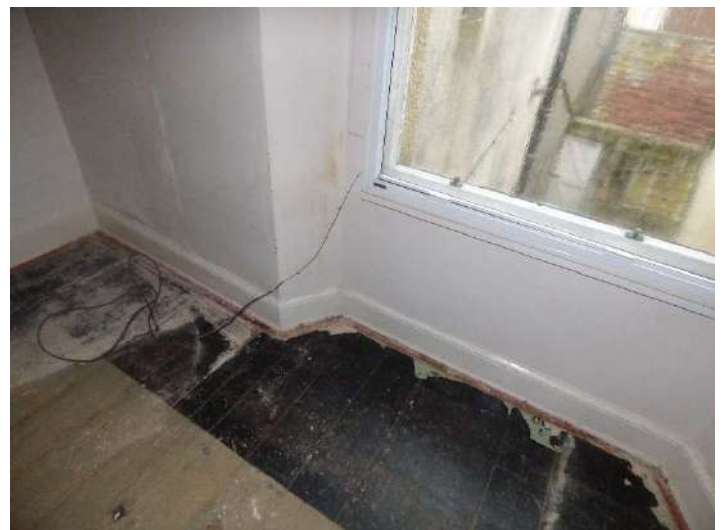
Existing floorboards generally in good condition. Minor repairs to plaster work in window reveals to be repaired.

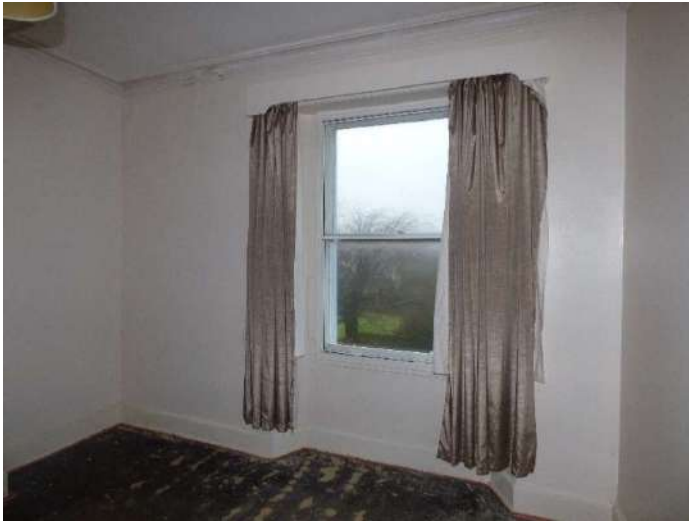
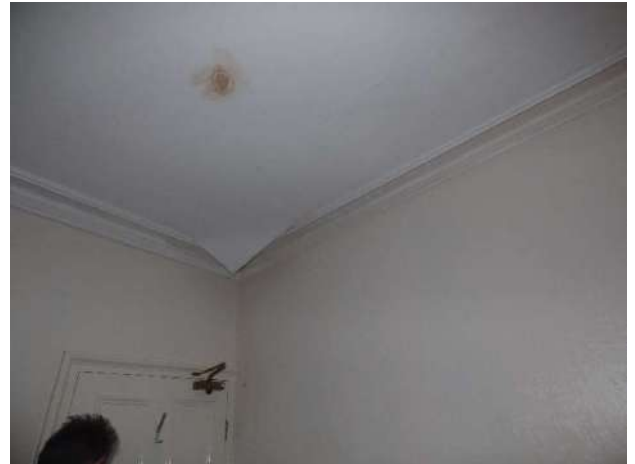
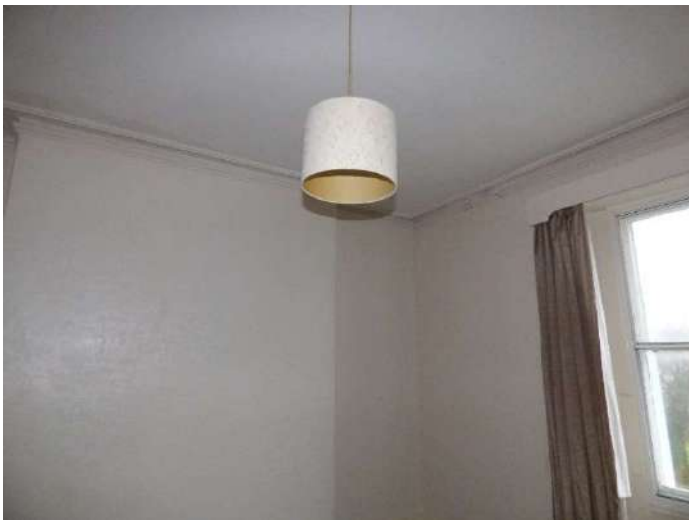
Left and above: Large front bedroom. Skirtings, cornices, and architraves to be retained and minor repairs where necessary. Existing flush panelled door to be replaced with new Georgian heritage style 4 panel door to be provided and installed by specialist joinery company such as Batty Joinery Ltd. Where possible it is proposed to refurbish any original doors with door closers and intumescent paint subject to building control approval.

Existing floorboards in good condition.

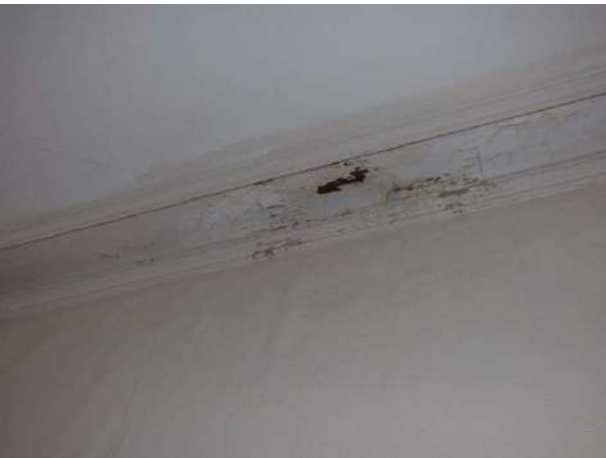
Left: Front Bedroom (small) skirtings and architraves to be retained, existing door to be replaced with new Georgian heritage style 4 panel door to be provided and installed by specialist joinery company such as Batty Joinery Ltd. Where possible it is proposed to refurbish any original doors with door closers and intumescent paint subject to building control approval.

Damp damage to plastered ceiling to be repaired due to water ingress in attic.

Below Left: Existing cornice damaged due to water ingress from attic room above. Cornice to be repaired.

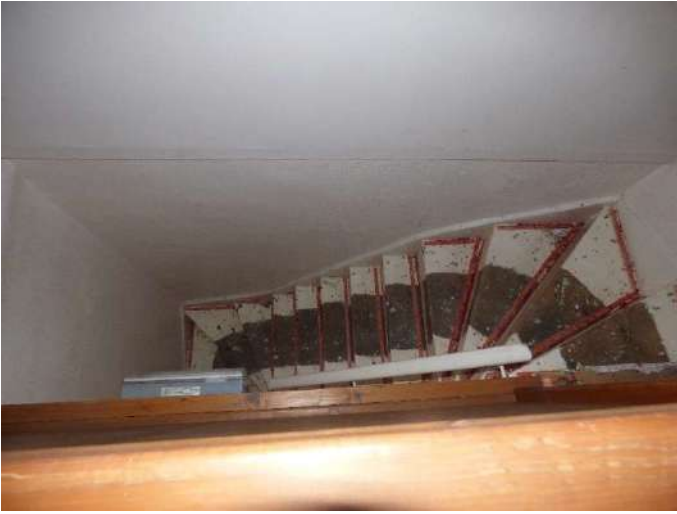
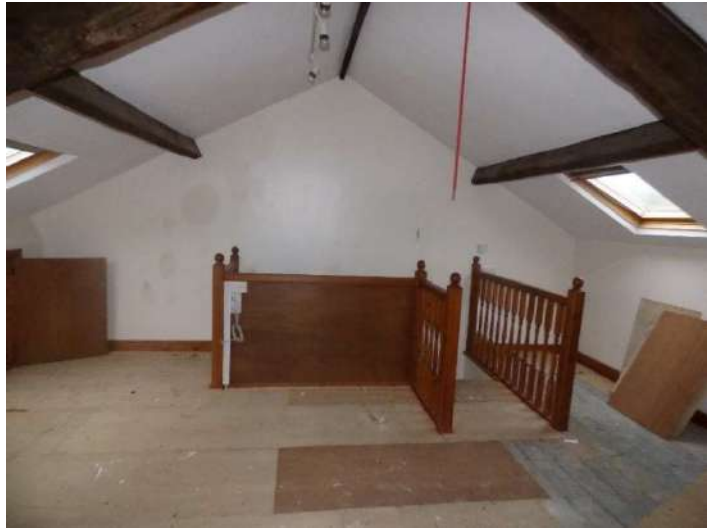
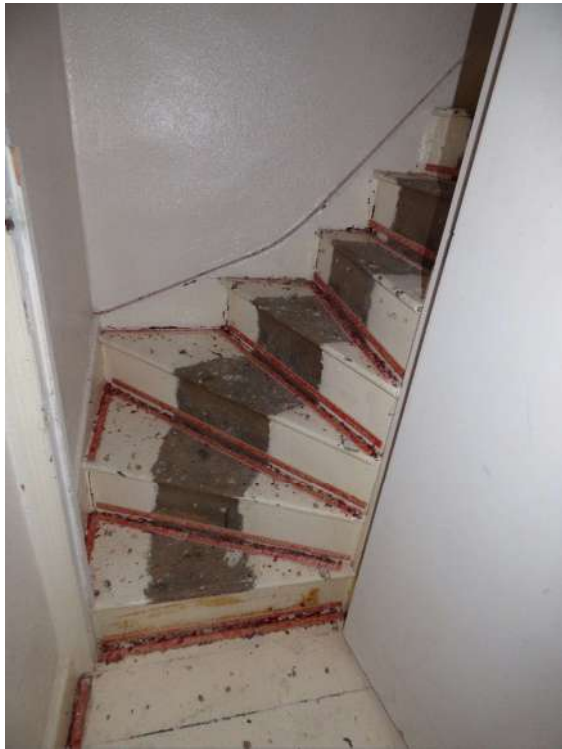
Above and right: Staircase to attic room.

Handrail, balusters, and rails are not original; however, it is proposed to replace to suit reconfigured attic space with handrails and balusters to match the existing.

Apply an insulated plasterboard 62mm thick to underside of sloping ceiling, above staircase. Boards to be taped and skimmed.

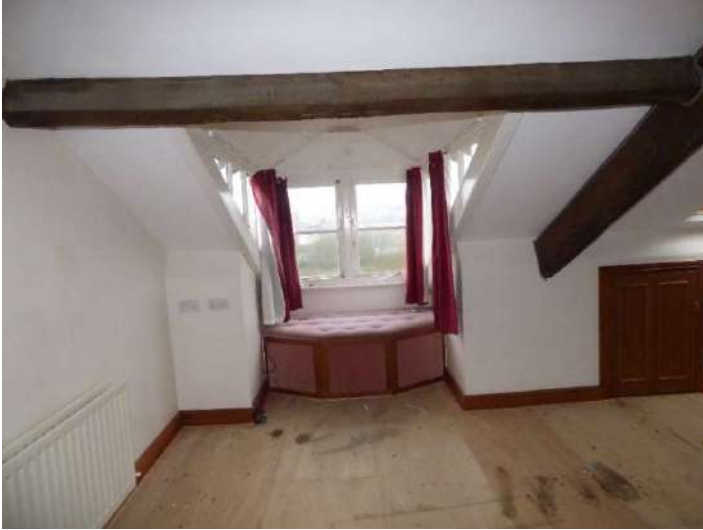
Existing attic space is proposed to be reconfigured to provide additional bedroom accommodation.

New plasterboard stud partitions to be installed to form new spaces.

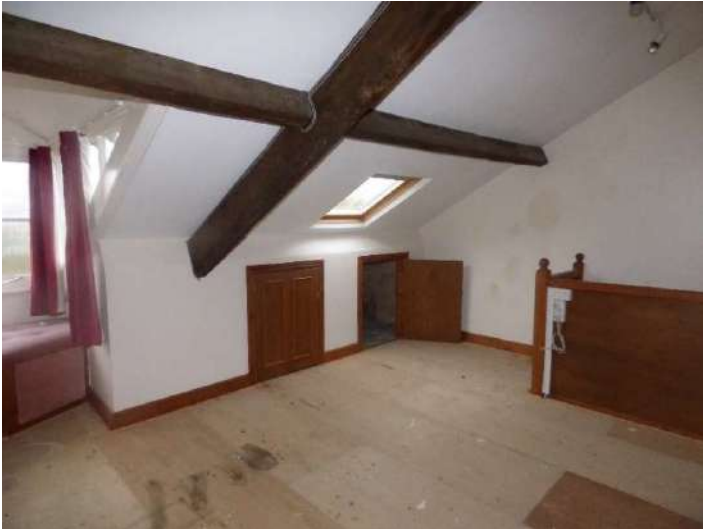
All damp and damaged/blown plasterwork to be repaired with lime plaster (Solo lime plaster from Lime Centre) and skim and decorate throughout.

Floorboards are not the original and likely to have been installed due to water ingress. It is proposed to replace with softwood timber floorboards. The skirtings are not original, and it is proposed to remove them and replace with new soft wood skirtings to match the skirtings throughout the rest of the property.

Apply an insulated plasterboard 62mm thick to underside of ceiling. The Laminated plasterboard and PIR has a vapour barrier incorporated so interstitial moisture would be prevented. New rooflights to be installed with flashing kit that mounts unit flush with the roof surface.

Tape and skim and undertake full decorations. Replace existing modern rooflights with new heritage style Velux rooflight (or Rooflight company equivalent).

New doors to be provided to newly formed rooms to be 4 panelled Georgian style timber doors to match the doors being reinstated throughout the rest of the property. Doors to be fire rated.

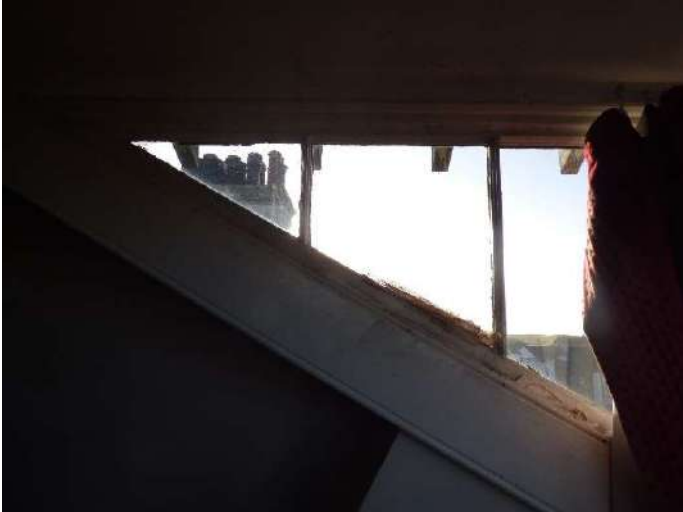
The existing dormer window has suffered considerable damage, with windows missing and considerable fabric damage due to water ingress.

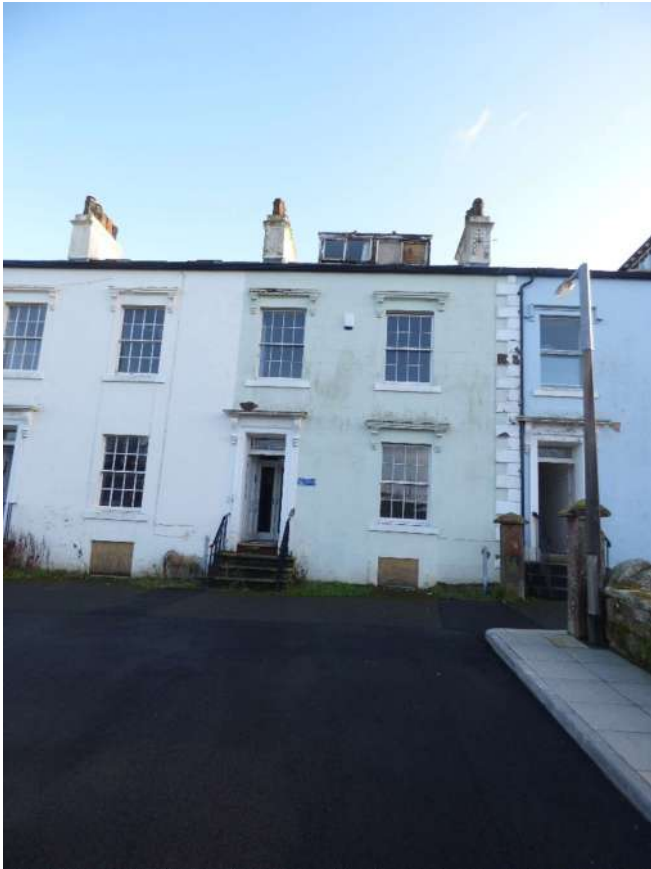
Left: The main entrance is mentioned in the listing text and is to be entirely retained.

Both front and rear elevations are currently rendered, with colour to the front and side and natural to the rear. All elevations require to be prepared for render repairs and redecoration by specialist using lime render and stucco (Parax LTD) to be applied by specialist. The stucco features above the windows and door on the front elevation will be carefully restored by a specialist. Colour of all render and stucco to match existing.

The existing door and frame are to be retained and made good with the provision of new ironmongery. Once repaired full decoration will be undertaken.

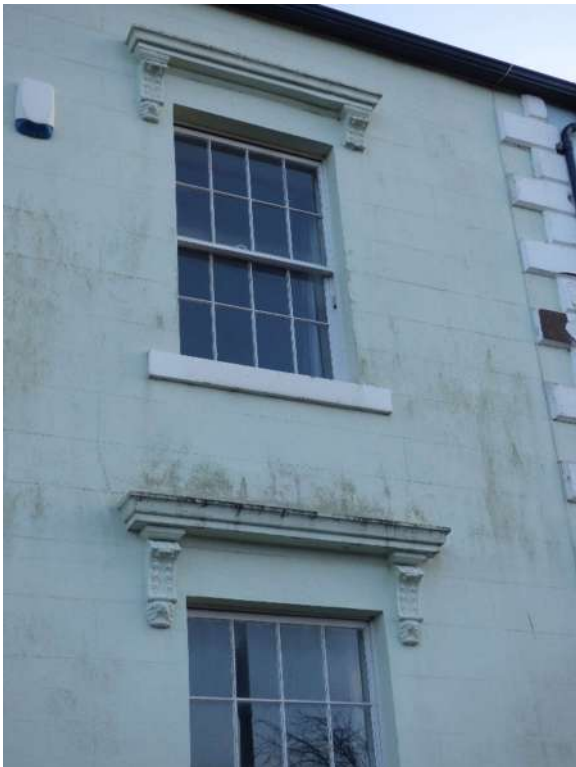
Existing gutters and downpipes to be retained, repaired where necessary and decorated.

All existing single glazed windows to either be refurbished or replaced subject to planning condition.

The existing stone steps to be cleaned up, and existing painted metal handrails to be replaced with new handrails (refer to D&A statement).

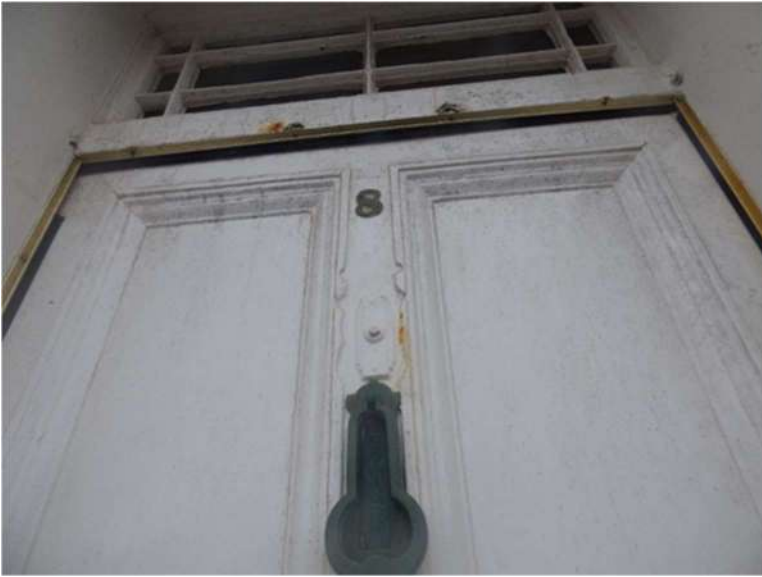
Existing door and fanlight to be retained and repaired.

All existing single glazed windows to be repaired / replaced subject to planning condition.

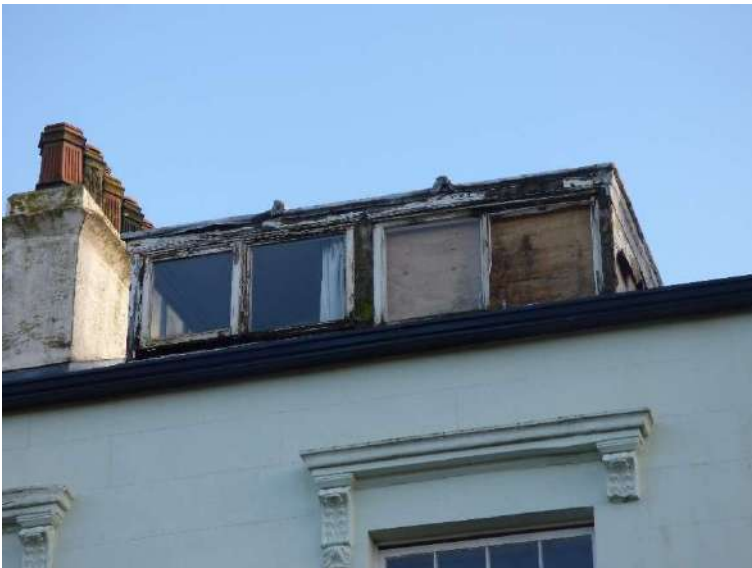
Left: Dormer windows to front of property have been damaged beyond repair, and it is therefore proposed to repair / replace dormer window, subject to planning condition.

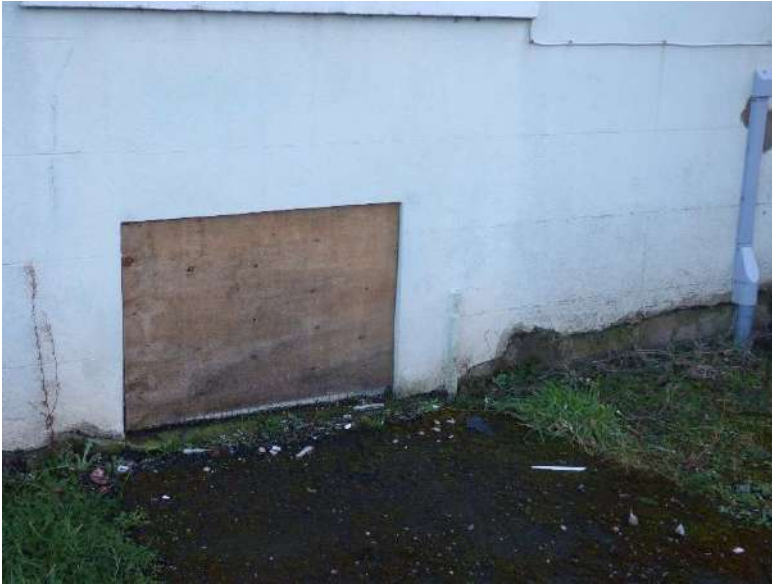
Boarded up window to basement on front elevation, to have new windows installed subject to planning condition.

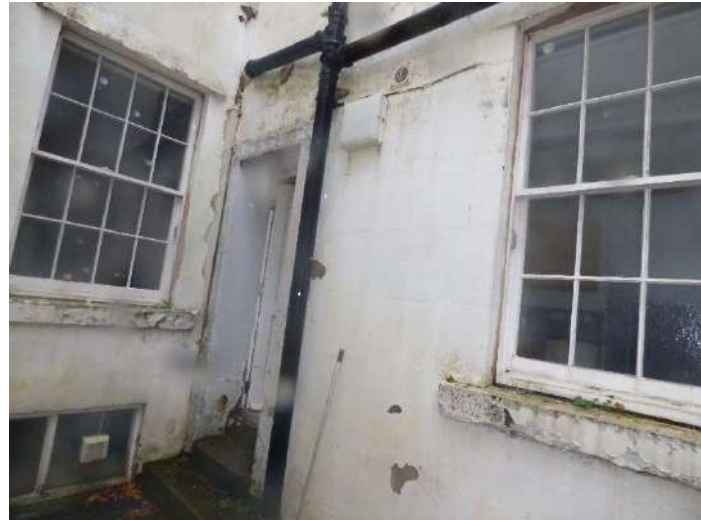
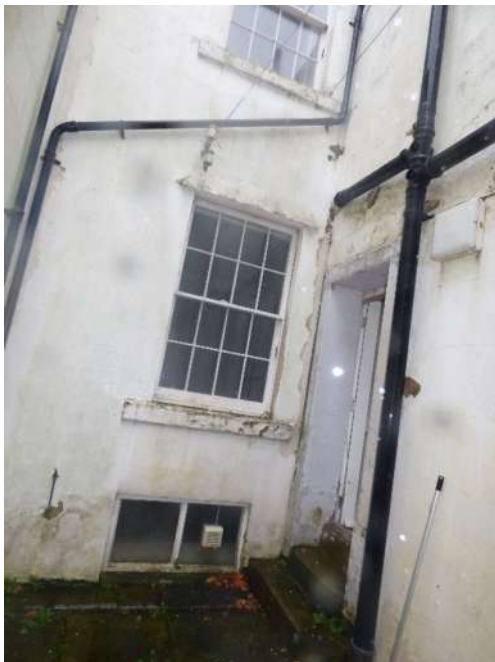
Rear of property – render to be repaired by specialist and decorated with off white render.

New door to be provided to rear to be Georgian style as front door.

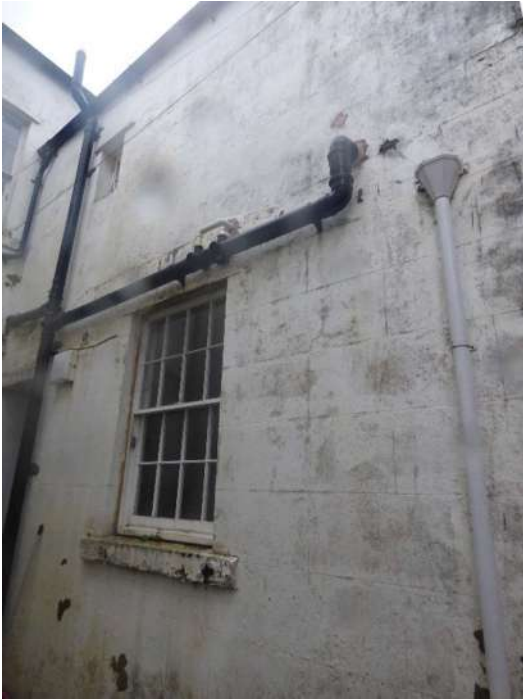
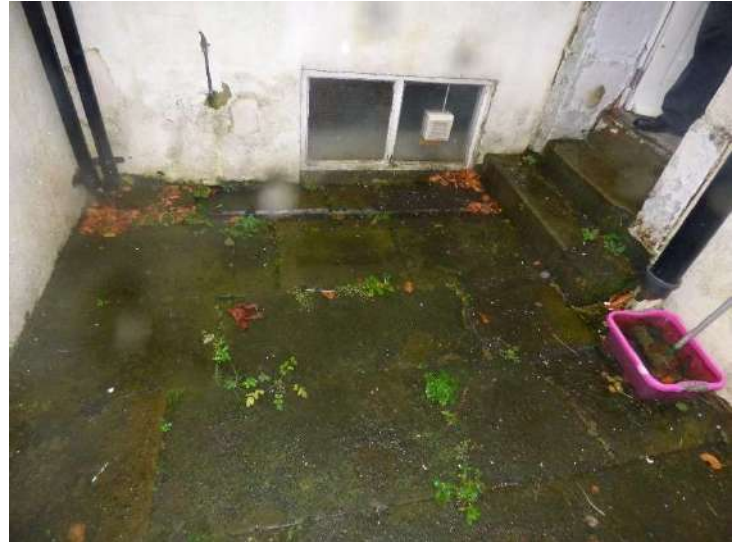
Rear of property – render to be repaired by specialist and decorated with off white render.

Windows to be repaired / replaced subject to planning condition.

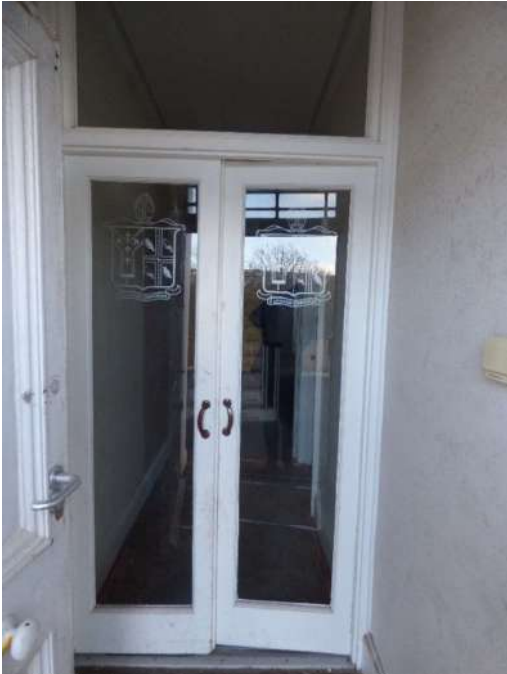
Left and below: New lobby installed when the building was converted into a dormitory to be removed.

Existing parquet floor to be retained and restored.

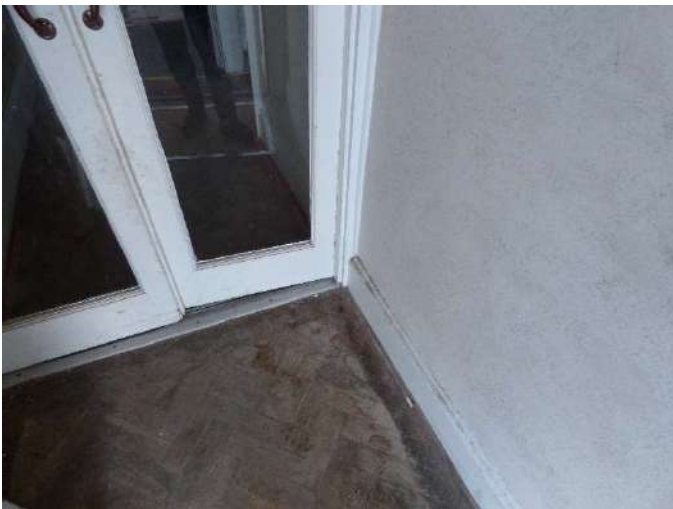
Left: Modern doors and clerestory glazing to be removed and walls, floor, and ceiling to be made good.

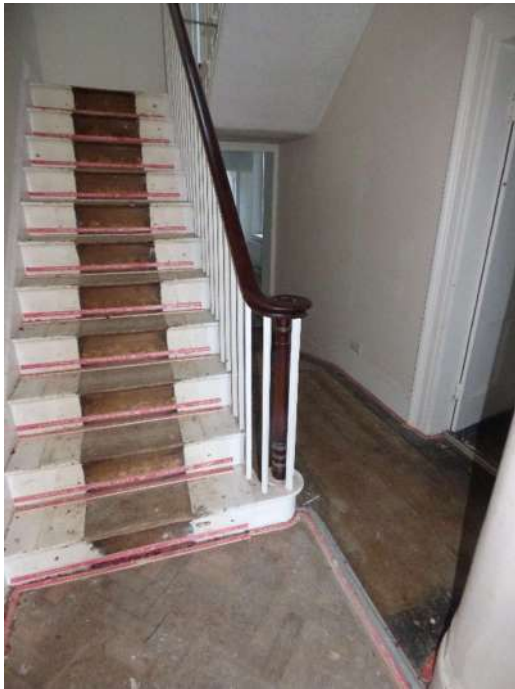
Existing staircase. Handrails, balusters, and rails are original and to be retained.

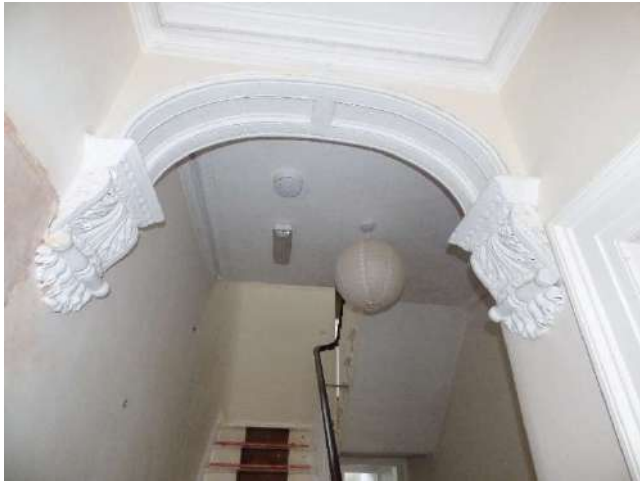
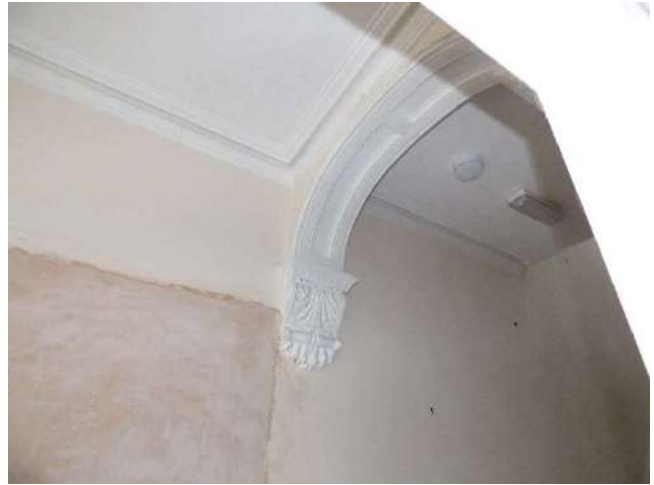
Above and below: Redundant M&E to be removed and wall/ceiling finishes made good.

Period features to be retained, including archway and architraves.

(Modern lighting to all be stripped out and surfaces restored.

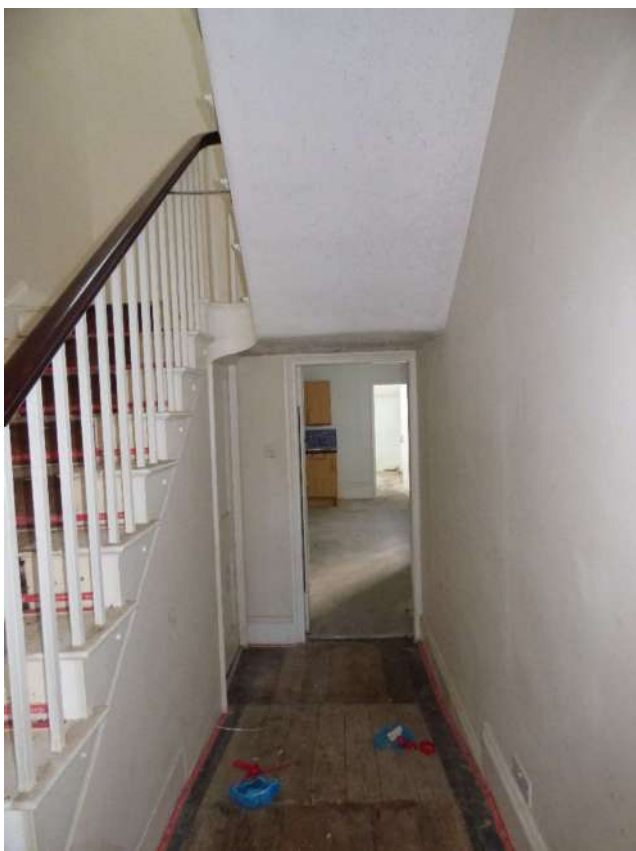
Flush panel doors to be replaced with heritage style four panel painted timber fire doors to enhance the heritage asset.

Existing ramp to be removed and original step down to kitchen to be reinstated.

Existing floorboards in good condition.

Where possible it is proposed to refurbish any original doors with door closers and intumescent paint subject to building control approval.

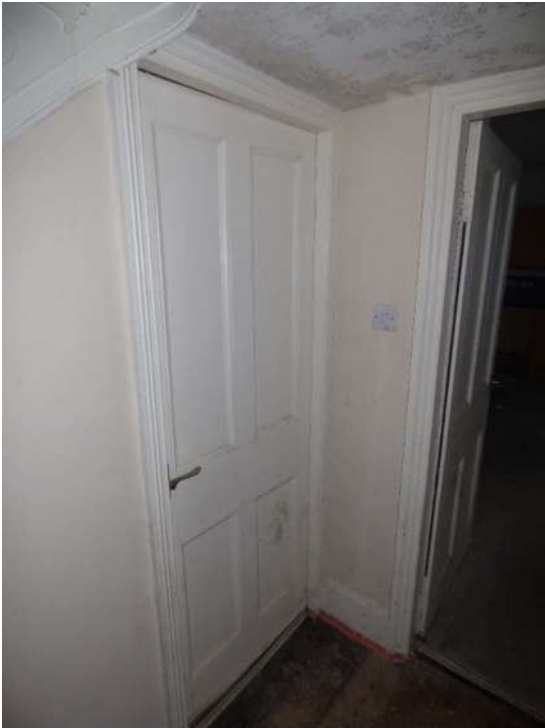
Left: Doors to all existing rooms to be replaced with new 4 panel fire doors to match existing. All existing architraves and skirtings to be retained.

Where possible it is proposed to refurbish any original doors with door closers and intumescent paint subject to building control approval.

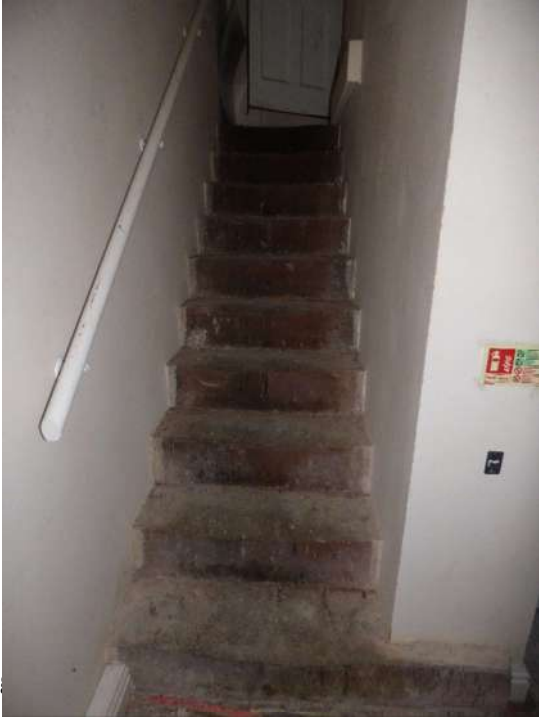
Left: Basement.

The existing walls and floor are generally in sound condition so would be suitable for the application of damp proof slurry system. All existing paint and surface finished must be removed and made good including all snots removed and damage to existing surfaces, prior to the installation of a Koster Polysil NB1.

Existing walls have previously been plastered, but not with a suitable waterproof system and damp is penetrating through.

This migratory crystalline tanking slurry is used to seal below

Koster NB1 is considered to be a Type A waterproofing system as defined by BS8102:2009 and is generally used to seal the inside face of basement structures, slabs and retaining walls.

Koster NB1 works by providing both a physical barrier against water ingress as well as providing a migratory crystal sealant that penetrates deep into the structure to seal micropores and cracks against water ingress.

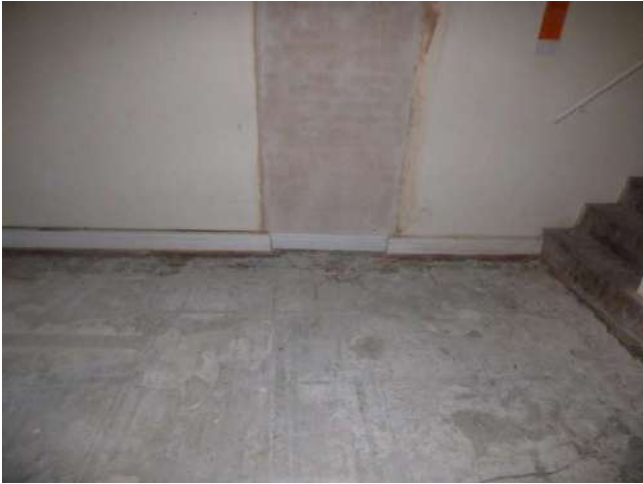
The walls down to the basement also require the full treatment.

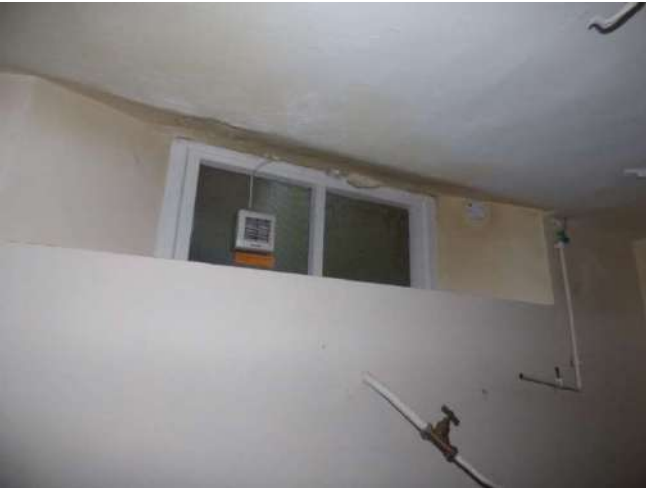
In the basement all existing services are to be carefully stripped out and replaced with new compliant infrastructure.

Existing window to basement to be repaired / replaced subject to planning condition. Existing reveals to be made good.

All existing services to be carefully removed and new gas and electric services installed.

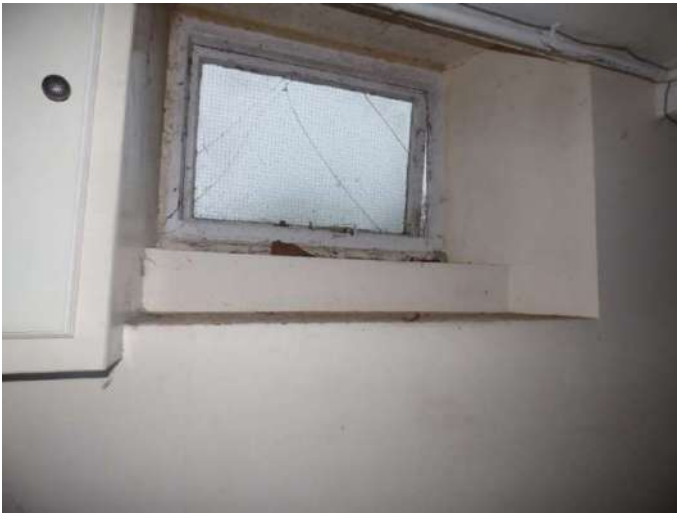
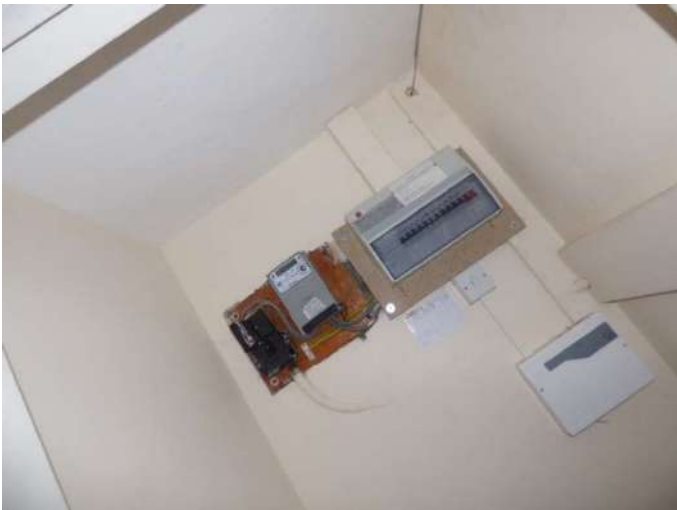
Left: Existing window to be repaired / replaced subject to planning condition.

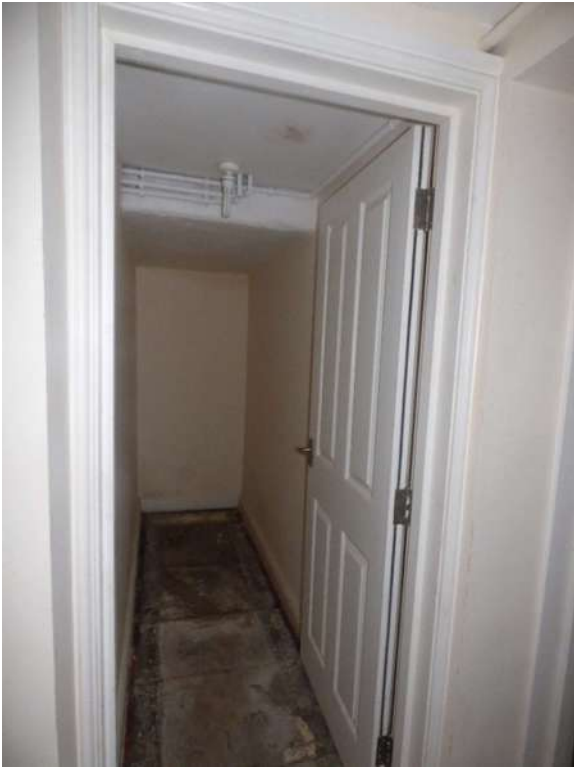
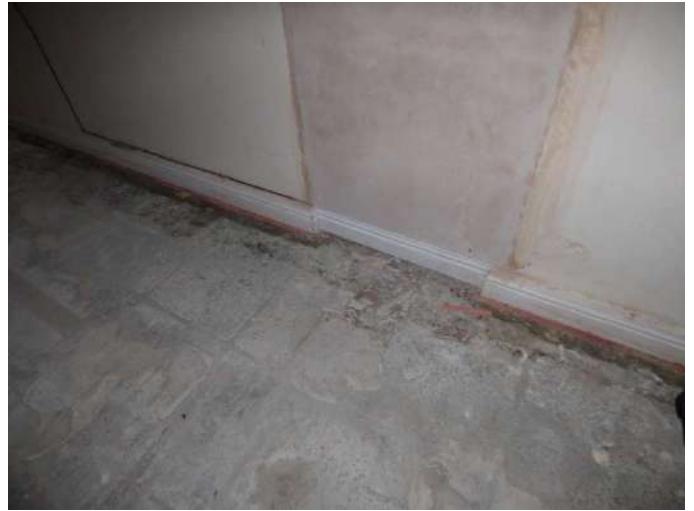
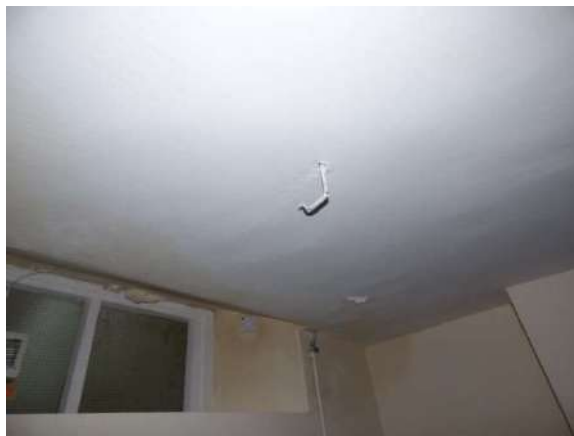
Views of existing basement.

Existing doors to be replaced with new heritage style four panelled Georgian style fire doors.

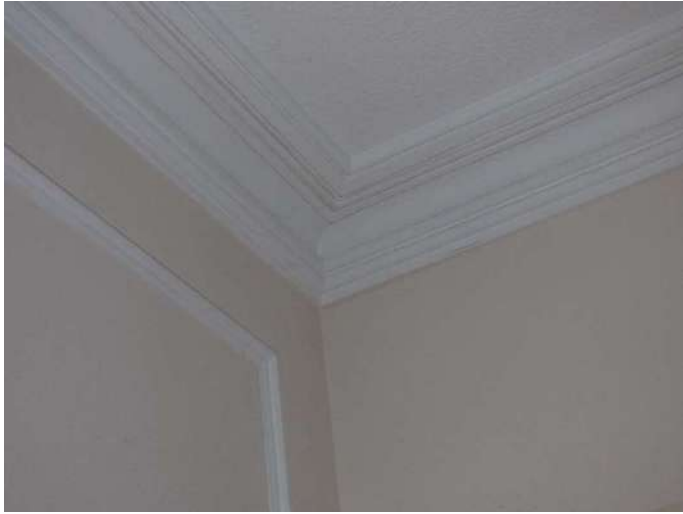
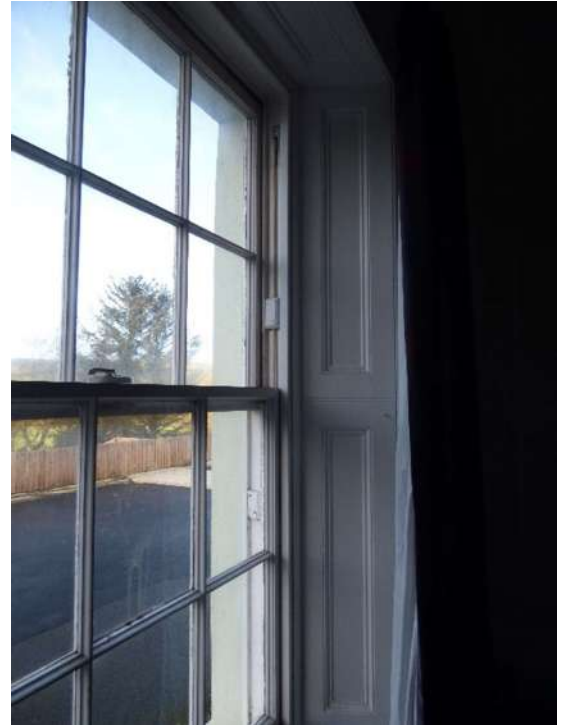
Above: In the existing front room, the features below and to the sides of the existing window are in good condition, it is proposed to carefully refurbish the existing timber shutters.

Left: Existing cornice to be retained and period features to walls to be retained and made good where required.

Existing architraves, and skirtings to be retained and made good.

Below: Existing door to be replaced with heritage style four panel painted timber fire door to enhance the heritage asset.

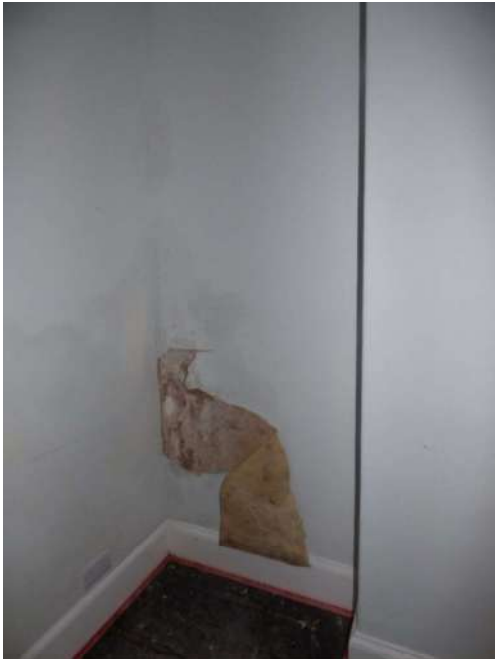
Left and below: In the existing dining room at the rear of the property, the period features below and to the sides of the existing window are in good condition, it is proposed to carefully refurbish the existing timber shutters.

Existing cornice to be made good in locations and where hairline cracks have appeared.

Here plasterwork has been damaged from damp ingress, blown plaster is to be removed, and reinstated with lime plaster finish.

Existing door to be replaced with heritage style four panel painted timber fire door to enhance the heritage asset.

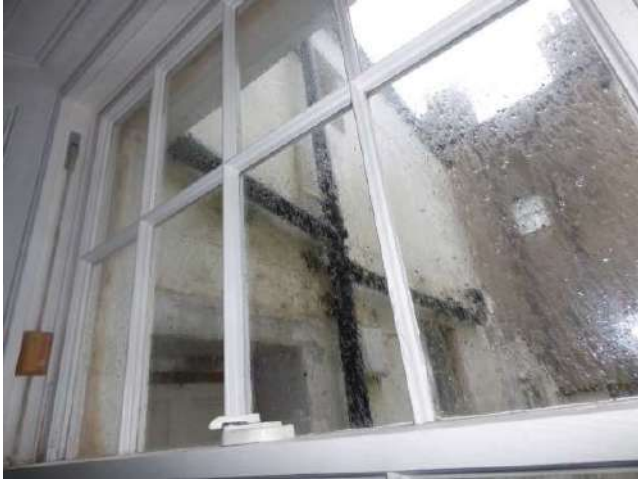
Left: In the existing dining room, the existing window is proposed to be repaired / replaced subject to planning condition.

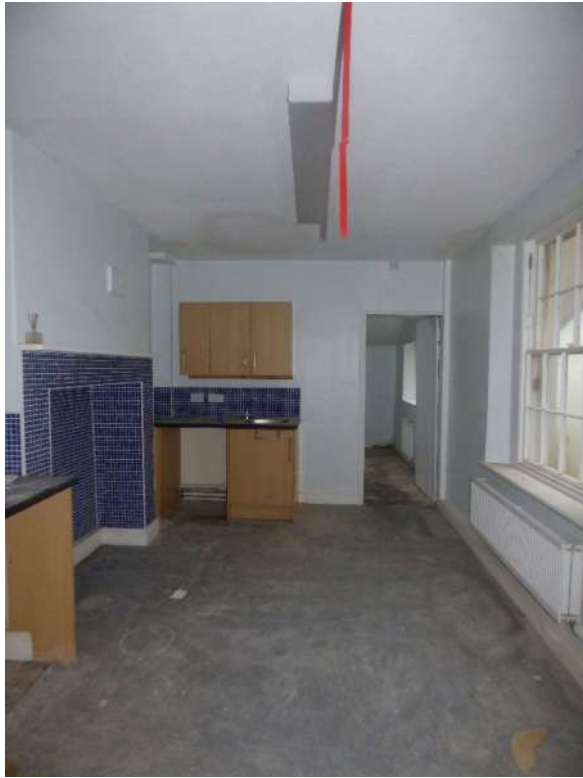
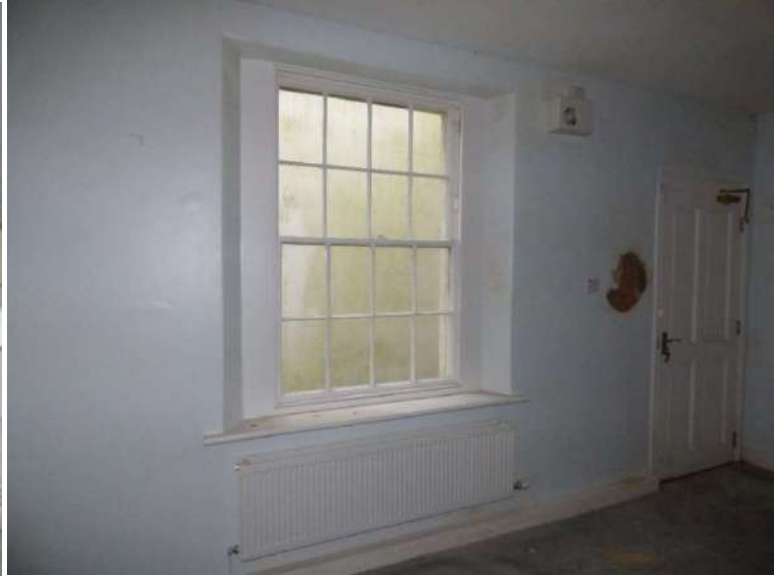
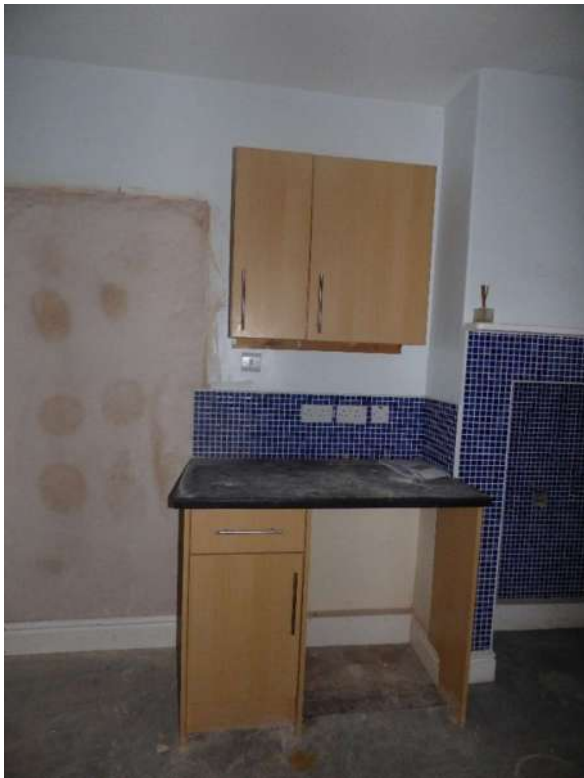
Above, left, and below: In the existing kitchen, the existing M&E services are to be removed and modern kitchen removed. Internal walls and ceilings to be made good.

Existing cornice to be made good in locations where redundant services are to be removed and where hairline cracks have appeared.

Existing architraves and skirtings to be retained and made repaired.

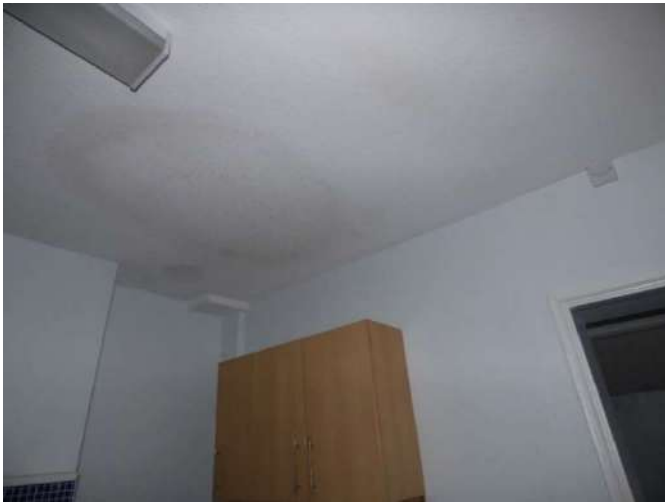
Left: Water ingress through the roof has damaged the existing ceiling.

Roof and ceiling to be repaired to match existing.
