# HERITAGE STATEMENT

## FULL RENOVATION OF EXISTING No 11 TERRACE HOUSES

St Bees, 1-11 Lonsdale Terrace, Parish Council, Cumbria

M.A.C Architects, Project Number: 2019:303

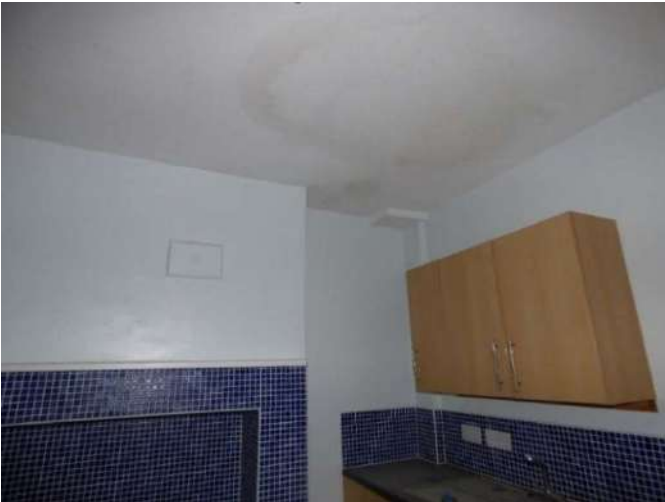
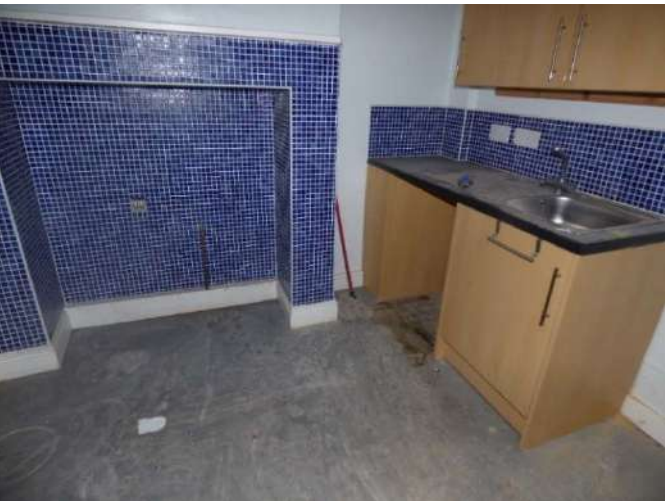
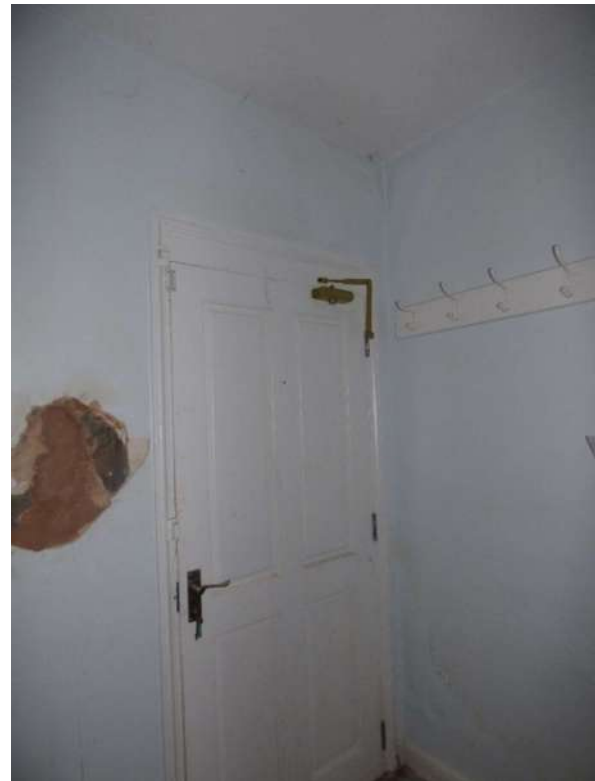
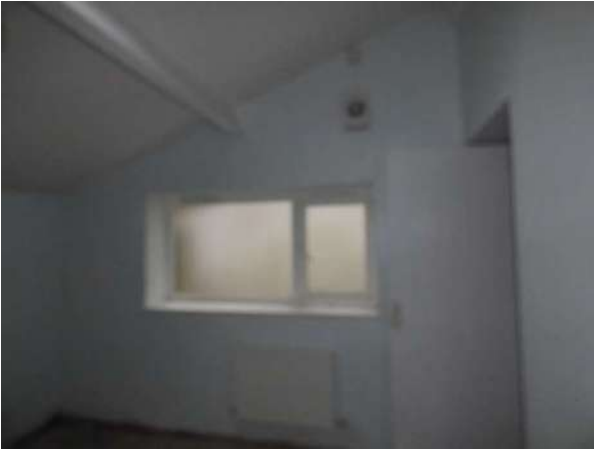
Left and below: The existing wc and utility area is to be reconfigured. All internal finishes to be stripped out and ceilings, walls, and floors to be made good.

Roof to be repaired and ceiling to receive new insulated plasterboard.

Apply an insulated plasterboard 62mm thick to underside of ceiling. The Laminated plasterboard and PIR has a vapour barrier incorporated so interstitial moisture would be prevented. New rooflights to be installed with flashing kit that mounts unit flush with the roof surface.

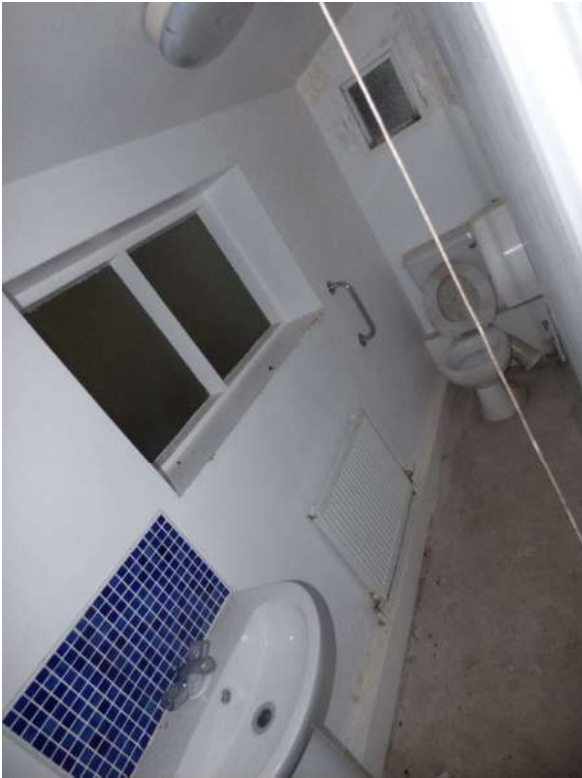
Left: Existing wc area to be reconfigured. Existing ceiling to be repaired.

Damp treatment is to be provided as Koster NB1 system.

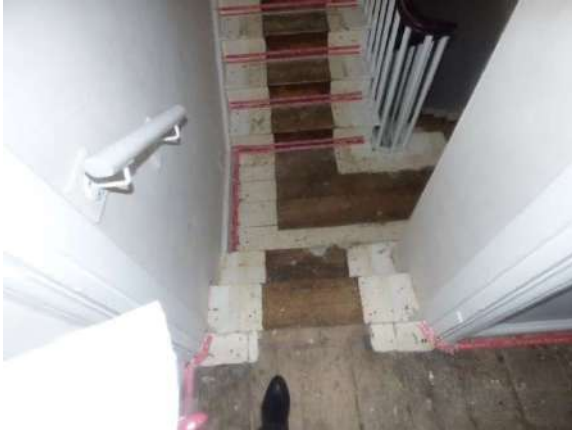
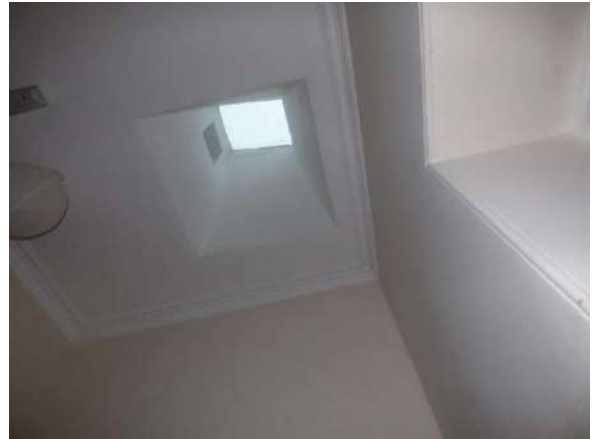
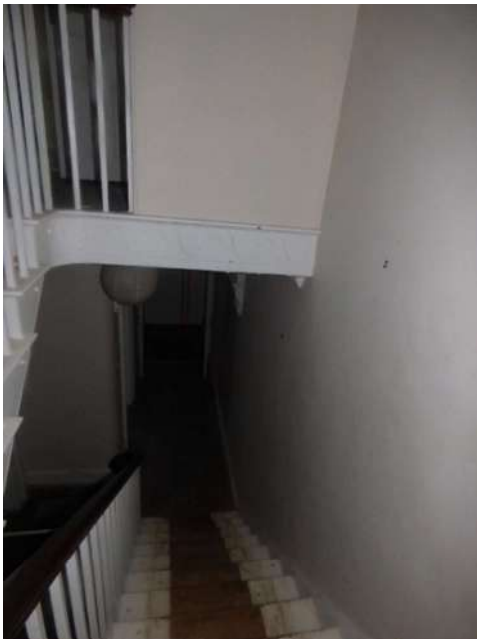
Retain original staircase, which is in good condition.

Handrail, balusters, and rails are original and are to be retained. Missing

Baluster to be replaced with matching baluster and decorated to match existing.

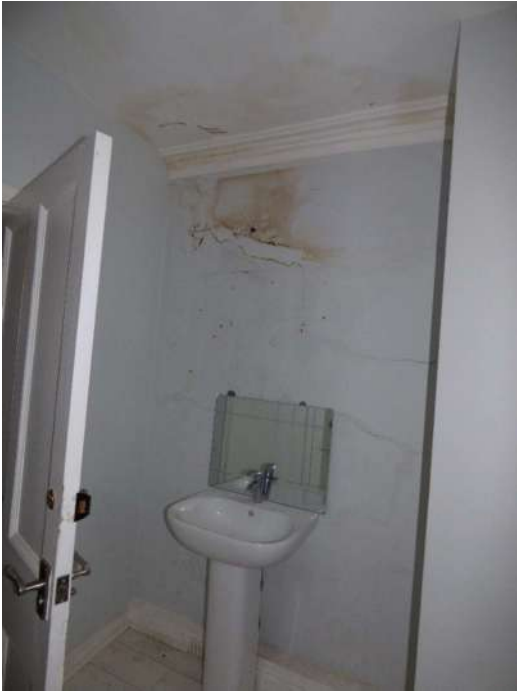
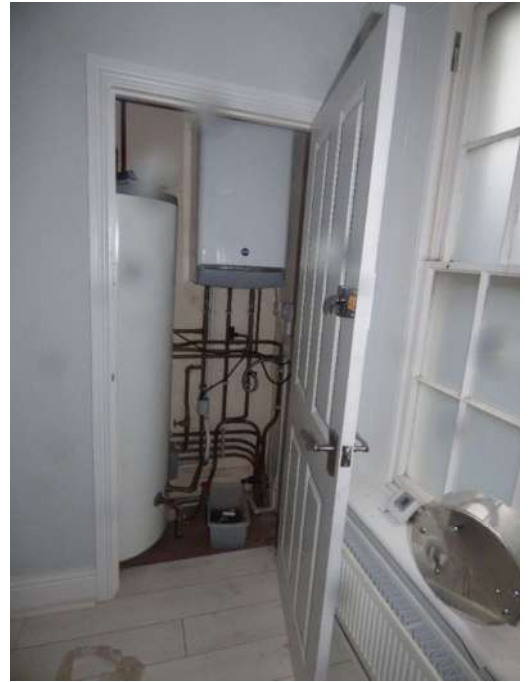
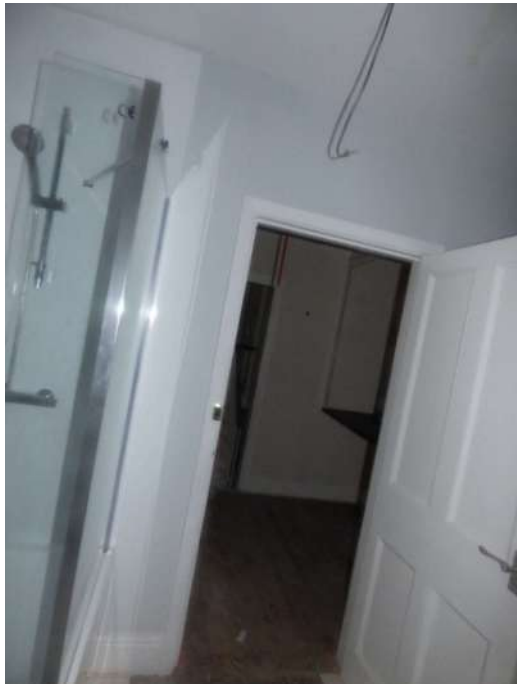
Existing bathroom - skirtings and architraves to be retained. Existing flush panelled door to be replaced with new Georgian heritage style 4 panel door to be provided and installed by specialist joinery company such as Batty Joinery Ltd. Where possible it is proposed to refurbish any original doors with door closers and intumescent paint subject to building control approval.

Ceiling and walls to be repaired where damaged from moisture ingress from leaking roof. Localised repairs to roof to be undertaken to ensure watertightness is achieved. All repairs to match existing.

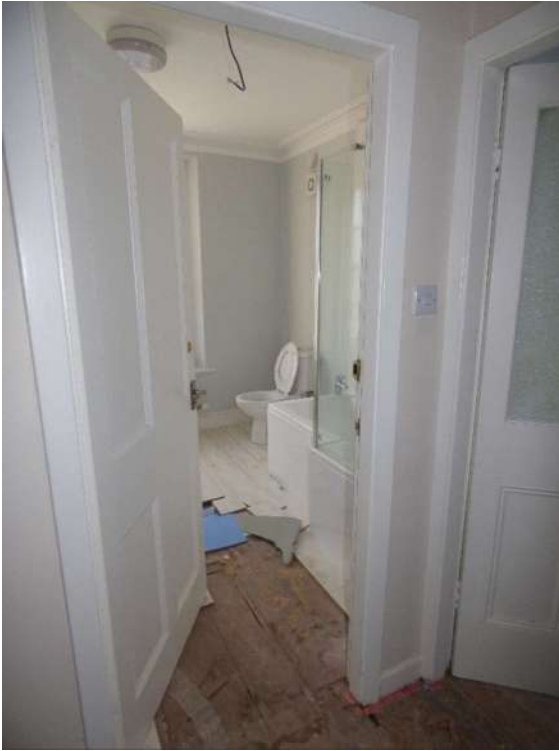
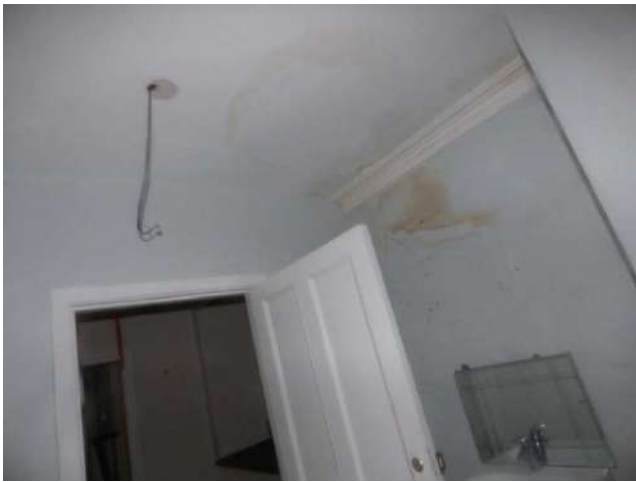
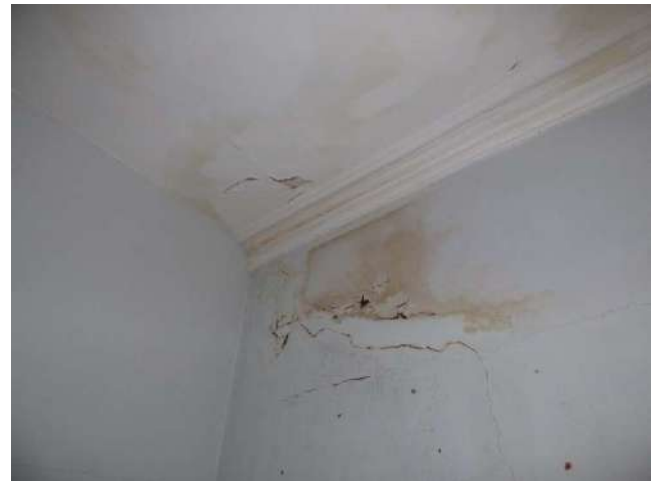
Above and right: Cornice to be installed to match existing on stud partition wall. Blown plaster to be carefully removed and new lime plaster finish to be carefully applied to repair finishes.

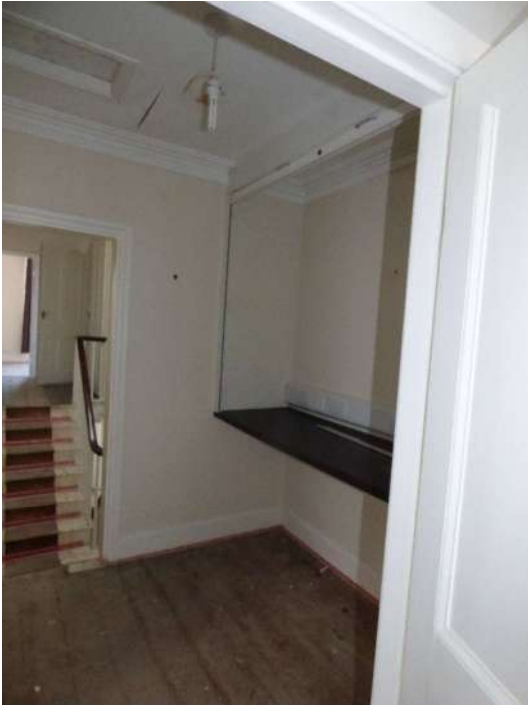
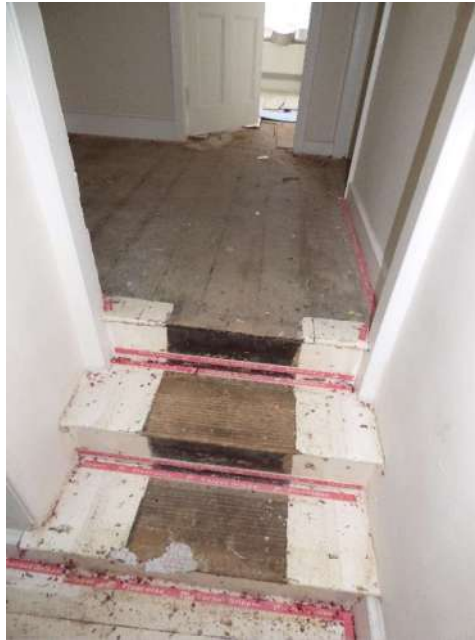
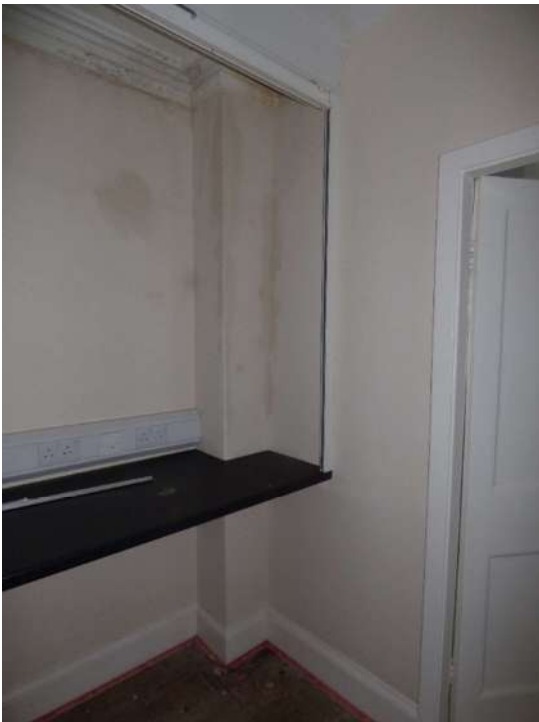
Left and above: Lobby to bathroom and existing wc to be reconfigured to make better use of space. Ceiling and walls to be repaired further to damp ingress damage.

Cornice to be provided where missing.

Existing non original fixtures and fittings to be removed and walls to be made good.

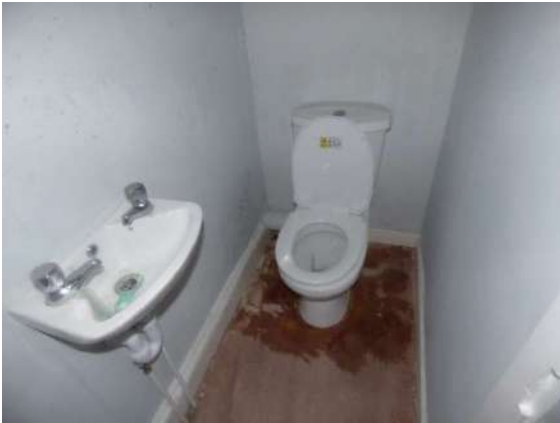
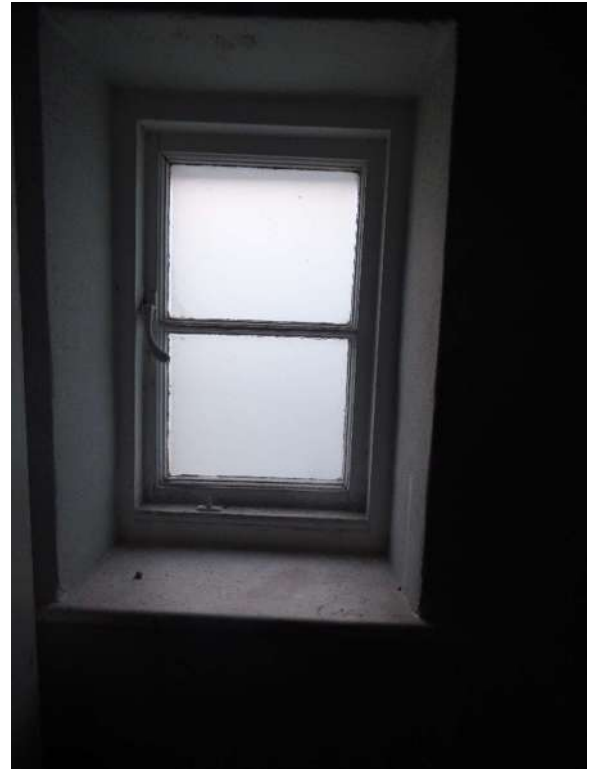
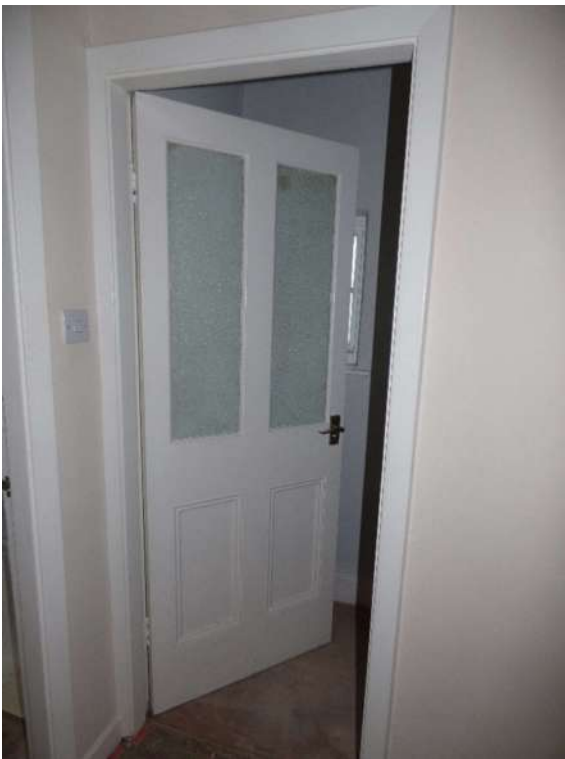
Left: Existing w.c. (not original) to be stripped out and space reconfigured. All skirtings and cornices to be reinstated to match existing.

Existing window to be repaired / replaced subject to planning condition.

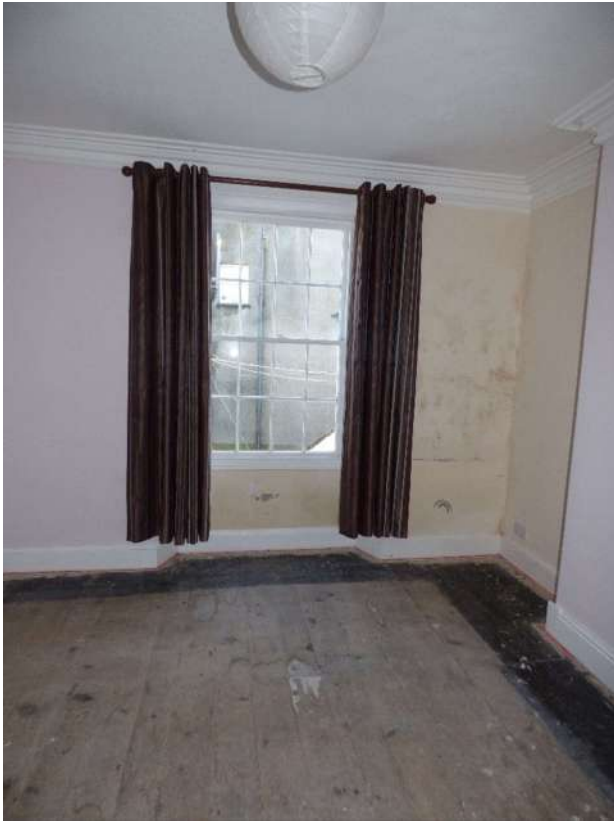
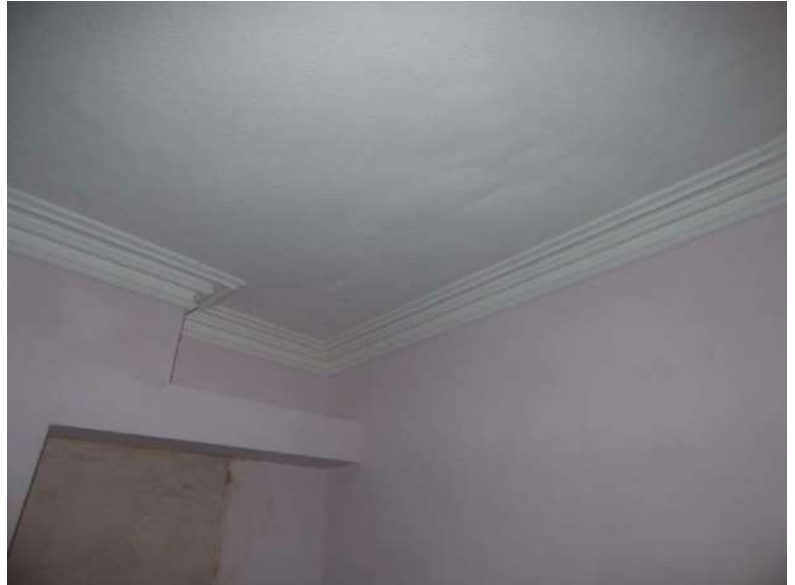
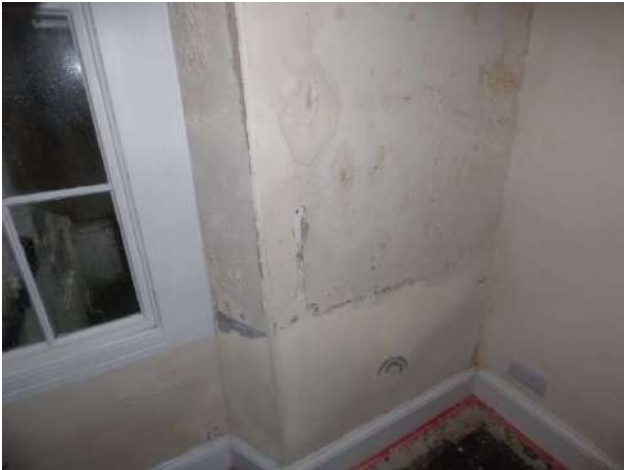
Rear bedroom skirtings, cornices, and architraves to be retained. Existing flush panel door to be replaced with new Georgian heritage style four panel door to be provided and installed by specialist joinery company such as Batty Joinery Ltd.

Left and below: Blown plasterwork to be repaired with lime plaster (Solo lime plaster from Lime Centre) below window.

Where possible it is proposed to refurbish any original doors with door closers and intumescent paint subject to building control approval.

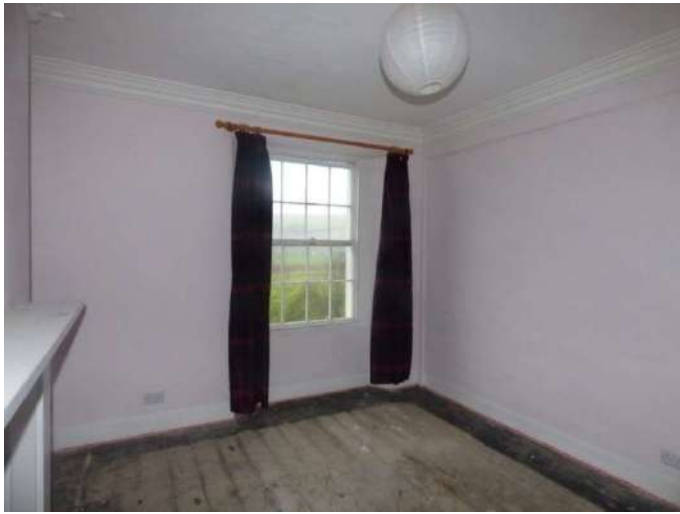
Large front bedroom, skirtings, covings, and architraves to be retained. Existing panelled door to be replaced with new Georgian heritage style four fire panel door.

Existing floorboards in good condition.

Where possible it is proposed to refurbish any original doors with door closers and intumescent paint subject to building control approval.

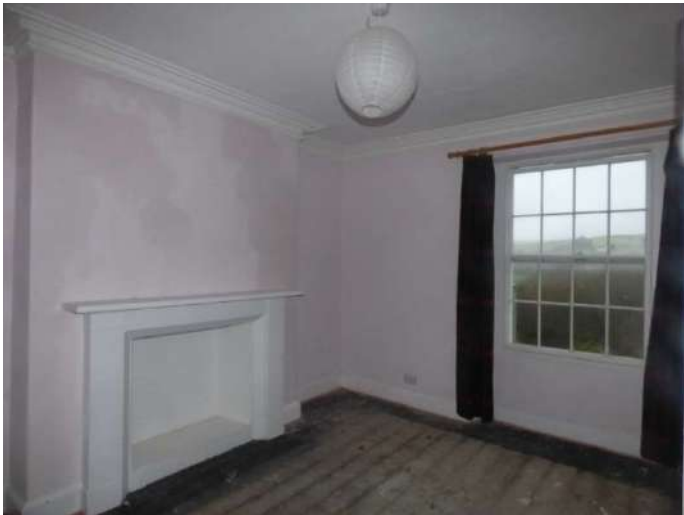
Fire surround to be retained.

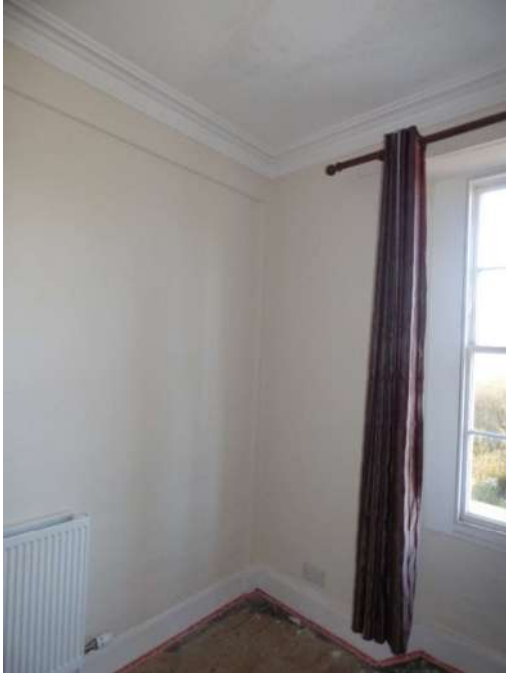
Existing small front bedroom - cornice, skirtings, and architraves to be retained. Existing door to be removed and new Georgian heritage style four panel door to be provided and installed by specialist joinery company such as Batty Joinery Ltd. In new location. Where possible it is proposed to refurbish any original doors with door closers and intumescent paint subject to building control approval.

Existing doorway to be walled up to match existing.

Blown plaster to walls and ceiling to be replaced and repaired with lime plaster (Solo lime plaster from Lime Centre) all to match existing.

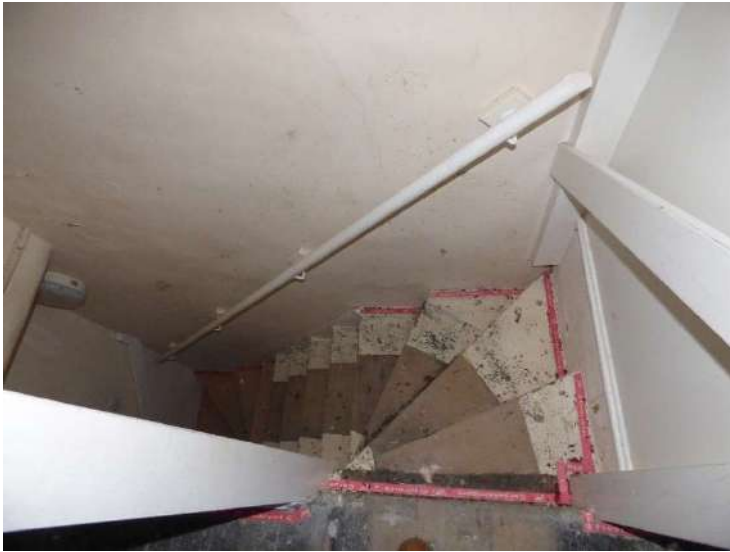
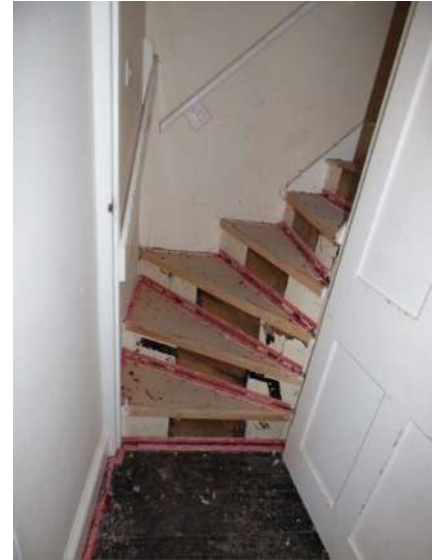
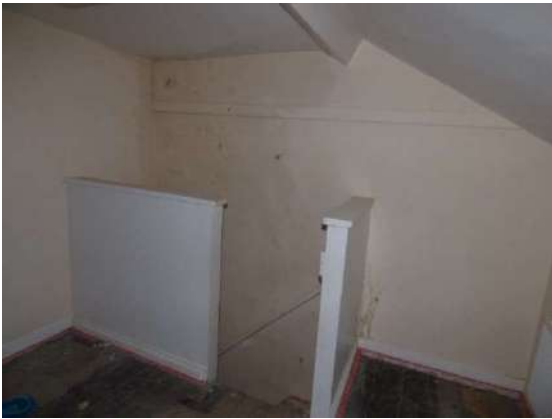
Above and left: Staircase to attic rooms.

At the top of the staircase on the landing, remove all damp and damaged/blown plasterwork and repair with lime plaster and skim and decorate throughout.

Provide and install new Georgian style heritage four panelled fire door to match existing (refer also to D&A statement). Where possible it is proposed to refurbish any original doors with door closers and intumescent paint subject to building control approval.

Apply an insulated plasterboard 62mm thick to underside of ceiling. The Laminated plasterboard and PIR has a vapour barrier incorporated so interstitial moisture would be prevented underside of ceiling tape and skim and undertake full decorations.

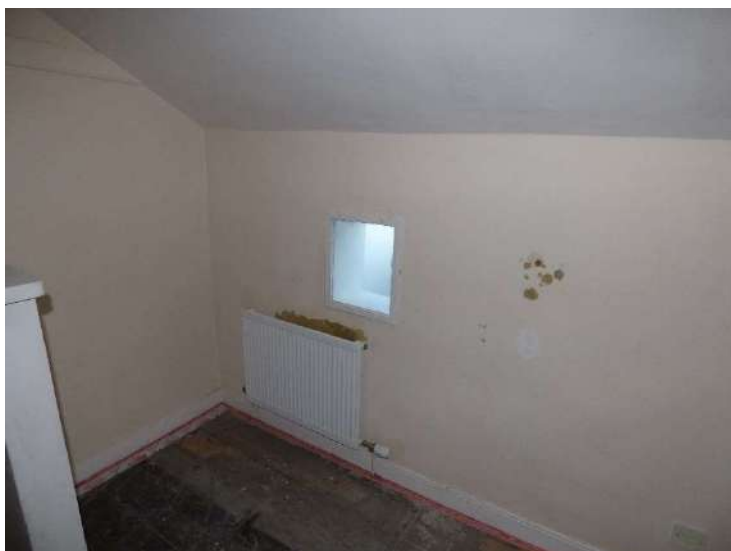
Left: Landing at the top of the staircase.

Floorboards are in good condition (but may require minor repairs)

Replace existing modern rooflights with new heritage rooflight windows (Velux or Rooflight company or similar) A with flashing kit that mounts unit flush with the roof surface).

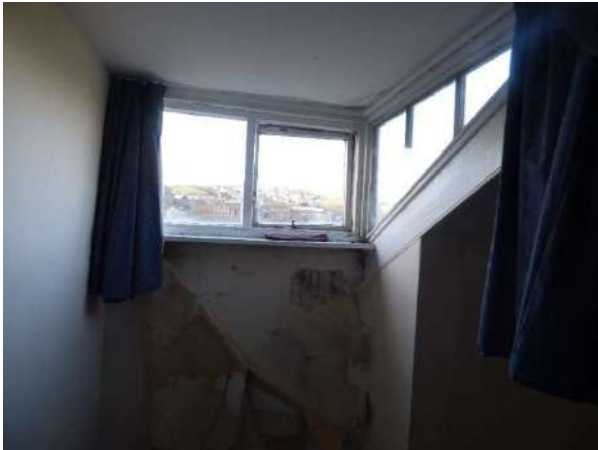
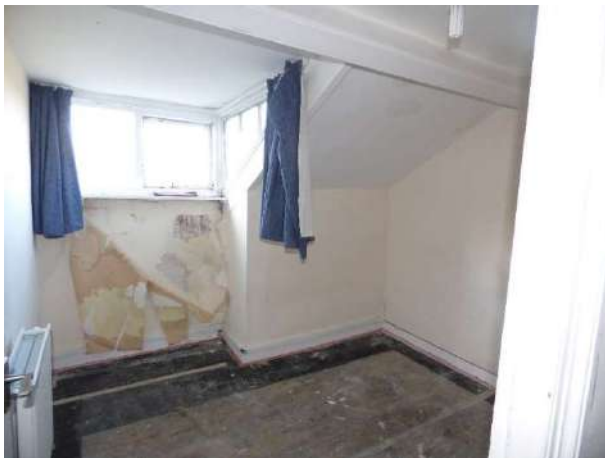
Left: the attic space has suffered from severe damp ingress which has caused considerable fabric damage.

The dormer window has degraded to a considerable extent.

The window will be subject to a planning condition. The dormer between two existing rooms, which are to be reconfigured to make the space within the attic more usable.

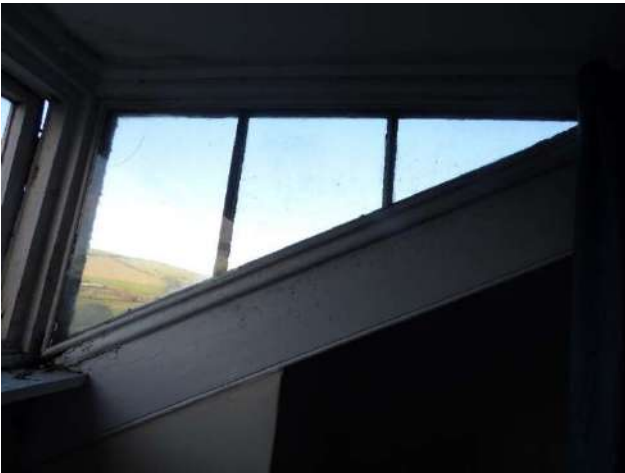
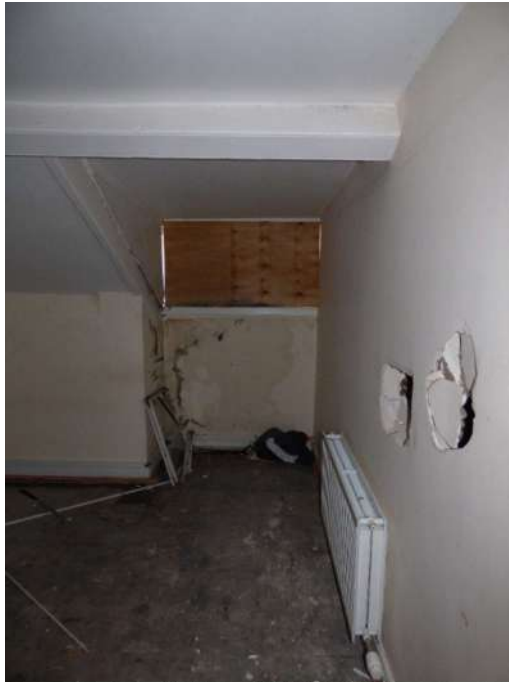
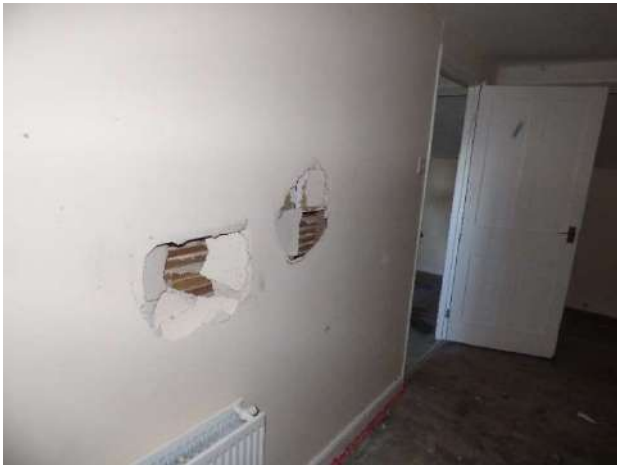
Left - Attic bedroom:

Floorboards require minor repairs.

In the bedroom remove all damp and damaged/blown plasterwork and repair with lime plaster and skim and

Apply an insulated plasterboard 62mm thick to underside of ceiling. The Laminated plasterboard and PIR has a vapour barrier incorporated so interstitial moisture would be prevented. tape and skim and undertake full decorations. New rooflights to be installed.

Provide and install new heritage rooflight windows (Velux or similar), to replace existing velux windows.

Existing doors are to be removed and replaced with new heritage style four panel fire doors.

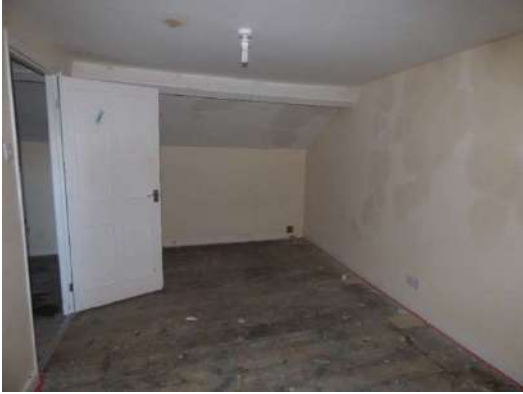
The existing bedroom partition is damaged. It is proposed to remove this wall and reconfigure the space.

In the bedroom remove all damp and damaged/blown plasterwork and repair with lime plaster and skim and decorate throughout.

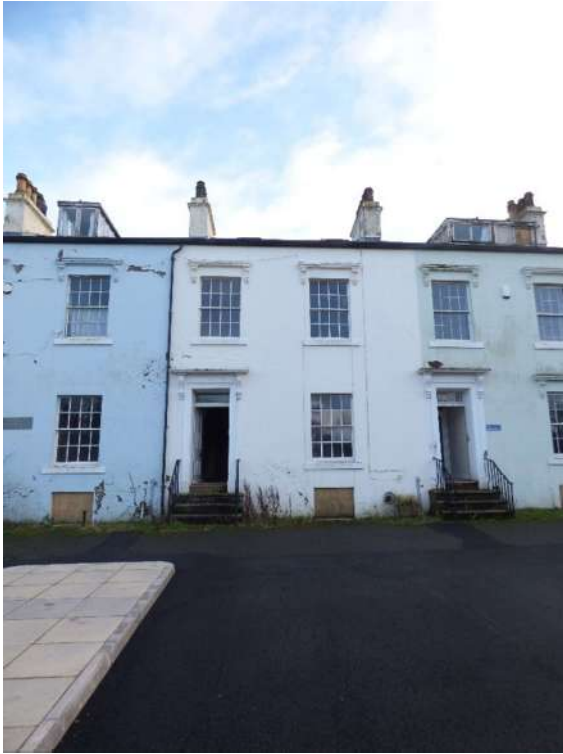
Left: The main entrance is mentioned in the listing text and is to be entirely retained.

Both front and rear elevations are currently rendered, with colour to the front and side and natural to the rear. All elevations require to be prepared for render repairs and redecoration by specialist using lime render and stucco (Parax LTD) to be applied by specialist.

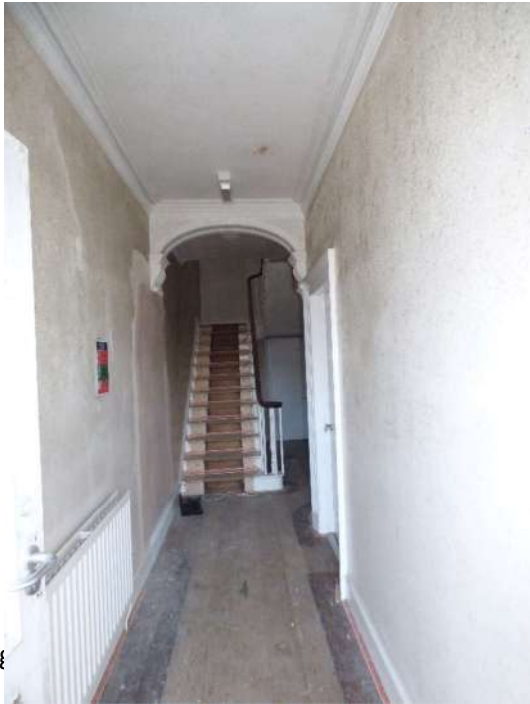
Left: The existing walls and floor are generally in good condition.

Redundant M&E to be removed and wall/ceiling finishes made good and primed, prepared and fully decorated.

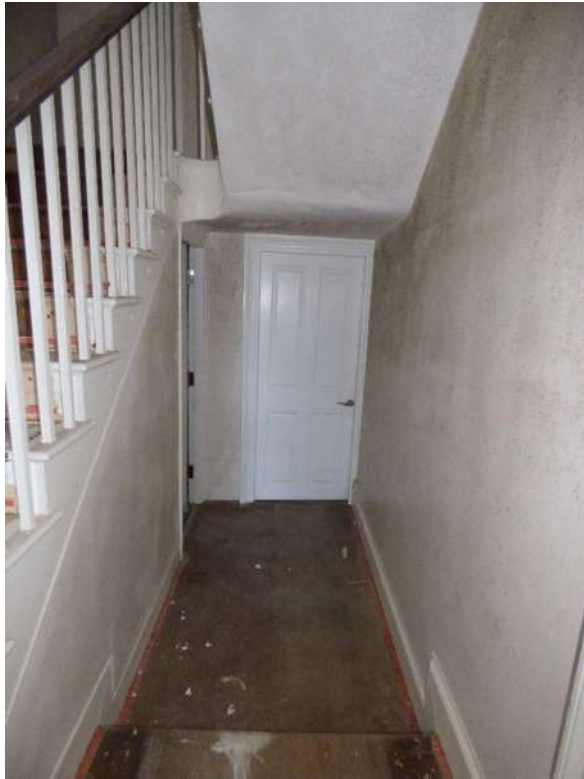
Existing staircase is original and is in excellent condition.

Below: Existing door and fanlight to be retained.

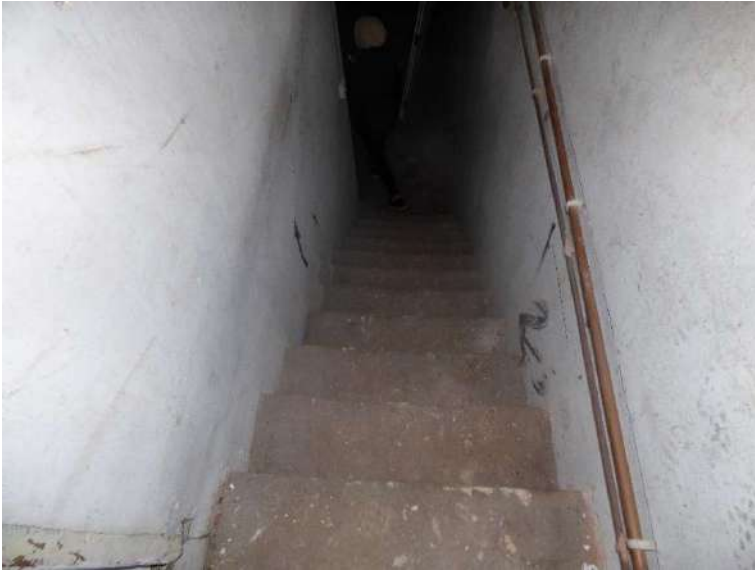
Left: The basement

The existing walls and floor are generally in sound condition so would be suitable for this application of damp proof slurry system. All existing paint and surface finishes must be removed and made good including all snots removed, and damage to existing surfaces, prior to the installation of a Koster Polysil NB1.

This migratory crystalline tanking slurry is used to seal below ground structures against water ingress.

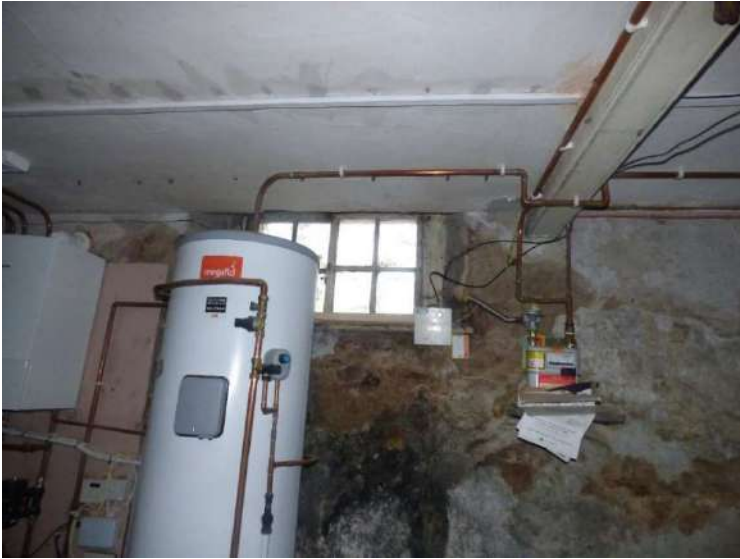
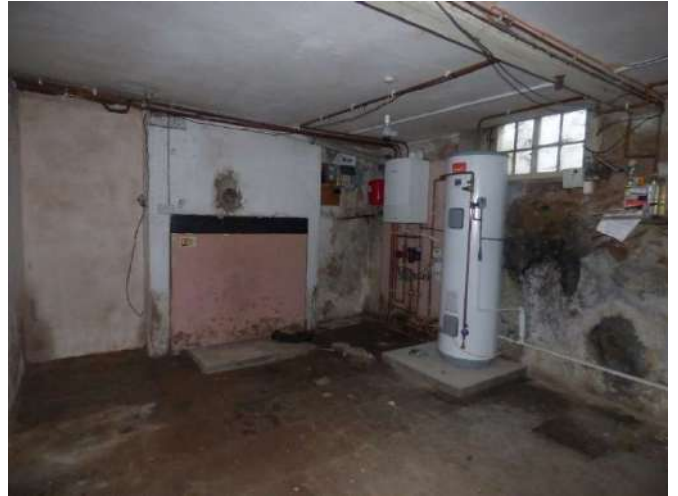
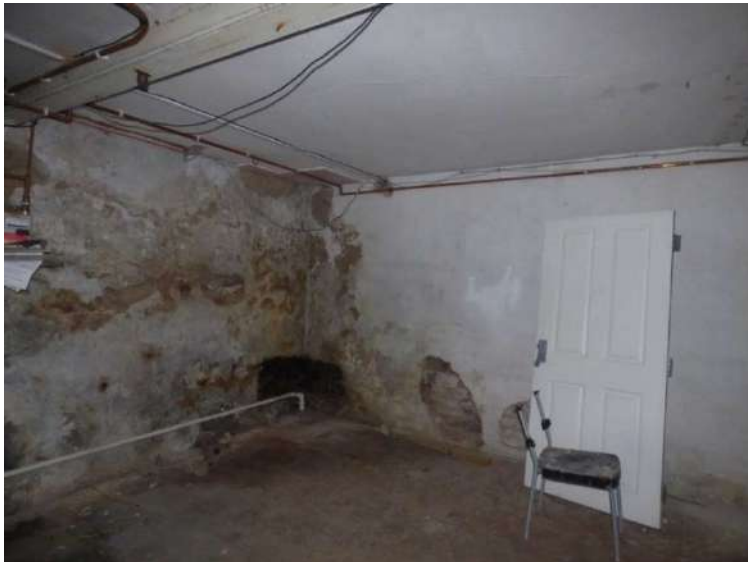
The walls down to the basement also require the full treatment.

Existing window to basement to be removed and reveals made good. Windows to be repaired / replaced subject to planning condition.

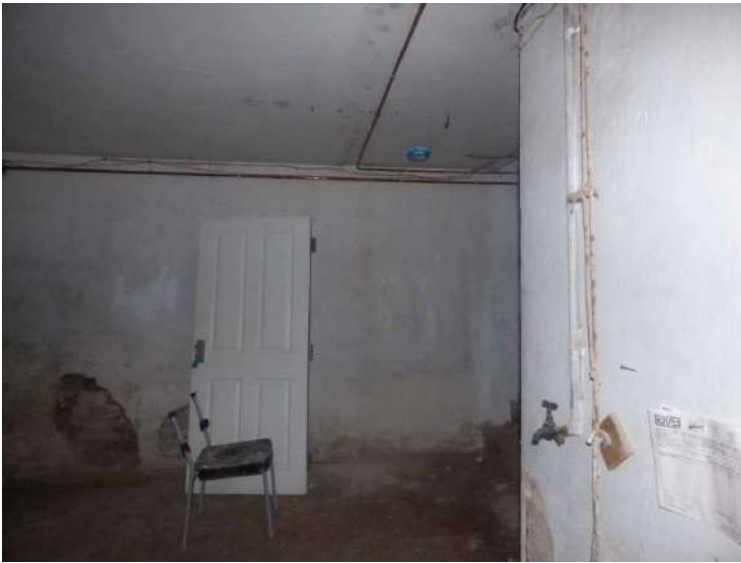
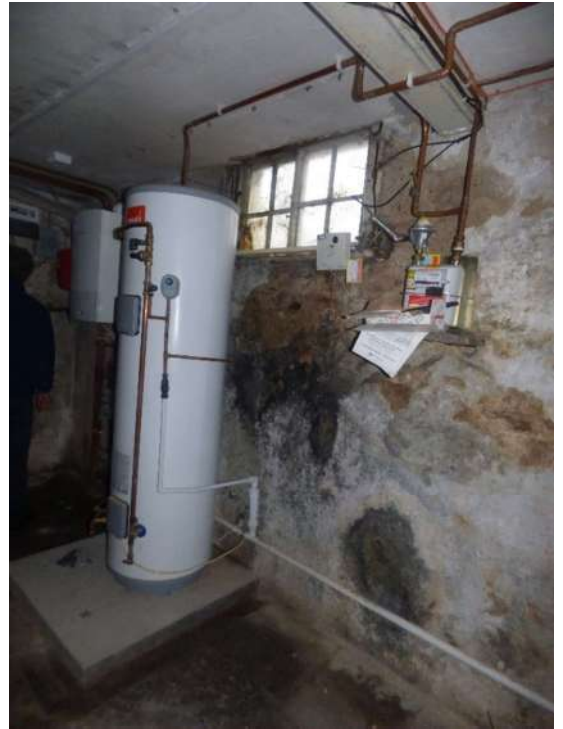
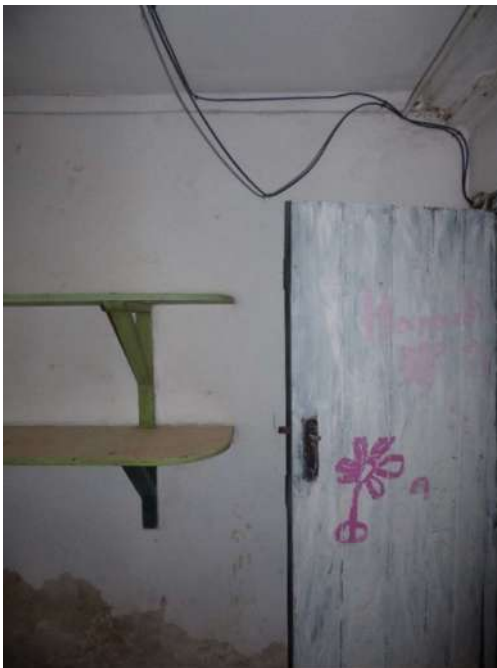
Left and above: New boiler installations have been undertaken prior to the sale of the properties.

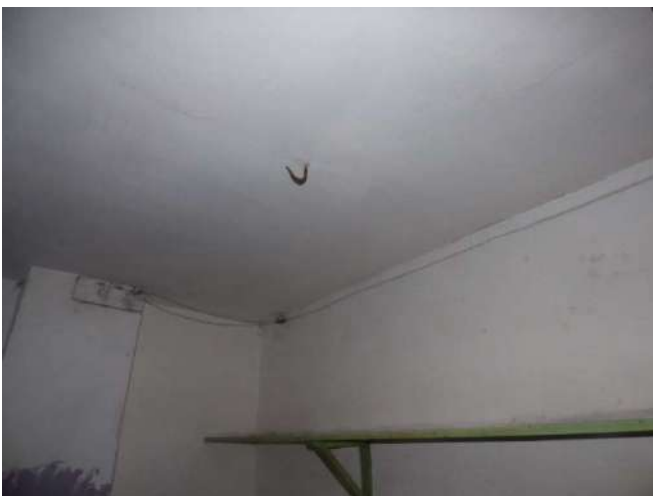
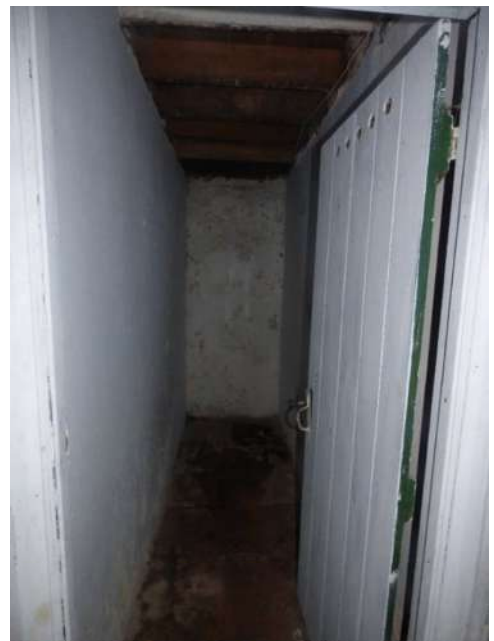
Below, left: Former window has been walled up. It is proposed to wall up properly with insulation and masonry.

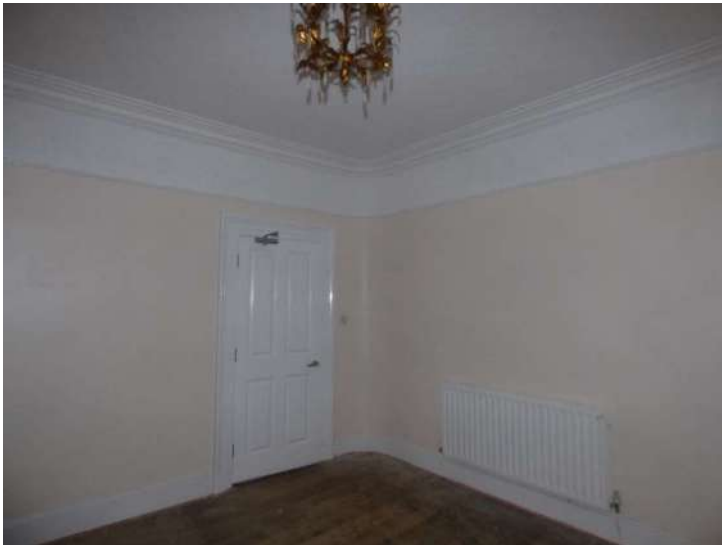
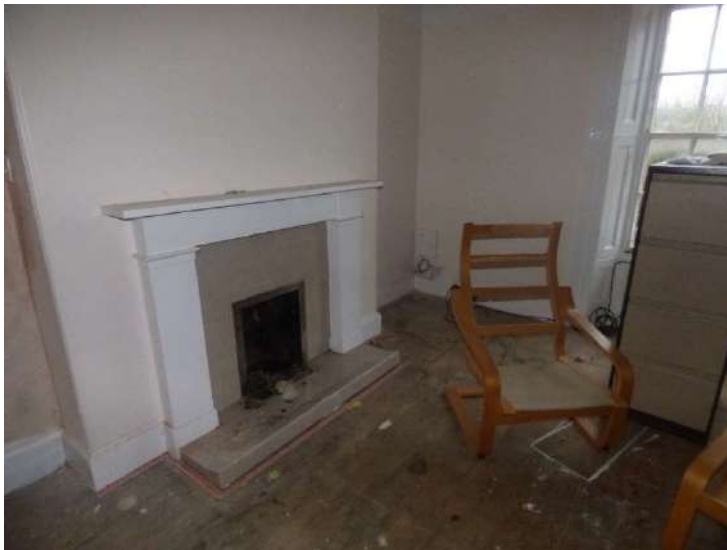
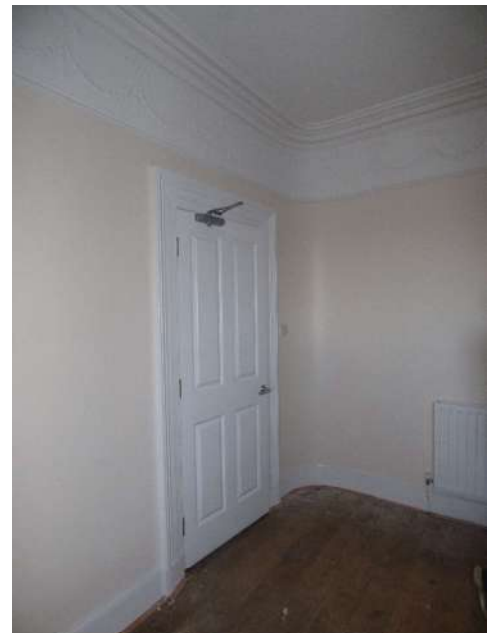
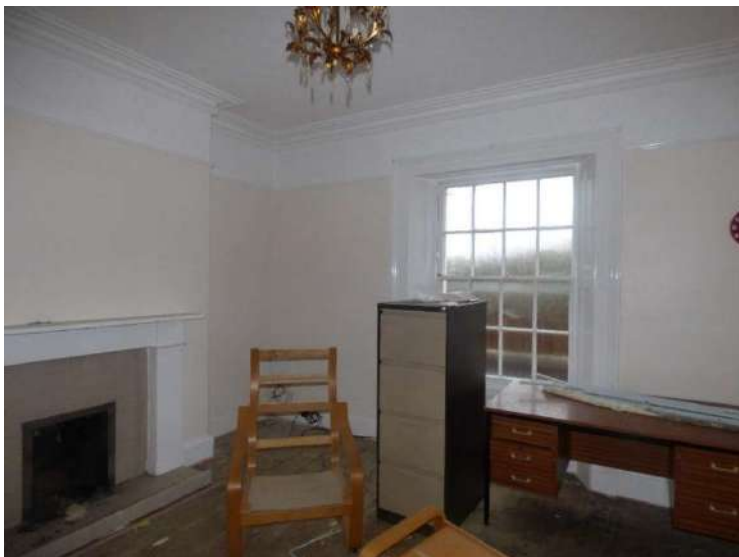
Left and below: In the existing front room, the period features below and to the sides of the existing window are in good condition, it is proposed to carefully refurbish the existing timber shutters.

Existing cornices, picture rail is all in excellent condition and are to be retained.

Existing doors to be replaced with heritage style four panel painted timber fire doors to enhance the heritage asset.

Where possible it is proposed to refurbish any original doors with door closers and intumescent paint subject to building control approval.

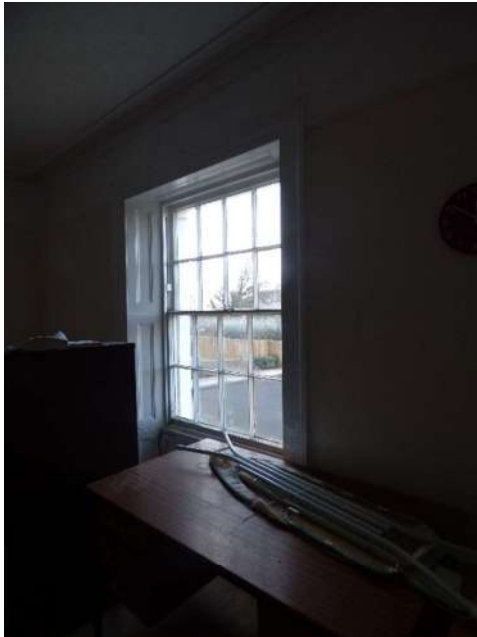
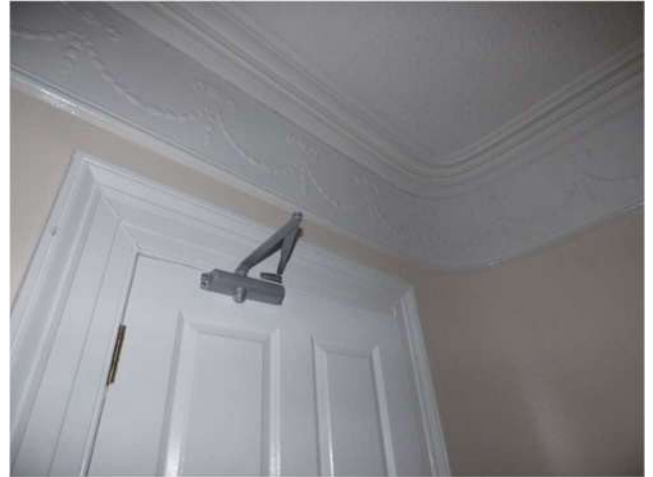
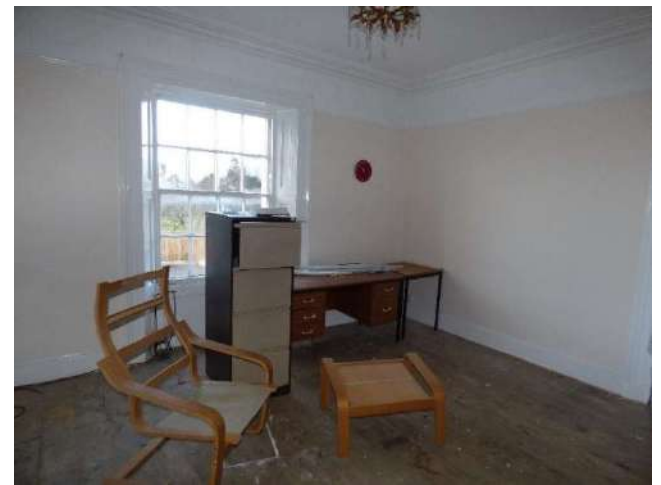
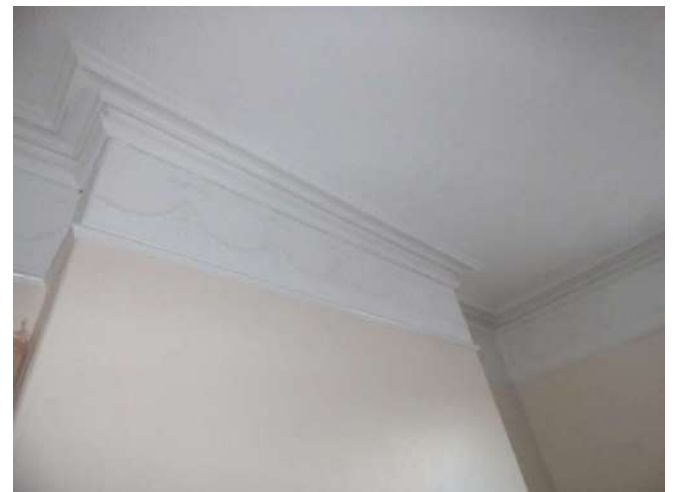
Right, above, and below: In the existing lounge at the front of the property, it is proposed to carefully refurbish the existing timber shutters.

Fireplace is not original and is not proposed to retain it.

Existing architraves and skirtings to be retained and made good.

It is proposed to form a new opening between lounge and dining to create a more open plan living environment. The new opening will be formed 300mm beneath the cornice to ensure cornice features are retained.
