# HERITAGE STATEMENT

## FULL RENOVATION OF EXISTING No 11 TERRACE HOUSES

St Bees, 1-11 Lonsdale Terrace, Parish Council, Cumbria

M.A.C Architects, Project Number: 2019:303

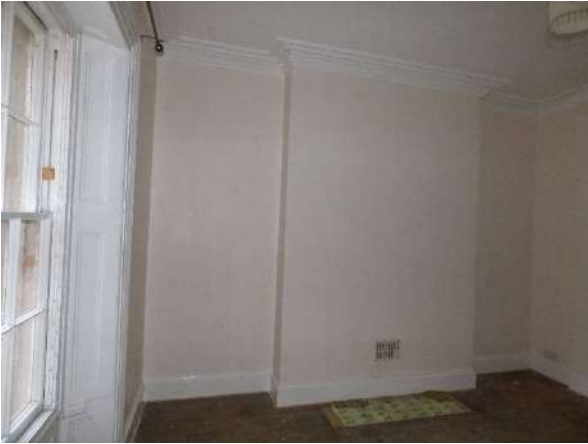
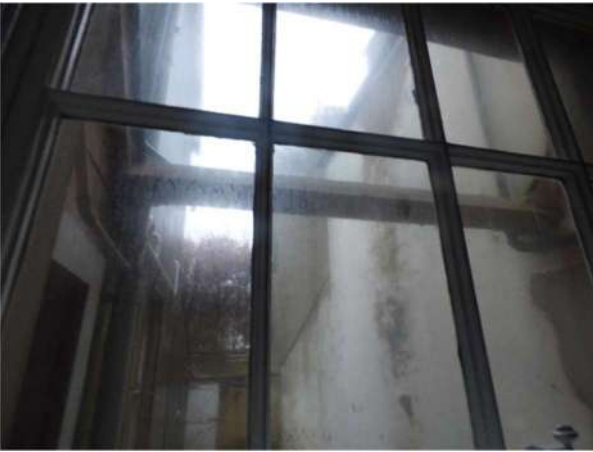
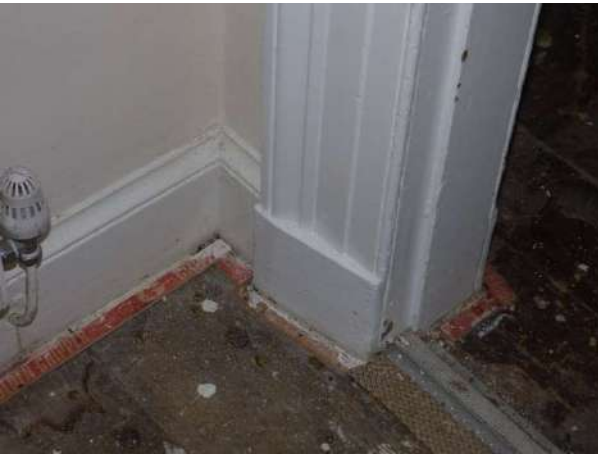
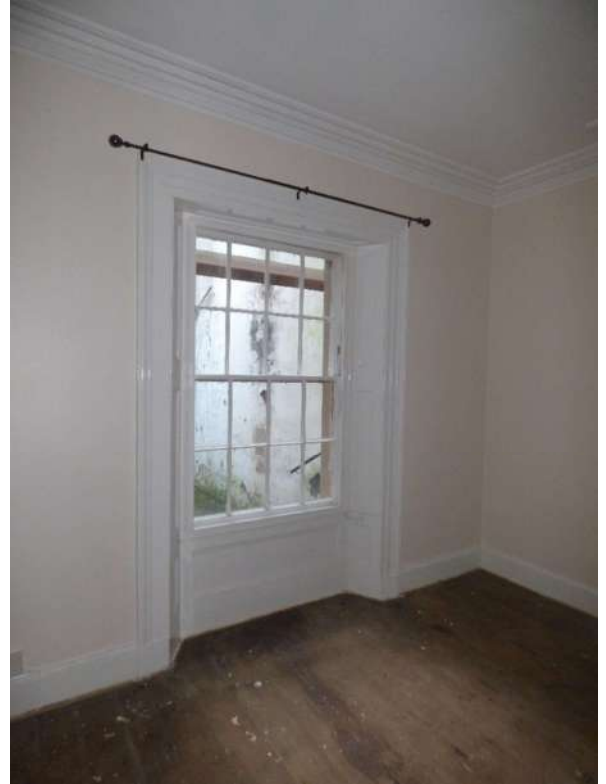
In the existing dining room, the period features below and to the sides of the features below and to the sides of the existing windows both front and back are in good condition, it is proposed to carefully refurbish the existing timber shutters.

Existing cornice to be retained.

Existing door to be replaced with heritage style four panel painted timber fire door to enhance the heritage asset. Where possible it is proposed to refurbish any original doors with door closers and intumescent paint subject to building control approval.

New opening to be formed between existing dining and lounge to accommodate open space living area (as with houses 1-5). Openings to be below cornices, which will remain intact.

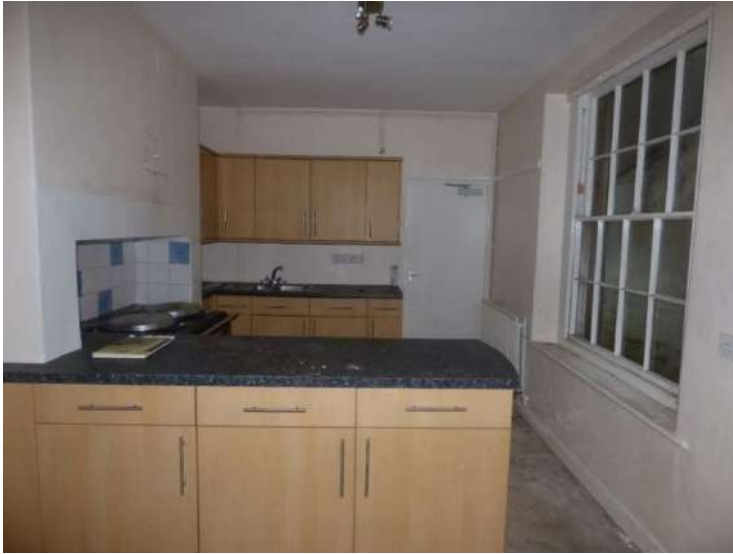
In the existing kitchen it is proposed to remove all fixtures and fittings.

Blown plaster to existing walls to be repaired with new lime paster and made good.

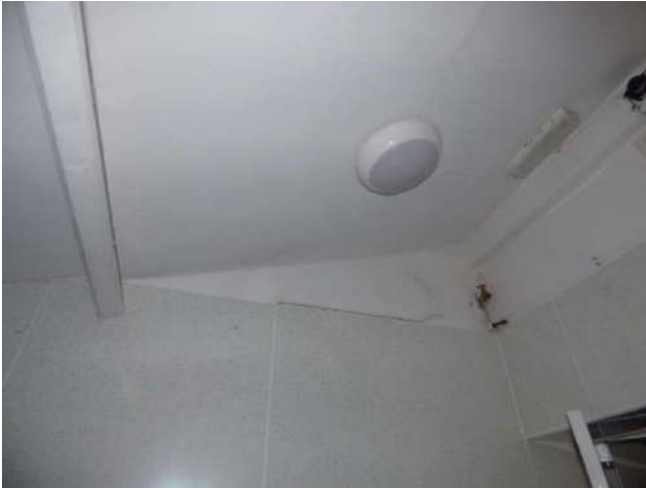
Left: The existing former shower area is to be reconfigured to provide a new utility and w.c. at ground floor.

The existing modern rooflight is proposed to be replaced with a new heritage style rooflight (Velux or Rooflight company or similar). New rooflights to be installed with flashing kit that mounts unit flush with the roof surface

Apply an insulated plasterboard 62mm thick to underside of ceiling. The Laminated plasterboard and PIR has a vapour barrier incorporated so interstitial moisture would be prevented to be taped and skimmed.

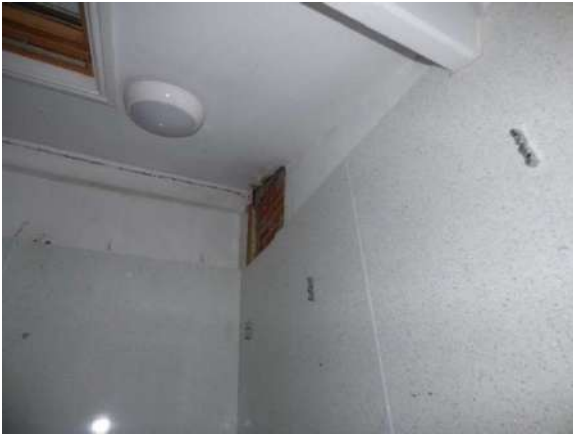
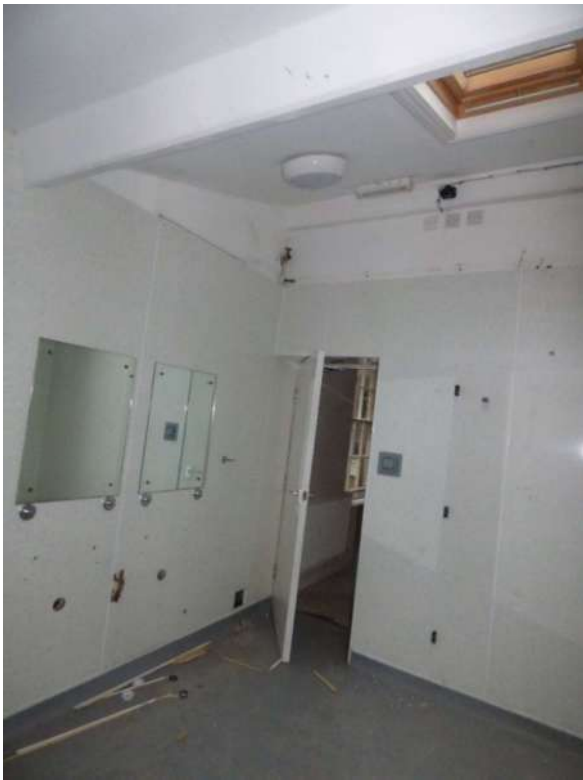
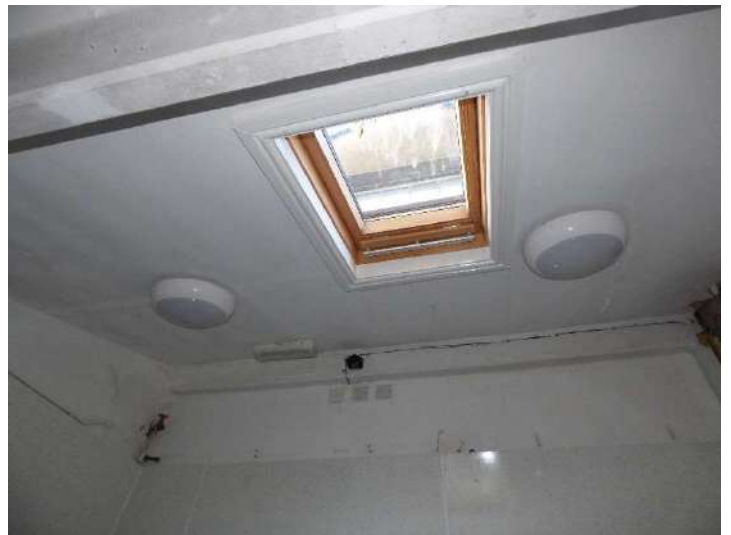
Left and below: The existing shower block to be reconfigured.  
The roof may require some minor repairs to make watertight.

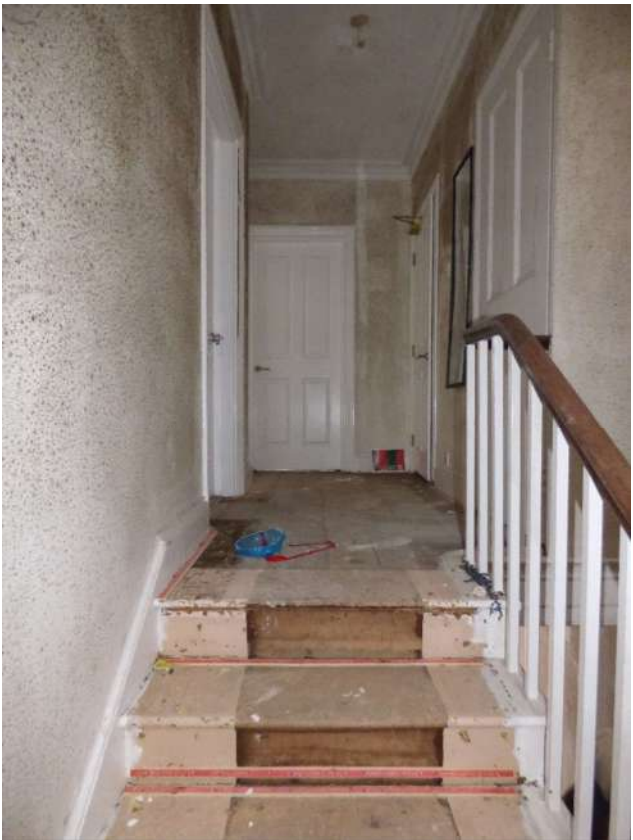
Left and above: Existing ceiling to be made good by removing mould and replacing blown plaster with lime plaster as required.

Windows to be repaired / replaced subject to planning condition.

New bathroom to be four panelled door to match the existing – bathroom door does not need to be a fire rated door. To replace existing modern bathroom door.

All finishes to be made good, and skirtings to match the original to be installed.

Existing cornices to be made good and skirtings to match existing to be reinstated.

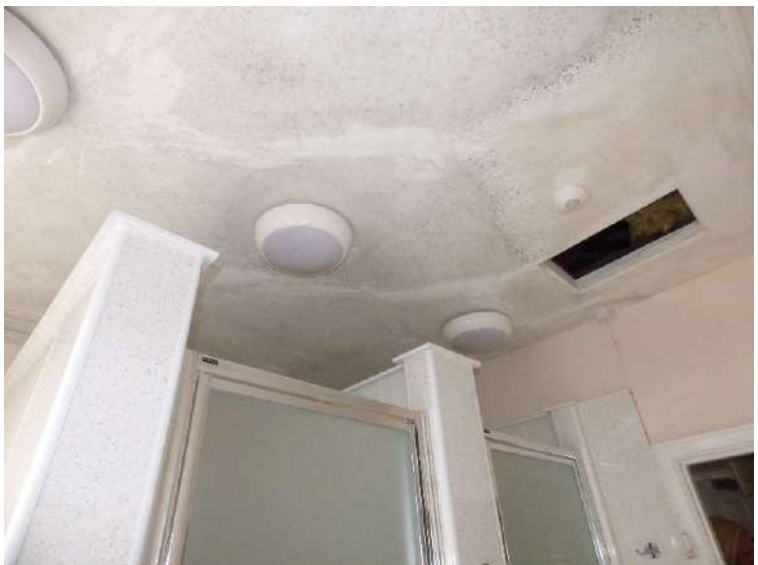
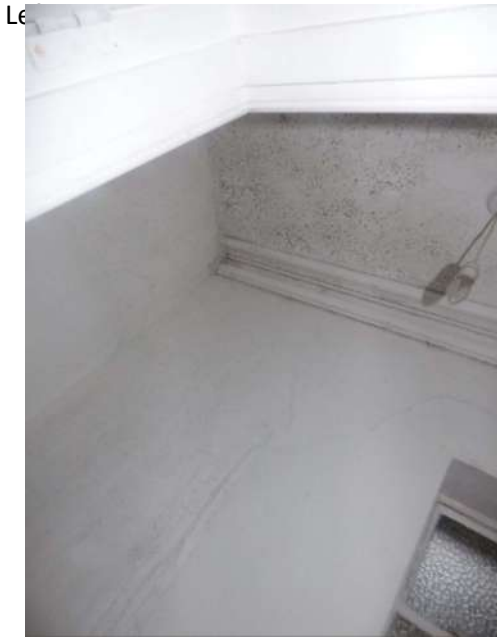
First floor w.c. to be reconfigured, and cornices and skirtings to be reinstated. All existing plasterwork affected by damp to be repaired and or reinstated as required. Roof to be repaired to ensure completely watertight.

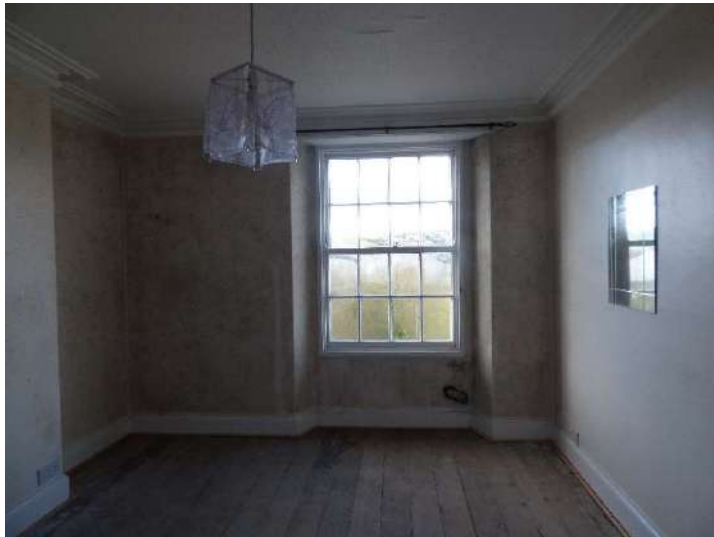
Left and below:

Rear bedroom - skirtings and architraves to be retained. Existing flush panelled door to be replaced with Georgian heritage style four panel fire door to be provided and installed by specialist such as Batty joinery ltd. Where possible it is proposed to refurbish any original doors with door closers and intumescent paint subject to building control approval.

Existing floorboards in good condition.

Cornice in good condition and to be retained.

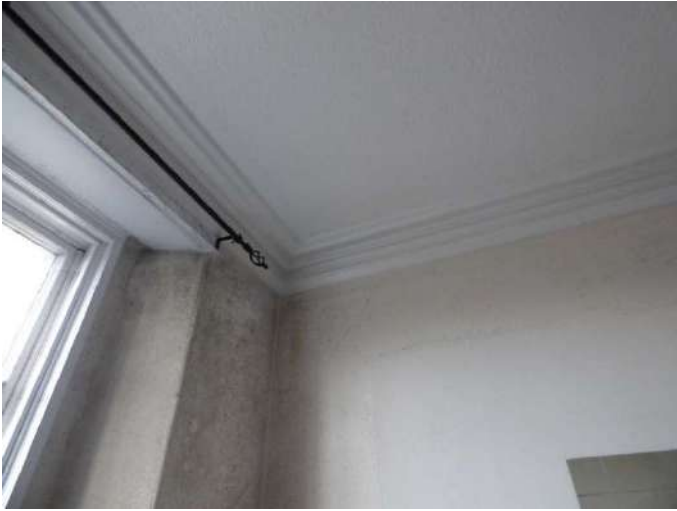
Left:

Large front bedroom, skirtings and architraves to be retained. Existing door to be replaced with new Georgian heritage style four panel door to be provided and installed by specialist joinery company such as Batty Joinery Ltd. Where possible it is proposed to refurbish any original doors with door closers and intumescent paint subject to building control approval.

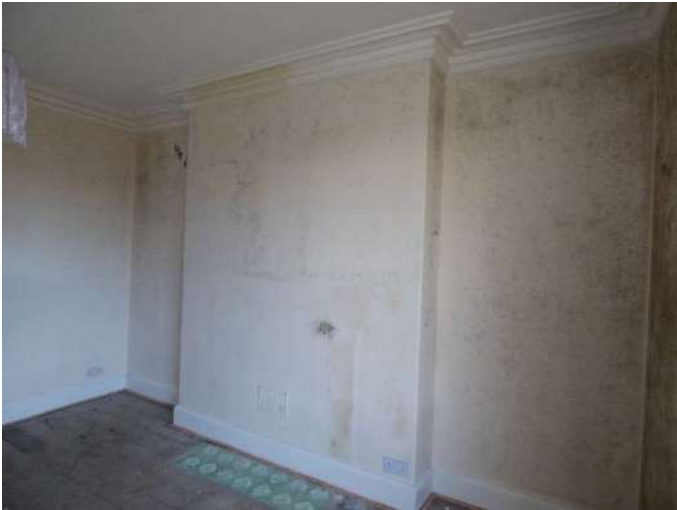
Damp ingress evident with mould to walls and ceiling.

Attic and roof to be made watertight.

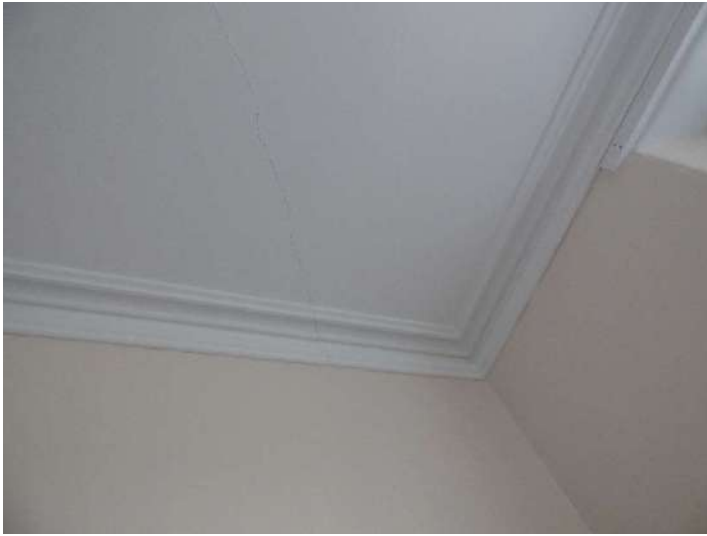
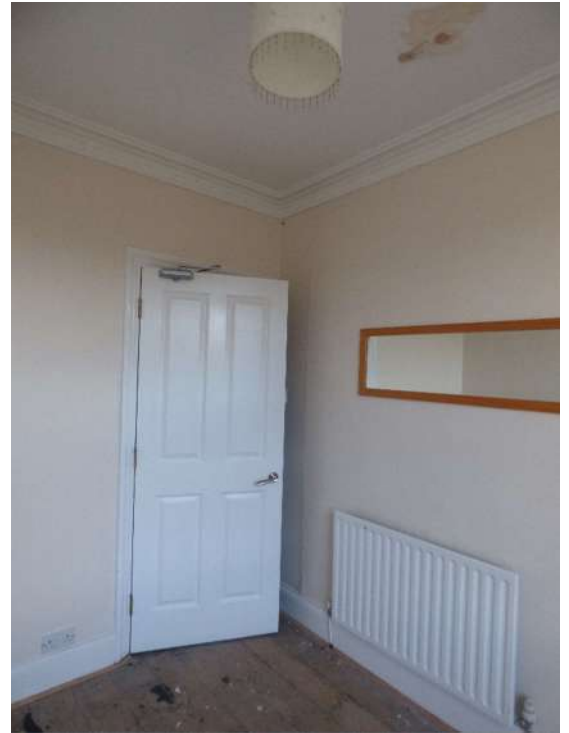
Existing floorboards in good condition.

Existing small bedroom skirtings and architraves to be retained. Existing door to be removed and new doorway from proposed master bedroom to be provided and installed with new Georgian heritage style four panel door to be provided and installed by specialist joinery company such as Batty Joinery Ltd. Where possible it is proposed to refurbish any original doors with door closers and intumescent paint subject to building control approval.

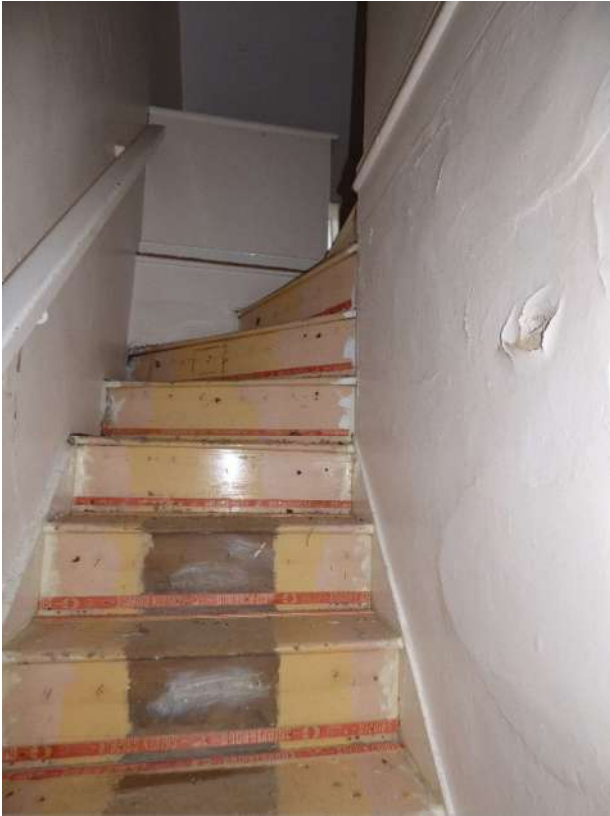
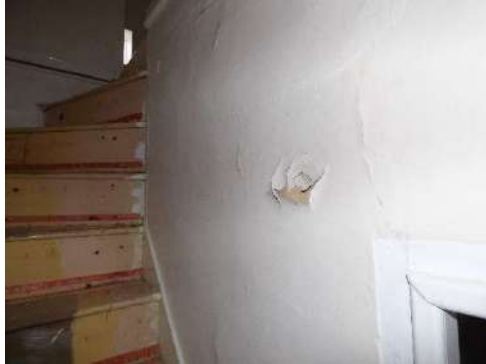
Existing staircase to attic. Existing walls require minor fabric repairs.

New four panelled fire door to be installed at first floor.

Where possible it is proposed to refurbish any original doors with door closers and intumescent paint subject to building control approval.

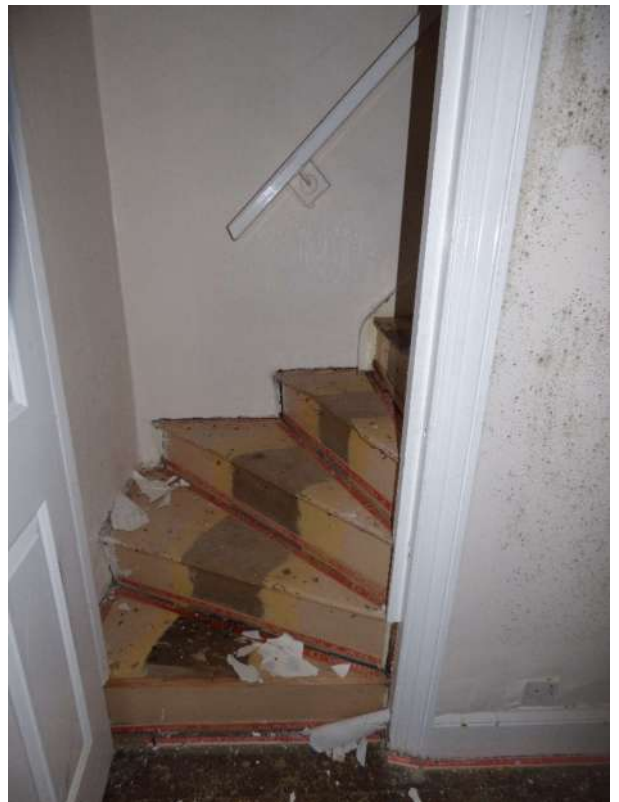
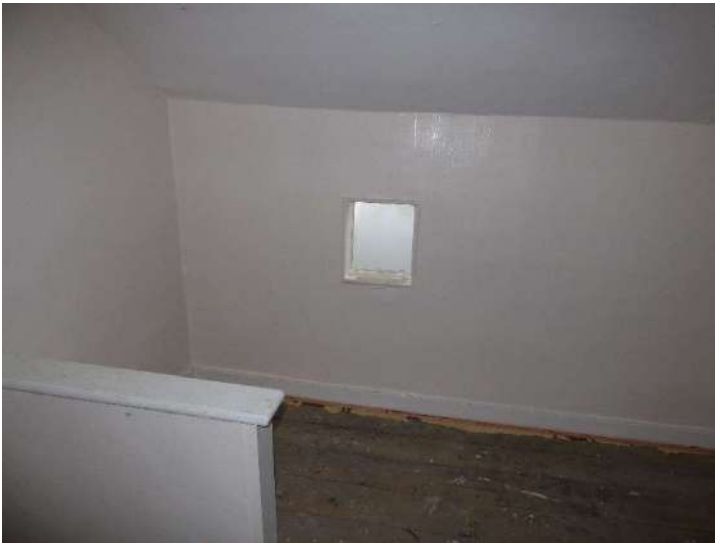
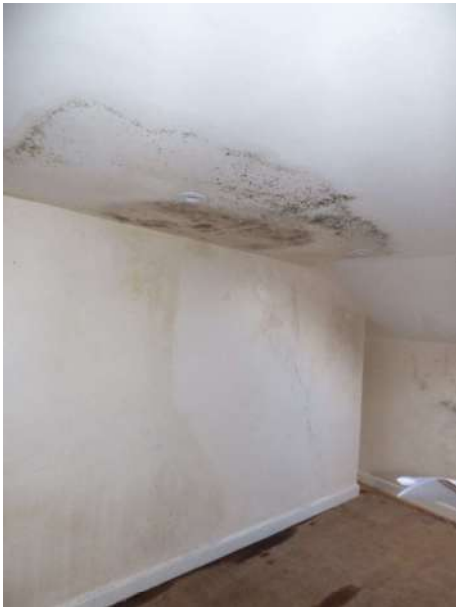
Left: Attic landing.

Floorboards are in good condition (but require minor repairs).

Existing internal window is proposed to be walled up subject to planning condition.

Existing damaged plaster to be replaced and repaired with lime plaster (Solo lime plaster from Lime Centre)..

Apply an insulated plasterboard 62mm thick to underside of ceiling. The Laminated plasterboard and PIR has a vapour barrier incorporated so interstitial moisture would be prevented. New rooflights to be installed with flashing kit that mounts unit flush with the roof surface.

Provide and install new heritage rooflight windows (Velux or similar) to replace existing modern Velux rooflights.

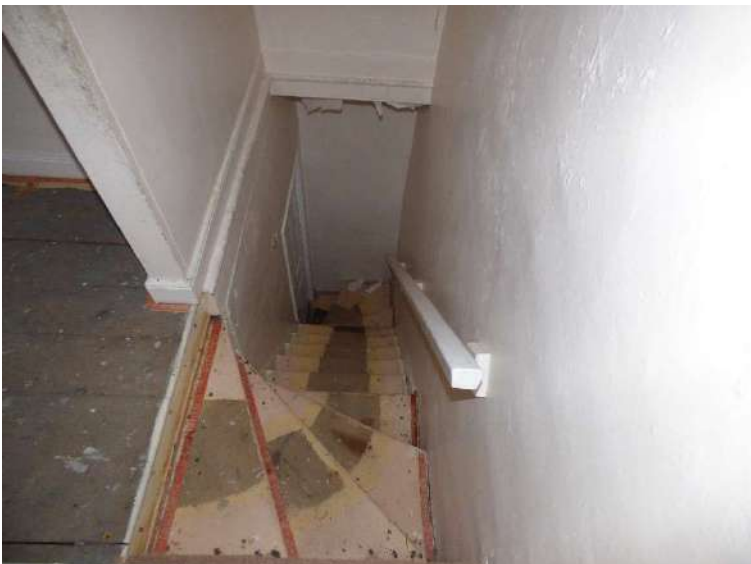
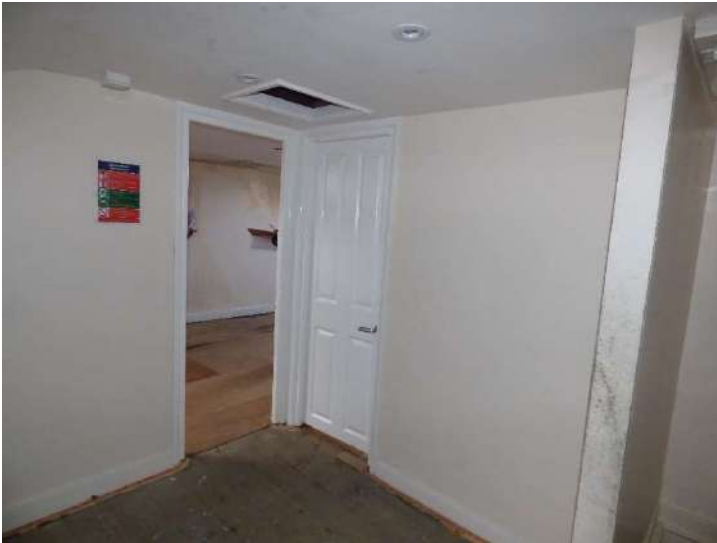
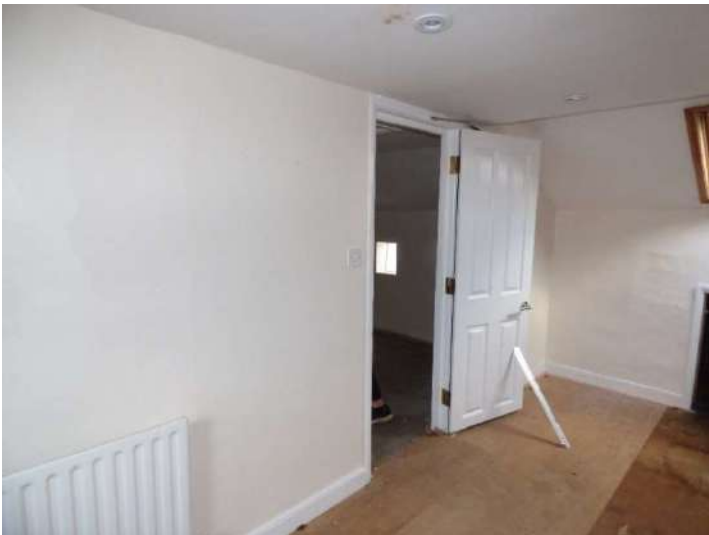
Left: Attic bedroom

Floorboards are in good condition (but require minor repairs).

The existing attic bedrooms are to be reconfigured to maximise the space.

In the bedroom it is proposed to remove all blown plasterwork and repair with lime plaster and skim.

Apply an insulated plasterboard 62mm thick to underside of ceiling. The Laminated plasterboard and PIR has a vapour barrier incorporated so interstitial moisture would be prevented. New rooflights to be installed with flashing kit that mounts unit flush with the roof surface.

Provide and install new heritage rooflight windows (Velux or Rooflight company or similar) to replace existing modern Velux windows.

Existing doors are to be removed and replaced with new heritage style four panel fire doors.

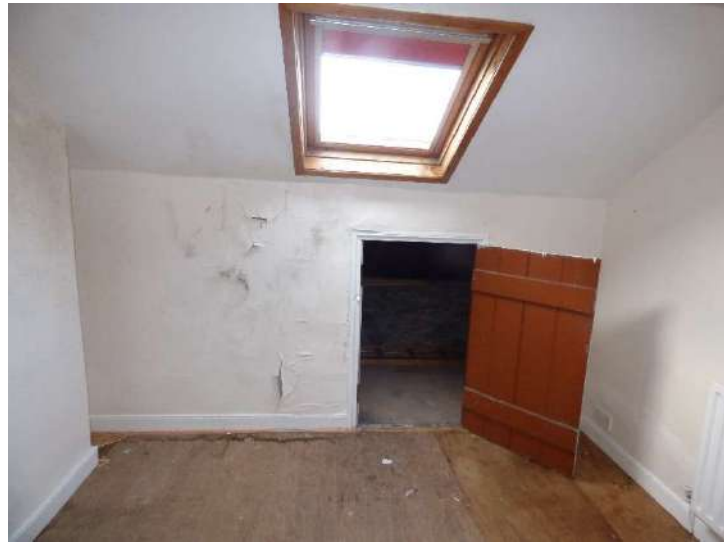
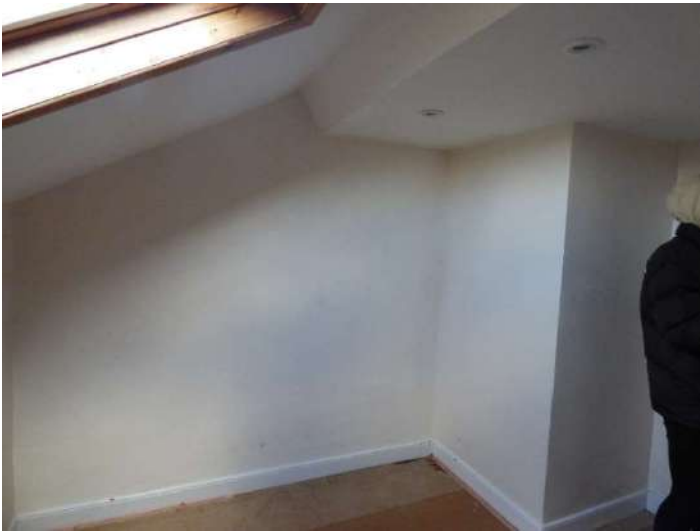
Left: Attic bedroom

Floorboards are not original and it is proposed to replace with T&G timber floorboards

The existing small attic bedroom will be reconfigured to maximise the space.

In the bedroom it is proposed to remove all blown plasterwork and repair with lime plaster and skim.

Apply an insulated plasterboard 62mm thick to underside of ceiling. The Laminated plasterboard and PIR has a vapour barrier incorporated so interstitial moisture would be prevented. New rooflights to be installed with flashing kit that mounts unit flush with the roof surface.

Provide and install new heritage rooflight windows (Velux or Rooflight company or similar) to replace modern Velux rooflights.

Existing doors are to be removed and replaced with new heritage style four panel fire doors.

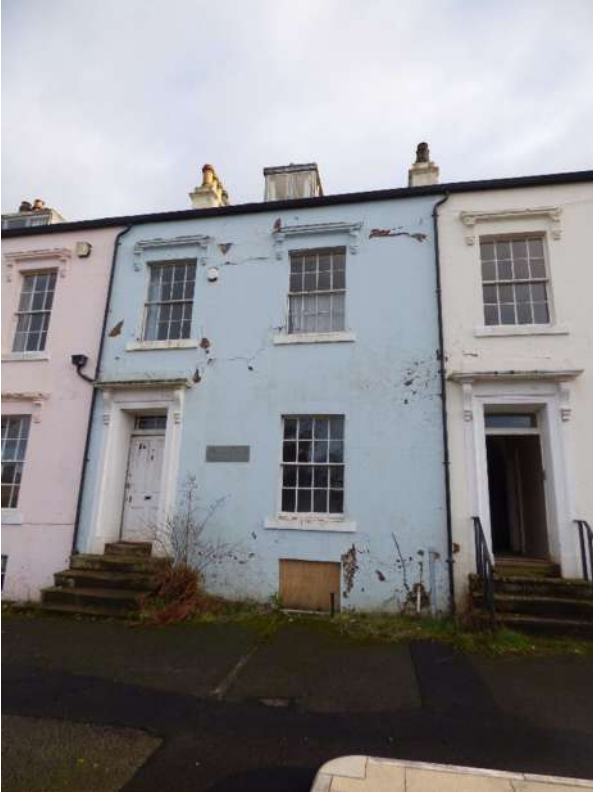
Left: The main entrance is mentioned in the listing text and is to be entirely retained.

Both front and rear elevations are currently rendered, with colour to the front and side and natural to the rear. All elevations require to be prepared for render repairs and redecoration by specialist using lime render and stucco (Parax LTD) to be applied by specialist. The stucco features above the windows and door on the front elevation will be carefully restored by a specialist. Colour of all render and stucco to match existing.

The existing door and frame are to be retained and made good with the provision of new ironmongery. Once repaired full decoration will be undertaken.

Existing gutters and downpipes to be retained, repaired where necessary and decorated.

All existing single glazed windows to be replaced / repaired subject to planning condition.

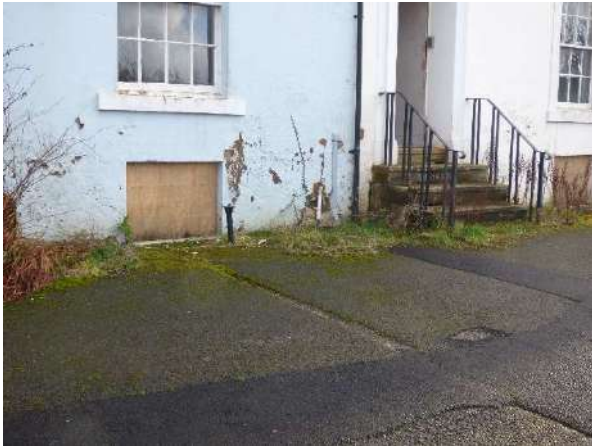
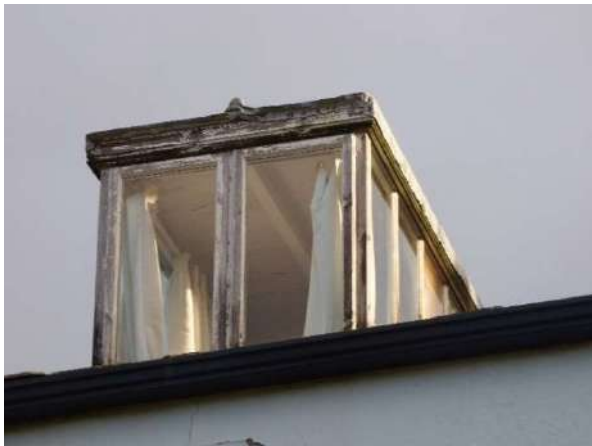
Existing dormer window is in extremely poor condition and it is proposed to completely reconstruct the dormer, in a style to match the other dormer windows on the adjacent buildings.

All existing single glazed windows to be repaired / replaced subject to planning condition.

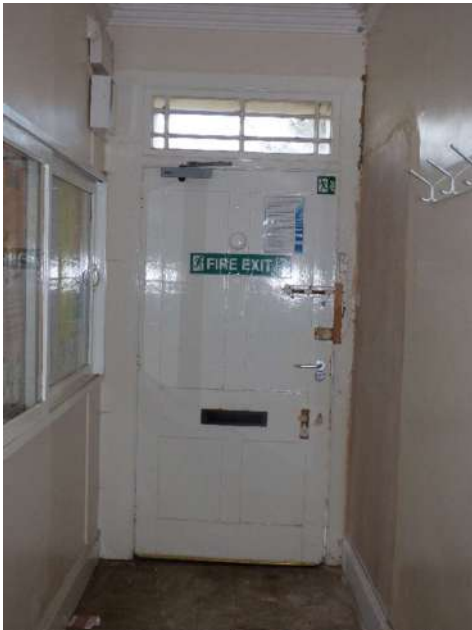
Left: The existing walls and floor are generally in good condition.

Redundant M&E to be removed and wall/ceiling finishes made good, primed, prepared and fully decorated.

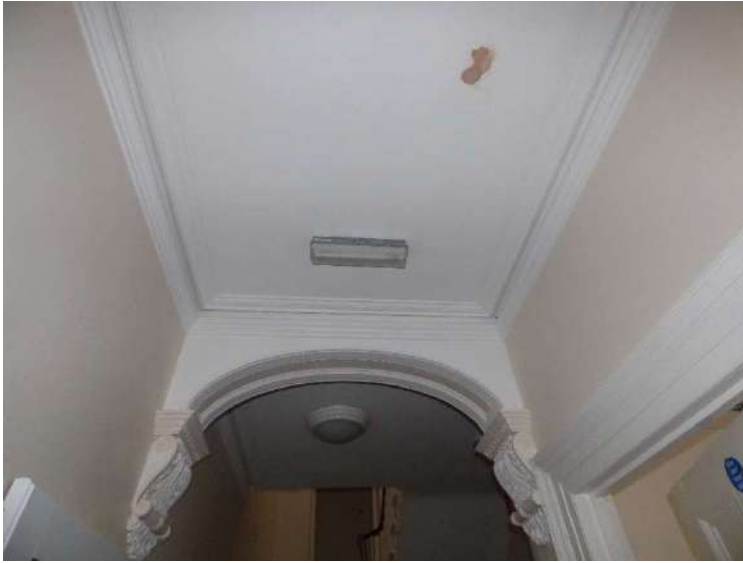
Left: Cornices, architraves and skirtings all in good condition and to be retained.

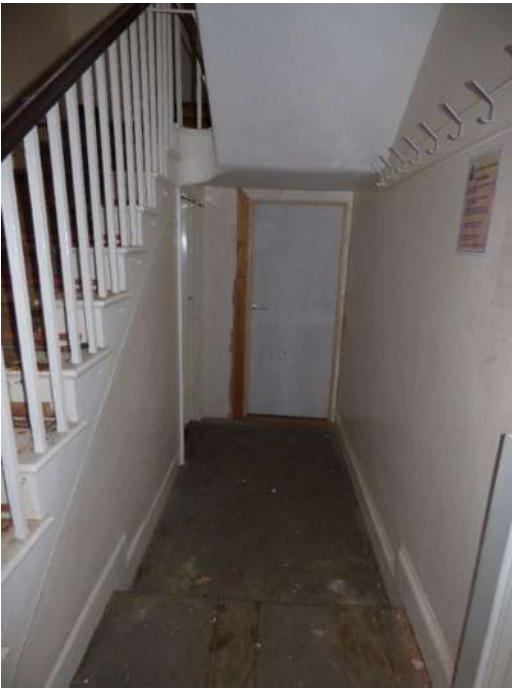
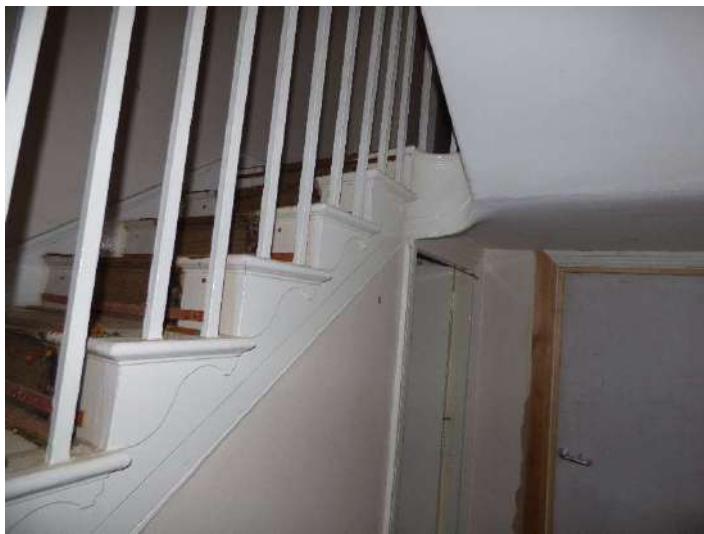
Left and below: The existing walls and skirtings and floor are generally in good condition.

Redundant M&E to be removed and wall ceiling finishes made

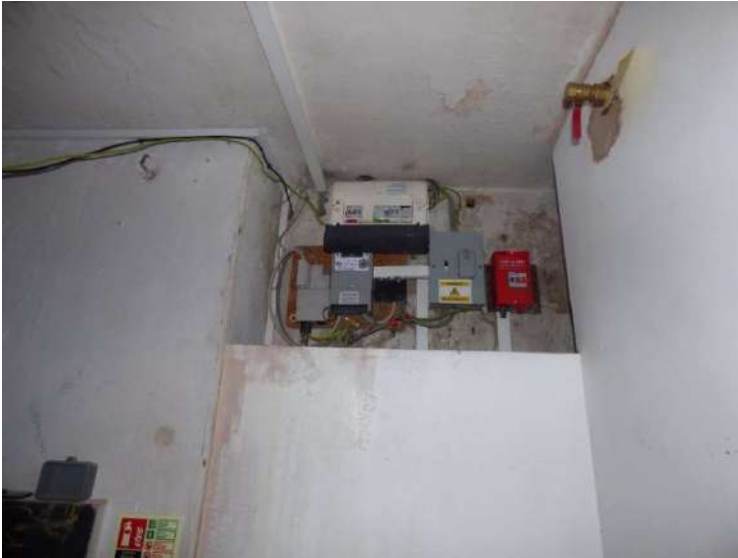
Left: The existing basement, the existing walls and floor are generally in sound condition so would be suitable for the application of damp proof slurry system.

Walls have been boarded over but not treated properly for damp, so it is proposed to remove the boards and apply waterproofing.

All existing paint and surface finishes must be removed and made good including all snots removed, and damage to existing surfaces, prior to the installation of a Kloster Polysil NB1.

Once applied then the walls can be prepared and primed for decorating and for the floor finishes to be installed. Complete new boiler and heating system is required, new distribution boards, etc.

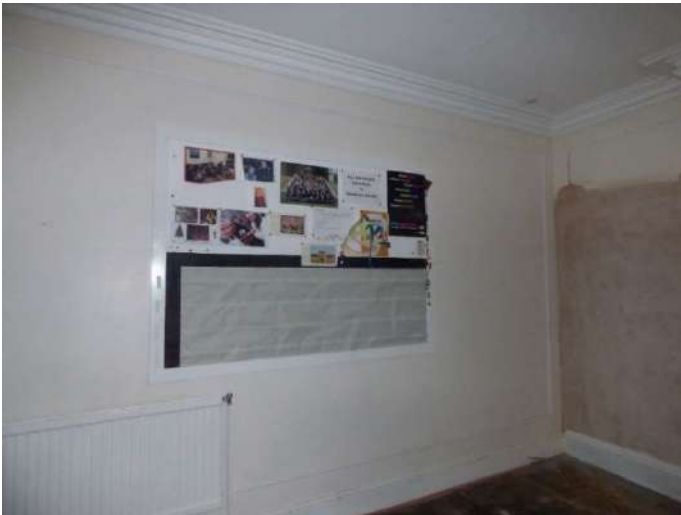
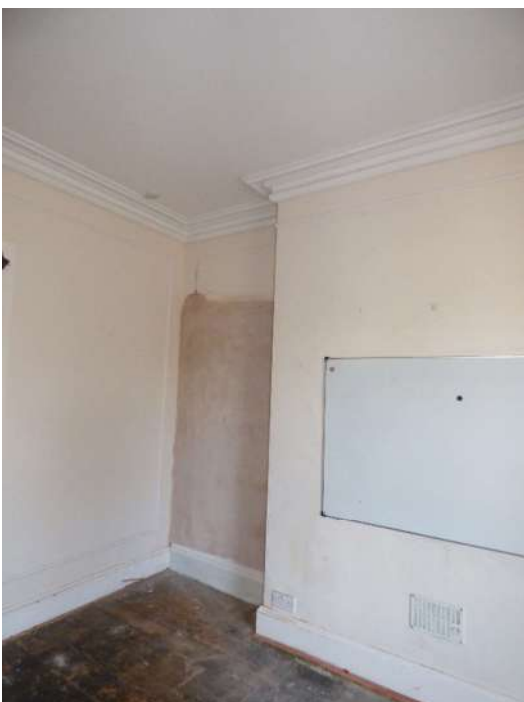
Left: Existing services to be stripped out and walls made good.

Architraves, skirtings, and cornices are all in good condition and are to be retained.

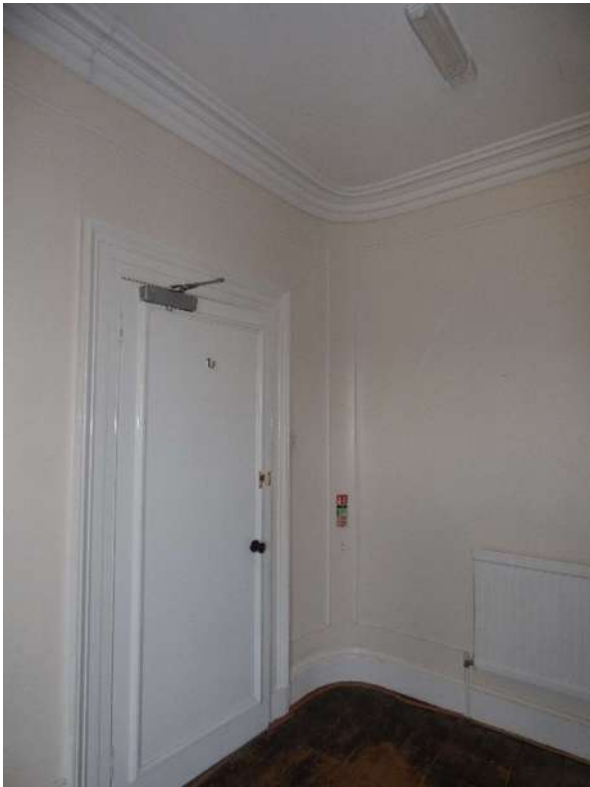
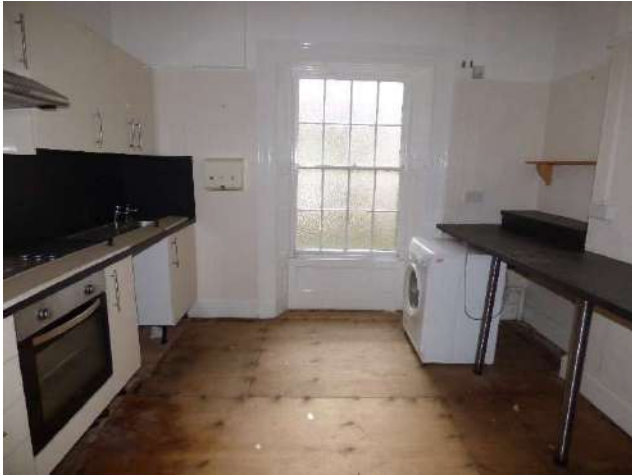
The exiting kitchen dining area to the rear of the property.

The period features below and to the sides of the existing window are in good condition, it is proposed to carefully refurbish the existing timber shutters.

Below: Existing cornice to be made good in locations and where hairline cracks have appeared.

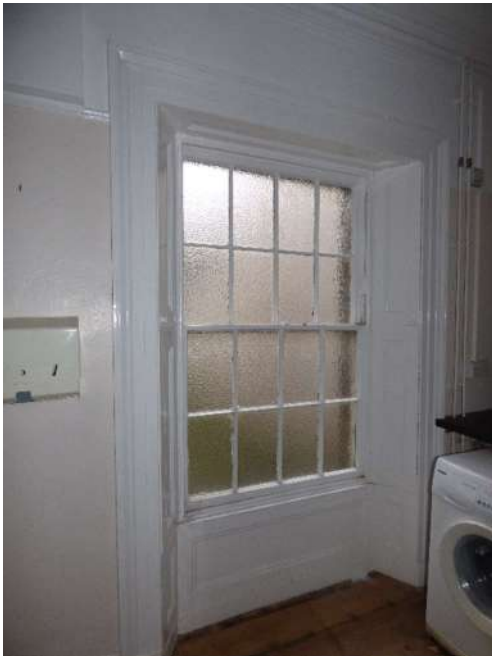
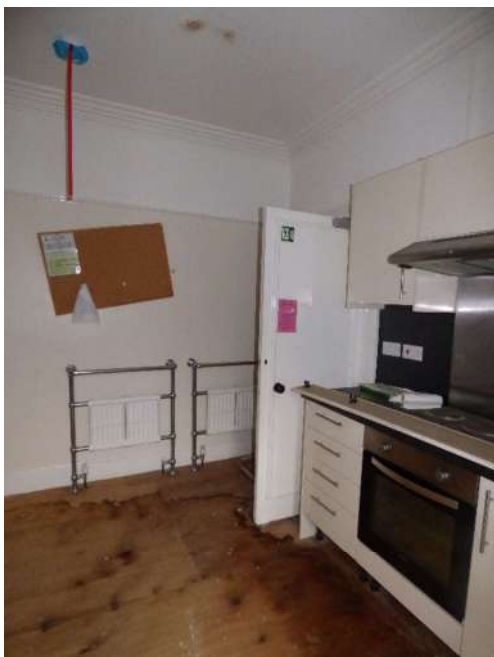
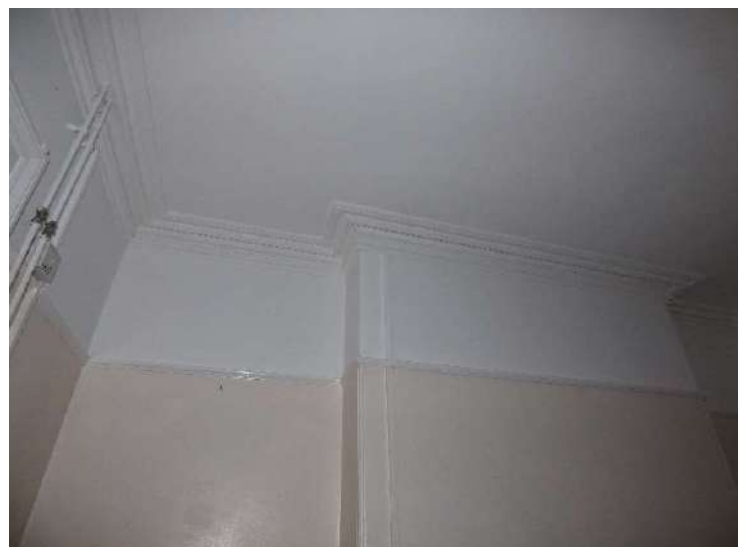
The existing floor is not original as it is plywood boarded, so it is proposed to lift the existing floor and investigate the condition of floor joists and then replace with timber floorboards.

Flush panel doors to be replaced with heritage style four panel painted timber fire doors to enhance the heritage asset.

Where possible it is proposed to refurbish any original doors with door closers and intumescent paint subject to building control approval.

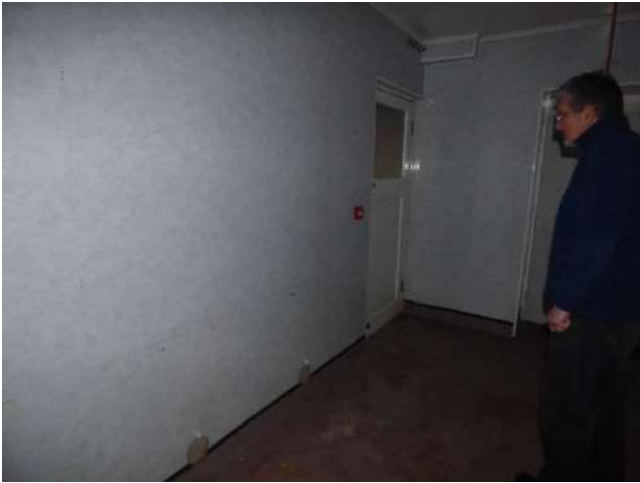
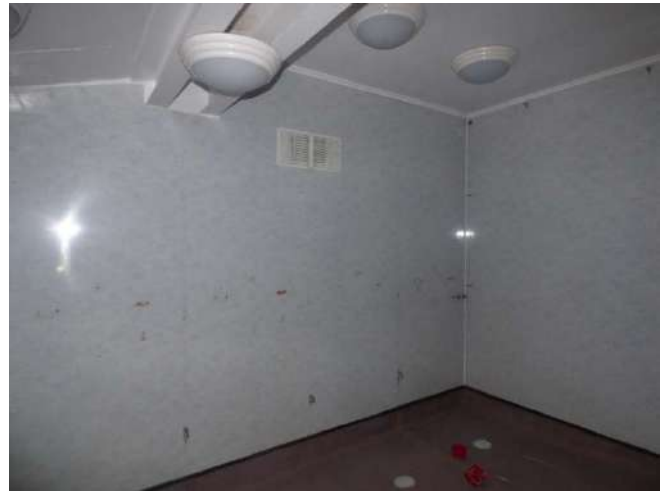
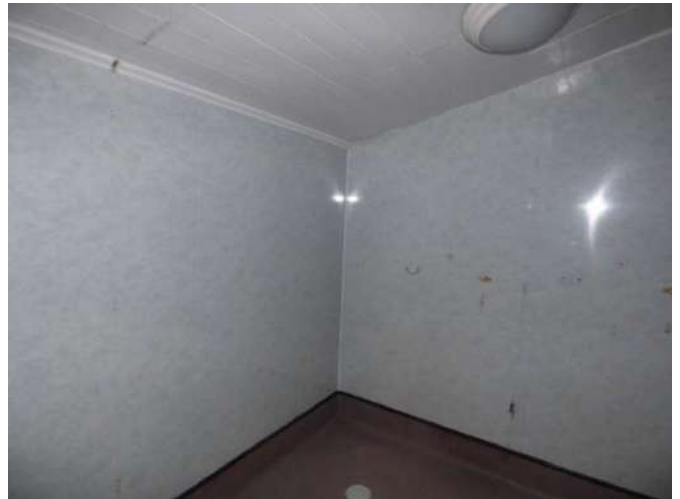
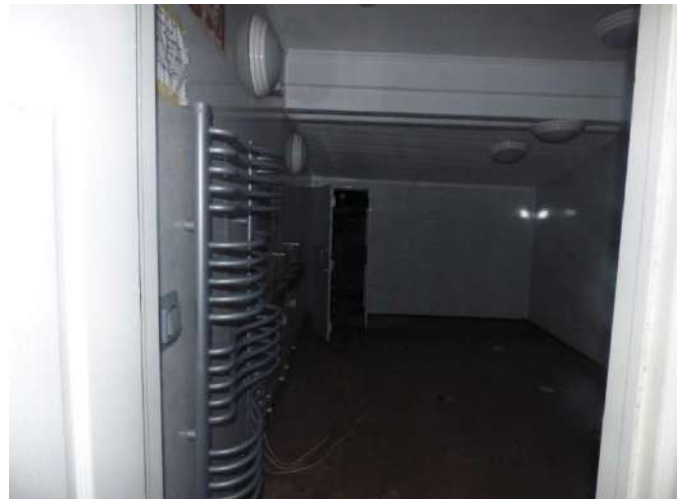
Above and right: The existing former shower block is to be converted back into a kitchen.

All the existing walls and floor finishes are to be stripped out and walls and floors made good. The existing window which has been boarded over will be replaced / repaired subject to planning condition.

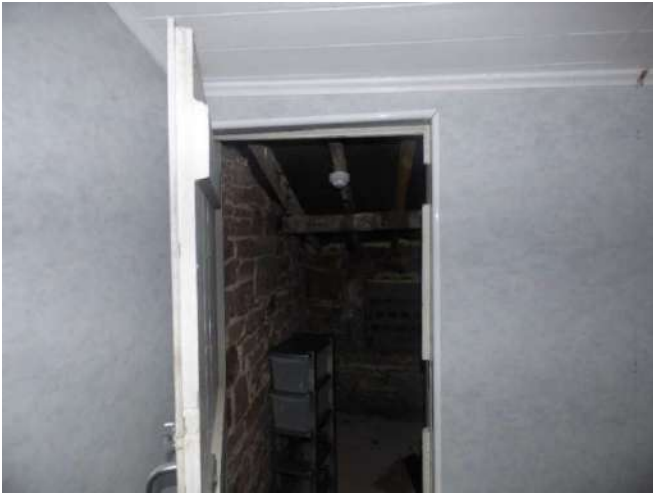
Left: Views of the existing shower block. The area behind the proposed new kitchen will be reconfigured to accommodate a new utility and w.c.

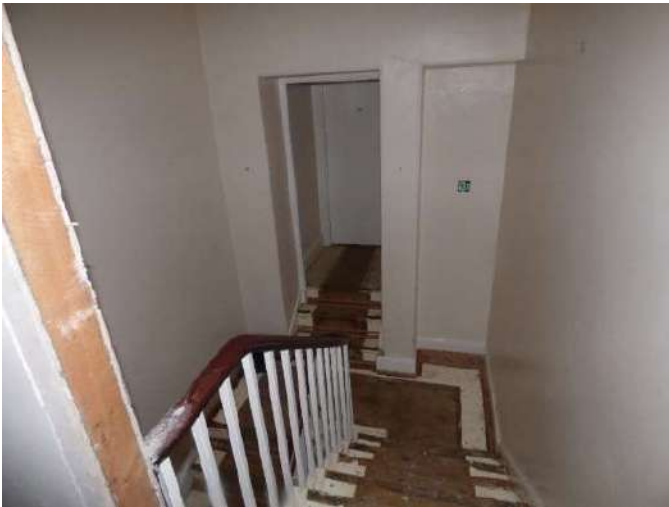
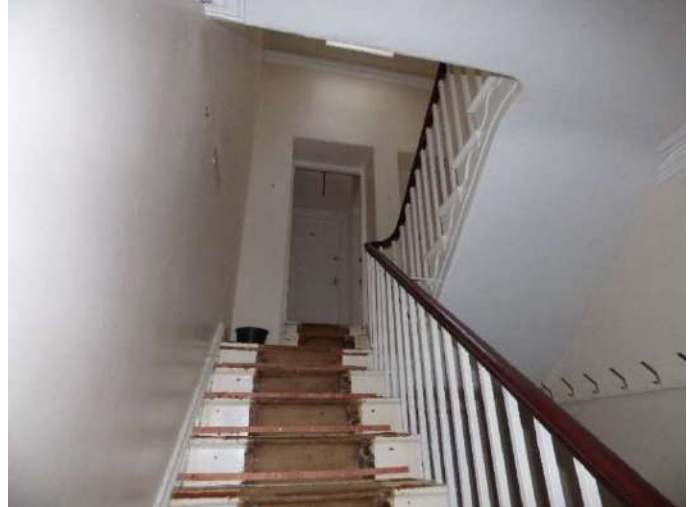
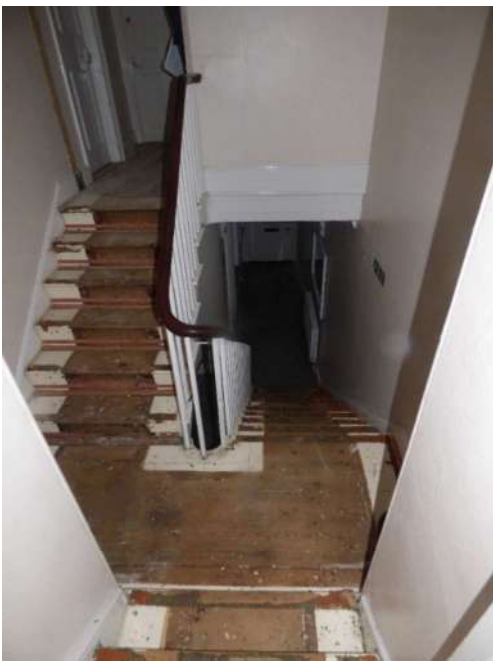
The original staircase is in good condition and is to be retained.

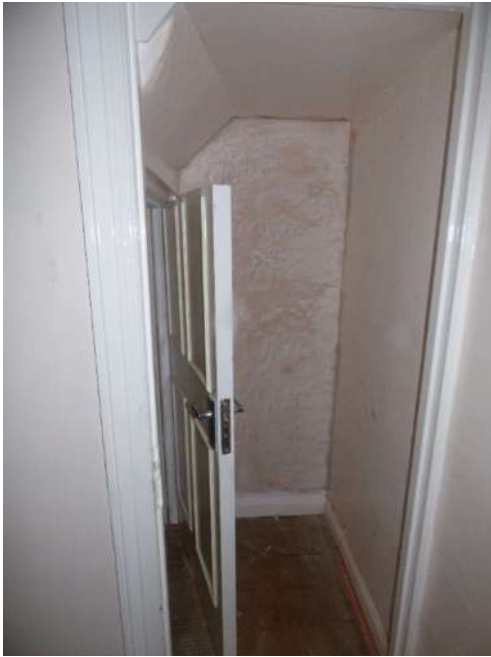
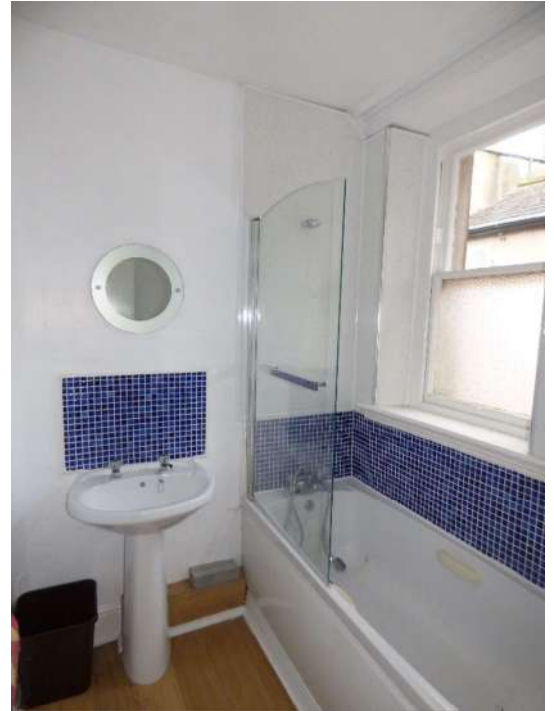
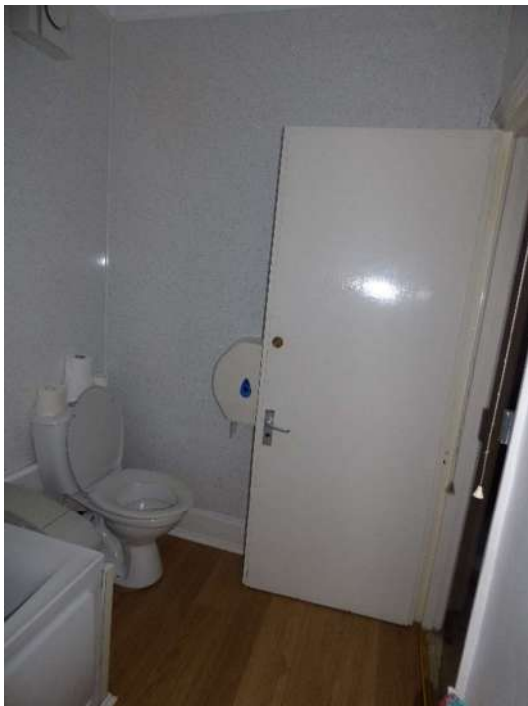
Above left; under stairs storage to be reconfigured to make better use of space.

Above and left: Existing bathroom to be stripped out and the existing walls to be removed to reconfigure this space to be more conducive to modern day living.

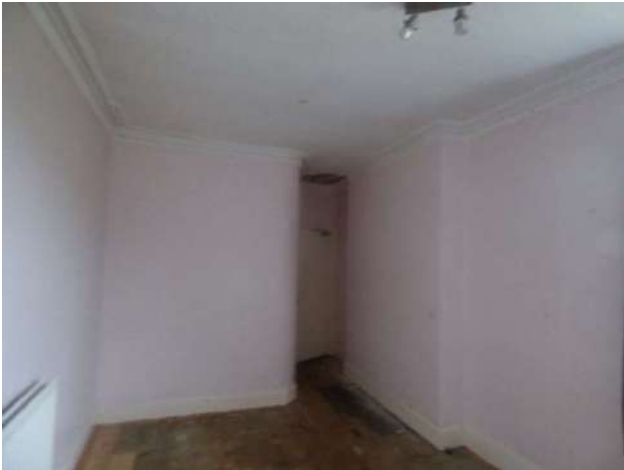
Existing bedroom to be reconfigured into a new family bathroom. The existing bathroom is too small for use as a family bathroom.

The damaged ceiling is to be repaired with lime plaster.

New bathroom door to be anew four panelled door – bathroom door does not need to be a fire rated door. Where possible it is proposed to refurbish any original doors with door closers and intumescent paint subject to building control approval.

All finishes to be made good and skirting to match the original to be installed.

The reconfigured spaces will have architraves, cornices and skirtings to match existing.
