# HERITAGE STATEMENT

## FULL RENOVATION OF EXISTING No 11 TERRACE HOUSES

St Bees, 1-11 Lonsdale Terrace, Parish Council, Cumbria

M.A.C Architects, Project Number: 2019:303

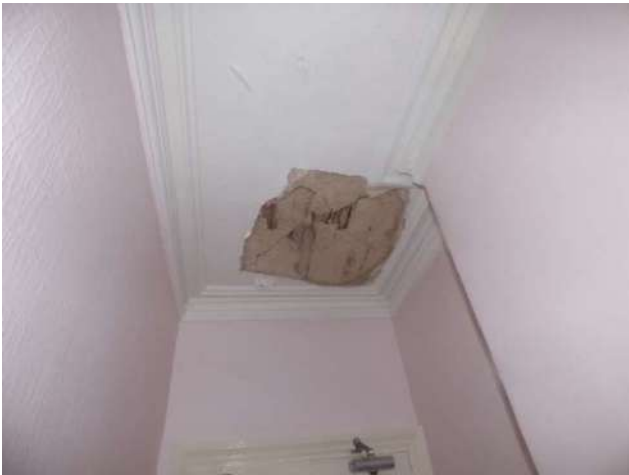
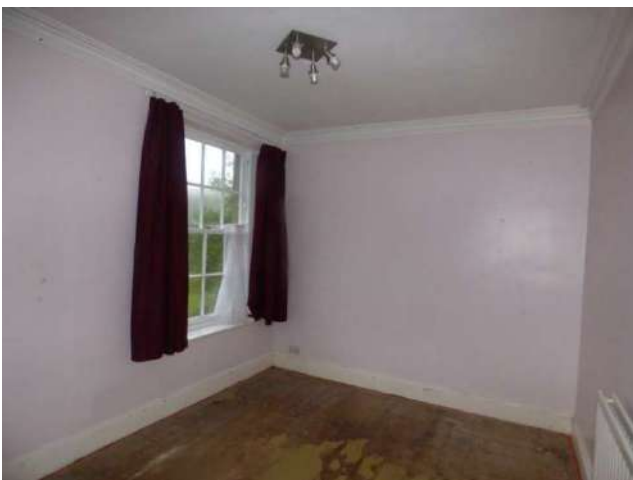
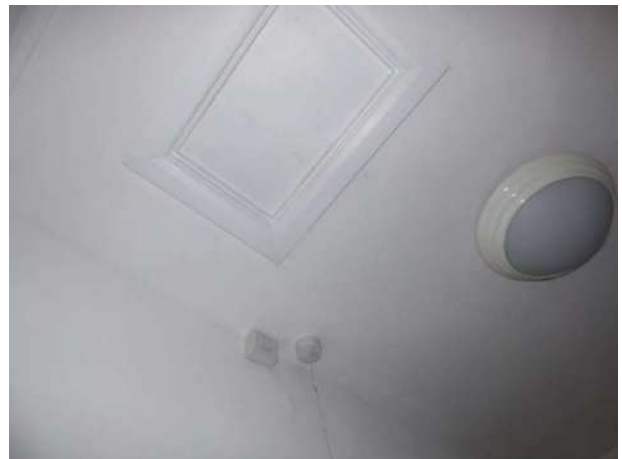
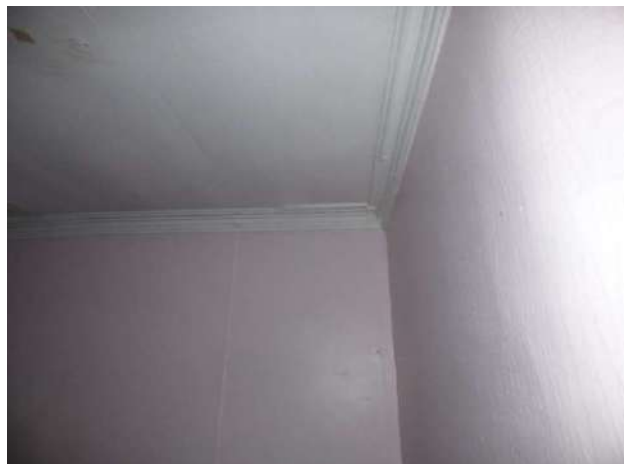
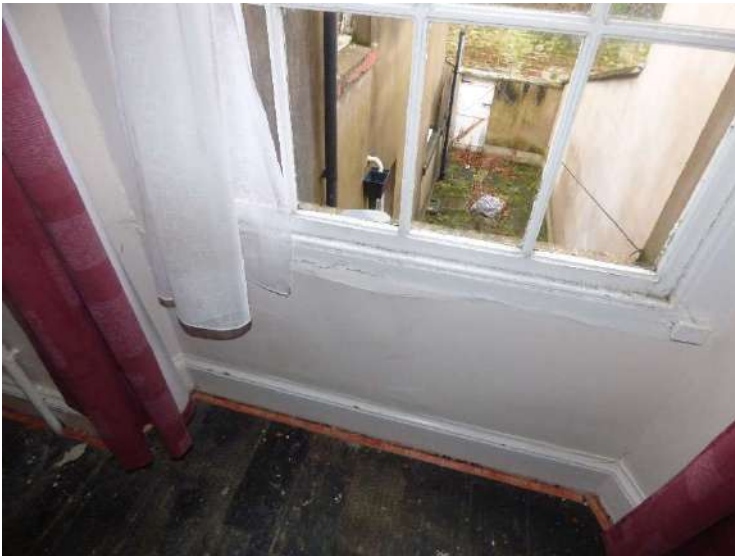
Rear bedroom skirtings and architraves to be retained. Existing flush panelled door to be replaced with new heritage style four panel door to be provided and installed by specialist joinery company such as Batty Joinery Ltd. Where possible it is proposed to refurbish any original doors with door closers and intumescent paint subject to building control approval.

Existing floorboards in good condition.

Evidence of damp damage to ceiling and surrounding the existing window are to be repaired with lime plaster (Solo lime plaster from Lime Centre).

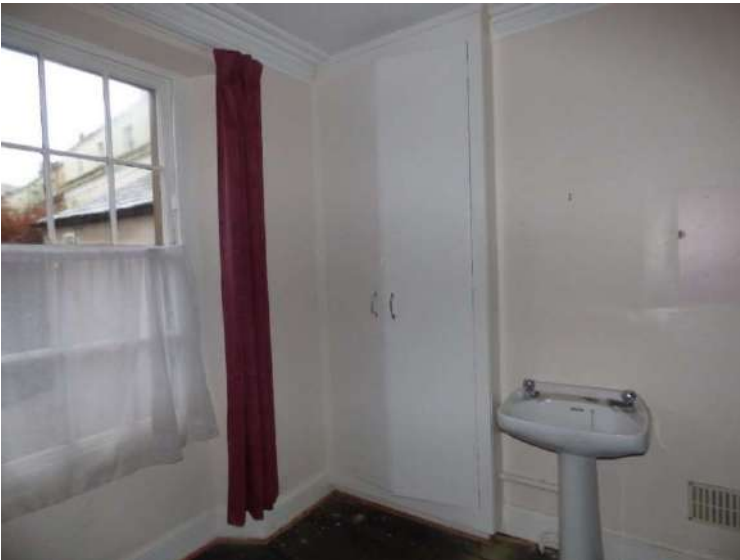
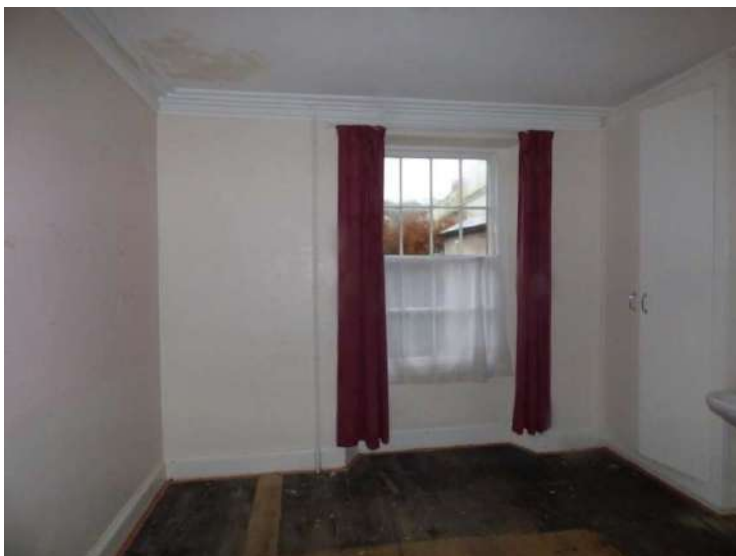
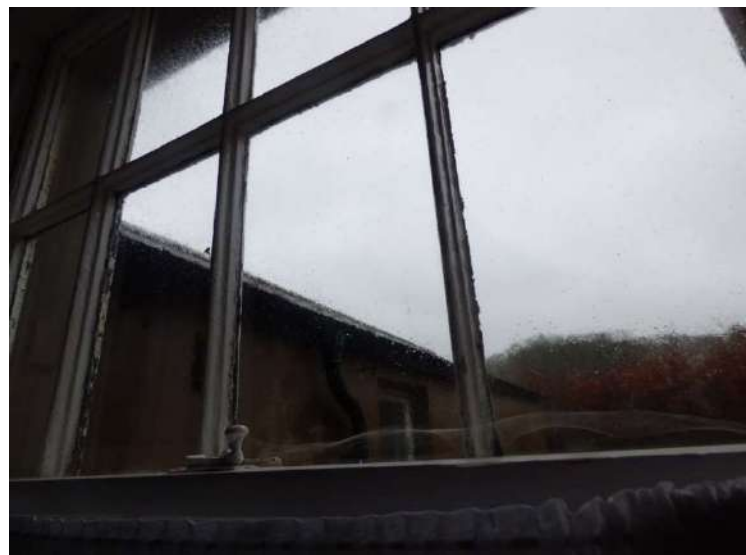
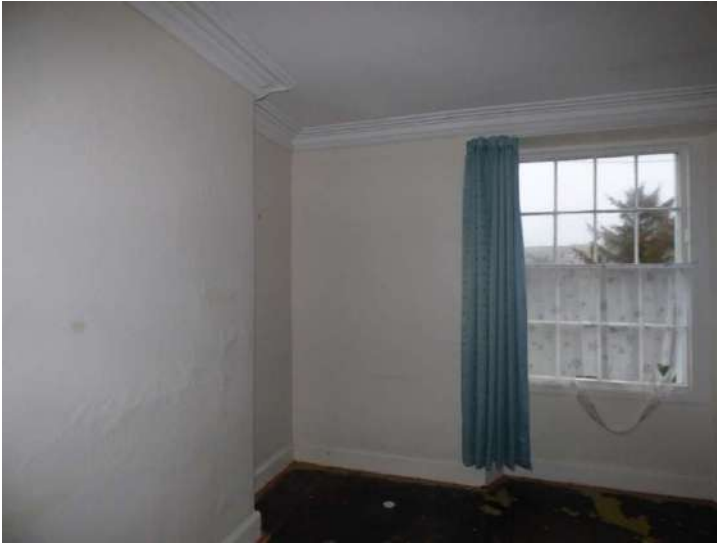
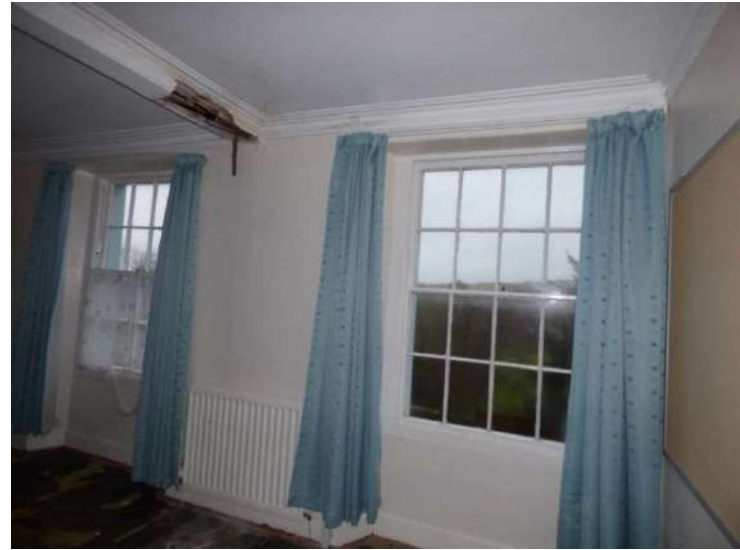
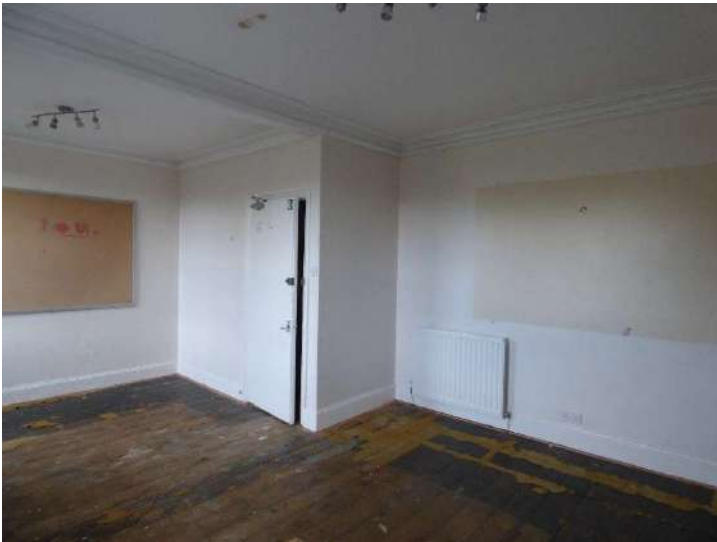
Front bedroom skirtings and architraves to be retained. Wall to be reinstated (where existing down stand is) between bedroom and new En-Suite, and existing doorway to be walled up to where the small bedroom would once have been to form the En-suite.

Existing floorboards in good condition.

Existing flush panelled door to be replaced with new heritage style four panel fire door to be provided and installed by specialist joinery company such as Batty Joinery Ltd. In original location (has been walled up). Where possible it is proposed to refurbish any original doors with door closers and intumescent paint subject to building control approval.

With architraves to match the existing.

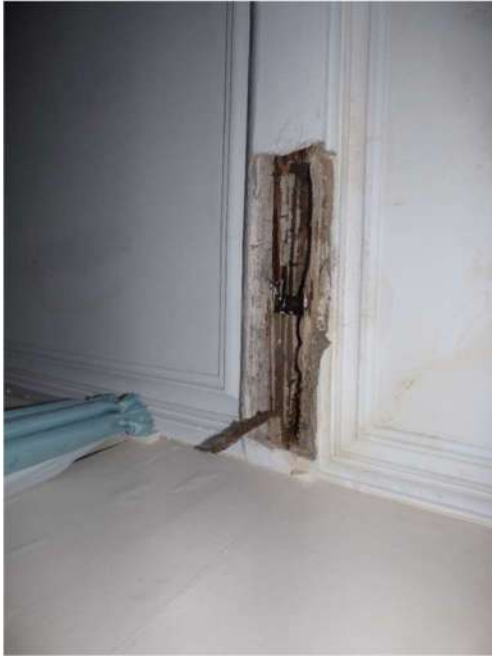
Damaged down stand timber beam to be replaced. Damaged cornice to be repaired and reinstated.

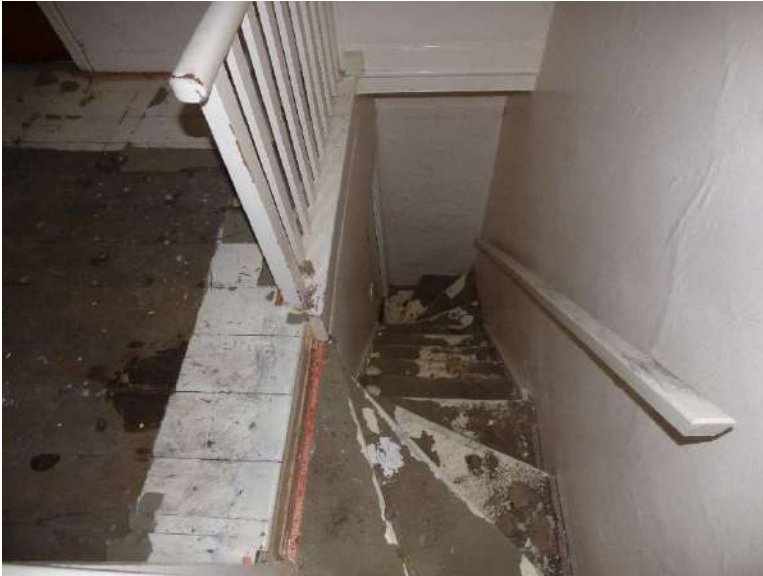
Left:

Location of original doorway which has been walled up. Original doorway to be reinstated.

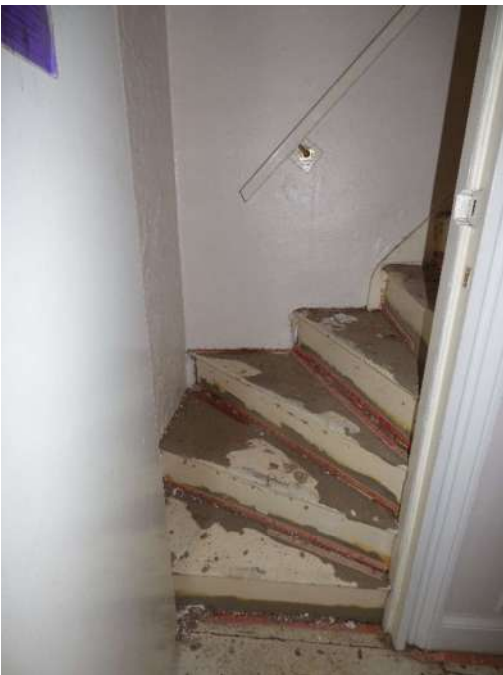
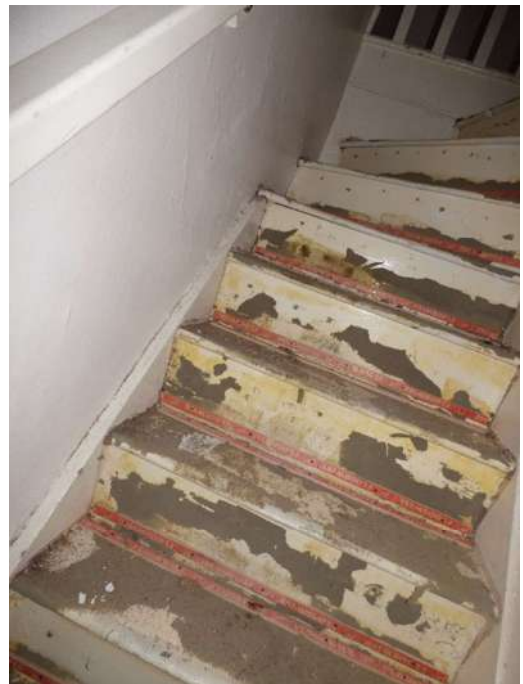
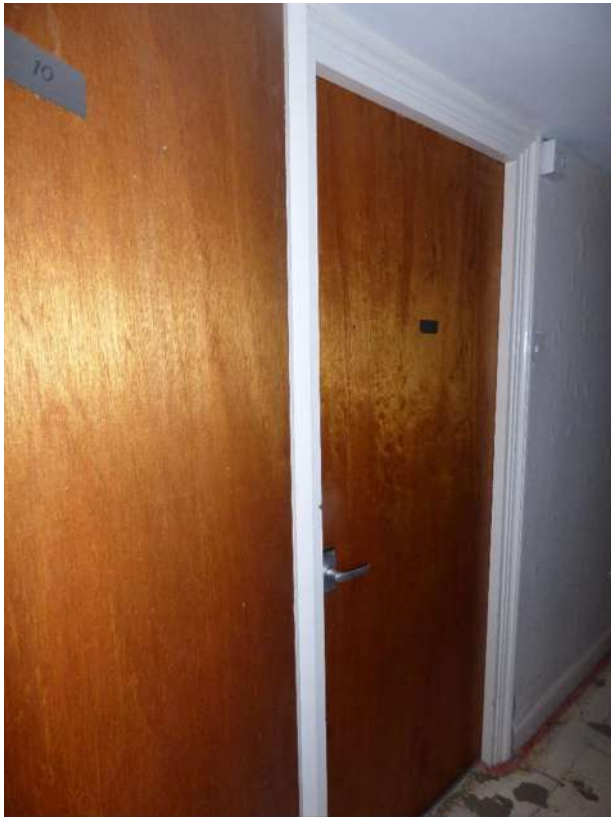
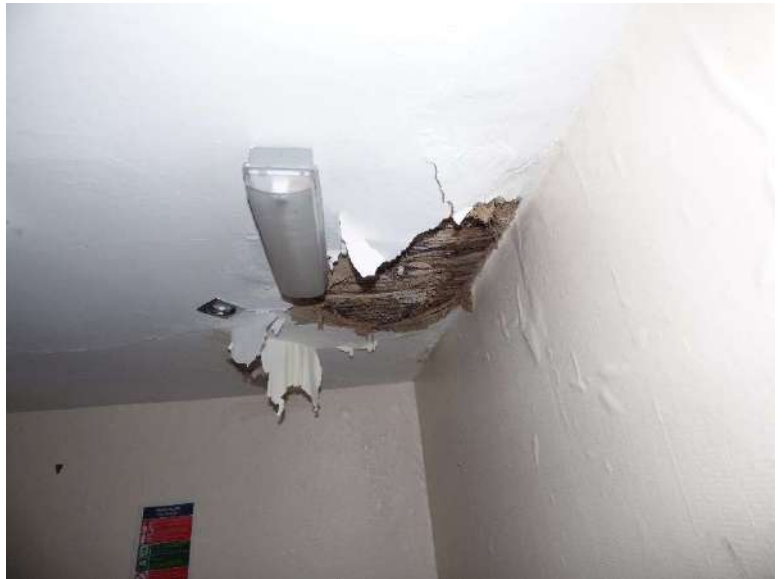
Above and below:

Existing staircase to attic rooms. New balustrade and handrail to be installed to match the existing at ground / first floor and at a height to comply with building regulations.

Apply an insulated plasterboard 62mm thick to underside of ceiling. The Laminated plasterboard and PIR has a vapour barrier incorporated so interstitial moisture would be prevented. Tape and skim and undertake full decorations.

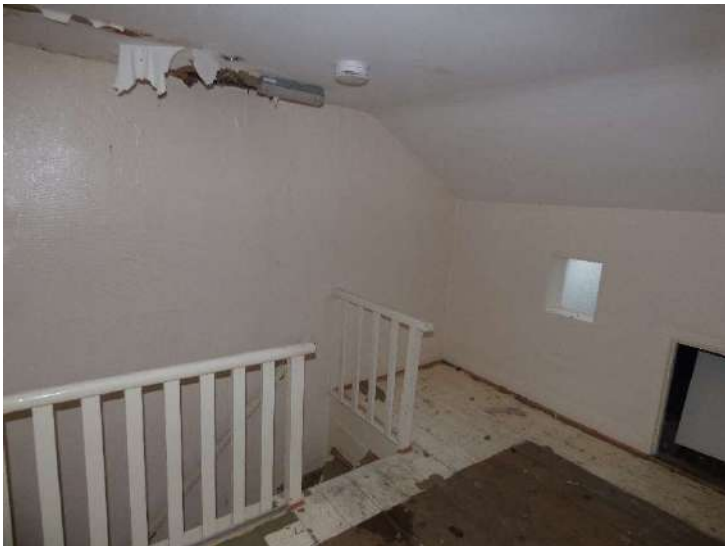
Existing Attic space is proposed to be reconfigured to maximise the space.

The modern doors are to be replaced with four panelled fire doors to match the rest of the property.

Damaged plaster to ceiling to be repaired with a lime plaster finish (Solo lime plaster from Lime Centre)..

New plasterboard stud partitions to be installed to reconfigured space.

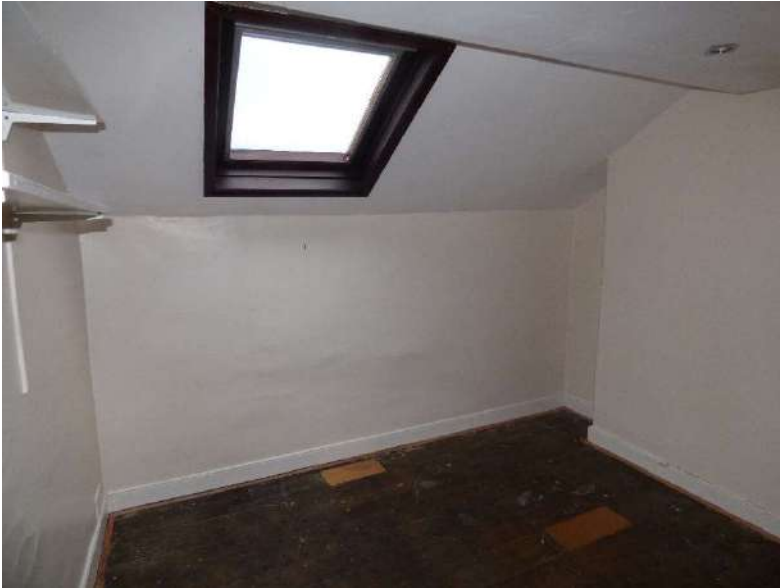
In the bedroom remove all damp and damaged/blown plaster and repair with lime plaster and skim and decorate throughout.

Apply an insulated plasterboard 62mm thick to underside of ceiling. The Laminated plasterboard and PIR has a vapour barrier incorporated so interstitial moisture would be prevented. New rooflights to be installed with flashing kit that mounts unit flush with the roof surface.

Tape and skim plasterboard and undertake full decoration. Existing rooflights to be replaced with new heritage style rooflights by Velux or the Rooflight company or similar.

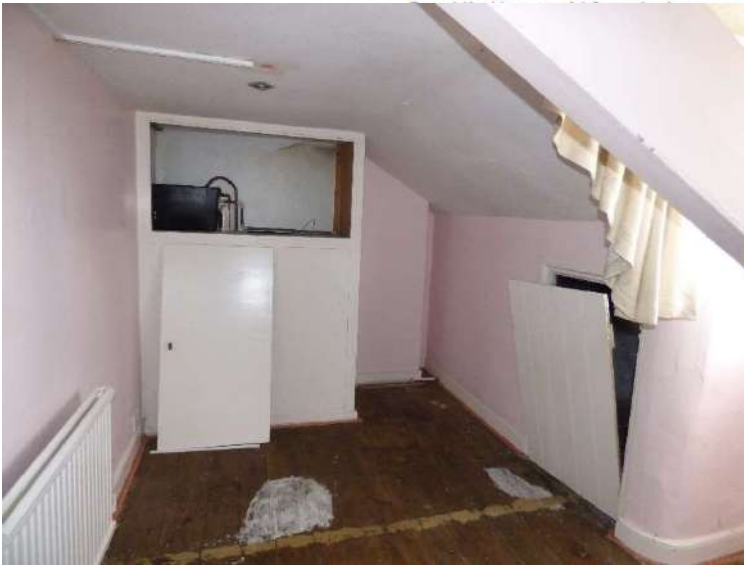
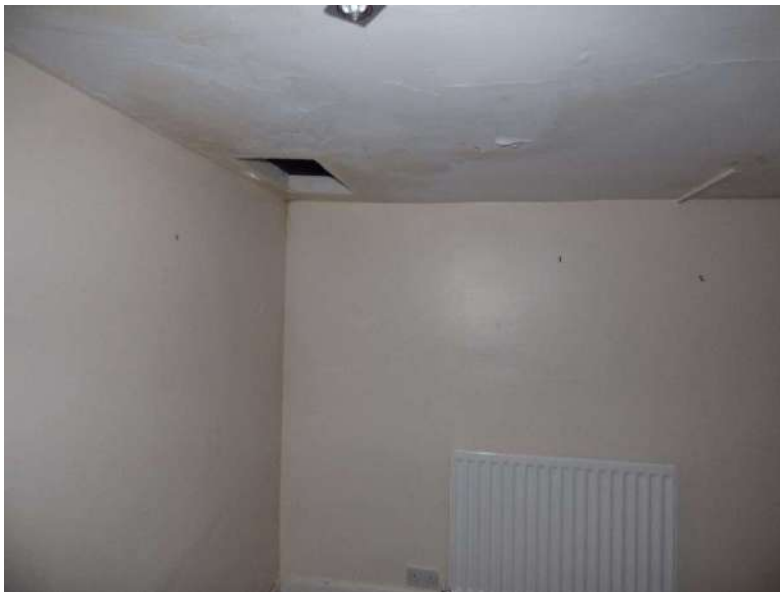
Left: Attic bedroom

New plasterboard stud partitions to be installed in reconfigured attic space.

Remove all damp and damaged/blown plaster and repair with lime plaster and skim and decorate throughout.

Apply an insulated plasterboard 62mm thick to underside of ceiling. The Laminated plasterboard and PIR has a vapour barrier incorporated so interstitial moisture would be prevented. New rooflights to be installed with flashing kit that mounts unit flush with the roof surface.

Tape and skim and undertake full decoration.

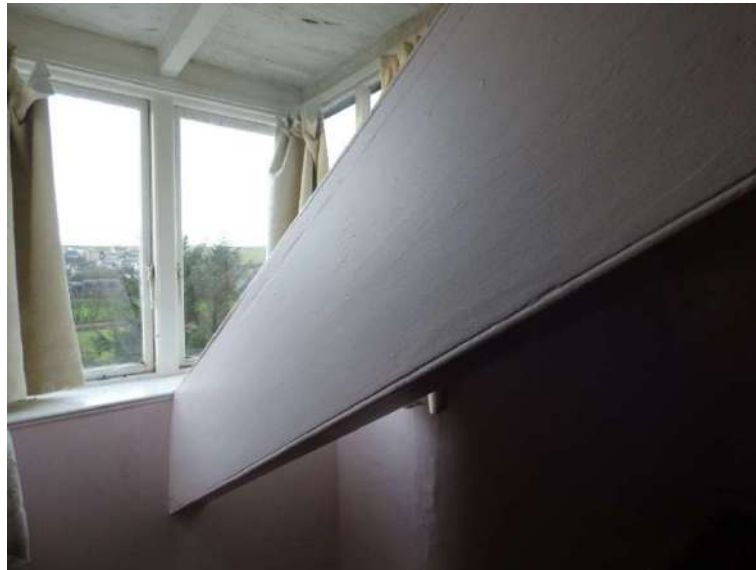
New heritage style window to be installed subject to planning condition. and new heritage rooflights (Velux or similar), in lieu of existing modern rooflights. And new heritage rooflight windows (Velux or similar with flashing kit that mounts unit flush with the roof surface).

Floorboards are in good condition (but may require some minor repairs)

It is proposed to remove the timber beam that slices through the existing dormer and for the structural engineer to design supports either side of the new dormer window.

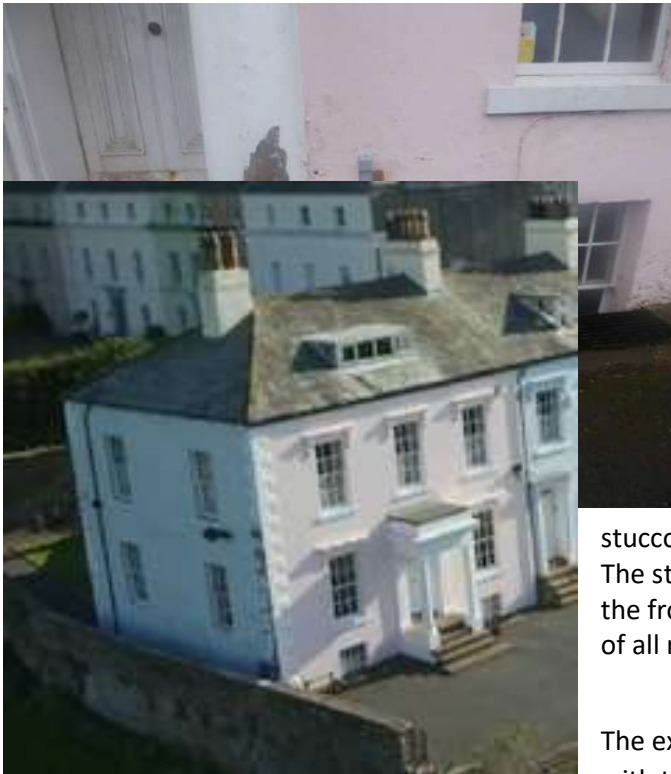
Left: The main entrance is mentioned in the listing text and is to be entirely retained.

All elevations require to be prepared for render repairs and redecoration by specialist using lime render and stucco (Parax LTD) to be applied by specialist. The stucco features above the windows and door on the front elevation will be carefully restored by a specialist. Colour of all render and stucco to match existing.

The existing door and frame are to be retained and made good with the provision of new ironmongery. Once repaired full decoration will be undertaken.

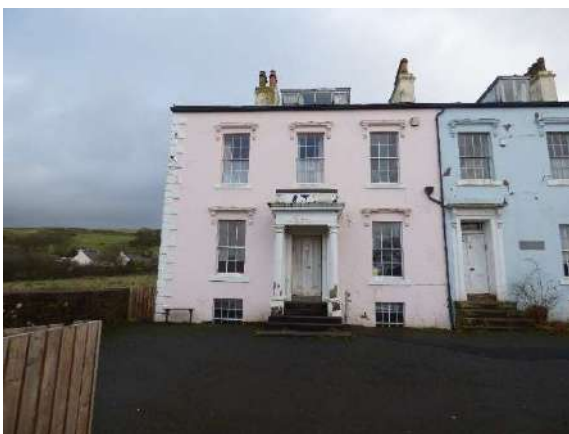
The existing stone steps to be cleaned up and the portico at the front to be restored to original sandstone with paint removed.

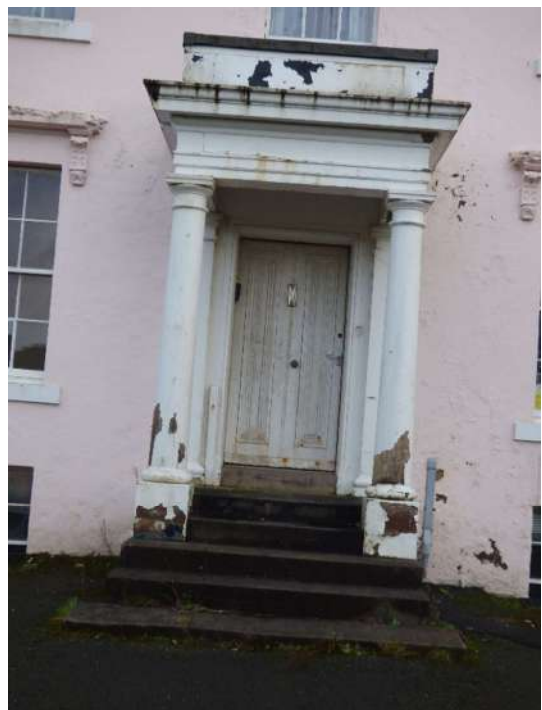
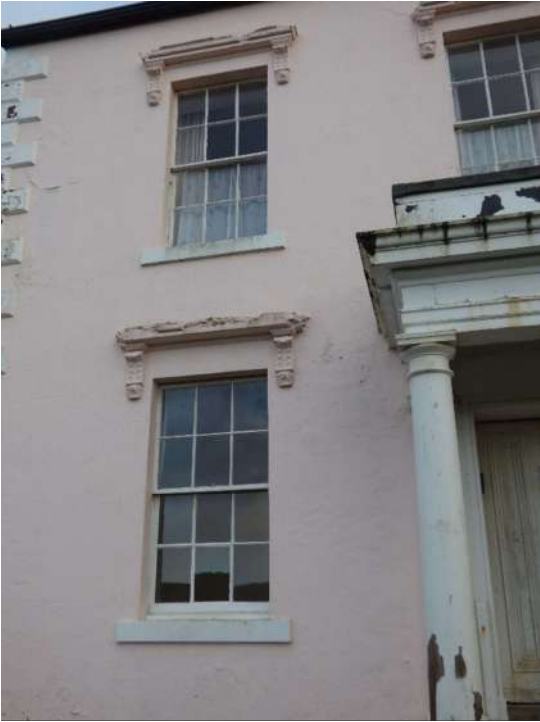
Existing gutters and downpipes to be retained, repaired where necessary and decorated.

All existing single glazed windows to either be replaced / repaired subject to planning condition.

Existing cills to be repaired and decorated.

Localised lead repair work required to chimneys, to prevent leaking.

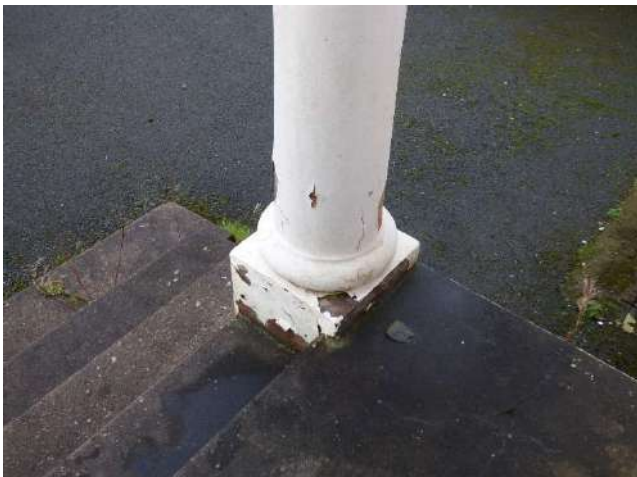
Left: Existing door to be repaired and rehung. Existing portico to be fully repaired and pillars to have paint removed and original stone restored.

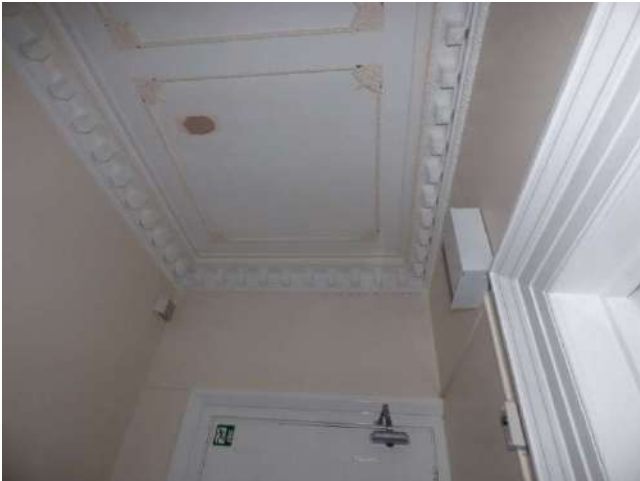
Left: Period features to be retained, including archway and architraves. (Modern lighting to all be stripped out and make good services./ All architraves and plaster features to be retained.

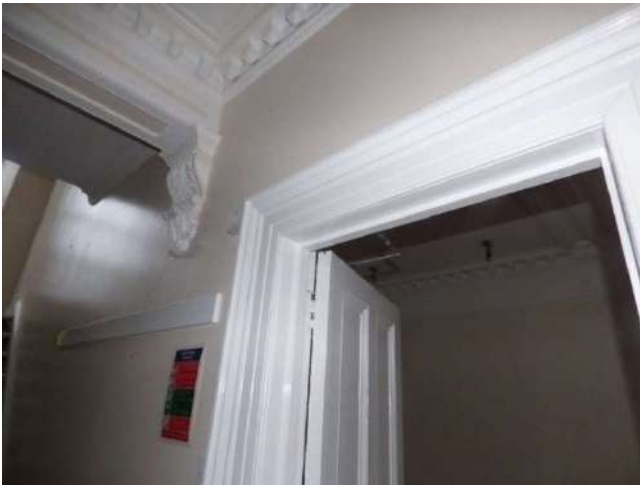
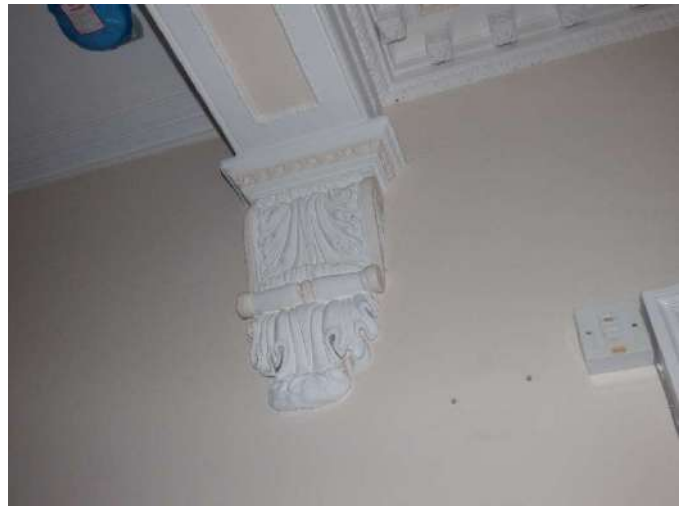
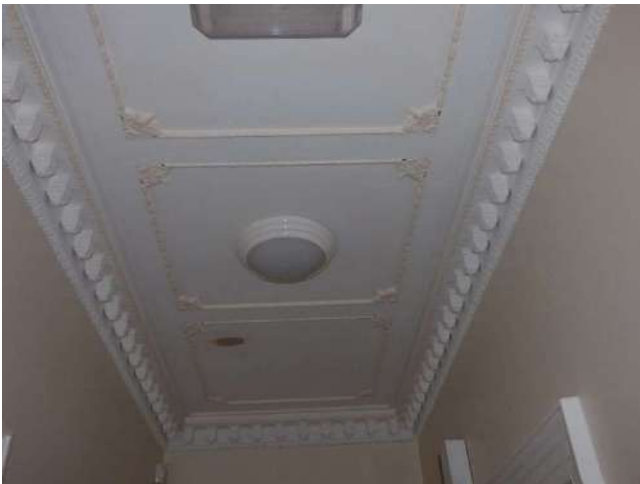
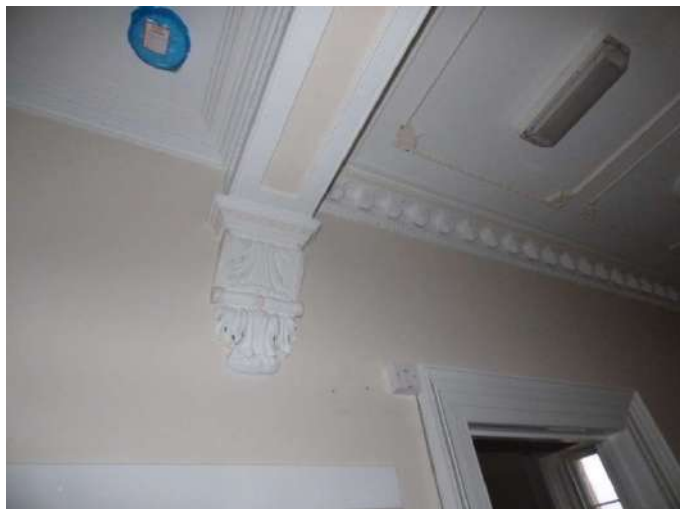
Left and below:

Period features are in extremely good condition and all are to be retained.

Ceiling to be repaired where existing light fittings are to be removed.

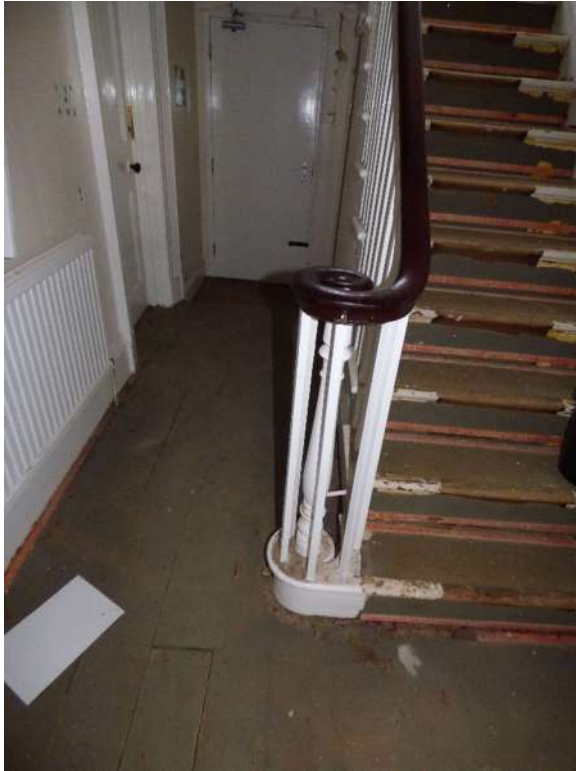
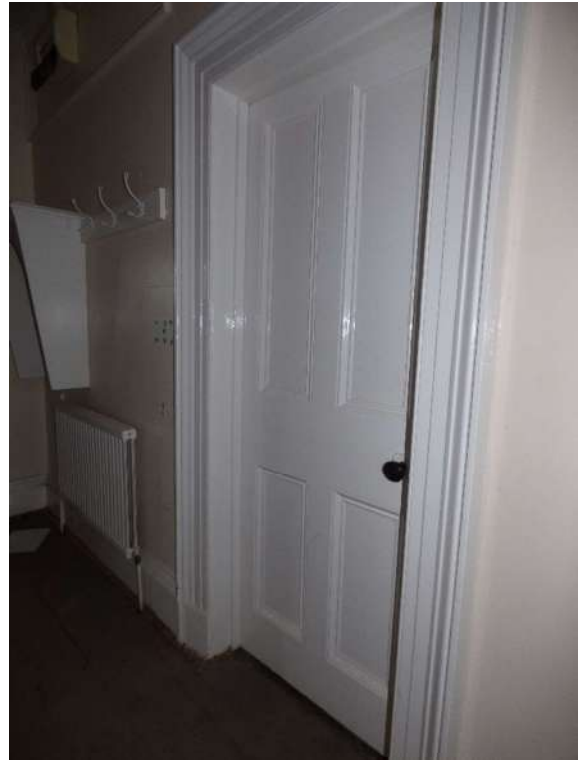
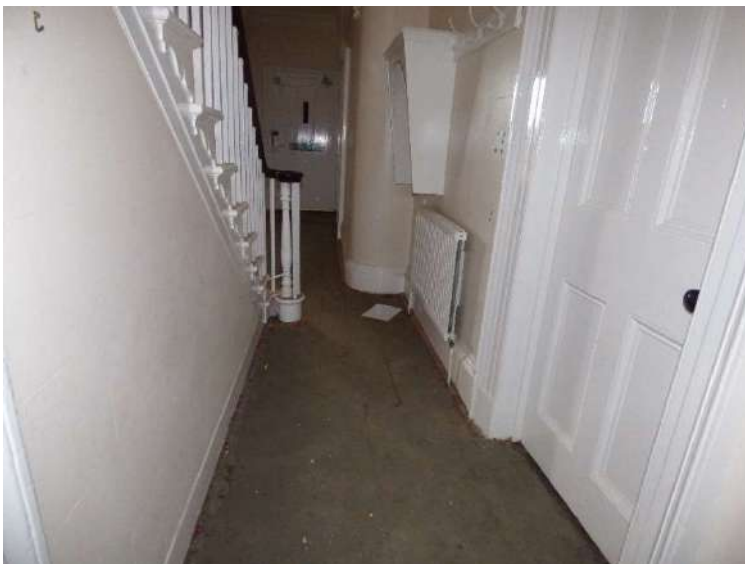
Above:

Joinery details to be retained.

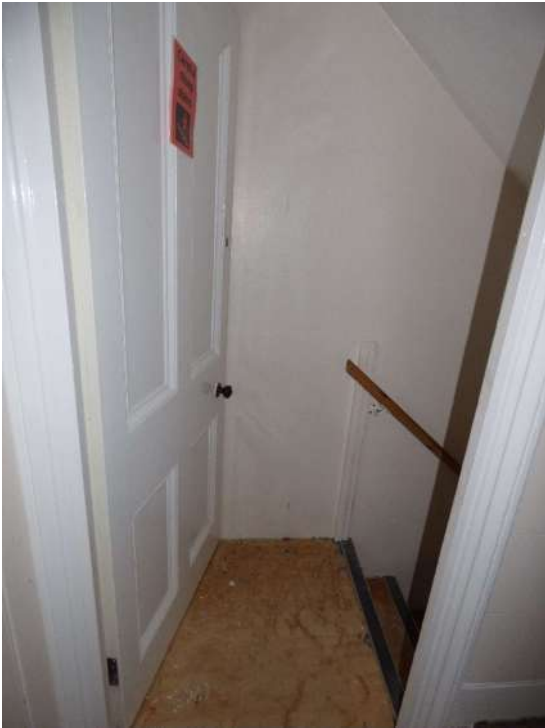
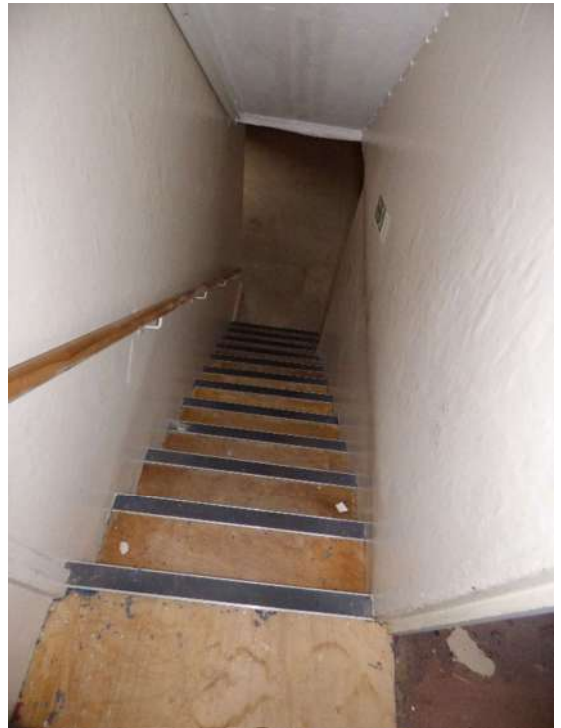
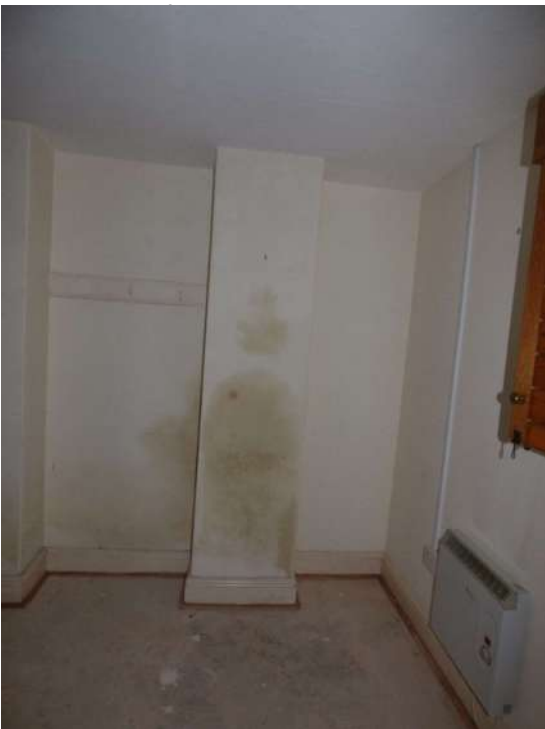
Above and left:

All architraves and skirtings to be retained.

The existing basement. The existing walls and floor are generally in sound condition so would be suitable for the application of damp proof slurry system.

Some of the walls have been overboarded, but the basement has not been treated for damp and moisture is penetrating the walls that have been overboarded.

All existing paint and surface finishes must be removed and made good including all snots removed, and damage to existing surfaces, prior to the installation of a Kloster Polysil NB1. This migratory crystalline tanking slurry is used to seal below ground structures against water ingress.

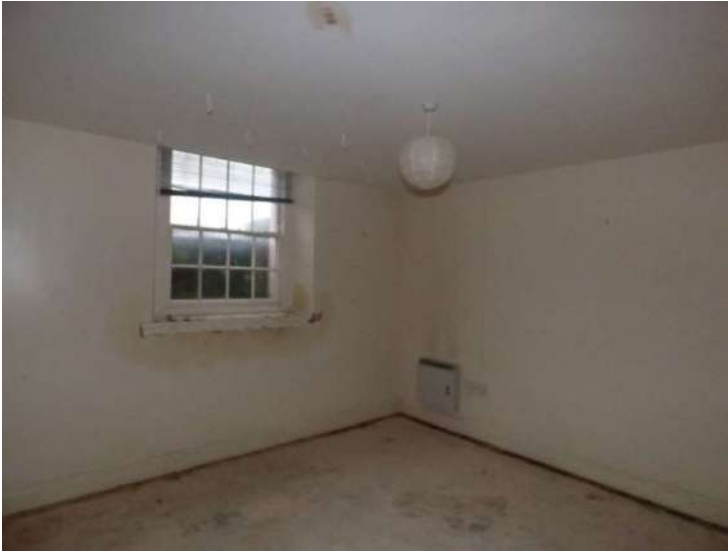
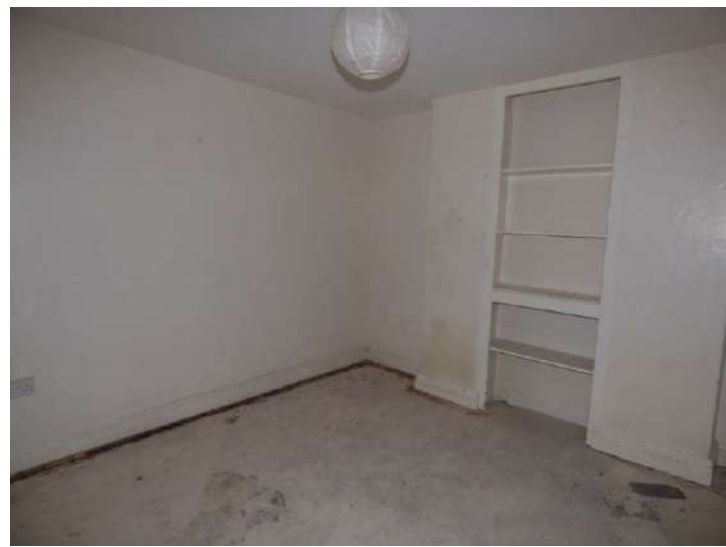
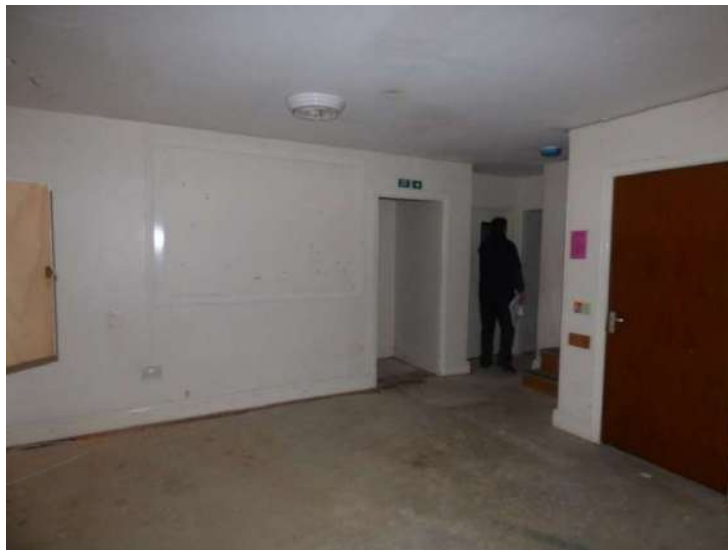
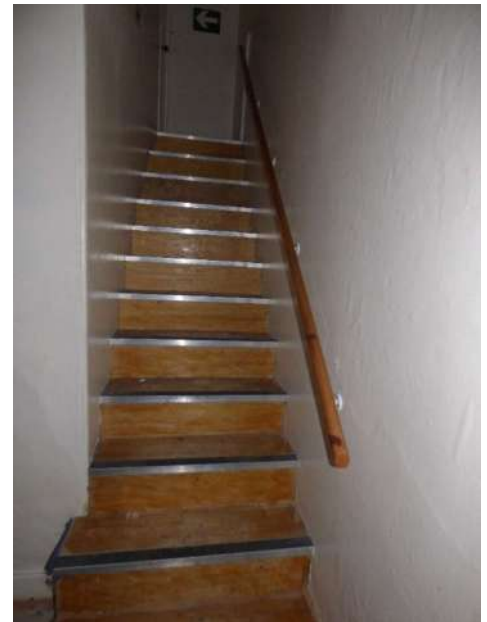
The basement is sub divided into a number of rooms, and it is proposed for these rooms to remain as existing, with the exception of replacing the existing doors with new flush painted fire doors.

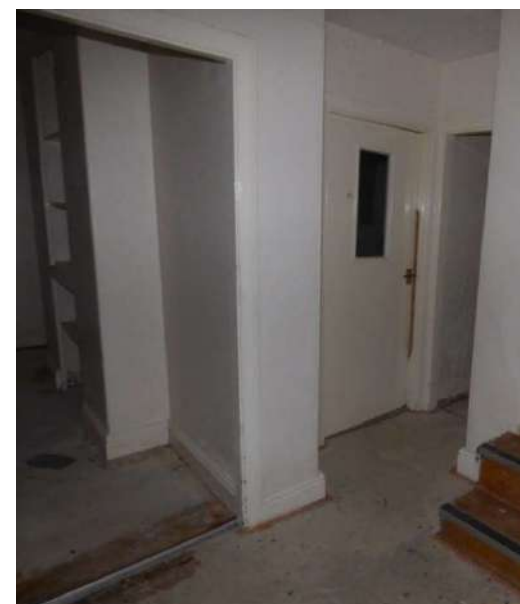
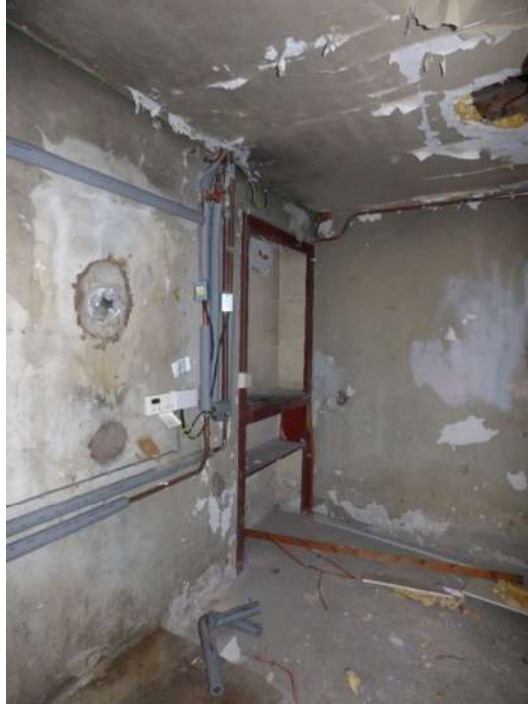
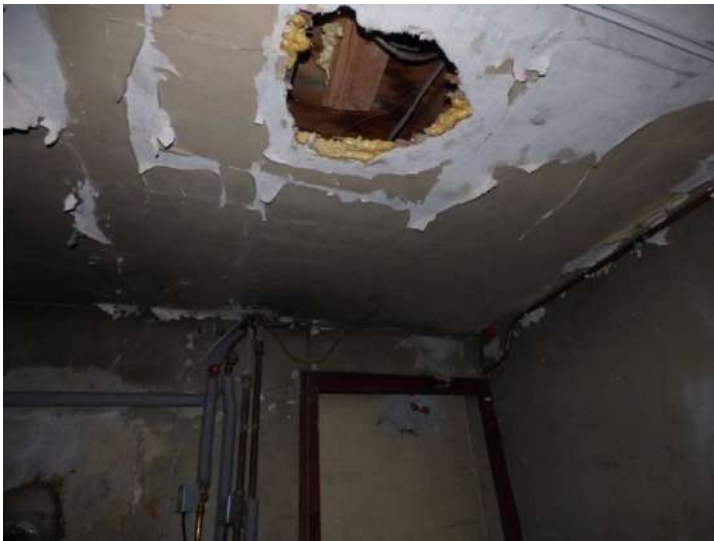
Damp affects the entire basement.

All redundant M&E, conduits and FF&E to be removed.

Ceiling to be repaired with fire resistant plasterboard.

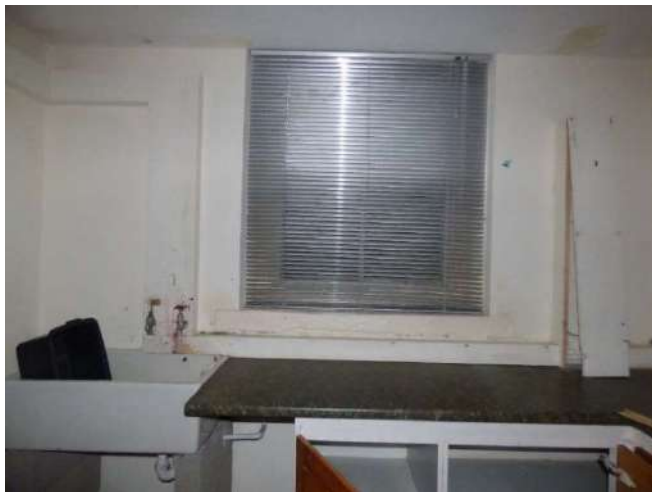
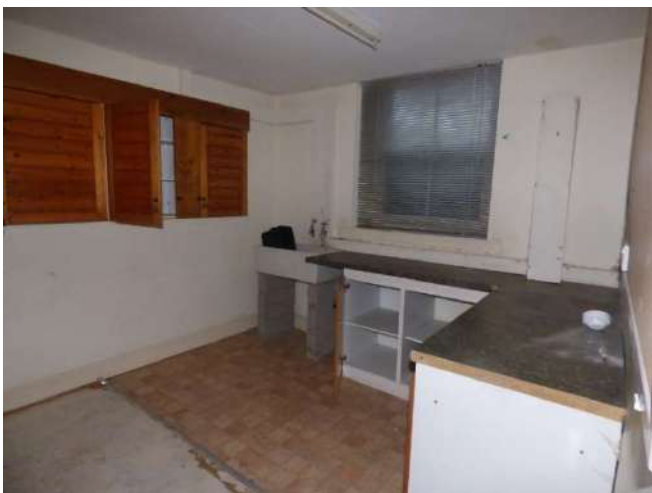
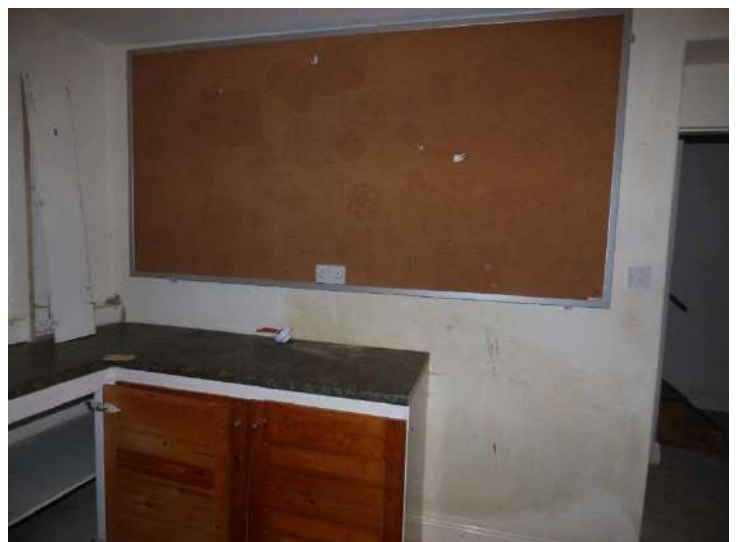
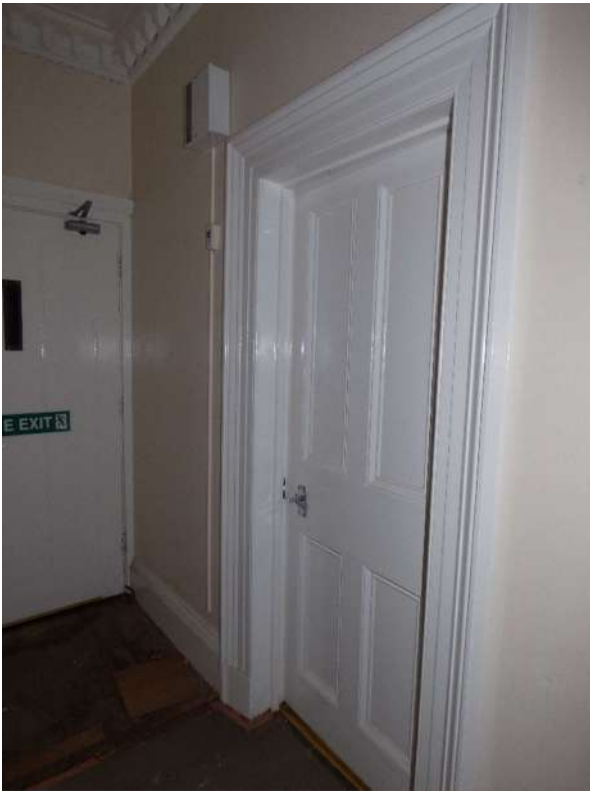
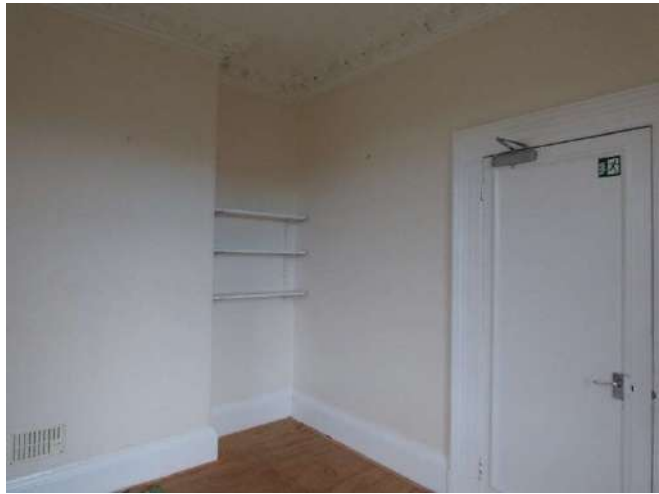
Existing front room requires minor damp treatment and walls to be made good following repairs.

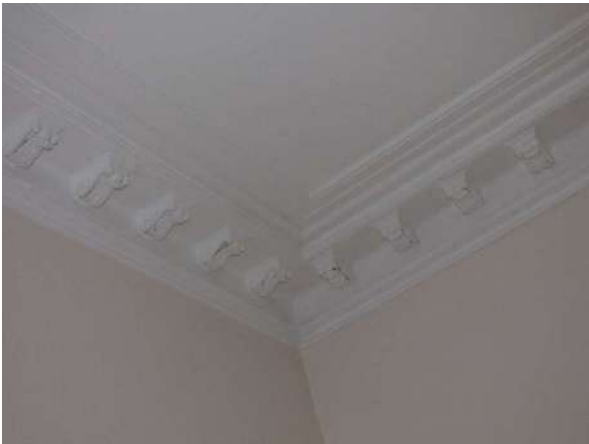
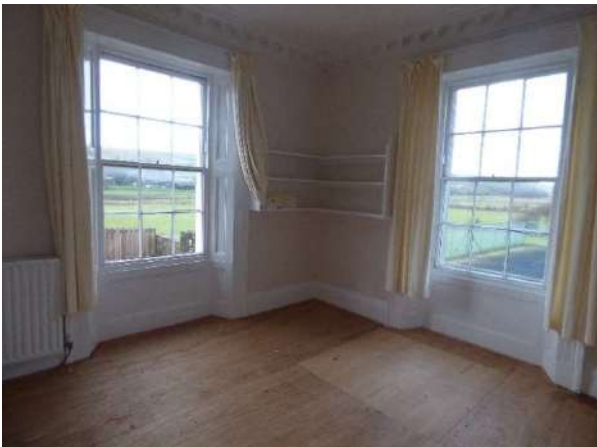
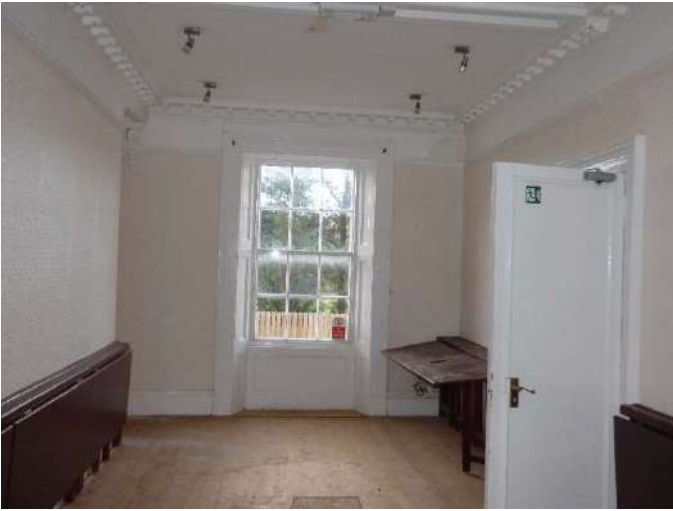
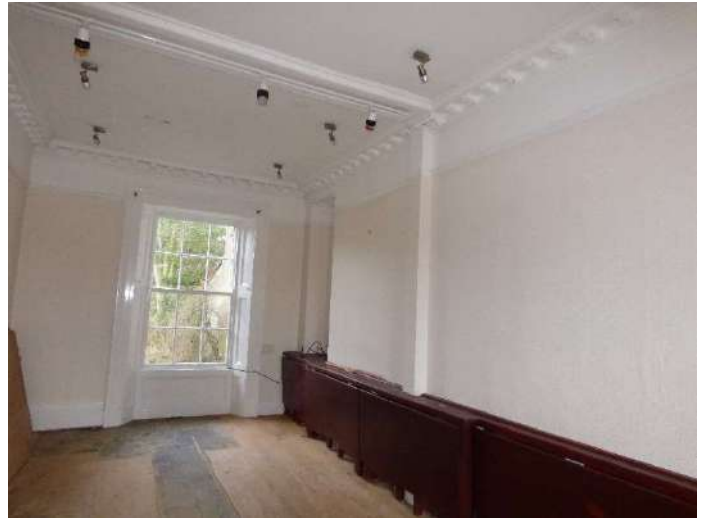
Above and below: In the existing through lounge, the period features below and to the sides of the existing windows both front and back are in good condition. It is proposed to carefully refurbish the existing timber shutters.

Existing cornice to be made good in locations where redundant services are to be removed and where hairline cracks have appeared.

Flush panel doors to be replaced with heritage style painted timber fire doors to enhance the heritage asset. Where possible it is proposed to refurbish any original doors with door closers and intumescent paint subject to building control approval.

The existing floor is not original and is plywood. It is proposed to lift the plywood boards and examine the existing joists to ensure that they are in good condition, and reinstate and repair as necessary.

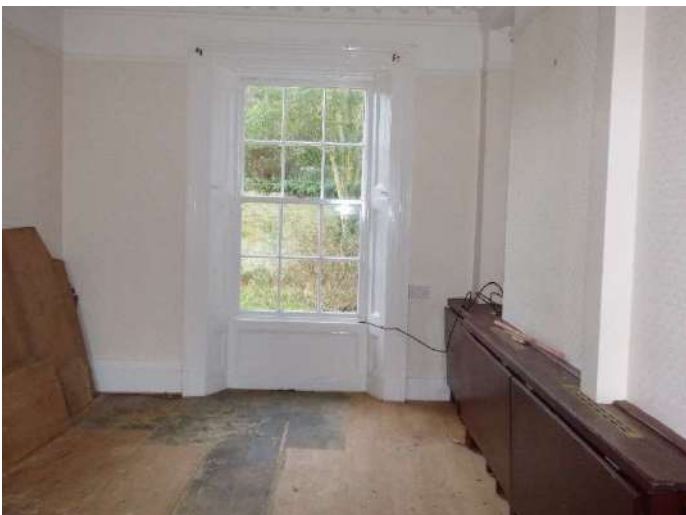
Existing cornice to be made good in locations where redundant services are to be removed and where hairline cracks have appeared.

Flush panel doors to be replaced with heritage style painted timber fire doors to enhance the heritage asset.

Where possible it is proposed to refurbish any original doors with door closers and intumescent paint subject to building control approval.
