# HERITAGE STATEMENT

## FULL RENOVATION OF EXISTING No 11 TERRACE HOUSES

St Bees, 1-11 Lonsdale Terrace, Parish Council, Cumbria

M.A.C Architects, Project Number: 2019:303

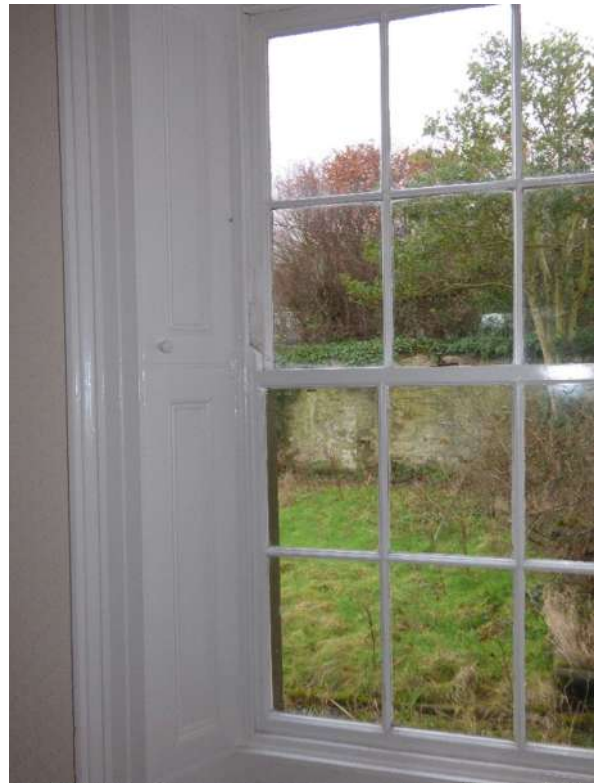
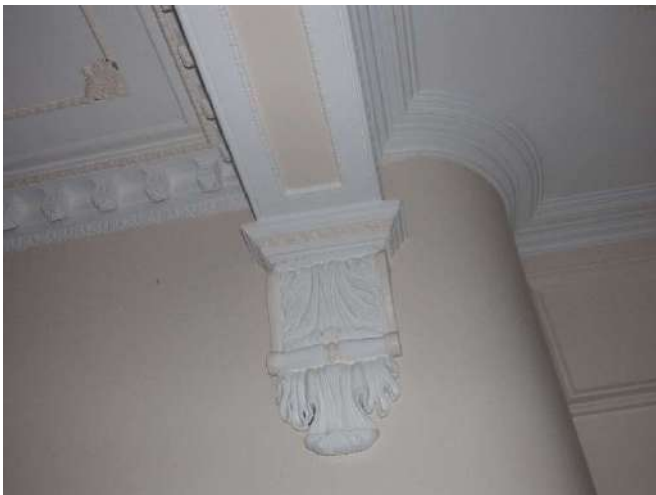
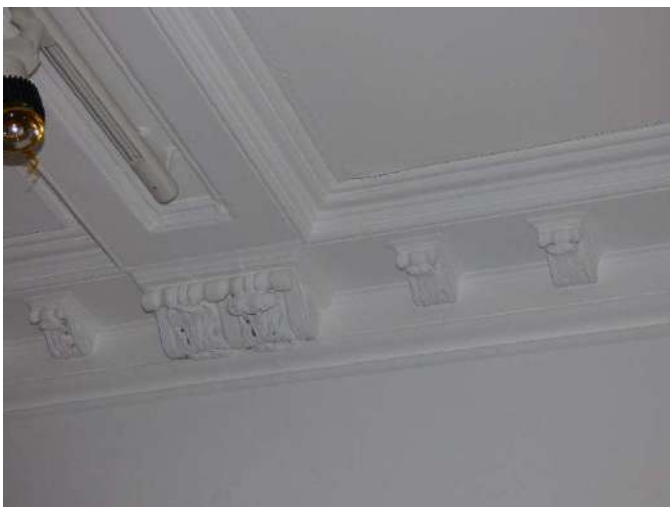
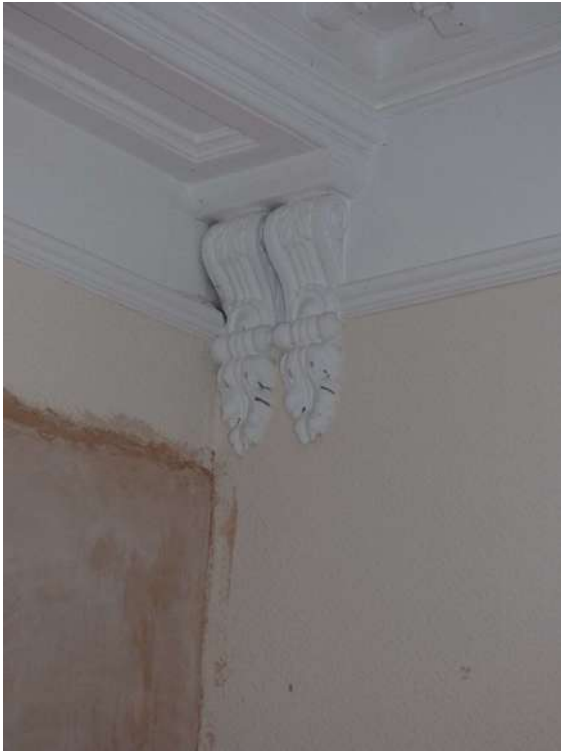
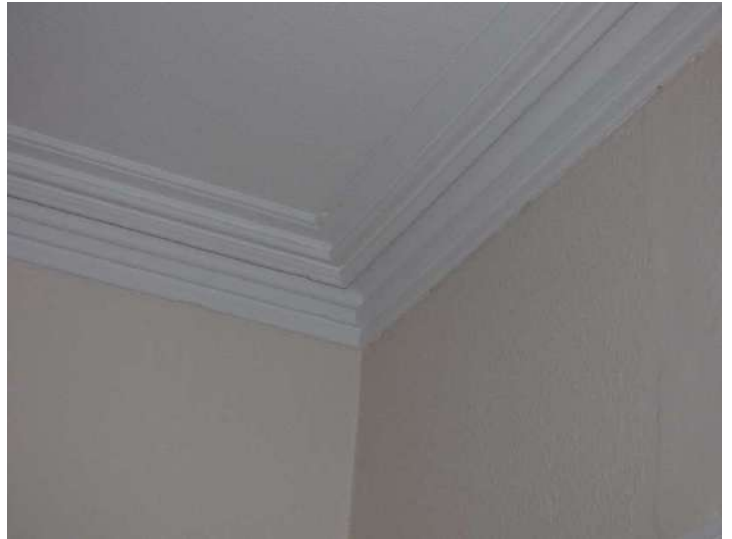
Above: Period features have remained in excellent condition and are to be retained.

the period features below and to the sides of the existing windows are in good condition, it is proposed to carefully refurbish the existing timber shutters.

Below: existing cornice to be made good in locations and where hairline cracks have appeared.

Existing architraves and skirtings to be retained and made good.

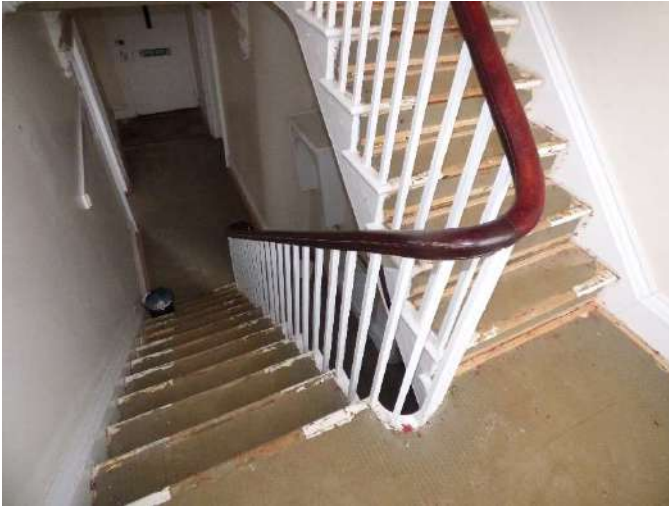
Retain the original staircase, which is in good condition.

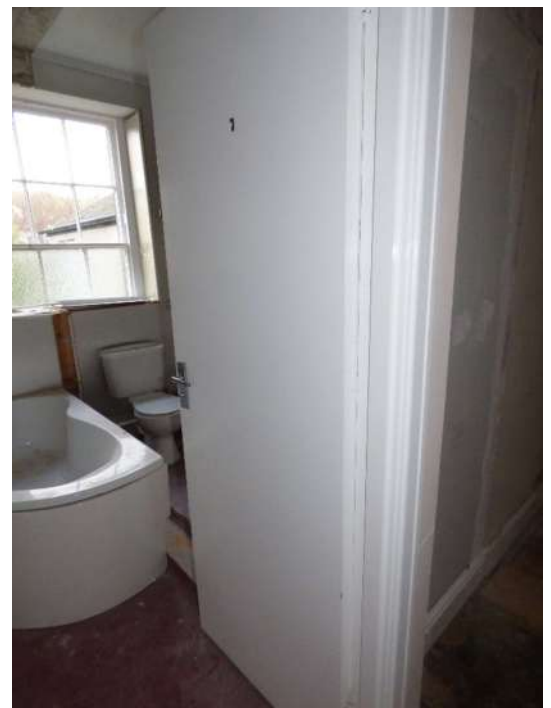
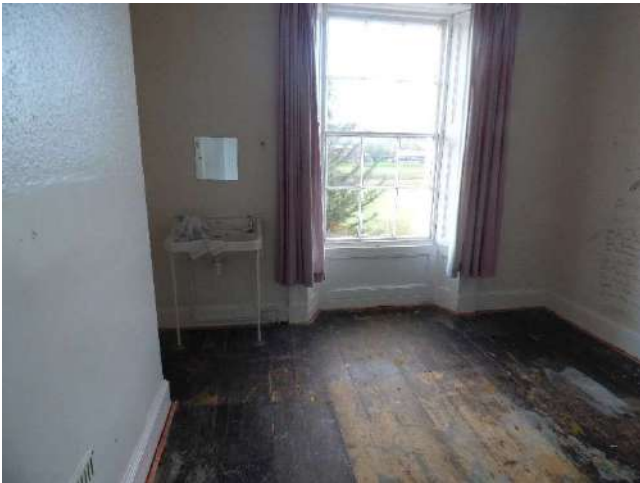
Left and below:

Rear bedroom, skirting and architraves to be retained. Existing flush panelled door to be replaced with new Georgian heritage style four panel fire door to be provided and installed by specialist joinery company such as Batty Joinery Ltd . Where possible it is proposed to refurbish any original doors with door closers and intumescent paint subject to building control approval.

Existing floorboards in good condition.

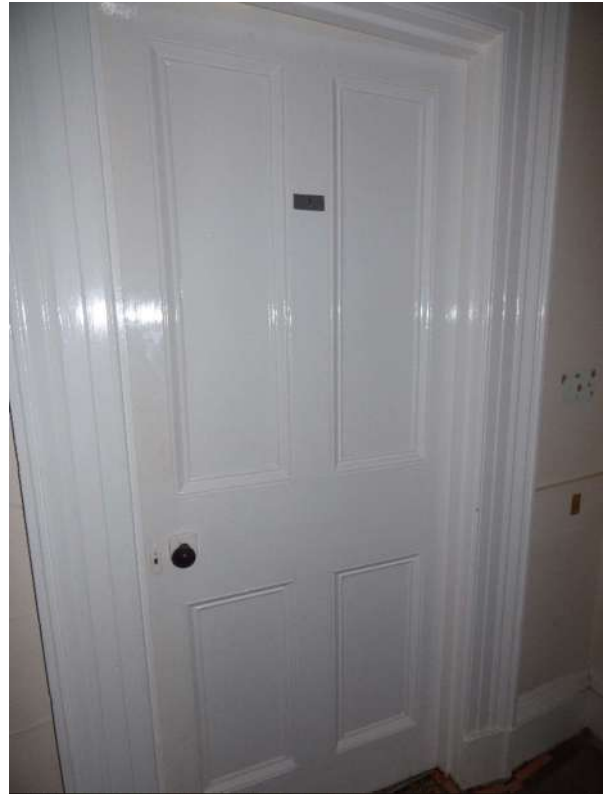
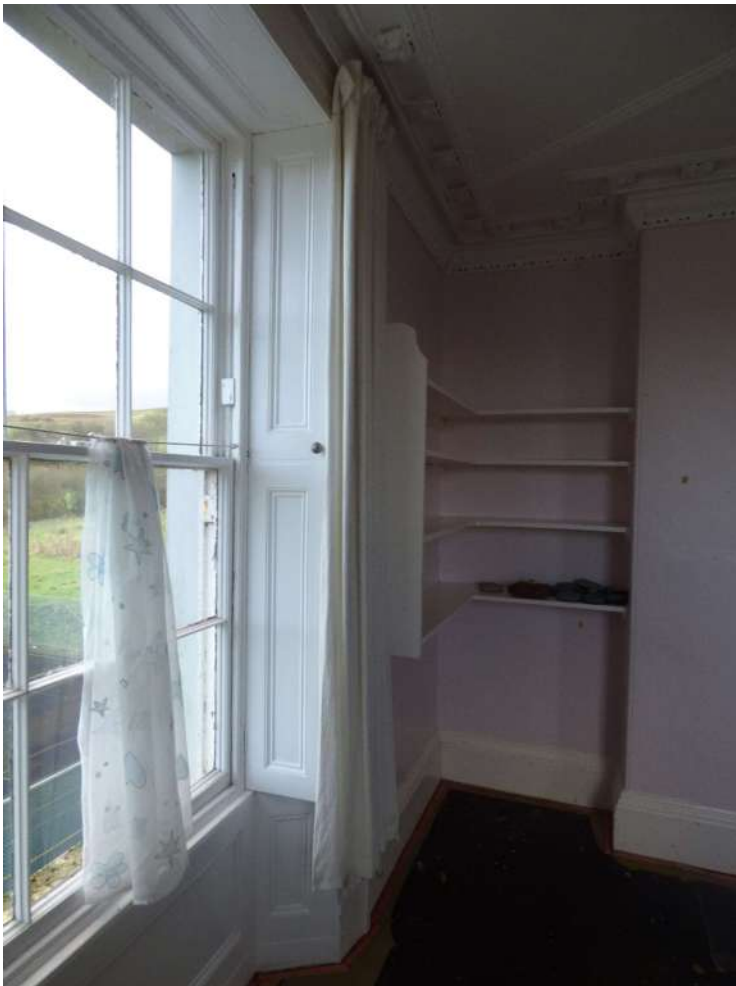
Above and left:

Front bedroom has stunning heritage features in excellent condition. Skirtings, cornices and architraves to be retained. Existing flush panelled door to be replaced with new Georgian heritage style four panel fire door to be provided and installed by specialist joinery company such as Batty Joinery Ltd.

Where possible it is proposed to refurbish any original doors with door closers and

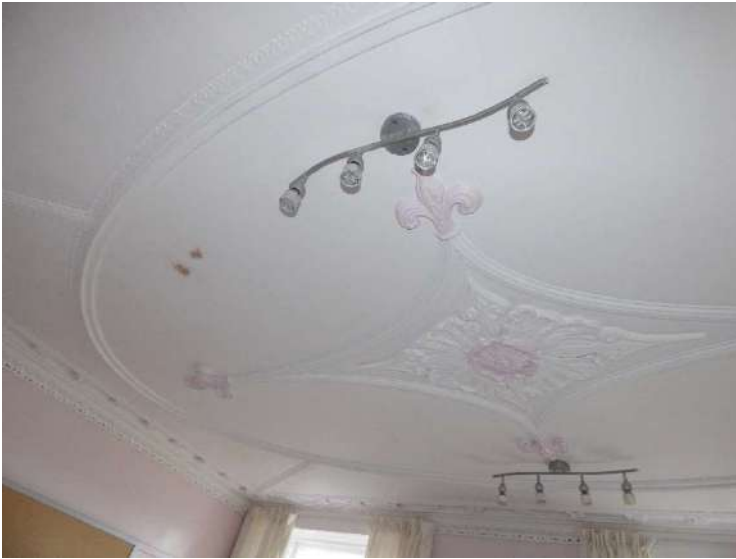
Left: Intricate ceiling moulds are to be retained, and existing lighting to be removed.

Left Cornice to be retained.

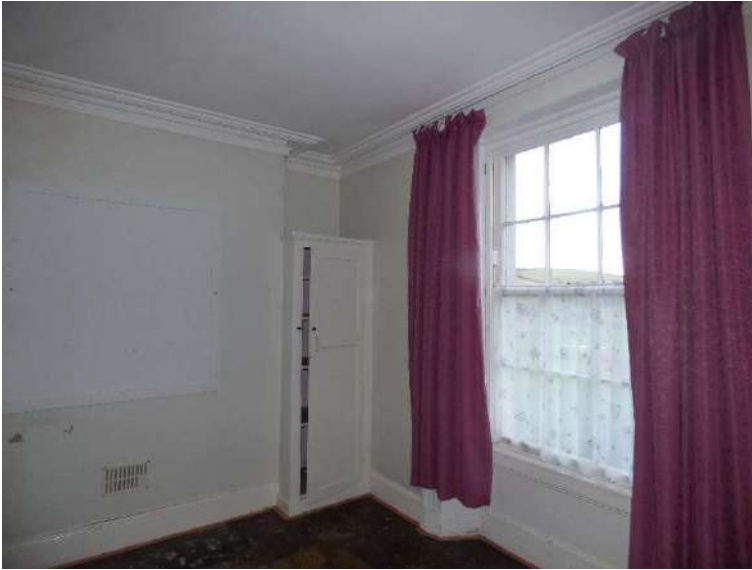
Left:

Front bedroom, skirtings, cornices and architraves to be retained. Existing flush panelled door to be replaced with new Georgian heritage style four panel door to provided and installed by specialist joinery company such as Batty Joinery Ltd. Where possible it is proposed to refurbish any original doors with door closers and intumescent paint subject to building control approval.

Bedroom to become En-suite to master bedroom.

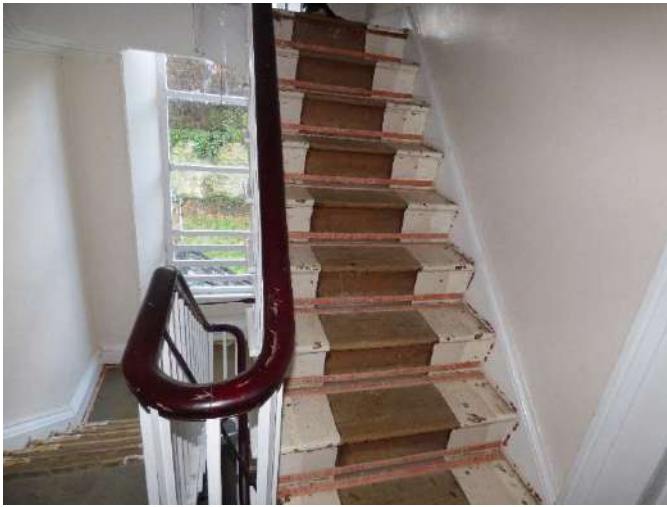
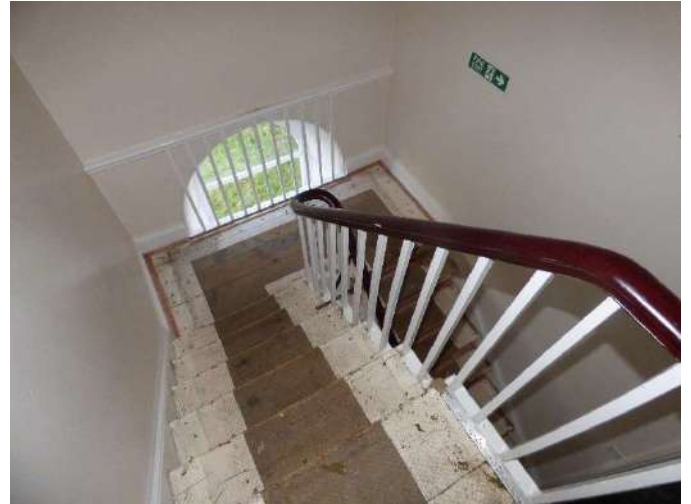
Above and below:

Handrail, balusters and rails are original and are to be retained.

Apply an insulated plasterboard 62mm thick to underside of sloping ceiling, tape and skim and undertake full decorations.

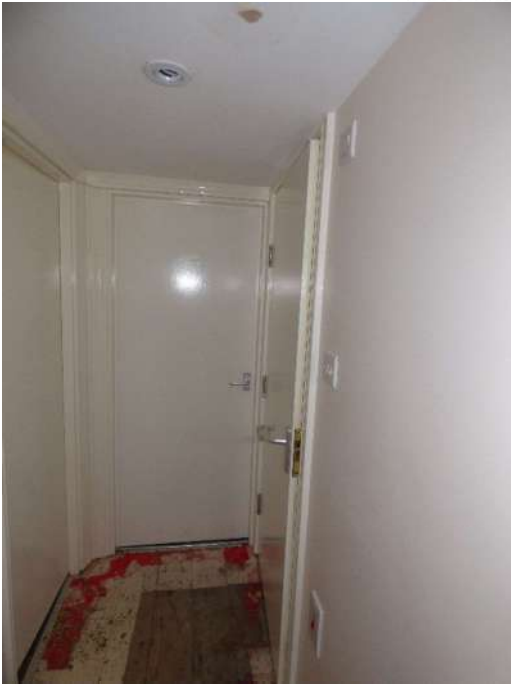
Left and following pages:

Kitchen / Living areas

Repair existing ceiling following repairs to slate roof and replacement lead flashings to chimneys.

Remove all damp and damaged / blown plasterwork and repair with lime plaster and skim and decorate throughout.

Once ceiling has been repaired, apply an insulated plasterboard 62mm thick to underside of ceiling tape and skim, and undertake full decorations.

Completely remove existing dormer and reconstruct new dormer (compliant with statutory requirements).

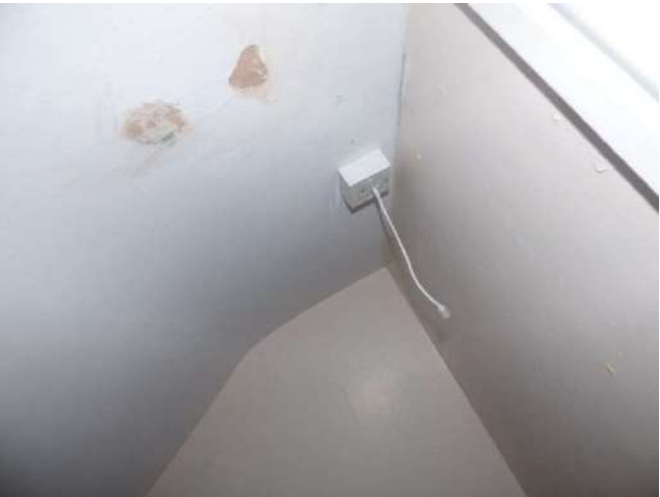
Above and left:

Existing bathroom.

Replace existing sanitaryware with new. Remove existing wall finishes and install new tile finishes to walls and floor.

Replace existing modern door with new four panelled Georgian style traditional door.

Apply an insulated plasterboard 62mm thick to underside of ceiling. The Laminated plasterboard and PIR has a vapour barrier incorporated so interstitial moisture would be prevented. New rooflights to be installed with flashing kit that mounts unit flush with the roof surface.
