# HERITAGE STATEMENT

## FULL RENOVATION OF EXISTING No 11 TERRACE HOUSES

St Bees, 1-11 Lonsdale Terrace, Parish Council, Cumbria

M.A.C Architects, Project Number: 2019:303

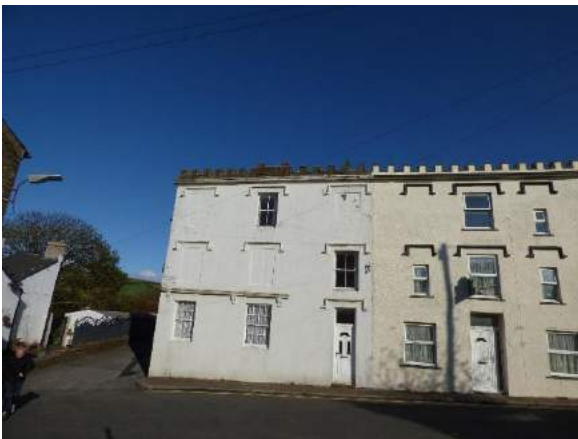
Left: The main entrance on the west facade is mentioned in the listing text and is to be entirely retained.

Investigations to the blind windows have confirmed that that the walls behind are solid masonry and no internal openings were in these locations, so they have never actually been windows.

The entrance to the apartment at first and second floor is accessed from Finkle Street and it is proposed to retain this.

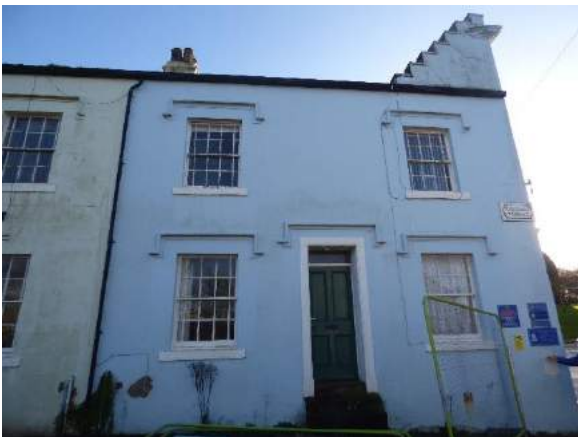
Both front and rear elevations are currently rendered, with colour to the front and side and natural to the rear. All elevations require to be prepared for render repairs and redecoration by specialist using lime render and stucco (Parax LTD) to be applied by specialist.

The stucco features above the windows and door on the front elevation will be carefully restored by a specialist. Colour of all render and stucco to match existing.

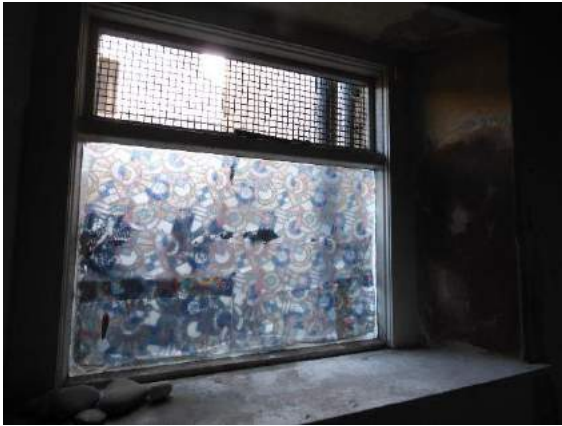
Left: The ground floor window to the rear is not original and requires repair / replacement subject to planning condition.

Existing external cills to be repaired and decorated.

Existing Velux windows to be replaced with Velux conservation rooflights (or rooflight company, heritage rooflights) (size to match existing), and new flashings to suit.

Localised lead repair work may be required to chimneys, to prevent leaking.

Roof to be repaired where necessary with slates to match existing to make the roof completely watertight.

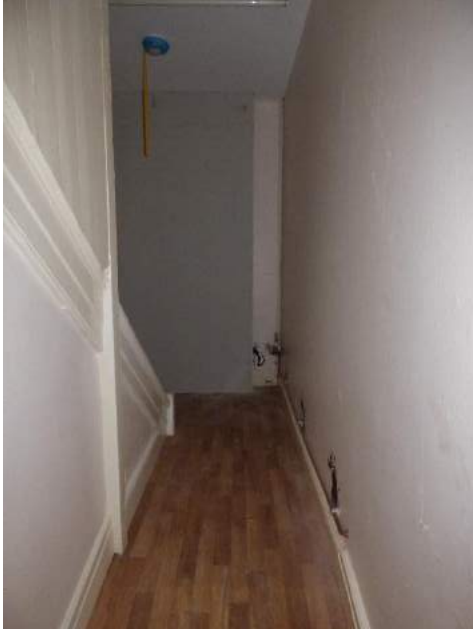
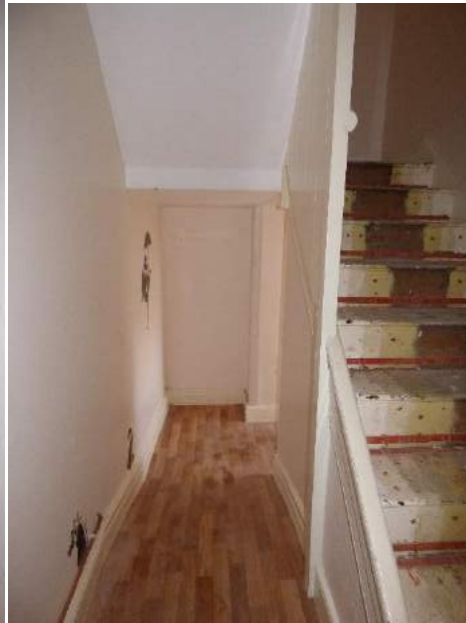
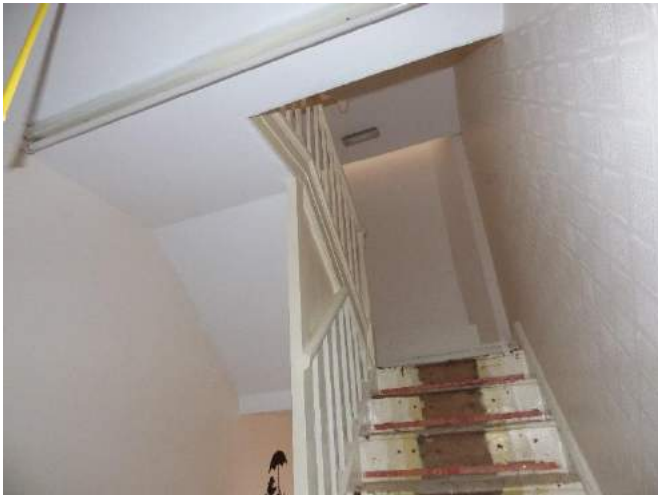
The existing staircase at ground floor has been modified as part of later alterations to the building. It is proposed to reinstate balusters and rails to match the existing to the lower part of the staircase, where they have been removed.

The existing staircase is to be retained as existing throughout the rest of the building.

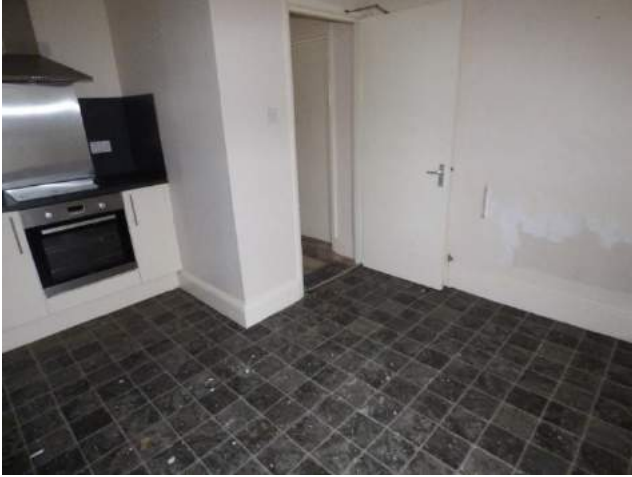
Existing kitchen, bathroom and living area at the front of the first floor, has lost most of the original heritage features.

It is proposed to remain as existing subject to minor decorative repairs. Flush panel doors to be replaced with heritage style 4 panel painted timber fire doors to enhance the heritage asset. Where possible it is proposed to refurbish any original doors with door closers and intumescent paint subject to building control approval.

Original floors to be made good using T & G flooring to match existing where required.

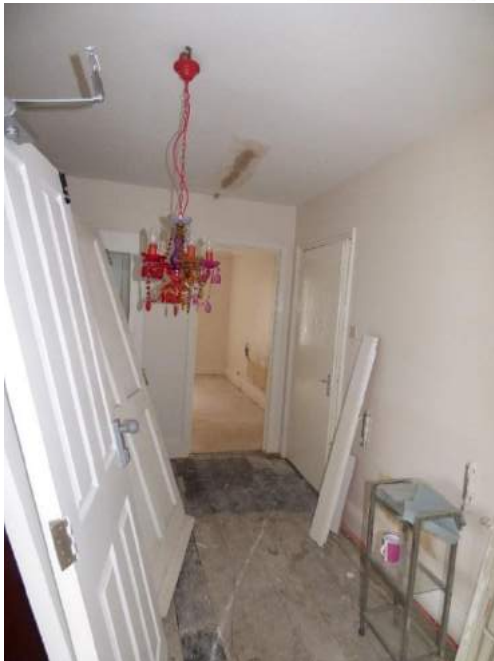
Existing living area at the rear of the first floor is proposed to remain as existing subject to minor decorative repairs. Flush panel doors to be replaced with heritage style 4 panel painted timber fire doors to enhance the heritage asset. Where possible it is proposed to refurbish any original doors with door closers and intumescent paint subject to building control approval.

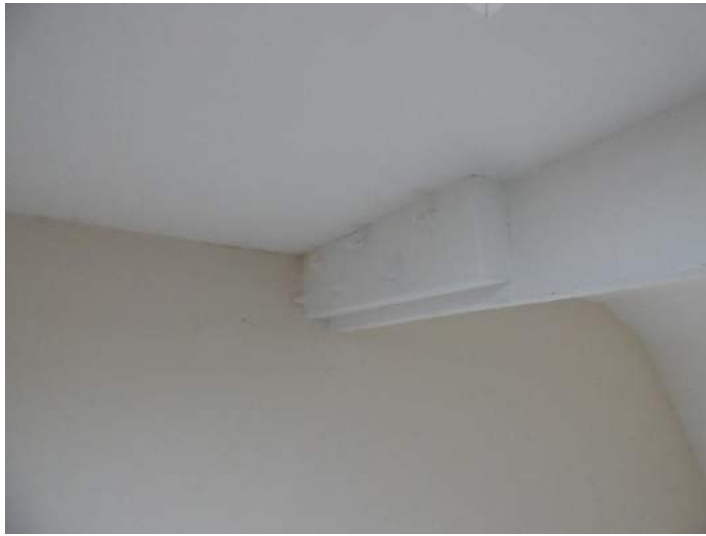
### Attic Bedroom

Remove all damp and damaged / blown plasterwork and repair with lime plaster and skim and decorate throughout.

Apply an insulated plasterboard 62mm thick to underside of ceiling tape and skim, and undertake full decorations. The laminated plasterboard and PIR has a vapour barrier incorporated so interstitial moisture would be prevented. New rooflights to be installed with flashing kit that mounts unit flush with the roof surface.

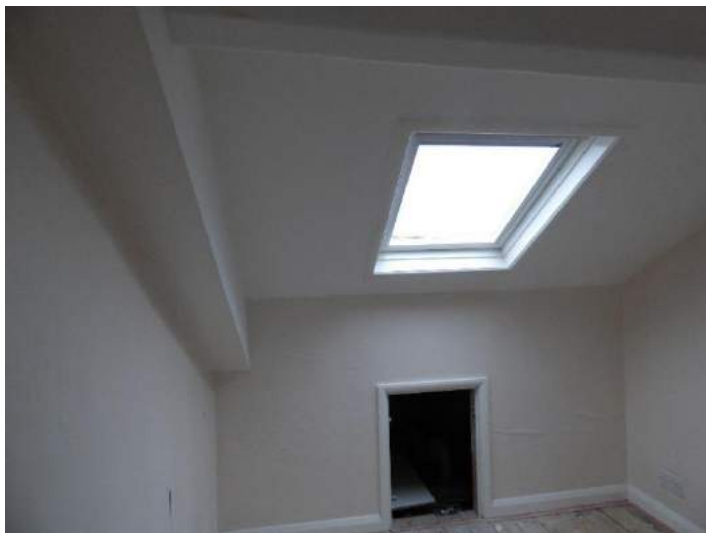
Floorboards are in good condition (but may require minor repairs).

Existing flush panel doors are not original and are to be removed and replaced with new heritage style four panel fire rated doors.

Provide and install new heritage rooflight windows (Velux or similar) with flashing kit that mounts unit flush with the roof surface.

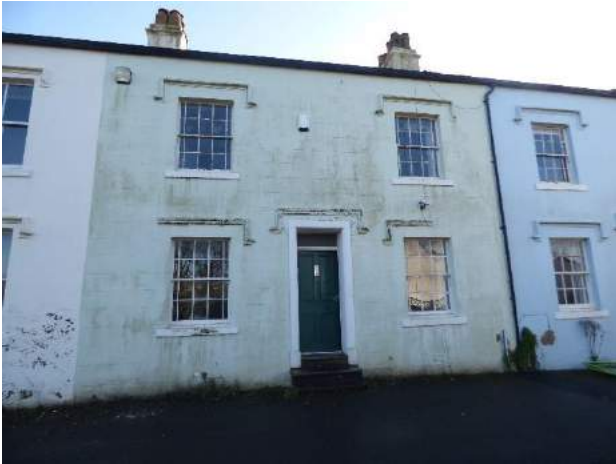
Left: The main entrance is mentioned in the listing text and is to be entirely retained.

Both front and rear elevations are currently rendered, with colour to the front and side and natural to the rear. All elevations require to be prepared for render repairs and redecoration by specialist using lime render and stucco (Parax LTD) to be applied by specialist.

The stucco features above the windows and door on the front elevation will be carefully restored by a specialist. Colour of all render and stucco to match existing.

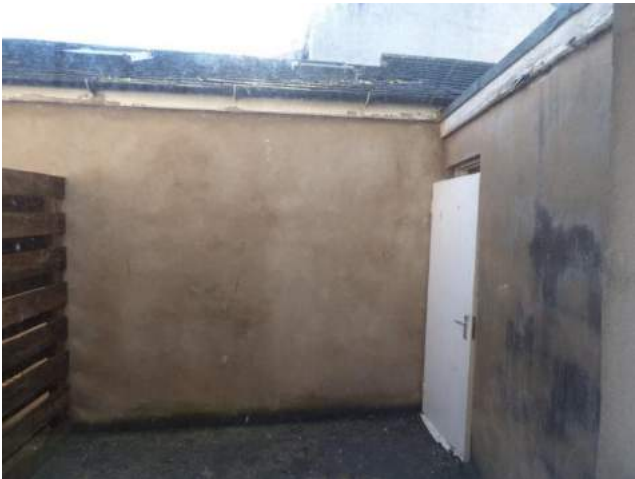
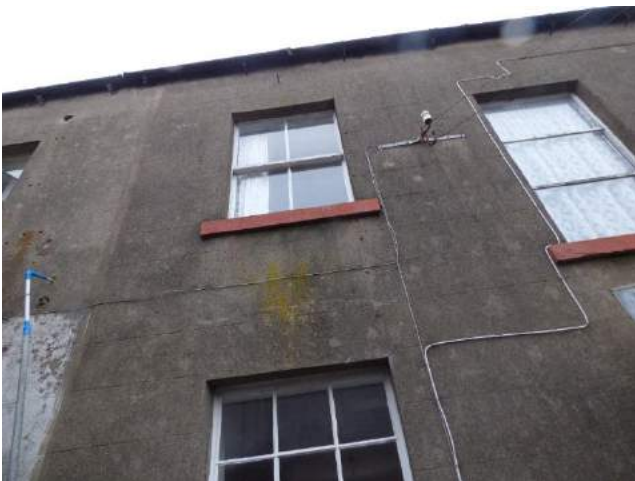
The rear courtyard is divided by a single storey 'link' building to an outbuilding at the rear. It is proposed to demolish both these structures. The link building is in extremely poor condition, and also to demolish the existing rear building, as they were a later mid-century addition to the property and the intention is to restore the rear garden to its original state to provide additional amenity space for the property and allow more light into the existing dwelling.

All existing single glazed windows to either be repaired / replaced (subject to planning condition).

Existing cills to be repaired and decorated.

Existing roof windows to be replaced with Velux conservation rooflights (or rooflight company, heritage rooflights)

New heritage rooflight windows (Velux or similar) with flashing kit that mounts unit flush with the roof surface.

Localised lead repair work required to chimneys, to prevent leaking.

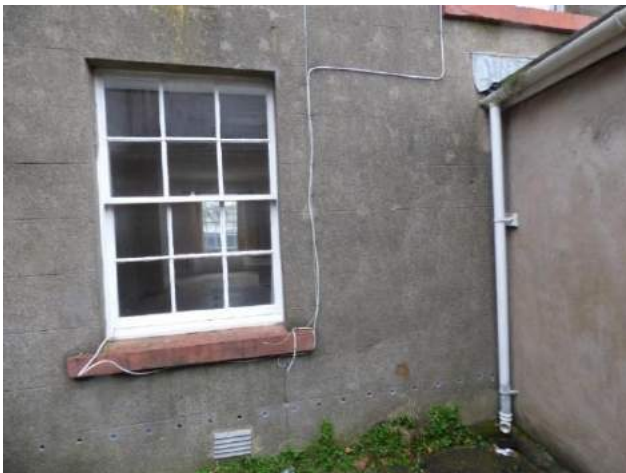
Left: The ground floor window to the kitchen is not original and requires replacement. The proposal is to remove the existing modern window and reinstate the original Georgian style of window, in the original opening (which has been walled up), with a double-glazed slimline heritage painted timber sash – albeit this will be subject to planning condition to reflect what would have been originally installed.

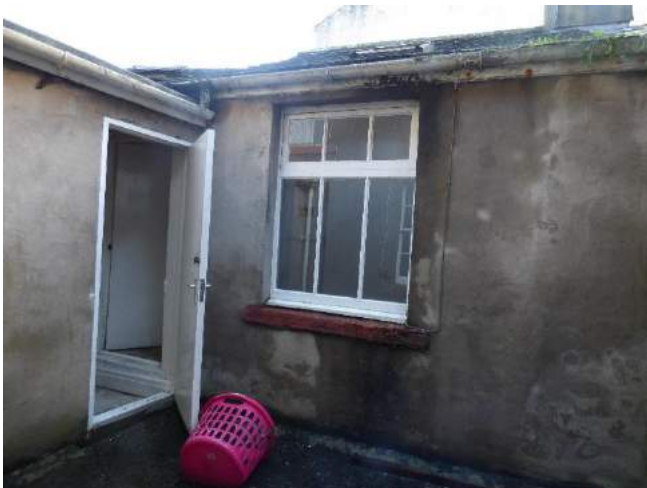
Poorly constructed 'link' building and out-building to be removed to return the original building back to its former configuration.

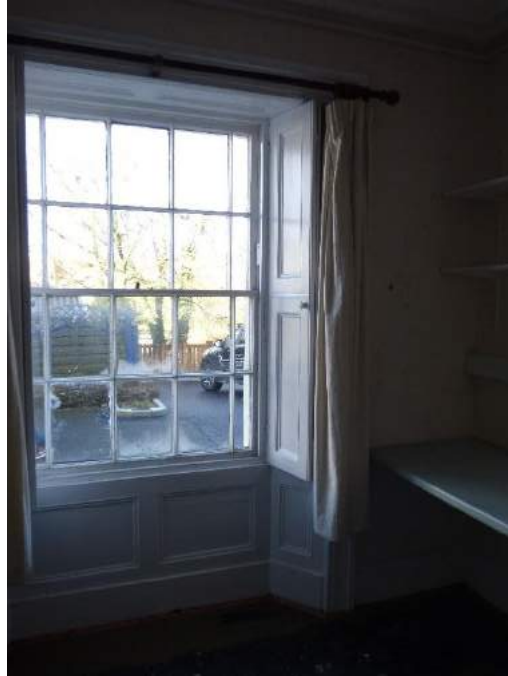
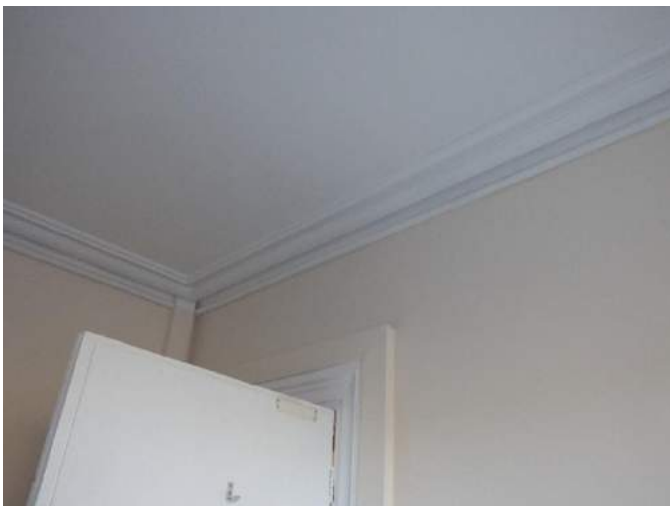
Above: In the existing study, the period features below and to the sides of the existing window are in good condition, it is proposed to carefully refurbish the existing timber shutters.

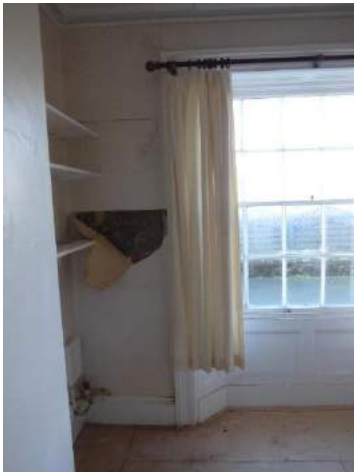
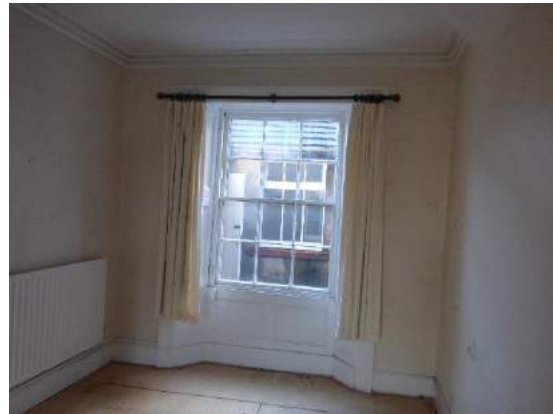
Above: In the existing lounge at the front of the property and

Left and below: the existing dining area to the rear of the property, the period features below and to the sides of the existing window are in good condition, it is proposed to carefully refurbish the existing timber shutters.

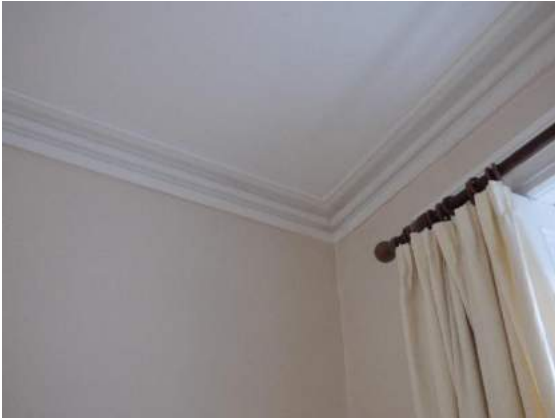
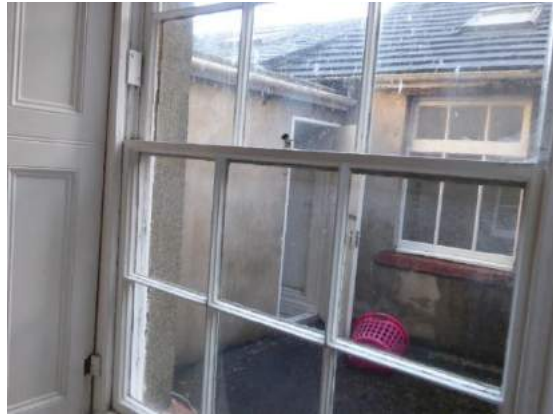
Above: Existing architraves, and skirtings to be retained and made good

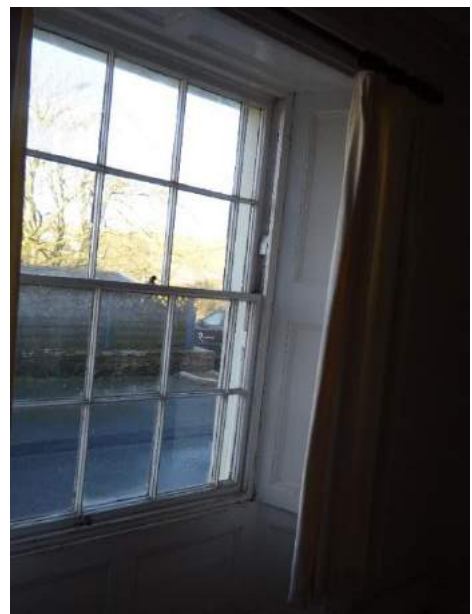
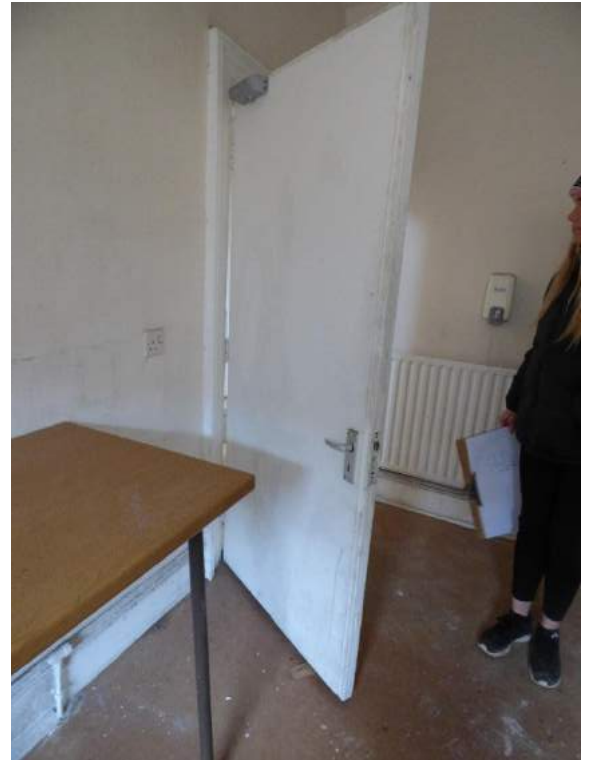
Flush panel doors to be replaced with heritage style four panel painted timber fire doors to enhance the heritage asset. Where possible it is proposed to refurbish any original doors with door closers and intumescent paint subject to building control approval.

Existing modern single glazed window to be repaired / replaced subject to planning condition.

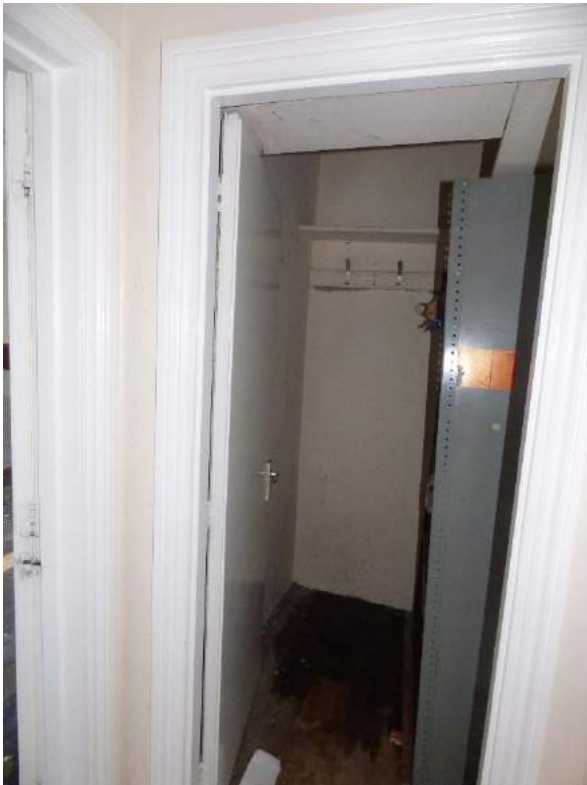
All architraves, to be retained. New Georgian four panel doors to be provided in lieu of flush panel doors.

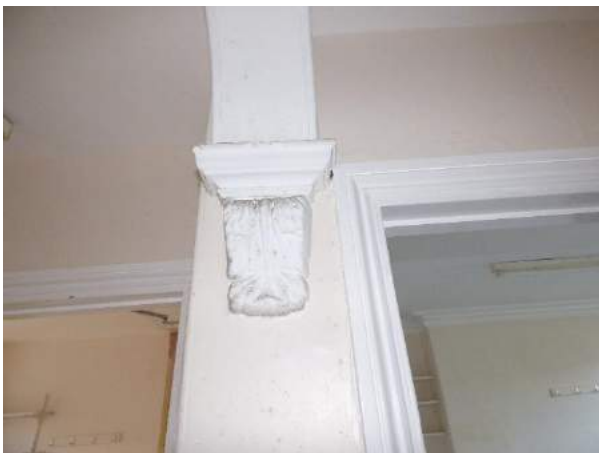
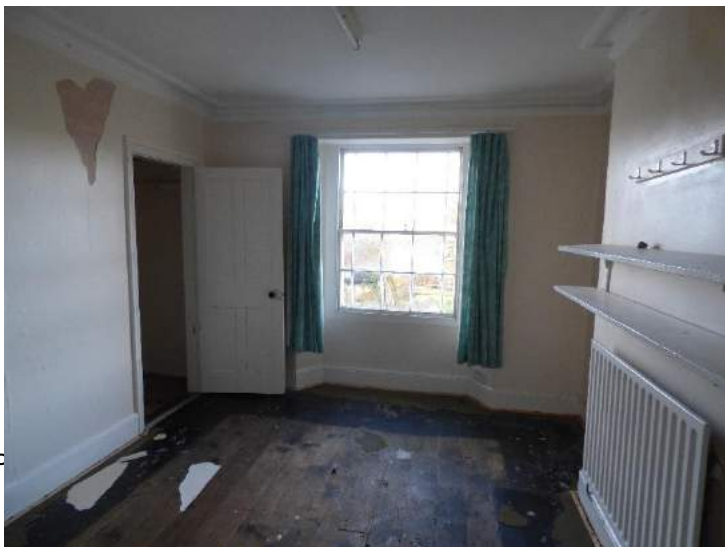
Front bedroom (First floor RHS), cornice, skirtings, and architraves to be retained. Existing flush panelled door to be replaced with new Georgian heritage style 4 panel fire door to be provided and installed by specialist joinery company such as Batty Joinery Ltd.

Existing floorboards in good condition.

It is proposed to form new doorway with architraves to match existing, and new four panelled door, into a new ensuite to be formed from part of the existing over large bathroom to make efficient use of the space and reflect the requirements of modern-day living.

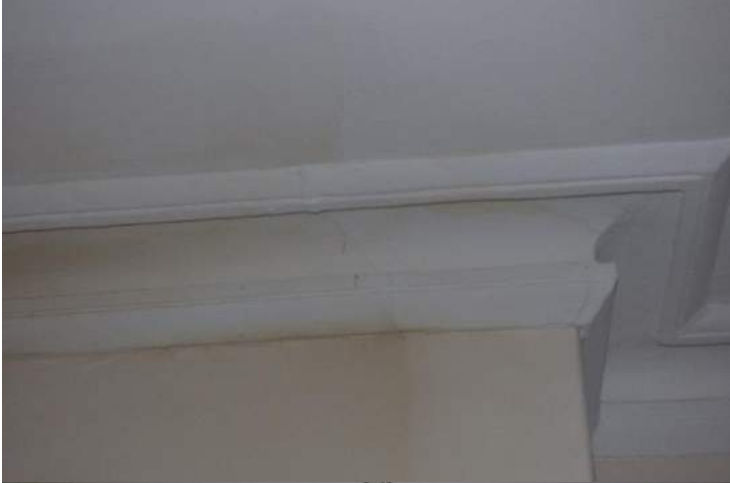
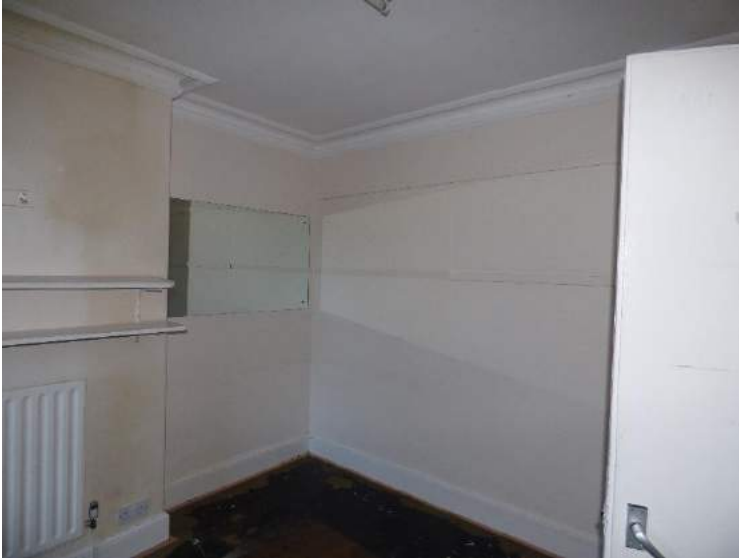
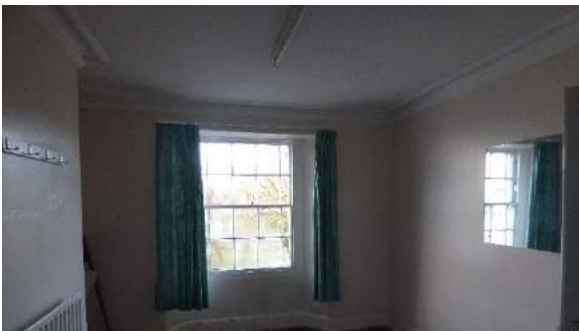
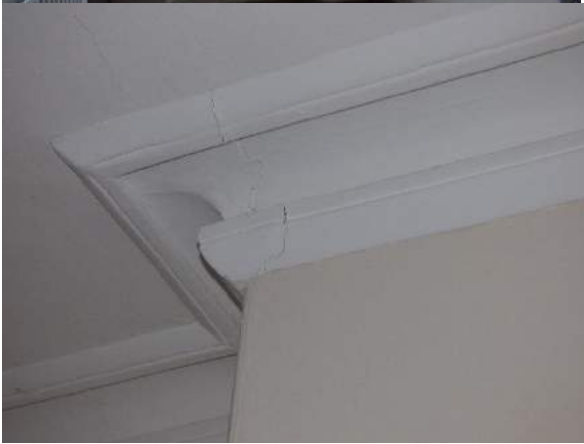
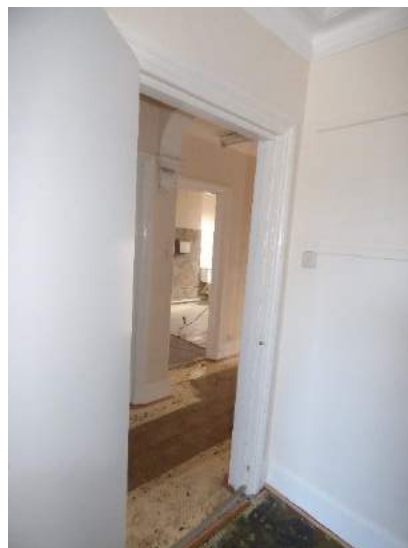
Front bedroom (First floor LHS), cornice, skirtings, and architraves to be retained. Existing flush panelled door to be replaced with new Georgian heritage style four panel fire door to be provided and installed by specialist joinery company such as Batty Joinery Ltd. Where possible it is proposed to refurbish any original doors with door closers and intumescent paint subject to building control approval.

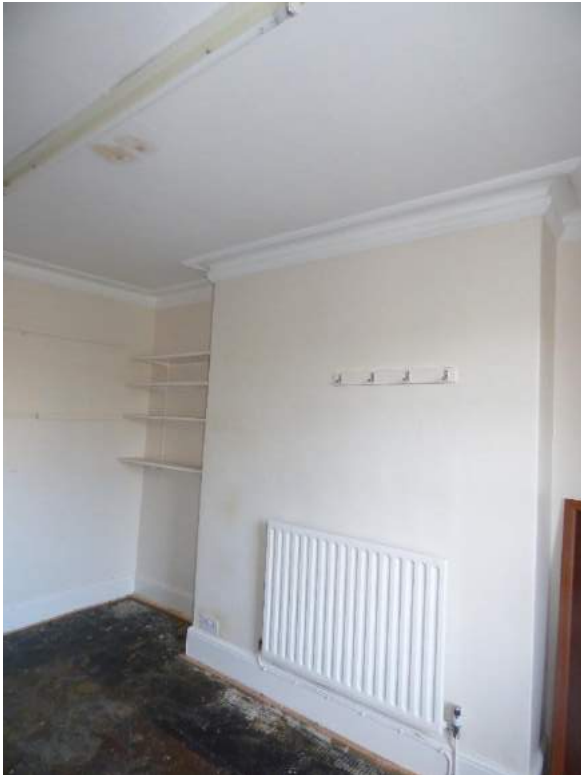
Existing floorboards in good condition. Minor repairs may be necessary.

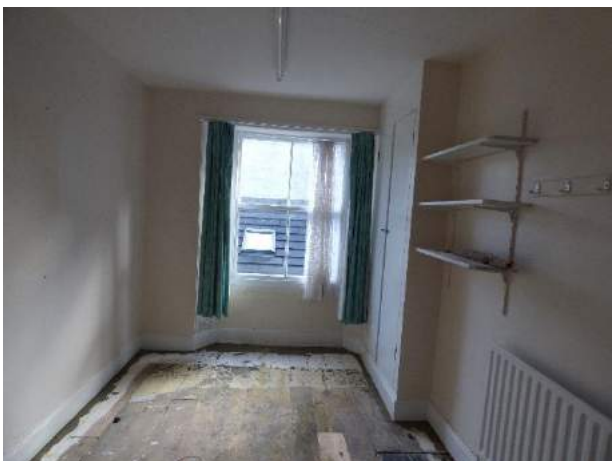
Rear bedroom existing skirtings and architraves to be retained. Existing modern flush panelled door to be replaced with new Georgian heritage style 4 panel door fire door to be provided and installed by specialist joinery company such as Batty Joinery Ltd.

Damp ingress has affected plasterwork by window. It is proposed to rake back existing blown plaster and repair with new lime plaster.

Existing floorboards in good condition. Minor repairs may be necessary.

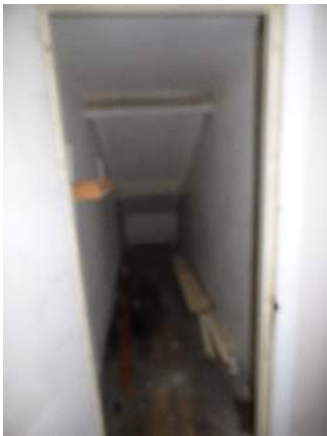
Left: Attic Store is proposed to be converted into a bathroom to be shared by the attic bedrooms by increasing the size of the room to each side to allow for the new

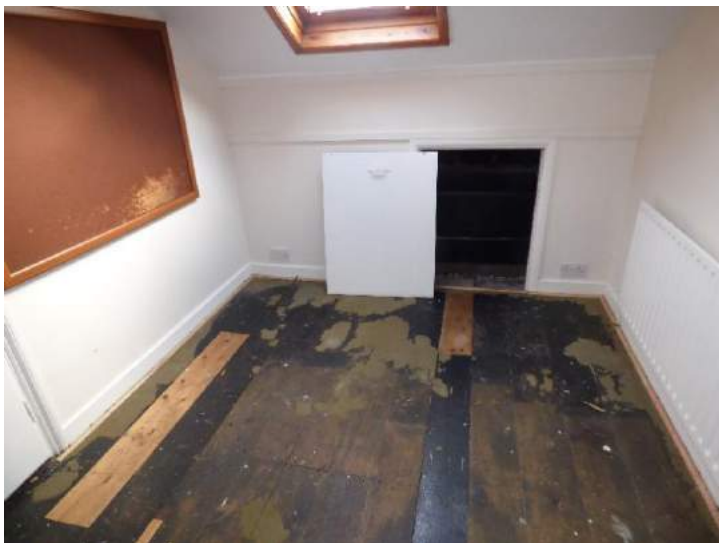
Left: Attic Bedroom

Floorboards are in good condition (but may require minor repairs).

New plasterboard stud partition to be installed in lieu of removal of part of existing store / bedroom partition (existing lath and plaster) to allow for bathroom to be useable size.

In the bedroom remove all damp and damaged / blown plasterwork and repair with lime plaster (Solo lime plaster from Lime Centre).and skim and decorate throughout.

Apply an insulated plasterboard 62mm thick to underside of ceiling. The Laminated plasterboard and PIR has a vapour barrier incorporated so interstitial moisture would be prevented. New rooflights to be installed with flashing kit that mounts unit flush with the roof surface.

Existing flush panel doors are to be removed and replaced with new heritage style 4 panel fire doors.

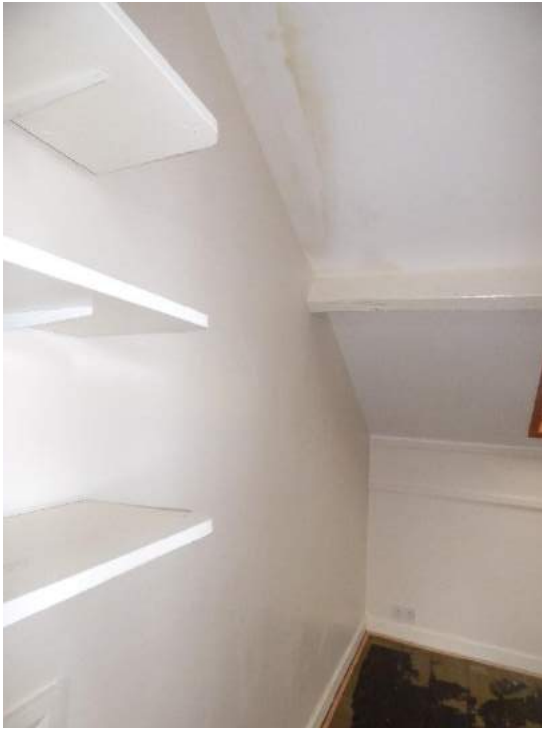
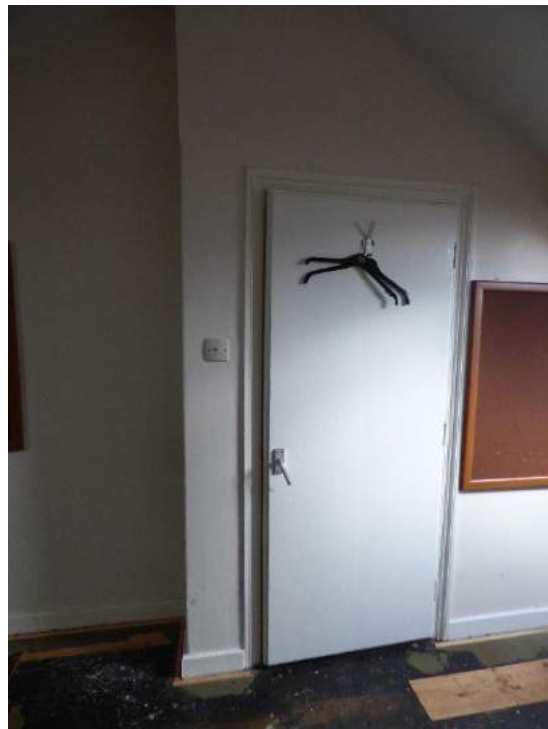
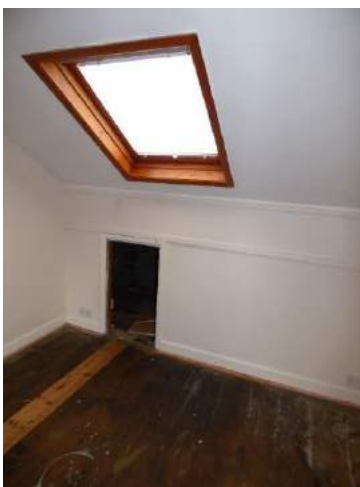
Above and below: Attic Bedroom

Floorboards are in good condition (but may require minor repairs).

New plasterboard stud partition to be installed in lieu of removal of part of existing store / bedroom partition to allow for bathroom to be useable size.

In the bedroom remove all damp and damaged / blown plasterwork and repair with lime plaster (Solo lime plaster) and skim and decorate throughout.

Apply an insulated plasterboard 62mm thick to underside of ceiling tape and skim. The laminated plasterboard and PIR has a vapour barrier incorporated so interstitial moisture would be prevented and undertake full decorations. New heritage style rooflights to be installed replacing the existing modern velux rooflights with flashing kit that mounts unit flush with the roof surface.

Existing flush panel doors are to be removed and replaced with new heritage style 4 panel fire doors.

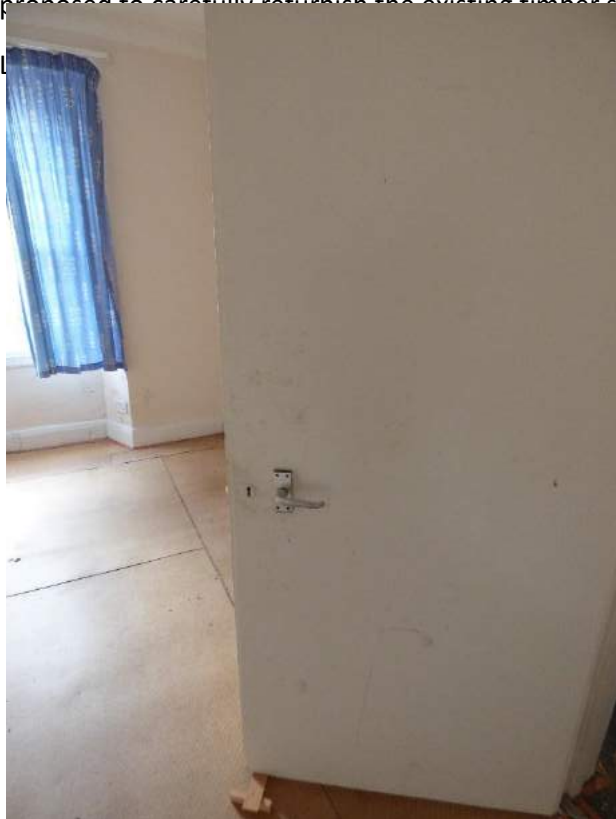
Where redundant services are to be removed and where hairline cracks have appeared.

Existing architraves, and skirtings to be retained and made good.

Flush panel doors to be replaced with heritage style 4 panel painted timber fire doors to enhance the heritage asset.

Where possible it is proposed to refurbish any original doors with door closers and intumescent paint subject to building control approval.

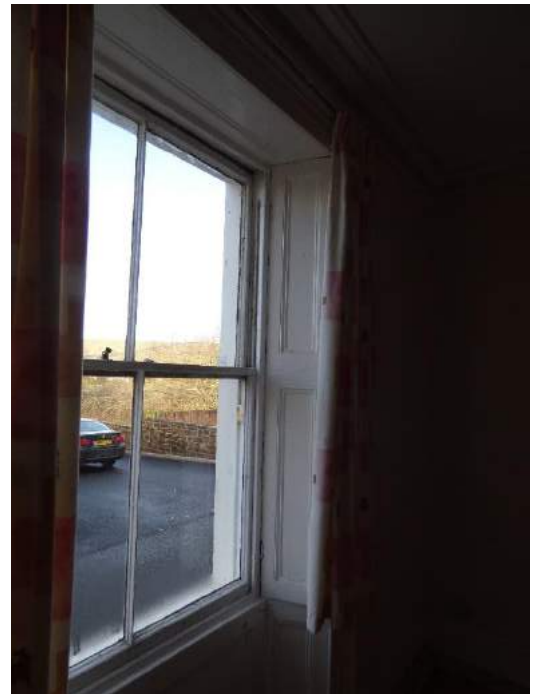
Right and below: The existing dining area to the rear of the property, the period features below and to the sides of the existing window are in good condition, it is proposed to carefully refurbish the existing timber shutters.

Below: Existing cornice to be made good in locations and where hairline cracks have appeared.

Flush panel fire door to be replaced with heritage style four panelled fire doors to enhance the heritage asset.

Where possible it is proposed to refurbish any original doors with door closers and intumescent paint subject to building control approval.

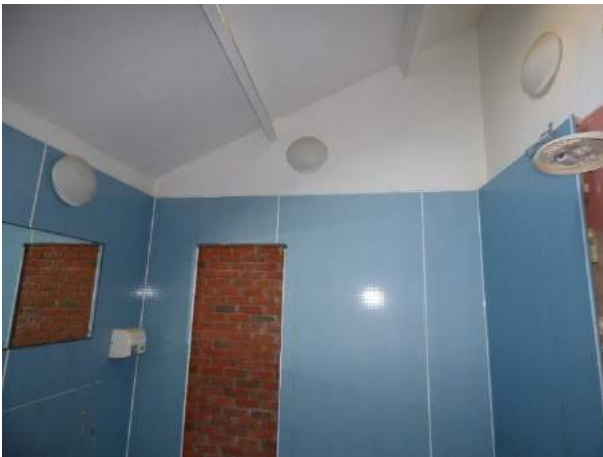
Above, Right, and below: In the existing lounge, the period features below and to the sides of the existing windows both front and back are in good condition, it is proposed to carefully refurbish the existing timber shutters.

Existing cornice to be made good in locations where redundant services are to be removed and where hairline cracks have appeared.

Existing architraves, and skirtings to be retained and made good.

Flush panel doors to be replaced with heritage style four panel painted timber fire doors to enhance the heritage asset.

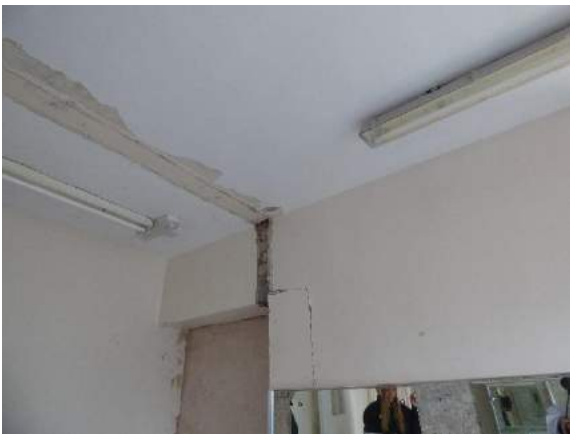
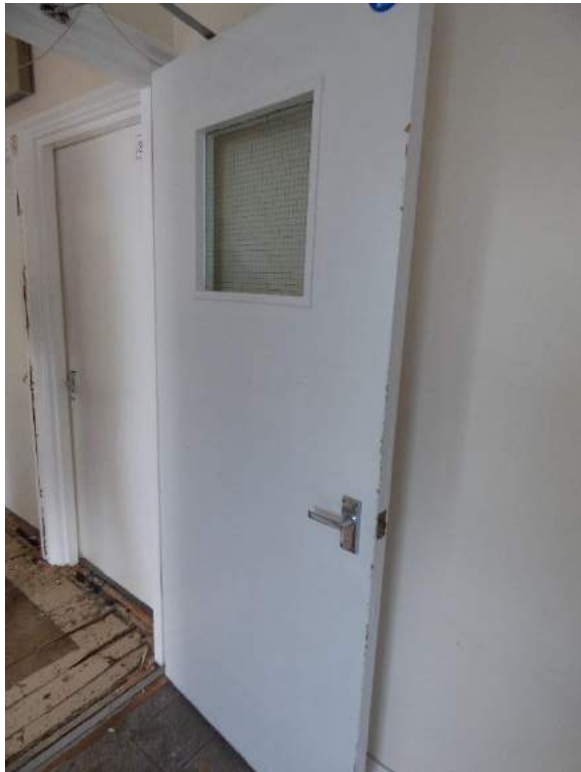
Left: Existing bathroom to be reduced in size to allow for new en-suite to master which backs on to the bathroom. This allows for a decent sized family bathroom and a new en-suite providing accommodation suitable for modern day living.

Existing ceiling to be made good and provide and install new extract fan linked back to light switch.

Existing single glazed windows to either be repaired / replaced (subject to planning condition).

New bathroom door to be new four panelled heritage style door - bathroom door does not need to be a fire rated door.

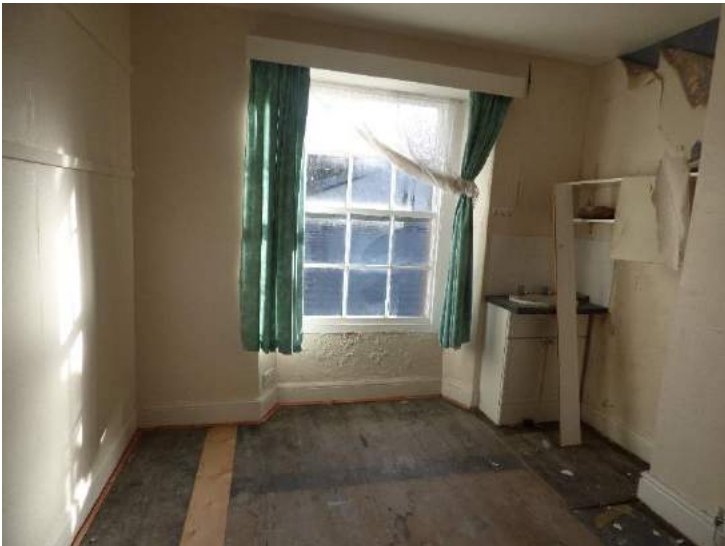
Existing floorboards generally in good condition.

Damp and associated blown plaster below window and to window reveals to be repaired with lime plaster. All existing single glazed windows to either be repaired / replaced (subject to planning condition).

Rear bedroom skirtings and architraves to be retained. Existing flush panelled door to be replaced with new Georgian heritage style 4 panel door to be provided and installed by specialist joinery company such as Batty Joinery Ltd.

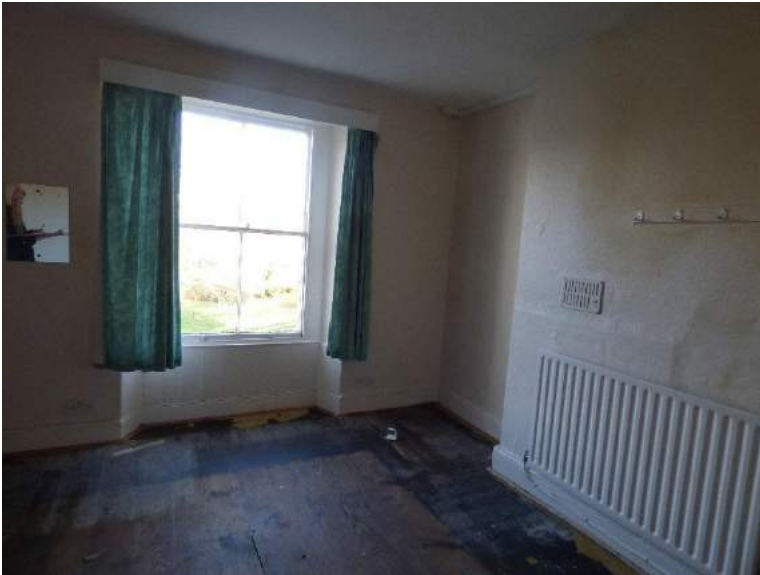
Front bedroom (First floor RHS), skirtings and architraves to be retained. Existing flush panelled door to be replaced with new Georgian heritage style 4 panel door to be provided and installed by specialist joinery company such as Batty Joinery Ltd. Where possible it is proposed to refurbish any original doors with door closers and intumescent paint subject to building control approval.

Existing floorboards in good condition.

It is proposed to form new doorway with architraves to match existing, and new four panelled door, into a new en-suite to be formed from part of the existing over large bathroom to make efficient use of the space and reflect the requirements of modern-day living.

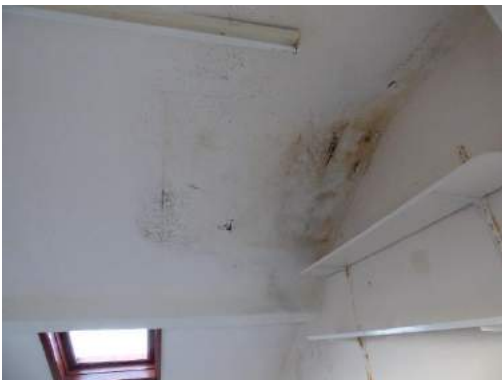
Left: Attic Store is proposed to be converted into a bathroom to be shared by the attic bedrooms by increasing the size of the room to each side to allow for the new bathroom.

Left and below: Attic Bedroom.

Floorboards are in good condition (but may require minor repairs).

New plasterboard std partition to be installed in lieu of removal of part of existing store / bedroom partition to allow for bathroom to be useable size.

In the bedroom remove all damp and damaged / blown plasterwork and repair with lime plaster and skim and decorate throughout.

Apply an insulated plasterboard 62mm thick to underside of ceiling tape and skim and undertake full decorations. New rooflights to be installed.

Replace modern Velux rooflight with new heritage rooflight windows (Velux or similar).

Existing modern flush panel doors are to be removed and replaced with new heritage style 4 panel doors.

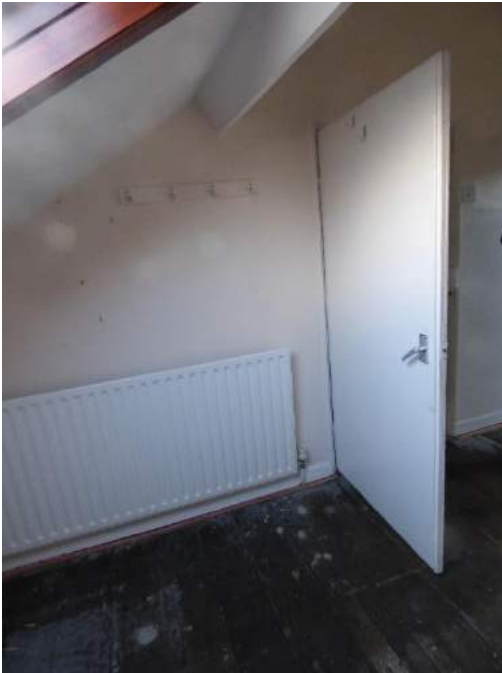
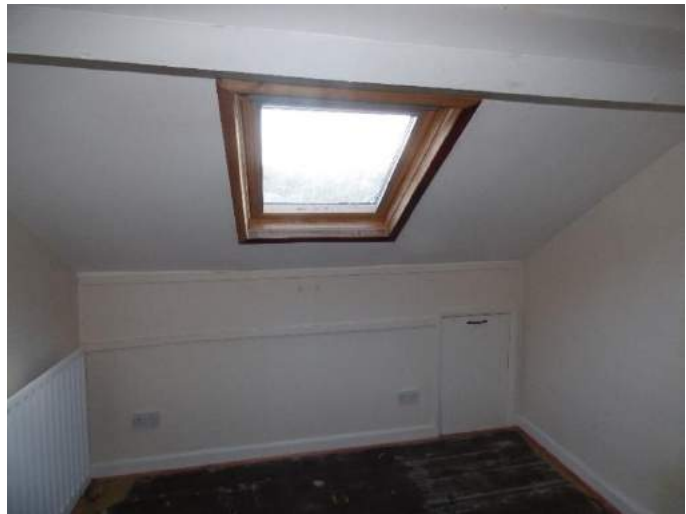
Left and below: Attic Bedroom.

Floorboards are generally in good condition (but may require minor repairs).

New plasterboard stud partition to be installed in lieu of removal of part of existing store / bedroom partition to allow for bathroom to be useable size.

In the bedroom remove all damp and damaged / blown plasterwork and repair with lime plaster (Solo lime plaster from Lime Centre) and skim and decorate throughout.

Apply an insulated plasterboard 62mm thick to underside of ceiling tape and skim and undertake full decorations. Replace existing rooflights to with new heritage style rooflights (Velux or similar).

Existing modern flush panel doors are to be removed and replaced with new heritage style 4 panel fire doors.

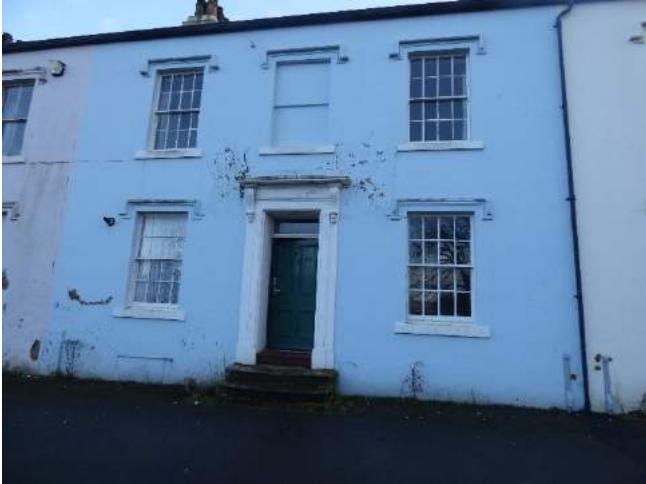
Left: The main entrance is mentioned in the listing text and is to be entirely retained.

Both front and rear elevations are currently rendered, with colour to the front and side and natural to the rear. All elevations require to be prepared for render repairs and redecoration by specialist using lime render and stucco (Parax LTD) to be applied by specialist.

The stucco features above the windows and door on the front elevation will be carefully restored by a specialist. Colour of all render and stucco to match existing.

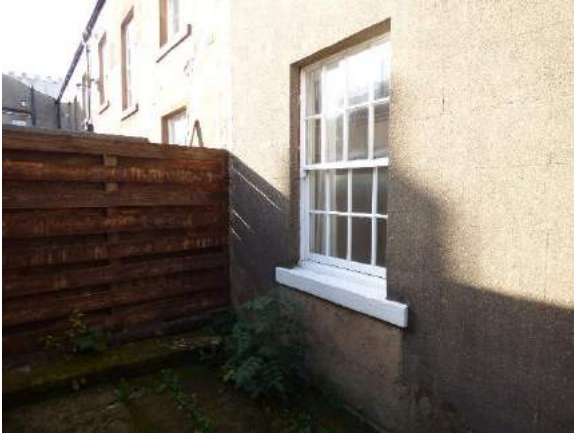
The rear courtyard is divided by a single storey 'link' building to an outbuilding at the rear. It is proposed to demolish this link structure as it is in extremely poor condition, and also to demolish the existing rear building, which was a mid-20<sup>th</sup> Century addition to the property to facilitate washroom accommodation for the boarding house, to provide additional amenity space for the property and allow more light into the existing dwelling.

All existing single glazed windows to either be repaired / replaced (subject to planning condition).

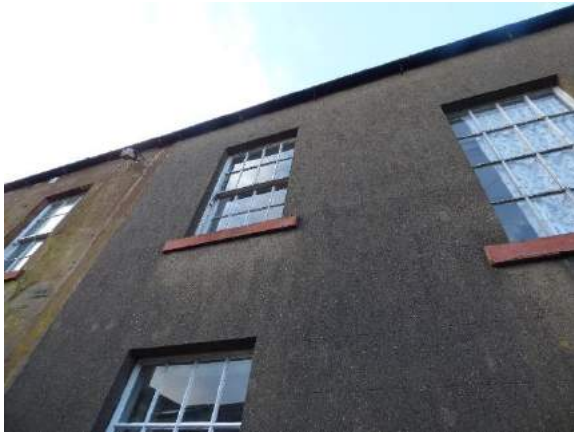
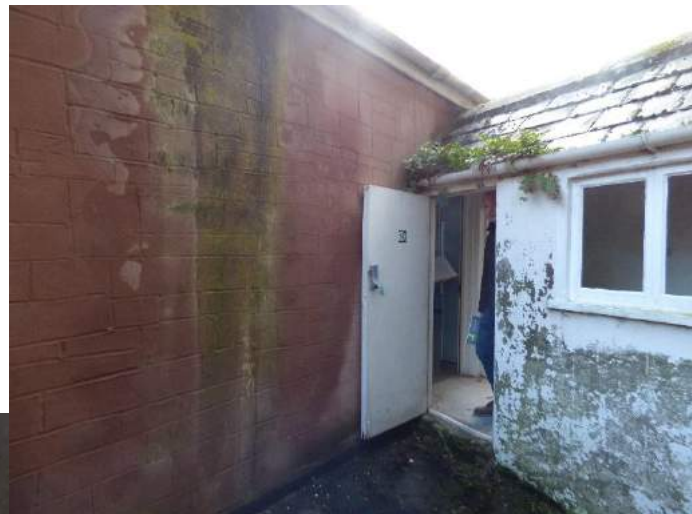
Rear of property – render to be repaired by specialist and decorated with off white render.

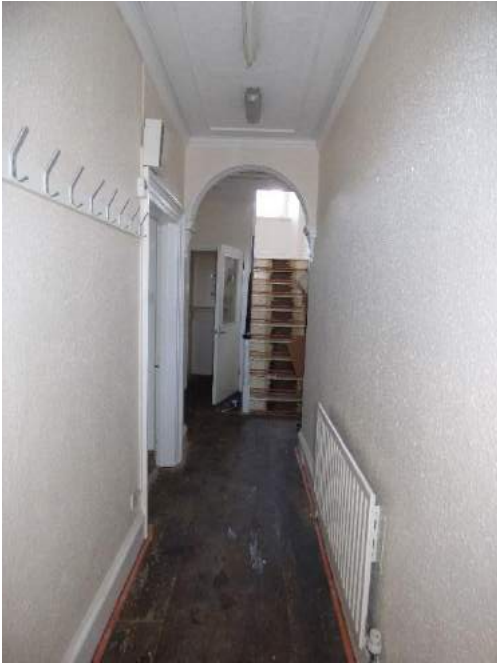
Left: The existing walls and floor are generally in good condition.

Redundant M&E to be removed and wall / ceiling finishes made good, and primed, prepared, and fully decorated.

Flush panel doors to be replaced with heritage style 4 panel heritage asset. Where possible it is proposed to refurbish any original doors with door closers and intumescent paint subject to building control approval.

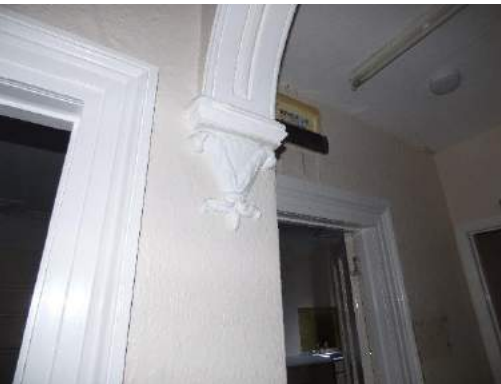
Left: period features to be retained, including archway and architraves. (Modern lighting to all be stripped out and make good surfaces). All architraves and plaster features to be retained.

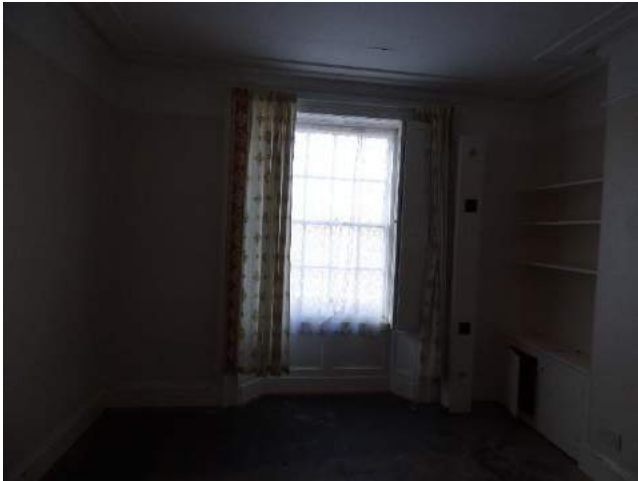
Left: In the existing study, the period features below and to the sides of the existing window are in good condition, it is proposed to carefully refurbish the existing timber shutters.

Left: Existing cornice to be made good in locations where redundant services are to be removed and where hairline cracks have appeared.

Existing architraves, and skirtings to be retained and made good.

Flush panel doors to be replaced with heritage style 4 panel painted timber fire doors to enhance the heritage asset.

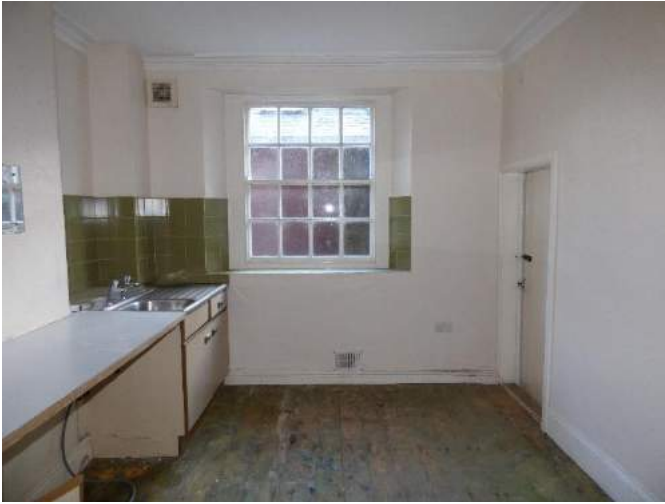
Left and below: the existing kitchen area to the rear of the property, the period features below and to the sides of the existing window are in good condition.

Below: Existing cornice to be made good in locations and where hairline cracks have appeared.

Flush panel doors to be replaced with heritage style 4 panel painted timber fire doors to enhance the heritage asset.

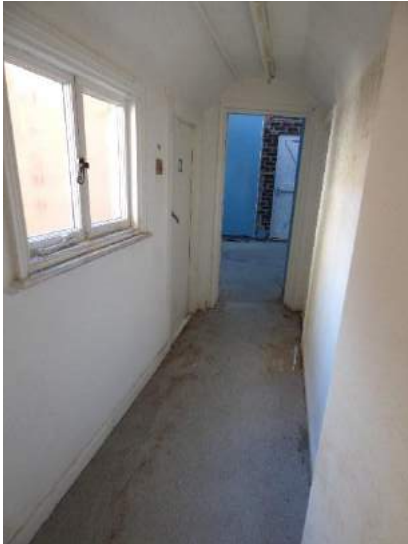
Left: Existing single skin link building extension to be removed.
