# HERITAGE STATEMENT

## FULL RENOVATION OF EXISTING No 11 TERRACE HOUSES

St Bees, 1-11 Lonsdale Terrace, Parish Council, Cumbria

M.A.C Architects, Project Number: 2019:303

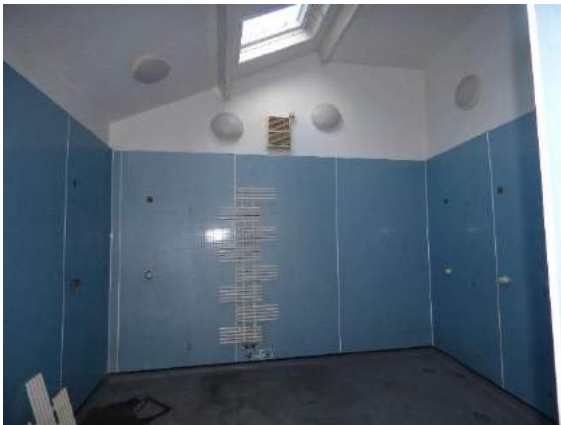
Left: Shower block to be removed to provide additional amenity space to the property. Not original building. Constructed mid-20<sup>th</sup> Century to provide washroom facilities for the boarding house.

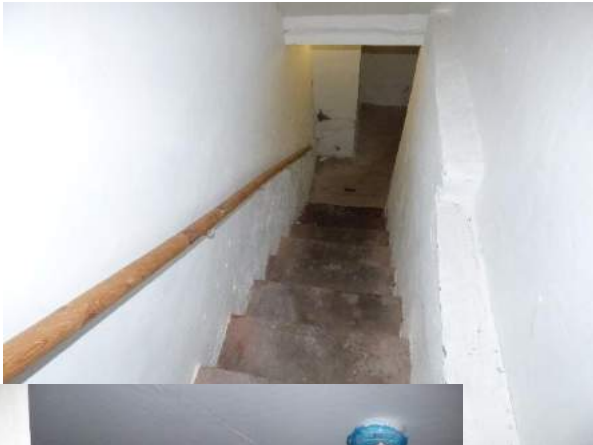
The existing walls and floor to the basement are generally in sound condition so would be suitable for the application of damp proof slurry system. All existing paint and surface finishes must be removed and made good including all snots removed, and damage to existing surfaces, prior to the installation of a Koster Polysil NB1. This migratory crystalline tanking slurry is used to seal below ground structures against water ingress.

Koster NB1 is considered to be a Type A waterproofing system as defined by BS8102:2009 and is generally used to seal the inside face of basement structures, slabs and retaining walls.

Koster NB1 works by both providing a physical barrier against water ingress as well as providing a migratory crystal sealant that penetrates deep into the structure to seal micropores and cracks against water ingress.

Once applied then the walls can be prepared and primed for decorating and for the floor finish to be installed. Complete new boiler and heating system is required, new distribution boards etc.

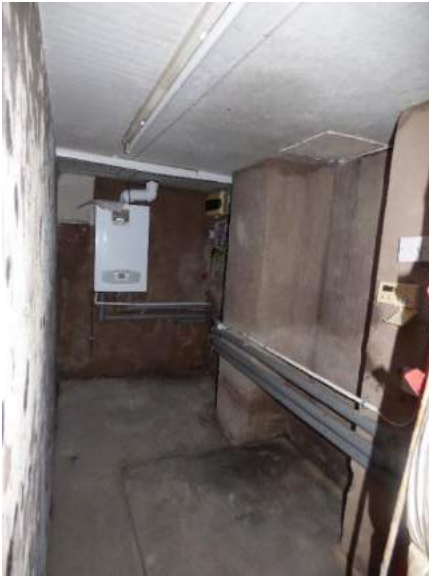
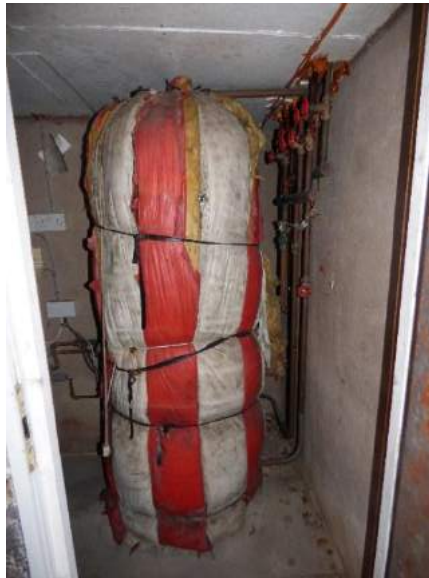
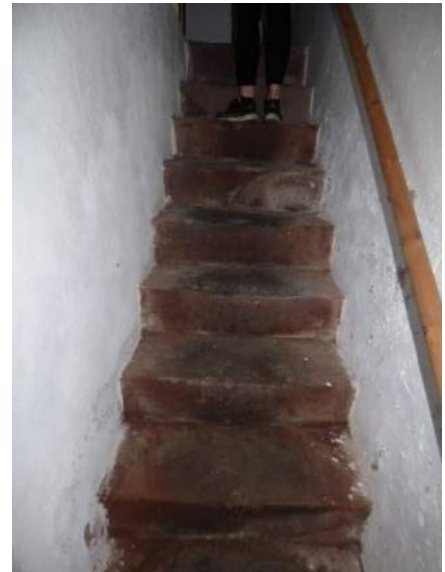
The walls down to the basement also require the full treatment.

Existing window to basement has been walled up. This is to be removed and reveals made good. The proposed new window to the basement to be subject to planning condition.

In the basement all existing services are to be carefully stripped out and replaced with new compliant infrastructure.

All existing services to be carefully removed and new gas and electric services installed.

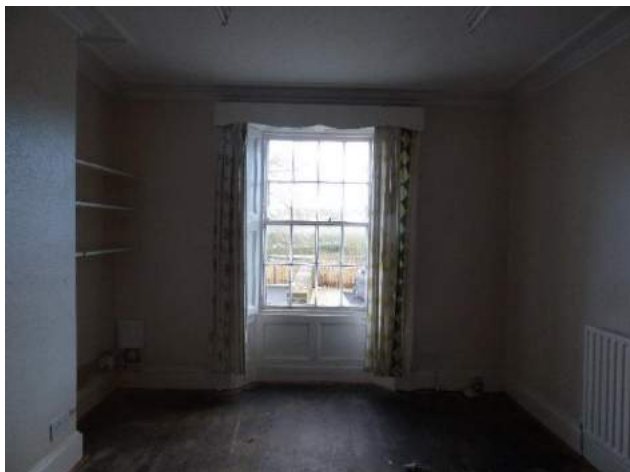
Above and Left: In the existing study, the period features below and to the sides of the existing windows both front and back are in good condition, it is proposed to carefully refurbish the existing timber shutters.

Existing cornice to be made good in locations where redundant services are to be removed and where hairline cracks have appeared.

Flush panel doors to be replaced with heritage style 4 panel painted timber fire doors to enhance the heritage asset.

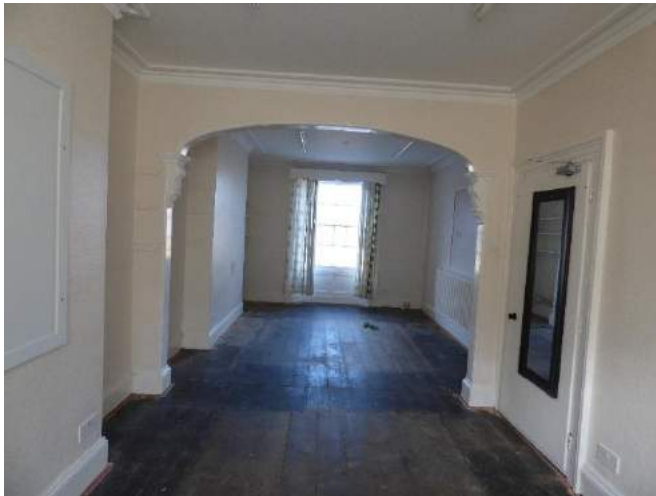
Left: period features to be retained, including archway and architraves. (Modern lighting to all be stripped out and make good surfaces). All architraves and plaster features to be retained.

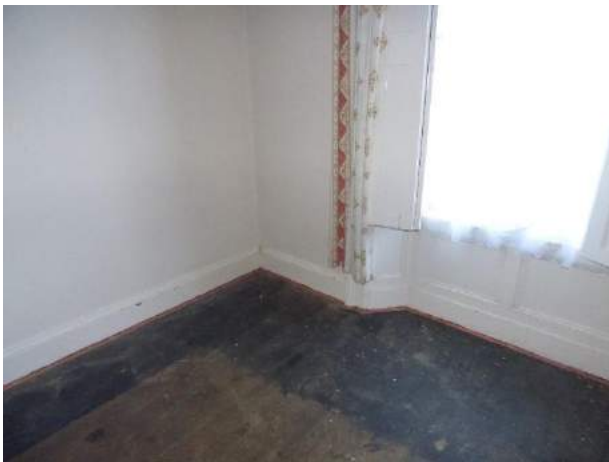
Above and Left: In the existing lounge, the period features below and to the sides of the existing windows both front and back are in good condition, it is proposed to carefully refurbish the existing timber shutters.

Existing cornice to be made good in locations where redundant services are to be removed and where hairline cracks have appeared.

Flush panel doors to be replaced with heritage style four panel painted timber fire doors to enhance the heritage asset. Where possible it is proposed to refurbish any original doors with door closers and intumescent paint subject to building control approval.

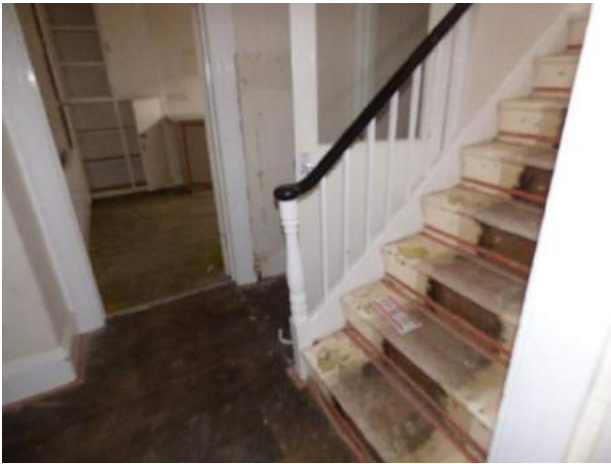
Retain original staircase, which is in good condition.

The requirement for the steel post at the top of the staircase

To be confirmed by structural engineer, if possible, the intention is to remove and strengthen the balusters if required to revert to the original staircase detail.

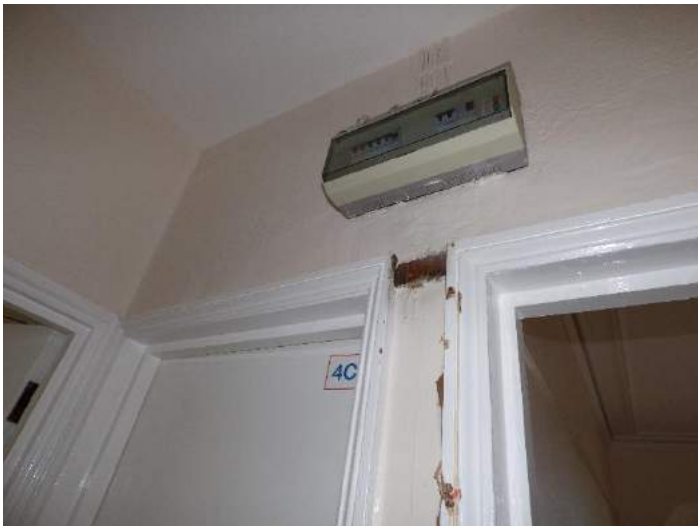
Original architraves to be retained.

Redundant M&E fixtures and fittings to be removed and surfaces made good.

Flush panel doors to be replaced with heritage style Georgian 4 panel fire doors.

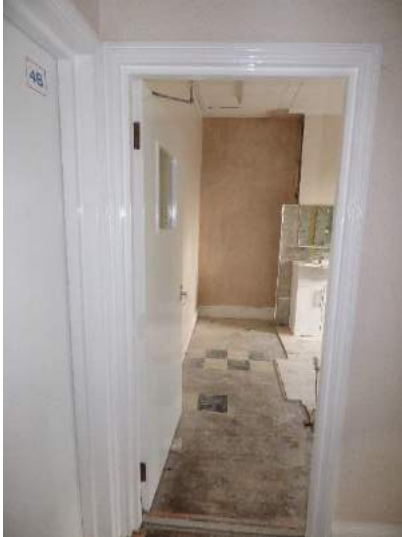
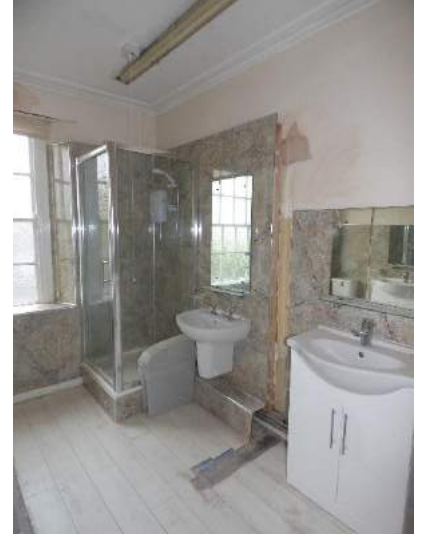
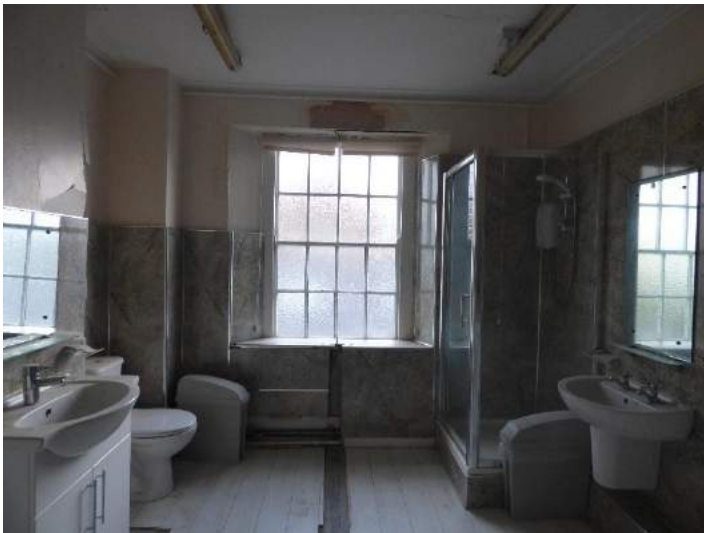
Left and above: Existing bathroom, to be completely renovated. All existing FF&E and M&E to be removed and all surface finishes to be completely removed and walls made good.

New Georgian heritage style four panel door to be provided and installed by specialist joinery company such as Batt Joinery Ltd. All fabric damage to be carefully repaired. To replace existing modern flush glazed door.

Bathroom to be reduced in size to allow for the installation of a new en-suite to the master bedroom.

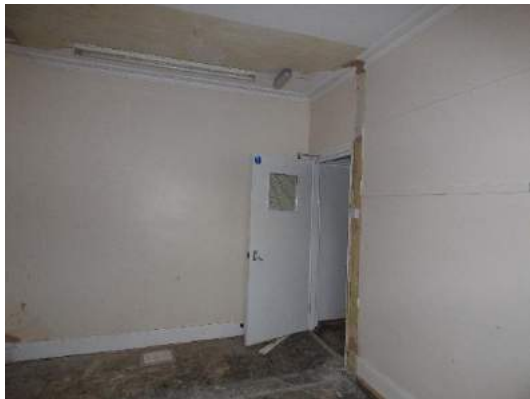
Left and above: Rear bedroom existing skirtings and architraves to be retained. Existing modern flush panelled door to be replaced with new Georgian heritage style four panel door to be provided and installed by specialist joinery company such as Batty Joinery Ltd.

Existing floorboards in good condition.

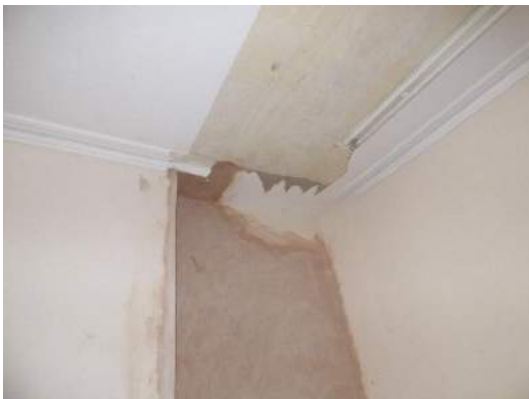
Front bedroom (First floor LHS), cornice, skirtings, and architraves to be retained.

Existing floorboards in good condition.

Existing flush panelled door to be replaced with new Georgian heritage style four panel door to be provided and installed by specialist joinery company such as Batty Joinery Ltd. Where possible it is proposed to refurbish any original doors with door closers and intumescent paint subject to building control approval.

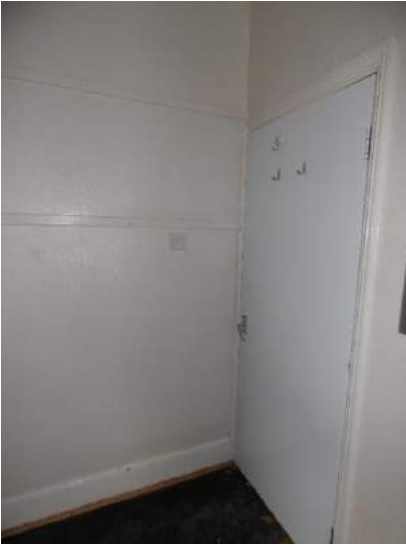
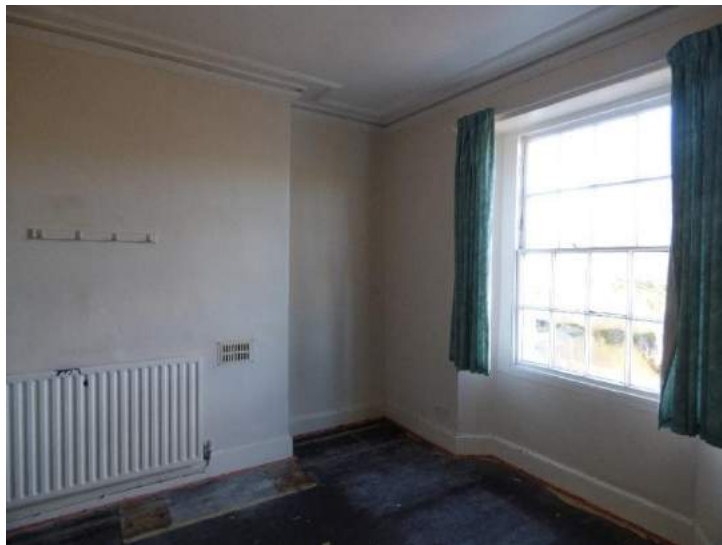
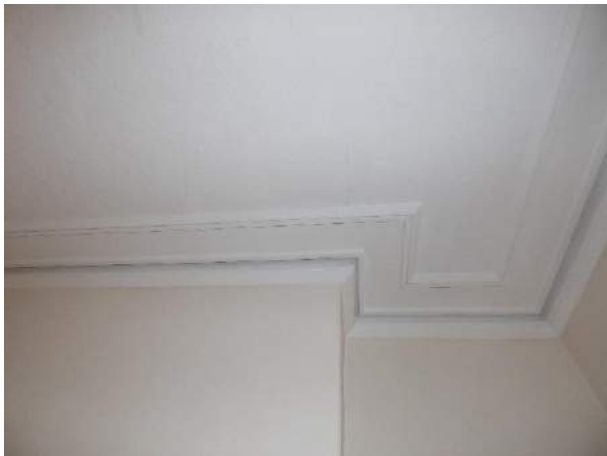
Front bedroom (First floor RHS), cornice, skirtings and architraves to be retained. Existing flush panelled door to be replaced with new Georgian heritage style 4 panel door to be provided and installed by specialist joinery company such as Batty Joinery Ltd. Where possible it is proposed to refurbish any original doors with door closers and intumescent paint subject to building control approval.

Existing floorboards generally in good condition.

It is proposed to form new doorway with architraves to match existing, and new four panelled door, into a new en-suite to be formed from part of the existing over large bathroom to make efficient use of the space and reflect the requirements of modern-day living.

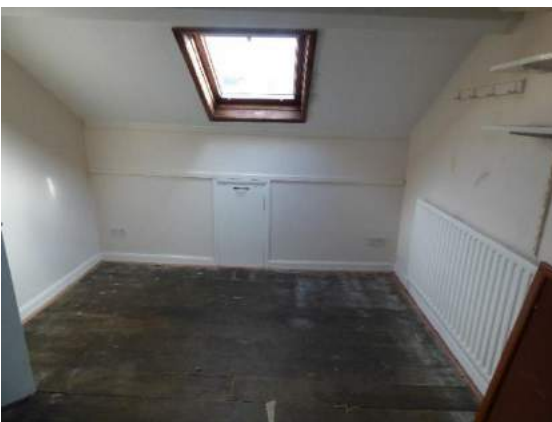
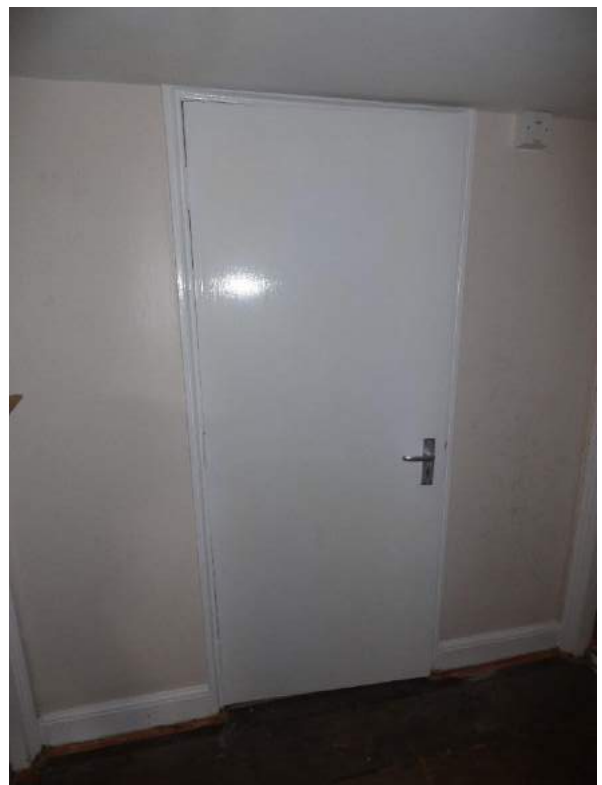
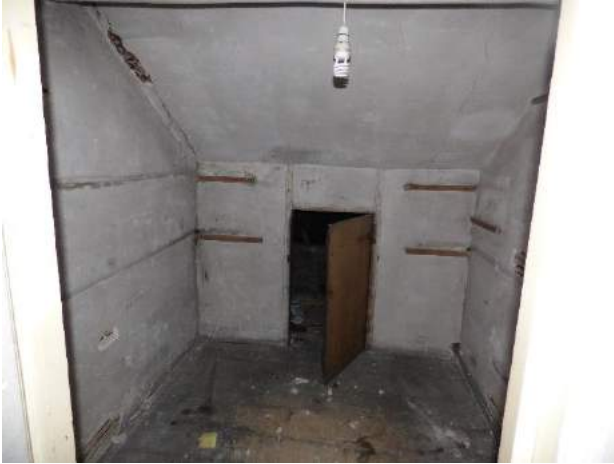
Left: Attic Store is proposed to be converted into a bathroom to be shared by the attic bedrooms by increasing the size of the room to each side to allow for the new bathroom.

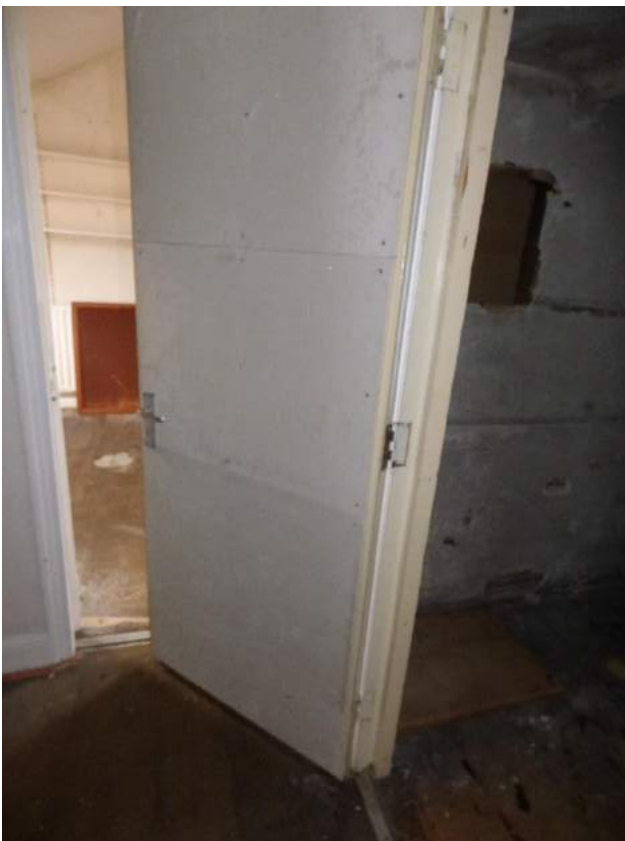
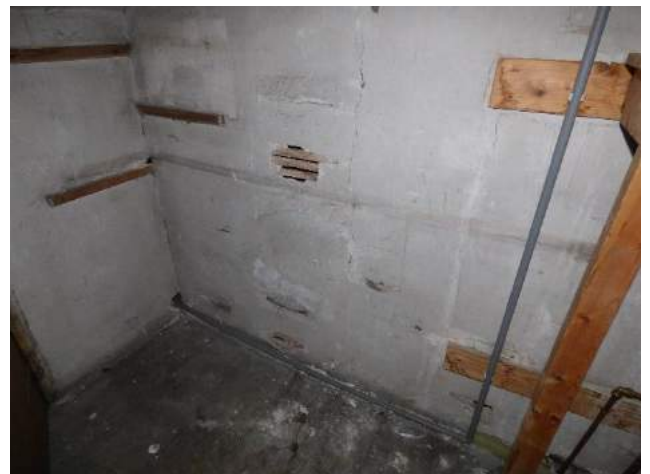
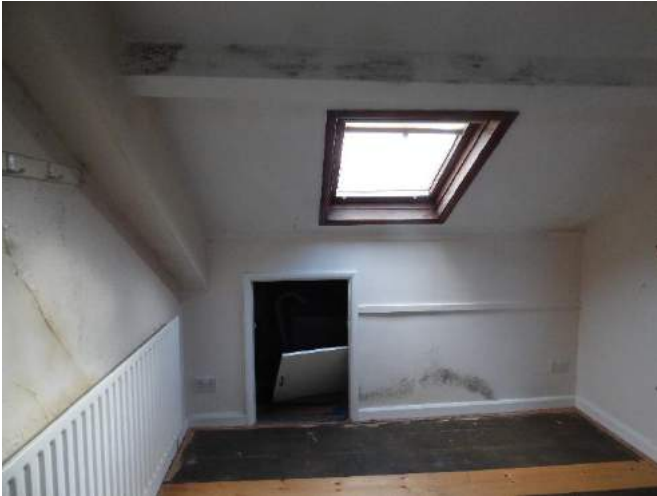
Left: Attic Bedroom

In the bedroom remove all damp and damaged / blown plasterwork and repair with lime plaster (Solo lime plaster from Lime Centre) and skim and decorate throughout.

Floorboards are in good condition (but may require minor repairs).

New plasterboard stud partition to be installed in lieu of removal of part of existing store / bedroom partition to allow for bathroom to be useable size.

Apply an insulated plasterboard 62mm thick to underside of ceiling. The Laminated plasterboard and PIR has a vapour barrier incorporated so interstitial moisture would be prevented.

Replace modern Velux windows with heritage rooflight windows (Velux or similar with flashing kit that mounts unit flush with the roof surface).

Existing flush panel doors are to be removed and replaced with new heritage style four panel fire doors.

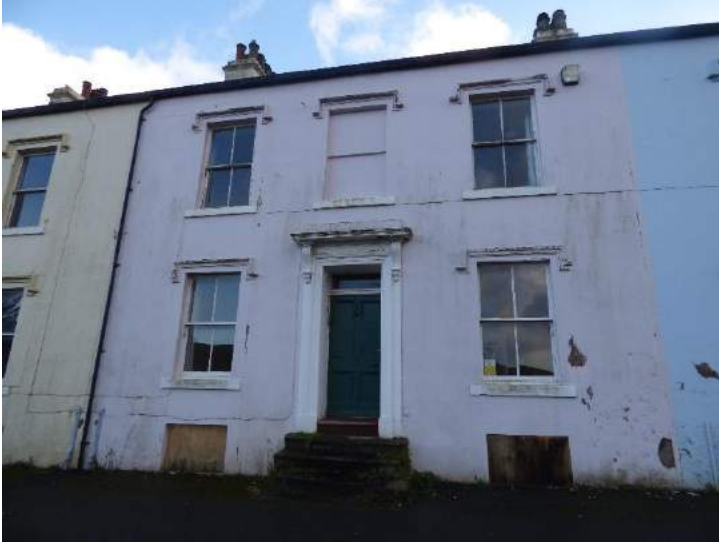
Left: The main entrance is mentioned in the listing text and is to be entirely retained.

Both front and rear elevations are currently rendered, with colour to the front and side and natural to the rear. All elevations require to be prepared for render repairs and redecoration by specialist using lime render and stucco (Parax LTD) to be applied by specialist.

The stucco features above the windows and door on the front elevation will be carefully restored by a specialist. Colour of all render and stucco to match existing.

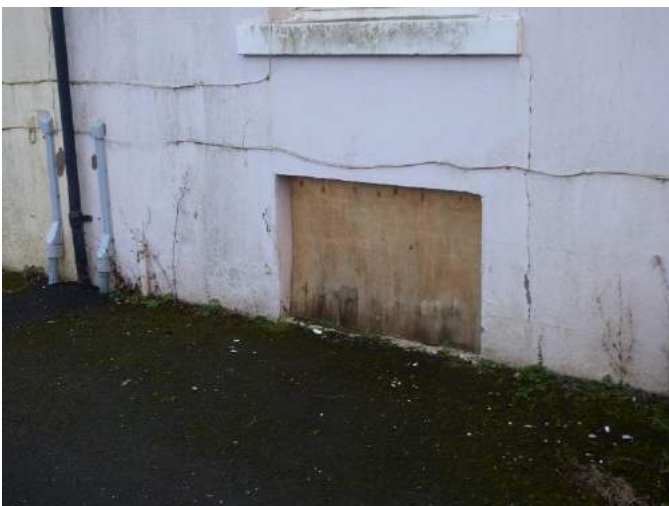
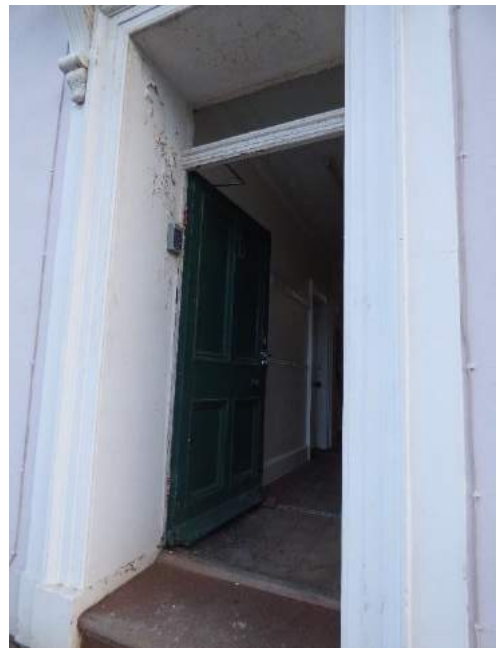
Localised lead repair work repair required to chimneys, to prevent leaking.

Existing cills to be repaired and decorated.

Existing Velux windows to be replaced with Velux conservation rooflights (or Rooflight company, heritage rooflights) (size to match existing) and new flashings to suit.

Rear of property – render to be repaired by specialist and decorated with off white render.

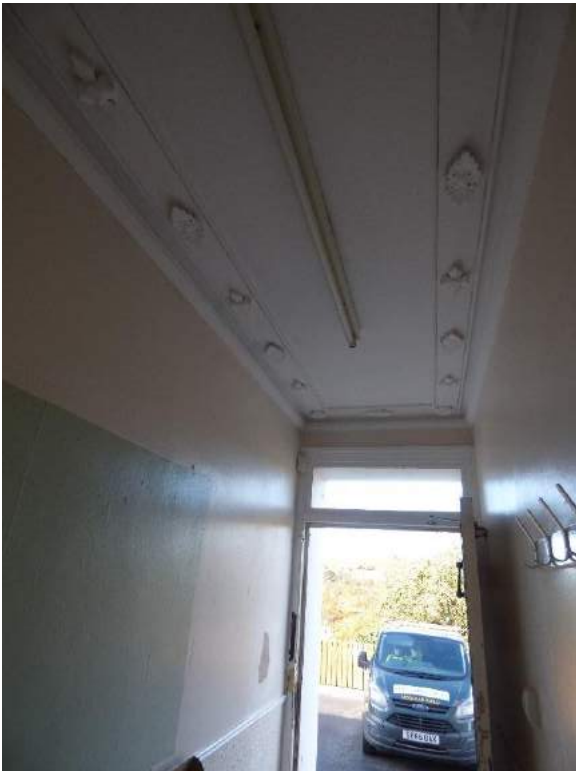
Left and below: The existing walls and floor are generally in good condition.

Redundant M&E to be removed and wall/ceiling finishes made good, and primed, prepared and fully decorated.

Flush panel doors to be replaced with heritage style panel painted timber fire doors to enhance the heritage asset.

Where possible it is proposed to refurbish any original doors with door closers and intumescent paint subject to building control approval.

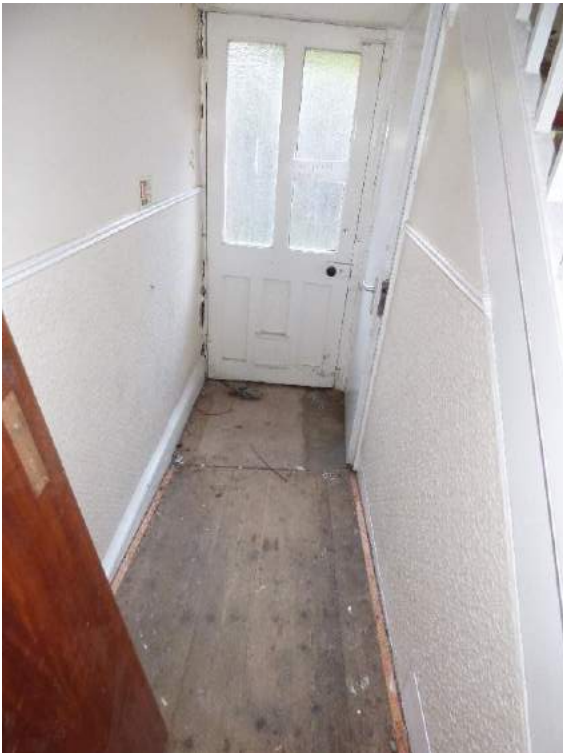
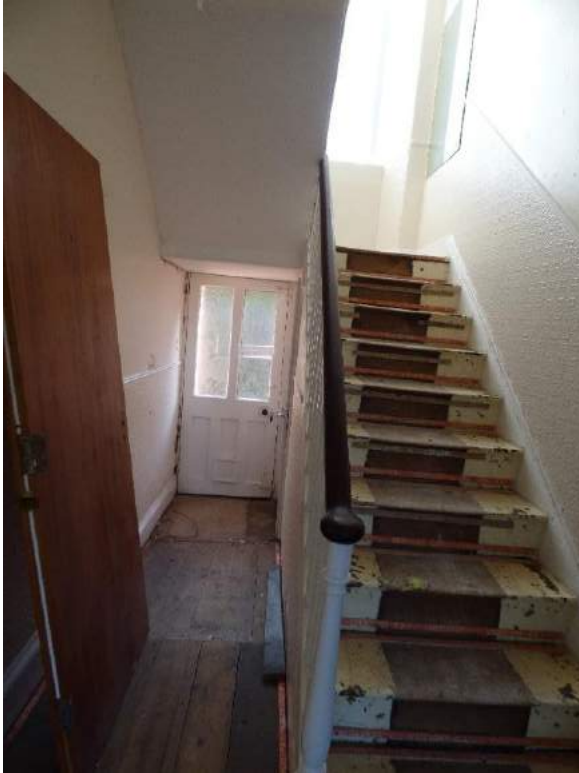
Retain original staircase, which is in good condition.

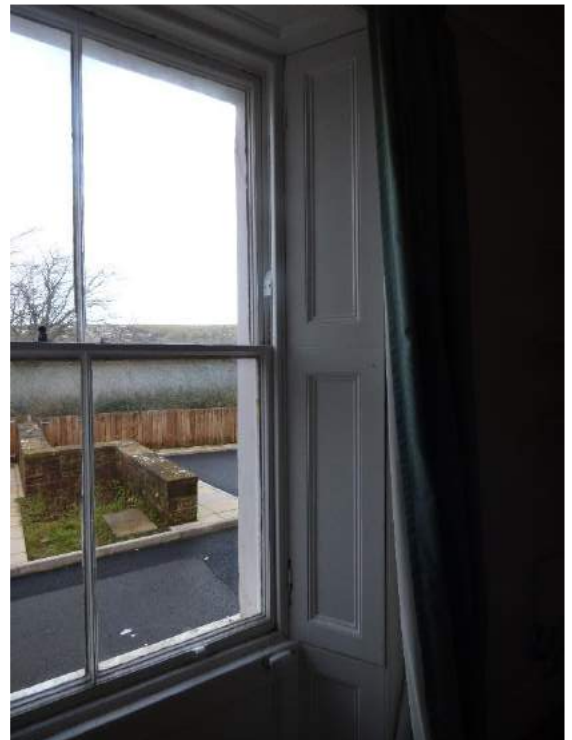
Below: Existing cornice to be made good in locations where redundant services are to be removed and where hairline cracks have appeared.

Existing architraves, and skirtings to be retained and made good.

Flush panel doors to be replaced with heritage style four panel painted timber fire doors to enhance the heritage asset.

Where possible it is proposed to refurbish any original doors with door closers and intumescent paint subject to building control approval.

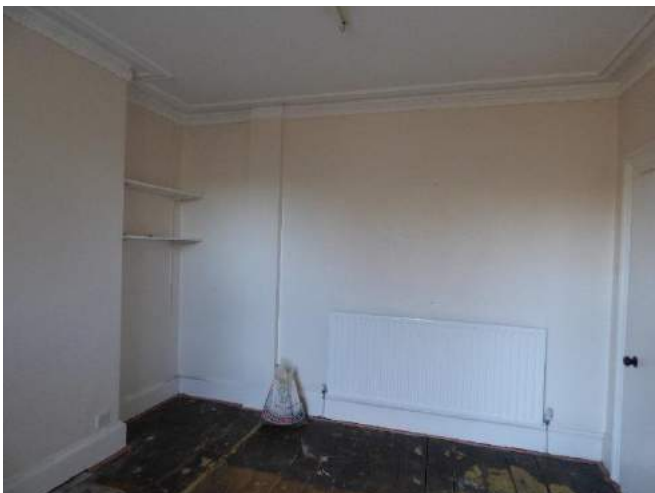
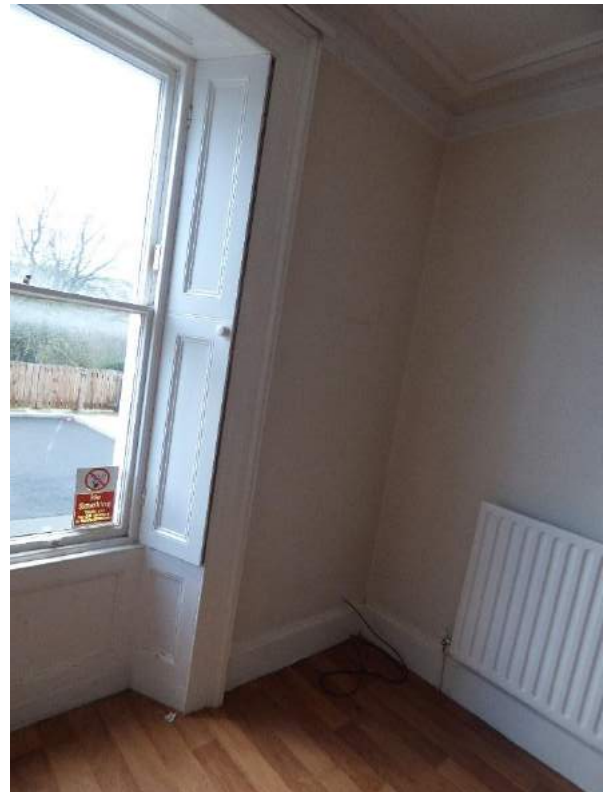
Above, right, and below: In the existing lounge at the front of the property and the existing dining area to the rear of the property, the period features below and to the sides of the existing window are in good condition, it is proposed to carefully refurbish the exiting timber shutters.

Below: Existing cornice to be made good in locations and where hairline cracks have appeared.

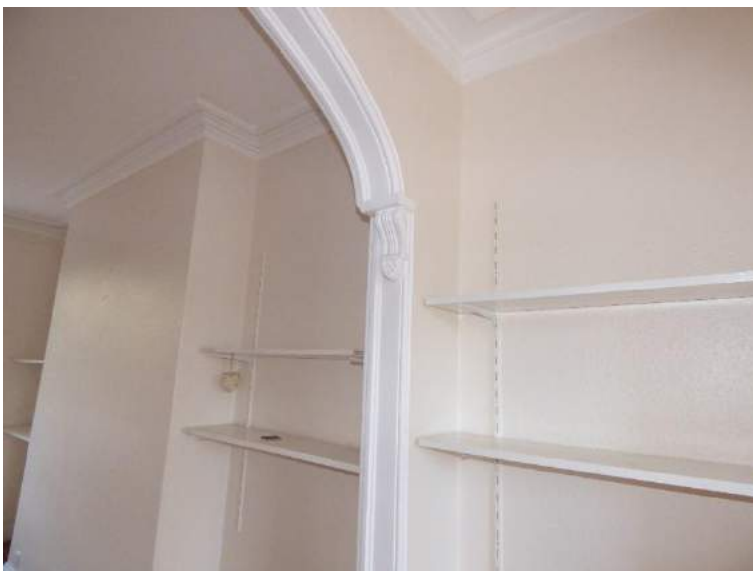
Below: In the existing lounge, the period features below and to the sides of the existing windows both front and back are in good condition, it is proposed to carefully refurbish the existing timber shutters

Existing cornice to be made good in locations where redundant services are to be removed and where hairline cracks have appeared.

Existing architraves and skirtings to be retained and repaired where necessary.

Flush panel doors to be replaced with heritage style for panel painted timber fire doors to enhance the heritage asset.

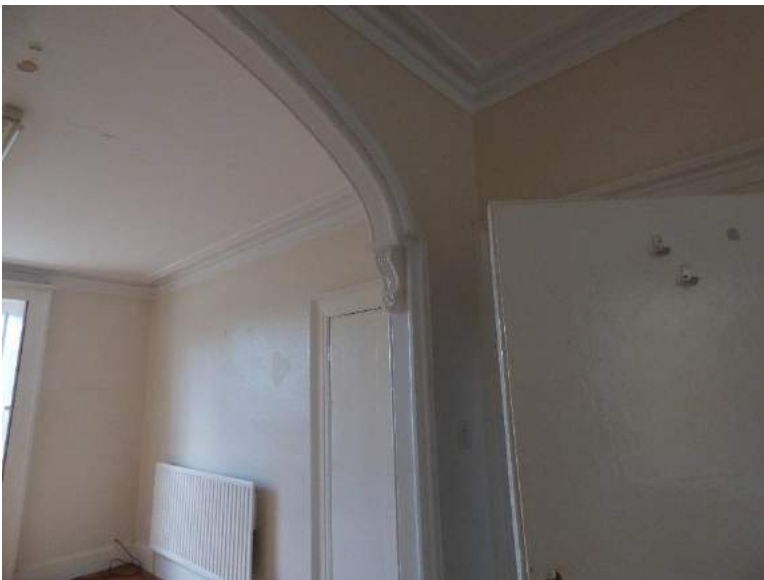
Left and below: In the existing lounge, the period features below and to the sides of the existing windows both front and back are in good condition, it is proposed to carefully refurbish the existing timber shutters.

Existing cornice to be made good in locations where redundant services are to be removed and where hairline cracks have appeared.

Existing architraves and skirtings to be retained and made good.

Flush panel doors to be replaced with heritage style four panel painted timber fire doors to enhance the heritage asset.

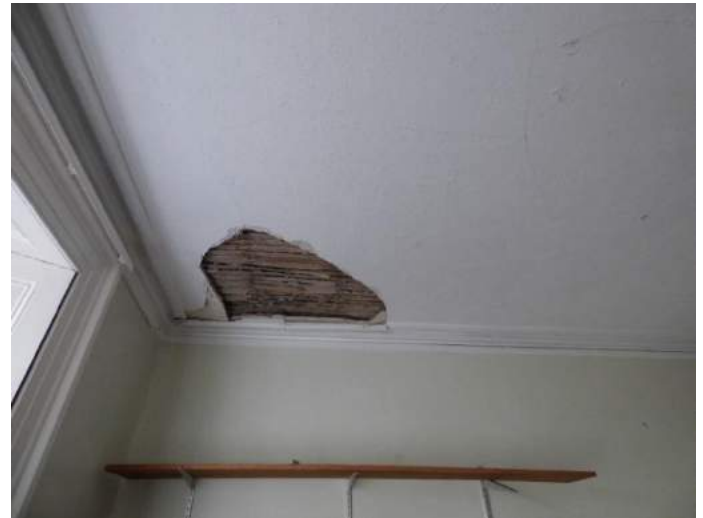
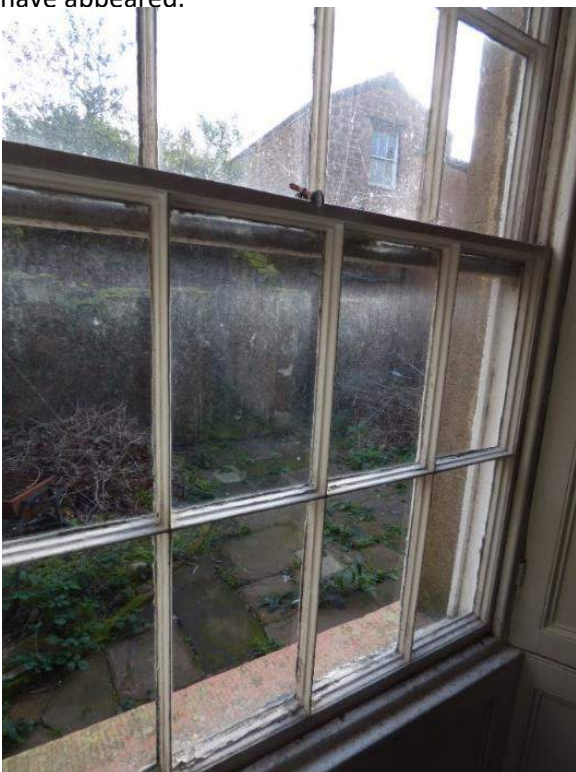
Left and below: The period features below and to the sides of the existing window are in good conditions, it is proposed to carefully refurbish the existing timber shutters.

Existing cornice to be made good in locations where redundant services are to be removed and where hairline cracks have appeared.

Existing architraves and skirtings with heritage style four panel painted timber fire doors.

Left and below: Ceiling to be repaired to original lath and plaster ceiling by specialist using lime plaster.

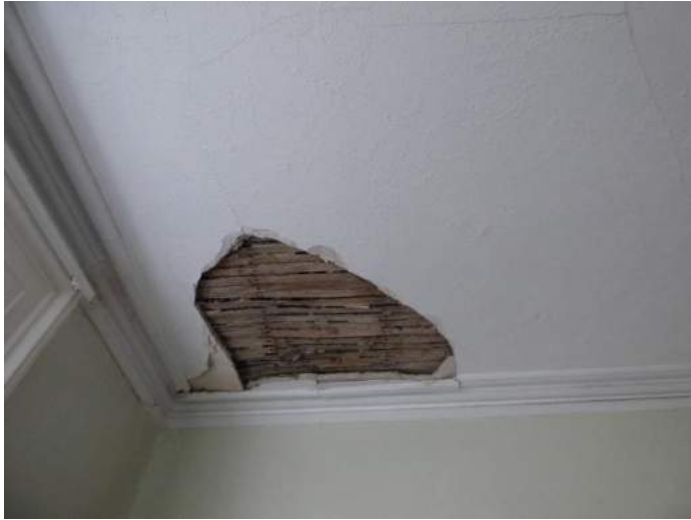
Left and below: The period features below and to the sides of the existing window are in good conditions, it is proposed to carefully refurbish the existing timber shutters.

Existing cornice to be made good in locations where redundant services are to be removed and where hairline cracks have appeared.

Existing architraves and skirtings with heritage style four panel painted timber fire doors.

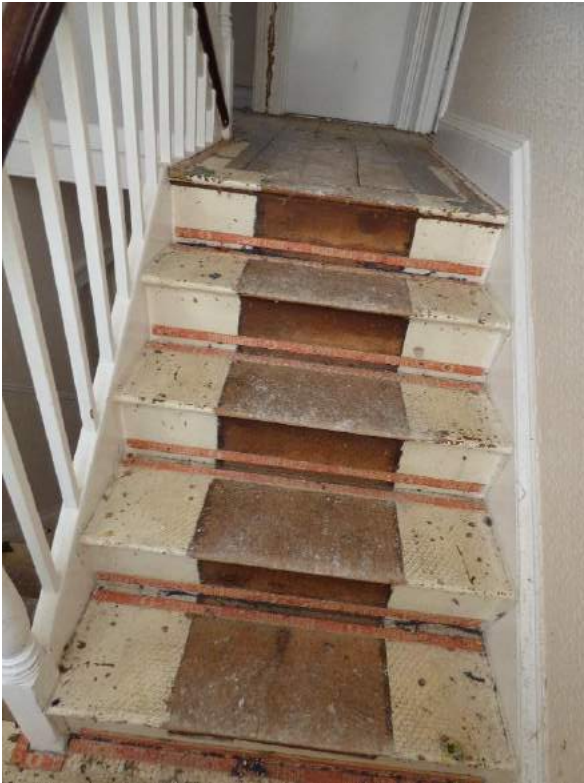
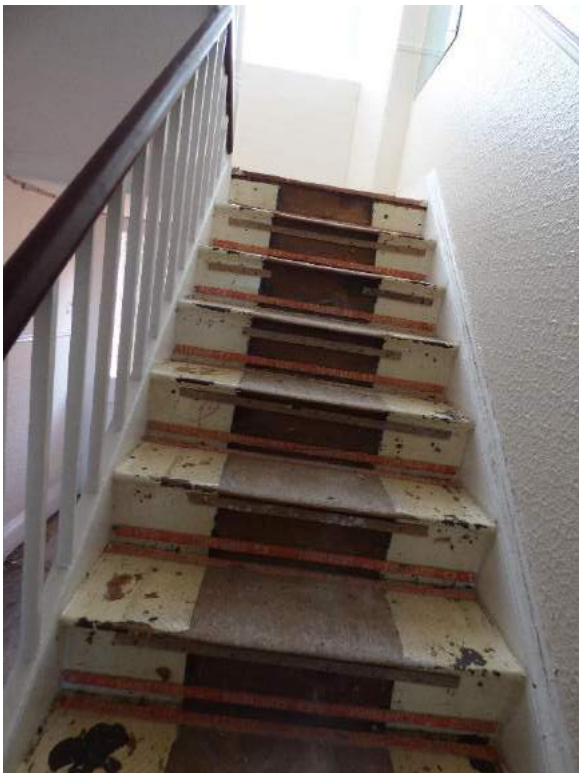
Retain original staircase, which is in good condition.

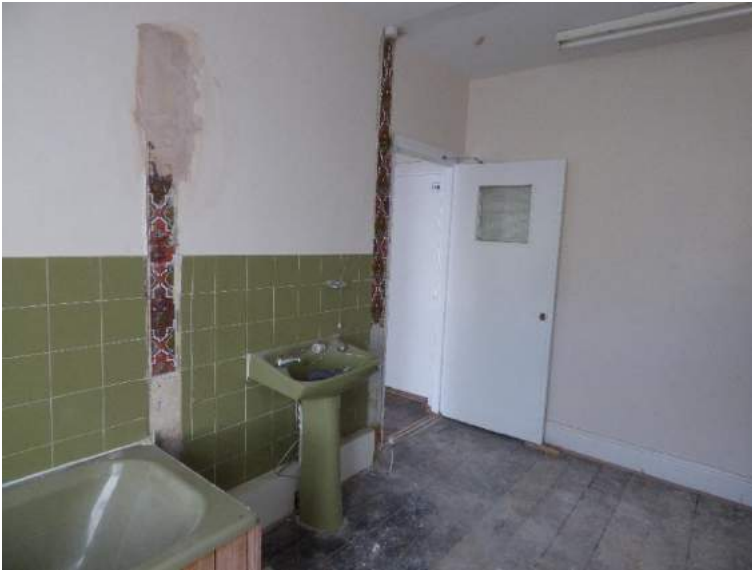
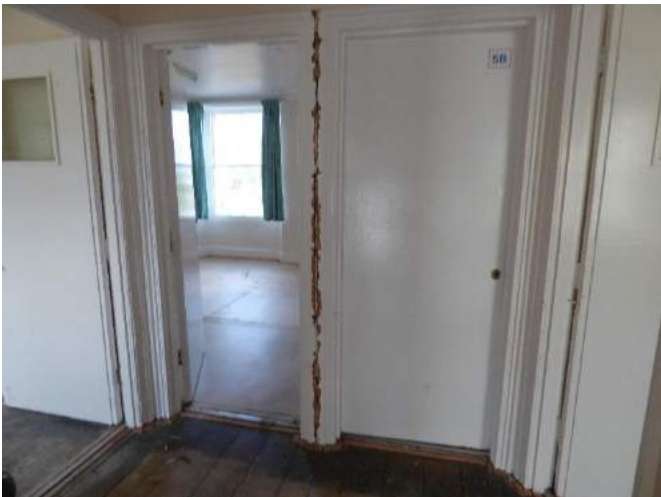
Left:

Bathroom at first floor:

Existing tiles, fixtures and fittings are currently being completely removed.

The existing ceiling will be made good with the installation of a new extract fan linked back to light switch

Bathroom door does not need to be a fire rated door but will be replaced with new four panel Georgian style door, to match all the doors throughout.

It is proposed to reduce the size of the family bathroom to provide an en-suite to the master bedroom and provide a more usable family bathroom.

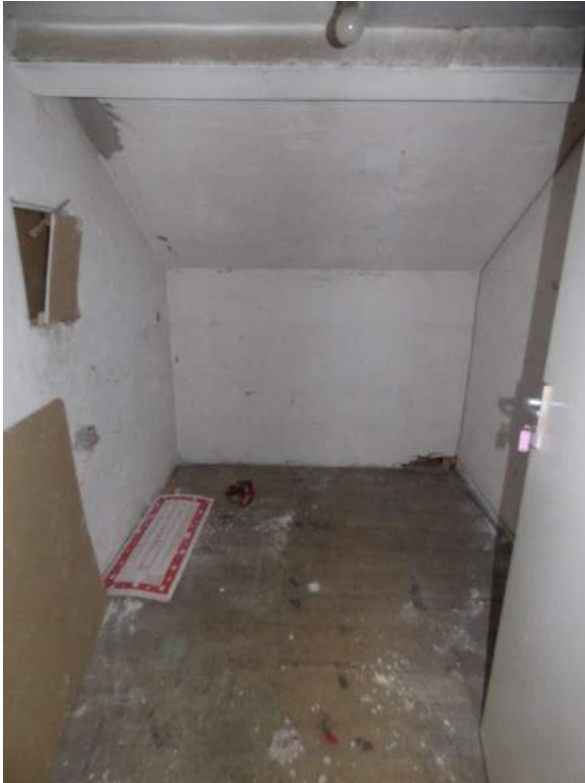
Left: Existing attic store is proposed to be converted into a bathroom to be shared by the attic bedrooms by increasing the size of room to each side to allow for the new bathroom.

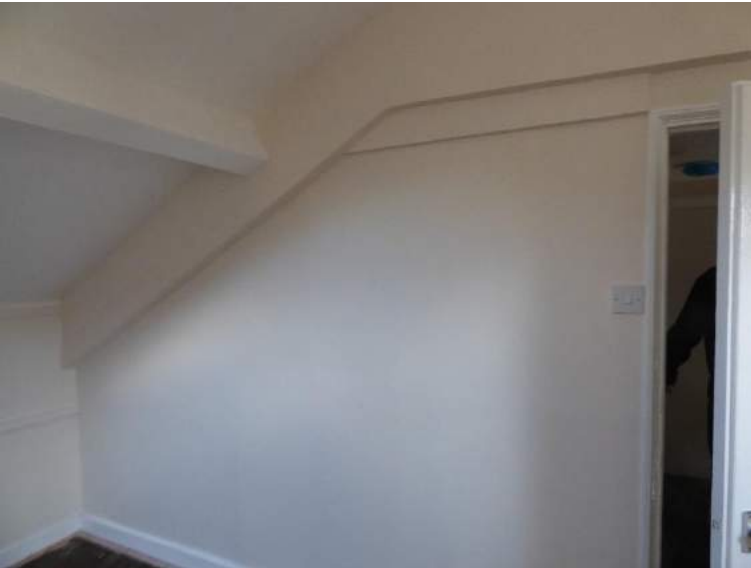
Left and below: Attic bedroom.

In the bedroom, remove all damp and damaged/blown plasterwork and repair with lime plaster and skim and decorate throughout.

Apply an insulated plasterboard 62mm thick to underside of ceiling tape and skim and undertake full decoration. New rooflight to be installed.

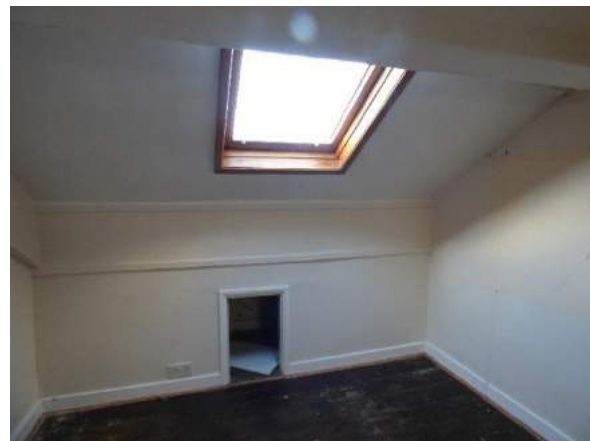
Floorboards are in good condition (but may require minor repairs)

Provide and install new heritage rooflight window to replace the existing modern rooflights.

Existing flush panel doors are to be removed and replaced with new heritage style 4 panel doors.

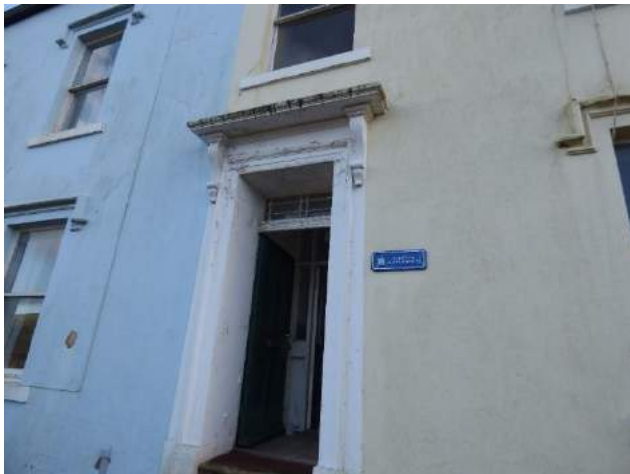
The blue plaque by the door states that this property was for the Lonsdale house Mistress. It is not proposed to retain this as it is a modern sign, and it is proposed to revert the property back to its historic purpose.

All existing single glazed windows to either be repaired / replaced subject to planning condition.

The existing stone steps to be cleaned up, and new painted metal handrails provided, that would have originally been installed.

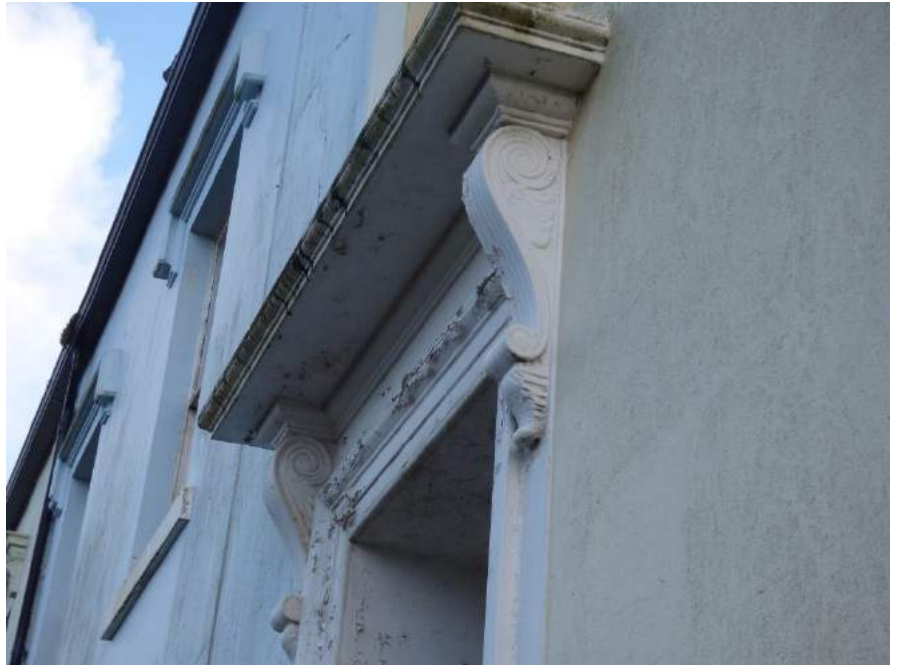
Left: View of rear of property – render to be repaired by specialist and decorated with off white render.

Cills to be repaired, as necessary.

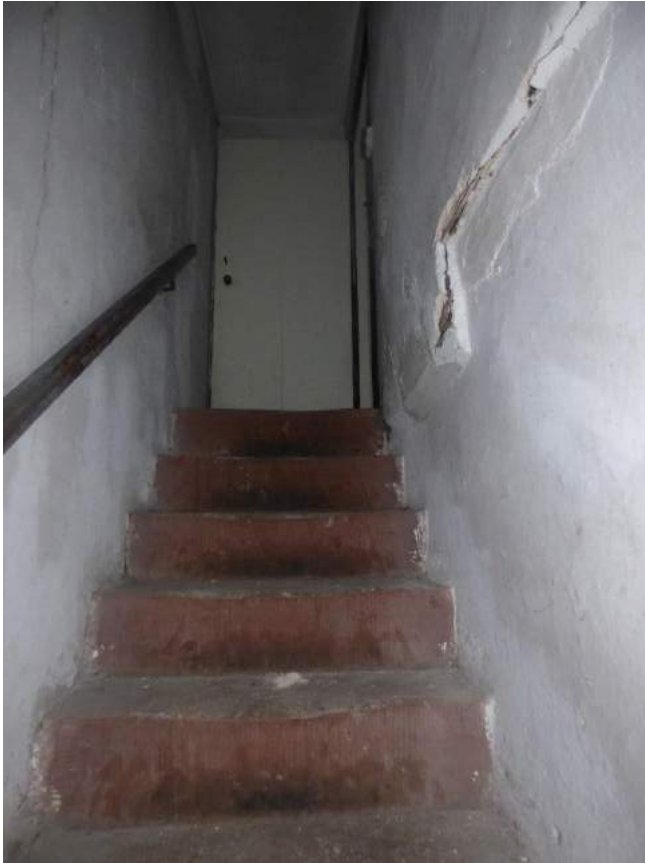
Left: The basement.

The existing walls and floor are generally in sound condition so would be suitable for the application of damp proof slurry system. All existing paint and surface finishes must be removed and made good including all snots removed, and damage to existing surfaces, prior to the installation of a Koster Polysil NB1.

The walls down to the basement also require full treatment.

In the basement all existing services are to be carefully stripped out and replaced with new compliant infrastructure.

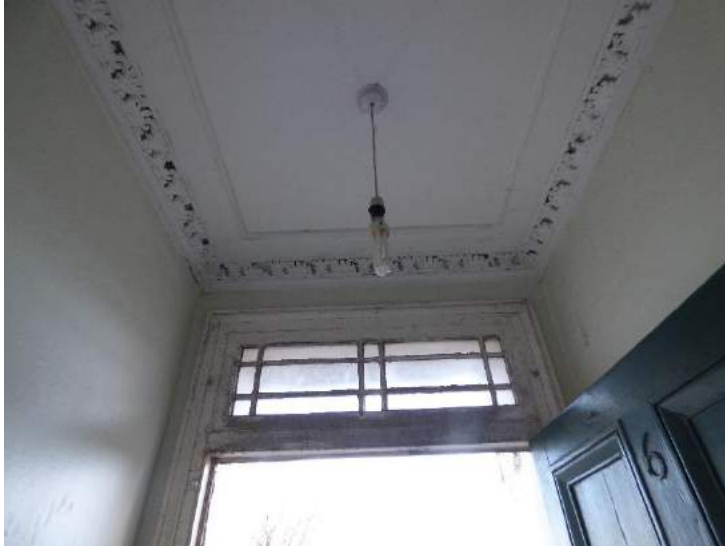
Left: Entrance, hall, and stairs.

The existing walls and floor are generally in good condition.

Redundant M&E to be removed and wall/ceiling finishes made good, and primed and fully decorated.

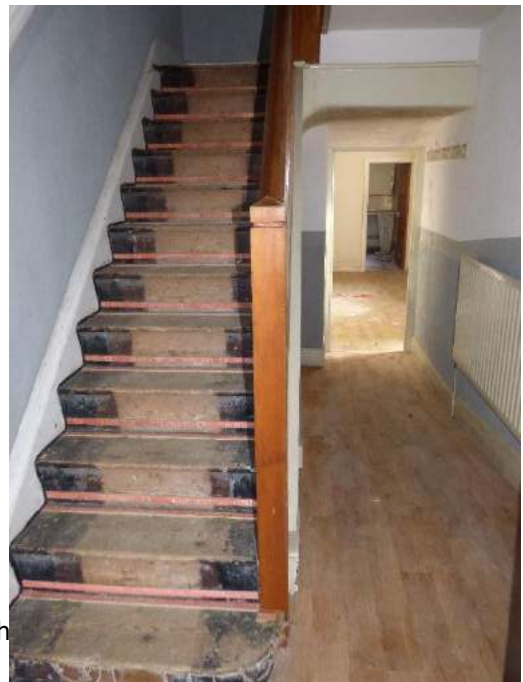
The handrails, balusters, and rails are not original; however, it is proposed to be retain them, and decorate so they are more in keeping with the historic context of

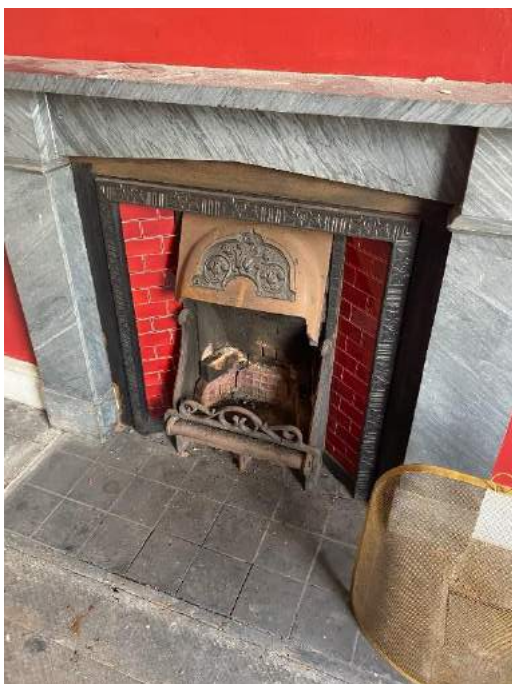
Left: The existing fireplace is to be retained, however it is proposed to replace the surround and tiles (which are not original), with a more in keeping traditional fire surround with traditional tiles that reflect the period of the property.
