# HERITAGE STATEMENT

## FULL RENOVATION OF EXISTING No 11 TERRACE HOUSES

St Bees, 1-11 Lonsdale Terrace, Parish Council, Cumbria

M.A.C Architects, Project Number: 2019:303

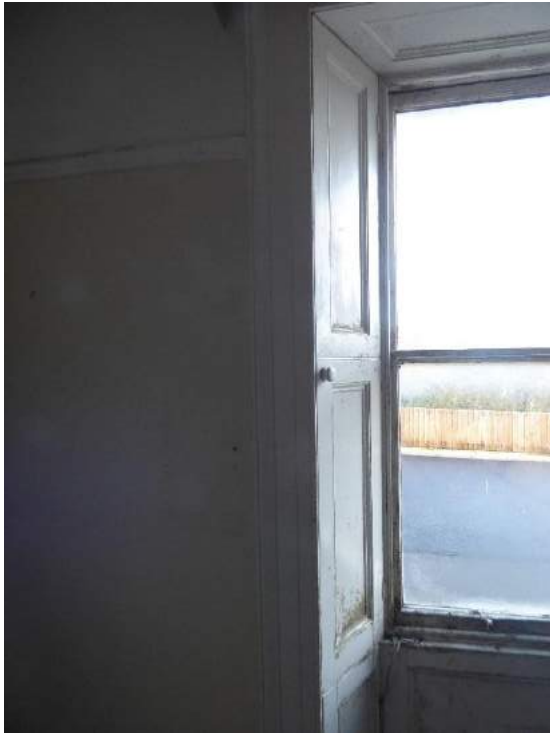
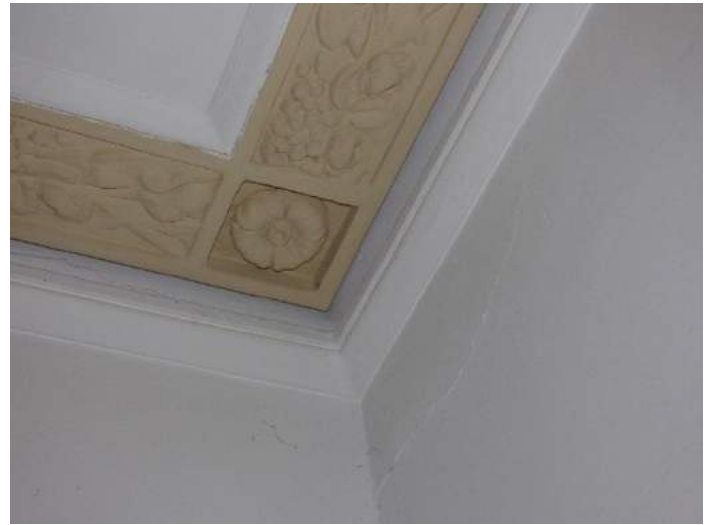
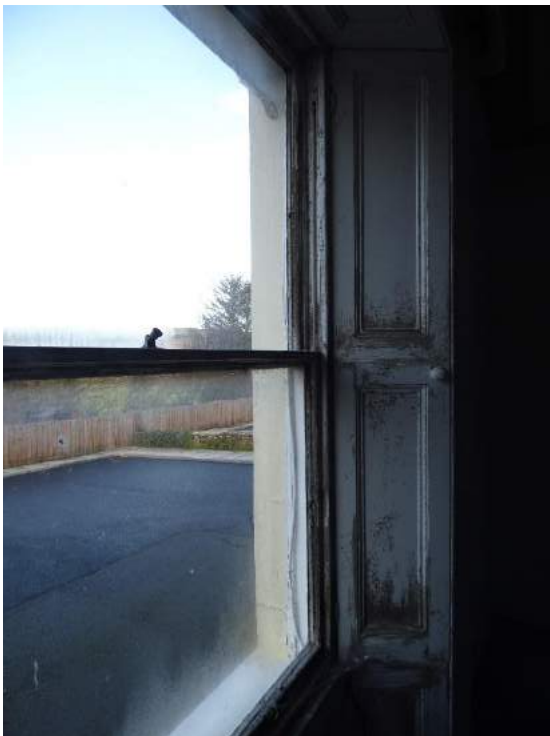
In the existing lounge, the period features below and to the sides of the existing windows both front and back are in good condition, it is proposed to carefully refurbish the existing timber shutters.

Existing cornice to be made good in locations where redundant services are to be removed and where hairline cracks have appeared.

Existing architraves and skirtings to be retained and made good.

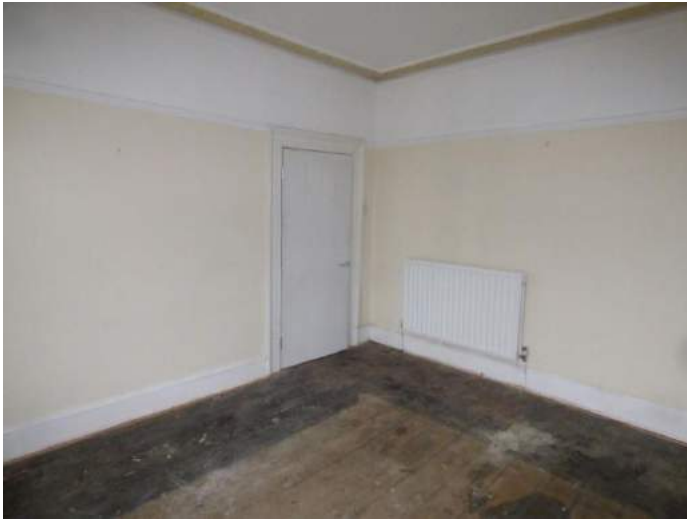
Flush panel doors to be replaced with heritage style four panel painted timber fire doors by Batty joinery Ltd or like enhance the heritage asset.

The existing four panel door present is proposed to be utilised for the new en-suite being installed on the first floor.

Where possible it is proposed to refurbish any original doors with door closers and intumescent paint subject to building control approval.

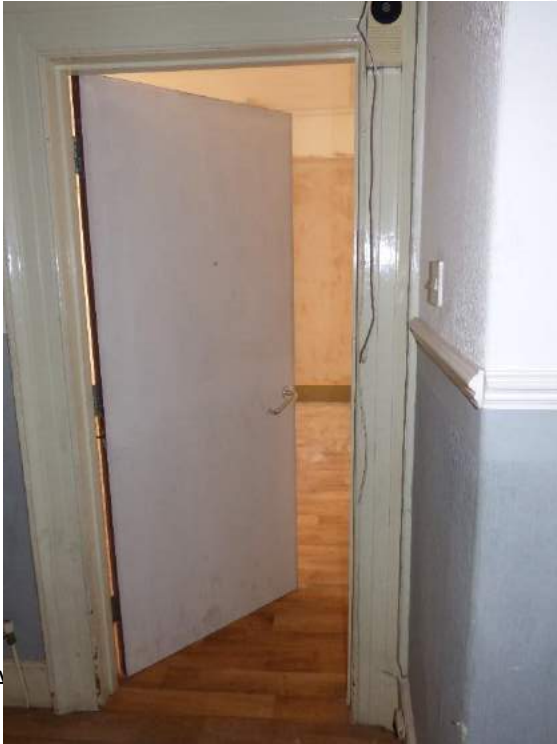
Flush panel doors to be replaced with heritage style four panel painted timber fire doors to enhance heritage asset. Where possible it is proposed to refurbish any original doors with door closers and intumescent paint subject to building control approval.

The dining room requires repairs to the ceiling and walls affected by damp ingress.

Blown plaster will be removed and replaced with lime plaster.

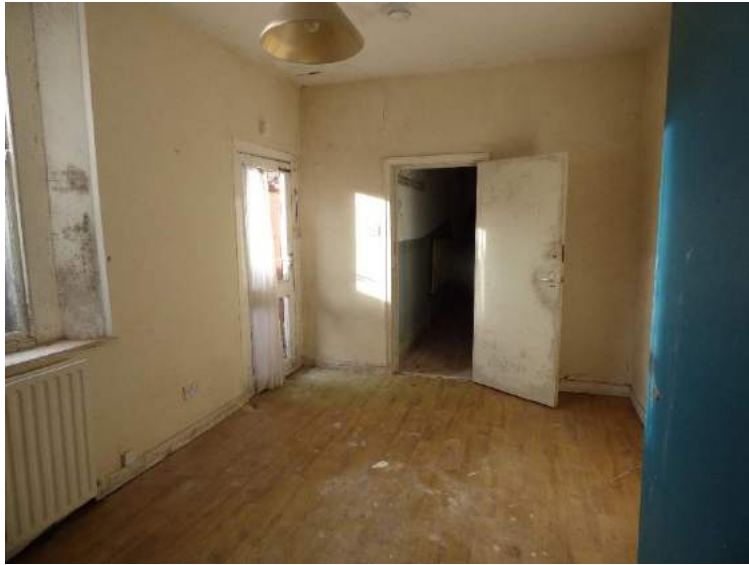
Left and below: Flush panel doors to be replaced with heritage style four panel painted timber fire doors to enhance heritage asset.

Where possible it is proposed to refurbish any original doors with door closers and intumescent paint subject to building control approval.

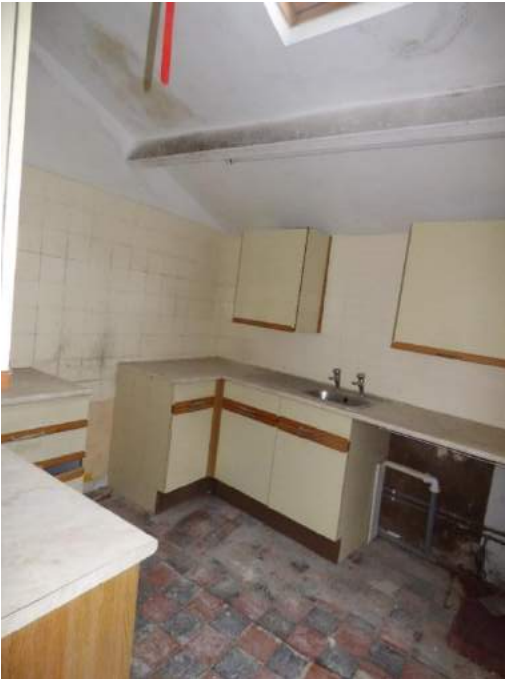
Left: Existing utility spaces to be fully renovated.

All damp and damaged/blown plasterwork and repair with lime plaster (Solo lime plaster from Lime Centre).and skim and decorate throughout.

Apply an insulated plasterboard 62mm thick to underside of ceiling. The Laminated plasterboard and PIR has a vapour barrier incorporated so interstitial moisture would be prevented. New heritage style rooflights to replace existing modern style rooflights and to be installed with flashing kit that mounts unit

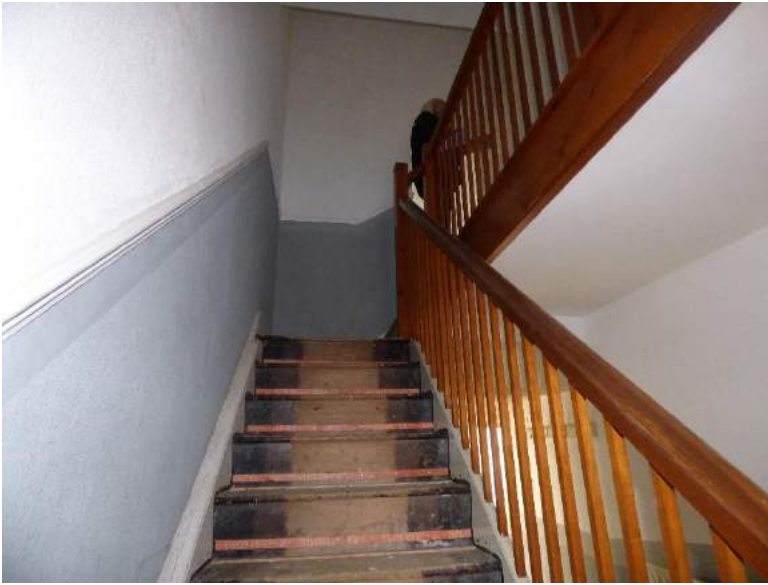
Left Retain staircase, which although not original is in good condition. Its is proposed to redecorate.

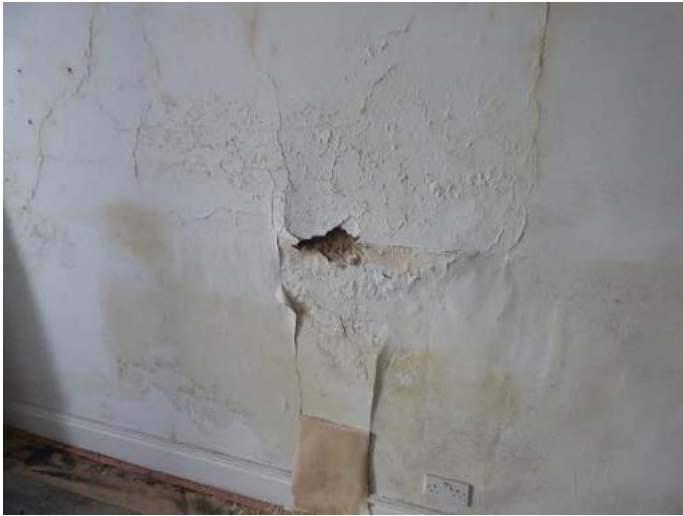
Existing rear bedroom requires considerable plaster repair work, due to damp ingress. Remove all damp and damaged / blown plasterwork and repair with lime plaster (Solo lime plaster from Lime Centre).

Lath and plaster generally requires repair and damaged plasterwork will require specialist reinstatement.

Existing flush panel door to be replaced with new Georgian heritage style 4 panel door to be provided and installed by specialist Joinery Company such as Batty Joinery Ltd. Where possible it is proposed to refurbish any original doors with door closers and intumescent paint subject to building control approval.

Skirtings to be repaired / replaced to match existing as required.

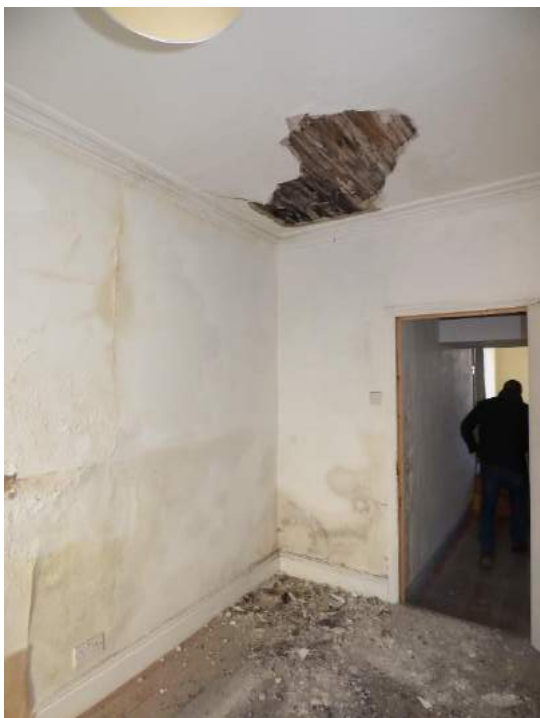
Left: Damp ingress to be resolved by repairs to external wall and render. Blown plaster to be removed and new plastering to be undertaken using lime plaster (Solo lime plaster from Lime Centre).

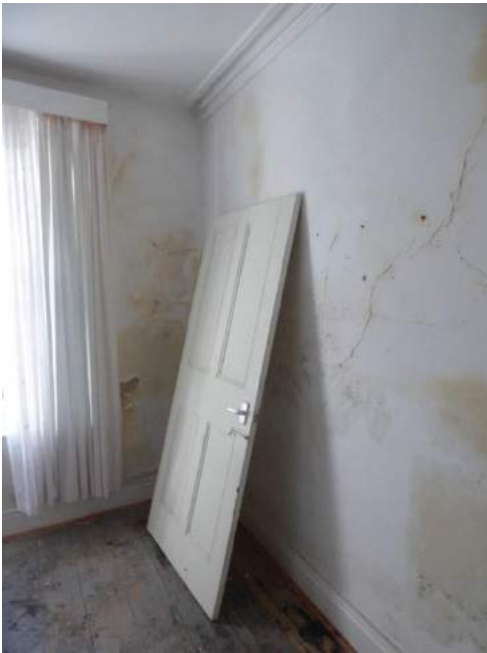
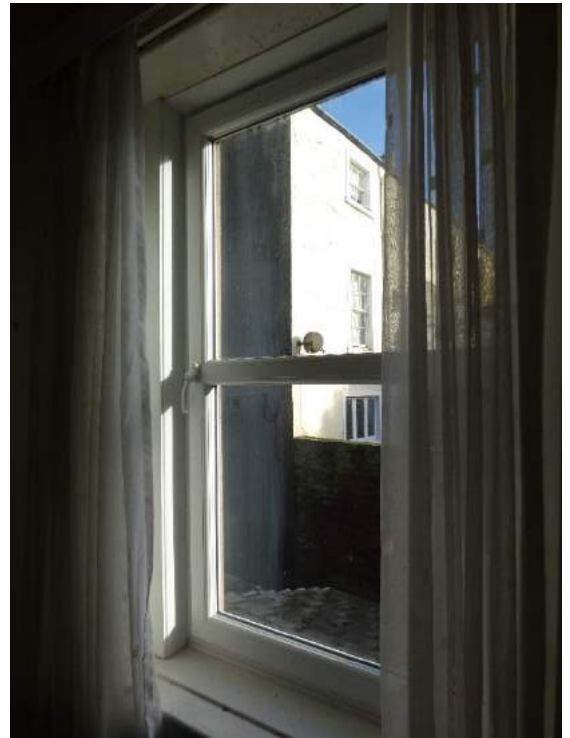
Above, right, and below: Rear bedroom skirtings, cornices and architraves to be retained. Flush panel door to be replaced with new Georgian heritage style 4 panel door to be provided and installed by specialist joinery company such as Batty joinery ltd.

Where possible it is proposed to refurbish any original doors with door closers and intumescent paint subject to building control approval.

Existing floorboards in generally good condition, with minor repairs being required. Damaged floorboards to be replaced with boards to match existing.

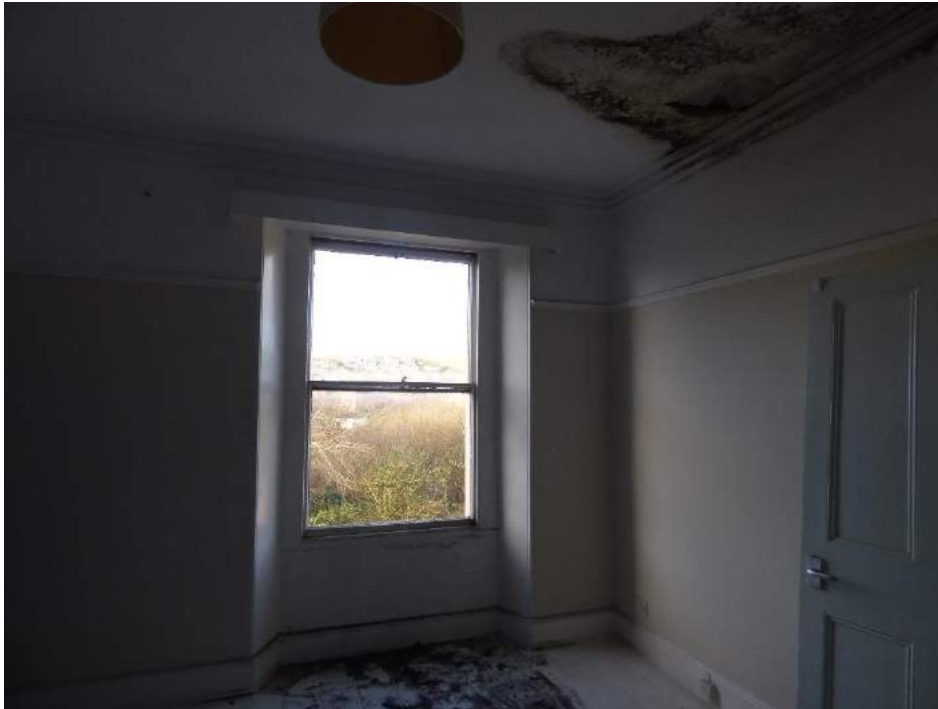
Front bedroom (First floor LHS) cornice, skirtings, and architraves to be retained. Existing flush panelled door to be replaced with new Georgian heritage style 4 panelled door to be provided and installed by specialist joinery company such as Batty Joinery Ltd.

Where possible it is proposed to refurbish any original doors with door closers and intumescent paint subject to building control approval.

Damaged lath and plaster ceilings to be repaired and restored.

Existing floorboards in good condition.

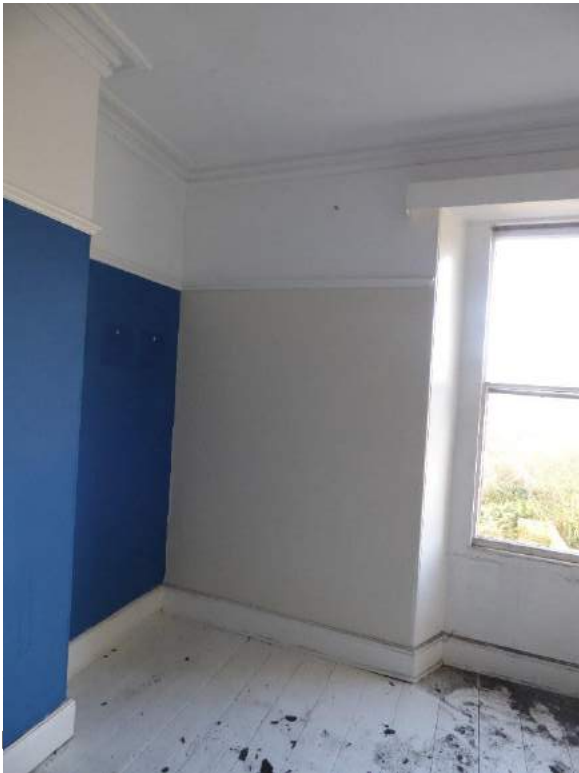
Front bedroom (First floor LHS) cornice, skirtings, and architraves to be retained. Existing flush panelled door to be replaced with new Georgian heritage style 4 panelled door to be provided and installed by specialist joinery company such as Batty Joinery Ltd.

Where possible it is proposed to refurbish any original doors with door closers and intumescent paint subject to building control approval.

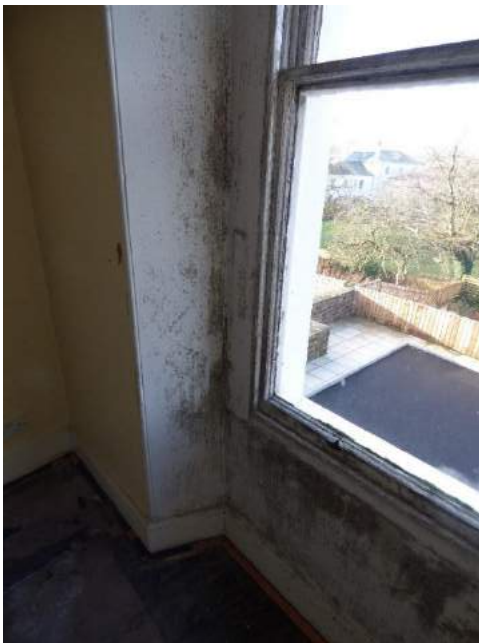
Front bedroom (First floor RHS), cornices, skirtings and architraves to be retained. Existing flush panelled door to be replaced with new Georgian heritage style 4 panelled fire door to be provided and installed by specialist joinery company such as Batty Joinery Ltd. Where possible it is proposed to refurbish any original doors with door closers and intumescent paint subject to building control approval.

Existing floorboards generally in good condition

Left: Damp ingress around windows has blown the existing plaster. It is proposed to replace damaged plaster with lime plaster.

Damp damage to plaster ceiling to be removed and reinstated. Any damage to lath and plaster to be repaired by specialist.

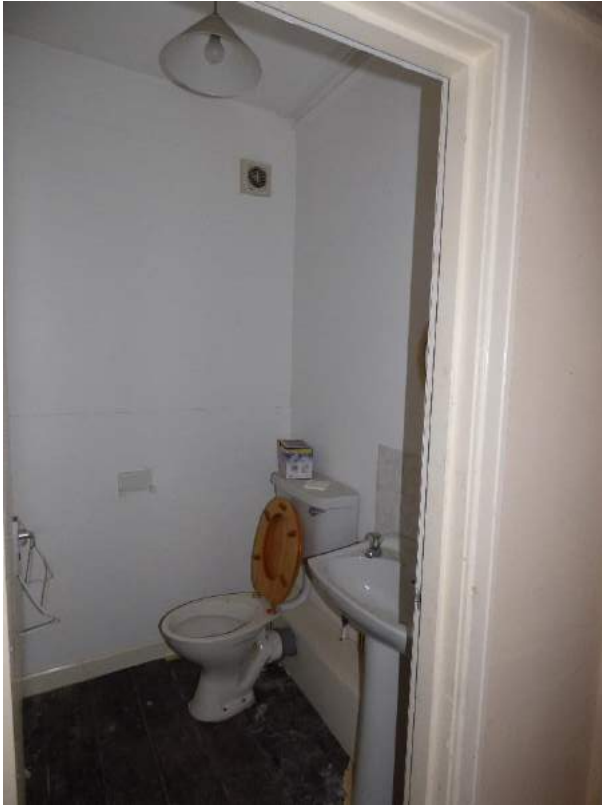
Existing w.c. to be removed and landing area to be reconfigured.

Partitions are not original.

Floors to be made good using timber floorboards to match existing.

All finishes to be made good, and skirtings to match the original to be installed.

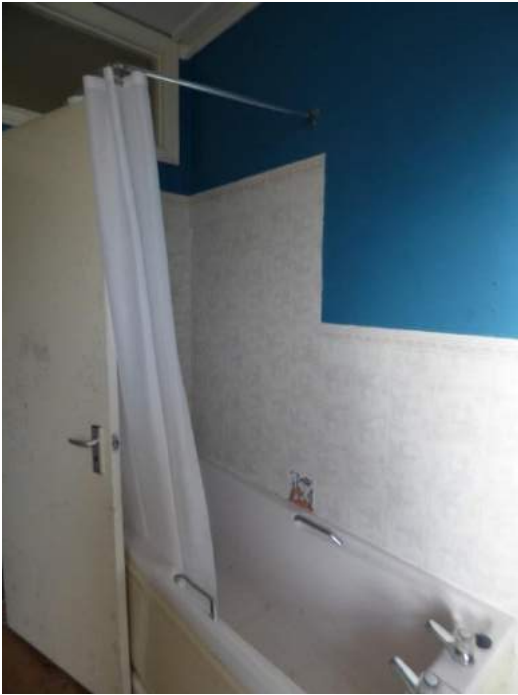
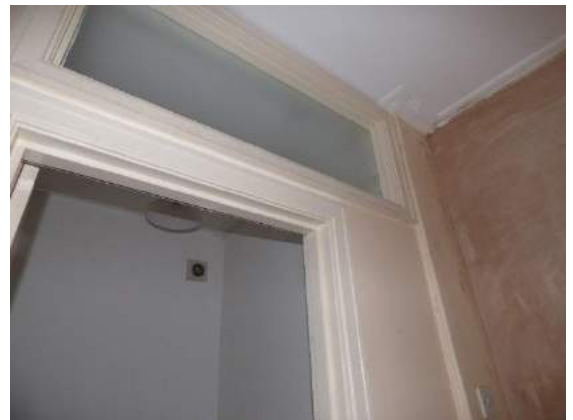
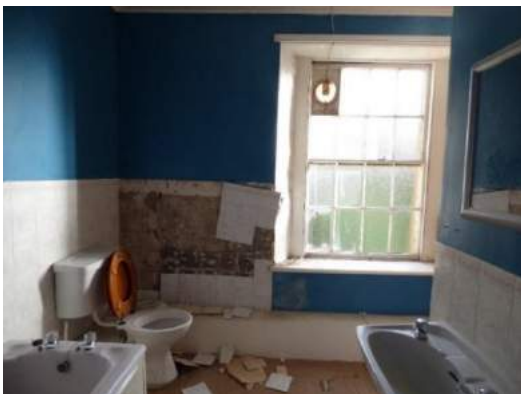
Left and below: Existing ceiling to be made good and provide and install new extract fan linked back to light switch.

New bathroom door to be 4 panelled heritage style door to replace exiting modern door – bathroom door does not need to be a fire rated door.

Blown plaster to be removed and new lime plaster repairs to be undertaken. Floor to be made good with floorboards to match the existing.

All finishes to be made good and skirtings to match the original to be installed.

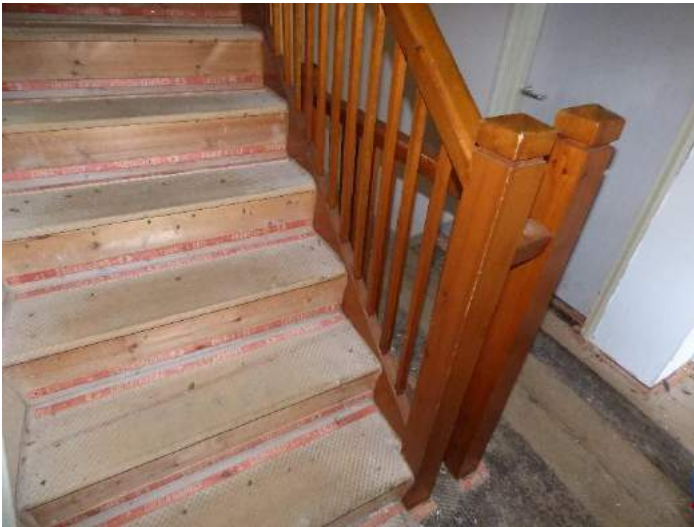
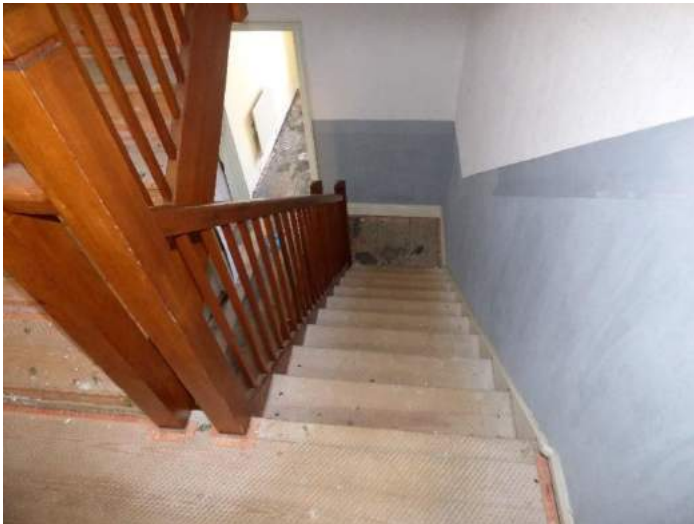
Balustrading is not original but will be retained and decorated to be in keeping with the property.

New handrail and balusters to be installed where railings have been installed (below), and half landing returned to former layout.

All finishes to be made good.

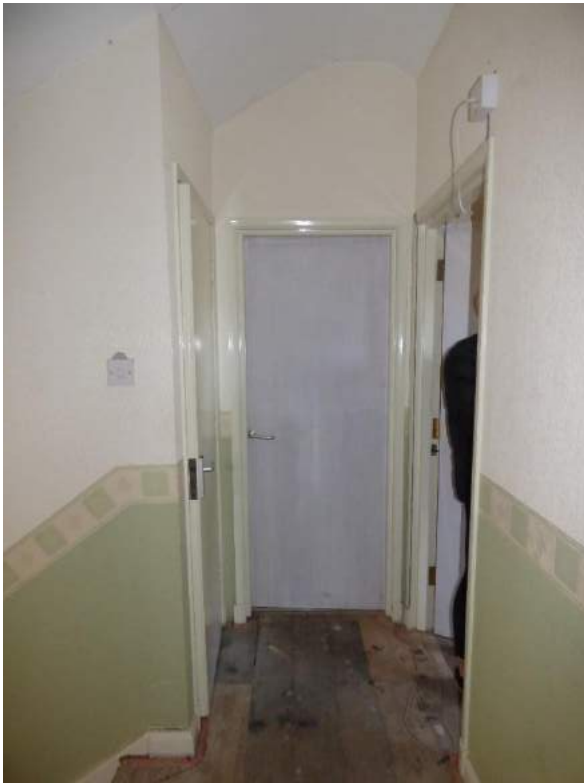
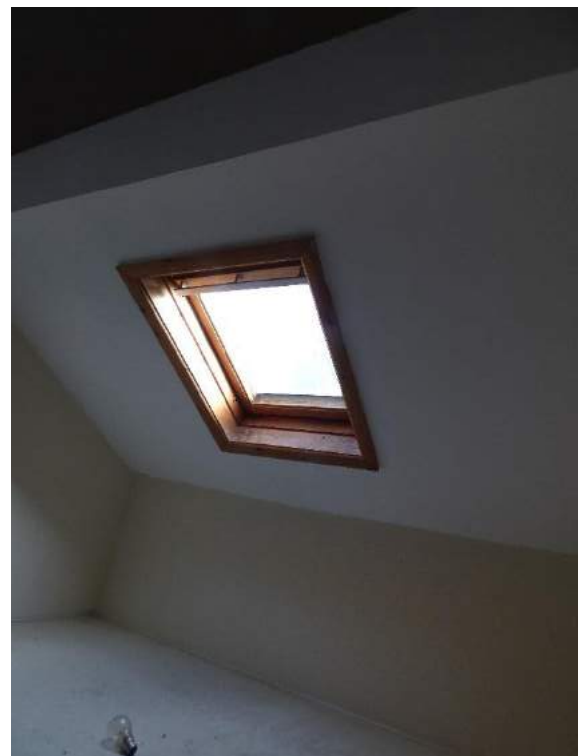
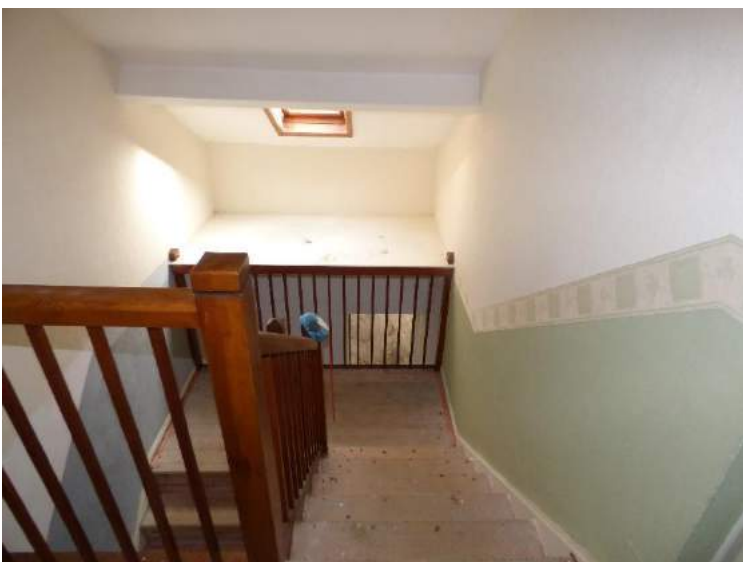
Second Floor Landing area to be reconfigured along with the layout of the second floor.

Existing rooflights to be replaced with new heritage style rooflights.

Apply an insulated plasterboard 62mm thick to underside of ceiling. The Laminated plasterboard and PIR has a vapour barrier incorporated so interstitial moisture would be prevented. New heritage style rooflights to be installed to replace existing modern style Velux rooflights with flashing kit that mounts unit flush with the roof surface.

Existing flush panel doors are to be removed and replaced with heritage style 4 panel fire doors by specialist joinery company such as Batty Joinery Ltd.

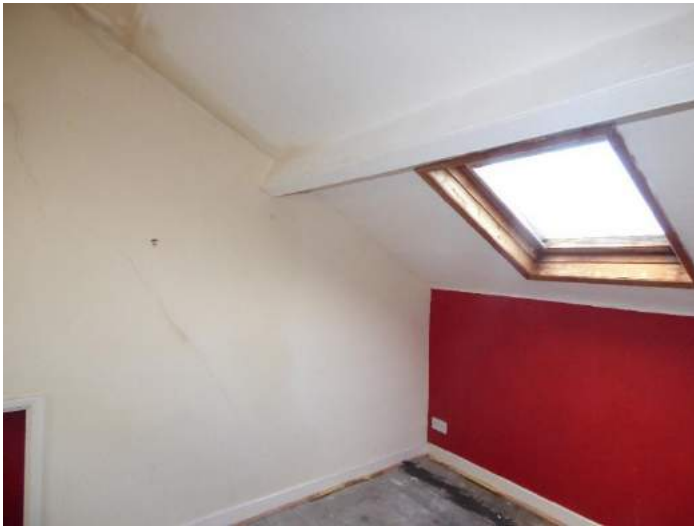
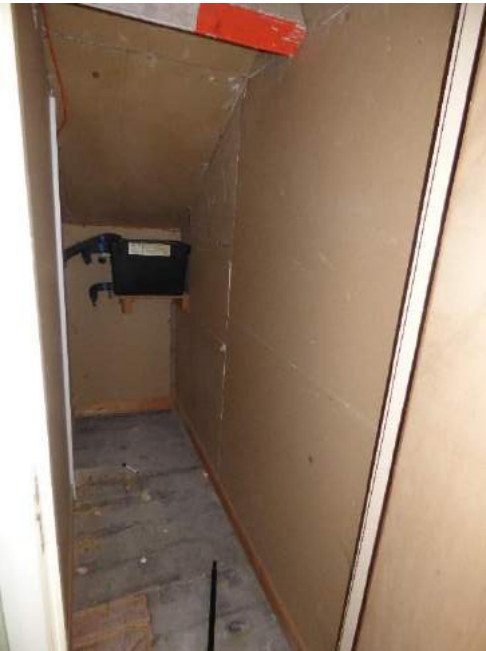
Left and below: Attic bedroom.

In the bedroom all damp and damaged/blown plasterwork will be repaired with lime plaster (Solo lime plaster from Lime Centre). and skim and decorate throughout.

Areas of water ingress to be investigated and roof repairs undertaken a necessary.

Floorboards are in good condition (but may require minor repairs, due to damp ingress).

Apply an insulated plasterboard 62mm thick to underside of ceiling. The Laminated plasterboard and PIR has a vapour barrier incorporated so interstitial moisture would be prevented tape and skim and undertake full decorations. New heritage style rooflights to be installed in lieu of the modern style Velux windows. New heritage rooflight windows (Velux or similar with flashing kit that mounts unit flush with the roof surface).

Existing flush panel doors are to be removed and replaced with new heritage style 4 panel fire doors.

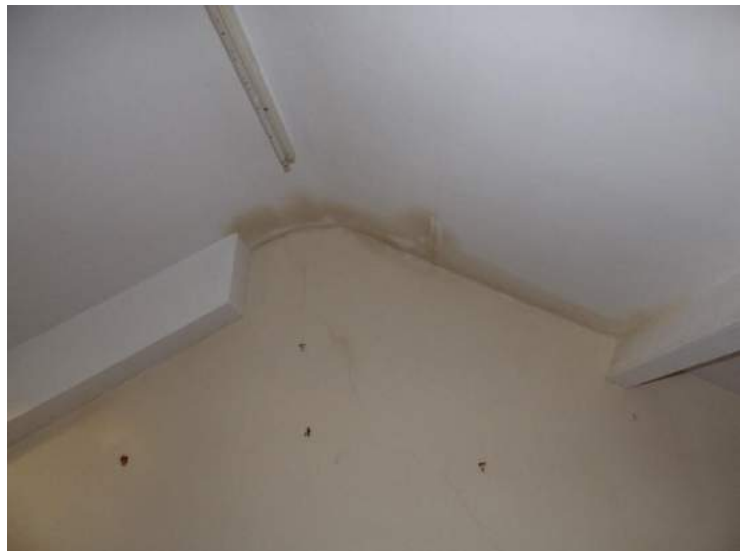
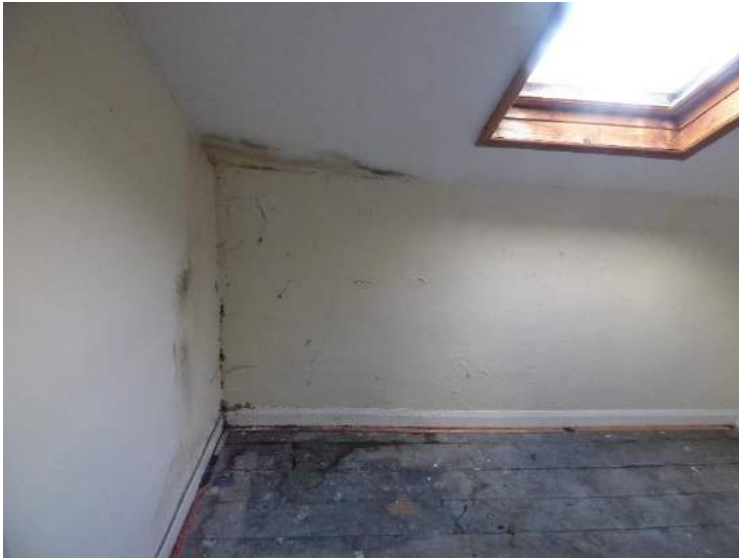
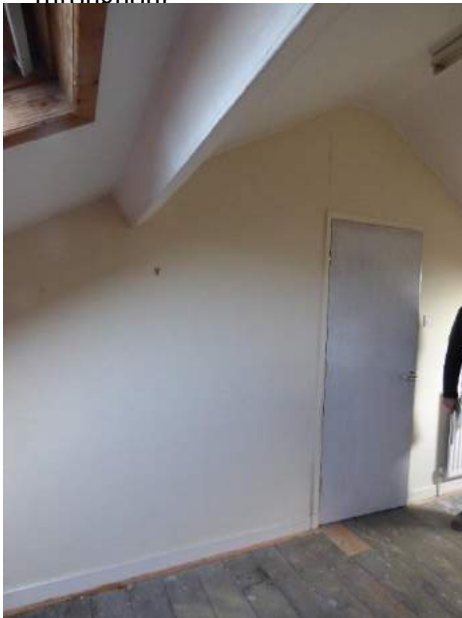
Left and below: Small attic bedroom.

In the bedroom all damp and damaged/blown plasterwork will be repaired with lime plaster (Solo lime plaster from Lime Centre) and skim and decorate

Areas of water ingress to be investigated and roof repairs undertaken a necessary.

Floorboards are in good condition (but may require minor repairs, due to damp ingress).

Apply an insulated plasterboard 62mm thick to underside of ceiling. The Laminated plasterboard and PIR has a vapour barrier incorporated so interstitial moisture would be prevented.

Existing flush panel doors are to be removed and replaced with new heritage style 4 panel fire doors.

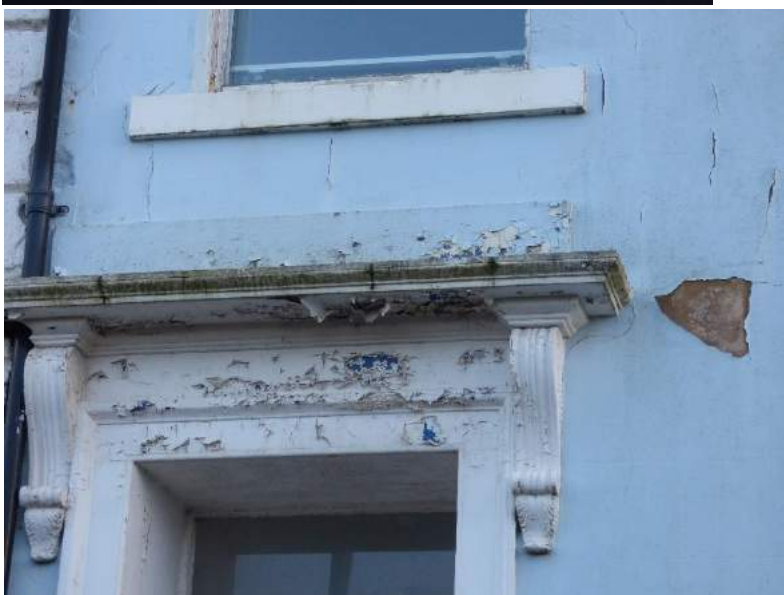
Both front and rear elevations are currently rendered, with colour to the front and side and natural to the rear. All elevations require to be prepared for render repairs and redecoration by specialist using lime render and stucco (Parax LTD) to be applied by specialist.

The stucco features above the windows and door on the front elevation will be carefully restored by a specialist. Colour of all render and stucco to match existing.

The existing door and frame are to be retained and made good with the provision of new ironmongery. Once repaired full decoration will be undertaken.

Existing gutters and downpipes to be retained, repaired where necessary and decorated. All existing single glazed windows to be repaired / replaced subject to planning condition.

The existing stone steps to be cleaned up, and existing painted metal handrails replaced with new (refer to detail in D&A statement) and decorated.

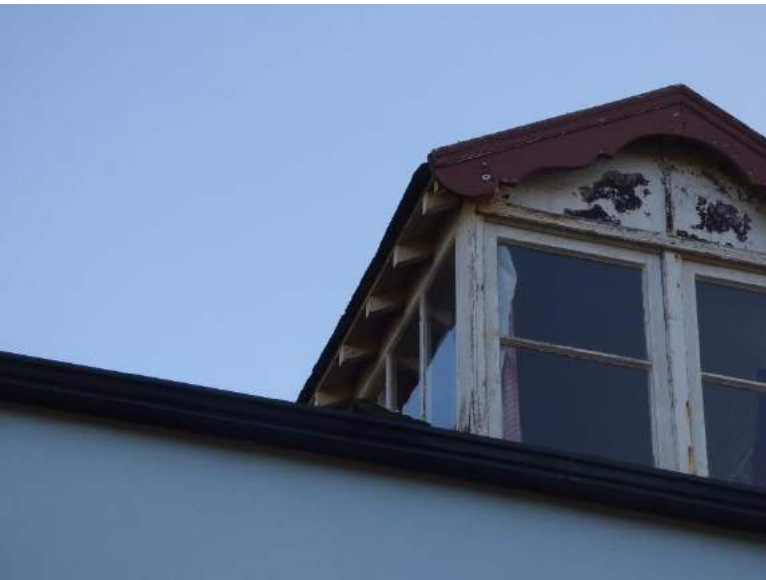
Existing dormer windows are in extremely poor condition. Considerable fabric damage internally has been the result of the extent of damage to these dormers. It is proposed to completely rebuild these in the same style as indicated on the proposed elevations with windows details of which are to be confirmed subject to planning condition.

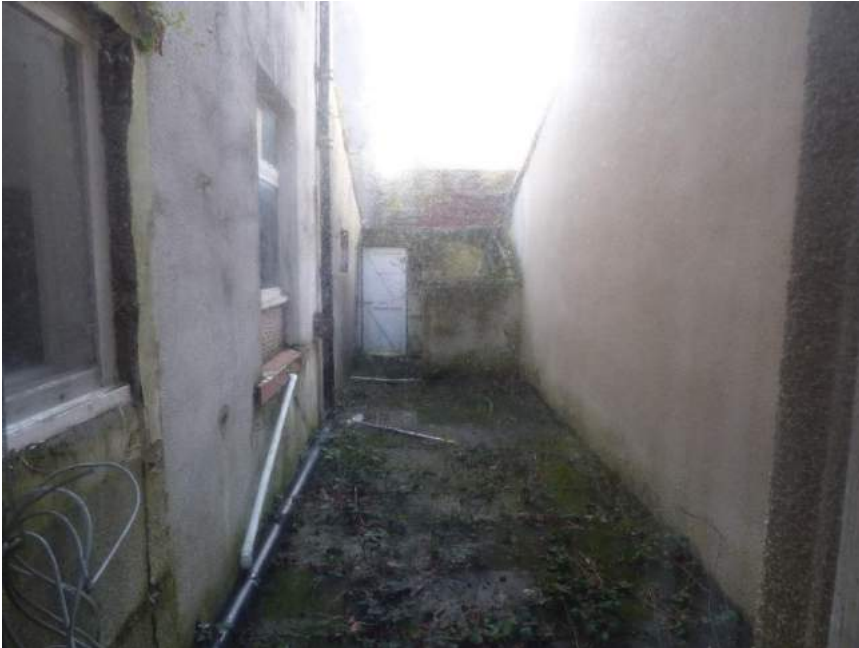
Modern timber / UPVC windows installed to the rear of the property, to be repaired / replaced subject to planning condition.

Existing external walls to be repaired with lime render and decorated off white, to create a more aesthetically pleasing rear courtyard area.

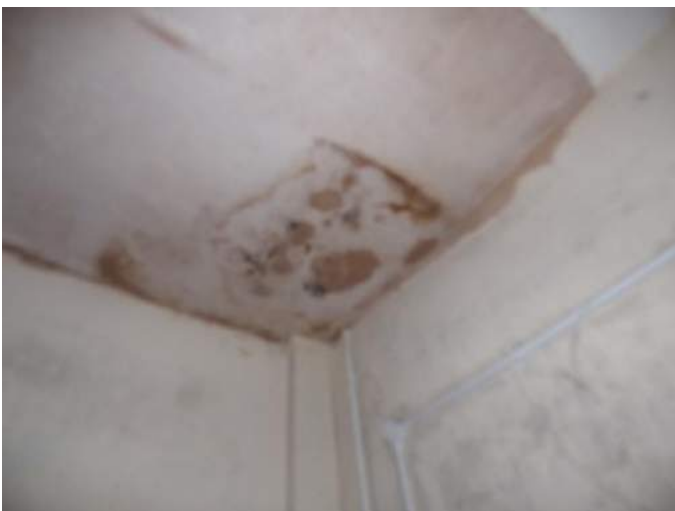
The walls down to the basement also require the full treatment.

In the basement all existing services are to be carefully stripped out and replaced with compliant infrastructure.

Existing window to basement to be replaced or repaired subject to planning condition, and reveals made good. New double glazed heritage timber painted windows.

All existing services to be carefully removed and new gas and electric services installed.

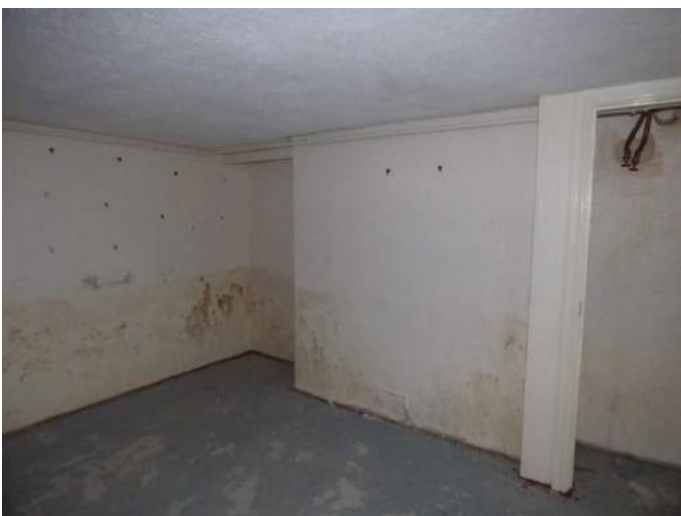
Views of basement to be renovated.

It is clear to identify where damp is penetrating the structure.

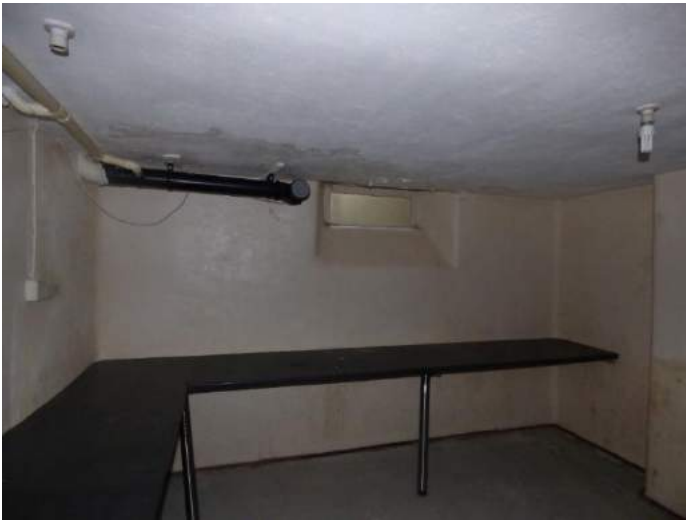
Views of basement to be renovated to create a dry area for basement storage.

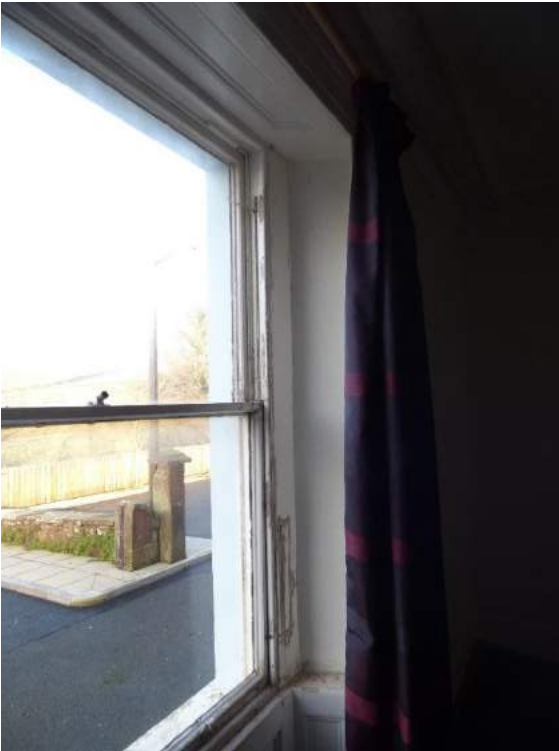
Left: In the existing lounge, the period features below and to the sides of the existing window are generally in good condition, it is proposed to carefully refurbish the existing timber shutters, which require careful minor repairs by a specialist.

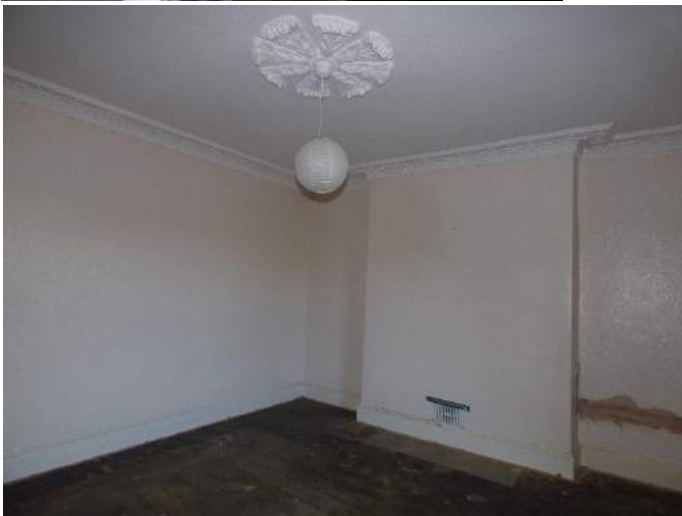
Left: Existing cornice to be made good in locations where redundant services are to be removed and where hairline cracks have appeared.

Existing architraves and skirtings to be retained and made good.

Flush panel doors to be replaced with heritage style 4 panel painted timber fire doors to enhance heritage asset, unless the existing can be suitably refurbished and then an apply an intumescent paint.

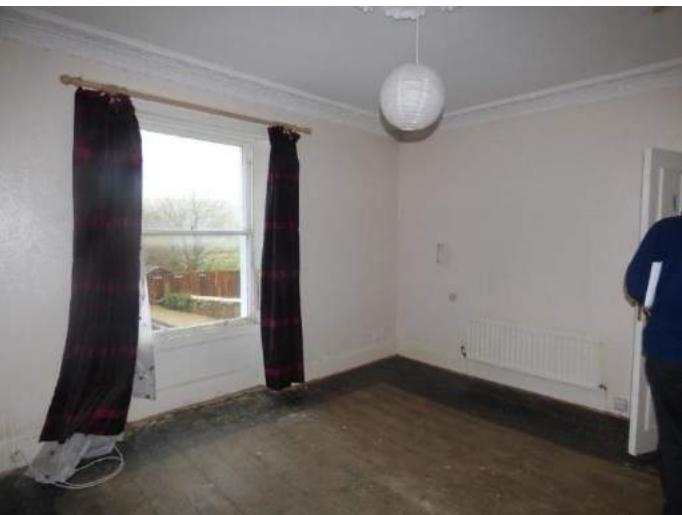
Right: Existing cornice is in excellent condition.

Existing architraves and skirtings to be retained and made good, where required.

Retain existing ceiling rose.

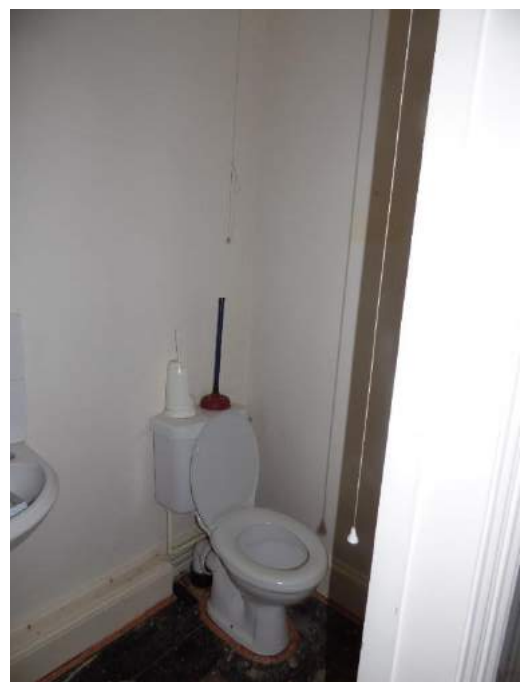
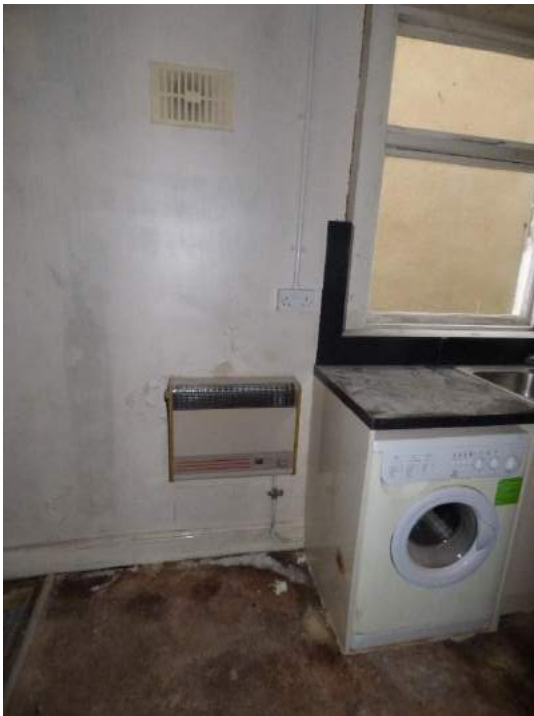
Left and below; In the existing kitchen, the existing kitchen will be completely removed. The existing modern single glazed windows will be replaced / repaired subject to planning condition. The existing floor has been over-boarded with a ply decking. It is proposed to lift the ply decking and examine the original floors. It is proposed to apply water resistant chipboard, subject to the sub floor and the condition of the joists etc which may require replacement.

Existing services to be removed and walls, and ceilings made good.

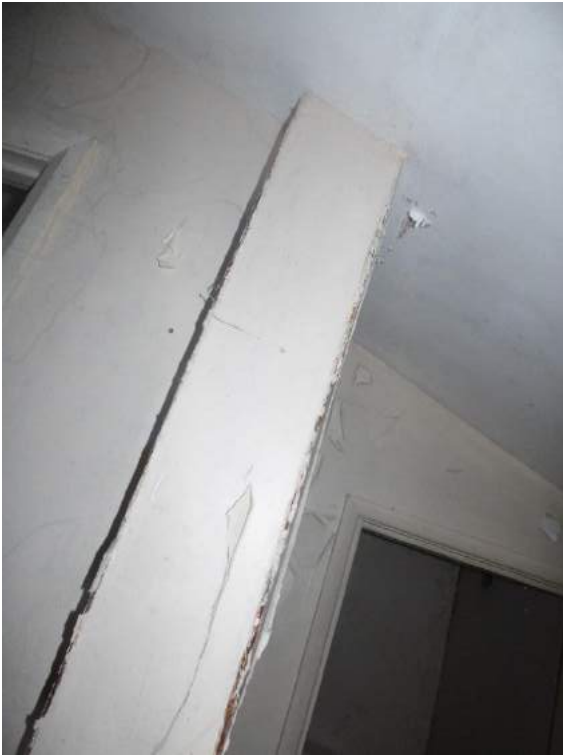
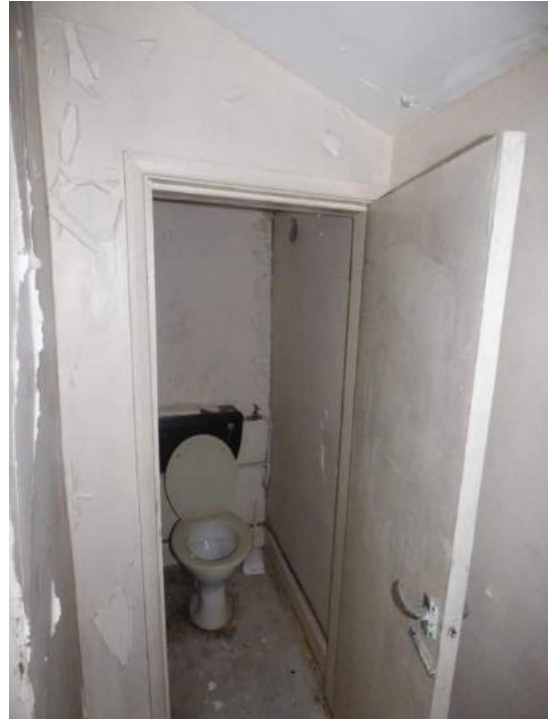
Above and below: Existing wc to be removed, as part of the reconfiguration of the area, and new sanitaryware to be provided. All walls, floor, ceilings to be made good and prepared for full decoration.

Existing rear door to be removed and replaced with a new hardwood painted door to match the front door (in style), and Georgian style ironmongery.

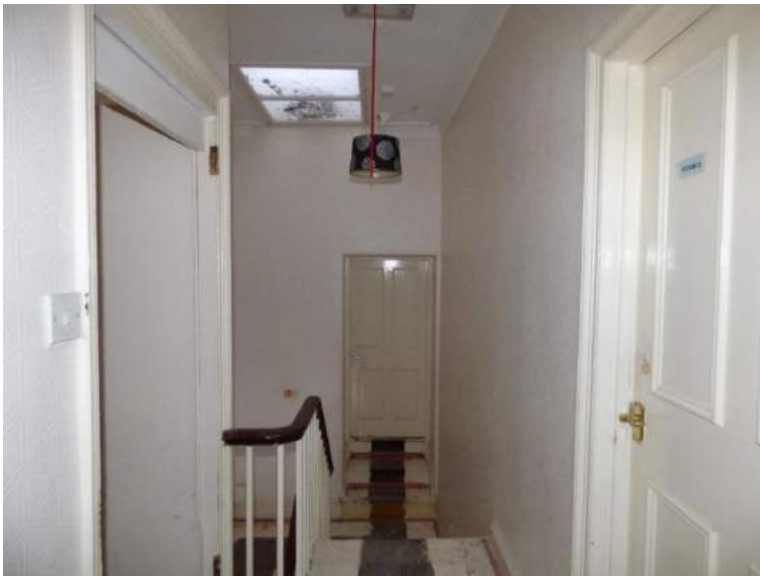
Left: At first floor all existing architraves and skirting to be retained.

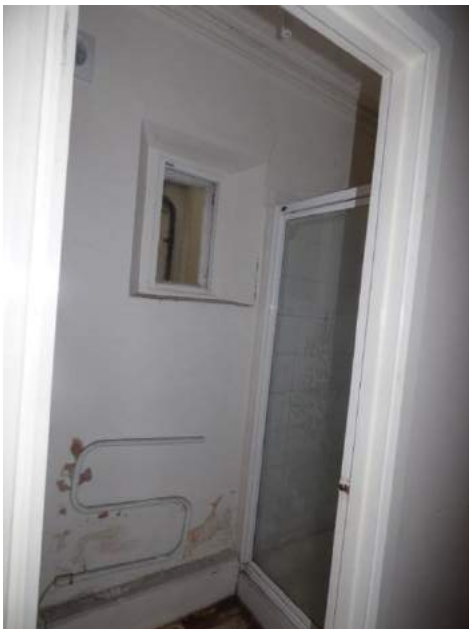
Left: The existing shower room is not original, and it is proposed to remove to reconfigure the space.

skirtings to be reinstated to match the existing.

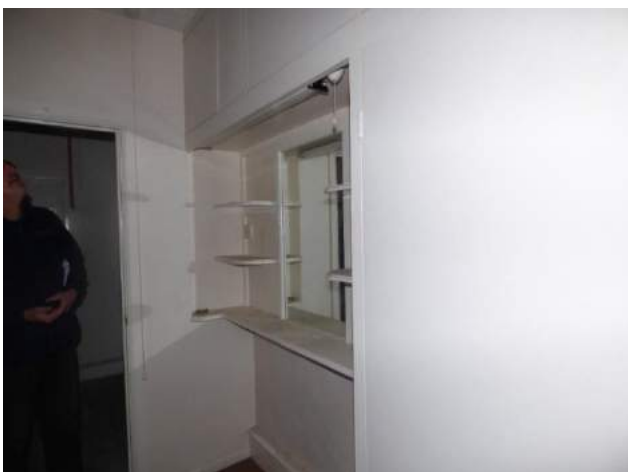
Left: existing corridor to bathroom.

Recent features added as part of the room as part of the conversion to dormitory accommodation to be removed and walls reinstated as original.

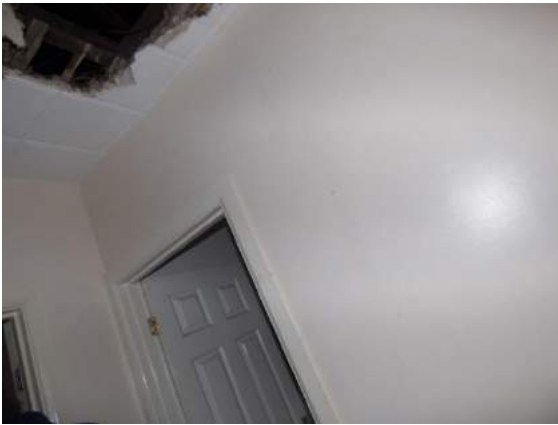
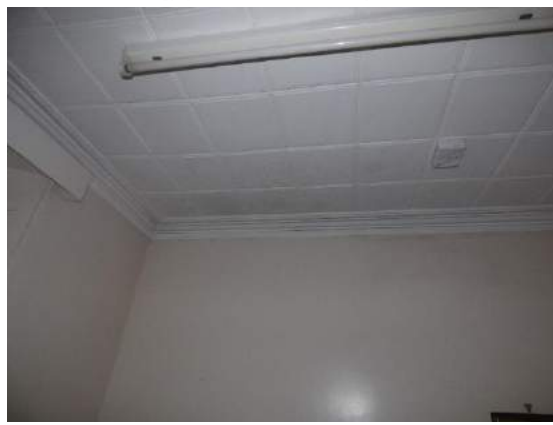
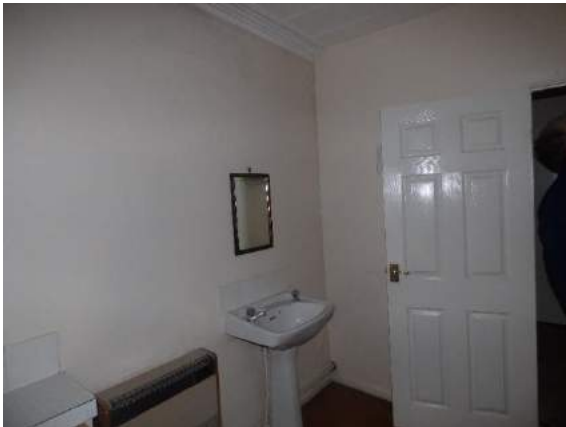
Above, left, and below: Existing bathroom. The existing ceiling finishes to be removed, and the ceiling to be made good including remediation of lath and plaster ceiling by specialist.

Existing modern window to be removed and repaired / replaced subject to planning condition.

Existing modern replica six panel door to be replaced with new traditional timber four panelled Georgian style door – bathroom door does not need to be a fire door.

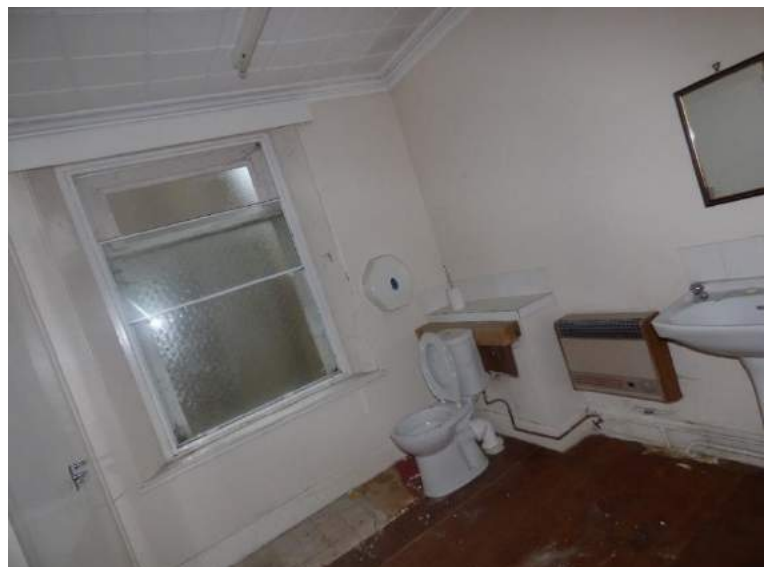
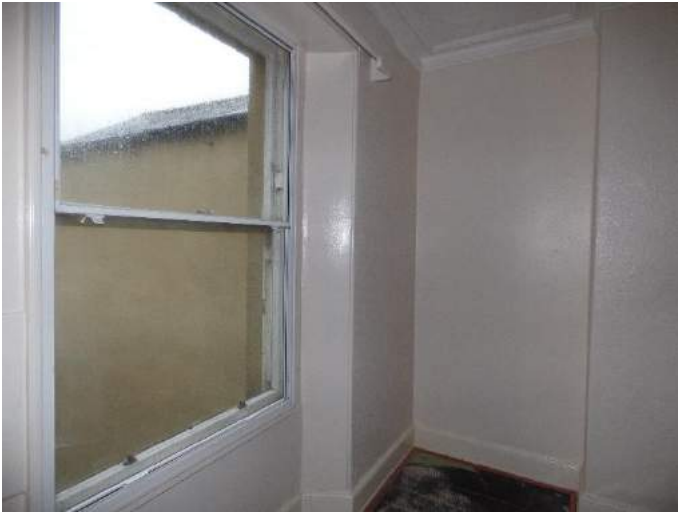
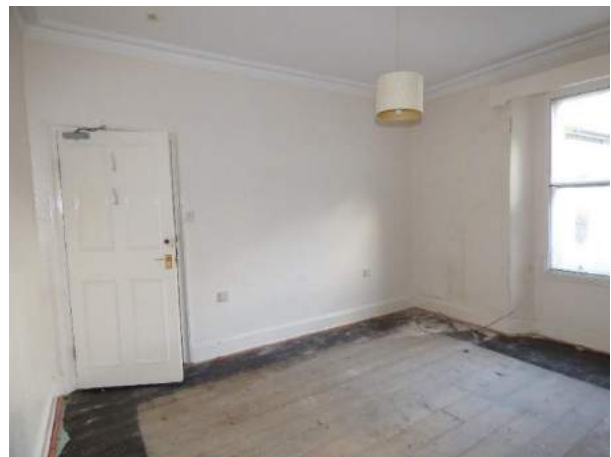
Rear bedroom.

Existing floorboards generally in good condition. Minor repairs to plaster work in window reveals to be repaired.

Skirtings and architraves to be retained and repaired where necessary. Existing door to be replaced with new Georgian heritage style 4 panel door to be provided and installed by specialist joinery company such as Batty Joinery Ltd.
