# HERITAGE STATEMENT

## FULL RENOVATION OF EXISTING No 11 TERRACE HOUSES

St Bees, 1-11 Lonsdale Terrace, Parish Council, Cumbria

M.A.C Architects, Project Number: 2019:303

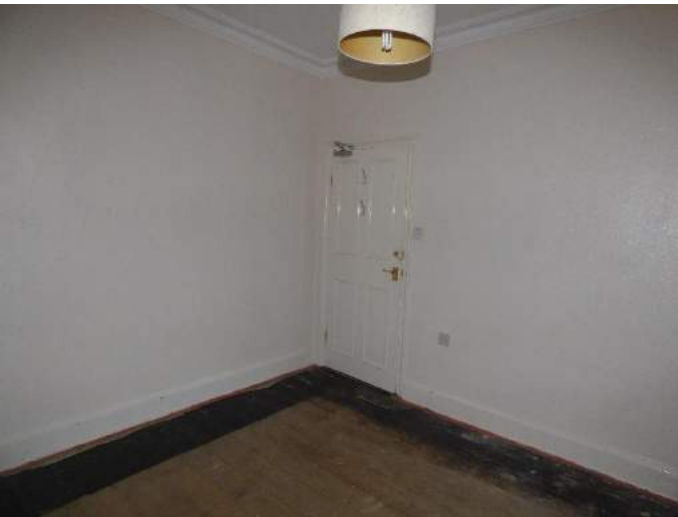
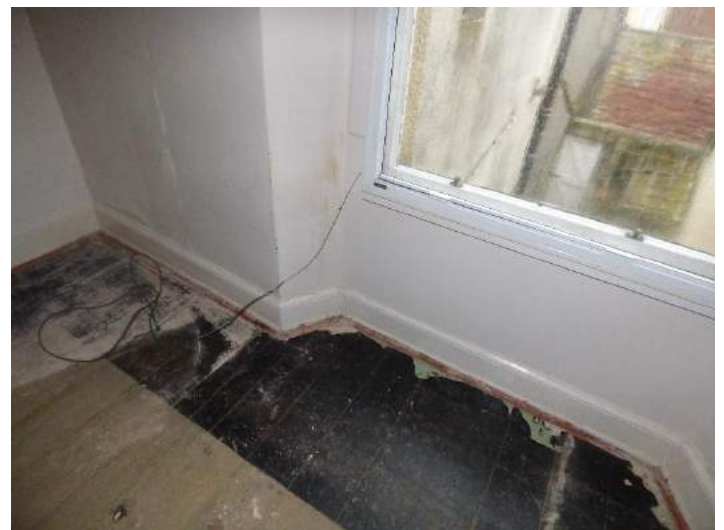
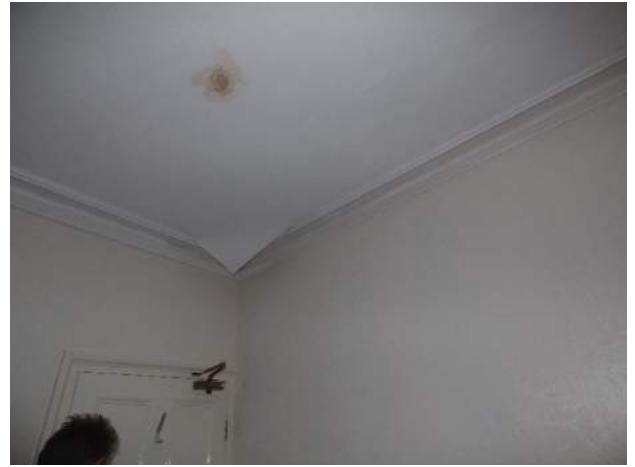
Left and above: Large front bedroom. Skirtings, cornices, and architraves to be retained and minor repairs where necessary. Existing flush panelled door to be replaced with new Georgian heritage style 4 panel door to be provided and installed by specialist joinery company such as Batty Joinery Ltd. Where possible it is proposed to refurbish any original doors with door closers and intumescent paint subject to building control approval.

Existing floorboards in good condition.

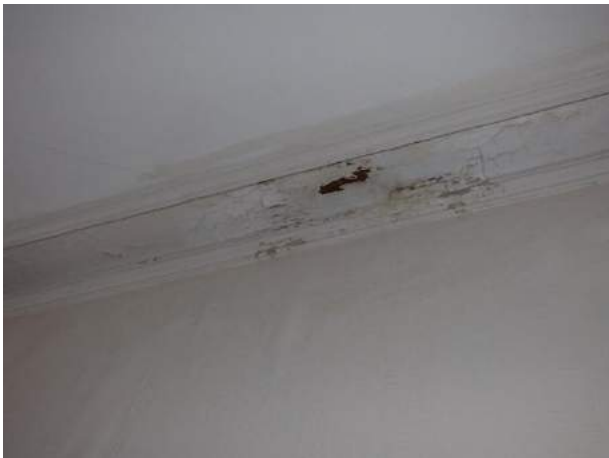
Left: Front Bedroom (small) skirtings and architraves to be retained, existing door to be replaced with new Georgian heritage style 4 panel door to be provided and installed by specialist joinery company such as Batty Joinery Ltd. Where possible it is proposed to refurbish any original doors with door closers and intumescent paint subject to building control approval.

Damp damage to plastered ceiling to be repaired due to water ingress in attic.

Below Left: Existing cornice damaged due to water ingress from attic room above. Cornice to be repaired.

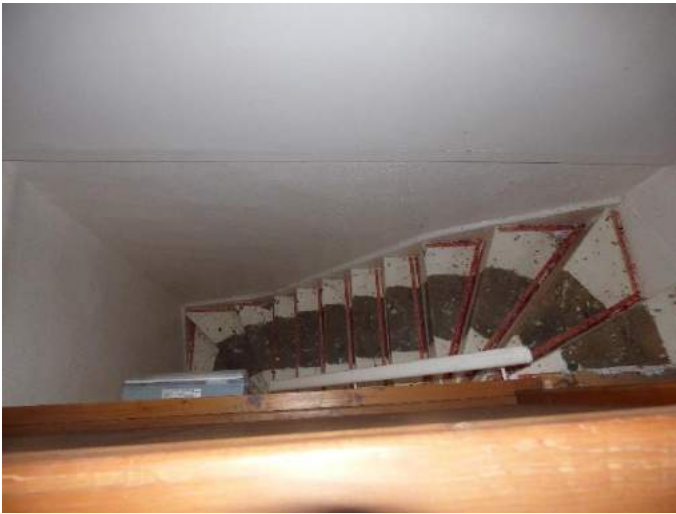
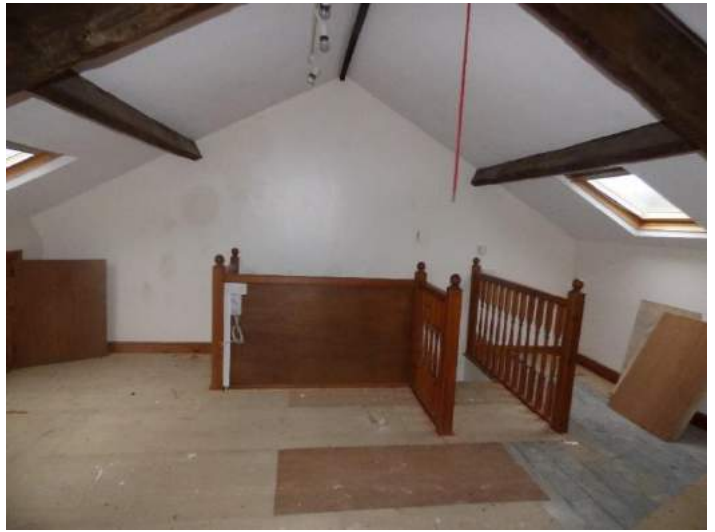
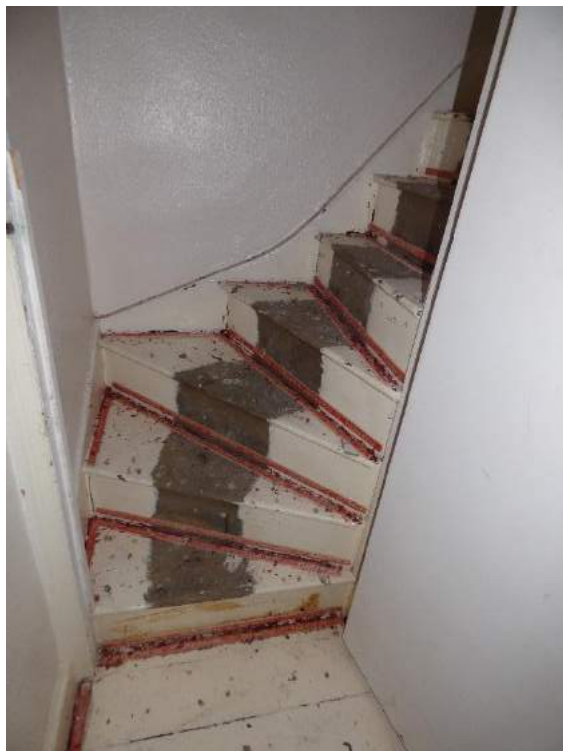
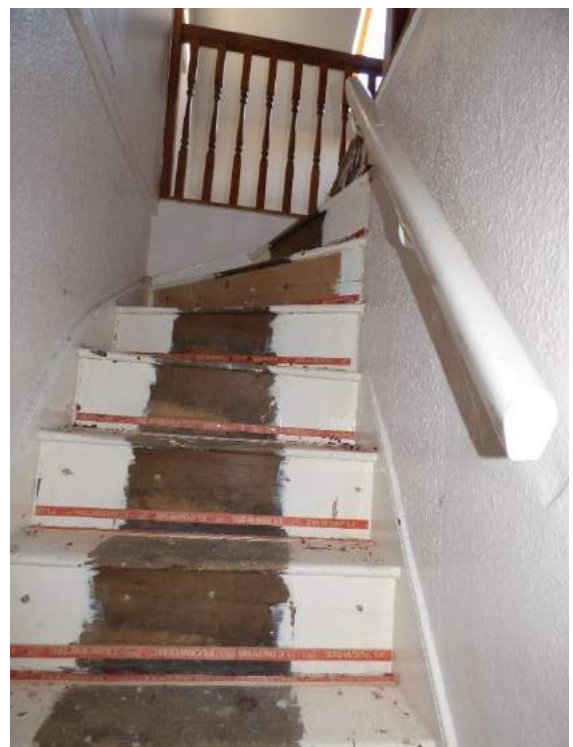
Above and right: Staircase to attic room.

Handrail, balusters, and rails are not original; however, it is proposed to replace to suit reconfigured attic space with handrails and balusters to match the existing.

Apply an insulated plasterboard 62mm thick to underside of sloping ceiling, above staircase. Boards to be taped and skimmed.

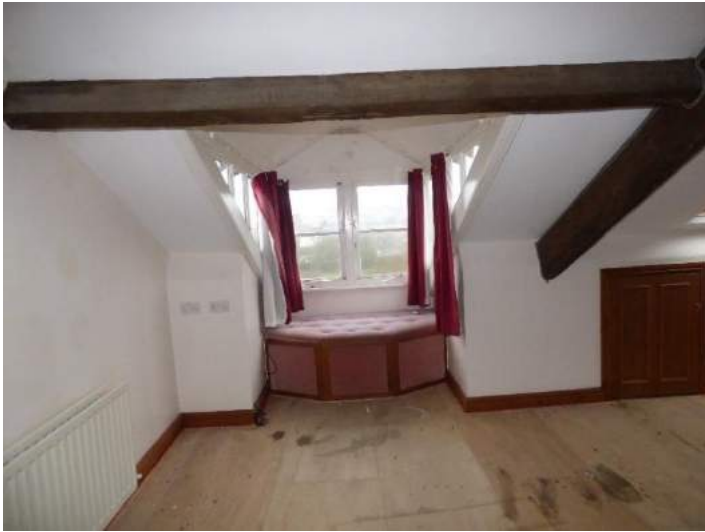
Existing attic space is proposed to be reconfigured to provide additional bedroom accommodation.

New plasterboard stud partitions to be installed to form new spaces.

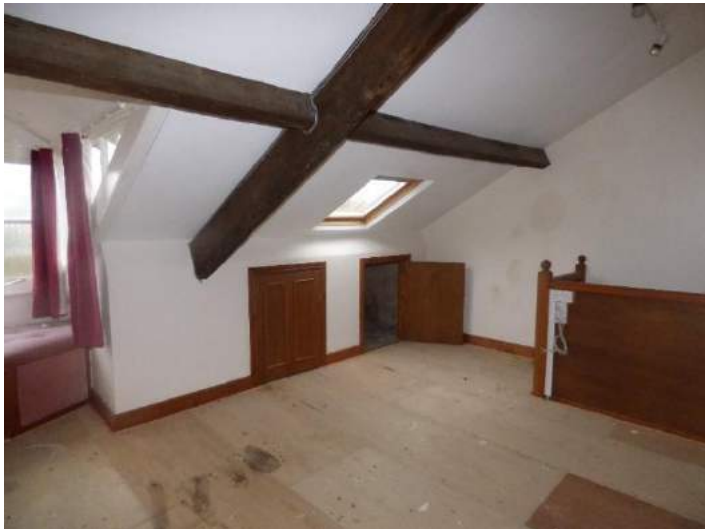
All damp and damaged/blown plasterwork to be repaired with lime plaster (Solo lime plaster from Lime Centre) and skim and decorate throughout.

Floorboards are not the original and likely to have been installed due to water ingress. It is proposed to replace with softwood timber floorboards. The skirtings are not original, and it is proposed to remove them and replace with new soft wood skirtings to match the skirtings throughout the rest of the property.

Apply an insulated plasterboard 62mm thick to underside of ceiling. The Laminated plasterboard and PIR has a vapour barrier incorporated so interstitial moisture would be prevented. New rooflights to be installed with flashing kit that mounts unit flush with the roof surface.

Tape and skim and undertake full decorations. Replace existing modern rooflights with new heritage style Velux rooflight (or Rooflight company equivalent).

New doors to be provided to newly formed rooms to be 4 panelled Georgian style timber doors to match the doors being reinstated throughout the rest of the property. Doors to be fire rated.

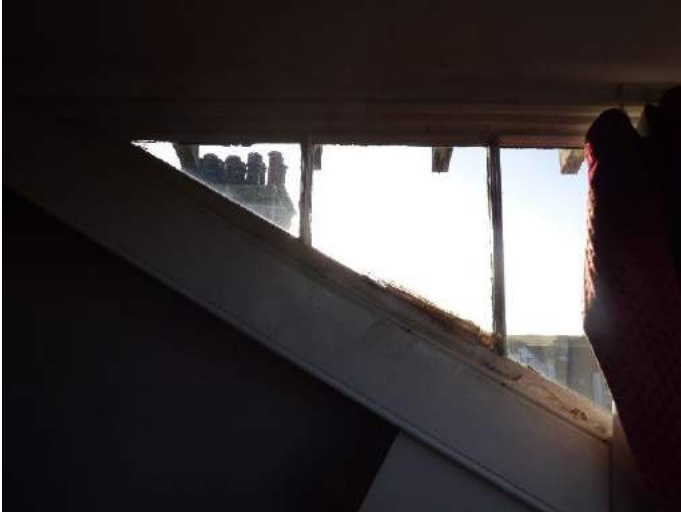
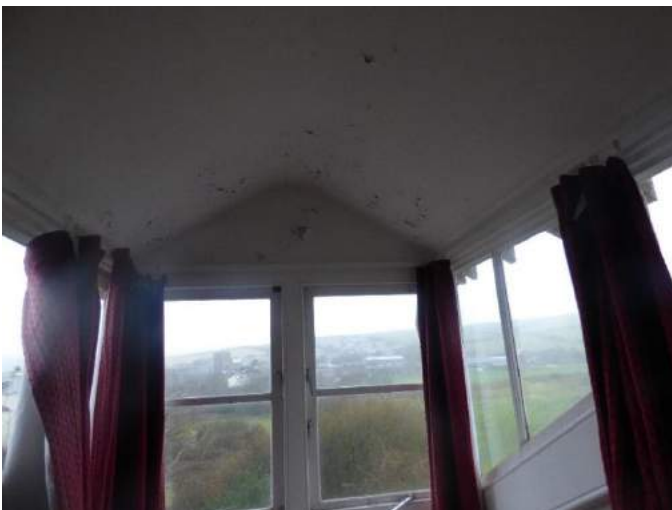
The existing dormer window has suffered considerable damage, with windows missing and considerable fabric damage due to water ingress.

It is proposed to reconstruct the dormer windows to the same details as the existing, with new windows subject to planning condition. Refer to plan and elevations as proposed.

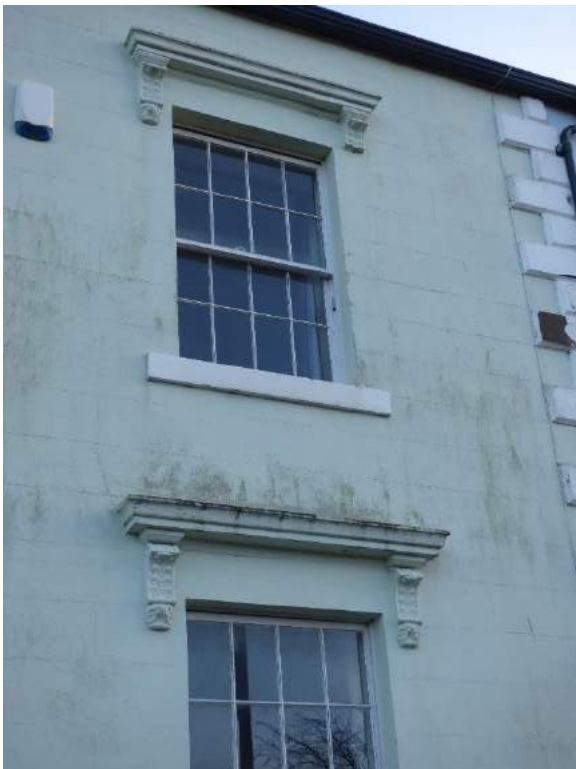
Both front and rear elevations are currently rendered, with colour to the front and side and natural to the rear. All elevations require to be prepared for render repairs and redecoration by specialist using lime render and stucco (Parax LTD) to be applied by specialist. The stucco features above the windows and door on the front elevation will be carefully restored by a specialist. Colour of all render and stucco to match existing.

The existing door and frame are to be retained and made good with the provision of new ironmongery. Once repaired full decoration will be undertaken.

Existing gutters and downpipes to be retained, repaired where necessary and decorated.

All existing single glazed windows to either be refurbished or replaced subject to planning condition.

The existing stone steps to be cleaned up, and existing painted metal handrails to be replaced with new handrails (refer to D&A statement).

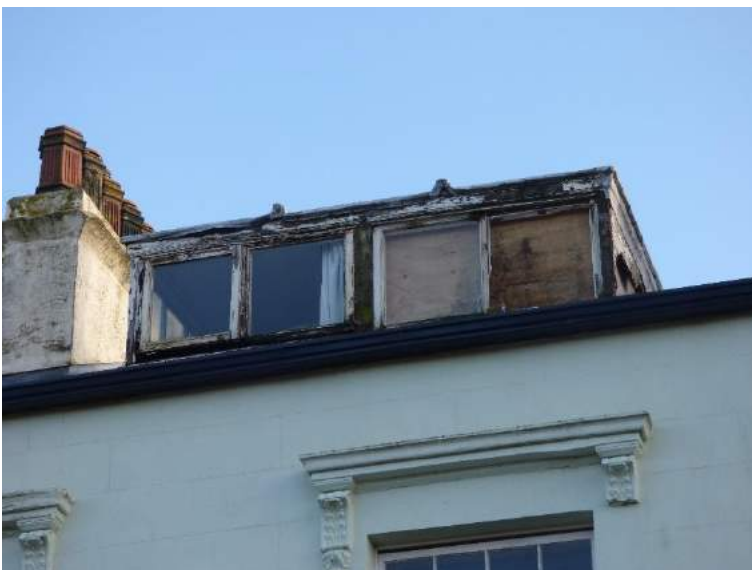
Left: Dormer windows to front of property have been damaged beyond repair, and it is therefore proposed to repair / replace dormer window, subject to planning condition.

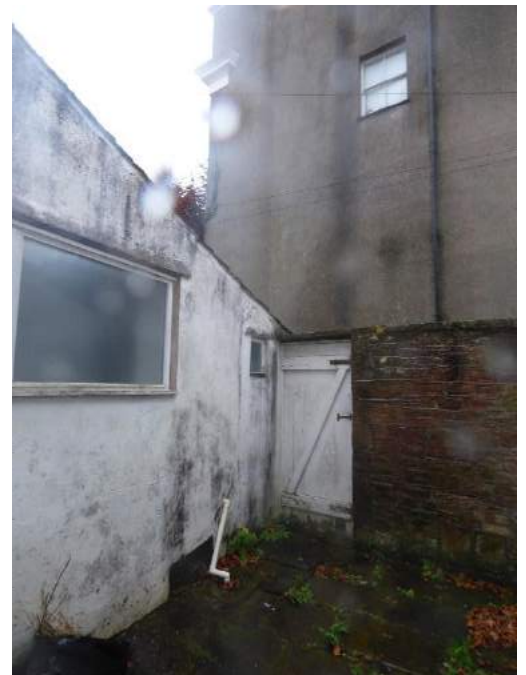
Rear of property – render to be repaired by specialist and decorated with off white render.

New door to be provided to rear to be Georgian style as front door.

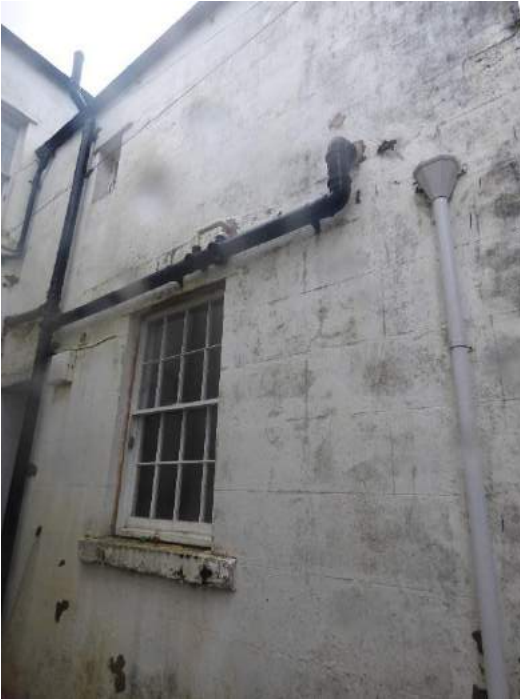
Rear of property – render to be repaired by specialist and decorated with off white render.

Windows to be repaired / replaced subject to planning condition.

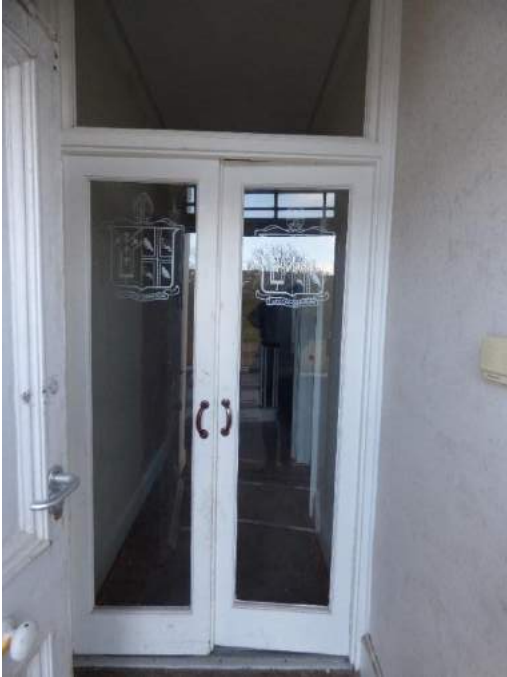
Left and below: New lobby installed when the building was converted into a dormitory to be removed.

Existing parquet floor to be retained and restored.

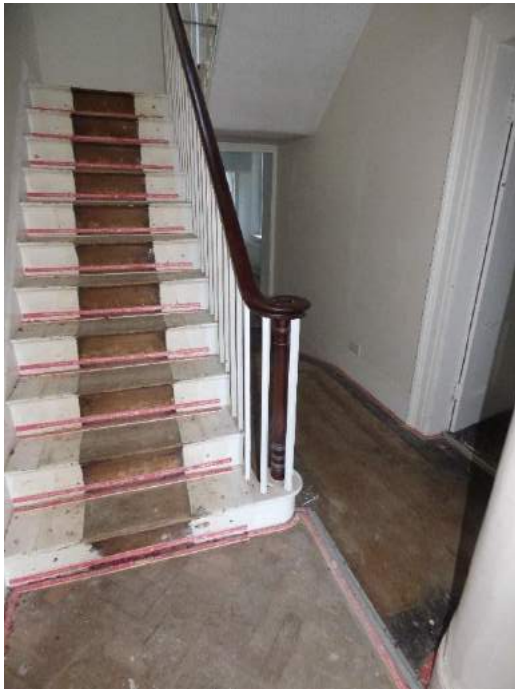
Existing staircase. Handrails, balusters, and rails are original and to be retained.

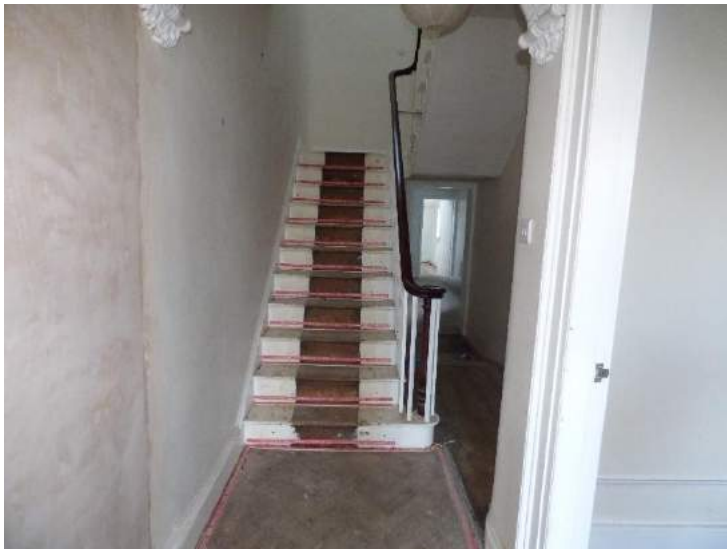
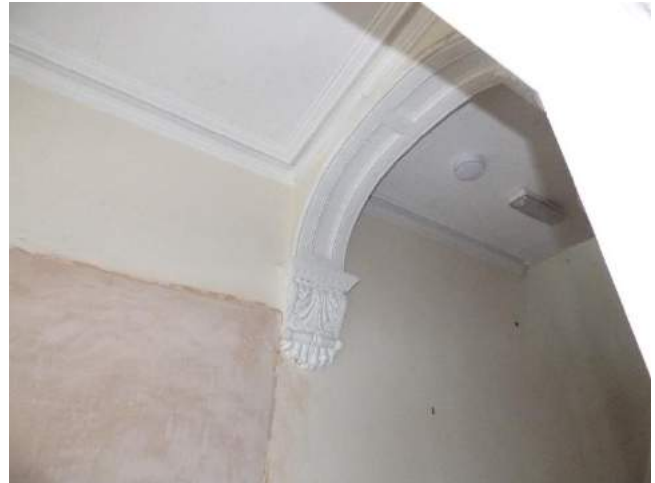
Above and below: Redundant M&E to be removed and wall/ceiling finishes made good.

Period features to be retained, including archway and architraves.

(Modern lighting to all be stripped out and surfaces restored.

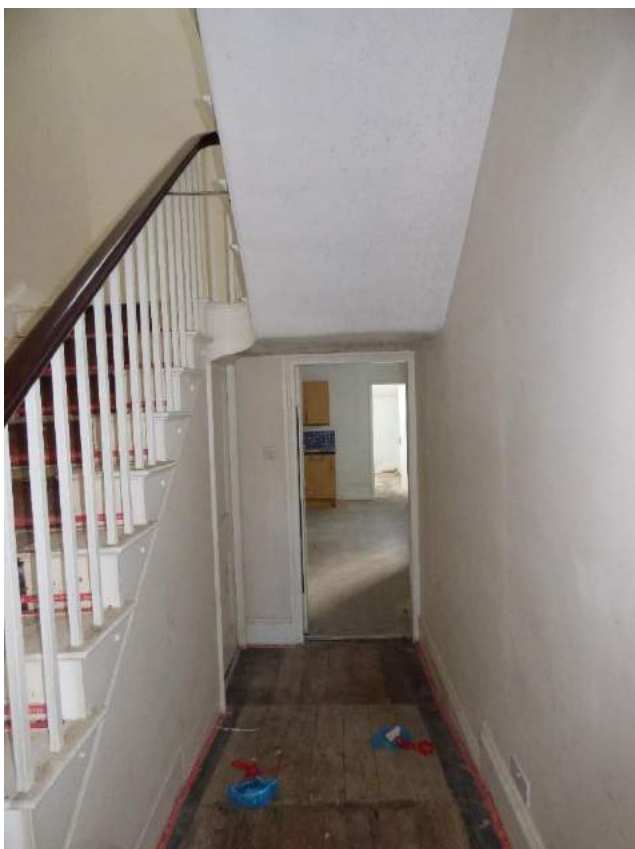
Flush panel doors to be replaced with heritage style four panel painted timber fire doors to enhance the heritage asset.

Existing ramp to be removed and original step down to kitchen to be reinstated.

Existing floorboards in good condition.

Where possible it is proposed to refurbish any original doors with door closers and intumescent paint subject to building control approval.

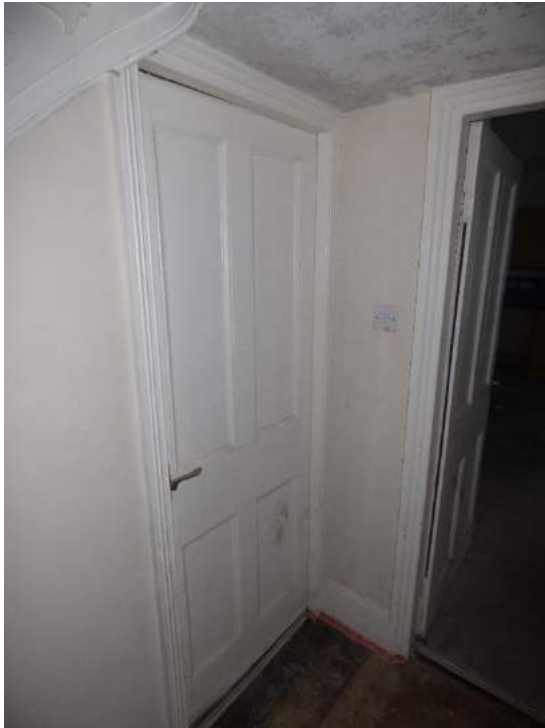
Left: Doors to all existing rooms to be replaced with new 4 panel fire doors to match existing. All existing architraves and skirtings to be retained.

Where possible it is proposed to refurbish any original doors with door closers and intumescent paint subject to building control approval.

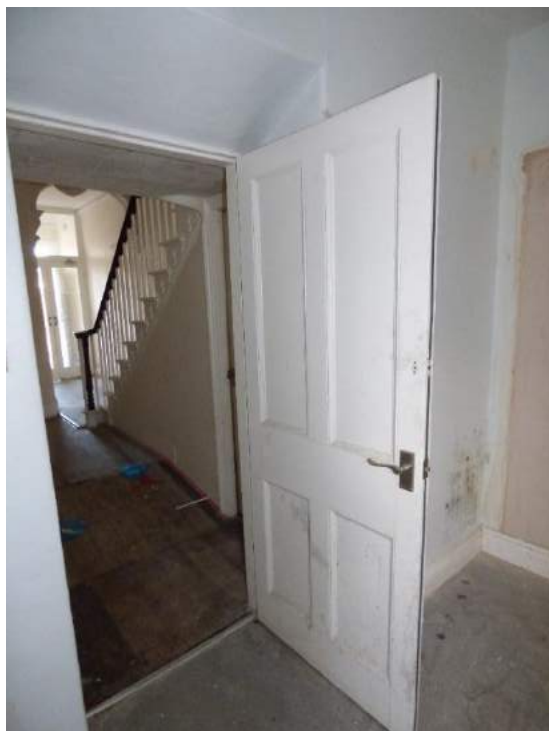
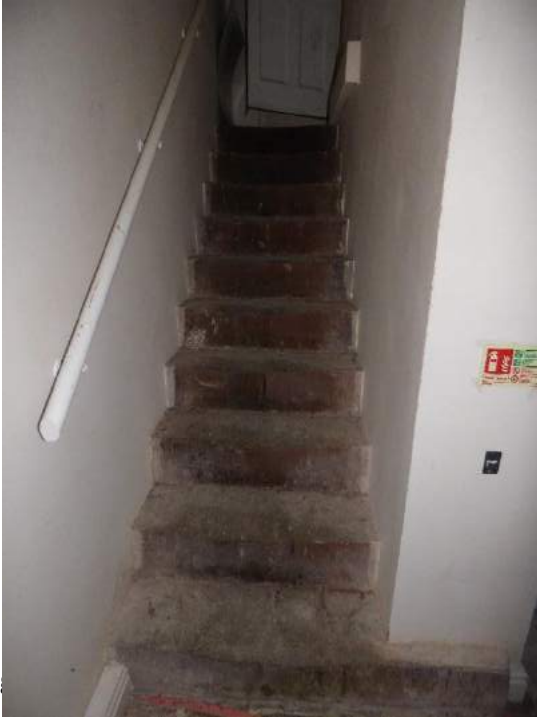
Left: Basement.

The existing walls and floor are generally in sound condition so would be suitable for the application of damp proof slurry system. All existing paint and surface finished must be removed and made good including all snots removed and damage to existing surfaces, prior to the installation of a Koster Polysil NB1.

This migratory crystalline tanking slurry is used to seal below

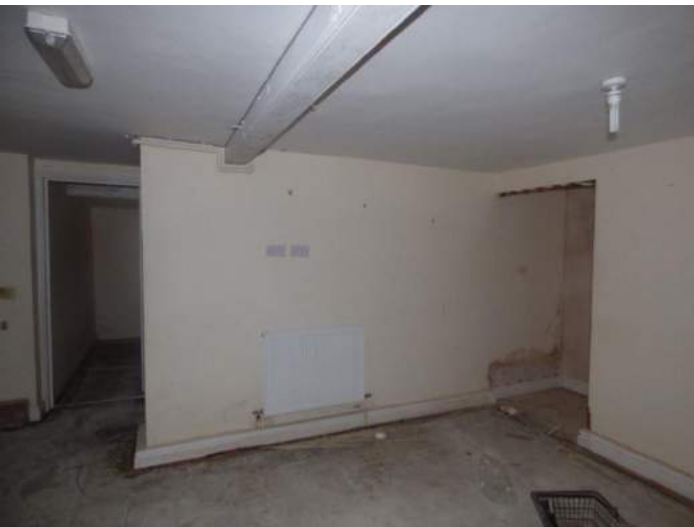
Existing walls have previously been plastered, but not with a suitable waterproof system and damp is penetrating through.

Koster NB1 is considered to be a Type A waterproofing system as defined by BS8102:2009 and is generally used to seal the inside face of basement structures, slabs and retaining walls.

Koster NB1 works by providing both a physical barrier against water ingress as well as providing a migratory crystal sealant that penetrates deep into the structure to seal micropores and cracks against water ingress.

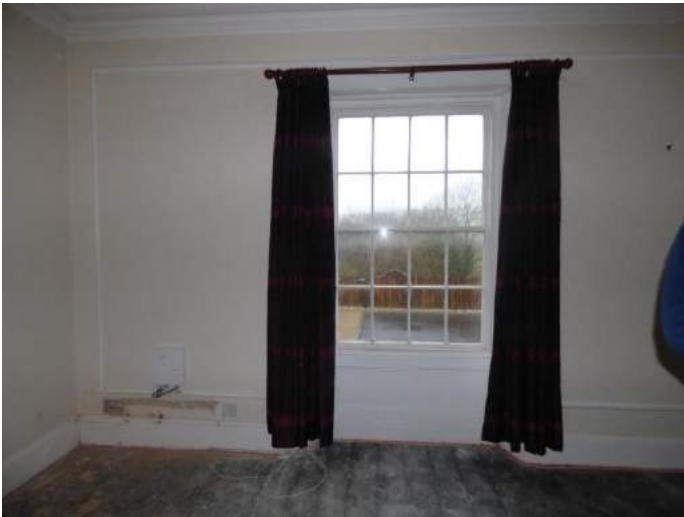
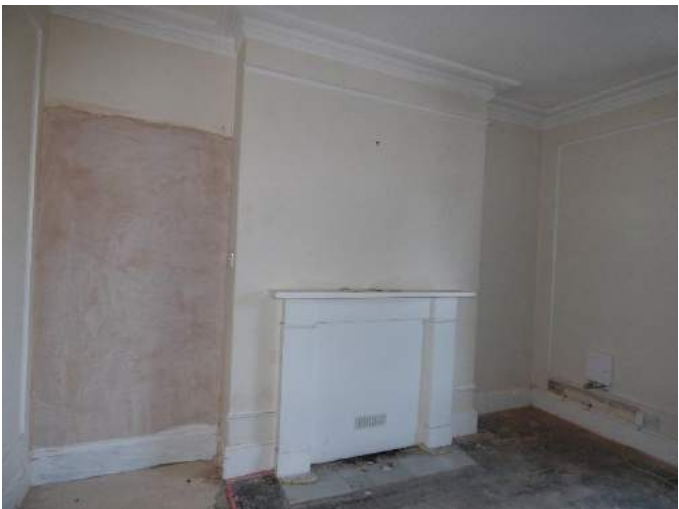
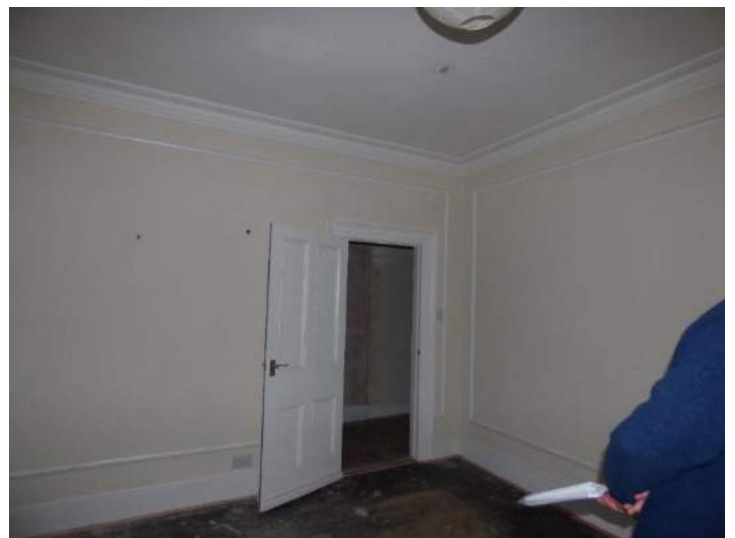
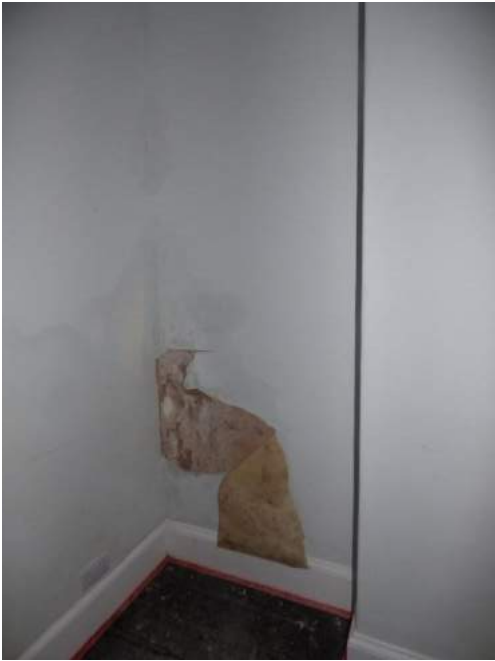
Left and below: In the existing dining room at the rear of the property, the period features below and to the sides of the existing window are in good condition, it is proposed to carefully refurbish the existing timber shutters.

Existing cornice to be made good in locations and where hairline cracks have appeared.

Here plasterwork has been damaged from damp ingress, blown plaster is to be removed, and reinstated with lime plaster finish.

Existing door to be replaced with heritage style four panel painted timber fire door to enhance the heritage asset.

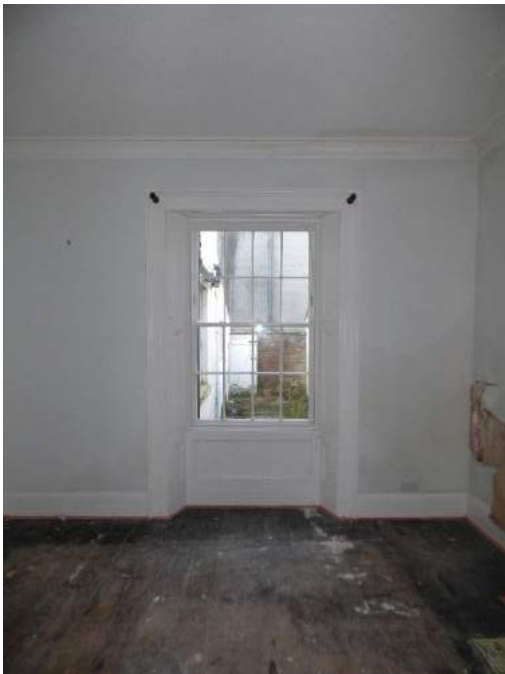
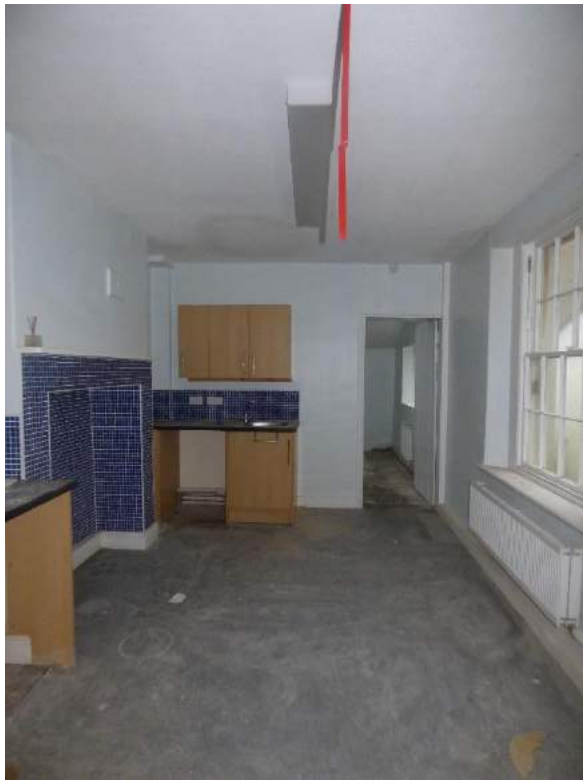
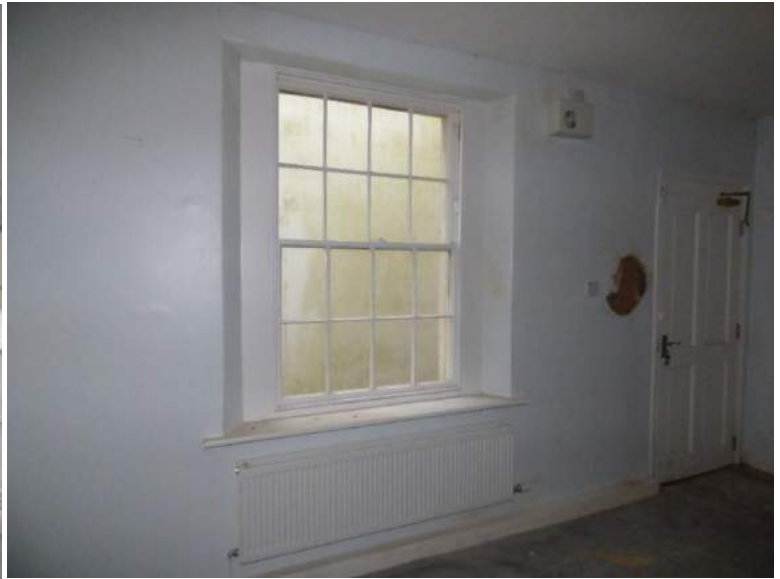
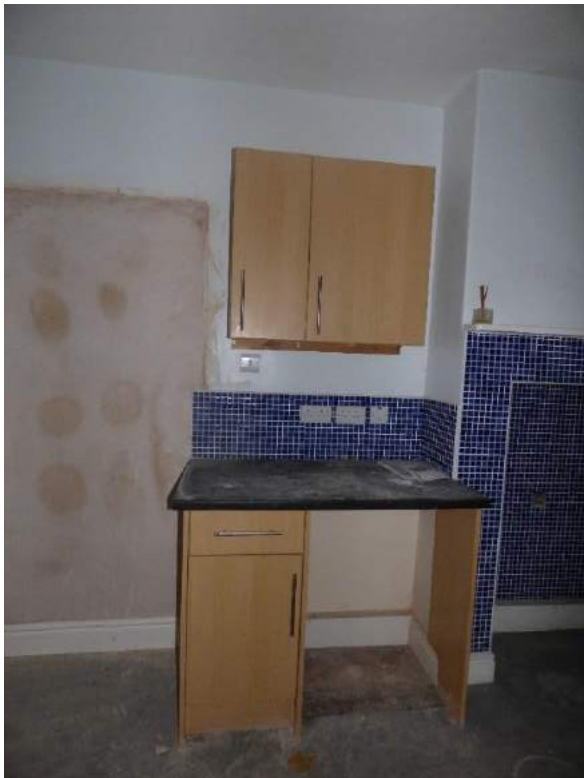
Above, left, and below: In the existing kitchen, the existing M&E services are to be removed and modern kitchen removed. Internal walls and ceilings to be made good.

Existing cornice to be made good in locations where redundant services are to be removed and where hairline cracks have appeared.

Existing architraves and skirtings to be retained and made repaired.

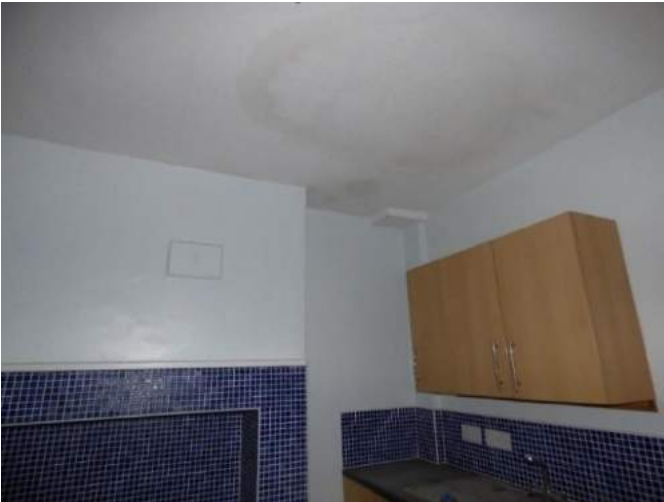
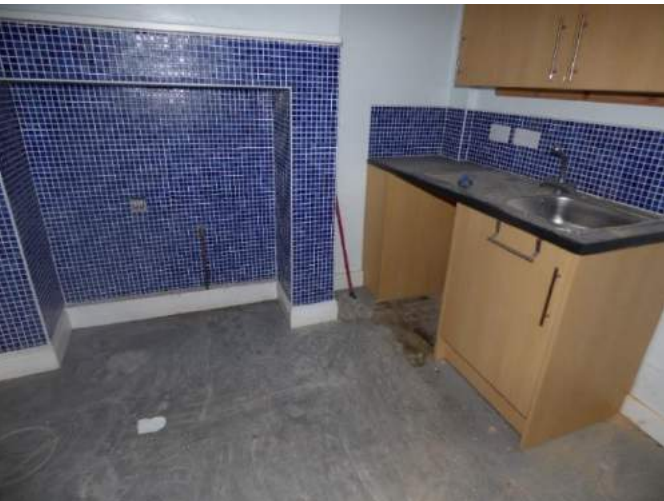
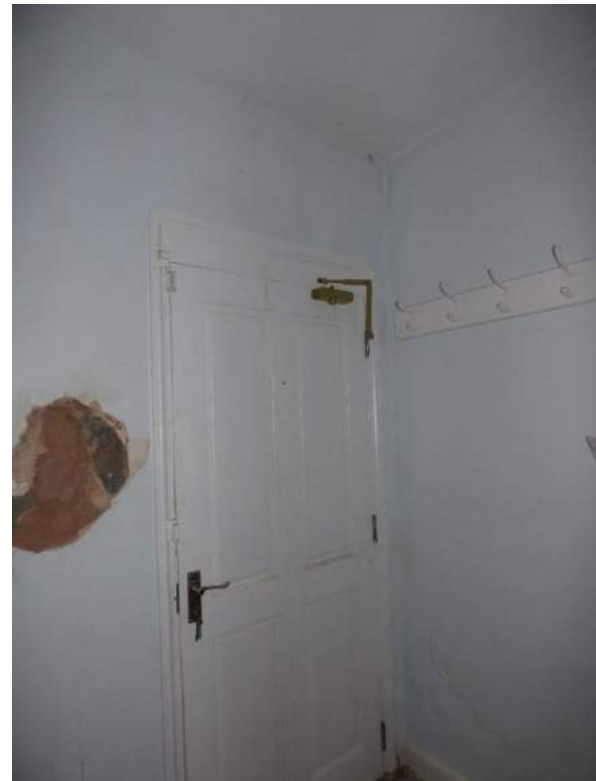
Left and below: The existing wc and utility area is to be reconfigured. All internal finishes to be stripped out and ceilings, walls, and floors to be made good.

Roof to be repaired and ceiling to receive new insulated plasterboard.

Apply an insulated plasterboard 62mm thick to underside of ceiling. The Laminated plasterboard and PIR has a vapour barrier incorporated so interstitial moisture would be prevented. New rooflights to be installed with flashing kit that mounts unit flush with the roof surface.

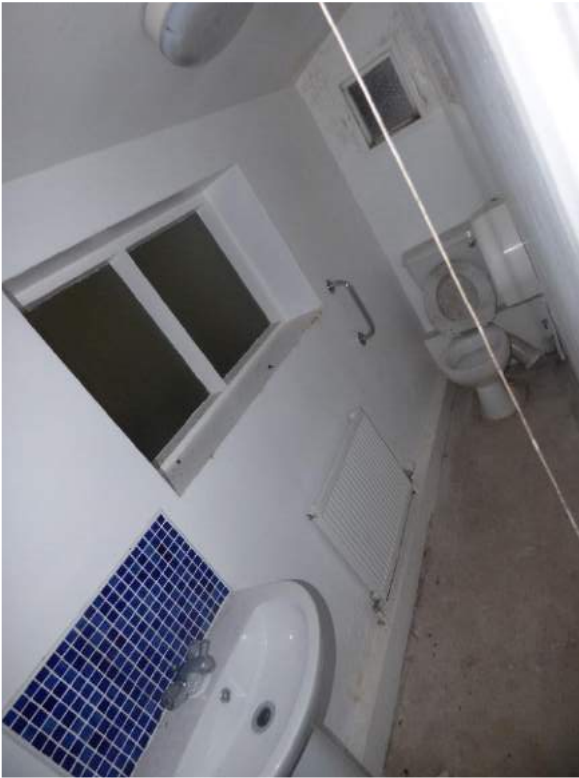
Left: Existing wc area to be reconfigured. Existing ceiling to be repaired.

Damp treatment is to be provided as Koster NB1 system.

Koster NB1 works by providing both a physical barrier against water ingress as well as providing a migratory crystal sealant that penetrates deep into the structure to seal micropores and cracks against water ingress.

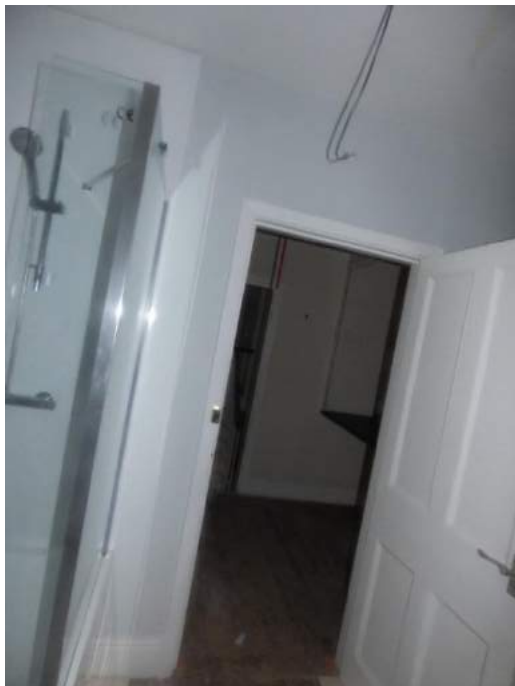
Existing bathroom - skirtings and architraves to be retained. Existing flush panelled door to be replaced with new Georgian heritage style 4 panel door to be provided and installed by specialist joinery company such as Batty Joinery Ltd. Where possible it is proposed to refurbish any original doors with door closers and intumescent paint subject to building control approval.

Ceiling and walls to be repaired where damaged from moisture ingress from leaking roof. Localised repairs to roof to be undertaken to ensure watertightness is achieved. All repairs to match existing.

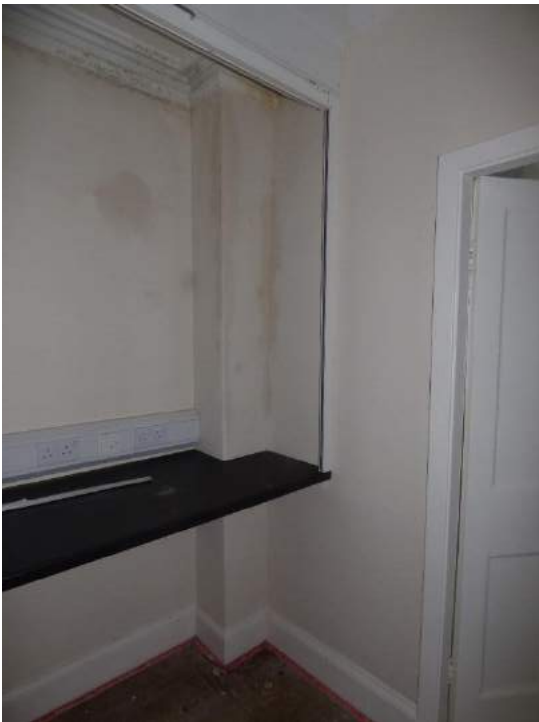
Left and above: Lobby to bathroom and existing wc to be reconfigured to make better use of space. Ceiling and walls to be repaired further to damp ingress damage.

Cornice to be provided where missing.

Existing non original fixtures and fittings to be removed and walls to be made good.

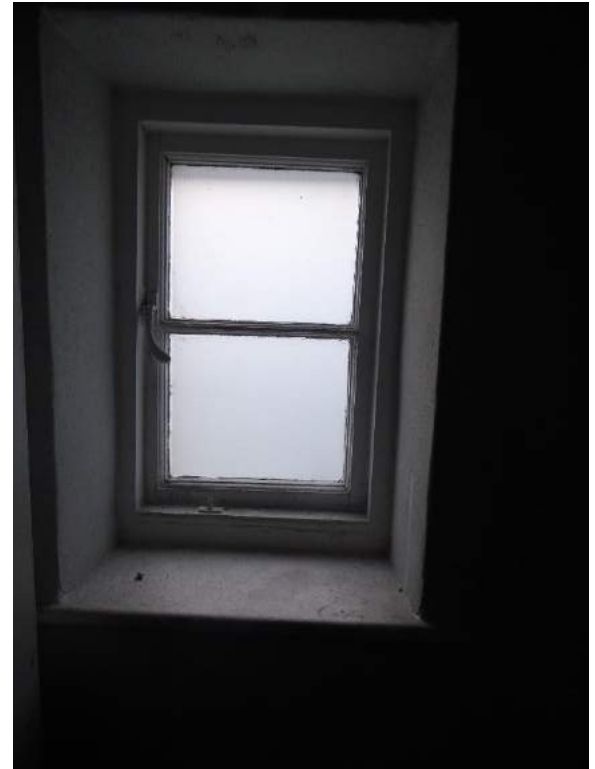
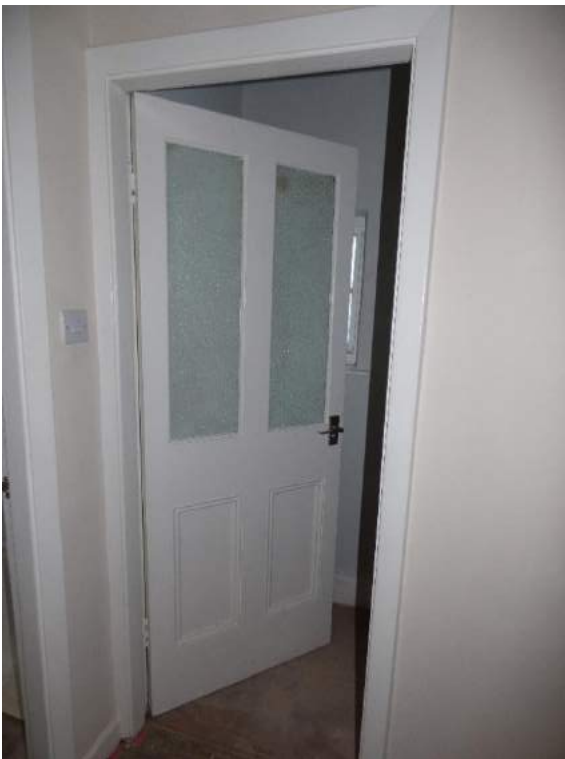
Left: Existing w.c. (not original) to be stripped out and space reconfigured. All skirtings and cornices to be reinstated to match existing.

Existing window to be repaired / replaced subject to planning condition.

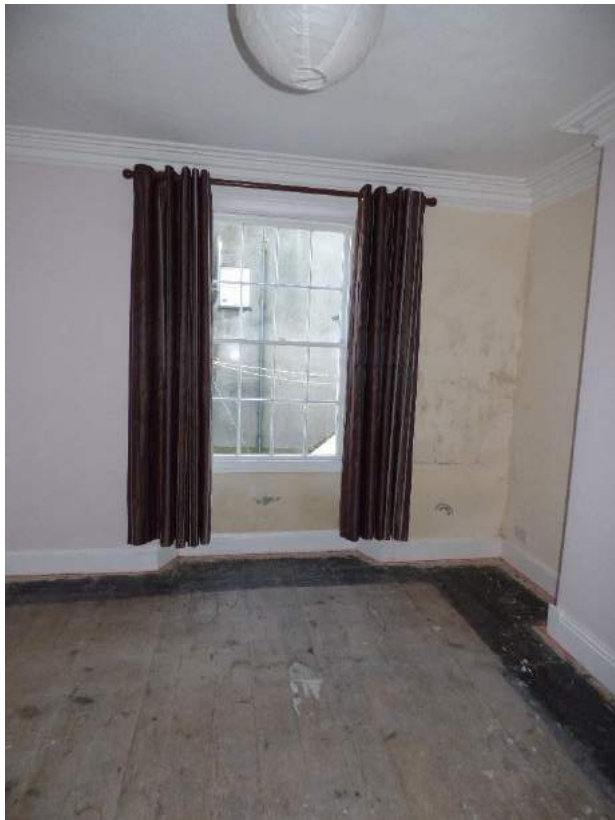
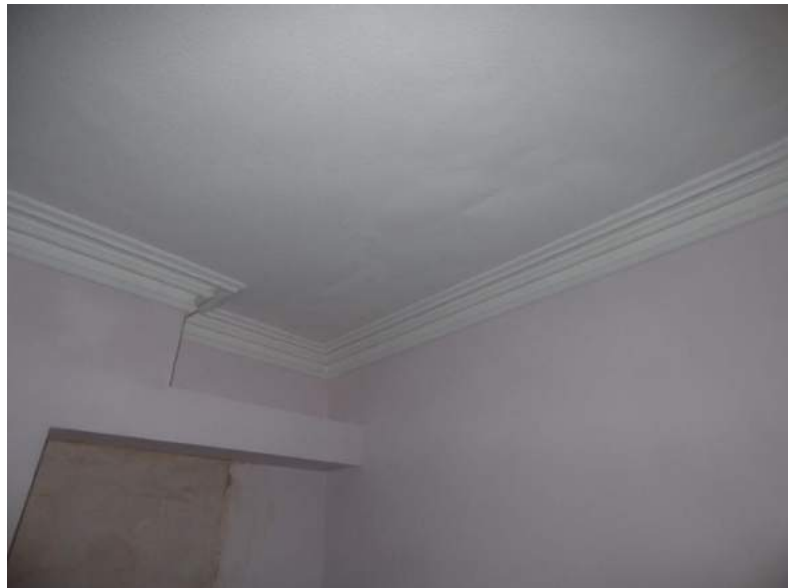
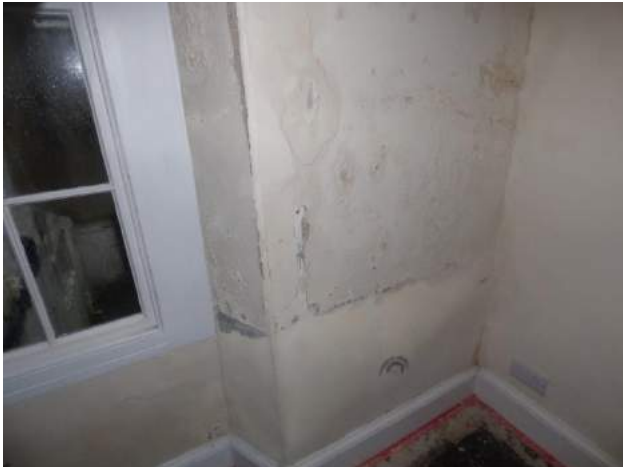
Rear bedroom skirtings, cornices, and architraves to be retained. Existing flush panel door to be replaced with new Georgian heritage style four panel door to be provided and installed by specialist joinery company such as Batty Joinery Ltd.

Where possible it is proposed to refurbish any original doors with door closers and intumescent paint subject to building control approval.

Left and below: Blown plasterwork to be repaired with lime plaster (Solo lime plaster from Lime Centre) below window.

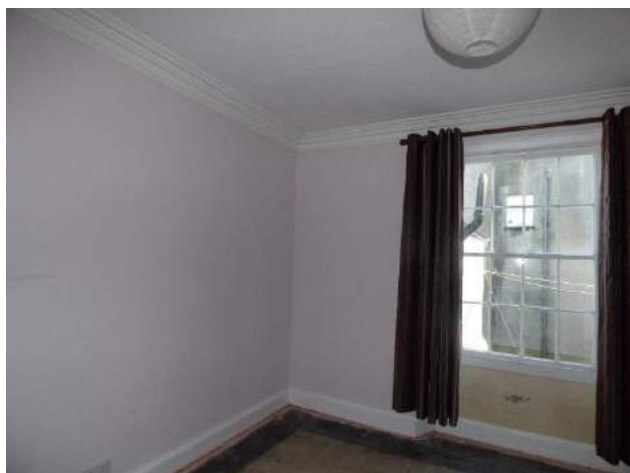
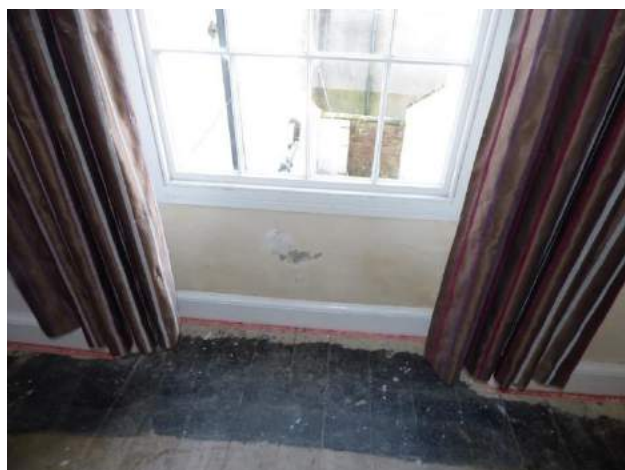
Large front bedroom, skirtings, covings, and architraves to be retained. Existing panelled door to be replaced with new Georgian heritage style four fire panel door.

Existing floorboards in good condition.

Where possible it is proposed to refurbish any original doors with door closers and intumescent paint subject to building control approval.

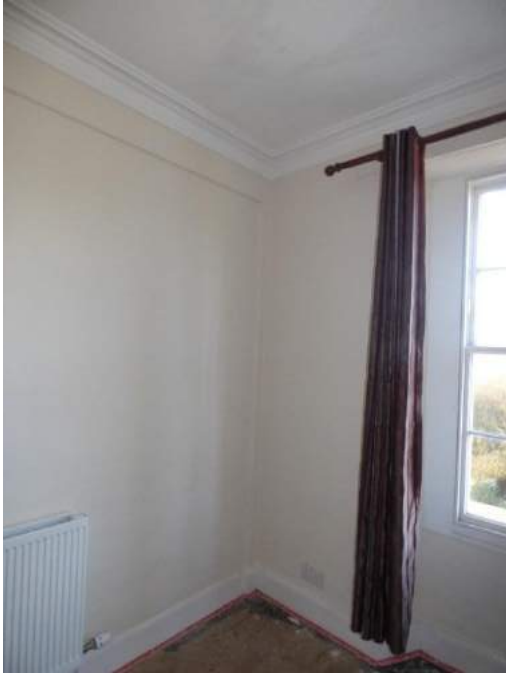
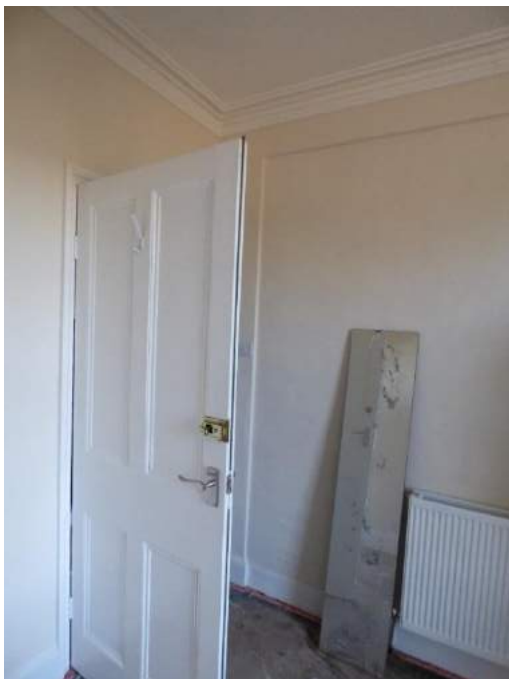
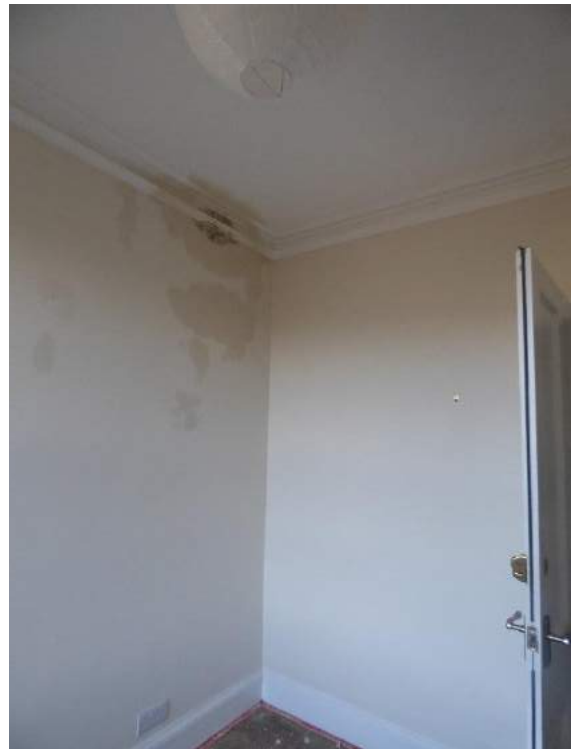
Existing small front bedroom - cornice, skirtings, and architraves to be retained. Existing door to be removed and new Georgian heritage style four panel door to be provided and installed by specialist joinery company such as Batty Joinery Ltd. In new location. Where possible it is proposed to refurbish any original doors with door closers and intumescent paint subject to building control approval.

Existing doorway to be walled up to match existing.

Blown plaster to walls and ceiling to be replaced and repaired with lime plaster (Solo lime plaster from Lime Centre) all to match existing.

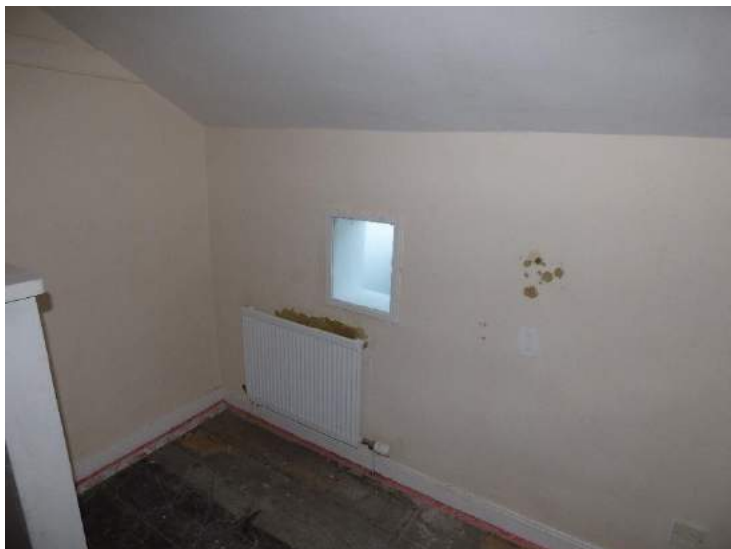
Left: Landing at the top of the staircase.

Floorboards are in good condition (but may require minor repairs)

Replace existing modern rooflights with new heritage rooflight windows (Velux or Rooflight company or similar) A with flashing kit that mounts unit flush with the roof surface).

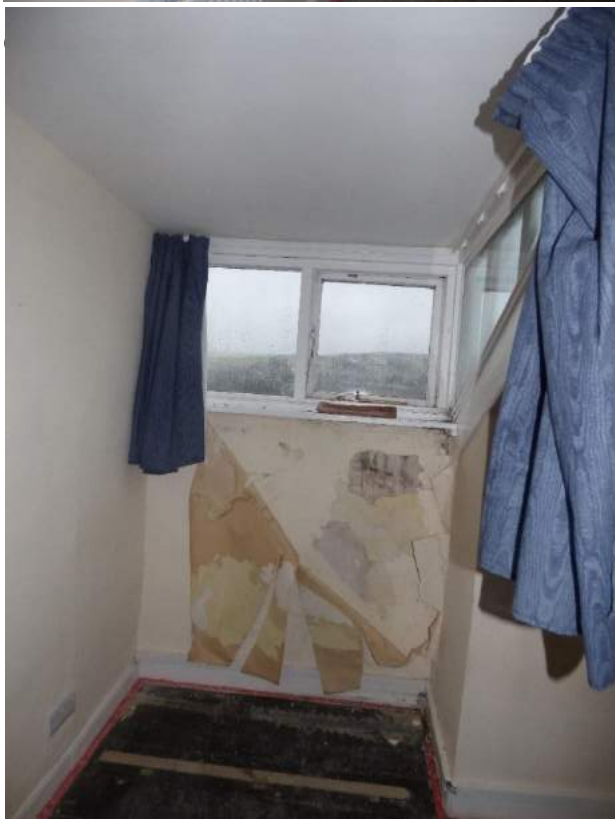
Floorboards require minor repairs.

Apply an insulated plasterboard 62mm thick to underside of ceiling. The Laminated plasterboard and PIR has a vapour barrier incorporated so interstitial moisture would be prevented. tape and skim and undertake full decorations. New rooflights to be installed.

Provide and install new heritage rooflight windows (Velux or similar), to replace existing velux windows.

Existing doors are to be removed and replaced with new heritage style four panel fire doors.
