# HERITAGE STATEMENT

## FULL RENOVATION OF EXISTING No 11 TERRACE HOUSES

St Bees, 1-11 Lonsdale Terrace, Parish Council, Cumbria

M.A.C Architects, Project Number: 2019:303

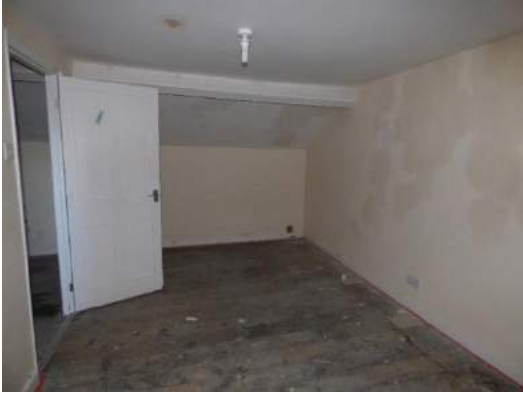
The existing bedroom partition is damaged. It is proposed to remove this wall and reconfigure the space.

In the bedroom remove all damp and damaged/blown plasterwork and repair with lime plaster and skim and decorate throughout.

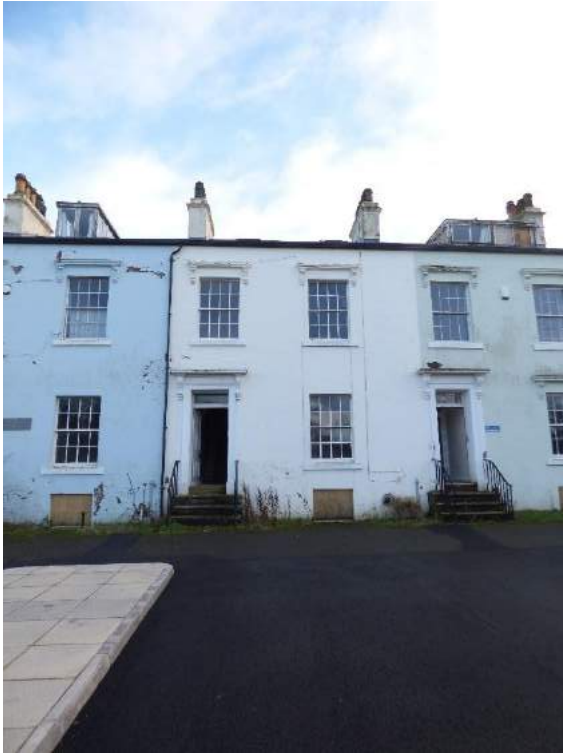
Left: The main entrance is mentioned in the listing text and is to be entirely retained.

Both front and rear elevations are currently rendered, with colour to the front and side and natural to the rear. All elevations require to be prepared for render repairs and redecoration by specialist using lime render and stucco (Parax LTD) to be applied by specialist.

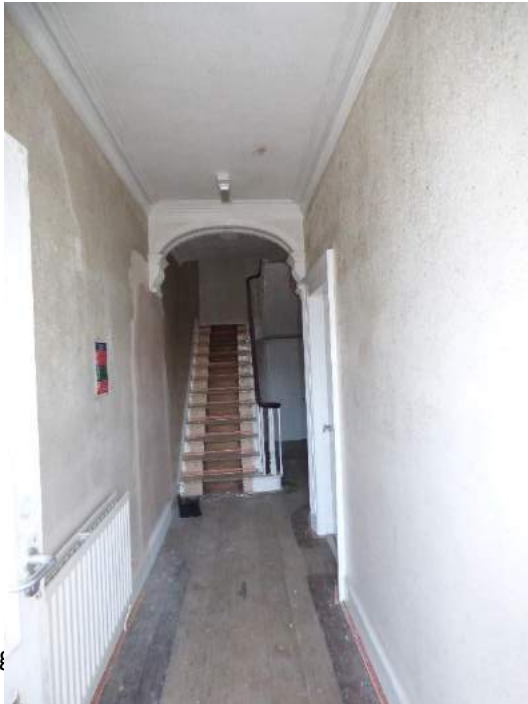
Left: The existing walls and floor are generally in good condition.

Redundant M&E to be removed and wall/ceiling finishes made good and primed, prepared and fully decorated.

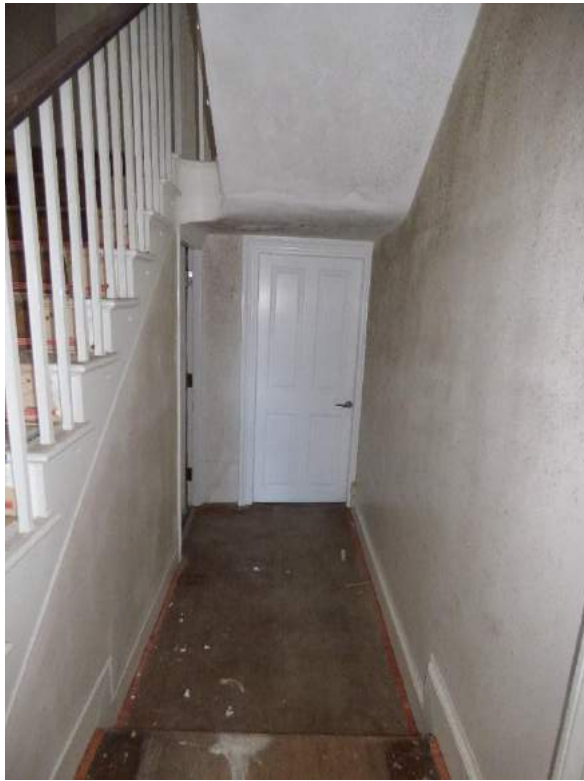
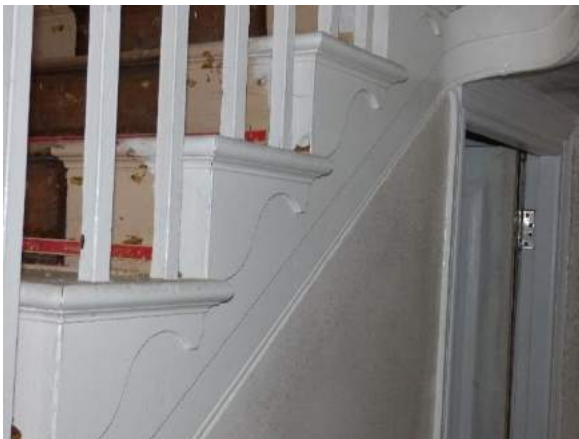
Existing staircase is original and is in excellent condition.

Below: Existing door and fanlight to be retained.

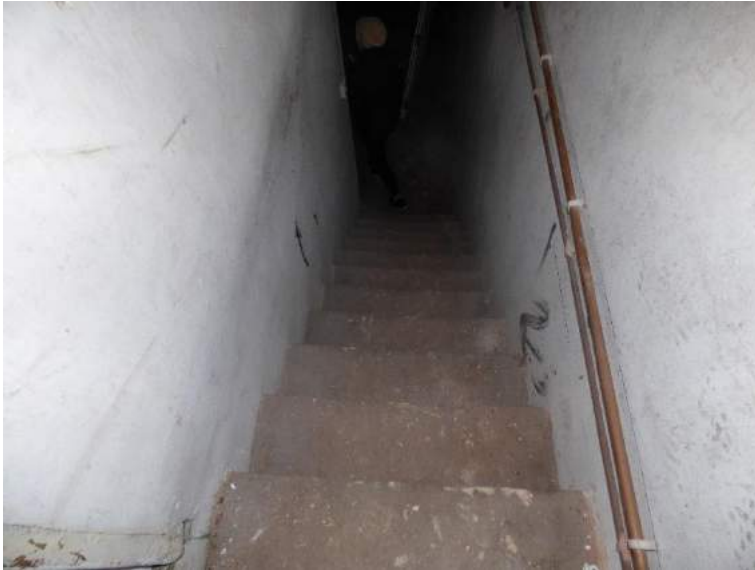
Left: The basement

The existing walls and floor are generally in sound condition so would be suitable for this application of damp proof slurry system. All existing paint and surface finishes must be removed and made good including all snots removed, and damage to existing surfaces, prior to the installation of a Koster Polysil NB1.

This migratory crystalline tanking slurry is used to seal below ground structures against water ingress.

Koster NB1 is considered to be a Type A waterproofing system as defined by BS8102:2009 and is generally used to seal the inside face of basement structures against water ingress.

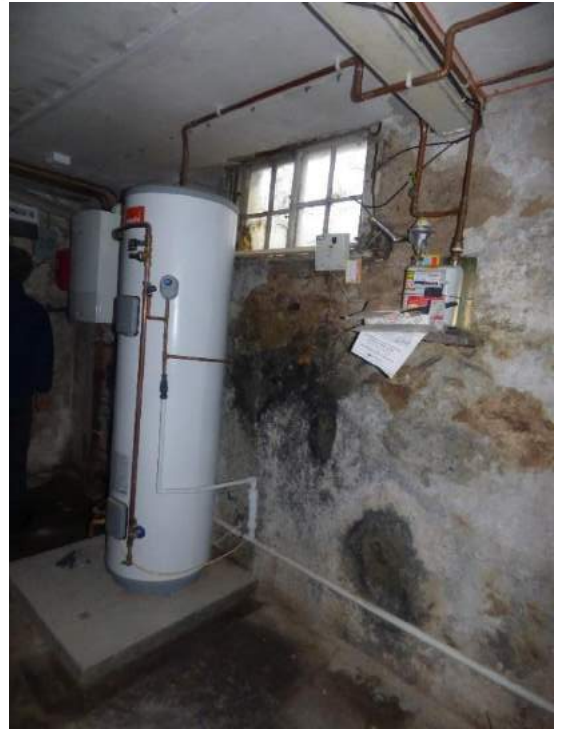
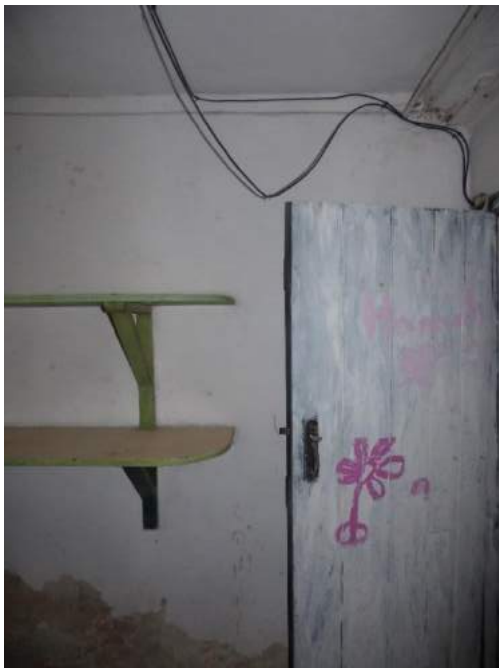
Left and above: New boiler installations have been undertaken prior to the sale of the properties.

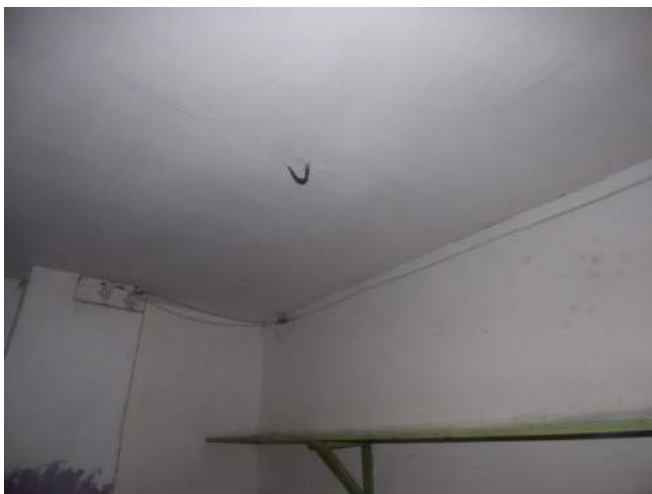
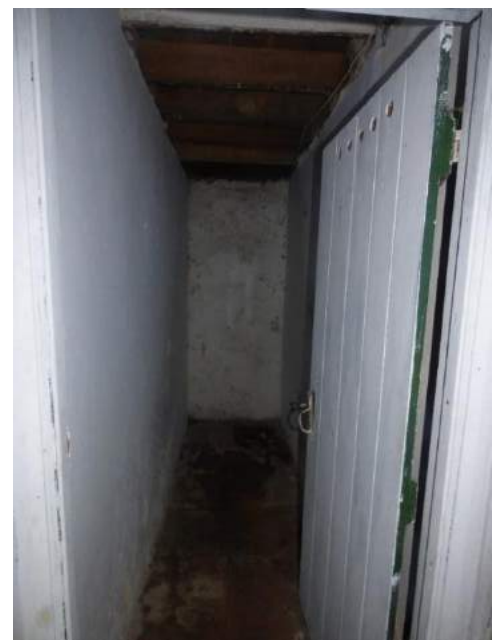
Below, left: Former window has been walled up. It is proposed to wall up properly with insulation and masonry.

The rear of the basement requires new fire doors which will be plain fire rated flush panel doors, to replace the existing.

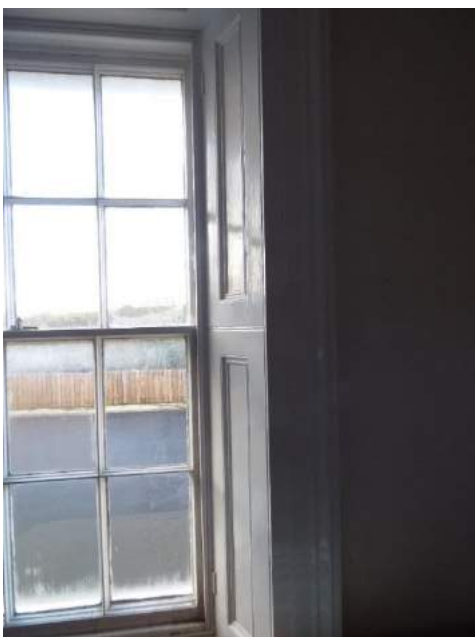
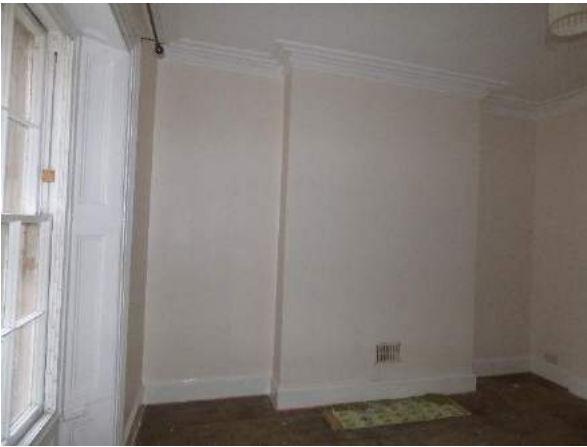
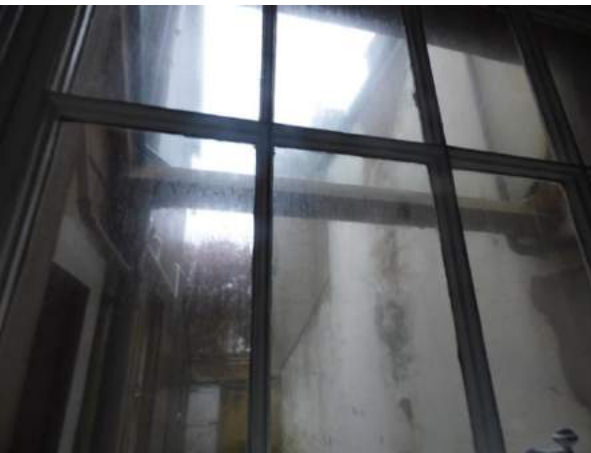
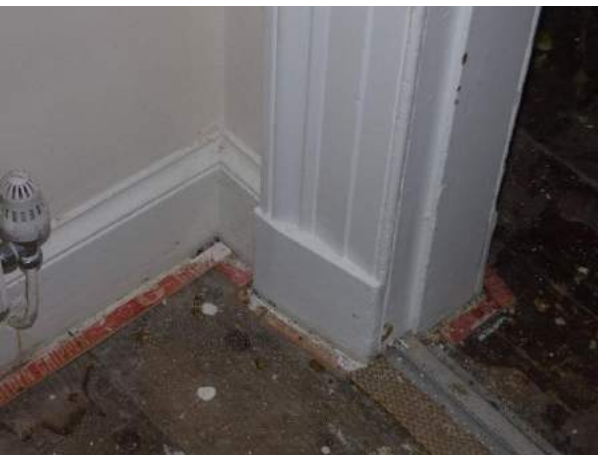
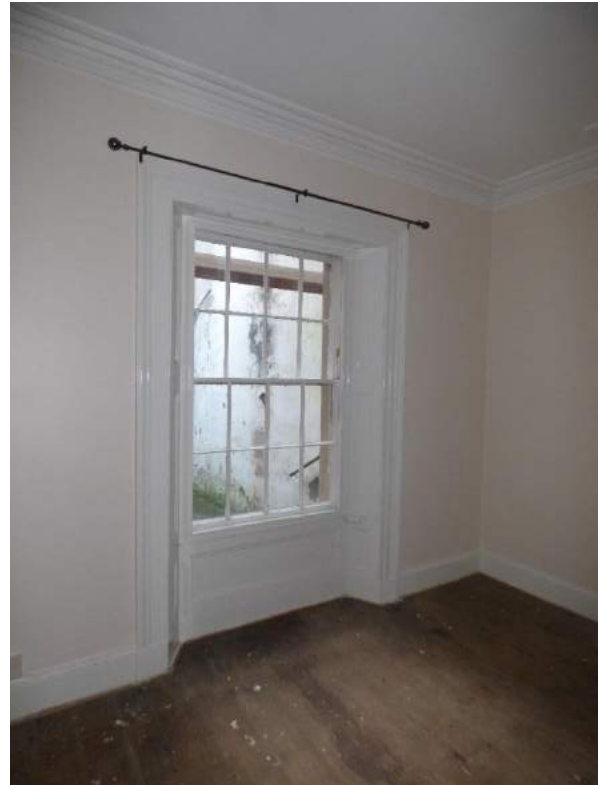
In the existing dining room, the period features below and to the sides of the features below and to the sides of the existing windows both front and back are in good condition, it is proposed to carefully refurbish the existing timber shutters.

Existing cornice to be retained.

Existing door to be replaced with heritage style four panel painted timber fire door to enhance the heritage asset. Where possible it is proposed to refurbish any original doors with door closers and intumescent paint subject to building control approval.

New opening to be formed between existing dining and lounge to accommodate open space living area (as with houses 1-5). Openings to be below cornices, which will remain intact.

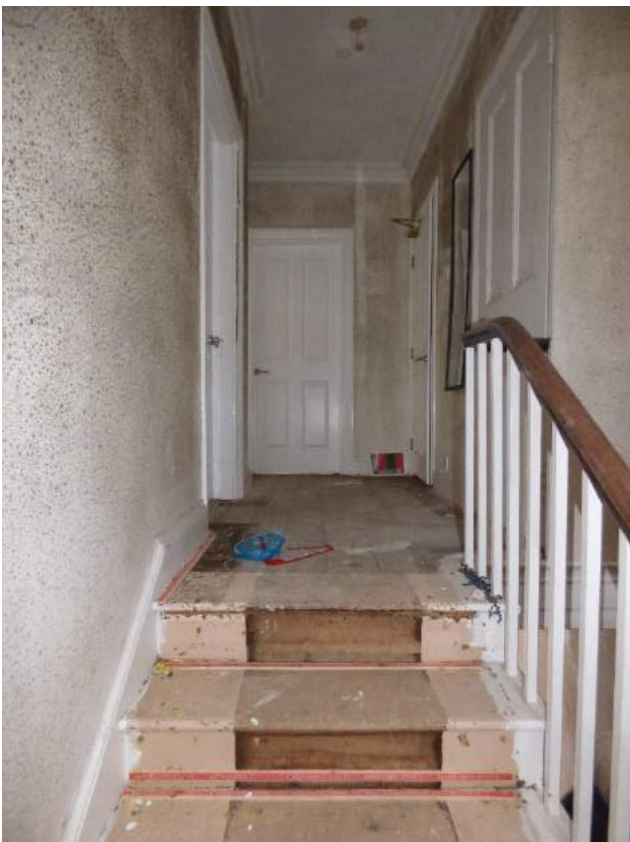
Left and above: Existing ceiling to be made good by removing mould and replacing blown plaster with lime plaster as required.

Windows to be repaired / replaced subject to planning condition.

New bathroom to be four panelled door to match the existing – bathroom door does not need to be a fire rated door. To replace existing modern bathroom door.

All finishes to be made good, and skirtings to match the original to be installed.

Existing cornices to be made good and skirtings to match existing to be reinstated.

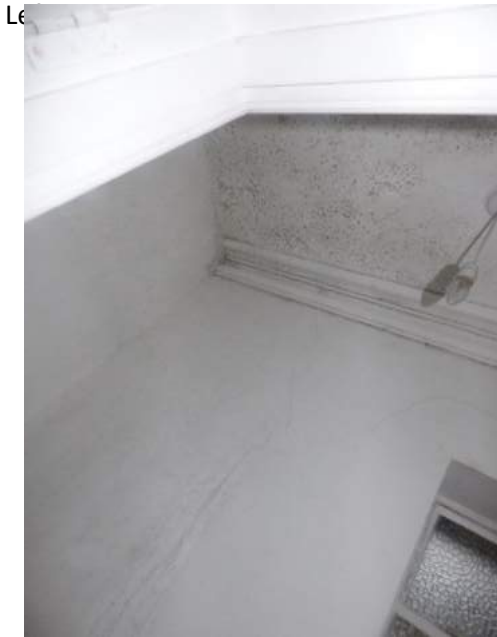
First floor w.c. to be reconfigured, and cornices and skirtings to be reinstated. All existing plasterwork affected by damp to be repaired and or reinstated as required. Roof to be repaired to ensure completely watertight.

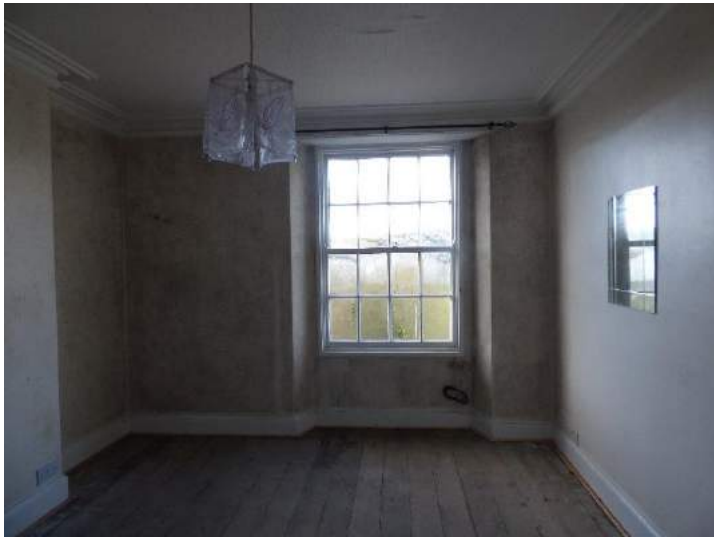
Rear bedroom - skirtings and architraves to be retained. Existing flush panelled door to be replaced with Georgian heritage style four panel fire door to be provided and installed by specialist such as Batty joinery ltd. Where possible it is proposed to refurbish any original doors with door closers and intumescent paint subject to building control approval.

Existing floorboards in good condition.

Cornice in good condition and to be retained.

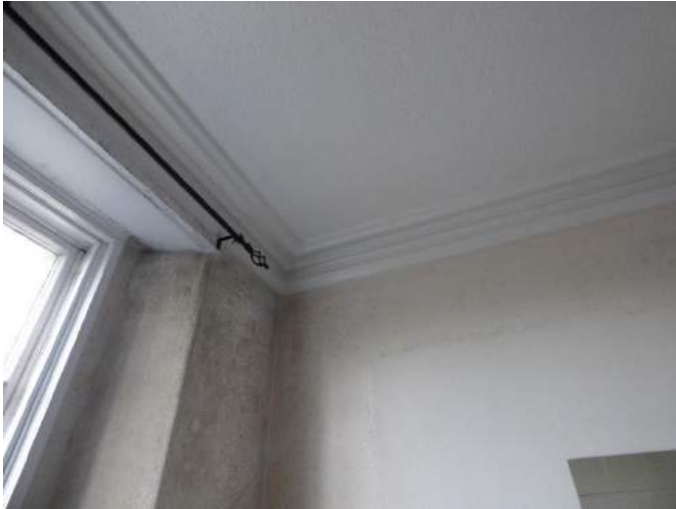
Large front bedroom, skirtings and architraves to be retained. Existing door to be replaced with new Georgian heritage style four panel door to be provided and installed by specialist joinery company such as Batty Joinery Ltd. Where possible it is proposed to refurbish any original doors with door closers and intumescent paint subject to building control approval.

Damp ingress evident with mould to walls and ceiling.

Attic and roof to be made watertight.

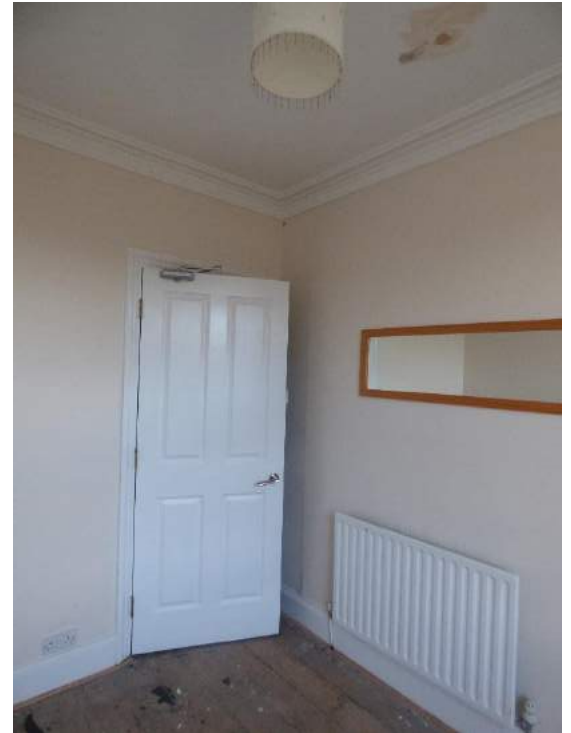
Existing small bedroom skirtings and architraves to be retained. Existing door to be removed and new doorway from proposed master bedroom to be provided and installed with new Georgian heritage style four panel door to be provided and installed by specialist joinery company such as Batty Joinery Ltd. Where possible it is proposed to refurbish any original doors with door closers and intumescent paint subject to building control approval.

Existing floorboards in good condition.

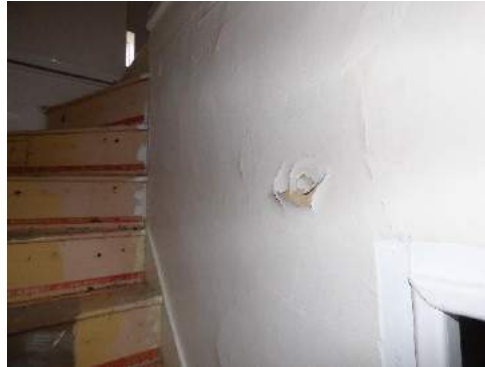
Existing staircase to attic. Existing walls require minor fabric repairs.

New four panelled fire door to be installed at first floor.

Where possible it is proposed to refurbish any original doors with door closers and intumescent paint subject to building control approval.

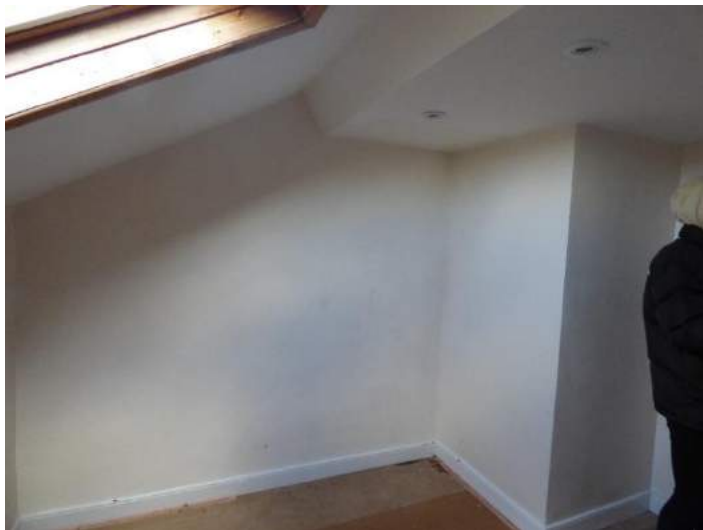
Left: Attic bedroom

The existing small attic bedroom will be reconfigured to maximise the space.

In the bedroom it is proposed to remove all blown plasterwork and repair with lime plaster and skim.

Floorboards are not original and it is proposed to replace with T&G timber floorboards

Apply an insulated plasterboard 62mm thick to underside of ceiling. The Laminated plasterboard and PIR has a vapour barrier incorporated so interstitial moisture would be prevented. New rooflights to be installed with flashing kit that mounts unit flush with the roof surface.

Provide and install new heritage rooflight windows (Velux or Rooflight company or similar) to replace modern Velux rooflights.

Existing doors are to be removed and replaced with new heritage style four panel fire doors.

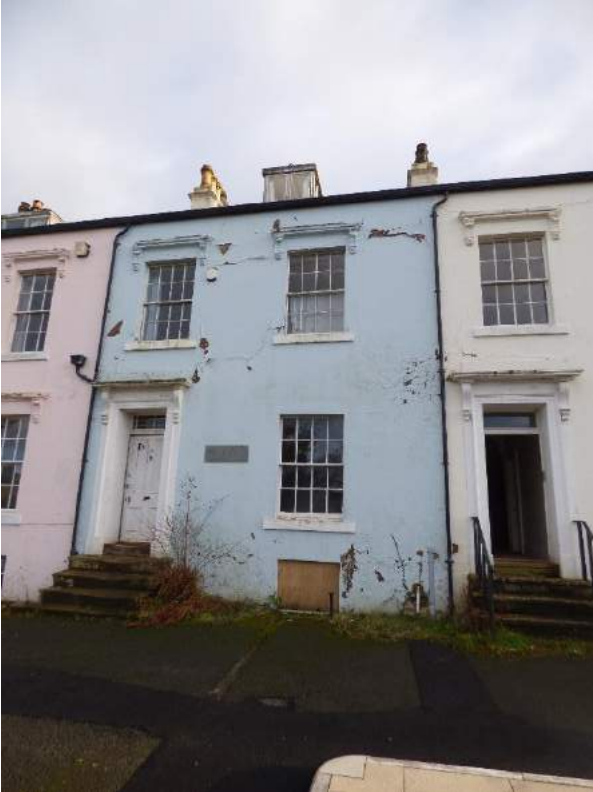
Left: The main entrance is mentioned in the listing text and is to be entirely retained.

Both front and rear elevations are currently rendered, with colour to the front and side and natural to the rear. All elevations require to be prepared for render repairs and redecoration by specialist using lime render and stucco (Parax LTD) to be applied by specialist.

The existing door and frame are to be retained and made good with the provision of new ironmongery. Once repaired full decoration will be undertaken.

Existing gutters and downpipes to be retained, repaired where necessary and decorated.

All existing single glazed windows to be replaced / repaired subject to planning condition.

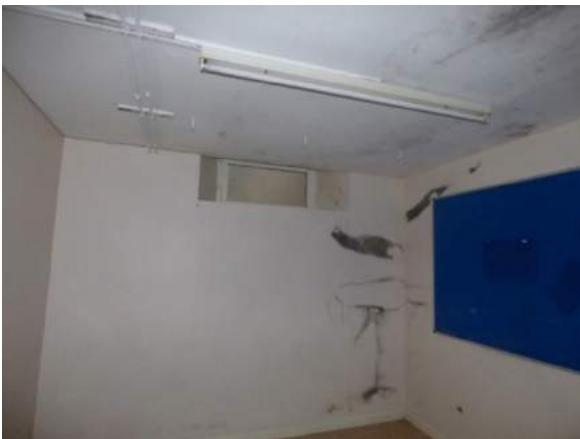
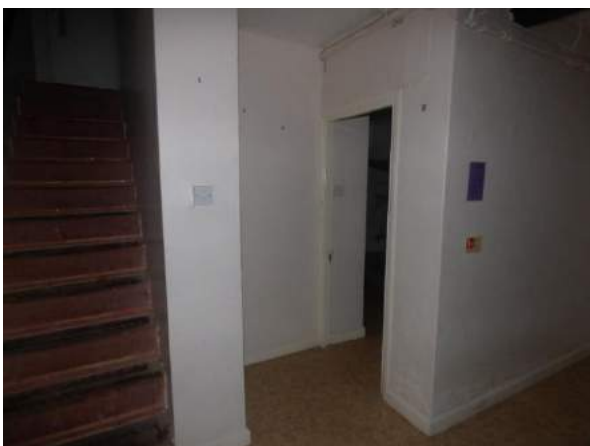
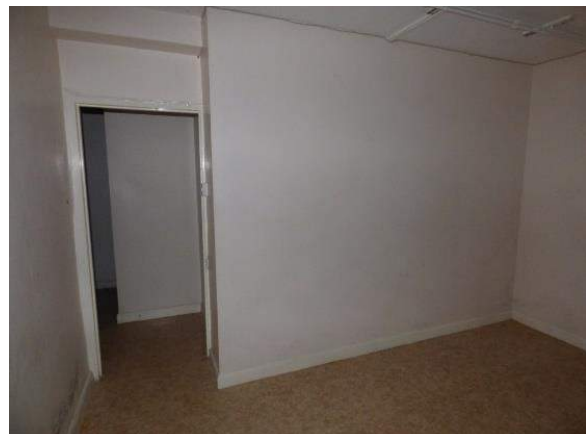
Left and below:

The walls down to the basement also require the full treatment.

In the basement all existing services are to be carefully stripped out and replaced with new compliant infrastructure.

Existing window to basement to be repaired / replaced subject to planning condition.

All existing services to be carefully removed and new gas and electric services installed.

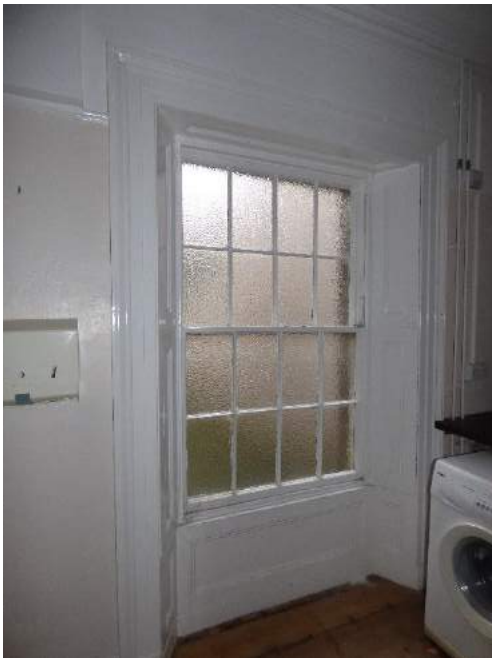
Left and below:

The exiting kitchen dining area to the rear of the property.

The period features below and to the sides of the existing window are in good condition, it is proposed to carefully refurbish the existing timber shutters.

Below: Existing cornice to be made good in locations and where hairline cracks have appeared.

The existing floor is not original as it is plywood boarded, so it is proposed to lift the existing floor and investigate the condition of floor joists and then replace with timber floorboards.

Flush panel doors to be replaced with heritage style four panel painted timber fire doors to enhance the heritage asset.

Where possible it is proposed to refurbish any original doors with door closers and intumescent paint subject to building control approval.

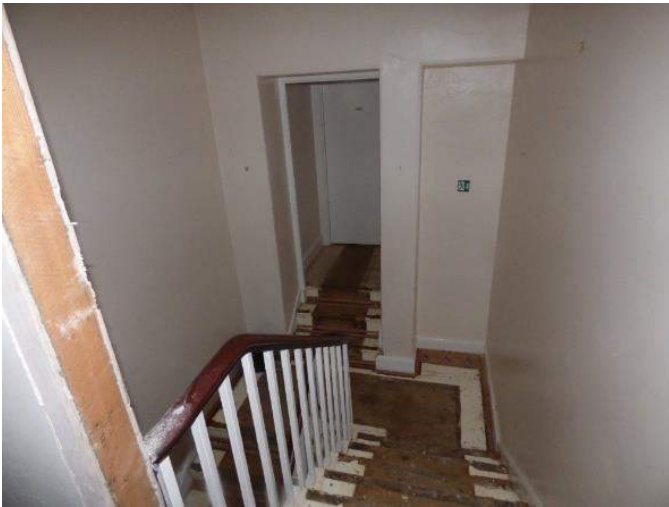
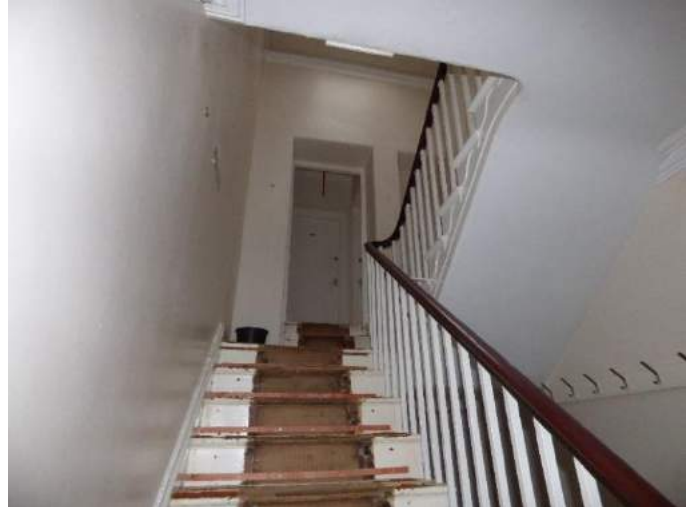
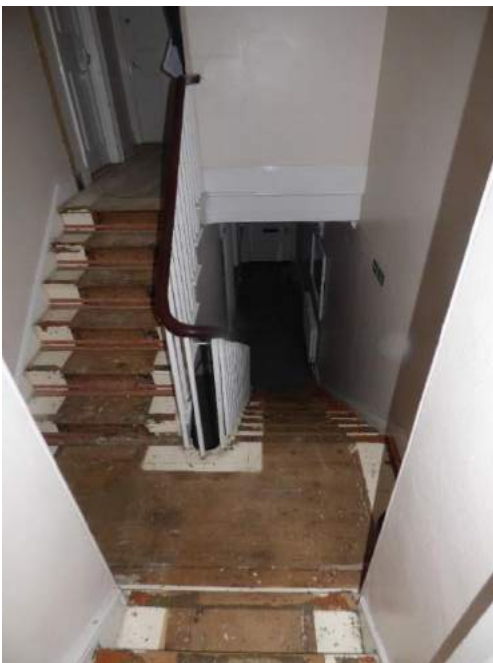
The original staircase is in good condition and is to be retained.

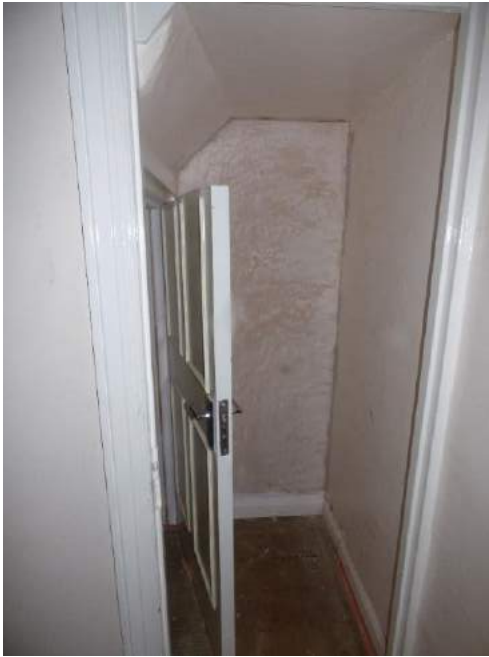
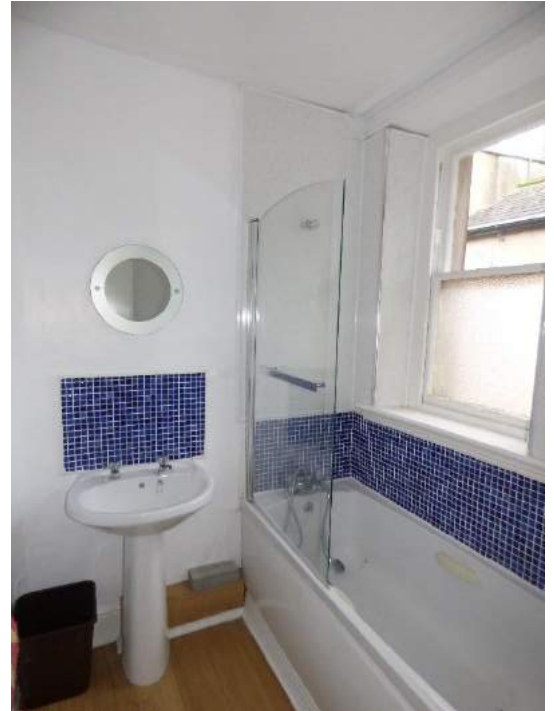
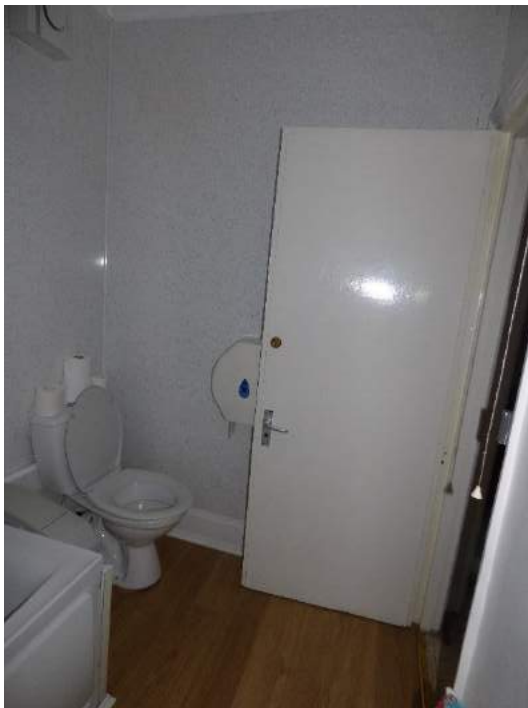
Above left; under stairs storage to be reconfigured to make better use of space.

Above and left: Existing bathroom to be stripped out and the existing walls to be removed to reconfigure this space to be more conducive to modern day living.

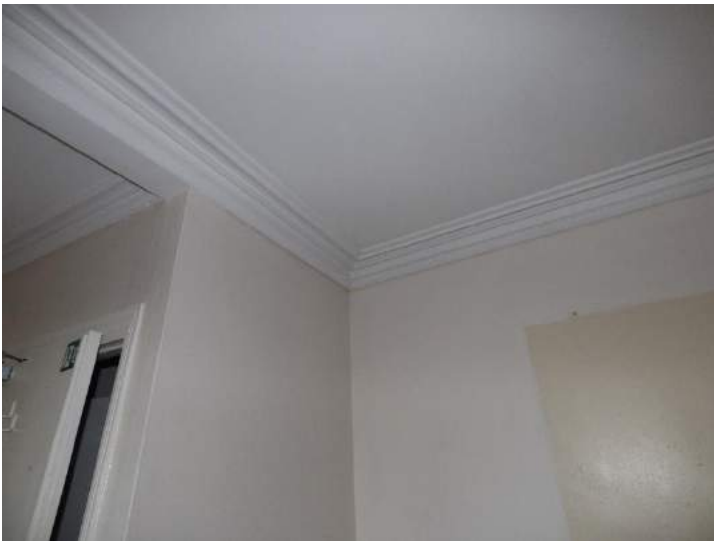
Location of original doorway which has been walled up. Original doorway to be reinstated.

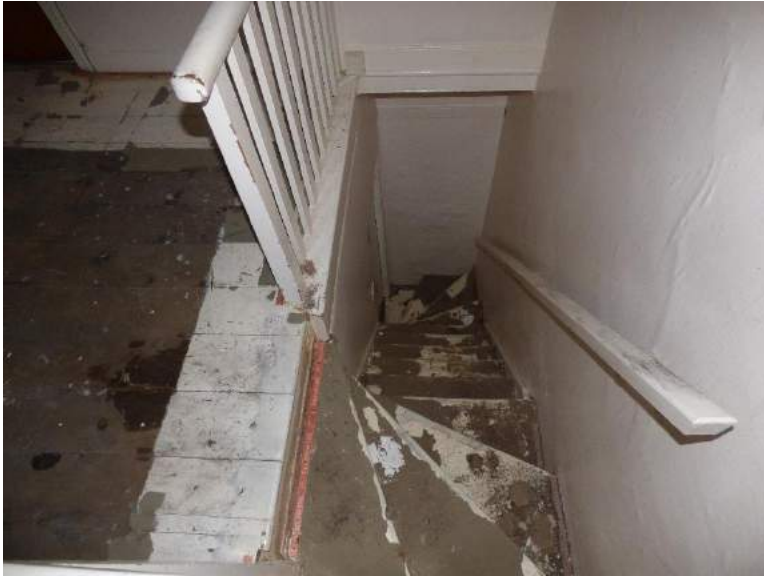
Existing staircase to attic rooms. New balustrade and handrail to be installed to match the existing at ground / first floor and at a height to comply with building regulations.

Apply an insulated plasterboard 62mm thick to underside of ceiling. The Laminated plasterboard and PIR has a vapour barrier incorporated so interstitial moisture would be prevented. Tape and skim and undertake full decorations.

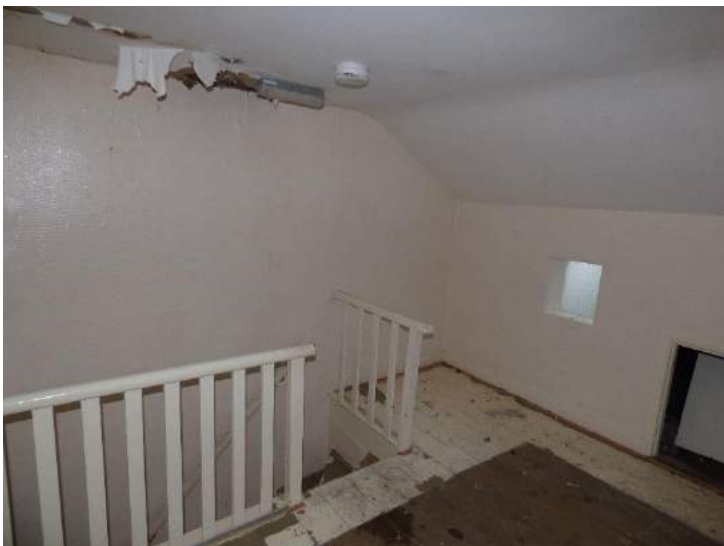
Damaged plaster to ceiling to be repaired with a lime plaster finish (Solo lime plaster from Lime Centre)..

New plasterboard stud partitions to be installed to reconfigured space.

In the bedroom remove all damp and damaged/blown plaster and repair with lime plaster and skim and decorate throughout.

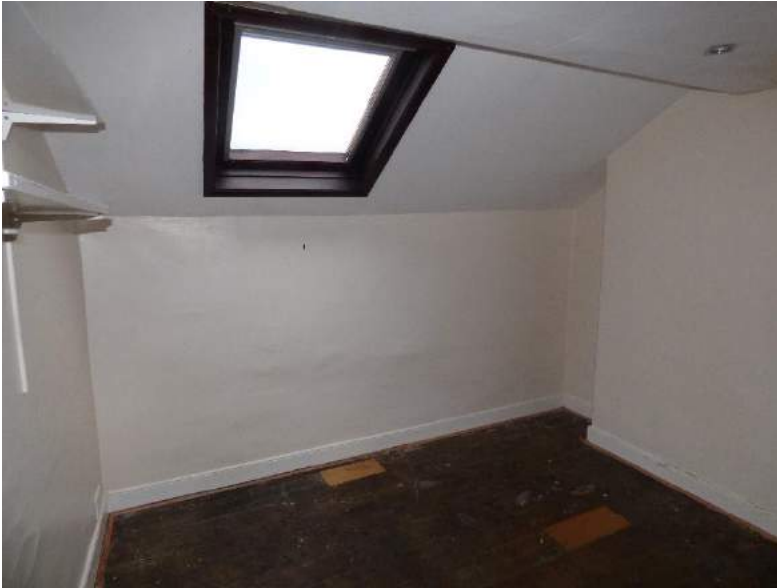
Floorboards are generally in good condition (but may require some minor repairs).

Apply an insulated plasterboard 62mm thick to underside of ceiling. The Laminated plasterboard and PIR has a vapour barrier incorporated so interstitial moisture would be prevented. New rooflights to be installed with flashing kit that mounts unit flush with the roof surface.

Tape and skim plasterboard and undertake full decoration. Existing rooflights to be replaced with new heritage style rooflights by Velux or the Rooflight company or similar.

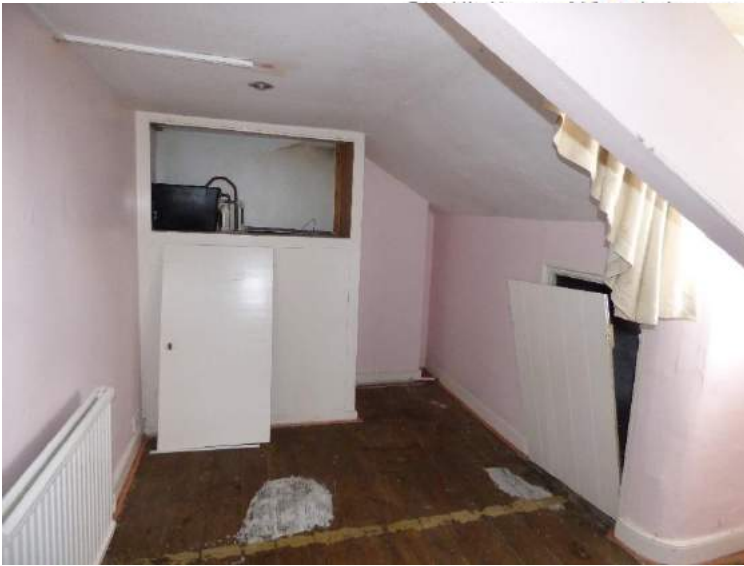
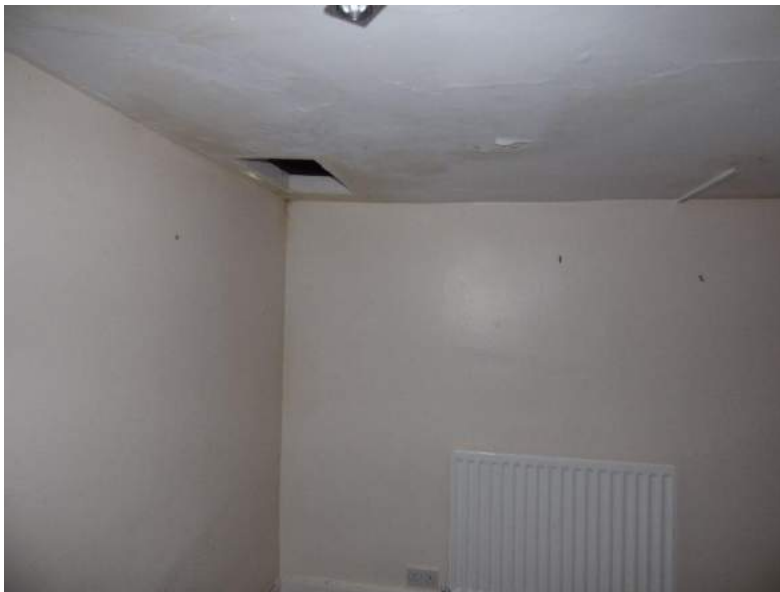
Left: Attic bedroom

Remove all damp and damaged/blown plaster and repair with lime plaster and skim and decorate throughout.

New plasterboard stud partitions to be installed in reconfigured attic space.

Apply an insulated plasterboard 62mm thick to underside of ceiling. The Laminated plasterboard and PIR has a vapour barrier incorporated so interstitial moisture would be prevented. New rooflights to be installed with flashing kit that mounts unit flush with the roof surface.

Tape and skim and undertake full decoration.

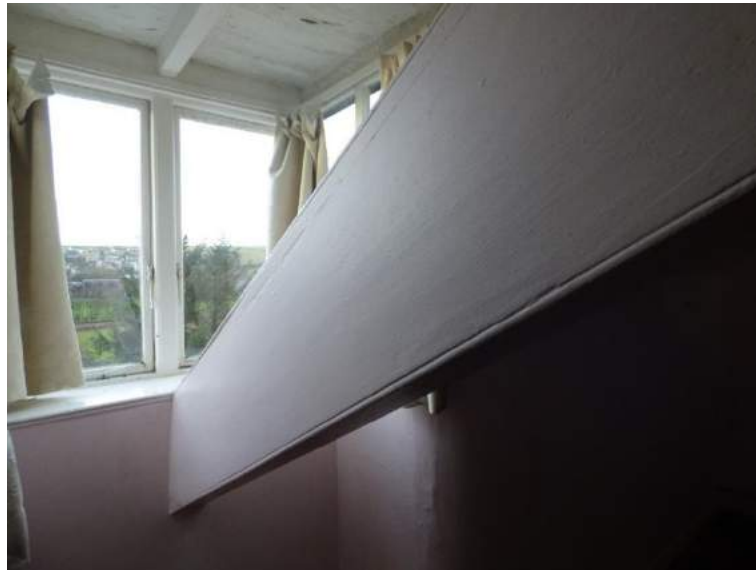
Floorboards are in good condition (but may require some minor repairs)

New heritage style window to be installed subject to planning condition. and new heritage rooflights (Velux or similar), in lieu of existing modern rooflights. And new heritage rooflight windows (Velux or similar with flashing kit that mounts unit flush with the roof surface).

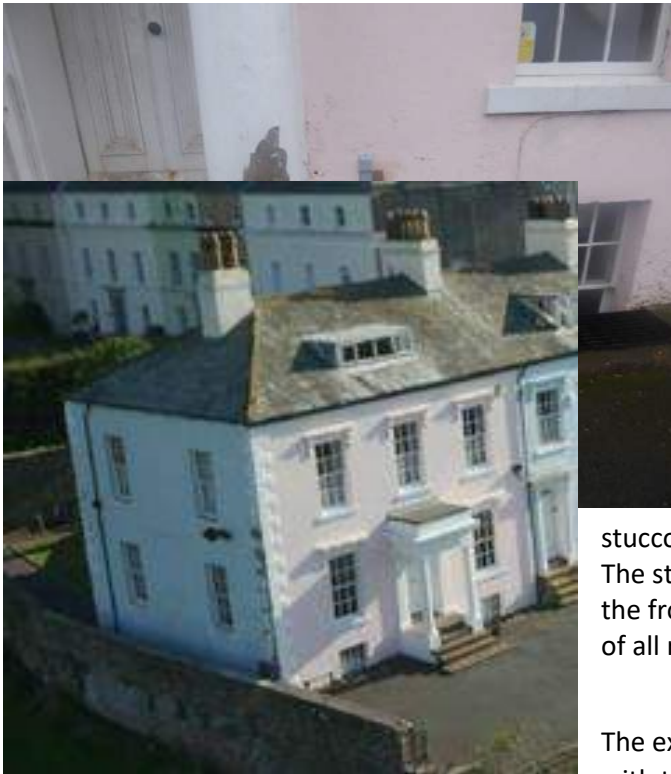
Left: The main entrance is mentioned in the listing text and is to be entirely retained.

All elevations require to be prepared for render repairs and redecoration by specialist using lime render and stucco (Parax LTD) to be applied by specialist. The stucco features above the windows and door on the front elevation will be carefully restored by a specialist. Colour of all render and stucco to match existing.

The existing door and frame are to be retained and made good with the provision of new ironmongery. Once repaired full decoration will be undertaken.

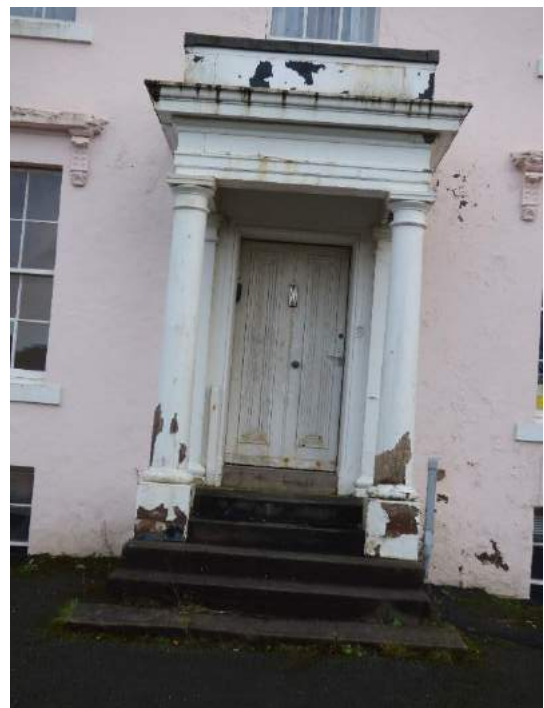
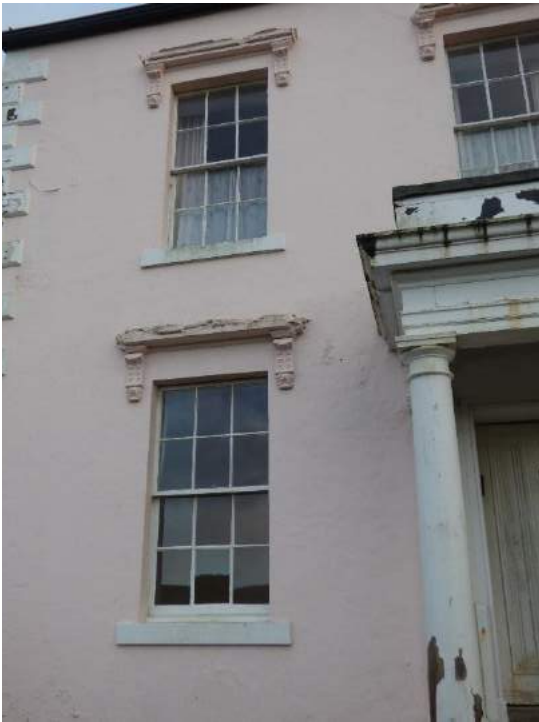
Localised lead repair work required to chimneys, to prevent leaking.

Existing gutters and downpipes to be retained, repaired where necessary and decorated.

All existing single glazed windows to either be replaced / repaired subject to planning condition.

Existing cills to be repaired and decorated.

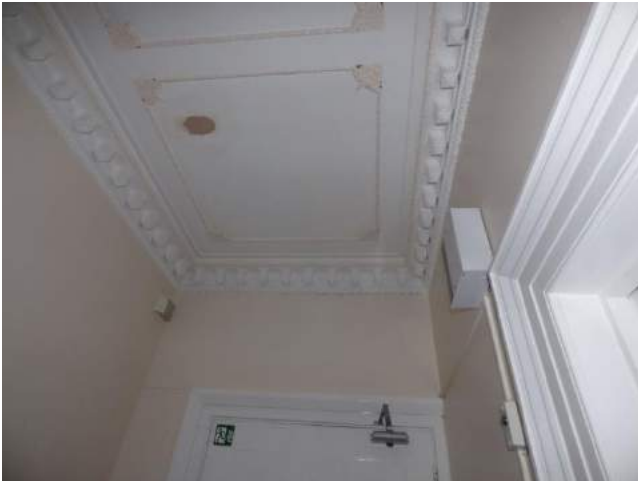
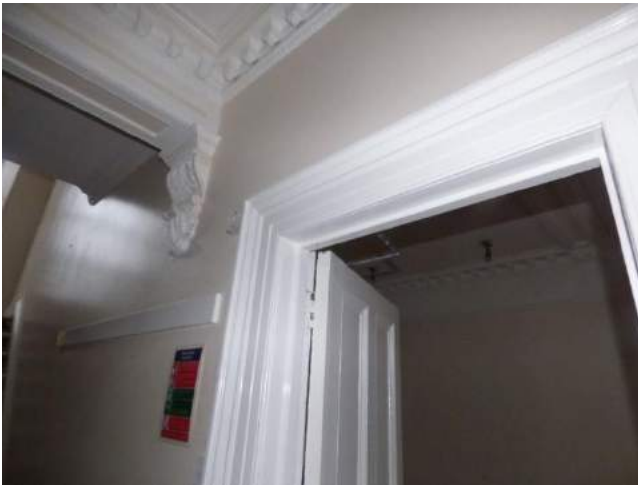
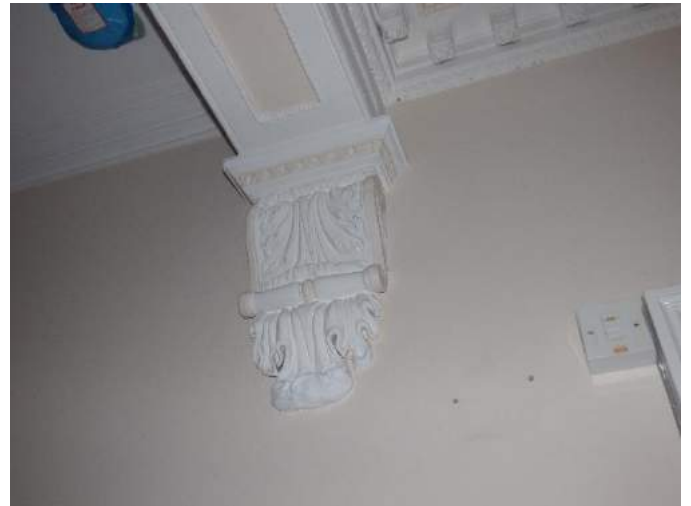
Period features are in extremely good condition and all are to be retained.

Ceiling to be repaired where existing light fittings are to be removed.

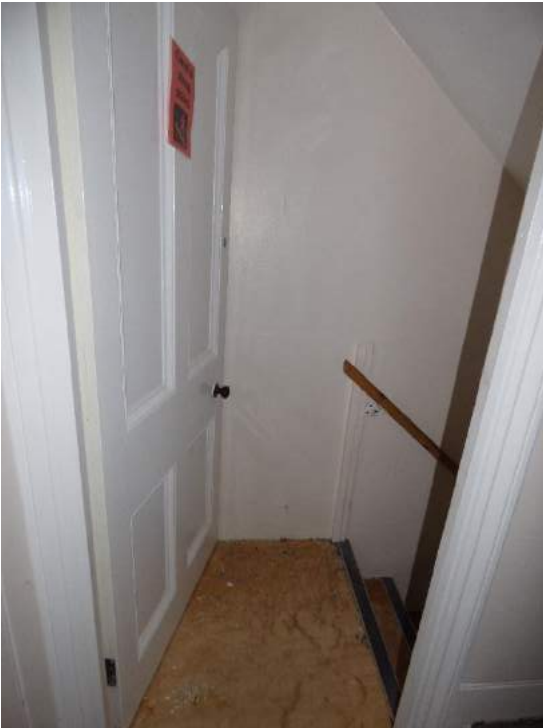
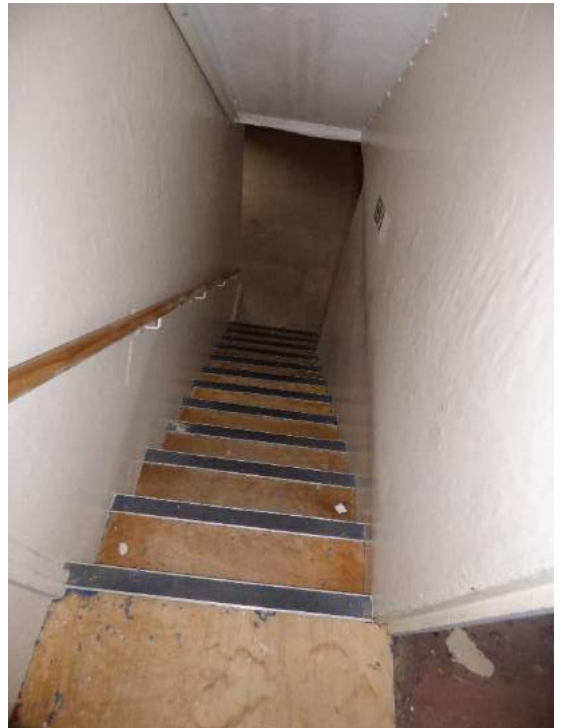
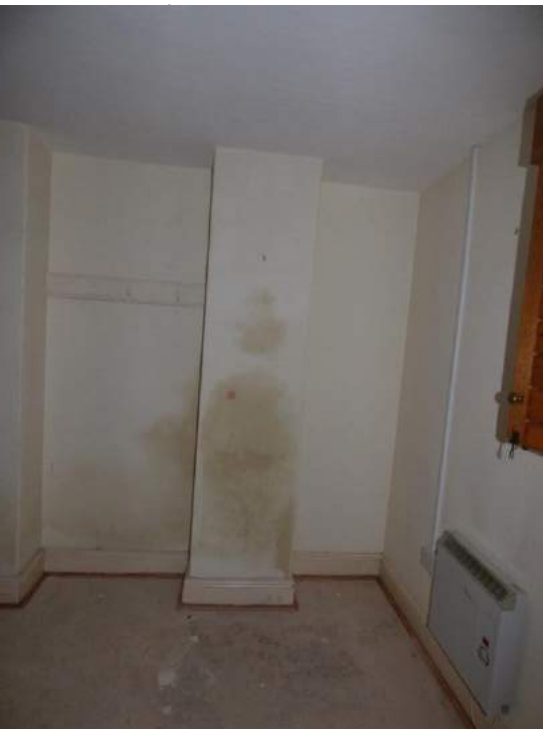
The existing basement. The existing walls and floor are generally in sound condition so would be suitable for the application of damp proof slurry system.

Some of the walls have been overboarded, but the basement has not been treated for damp and moisture is penetrating the walls that have been overboarded.

All existing paint and surface finishes must be removed and made good including all snots removed, and damage to existing surfaces, prior to the installation of a Kloster Polysil NB1. This migratory crystalline tanking slurry is used to seal below ground structures against water ingress.

Kloster NB1 is a breathable water proof system which will enhance the thermal value of the building without increasing the moisture content of the wall.

Koster NB1 is considered to be a Type A waterproofing system as defined by BS8102:2009 and is generally used to seal the inside face of basement structures, slabs and retaining walls.

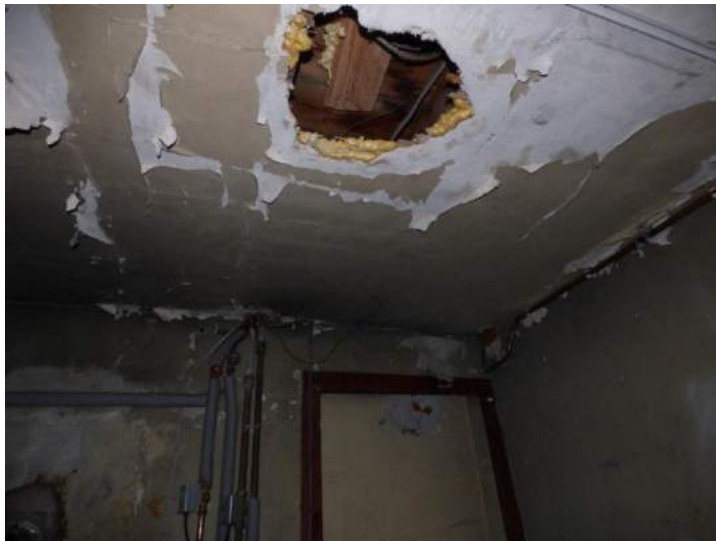
Damp affects the entire basement.

All redundant M&E, conduits and FF&E to be removed.

Ceiling to be repaired with fire resistant plasterboard.

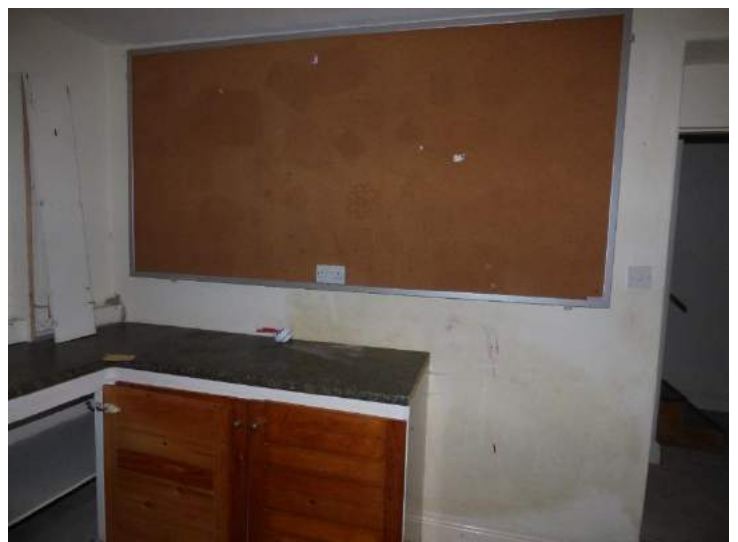
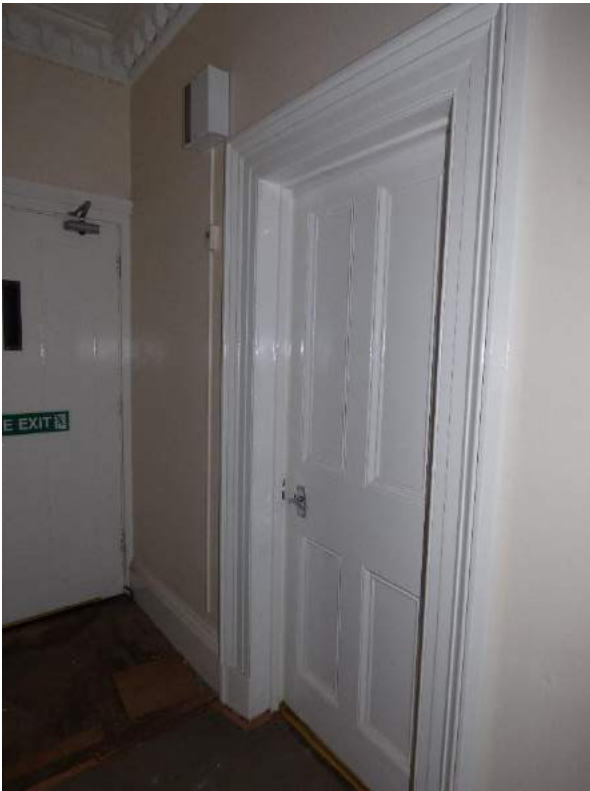
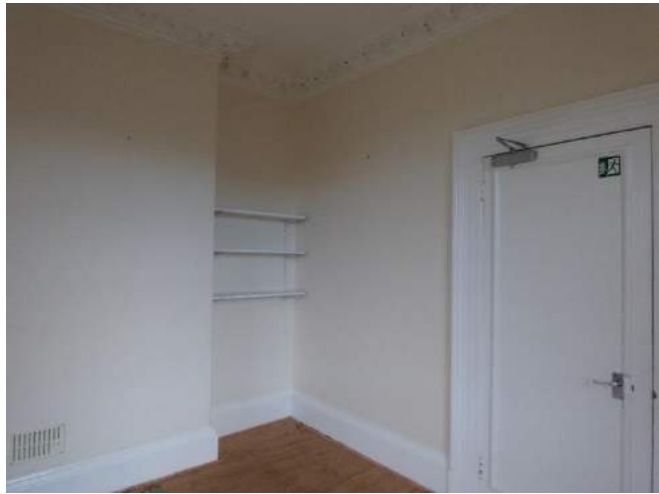
Above and Left:

Existing front room requires minor damp treatment and walls to be made good following repairs.
