# HERITAGE STATEMENT

## FULL RENOVATION OF EXISTING No 11 TERRACE HOUSES

St Bees, 1-11 Lonsdale Terrace, Parish Council, Cumbria

M.A.C Architects, Project Number: 2019:303

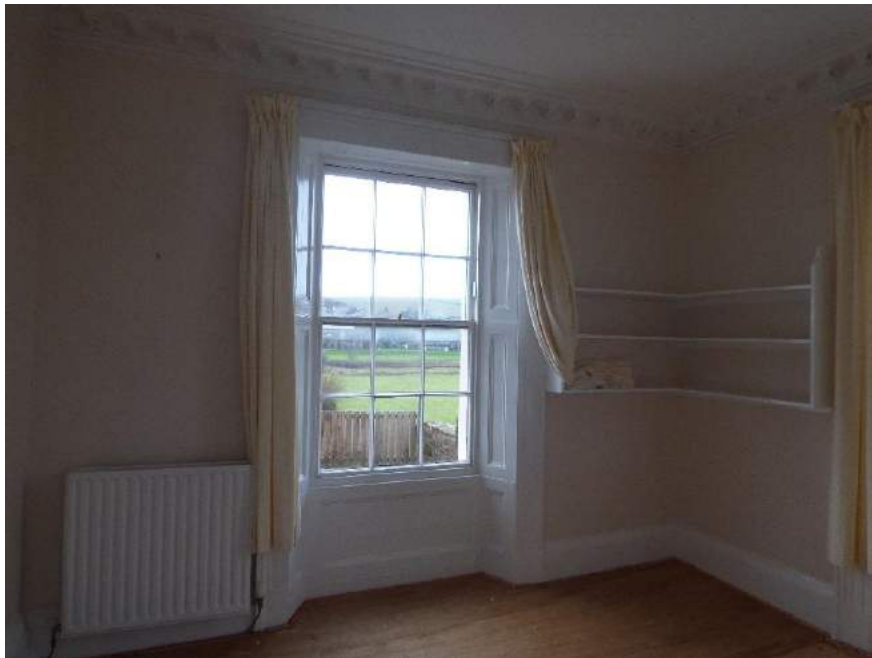
The period features below and to the sides of the existing window are in good condition, it is proposed to carefully refurbish the existing timber shutters.

Left: Existing cornice to be made good in locations where redundant services are to be removed and where hairline cracks have appeared.

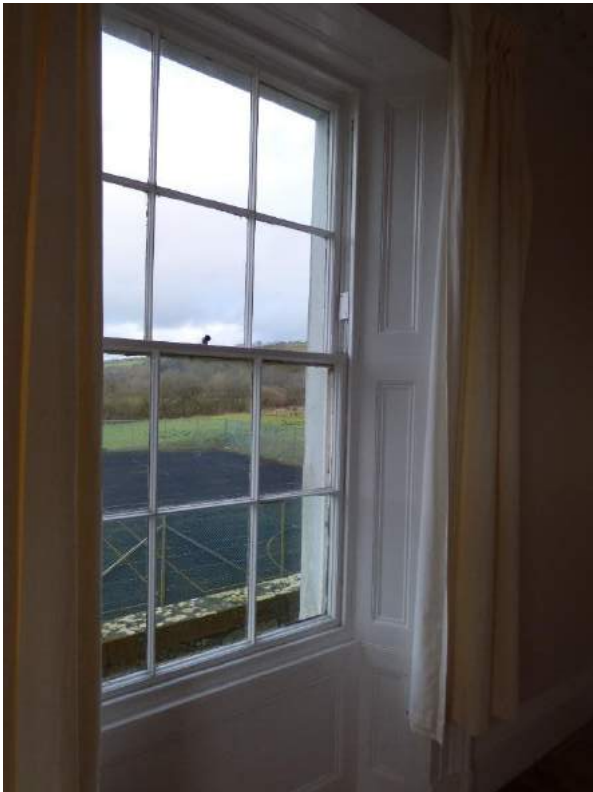
In the existing dining room at the rear of the property the period features below and to the sides of the existing window are in good condition, it is proposed to carefully refurbish the existing timber shutters.

Below: existing cornice to be made good in locations and where hairline cracks have appeared.

Existing architraves and skirtings to be retained and made good.

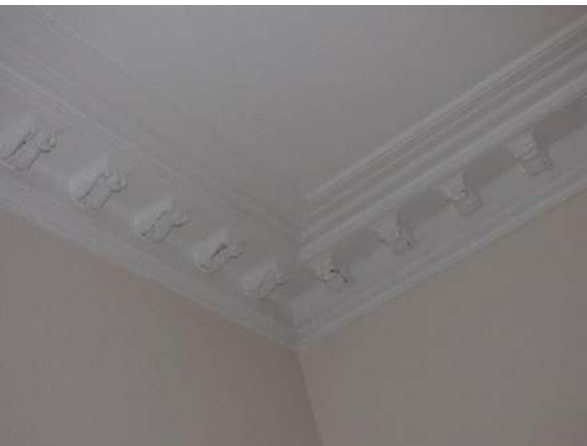
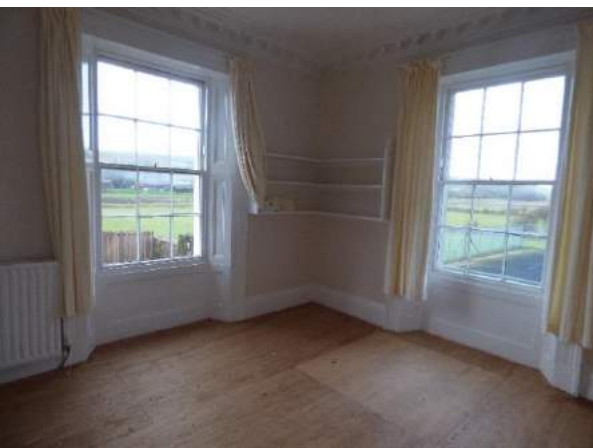
Above and below: In the existing through lounge, the period features below and to the sides of the existing windows both front and back are in good condition. It is proposed to carefully refurbish the existing timber shutters.

The existing floor is not original and is plywood. It is proposed to lift the plywood boards and examine the existing joists to ensure that they are in good condition, and reinstate and repair as necessary.

Existing cornice to be made good in locations where redundant services are to be removed and where hairline cracks have appeared.

Flush panel doors to be replaced with heritage style painted timber fire doors to enhance the heritage asset. Where possible it is proposed to refurbish any original doors with door closers and intumescent paint subject to building control approval.

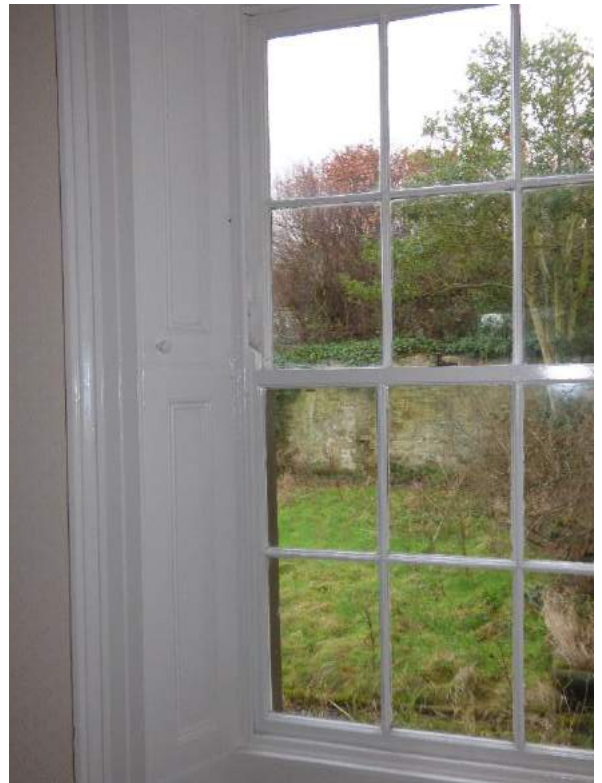
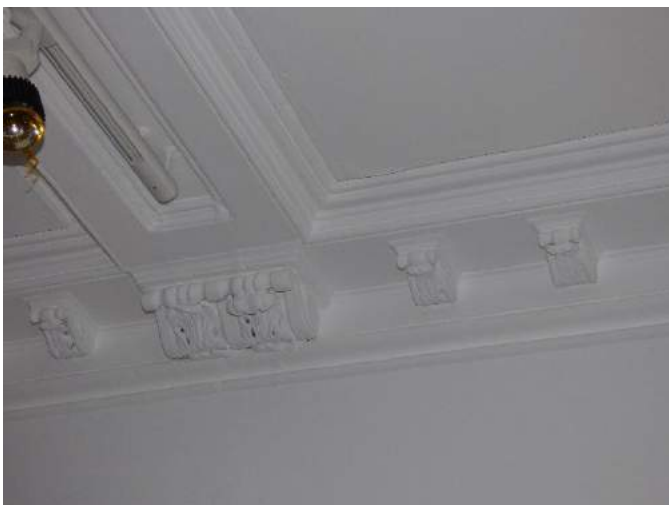
Above: Period features have remained in excellent condition and are to be retained.

Left: In the existing dining room at the rear of the property

the period features below and to the sides of the existing windows are in good condition, it is proposed to carefully refurbish the existing timber shutters.

Below: existing cornice to be made good in locations and where hairline cracks have appeared.

Existing architraves and skirtings to be retained and made good.

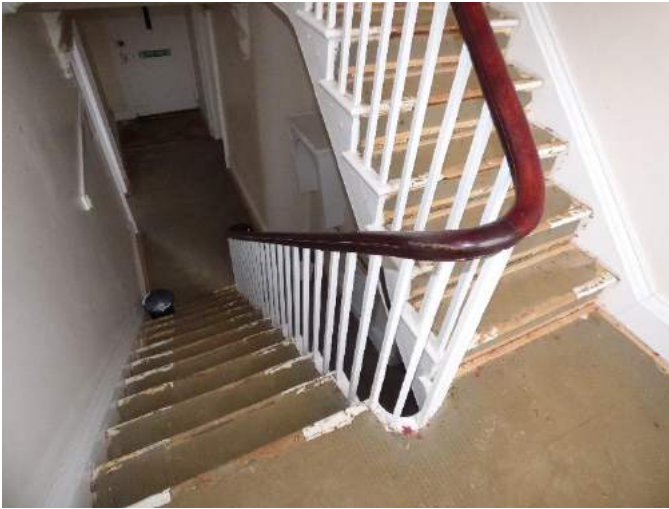
Retain the original staircase, which is in good condition.

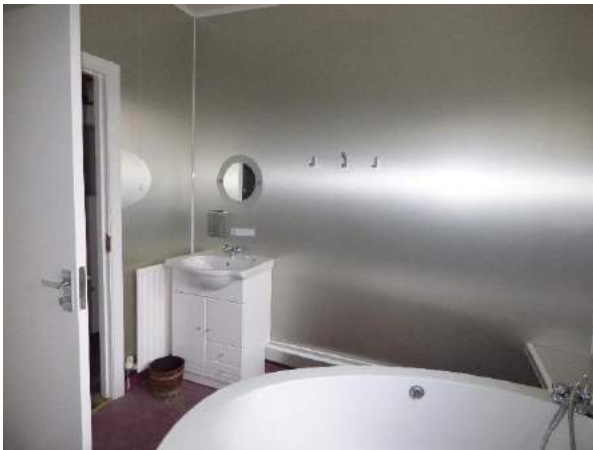
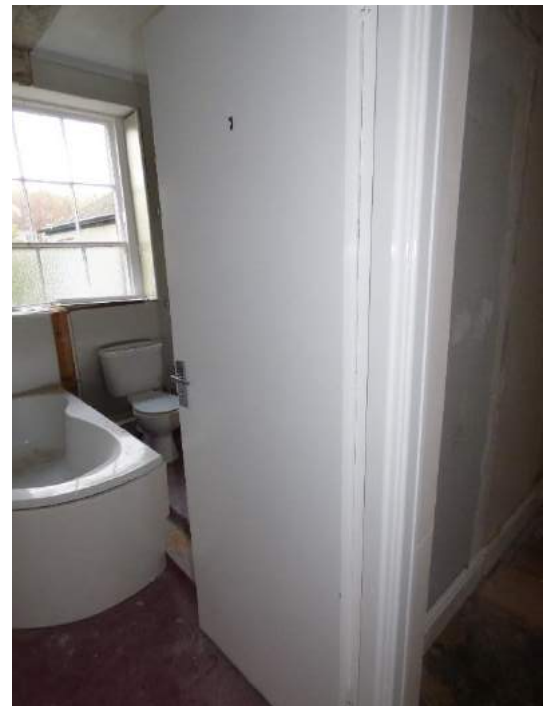
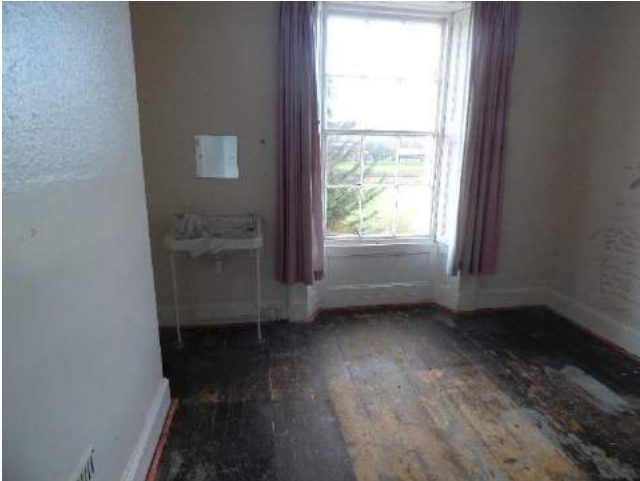
Left and below:

Rear bedroom, skirting and architraves to be retained. Existing flush panelled door to be replaced with new Georgian heritage style four panel fire door to be provided and installed by specialist joinery company such as Batty Joinery Ltd . Where possible it is proposed to refurbish any original doors with door closers and intumescent paint subject to building control approval.

Existing floorboards in good condition.

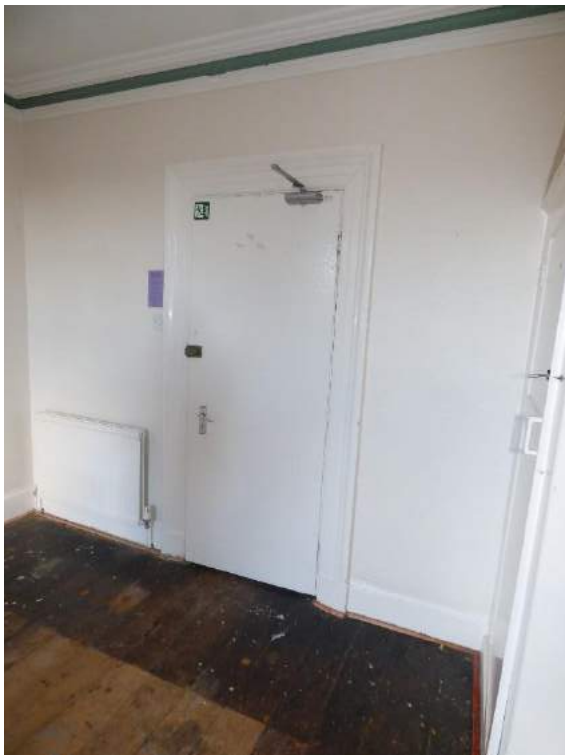
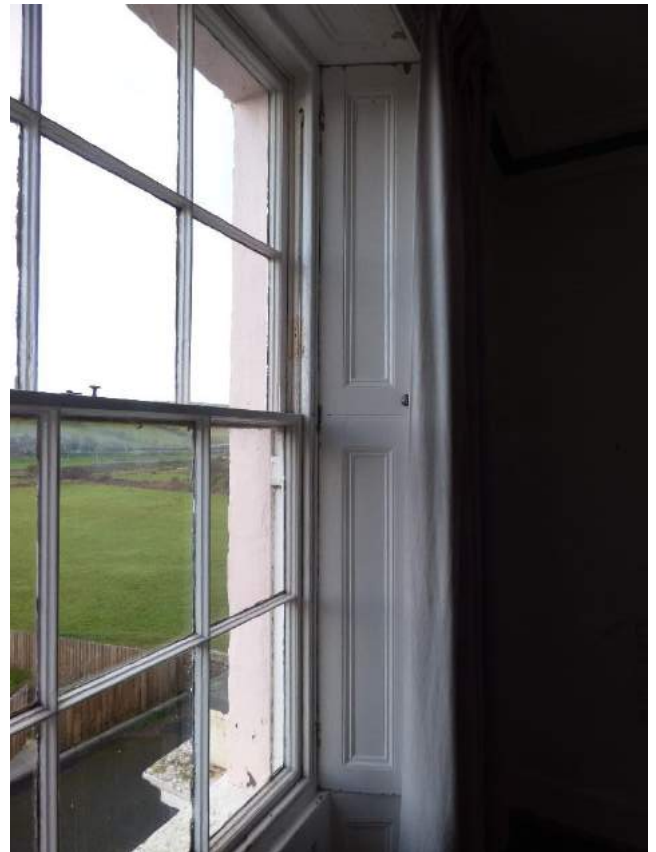
Above and left:

Front bedroom has stunning heritage features in excellent condition. Skirtings, cornices and architraves to be retained. Existing flush panelled door to be replaced with new Georgian heritage style four panel fire door to be provided and installed by specialist joinery company such as Batty Joinery Ltd.

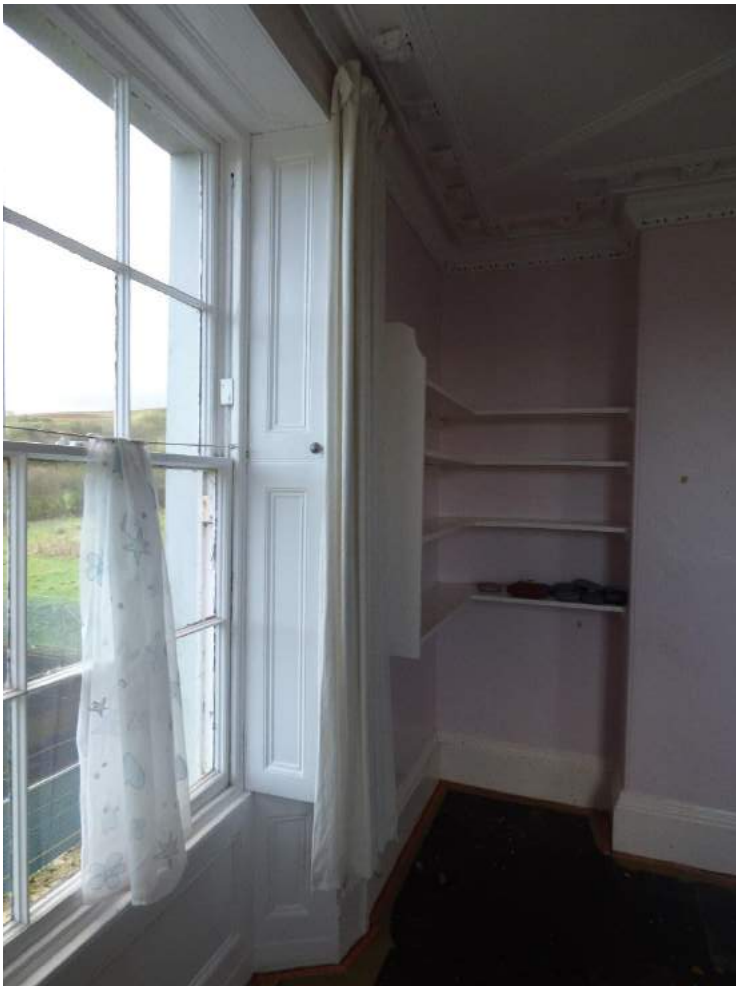
Left: Intricate ceiling moulds are to be retained, and existing lighting to be removed.

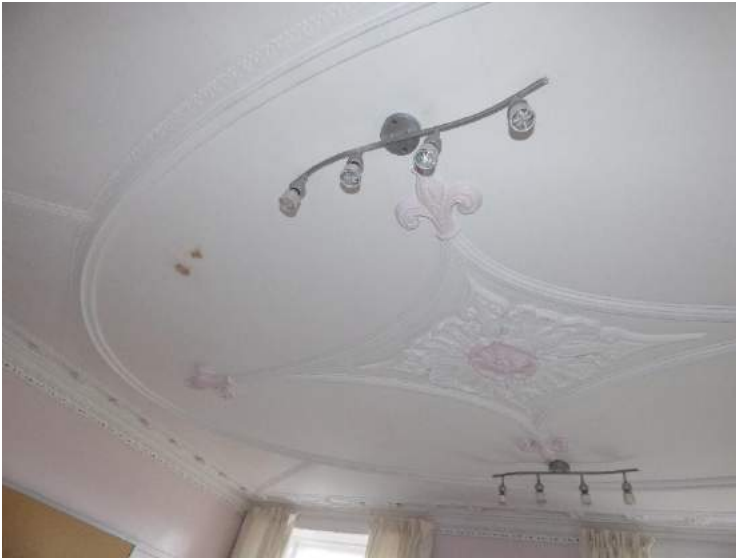
Left Cornice to be retained.

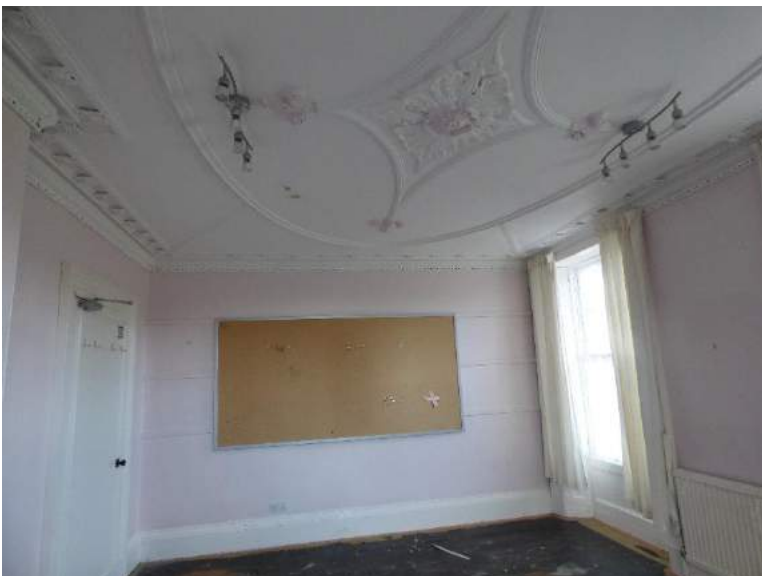
Left:

Front bedroom, skirtings, cornices and architraves to be retained. Existing flush panelled door to be replaced with new Georgian heritage style four panel door to provided and installed by specialist joinery company such as Batty Joinery Ltd. Where possible it is proposed to refurbish any original doors with door closers and intumescent paint subject to building control approval.

Bedroom to become En-suite to master bedroom.

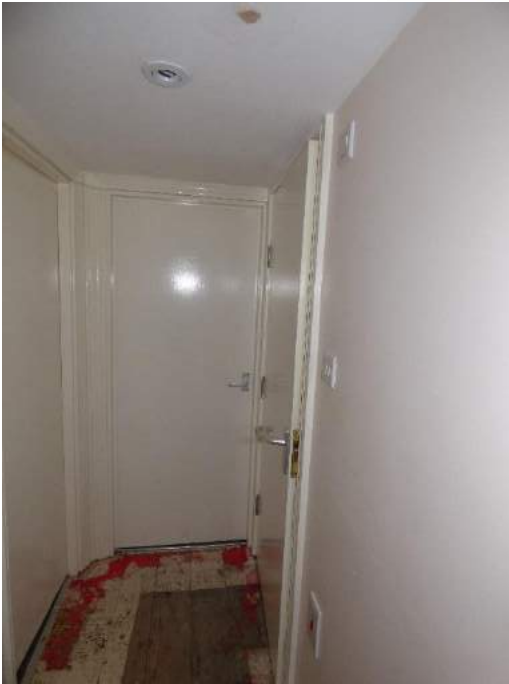
Left and following pages:

Kitchen / Living areas

Remove all damp and damaged / blown plasterwork and repair with lime plaster and skim and decorate throughout.

Repair existing ceiling following repairs to slate roof and replacement lead flashings to chimneys.

Once ceiling has been repaired, apply an insulated plasterboard 62mm thick to underside of ceiling tape and skim, and undertake full decorations.

Completely remove existing dormer and reconstruct new dormer (compliant with statutory requirements).

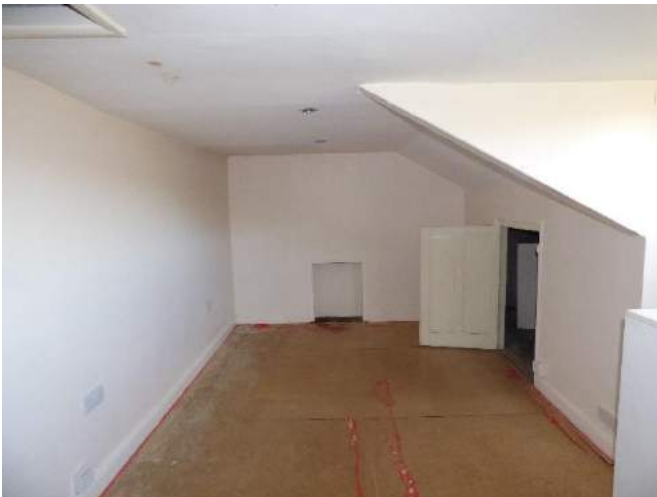
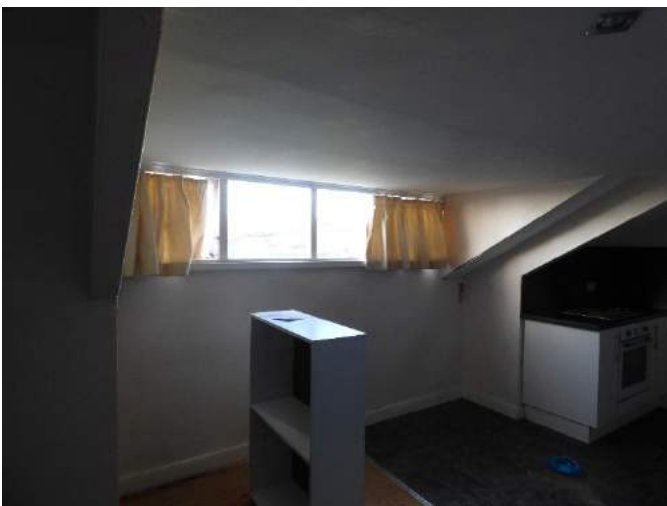
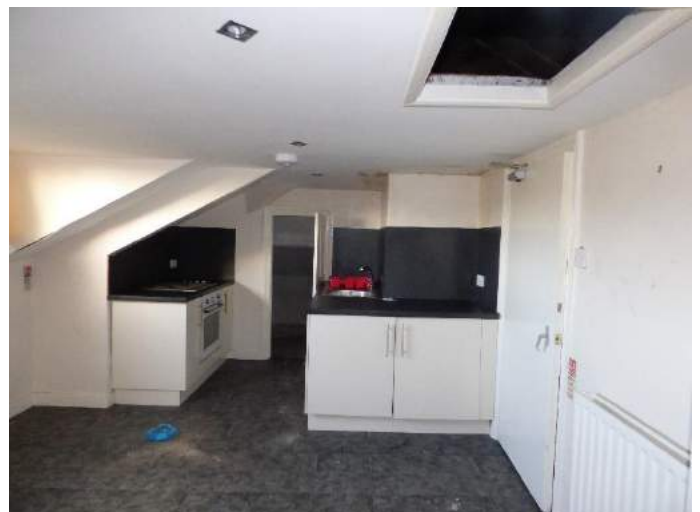
Left and below: All redundant fixtures and fittings to be removed and rooms to be reconfigured to convert existing 'apartment' back into bedroom accommodation.

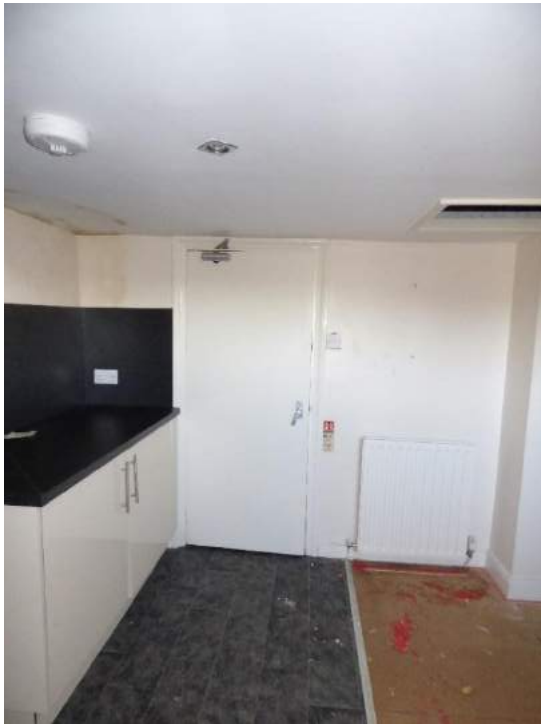
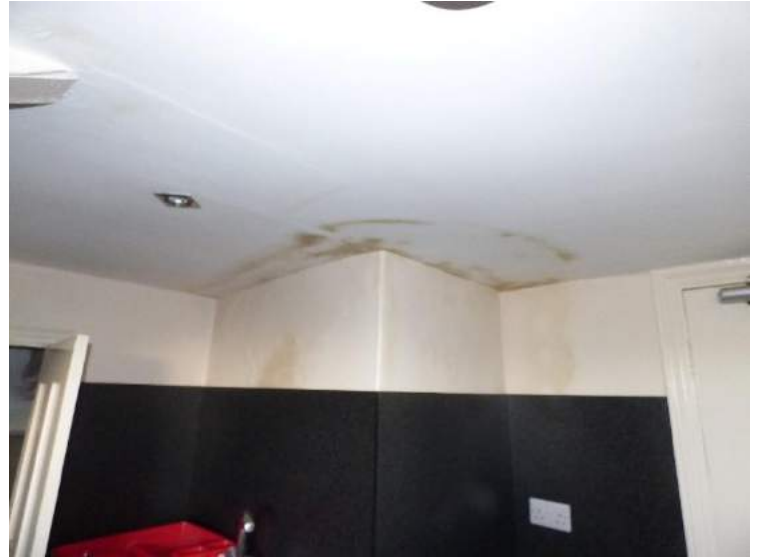
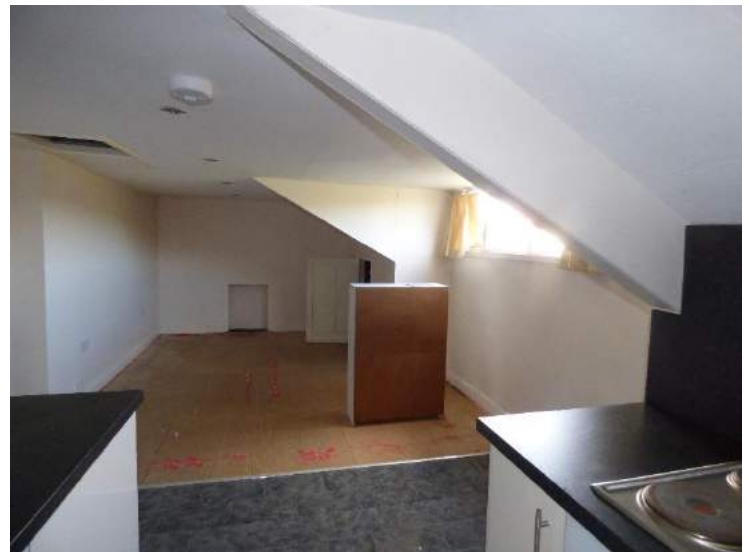
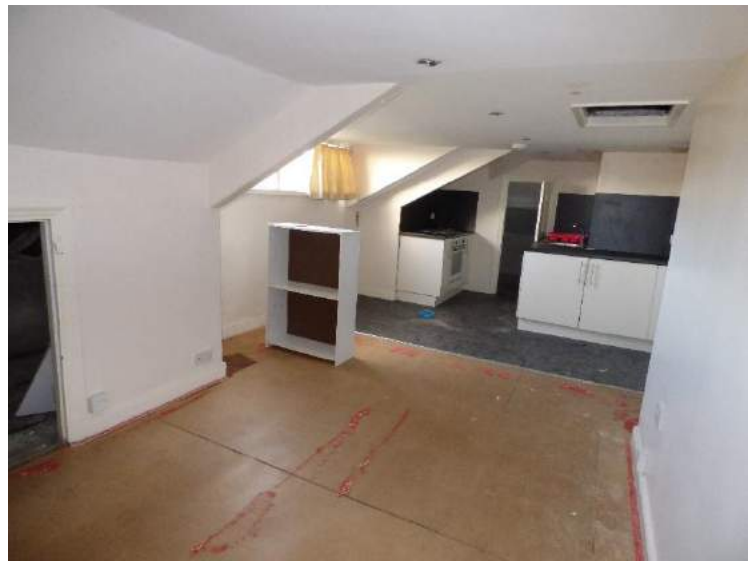
Right and above:

Existing flush panel fire doors to be replaced with four panel heritage style doors.

Apply an insulated plasterboard 62mm thick to underside of ceiling. The Laminated plasterboard and PIR has a vapour barrier incorporated so interstitial moisture would be prevented. New rooflights to be installed with flashing kit that mounts unit flush with the roof surface.

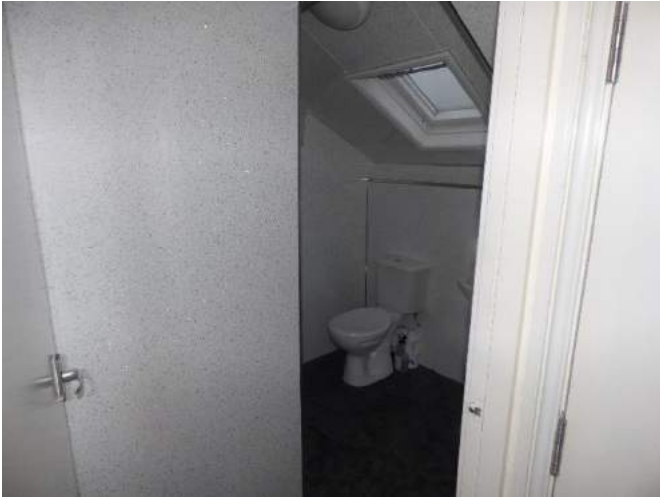
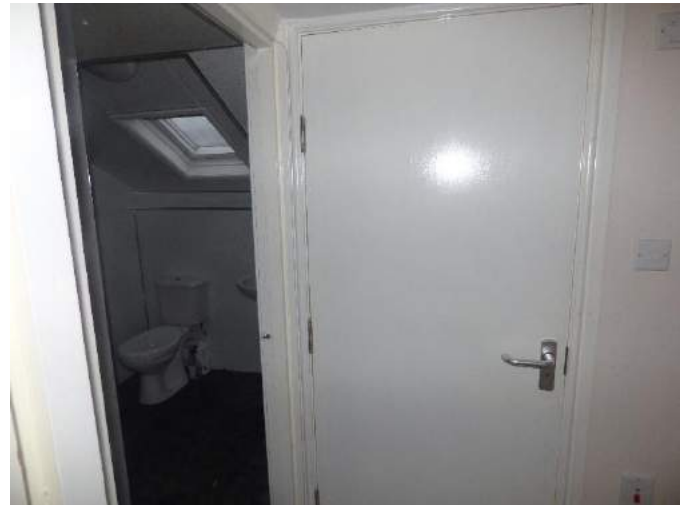
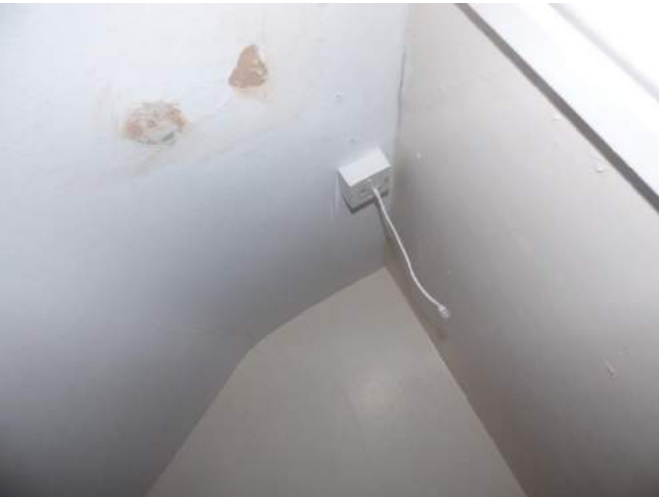
Above and left:

Existing bathroom.

Replace existing sanitaryware with new. Remove existing wall finishes and install new tile finishes to walls and floor.

Replace existing modern door with new four panelled Georgian style traditional door.

Apply an insulated plasterboard 62mm thick to underside of ceiling. The Laminated plasterboard and PIR has a vapour barrier incorporated so interstitial moisture would be prevented. New rooflights to be installed with flashing kit that mounts unit flush with the roof surface.
