Our Ref: **J487/D01**

21<sup>st</sup> October 2022

**RE: Bat Inspection Survey, The Walled Garden, Distington Cemetery**

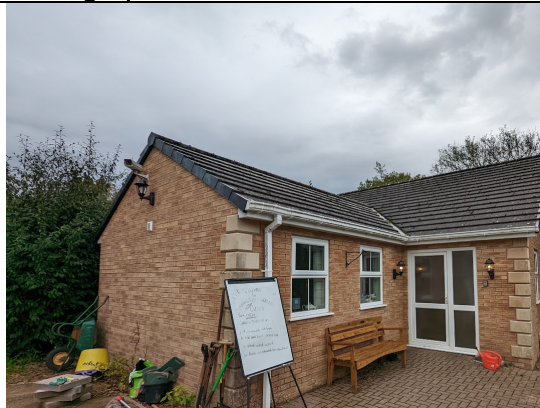
Photograph 1: Western elevations

The elevations of the property are brick built, which is all well pointed; this therefore prevents bat access to the walls themselves. The roof is covered with ceramic tiles which have a relatively uniform shape and therefore are tight-fitting and appear to prevent any bat access. No broken or slipped tiles were observed during the inspection. In addition, the ridge tiles appeared to be well sealed with mortar, as well as featuring areas of moss, which is likely to grow between the tiles and block internal access. The gables of the roof are capped with pvc caps, which essentially prevents any access to bats.
