| <b>Curtins Consulting Ltd</b><br><br>K Village, Riverside Place, Units<br>24-25, Lound Rd, Kendal LA9 7FH | <b>Subject</b><br><br>Cleator Moor Innovation Quarter<br>Photograph Survey Log | | <br><br>Sheet No: 01 |
| | <b>Job No:</b><br><b>085788</b> | <b>Made by:</b> JTS<br><b>Chkd by:</b> PT | |

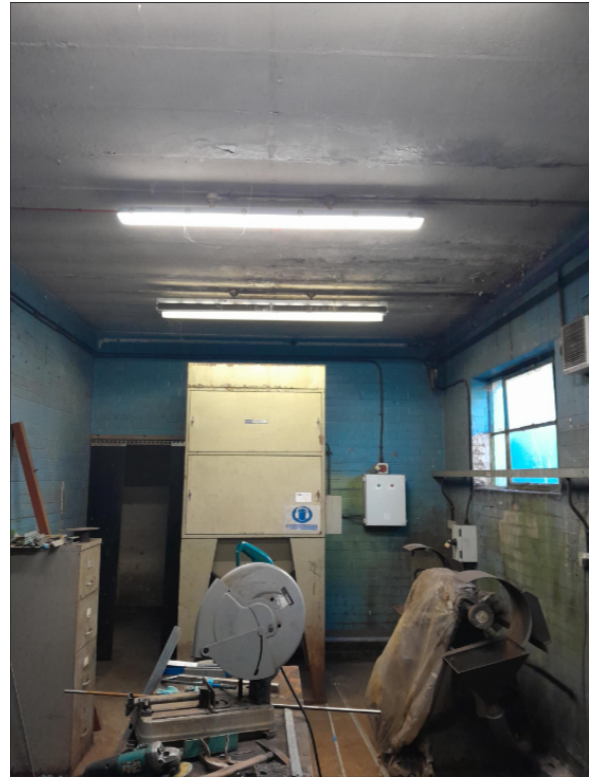
Figure 33 - existing buildings **to be demolished**, single storey workshop. LB Masonry

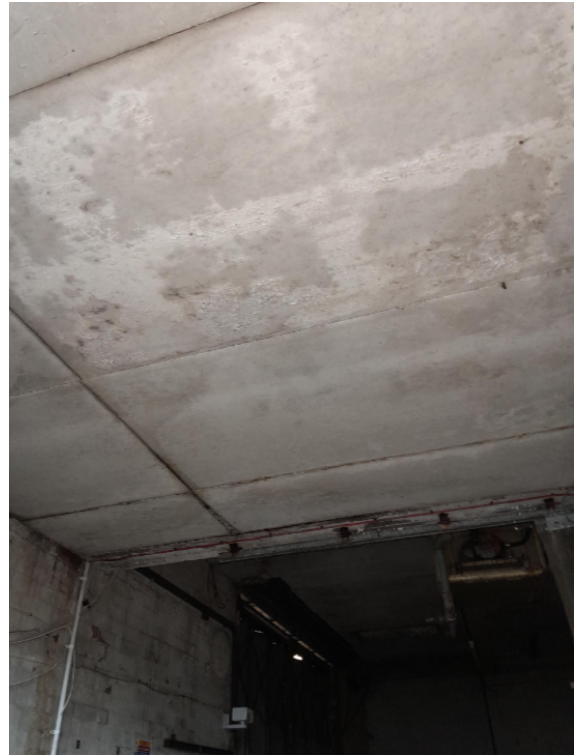
Figure 51 - existing buildings **to be demolished**, SCREWED ON SOFFIT, CONCRETE LINTEL

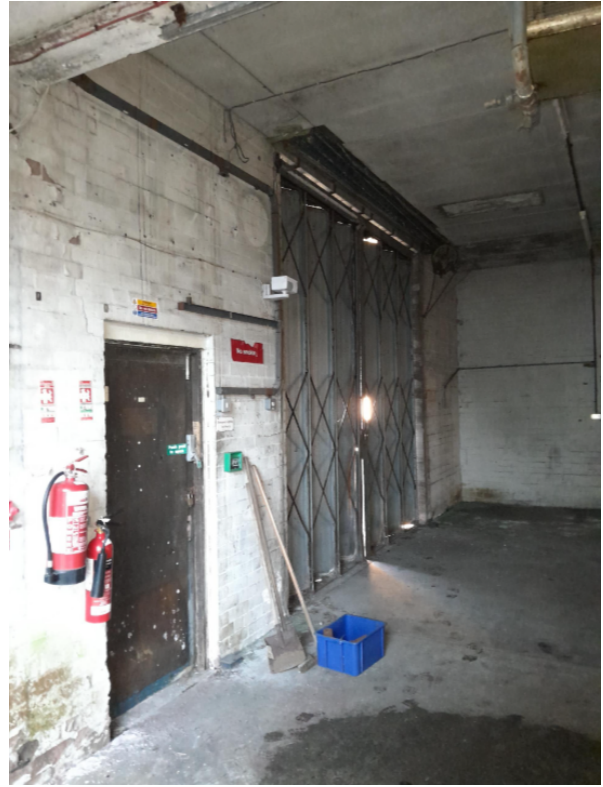
Figure 53 - existing buildings **to be demolished**, zone 3 internal view of ACCESS DOOR
