# The Stirling Memorial Fountain, Cleaton Moor

Proposals for Fountain Restoration.

***Edited Version - Associated with Level 2 Historic Buildings Record Report***

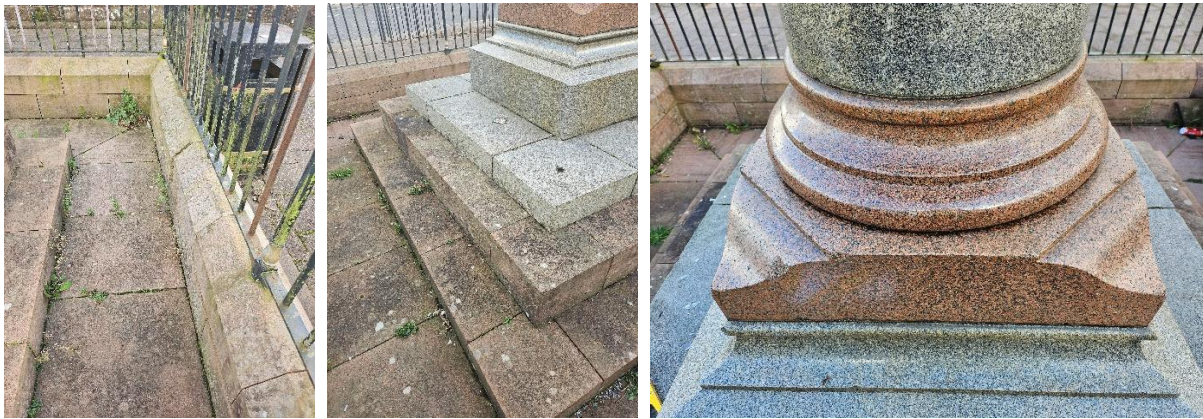
The fountain structure consists of a square base/collection pool with red sandstone walls (Approximately 5.2m x 5.2m) and two centrally positioned square red sandstone steps/plinths, set on these sandstone steps is a further square step of grey Rubislaw granite.

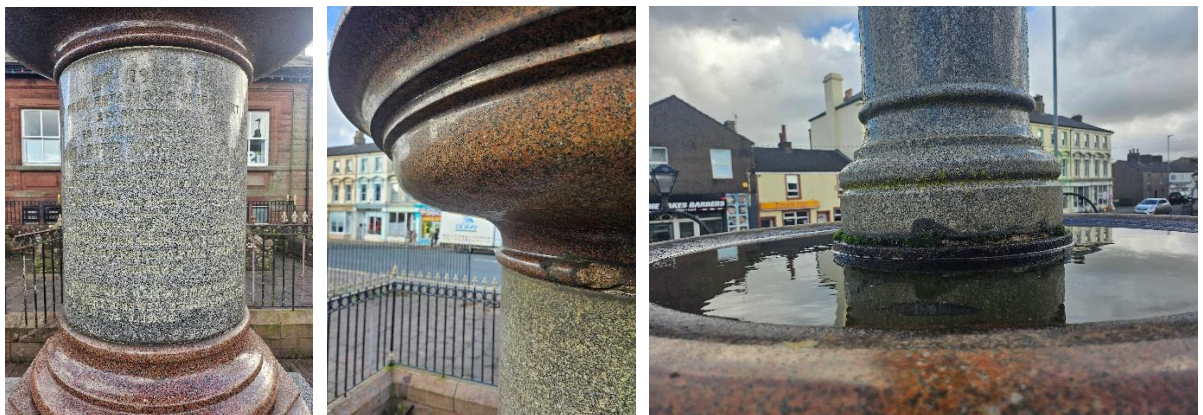
Set centrally on the square steps is a lower square grey Rubislaw plinth and upper Balmoral granite square base to the circular column which rises to the main bowl. The column incorporates engraved inscriptions dedicating the fountain to the Golden Wedding of John and Marion Stirling by the people of Cleaton Moor. The main bowl is formed in Balmoral granite and is approximately 1.3m diameter.
