## **VISUAL STRUCTURAL INSPECTION**

**BARNS ADJACENT TO  
MOWBRAY FARM  
FRIZINGTON  
CUMBRIA**

**Reference - WDS/05/9202/REP01**

**Date - 25/04/2025**

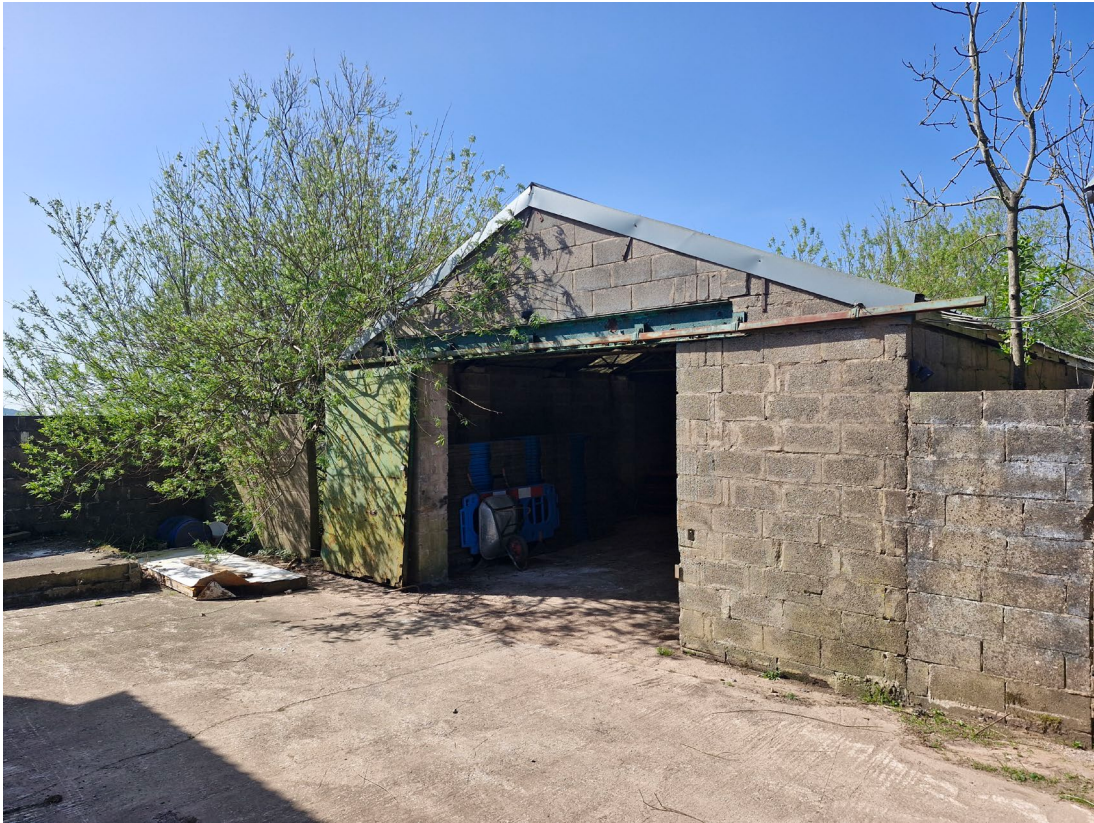
PHOTO 05 BUILDING 4 FRONT ELEVATION

- 3.2** Barn 4 needs the rear wall underpinned and the cracking to the rear gable masonry wall tied. Depending on the foundation extent it may be more cost effective to rebuild the rear wall off a new foundation. The roof structure will need replaced as part of any conversion scheme. With the works noted completed the building will be suitable to be retained as part of a conversion scheme.

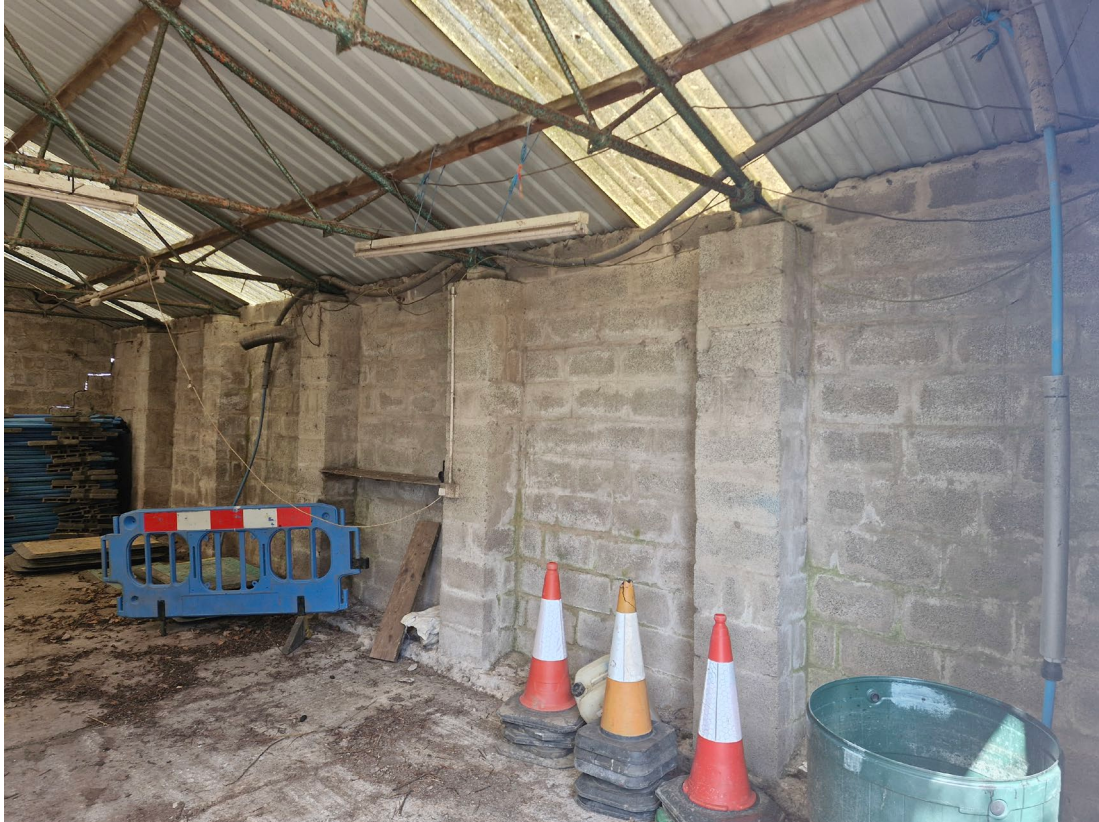
PHOTO 06 BARN 4 INTERNAL VIEW

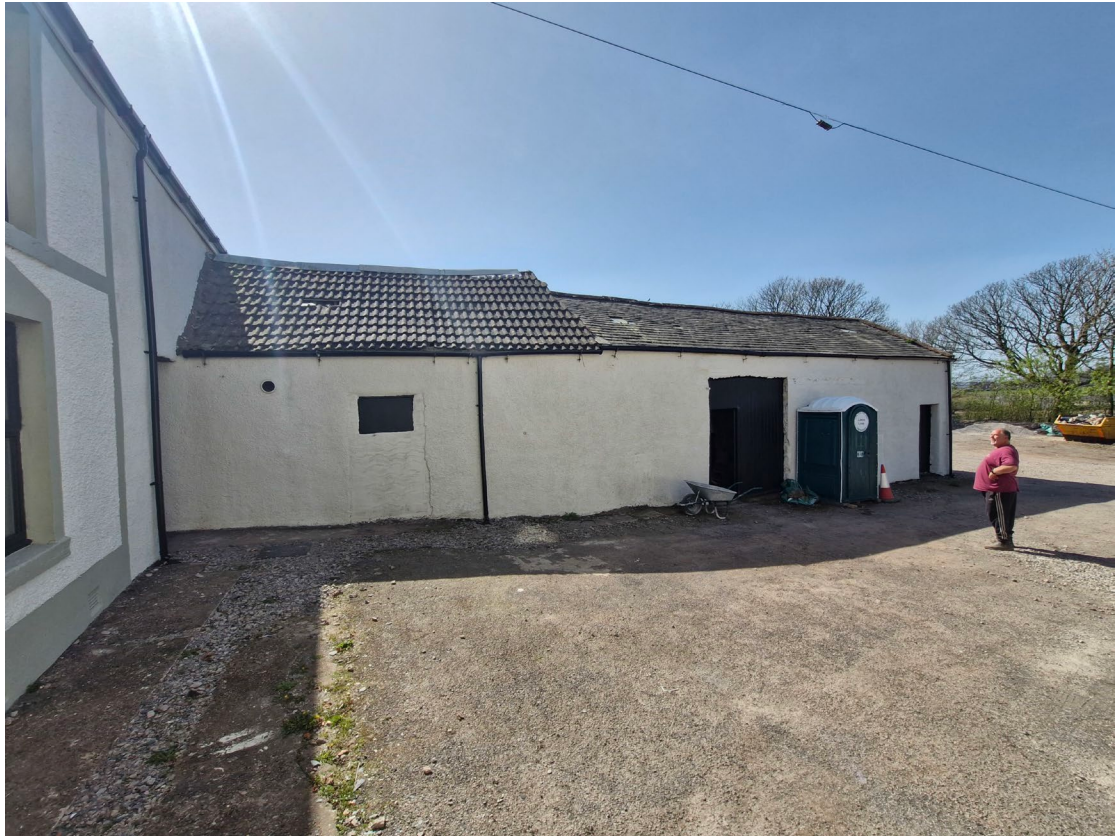
- 2.3** Barn 6 is generally in poor condition due to a lack of maintenance. The walls have numerous cracks and there a numerous rotten/woodworm infested inset timber lintels. The walls to the single storey extent are out of plumb especially to the front and left hand flank walls. There is evidence of separation cracking to the two storey extent gable wall although this appears due to historic movement. The roof structure to the single storey extent is in a poor condition and needs removed; the roof to the two storey extent is in a better condition and could be retained with some strengthening works. See photographs 10-11 attached.

PHOTO 07 BARN 6 FRONT SINGLE STOREY EXTENT

- The masonry corners to the rear two storey extent need retied as part of any conversion scheme. There are numerous areas of loose masonry which will need rebuilt/pointed. In addition, there are numerous masonry cracks which will need re-tied as part of the general building refurbishment works. The bowed walls may need some rebuild however we see this as less than 20 percent of the overall building wall extent.

- The timber lintels and inserts throughout the building will need replaced with precast concrete or steel sections to suit spans and loadings.
- We recommend that a trial hole is excavated at each corner of the barns to expose the base level of the wall such that the ground floor slab and insulation detail can be specified to ensure that undermining of the wall does not occur during construction.

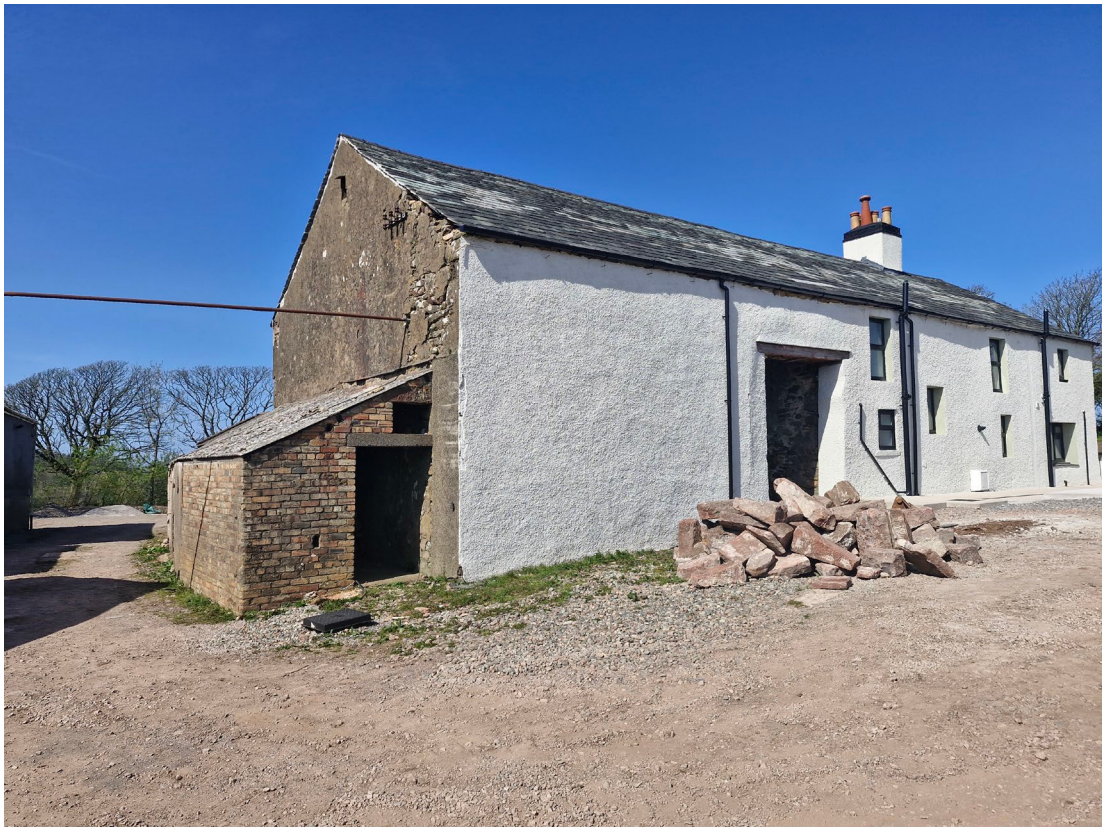
PHOTO 08 BARN 6 REAR ELEVATION
