# Coal Mining Risk Assessment

71009847026001

17 Irish Street, Whitehaven, Cumberland, CA28 7BU

Demolish an existing garage and construction of a residential dwelling

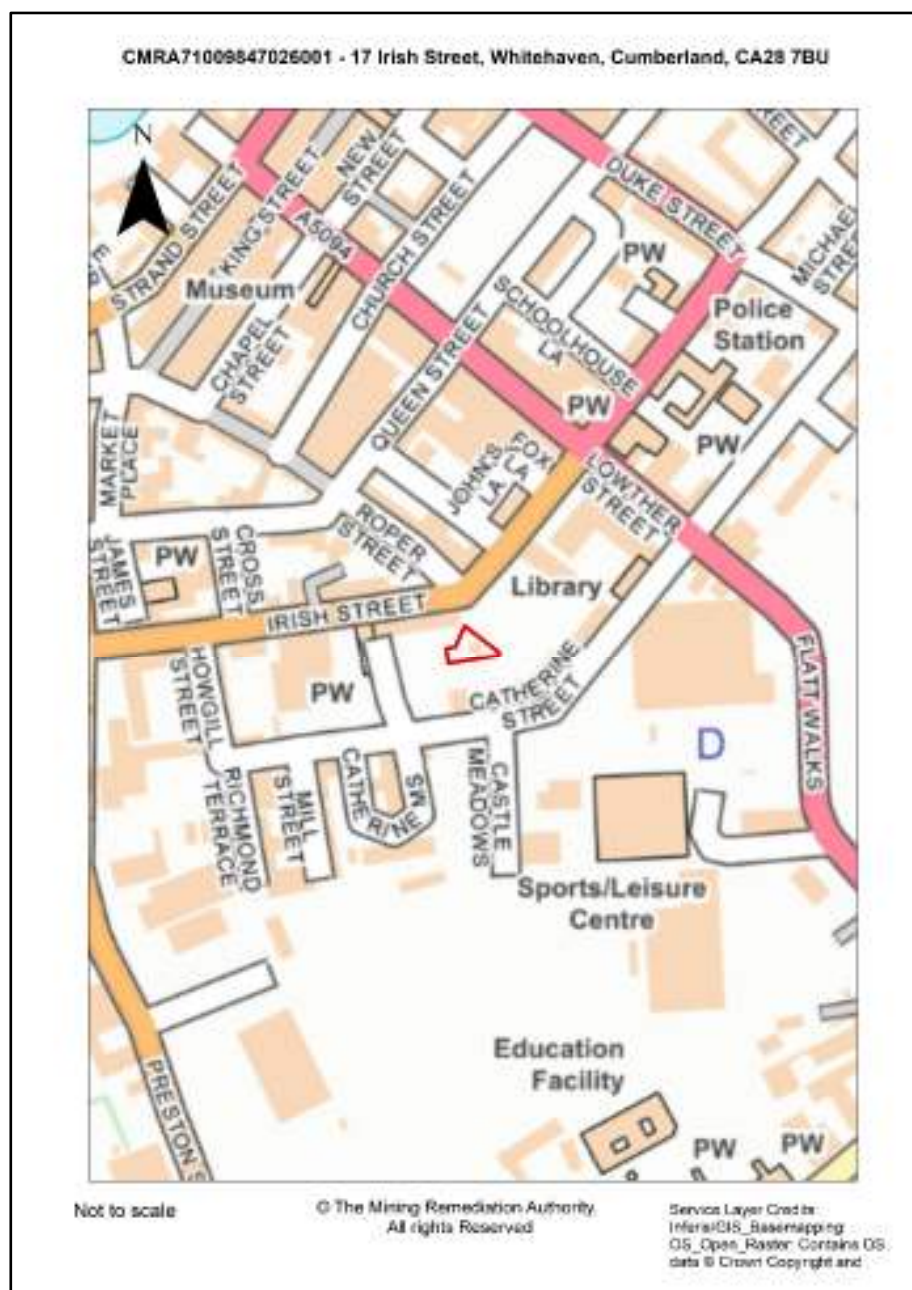
**Figure 1: Site location plan**

The Mining Remediation Authority has been commissioned to prepare a Coal Mining Risk Assessment Report for a proposed development at 17 Irish Street, Whitehaven, Cumberland, CA28 7BU (see Figure 1), in order to provide the Local Planning Authority with information on coal mining and an assessment of its impact on land stability.

The approximate site centre co-ordinates are E297415, N517898. The proposed development area requires access via Irish Street. The site has an approximate elevation of 7m AOD, with the site relatively flat.

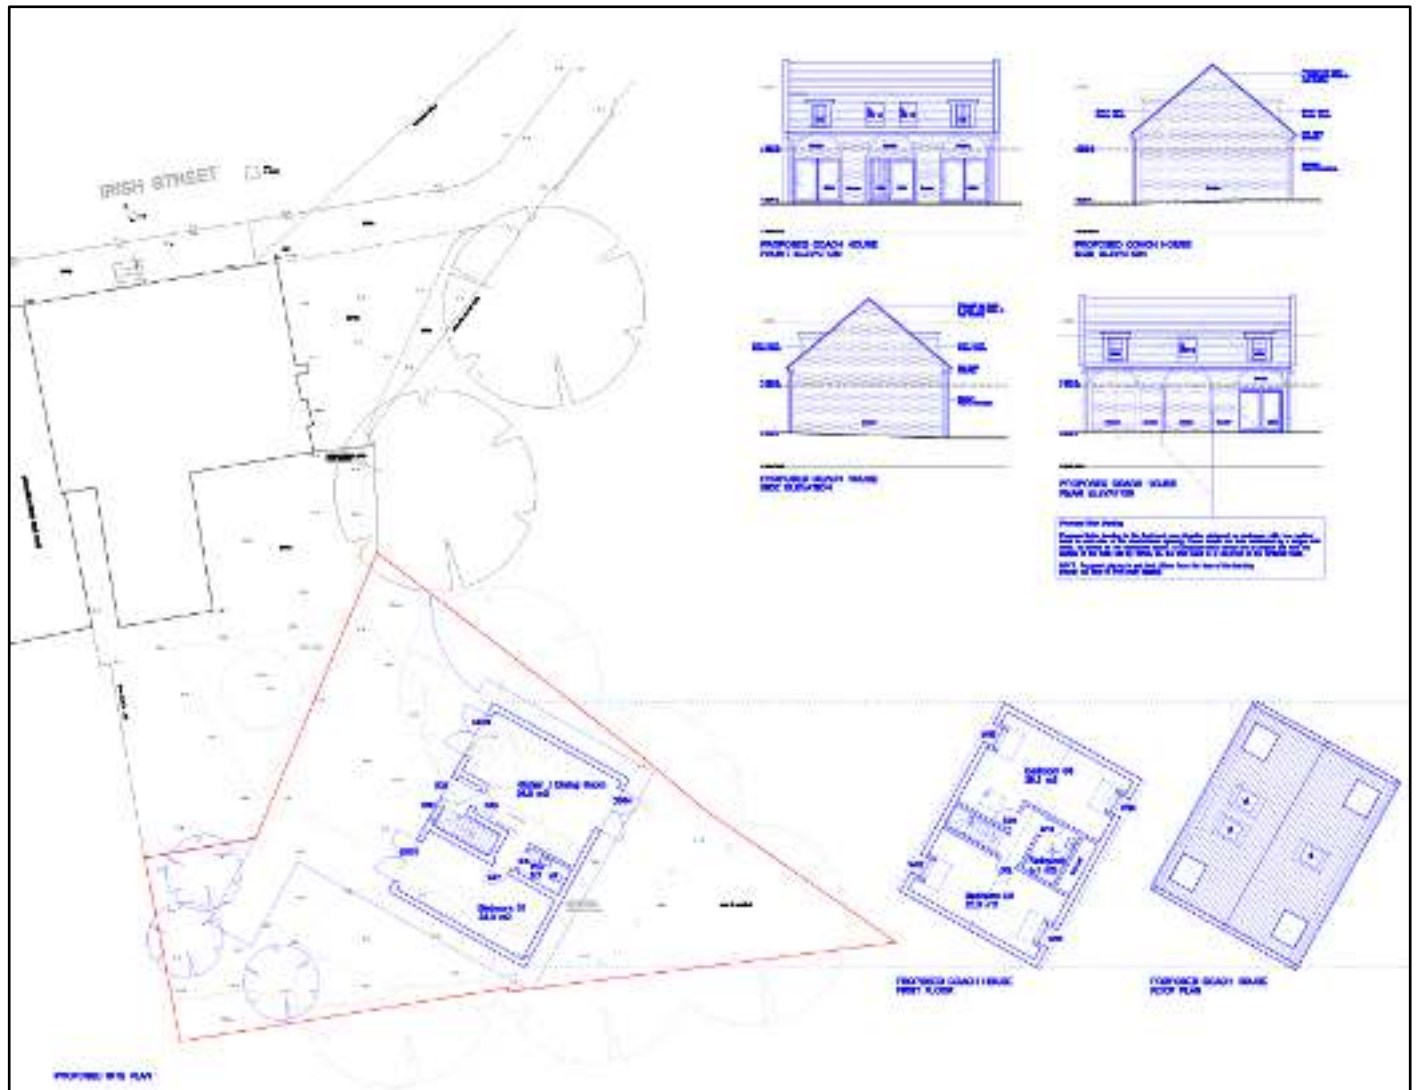
### Appendix A – Plan showing proposed development layout

The Mining Remediation Authority understands that the developer plans to demolish an existing garage and construct a detached residential dwelling (see appendix A).

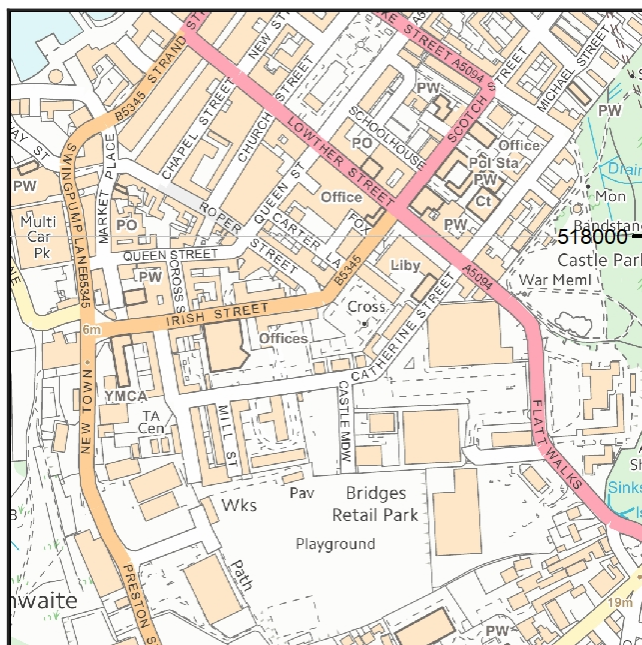
Approximate position of property

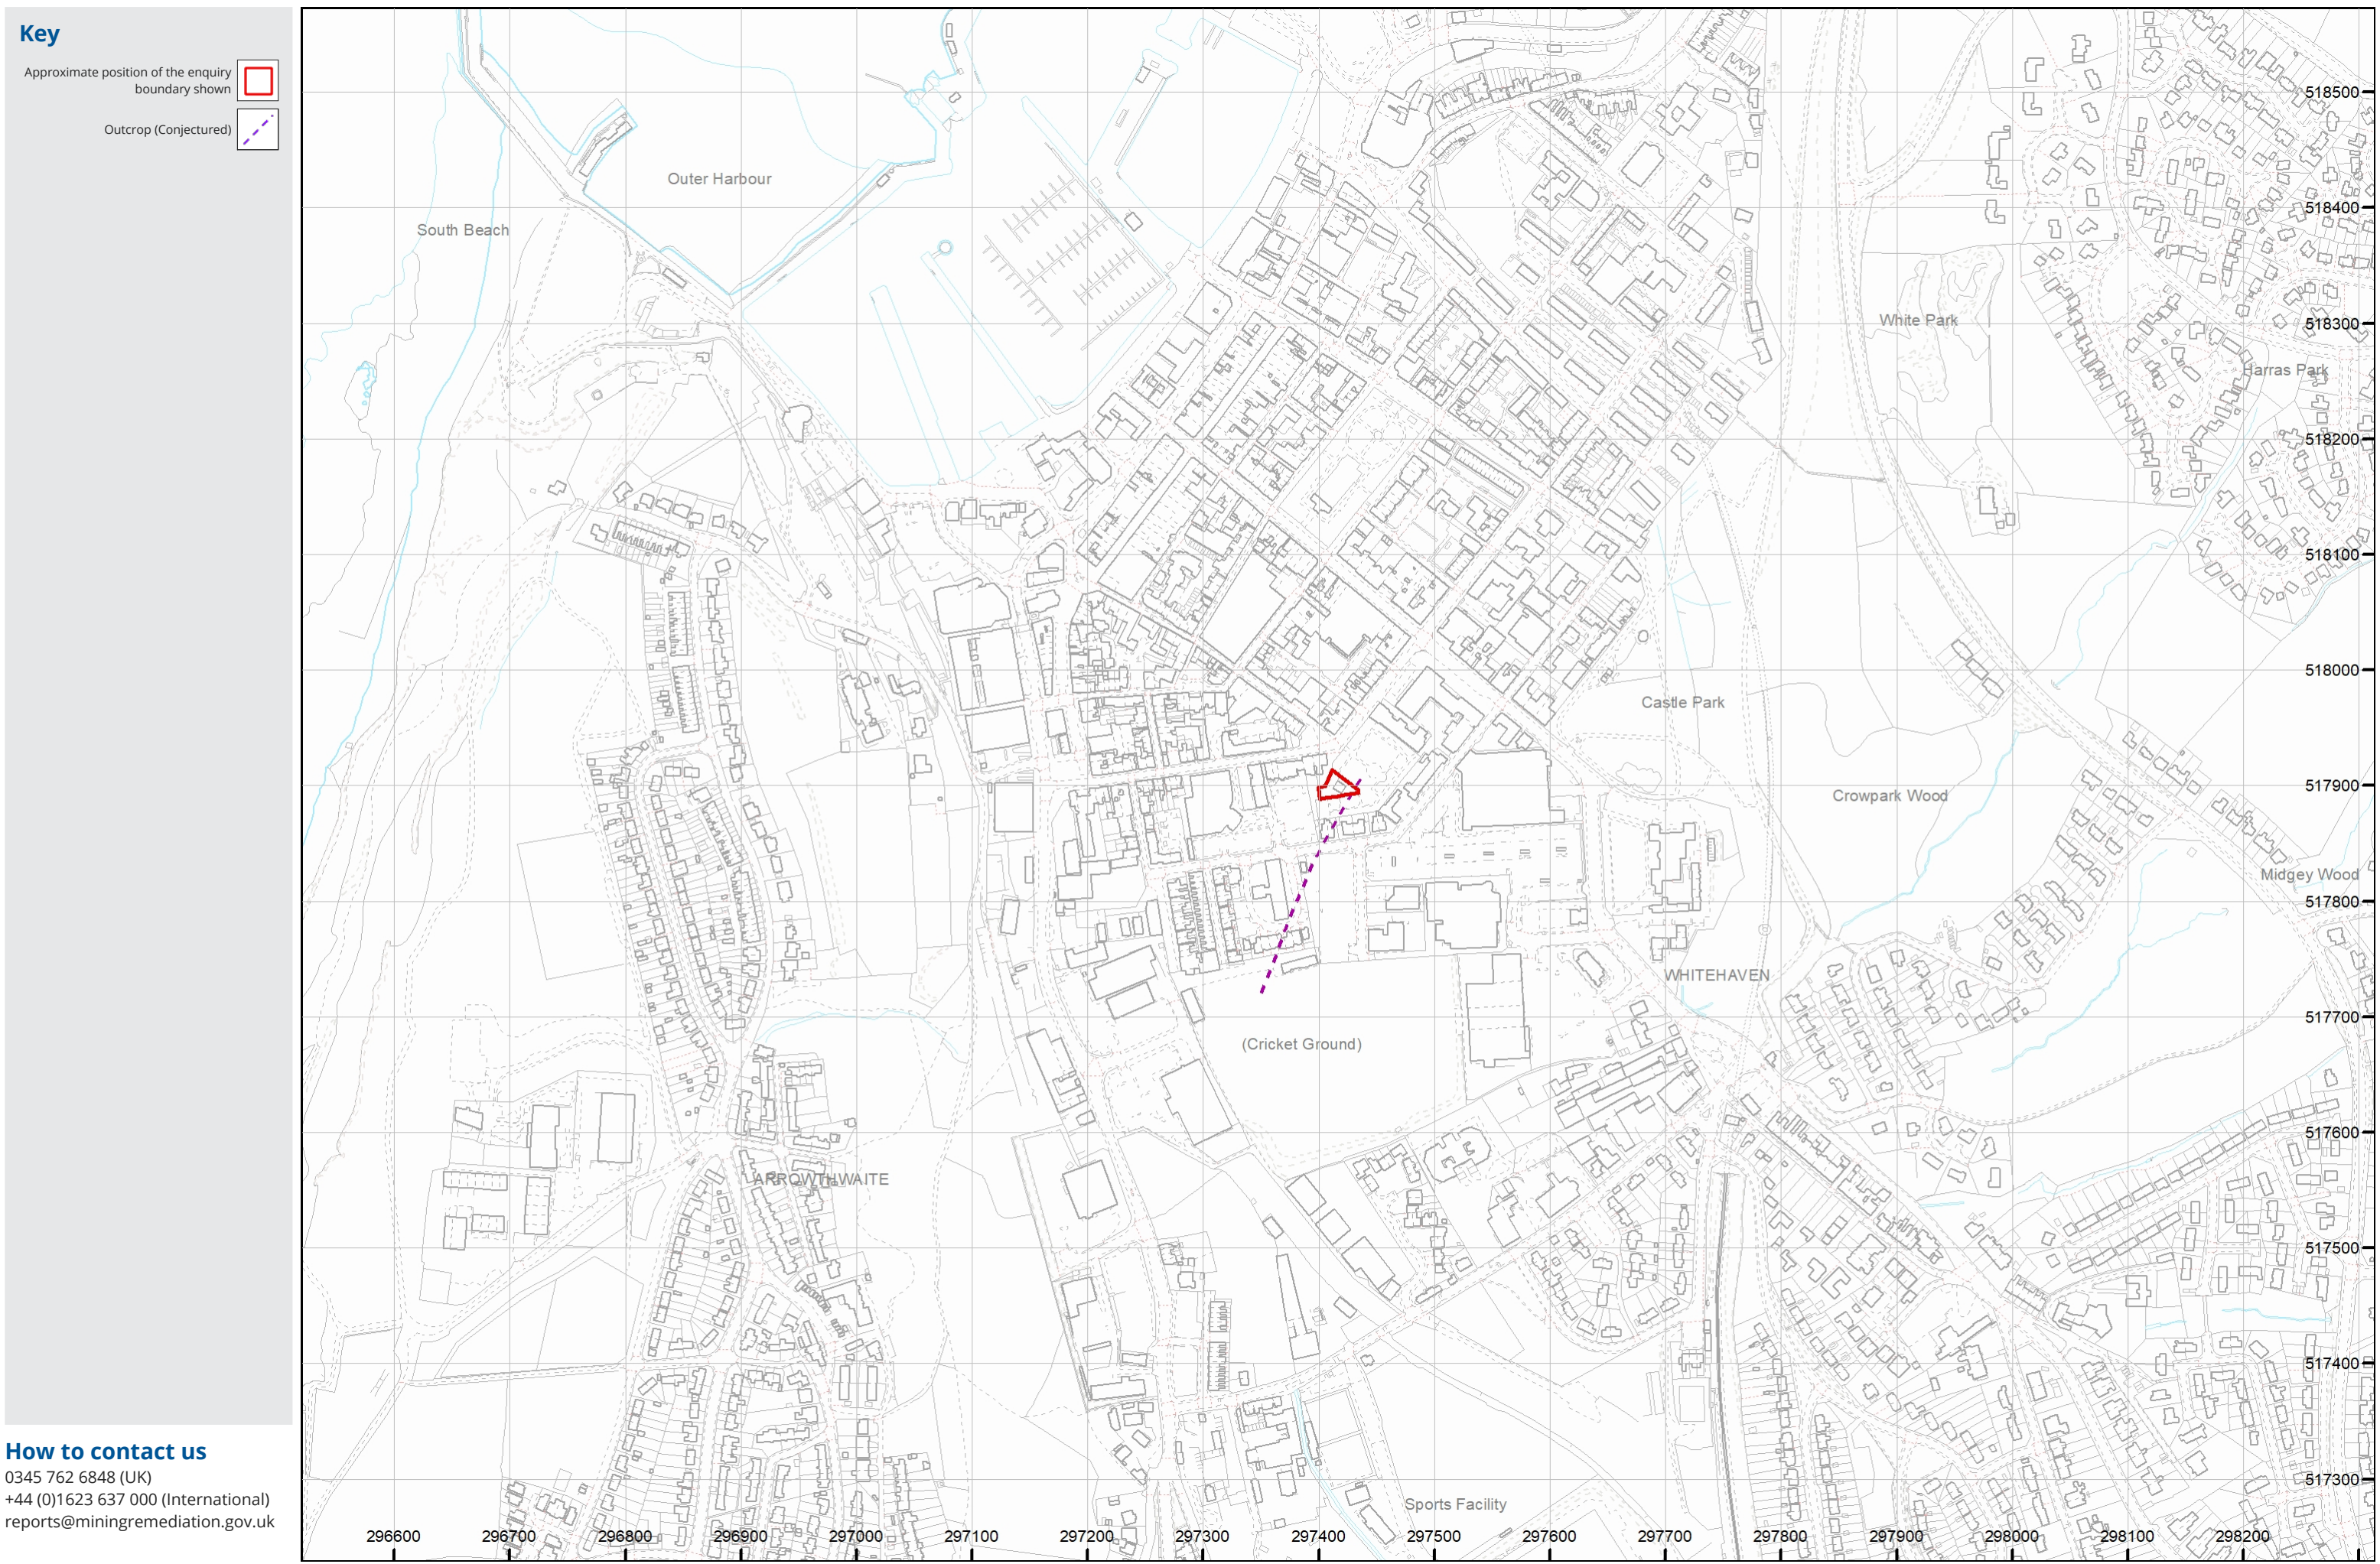
The map highlights any specific surface or subsurface features within or near to the boundary of the site.
