**Project No:** GEO2024-6313

**Project:** Land at Brewery Brow, Parton, Cumbria

**Report Title:** Coal Mining Risk Assessment

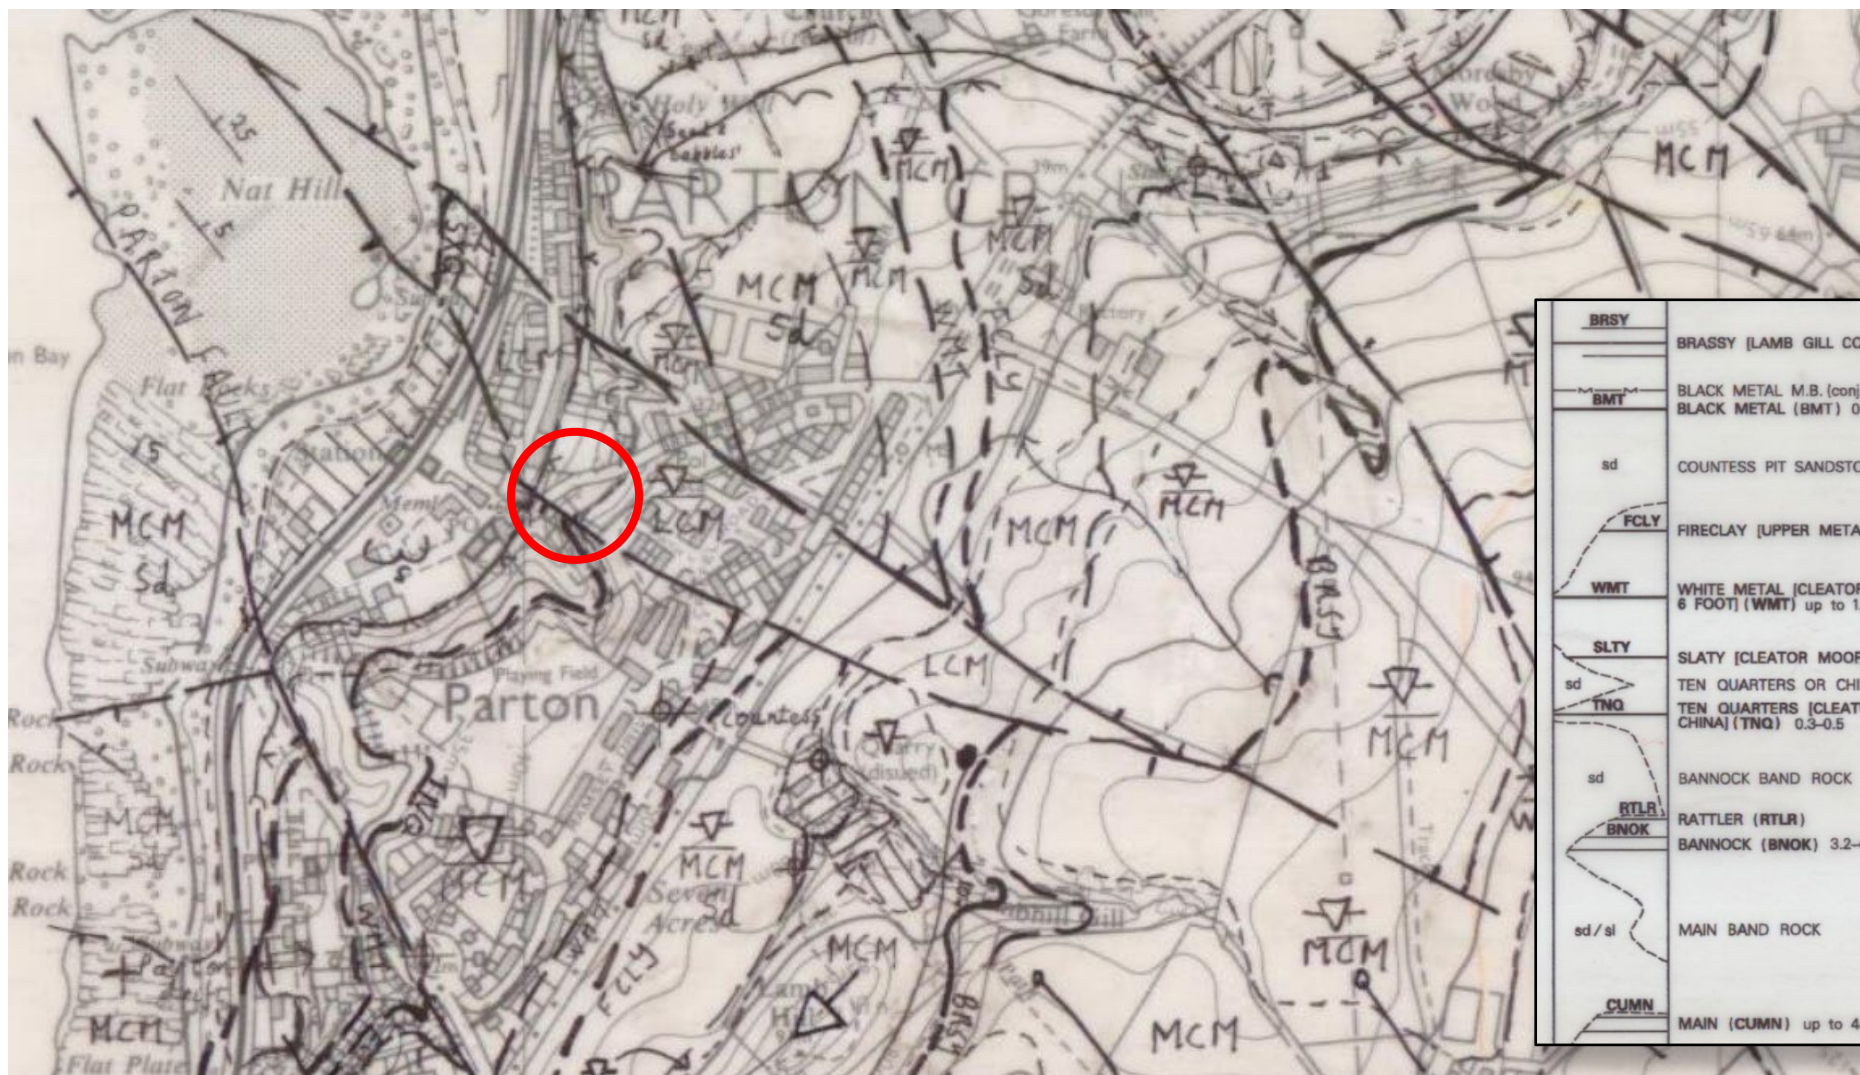
**GEO2023-6313: Brewery Brow, Parton, Cumbria – British Geological Survey, 1:10,000 Geological Map Extract & GVS**

| <b>BRSY</b> | BRASSY [LAMB GILL COALS] (BRSY) 0.5-0.9 |
| <b>BMT</b> | BLACK METAL M.B. (conj.)<br>BLACK METAL (BMT) 0.6-1.8 |
| <b>sd</b> | COUNTLESS PIT SANDSTONE |
| <b>FCLY</b> | FIRECLAY [UPPER METAL] (FCLY) up to 0.75 |
| <b>WMT</b> | WHITE METAL [CLEATOR MOOR 6 FOOT] (WMT) up to 1.0 |
| <b>SLTY</b> | SLATY [CLEATOR MOOR 4 FOOT] (SLTY) 0.5 |
| <b>sd</b> | TEN QUARTERS OR CHINA ROCK |
| <b>TNO</b> | TEN QUARTERS [CLEATOR MOOR 5 FOOT, CHINA] (TNO) 0.3-0.5 |
| <b>sd</b> | BANNOCK BAND ROCK |
| <b>RTLR</b><br><b>BNOK</b> | RATTLER (RTLR)<br>BANNOCK (BNOK) 3.2-4.0 |
| <b>sd/sl</b> | MAIN BAND ROCK |
| <b>CUMN</b> | MAIN (CUMN) up to 4.0 |
