## **REVISED CONTAMINATION REMEDIATION STRATEGY**

**PROPOSED RESIDENTIAL DEVELOPMENT OF LAND AT**

**IVY MILLS (PHASES 1 AND 2), MAIN STREET**

**Report Type:** Draft Revised Contamination Remediation Strategy (RS)

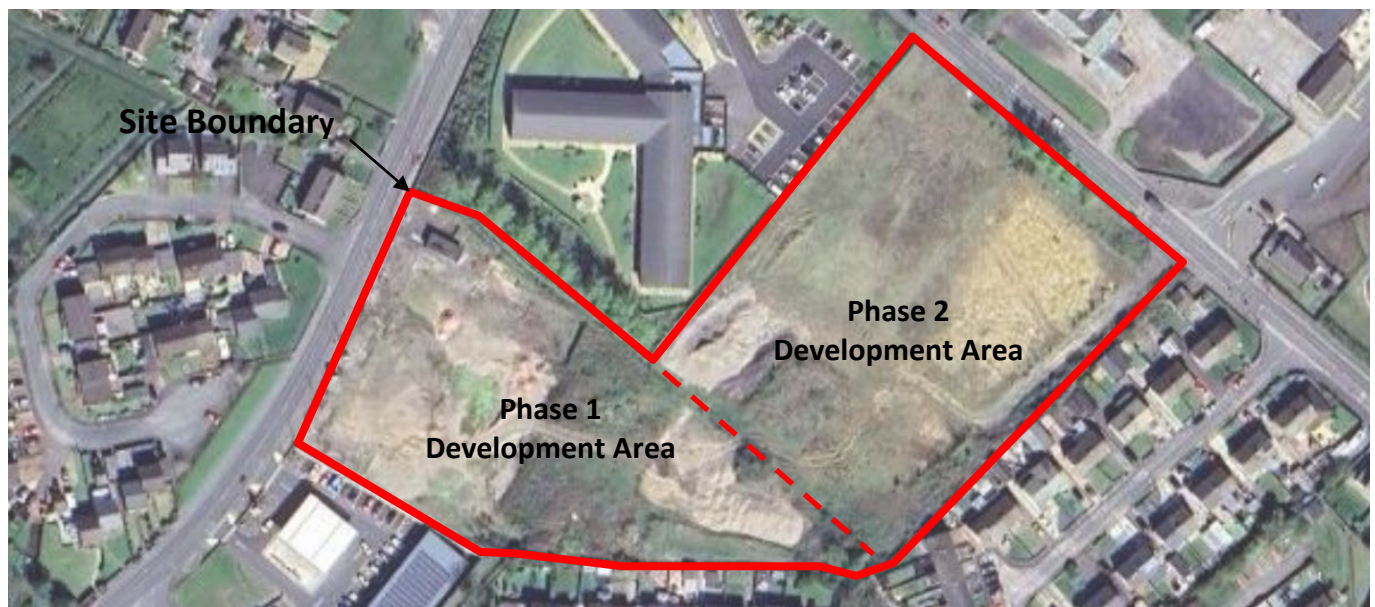
**Figure 1.** Site Boundary and Phase 1 and Phase 2 Development Areas.

The combined site area, occupying c.2.1Ha is located in Hensingham to the east of Whitehaven as indicated on the site location plan in Appendix I. The site boundary is indicated in Figure 1 below which also includes the areas previously known as (development) Phases 1 and 2.

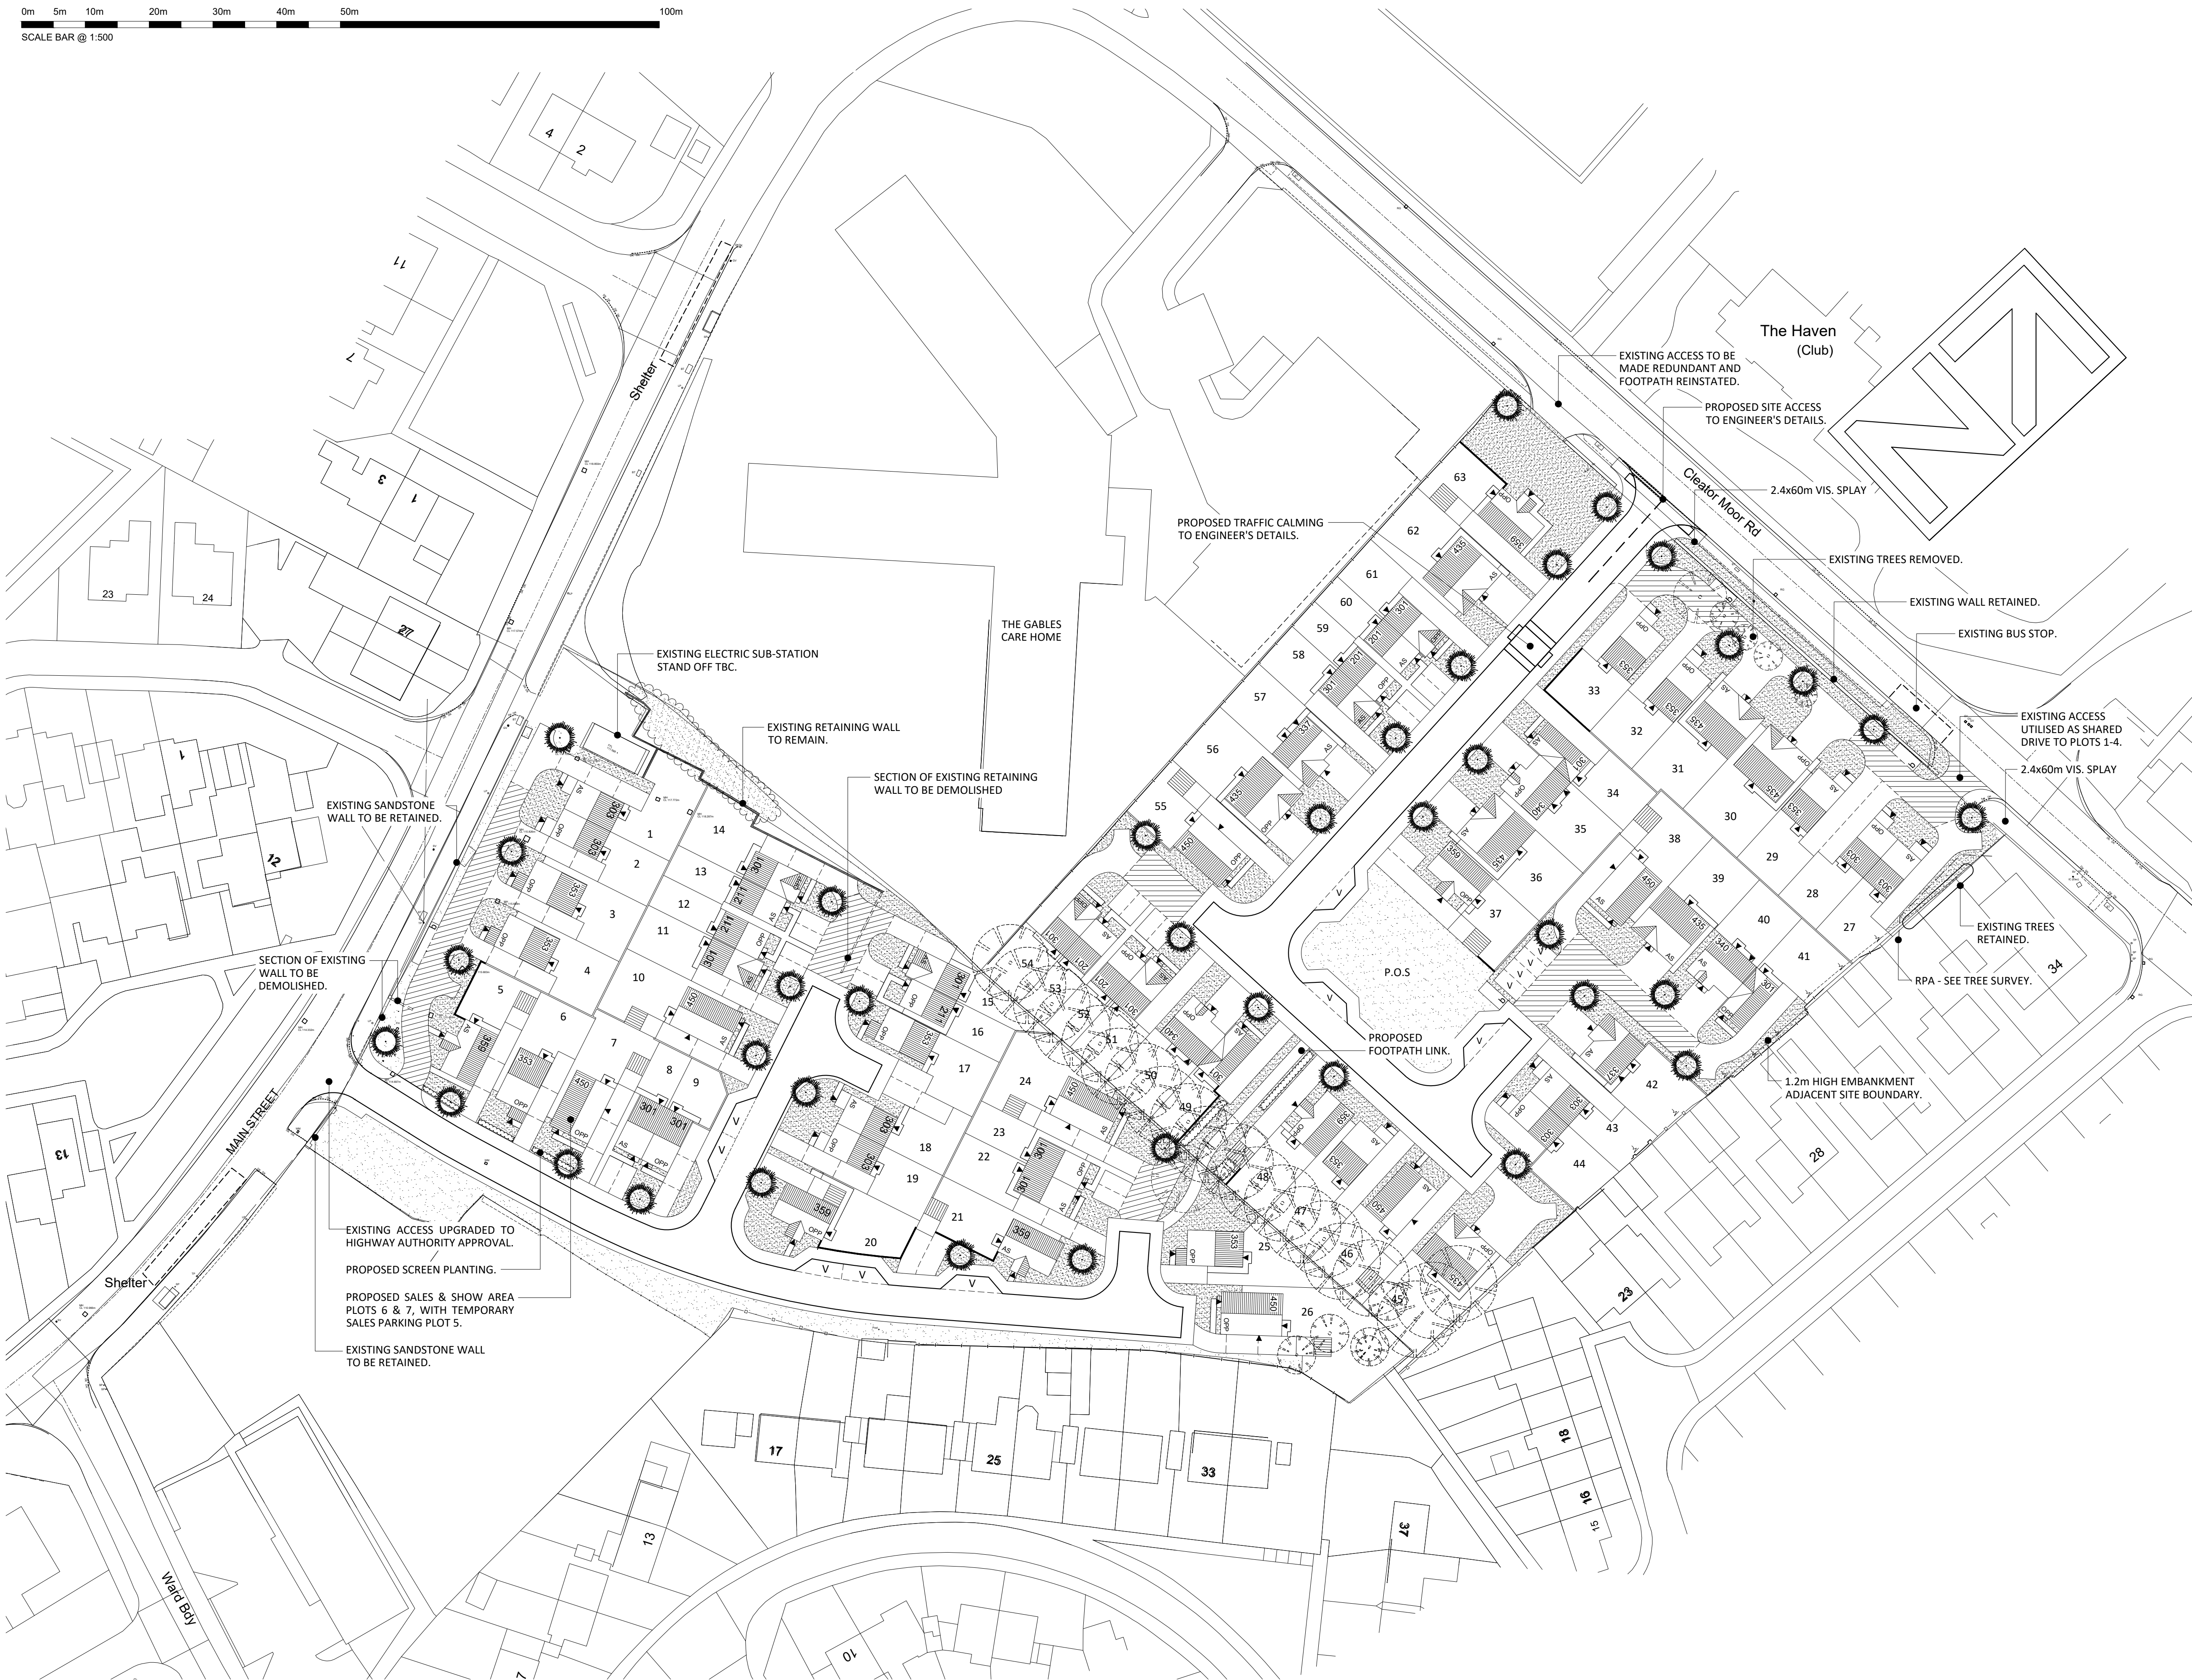
# IVY MILL, WHITEHAVEN (COMBINED LAYOUT)
