Coal Mining Risk Assessment: Desk Study

**High House Farm**

**Greenbank**

**Whitehaven**

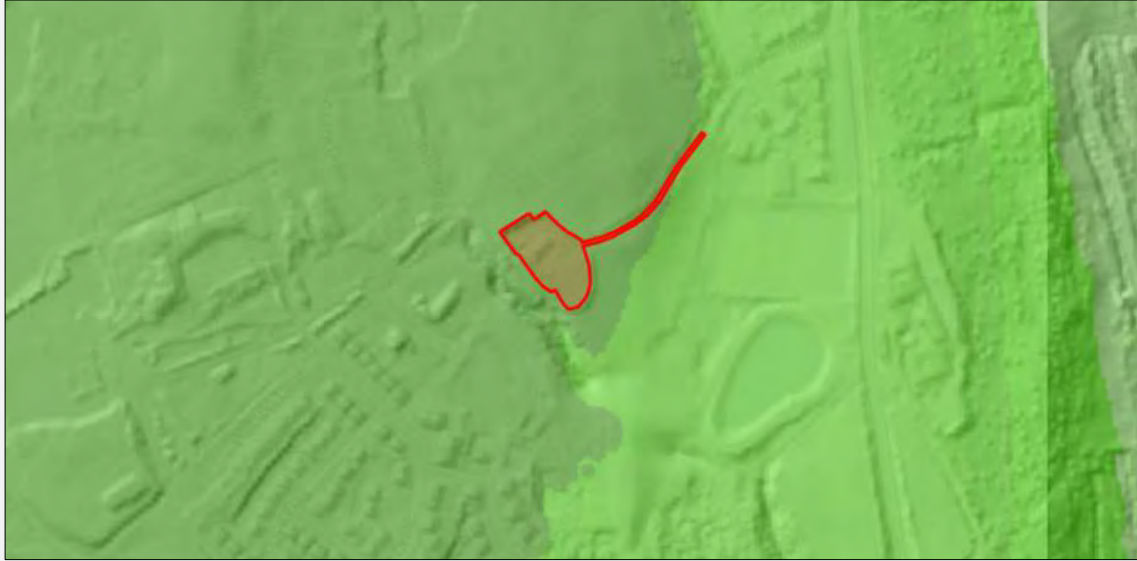
**Plate 3: Lidar Imagery** [Groundsure insights](#)

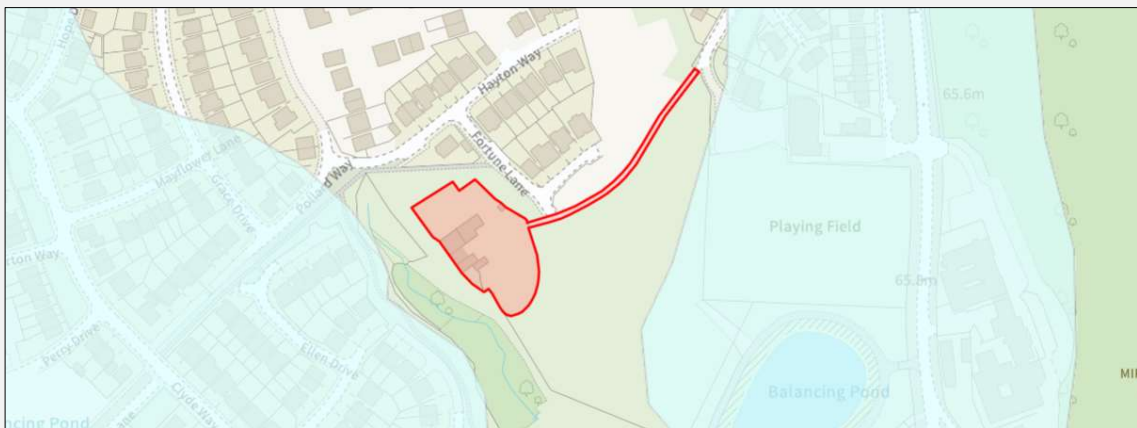
**Plate 5: BGS 50k Superficial Deposits - No Superficial ground recorded on site. Devensian Till - Diamicton either side** [Groundsure insights](#)

**Geology and Ground Conditions** – The site is underlain by competent Pennine Middle Coal Measures bedrock comprising mudstone, siltstone, and sandstone. Two minor faults intersect the Black Metal Seam at depth, with no evidence of surface instability. Standard geotechnical assessment is recommended prior to construction to confirm local ground conditions. No superficial deposits are recorded within the development area.

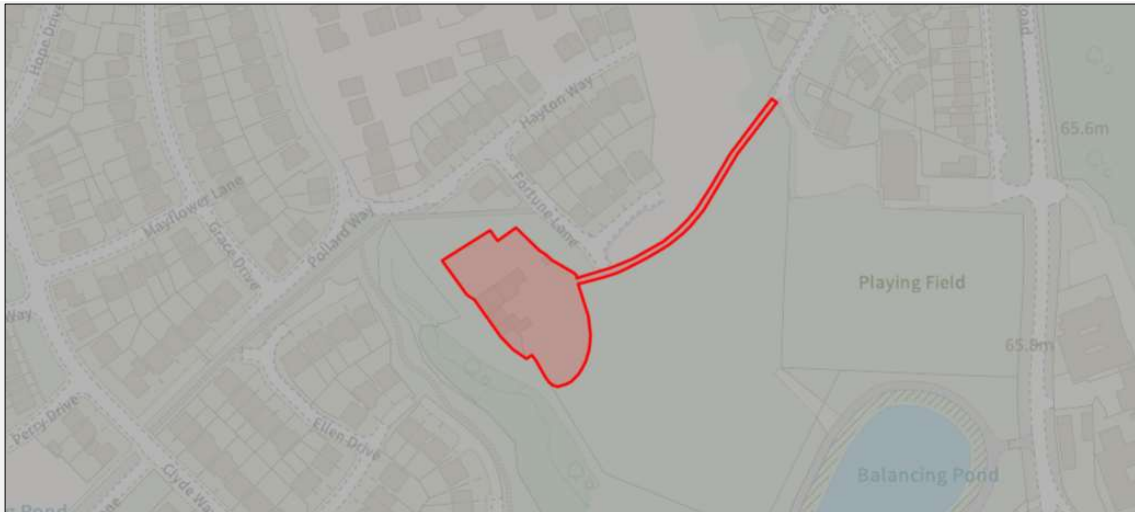
**Plate 6: BGS 50k Bedrock - Pennine Middle Coal Measures Formation-Mudstone, Siltstone and Sandstone** [Groundsure insights](#)

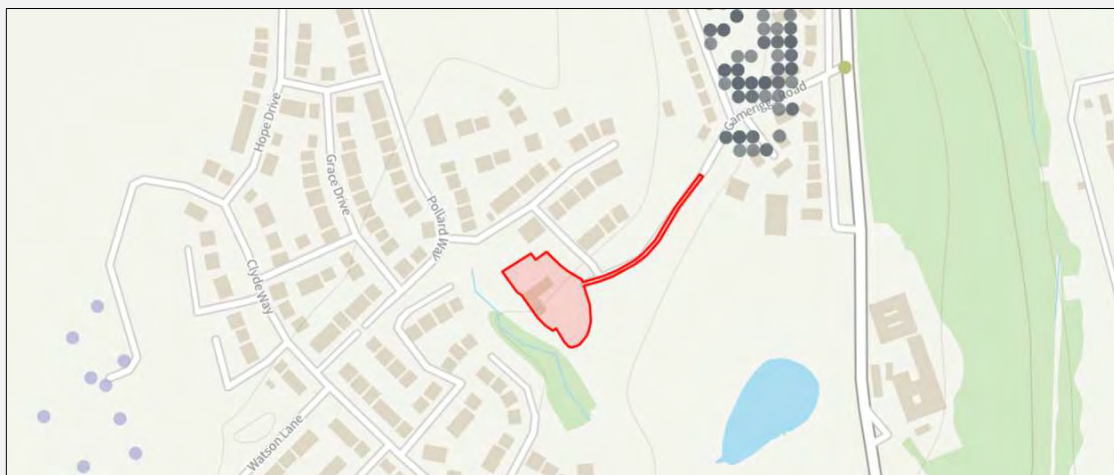
**Plate 7: BGS borehole records surrounding the site** [Groundsure insights](#)
