**SUPPLEMENTARY PHASE 2:**

**GROUND INVESTIGATION REPORT**

**(GROUND GAS RISK ASSESSMENT)**

**PROPOSED RESIDENTIAL DEVELOPMENT OF  
LAND THE FORMER FISH FACTORY, HENSINGHAM**

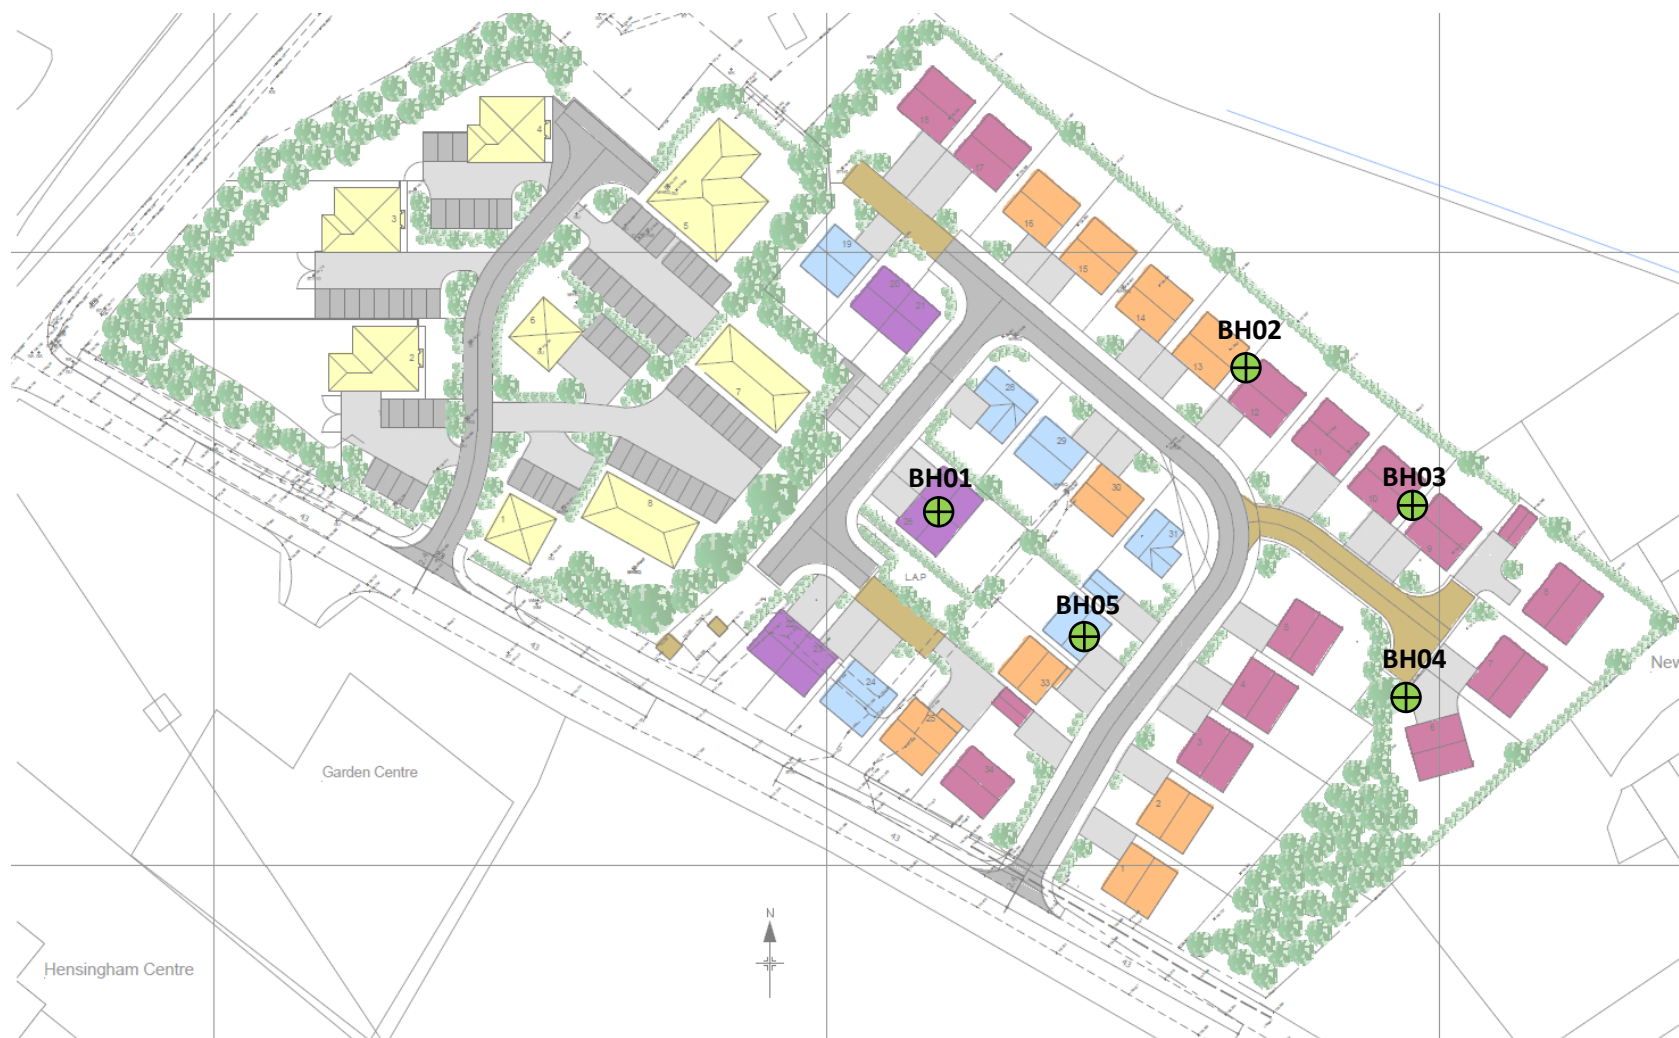
**GEO2018-3413: Former Fish Factory, Whitehaven, Cumbria – Exploratory Hole Location Plan**

The ground investigation works were completed on the 8<sup>th</sup> November 2018. The boreholes were located across the site to provide general site coverage taking cognisance of buried utilities, site topography, mounds of materials and locations of the proposed residential units. The exploratory hole location plan is provided in Appendix I.

- 5 No. Dynamic Sampling Boreholes (BH01 to BH05) to depths of between c.0.95m and c.2.70m bgl.
- Site supervision by a suitably qualified and experienced Geo-Environmental Engineer.
- Gas and groundwater monitoring (6 visits completed to date).
