**GROUND INVESTIGATION &**

**REMEDIATION SUMMARY REPORT**

**PROPOSED RESIDENTIAL DEVELOPMENT OF**

**LAND AT FORMER IVY MILLS**

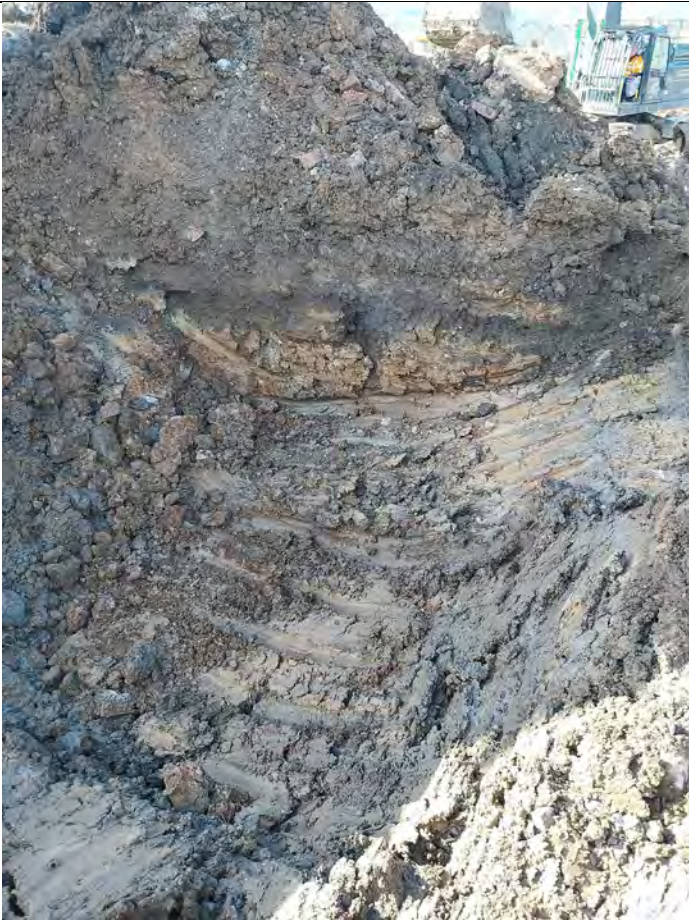
| <p><b>Photograph 12:</b></p> <p>TP207 hotspot excavation and validation</p> | |

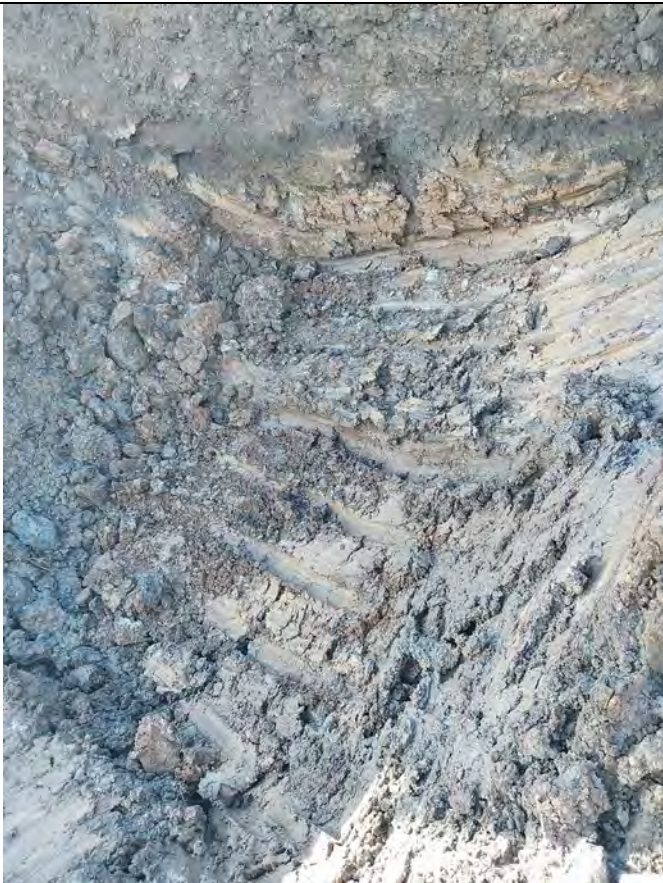
| <p><b>Photograph 13:</b></p> <p>TP207 hotspot excavation and validation</p> | |

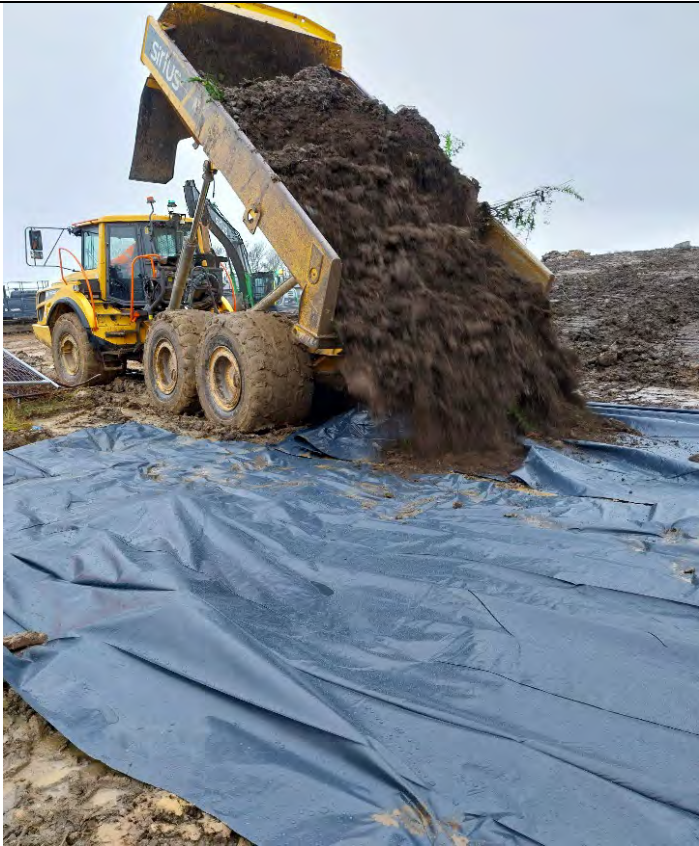
| <p><b>Photograph 14:</b></p> <p>Invasive plant species impacted soils being loaded onto plastic sheeting for temporary storage pending off-site disposal</p> | A yellow excavator with 'SIRIUS' written on its arm is shown in the process of dumping a large quantity of dark, moist soil onto a large pile. The pile is situated on a surface covered with a blue plastic sheet. The excavator's bucket is raised, and the soil is falling from it. The background shows a cloudy sky and some distant structures. |

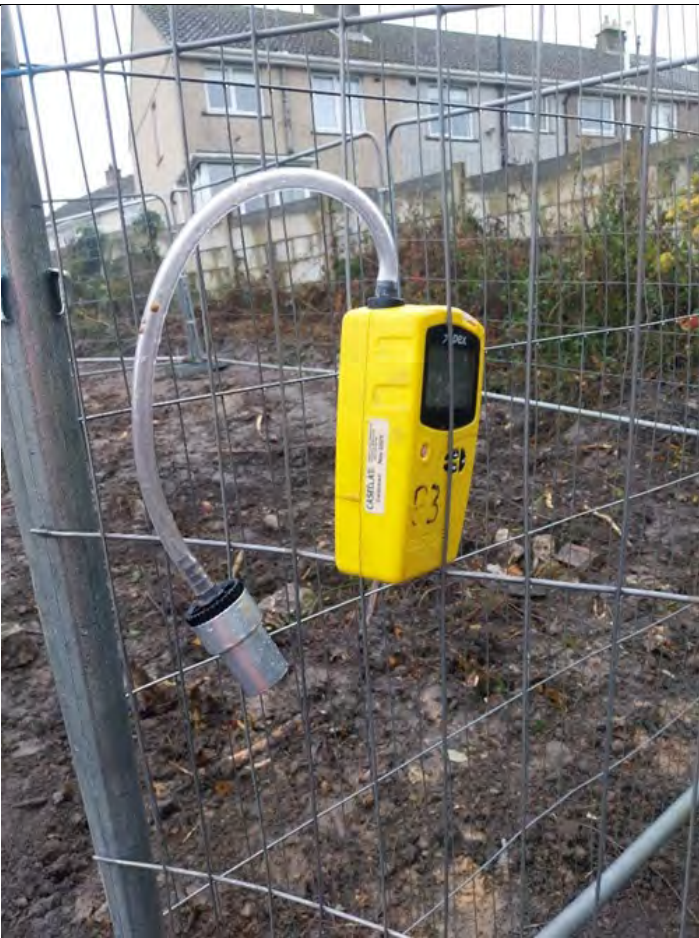
| <p><b>Photograph 15:</b></p> <p>Assurance air monitoring taking place during processing and placement of Stockpile SP105</p> | A yellow air monitoring device, labeled 'SIRIUS' and 'SP105', is attached to a metal fence. A clear plastic tube is connected to the device, leading to a sampling point. The device is mounted on a vertical metal post. The background shows a residential area with houses and some vegetation. |

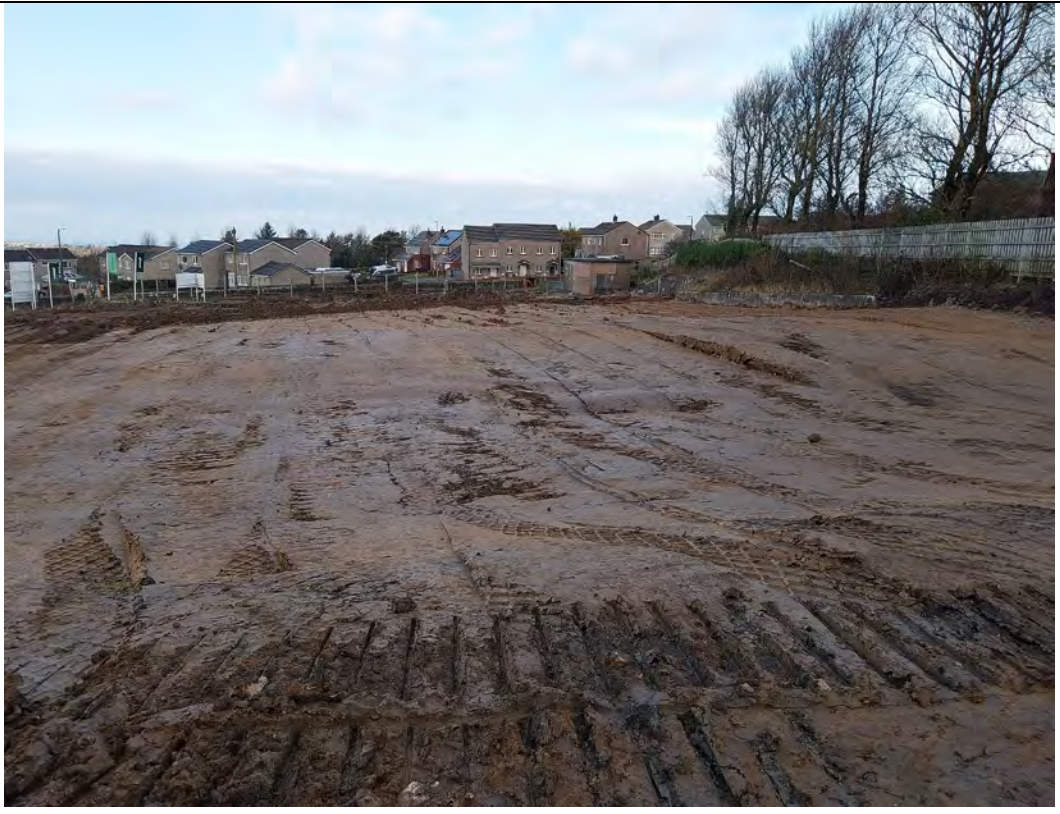
| <p><b>Photograph 16:</b></p> <p>Placed and compacted fill in Phase 1</p> | |
