# Heritage, Design and Access Statement

## 38 Roper Street

**Project:** Listed Building Consent for the demolition and re-building of a rear garden boundary wall

**Location:** 38 Roper Street, Whitehaven, CA28 7BS

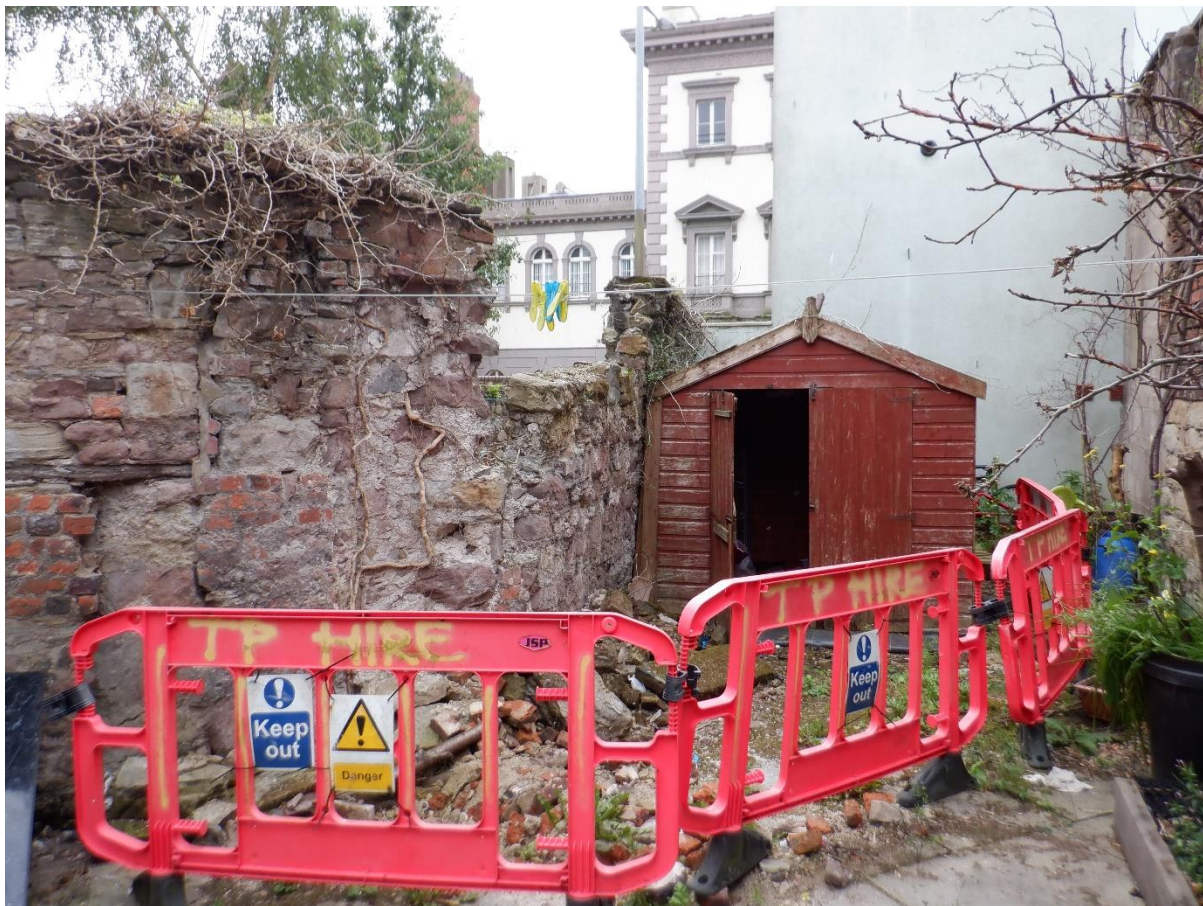
#### 4. PHOTOS

To the rear of the property is an enclosed garden divided from the adjoining owner by an approximately 2.4m high natural stone wall. The wall is currently in extremely poor condition and has partially collapsed, the remaining sections of wall that still stand present a significant risk to the occupants of the property should they also collapse.

We cannot see any evidence from the listing detail that the boundary wall in question is of any architectural or historical significance and given its current state of disrepair, cannot remain due to its imposed risk upon residents. We can also see that the wall has been historically repaired to a poor standard using non sympathetic materials, including modern brickwork, cement mortar and timber. We propose to demolish the existing wall, attempting to reclaim and salvage any large sections of stone for intended re-use. The wall will then be re-built like for like using reclaimed / salvaged stone of a similar texture and appearance, to the same height, on the same line of junction and upon appropriately sized concrete foundations. We propose the use of a non-hydraulic lime mortar mix (NHL 5). The wall will

2.1 The proposal is for the demolition and re-building of the rear garden boundary wall using existing materials where possible. The wall is structurally unstable and has partly collapsed. Without these works the wall poses a health and safety hazard to the occupants of the property.

be finished at head height with reclaimed stone copings, including any that can be salvaged from the existing structure.
