# **Heritage, Design and Access Statement**

## **38 Roper Street**

**Project:** Demolition and re-building of rear garden boundary wall

**Location:** 38 Roper Street, Whitehaven, CA28 7BS

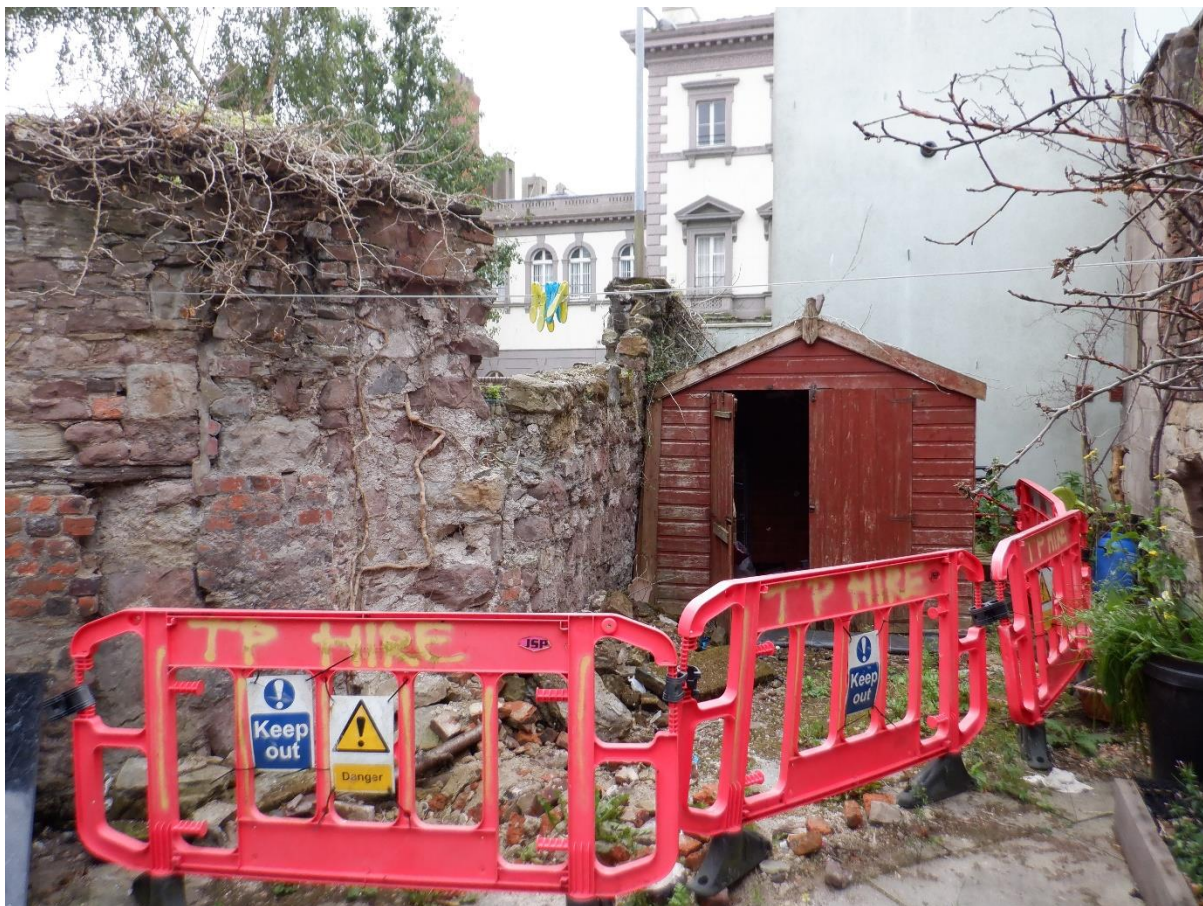
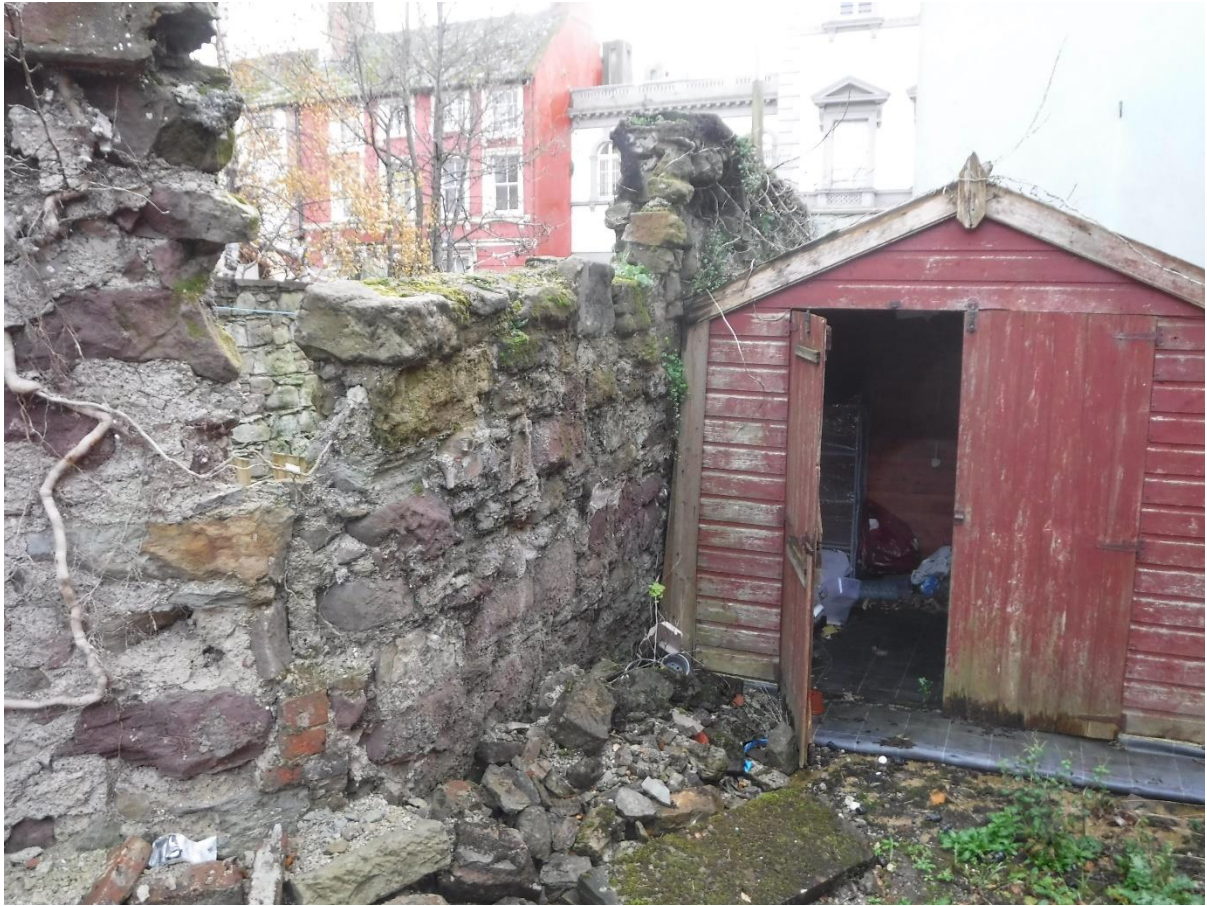
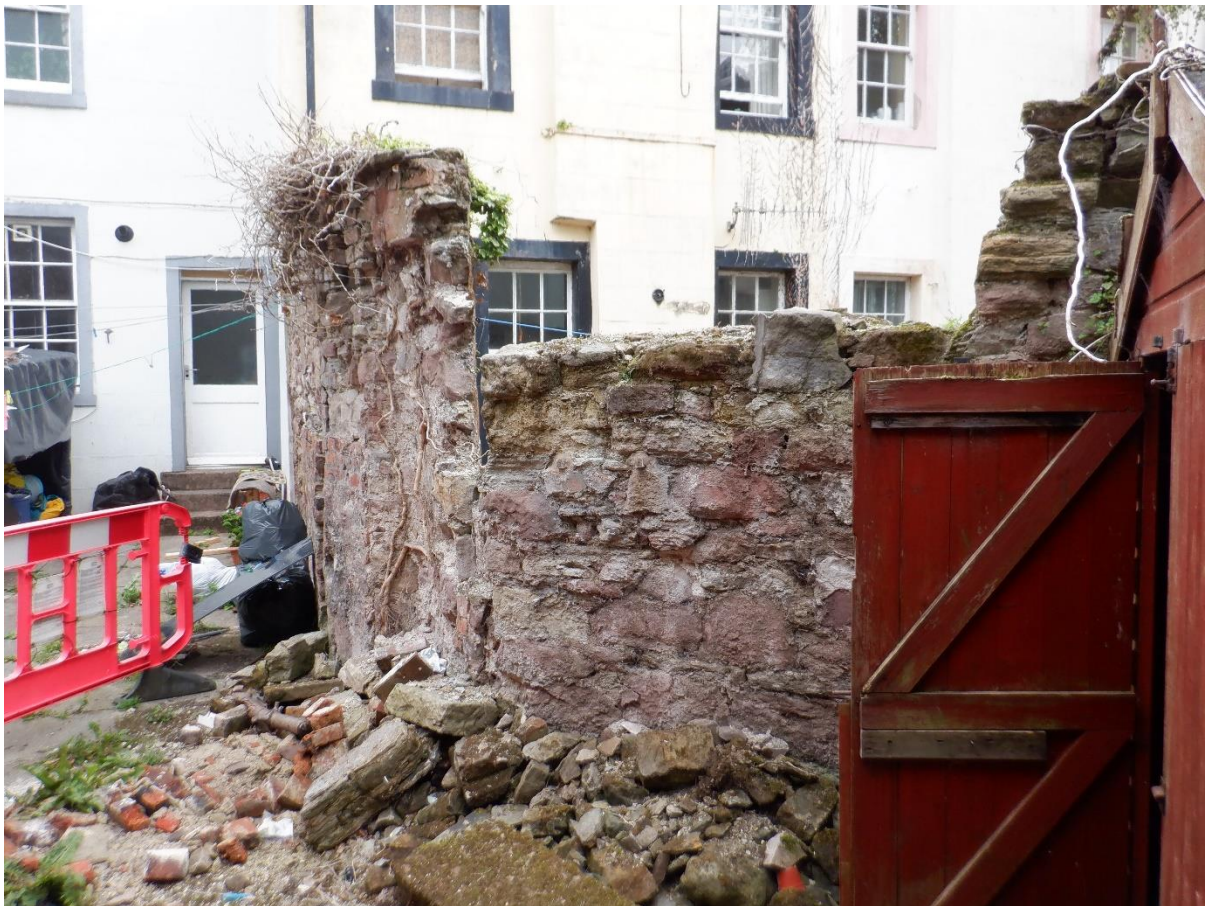
#### **4. PHOTOS**

To the rear of the property is an enclosed garden divided from the adjoining owner by an approximately 2.4m high natural stone wall. The wall is currently in extremely poor condition and has partially collapsed, the remaining sections of wall that still stand present a significant risk to the occupants of the property should they also collapse.

We cannot see any evidence from the listing detail that the boundary wall in question is of any architectural or historical significance and given its current state of disrepair, cannot remain due to its imposed risk upon residents. We can also see that the wall has been historically repaired to a poor standard using non sympathetic

materials, including modern brickwork, cement mortar and timber. We propose to demolish the existing wall, attempting to reclaim and salvage any large sections of stone for intended re-use. The wall will then be re-built like for like using reclaimed / salvaged stone of a similar texture and appearance, to the same height, on the same line of junction and upon appropriately sized concrete foundations. We propose the use of a natural hydraulic lime (NHL 3.5). The wall will be finished at head height with reclaimed stone copings, including any that can be salvaged from the existing structure. The new wall will have a vertical DPM to the abutment to the building and a dry mortar fillet. On the opposite side it will abut the existing wall with a dry mortar fillet only.
