## FLOOD RISK ASSESSMENT

### **Cleator Mill, Proposed Commercial Development, Flood Risk Assessment.**

| Reference | RO/FRA/NEWCOM/13000.1 |

### **Asset Condition survey: River Ehen (right bank) Flood Defence at Cleator Mills**

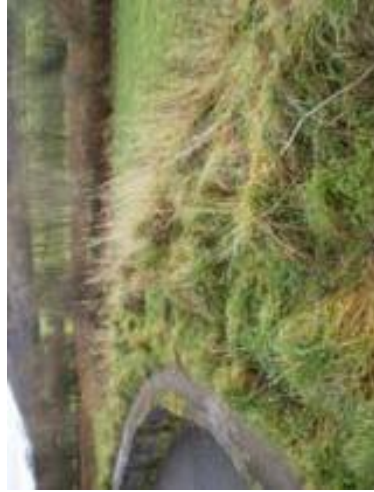
The defence fails to meet target 3 as currently set and wholesale vegetation clearance is required along the whole length of defence, with selective vegetation management in co-operation with EA's Fisheries, Recreation and Biodiversity team on the berm and channel side. The rock revetment at the toe of the channel side is helping to prevent undercutting of the berm and strategic repair might be appropriate.

*Heavily overgrown Flood crest*

Once vegetation has been cleared the entire bank requires re-shaping to reduce its current fragility.

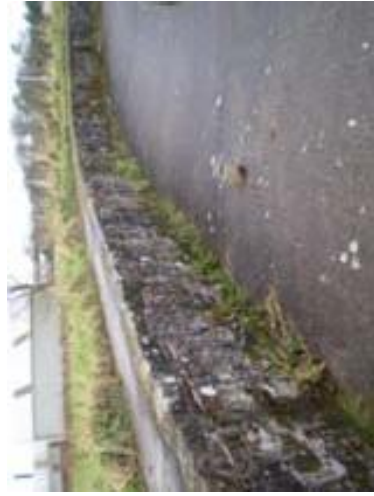
*Inward face (masonry) and flood crest*

Vegetation management of Face Outward and Flood Crest, some pointing to masonry wall; reseeding bare patches and fencing with an approximate cost of circ £3,000. Maintenance to retain target condition requires superficial vegetation management and regular inspection to monitor any deterioration.

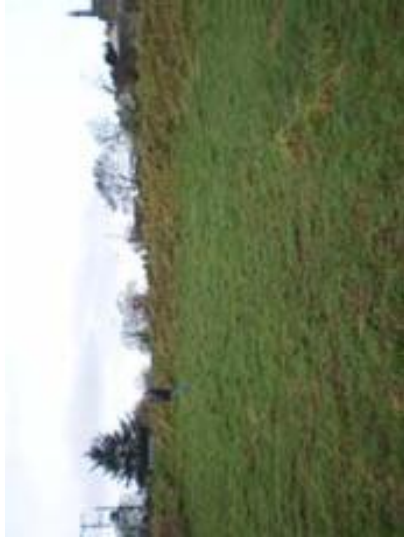
*Outward Face and protected area*

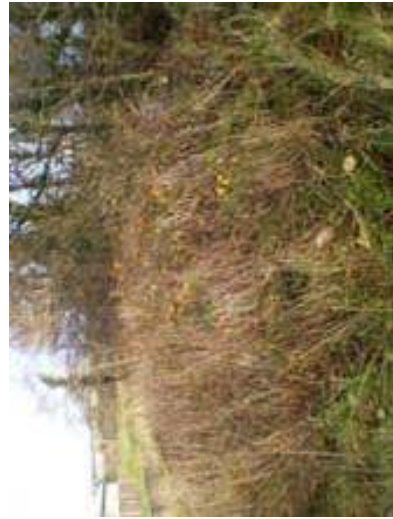
*“Embankment at rear of Kangol*

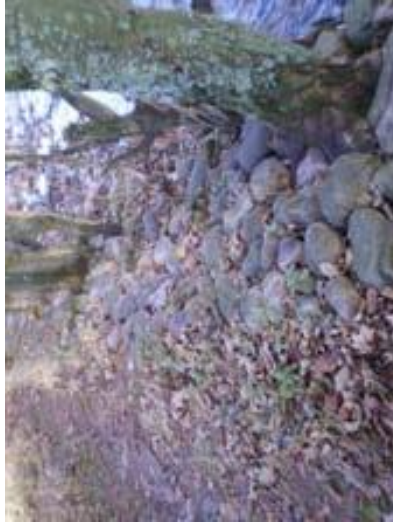
*Stone revetment on channel side*

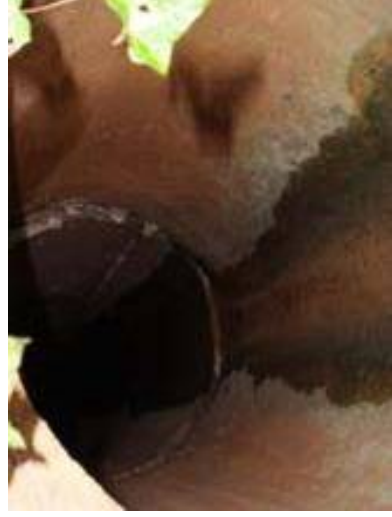
*D/S 18" clay pipe flowing clear #1*

- Following construction of the development the clay pipes or their replacements should be fitted with flaps to prevent ingress of flood water.

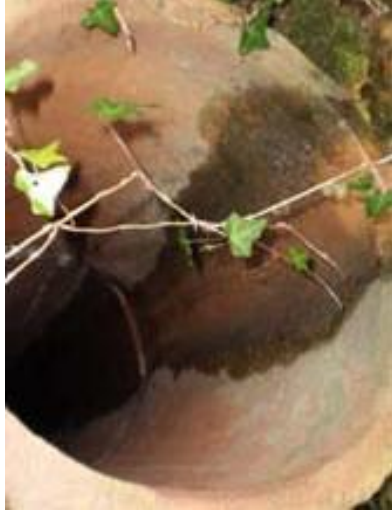
*D/S 18" clay pipe #2*

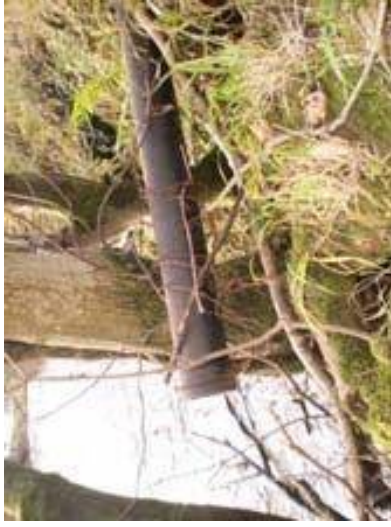
*6" iron pipe #1*

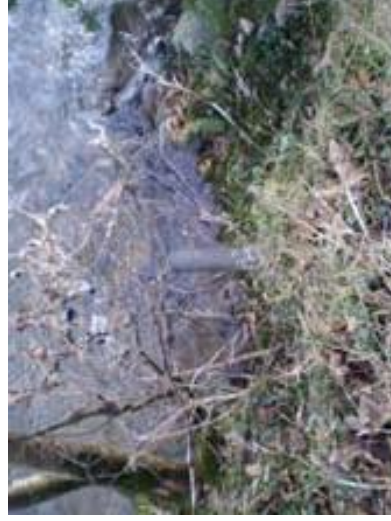
*6" iron pipe #2*
