| <b>Curtins Consulting Ltd</b><br><br>K Village, Riverside Place, Units<br>24-25, Lound Rd, Kendal LA9 7FH | <b>Subject</b><br><br>Cleator Moor Innovation Quarter<br>Photograph Survey Log | | <br><br>Sheet No: 01 |
| | <b>Job No:</b><br><b>085788</b> | <b>Made by:</b> JTS<br><b>Chkd by:</b> PT | |

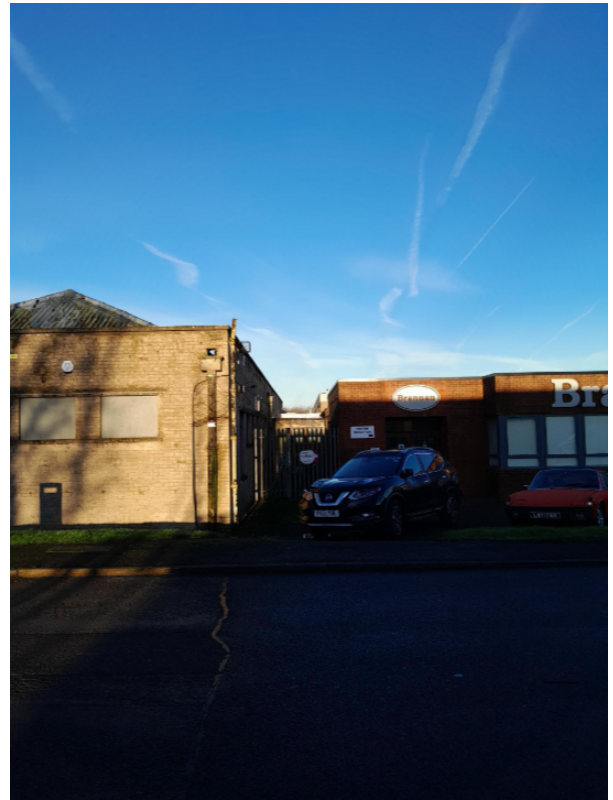
Figure 03 - existing buildings to remain

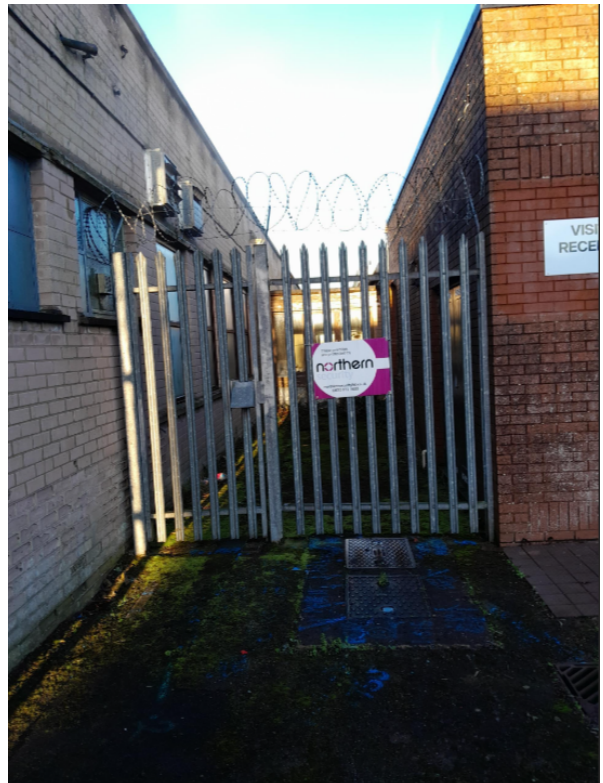
Figure 04 - existing buildings to remain

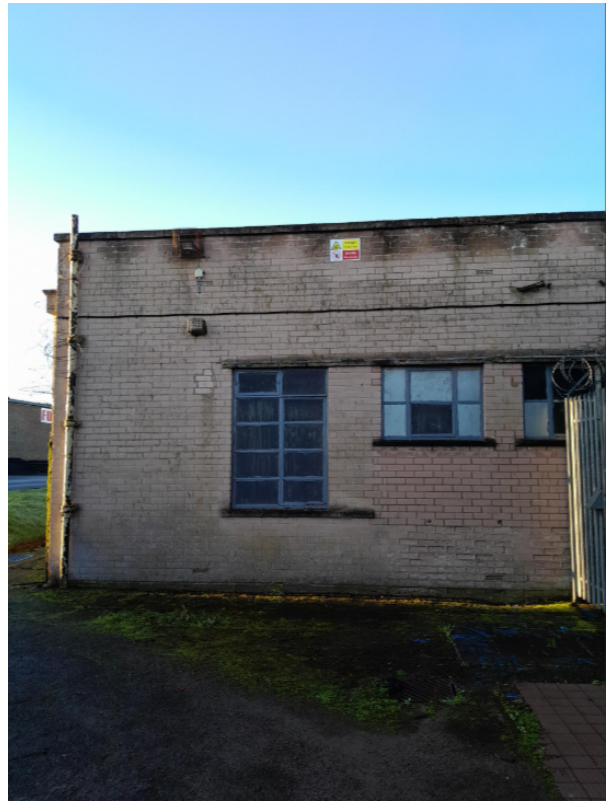
Figure 05 - existing buildings to remain

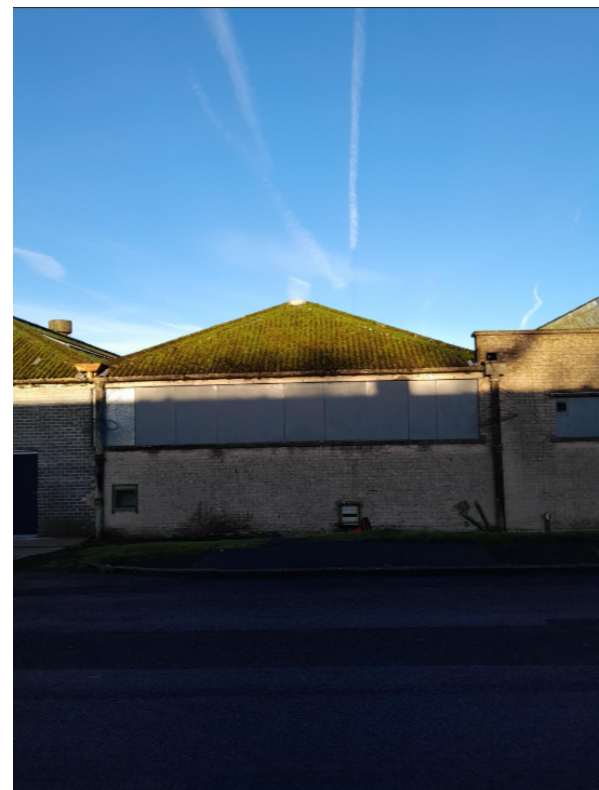
Figure 10 - existing buildings to remain

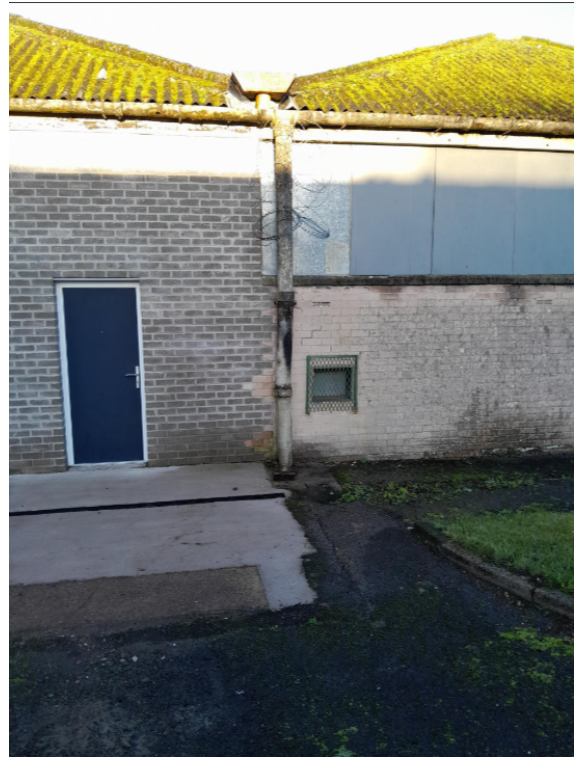
Figure 11 - existing buildings to remain, MASONRY COLOUR CHANGE

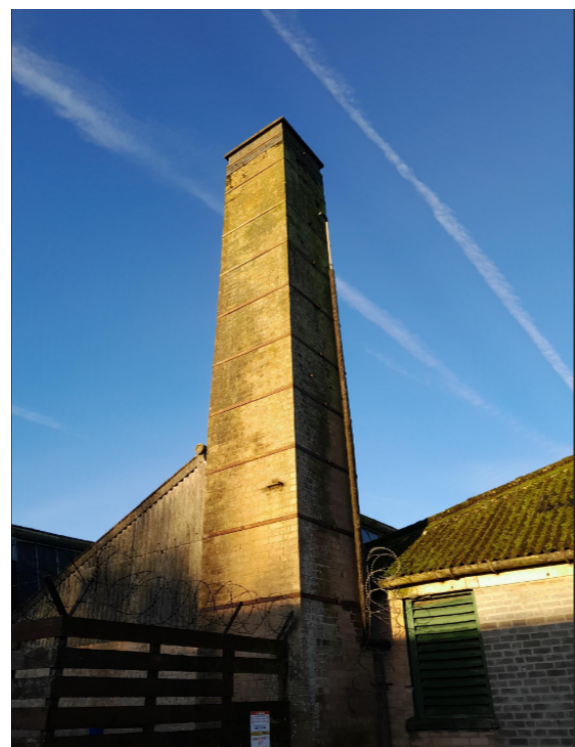
Figure 12 - existing CHIMNEY to remain

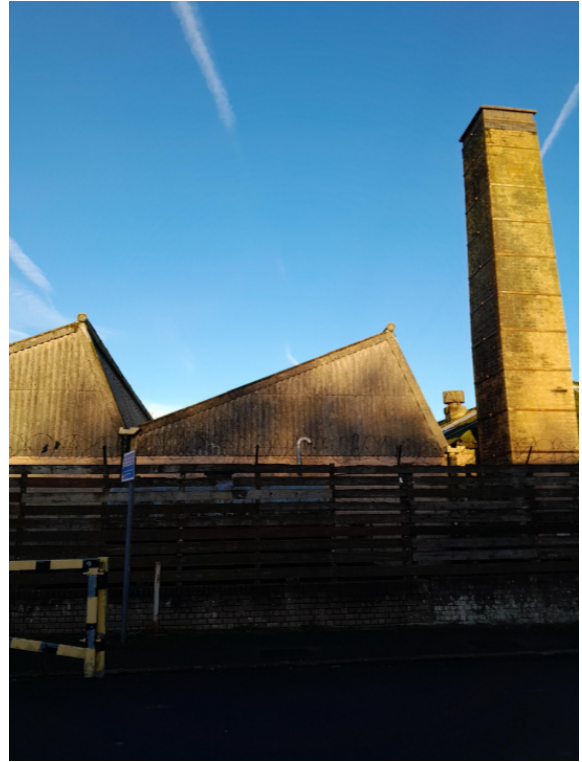
Figure 13 - existing buildings **to be demolished**, ASYMMETRIC ROOF

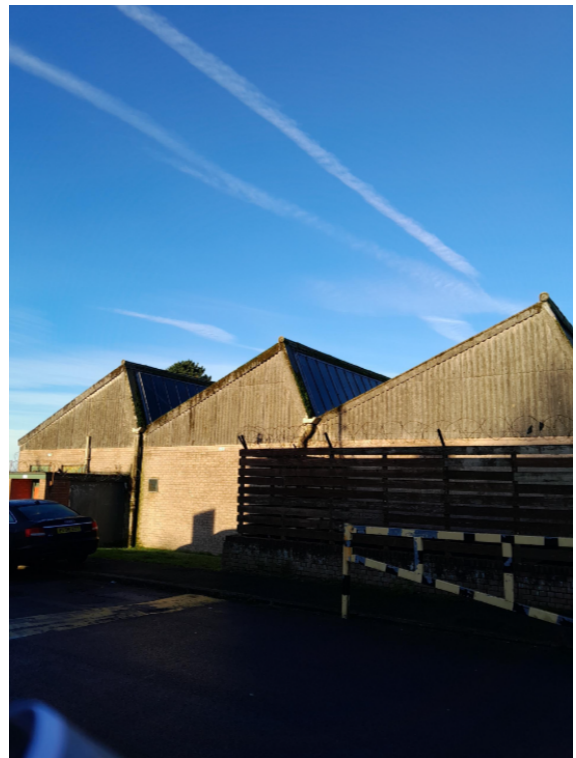
Figure 14 - existing buildings **to be demolished**, ASYMMETRIC ROOF

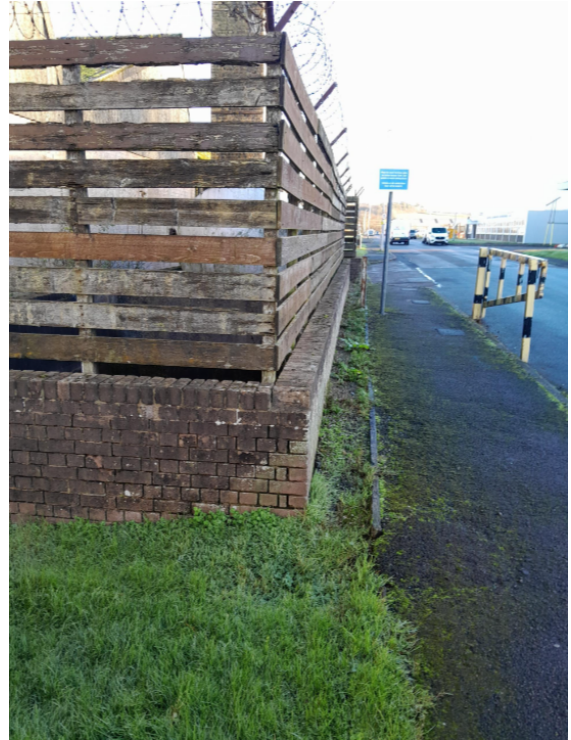
Figure 15 - pavement and perimeter wall to tank zone. **Council to confirm if demolition is required.**

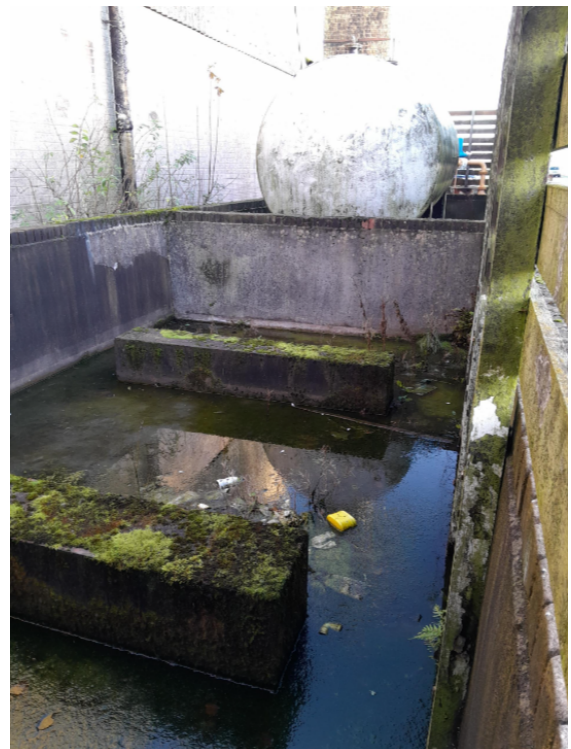
Figure 16 - pavement and perimeter wall to tank zone. **Council to confirm if demolition is required.**

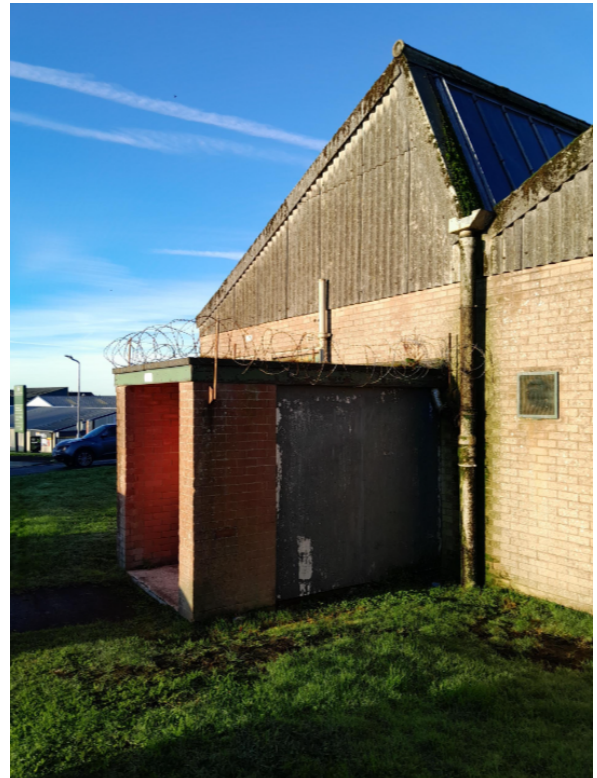
Figure 18 - existing buildings **to be demolished**, SINGLE STOREY ENTRANCE

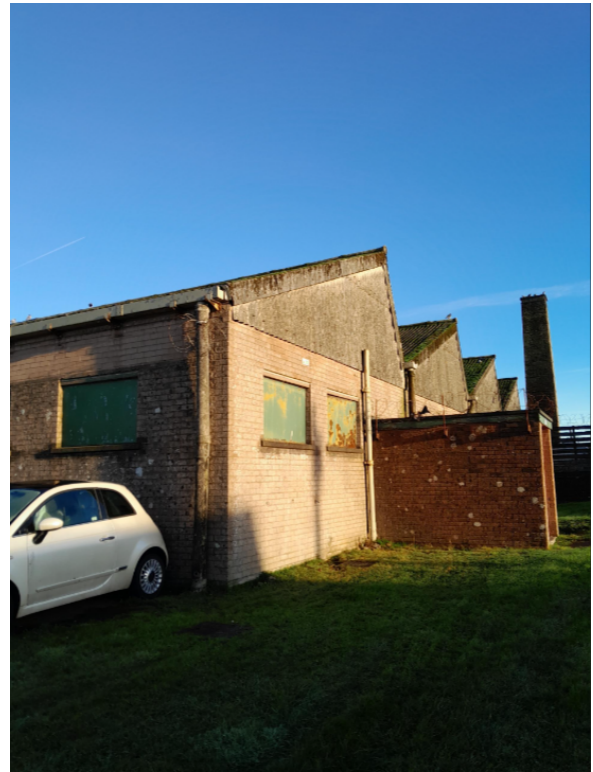
Figure 19 - existing buildings **to be demolished**, ASYMMETRIC ROOF

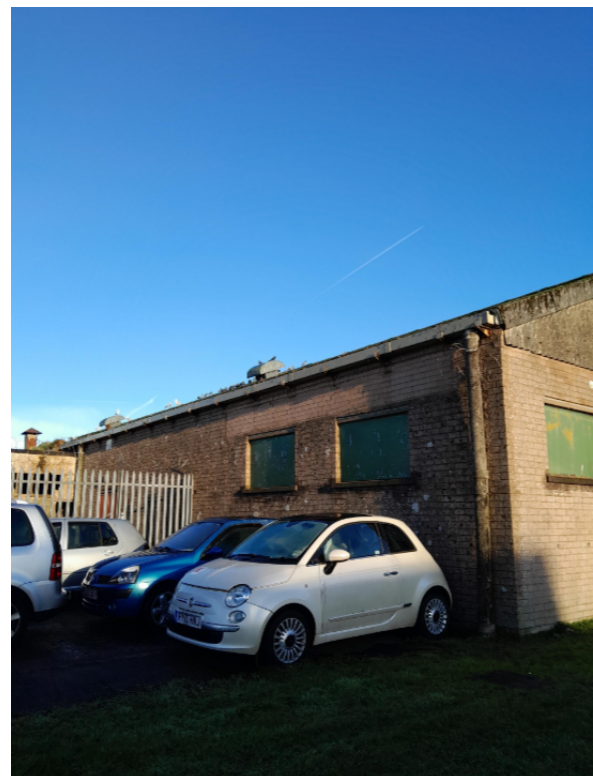
Figure 20 - existing buildings **to be demolished**, ASYMMETRIC ROOF

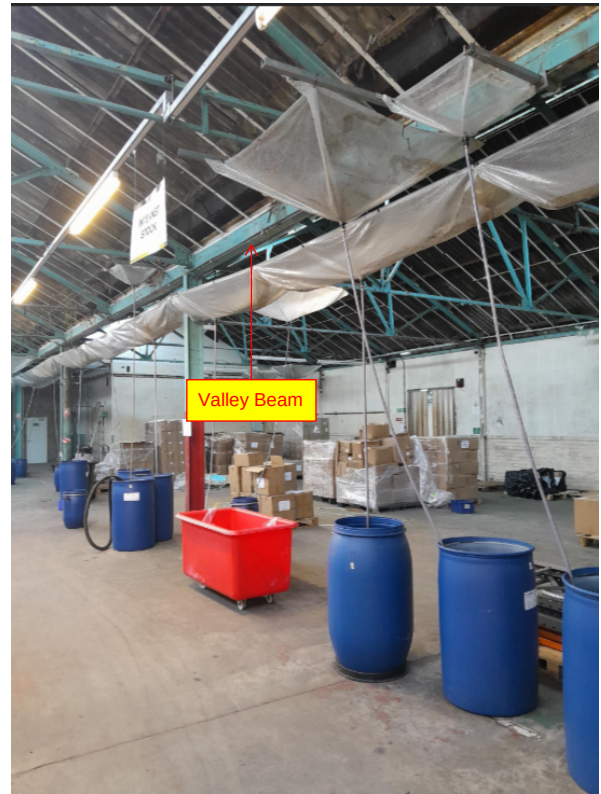
Figure 23 - existing buildings VIEW OF INTERNAL SPINE WALL which is to remain taken from retained side

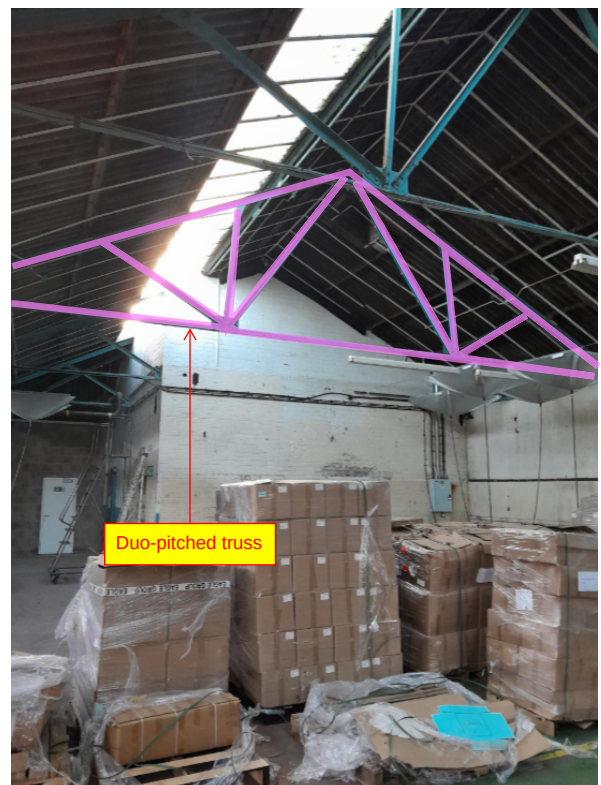
Figure 24 - existing buildings internal outrigger to remain, taken from retained side

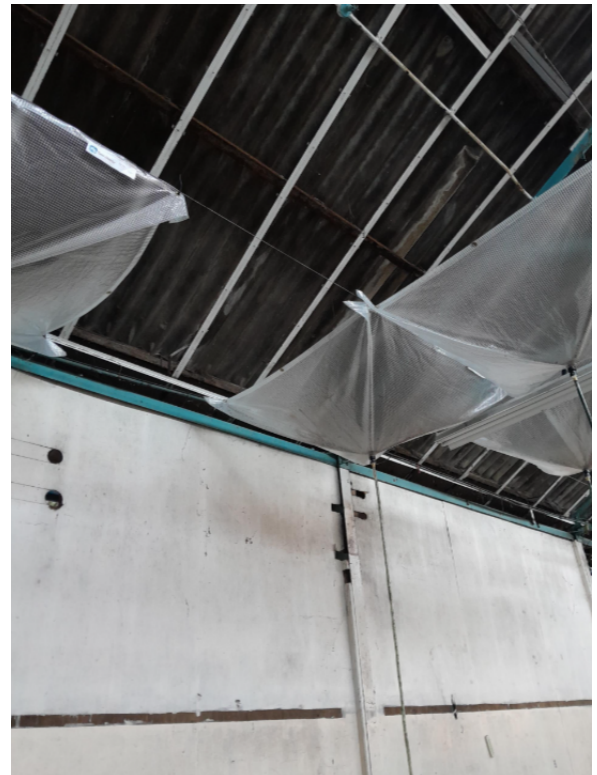
Figure 26 - existing buildings VIEW OF INTERNAL SPINE WALL which is to remain taken from retained side

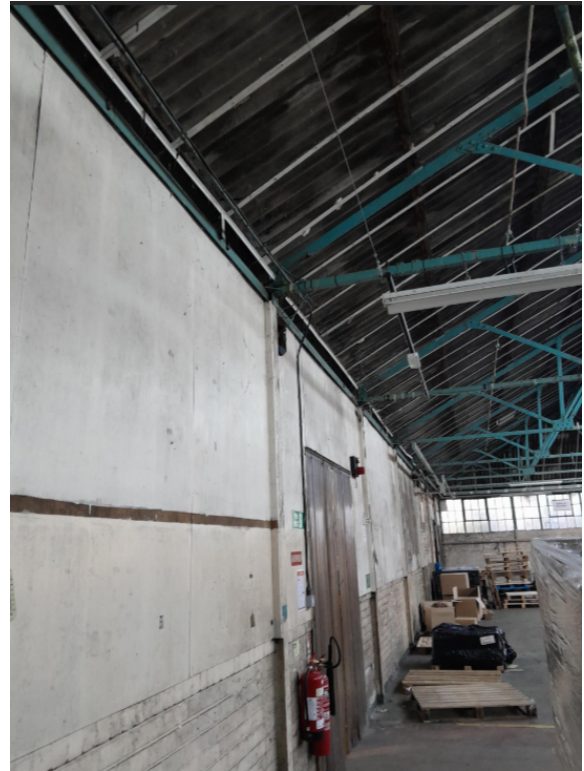
Figure 27 - existing buildings VIEW OF INTERNAL SPINE WALL which is to remain taken from retained side

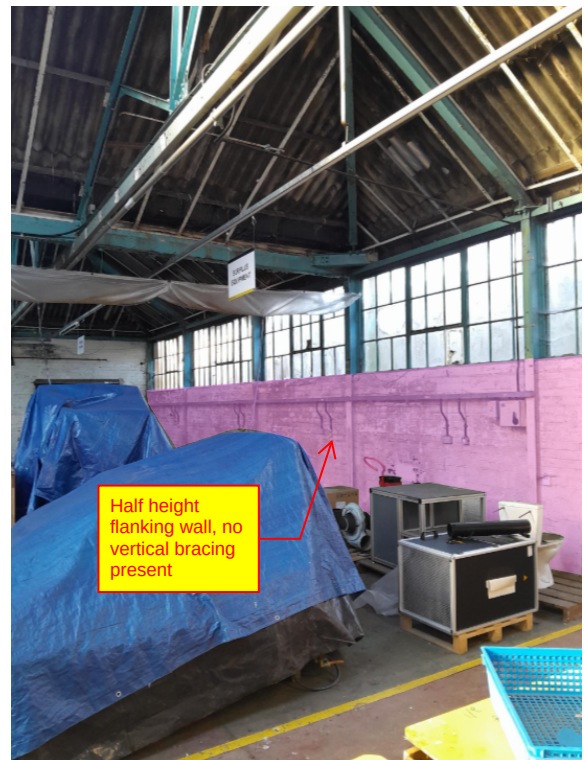
Figure 28 - existing buildings VIEW OF HALF-HEIGHT MASONRY WALL taken from retained side

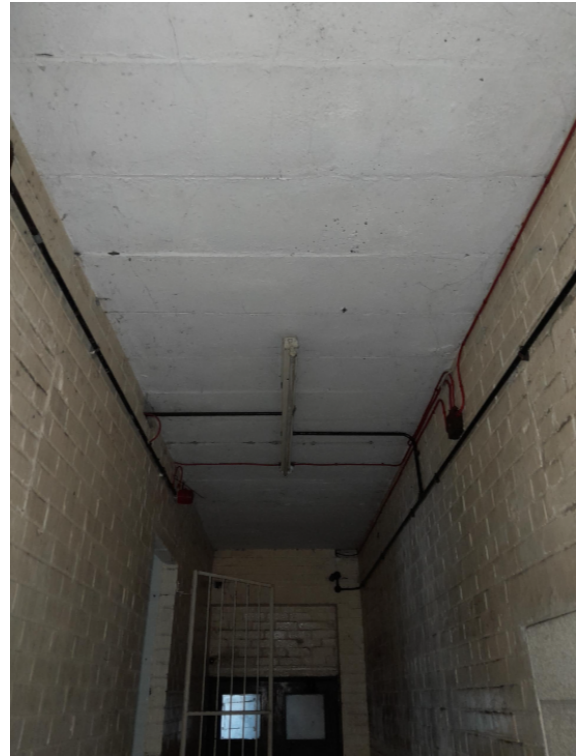
Figure 29 - existing buildings **to be demolished**, APPEARS AS CONCRETE SOFFIT to single storey. LB Masonry

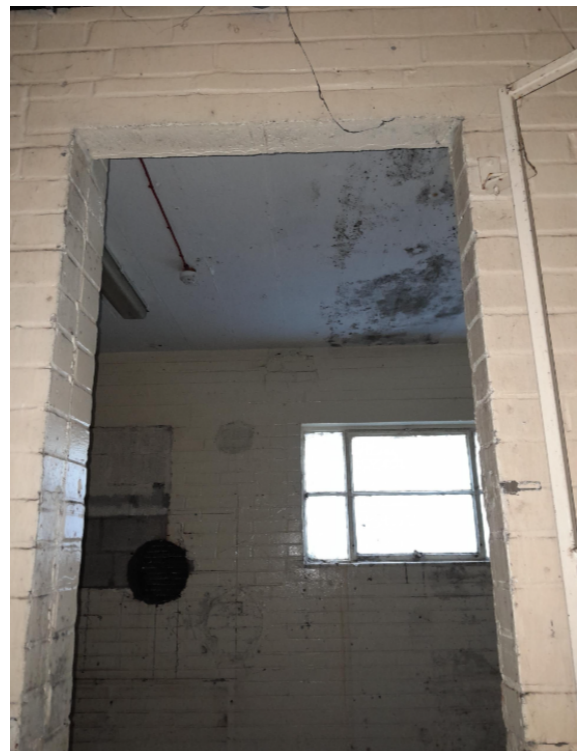
Figure 30 - existing buildings **to be demolished**, APPEARS AS CONCRETE SOFFIT to single storey. LB Masonry

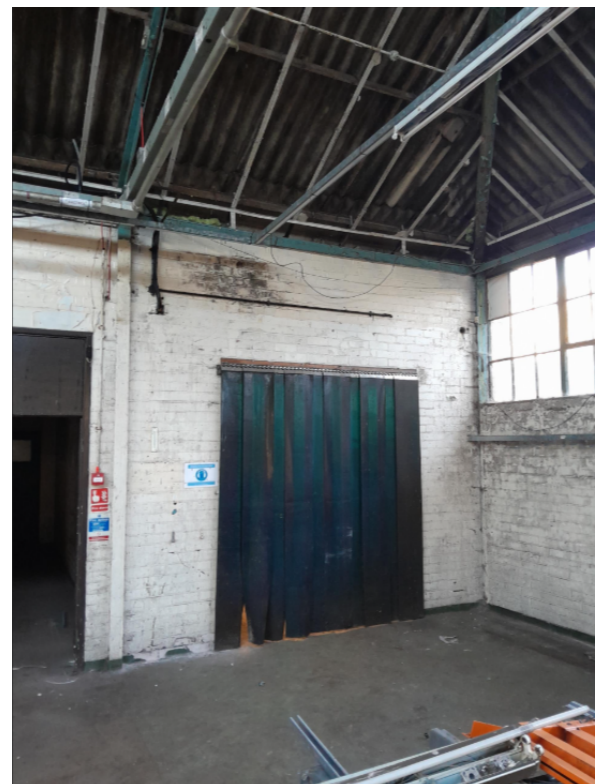
Figure 32 - existing buildings VIEW OF INTERNAL SPINE WALL which is to remain taken from retained side

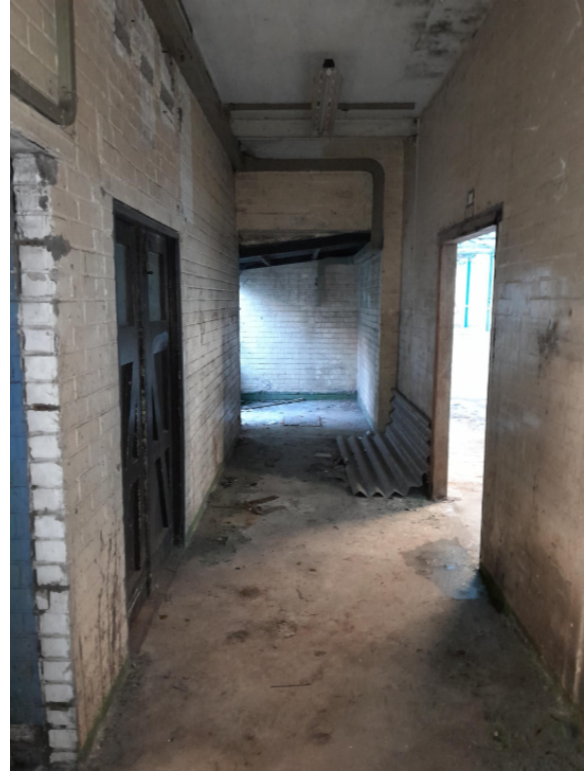
Figure 35 - existing buildings **to be demolished**, single storey workshop. DOWNSTAND STEEL (A)

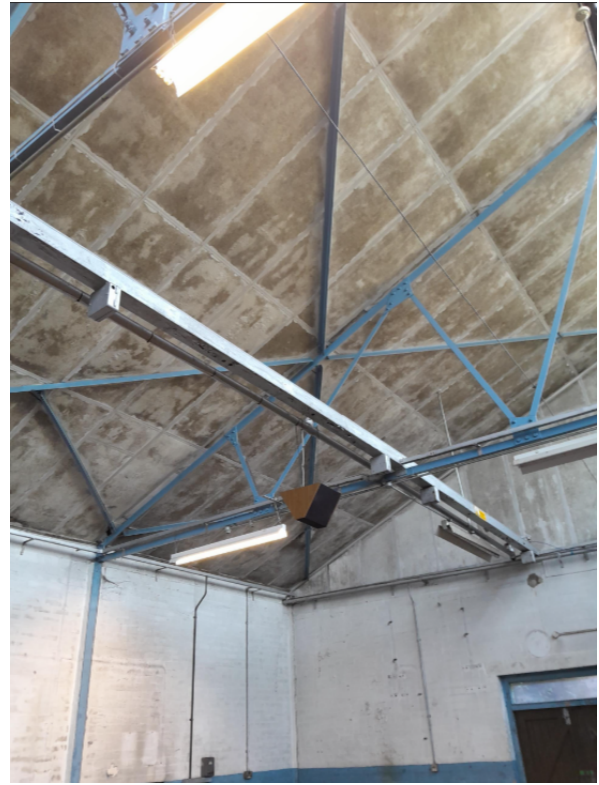
Figure 37 - existing buildings **to be demolished**, ROOF BRACING

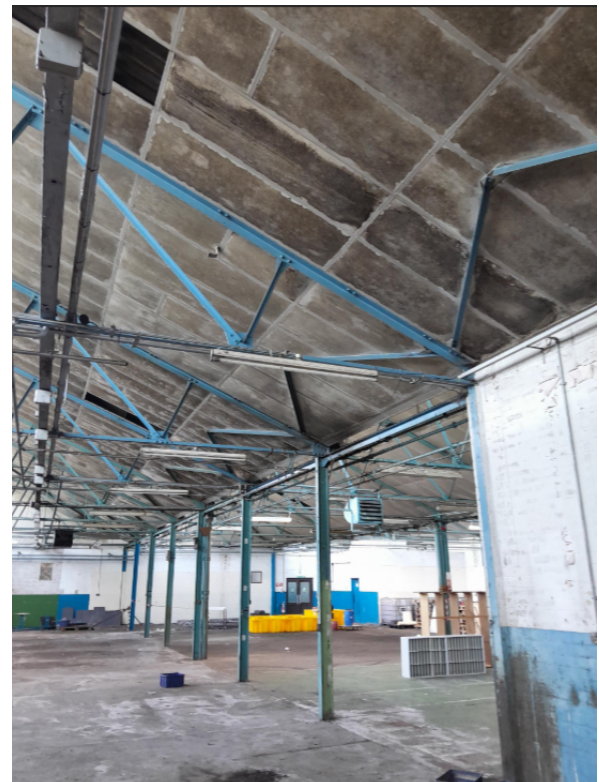
Figure 38 - existing buildings **to be demolished**, ROOF BRACING

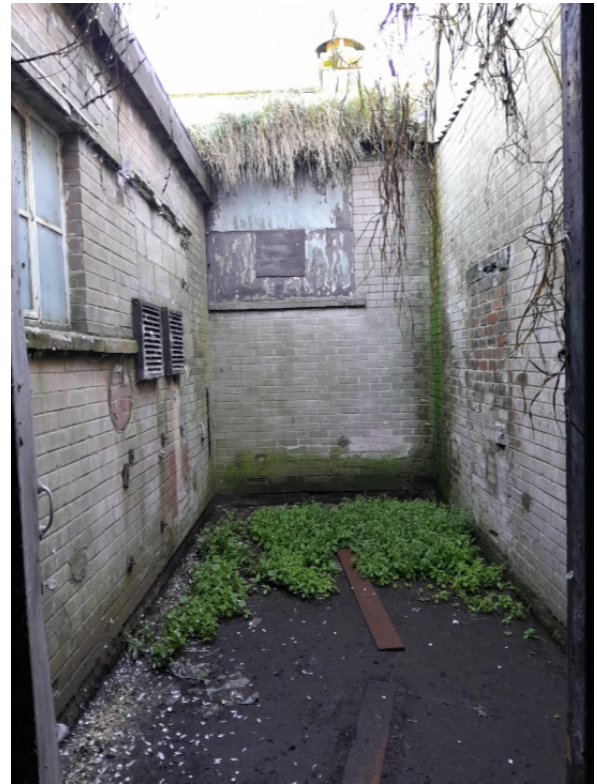
Figure 39 - BACK WALL REMAINING

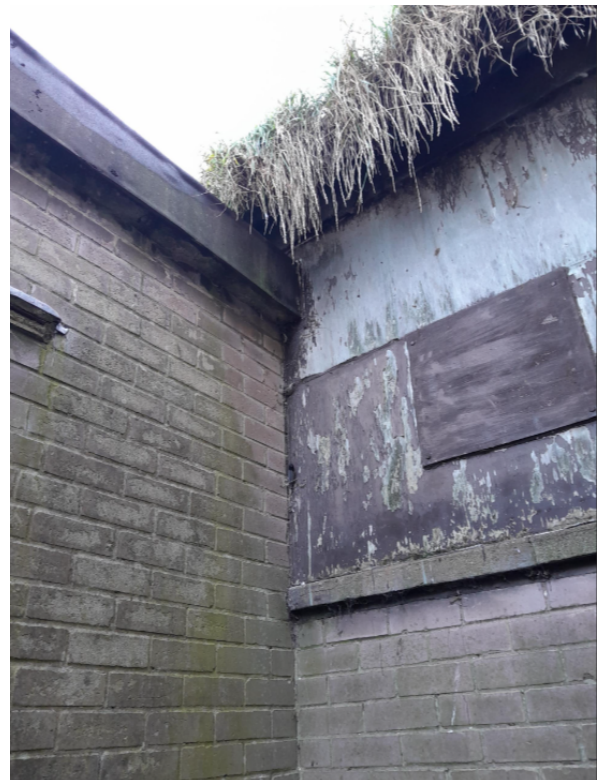
Figure 40 - BACK WALL REMAINING perpendicular wall to be demolished

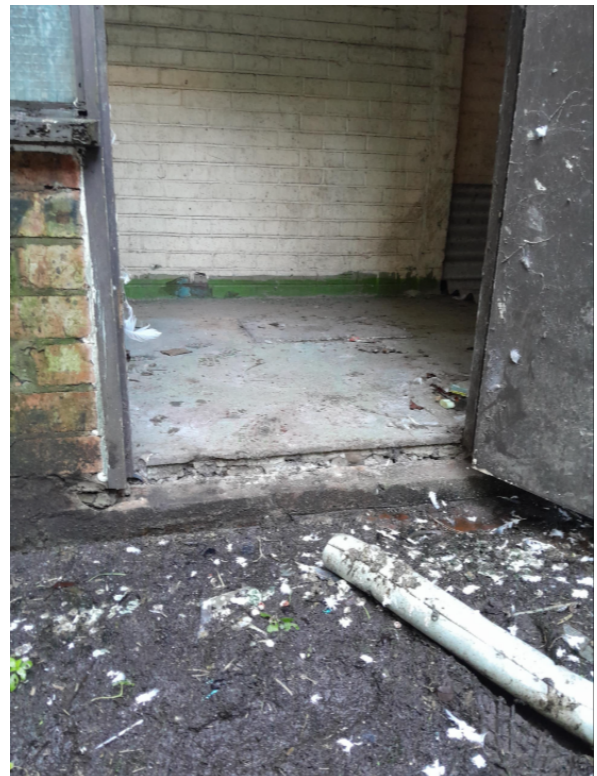
Figure 42 - existing buildings **to be demolished**, DOOR THRESHOLD

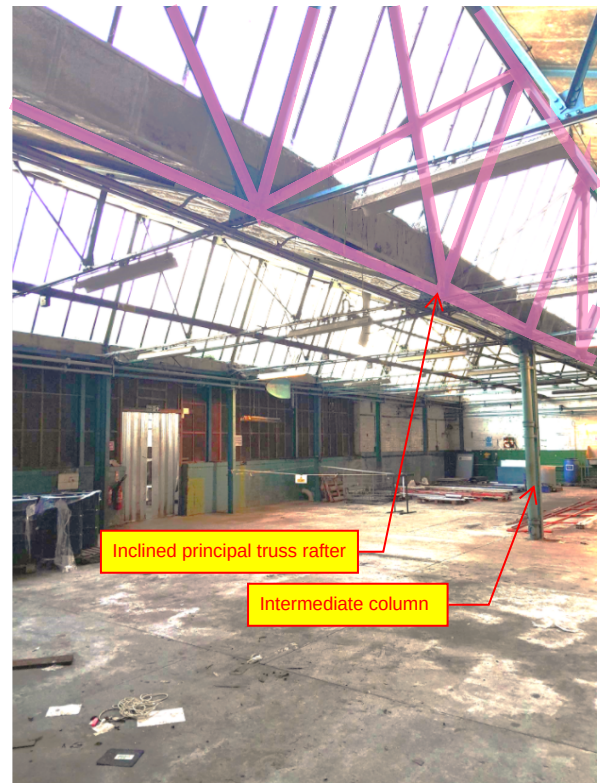
Figure 43 - existing buildings **to be demolished**, FLAT ROOF TRUSS, for open floor zone

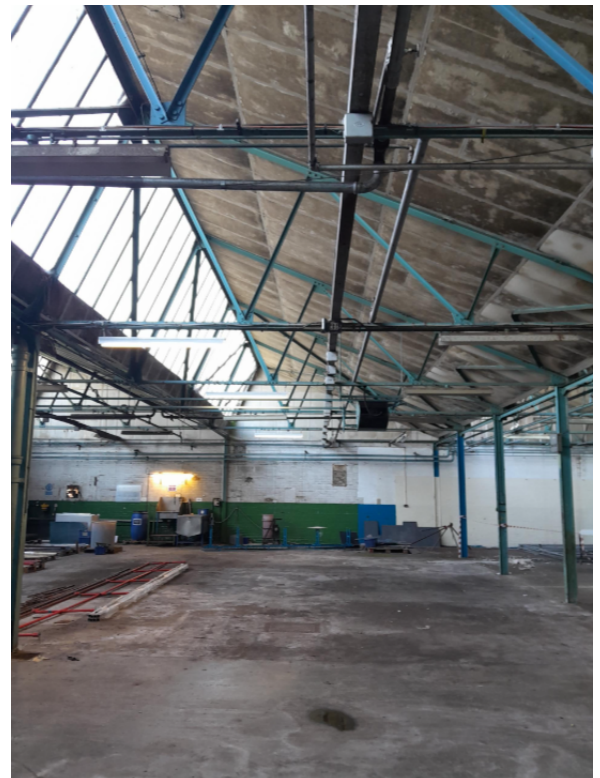
Figure 44 - existing buildings **to be demolished**, FLAT ROOF TRUSS adjacent to glazing

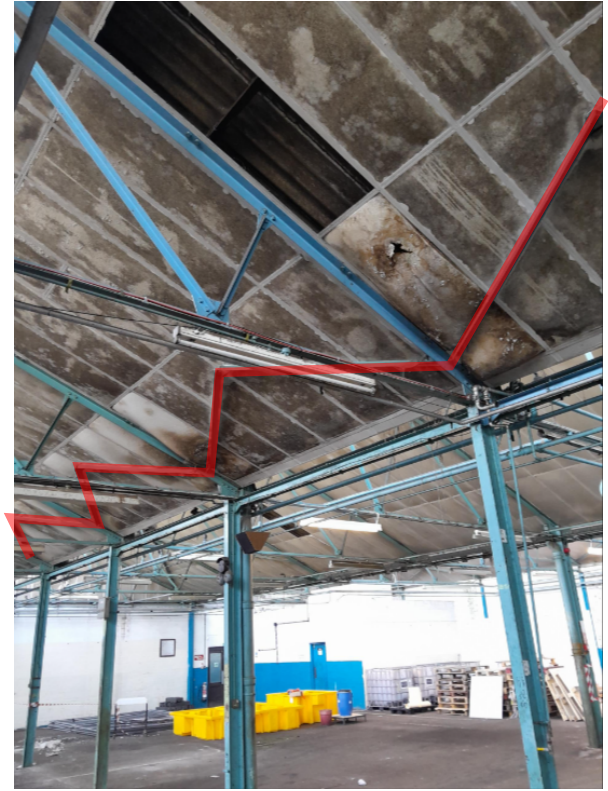
Figure 45 - existing buildings **to be demolished**, HOT-ROLLED PURLIN

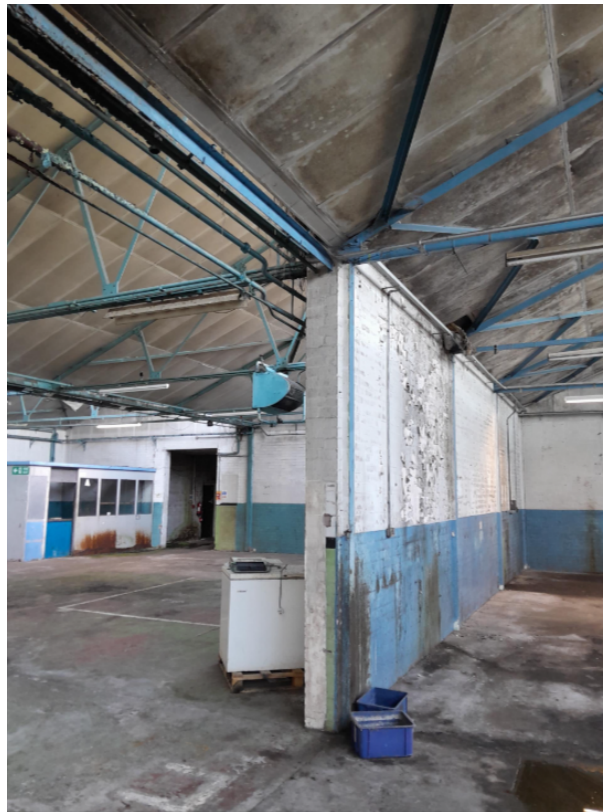
Figure 46 - existing buildings **to be demolished**, TWO-BRICK THICK MASONRY WALL

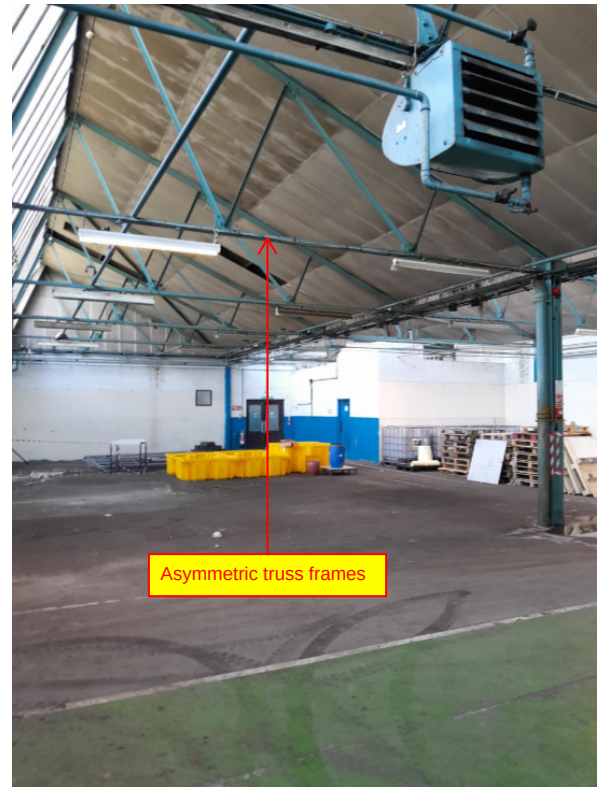
Figure 47 - existing buildings **to be demolished**, INTERNAL ROOF TRUSS

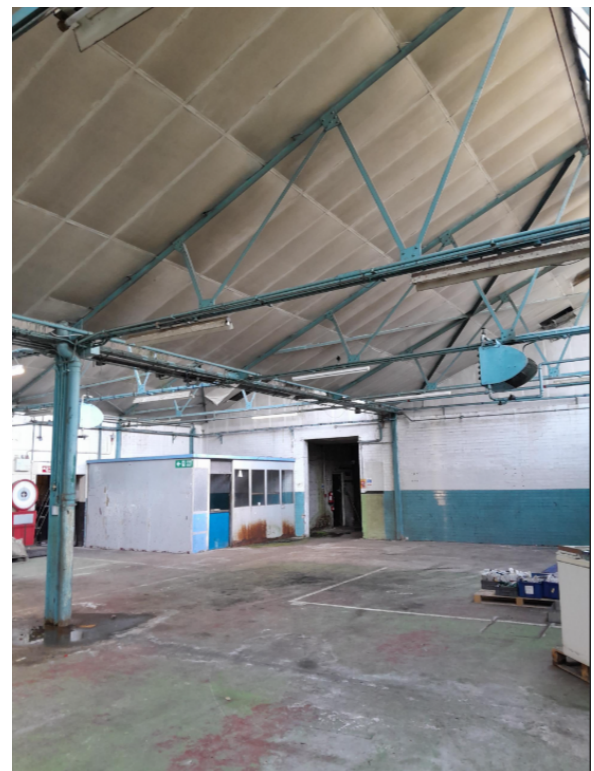
Figure 48 - existing buildings **to be demolished**, INTERNAL ROOF TRUSS, LGS free standing structure

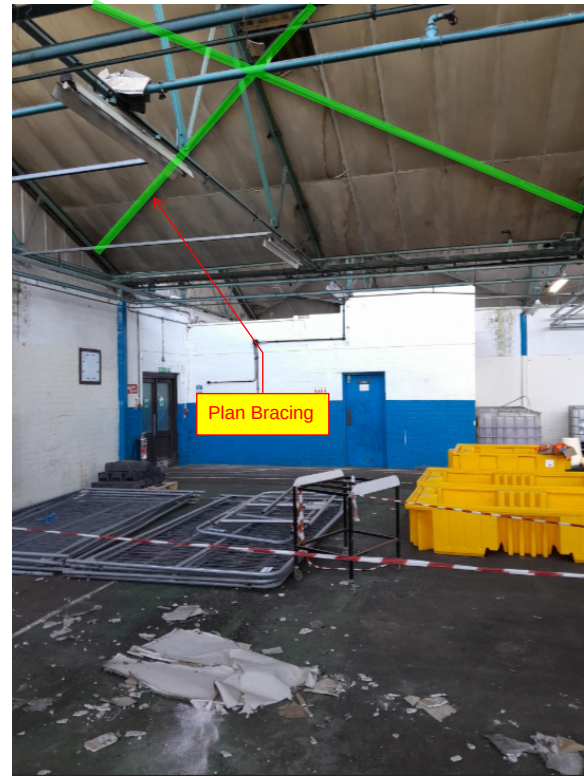
Figure 49 - existing buildings **to be demolished**, INTERNAL ROOF TRUSS, ROOF BRACING

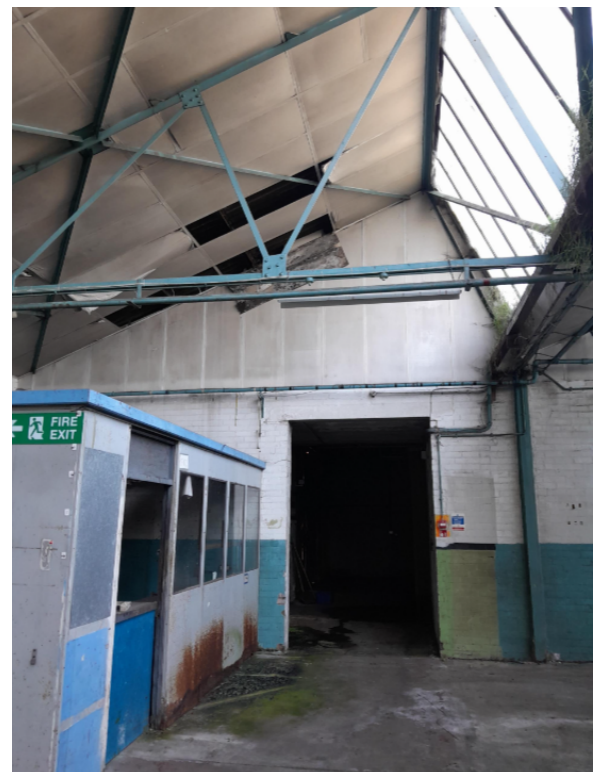
Figure 50 - existing buildings **to be demolished**, INTERNAL ROOF TRUSS, HALF HEIGHT MASONRY WALL

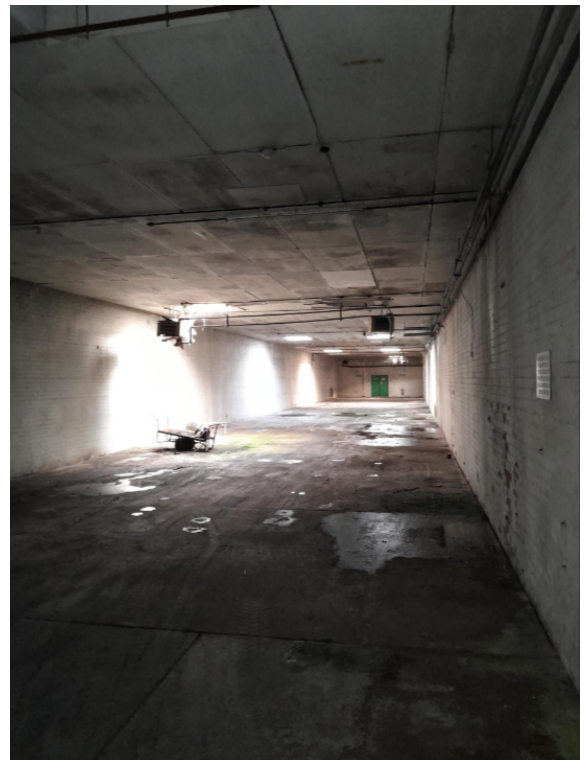
Figure 52 - existing buildings **to be demolished**, view of zone 3

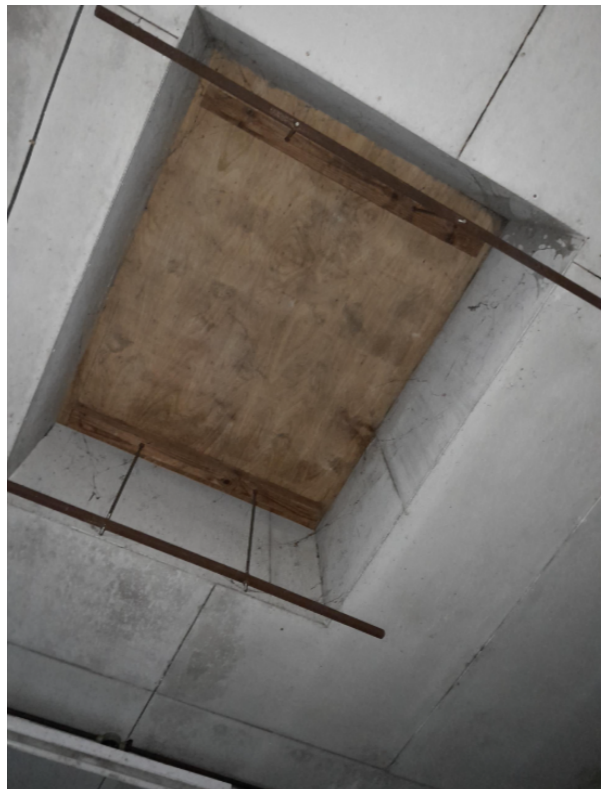
Figure 54 - existing buildings **to be demolished**, zone 3 ROOFLIGHT, SOFFIT

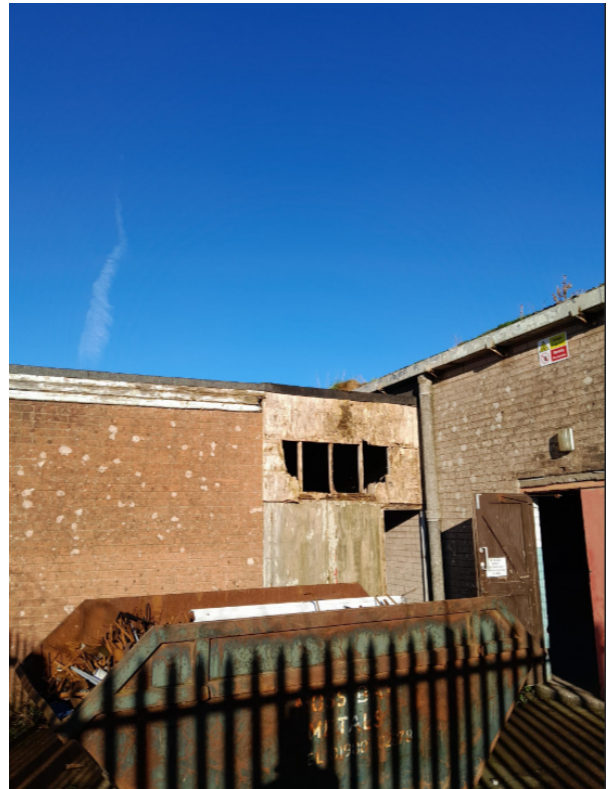
Figure 55 - existing buildings **to be demolished**, FLAT ROOF

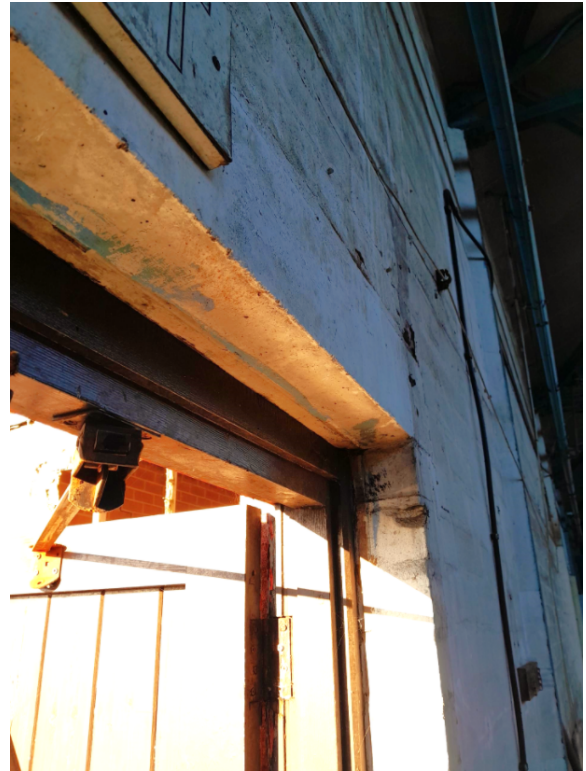
Figure 57 - existing buildings to be demolished, perimeter wall INNER LEAF - CAVITY - OUTER LEAF

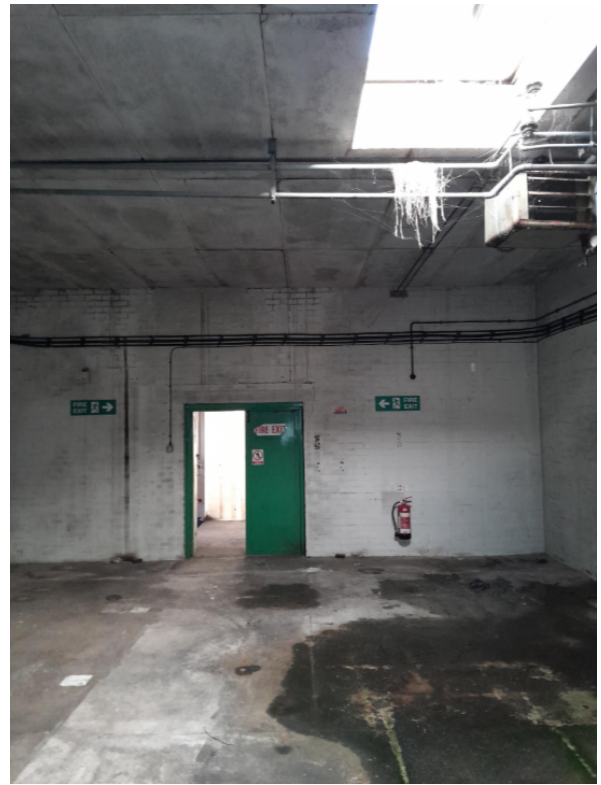
Figure 59 - existing buildings VIEW OF BACK WALL to zone 3 to the remain

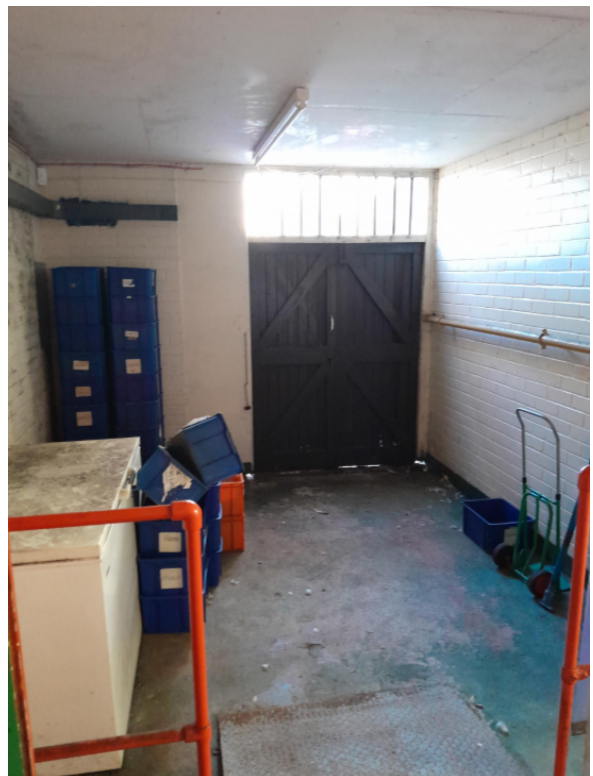
Figure 60 - existing buildings VIEW OF PLANT ROOM to remain

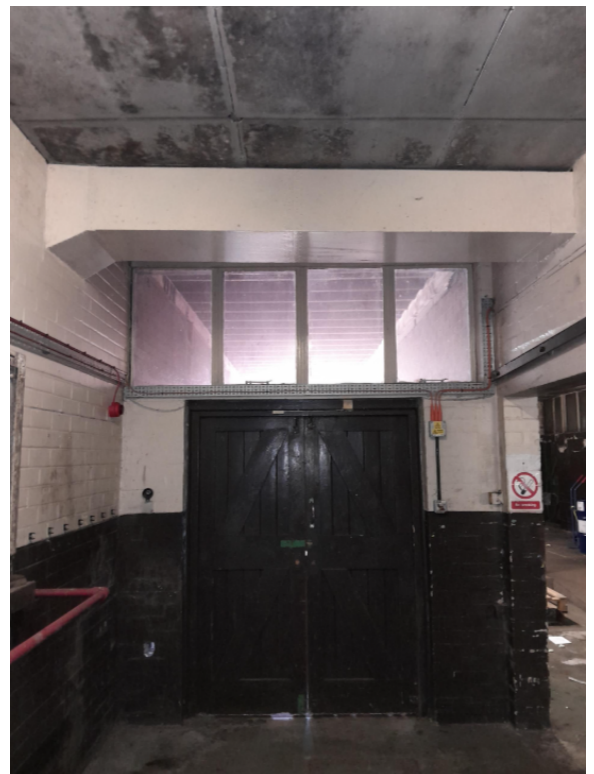
Figure 62 - existing buildings to be demolished

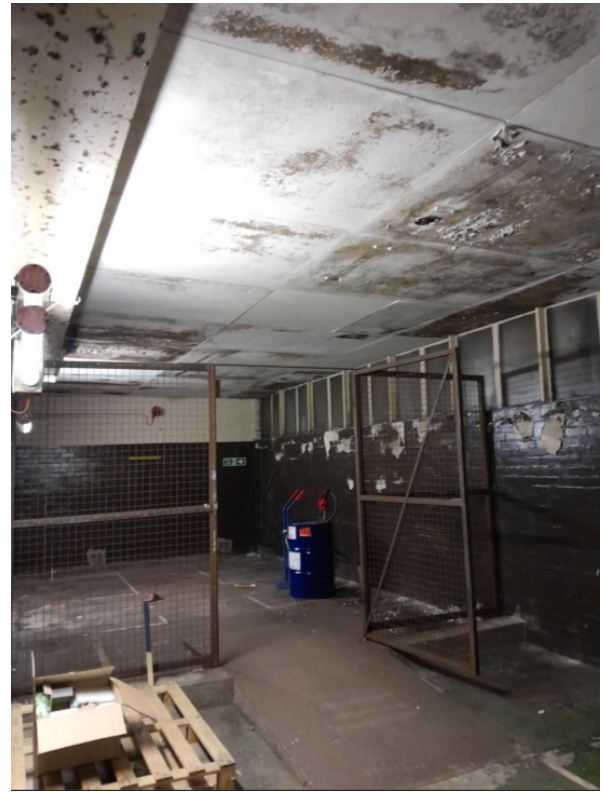
Figure 63 - existing buildings to be demolished

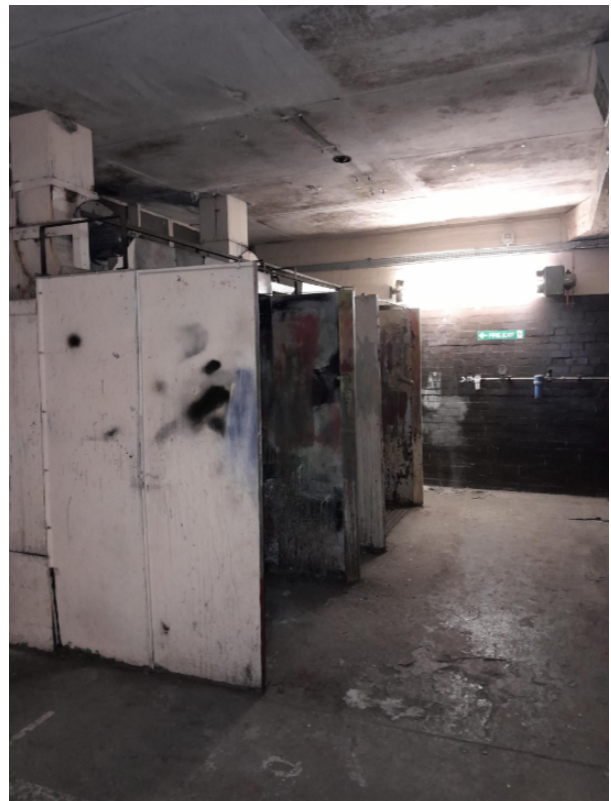
Figure 64 - existing buildings to be demolished

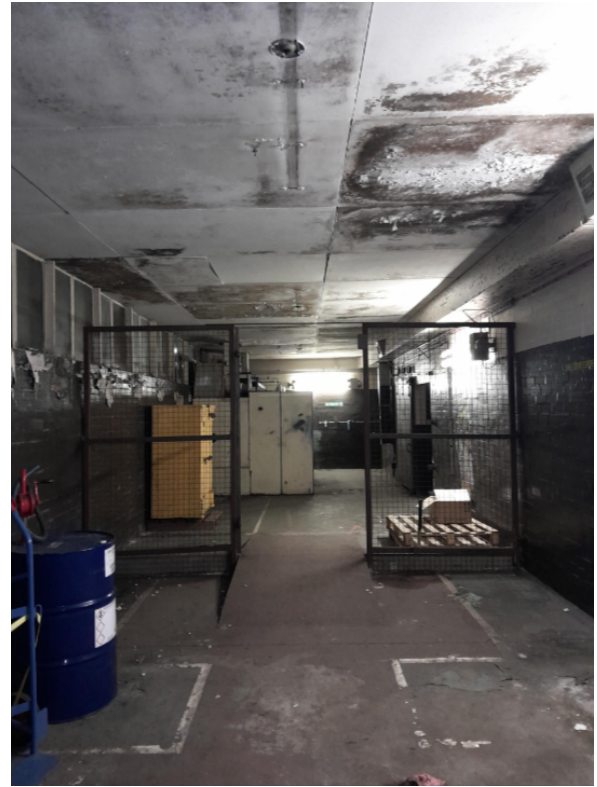
Figure 65 - existing buildings to be demolished

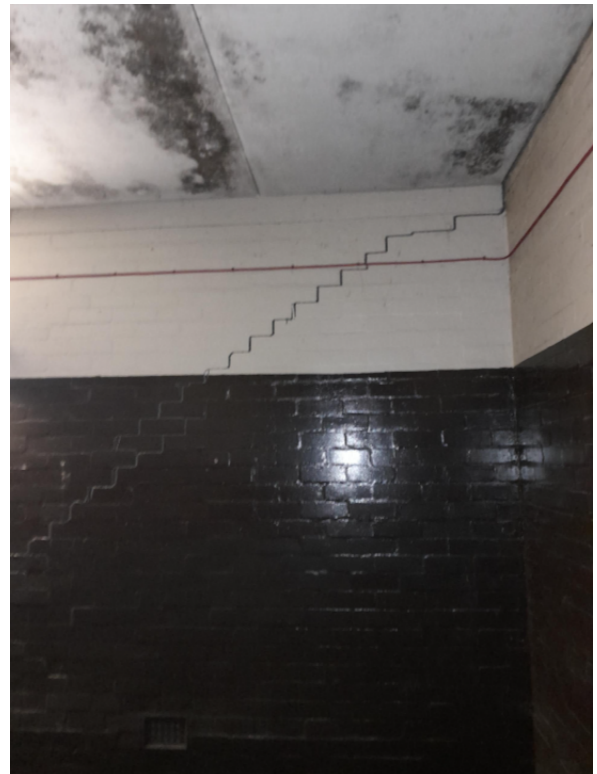
Figure 66 - existing buildings to be demolished

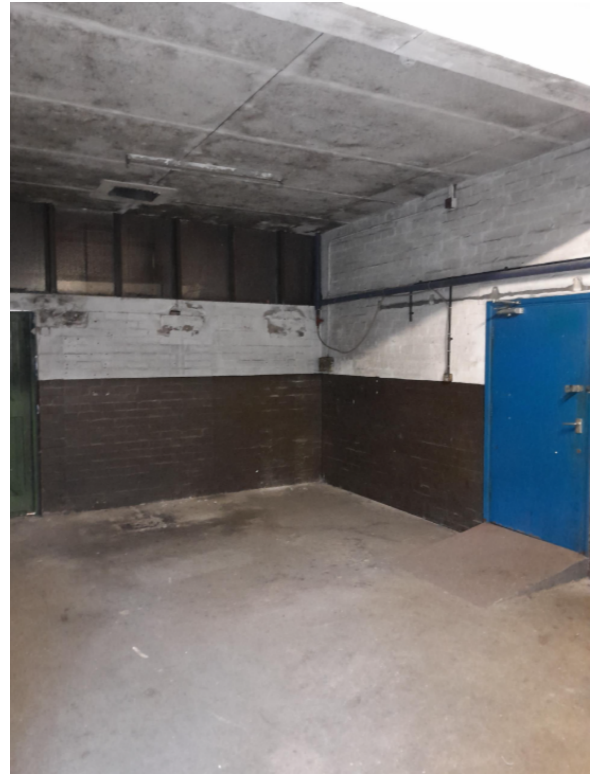
Figure 67 - existing buildings to be demolished **to be demolished**

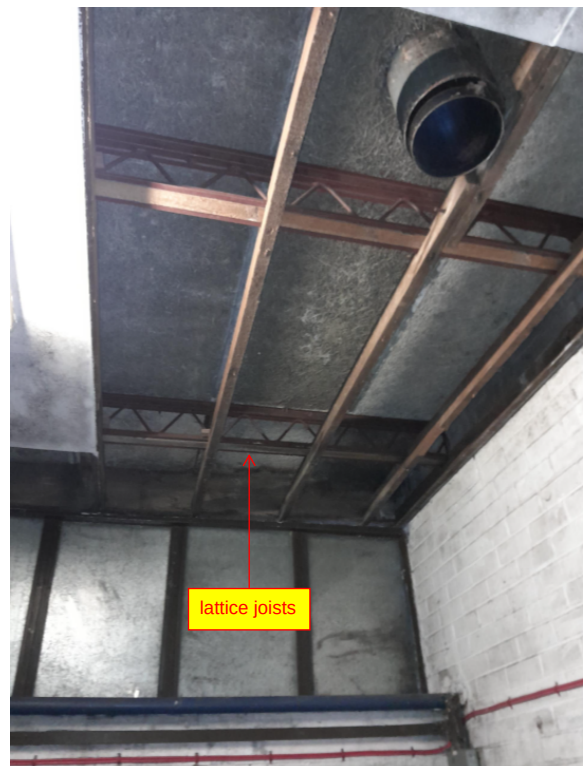
Figure 68 - existing buildings **to be demolished**
